# NATIONAL TRANSPORTATION SAFETY BOARD

MATERIALS LABORATORY FACTUAL REPORT

Report No. 03-078

Place : Miami, Florida  
Date : May 25, 2003  
Vehicle : Cruise ship S/S Norway  
NTSB No. : DCA03MM032  
Investigator : Robert Ford

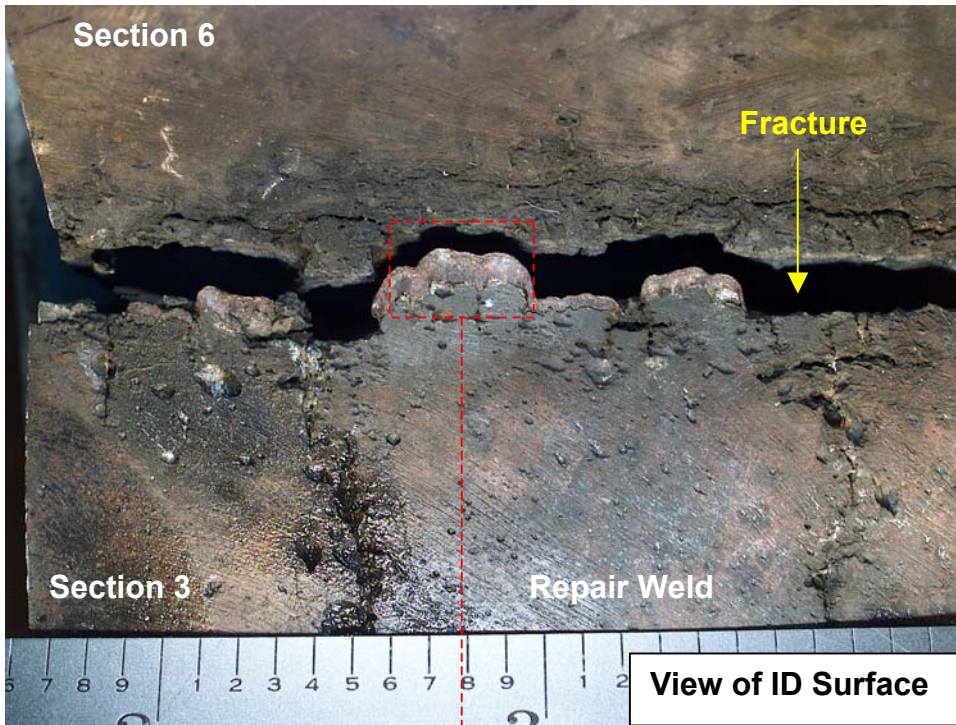
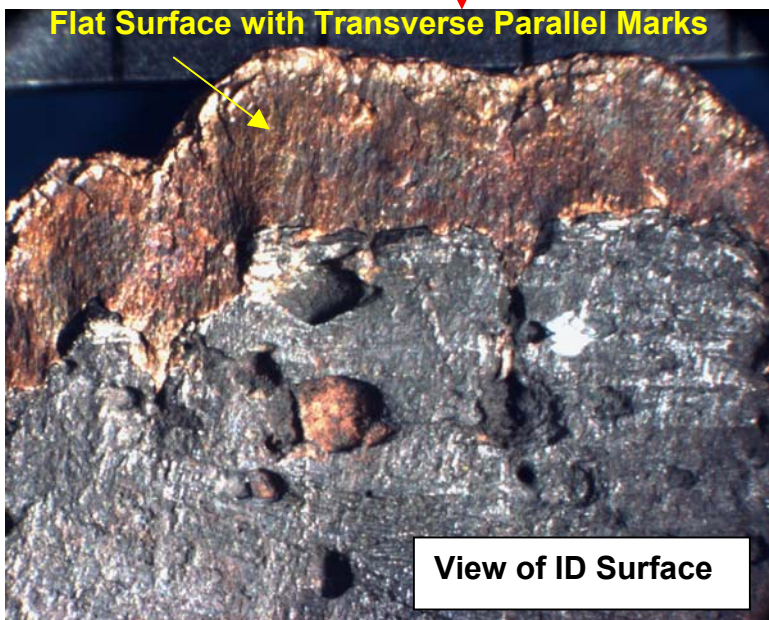
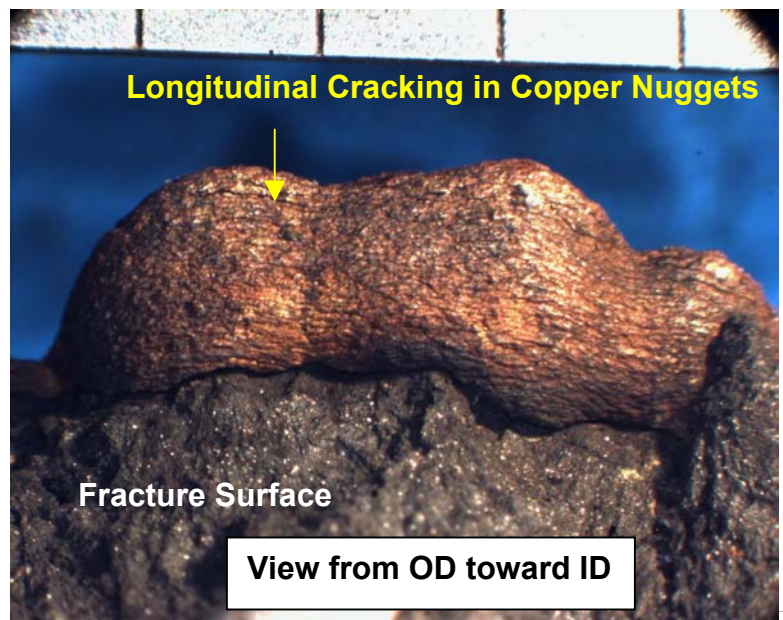
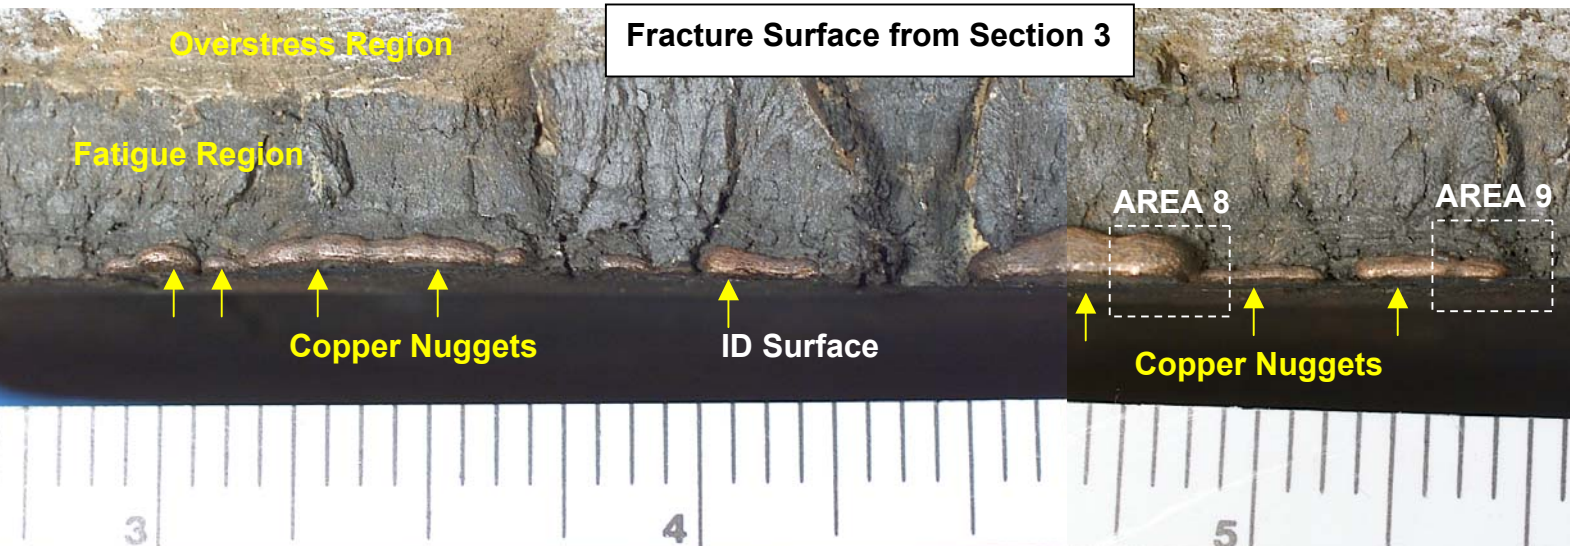
**Figure 33:** The top images are views of the copper nuggets on the fracture surface of Section 3 near the ID surface. The lower images are EDS spectra taken at the locations shown in the upper left image.

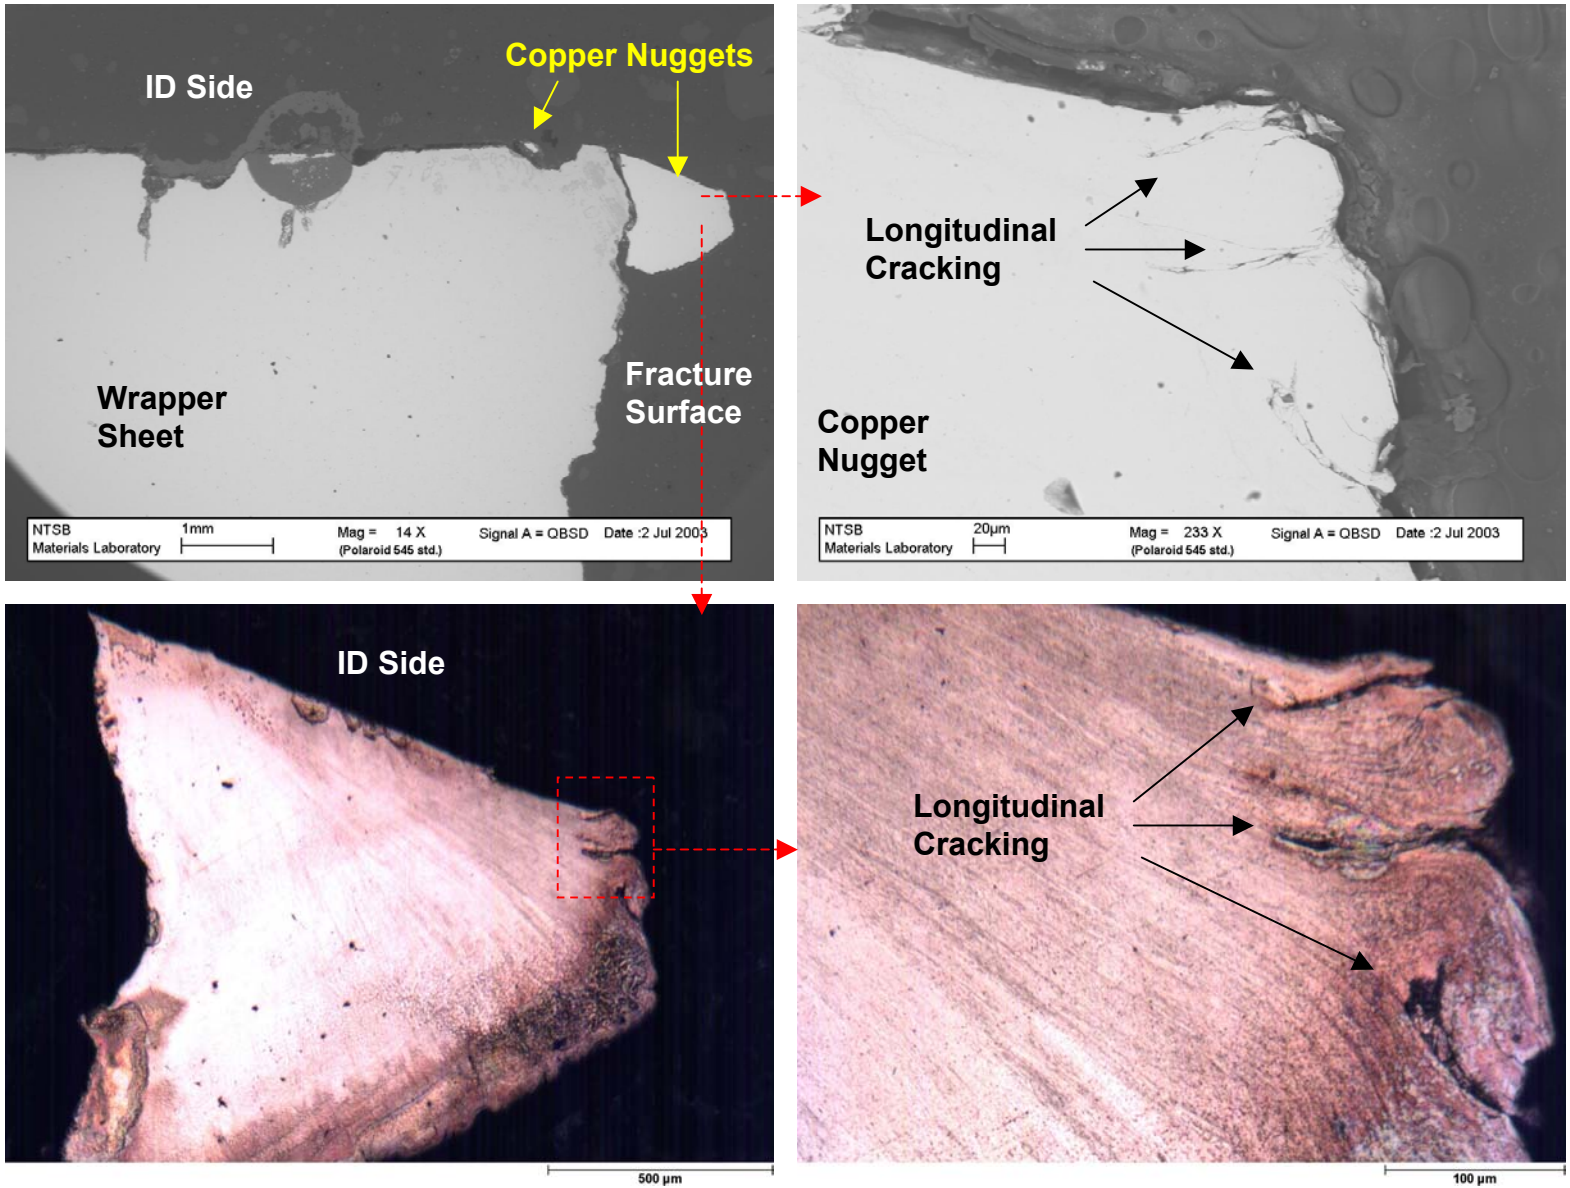
**AREA 7- Copper Nugget from Section 3**

**Figure 34:** Varying magnification SEM views of the transverse cross-section of the copper nugget found on the fracture surface of Section 3 (top two images). The lower images are varying magnification optical micrographs of the same copper nugget.

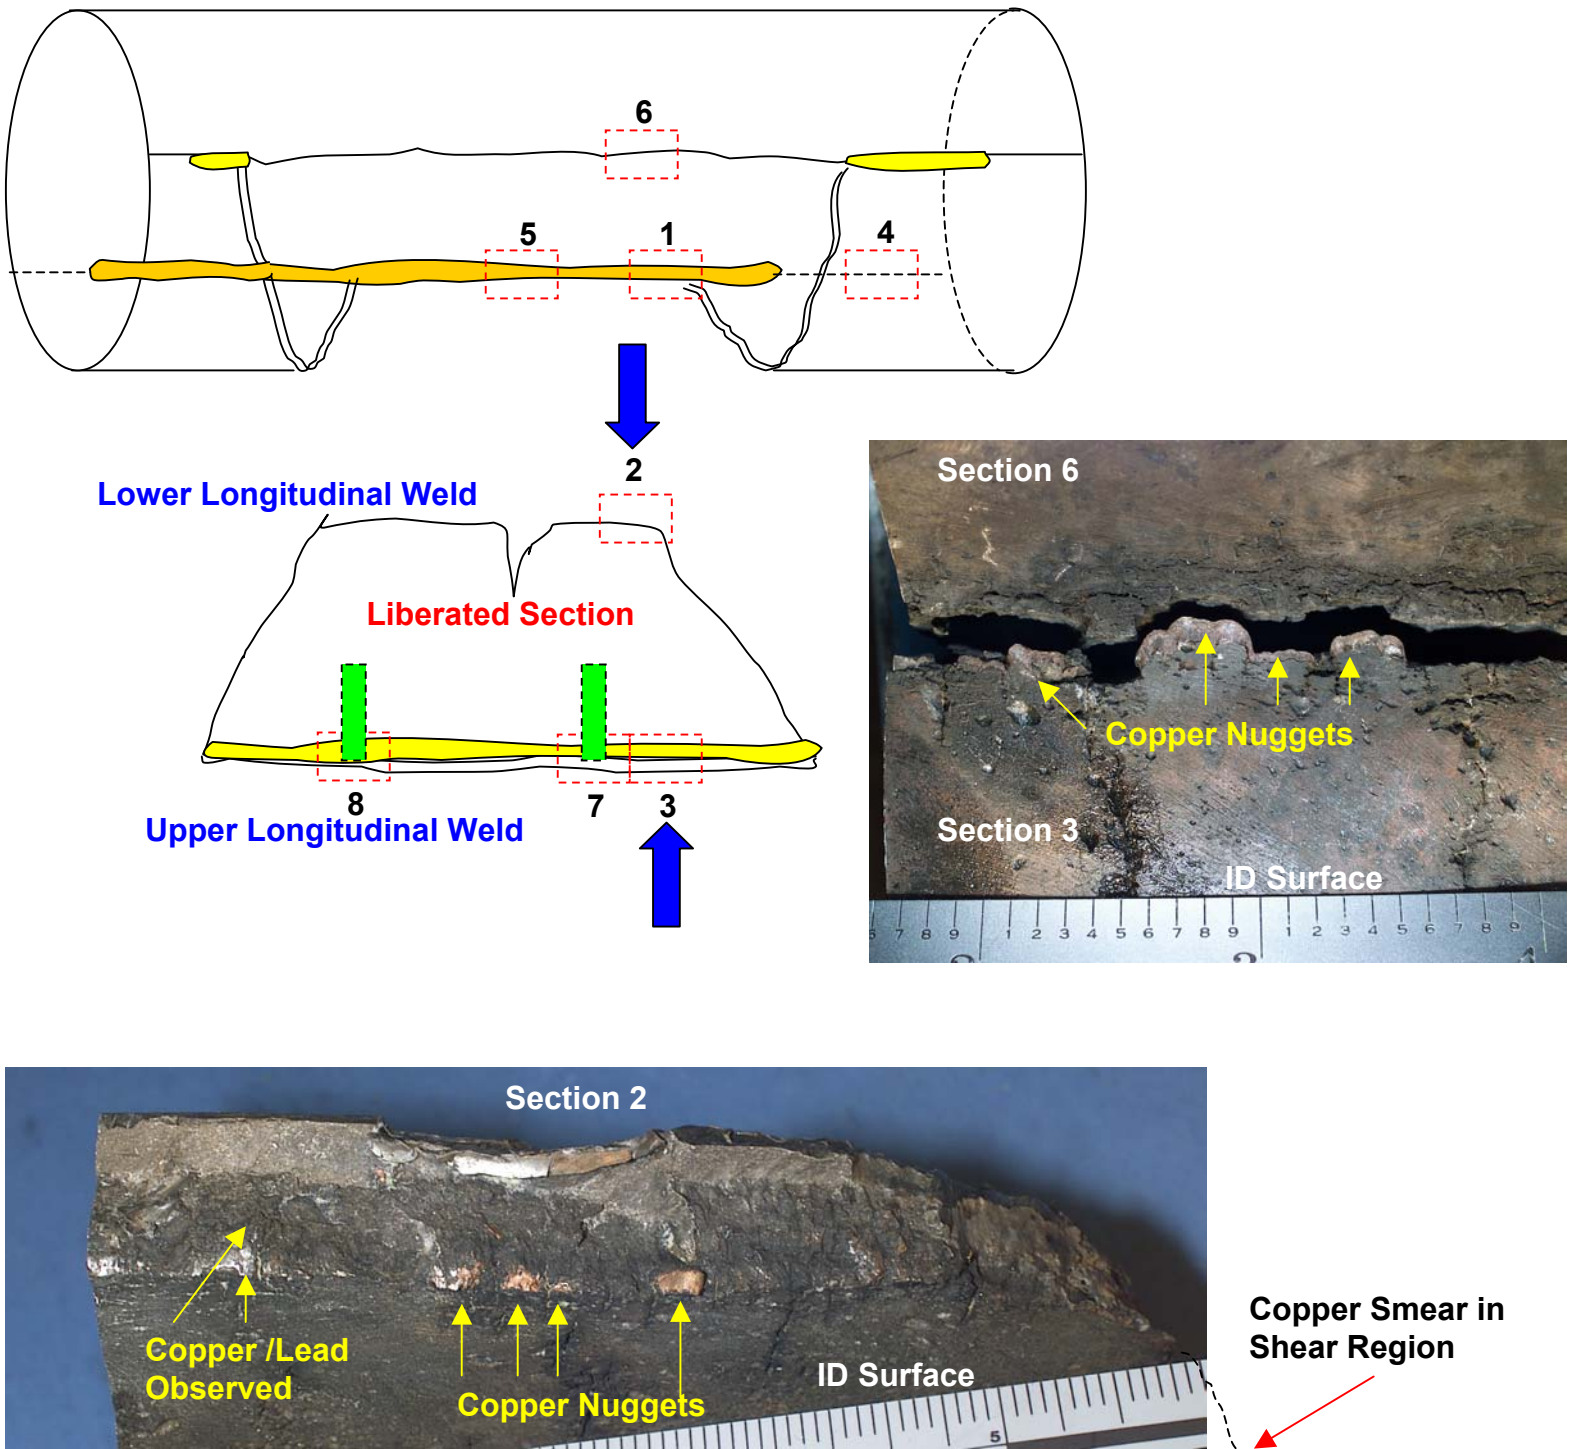
**Figure 35:** Summary schematic illustrating the location where copper nuggets and lead deposits were observed on the sections examined (top left image). The right image shows where copper was found on Section 3 and lower image shows where copper and lead were found on Section 2.
