# NATIONAL TRANSPORTATION SAFETY BOARD

MATERIALS LABORATORY FACTUAL REPORT

Report No. 11-063

Place : Staten Island, New York  
Date : May 8, 2010  
Vehicle : Andrew J. Barberi (Staten Island Ferry)  
NTSB No. : DCA10MM017  
Investigator : Eric Stolzenberg, MS-30

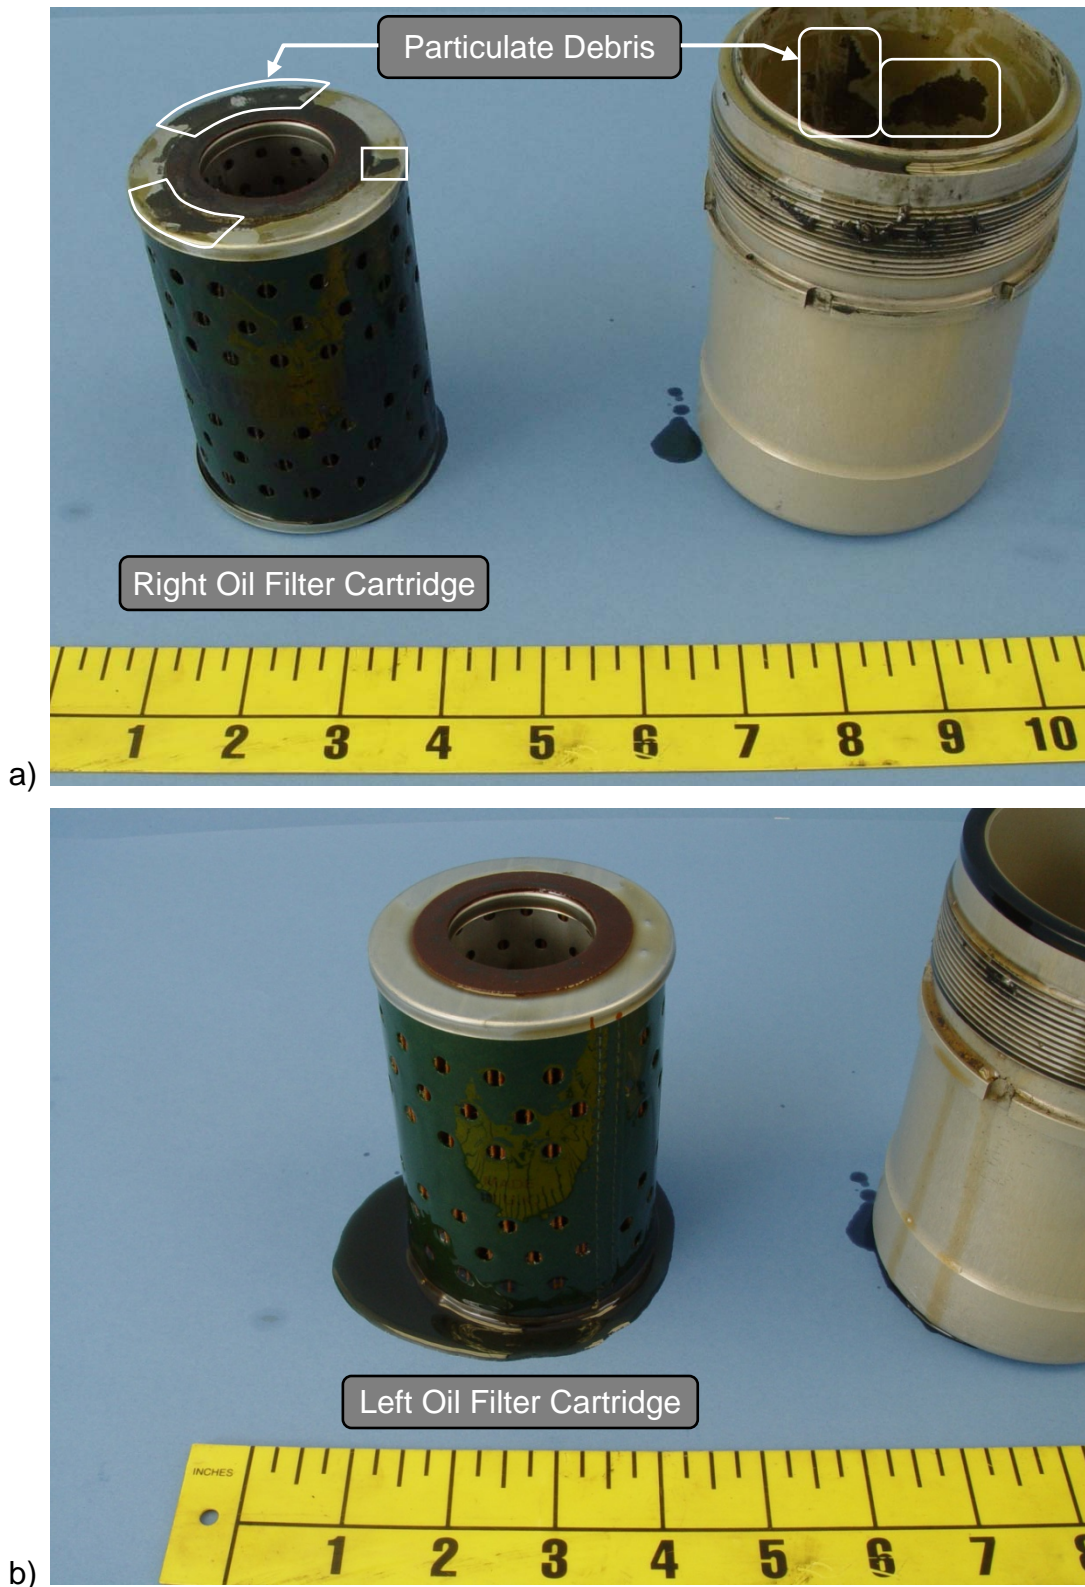
The oil filters were examined by eye at the group exam and later in greater detail. The right and left oil filter cartridges and housings are shown in figures 3a and b, respectively. The flow of oil was from the outside of the cartridge, inward through the filter, and out through the top center of the cartridge. The rim around the gasket of the right filter cartridge had occasional patches of a thin-layered dark-green substance consistent with particulate debris, as shown in figure 3a. Similar patches were observed on the interior wall of the right filter housing. There were no indications of particulate

debris on the left filter cartridge or in the left filter housing, as shown in figure 3b. Later, the right filter cartridge was disassembled and the filter paper was examined in greater detail. The filter paper had a dark-green color, similar to the color of the particulate debris observed on the filter cartridge, as shown in figure 4a. By contrast, the filter paper from the left filter cartridge had a light-brown color, as shown in figure 4b. There were no apparent perforations in the right oil filter, neither in the folds nor at the glued ends.

**Figure 3:** Overview of the; a) right (online) oil filter cartridge and housing; b) left (offline) oil filter cartridge and housing.

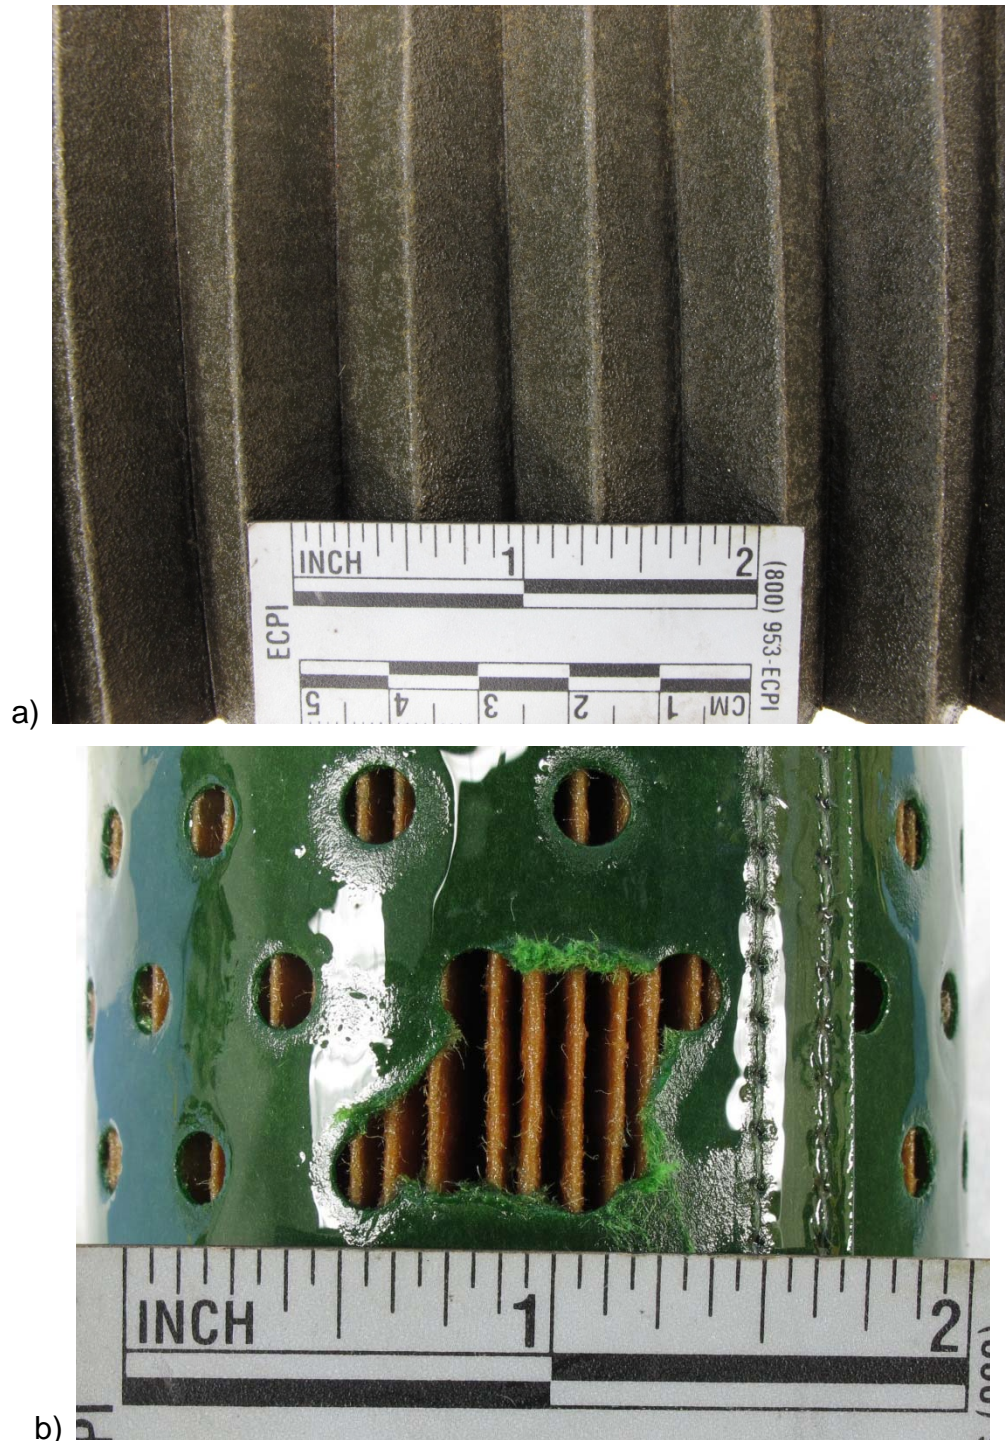
**Figure 4:** a) Folds of right (online) oil filter after disassembly of the cartridge; b) folds of left (offline) oil filter viewed through a hole cut in the jacket.

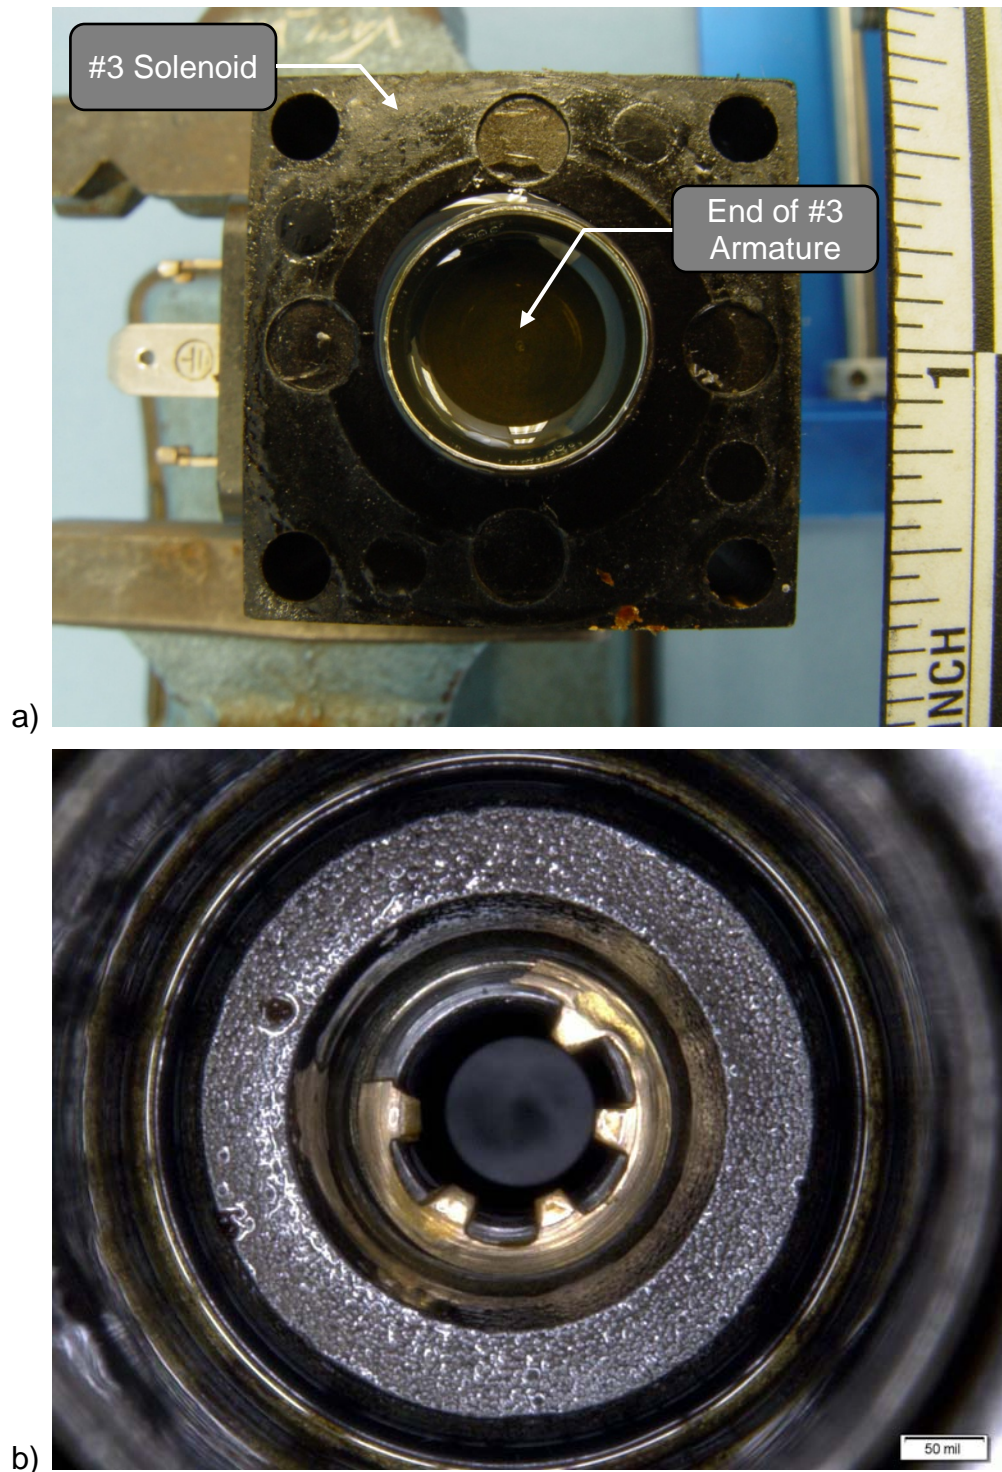
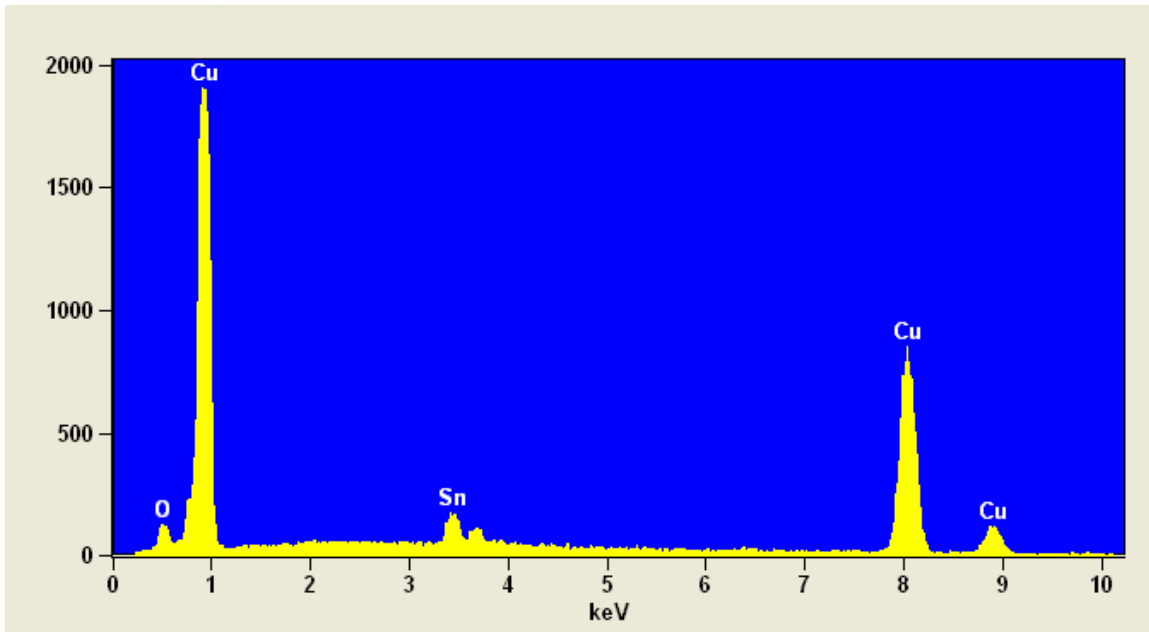
The number 3 solenoid was disassembled by removing the manual override control button, as shown in figure 7a. The solenoid was filled with oil. The oil was drawn off with a syringe and the number 3 armature was removed from the barrel. At the base of the barrel, there was a copper-colored ring, as shown in figure 7b. The chemical composition of the ring was analyzed using scanning electron microscopy (SEM) and energy dispersive spectroscopy (EDS) and found to consist of copper (Cu) and tin (Sn), as shown in figure 7c, consistent with a phosphor bronze. The ring appeared to have been originally fabricated with six tabs extending radially inward. The ring had a circumferential wear pattern on its flat face. One tab and approximately one-quarter of the bronze ring were missing and could not be located. Several of the tabs were bent in the longitudinal direction.

The bronze ring fracture surfaces were examined by SEM and had an appearance consistent with post fracture contact damage.

**Figure 7:** Disassembly of the number 3 solenoid from the propulsion control valve; a) end view of the solenoid with the manual override control button removed; b) inside view of the solenoid, drained of oil and with the number 3 armature removed. At the end of the barrel there was a bronze ring. The ring had circumferential wear patterns on the flat face. Approximately one-quarter of the ring was missing.

**Figure 7 (cont.):** c) EDS spectrum of bronze ring containing copper (Cu) and tin (Sn).

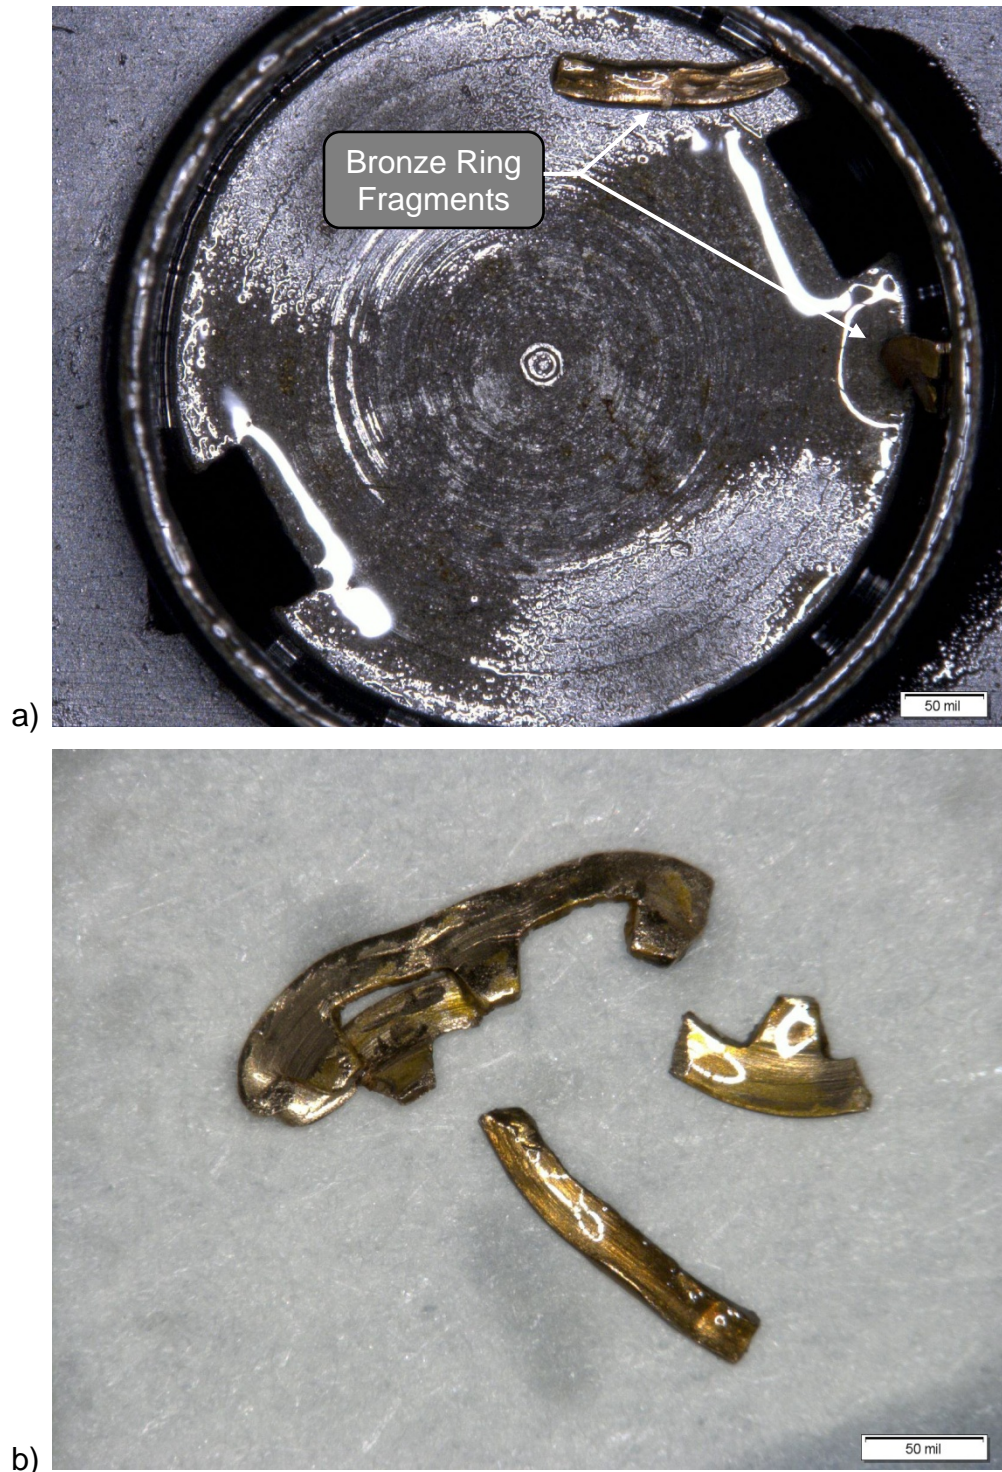
The number 2 solenoid was similarly examined and was also found to be filled with oil. However, two fragments of a similar bronze ring were observed in the cavity between the end of the number 2 armature and the manual override control button, as shown in figure 8a. The number 2 armature was removed from the solenoid housing, revealing one additional fragment of bronze ring. The ring fragments from the number 2 solenoid are shown in figure 8b. Similar to the number 3 solenoid, a fragment (one tab) was missing and could not be located.

**Figure 8:** Disassembly of the number 2 solenoid from the propulsion control valve; a) bronze ring fragments located in the cavity between the number 2 armature and the manual override control button. The excess oil was drawn off with a syringe; b) all recovered bronze ring fragments.

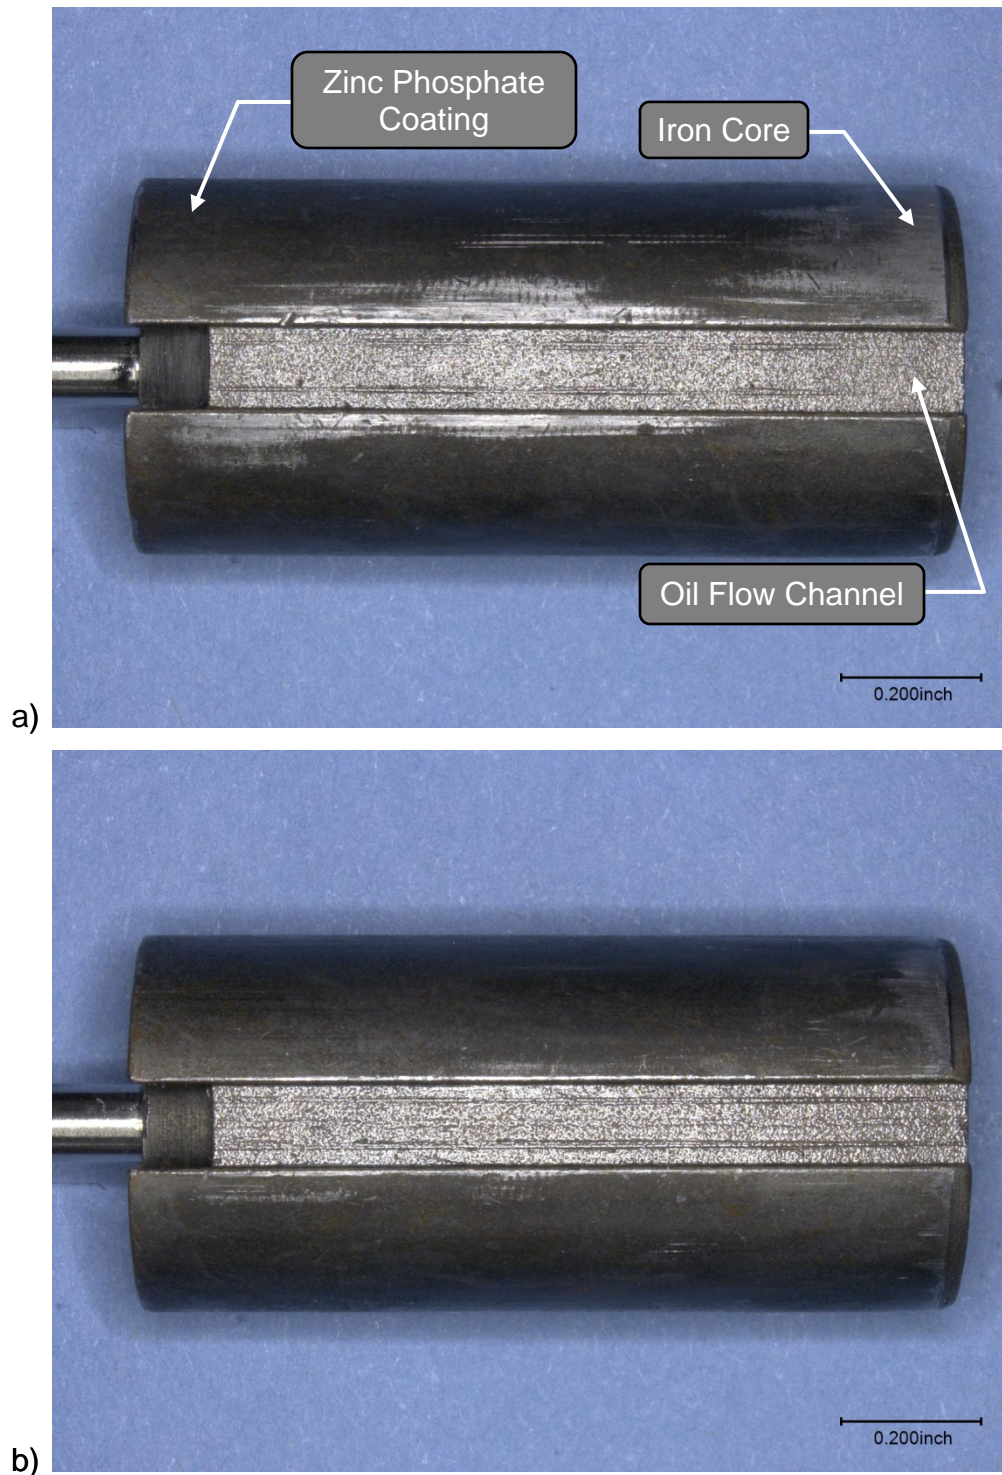
The number 2 and number 3 armatures exhibited wear, as evidenced by the light- and dark gray areas in figures 9 and 10. The composition of the light- and dark-gray areas was identified by SEM and EDS. EDS spectra of the dark-gray regions contained zinc (Zn), phosphorous (P), and iron (Fe), as shown in figure 11a, consistent with a zinc phosphate coating on an iron substrate. EDS spectra in the light-gray areas contained primarily iron, as shown in figure 11b, consistent with the iron substrate where the zinc phosphate coating had worn away. For each armature, the wear was most noticeable near one of the oil flow channels. The opposing channel (180°) showed comparatively little wear of the zinc phosphate coating. Occasional longitudinal groove lines were visible in the oil flow channels and were examined by SEM. No cracking or chipping of the coating was observed associated with the grooves.<sup>1</sup>

**Figure 9:** Propulsion control valve number 2 armature; a) side of armature with visible wear of zinc phosphate coating around oil flow channel; b) opposite side of armature.

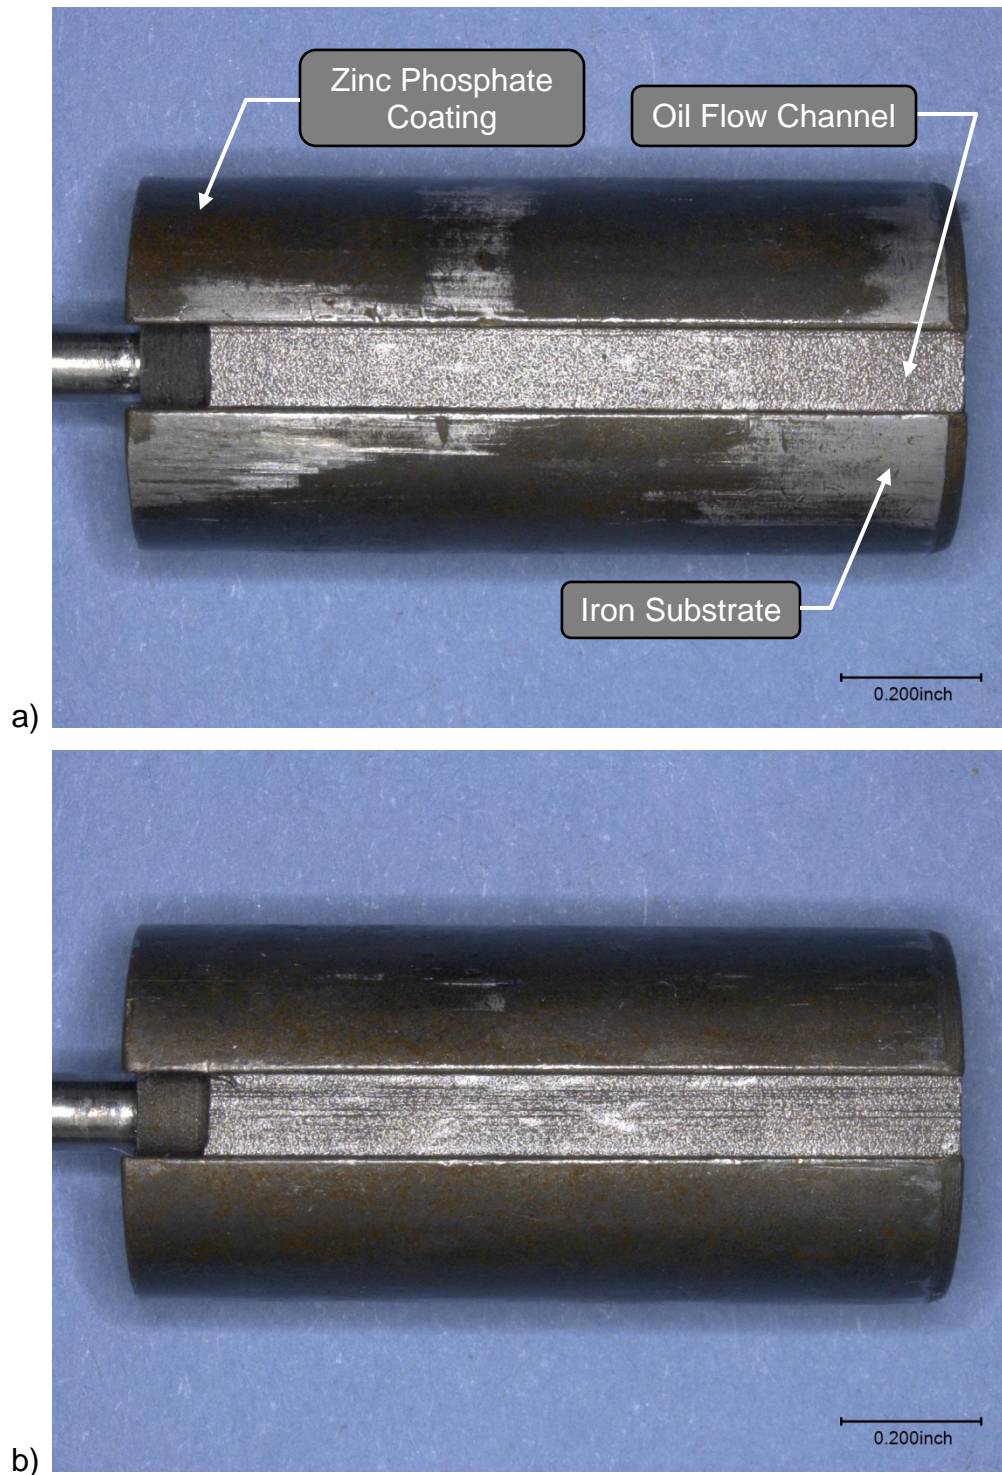
**Figure 10:** Propulsion control valve number 3 armature; a) side of armature with visible wear of zinc phosphate coating around oil flow channel; b) opposite side of armature.

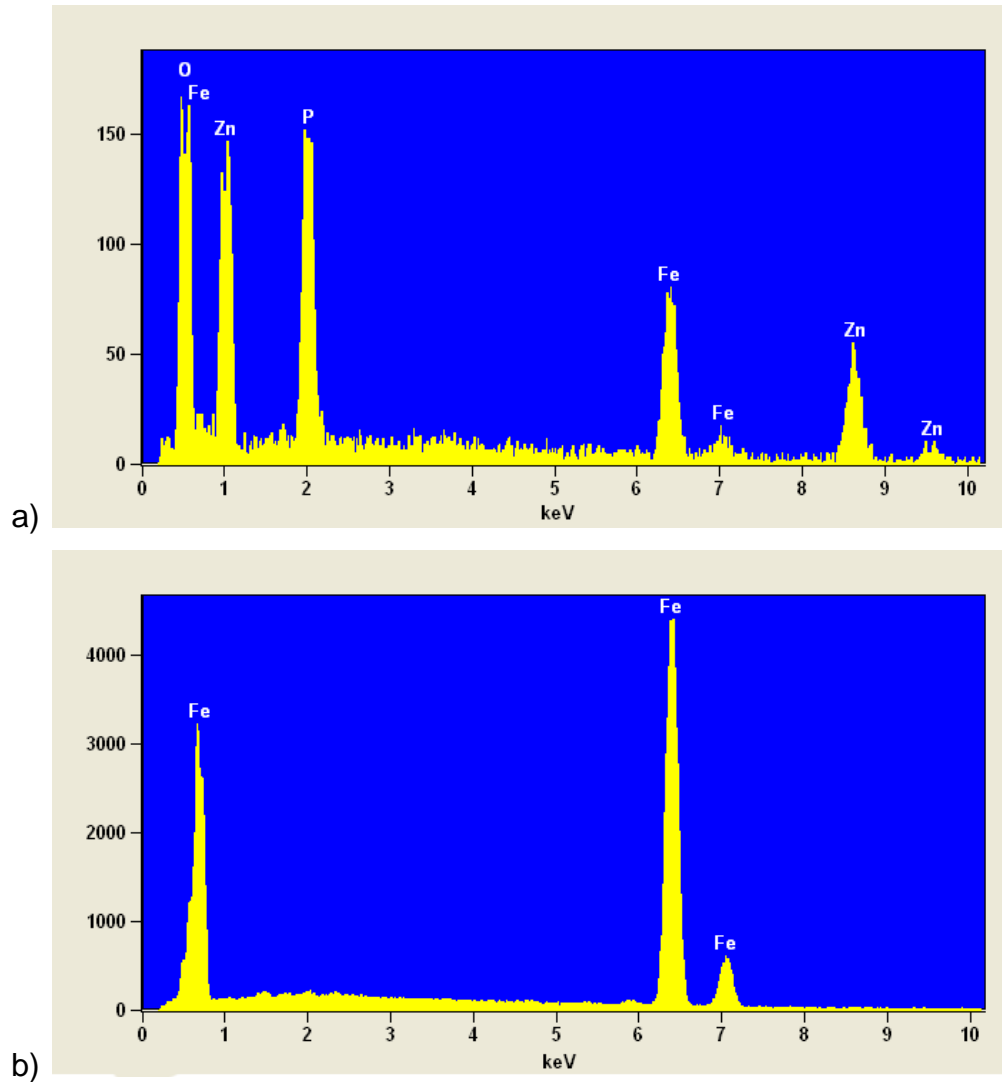
**Figure 11:** EDS spectra from the number 3 armature; a) spectrum from a dark-gray region containing zinc (Zn), phosphorous (P), and iron (Fe), consistent with a zinc phosphate coating on an Fe substrate; b) spectrum from a light-gray region consistent with the Fe substrate where the zinc phosphate coating had worn away.

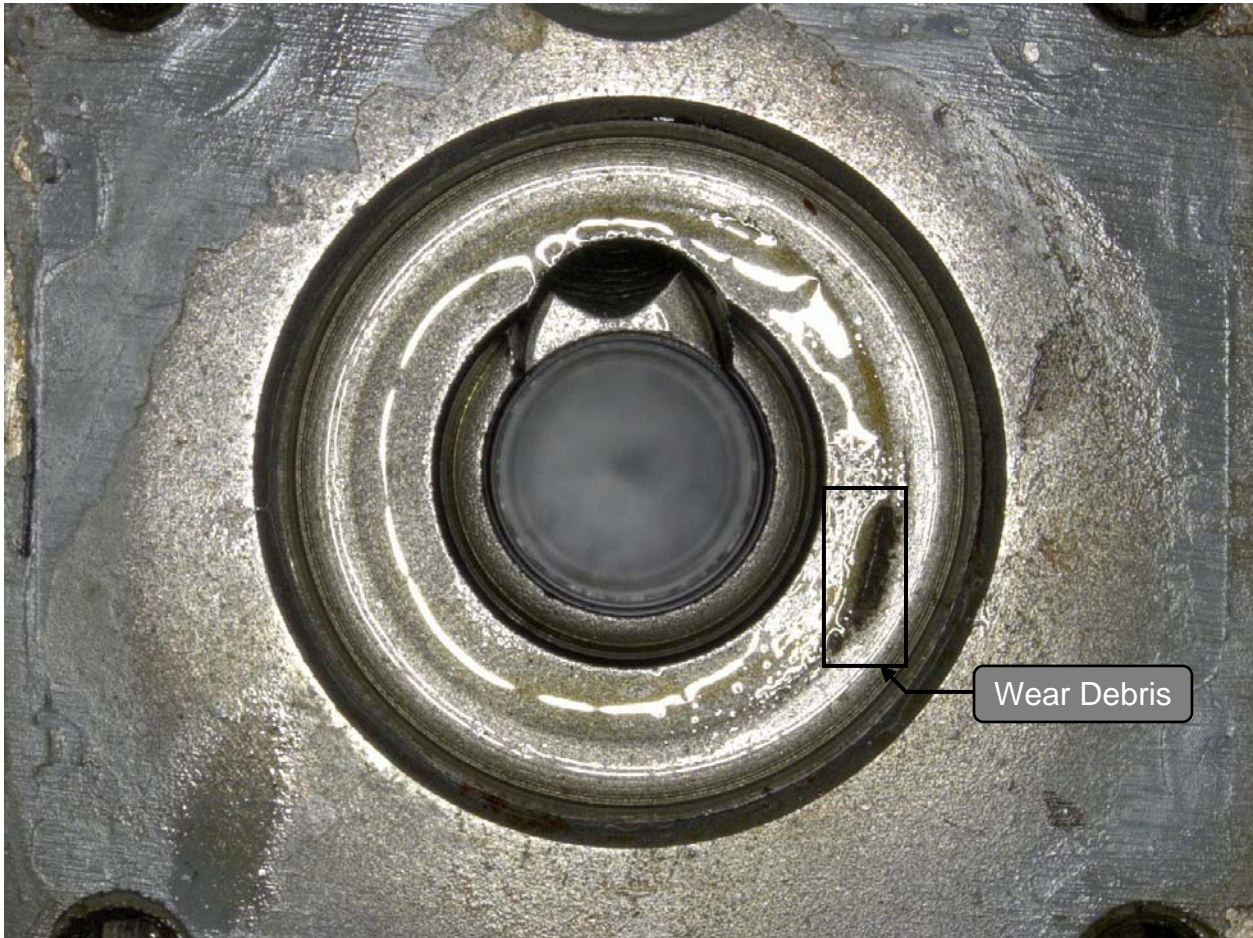
Wear debris was found inside the solenoid barrels and at the entrance to the valve housing, as shown in figure 12. Wear debris was flushed from the solenoids and the valve housing onto filter paper and analyzed by EDS. The debris consisted primarily of Fe, with traces of zinc phosphate and phosphor bronze, as shown in figures 13a, b, and c, respectively.

**Figure 12:** Entrance to the propulsion control valve housing on the number 2 solenoid side. Wear debris had accumulated near the entrance.

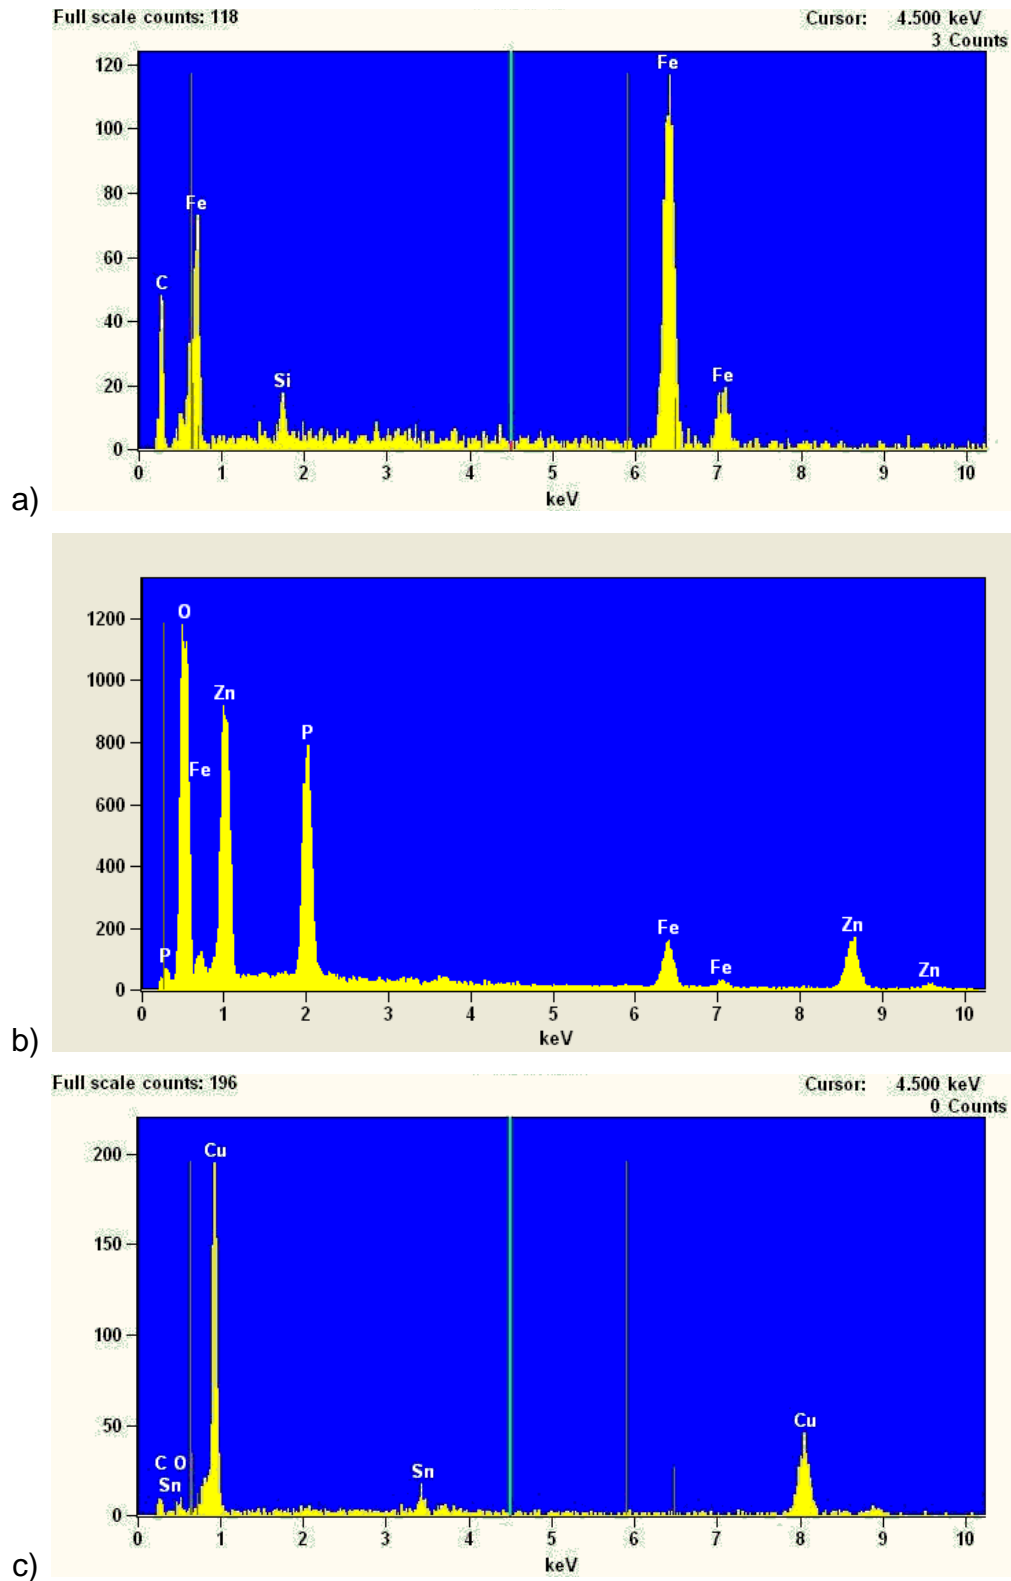
**Figure 13:** EDS spectra of debris collected from the propulsion control valve; a) iron debris consistent with the armature core; b) Zinc phosphate wear debris consistent with the number 2 and 3 armature coating; c) debris consistent with the bronze ring.

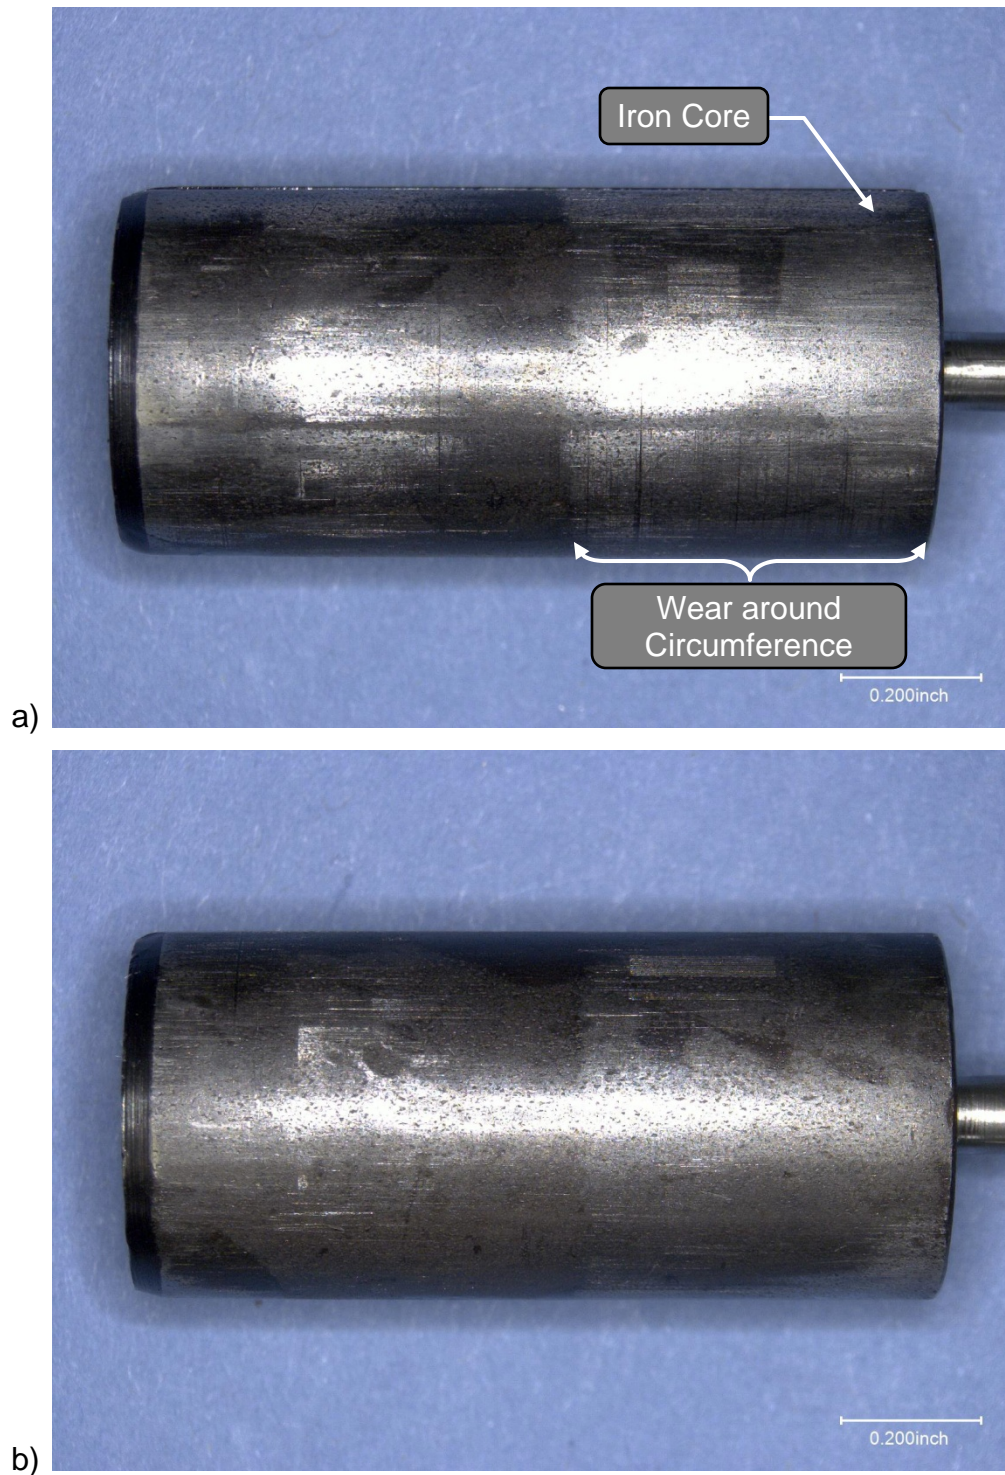
The number 5 and number 6 armatures exhibited wear as shown in figures 16 and 17, respectively. Wear was observed over a greater area on the number 5 armature than any other armature. Partial or complete wear through the oxide was observed around the entire circumference along the longitudinal length indicated in figure 16a. The number 6 armature showed a wear pattern similar to the number 2 and number 3 armatures from the propulsion control valve, as shown in figure 17a and b.

**Figure 16:** Steering control valve number 5 armature; a) and b) opposite sides of the armature showing wear of the oxide layer.

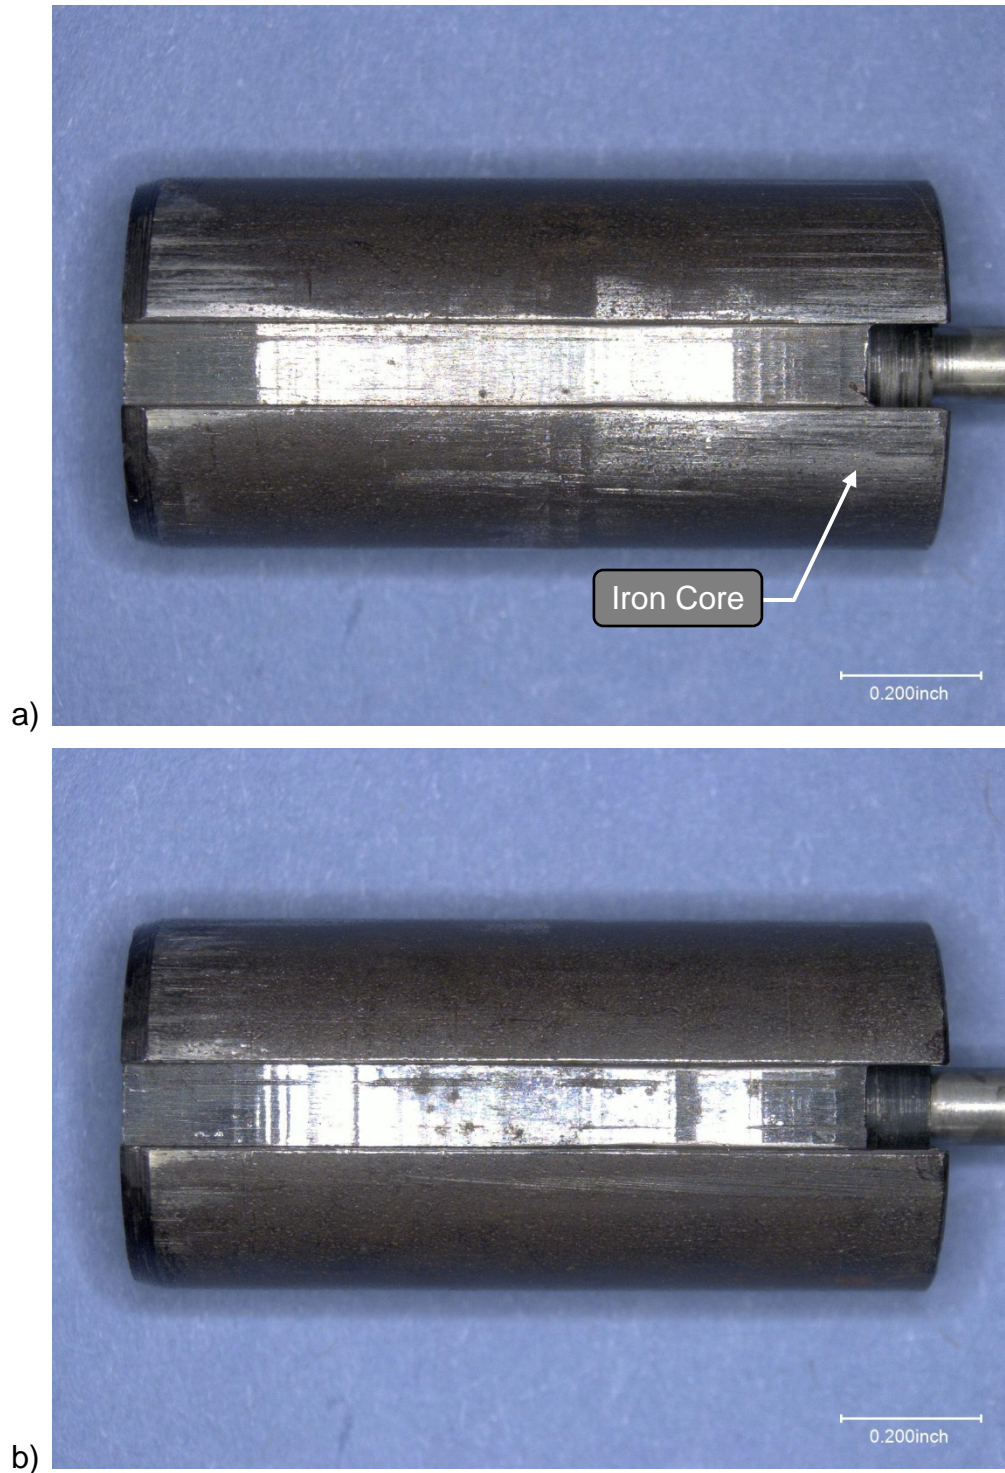
**Figure 17:** Steering control valve number 6 armature; a) side of armature with visible wear of the oxide layer around oil flow channel; b) opposite side of armature.
