From: Price Noreen
To: [Budinski Michael](#)
Subject: RE: ANC17FA009 Fairbanks, AK Email Report
Date: Thursday, March 29, 2018 11:04:00 AM

Fairbanks, AK
December 15, 2016
Bellanca Citabria, N88452
ANC17FA009
Noreen Price, ASI-ANC

Right Lift Strut Attachment Bracket
Throttle Cable Bracket, 2 pcs

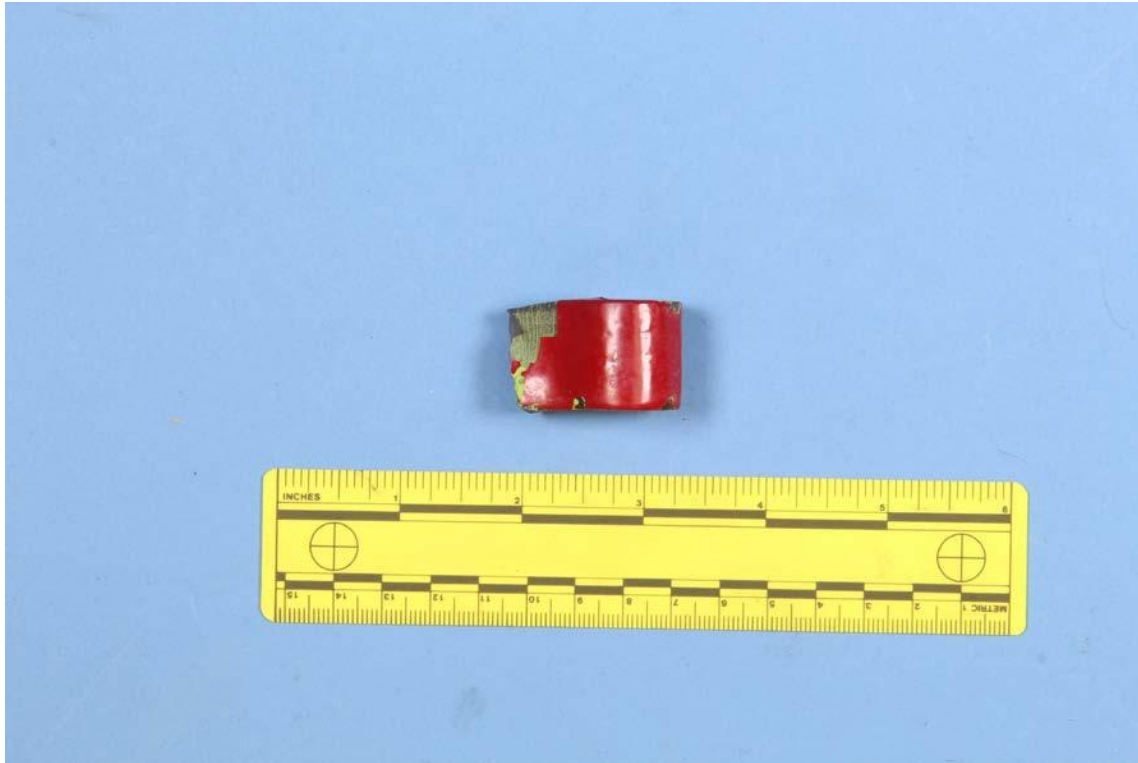
The strut attachment was separated near the attaching bolt hole. The fracture displayed fracture features and deformation patterns indicating a bending overstress separation. The bending plane was aligned with the axis of the bolt hole. No corrosion or preexisting cracking were noted.

1- Left wing strut end

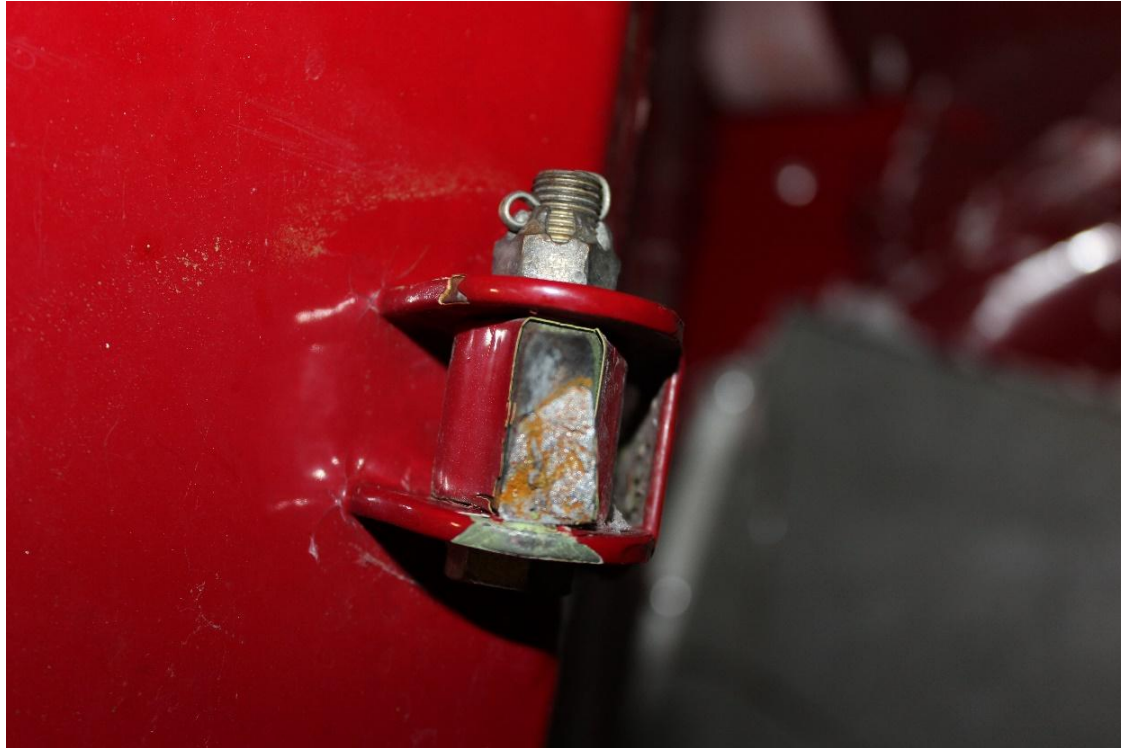
2- Left wing strut fracture, attached to airframe mount

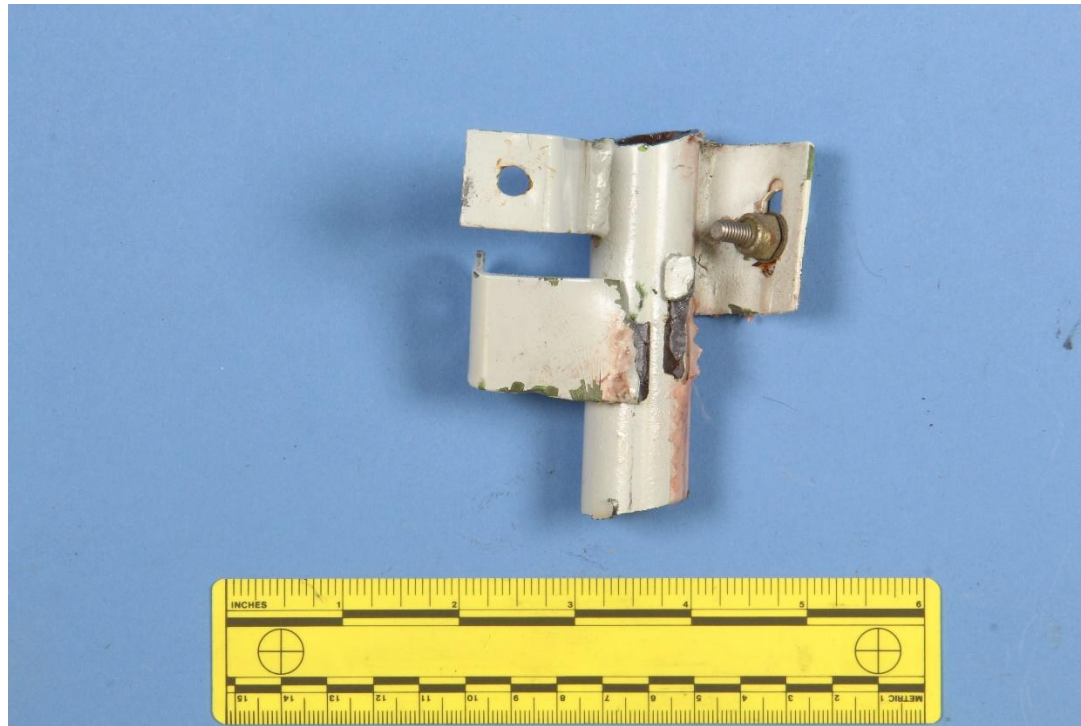
The throttle cable was fracture adjacent to the weld connecting it to a fuselage tube. Magnified examinations uncovered fracture features and overall deformation patterns consistent with a

twisting overstress fracture and separation after significant displacement of the bracket. The examinations also revealed a contact mark and adjacent local deformation indicative of the direction of the overall deformation and fracturing and consistent contact with another object. The separation uncovered areas of lack of fusion and incomplete fusion of the weld along with internal porosity but no evidence of preexisting cracking or corrosion of the bracket.

3- Throttle cable airframe bracket

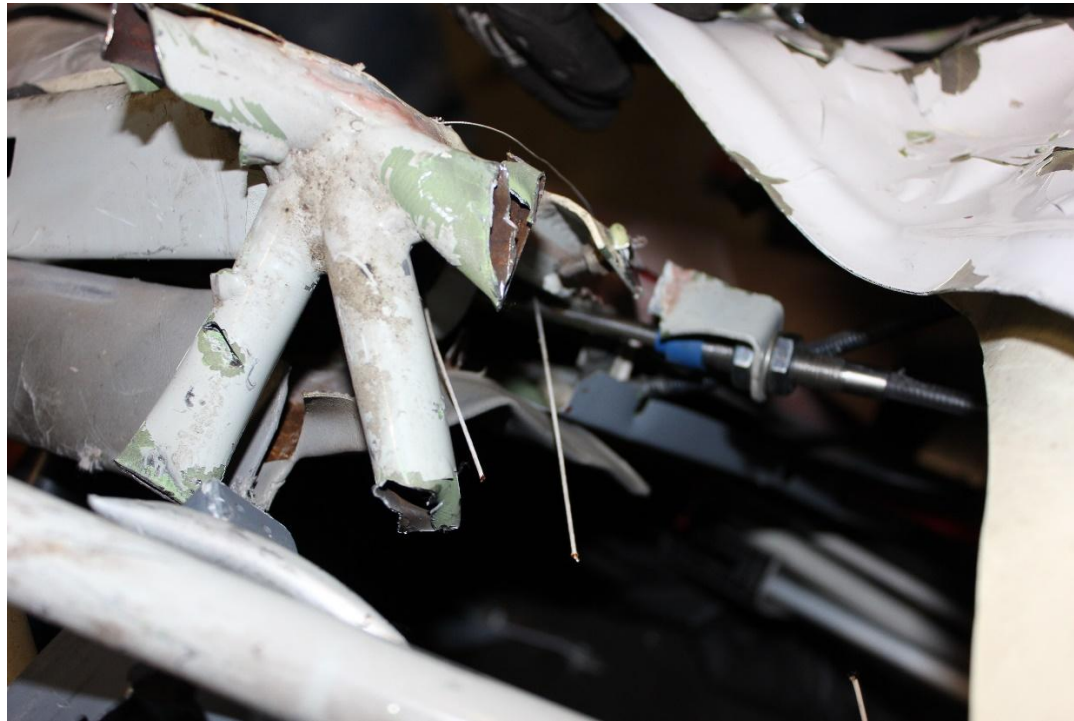
4- Throttle cable fractured bracket on the airplane
