# NATIONAL TRANSPORTATION SAFETY BOARD

MATERIALS LABORATORY DRAFT FACTUAL REPORT

Report No. 05-071

Place : Graniteville, South Carolina  
Date : January 6, 2005  
Vehicle : Tank Car UTLX 900270  
NTSB No. : DCA05MR008  
Investigator : Jim Henderson (RPH-30)

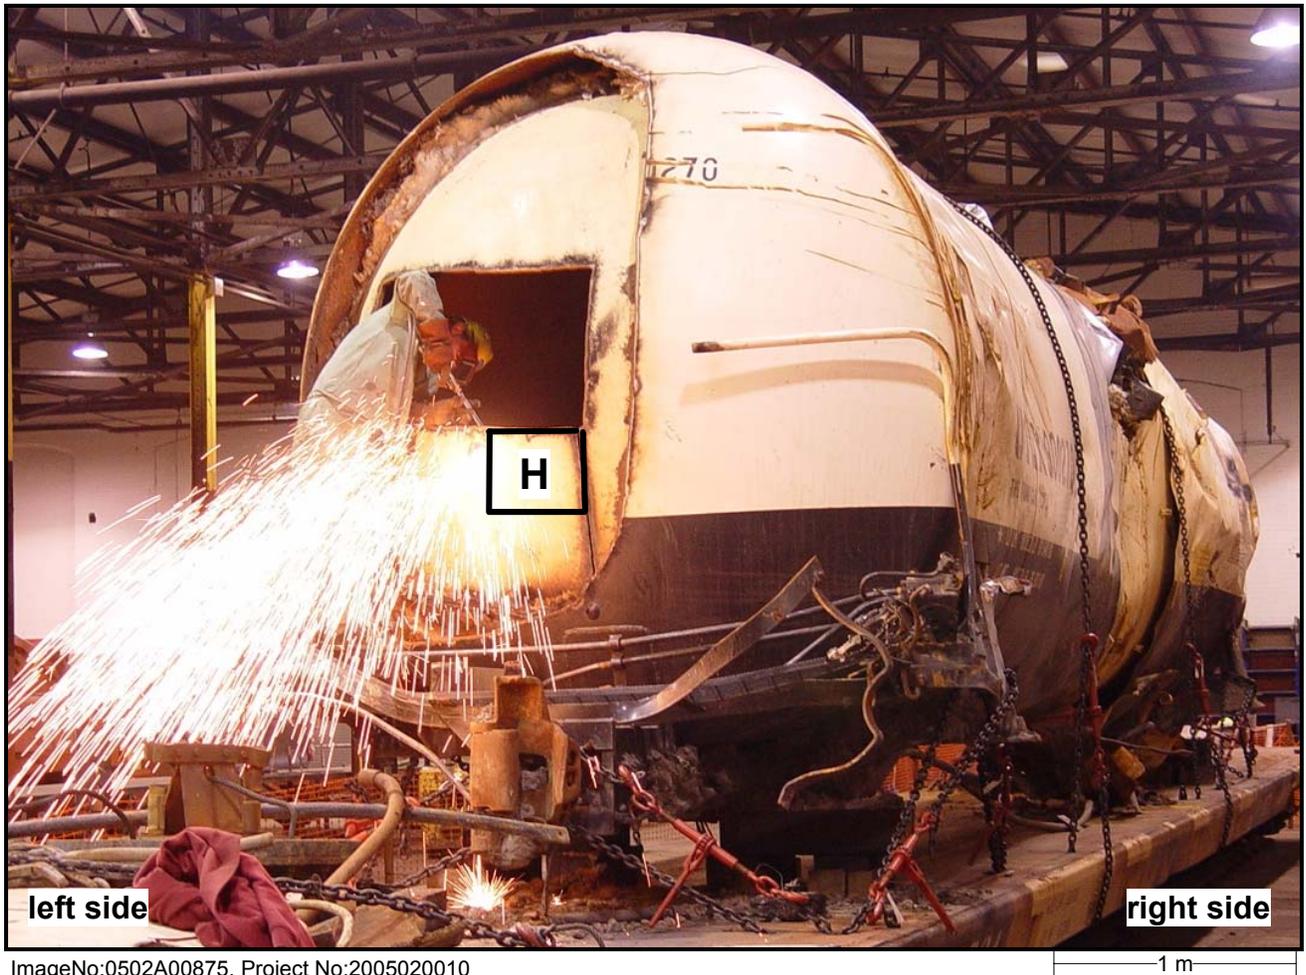
Tank car UTLX 900270 and flatbed car CSXT 496430 were examined in detail at a railcar repair facility, Union Tank Car, Altoona, Pennsylvania, on February 16 and 17, 2005. Figure 1 shows a photograph of the tank car.

Figure 1. View looking at the "B" end of tank car UTLX 900270. A torch cutting operation is under way to remove a test coupon from the head, from the the area outlined by box "H".

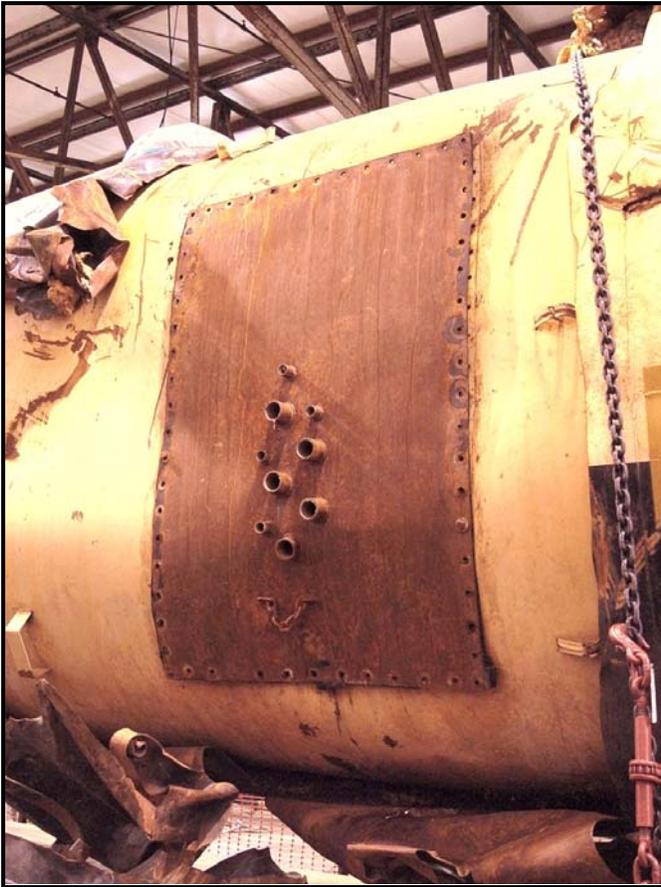
At the Union Tank Car facility, the patch was disassembled to expose the fracture for examination. Figures 2 and 3 show photographs of shell in the process of and after disassembly of the patch, respectively. The fracture was located approximately 16 feet from the circumferential weld for the head on the “A” end of the tank car. The length of the fracture (along the fracture path) measured approximately 34 inches, and the opening that resulted from the fracture measured a maximum of approximately 4.7 inches.<sup>5</sup> Figure 4 shows an overall view of the fracture and figure 5 shows the middle portion of the fracture. The fracture was centered about the 3:30 o’clock position relative to the “B” end. The shell contained four impression marks in the area of the fracture, randomly labeled “1” through “4”, from the highest to the lowest portion of the photograph. Figure 6 shows the location of the four impression marks. Of significance, the distance between impressions “1” and “2” was approximately 4.5 inches. The significance of this measurement will be explained in section IB and IC of this report. Impressions “1” and “2” were located on the shell portion that contained the “A” end of the fracture. Impression “3” was intersected by the fracture. Impression “4” was located on the shell portion that contains the “B” end of the fracture. A strip of tape was placed horizontally across the fracture so that the ends of the strip were on relatively undamaged portions of the shell. The depth of the dent (radial distance between the strip of tape and the deepest portion of the dent) measured approximately 20 inches.

Figure 2. View of the right side of the tank car showing a patch that covered the puncture.

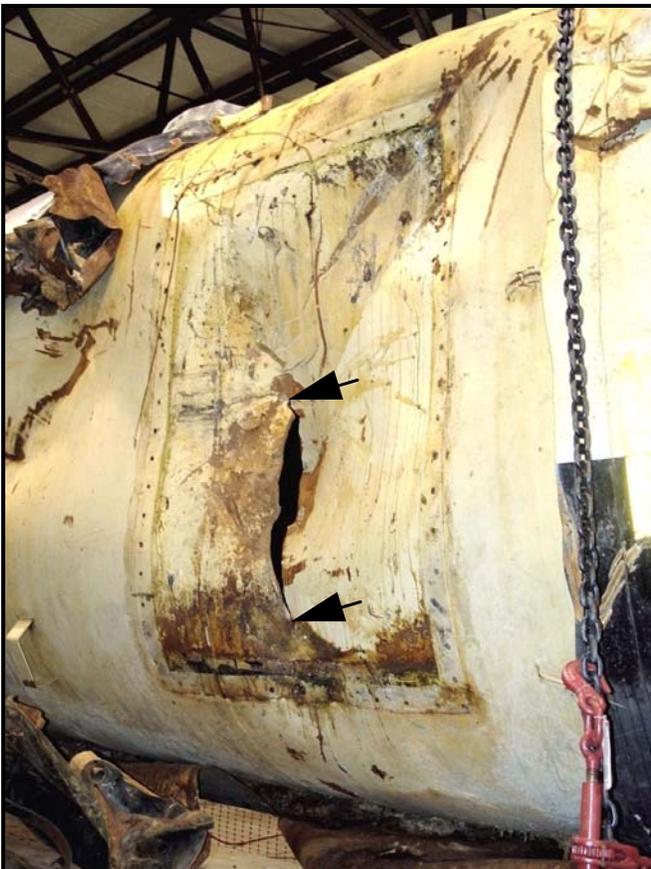
Figure 3. View of the right side of the tank car after the patch was disassembled. Arrows indicate the ends of the puncture (fracture).

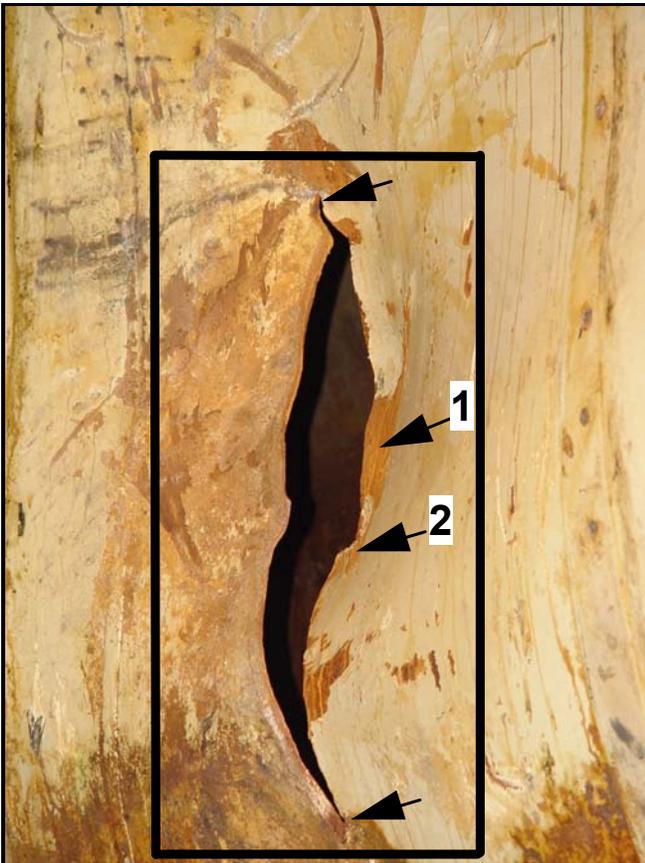
In the second method, the disassembled coupler assembly was placed up side down on the floor. A portion of the shell that contained the fracture and dent was torch cut from the tank car along the areas indicated by a solid line in figure 4. The mating faces of the fracture were separated by making circumferential saw cuts between the edges of the rectangular piece and the ends of the fracture. The excised shell portion that contained the fracture piece closer to the "A" end of the tank car was placed over the coupler assembly. Figure 14 shows the lower corner of the pin protector and the lower corner of the lower shelf of the coupler assembly aligned with dents "1" and "2" in the "A" end piece from the tank car. As indicated earlier, the exterior surface of the shell contained two impression marks (indicated by arrows "1" and "2" in figures 4 and 5) on the "A" end side of the fracture. Impression "1" was curved, with a radius similar to the lower corner for the pin protector. The deepest portion of impression "2" was consistent with the size of the

Figure 4. Close-up photograph of the fracture. The solid line indicates the portion of the shell that was torch cut to facilitate removal of the fracture. Arrows indicate the ends of the fracture. Arrows "1" and "2" indicate the location of two impression marks.

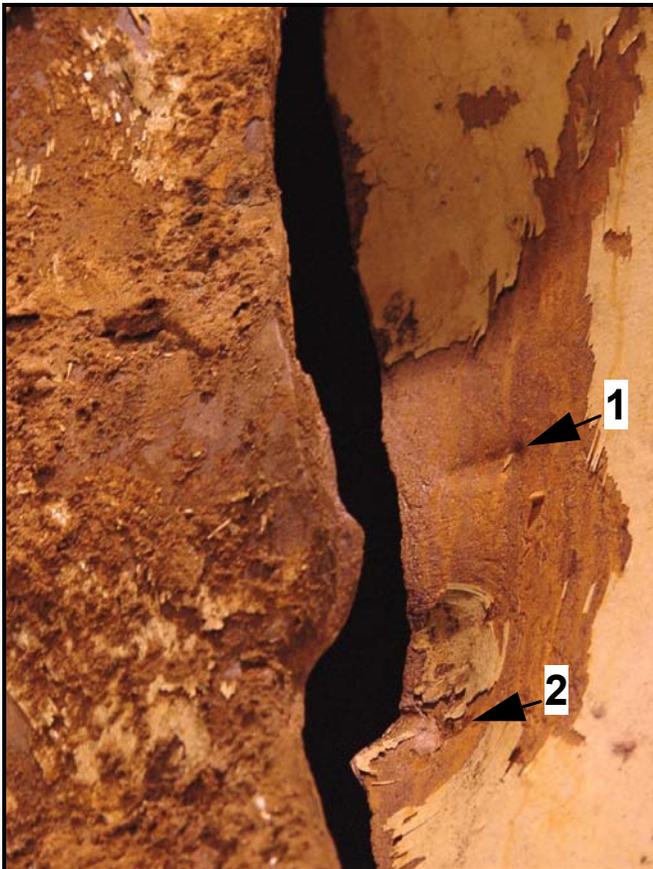
Figure 5. Higher magnification view of impression marks arrowed "1" and "2" in figure 4.

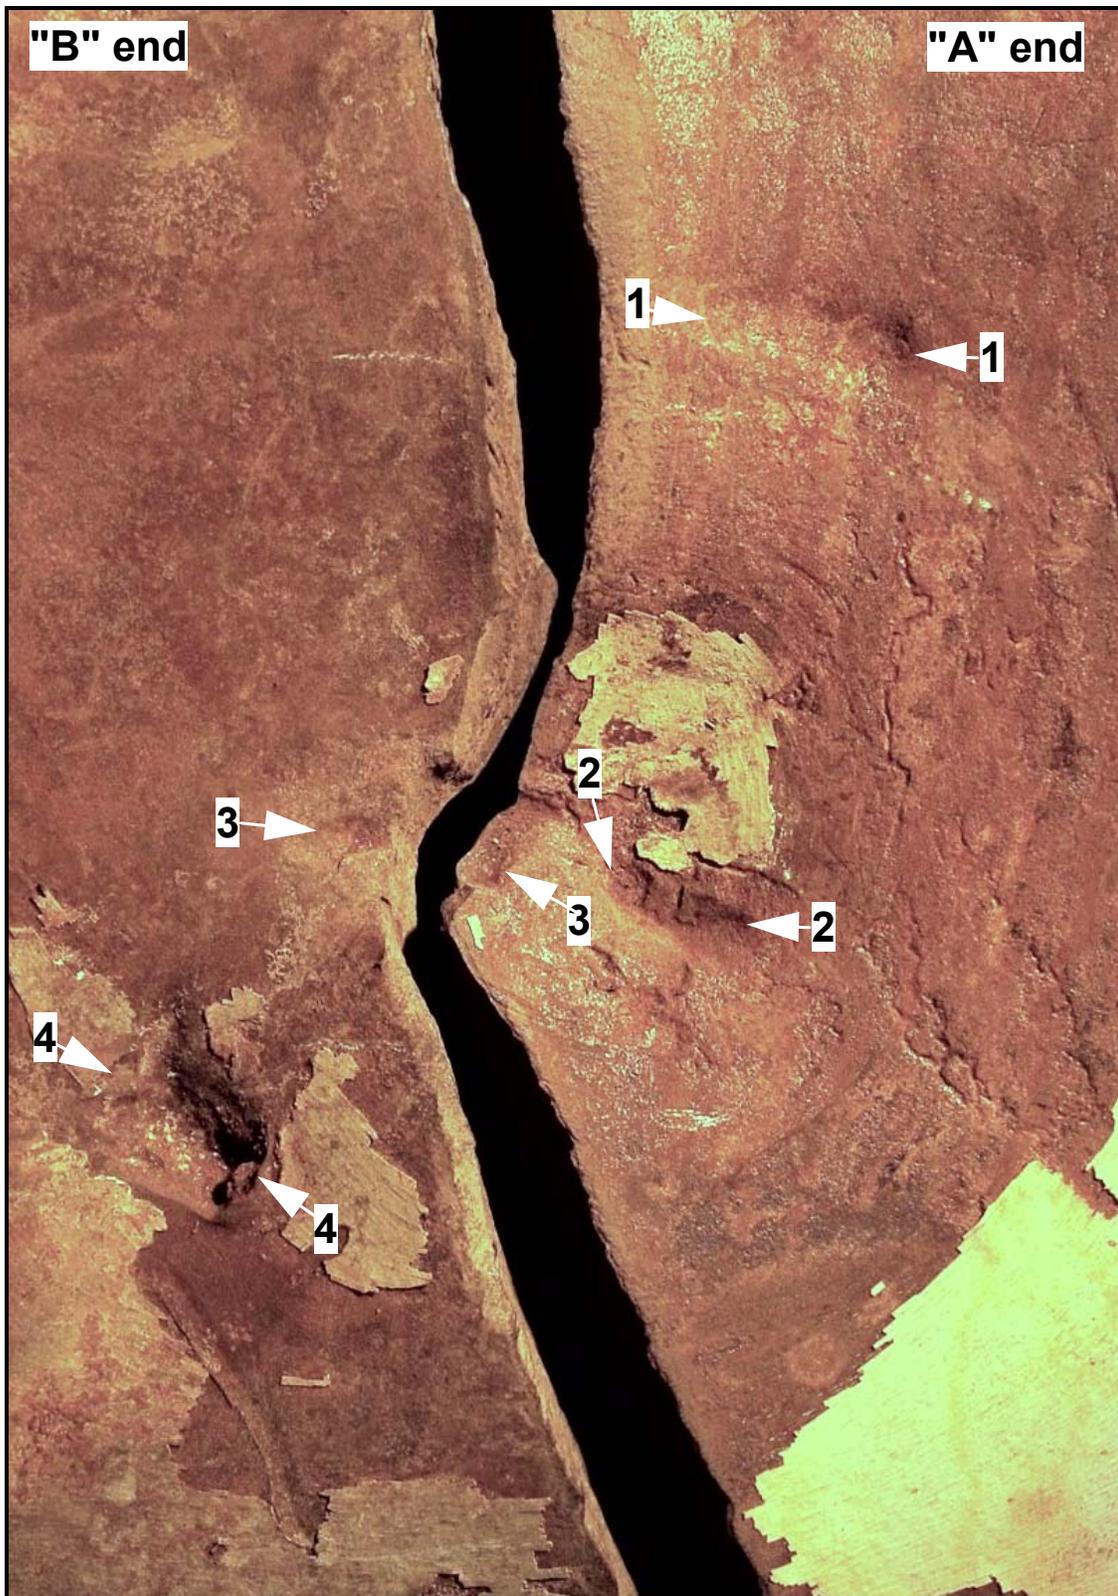
Figure 6. External face of the shell showing a portion of the mating fractures that was located nearly midway between the ends of the fracture. Impression marks arrows "1" through "4" are located between arrows with the same respective numbers. Photograph was taken after the mating fracture was excised and reassembled, as if the shell pieces were intact.

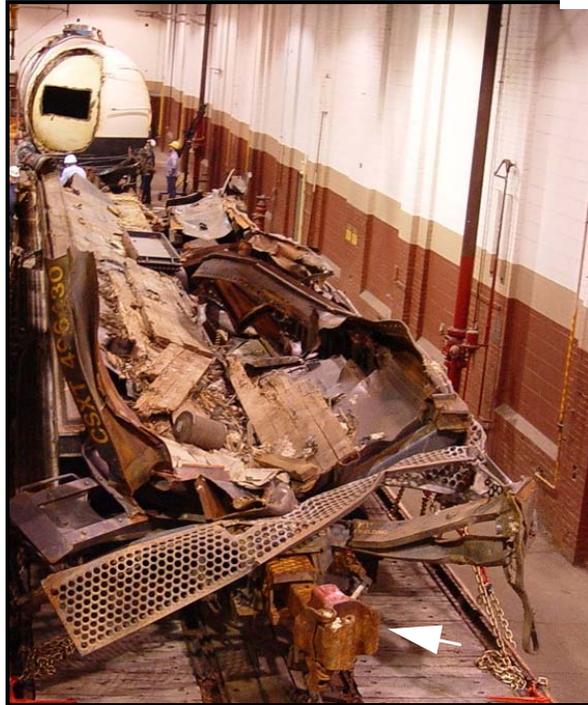
Figure 7. View of the flatbed car at the "B" end. Arrow indicates the coupler assembly.

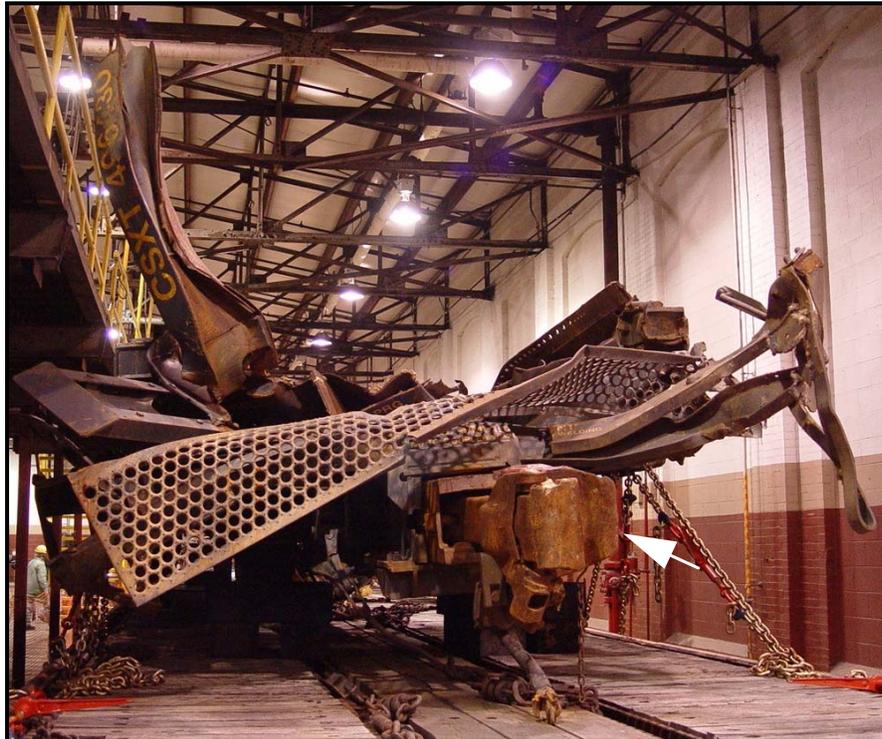
Figure 8. Another view of the flatbed car at the "B" end. Arrow indicates the coupler assembly.

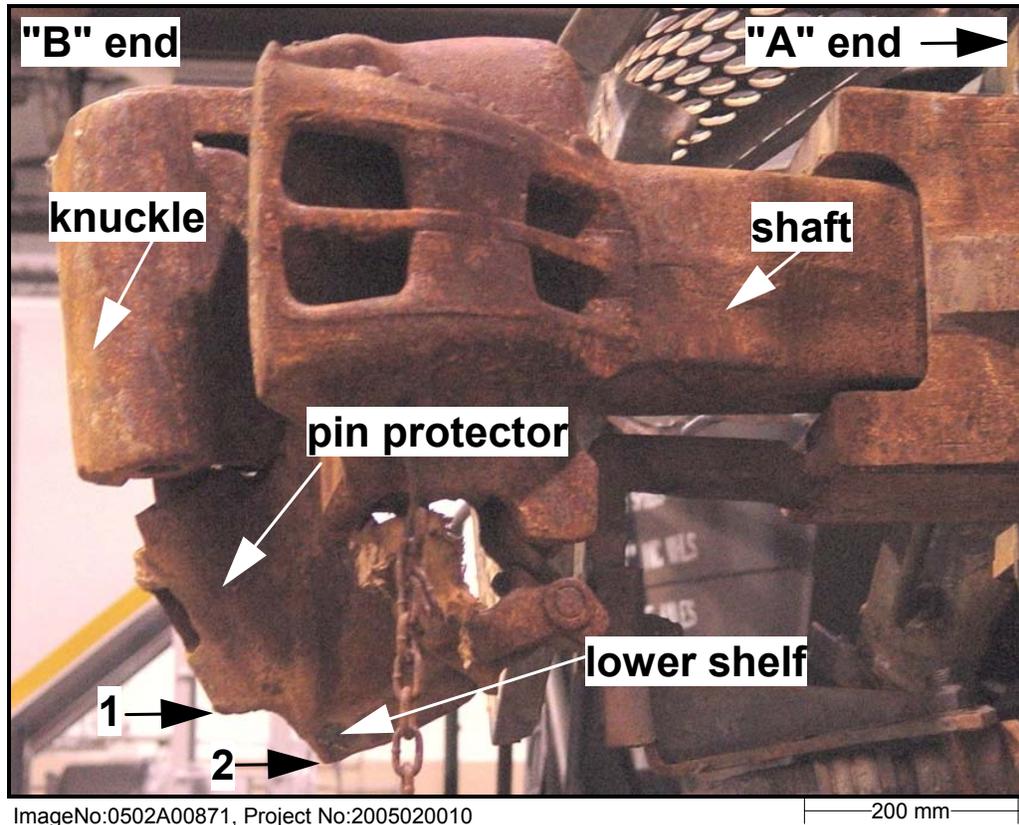
Figure 9. View of the "B" end coupler assembly showing the right side. The lower shelf was deformed toward the "A" end of the tank car.

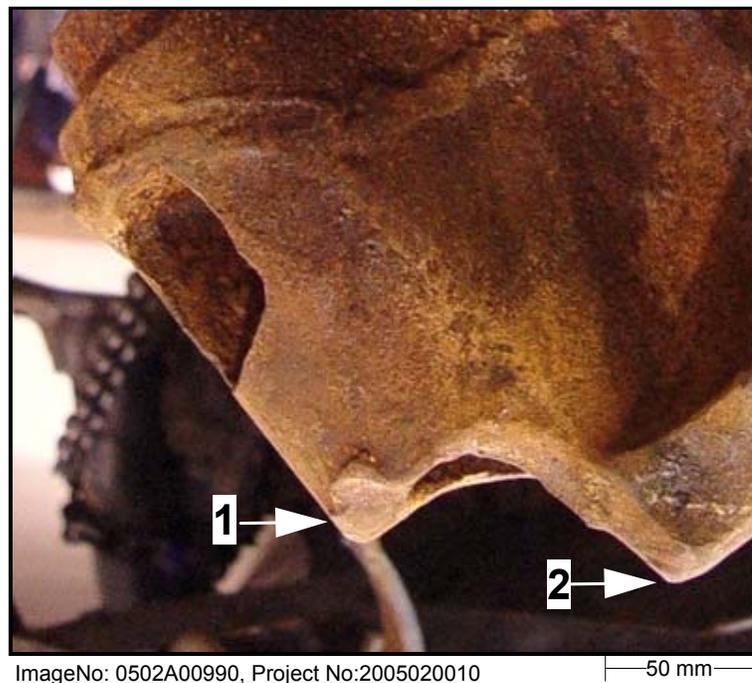
Figure 10. Closer view of the lower shelf showing deformation at the lower corner of the pin protector, indicated by arrow "1", and deformation at the lower corner of the lower shelf, indicated by arrow "2".

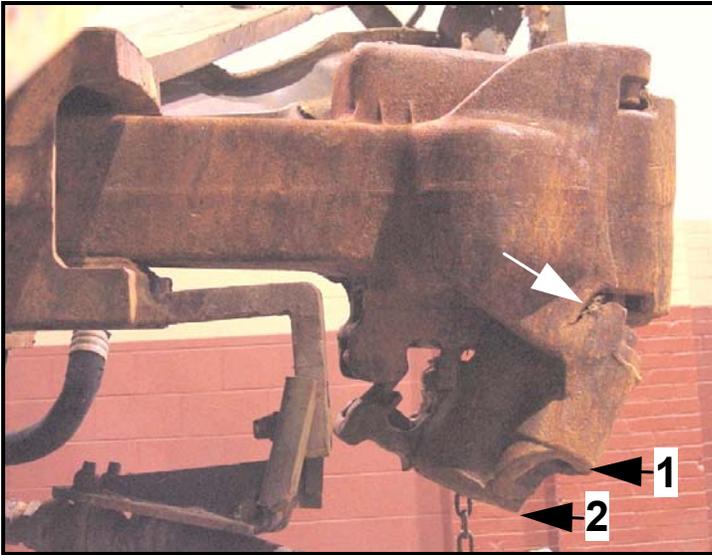
assembly. The lower shelf of the accident coupler assembly was deformed down and toward the "A" end. The coupler assembly below the knuckle contained a gaping crack, one end of which is indicated by an arrow in figures 11 and 12. The crack extended through approximately 75% of the cross sectional thickness of the connection between the lower shelf and the shaft of the coupler assembly. The pin protector at the lower corner showed evidence of metal flow in the area indicated by arrow "1" in figure 10. The lower shelf at the lower corner also showed evidence of metal flow in the area indicated by arrow "2" in figure 10. The distance between the lower corner of the pin protector and the lower corner of the lower shelf measured approximately 4.5 inches. Identification marks found on the surface of the coupler at the "B" end indicate this coupler assembly was model "SBE67CE", manufactured on March 2000, by McConway and Tourley, at the facility located in Kutztown, Pennsylvania.

Figure 11. Left side of the coupler assembly at the "B" end showing a gaping crack, indicated by arrow, in the area above the pin protector.

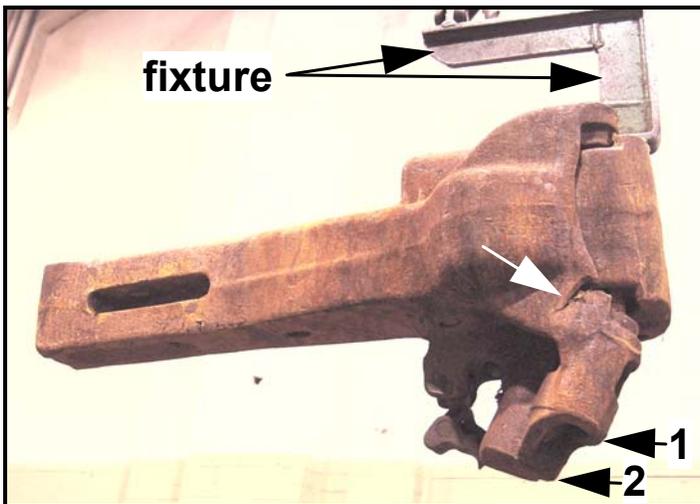
Figure 12. Left side of the coupler assembly after disassembly. Arrow indicates the location of a gaping crack.

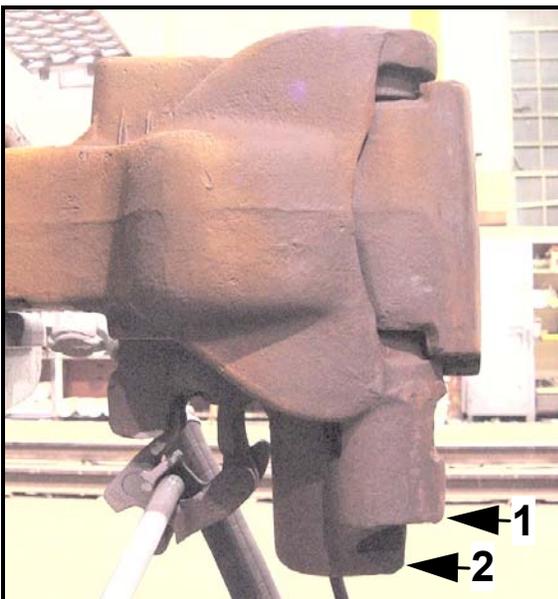
For comparison purposes, figure 13 shows a photograph of an exemplar coupler assembly that was not involved in the accident. On this exemplar coupler assembly, the length of the pin protector was vertically aligned and was perpendicular to the length of the tank car, and the lower shelf did not show evidence of deformation.

Figure 13. Left side of a coupler assembly from a flatbed car that was not involved in the accident. Shown for comparison purpose. Arrow "1" indicates the location of the lower corner of the pin protector, and arrow "2" indicates the location of the lower corner of the lower shelf.

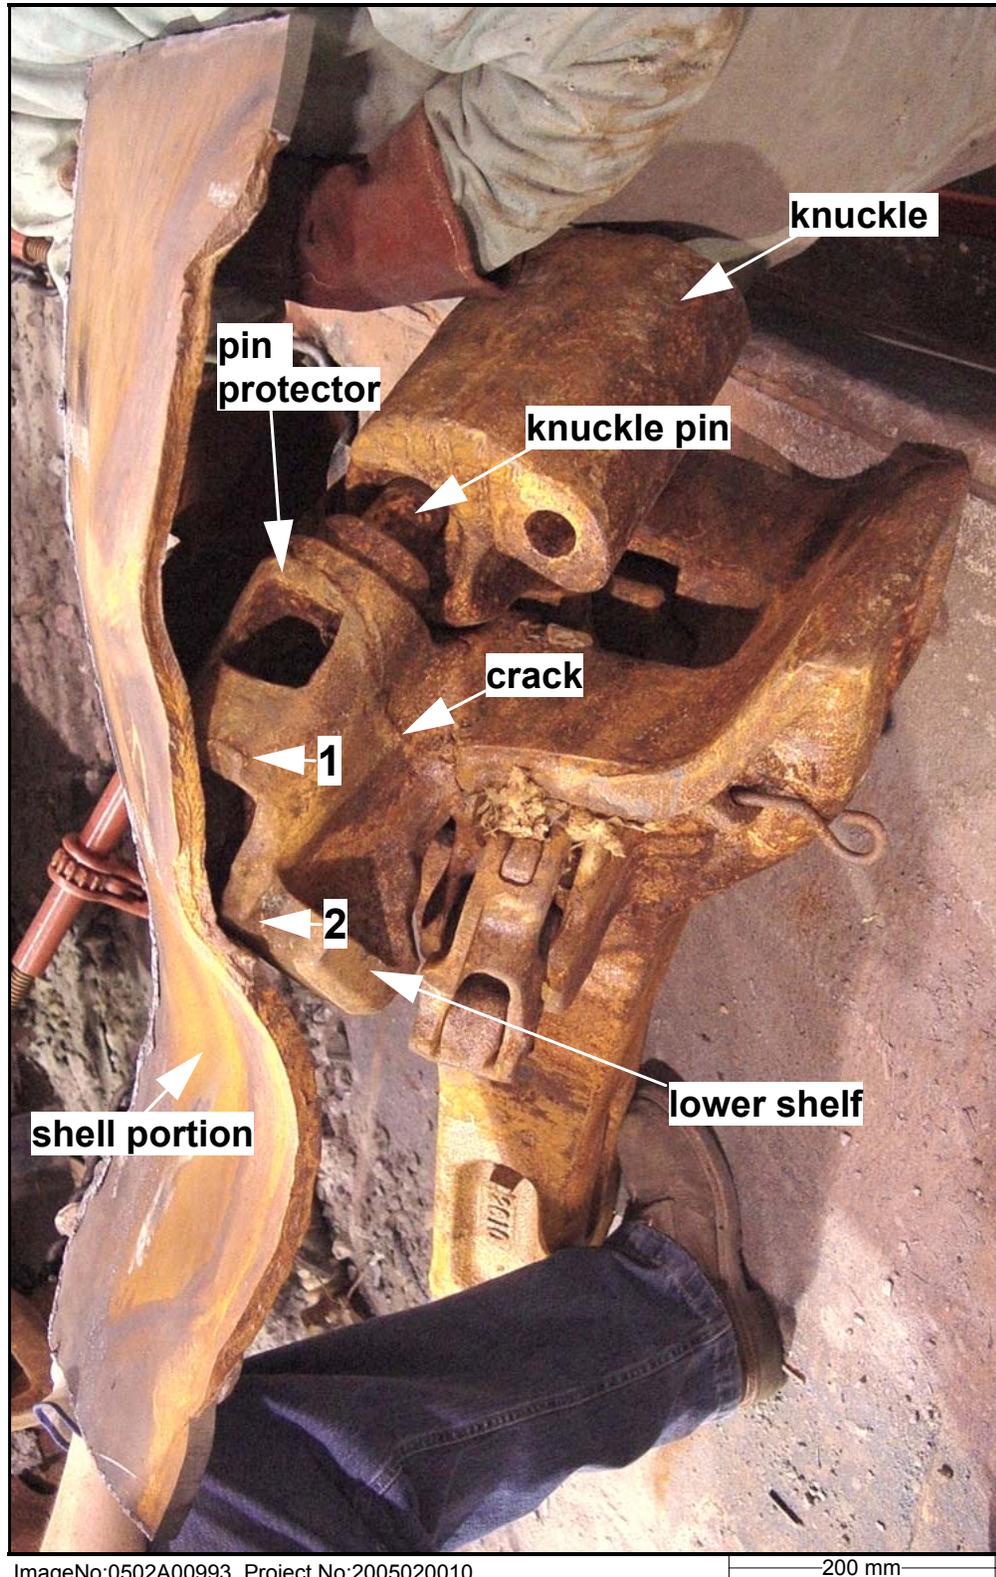
lower corner of the lower shelf of the coupler assembly. The distance between impressions "1" and "2" measured approximately 4.5 inches, same as the distance between the lower corner of the pin protector and the lower corner of the lower shelf.

The excised shell portion with the "B" end of the fracture was also placed over the various parts of the coupler assembly. A portion of the lower corner of the lower shelf was the only area that fitted within the impression at deformation marks "3" and "4".

Figure 14. Fit-up test showing the coupler assembly (right side of photograph) as it was placed against the external face of the shell portion (left side of photograph) that contained the "A" end of the fracture. Deformation at the lower corner of the pin protector, arrowed "1", and at the lower corner of the lower shelf, arrowed "2", corresponded with impression marks found at the external face of the shell, indicated by arrows "1" and "2" in figures 4 and 5, respectively.

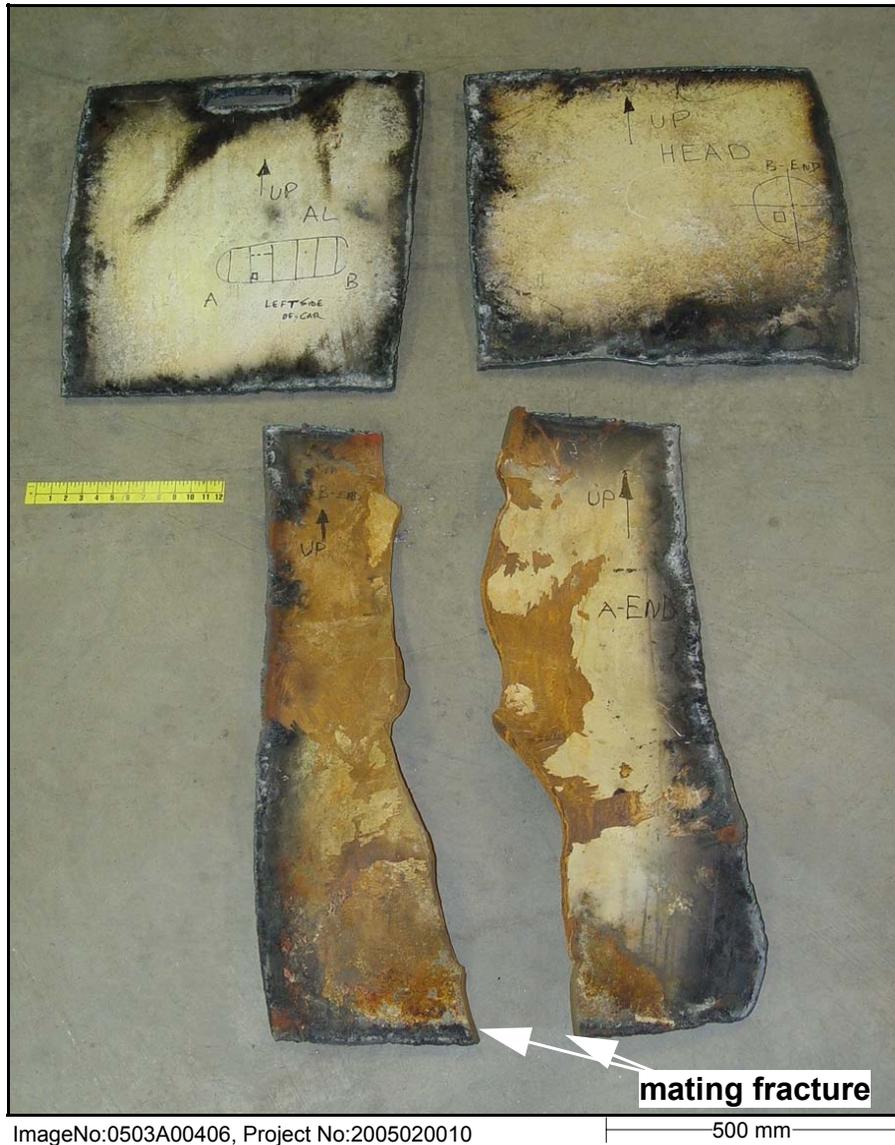
Figure 15 shows a photograph of excised head and shell coupons, and mating fracture pieces from the shell of tank car UTLX 900270 that were submitted to the Safety Board Materials Laboratory.

Figure 15. Excised shell coupon (upper left corner); head coupon (upper right corner), and mating fractures of the shell (lower side of photograph) showing the external faces.

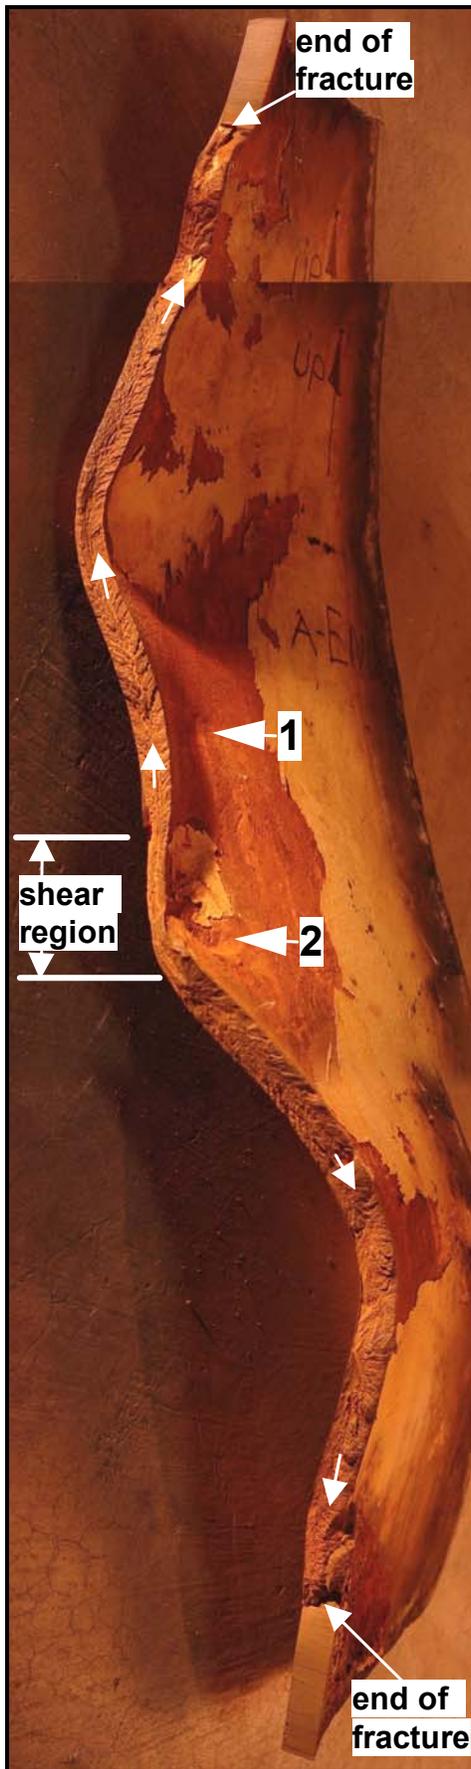
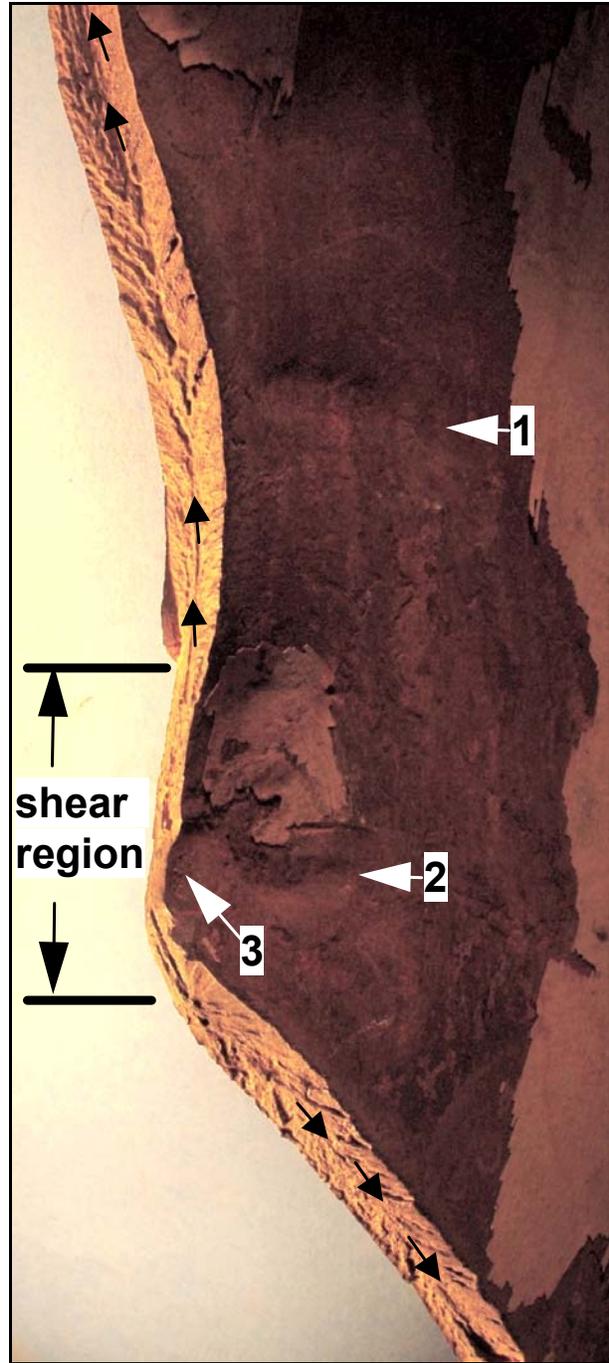
The mating fracture faces were cleaned with a nylon brush and rinsed with alcohol. Figure 16 show a composite photograph of the fracture face at the "A" end and close-up photograph of a portion of the fracture near the center of the fracture. Examination of the fracture face at the "A" end revealed a fracture on a slant plane typical of a shear fracture in an area located nearly midway between the ends of the fracture. The length of the fracture in the shear region measured approximately 2.5 inches, which is approximately 7% of the total length of the fracture (34 inches). Additional photographs of the fracture in the shear region are shown in figure 17. The remaining portion of the fracture exhibited a chevron pattern typical of a brittle overstress fracture. The chevron pattern emanated from the upper and lower ends of the shear region and extended approximately 15.5 inches above upper end of the shear fracture and approximately 16 inches below the lower end of the shear fracture. The fracture faces contained no evidence of crack arrest marks. Visual examination of the fracture faces with a magnifying glass revealed that fine fracture features appeared to have been etched away, probably from exposure to the accident conditions.

Figure 16. Composite photograph of the shell fracture on the "A" end (left side of the page) and a higher magnification photograph of the shear fracture region (right side of page). Arrows indicate direction of fracture propagation.

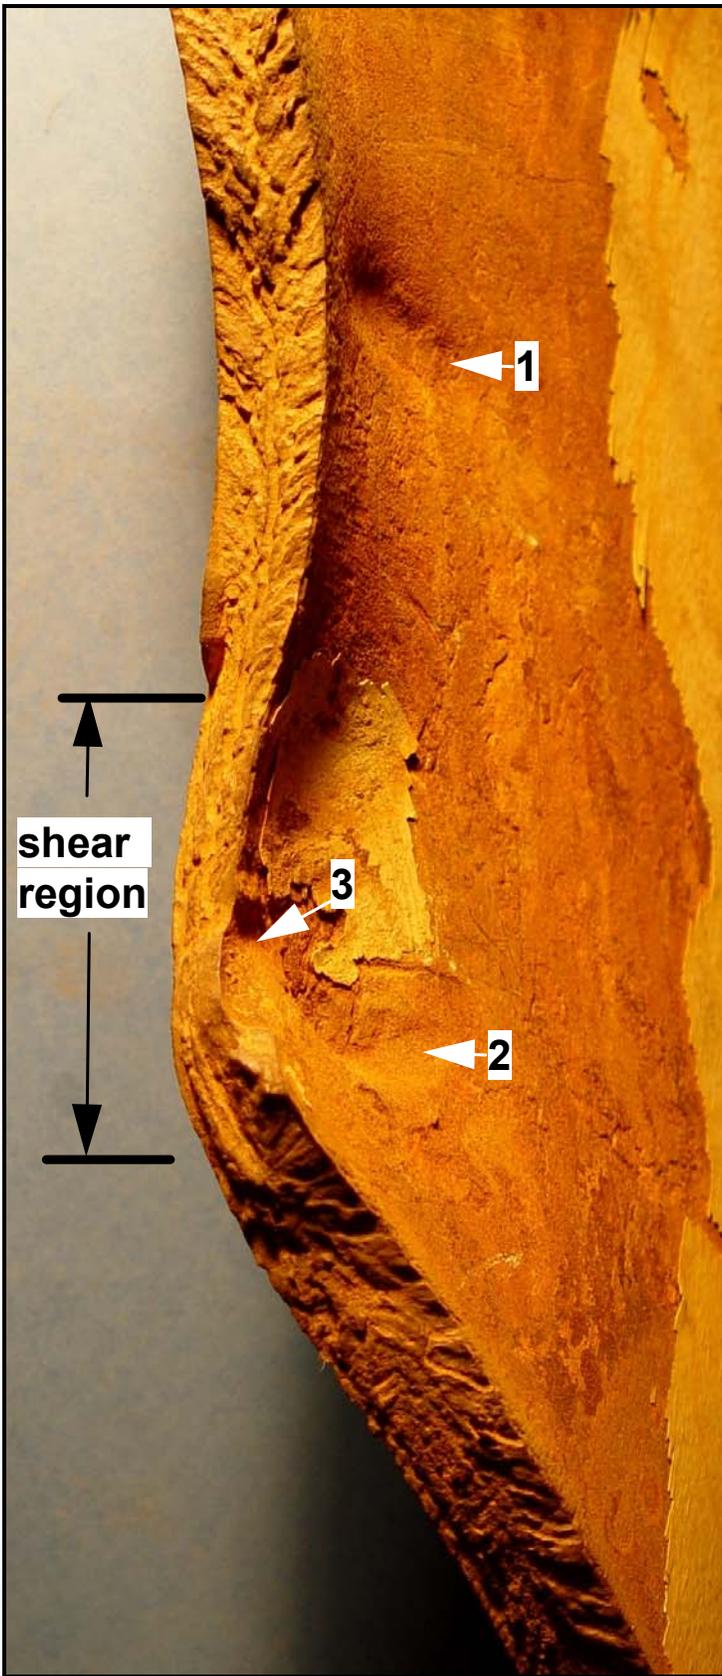
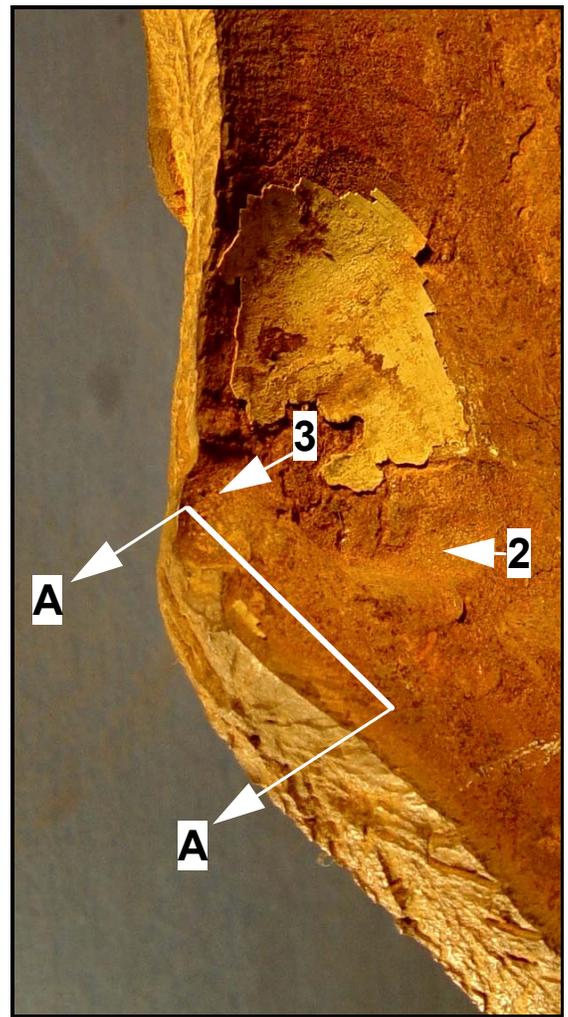
Figure 17. Close-up views of impression marks "1" and "2" and the shear fracture region.

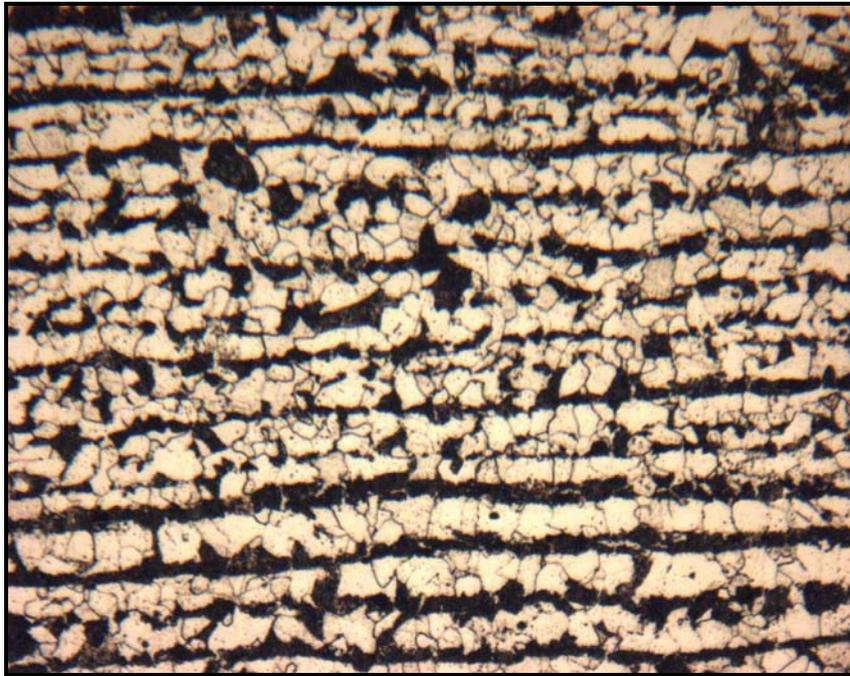
Figure 18. Microstructure of the shell showing the plane that was parallel to the circumference of the tank car. This is the plane that was parallel to the rolling direction determined for the steel plate.

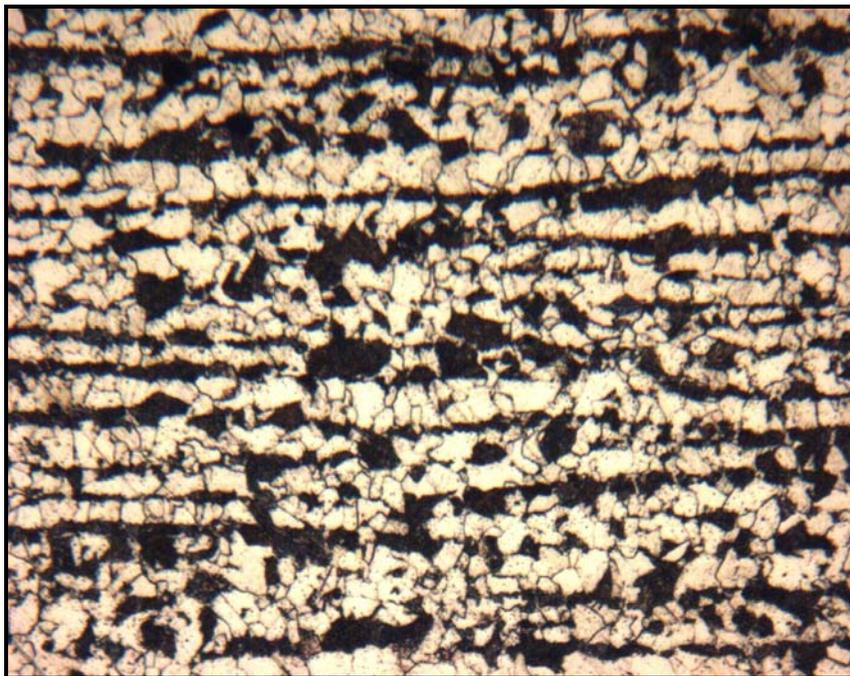
Figure 19. Microstructure of the shell showing the radial plane that was longitudinal to the tank car. This is the plane that was perpendicular to the rolling direction determined for the steel plate.

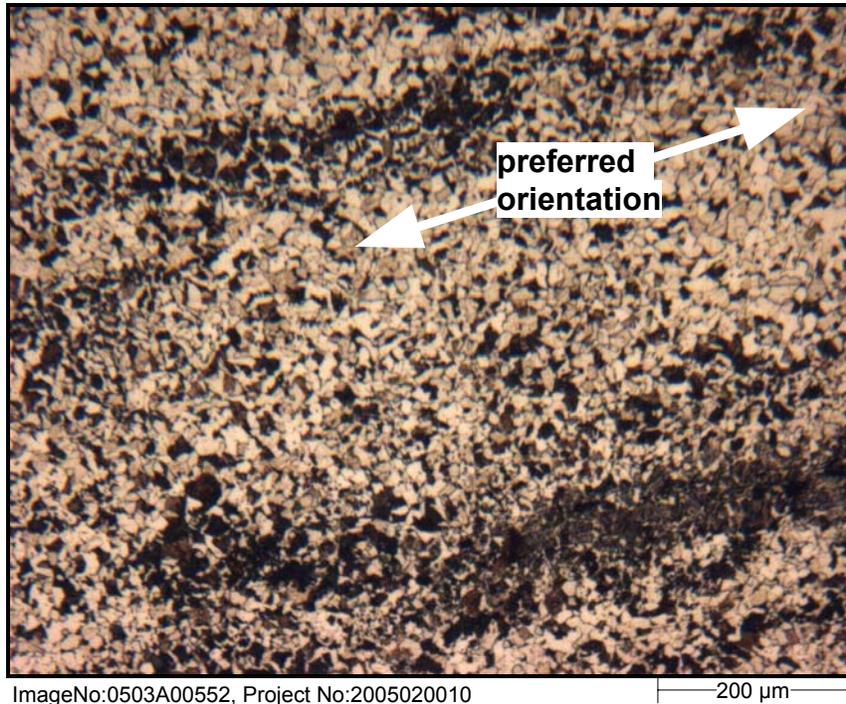
Figure 20. Microstructure of the shell showing the plane that corresponds to the surface that was located midway between the shell's interior and exterior surface. The pearlite colonies (appear dark) follow a preferred orientation indicated by arrows.

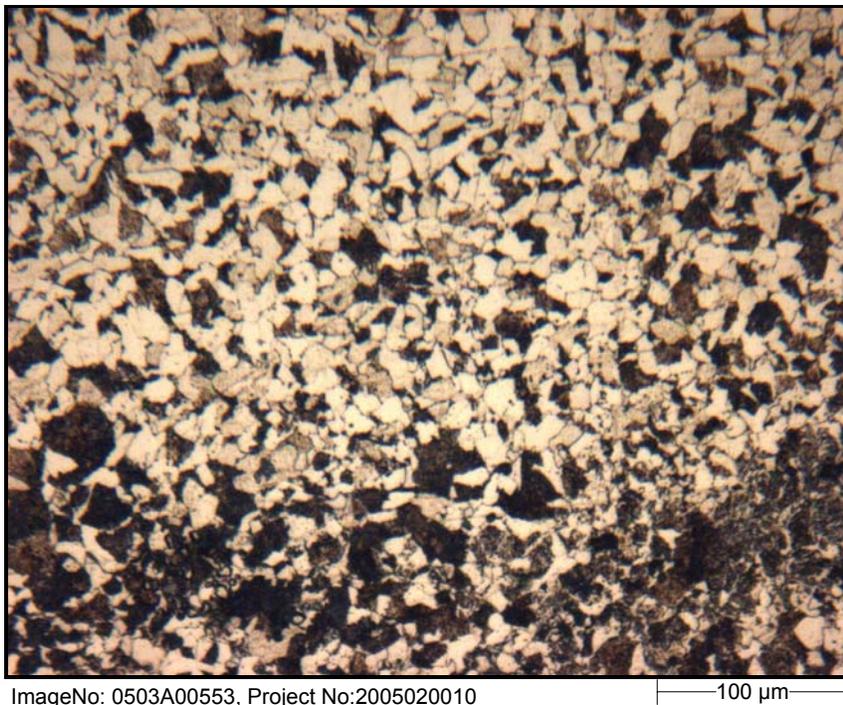
Figure 21. Microstructure of the shell showing the plane that corresponds to the surface that was located midway between the shell's interior and exterior surface. Same as in figure 20 except at higher magnification.

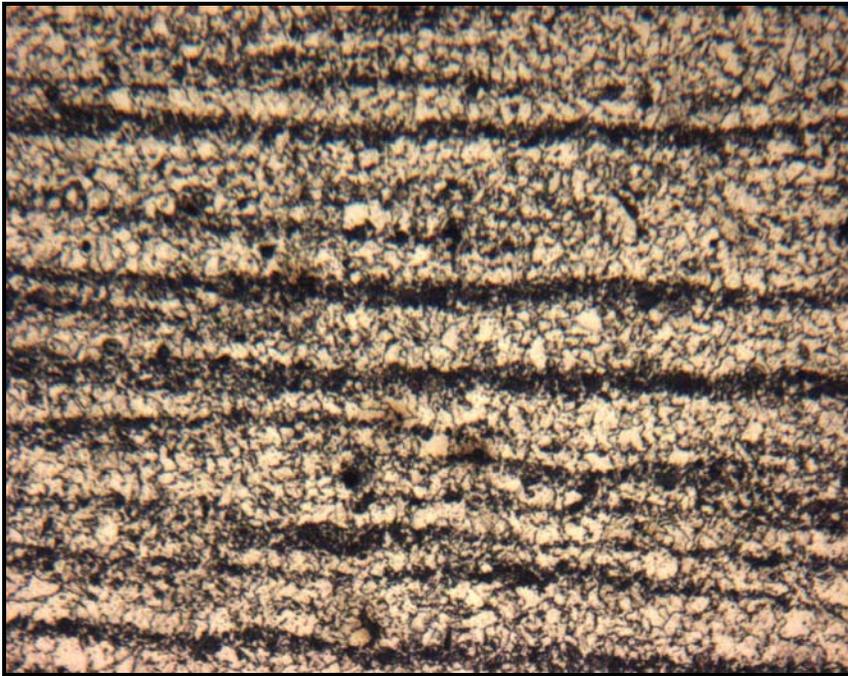
Figure 22. Microstructure of the head that was through the thickness of the steel plate. This plane was parallel to the preferred orientation.

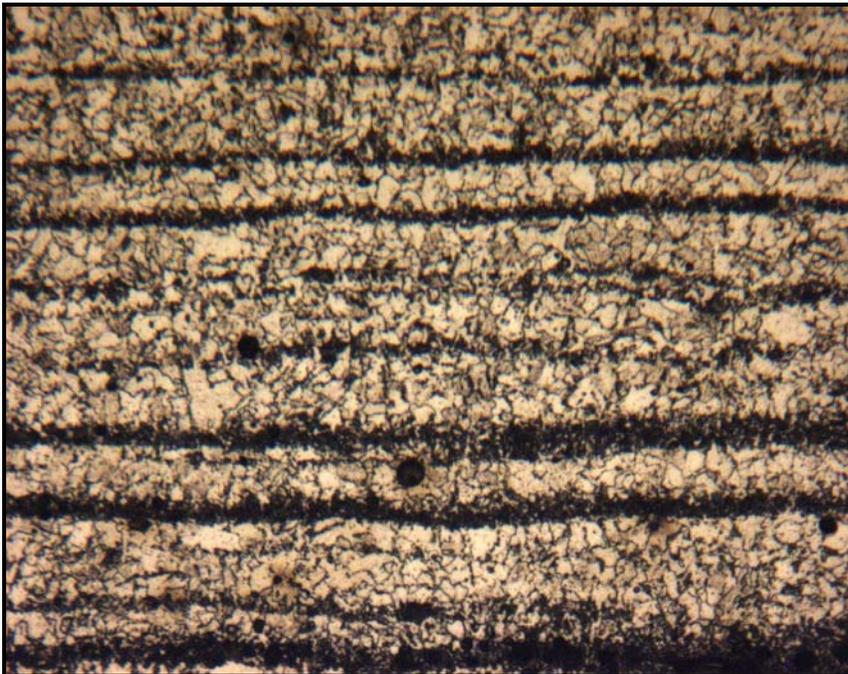
Figure 23. Microstructure of the head showing the plane that was perpendicular to the orientation of the pearlite colonies.

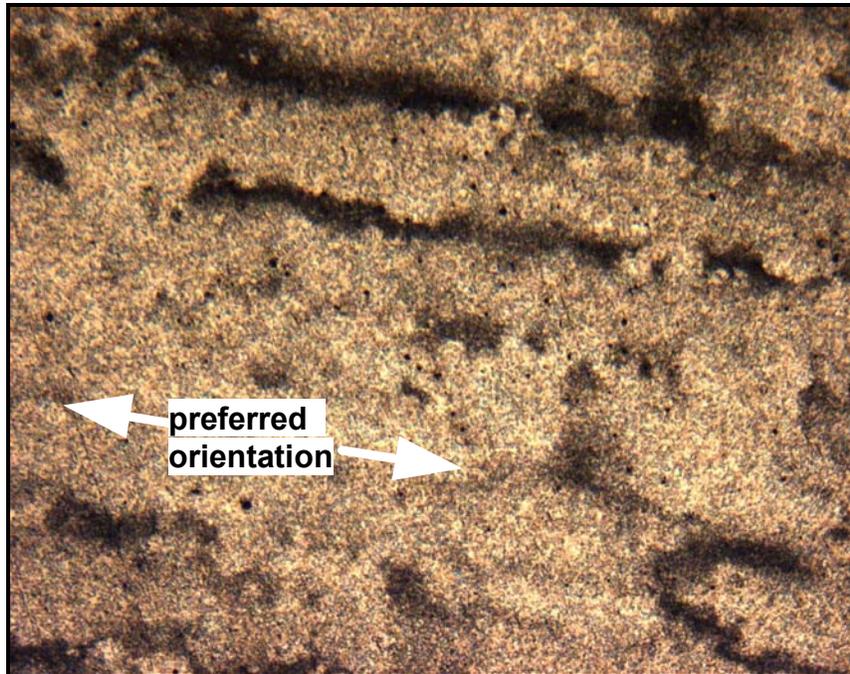
Figure 24. Microstructure of the head showing the plane that corresponds to the surface that was located midway between the head's interior and exterior surface. The pearlite colonies (appear dark) follow a preferred orientation indicated by arrows.

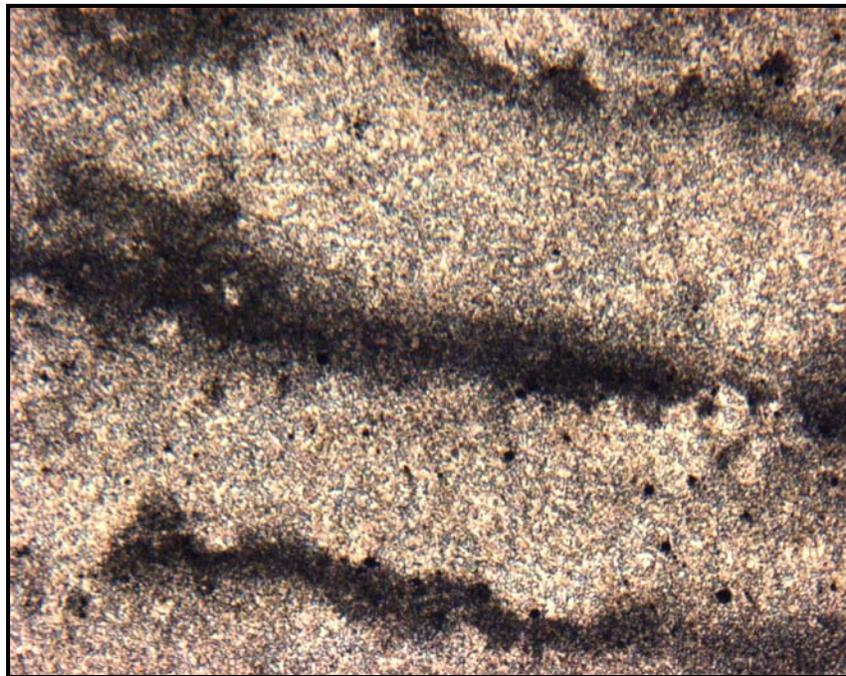
Figure 25. Microstructure of the head showing the plane that corresponds to the surface that was located midway between the head's interior and exterior surface. Same as in figure 24 except at higher magnification.
