# NATIONAL TRANSPORTATION SAFETY BOARD

MATERIALS LABORATORY DRAFT FACTUAL REPORT

Report No. 05-071

Place : Graniteville, South Carolina  
Date : January 6, 2005  
Vehicle : Tank Car UTLX 900270  
NTSB No. : DCA05MR008  
Investigator : Jim Henderson (RPH-30)

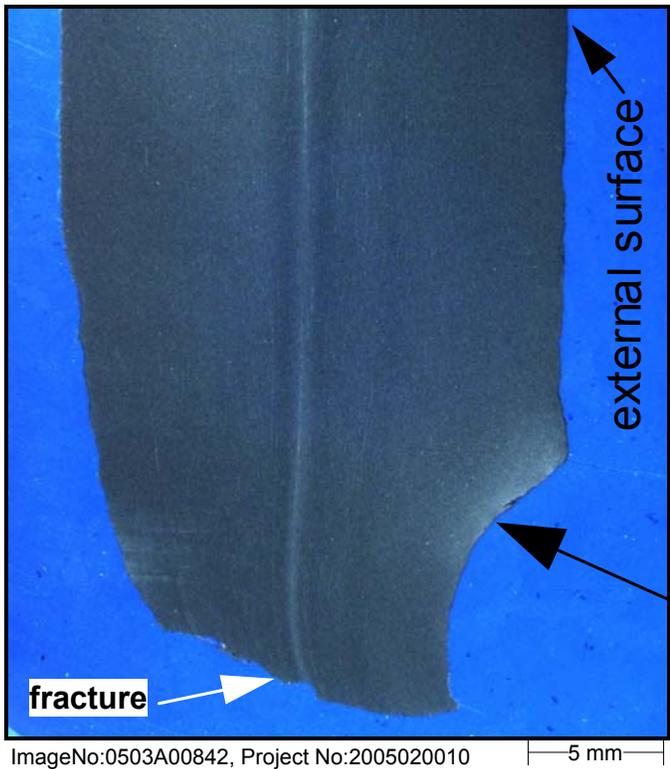
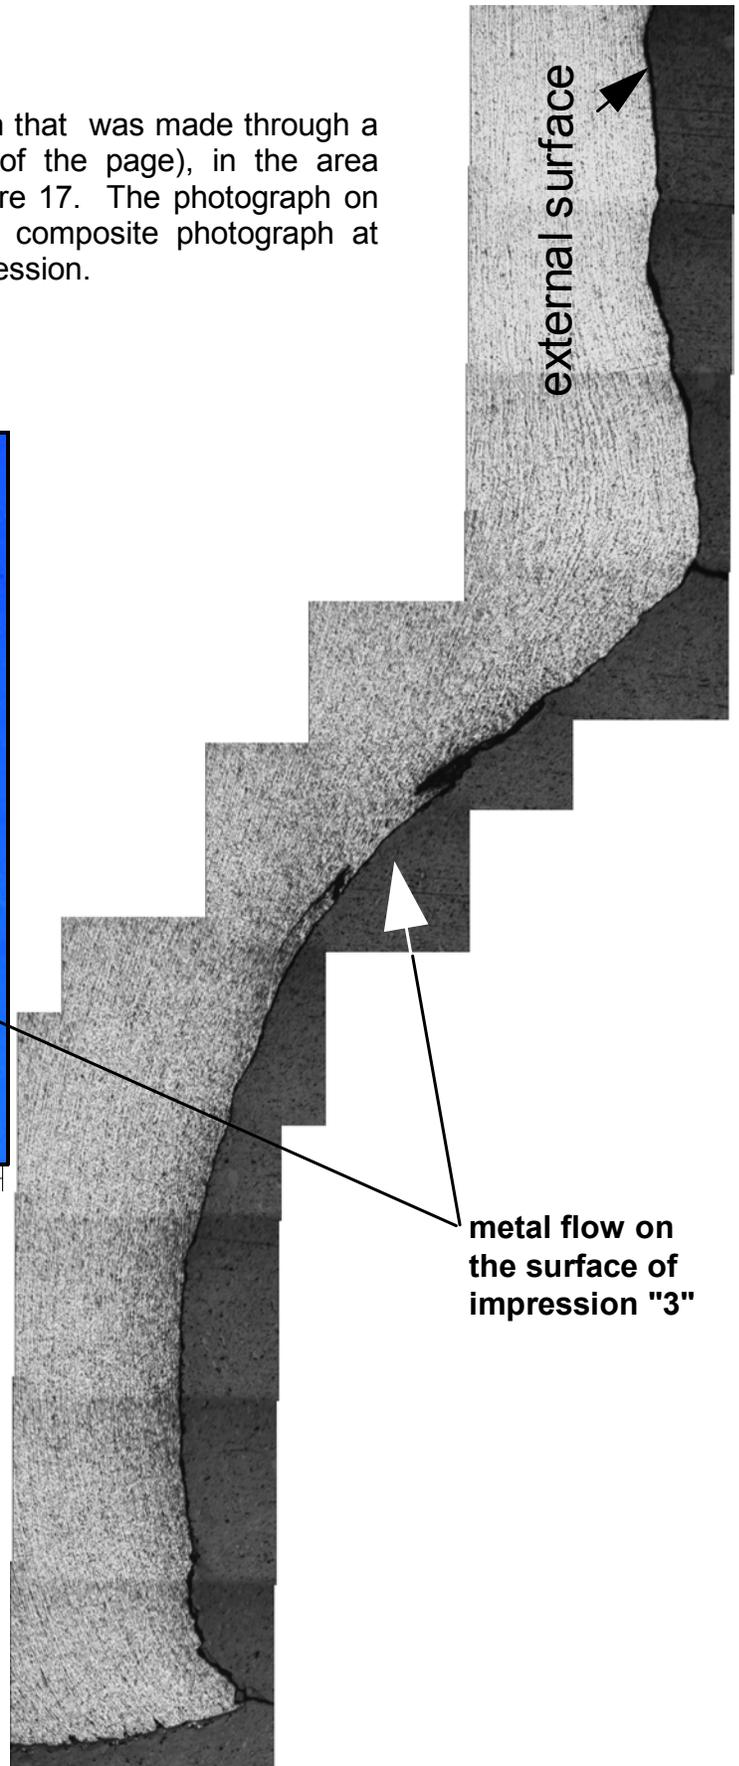
A metallurgical section was made through impression "3" in the area indicated by section line "A-A" in figure 17. Figure 26 shows photographs of the polished and etched section. The etched section showed that the banded microstructure was deformed to approximately follow the surface of the impression. An area of metal flow was noted, as indicated in figure 26.

Figure 26. Metallurgical cross section that was made through a portion of impression "3" (left side of the page), in the area indicated by section line "A-A" in figure 17. The photograph on the right side of the page shows a composite photograph at higher magnification of the same impression.
