NATIONAL TRANSPORTATION SAFETY BOARD

MATERIALS LABORATORY FACTUAL REPORT

Report No. 16-034

Place : St. Thomas Virgin Islands
Date : September 7, 2015
Vehicle : M/V Carnival Liberty
NTSB No. : DCA15FM035
Investigator : [REDACTED]
NTSB OMS

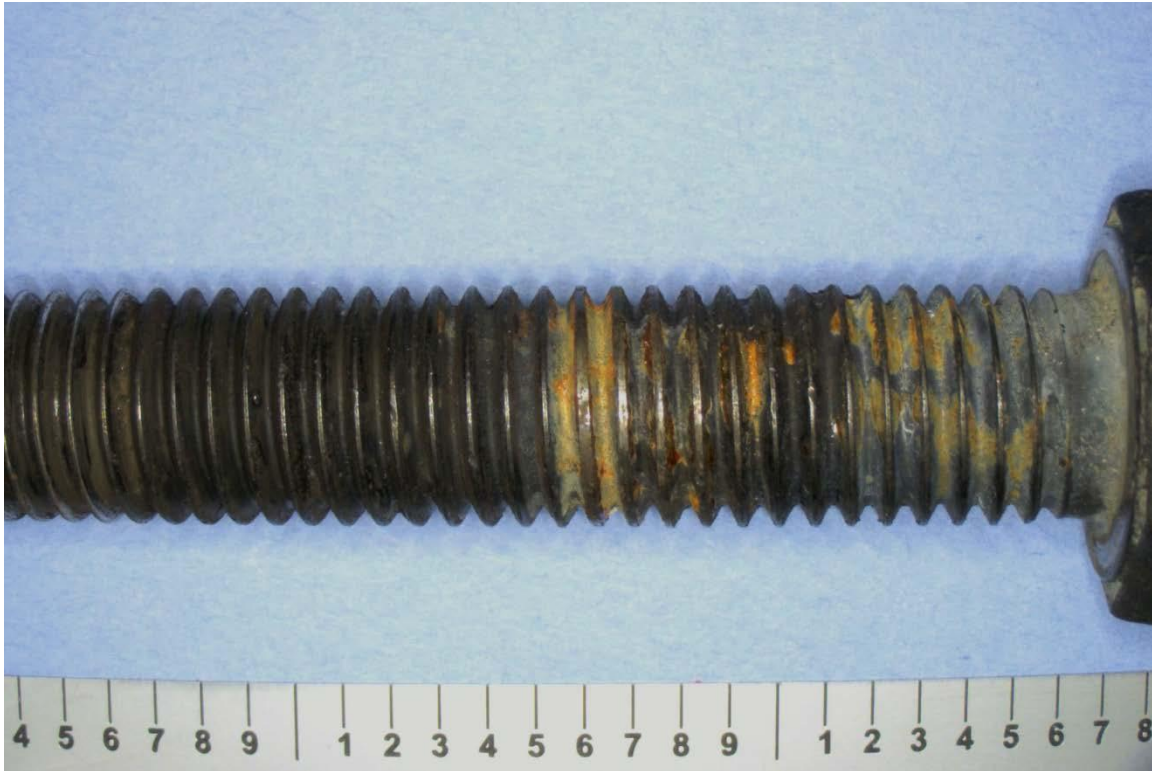
The two bolts were visually examined using 20-200X zoom stereomicroscope. The attached bolt appeared to have some rotational wear on the crests of 3 of the threads (threads 11, 12 and 13, located 0.853 inch to 0.101 inch from the bottom of the bolt head). There was some foreign material inside the thread roots in approximately 10% of the thread root volume.

The spectrum for the attached bolt scrapings contained spectral peaks that corresponded to particular functional groups found within the molecular structure of the unknown material. The presence of a broad spectral signature at $\sim 3340\text{ cm}^{-1}$ corresponds to an oxygen-hydrogen bond. A doublet peak at $\sim 2922\text{ cm}^{-1}$ and ~ 2852 corresponds to carbon-hydrogen stretching bonds. A strong single peak at $\sim 1735\text{ cm}^{-1}$ is indicative of a carbon-oxygen double bond. A single peak at $\sim 1594\text{ cm}^{-1}$ is indicative of a carbon-carbon double bond. A doublet at $\sim 1456\text{ cm}^{-1}$ and $\sim 1422\text{ cm}^{-1}$ is indicative of a carbon-hydrogen (2) bending bond. A doublet at $\sim 1371\text{ cm}^{-1}$ and $\sim 1325\text{ cm}^{-1}$ is indicative of a carbon-hydrogen (3) bending bond. A single peak at $\sim 1031\text{ cm}^{-1}$ is indicative of carbon-oxygen stretching bond. These signatures indicate that the material contains a methacrylate. A spectral library search was done on the attached scraping sample spectrum. No strong matches were found but several spectra of adhesives and thread locking compounds were found to have several significant similarities. Based on the visual examination of the attached bolt thread material spectrum and similarities to the known materials, the material found in the attached bolt threads is consistent with some type of thread locking compound.

Figure 1. Fuel pump housing bolt found attached to housing.

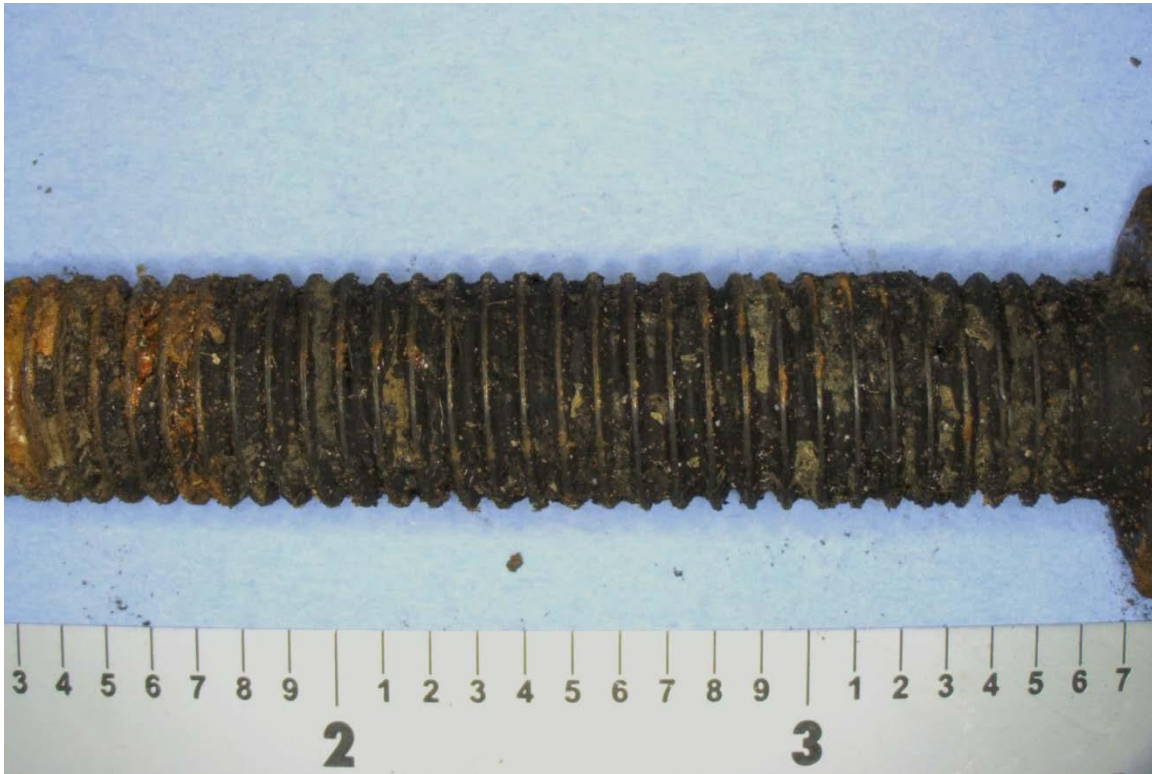
Using x-ray fluorescence (XRF), the bolt material was consistent with type 1215 carbon steel (UNS G12150). This is a resulfurized, rephosphorized steel. The bolt found detached from the manifold did not exhibit any wear on the thread crests. Most of the

thread root volume contained material with white and dark hues. Inspection using XRF found the bolt material to be consistent with type 1215 carbon steel.

The spectrum for the unattached bolt scrapings contained spectral peaks that corresponded to particular functional groups found within the molecular structure of the unknown material. The presence of a broad spectral signature at $\sim 3345\text{ cm}^{-1}$ corresponds to an oxygen-hydrogen bond. A doublet peak at $\sim 2921\text{ cm}^{-1}$ and ~ 2852 corresponds to carbon-hydrogen stretching bonds. A single peak at $\sim 1599\text{ cm}^{-1}$ is indicative of a carbon-carbon double bond. A weak peak at $\sim 1456\text{ cm}^{-1}$ can be indicative of a carbon-hydrogen (2) bending bond. A weak peak at $\sim 1376\text{ cm}^{-1}$ and can be indicative of a carbon-hydrogen (3) bending bond. A single peak at $\sim 1085\text{ cm}^{-1}$ is indicative of carbon-oxygen stretching bond. These signatures indicate that the material in the unattached bolt threads is a straight chained aliphatic hydrocarbon. A spectral library search was done on the unattached scraping sample spectrum. No strong matches were found. The unknown spectrum contained many similarities to several types of hydrocarbon based materials including paints, adhesives, fuel and lubricants. Based on the location where the unattached bolt was found, the material in the threads could contain one or several of these materials.

Figure 2. Fuel pump housing bolt found unattached from housing.
