NATIONAL TRANSPORTATION SAFETY BOARD

MATERIALS LABORATORY FACTUAL REPORT

Report No. 17-058

Place : Georgetown, Delaware
Date : January 28, 2017
Vehicle : Piper PA-22, N3659Z
NTSB No. : ERA17LA097
Investigator : Heidi Kemner

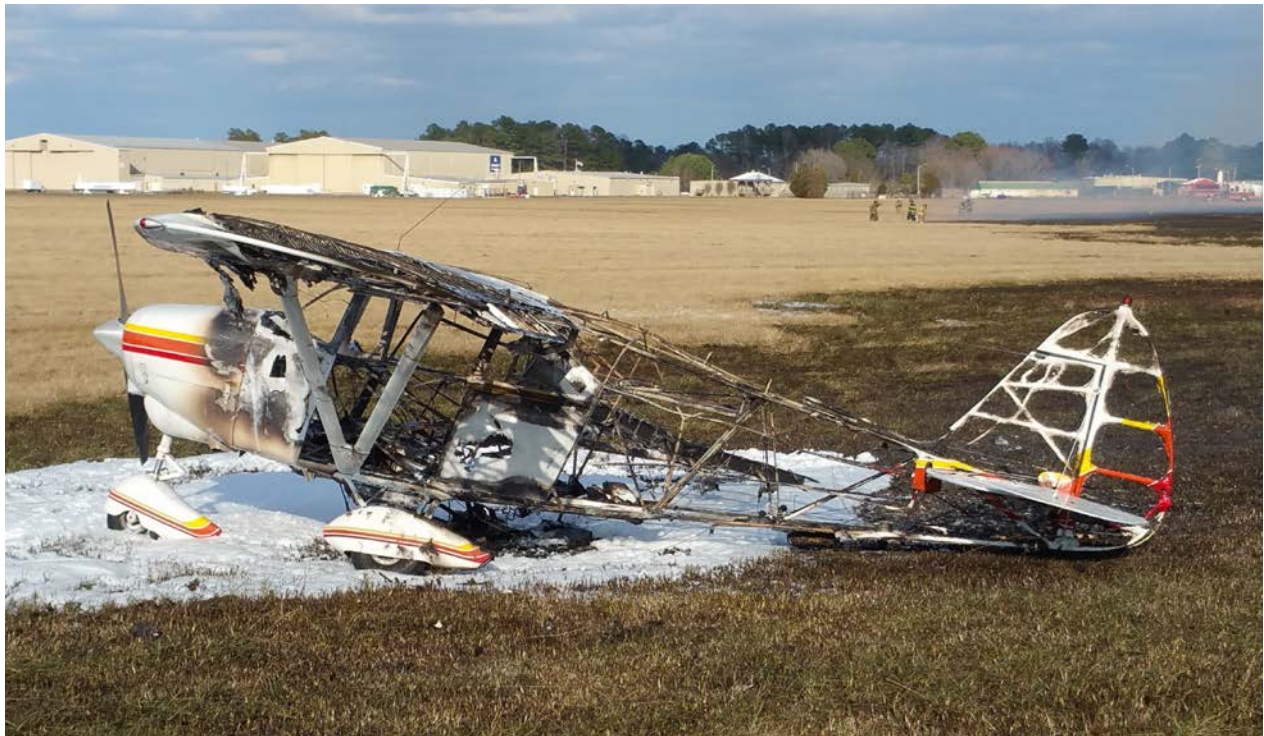
Figure 1: Aircraft remains after fire extinguishment.

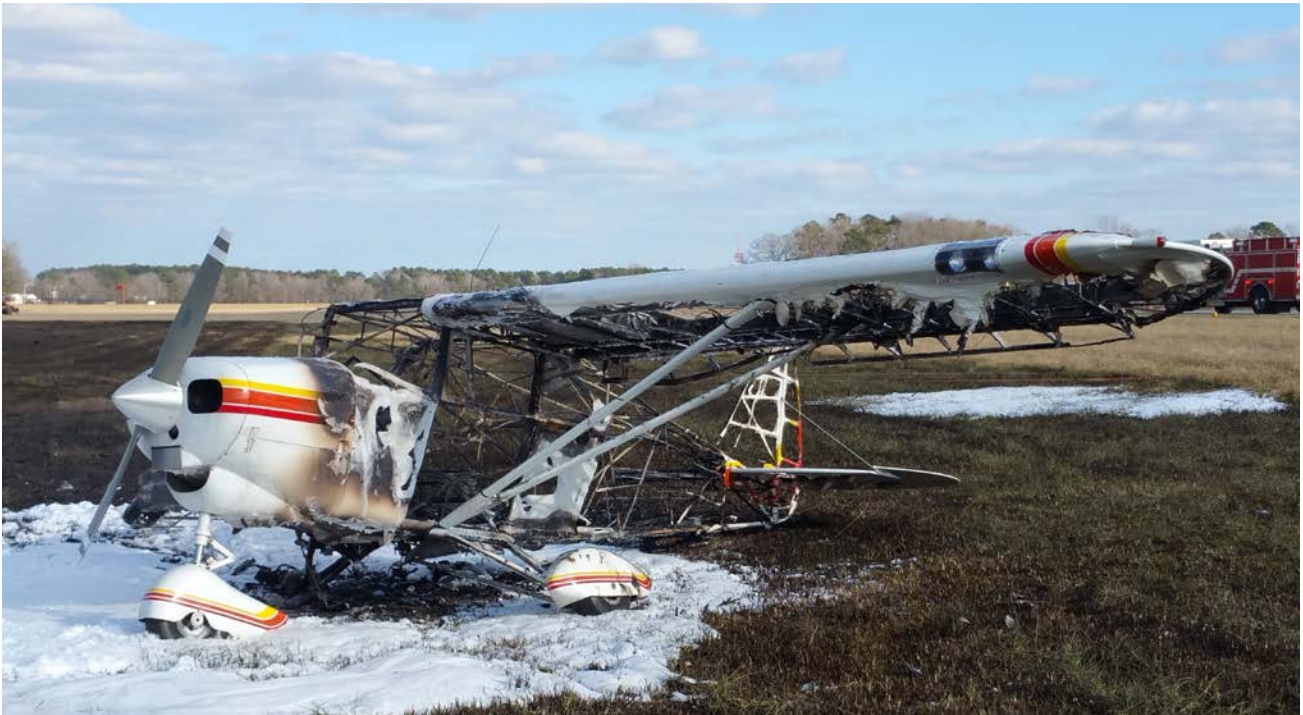
Figure 2: Aircraft remains after fire extinguishment.

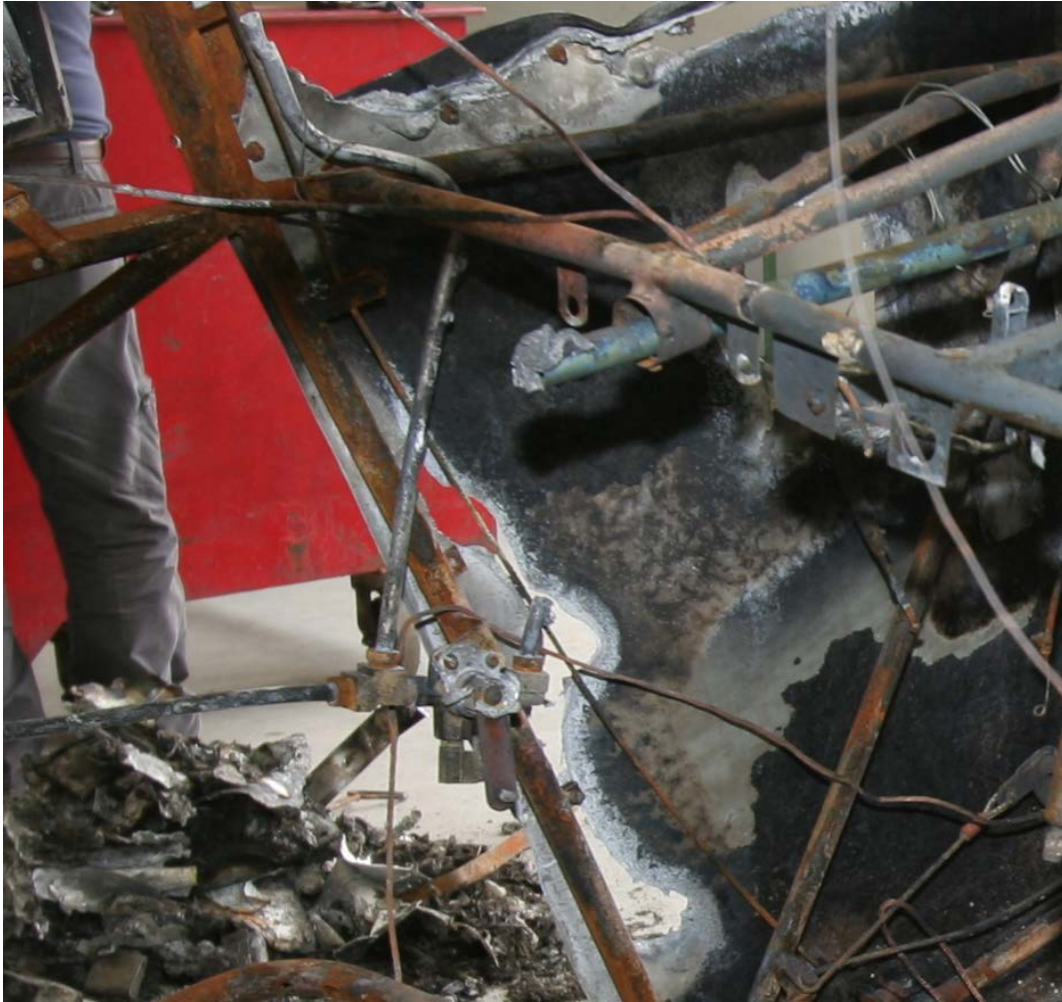
The wreckage examination took place at an aircraft recovery facility. The remains of the aircraft's fuel system were examined for potential sources of leaks. The fuel lines were constructed out of aluminum and in many areas, did not survive the heat of the fire. Inside the passenger compartment there is a fuel tank selector valve to the pilot's left and an engine priming pump on the instrument panel to the pilot's right. The fuel selector valve was thermally damaged and its function could not be verified (figure 3). The heat from the fire had melted the output fuel line from the selector valve up to the firewall. The input fuel line from the right-side wing tank was also missing with the exception of a small stub. The engine primer pump was missing and could not be located among the collected wreckage. Small stubs of the copper primer pump fuel lines were visible on the firewall with melted ends (figure 4). No remains of the primer pump fuel lines were found inside the cockpit. The fuel primer lines in the engine compartment remained intact and did not appear to have leaked. In the engine compartment, the main fuel line from the fuel strainer to the carburetor was found to be loose. Figure 5 shows a diagram of the fuel system and the fuel lines remaining are indicated with a green highlight.

Figure 3: Fuel selector valve with input from right wing tank missing and output fuel line also missing.

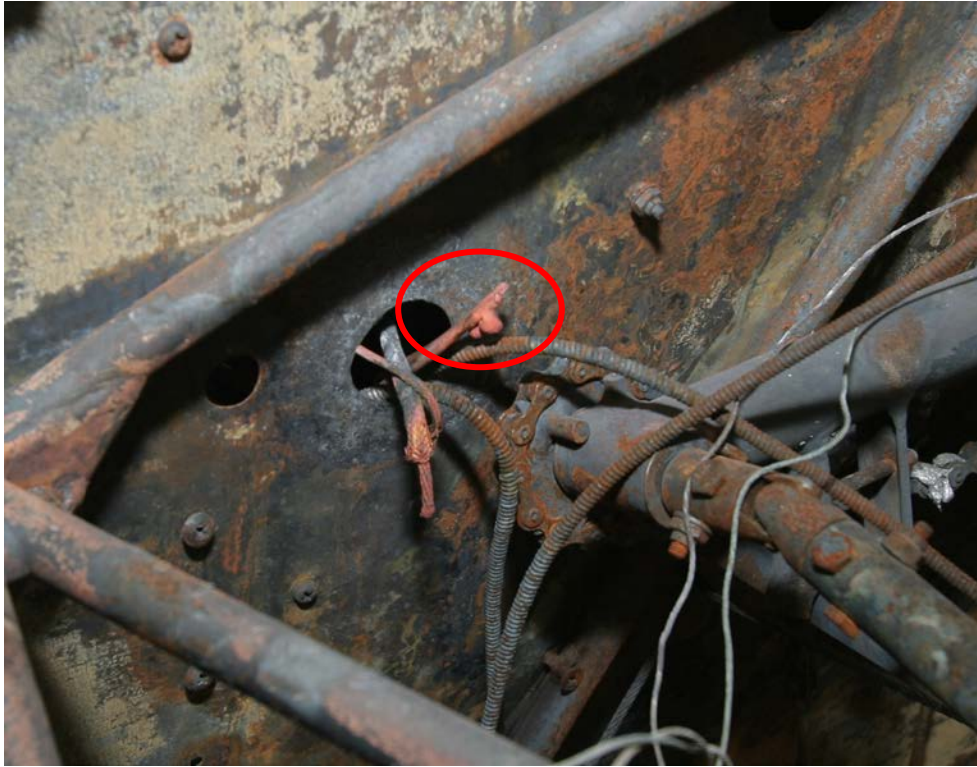
Figure 4: Melted engine primer pump fuel lines protruding into the cockpit from the engine compartment firewall.

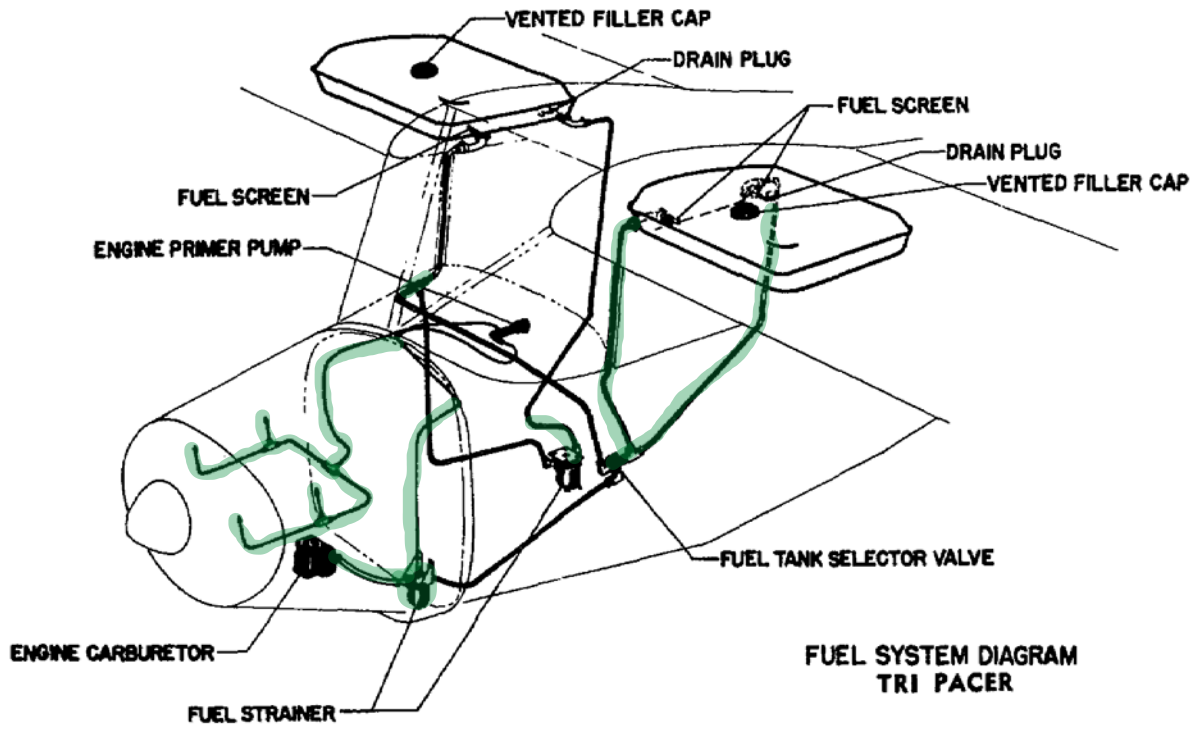
Figure 5: Fuel system diagram depicting the remaining fuel lines in green highlight.

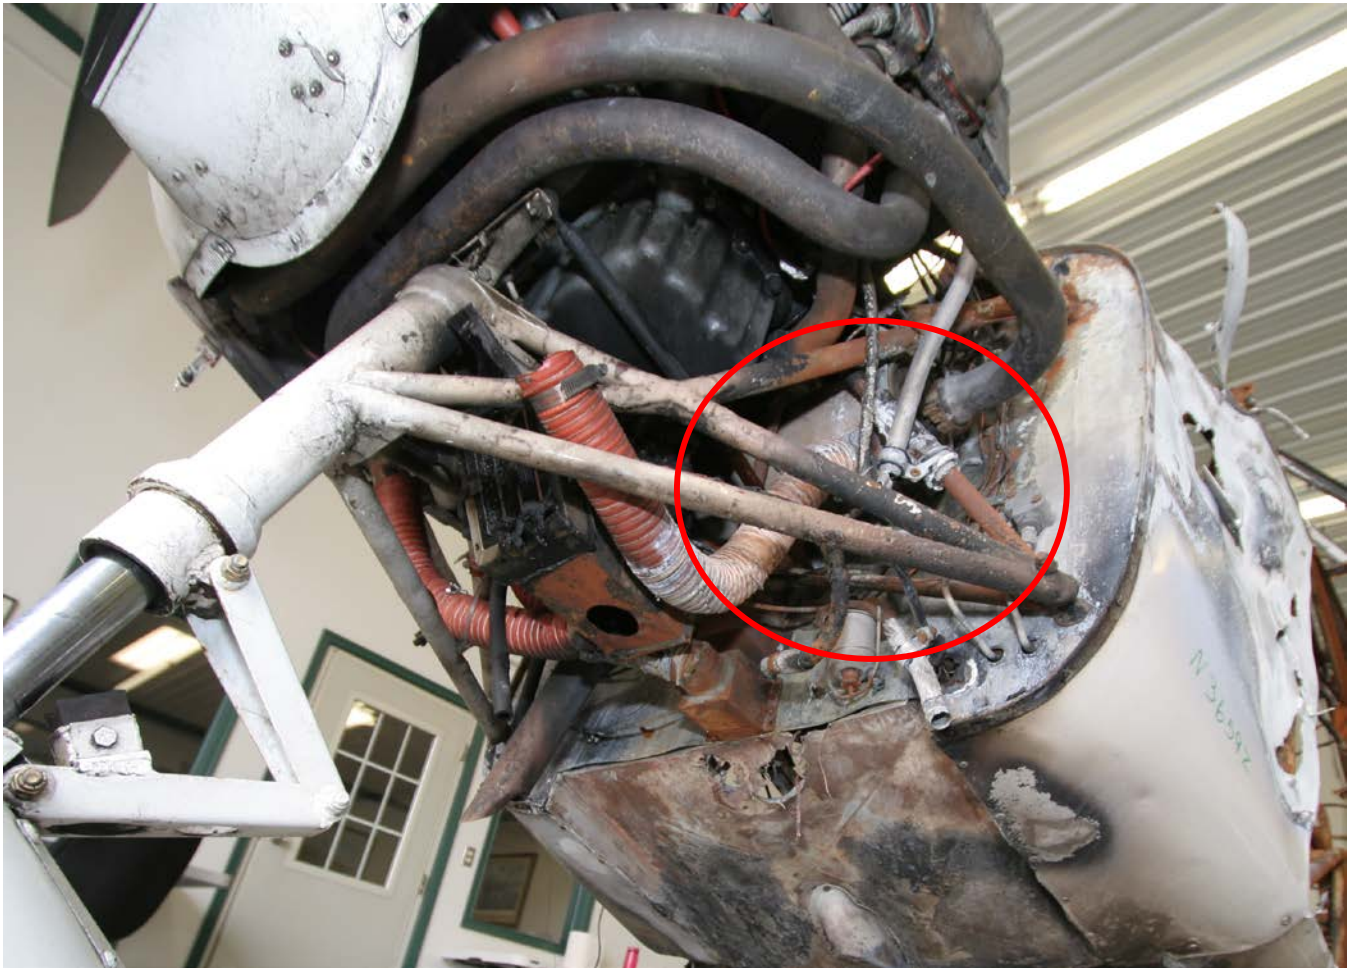
Overall, the right side of the aircraft received more thermal damage than the left. This could be attributed to the way the aircraft came to rest and the damage to the right wing after landing. The engine compartment was overall the least thermally-damaged part of the aircraft. There was more thermal damage on the lower left portion of the engine than there was on the lower right (figure 6). This area is consistent with the location of the loose fuel line supplying the carburetor.

Figure 6: Area of thermal damage at the lower left side of the engine.

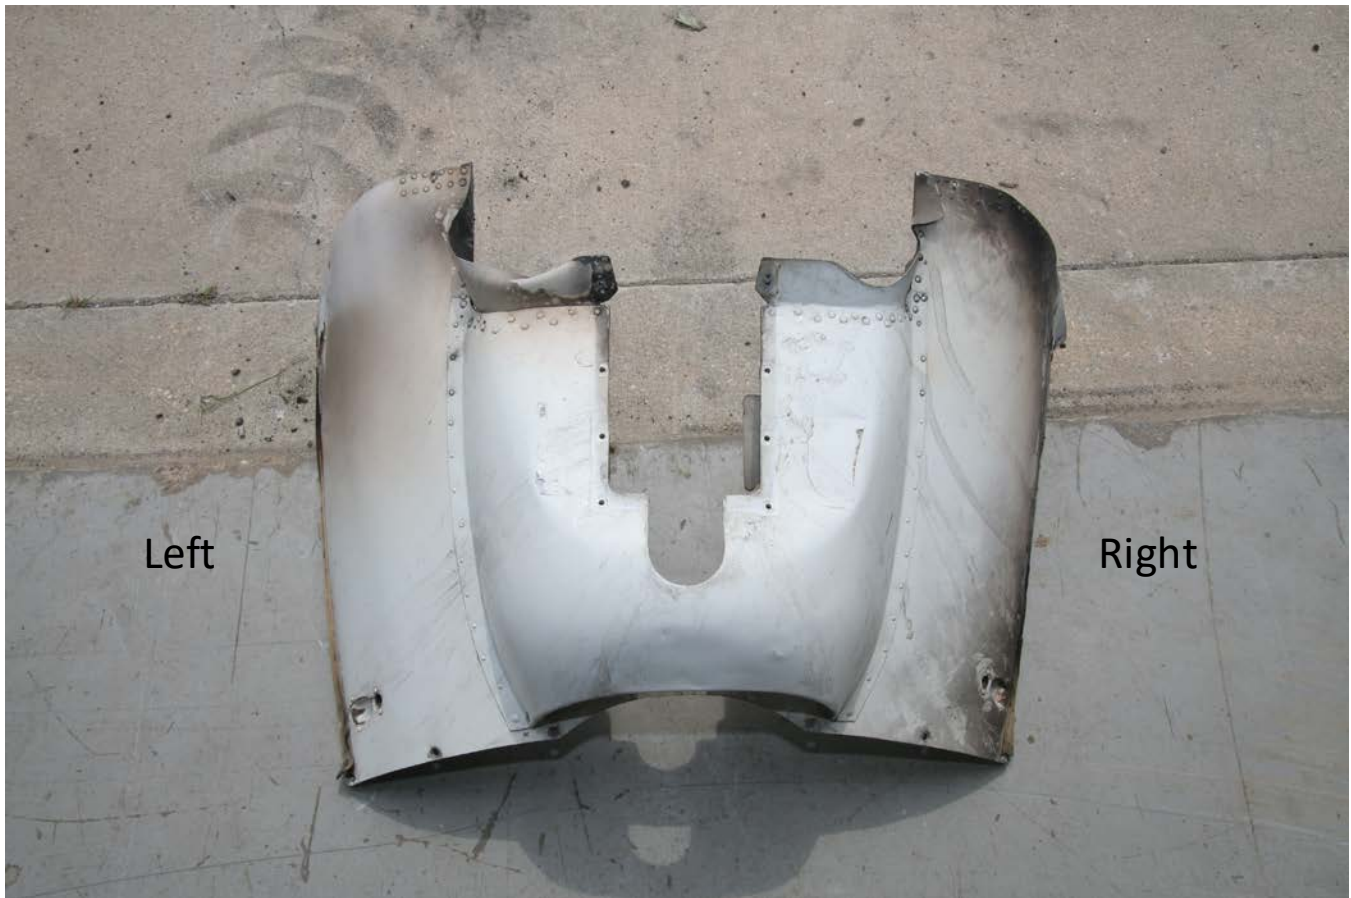
The lower engine cowling was removed and examined. Although on the exterior, this lower cowling exhibited comparable thermal damage on both the left and right sides (figure 7) on the interior there was more thermal damage to the left side than the right side (figure 8). Additionally, the overall thermal damage to the left side of this cowling was greater on the interior than on the exterior.

Figure 7: Engine compartment lower cowling (exterior side).

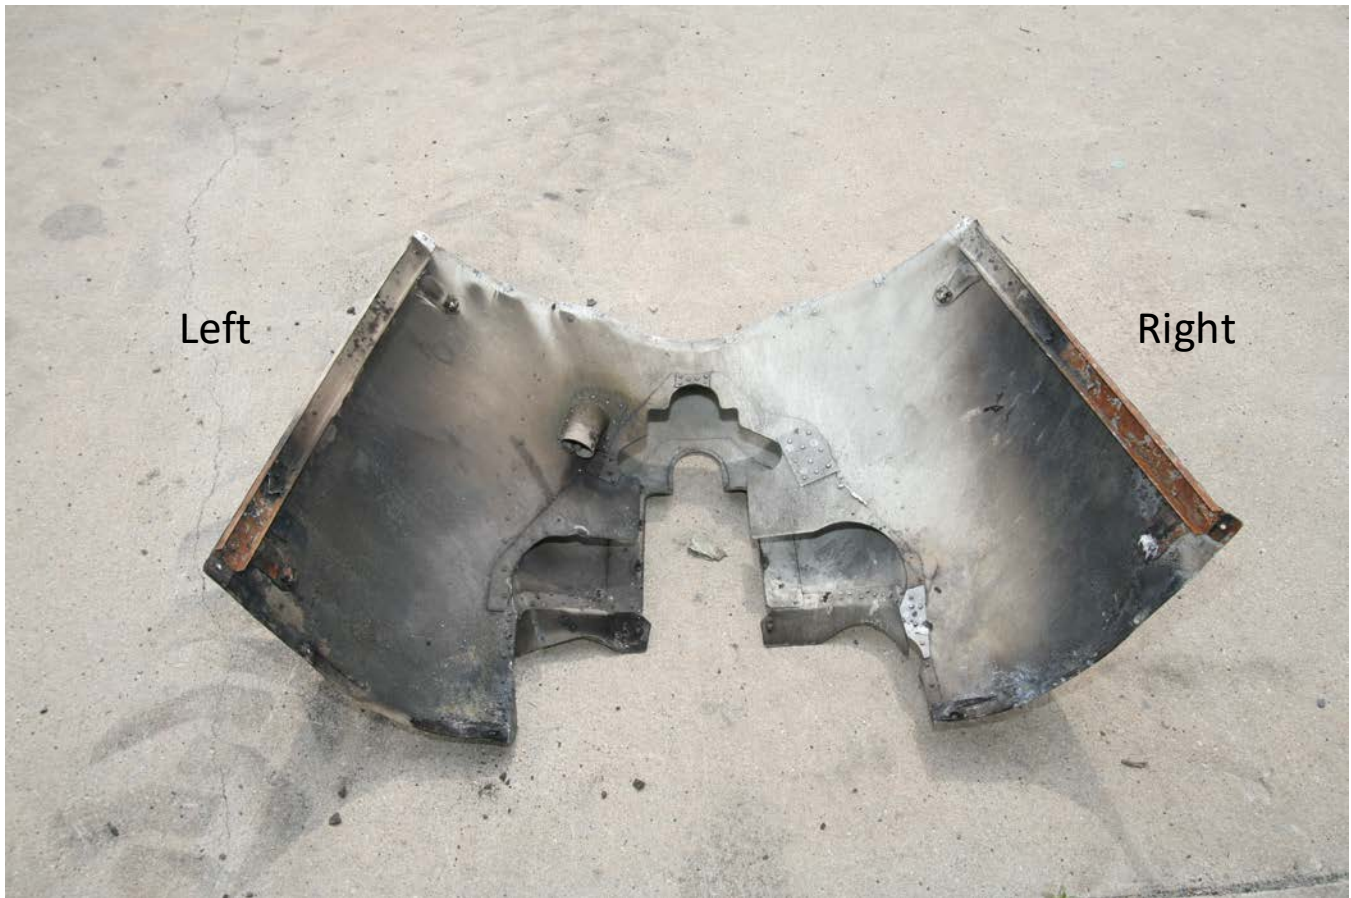
Figure 8: Engine compartment lower cowling (interior side).
