NATIONAL TRANSPORTATION SAFETY BOARD

MATERIALS LABORATORY ERRATA / ADDENDUM REPORT

Report No. 00-148

Place : Nantucket, Massachusetts
Date : October 31, 1999
Vehicle : Boeing 767-366ER
NTSB No. : ~~DCA00M-A006~~ DCA00MA006 GP
Investigator : Scott Warren, AS-40

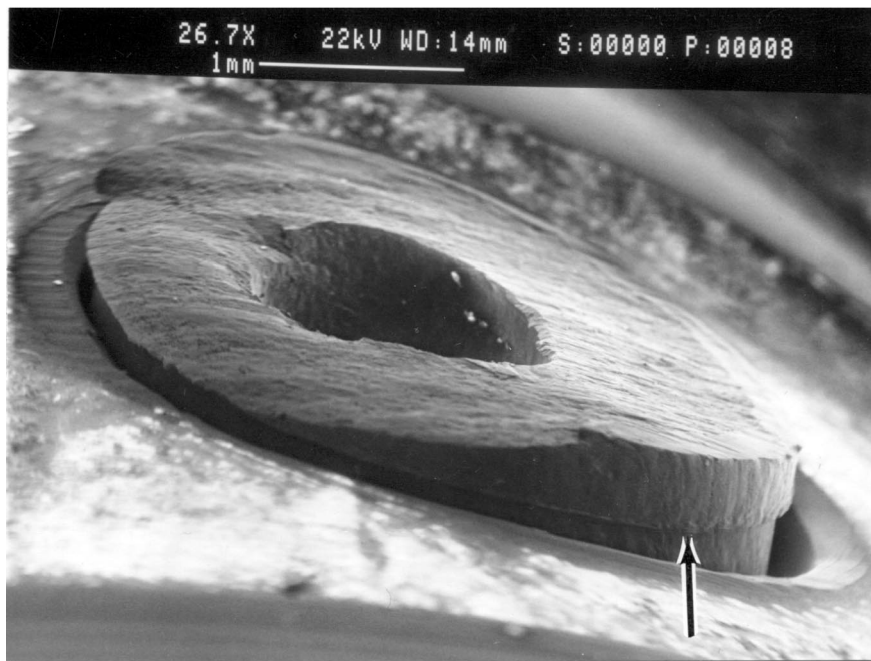
The shank of the other rivet from the No. 5 bellcrank's green arm (opposite from rivet "rv") contained a step at a similar location, flush with the bottom of the recess. Figure 29A shows an SEM view of this rivet fracture, with the step indicated by the arrow. The direction of the deformation associated with this step was as if the rivet was subjected to a shear load opposite to the direction of the shear load associated with the rivet fracture. None of the rivets from the No. 3 and No. 4 bellcranks contained evidence of similar damage. The circumferential damage (crack, mark or step) on the rivets from the No. 5 bellcrank appeared to follow the contour of the corner between the recessed portion of the bearing surface and the rivet hole.¹

Figure 29A. SEM view of the fracture in the rivet located opposite to the rivet denoted by arrow "rv" in figure 28. The arrow indicates the step. (26.7X).
