**Docket No. SA-522**

**Exhibit No. 15-A**

**NATIONAL TRANSPORTATION SAFETY BOARD**

Materials Specialists' Submission  
Selected Photographs and Drawings of the Damage Areas on  
the Vertical Stabilizer and Rudder

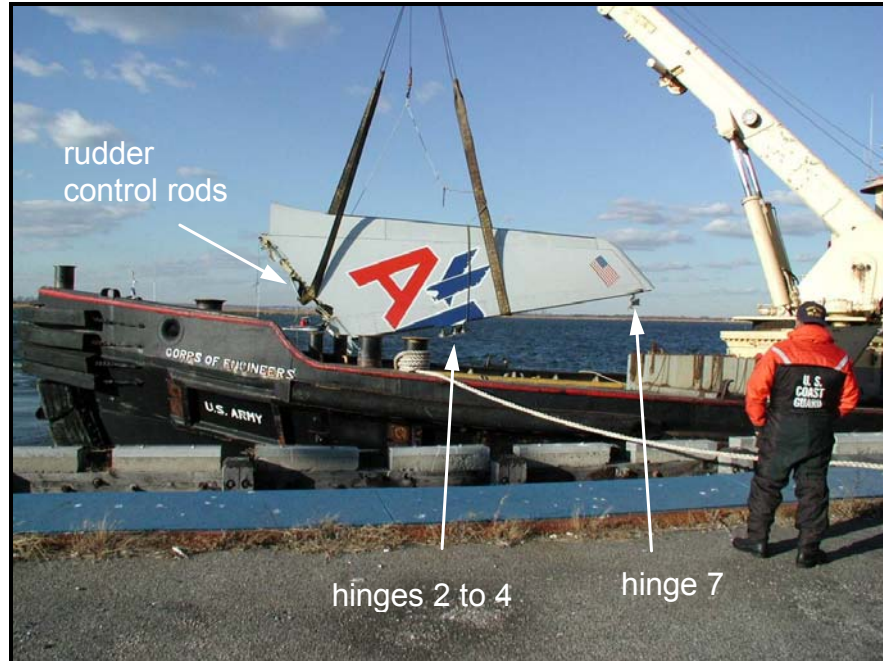
ImageNo:208A0112, Project No:A00386

Figure 3. Recovery photo showing the vertical stabilizer being hoisted from the water. Note hinge 5 is not visible and the control rods are swept aft under the strap at the lower end.

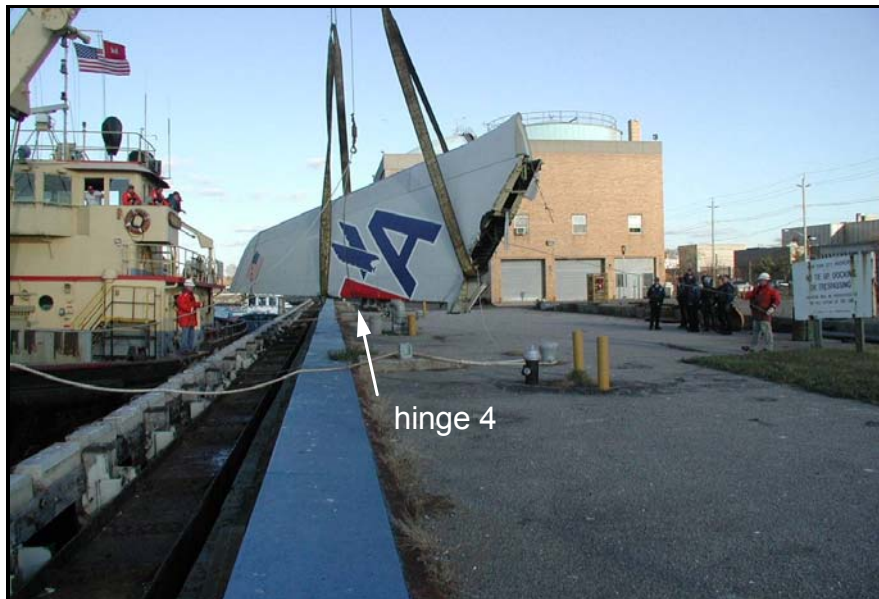
ImageNo: 208A0113, Project No:A00386

Figure 4. Another recovery photo showing the right side of the vertical stabilizer. Note the location of the hoist line just above hinge 4.

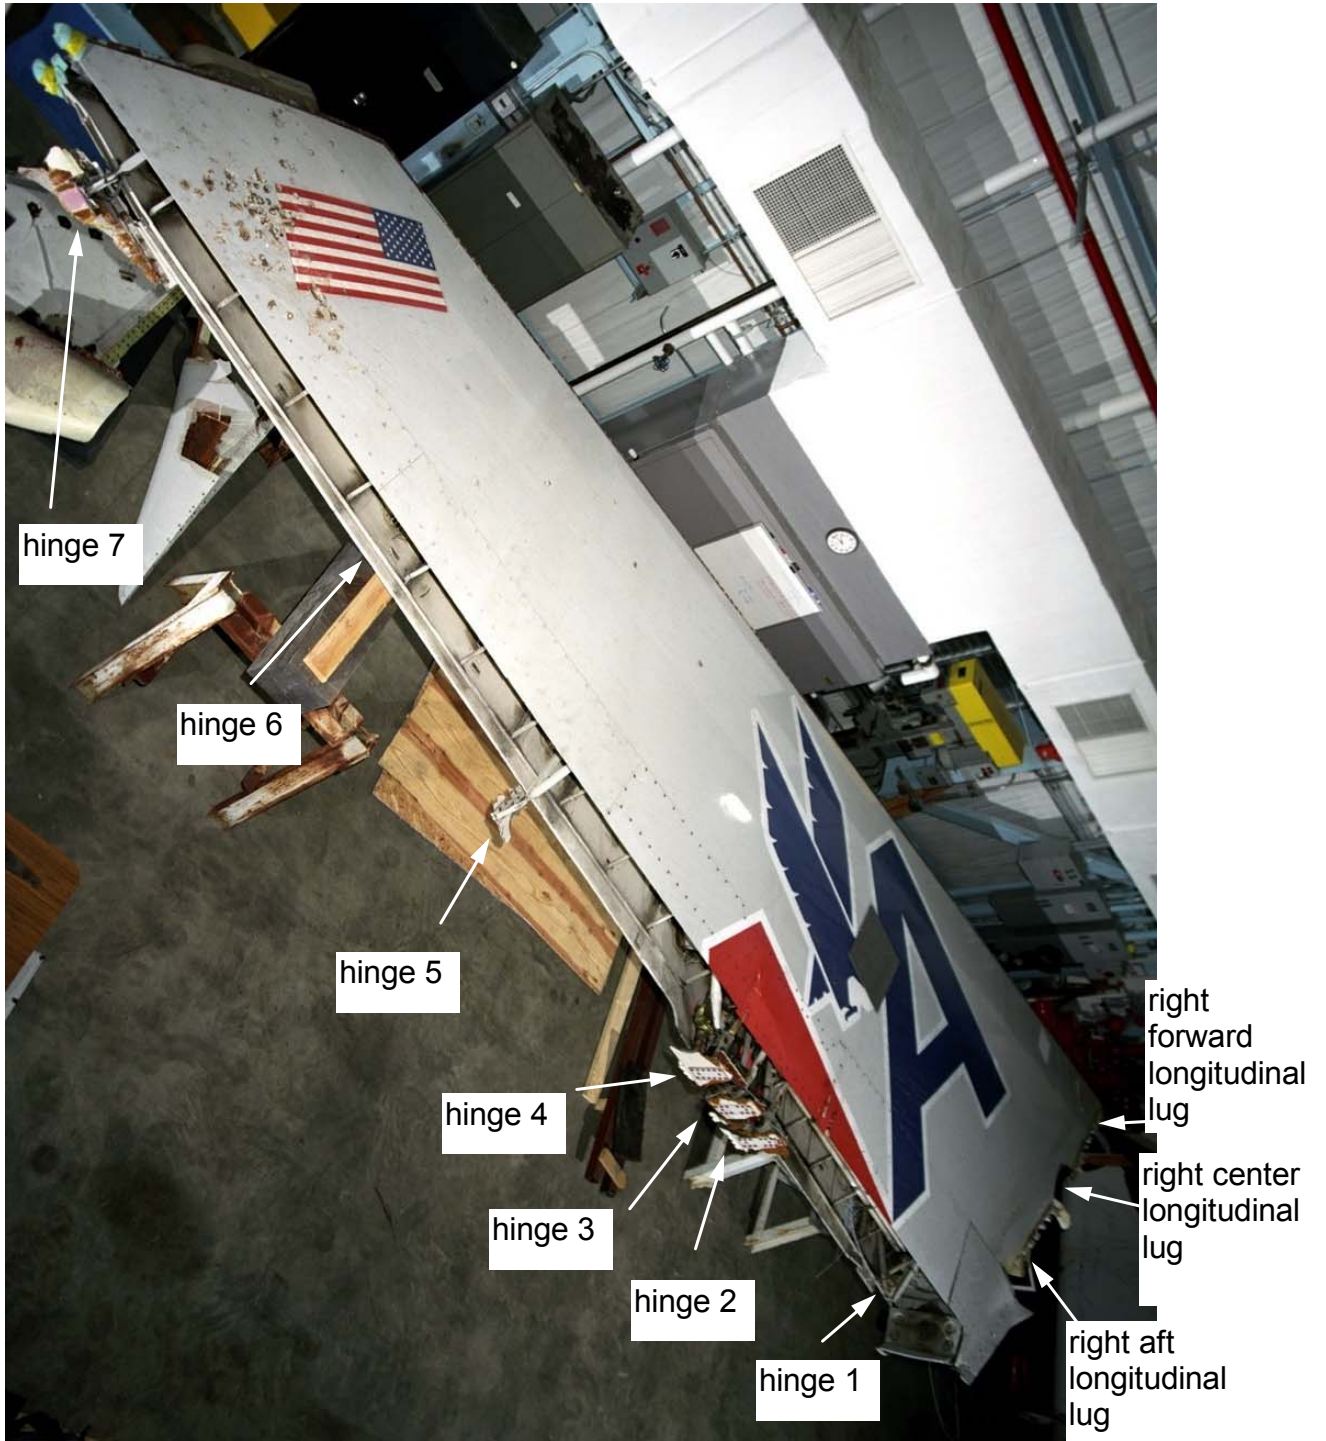
Figure 9. Overall view of the vertical stabilizer as it was examined at NASA Langley.

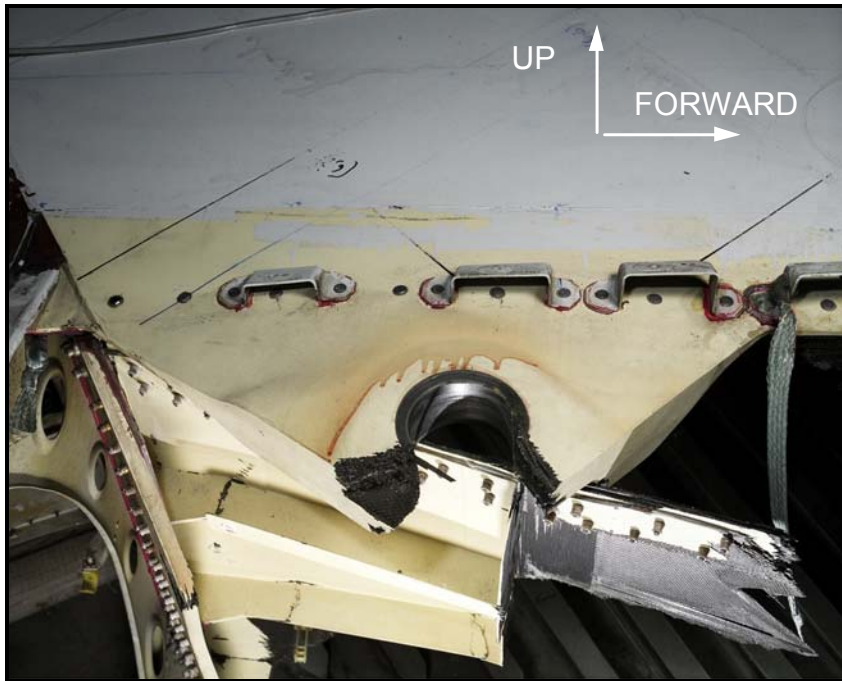
ImageNo:208A0259, Project No:A00386

Figure 12. View of the right aft longitudinal lug on the vertical stabilizer.

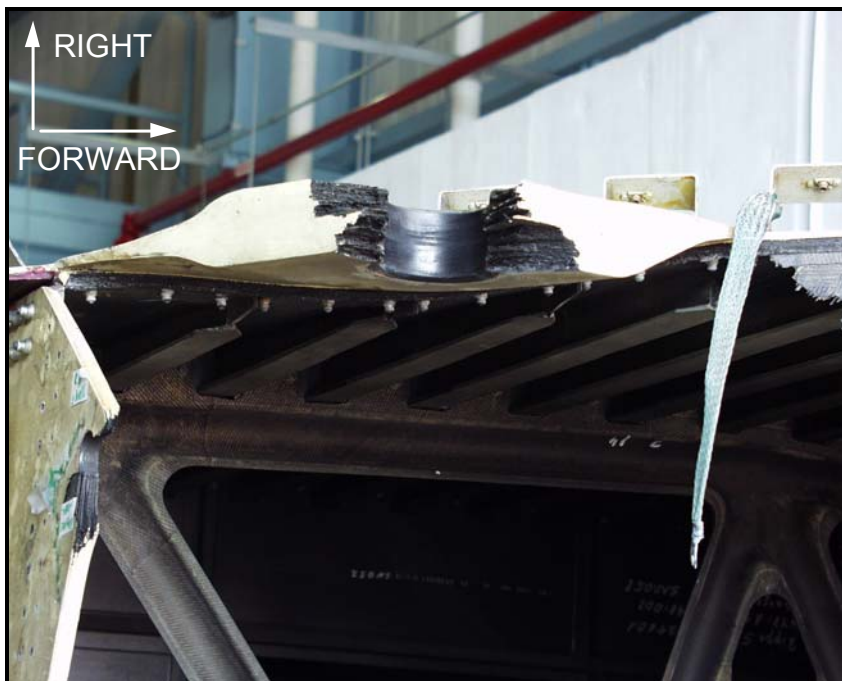
ImageNo: 208A0230, Project No:A00386

Figure 13. Another view of the right aft longitudinal lug on the vertical stabilizer shown after the piece of rib 1 that covered part of the fracture was removed.

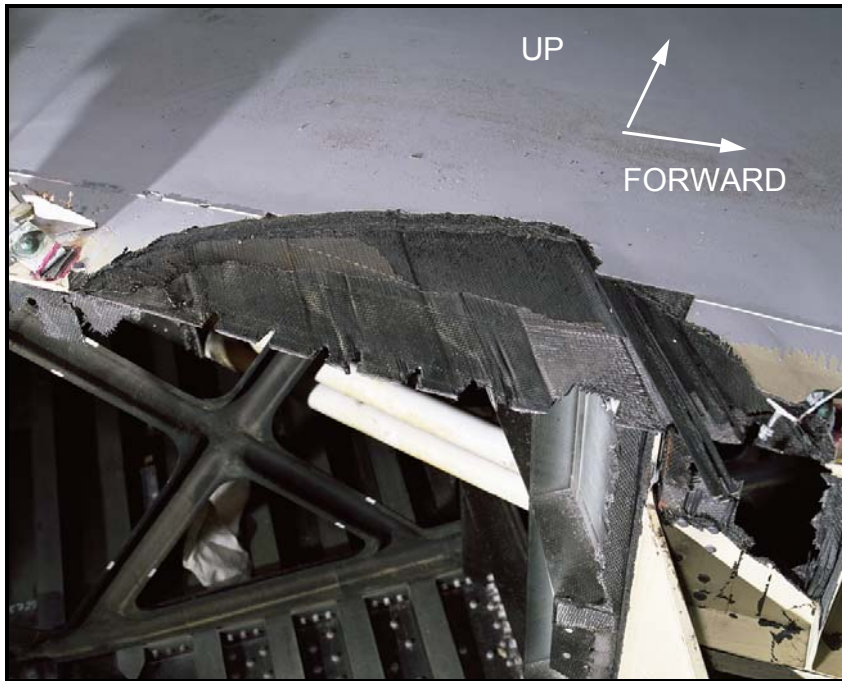
ImageNo:208A0221, Project No:A00386

Figure 14. View of the right center longitudinal lug area on the vertical stabilizer.

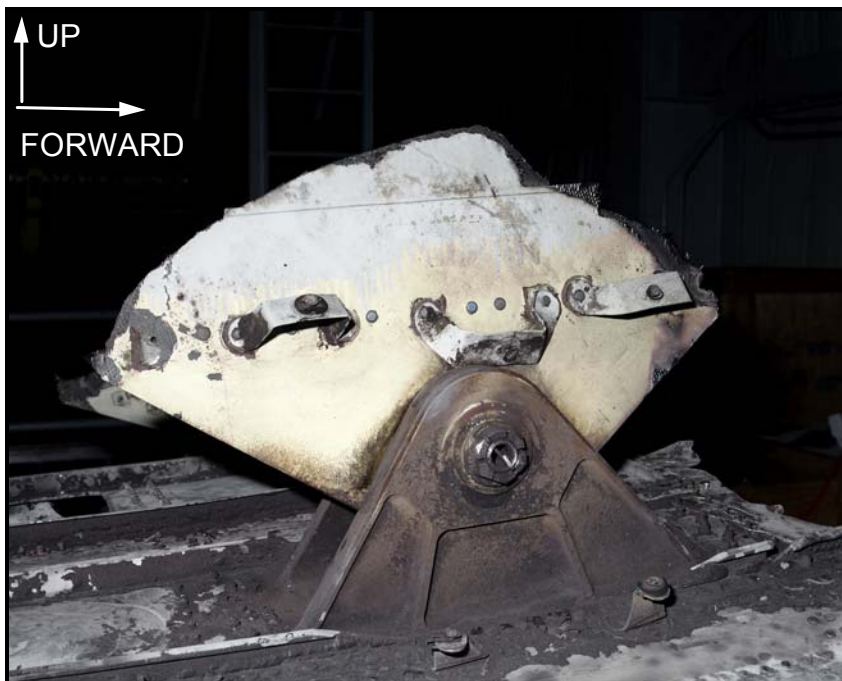
ImageNo: 208A0254, Project No:A00386

Figure 15. View of the mating piece of the right center longitudinal lug that remained attached to the fuselage.

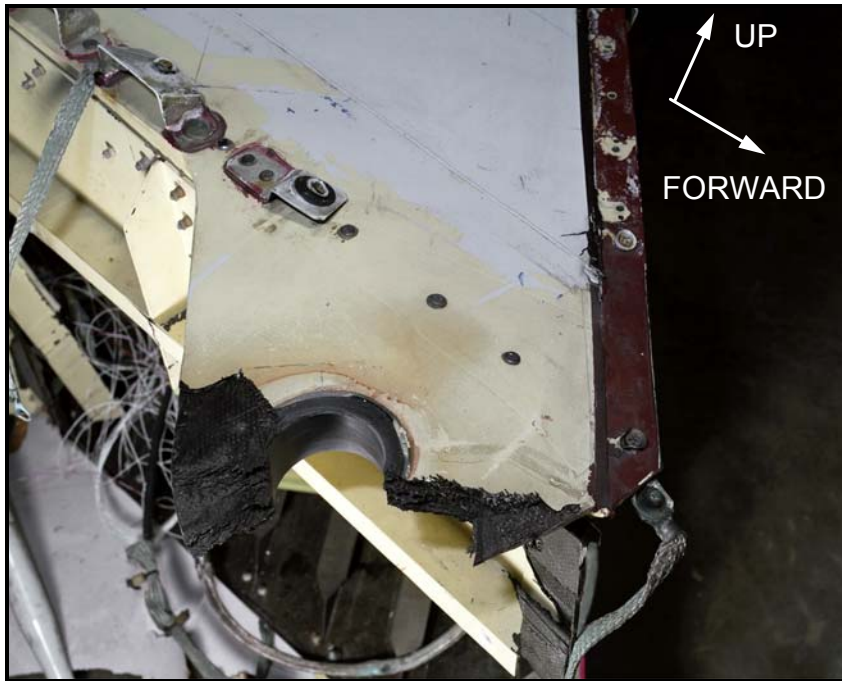
ImageNo:208A0260, Project No:A00386

Figure 16. View of the right forward longitudinal lug on the vertical stabilizer.

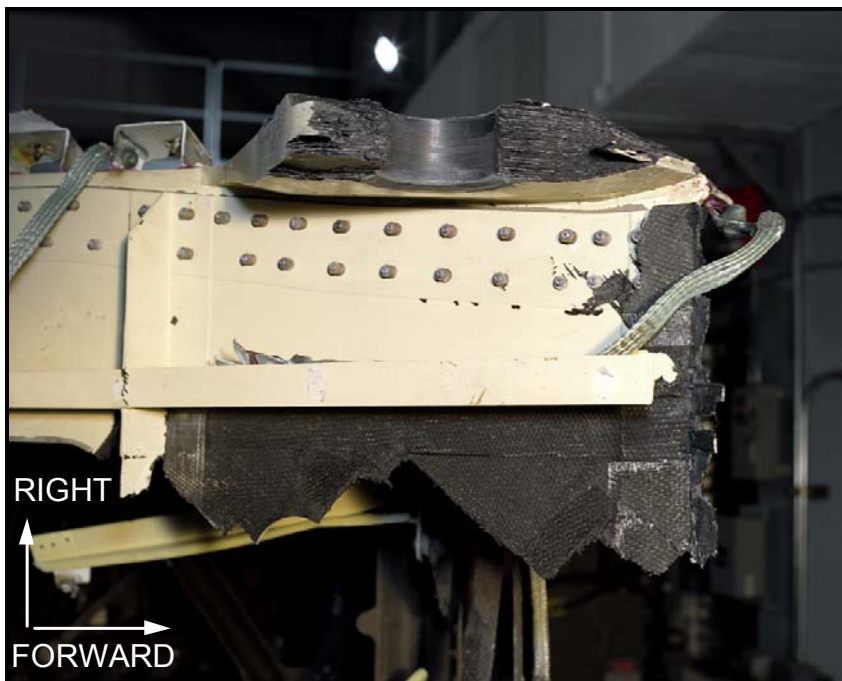
ImageNo: 208A0218, Project No:A00386

Figure 17. Another view of the right forward longitudinal lug on the vertical stabilizer.

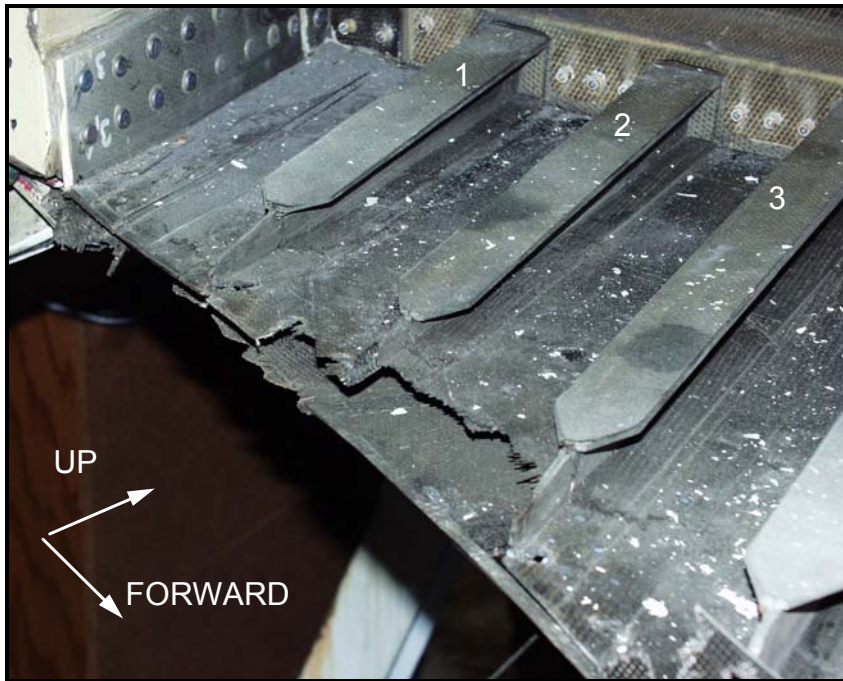
ImageNo:208A0226, Project No:A00386

Figure 18. View of the left aft longitudinal lug area on the vertical stabilizer. Stringers 1, 2, and 3 are labeled.

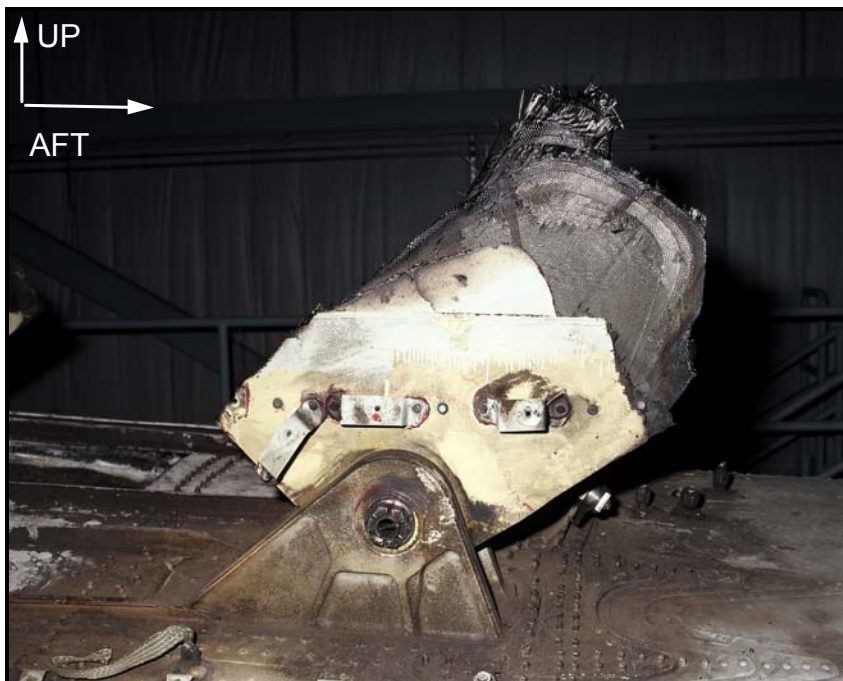
ImageNo: 208A0256, Project No:A00386

Figure 19. View of the mating left aft longitudinal lug piece that remained attached to the fuselage.

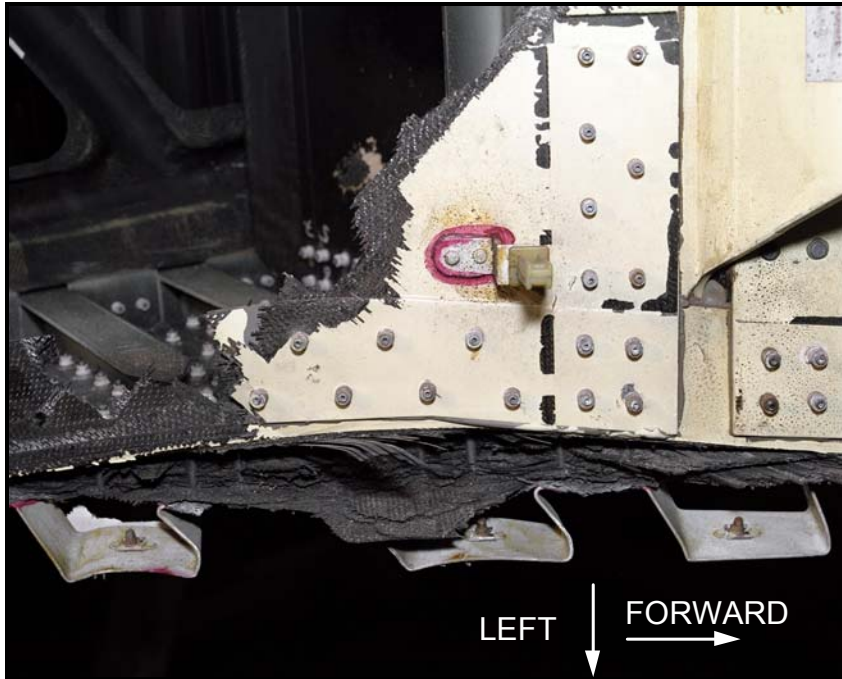
ImageNo:208A0253, Project No:A00386

Figure 20. View of the translaminar fracture for the left center longitudinal lug.

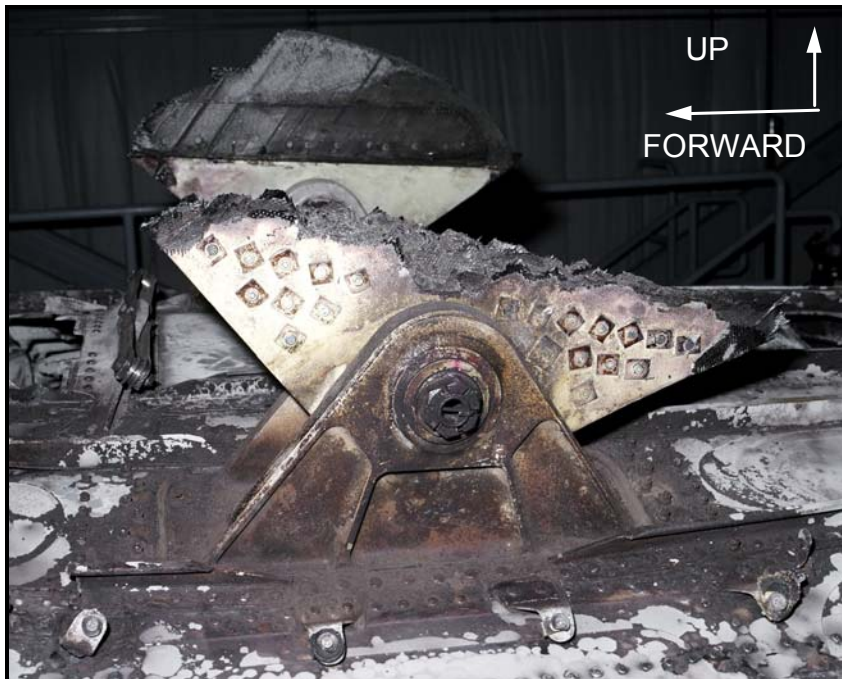
ImageNo: 208A0255, Project No:A00386

Figure 21. View of the left center longitudinal lug that remained attached to the fuselage. Repair rivets with square angle shims are visible on the surface.

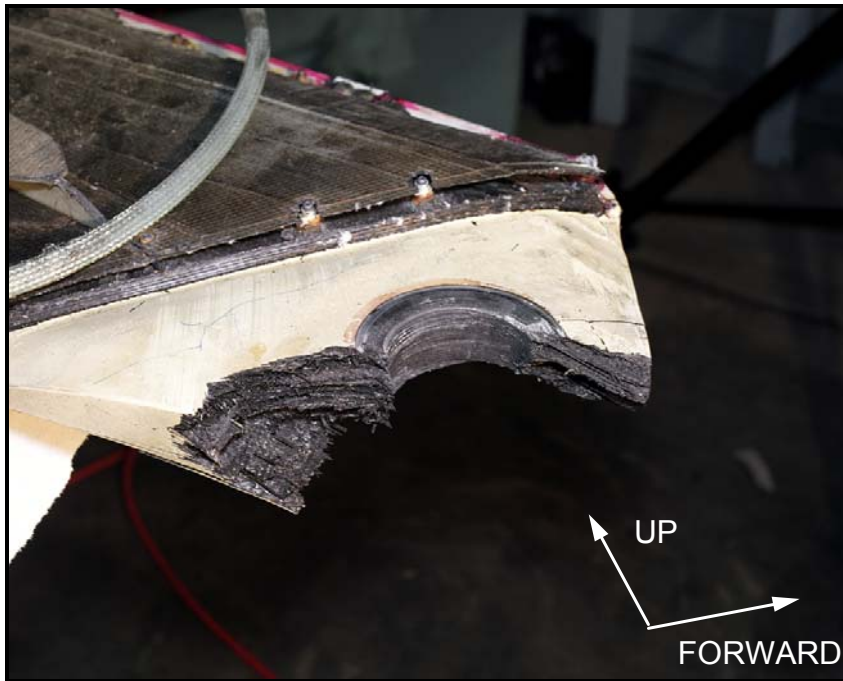
ImageNo:208A0219, Project No:A00386

Figure 22. View of the left forward longitudinal lug on the vertical stabilizer.

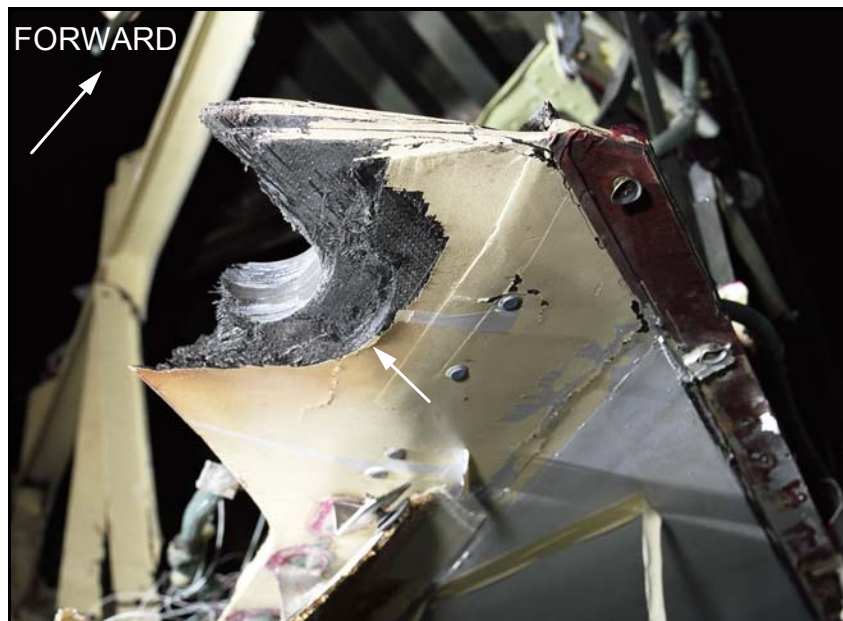
ImageNo: 208A0252, Project No:A00386

Figure 23. Another view of the left forward longitudinal lug on the vertical stabilizer showing the left side. An unlabeled arrow indicates an area of crushing damage corresponding contact with the upper end of the metal fuselage attach fitting lug.

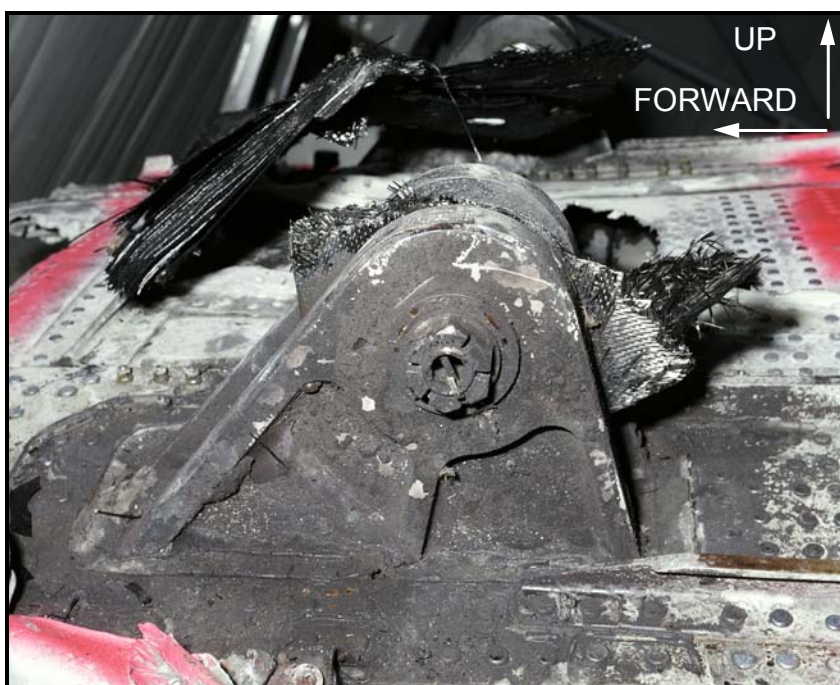
ImageNo:208A0257, Project No:A00386

Figure 24. View of the lower piece of the left forward longitudinal lug that remained attached to the fuselage.

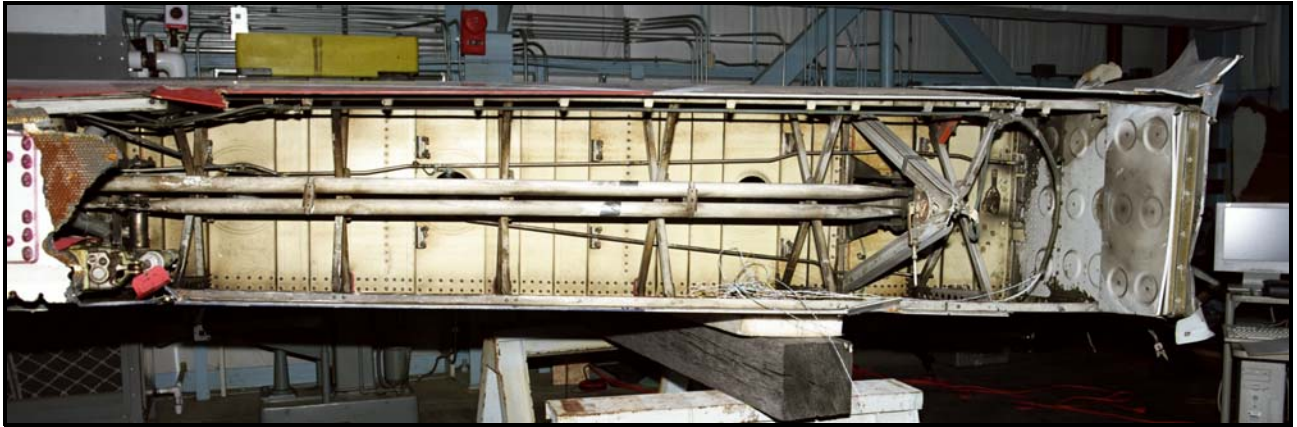
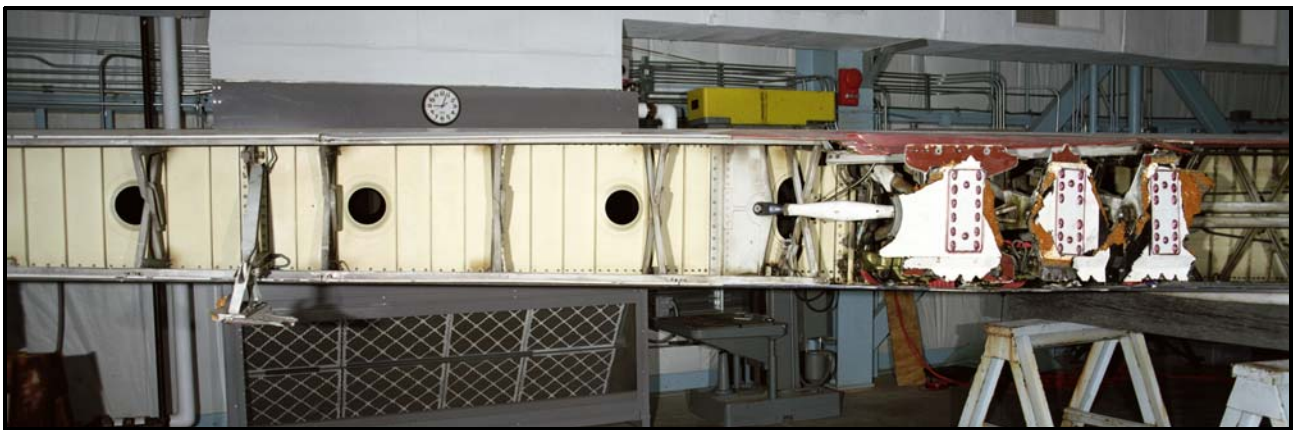
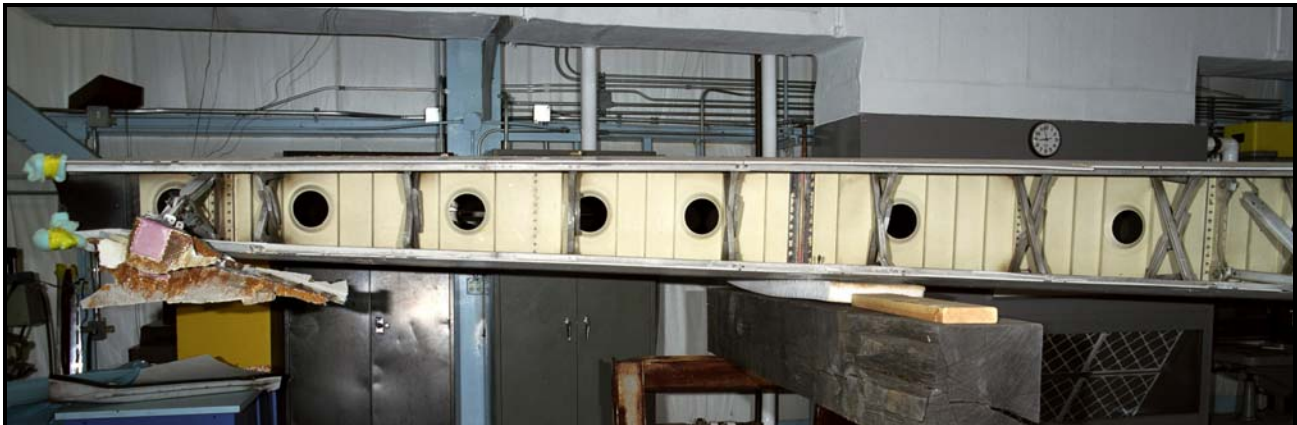
Figure 29. Overall views of the vertical stabilizer trailing edge.

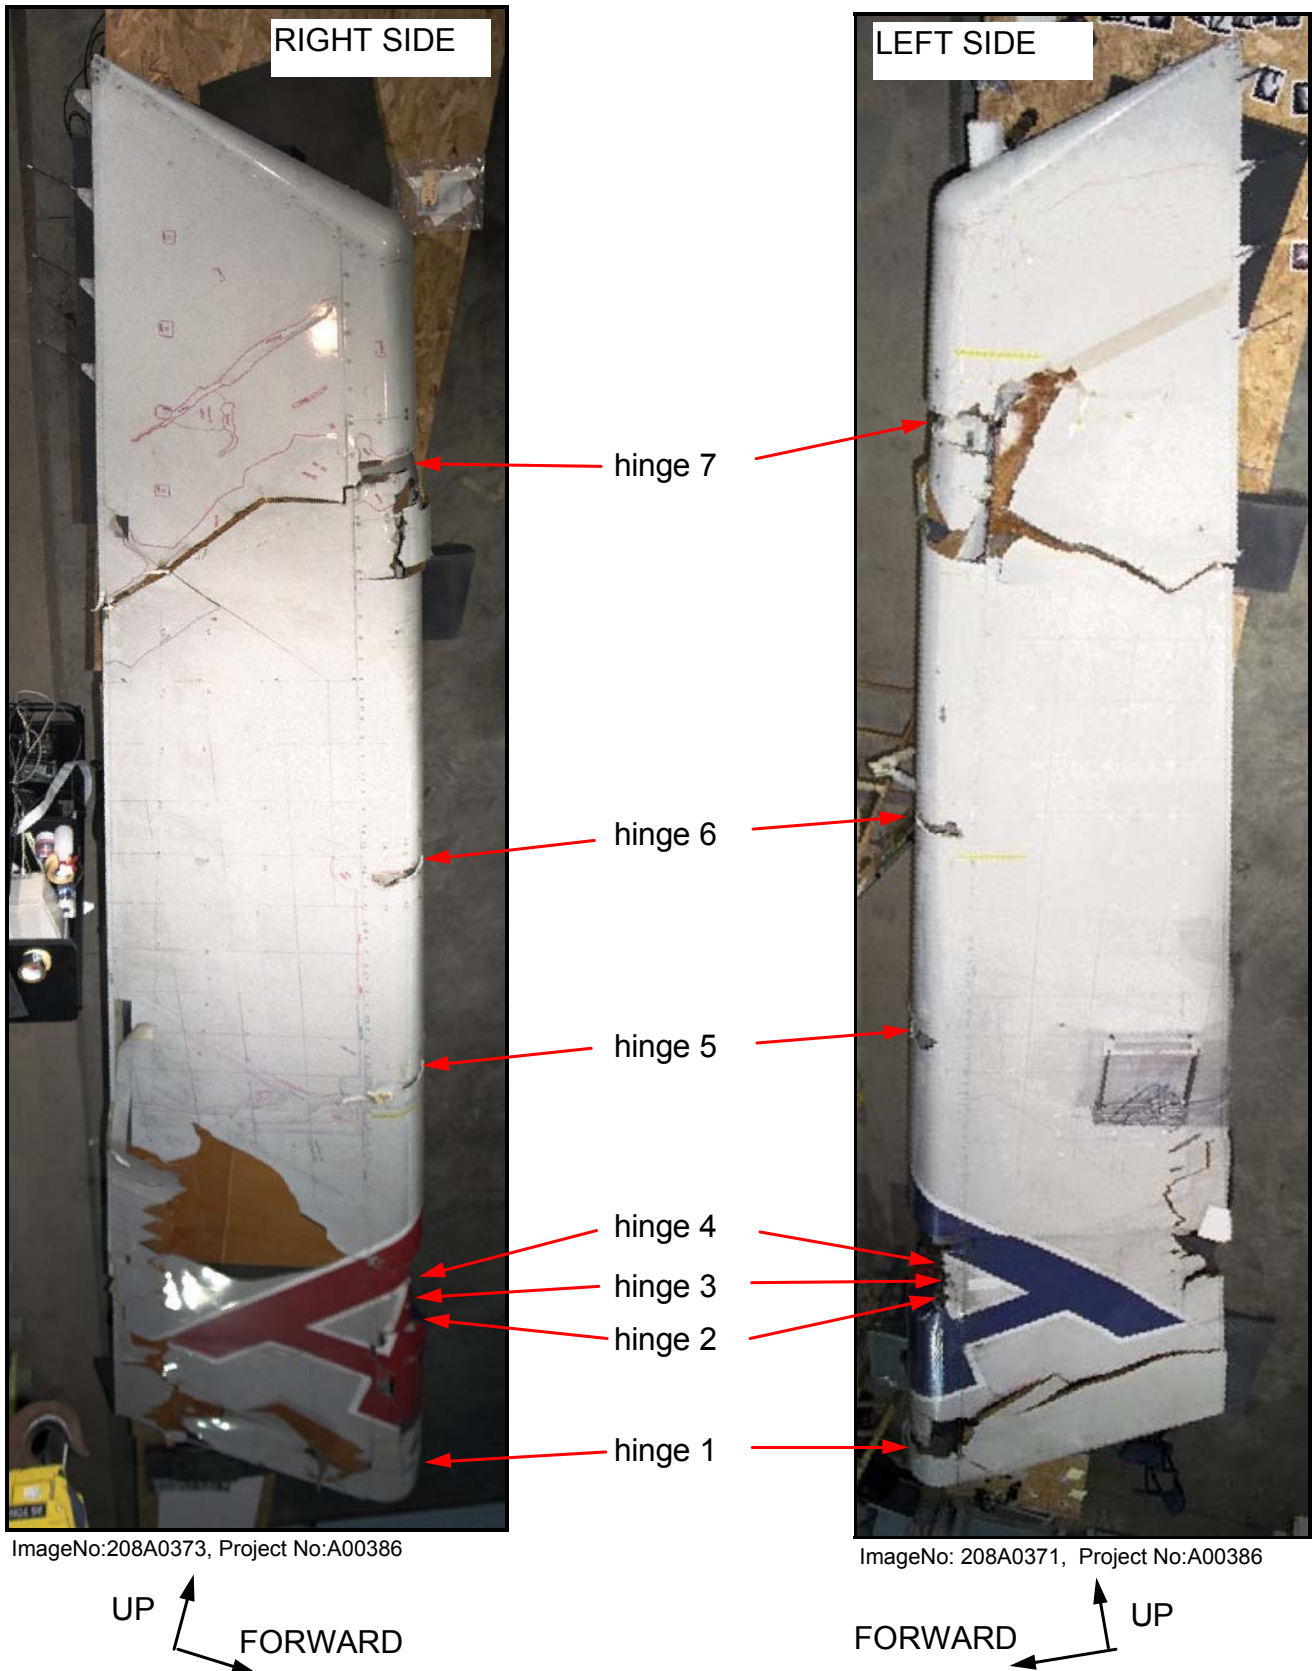
Figure 46. Overall view of the right and left sides of the rudder as viewed from above. With this perspective, the upper and lower ends appear larger and smaller, respectively. Lamb wave equipment used for nondestructive examination is shown on the left skin panel.

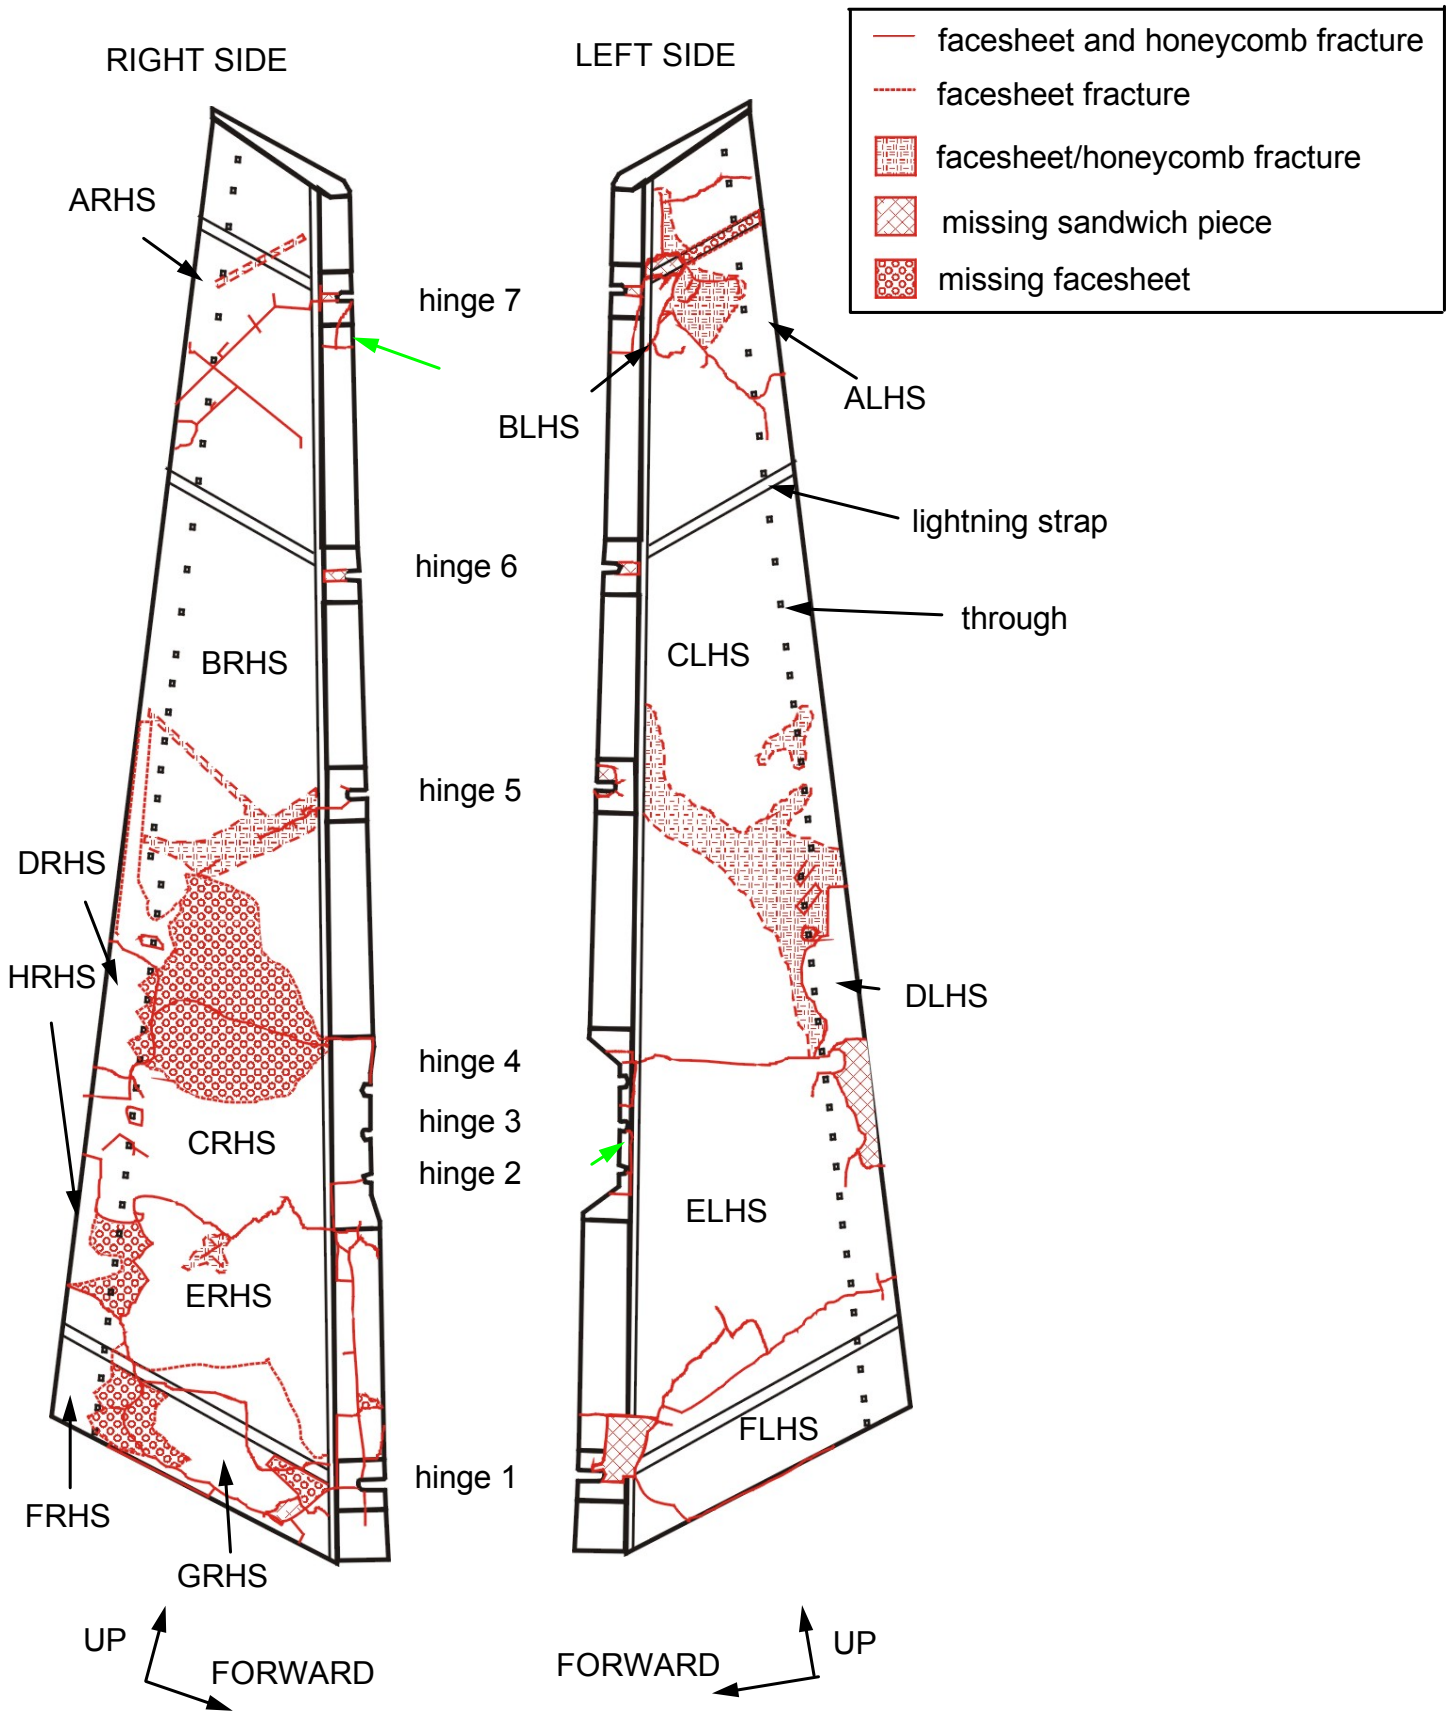
Figure 47. Drawings of the right and left sides of the rudder showing the approximate locations of fractures and missing pieces. Unlabeled green arrows indicate fairing pieces that were found on land. Piece GRHS was also found on land.
