Docket No. SA-522

NATIONAL TRANSPORTATION SAFETY BOARD

Materials Specialists' Submission
Selected Results of the Nondestructive Examination of the
Vertical Stabilizer and Rudder

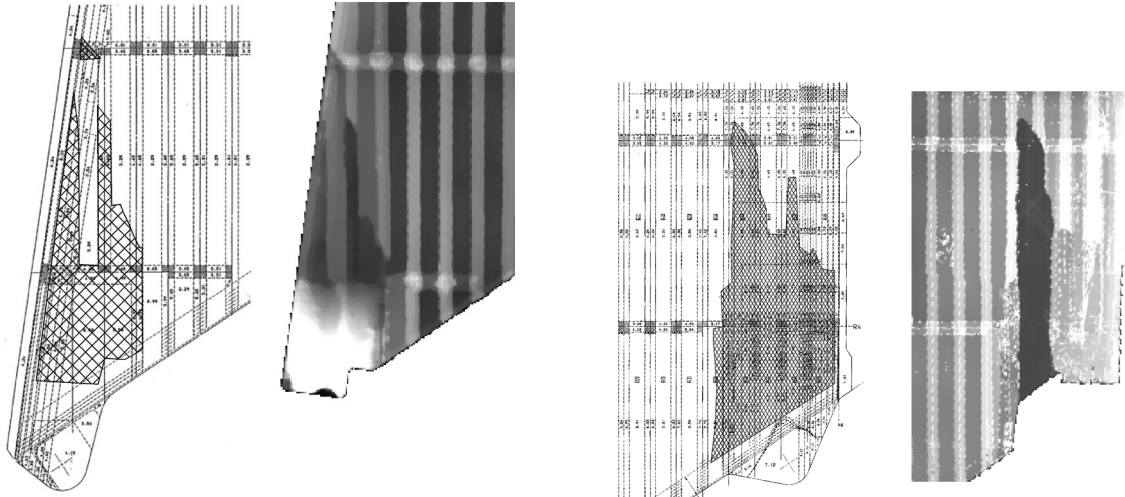
Figure 1.04 Expanded view showing delaminations at the lower end near the forward and aft spars.

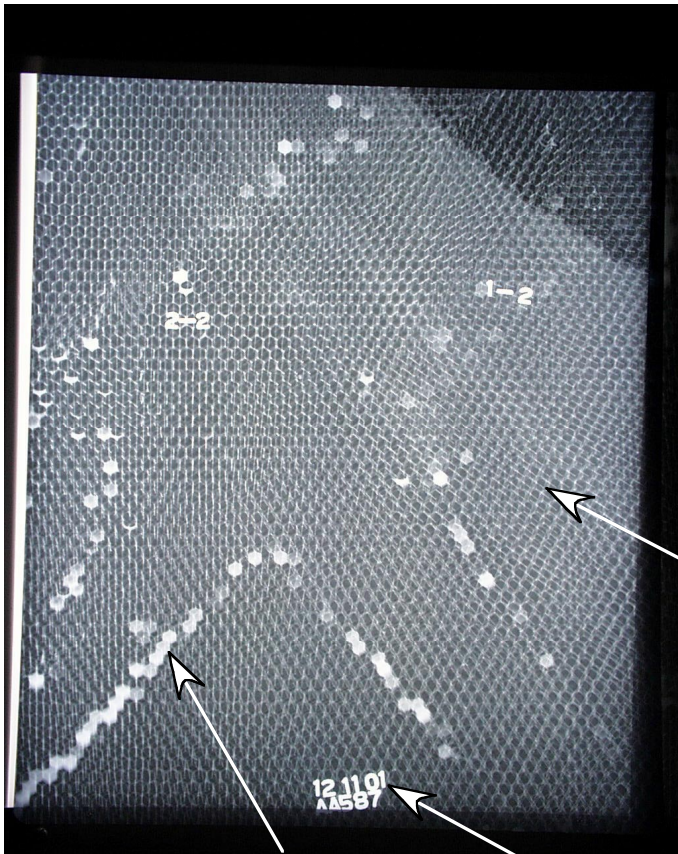
Figure 3.01 Radiographic image of water in honeycomb of rudder.

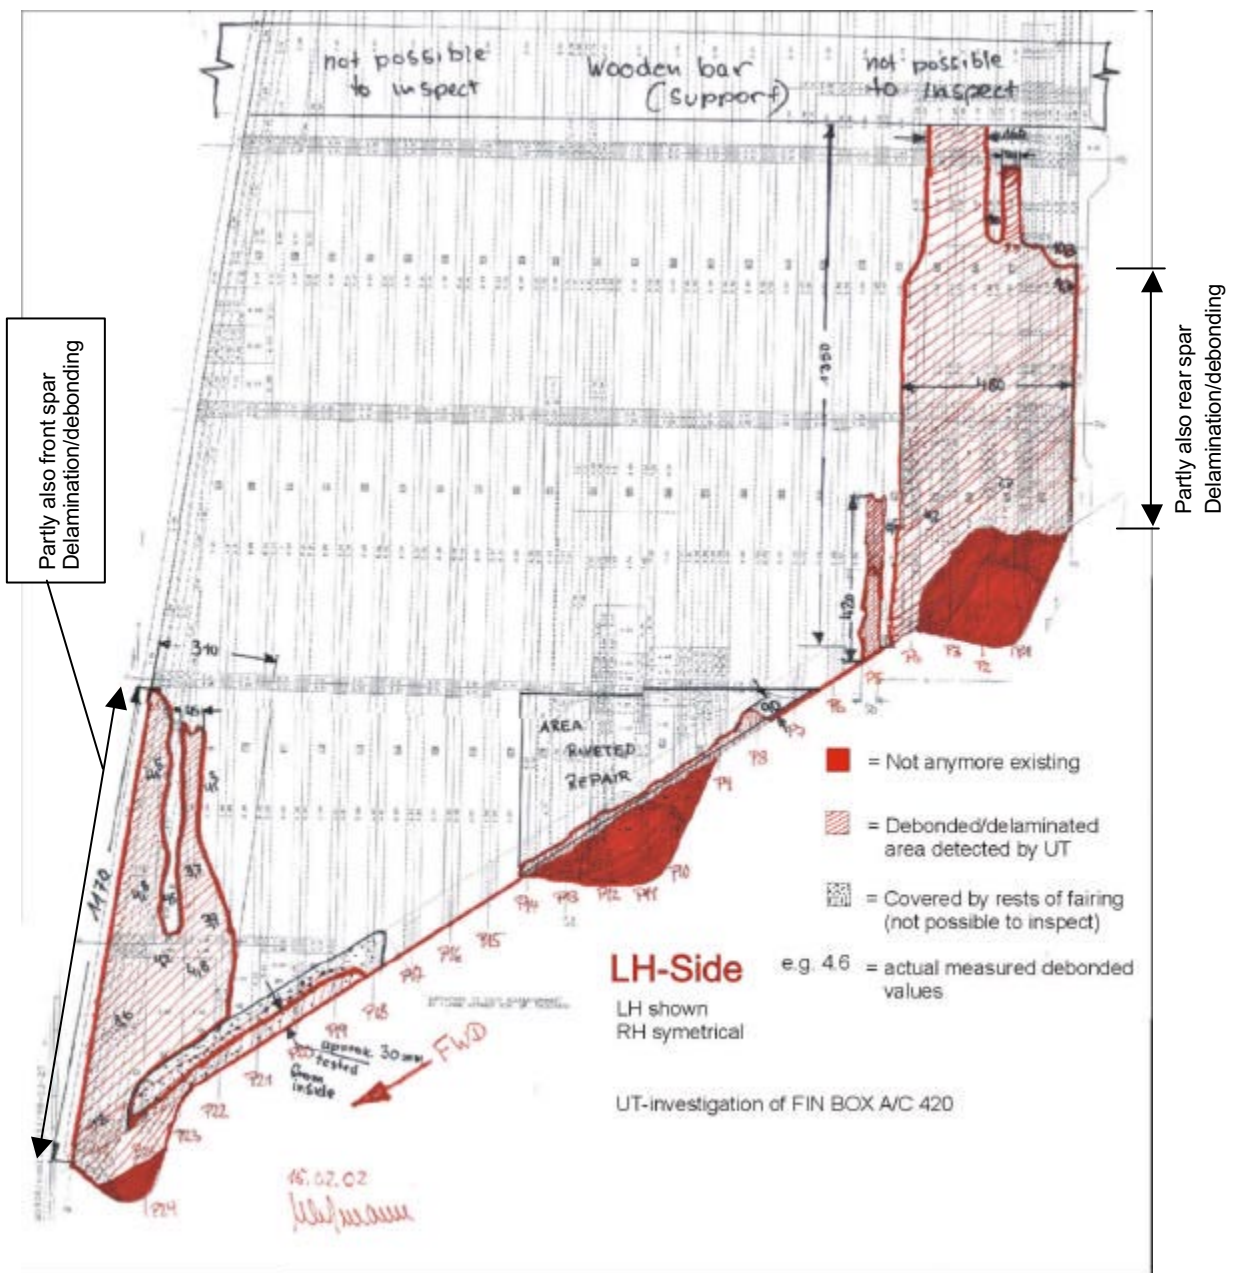
Fig.02: Test Results of Lug region from LH-side and shell above the lugs

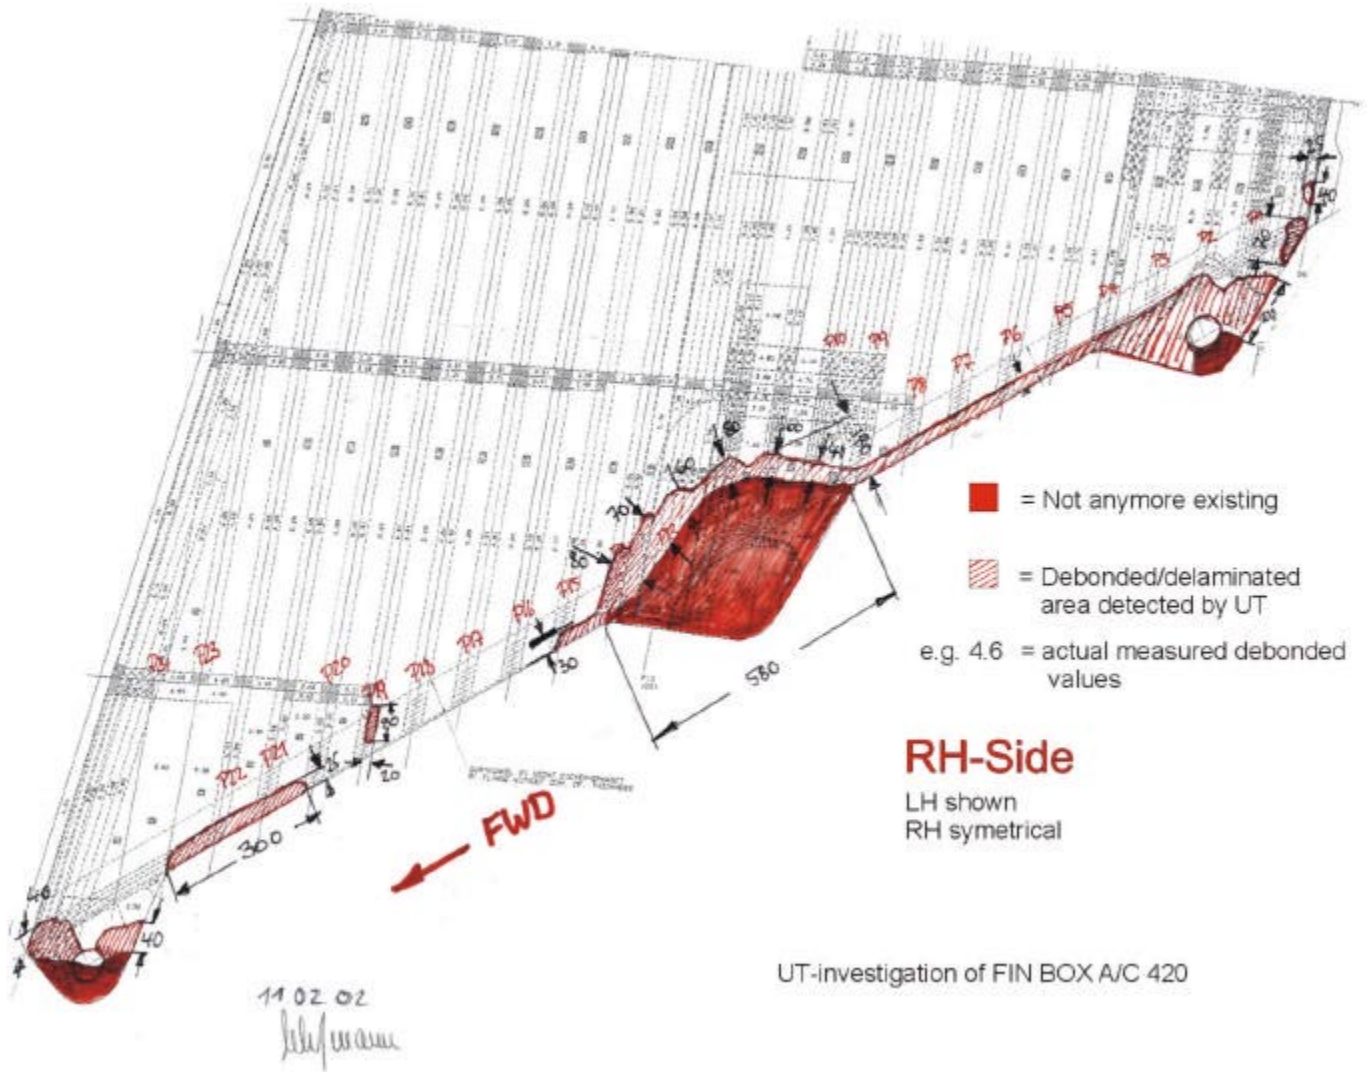
FIG. 03: Test Results of Lug region from RH-side and shell above the lugs

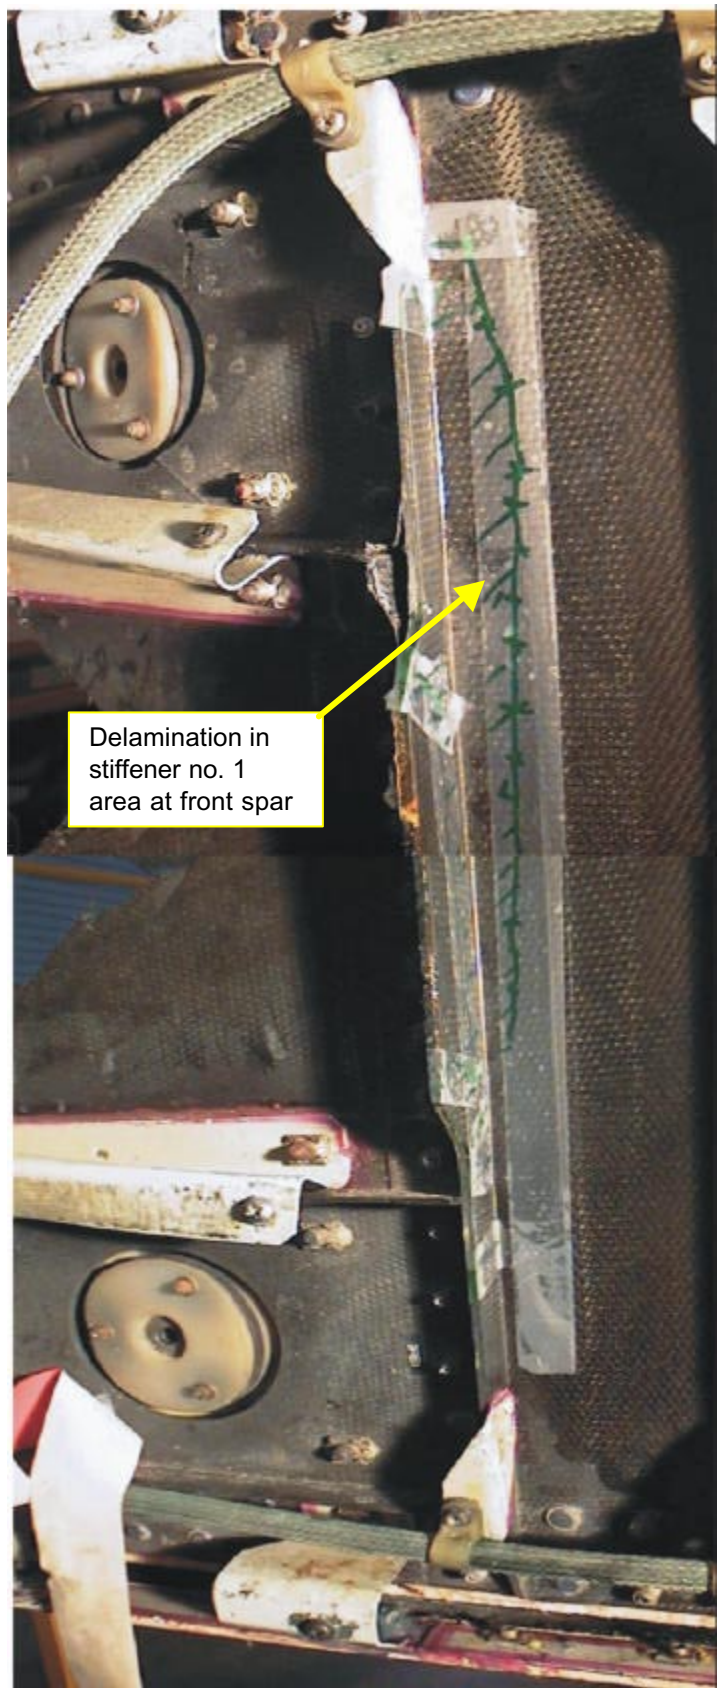
Delamination in stiffener no. 1 area at front spar

Photo no. 01: Delamination at front spar; stiffener no. 1

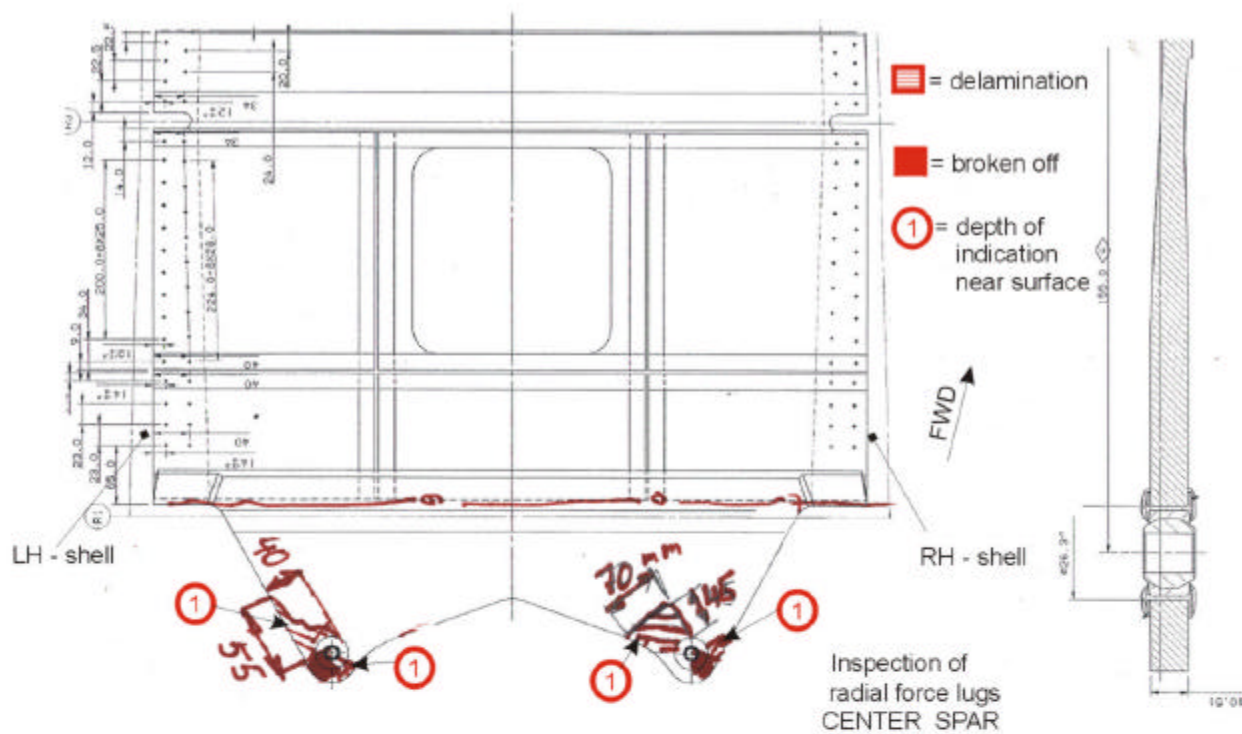
FIG. 05: Test results of center spar radial force lugs

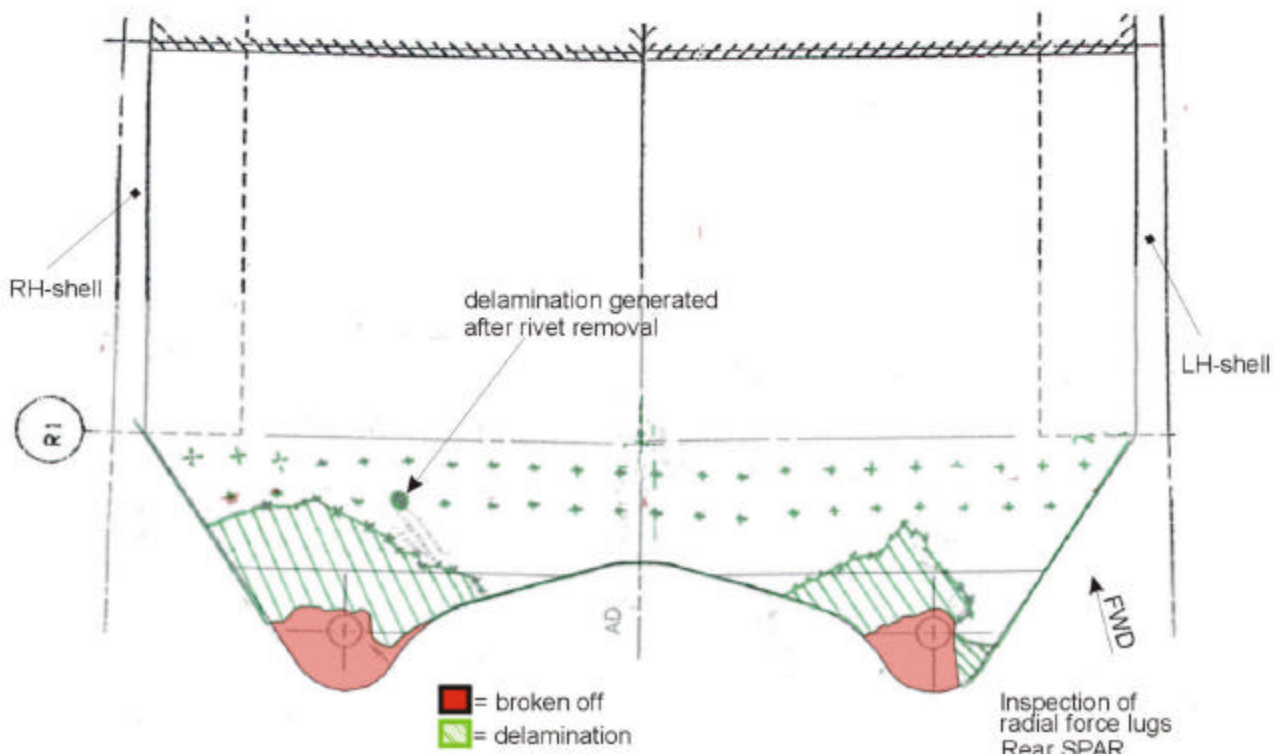
Fig.06: Test results of rear spar (radial force lugs)

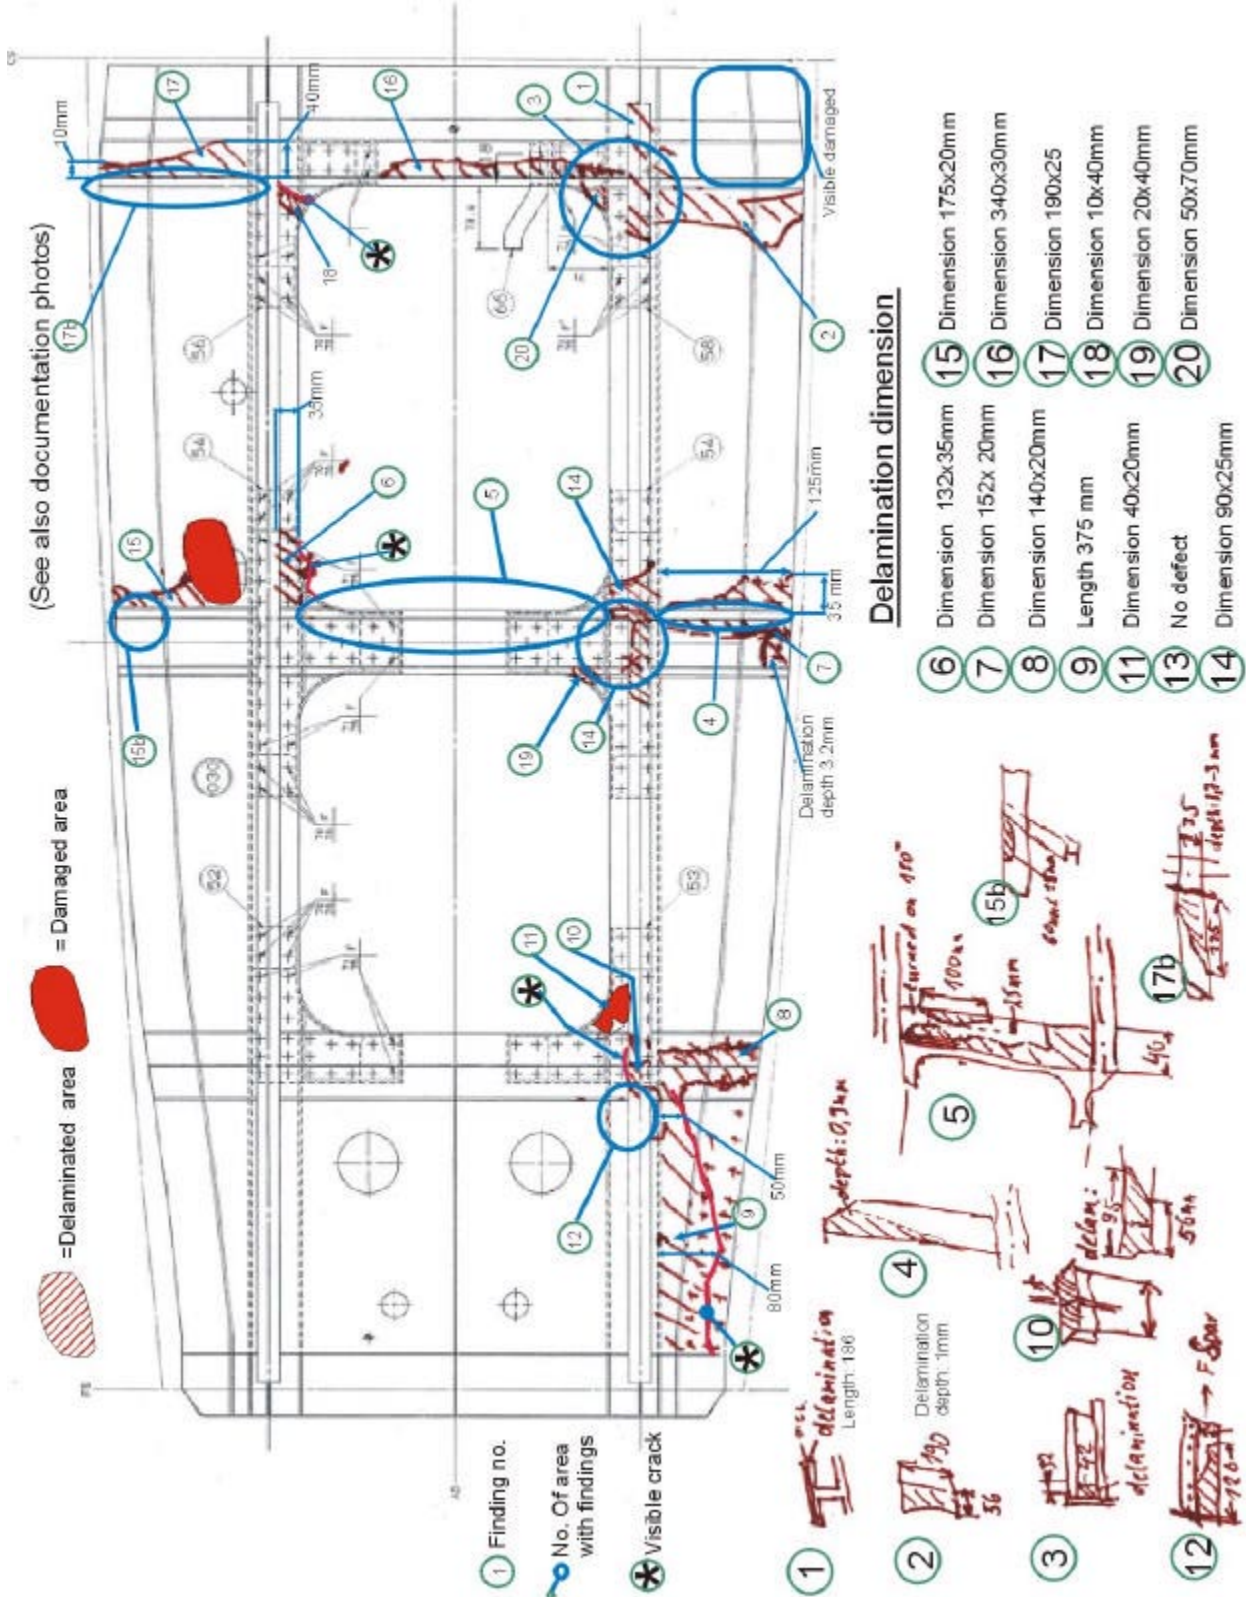
FIG.08: Delamination areas; damages in the area of rib no. 1 between center spar and front spar

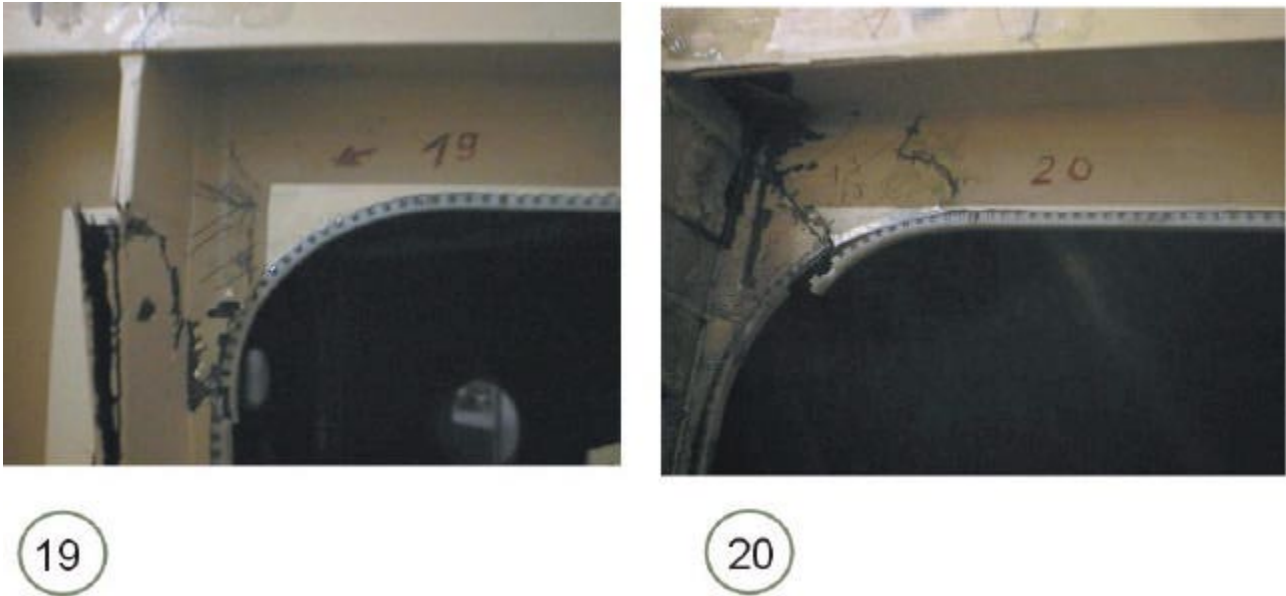
Fig.12: Photo documentaion of Findings 19-20 between center spar and front spar

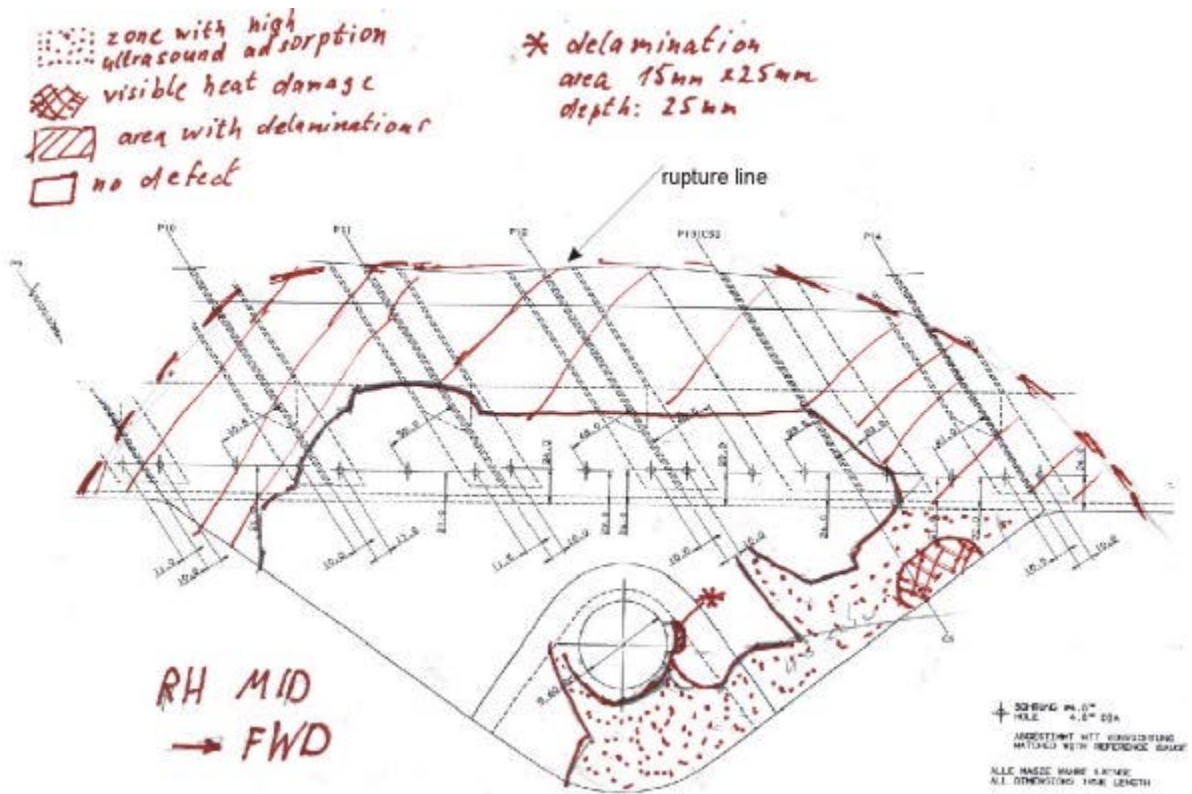
Fig. 13: Test results of UT-inspection at separated center lug / RH

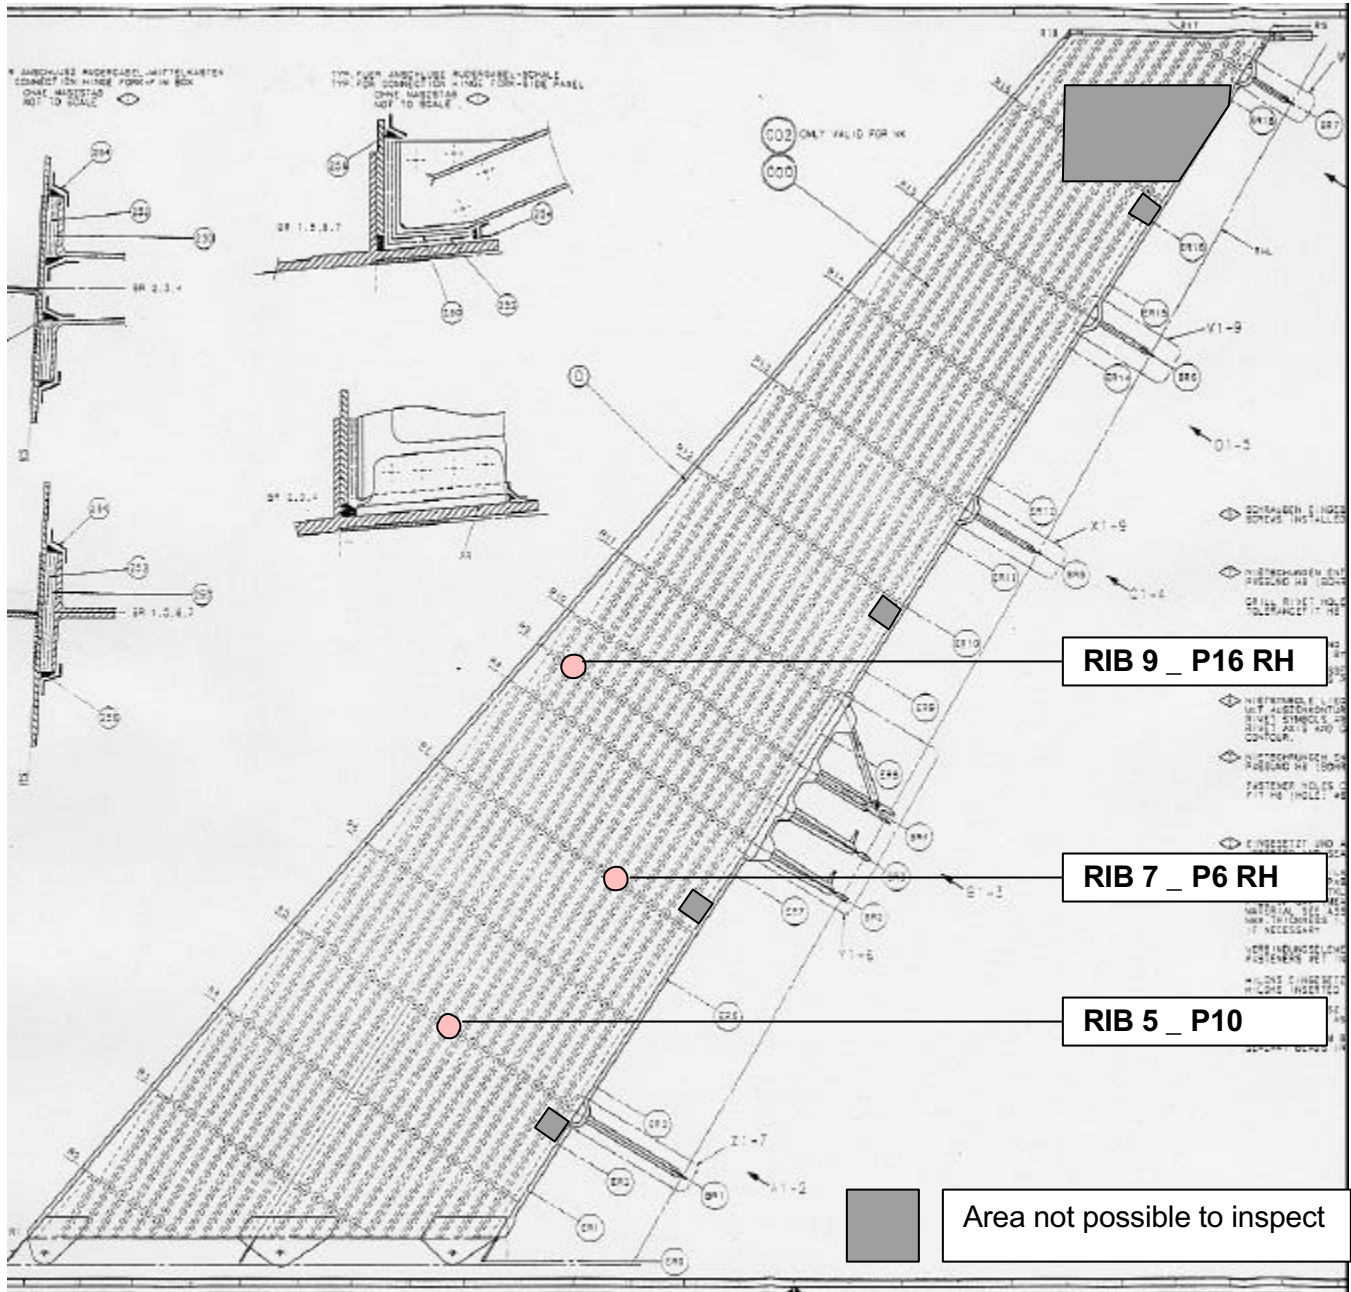
Indication vertical stabilizer A300-600 MSN420 RH

NOTE: All above documented indications are below the size to be registered in accordance with the quality requirements (see also the following detail sketches).

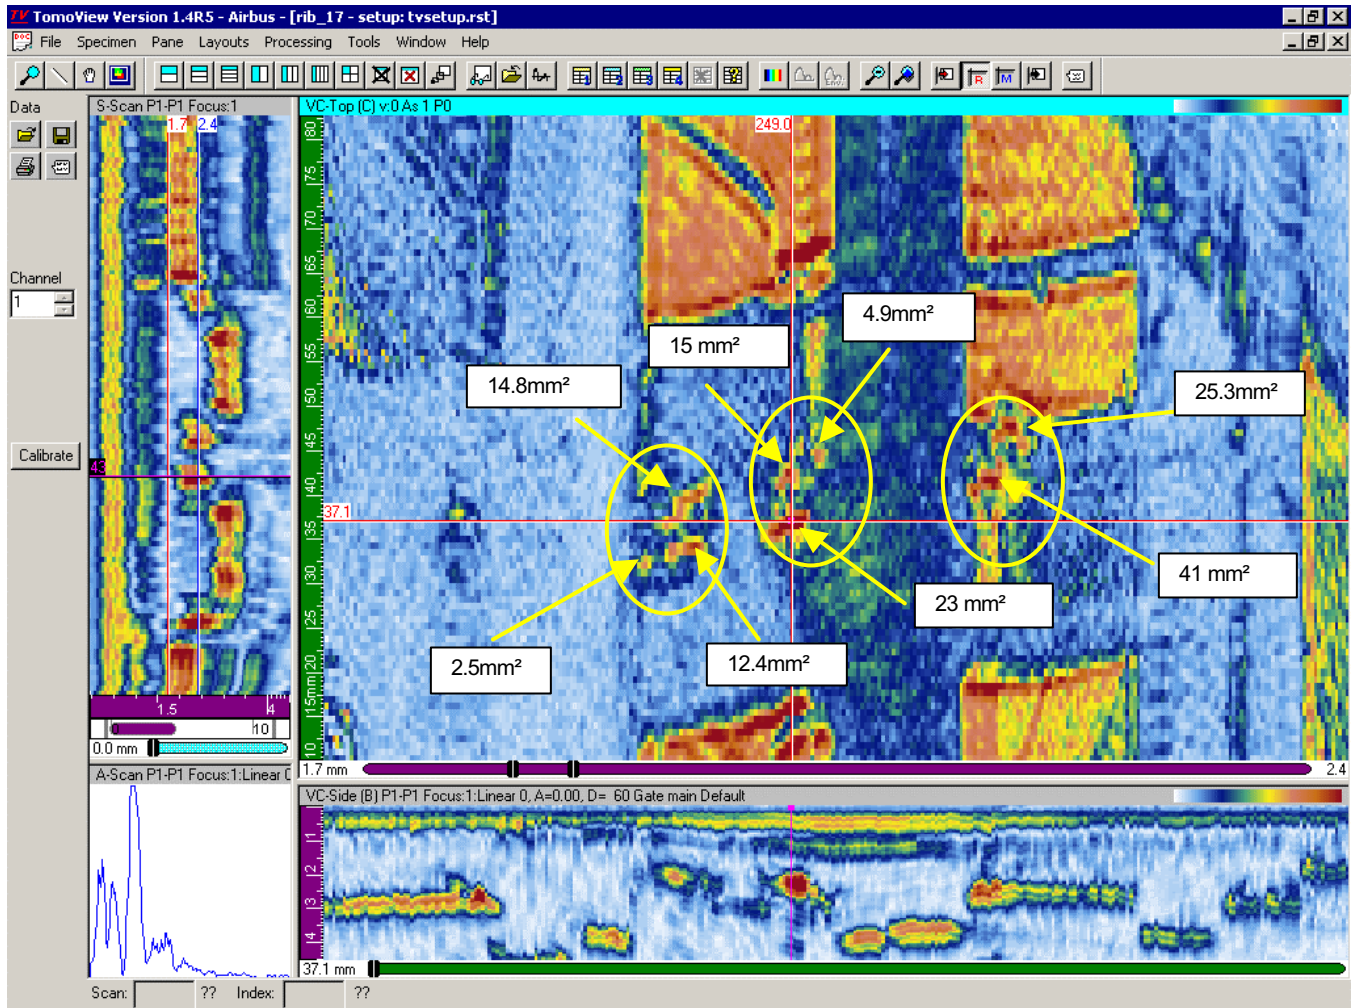
RIB 17 _ P1 - P3 LH

NOTE: The above illustrated area belongs to the quality requirement zone D, which means that a max. extension of de-lamination of 250mm² is permissible.

NOTE: All above documented indications are below the size to be registered in accordance with the quality requirements.
