Docket No. SA-522

Exhibit No. 15-C

NATIONAL TRANSPORTATION SAFETY BOARD

Materials Specialists' Submission
Selected Photographs of the Fractographic
Examination of the Vertical Stabilizer

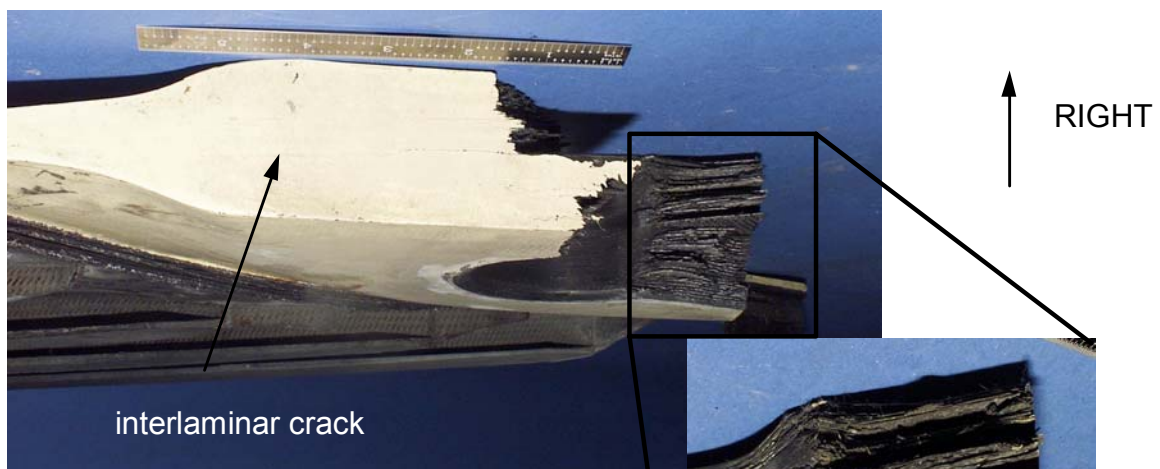
Figure 5. The right aft lug as viewed looking upward and forward. The fracture surface on the forward leg of the lug is shown in detail. Unlabeled arrows indicate bearing damage adjacent to the fracture.

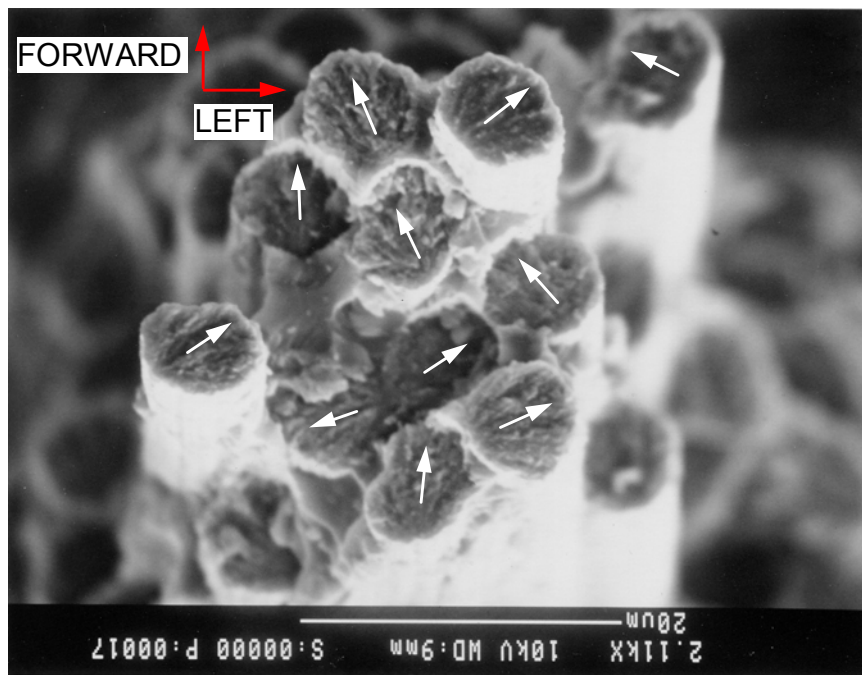
Figure 8. Typical appearance of the fractured zero-degree fibers on specimen RA3-2 near the center of the total lug thickness. Arrows on fractured fibers indicate direction of fracture propagation through the fiber.

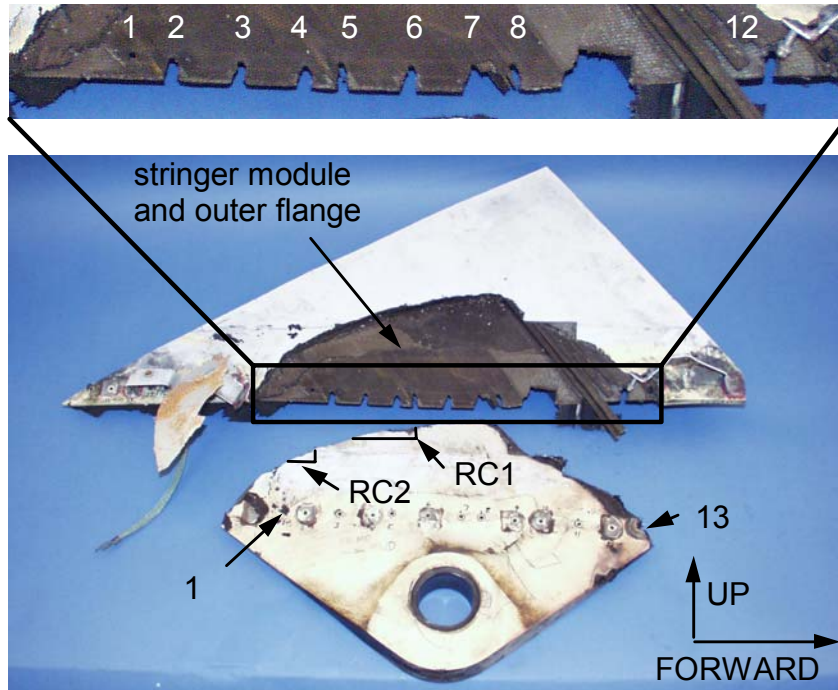
Figure 9. Overall view of the right center lug pieces viewed from the right with the upper photograph showing details of the rib 1 fastener hole tearouts in the stringer module and outer flange layers.

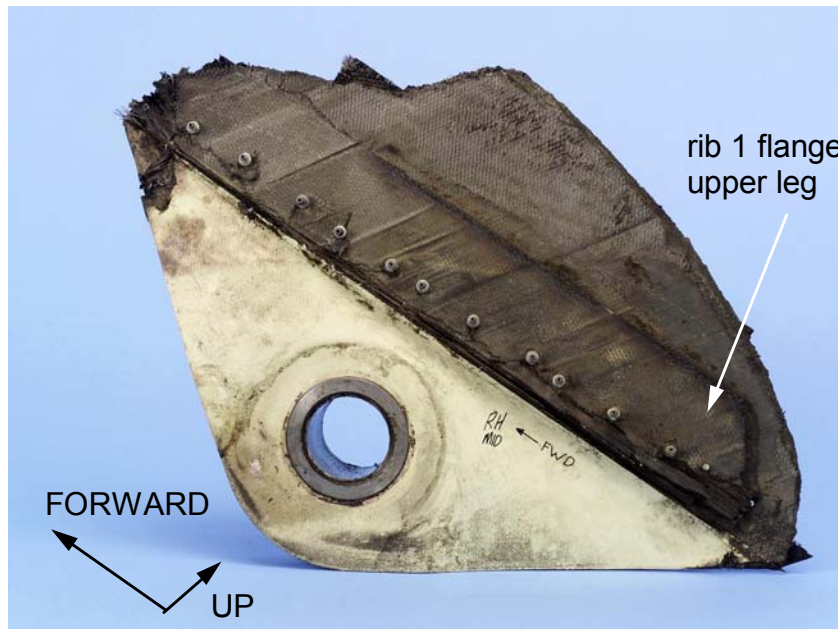
Figure 10. Overall view of the right center lug, lower piece, looking from the left.

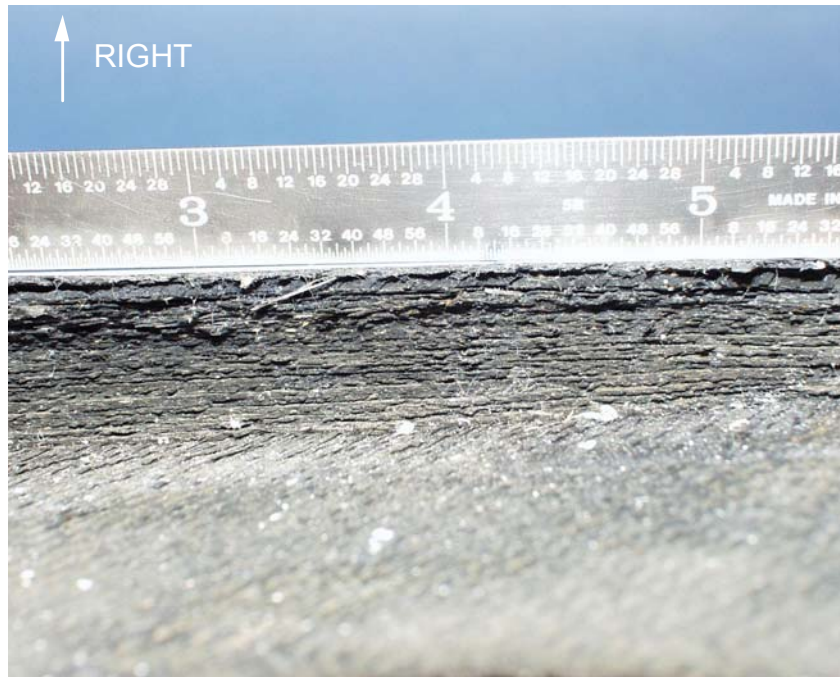
Figure 11. Right center lug upper fracture surface viewed looking upward parallel to the zero-degree fiber direction.

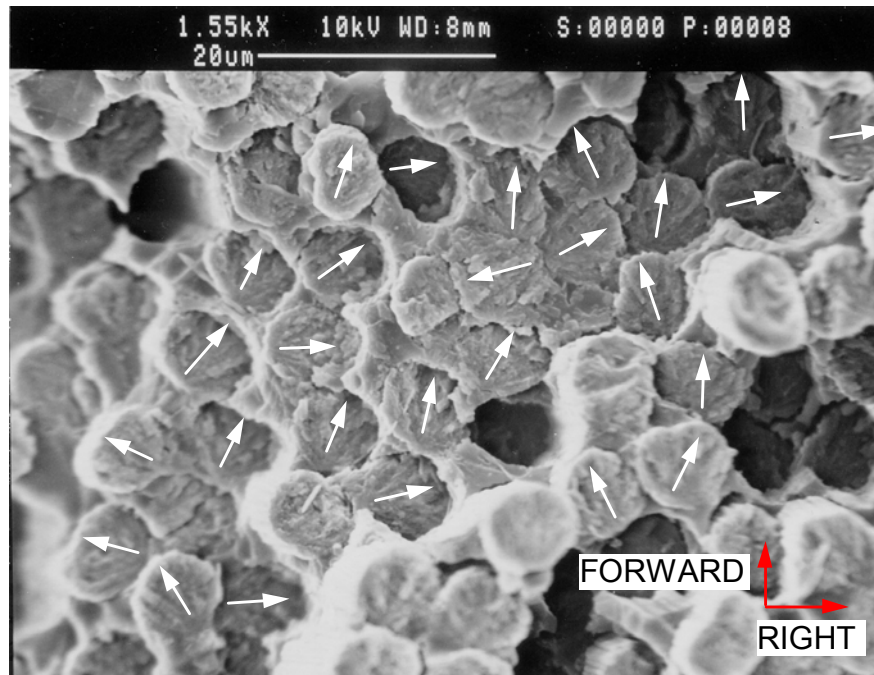
Figure 12. Typical appearance of the fractured zero-degree fibers on specimen RC2 near the exterior surface. Arrows on fractured fibers indicate direction of fracture propagation through the fiber.

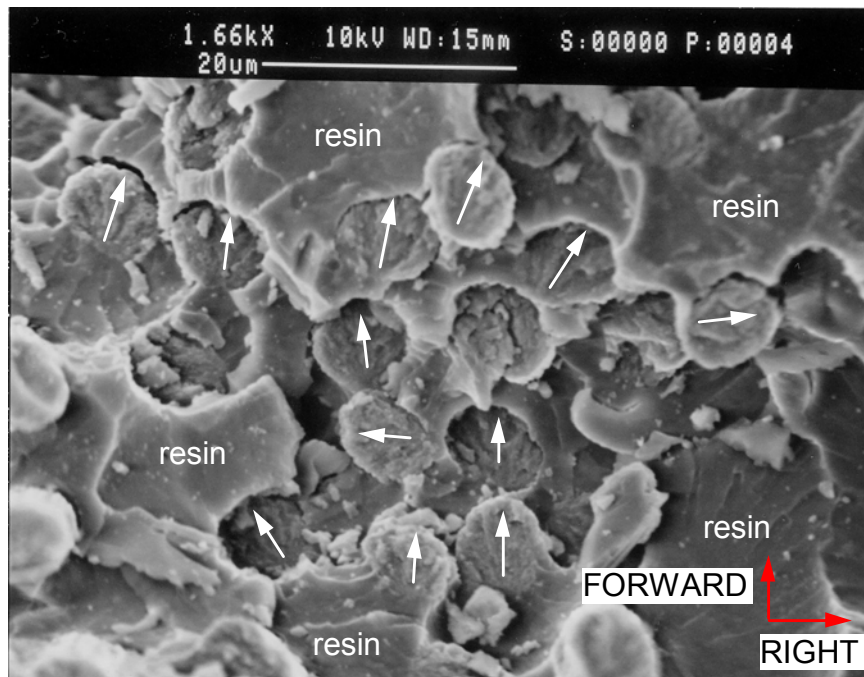
Figure 13. Typical appearance of the fractured zero-degree fibers on sample RC1 near the exterior surface. Arrows on fractured fibers indicate direction of fracture propagation through the fiber.

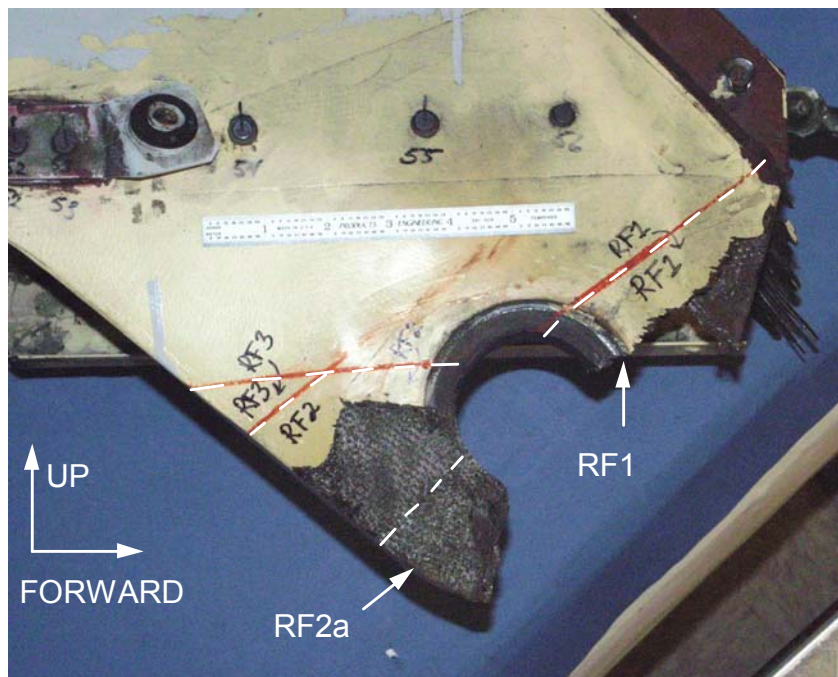
Figure 14. Overall view of the right forward lug upper fracture area. Dashed lines indicate locations where cuts were made.

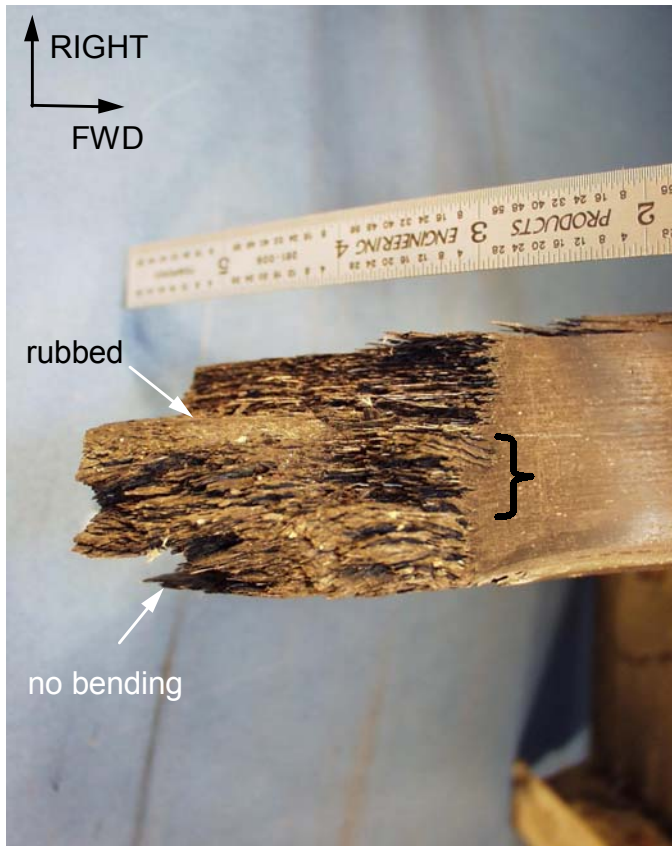
Figure 15. Direct view of the right forward lug, aft leg looking upward and aft. The bracket indicates fiber ends bent to the right.

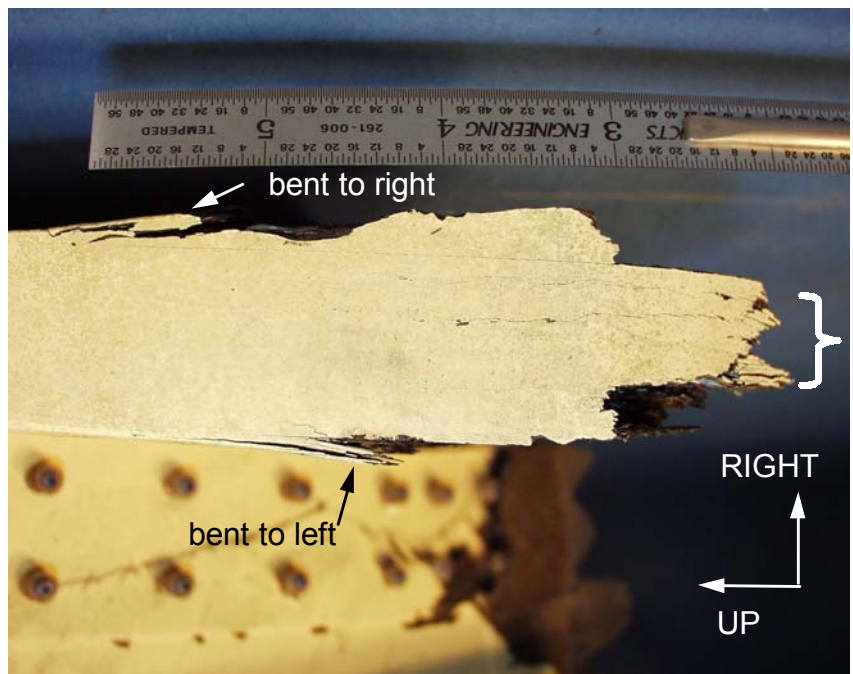
Figure 16. The aft surface of the right forward lug above the fracture through the aft leg, showing delaminations. View is looking upward and forward. The bracket indicates fiber ends bent to the left.

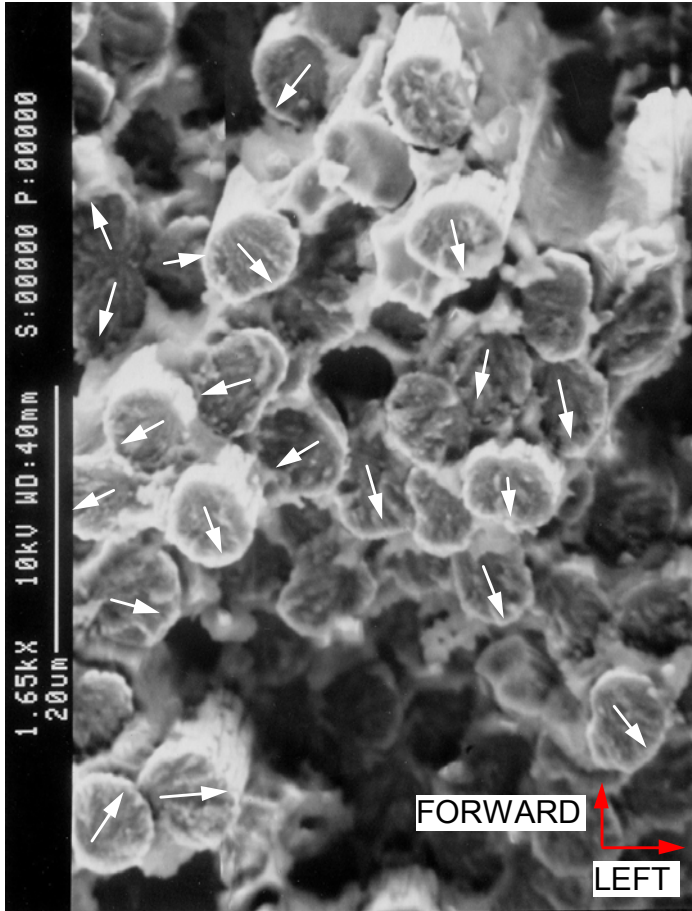
Figure 21. Typical appearance of the fractured zero-degree fibers on sample RF2a near the exterior surface. Arrows on fractured fibers indicate direction of fracture propagation through the fiber.

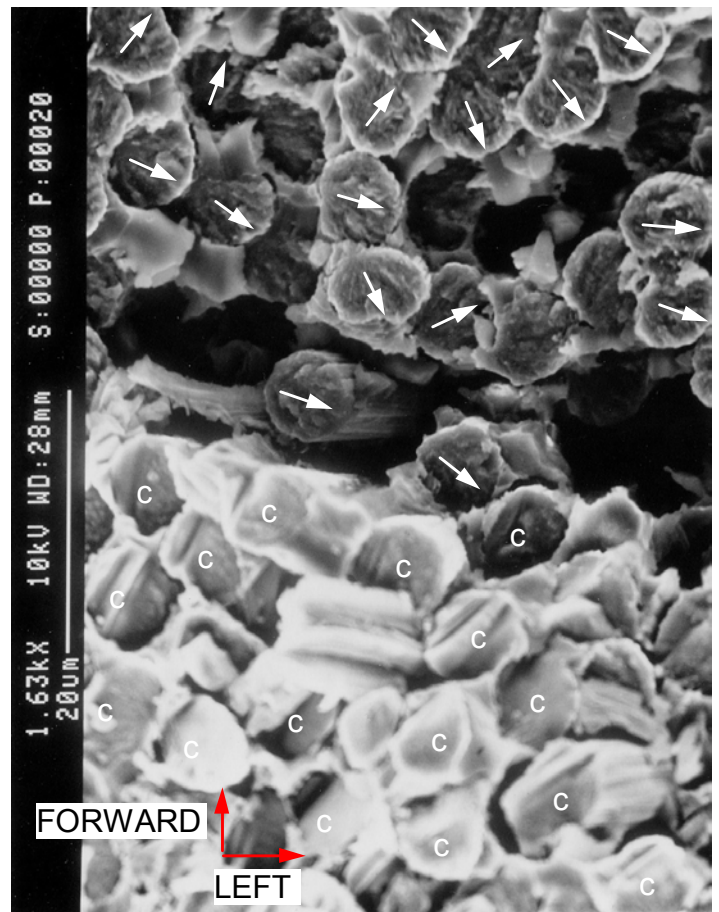
Figure 22. Typical appearance of the fractured zero-degree fibers on sample RF2a near the forward and center portions of the fracture. Arrows on fractured fibers indicate direction of fracture propagation through the fiber.

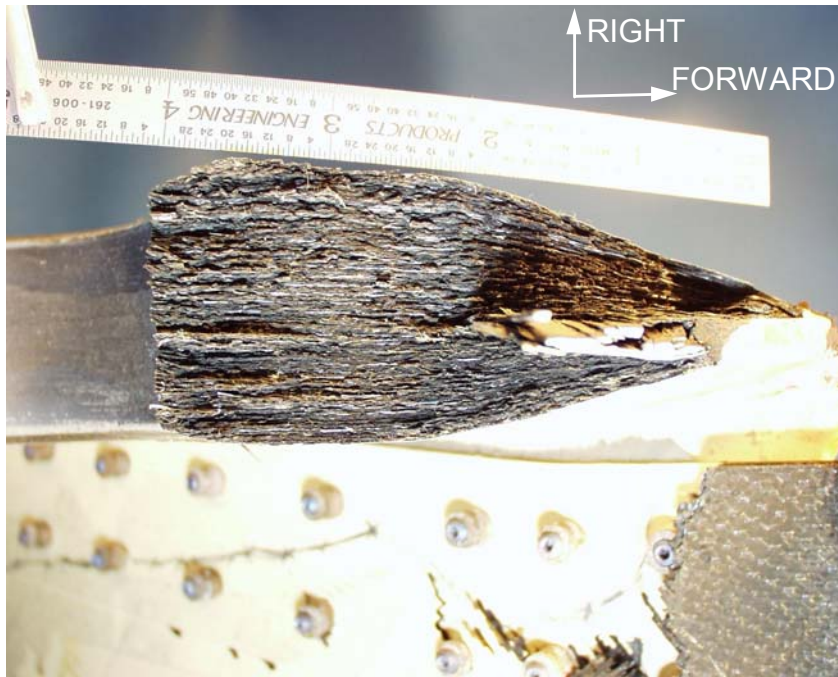
Figure 23. Fracture surface on the forward leg of the right forward lug, View is looking upward parallel to the zero-degree fiber direction.

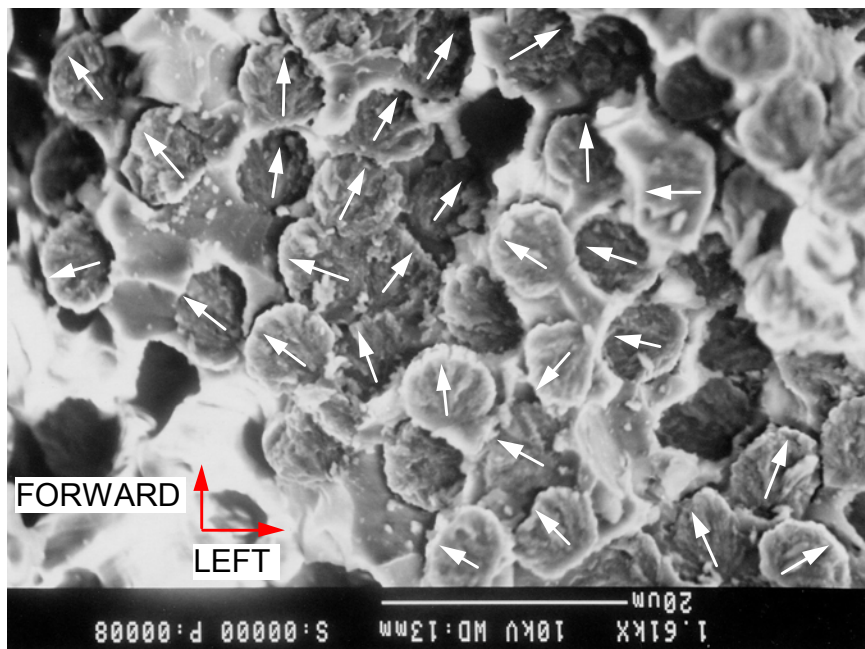
Figure 24. Typical appearance of the fractured zero-degree fibers on sample RF1 near the outer and aft portions of the fracture. Arrows on fractured fibers indicate direction of fracture propagation through the fiber.

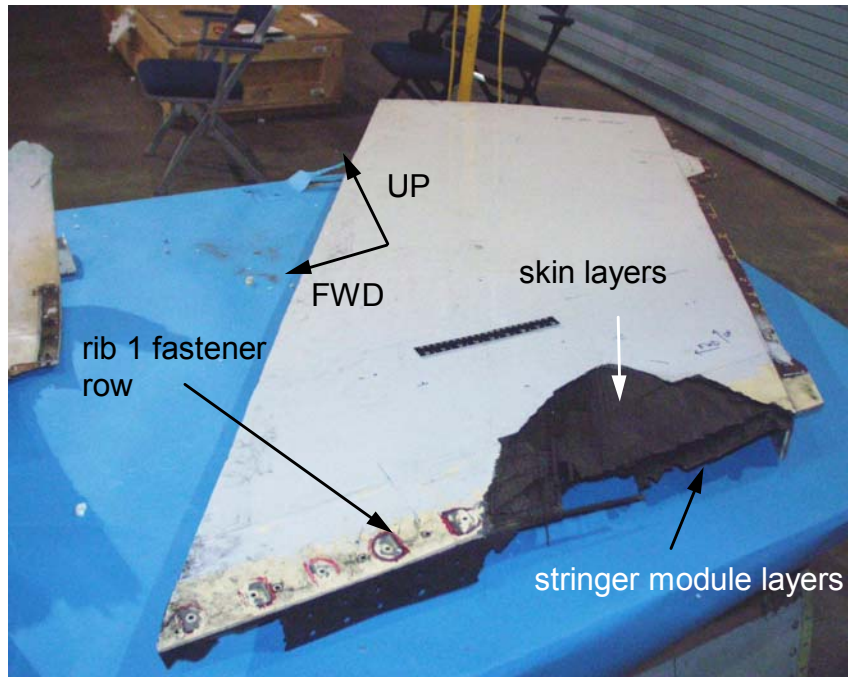
Figure 25. Overall view of the upper skin panel piece containing the upper portion of the fracture at the left aft lug, viewed looking up and to the right.

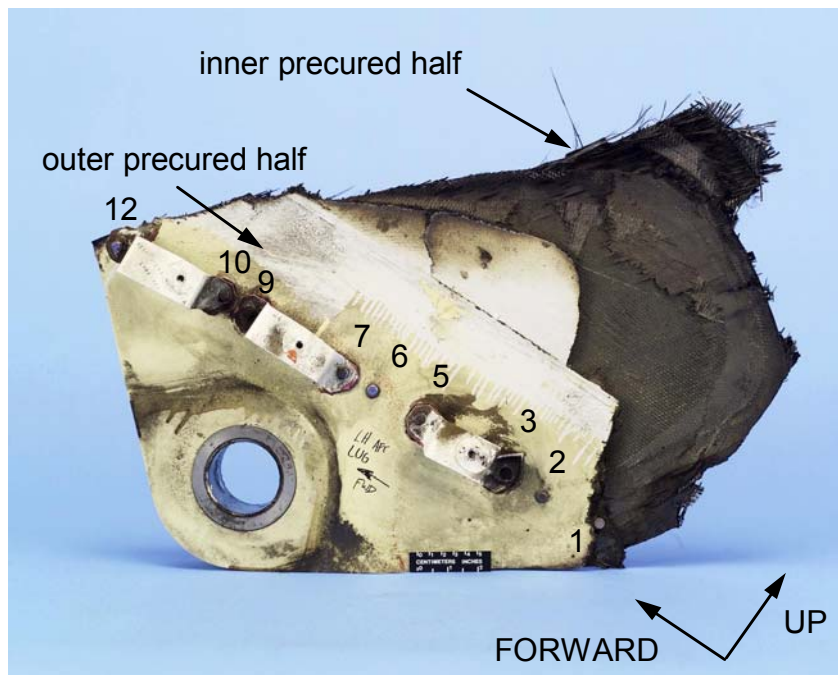
Figure 26. Overall view of the lower piece of the left aft lug, viewed looking to the right.

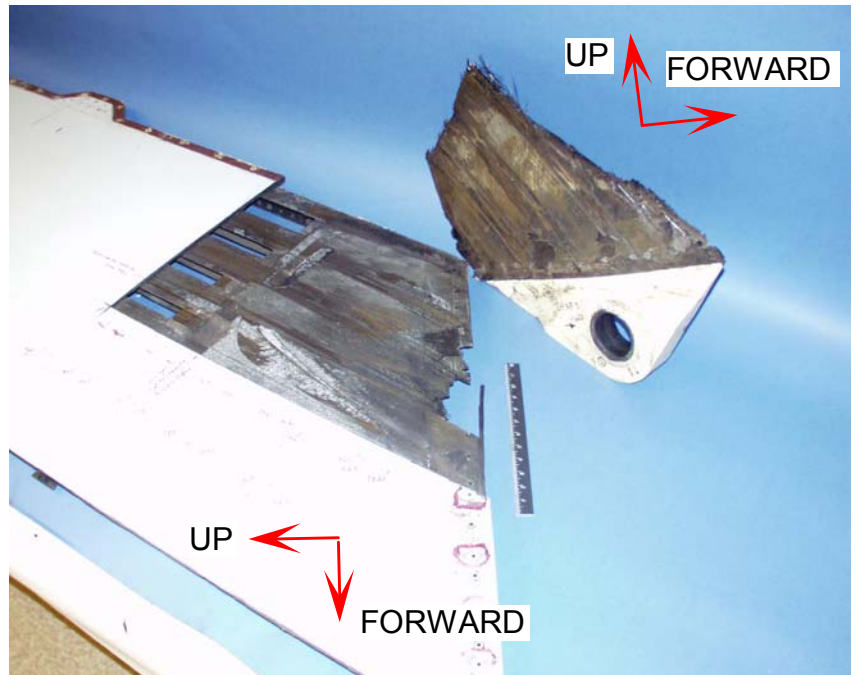
Figure 27. Mating fracture surfaces between the inner precured lug layers and the interior stringer structure of the left aft panel after cutting the skin panel section.

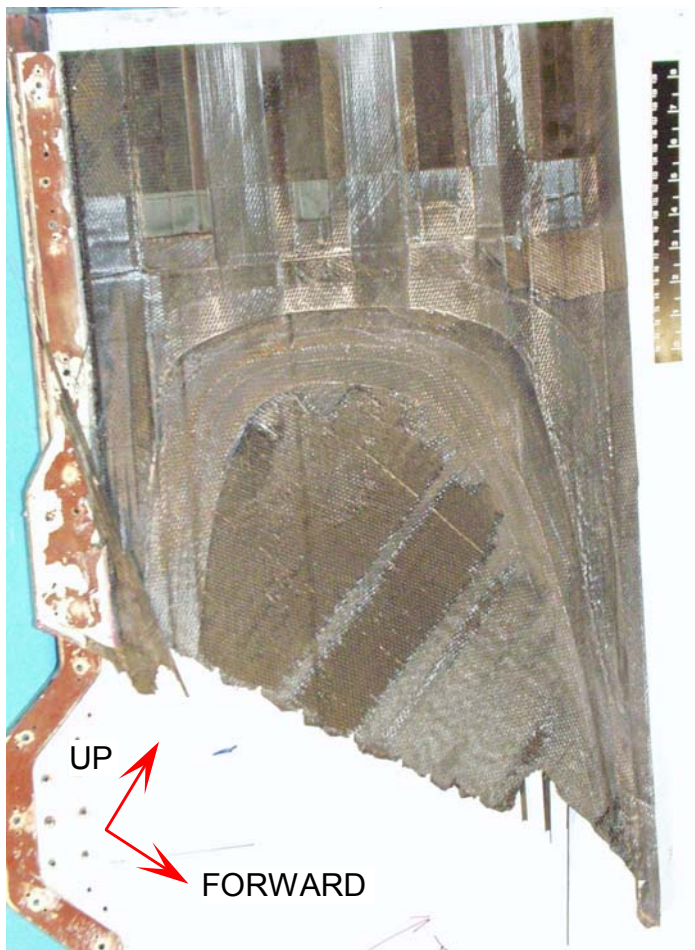
Figure 28. Inner surface of the vertical stabilizer left side skin section at the left aft lug after cutting from the upper skin panel piece. The lower portion of this interlaminar surface mates to the outer surface of the inner precured lug half.

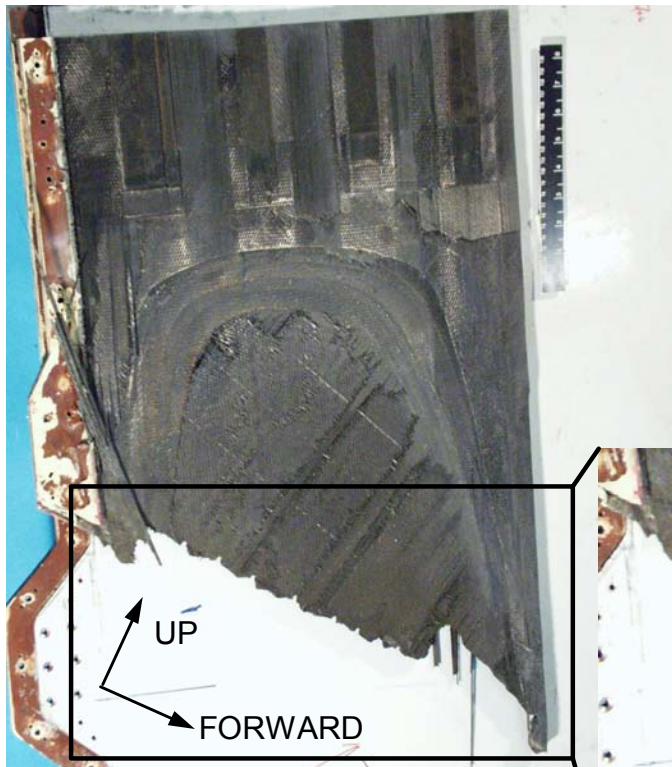
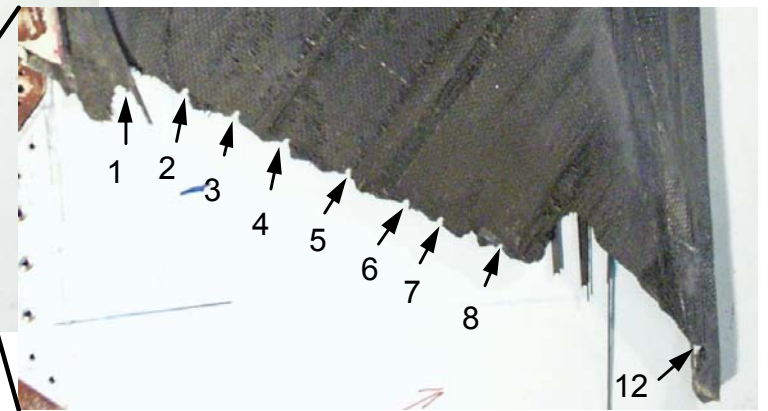
Figure 31. The interior surface of the vertical stabilizer skin section at the left aft lug fracture area after cutting from the upper skin panel piece. Inset photograph shows the numbered rib 1 fastener holes.

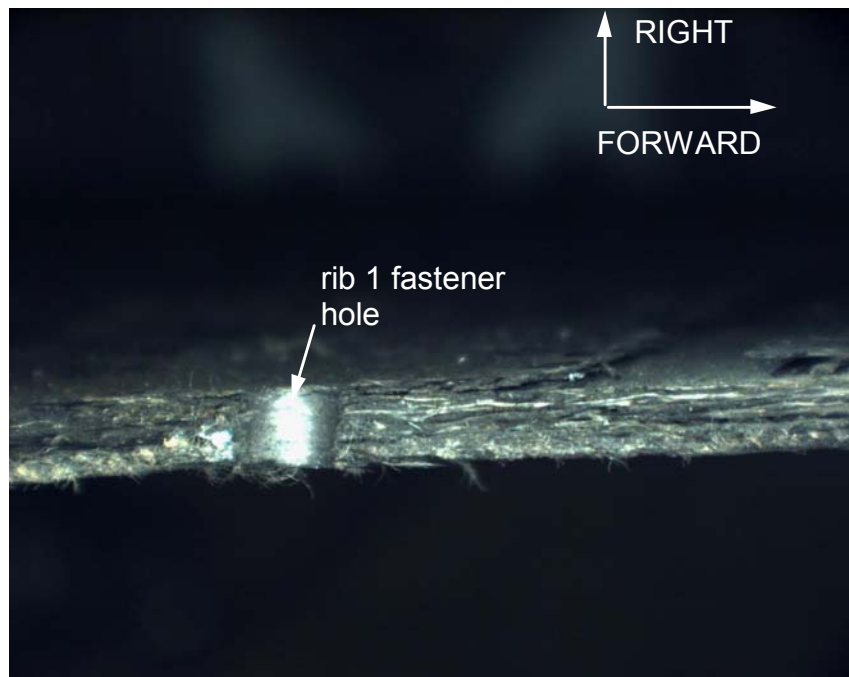
Figure 32. Vertical stabilizer skin fracture at a rib 1 fastener hole in the vicinity of the left aft lug, viewed looking upward.

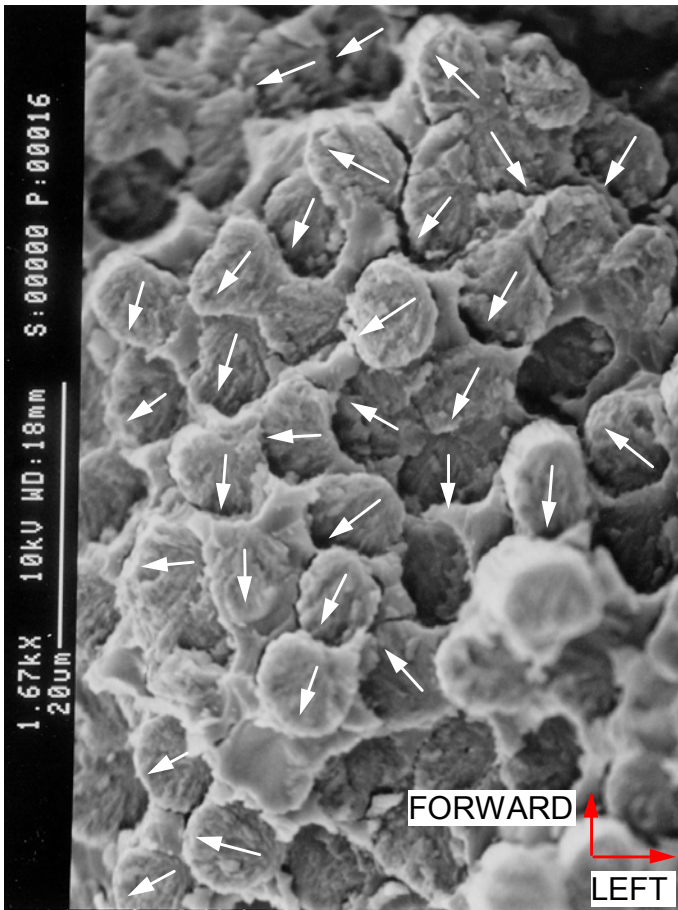
Figure 33. SEM photograph with arrows indicating the direction of tensile crack propagation on the ends of zero-degree fibers from the inside edge of specimen LA5a.

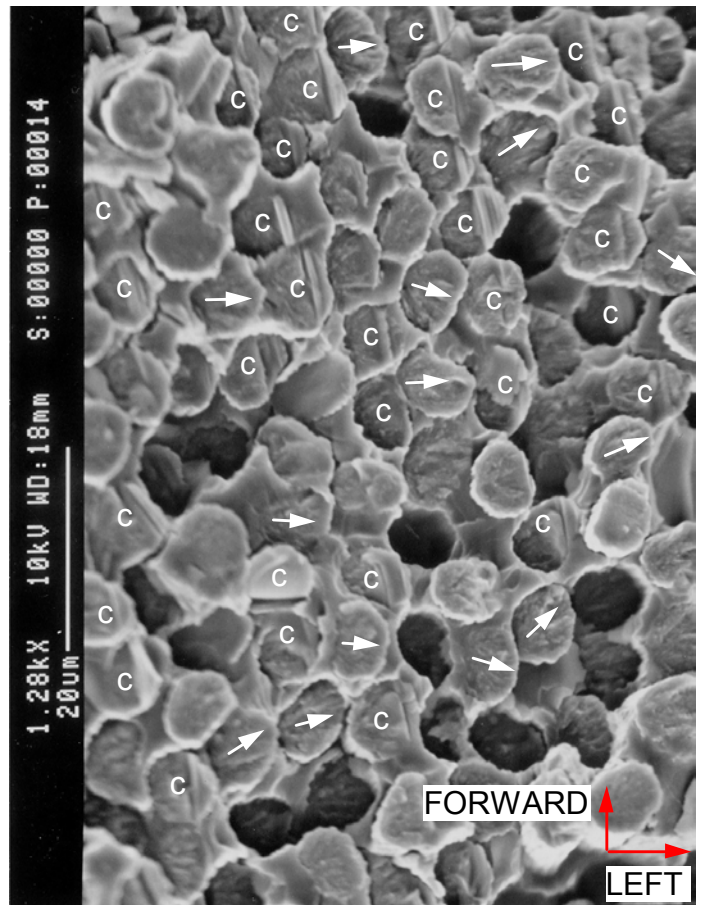
Figure 34. SEM photograph from the center of specimen LA5a. Arrows indicate the direction of tensile crack propagation and labels "c" indicate compressive failure on the ends of zero-degree fibers.

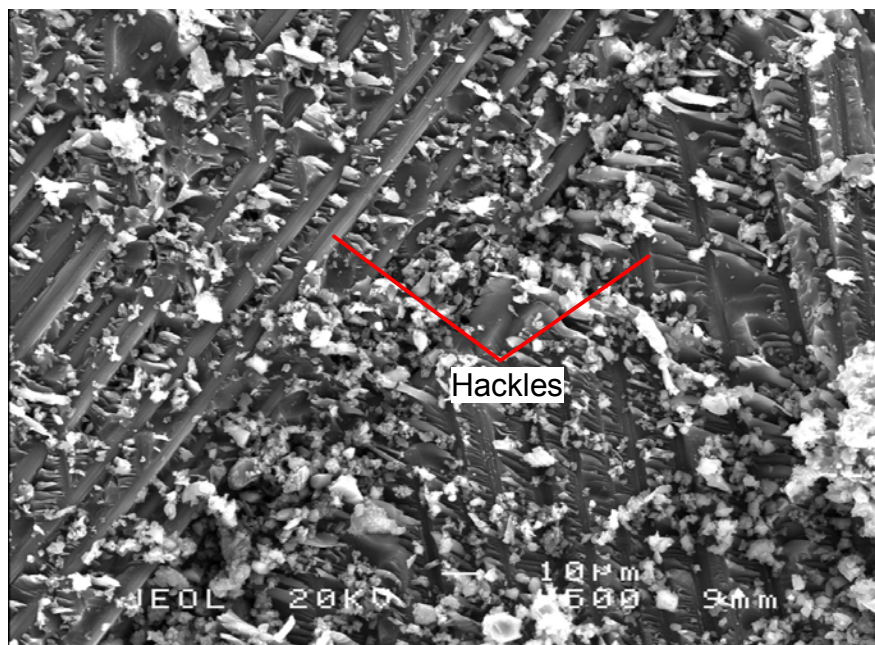
Figure 36. Example SEM photograph from the top forward area of specimen LA1a. Hackles are indicated between +45-degree fibers (left) and zero-degree imprints (right), pointing up and forward. Orientation as in figure 35.

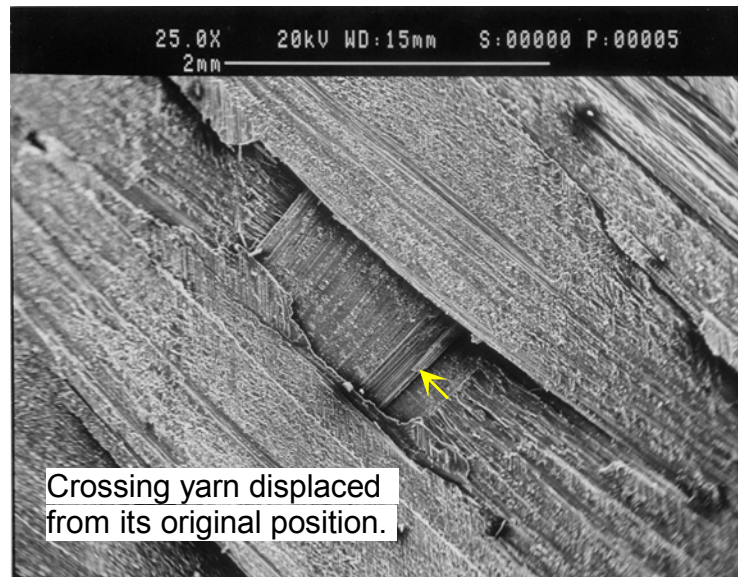
Figure 37. Specimen LA5 inner surface. An unlabeled arrow indicates a crossing yarn that was displaced from its original position. Orientation as in figure 35.

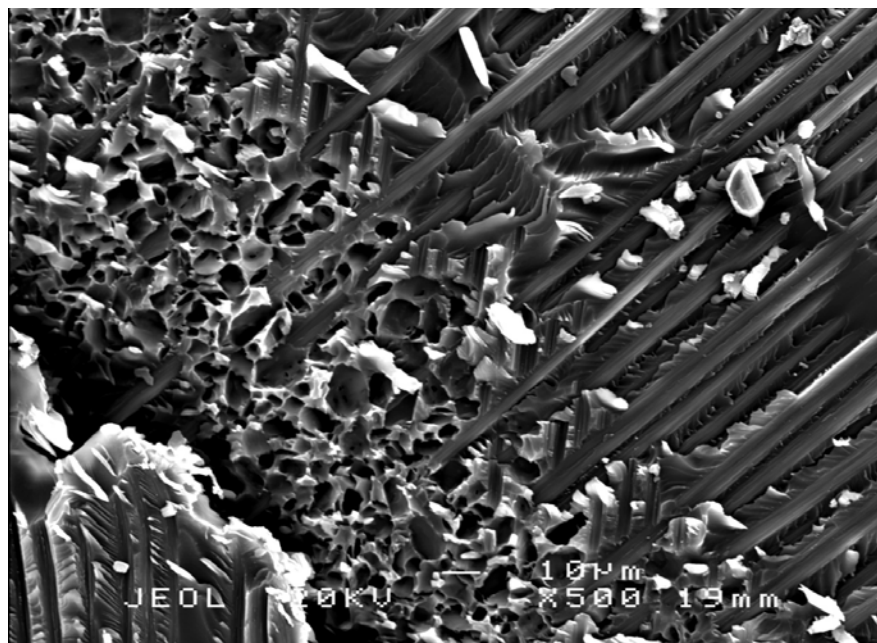
Figure 38. Microscopic matrix porosity in a region where yarns cross on specimen LA1b. The main yarn is at the upper right, with vertical imprints at the lower left. Orientation as in figure 35.

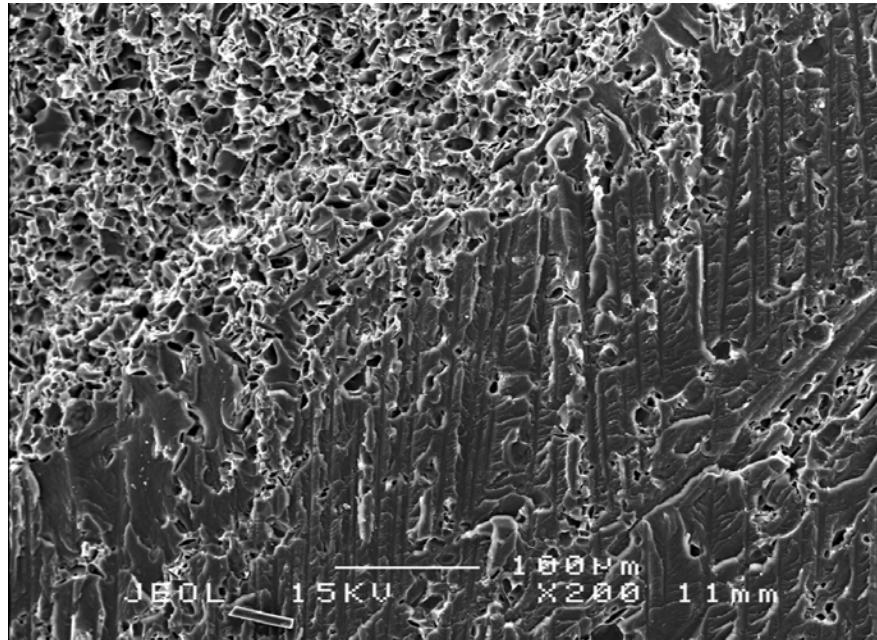
Figure 39. Microscopic matrix porosity on the outboard piece of LA1c. This porosity is shown at the upper left, with ill-defined hackles shown at the lower right. Orientation as in figure 35.

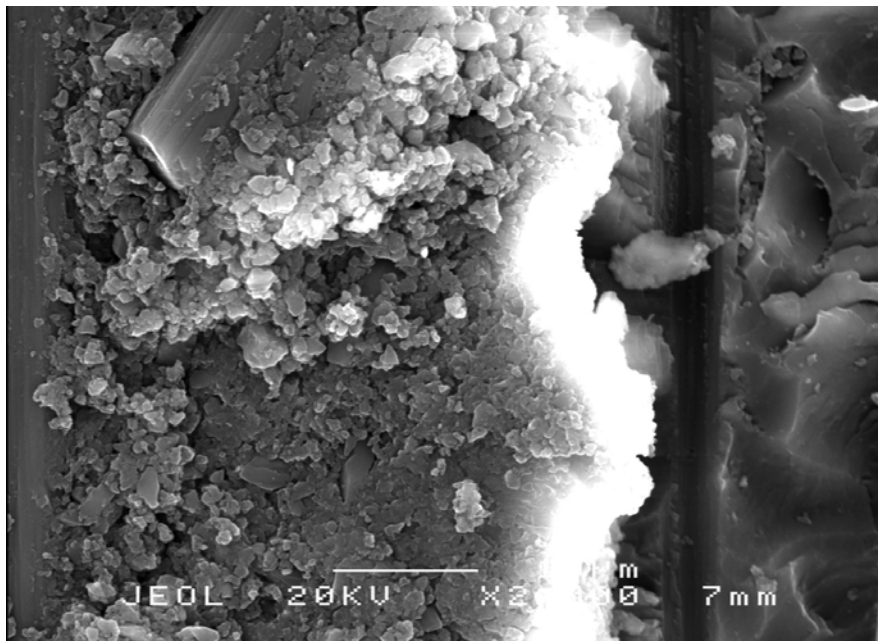
Figure 40. Microscopic matrix granularity on the outboard piece of LA1c. A fiber fragment is shown at the upper left. Orientation as in figure 35.

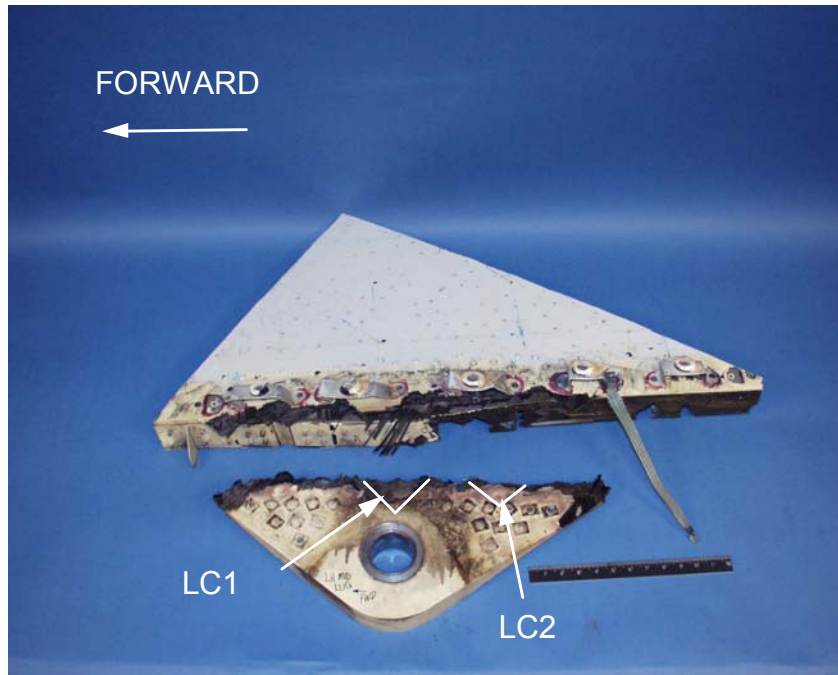
Figure 41. Overall view of the two portions of the fractured structure at the left center lug viewed looking from the left.

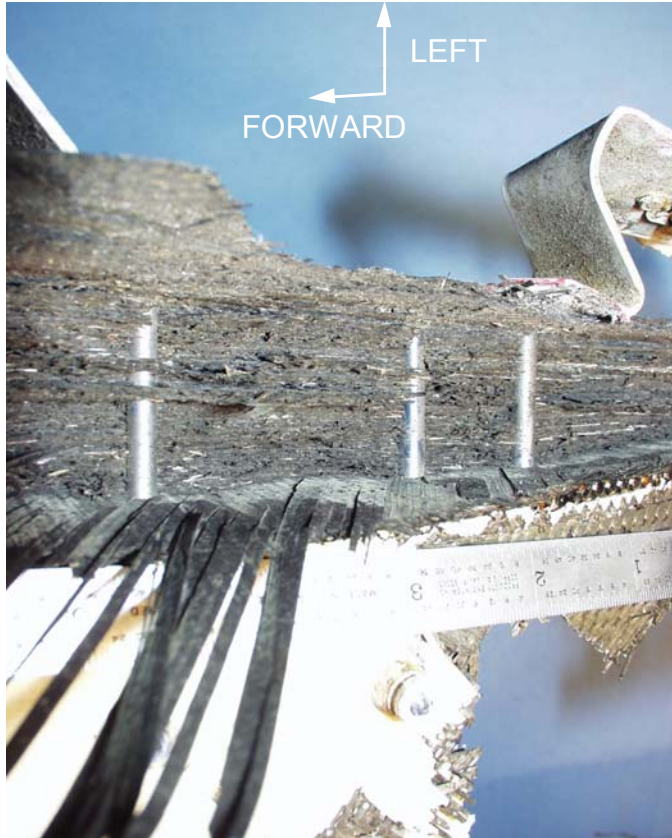
Figure 42. Upper fracture surface at the left center lug, viewed looking upward parallel to zero-degree fibers.

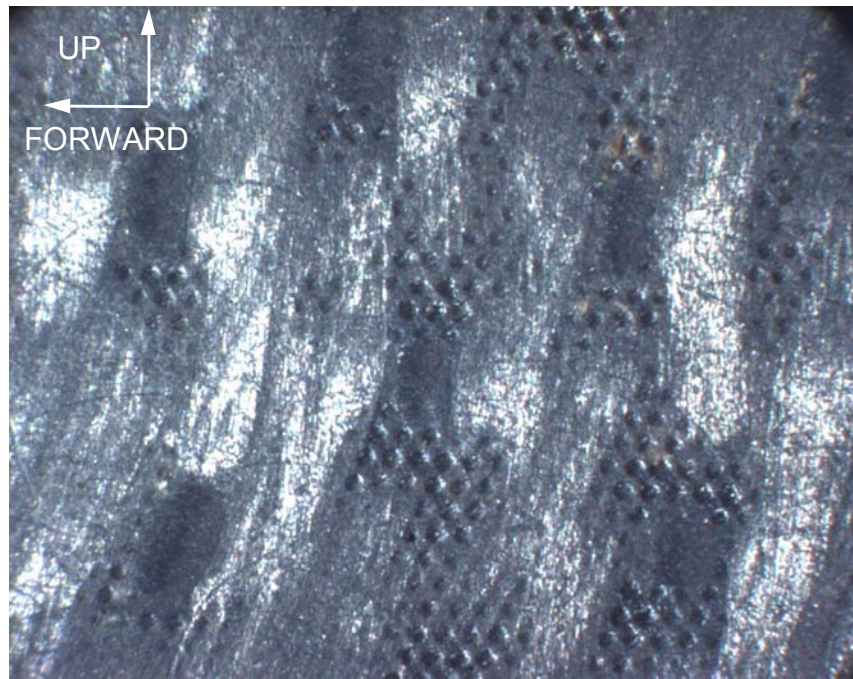
Figure 43. Translamellar fracture surface on the inboard piece of specimen LC2.

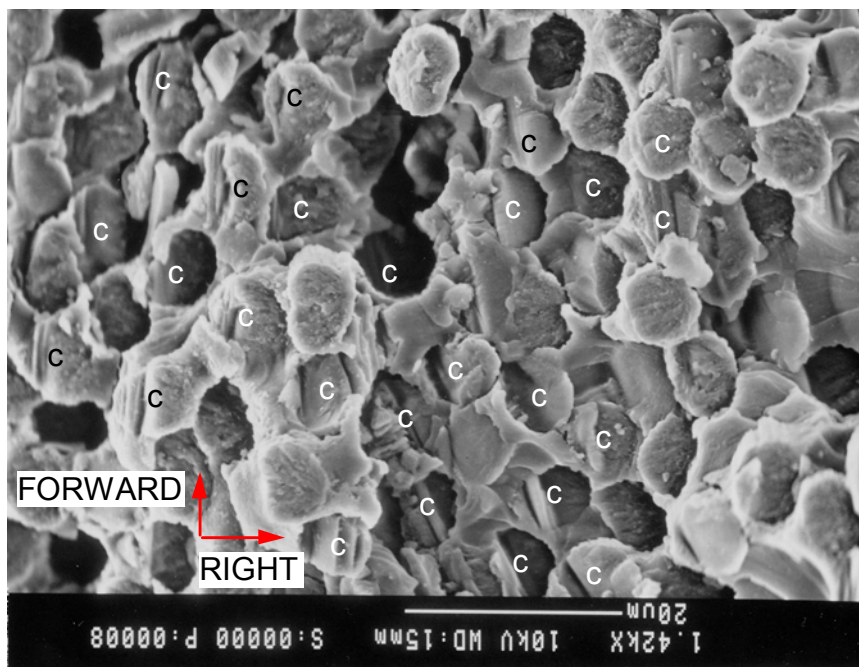
Figure 44. Translamellar fracture surface on the outboard piece from specimen LC2, with the fibers indicated by "c" containing features typical of chop marks.

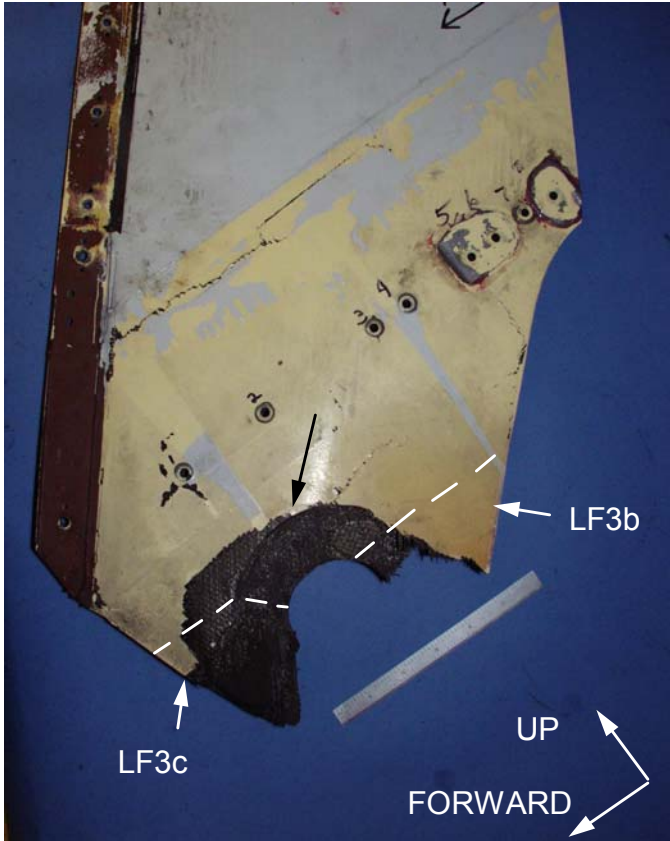
Figure 45. Overall view of the left forward lug translaminar fracture. An unlabeled arrow indicates the upper end of the bearing indentation.

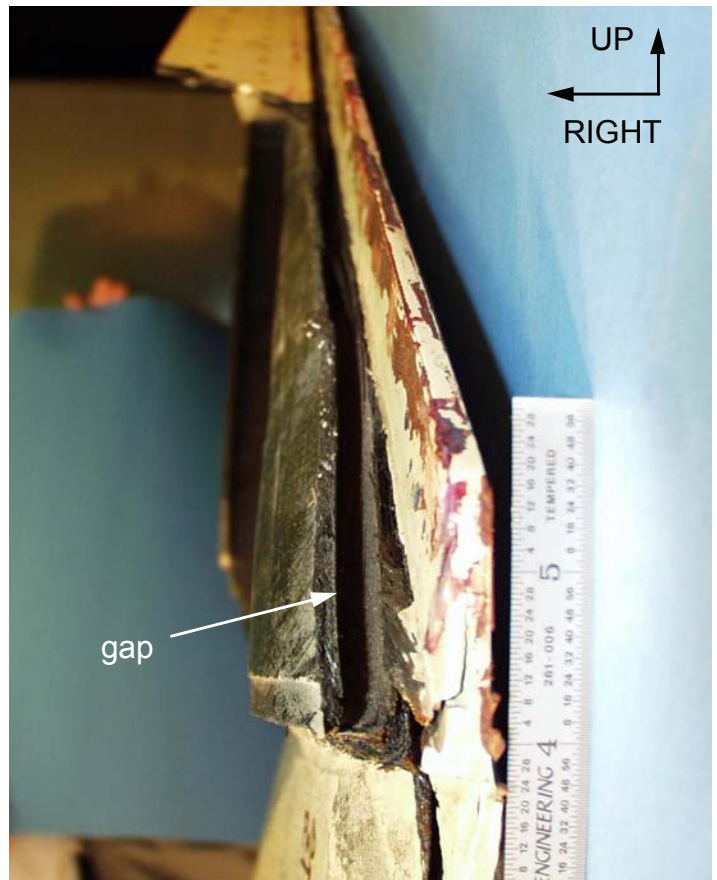
Figure 46. The visible gap at the forward lower end between the inner precured lug structure and the stringer outer flange structure as viewed looking aft.

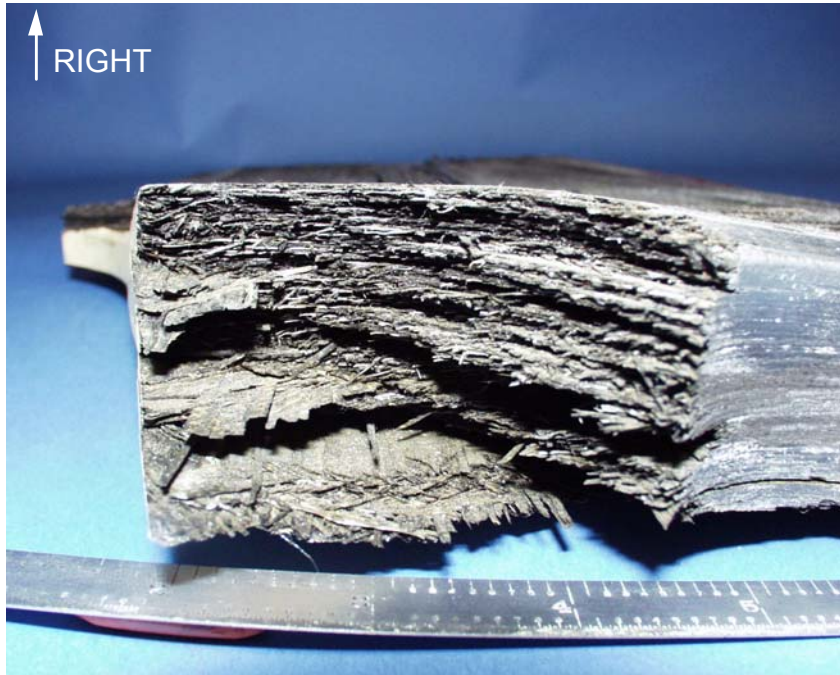
Figure 50. Closer view of the left forward lug upper fracture surface, aft leg, as viewed looking upward parallel to the zero-degree fiber direction.

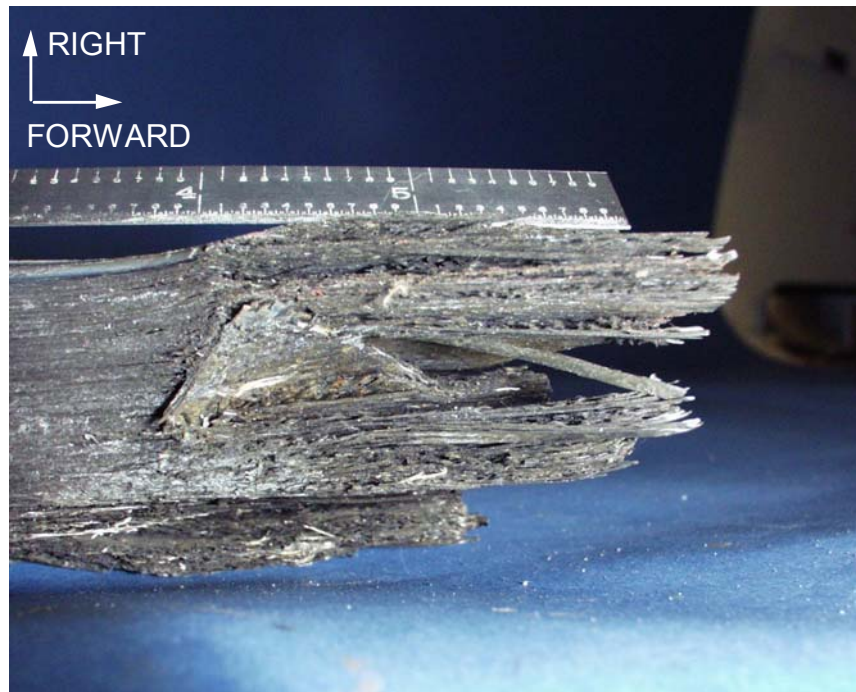
Figure 51. Closer view of the left forward lug upper fracture surface, forward leg, as viewed looking up.

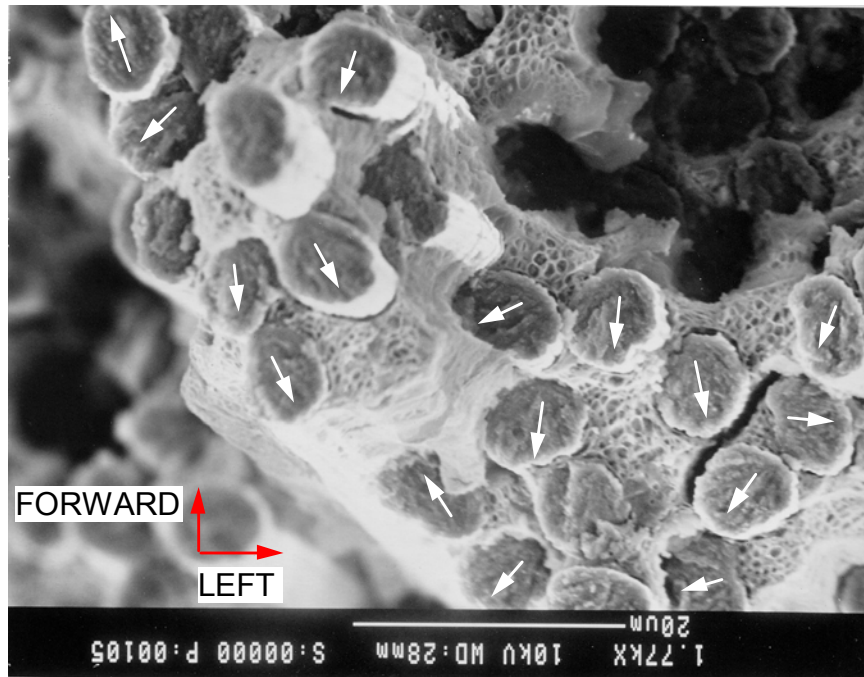
Figure 52. SEM photograph of the ends of zero-degree fibers from specimen LF3b. Arrows indicate fracture propagation direction in fibers with radial marks.
