Docket No. SA-522

Exhibit No. 15-C

NATIONAL TRANSPORTATION SAFETY BOARD

Materials Specialists' Submission
Selected Photographs of the Fractographic
Examination of the Vertical Stabilizer

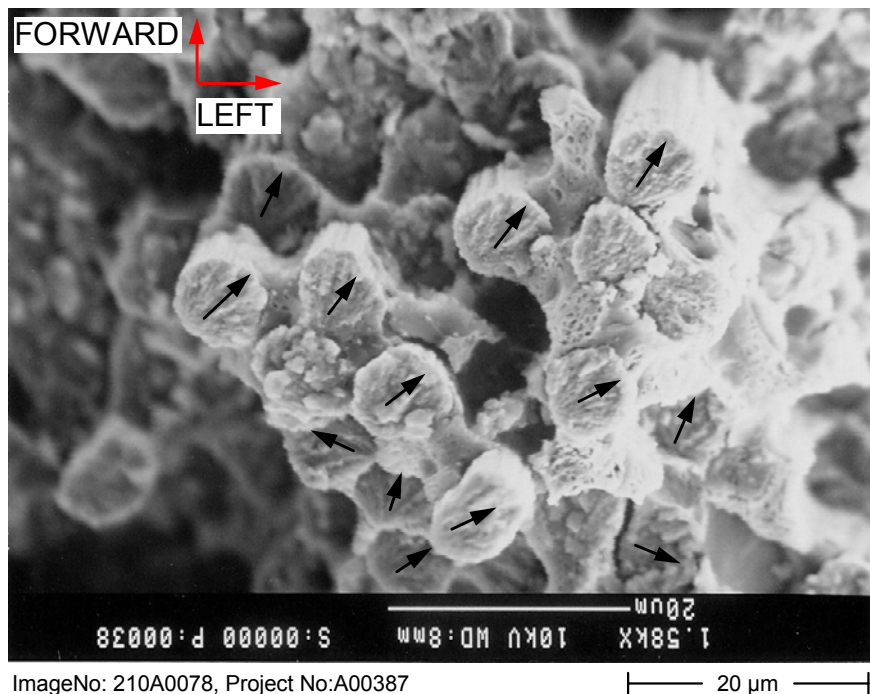
Figure 53. SEM photograph with arrows indicating the direction of tensile crack propagation on the ends of zero-degree fibers from the inboard center piece of specimen LF3c.

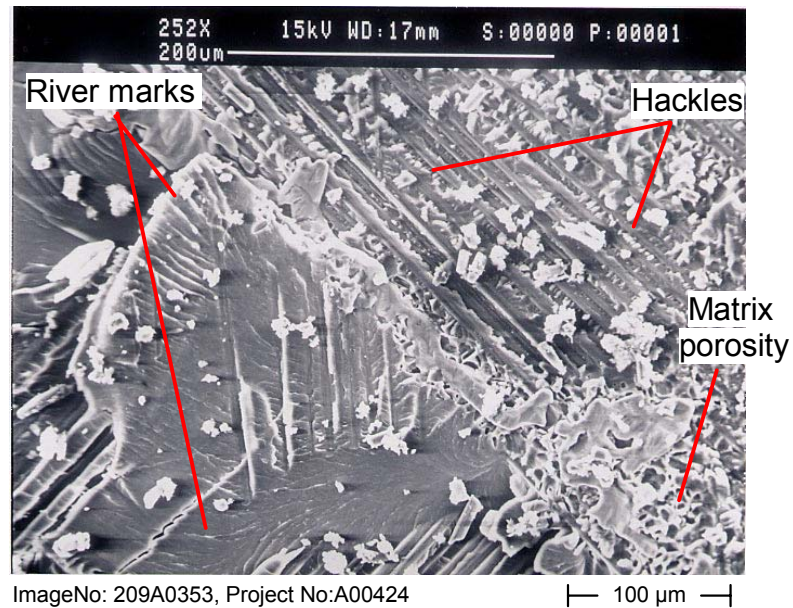
Figure 57. Example SEM photograph from the top forward corner of specimen LF3a-5b. Hackles indicated point up and forward, and river marks also point generally up and forward. Orientation as in figure 56.

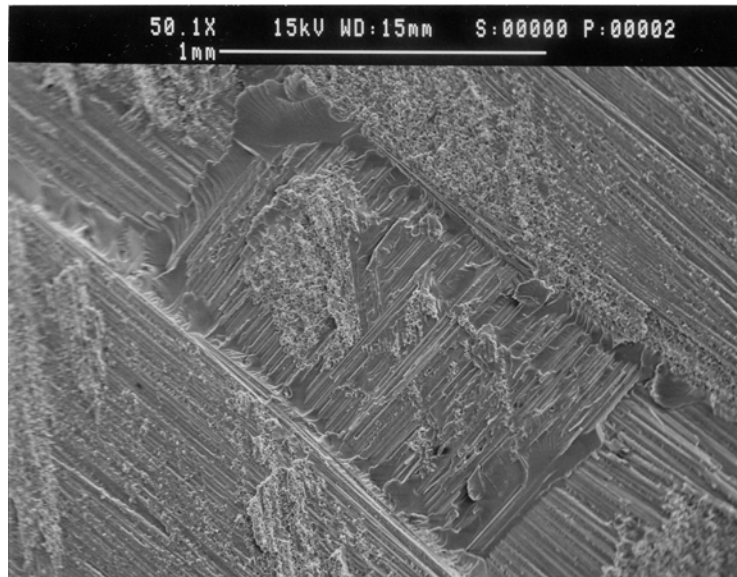
Figure 58. A view of the center of specimen LF3a-5c showing a yarn crossing in the woven fabric. Orientation as in figure 56.

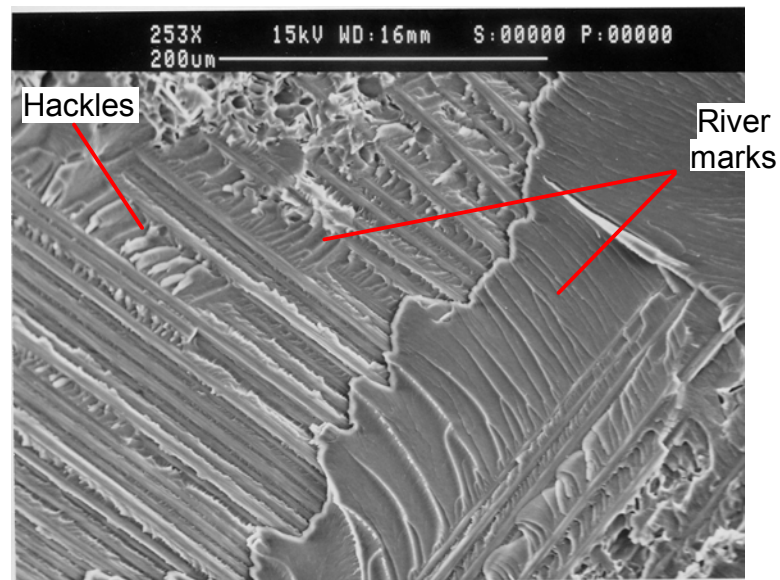
Figure 59. Higher magnification view of the upper left corner of the yarn crossing shown in figure 58. Orientation as in figure 56.

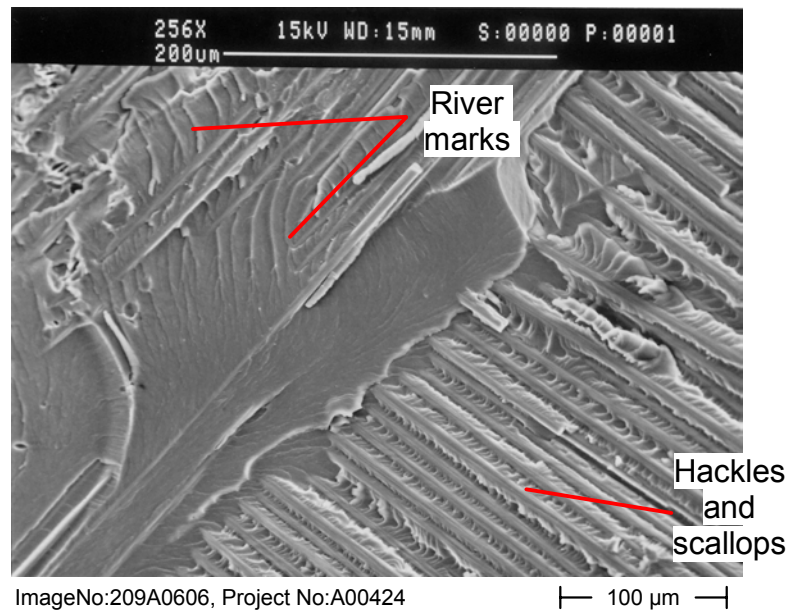
Figure 60. Higher magnification view of the lower right corner of the yarn crossing shown in figure 58. Orientation as in figure 56.

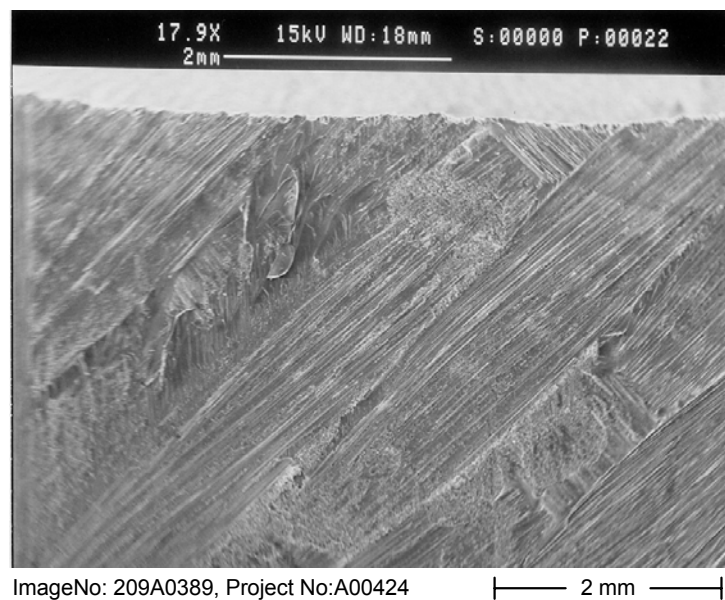
Figure 61. Faint bands at the top forward edge of section LF2b-1 indicate the direction of crack propagation upward and aft. Orientation as in figure 56.
