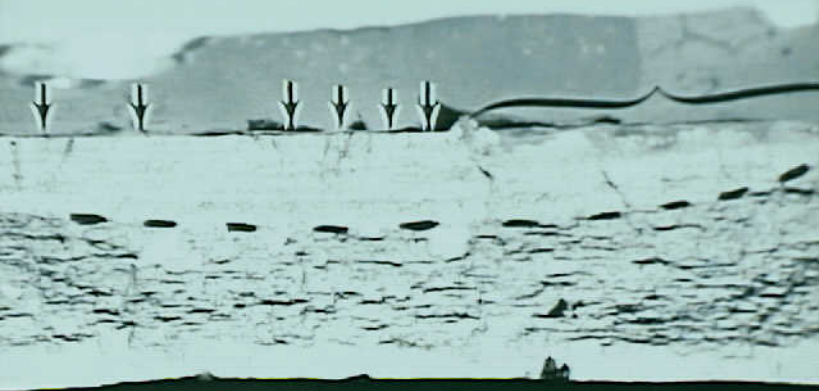
Materials Laboratory 15 - Exhibit No. 15A Photo 2. Fatigue crack region on the cut-out piece. The bracket indicated mechanical damage, and the arrowheads indicate origin areas, and the extent of preexisting cracking is indicated by the dashed line. (3X)
