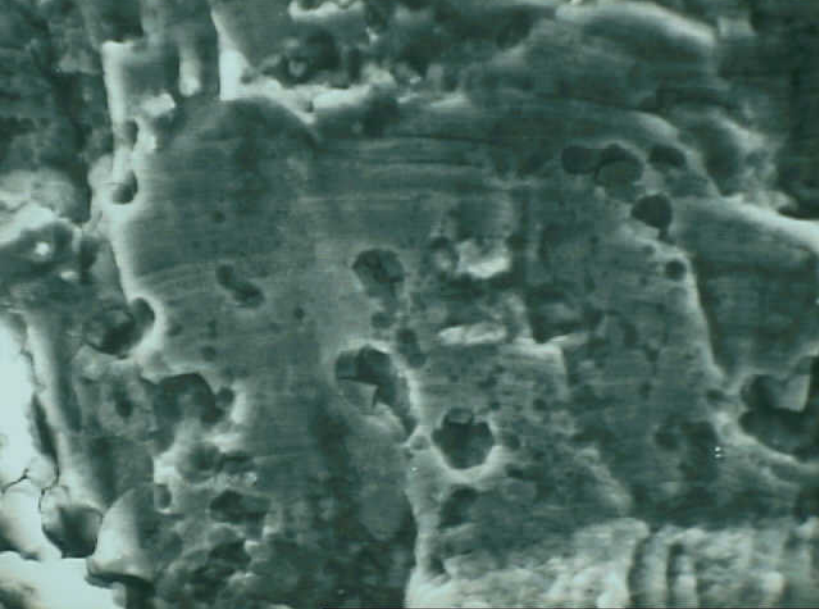
Materials Laboratory 15 - Exhibit No. 15A - Photo 5.
SEM photograph of a fracture area containing a fatigue
striation pattern.
