DOCKET NO.: SA-515

EXHIBIT NO. 15B

**NATIONAL TRANSPORTATION SAFETY BOARD
WASHINGTON, D.C.**

**METALLURGIST'S FACTUAL REPORTS
SUPPORTING MATERIAL
10 PAGES**

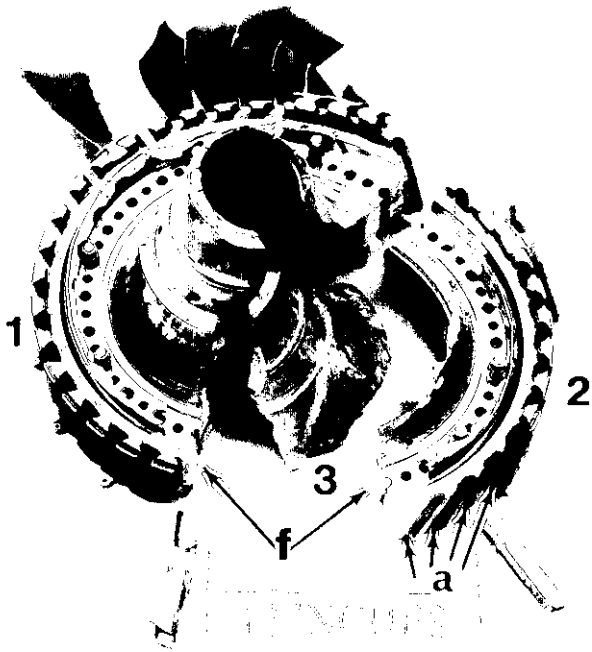
Figure 1. Overall view looking aft on the fan hub pieces, as received. Arrows "f" denote the primary separation through the tierod hole 6T.

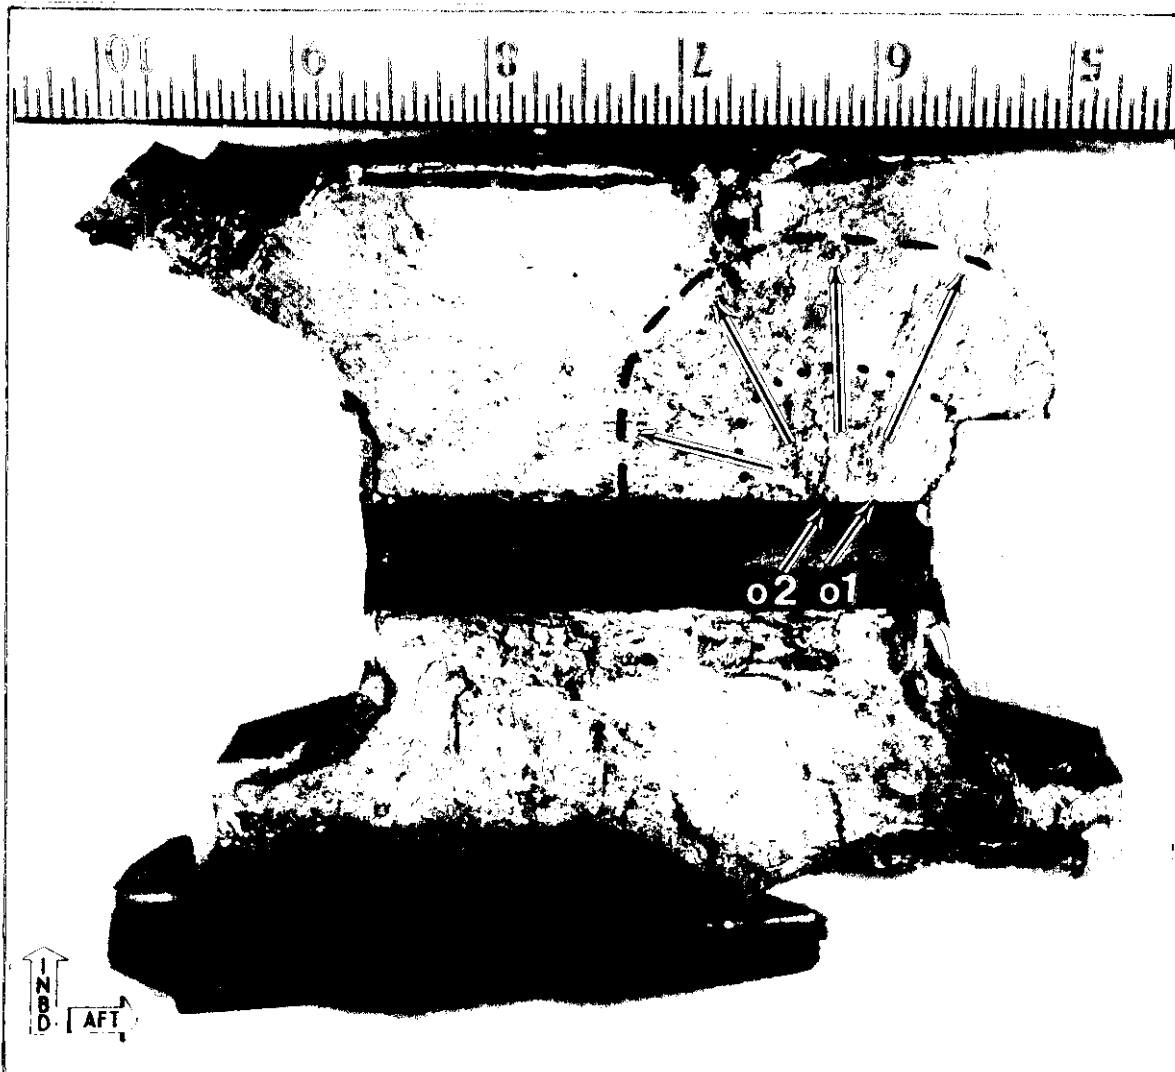
Figure 2. View of the fracture face on the segment of the hub labeled "1" in figure 1. Arrows "o1" and "o2" denote the two fatigue fracture origins. The extent of the fatigue fracture region is outlined by a dashed line. The discolored area on the fracture surface is outlined by the dotted line

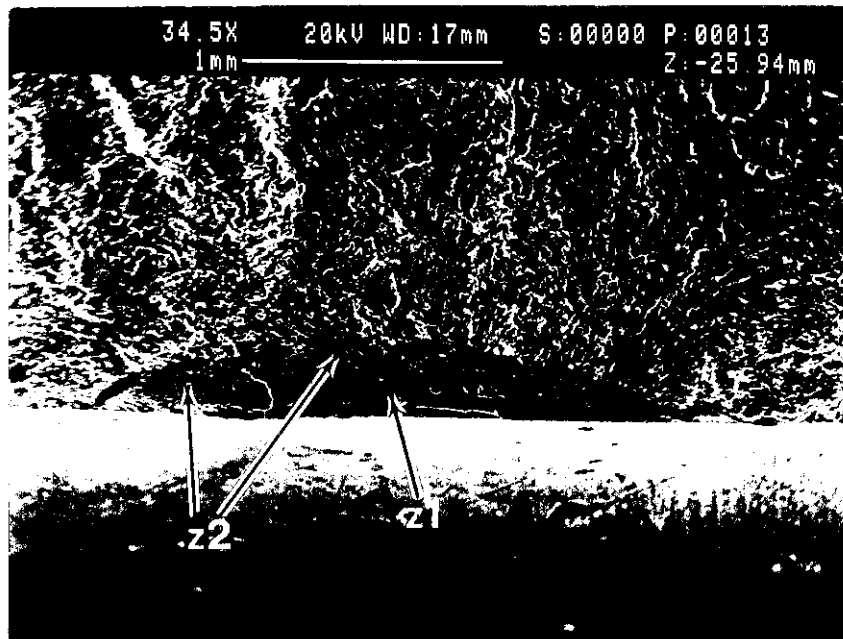
Figure 5. SEM view of the fatigue origin denoted by arrow "o1" in figure 4. The two fracture zones in the thumbnail mark are denoted by arrows "z1" and "z2"

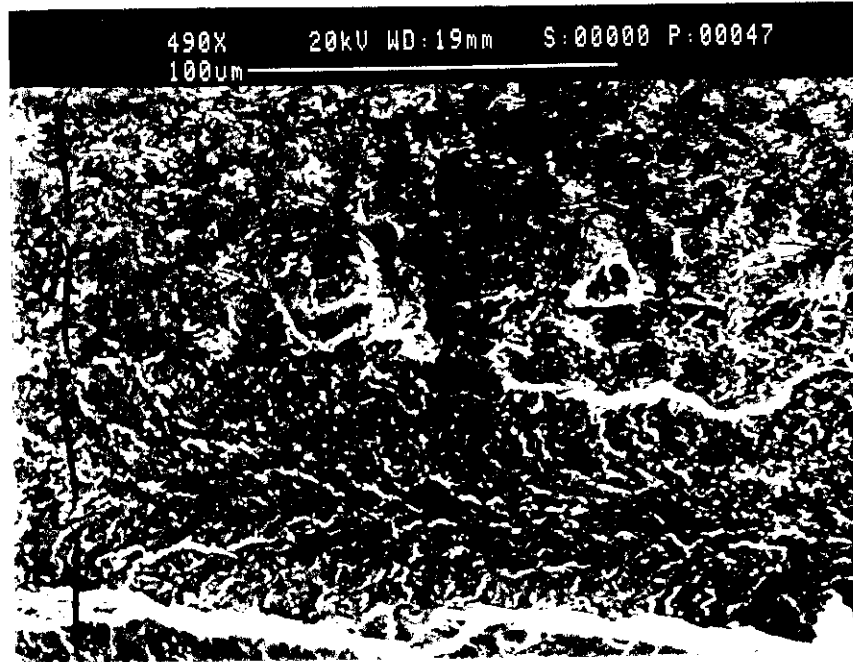
Figure 6. The interface between zones shown by arrows "z1" and "z2" in figure 5. The two zones are indicated by the brackets

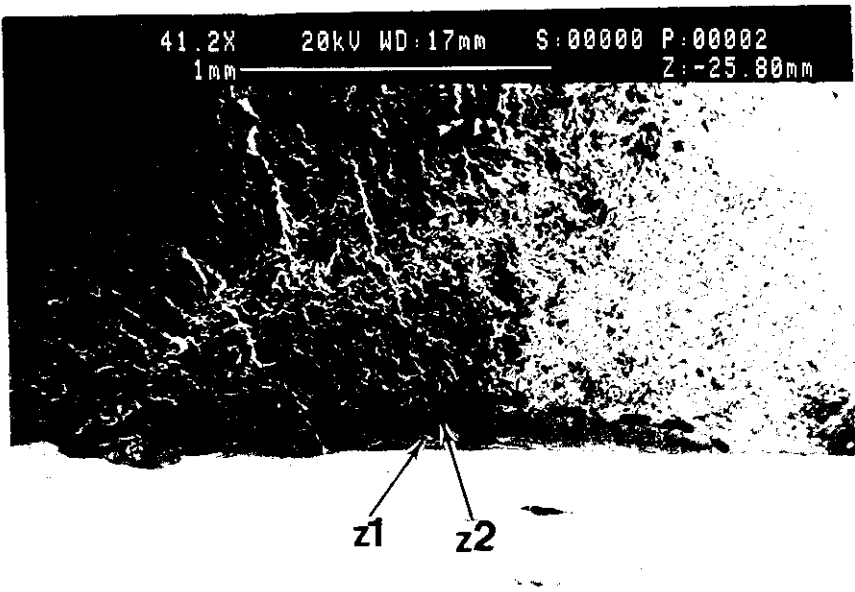
Figure 10. The SEM view of the fracture origin "o2". Arrows "z1" and "z2" show the locations of the overstress and microfissure zones, respectively.

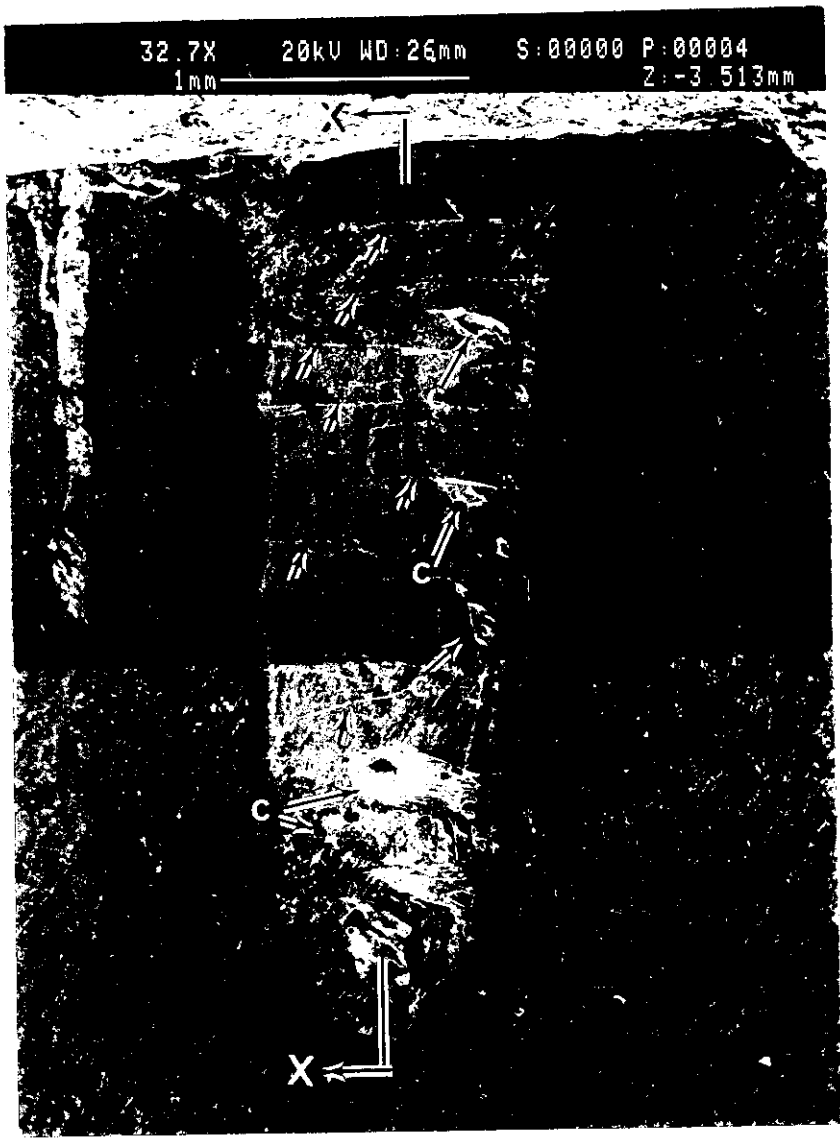
Figure 11. Composite photograph showing an SEM view of scuff marks at and near the fracture origin area "o2". Note numerous parallel cracks (ladder cracks) within the main scuffed area, some of which are shown by the arrowheads.

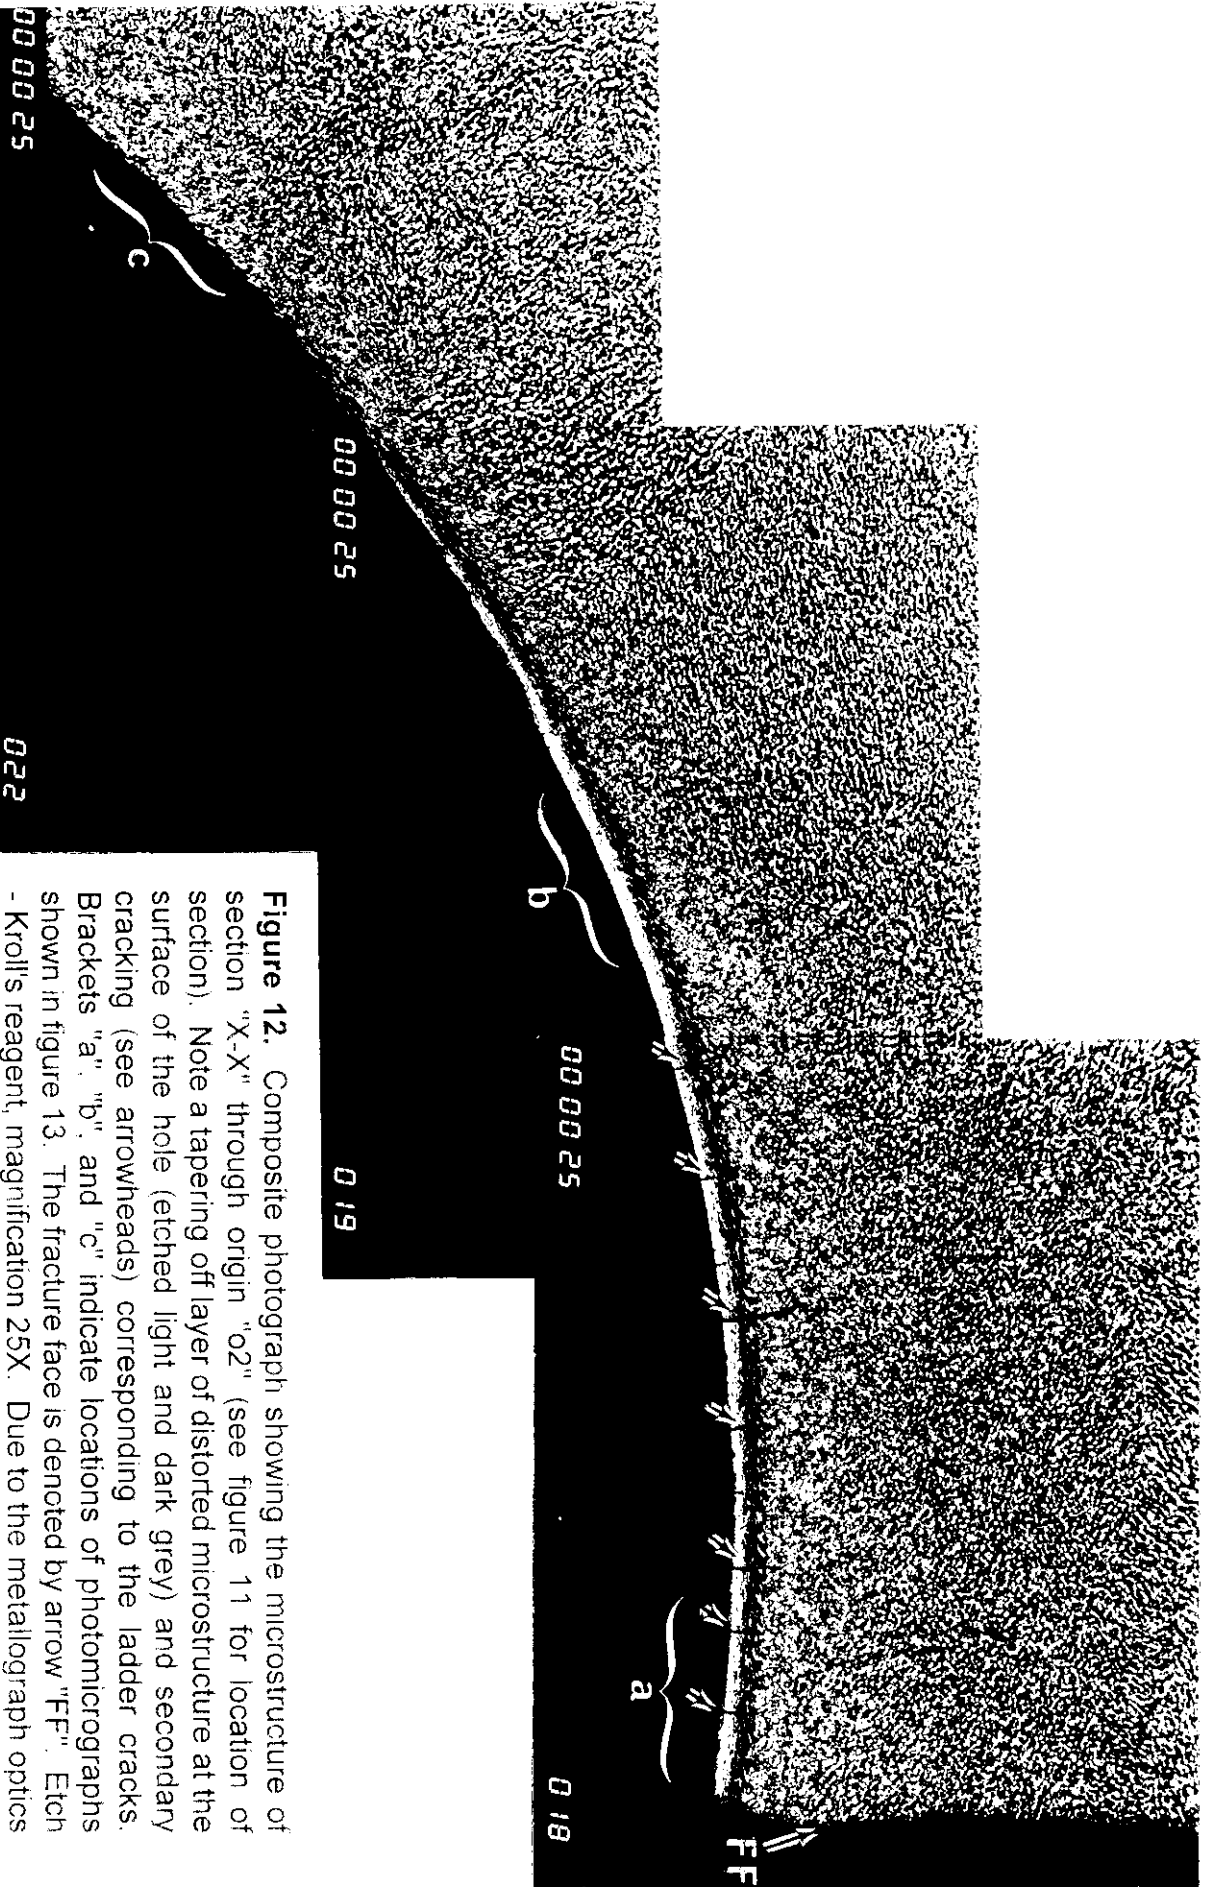
Distance from Edge		KNOOP (100 gram load)	HRC (converted)
1×10^{-3} inch	mm		
1	0.025	581	52
2	0.051	409	40
3	0.076	389	38
4	0.102	402	40
5	0.127	382	38
6	0.154	399	39
7	0.178	402	40
8	0.203	402	40
9	0.229	402	40
10	0.254	438	43
11	0.279	446	43
12	0.305	438	43
13	0.330	389	38
14	0.356	416	41
15	0.381	364	36
18	0.457	359	36
21	0.533	337	33
24	0.610	382	38
27	0.686	359	35
30	0.762	347	34
33	0.838	359	35
37	0.940	347	34

Figure 12. Composite photograph showing the microstructure of section "X-X" through origin "02" (see figure 11 for location of section). Note a tapering off layer of distorted microstructure at the surface of the hole (etched light and dark grey) and secondary cracking (see arrowheads) corresponding to the ladder cracks. Brackets "a", "b", and "c" indicate locations of photomicrographs shown in figure 13. The fracture face is denoted by arrow "FF". Etch -Kroll's reagent, magnification 25X. Due to the metallograph optics the photograph is a mirror image of the actual section.

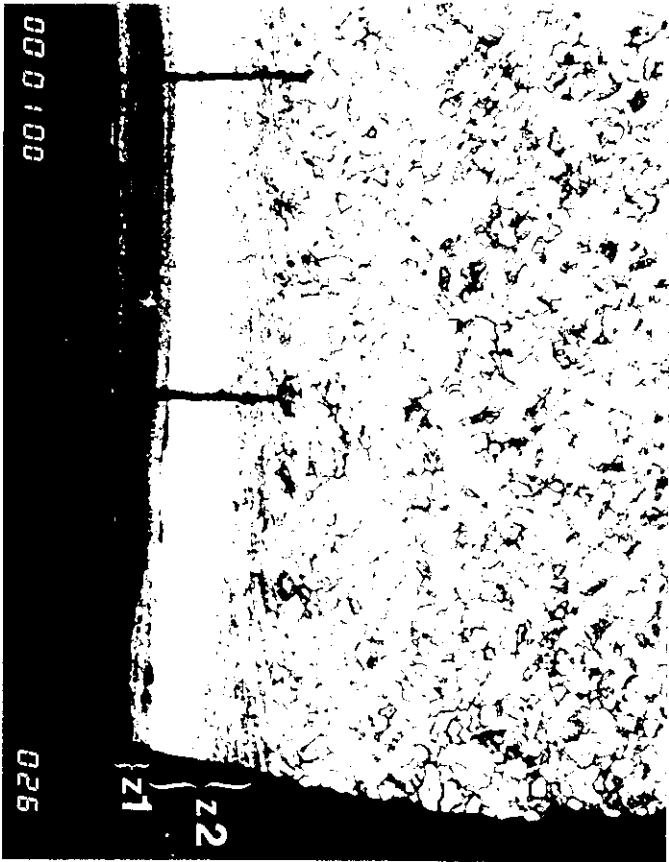
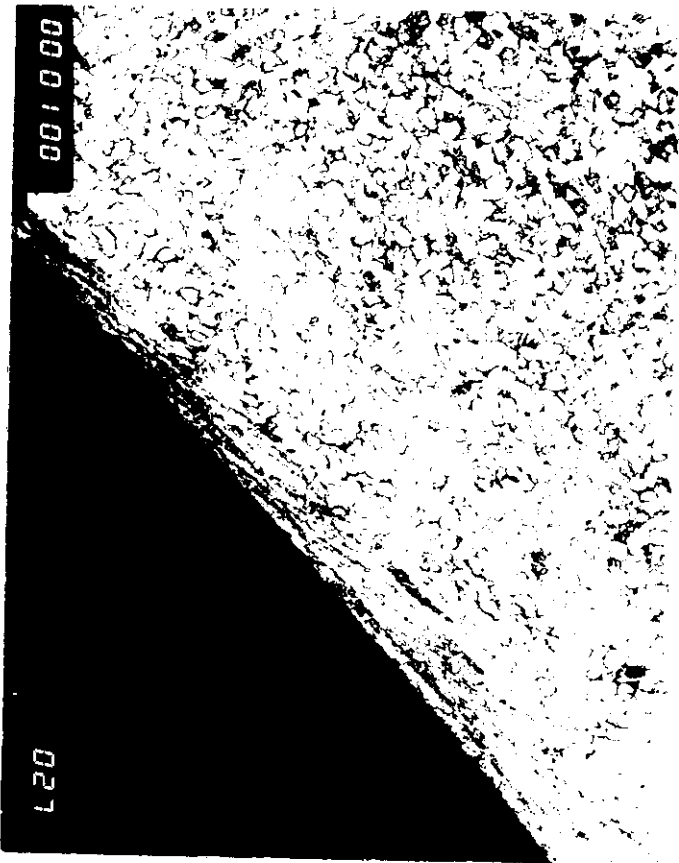
Figure 13. Microstructure in the areas shown by brackets "a" "b", and "c" in figure 14 showing the presence of two microstructural zones in area "a" (top left photomicrograph, brackets "z1" and "z2"), the absence of zone "z1" in area "b" (upper right photo) and the absence of both zones in area "c" (lower left photo). Kroll's reagent, magnification 100X.
