NATIONAL TRANSPORTATION SAFETY BOARD

MATERIALS LABORATORY FACTUAL REPORT

Report No. 98-107

Place : East Moriches, New York
Date : July 17, 1996
Vehicle : Boeing 747-131, N93119
NTSB No. : DCA96-M-A070
Investigator : Al Dickinson

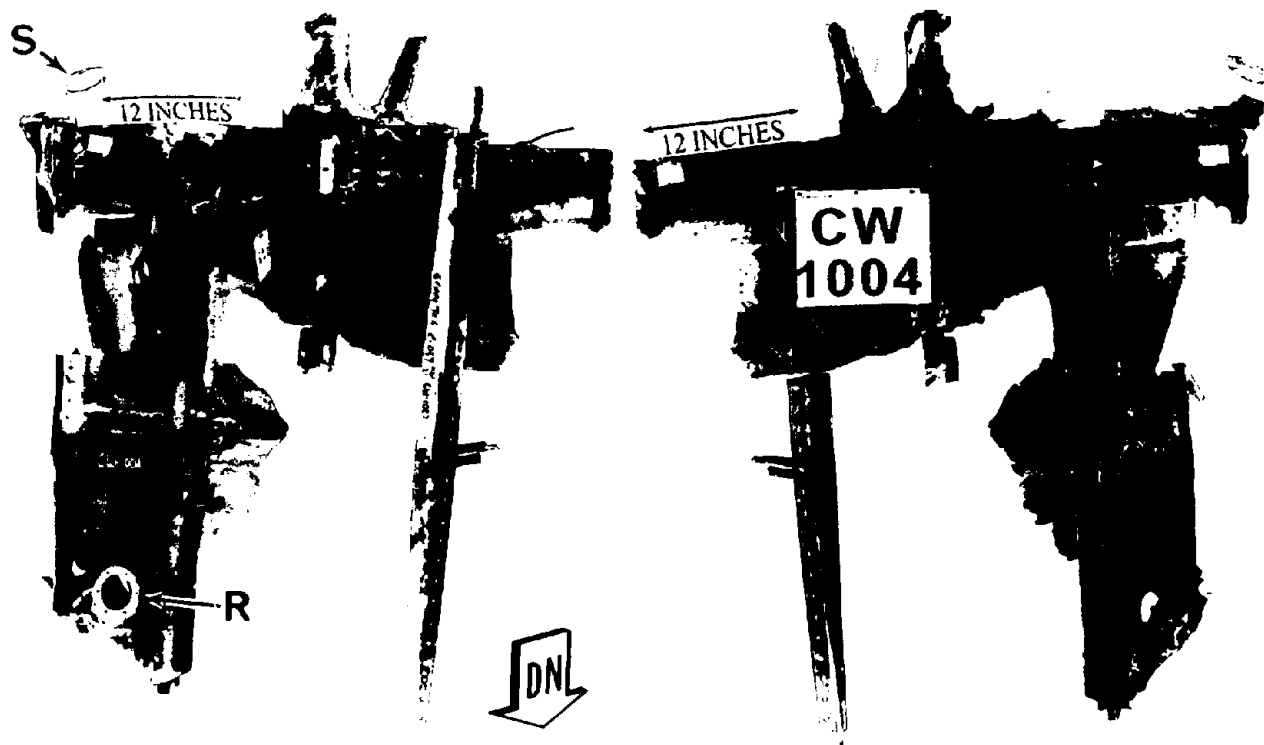
The spacer for the scavenge pump and aft spar fragment were delivered separated from each other to the Safety Board materials laboratory. A photograph of the as-received parts is shown in figure 1. According to the center fuel tank structures notes, titled " Rear Spar-Wing Center Tank, CW-1004, C-2139, Green", the aft spar fragment was recovered with the spacer still attached to the aft face of the spar, with three screws and safety wires intact. Two of the three screws were not available for examination.

Figure 1. As-received fragment of the aft spar showing the aft face (left) and forward face (right). The spacer, arrowed "S", for the scavenge pump is shown hanging above the spar.

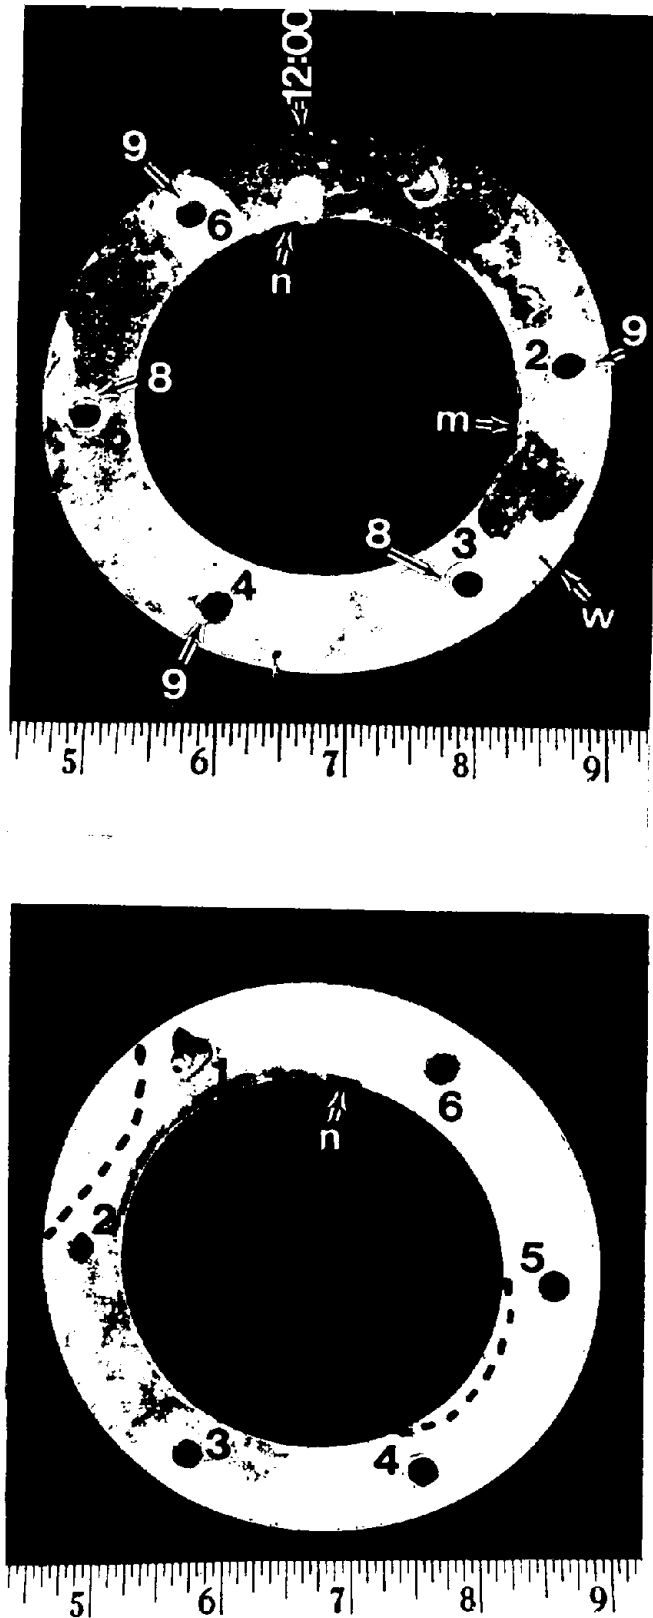
Figure 2 shows close-up photographs of the spacer, arrowed "S" in figure 1, for the scavenge pump. This spacer is manufactured with 6 screw holes, labeled "1" through "6" in figure 2. Screw hole "1" is located approximately in the 1 o'clock position looking forward.² Each screw hole has a corresponding attachment hole for a safety wire.

Visual examination of the spacer revealed overall deformation (cupping and twisting) such that the forward and aft faces did not sit flush with the surface of a flat table or the mating aft surface of the aft spar, regardless of the orientation. A screw containing bending deformation in the thread portion was found partially inserted into hole "1" and, in turn, a safety wire was attached between the head of this screw and the spacer. Fragments of safety wire were found attached to the spacer adjacent to holes "4" and "5". The ends of all the safety wires showed evidence that they were cut.

The wall of screw holes "3" and "5" on the aft face of the spacer contained an impression mark from the threads of a screw in the areas indicated by arrows "8" in figure 2. The edge of screw holes "2", "4", and "6" contained deformation marks towards the outer diameter in the areas indicated by arrows "9" in figure 2. These deformation marks are consistent with the screws bending toward the outer diameter. A wall fragment of the spacer had separated in the area indicated by arrow "w" in figure 2. The fracture from this fragment intersected a hole for a safety wire. Also, the inside diameter face of the spacer contained mechanical damage in the two areas indicated by arrows "m" and "n" in figure 2.

The forward face of the spacer contained a crescent shaped discoloration between holes "1" and "2" in the area bound by a dashed line and the outside diameter in figure 2. Another crescent shaped discoloration was found between holes "4" and "5" that was bound by a dashed line and the inside diameter in figure 2.

Figure 2. Overall view of the aft face (top) and forward face (bottom) of the spacer for the scavenge pump.

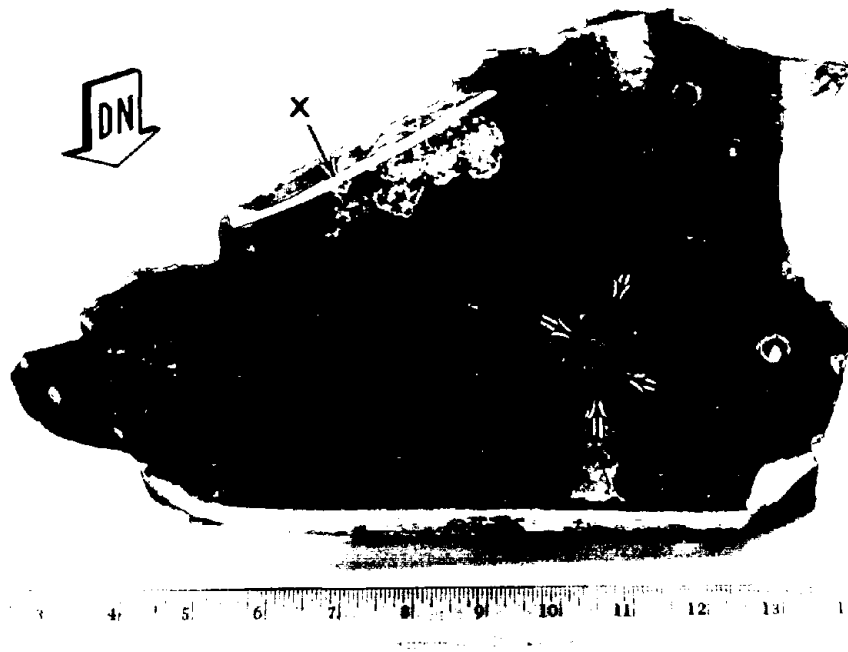
Figure 4 shows a photograph of the forward face of the bent portion of the spar after it was excised. The bottom end of this piece contained a portion of the lower spar cap that was coated with a layer of black sealant. A layer of sealant was found torn off the forward face of the cap in the area bound by unmarked arrows in figure 4, exposing bare metal surface. The bare metal surface contained random oriented gouge marks. The position of these gouge marks on the bent portion coincide with the installed location of the receiver housing. No fragment of the housing for the receiver was found attached to the aft spar and cap.

Figure 4. Close-up view of the excised bent portion of the aft spar showing the forward face which was not visible prior to excising. Cut end is indicated by arrow "X".

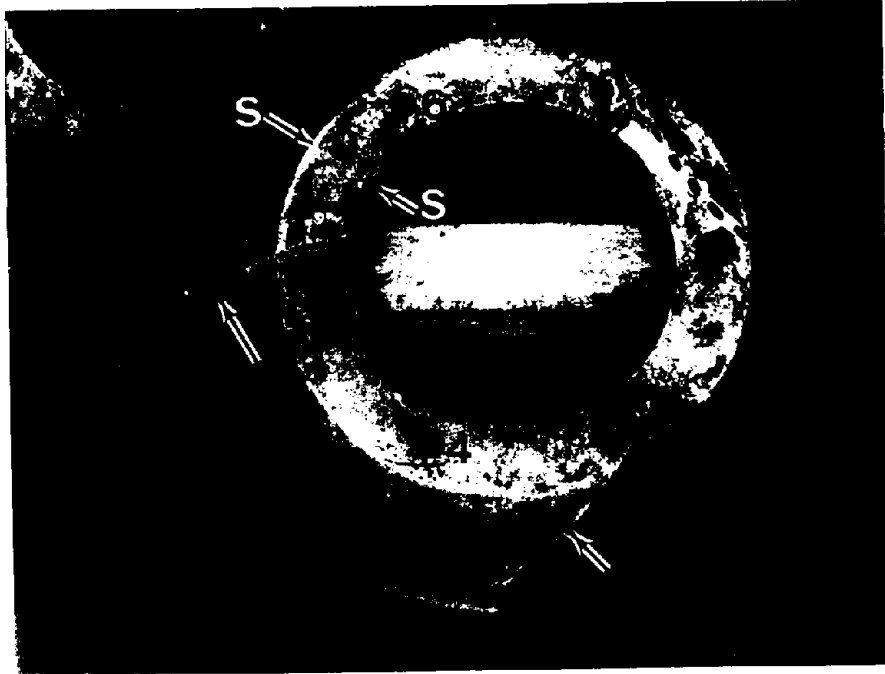
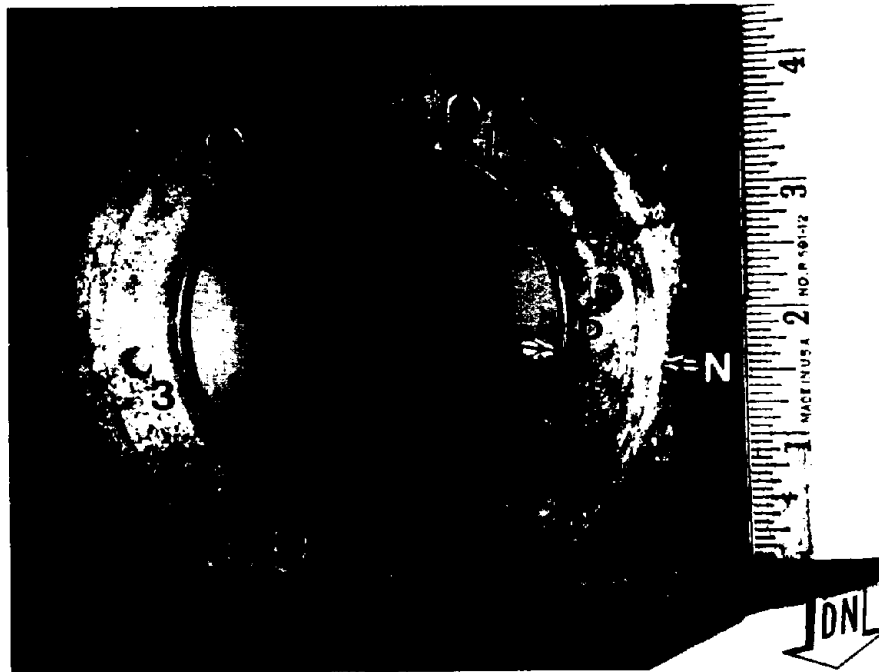
The aft face of the spar in the area of the attachment hole for the scavenge pump contained an outline pattern of the spacer between arrows "S" in figure 5. The area located outside this pattern contained a heavy deposit of dirt and soot. The region inside the outline pattern contained a crescent shaped discoloration between holes "1" and "2", in the areas bound by a dashed line and the outside diameter in the upper photograph of figure 5. Similar discoloration was found between holes "4" and "5", in the areas bound by

a dashed line and the inside diameter in the upper photograph of figure 5. These crescent shaped discoloration marks correspond to those found on the forward face of the spacer in figure 2. Further, the screw holes on this spar contained deformation and thread marks consistent with those found on the spacer. Two gouge marks in the shape of an arc were noted on the aft face of the spar in the areas indicated by unmarked arrows in the upper photograph of figure 5. One of these marks intersected screw hole "3" and the other nearly intersected screw hole "5".

The forward face of the spar in the area of the attachment hole for the scavenge pump contained an outline pattern of the receiver mounting flange between arrows "N" in the lower photograph of figure 5. The forward face of the aft spar in the area of the attachment hole contained a crescent soot mark between holes "1" and "2" (see area bound by a dashed line and the outer diameter of the receiver mounting flange in the lower photograph of figure 5). The surface of the aft spar underneath the receiver mounting flange showed no evidence of sooting, except for the crescent soot mark noted earlier. The attachment hole for the scavenger pump contained no mechanical damage that corresponded to the two mechanical damaged areas found in the inside diameter of the spacer (indicated by arrows "m" and "n" in figure 2).

Figure 5. Overall view of the aft face (top) and forward face (bottom) of the aft spar in the area of the scavenge pump attachment hole. The number next to each screw hole corresponds to those on the spacer in figure 2.

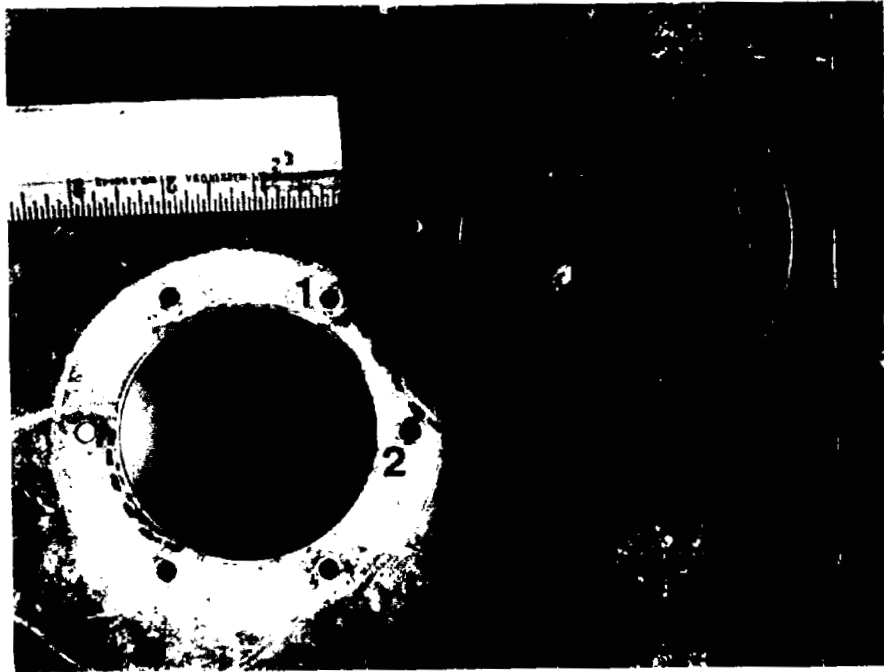
Figure 6 shows a photograph of the mating faces of the spacer and aft spar. Figure 7 shows a photograph of the spacer as if installed on the aft surface of the spar. As indicated earlier, the aft face of the spacer between the 9 and 1:30 o'clock position was covered with a dark deposit. The spar in the area above the spacer was also covered with the same dark deposit.

The orientation of the spacer and spar in figure 7 is consistent with the recovered position of the spacer, according to a photograph found in the center fuel tank structures notes. Examination of the photograph in the structures notes revealed screws were installed in holes "1", "3", and "5" in figure 6.

Figure 6. Mating surfaces of the spacer and aft spar.

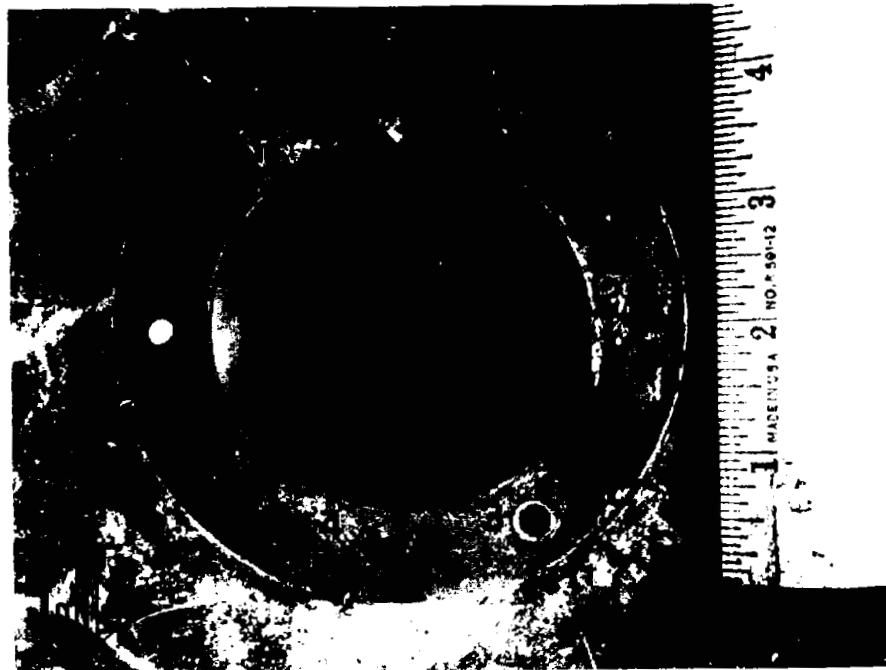
Figure 7. View looking forward showing the spacer attached to the aft spar, as if installed when recovered.

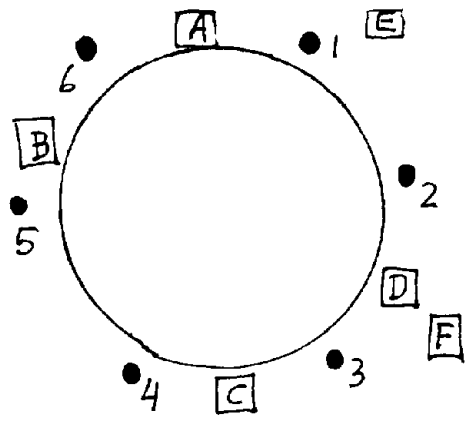
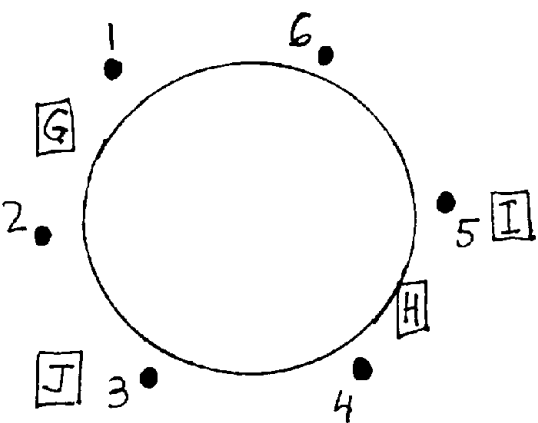
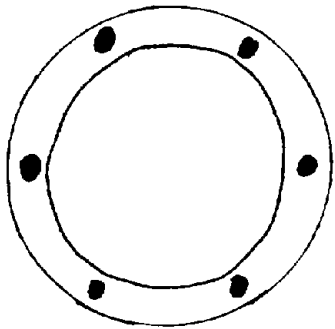
TABLE 1. EDDY CURRENT MEASUREMENTS

Conductivity measurements were made on the spacer and aft spar in the areas indicated in the sketch in Table 1. The conductivity measurements of the spacer and the aft spar were within BAC 5946 specified values (see Table 1). Rockwell hardness testing on the forward face of the spacer between holes "4" and "5" measured from 72 to 78 HRB, which was within the specified range (63 to 83.5 HRB).

<p>AFT SURFACE OF AFT SPAR</p>	<p>7075-T6 Aluminum alloy (1.6Cu, 2.5Mg, 0.23Cr, 5.6Zn, % by weight, nominal)</p>	<p>30 - 35</p>	<p>A = 30.5 B = 30.5 C = 30.6 D = 30.5 E = 30.5 F = 30.6</p>

<p>FWD SURFACE OF AFT SPAR</p>	<p>7075-T6 Aluminum alloy</p>	<p>30 - 35</p>	<p>G = 31.0 H = 31.0 I = 31.0 J = 31.0</p>

<p>SPACER (FWD & AFT SURFACE)</p>	<p>2024-T3 Aluminum Alloy (4.4Cu, 0.6Mn, 1.5Mg, % by weight, nominal)</p>	<p>28.5 - 32</p>	<p>All measurements were 29.0</p>
