# NATIONAL TRANSPORTATION SAFETY BOARD

MATERIALS LABORATORY FACTUAL ADDENDUM

Report No. 06-010B

Place : Miami, Florida  
Date : December 19, 2005  
Vehicle : Grumman G-73T Mallard, N2969  
NTSB No. : DCA06MA010  
Investigator : Brian Murphy, AS-40

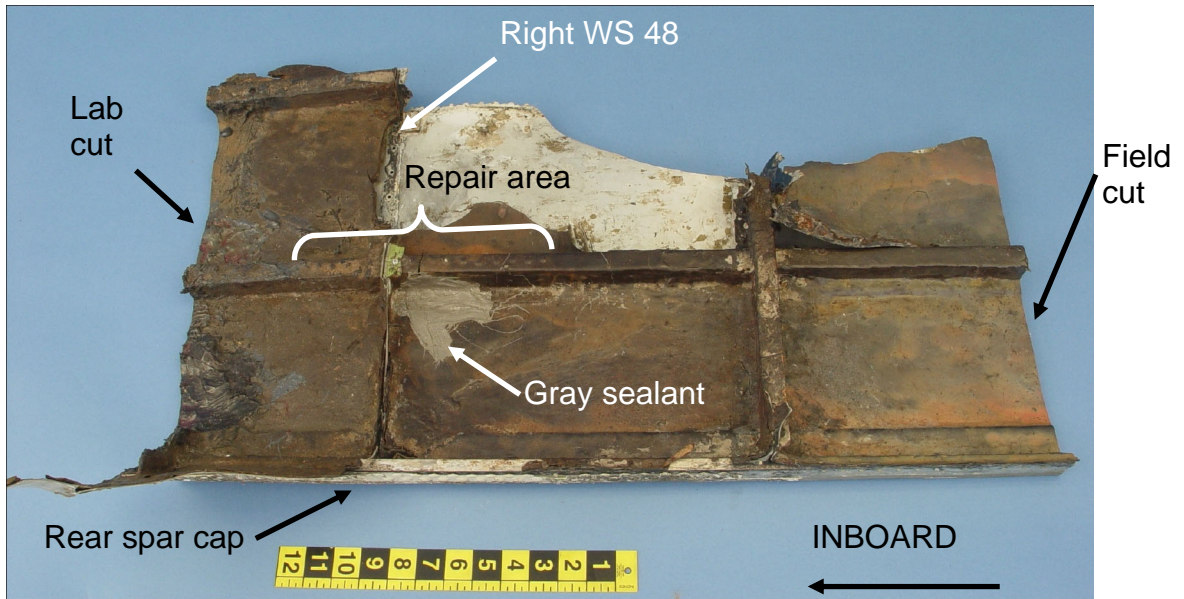
As shown in figure 1, most of the interior of the piece was covered with a reddish-brown sealant consistent with the fuel tank sealant observed throughout interior surfaces of the accident airplane wing fuel tanks. One area outboard of right WS 48 and at the aft side of the rear Z-stringer had a gray colored sealant. A closer view of the area of gray sealant is shown in figure 3.

Figure 1. Overall view of the interior surface of the wing box beam piece containing the rear Z-stringer repair at right WS 48.

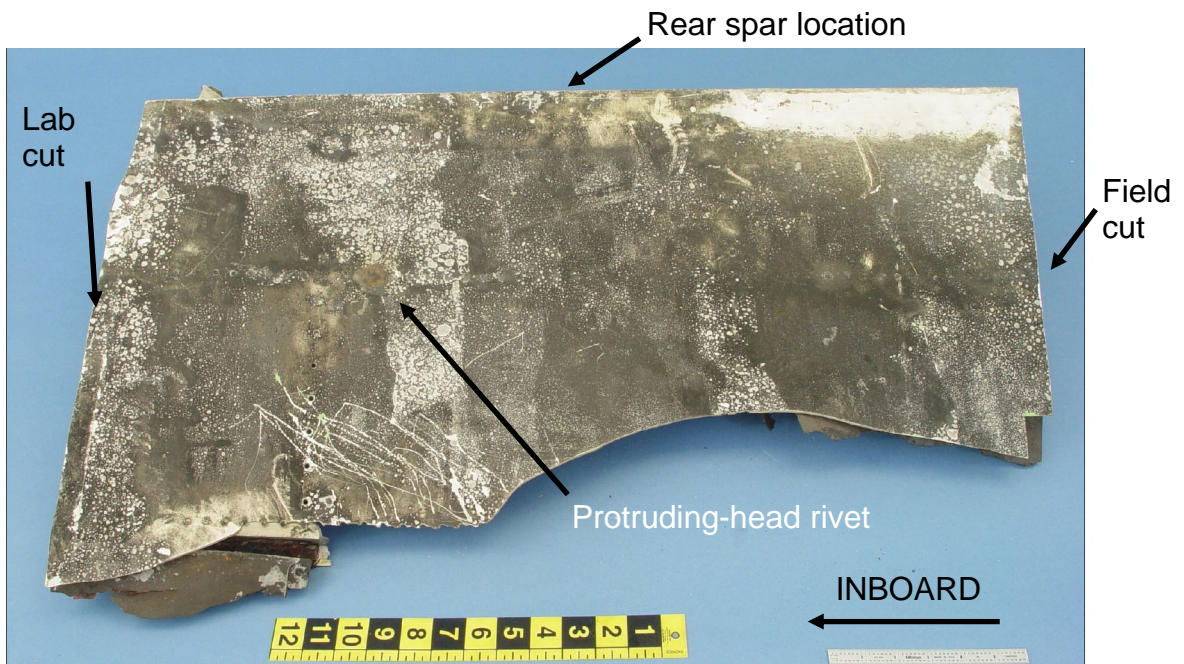
Most of the Z-stringer repair fasteners through the lower skin had heads that were flush to the skin surface. However, one rivet at the center of the repair area had a protruding head as indicated in figure 2. A closer view of the protruding-head rivet is shown in figure 4.

Figure 2. Overall view of the exterior surface of the wing box beam piece containing the rear Z-stringer repair at right WS 48. The protruding-head rivet was located near the center of the repair area.

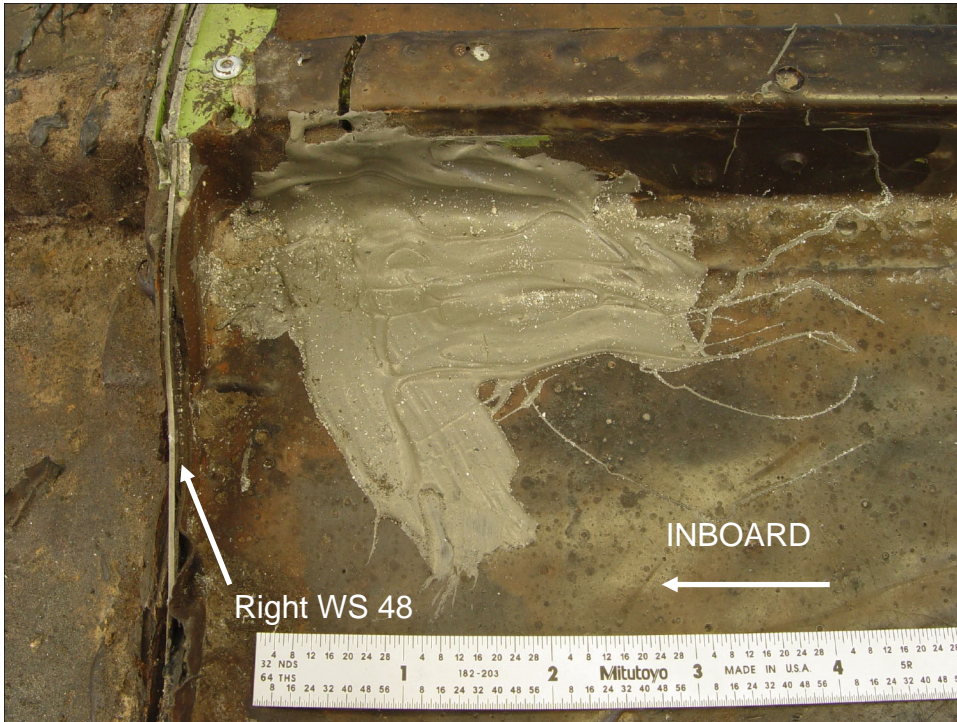
Figure 3. Closer view of the gray sealant shown in figure 1.

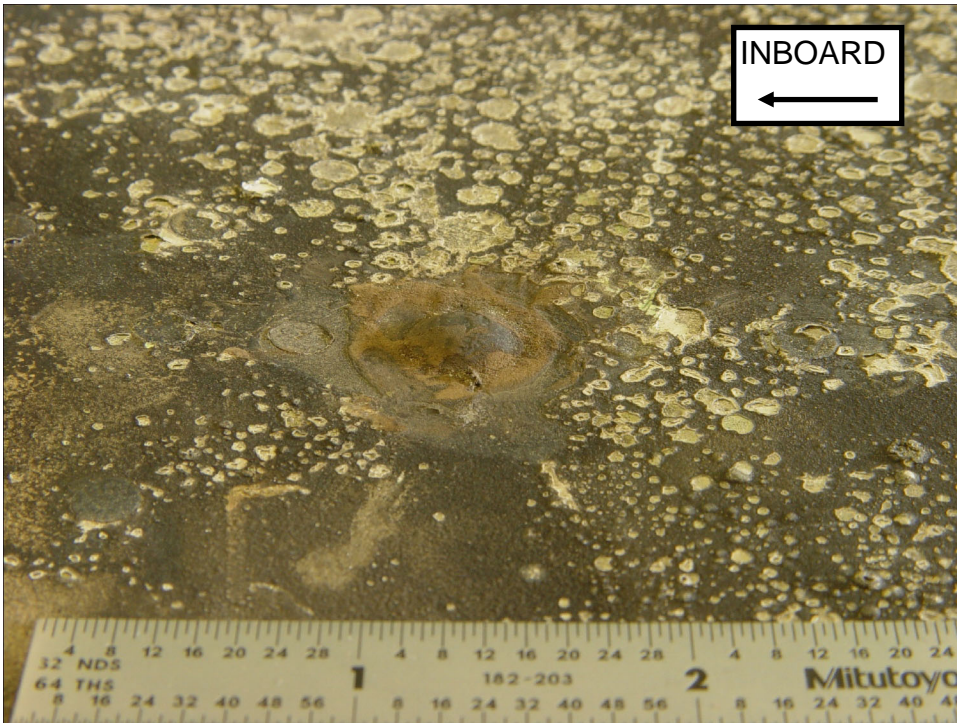
Figure 4. Closer view of the protruding-head rivet indicated in figure 2.

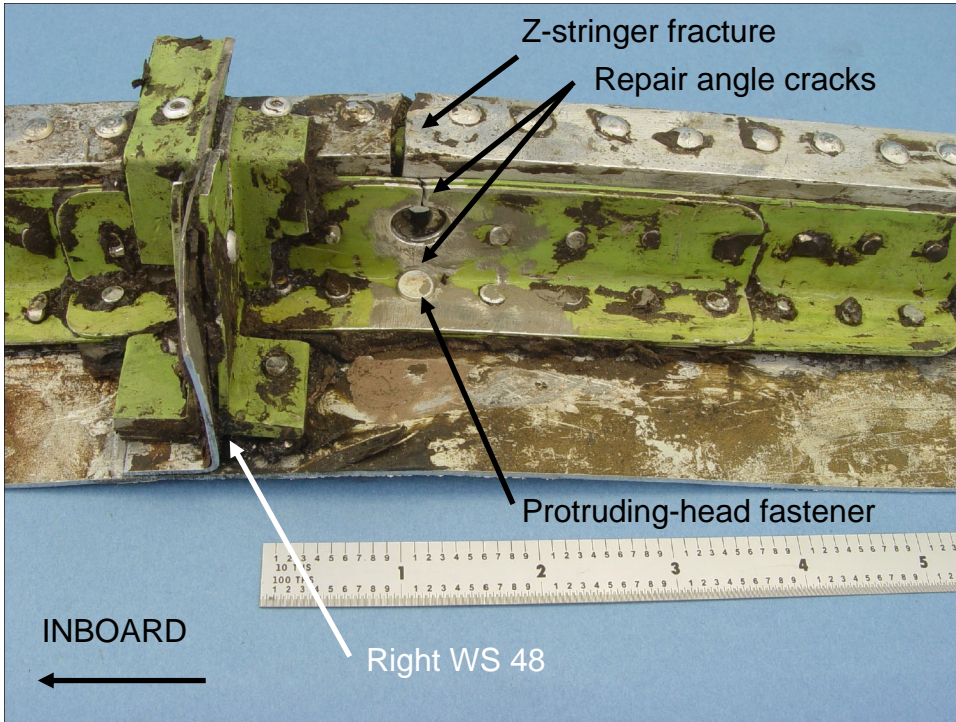
A view of the repair in the area of the slosh hole at the aft side of the rear Z-stringer after sealant removal is shown in figure 5. As indicated in figures 5, the rear Z-stringer was fractured, and the mating sides of the fracture were gaped open slightly at the visible upper flange. The repair angle brackets on the aft side of the Z-stringer were cracked at the slosh hole location from the forward side of the protruding head fastener through the slosh hole and up to the top of the vertical legs. In the most aft repair angle, sanding or grinding marks with missing paint were observed around the slosh hole in the vertical leg and on portions of the horizontal leg. During sealant removal, it was noted that reddish-brown sealant was not present in the local area in and around the sanding or grinding marks, and gray sealant was adhered directly to the repair angle surface.

Figure 5. View of the aft side of the rear Z-stringer repair after sealant removal.

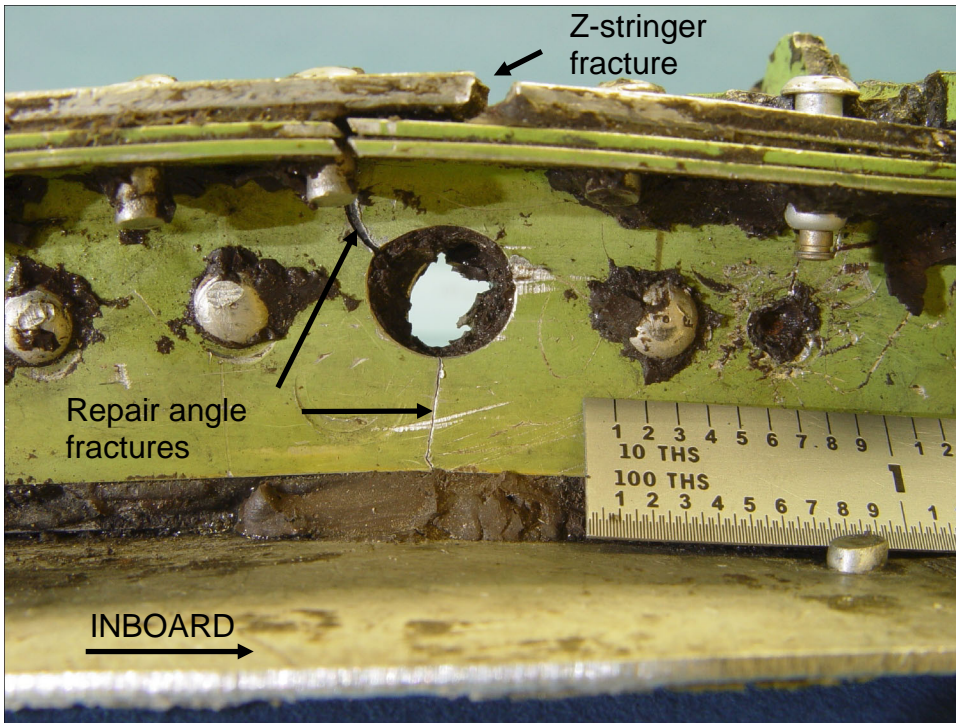
A close view of the repair in the area of the slosh hole at the forward side of the rear Z-stringer after sealant removal is shown in figure 6. Both repair angles at the forward side of the Z-stringer were fractured at the locations shown in figure 6.

All crack and fracture surfaces on the repair angles were on slant planes consistent with overstress fracture. No evidence of preexisting damage such as fatigue cracking was observed on the repair angle surfaces.

Figure 6. Close view of the forward side of the rear Z-stringer repair at the slosh hole location after sealant removal.

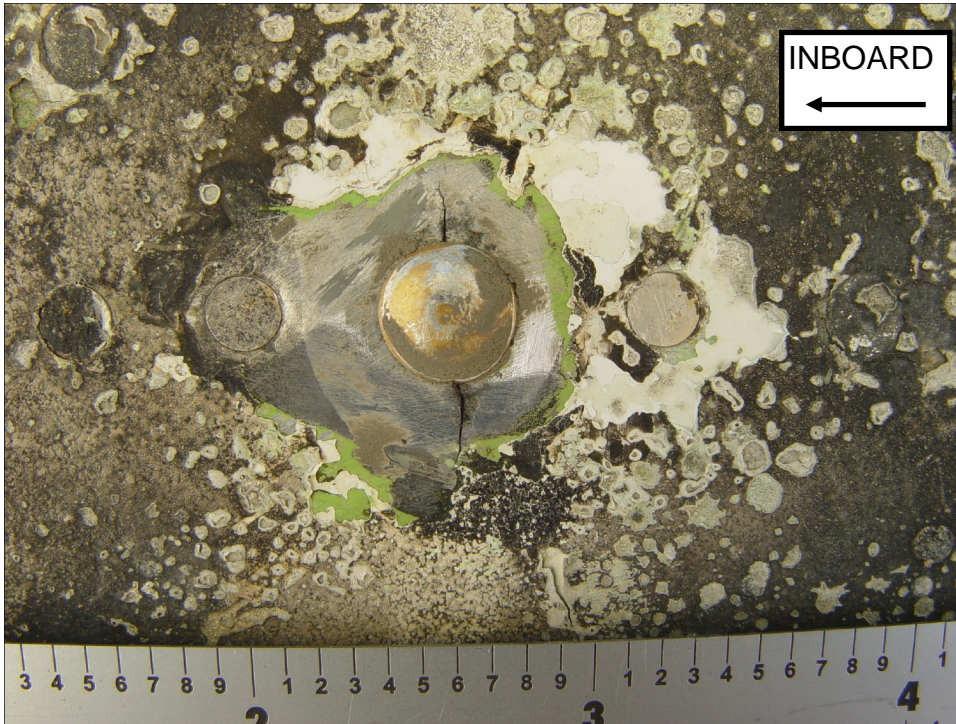
The area around the protruding-head rivet on the lower surface of the skin was covered with a sealant. The sealant was removed and the area was cleaned using acetone and a brush. The area is shown in figure 7 after sealant removal and cleaning. Cracks were observed emanating forward and aft of the rivet head. The area around the rivet head had missing paint with sanding or grinding marks in the skin.

Figure 7. View of the protruding-head rivet shown in figure 4 after cleaning and sealant removal with acetone and a brush.

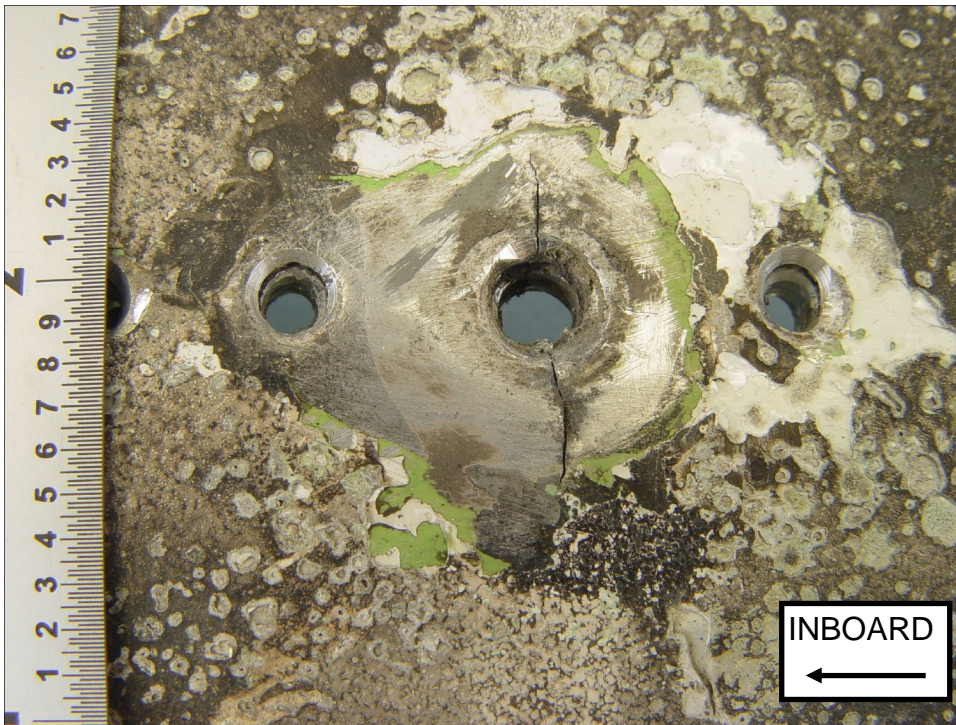
Figure 8. View of the skin lower surface in the area shown in figure 7 after fastener removal.

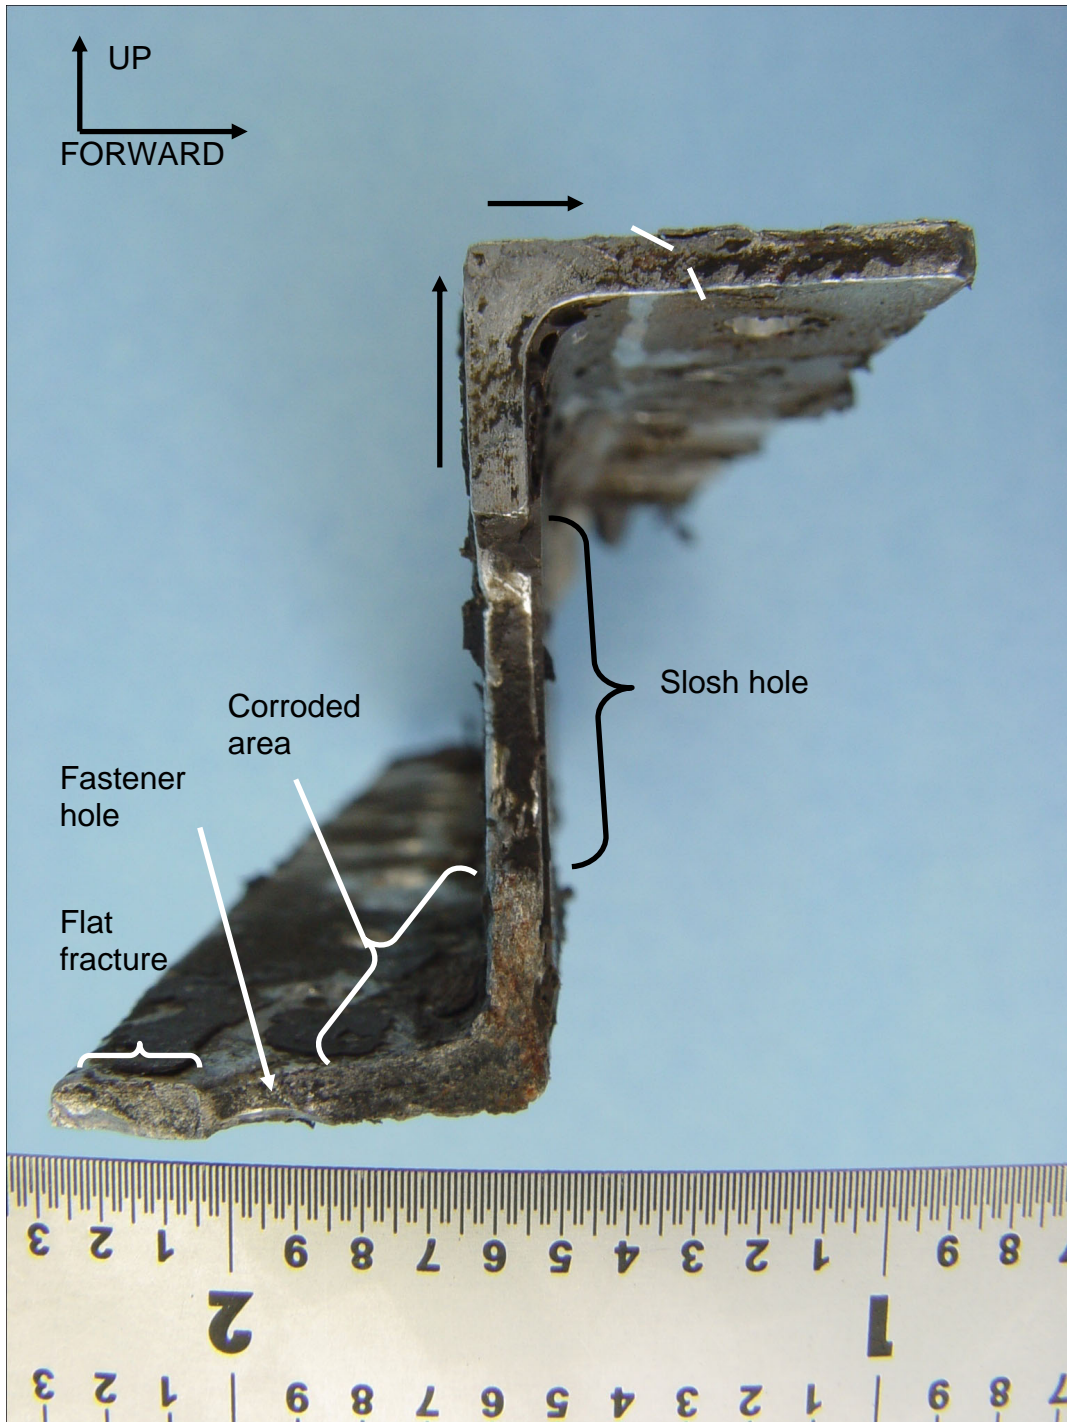
Portions of the rear Z-stringer fracture surfaces were relatively flat and perpendicular to the longitudinal axis, features consistent with fatigue. The fracture surface at the inboard side of the fracture was cleaned using acetone, soapy water, and a brush followed by ultrasonic cleaning in soapy water, and the resulting fracture surface is shown in figure 9. Flat fracture features with curving crack arrest lines consistent with fatigue were visible above the slosh hole up to the dashed line position in figure 9. The remainder of the upper flange beyond the dashed line position was fractured on a slant plane consistent with overstress fracture. Below the slosh hole, fracture features were mostly obliterated by post-fracture corrosion and contact damage. The fracture plane nearest the slosh hole appeared mostly flat and perpendicular to the fracture surface, but gradually changed to a slant plane closer to the fastener hole in the lower flange, where the fracture intersected the inboard side of the fastener hole. Forward of the fastener hole, flat fracture features were observed in a plane perpendicular to the Z-stringer surface, features consistent with fatigue.

Figure 9. View of the inboard surface of the rear Z-stringer fracture after removal of repair angles and cleaning with soapy water and a brush. The dashed line at the upper flange indicates the boundary of the fatigue region emanating upward from the slosh hole.

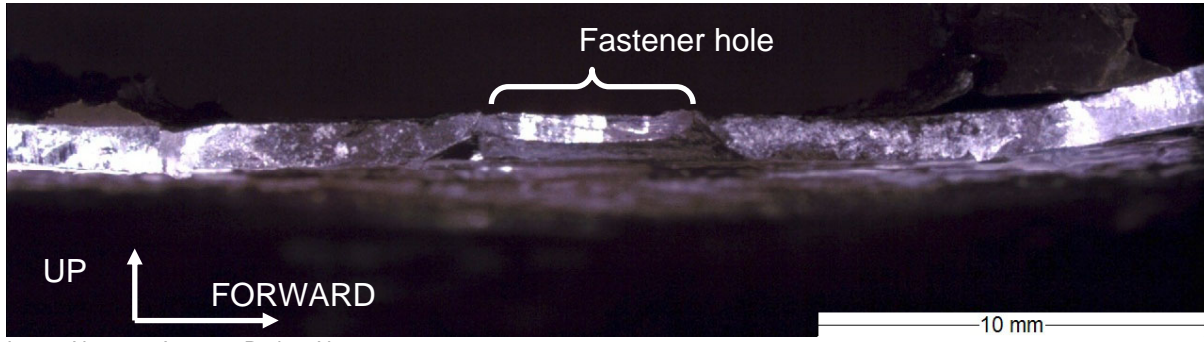
In order to separate the skin cracks, the skin was cut with snips to within approximately 0.1 inch of the crack tip, and as the cut was finished, the remaining ligament fractured. The crack surfaces were mostly covered with a black deposit. The inboard sides of the crack surfaces were cleaned using acetone and a brush followed by ultrasonic cleaning in soapy water. A view of the inboard side of the crack surfaces and the fastener hole bore after cleaning is shown in figure 10, and closer views of the surfaces aft and forward of the fastener hole are shown in figures 11 and 12, respectively. The crack surfaces were relatively flat and perpendicular to the skin surface, features consistent with fatigue. The extent of the fatigue regions are indicated with unlabeled brackets in figures 11 and 12. Aft of the fastener hole, the fracture features were mostly covered with black deposits as shown in figure 11. However, a curving crack arrest line was visible at the fatigue boundary at the aft end of the fatigue region. Forward of the fastener hole, fine fracture features were mostly obliterated by post fracture corrosion and rubbing damage. Corrosion pitting through approximately 20 percent of the thickness was observed locally at the crack location aft of the fastener hole shown in figure 12.

Figure 10. View of the skin inboard side of the skin crack surfaces after opening the cracks and cleaning with soap water, acetone, and a brush.

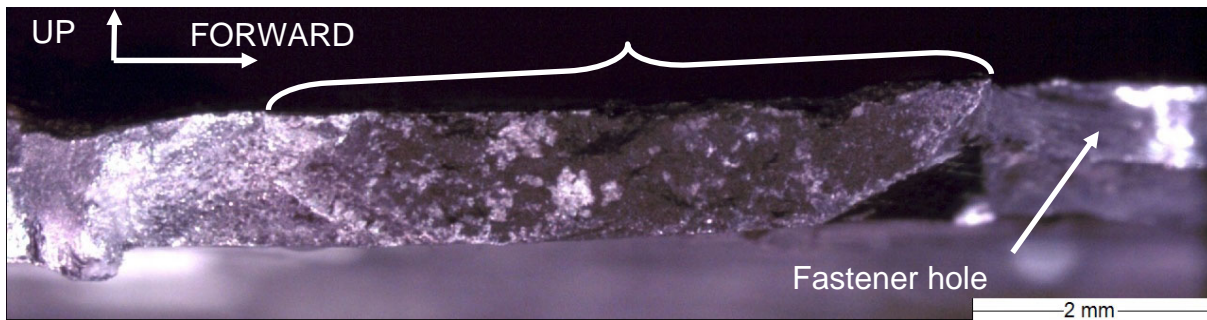
Figure 11. Closer view of the crack surface aft of the fastener hole. An unlabeled bracket indicates the extent of the flat fracture region perpendicular to the skin surface.

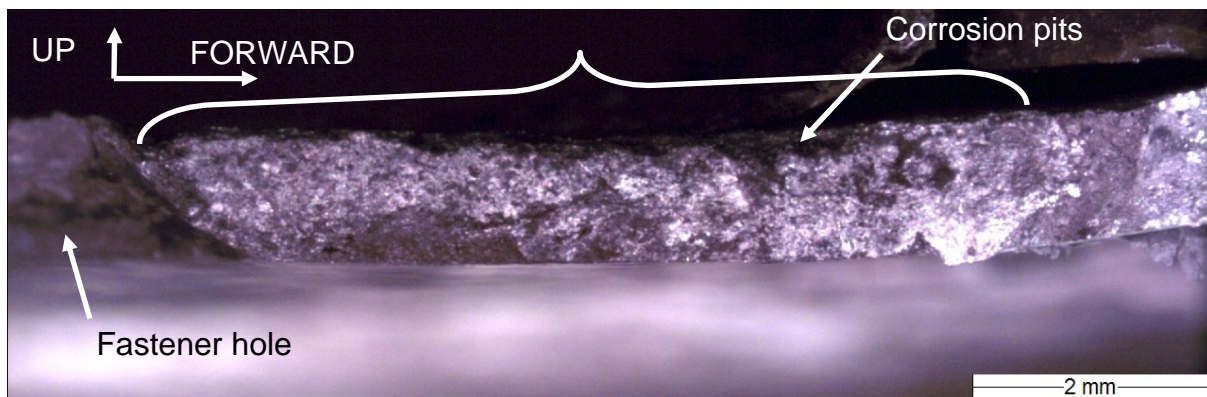
Figure 12. Closer view of the crack surface forward of the fastener hole. An unlabeled bracket indicates the extent of the flat fracture region perpendicular to the skin surface.
