NATIONAL TRANSPORTATION SAFETY BOARD

MATERIALS LABORATORY FACTUAL REPORT

Report No. 00-045

Place : Near Port Hueneme, California
Date : January 31, 2000
Vehicle : MD-83, N963AS
Operator : Alaska Airlines, Flight 261
NTSB No. : DCA00-M-A023

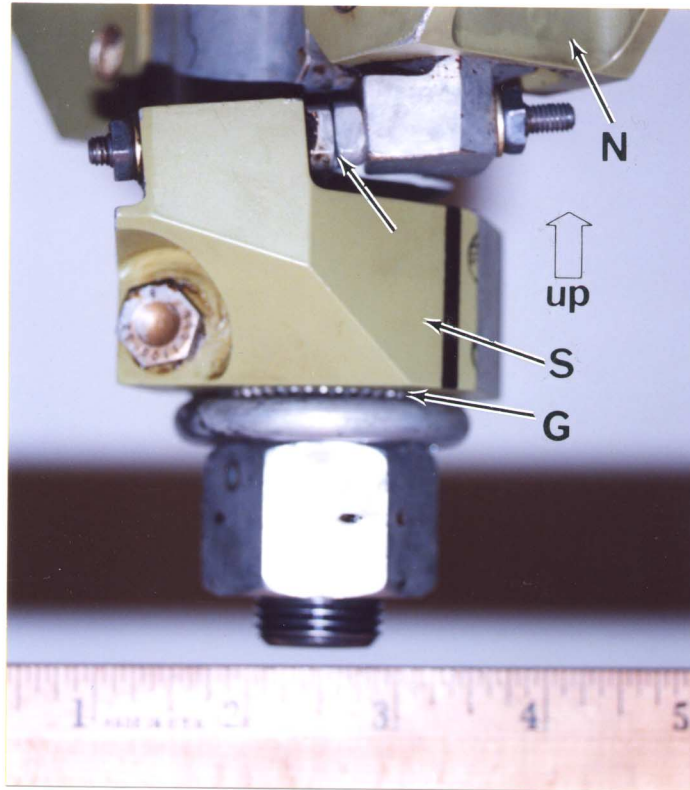
head of a similar bolt in the ACME (gimbal) nut. An example of proper contact for a jackscrew assembly similar to that of the accident assembly is shown in figure 1, where an unlabeled arrow indicates the contact location between the gimbal nut "N" and the mechanical stop "S". Neither the upper nor lower stop bolt faces showed evidence of contact at this location. The electrical control system for the jackscrew assembly also contains electrical stops, which during normal operation, stop screw rotation before the mechanical stops contact. A torque tube (quill shaft) passes through the center of the jackscrew with a threaded region extending below the lower surface of the jackscrew. The lower end of the quill shaft is secured against the lower surface of the jackscrew by a nut and washer, as shown in figure 1, leaving a gap, "G", between the washer and the lower surface of the lower stop.

Figure 1. View of the lower end of a jackscrew assembly similar to the accident assembly. An unlabeled arrow indicates the location of contact between the gimbal nut "N" and the mechanical stop "S".

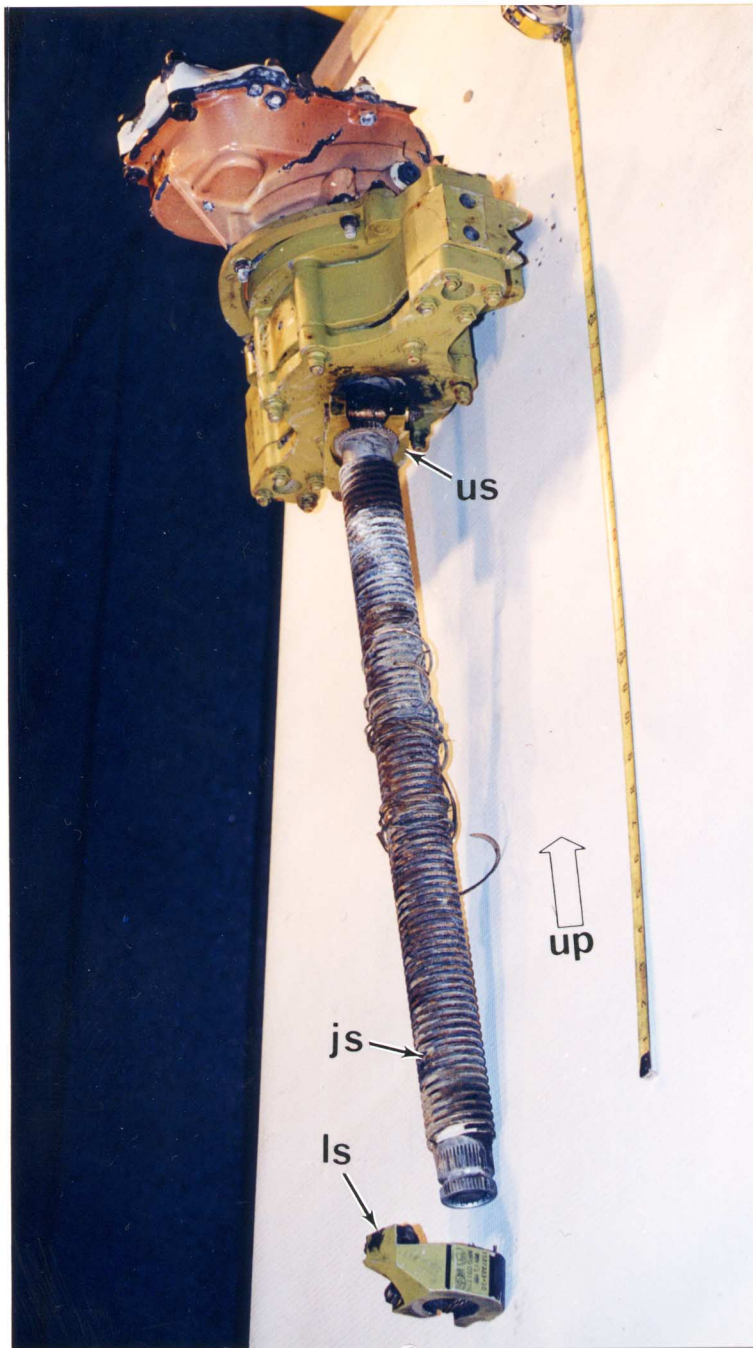
An overall view of the jackscrew assembly with the attached gearbox is shown in figure 2. The lower stop, labeled "ls" in figure 2, was received separated from the jackscrew, labeled "js" in figure 2. The lower stop is shown as received in figure 3. The tangential bolt that clamps the lower stop to the splines of the jackscrew was still in place within the stop. Two lengths of the safety wire, labeled "sw" in figure 3, (0.050 inch diameter) remained attached to the clamp bolt, and were separated from the torque tube nut. The upper stop, labeled "us" in figure 2, was disassembled from the jackscrew in the Materials Laboratory. After visual examination, the stops were ultrasonically cleaned in an Alconox solution, removing residual grease from the surface. The stops were then examined using optical microscopy, scanning electron microscopy (SEM), and energy dispersive x-ray spectroscopy (EDS).

Figure 2. An overall view of the jackscrew, "js", with the attached gearbox (photographed on-scene after removal from the horizontal stabilizer). Arrows "us" and "ls" indicate the attached upper stop and separated lower stop, respectively.

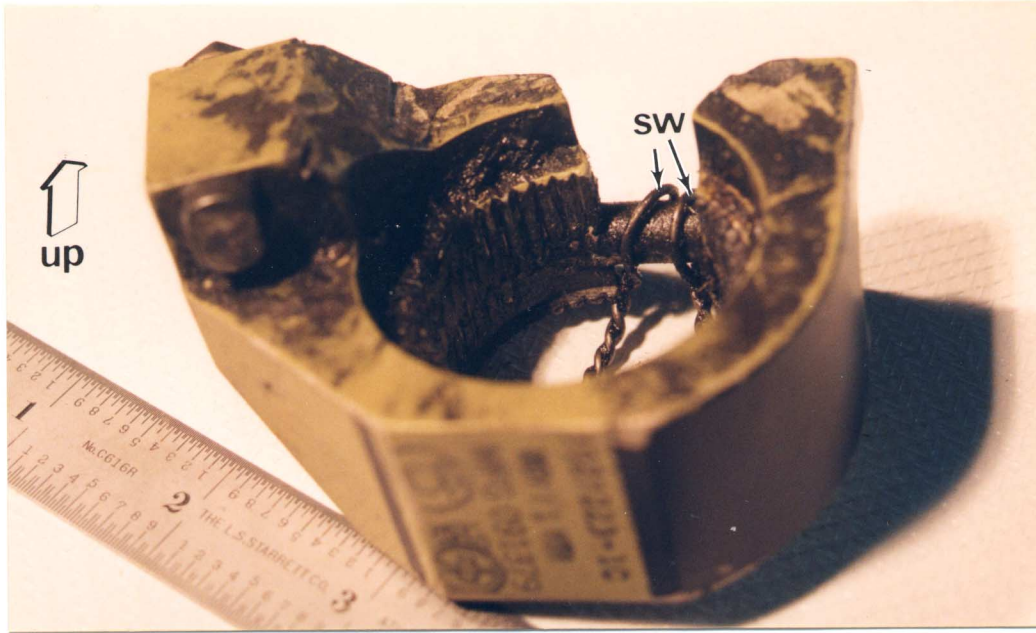
Figure 3. View of the lower stop as received. Arrows "sw" indicate safety wire attached to the clamp bolt.

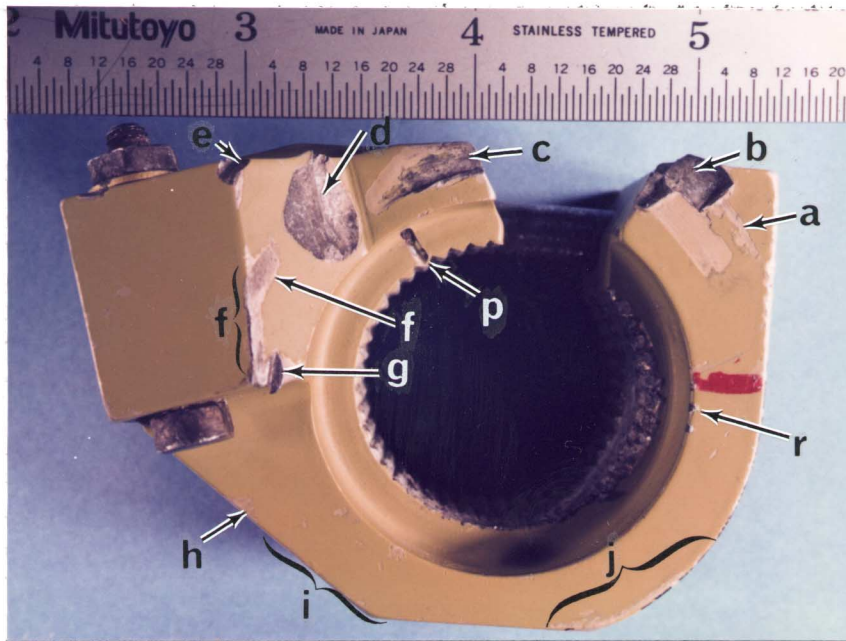
A view of the upper surface of the lower stop after cleaning is shown in figure 4. The upper surface showed multiple damage features, indicative of contact with another object. These features ranged from light marks in the primer to severe dents and deformation of the metal. Based on relative locations and feature shapes, features labeled "a" to "g" in figure 4, were all consistent with contact between the upper surface of the mechanical stop and various portions of the lower end of the gimbal nut, shown in figure 5. The lower stop lug of the gimbal nut protrudes below the main body of the nut, and as installed on the aircraft, is located on the aft side of the nut, indicated by bracket "2" in figure 5. The forward right corner of the lower stop lug was deformed at the position labeled "l" in figure 5, with wear of the right edge and deformation of the forward edge in the forward direction. Using the alignment pin hole (labeled "p" in figure 2) as a reference, the markings on the lower stop were used to determine the axial rotational orientations of probable contact between the lower stop and the gimbal nut. When assembled onto the jackscrew, the alignment pin is inserted through the alignment pin hole in the lower stop into a vertical slot (index spline) in the jackscrew splines. The angular orientations provided below are the clockwise rotational angle between the alignment pin hole and the aircraft forward direction as viewed from above. In other words,

Three impressions, labeled “r” in figure 4, were observed at the inside radius of the lower stop upper surface. The sizes, spacing, and geometry of the impressions are consistent with contact with the jackscrew splines. The raised lip of metal on the surface at the edge of the deformation indicates an upward motion of the jackscrew splines relative to the lower stop as the damage was created.

The inner portion of the alignment pin was missing from the alignment pin hole, labeled “p” in figures 4 and 7. The clockwise side of the inner portion of the alignment pin hole was deformed, consistent with movement of the alignment pin clockwise relative to the lower stop.

Figure 4. A view of the upper surface of the lower mechanical stop after cleaning. Areas of damage are labeled "a" through "j" and "r". The through hole for the alignment pin is labeled "p".

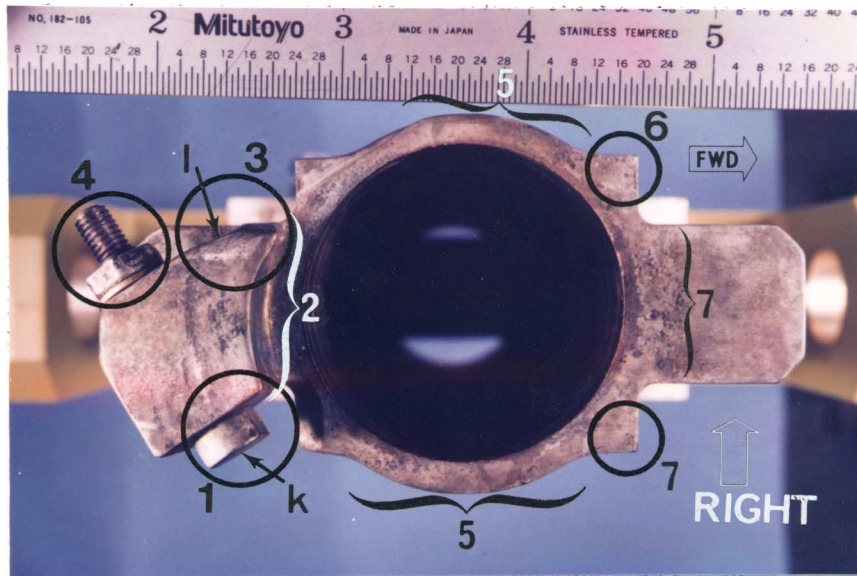
A total of seven different features on the lower end of the gimbal nut were identified as areas with a shape and radial location (from the axis of the jackscrew) consistent with the various damage areas on the lower stop. Those seven areas are described in the following table and are shown within the numbered circles or by numbered brackets in figure 5. Also listed in the table are the damage areas on the lower stop that correspond to each of the contacting areas described. The remainder of this section of the report discusses each of the lower stop contact areas in detail.

Figure 5. A view of the lower surface of the gimbal nut (looking up from below), where the head of the stop bolt is labeled "k", and the deformed forward right edge of the stop is labeled "l". Areas of probable contact with the lower stop are labeled "1" to "7".

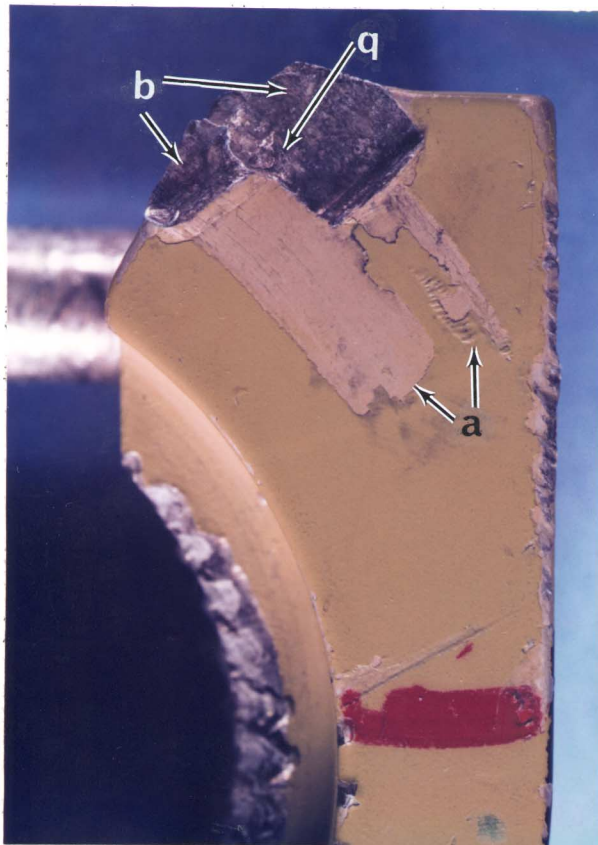
Figure 6 shows a closer view of damage areas “a” and “b” on the lower stop. Damage at location “a” is consistent with rotational sliding contact by area “1” of the gimbal nut. The damage covered an arc of about 20° at an orientation ranging from 110° to 130°. As can be seen in figure 6, the paint in area “a” was disturbed with little or no deformation to the metal below. Rotational scoring was observed, but the direction of the scoring was inconclusive by optical microscopy.

Substantial deformation at location “b” is also consistent with sliding contact by area “1” of the gimbal nut, but at an angle of orientation ranging from 133° to 140°. This marking showed significant deformation of the metal, consistent with greater contact loading than that associated with marking “a”. Raised lips of metal were observed at the edge of location “b” where it mated with the damage of location “a”, indicating that damage associated with

location "a" occurred before the damage at location "b". Scoring and deformation near the edge of the lower stop at location "b" indicate that the lower stop was rotating clockwise (as viewed from above) relative to the gimbal nut as most of the damage at location "b" was created.

At one location within area "b", deformation was in the clockwise direction, indicating that the lower stop also rotated counter-clockwise relative to the gimbal nut while in contact with the lower stop. This area with clockwise deformation is indicated by arrow "q" in figure 6.

Figure 6. A higher magnification view of damage at locations "a" and "b" on the lower stop. Arrow "q" indicates secondary features in location "b". (3.1x)

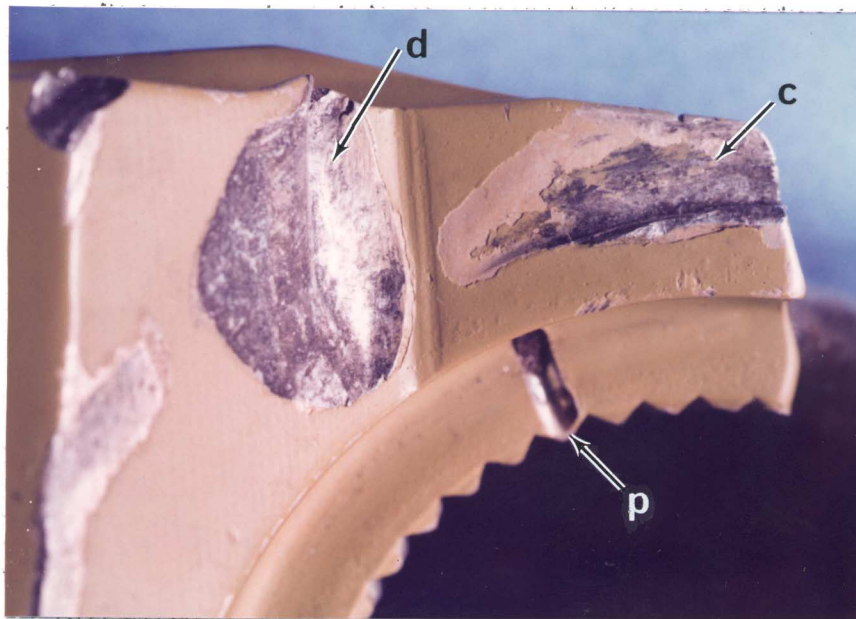
Figure 7 shows a closer view of damage areas "c" and "d" on the lower stop. Substantial deformation of the metal of the lower stop and rotational scoring was observed at location "c", corresponding with contact by the forward (circumferential) edge of the gimbal nut stop lug (area "2" in figure 5) at possible angles of orientation ranging from 133° to 174° . This deformation is consistent with contact by the forward edge of the stop lug on the gimbal nut lower surface before the edge was deformed forward.

Another area of large metal deformation in the lower stop was location "d", shown in figure 7, corresponding with contact by area "3" (figure 5) of the gimbal nut at an angle of orientation ranging from 167° to 183° . Multiple impressions were present in area "d", corresponding to an angle of orientation of approximately 174° . Rotational scoring was observed on both sides of these multiple impressions.

Figure 7. A higher magnification view of damage at locations "c" and "d" on the lower stop. (3.1x)

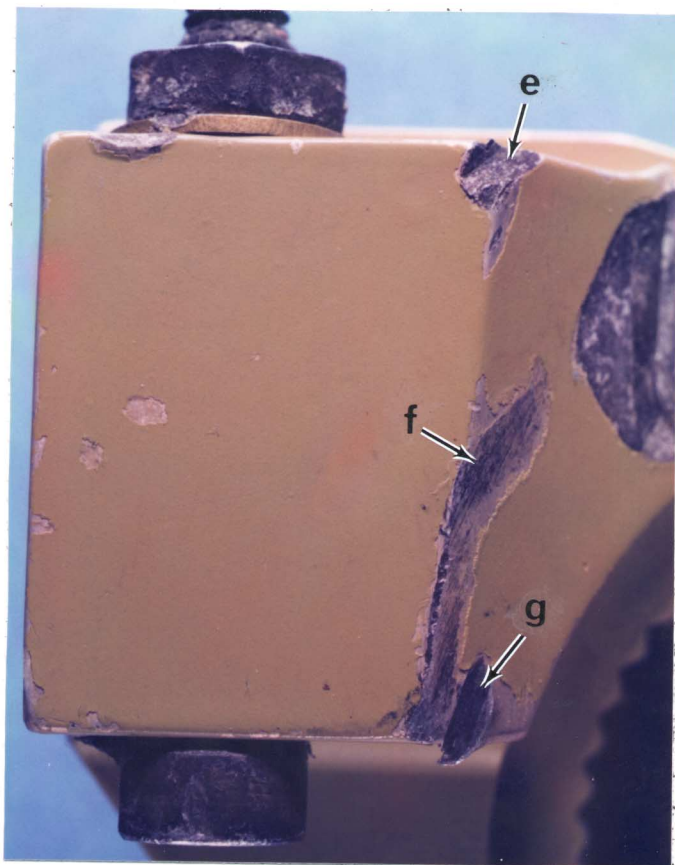
Figure 8 shows a closer view of damage areas "e", "f", and "g". The deformation at location "e" is consistent with contact by area "4" (figure 5) of the gimbal nut, in particular, the nut of the gimbal stop bolt. The angle of orientation associated with the creation of damage area "e" was 190° to 195° . Rotational scoring and a lip at the edge of the deformation area indicate the lower stop rotated clockwise (as viewed from above) relative to the gimbal nut as the damage in area "e" was created.

Damage at location "f" was relatively light, with disturbance of the paint and some rubbing deformation of the underlying metal. The damage in this area was consistent with contact from several portions of the gimbal nut. One area that matched well was area "6" (figure 5) of the gimbal nut with an angle of orientation from 345° (-15°) to 22° . Other portions of the gimbal nut, including areas "2", "3", and "7" (figure 5), also appeared to have contacted area "f" with angles of orientation ranging from 195° to 260° for areas "2" and "3" and from 22° to 110° for area "7". Scoring and deformation of the metal near the edge of location "f" indicate that the lower stop rotated clockwise (as viewed from above) relative to the gimbal nut as the damage in area "f" was created.

Damage at location "g", as shown in figure 8, was consistent with contact by area "5" (figure 5) on the right side of the gimbal nut with possible angles of orientation ranging from 110° to 160° . This damage was also consistent with contact with area "5" of the left side of the gimbal nut with possible angles of orientation ranging from 294° to 345° (-15°). Rotational scoring was observed, and general deformation at the edge of location "g" indicates that

rotation of the lower stop was clockwise (as viewed from above) relative to the gimbal nut as the damage in area “g” was created.

Figure 8. A higher magnification view of damage at locations "e" through "g" on the lower stop. (3.1x).

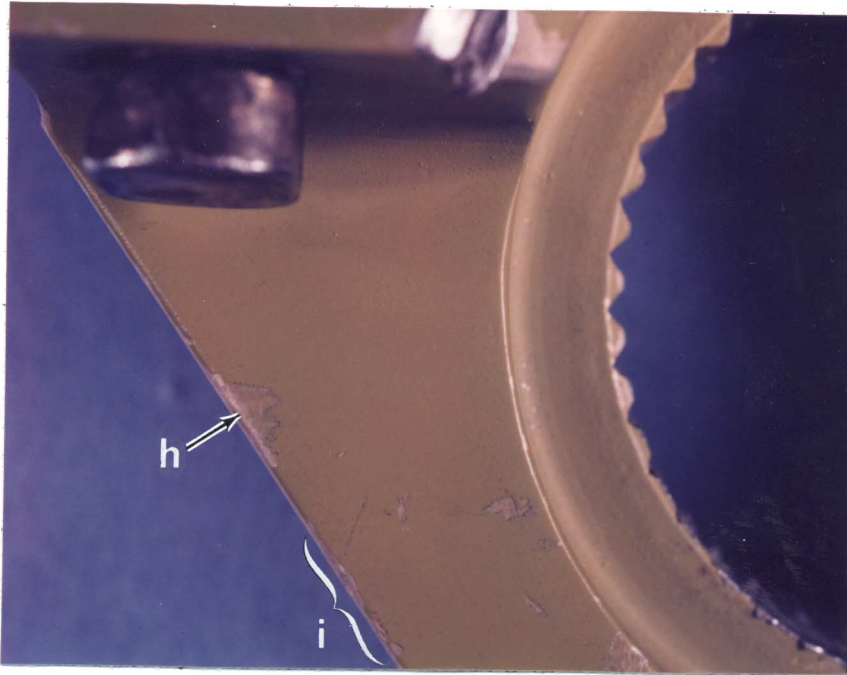
The damage at location “h” is shown in figure 9. Disturbance of the paint in area “h” was observed with rotational scoring, although the direction of relative rotation was not apparent because of the minimal deformation of the metal in this area. This mark in area “h” is consistent with contact with area “1” (figure 5) of the gimbal nut at an angle of orientation ranging from 294° to 298°.

Figure 9. A higher magnification view of damage at locations "h" and "i" on the lower stop. (3.1x)

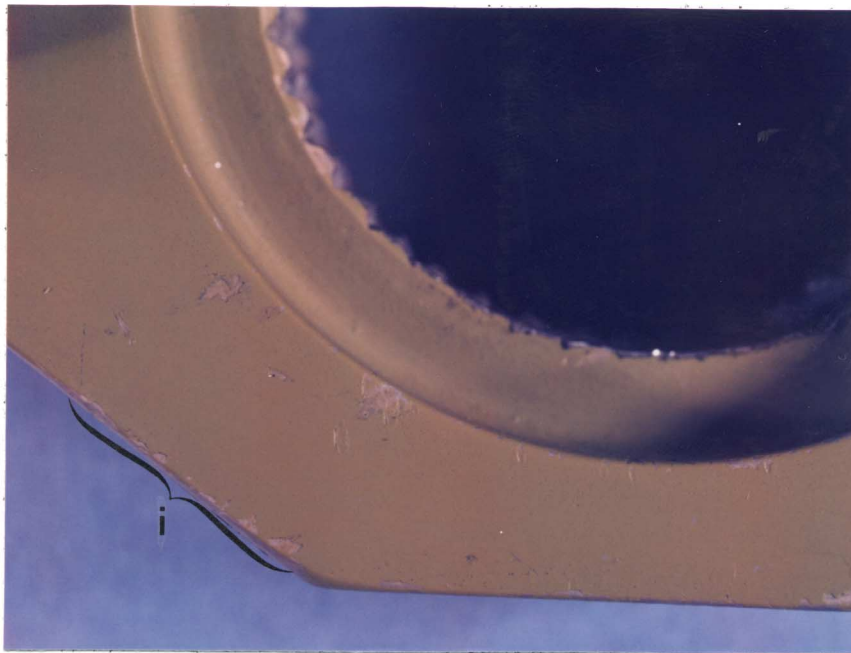
Disturbance of the paint on the lower stop was observed at locations “i” through “l” in figures 9 to 11. Some circumferential scoring was observed at location “i”. Location “j” was primarily radial. Little or no deformation of the metal was observed. These locations correspond to contact with area “2” (figure 5) of the gimbal nut at an angle of orientation ranging from 298° to 345°. Paint disturbances similar to those found in areas “i” and “j” were observed on various other edges of the lower stop, but these other disturbances could not be correlated to any specific location on the gimbal nut.

Figure 10. A higher magnification view of damage at location "i" on the lower stop. (3.1x)

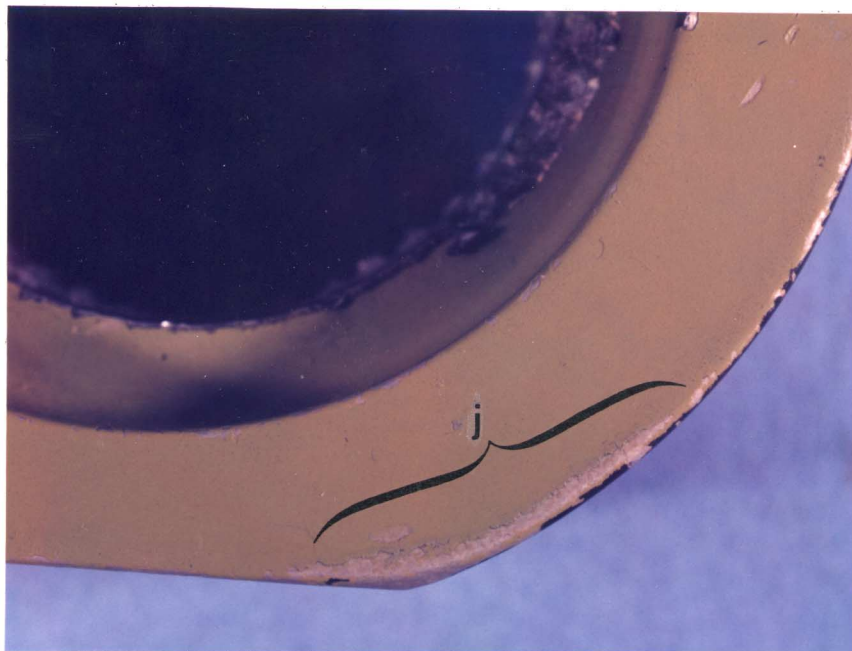
Figure 11. A higher magnification view of damage at location "j" on the lower stop. (3.1x)

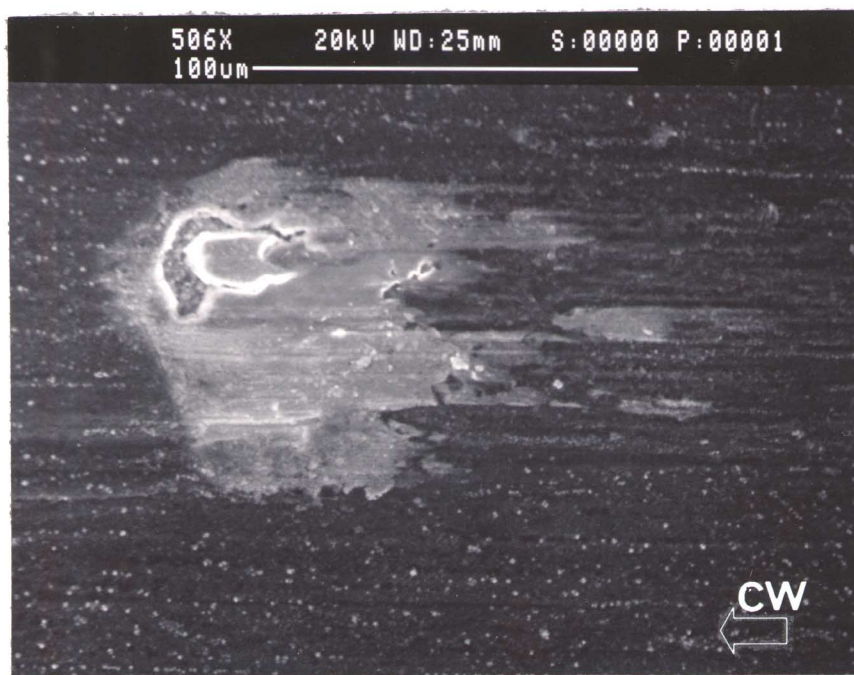
Damage locations “a” through “j” were examined using SEM and EDS. In locations “b” through “g”, areas were observed that appeared lighter by SEM, such as that shown in figure 12 for location “b”. EDS spectra of these lighter areas showed major peaks of cadmium. Also, the smearing of the lighter area in figure 12 indicated a clockwise rotation of the lower stop relative to the gimbal nut at that location.

Figure 12. SEM image of damage at location "b" on the lower stop. The EDS spectrum for the light region had a major peak of cadmium. (506X)

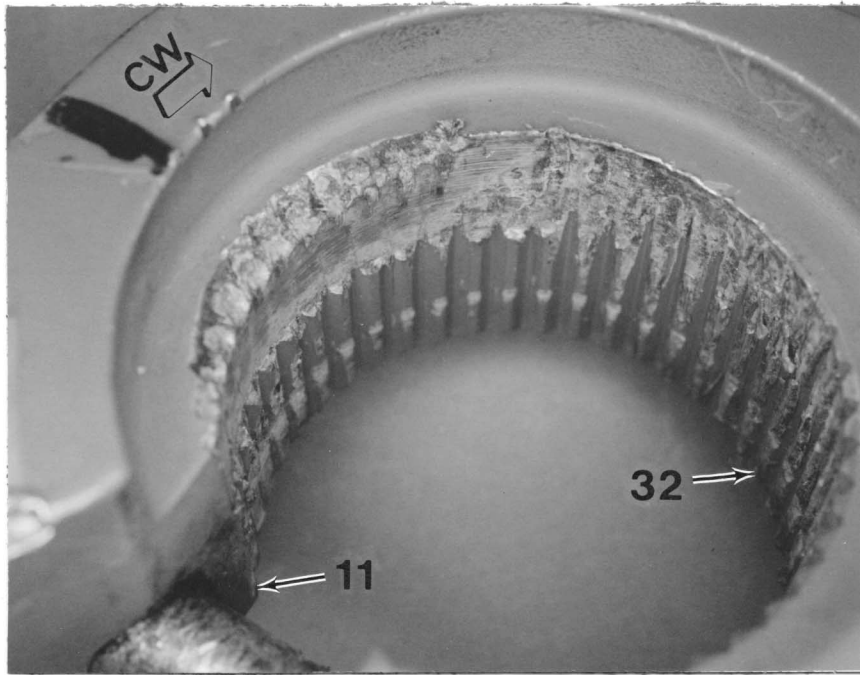
Rotational stripping was observed on different circumferential regions of the upper and lower portions of the spline teeth, as shown in figures 13 and 14. Stripping was defined as

being present in any region where individual spline teeth were nearly indistinguishable from each other. The middle portion of the splines, approximately $\frac{1}{4}$ inch wide, was damaged but not stripped at any circumferential location. This area corresponds to the gap in the jackscrew splines for the stop clamp bolt. In the upper portion, the stripping region extended from spline tooth 11 (adjacent to the spline gap for the clamp bolt) through 32 (angles of 90° through 262° from the alignment pin), as shown in figure 13. Note that the position opposite from spline tooth 32 was located in the gap for the stop clamp bolt. In the lower portion, stripping was observed in spline tooth 37 through the gap for the clamp bolt, and up to spline 13 (angles of -57° through 106°), as shown in figure 14. The remaining spline teeth showed decreasing levels of damage, with the minimum deformation observed in spline teeth 41 (angle of 335°) and 23 (angle 188°) for the upper and lower portions, respectively.

Figure 13. A view of the lower stop from above showing the stripped upper portion of the splines, where numbered arrows indicate spline teeth at the ends of the stripped area. (2X)

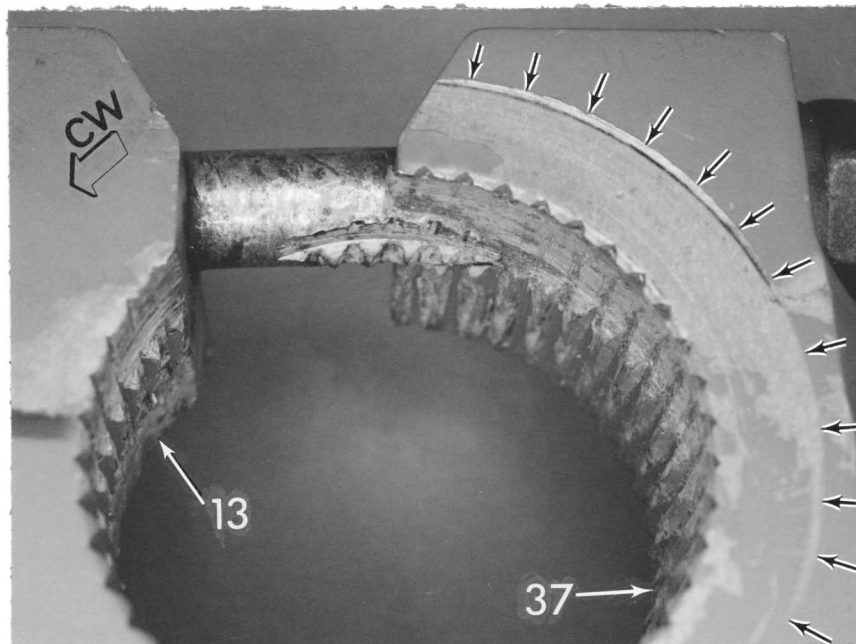
The portion of the lower stop clamp bolt visible in the gap in the lower stop is shown in figure 14. The exposed portion of the bolt contained damage along its length consistent with the rotational contact with the jackscrew spline teeth. The exposed portion of the bolt also had transversely oriented imprint marks consistent with contact with jackscrew splines. The marks showed sliding deformation indicative of a downward movement of the stop bolt relative to the jackscrew. These transverse marks were superimposed upon the rotational damage, consistent with the transverse damage being created, at least in part, after the rotational damage of the lower stop spline teeth.

A circumferential impression consistent with contact with the quill nut washer was observed on the lower surface of the lower stop, as shown in figure 14. Unlabeled arrows indicate the outer circumferential boundary of this contact area. Associated disturbance of the paint was observed from an angle of 287° to 41° relative to the alignment pin. The contact area ended adjacent to the gap for the lower stop clamp bolt at an angular position of 41° . (Angular notation is same as that used above). This contact area on the lower face of the lower stop was examined in the SEM. The direction of the circumferential scoring damage visible on the SEM was consistent with counter-clockwise rotation of the lower stop relative to the washer. Figure 18 shows an example of the scoring damage on the lower surface of the lower stop, as observed on the SEM.

Figure 14. A view of the lower stop from below showing the stripped lower portion of the spline teeth, where numbered arrows indicate spline teeth at the ends of the stripped area. Unlabeled arrows indicate circumferential scoring consistent with contact with the quill nut washer. (2X)

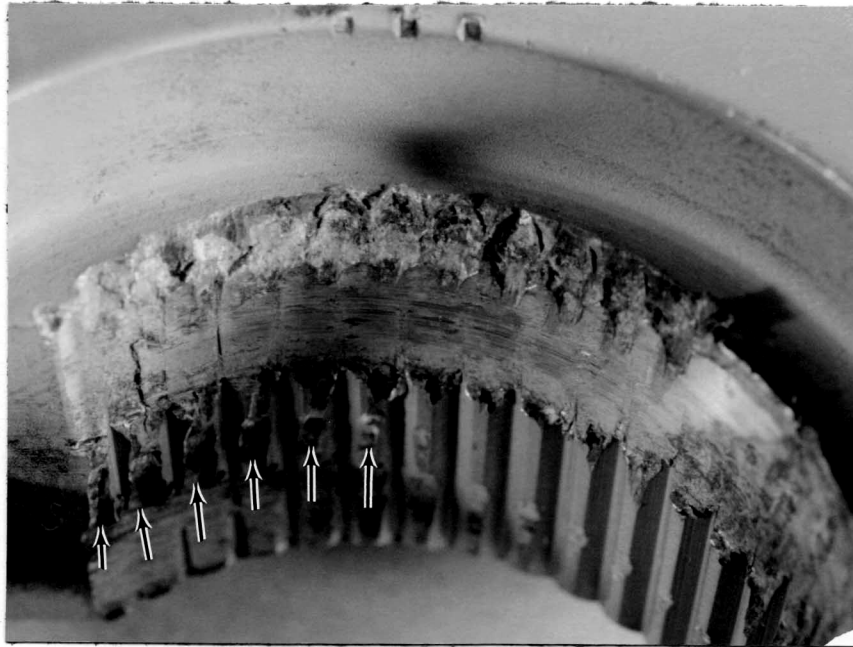
Damage was also observed in the middle portion of the lower stop spline teeth. In spline teeth 11 to 16 (angles 90° to 131°), grooves consistent with contact with the jackscrew spline teeth were observed intersecting the peaks of the spline teeth in the stop, as indicated by unlabeled arrows in figure 15. The grooves angled counter-clockwise from the lower to upper portions, and the direction of scoring indicates upward motion of the jackscrew relative to the stop. The scoring continued into the upper stripped portion, appearing to have been created after the stripping. In the middle portion of spline teeth 26 to 42 (angles 213° to 344°), grooves were observed on both sides of the spline tooth peaks, consistent with contact with the jackscrew spline teeth. Unlabeled arrows in figure 16 indicate this damage, where spline teeth 26 to 35 are shown. The spline tooth peaks were deformed counter-clockwise with upward scoring.

Figure 15. The stripped upper portion of the lower stop spline teeth viewed from above at higher magnification. Arrows indicate grooves in the middle portion of some spline teeth. (3.1X)

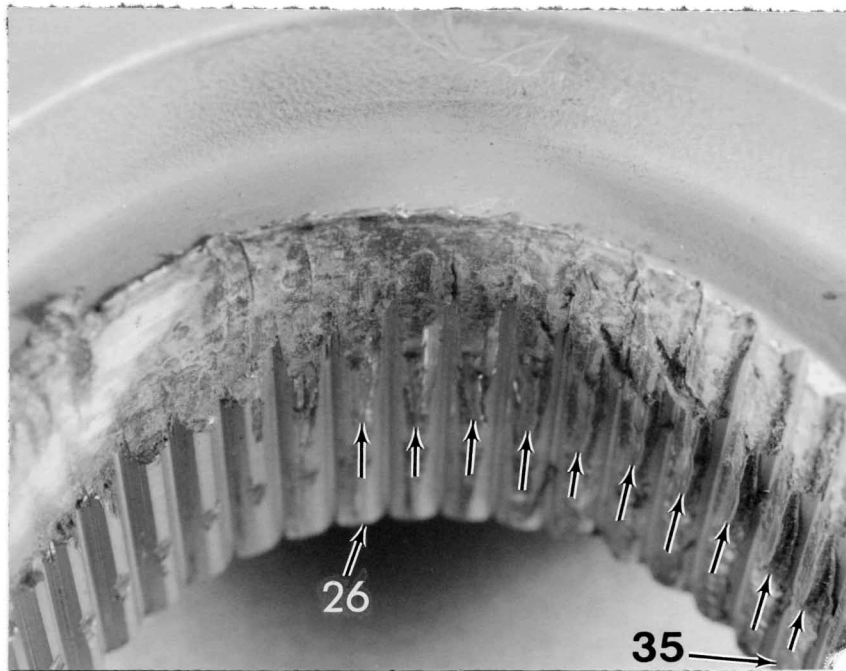
Figure 16. Lower stop spline teeth opposite to those of figure 15, viewed from above. Unlabeled arrows indicate deformation in middle portion of spline teeth 26 to 35. (3.1X)

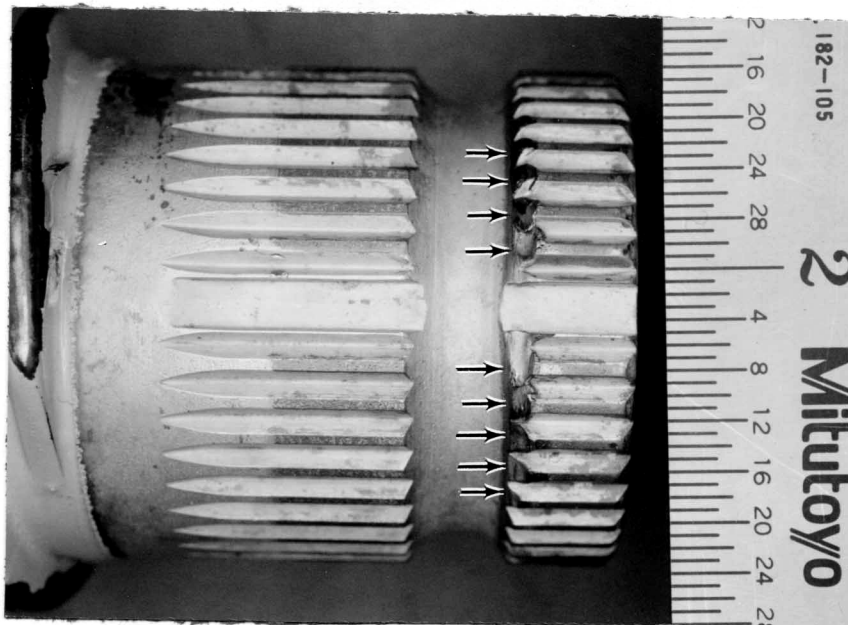
The spline teeth on the lower end of the jackscrew to which the lower stop is assembled were also examined. Figure 17 shows a side view of these spline teeth, with the gap for the lower stop clamp bolt readily visible. The upper ends of several lower portion jackscrew spline teeth were deformed on either side of the index spline area, as indicated by the unlabeled arrows in figure 17. The damage is consistent with contact with the stop clamp bolt due to a downward motion of the lower stop relative to the jackscrew. The number of damaged spline teeth on the jackscrew was greater than the number of transverse imprints on the clamp bolt, further indicating a relative rotation of the jackscrew and lower stop.

Figure 17. A view of the spline teeth on the lower end of the jackscrew. Unlabeled arrows indicate deformation to the upper end of some lower portion spline teeth.

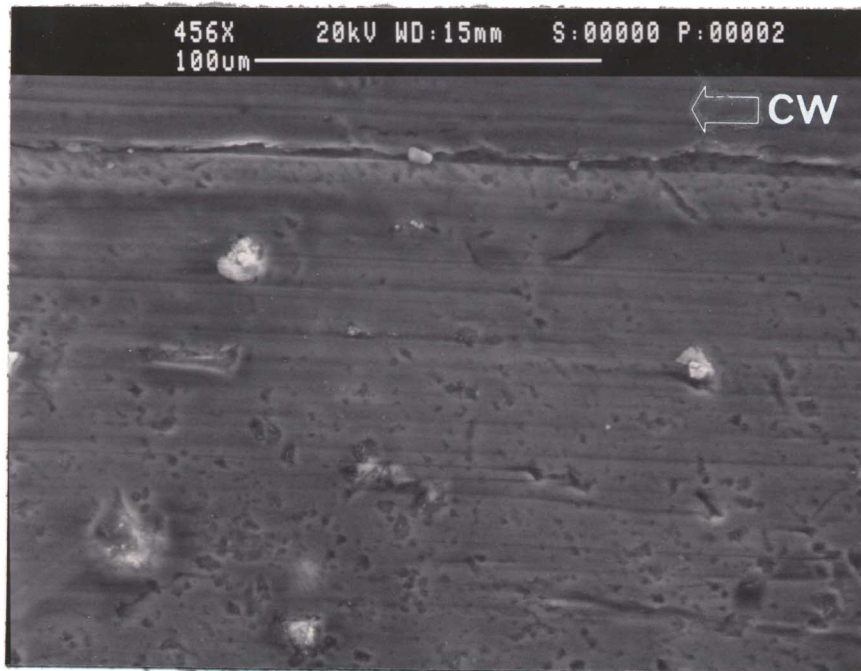
Figure 18. Circumferential scoring on the lower surface of the lower stop as viewed using SEM. Arrow "CW" indicates the clockwise direction as viewed from above. (456X)

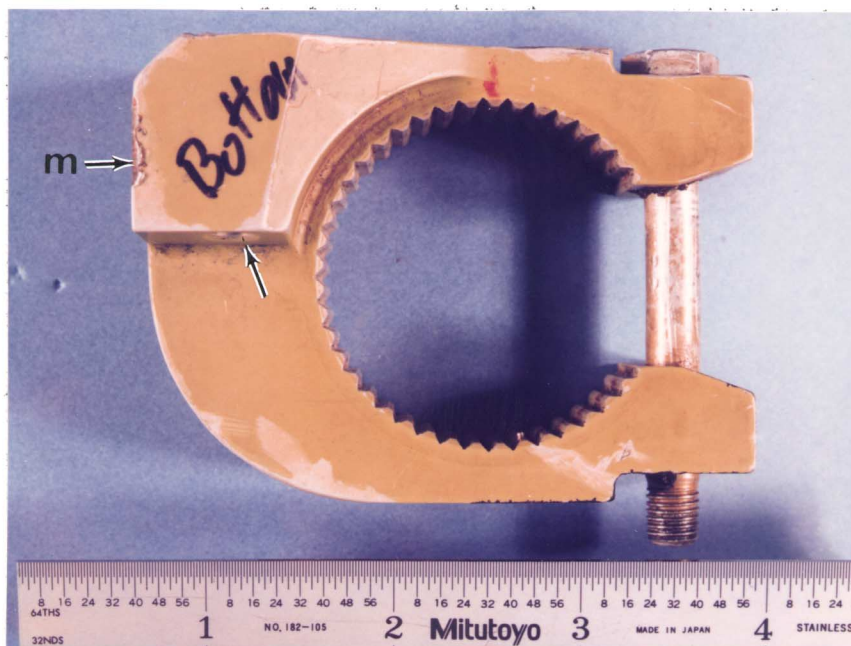
The lower surface of the upper stop is shown in figure 19 after disassembly from the jackscrew. There were multiple locations where disturbance of the paint was observed, but none were indicative of contact with any portion of the upper surface of the gimbal nut. Damage was observed at the edge indicated by arrow "m", with directional scoring both upward and downward relative to the stop. The clamp bolt was slightly bent and had impressions consistent with contact with both the upper and lower portions of the jackscrew spline teeth, with three impressions from the lower portion and four heavier impressions from the upper portion.

Figure 19. A view of the lower surface of the upper stop. Arrow "m" indicates damage to the edge. The unlabeled arrow indicates where the missing stop bolt should be assembled to the upper stop.

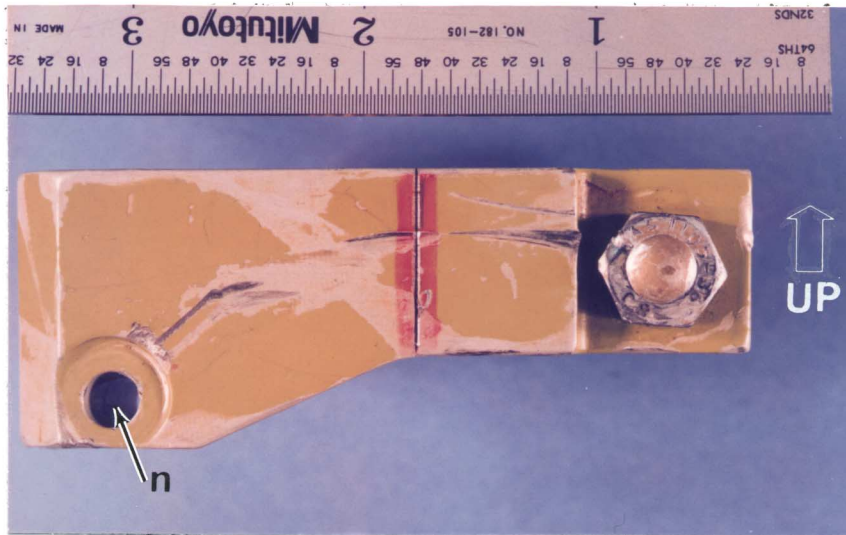
The unlabeled arrow in figure 19 indicates the location where the stop bolt is normally assembled in the upper stop. When received in the laboratory, the stop bolt was missing from the upper stop. Evidence of sliding contact with other structure, as shown in figure 20, was observed on the side of the upper stop (upper side as shown in figure 19). Arrow "n" in figure 20 indicates the nut end of the hole for the stop bolt. This end of the hole contained thread impressions as shown at higher magnification in figure 21. The location of these impressions is indicative of large side loading, approximately 45° upward, of the nut end of the stop bolt.

Figure 20. A side of the lower stop (top side of the stop as it is oriented in figure 19) showing evidence of sliding contact. The nut end of the stop bolt hole is labeled "n".

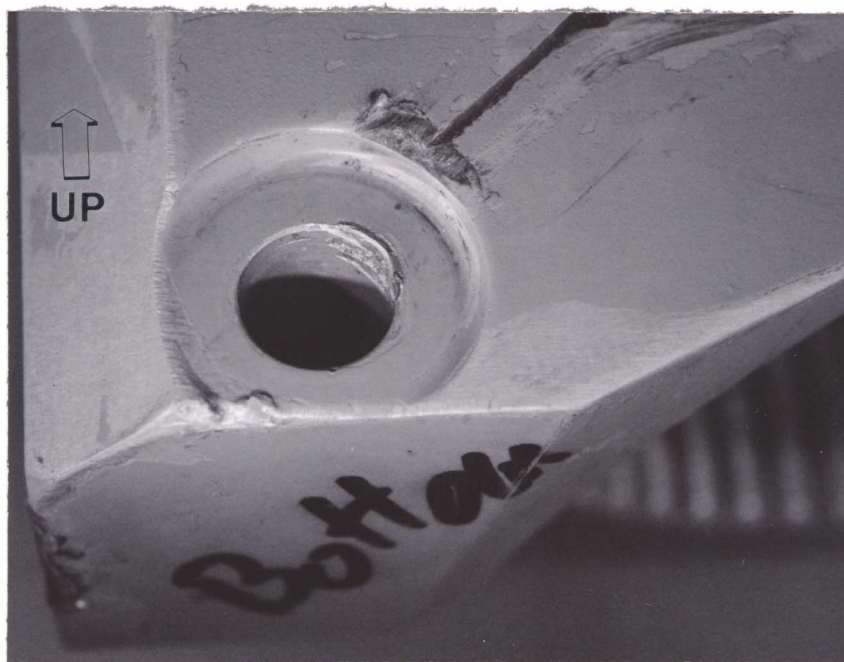
Figure 21. A higher magnification view of the nut end of the stop bolt hole "n" shown in figure 20. Thread impressions are shown in the hole for the stop bolt. (3.3x)
