# NATIONAL TRANSPORTATION SAFETY BOARD

MATERIALS LABORATORY FACTUAL REPORT

Report No. 01-082

Place : Near Port Hueneme, California  
Date : January 31, 2000  
Vehicle : Boeing MD-83, N963AS  
Operator : Alaska Airlines, Flight 261  
NTSB No. : DCA00-M-A023

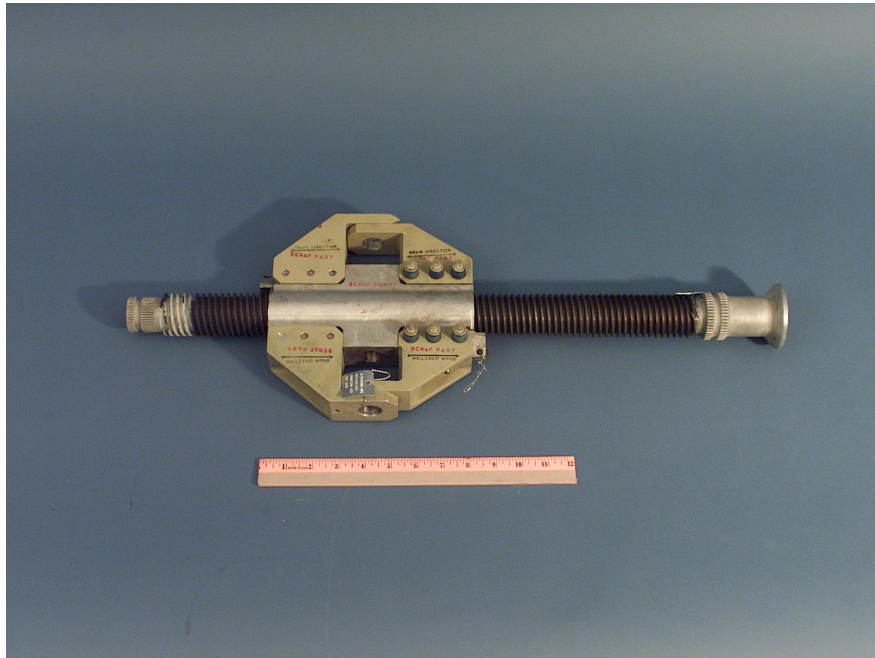
Figure 1--The as-received Acme nut assembly, s/n DCA110(a), from jackscrew assembly s/n DCA110.

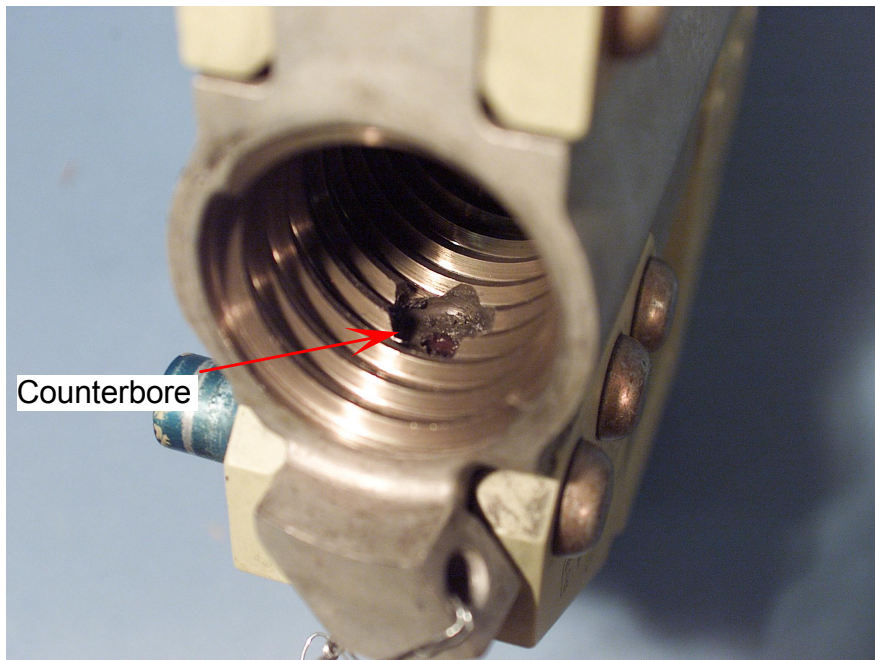
Figure 2--A view of the Acme nut grease fitting counterbore after additional samples were removed. (Nut s/n DCA110(a))

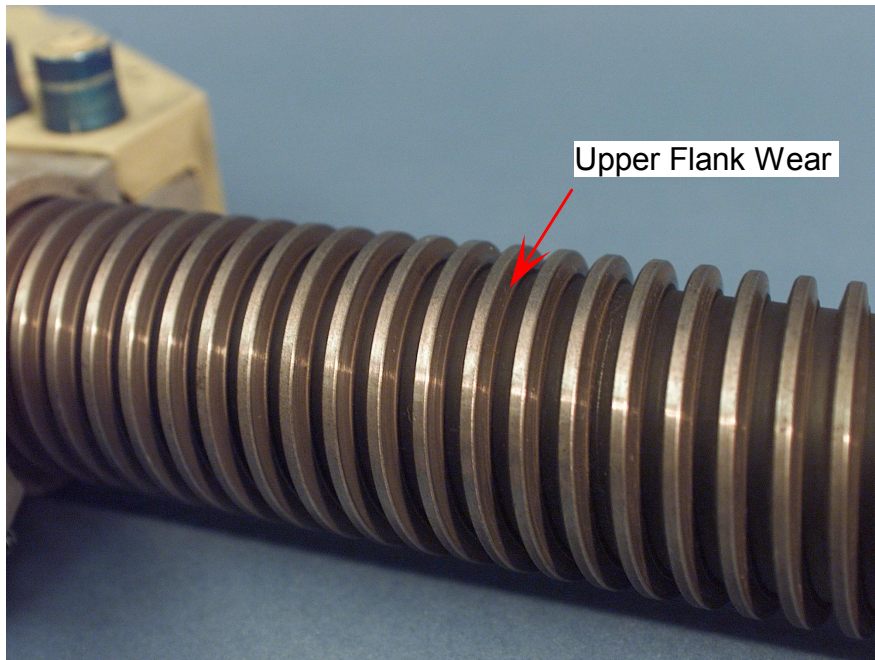
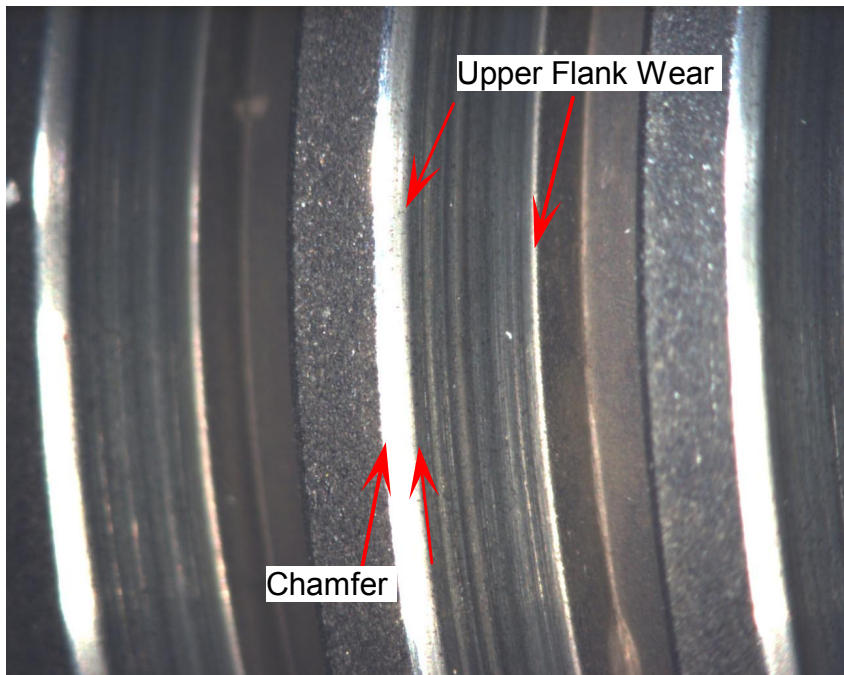
The central portion of the Acme screw had visible wear steps in both the upper and lower flanks of the threads. The step in the upper flank (normal screw pressure face) had a measurable depth over a length of about 15.5 inches in the central region of the thread (between 2.5 and 18 inches from the top thread). At its maximum, the step was 0.0068 inch deep below the projected original surface of the thread. Figure 3 shows two views of the screw and the wear step in the upper flank. Figure 4 shows a typical wear step in the upper thread flank as seen on an optical comparator. On the lower flank the step was visible and measurable between 7 and 14 inches from the top thread and had a maximum depth of 0.0029 inch. The depth of wear on the thread flanks was measured with an optical comparator.

Figure 3--Two views of the wear step (shiny bands) in the upper flanks of the screw. (Screw s/n DCA110(a))

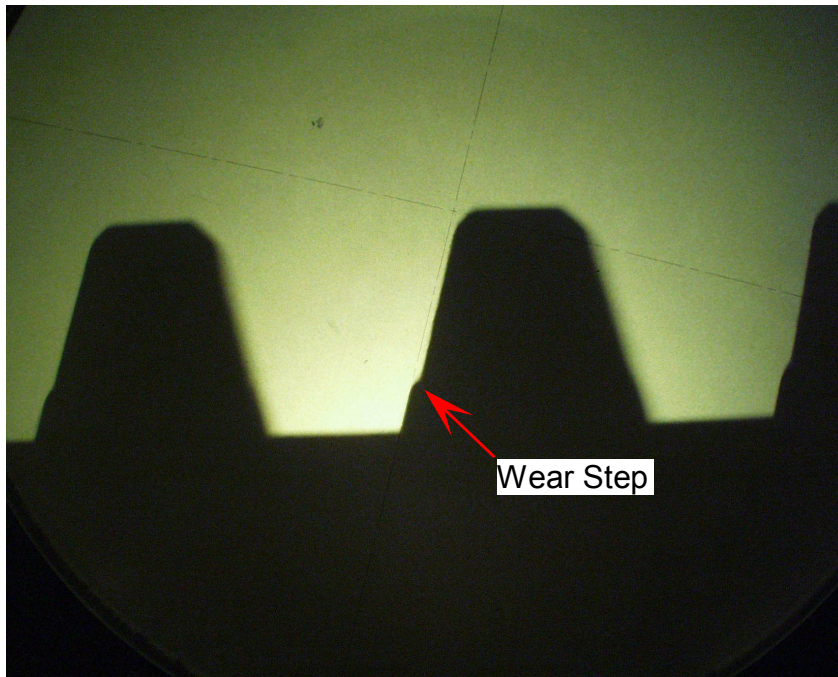
Figure 4--A optical comparator view of the step in the upper thread flank of the screw. Actual thread is dark. (Screw s/n DCA110(a))

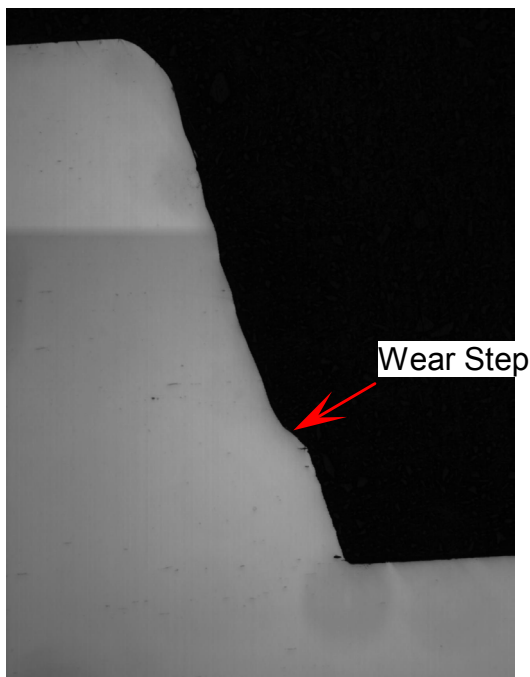
A longitudinal microsection was later cut through the heavily worn area near the center of the screw. Figure 5 shows a thread tooth profile showing the wear step.

Figure 5--A montage of a section through one of the worn upper thread flanks. Actual thread is light-colored area at left. Mirror view of figure 4. (Screw s/n DCA110(a))

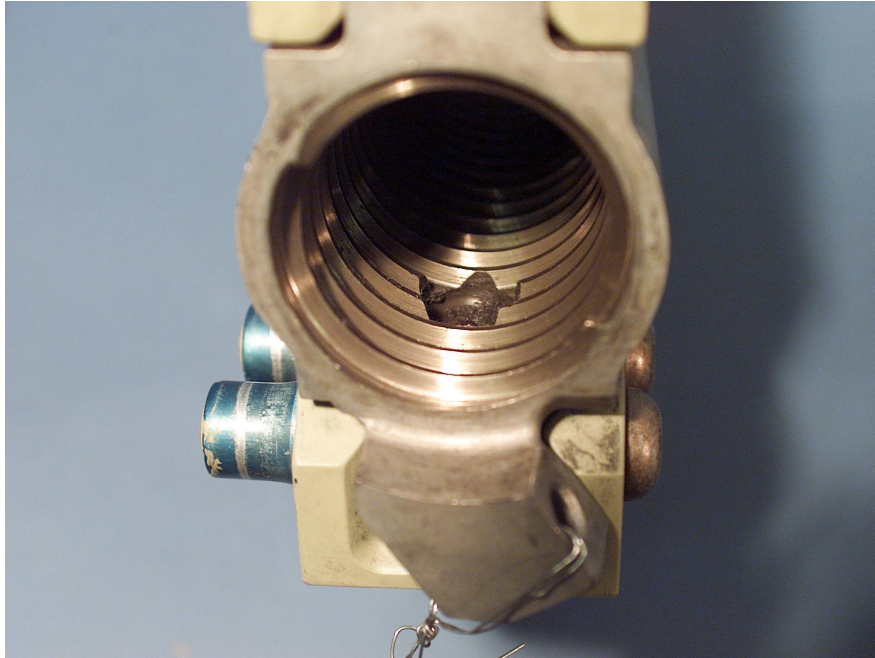
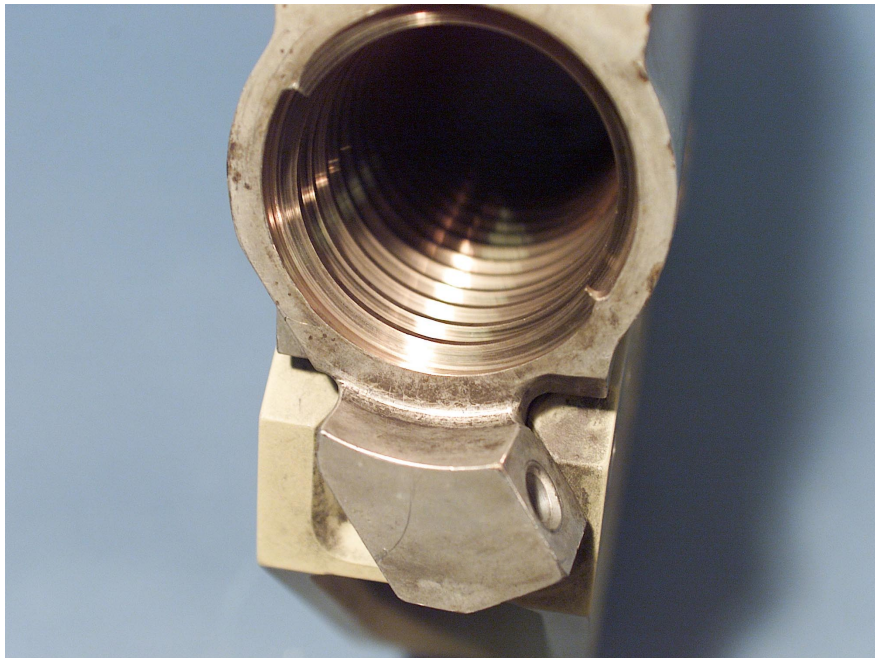
Initial examinations of the nut showed that both flanks of the nut threads were lustrous with circumferential marks consistent with wear (see figure 6). The major diameter of the threads (root area) was also worn and lustrous. The widths of the thread crests (minor diameter) appeared to be significantly reduced from as-new dimensions but for the

Figure 6--Top view looking at wear on the upper thread flanks of the Acme nut. Bottom view looking at wear on the lower flanks. (Nut s/n DCA110(a))

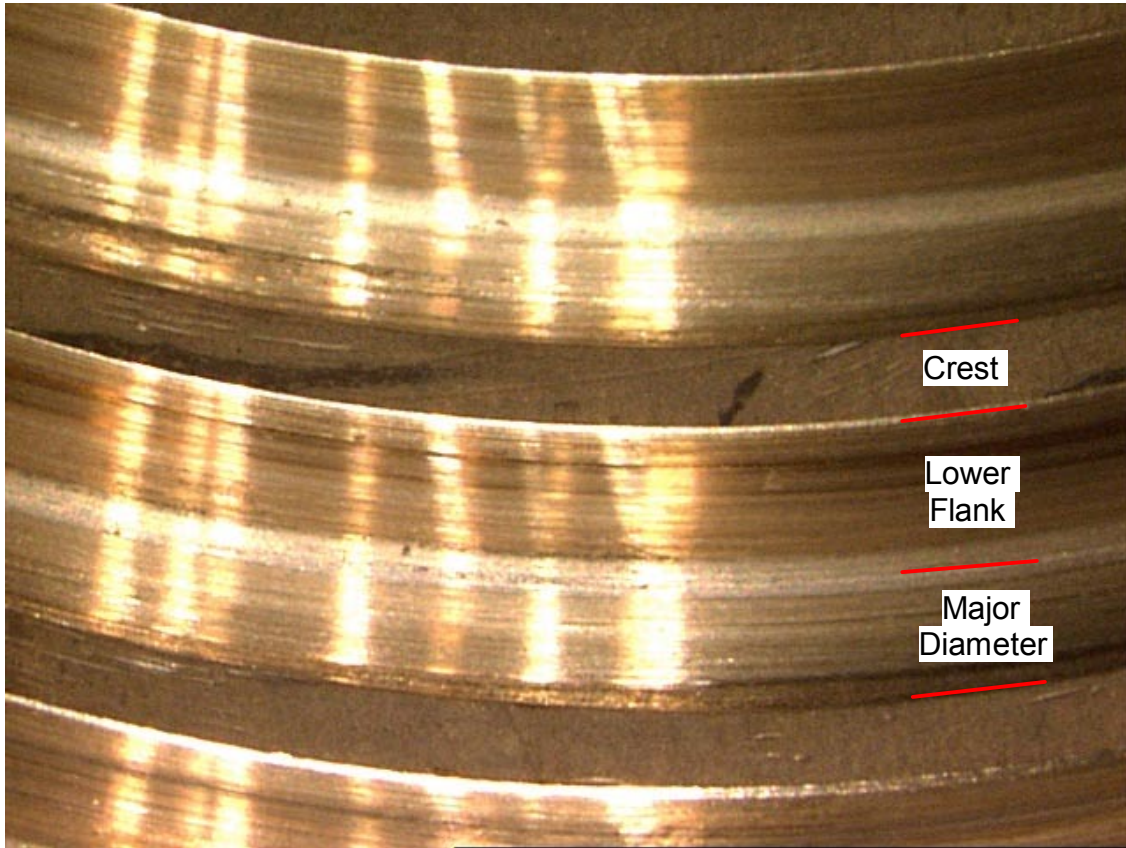
most part retained their original machined and grit blasted appearance. The edges of the thread flanks at the thread crests were sharp with no significant burrs visible on any of the threads. Figure 7 is an as-received view showing the wear on the lower flank and major diameter surfaces of threads near the bottom of the nut.

Figure 7--A closer view of the lower thread flanks of the Acme nut. Note the absence of a burr at the thread crest. The major areas of the thread are denoted at right. (Nut s/n DCA110(a))

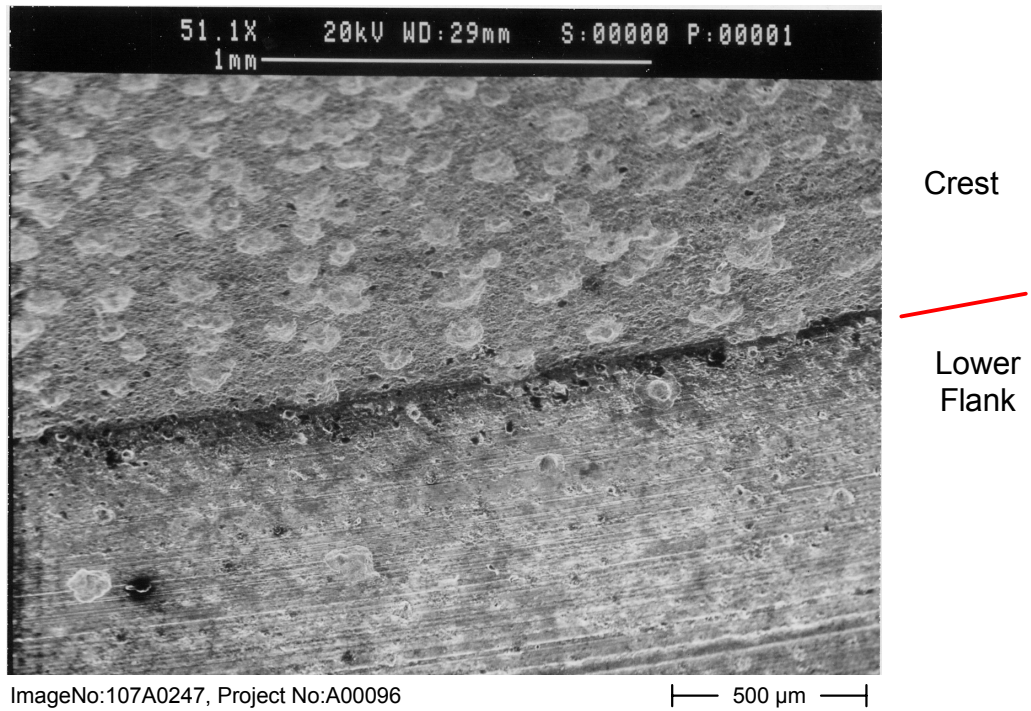
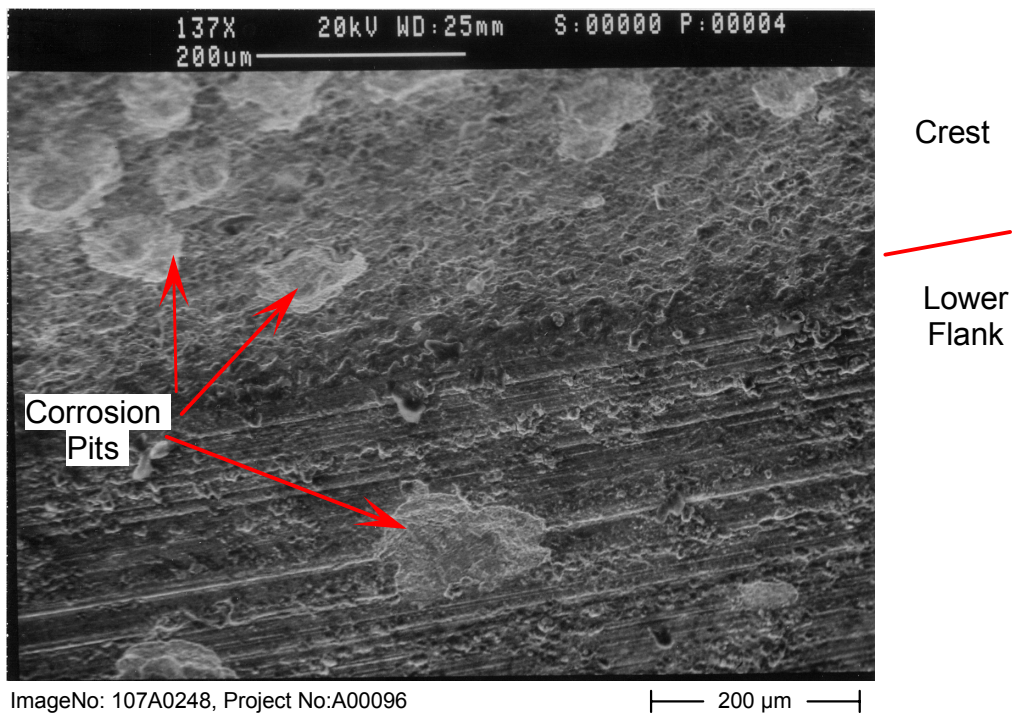
Figure 8--Two SEM views showing the pitting induced by EDM cutting and the lack of a burr at the lower thread flank to crest interface on the threads of nut DCA110(a).

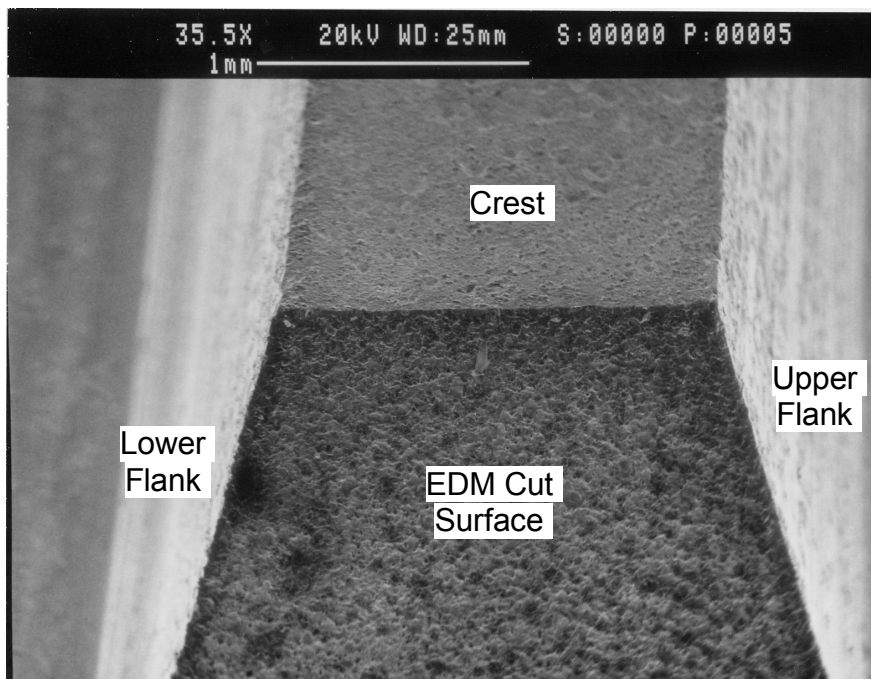
Figure 9--SEM profile view of a typical nut thread. Note the sharp corners at the crest to flank edges. Lower thread crest at left. (Nut s/n DCA110(a))

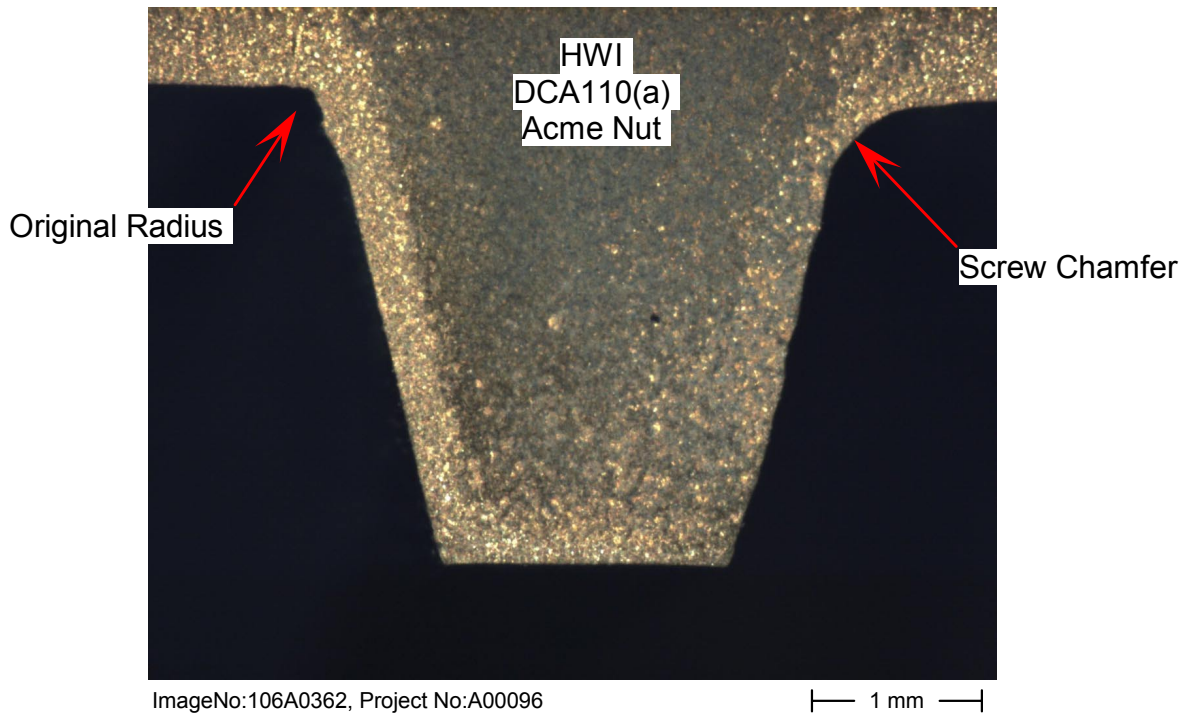
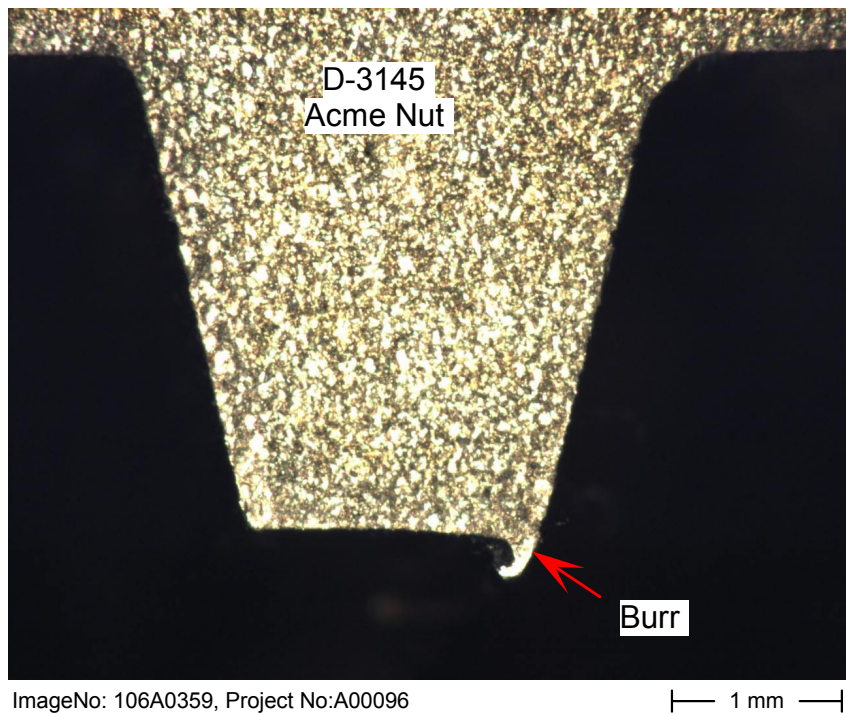
Figure 10--Two views showing the thread profiles from Acme nuts HWI DCA110(a) (top) and D-3145 (bottom). Note the prominent burr on the lower view at the lower thread flank to crest line.

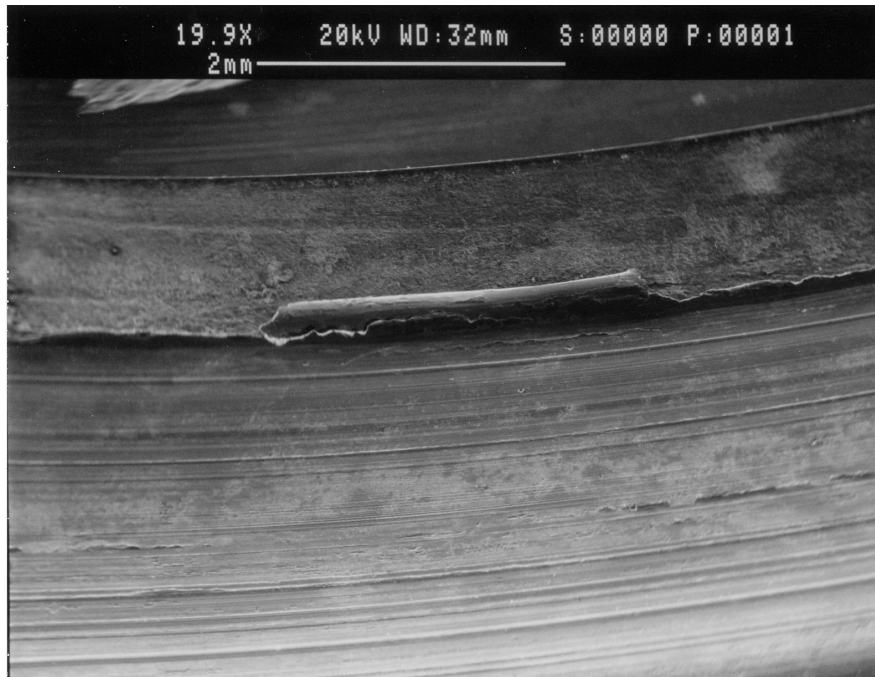
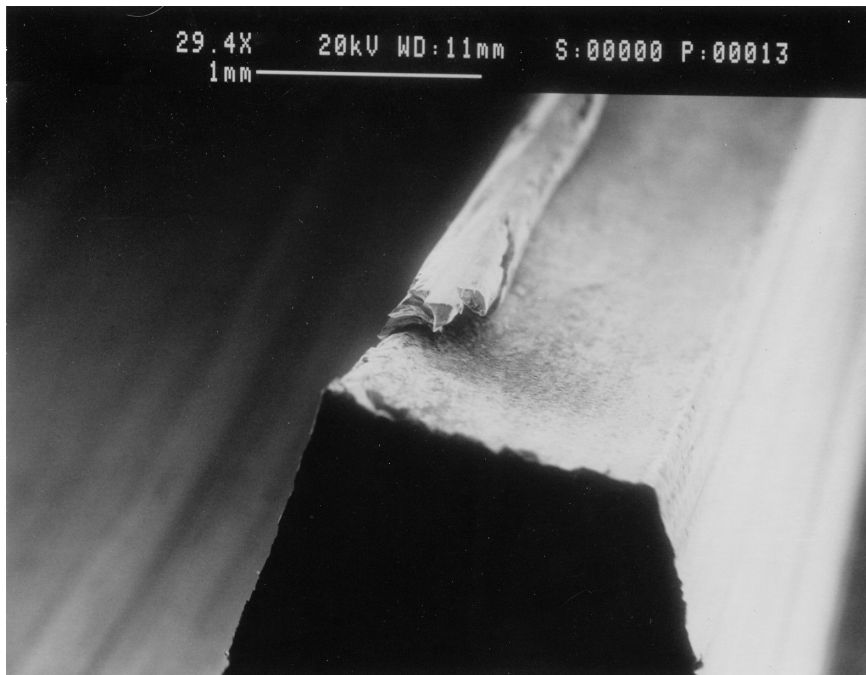
Figure 11--Two SEM views of typical burrs seen on Acme nut D-3145.

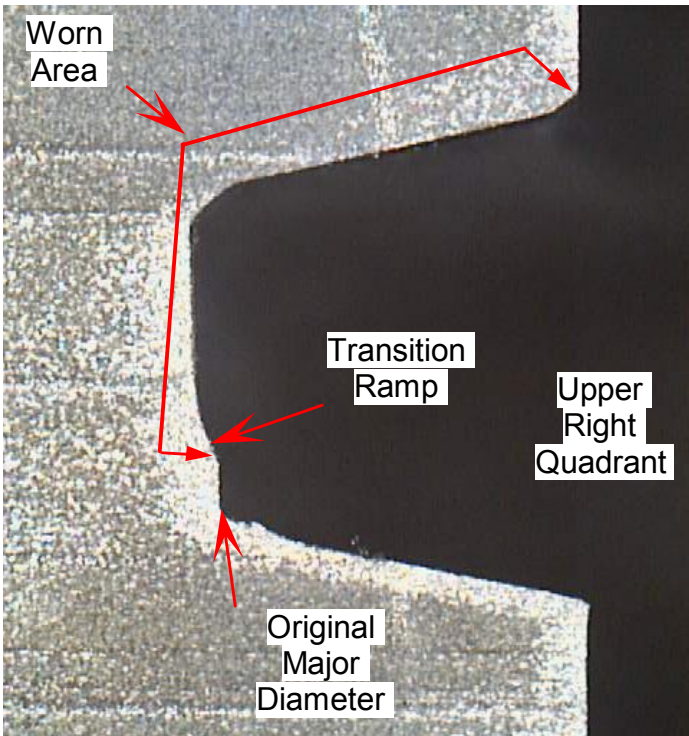
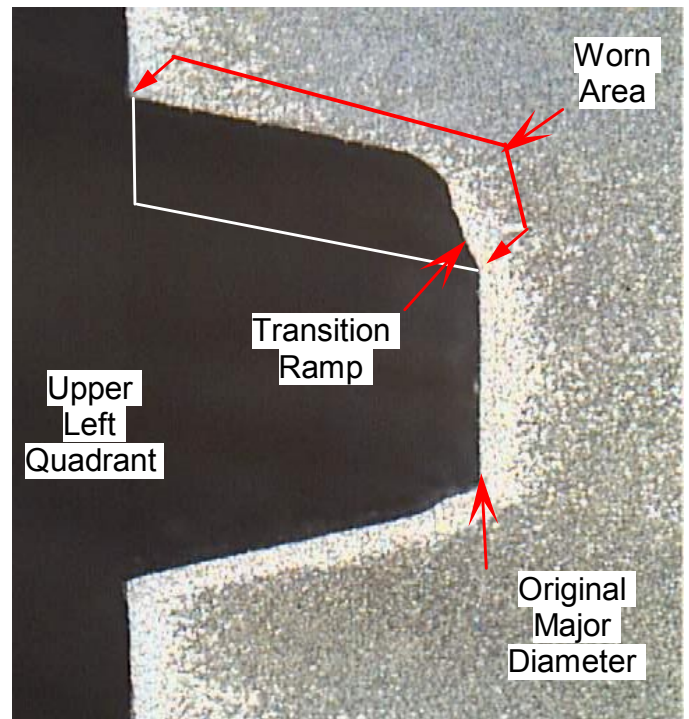
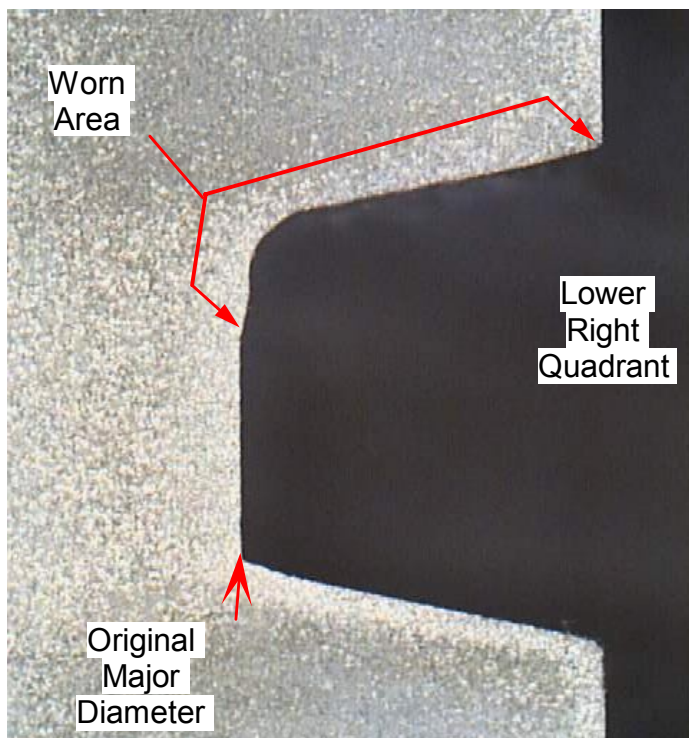
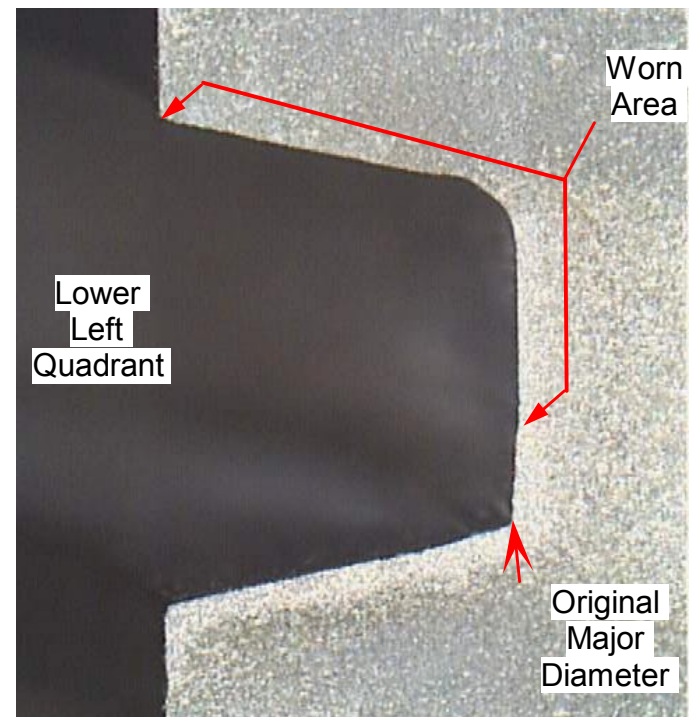
The major diameter surfaces of Acme nut s/n DCA110(a) also showed heavy localized wear that enlarged the diameter in some areas of the nut. Close inspection found that the wear was nonuniform both in the circumferential and vertical directions. As seen on the transverse cut surfaces of the nut, the heaviest wear and enlargement of the major diameter occurred in the upper right quadrant of the nut. Wear on the major diameter was also present but to a lesser extent in the lower left quadrant. The major diameter was not significantly worn diametrically opposite these locations. Figure 12 shows profiles of the major diameter and adjacent thread surfaces at the cut surfaces near the four lateral corners of the nut. The wear had removed approximately 0.009 inches of material from the major diameter at the upper right cut surface and about 0.001 inch from the lower left portion of the nut. The major diameter wear patterns are consistent with an angular misalignment of the screw axis to the nut axis with the upper end of the screw relatively displaced to the right and the lower end to the left. The transitions (transition ramps) from the original major diameters to the worn diameters were at angles to the nut axis indicating that the angular misalignment had increased with nut wear (endplay). For comparison, the approximate original shape of the thread is shown in the upper left quadrant view of figure 12.

Figure 12--Four views showing the nonuniform wear of the major diameter on the Acme nut. Aircraft up is to the top of each view and each view is looking aft. Note the highly visible transition ramps in the upper views. The approximate original contour of the nut thread is depicted by the white line in the upper left quadrant view. (Nut DCA110(a))

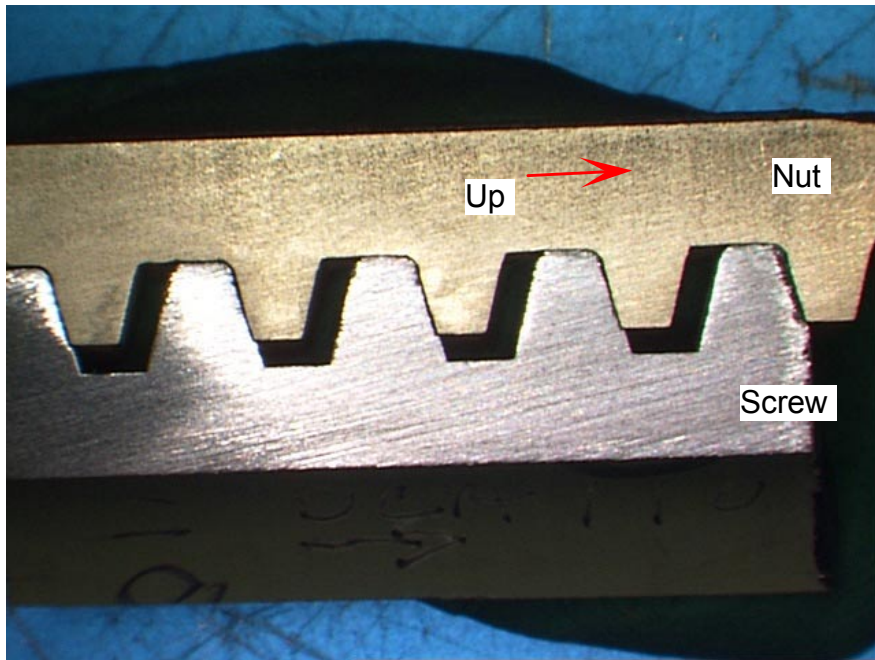
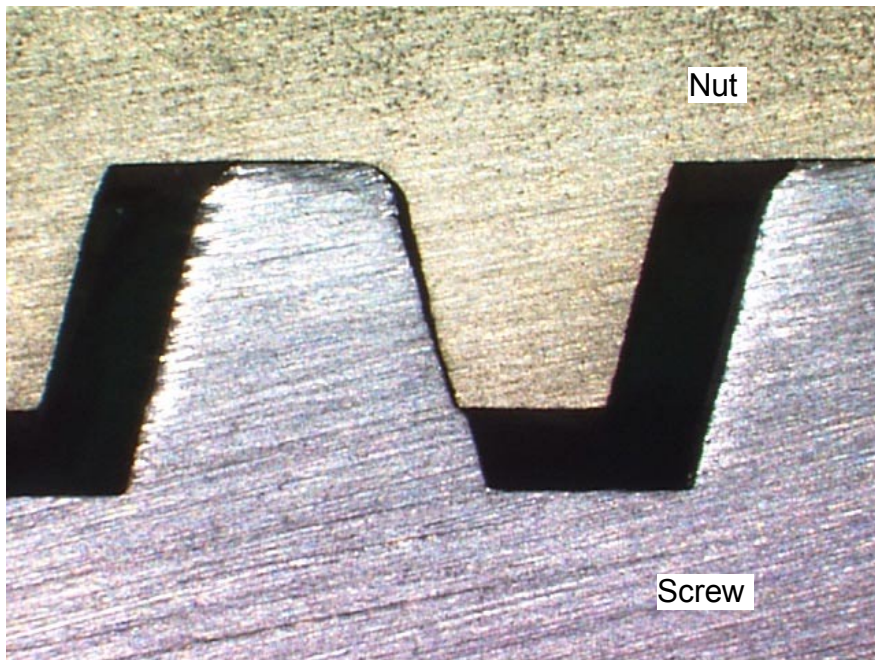
The two views in figure 13 show cross sections of the nut and screw mated together as if installed. The mated sections show the corresponding nature of the previously noted wear areas on each component and also the internal clearances at this stage of wear.

Figure 13--Two views of sections cut from DCA110(a) screw (silver color) and nut (brass color) mated together as if in operation showing the corresponding nature of the wear. Aircraft up to the right.

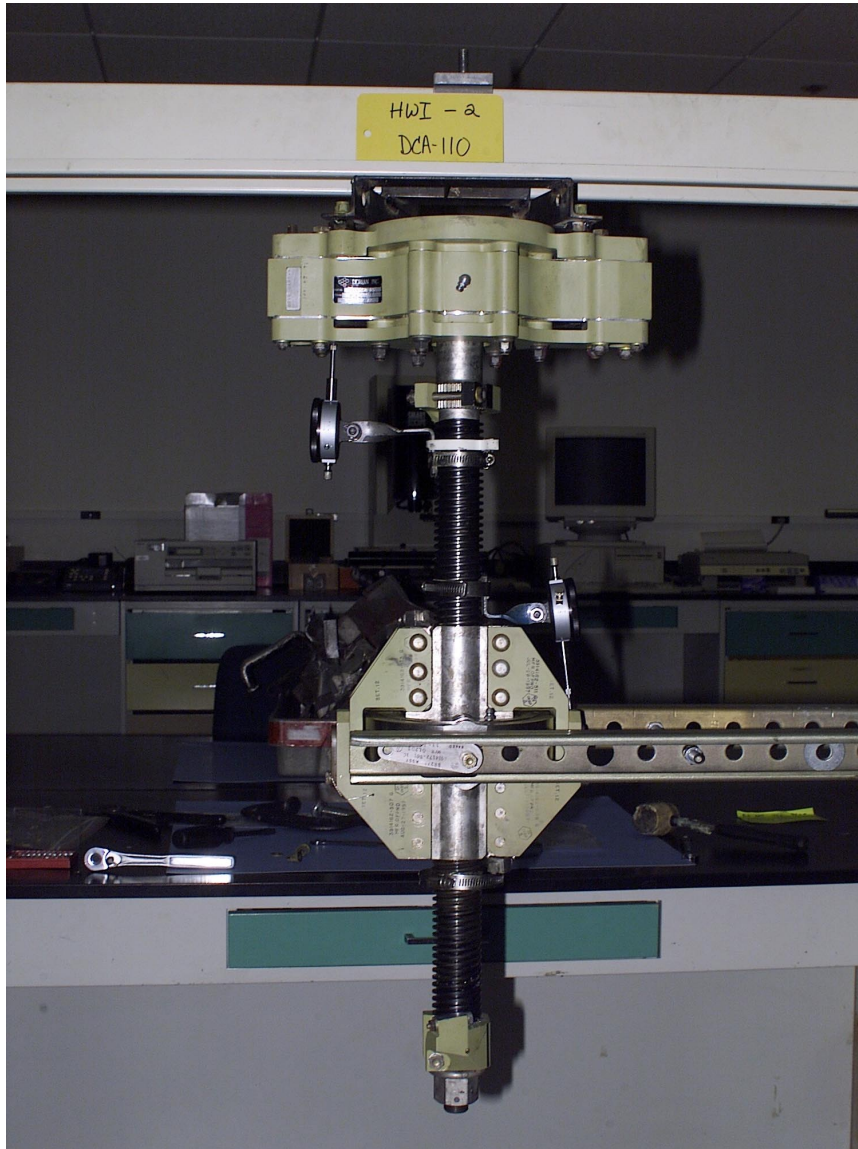
Acme screw / nut endplay measurements were performed with the assembly mounted to a fixture (see figure 14) and approximately 180 pounds applied in both directions to the nut. With the nut in the middle of the screw and the existing amounts of grease, the endplay consistently measured slightly greater than 0.028 inch. During the tests a noticeable snap or click movement of the nut was noted. Free play was not recorded.

Figure 14--As-received jackscrew assembly DCA110(b) with Acme nut assembly D-3351 mounted in the endplay test fixture.

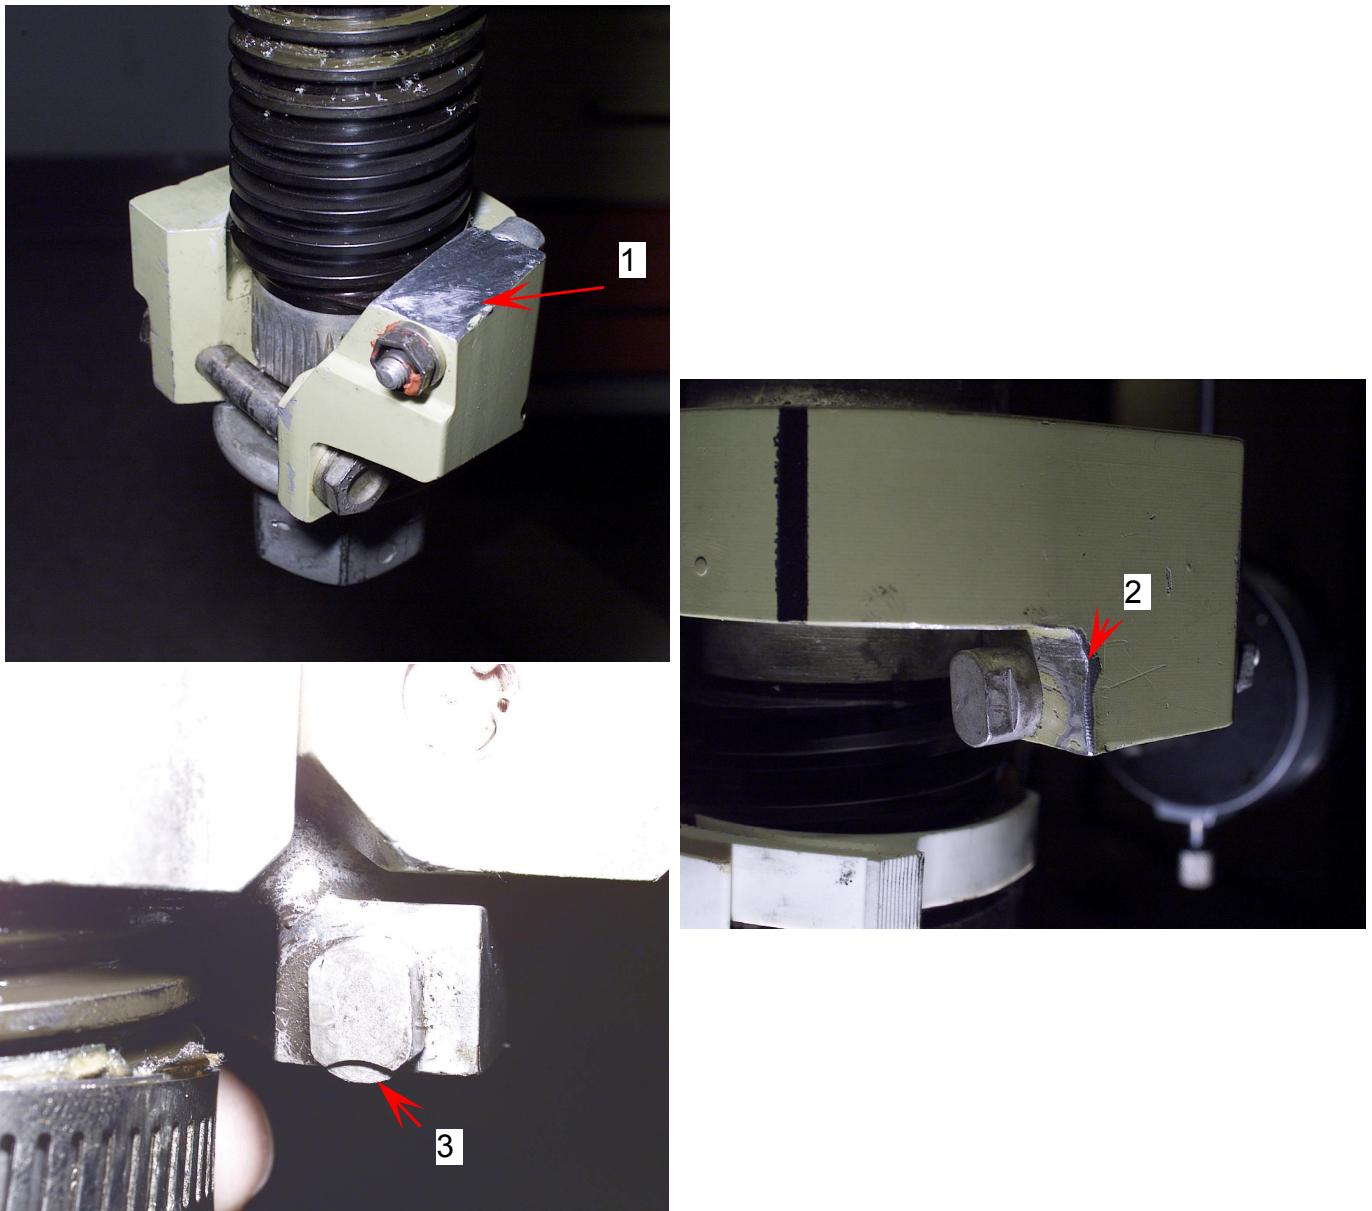
During initial examinations of jackscrew assembly DCA110(b) it was also noted that the upper lug surface of the lower mechanical stop appeared to have been filed and the primer removed. An impression was apparent on the head of the lower stop bolt on the

Acme nut and the cadmium plating was missing from the adjacent surface of the nut. The shape of the impression on the lower stop bolt matches the overall shape and orientation of the stop bolt installed in the lower mechanical stop. Also, the upper mechanical stop had areas where the primer was missing and the stop scratched. See figure 15 for photographs of the damage areas. The torque tube nut safety wire had been cut, and only a small piece of the wire was received attached to the lower mechanical stop clamp bolt.

Figure 15--Three views, clockwise from upper left, showing the filing on the top of the lower mechanical stop lug, arrow 1, the missing primer from the upper mechanical stop, arrow 2 and the impression in the head of the acme nut lower stop bolt, arrow 3. (s/n DCA110(b))

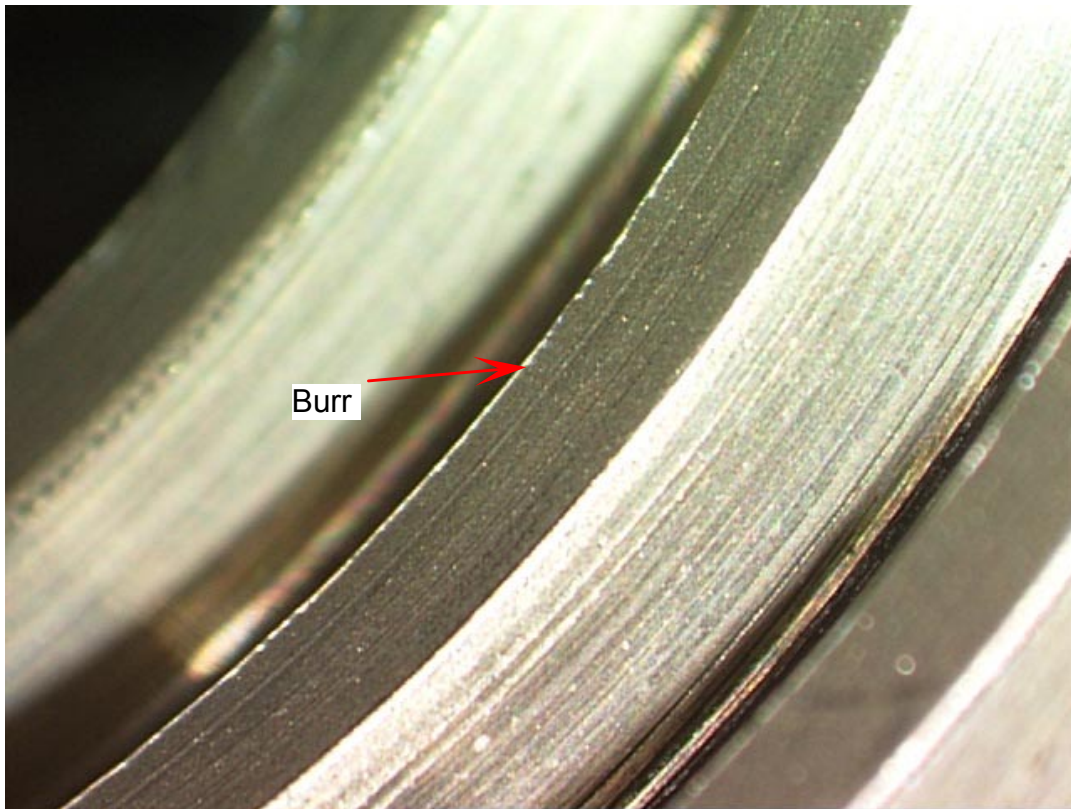
The lower flanks of the Acme nut threads were worn with a circular pattern, and the shape of the screw thread major diameter chamfer was worn into the nut threads. A small continuous burr was present at the intersection between the lower thread flank and the thread crest (minor diameter) as shown in figure 16. The upper threads flanks also appeared slightly worn but no burr was present.

Figure 16--Looking into the interior of Acme nut D-3351 showing the burr at the minor diameter of the lower thread flank.

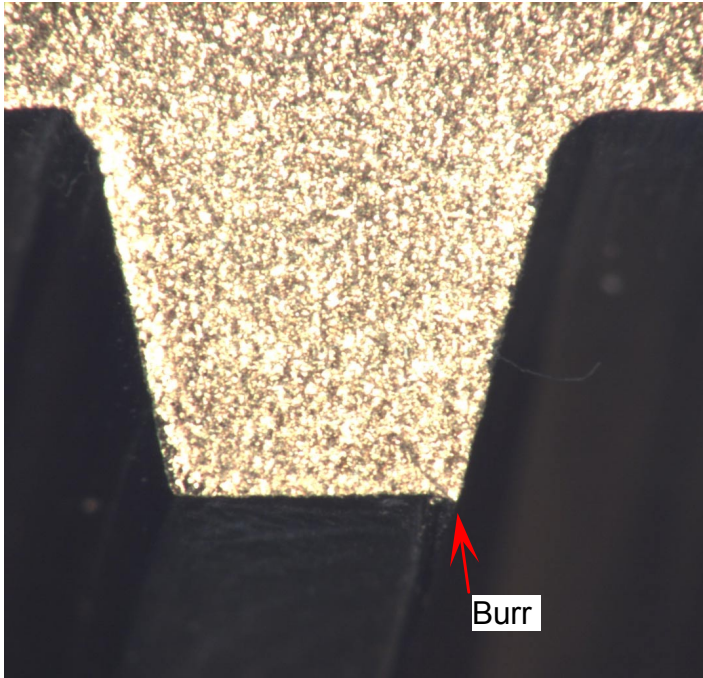
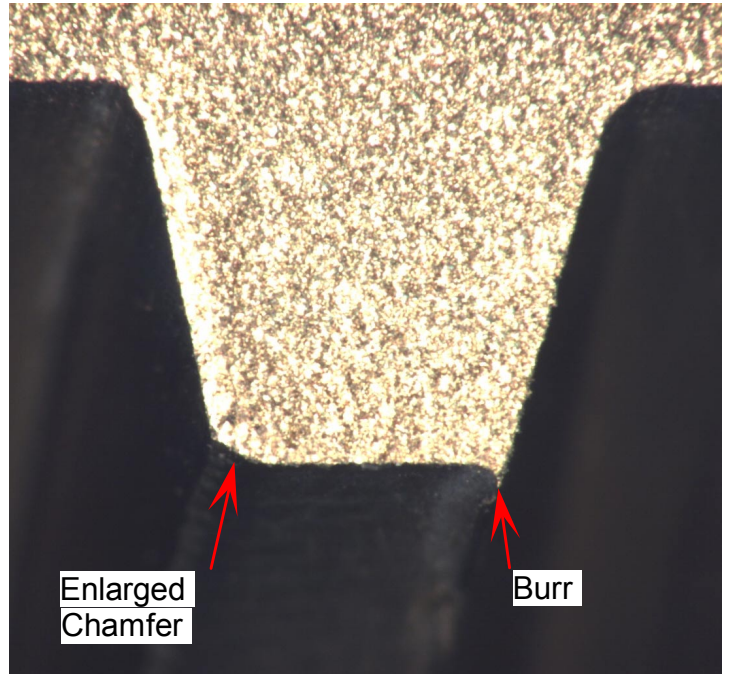
Examinations of the profile and interior surfaces of the nut after sectioning found that all threads had a small burr extending from the lower thread flank into the minor diameter area. The burrs on all teeth projected less than 0.010 inch from the thread crests but every other thread profile exhibited a much smaller burr of less than 0.004 inch see

Figure 17--A comparison of the burr heights on adjacent threads of Acme nut D-3351, left measured  $\sim 0.004$ , right  $\sim 0.010$  inch. Right thread also has an enlarged chamfer at the upper flank.

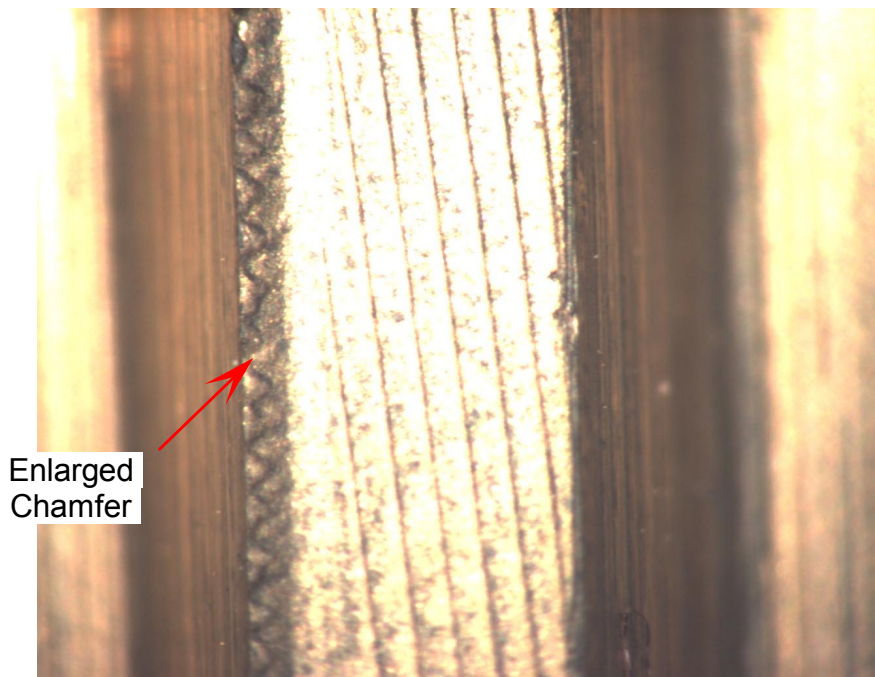
Figure 18--A view of the enlarged chamfer (right thread in figure 17) with repetitive marks on Acme nut D-3351.

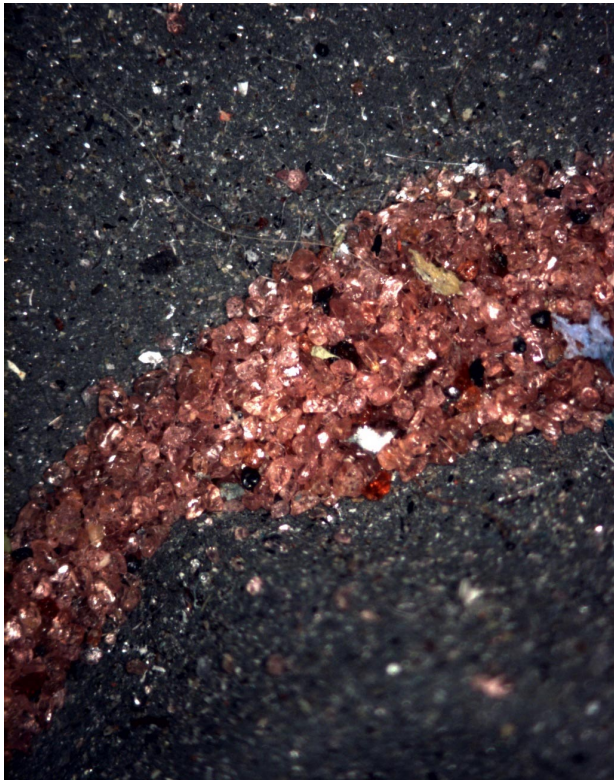
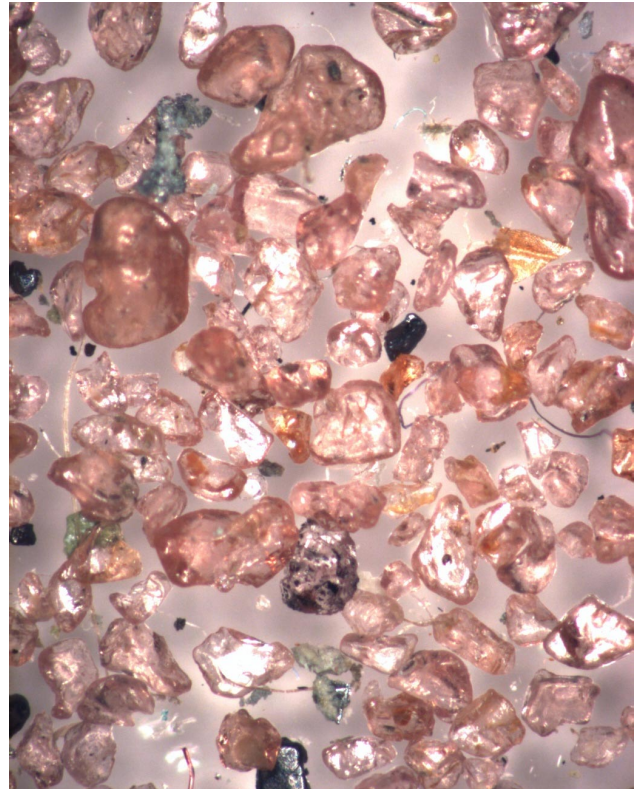
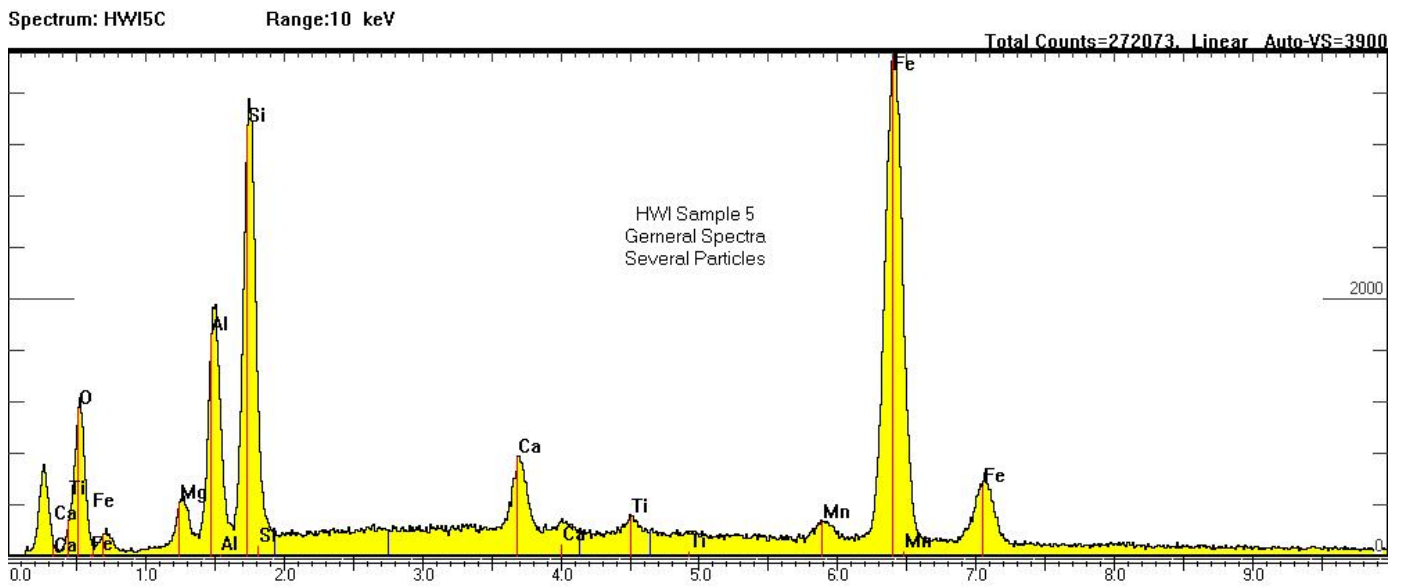
Figure 19--Upper two views show the pink sand found in the grease sample 103 removed from below the jackscrew in N601AP. EDS spectrum of pink particles shown at bottom.
