# NATIONAL TRANSPORTATION SAFETY BOARD

MATERIALS LABORATORY FACTUAL REPORT

Report No. 01-082

Place : Near Port Hueneme, California  
Date : January 31, 2000  
Vehicle : Boeing MD-83, N963AS  
Operator : Alaska Airlines, Flight 261  
NTSB No. : DCA00-M-A023

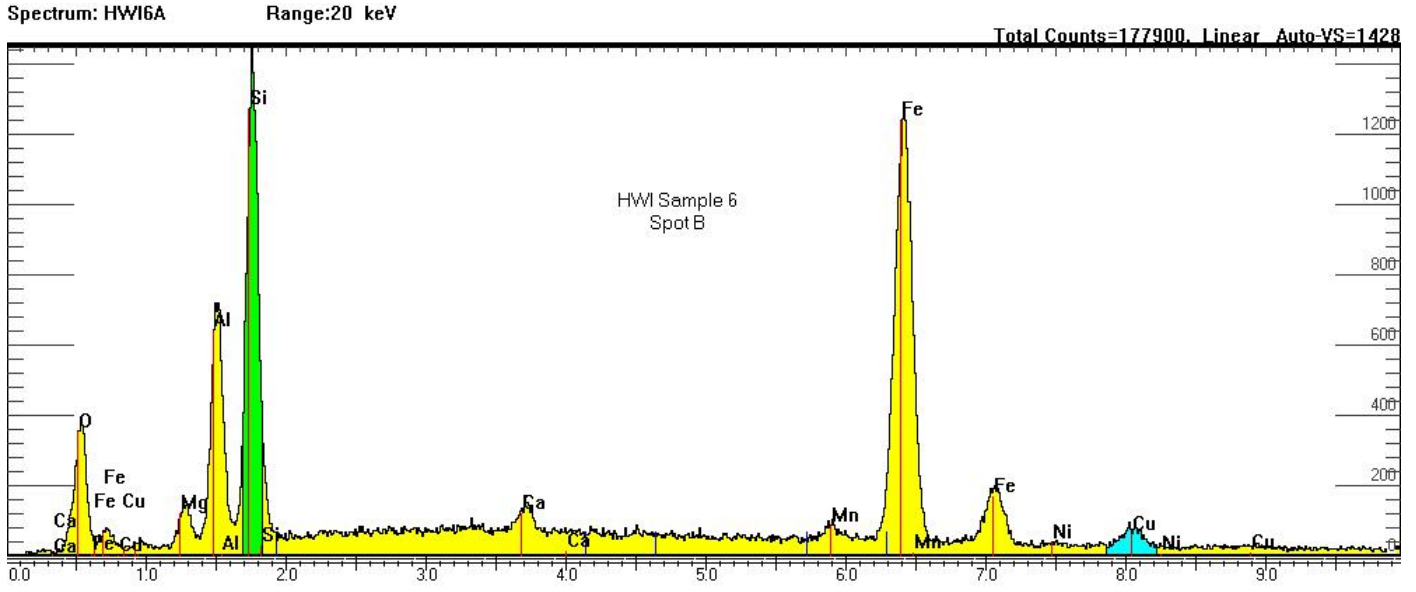
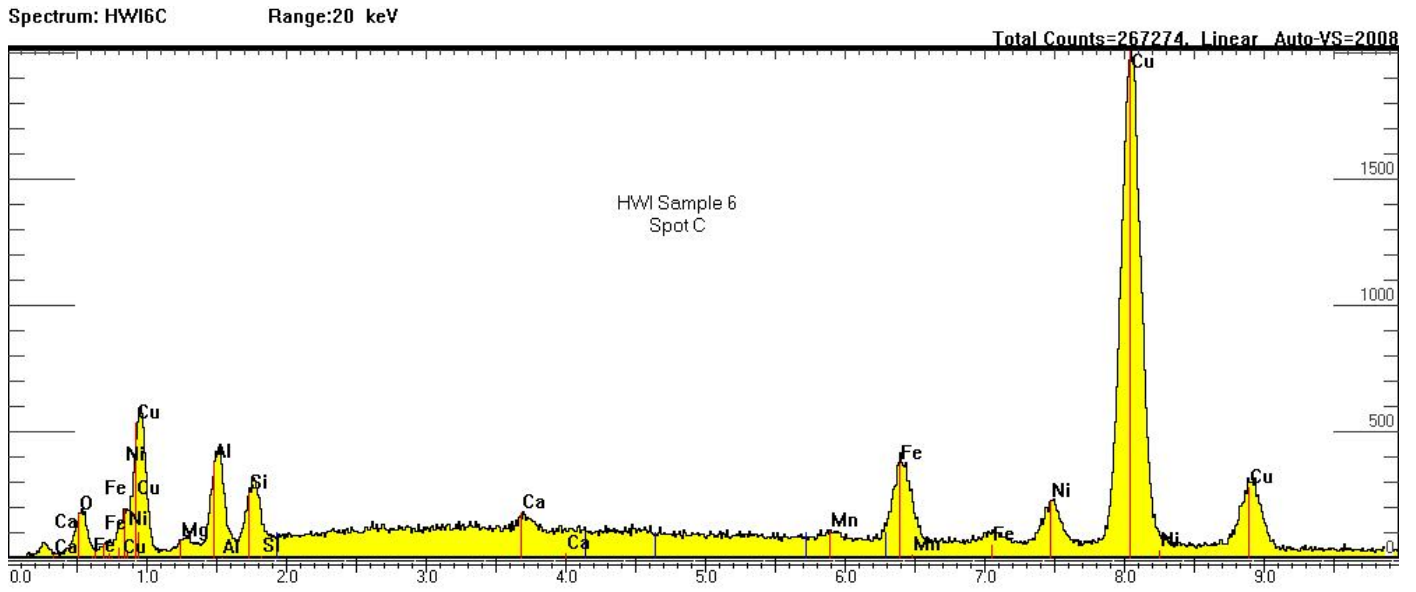
Figure 20--EDS Spectra from the two types of particle found in sample 104. Upper spectrum shows analysis of glassy particles similar to the pink particles in sample 103. Lower spectrum is from the fine agglomeration of particles in sample 104. Spectral peaks in the lower spectrum are consistent with the base metal of an Acme nut with additional peaks for silicon, oxygen and calcium.

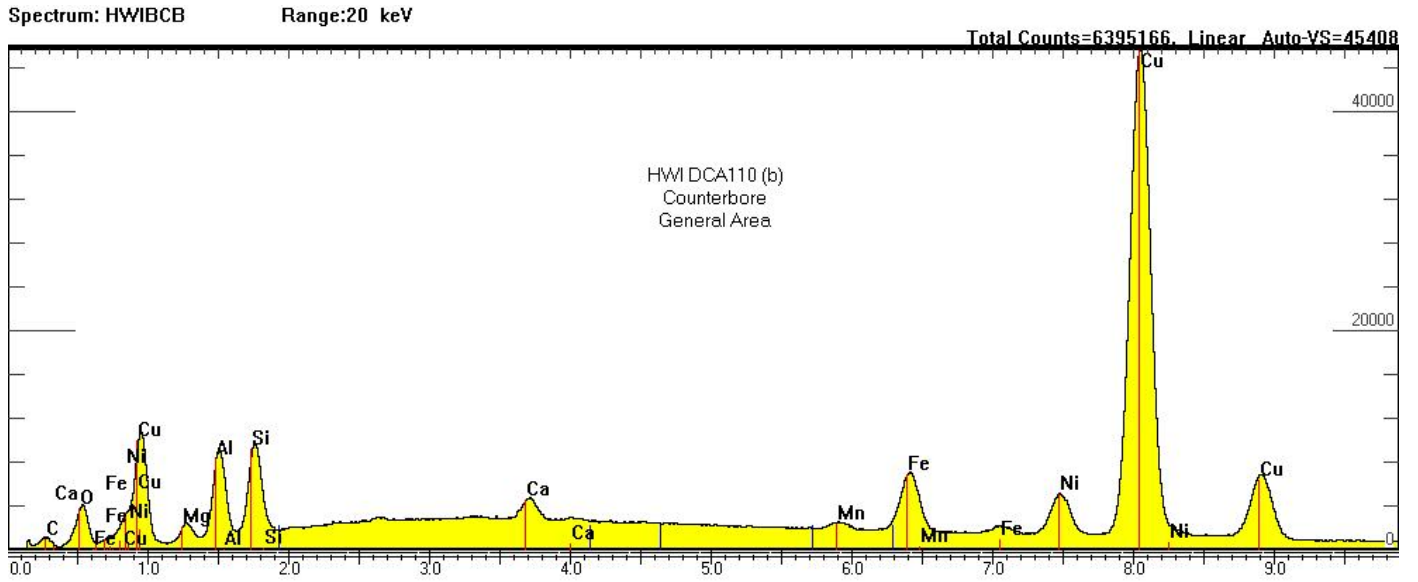
During disassembly of jackscrew assembly DCA110(b), one grease sample (133) was removed from the grease fitting counterbore area and another swab sample was taken from the thread surfaces of the nut (134). Initial examination of the particle extractions from samples 133 and 134 found large amounts of very fine particulate with many shiny brass colored particles and a few larger brass flakes in both. An EDS spectrum acquired from a general area of the filtrate of sample 133 exhibited peaks consistent with the base metal of the nut and additional peaks for silicon, calcium and oxygen as shown in figure 21. The overall spectrum of the filtrate from sample 133 was very similar to that found for the second type of particle found in from sample 104 of nut assembly DCA110(a) (compare figure 21 to the lower spectrum in figure 20). The additional silicon, calcium and oxygen peaks were also constituents found in the pink sand particles and glass beads. Later analysis also found that silicon, calcium and oxygen were the main constituents left by particle extractions on virgin samples of Aeroshell 22 discussed below.

Figure 21--EDS spectrum of particles extracted from DCA110(b) Acme nut grease fitting counterbore (sample 133) showing the base metal constituents plus oxygen, silicon and calcium.

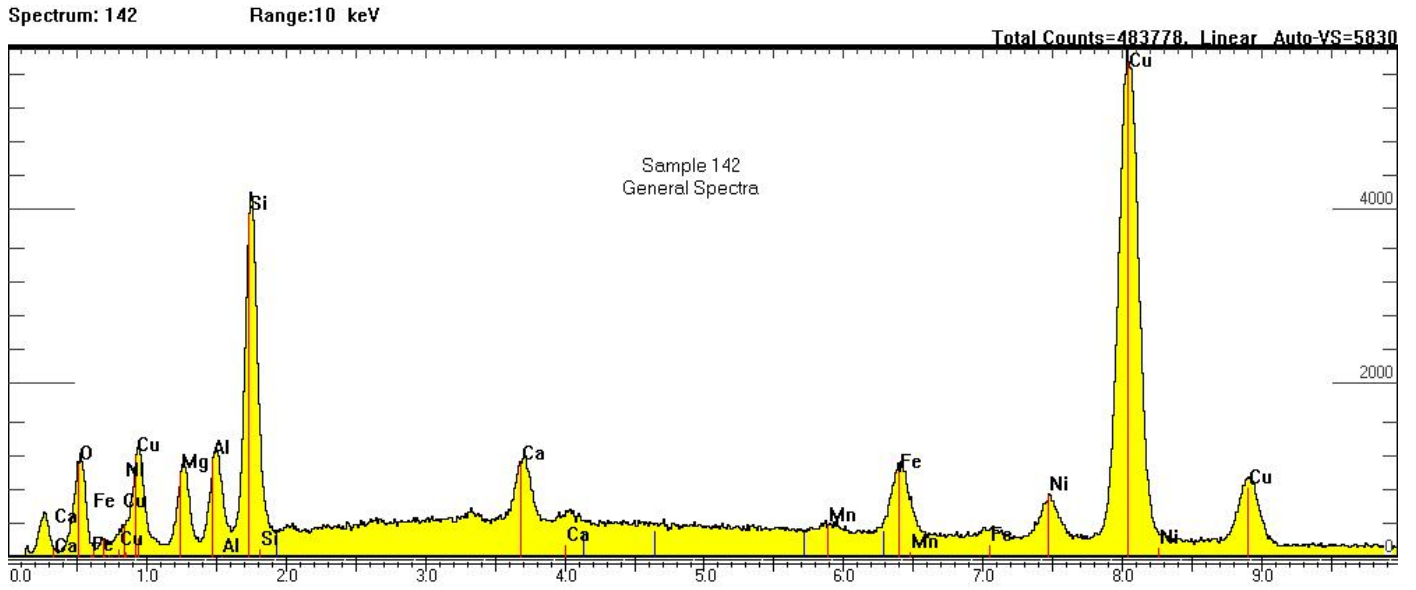
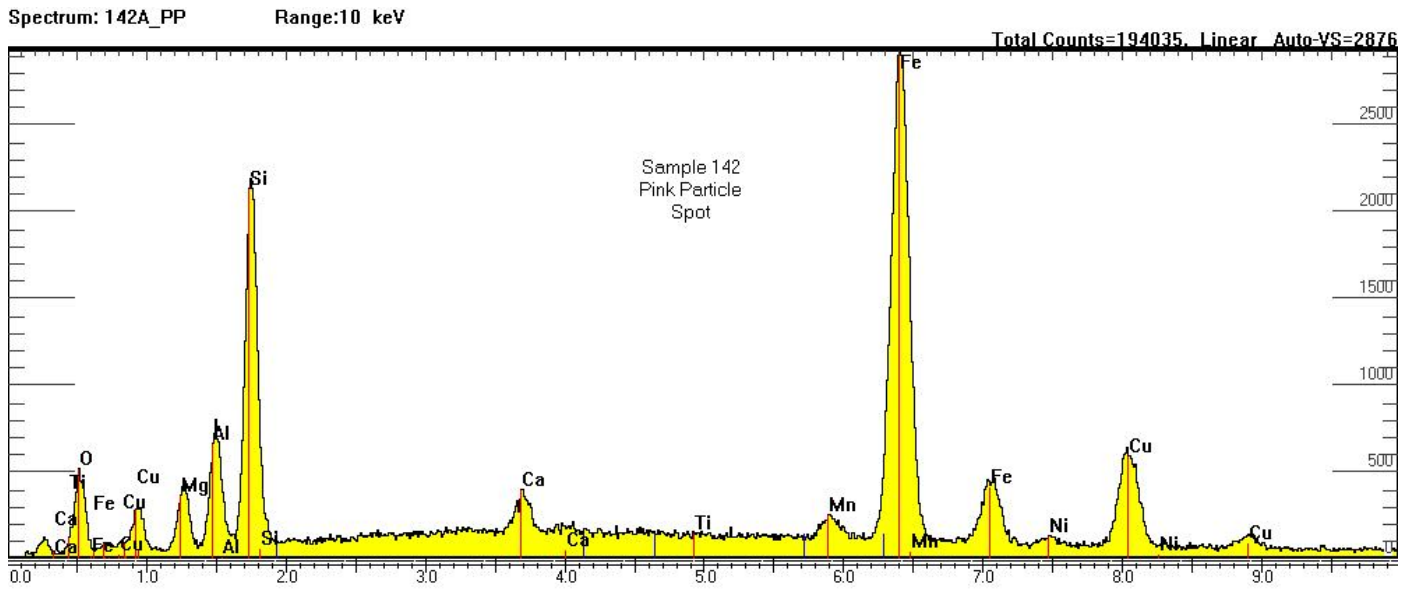
Extraction of particles from the grease sample (142) removed by Hawaiian Airlines from the exterior of DCA110(b) showed a heavy load of gray fines with many very small shiny brass colored flakes. In addition, many larger brass flakes were apparent, as were three small pink particles. A general area EDS spectrum of the fine material is shown in the upper view of figure 22 with elemental peaks consistent with the Acme nut base metal along with a large silicon peak and smaller calcium, oxygen and magnesium peaks. Spot EDS analysis of a pink particle found in sample 142 was also consistent with the pink particle analyzed in sample 103, see lower view of figure 22.

Figure 22--Two spectra from sample 142 removed by Hawaiian Airlines. Upper spectrum shows the elemental peaks from a general area of the sample. The lower peak is a spot spectrum from one of the pink particles in the sample.

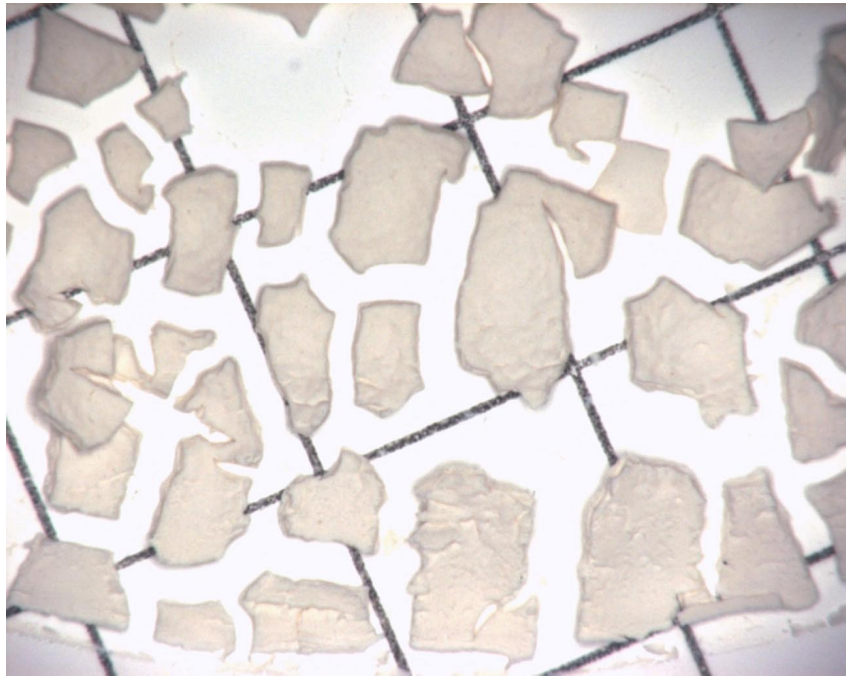
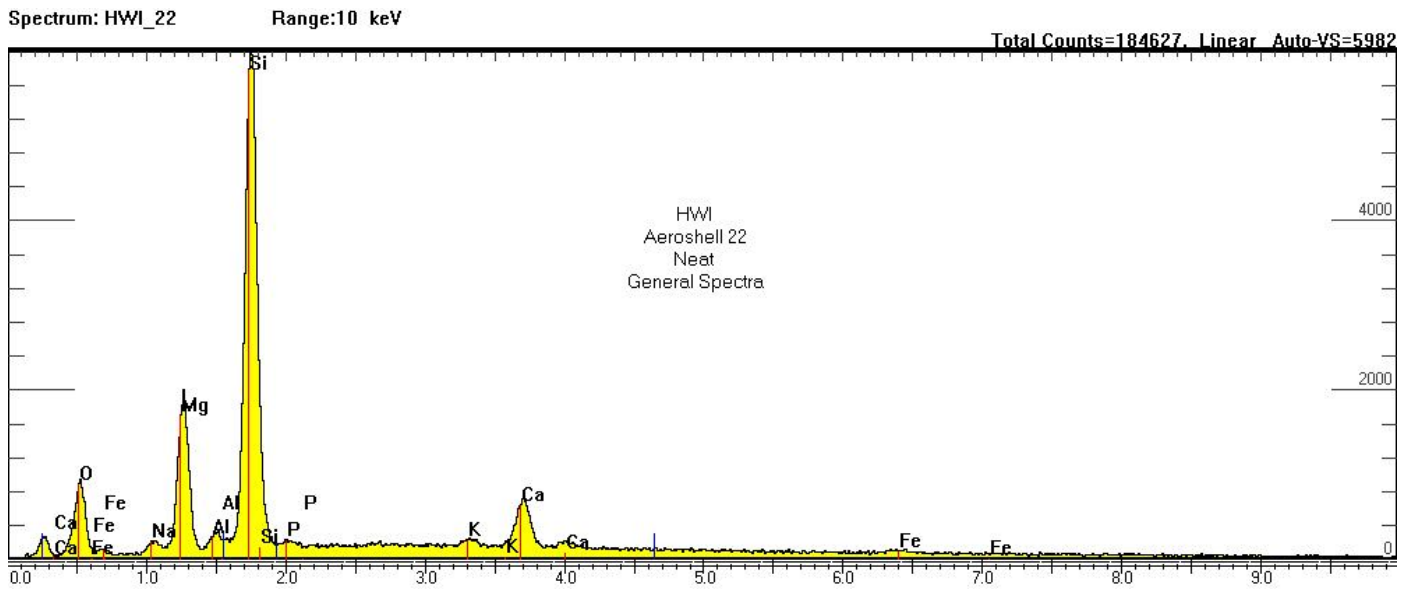
As of the date of this report, particle extractions on the samples removed during August 2001 have not yet been performed. A virgin sample of Aeroshell 22 used by Hawaiian to lubricate jackscrews was also acquired. A particle extraction on a portion of the clean Aeroshell 22 resulted in a thick waxy film that mud cracked and turned white when dried, see upper view in figure 23. EDS spectra showed large elemental peaks for silicon, magnesium, calcium and oxygen and smaller peaks for other elements as displayed in figure 23.

Figure 23--Upper view shows the results of a particle extraction on a sample of clean Aeroshell 22 grease. Spectrum below is the elemental make up of the resulting waxy material.

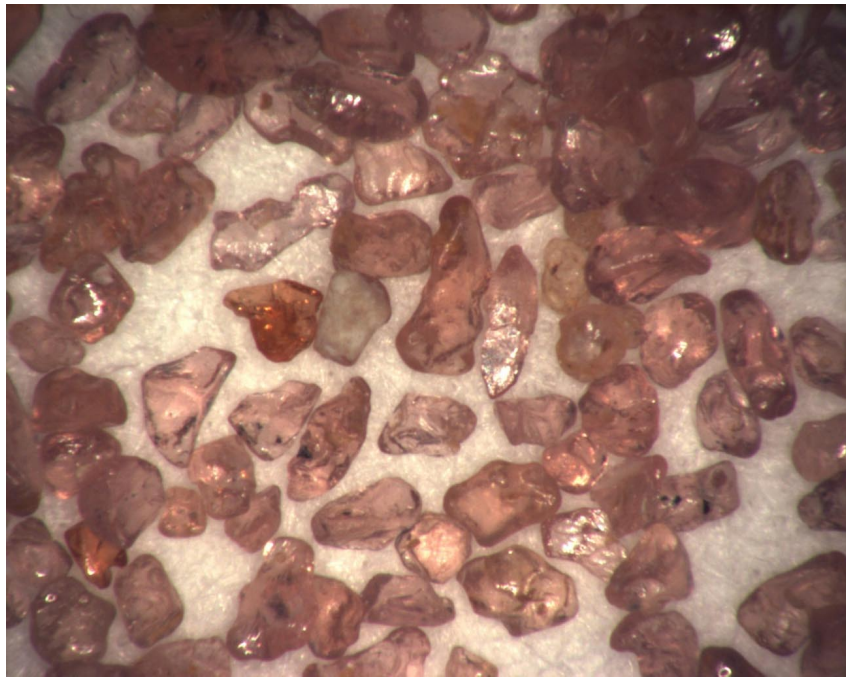
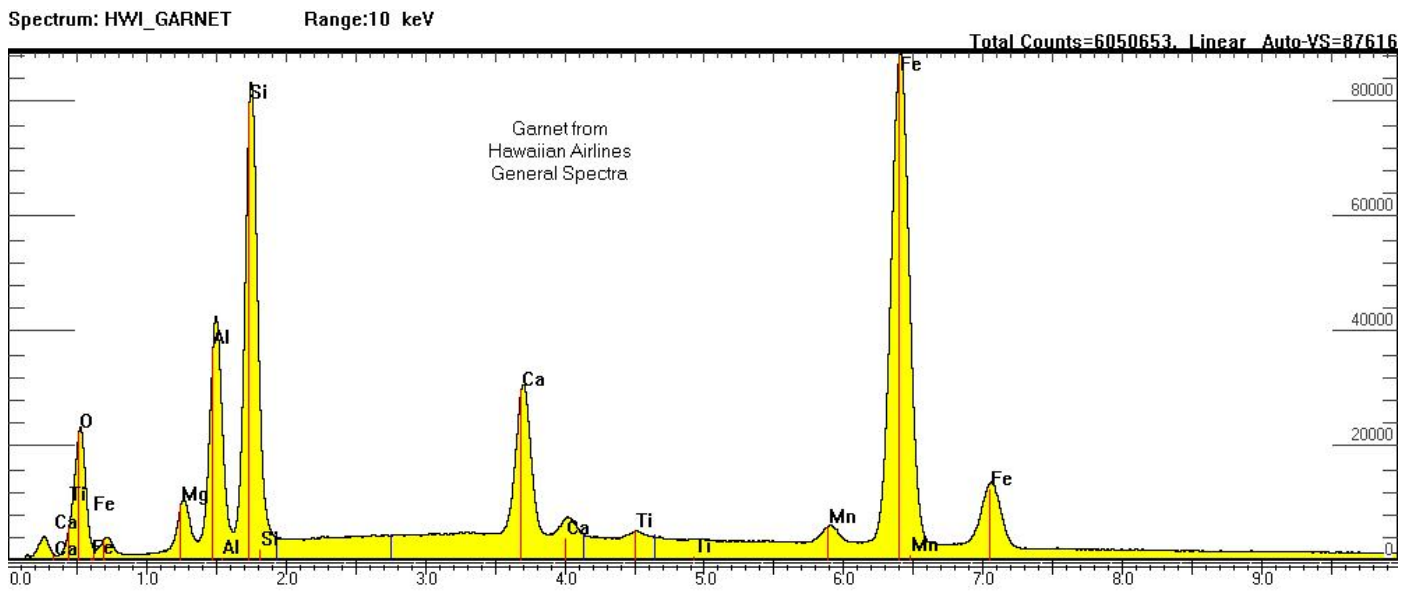
During this inspection it was discovered that Hawaiian Airlines also used a garnet material<sup>10</sup> as blasting media for corrosion cleanup. Visual inspections found this material to be pink sand like material as shown in figure 24 and visually very similar to the previously noted pink sand found in grease sample 103 and others. EDS spectrum acquired from a sample of the garnet blasting material (lower view in figure 24) found elemental peaks and peak height ratios almost identical to that of the pink sand spectrum from sample 103 (figure 19).

Figure 24--Upper view shows typical garnet blasting media from Hawaiian Airlines stock. EDS spectrum of the material is below. Compare both to the pink sand material found in sample 103 ( figure 18), sample 104 (figure 19) and sample 142 (figure 21).

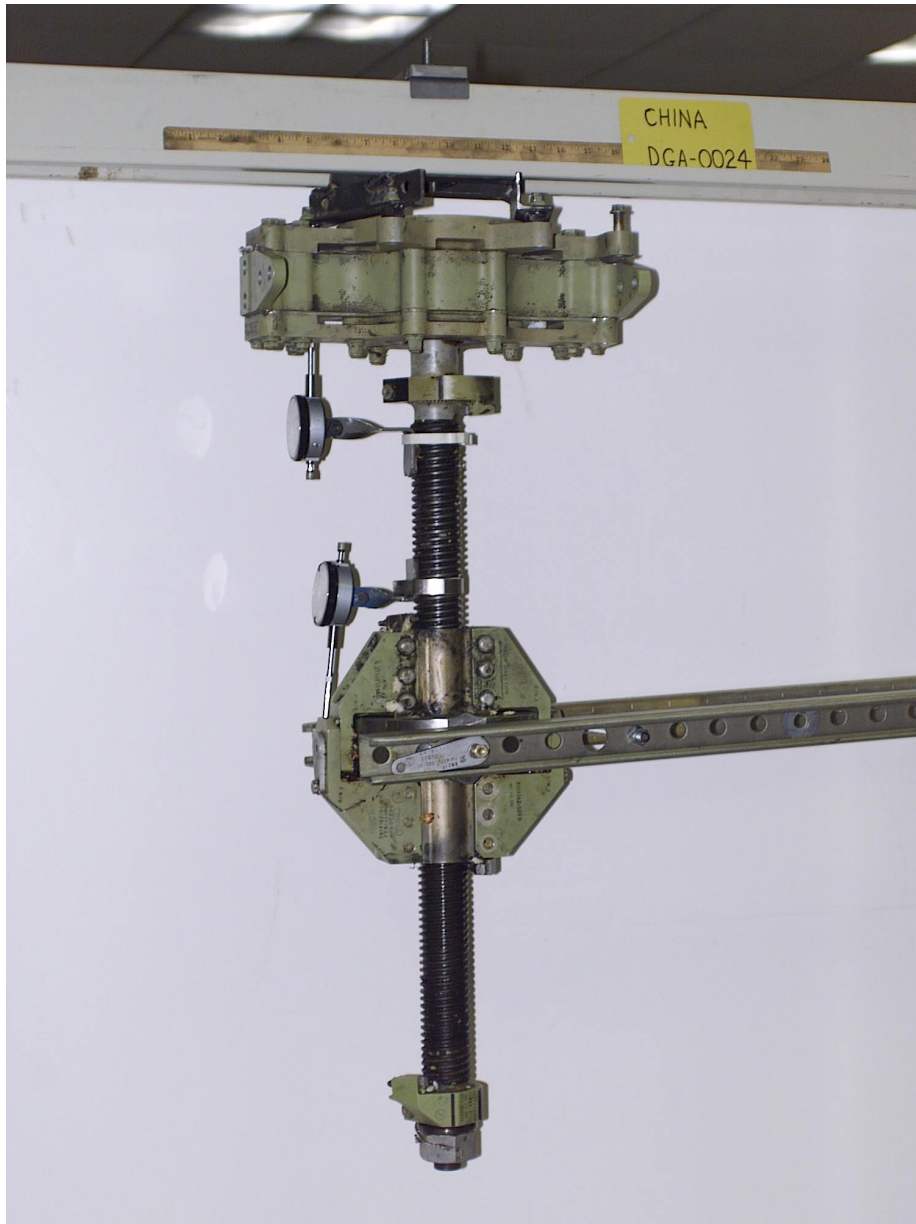
The complete as-removed jackscrew assembly was received on June 4, 2001 after being removed from the aircraft for reportedly high (0.10 inch) endplay measurements, see figure 25. Initial visual examinations found no visually apparent damage. No brass or other metal particles or flakes were noted anywhere on the assembly. The Acme screw showed localized polishing on the upper thread flanks in the central portion of the screw.

Further tests of the Acme screw / nut endplay were performed with the assembly mounted to a fixture (see figure 25) and approximately 180 pounds applied in both directions to the nut. With the nut in the middle of the screw and the existing amounts of grease, the endplay measured at slightly greater than 0.024 inch and the free play measured less than 0.001 inch. A noticeable snap or click movement of the Acme nut was noted during load application. The Acme nut was then moved to the upper screw position and the grease was manually removed from the screw with cloths. It was again cleaned with the nut positioned at the lower end of the screw. With the Acme nut placed in the center of the "cleaned" screw, the endplay measured 0.033 inch. The snapping movement was again noted during load application.

Figure 25--The China Northern Airlines jackscrew mounted in the endplay test fixture.

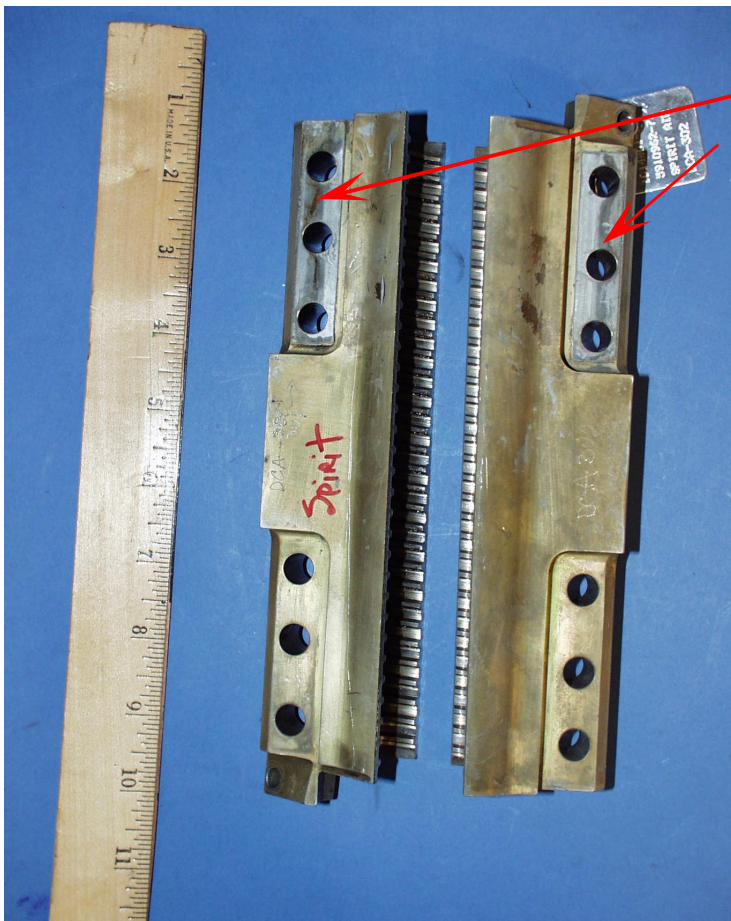
The Acme nut was split longitudinally as shown in figure 26 and one side wire EDM cut to expose an undisturbed profile of the threads. Examination of the profile showed a consistent wear pattern into the lower flanks of the threads with little or no indications of wear into the major diameter surfaces of the threads. The wear pattern was concentric and even from top to bottom.

Figure 26--A view of the Spirit Airlines acme nut after cutting. Note the overall surface coloration versus that under the upper supports.

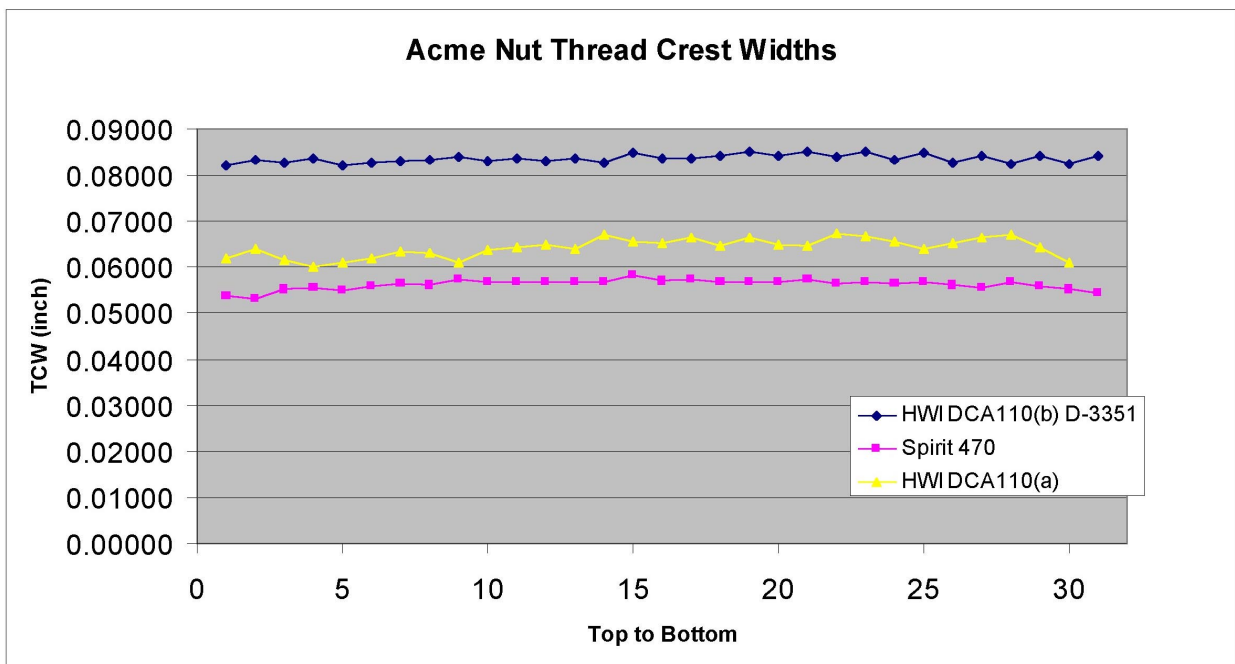
The remaining thickness of the thread crests were measured from top to bottom and averaged 0.056 inches. These are displayed in figure 27 along with similar measurements from DCA110(a) and DCA110(b).

Figure 27--Graphical representation of the the remaining thread crest widths in the nuts from Spirit, and Hawaiian DCA110(a) and (b).
