NATIONAL TRANSPORTATION SAFETY BOARD

MATERIALS LABORATORY FACTUAL REPORT

Report No. 01-118

Place : Near Port Hueneme, CA
Date : January 31, 2000
Vehicle : McDonnell Douglas MD-83, N963AS
NTSB No. : DCA00-M-A023
Investigator : Jeff Guzzetti

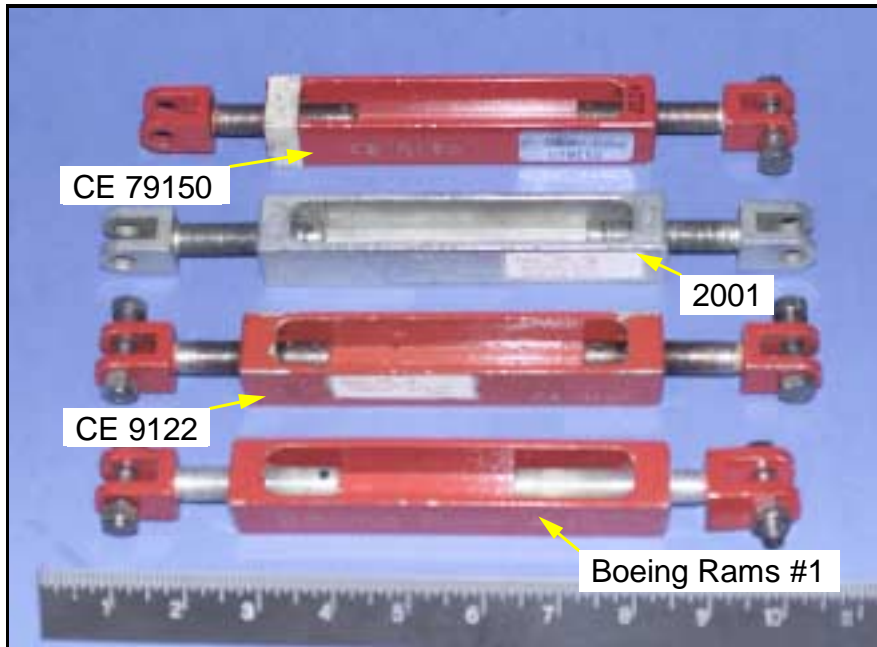
The Boeing stabilizer restraining fixtures submitted for examination are illustrated in figure 1 and the Airline restraining fixtures submitted for examination are illustrated in figure 2. Although of two distinctly different designs, the fixtures consist of the center portion identified as a nut and the two end pieces (that screw into the nut) identified as screws. The screws have left hand and right hand threads that match the threads in the nut. The resulting fixture is essentially a turnbuckle.

Visual examination revealed that the unthreaded portions of three of the Boeing tools were painted red, per the Douglas drawing. The fourth tool, s/n 2001, was not painted.

Figure 1. The Boeing stabilizer restraining fixtures received for examination.

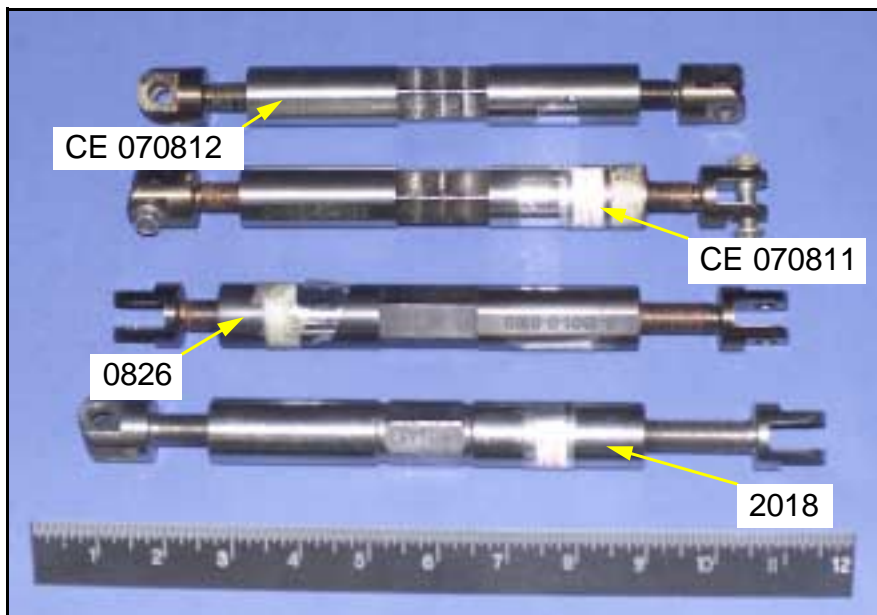
Visual examination of the Airline tools revealed that some of the components exhibited a brown surface discoloration that would be consistent with a heat-treating process. The components that were not discolored were the left hand screw and nut of fixture s/n 2018 and the left hand screw of fixture s/n CE 0826.

Figure 2. The Airline stabilizer restraining fixtures submitted for examination.

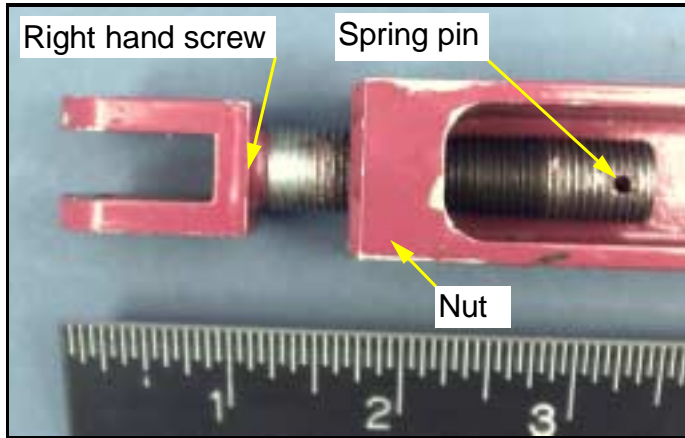
Figure 3 illustrates a right hand screw in the nut that is typical of all the Boeing tools. The spring pin at the end of the threaded portion prevents the screw being removed and was found installed on fixtures s/n Boeing Rams #1 and s/n 2001 only.

Figure 3. A typical right hand screw in the Boeing stabilizer fixtures.

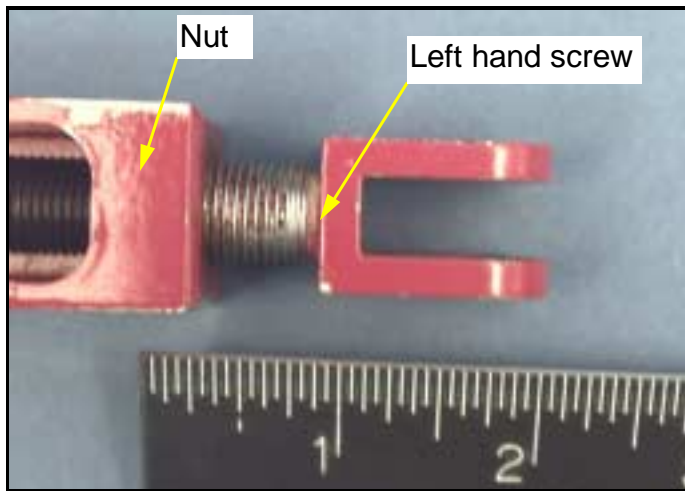
Figure 4 illustrates a left hand screw with the threaded portion aligned with the clevis portion, consistent with DAC drawing 4916750-1 requirements.

Figure 4. A Boeing fixture left hand screw with the clevis portion aligned with the threaded portion.

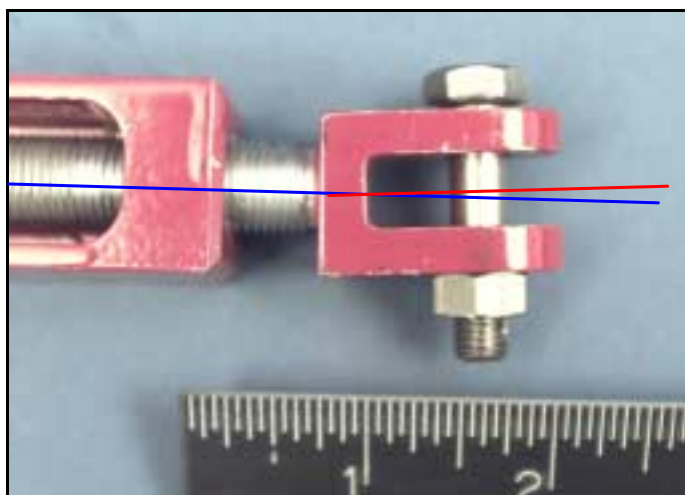
Figure 5 illustrates a left hand screw with the clevis portion offset to the threaded portion. The center of the threaded portion is indicated by the blue line and the center of the clevis is indicated by the red line. The offset was measured and found to be consistent with DAC drawing 4916750-503 requirements. The only offset clevis was observed on fixture s/n Boeing Rams #1.

Figure 5. A Boeing fixture left hand screw with the clevis portion offset to the threaded portion.

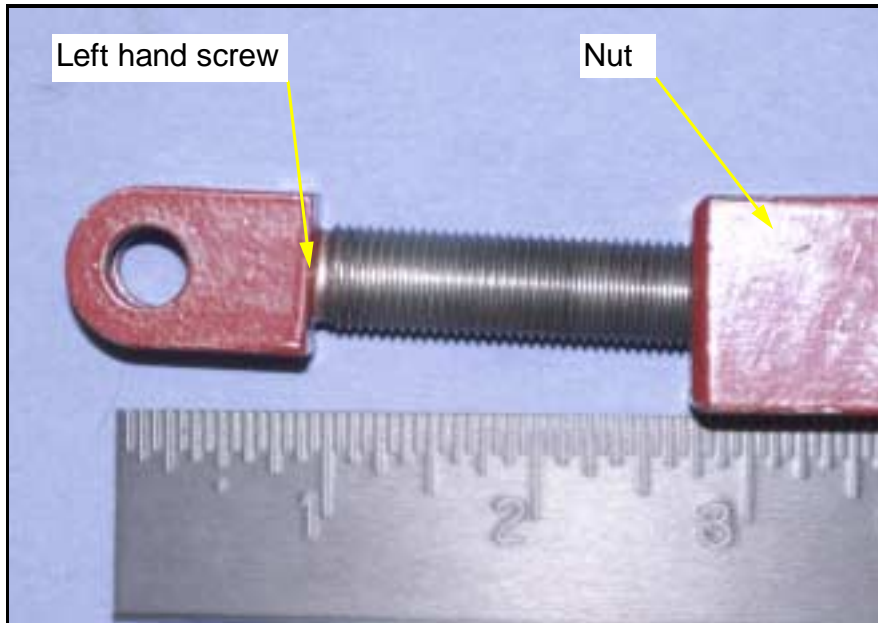
Figure 6 illustrates the left hand screw of fixture s/n CE 9150. The threaded portion was in alignment with the clevis portion, satisfying DAC drawing 4916750-1 requirements, but the threaded portion was not in alignment with the nut.

Figure 6. The left hand screw of Boeing fixture s/n CE 9150 illustrating the misalignment of the threaded portion with the nut.

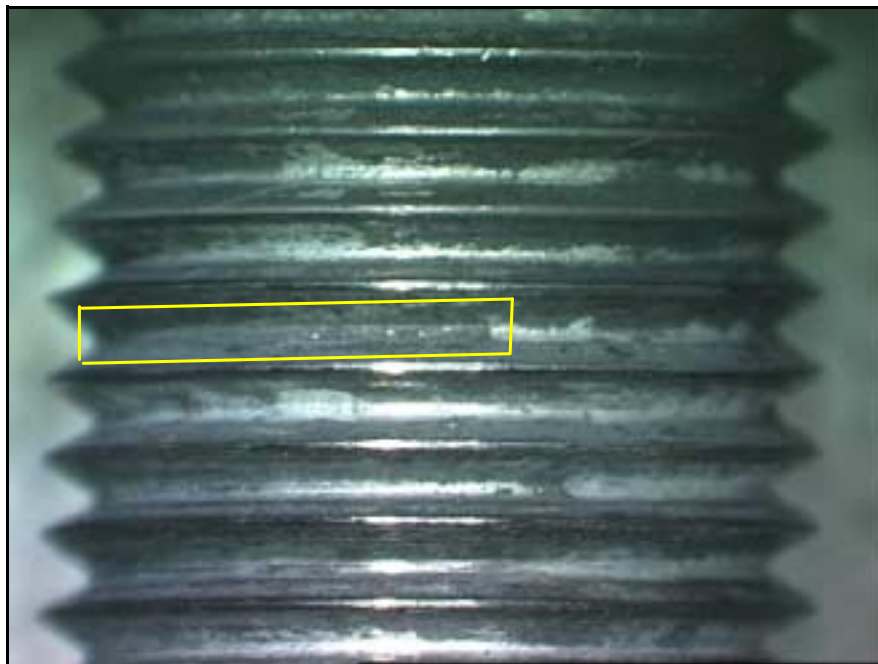
The screws of all the fixtures were screwed in and out of their respective nuts. When being screwed out, the left hand screw of fixture s/n 2001 came to a halt approximately 0.5 inches from the spring pin. Visual examination revealed that the root of a thread, in that approximate location, was packed with a hard gray material that appeared to consist of dirt particles embedded in a solidified lubricant. The gray deposit, located within the yellow box illustrated in figure 7, was removed and the screw then operated over its full length.

Figure 7. The deposit in the root of the left hand thread of fixture s/n 2001 that prevented full travel of the screw.

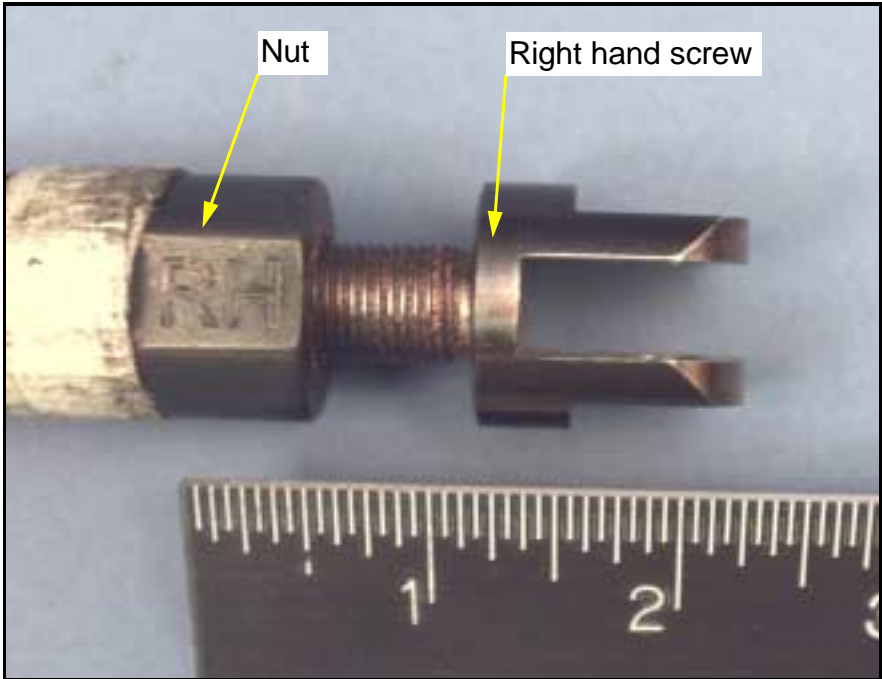
Figures 8 and 9 illustrate typical right hand and left hand screws respectively. All screws and nuts were in alignment as suggested by the Airline drawing. All the nut ends were stamped, as illustrated, with the thread direction with the exception of fixture s/n 2018.

Figure 8. A typical Airline fixture right hand screw in the appropriate end of the nut.

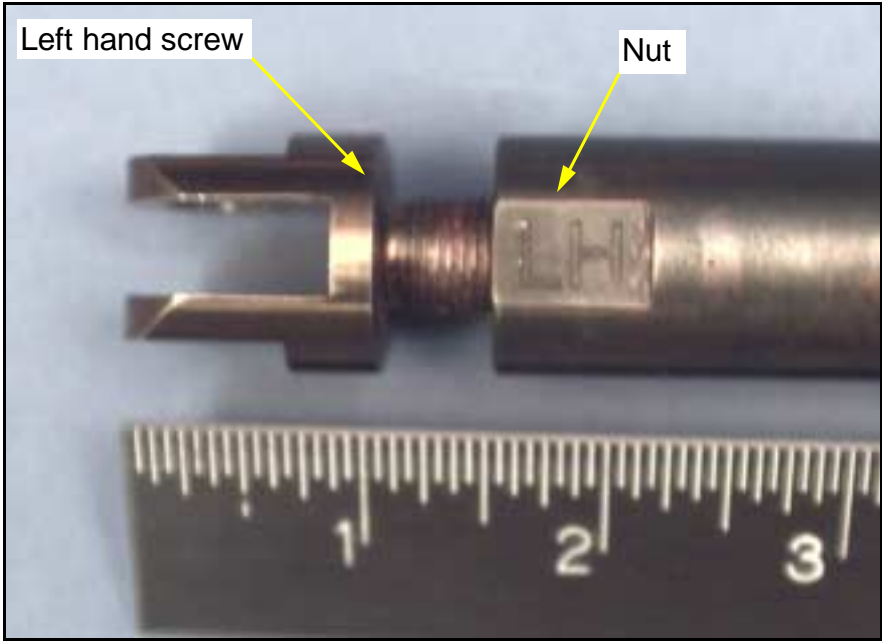
Figure 9. A typical Airline fixture left hand screw in the appropriate end of the nut.

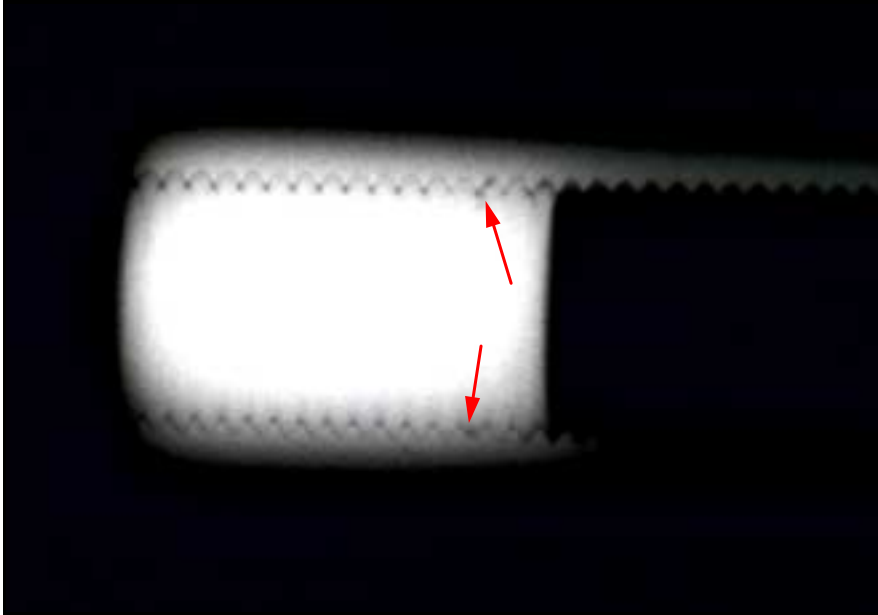
There was approximately 1 5/8 inches of the left hand screw of fixture s/n 2018 protruding from the nut. An x-ray, provided with the fixtures, revealed distortion of the mating threads, indicated by the red arrows in figure 10, approximately 1/8-inch from the end of the screw and 3/4-inch deep into the nut.

Figure 10. An x-ray of the left hand screw of Airline fixture s/n 2018 in its nut with the deformed threads indicated by the red arrows.

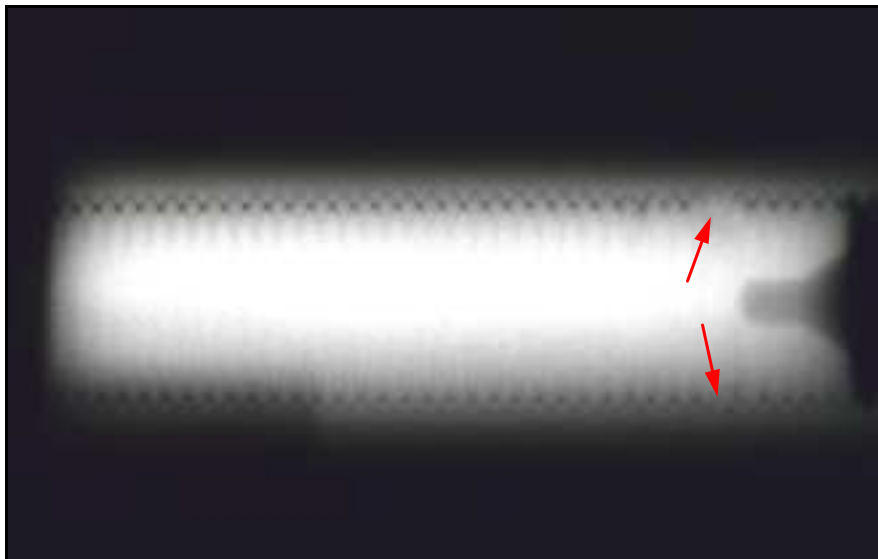
There was approximately 3/4-inch of the left hand screw of fixture s/n CE 070812 protruding from the nut. The same x-ray also revealed distortion to the mating threads, indicated by the red arrows in figure 11, approximately 1/4-inch from the end of the screw and 1 1/2 inch deep into the nut.

Figure 11. An x-ray of the left hand screw of Airline fixture s/n CE 070812 in its nut with the deformed threads indicated by the red arrows.

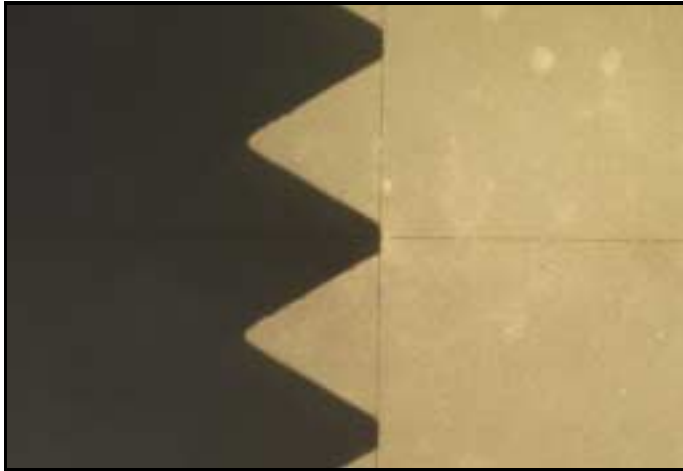
Measuring the major and minor diameters on the Opticom Qualifyer also revealed some differences in thread forms. Most of the threads were similar in form to the profile illustrated in figure 12. The thread form observed on the left and right hand screws of fixture s/n CE 9122 displayed an increased root radius as indicated in figure 13. The thread form observed on the right hand screw of fixture s/n CE 070812 displayed a curvature on one flank as it approached the root. The flank curvature is indicated in figure 14.

Figure 12. Typical thread form observed on the stabilizer fixtures. The dark area is the thread profile.

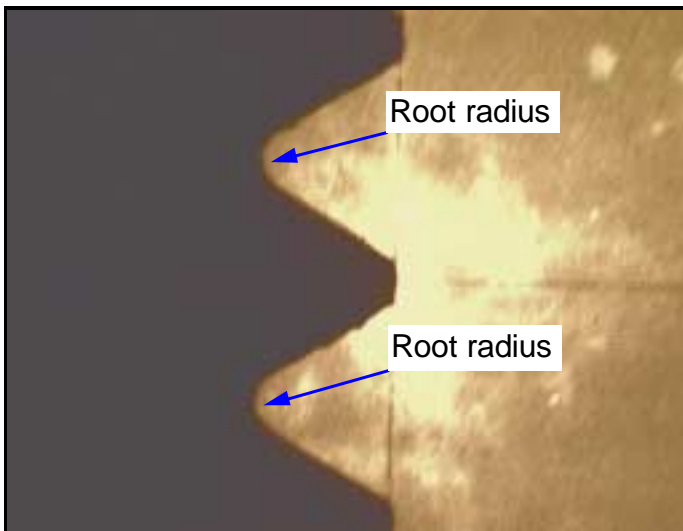
Figure 13. The root radius observed on the left and right hand screws of Boeing fixture s/n CE 9122. The dark area is the thread profile.

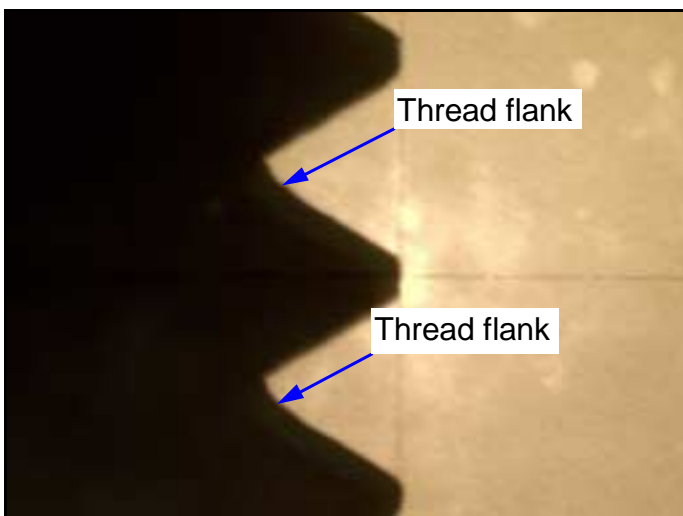
Figure 14. The curvature on the flank of the right hand screw of Airline fixture s/n CE 070812. The dark area is the thread profile.
