NATIONAL TRANSPORTATION SAFETY BOARD

MATERIALS LABORATORY FACTUAL REPORT

Report No. 01-120

Place : Near Port Hueneme, California
Date : January 31, 2000
Vehicle : Boeing MD-83, N963AS
Operator : Alaska Airlines, Flight 261
NTSB No. : DCA00-M-A023

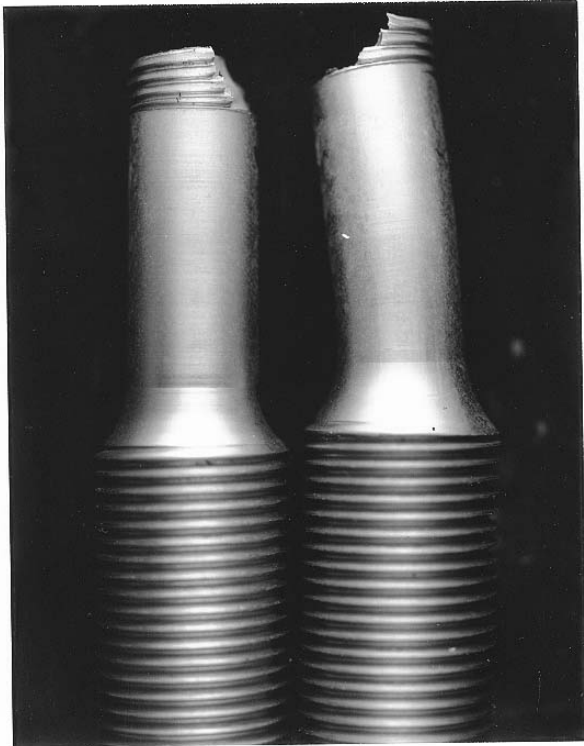
Macroscopic examination revealed fracture traces leading from the first full thread root on one side of the specimen and propagating to the diametrically opposite side. See figure 3. The initial portion of the fracture was flat; however, the entire fracture surface exhibited a dull coarse-grained texture surrounded by a shear lip, typical of an overstress fracture region. The terminal portion of the fracture occurred along an oblique plane. There was no evidence of a band, similar the band found on the ASA 261 quill shaft fracture surface. SEM study confirmed a predominant dimple mode of rupture, indicative of an overstress fracture region. See figure 4.

Figure 3--Specimen N-3B after the test. Note the bend in the right half of the specimen. The fracture face (below) was typical of an overstress separation and does not show a reflective band. Fracture initiation was from bottom of fracture as shown below, with the final shear lip at the top.

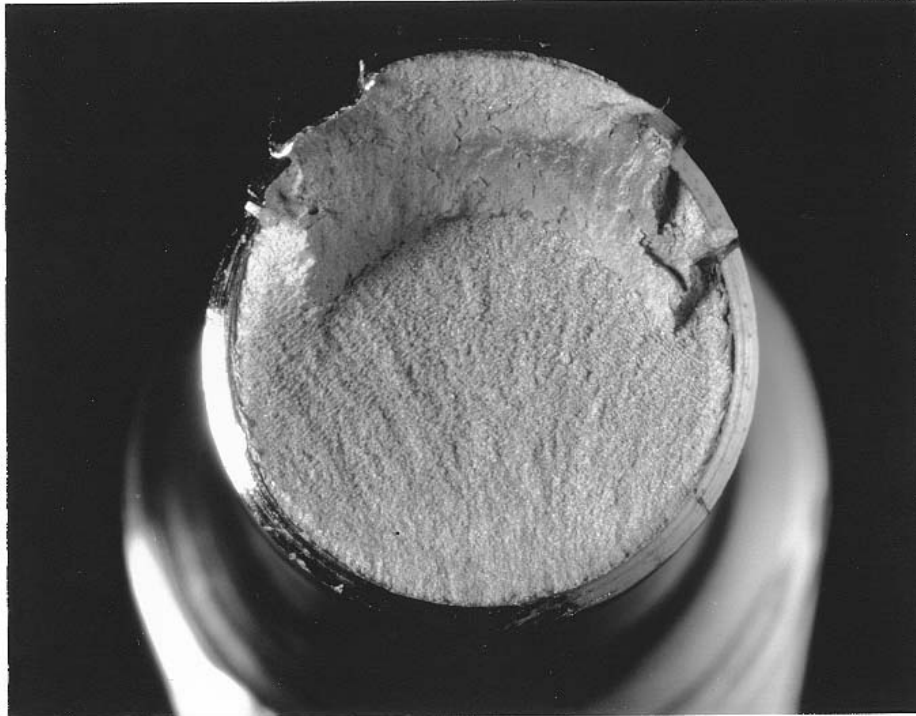
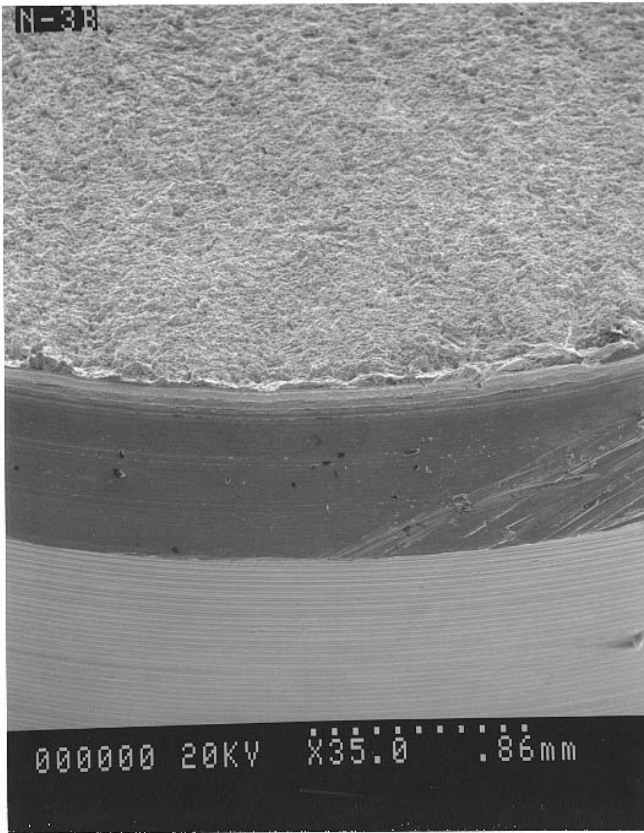
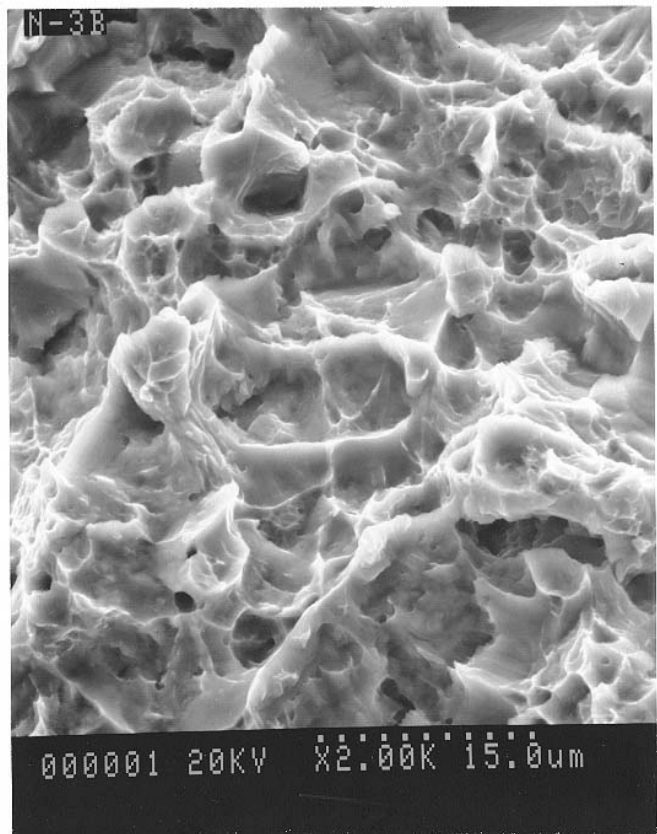
Figure 4--SEM views of specimen N-3B showing ductile overstress fracture features at low and high magnifications.

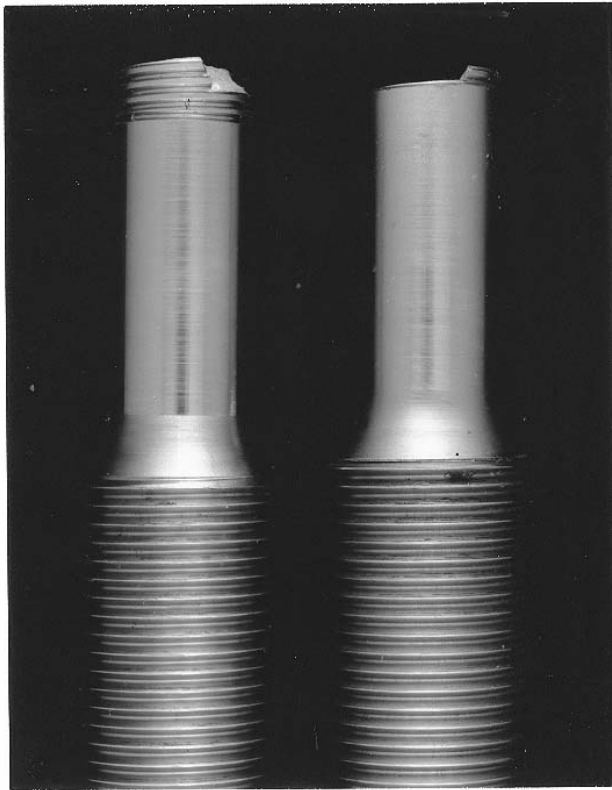
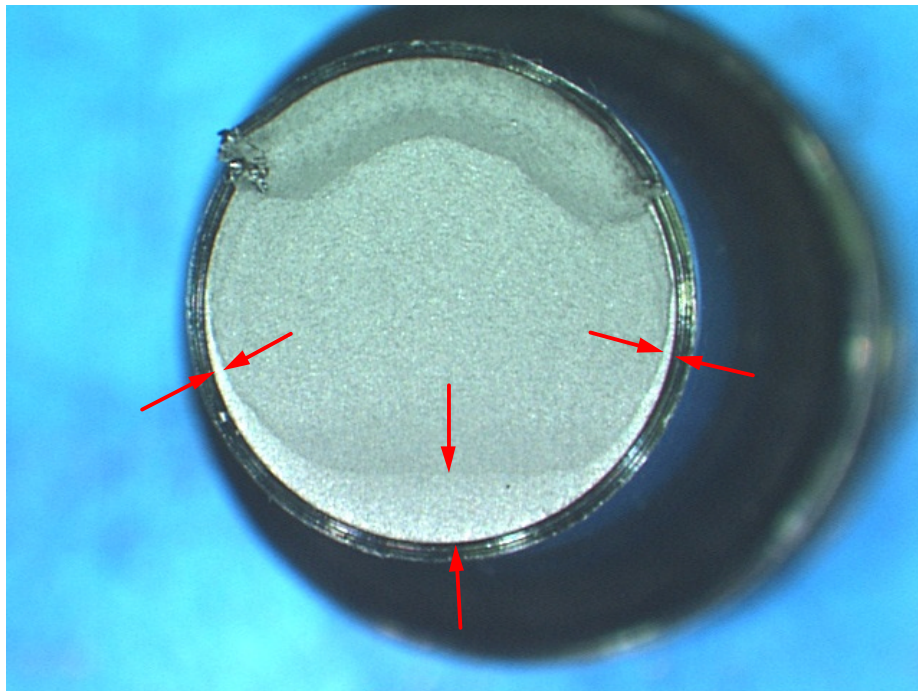
Specimen N-1B had been subjected to axial fatigue testing with an estimated maximum stress of 140 ksi. The specimen fractured after 1,549 cycles. Macroscopic examination revealed fracture traces leading from the first full thread root on one side of the specimen and propagating to the diametrically opposite side. See figure 5. The fracture surface exhibited a flat, fine-grained textured band (reflective band) surrounding approximately 70% of the outer periphery of the fracture surface. The remaining fracture surface, beyond the flat band, exhibited a dull coarse-grained texture, typical of a ductile overstress separation. A majority of the fracture surface was relatively flat; however, the terminal portion of the fracture surface occurred along an oblique plane. No evidence of a fine-grained texture was observed along the periphery of the terminal, oblique region.

Figure 5--Specimen N-1B after the test. Fracture face (below) shows initiation and reflective band (between arrows) at bottom of view and final shear lip at top.

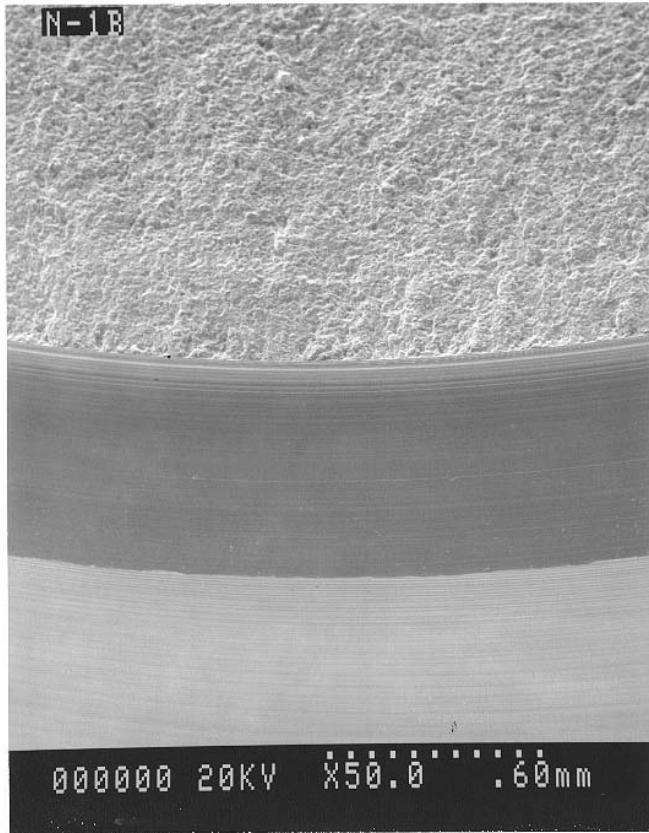
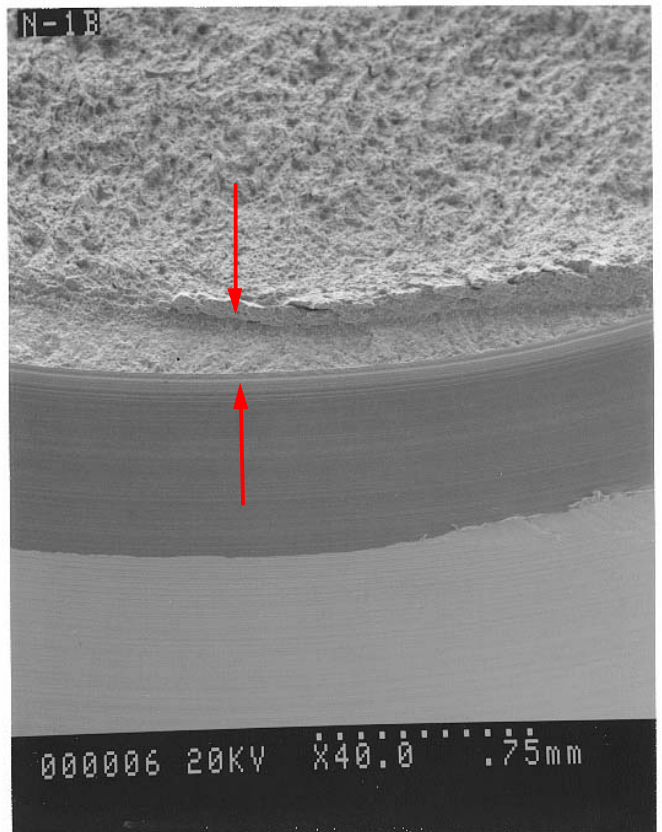
SEM analysis of the reflective band revealed multiple fatigue origins emanating from the thread root. Figure 6 contains SEM images of the reflective band in the central

region of the crescent and to one side. In the central region of the reflective band, fatigue striations were clearly visible emanating from multiple locations in the thread root to a depth of about 0.024 inches. Fatigue striation mixed with ductile dimples extended an additional 0.015 inches for a total band depth of approximately 0.04 inches. The remaining fracture surface beyond the reflective band revealed a predominant dimple mode of rupture, indicative of overstress separation. Figure 7 displays typical fatigue, mixed and overstress fracture features found in the different areas of the separation.

Figure 6--Two SEM views of the fracture surface of specimen N-1B showing the origin area at left and a view of the side portion of the band below. The reflective band is clearly visible in the lower view.

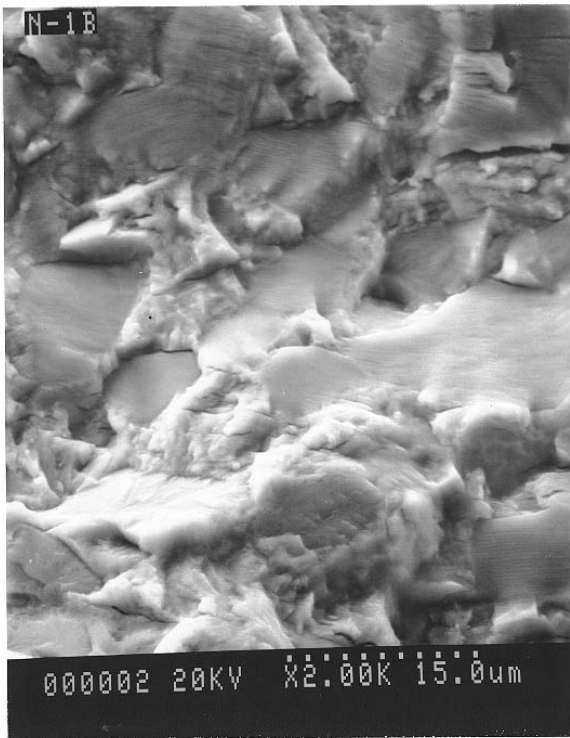
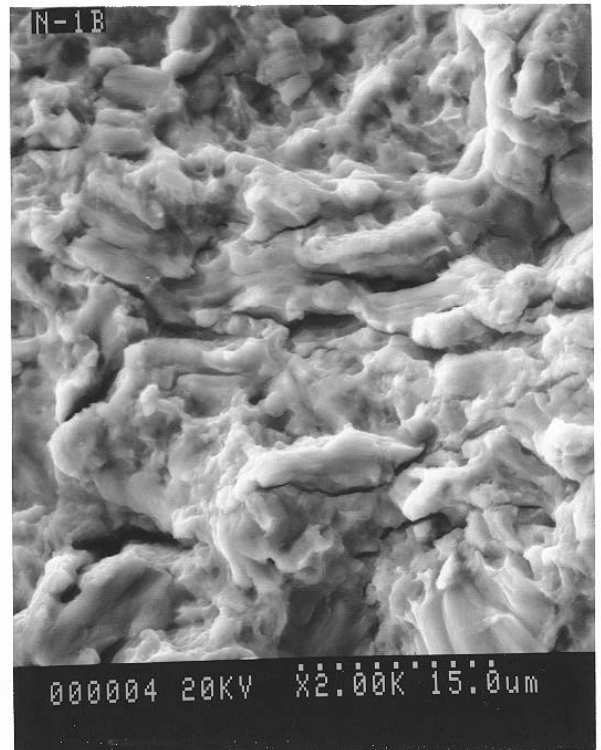
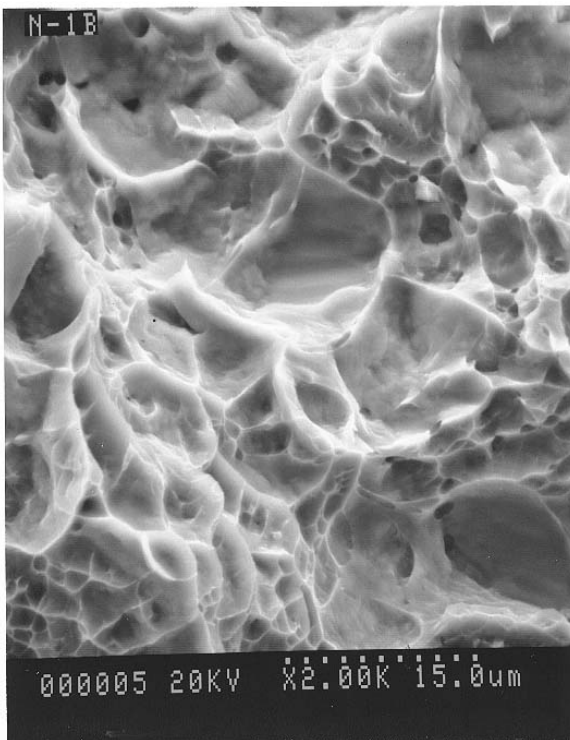
Figure 7--Three SEM views of the fracture face of specimen N-1B. Upper left shows fatigue striations within the reflective band near the initiation area. Upper right show the region of mixed striations and dimples near the terminus of the reflective band. View at lower left shows the dimples typical on the remaining fracture area.

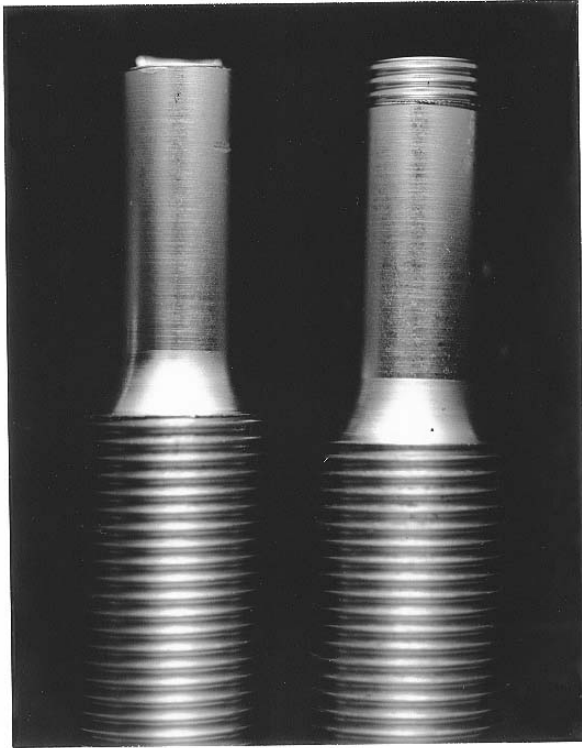
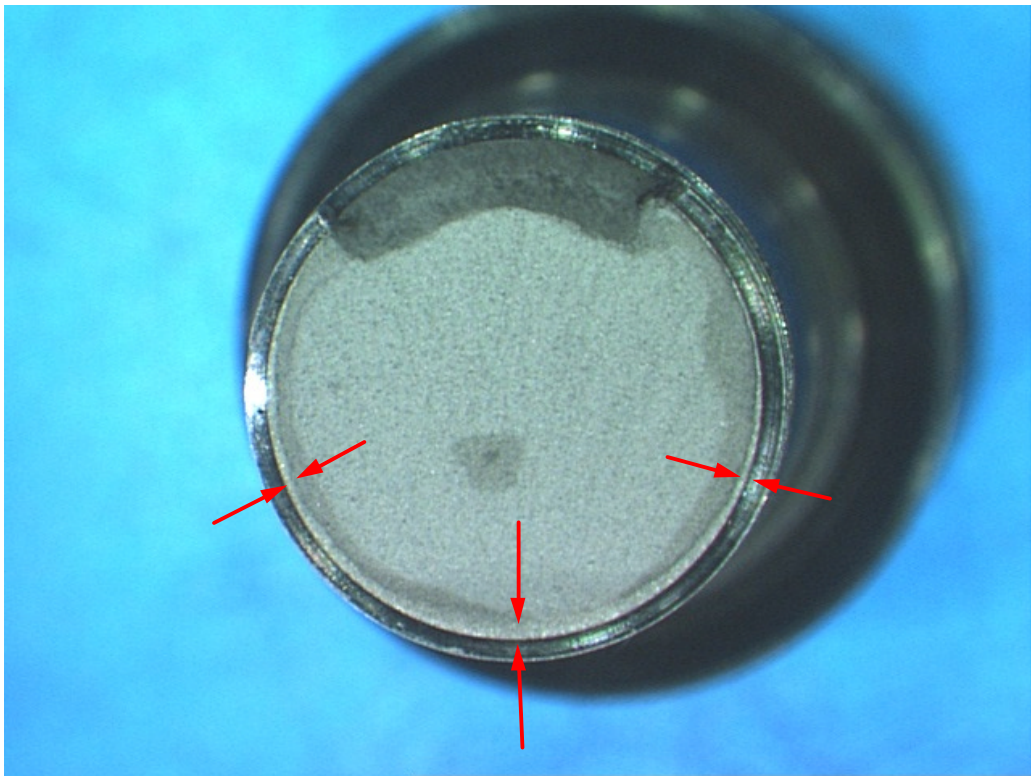
Specimen N-1A had been subjected to axial fatigue testing with an approximate maximum stress of 166 ksi. The specimen failed after 389 cycles. Macroscopic examination revealed fracture traces leading from the first full thread root on one side of the specimen and propagating toward the diametrically opposite side. See figure 8. The fracture surface exhibited a reflective band around approximately 80% of the fracture surface. See lower view of figure 8. The remaining fracture surface, beyond the flat band, exhibited a dull coarse-grained texture, typical of a ductile overstress separation. The terminal portion of the fracture occurred along an oblique plane. No evidence of a fine-grained textured band was found along the periphery of this terminal region.

Figure 8--Specimen N-1A after the test. Fracture face (below) shows initiation and reflective band (between arrows) at bottom of view and final shear lip at top.

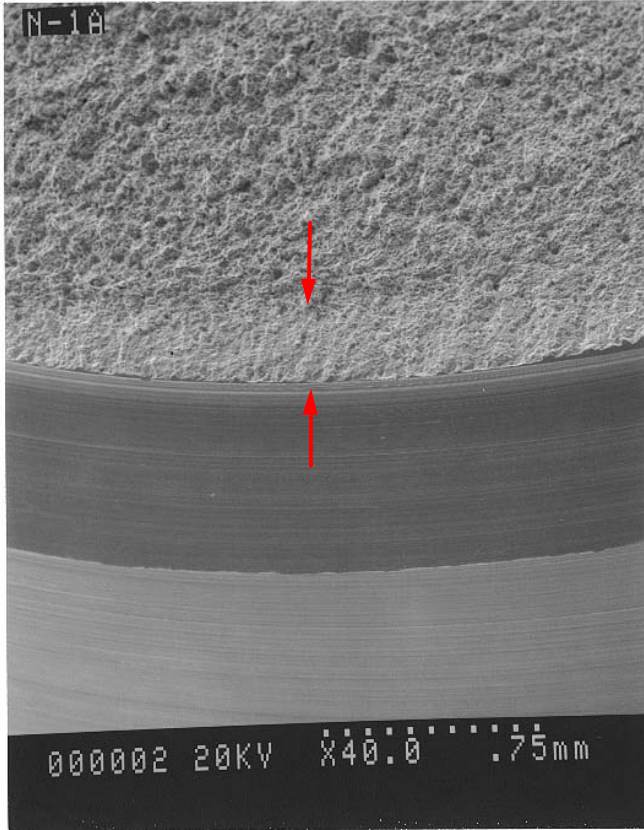
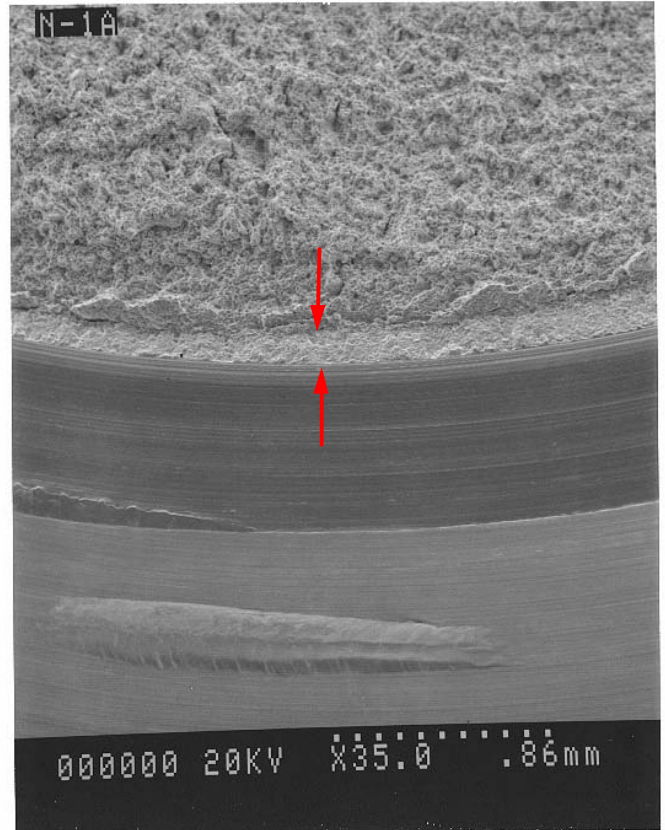
SEM analysis of the reflective band revealed multiple fatigue origins emanating from the thread root. The band was similar to that seen on specimen N-1B but was much thinner. Figure 9 contains SEM images of the reflective band in the central region of the crescent and to one side. In the central region of the reflective band, fatigue striations were clearly visible emanating from multiple locations in the thread root to a depth of about 0.004 inches. Fatigue striation mixed with ductile dimples extended an additional 0.004 inches for a total band depth of approximately 0.008 inches. The remaining fracture surface beyond the flat band revealed a predominant dimple mode of rupture, indicative of an overstress fracture region. Figure 10 displays typical fatigue, mixed and overstress fracture features found in the different areas of the separation.

Figure 9--Two SEM views showing the reflective band (between arrows) in the initiation area (left) and around the side of the specimen (right). Specimen N-1A

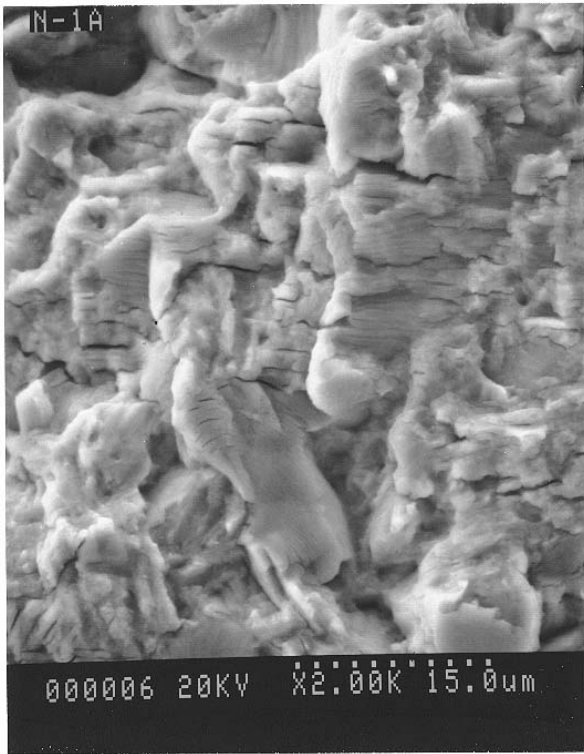
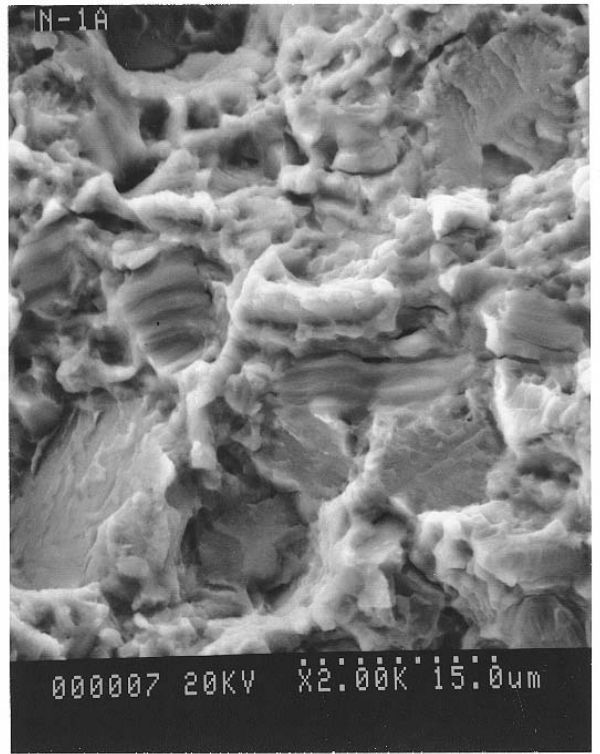
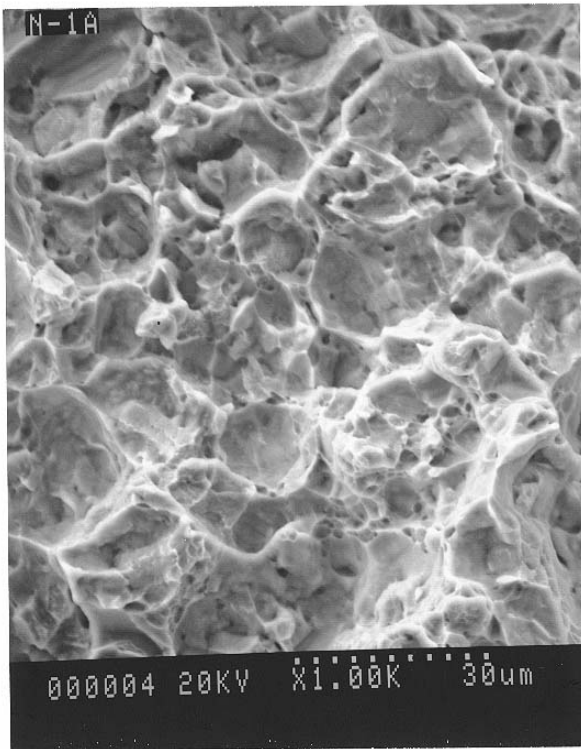
Figure 10--Three SEM views of the fracture face of specimen N-1A. Upper left shows fatigue striations within the reflective band near the initiation area. Upper right shows the region of mixed striations and dimples near the terminus of the reflective band. View at lower left shows the dimples typical on the remaining fracture area.

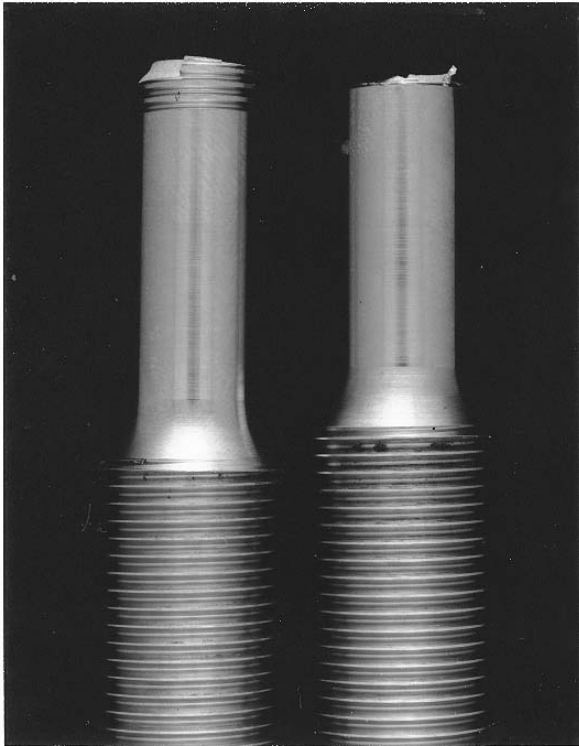
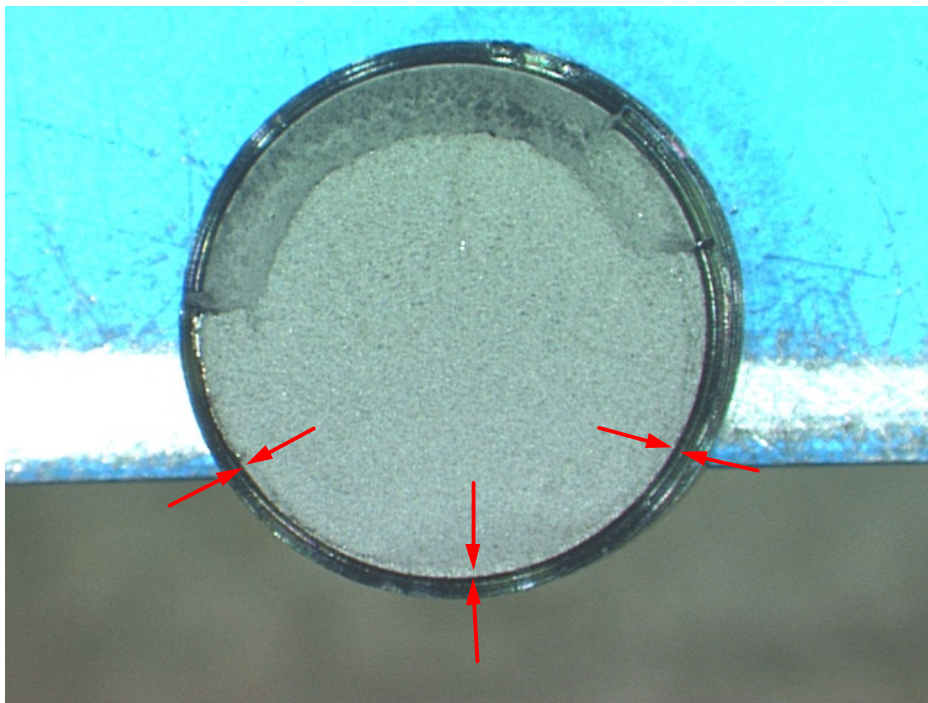
Specimen N-2A was subjected to axial fatigue testing with an estimated maximum stress of 185 ksi. The specimen failed at 100 cycles. Macroscopic examination revealed fracture traces leading from the first full thread root on one side of the specimen and propagating toward the diametrically opposite side. See figure 11. The fracture surface exhibited a reflective band surrounding approximately 50% of the outer periphery of the fracture surface. This thin reflective band was similar in overall appearance and shape to the thin band found on specimens N-1B and N-1A. The remaining fracture surface, beyond the flat band, exhibited a dull coarse-grained texture, typical of a ductile overstress separation. A majority of the fracture surface was relatively flat; however, the terminal portion of the fracture surface occurred along an oblique plane. No evidence of a fine-grained texture was observed along the periphery of the terminal, oblique region.

Figure 11--Specimen N-2A after the test. Fracture face (below) shows initiation and reflective band (between arrows) at bottom of view and final shear lip at top.

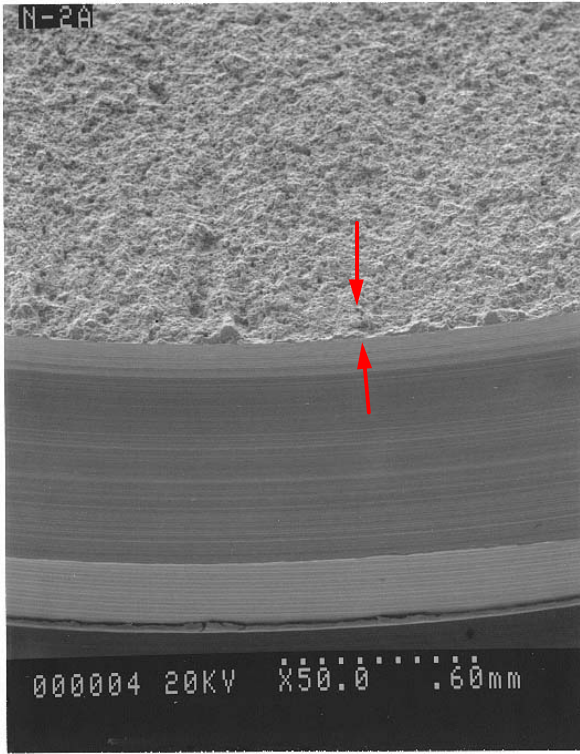
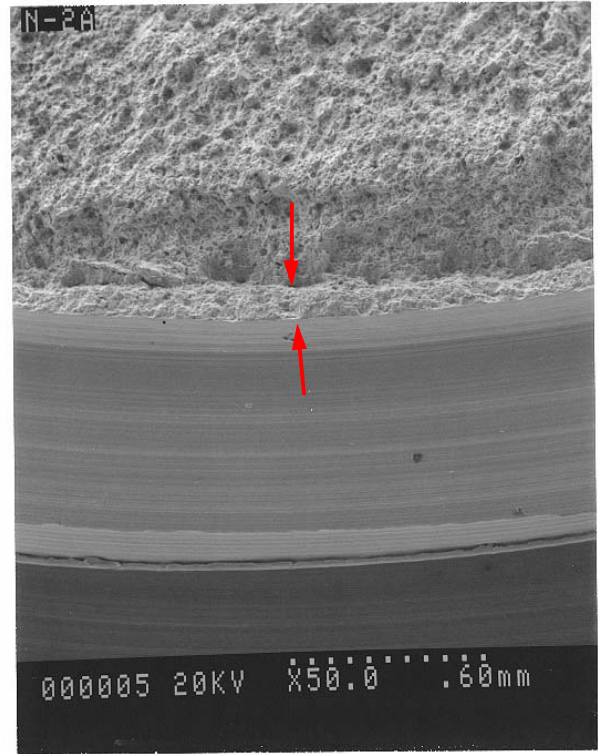
SEM analysis of the reflective band revealed multiple fatigue origins emanating from the thread root. Figure 12 contains SEM images of the reflective band in the central region of the crescent and to one side. Fatigue striations were clearly visible emanating from origin in the thread root to a depth of about 0.004 inches. The fracture features then transformed into entirely ductile dimple with little or no zone of mixed features that were seen in specimens N-1B, and N-1A. The remaining fracture surface beyond the flat band revealed a predominant dimple mode of rupture, indicative of an overstress fracture region. Figure 13 displays typical fatigue and overstress fracture features found in the different areas of the separation.

Figure 12--Two SEM views showing the reflective band (between arrows) in the initiation area (left) and around the side of the specimen (right).

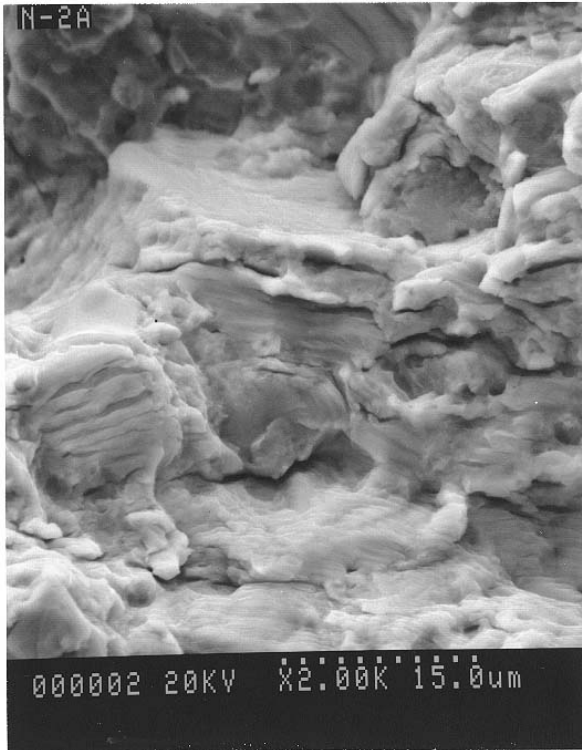
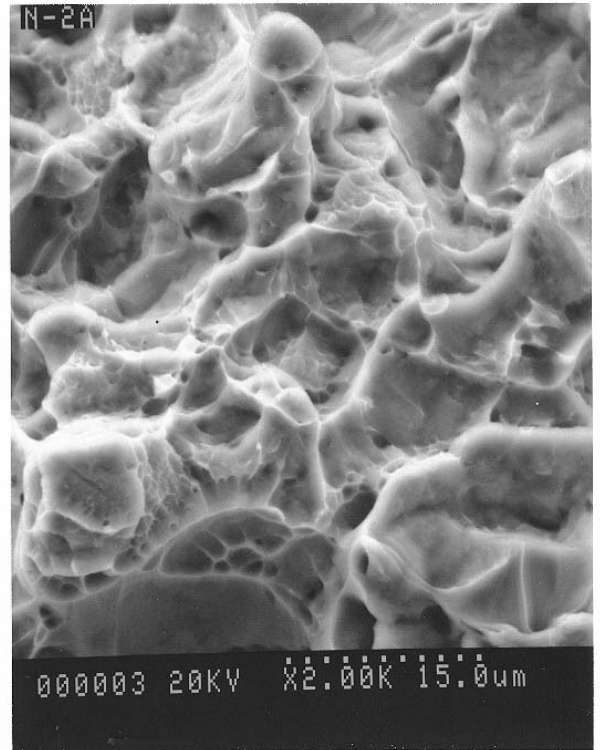
Figure 13--Two SEM views of the fracture face of specimen N-2A. View at left shows typical striations in the reflective band near the origin. Right view shows typical ductile dimples on remainder of fracture.

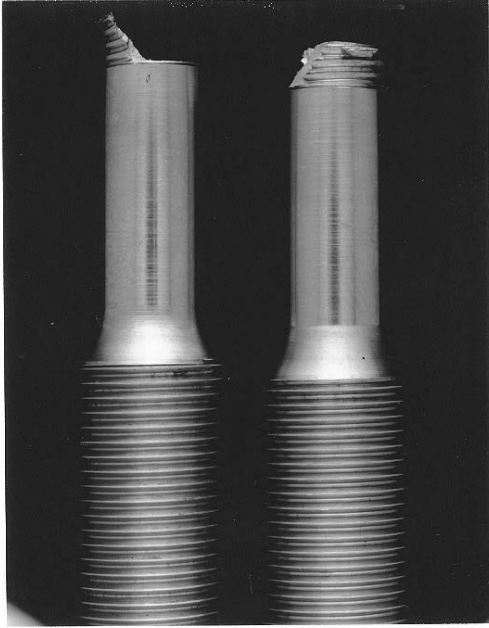
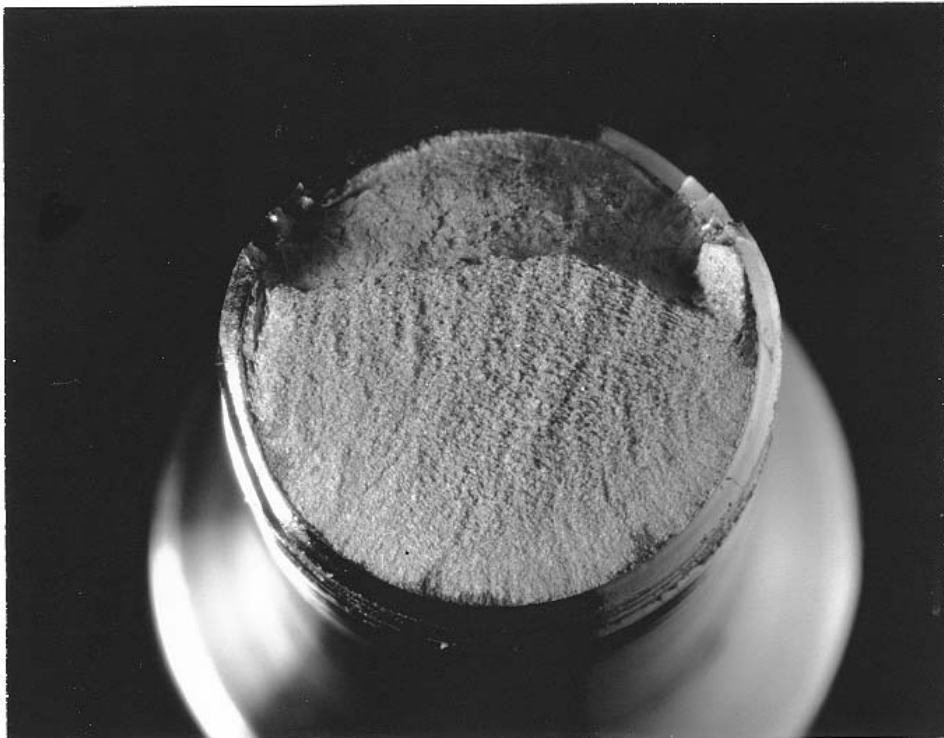
Specimen N-2B was not cycled but rather loaded to failure in single tension cycle. The specimen separated at approximately 200 ksi. Macroscopic examination revealed fracture traces leading from the first full thread root on one side of the specimen and propagating toward the diametrically opposite side. See figure 14. The initial portion of the fracture surface appeared flat; however, the entire fracture surface exhibited a dull coarse-grained texture, typical of an overstress separation. A small shear lip surrounded the entire fracture surface. The terminal portion of the fracture occurred along an oblique plane. No evidence of a reflective band was found along the outer periphery of the fracture surface. See figure 15.

Figure 14--Specimen N-2B after the tensioning to fracture. Fracture face (below) shows initiation at bottom of view and final shear lip at top.

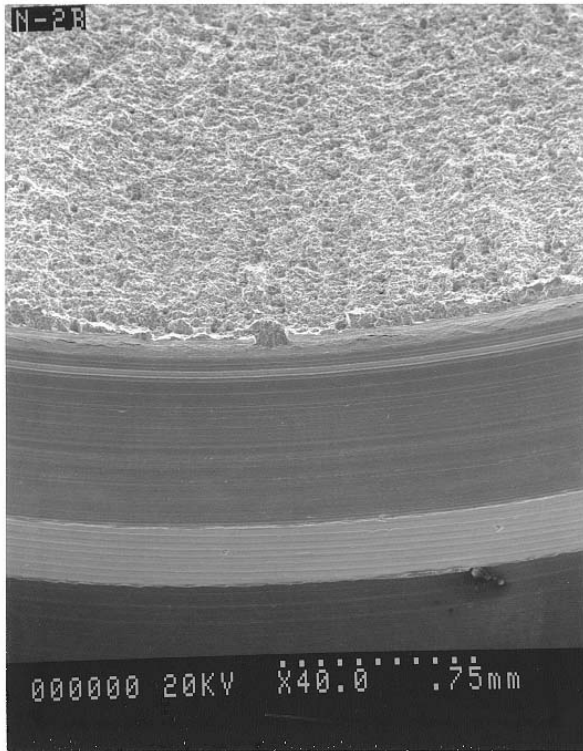
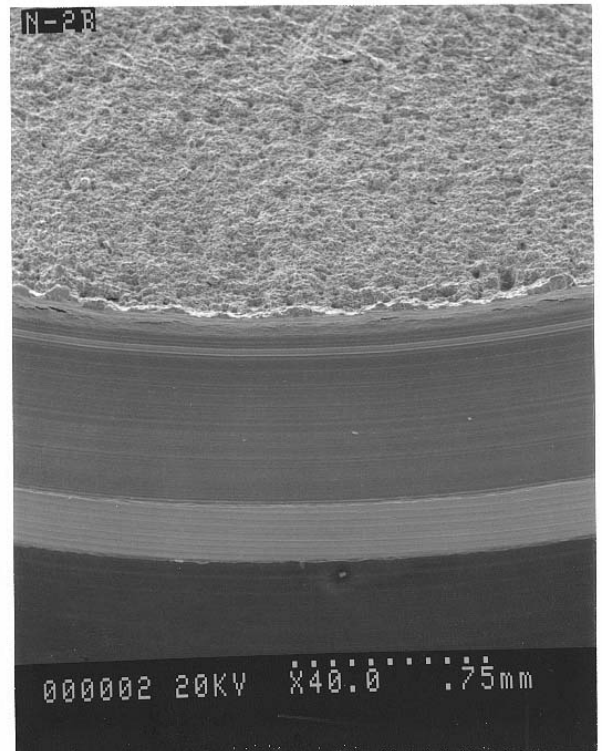
Figure 15--Two SEM views showing the lack of a reflective band on the specimen. Fracture initiation area at left and the side of the specimen at right.

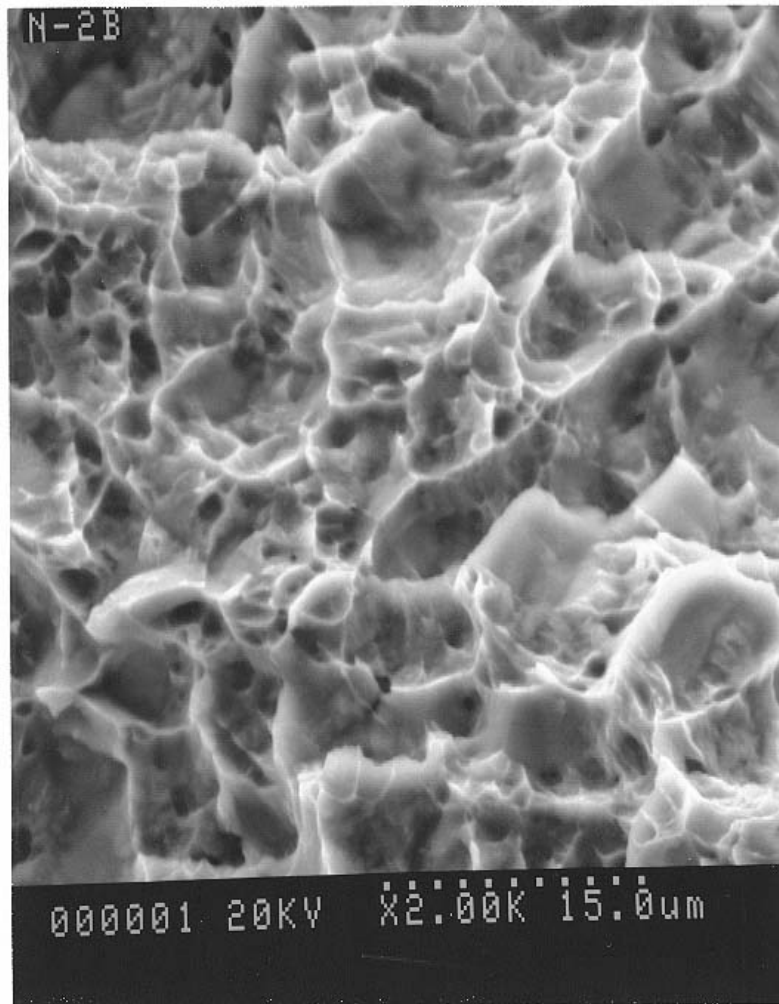
SEM analysis revealed a predominant dimple mode of rupture, indicative of ductile overstress separation. See Figure 16. No evidence of fatigue striations or other brittle/slow growth mechanism of failure was observed.

Figure 16--Typical ductile dimple found on the entire fracture face of specimen N-2B.

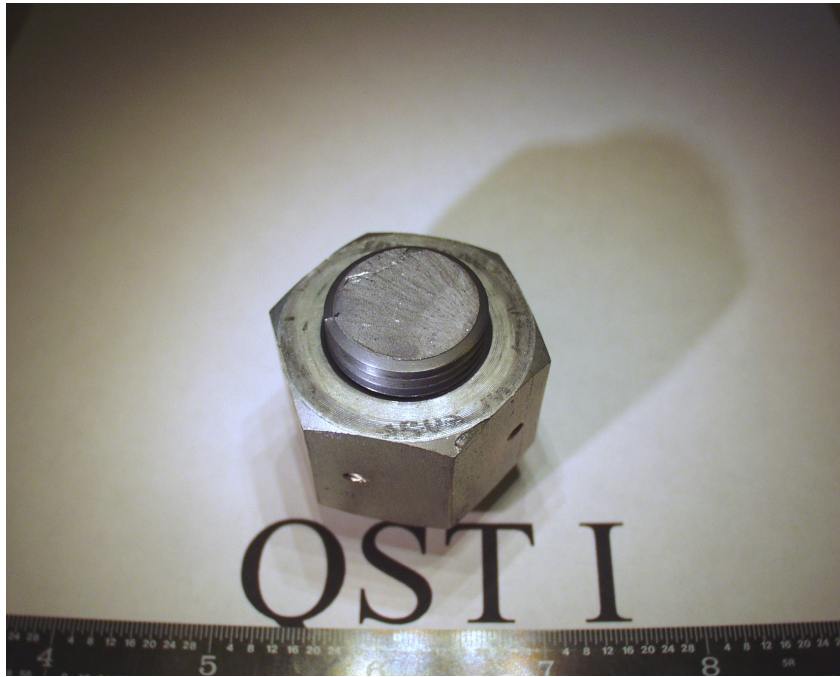
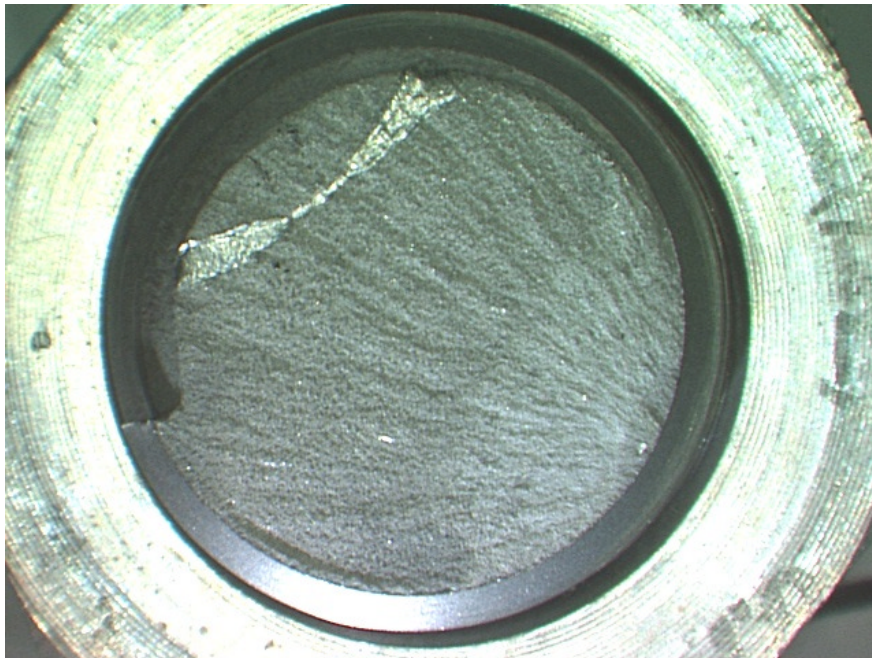
After the completion of the Quill Shaft Test I on July 26, 2000, the fracture surface of the separated torque tube was examined at the Boeing Huntington Beach M&PE laboratories. Macroscopic optical and SEM examinations found fracture traces indicating that the fracture initiated on one side of the tube in the root of the first full thread closest the lower spline region on the torque tube and propagated toward the diametrically opposite side. See figure 17. The fracture surface appeared flat and the entire fracture surface exhibited a dull coarse-grained texture, typical of an overstress separation. The fracture surface did not reveal a reflective band at the outer periphery of the fracture surface but rather a small shear lip was present entirely around the fracture. SEM analysis revealed a ductile dimple mode of rupture, indicative of ductile overstress fracture over the entire separation.

Figure 17--Two view of the fractured torque tube from QST I. Fracture initiated in lower right quadrant (lower view) and diametrically propagated across the tube. No reflective band was found.

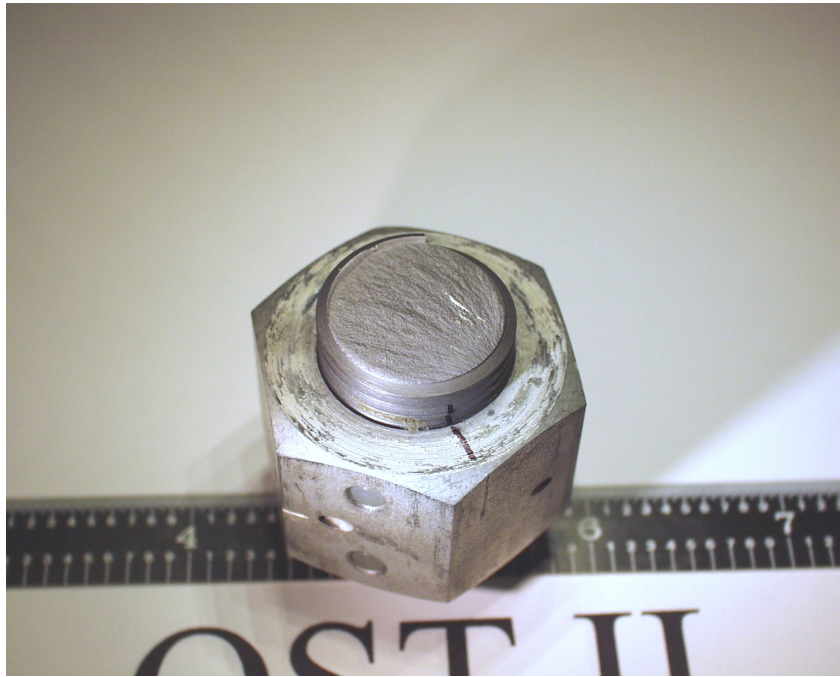
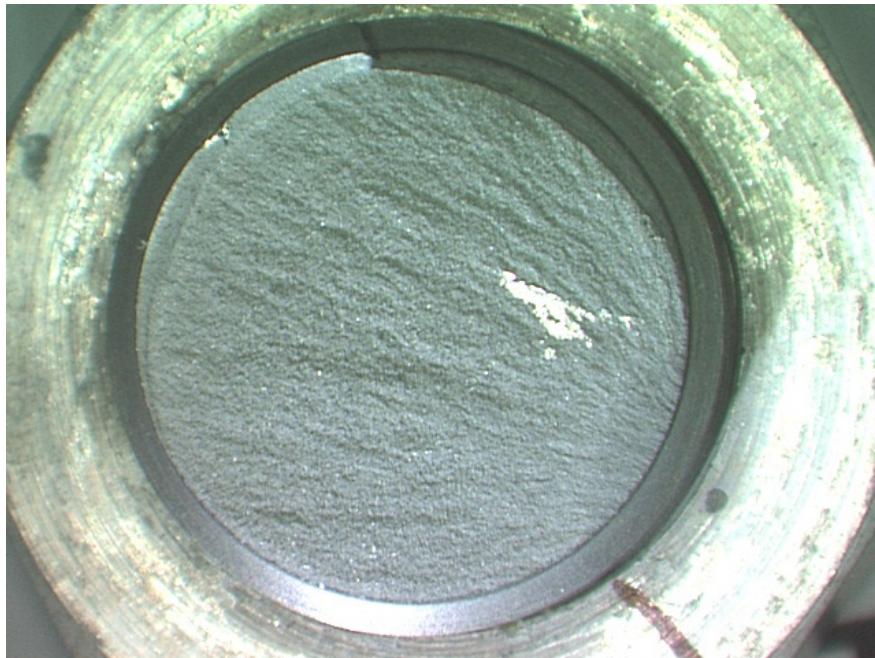
Macroscopic optical and SEM examinations found fracture traces indicating that the fracture initiated on one side of the tube in the root of the first full thread closest the lower spline region on the torque tube and propagated toward the diametrically opposite side. See Figure 18. The entire fracture surface was surrounded with a shear lip and had a dull coarse-grained texture consistent with an overstress separation. The shear lip region at the initiation site was extremely small. SEM analysis revealed a predominant ductile dimple mode of rupture, indicative of overstress separation. There was no evidence of preexisting cracks.

Figure 18--Two view of the fractured torque tube from QST II. Fracture initiated in lower right quadrant (lower view) and diametrically propagated across the tube. No reflective band was found.
