NATIONAL TRANSPORTATION SAFETY BOARD

MATERIALS LABORATORY FACTUAL REPORT

Report No. 01-150

Place : Near Port Hueneme, California
Date : January 31, 2000
Vehicle : MD-83, N963AS
Operator : Alaska Airlines, Flight 261
NTSB No. : DCA00-M-A023

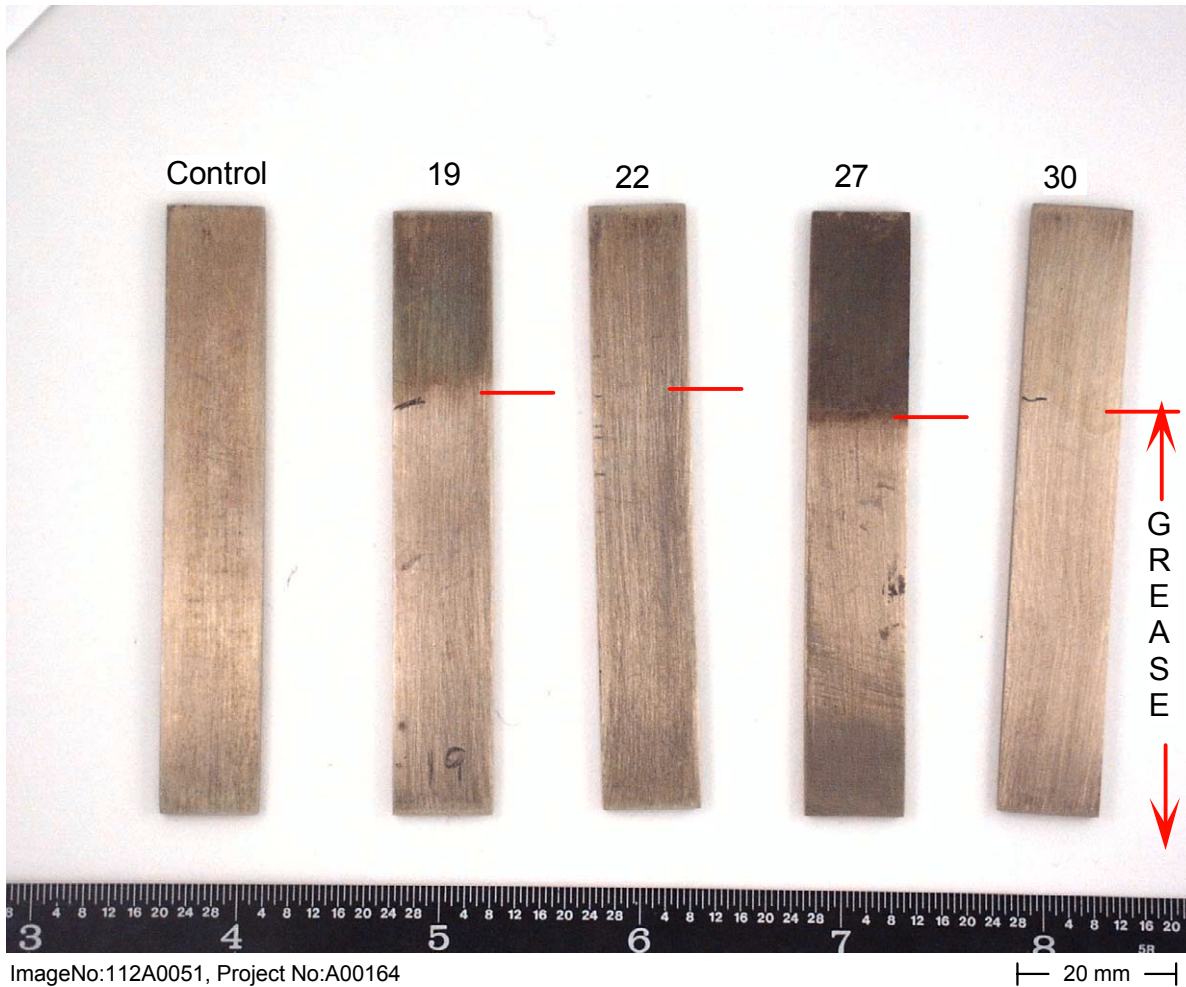
Each test coupon was about 0.5 inches wide, 0.1 inch thick and 3 inches long and manufactured from aluminum nickel bronze alloy C95500. All coupons exhibited a fine longitudinally oriented abraded surface finish consistent with fine sand paper. Closer examinations found that all coupons typically displayed a distinct scratch pattern. Fine longitudinal scratches dominated with interspersed individual larger (deeper and wider) scratches also running longitudinally. Individual swirling scratches were visible overlaying the longitudinal scratches. One surface of each coupon was examined optically at low magnification (<50X) and electronically with a scanning electron microscope at low (<100X), medium (~100 to ~500X) and high (>~1000X) magnifications. Both the submerged (below grease line) and upper (above grease line) regions of each coupon were examined with the interface region (grease line) determined by optical examinations. The five examined coupons are displayed in figure 1.

Figure 1--A view of the 5 examined test coupons, from left to right, control, 19, 22, 27 and 30. The red line denote the approximate grease level.

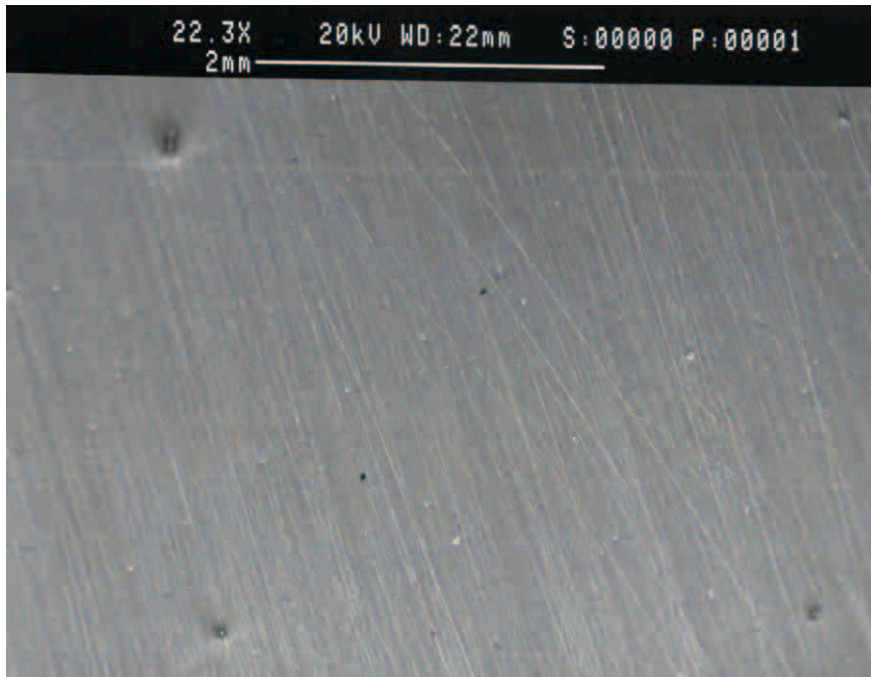
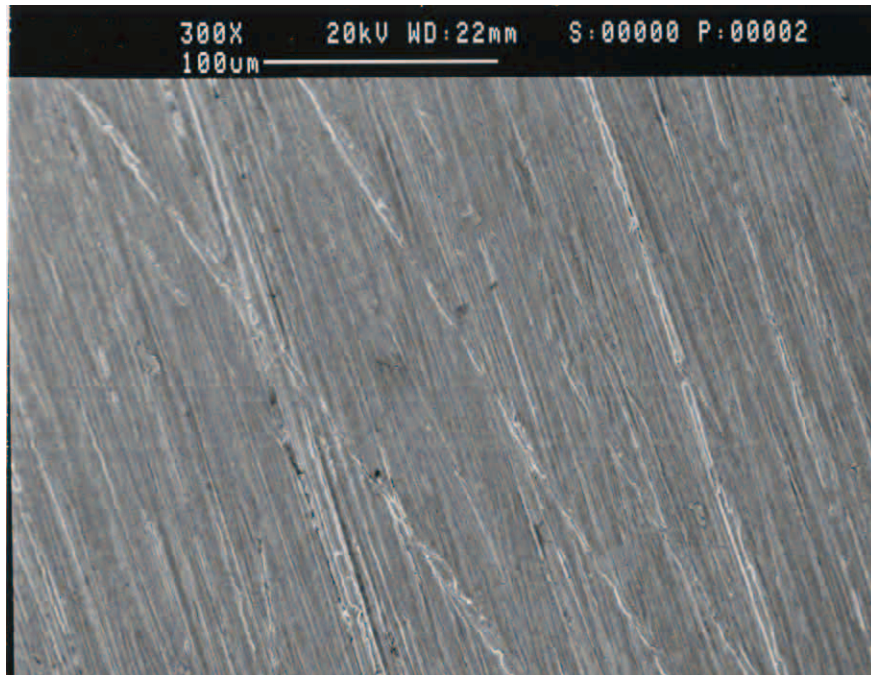
The surface of the control coupon displayed a fine pattern of mostly longitudinal scratches with intermittent larger longitudinal scratches and a few smaller swirling scratches as shown at lower and medium magnifications in figure 2. The surface was shiny with a uniform yellow gold coloration. At higher magnifications some surface tears were found, generally associated with the larger scratches, shown in figure 3. No indications of pitting were visible at any magnifications used.

Figure 2--Low and medium magnification views of typical areas of the control coupon.

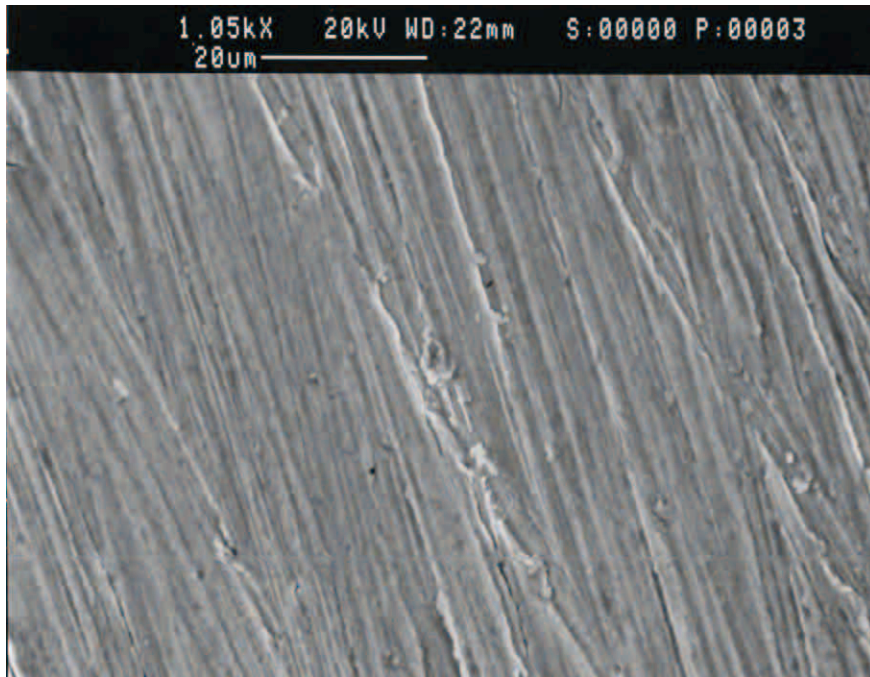
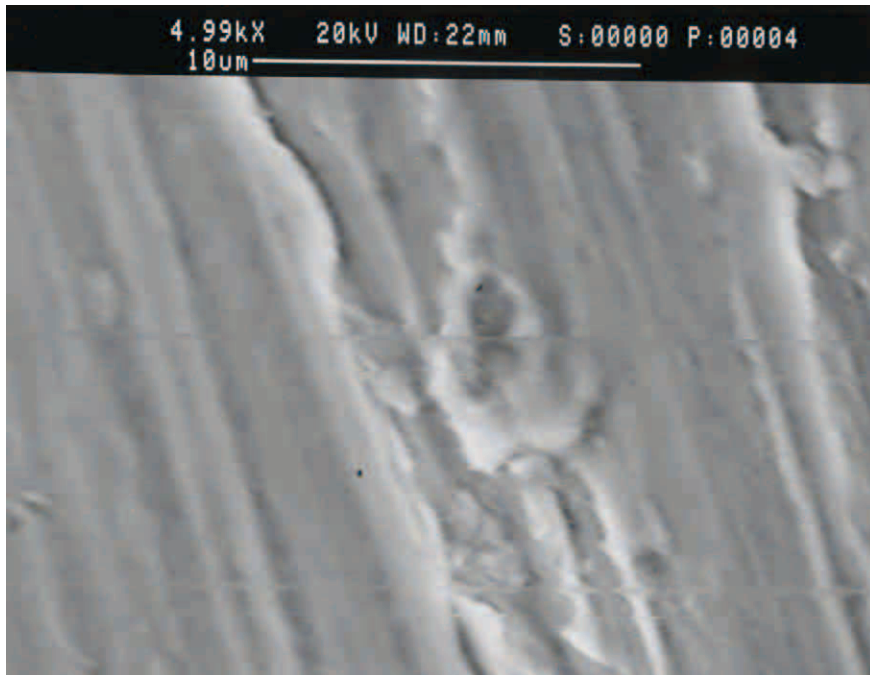
Figure 3--High magnification SEM views showing typical tears associated with scratches.

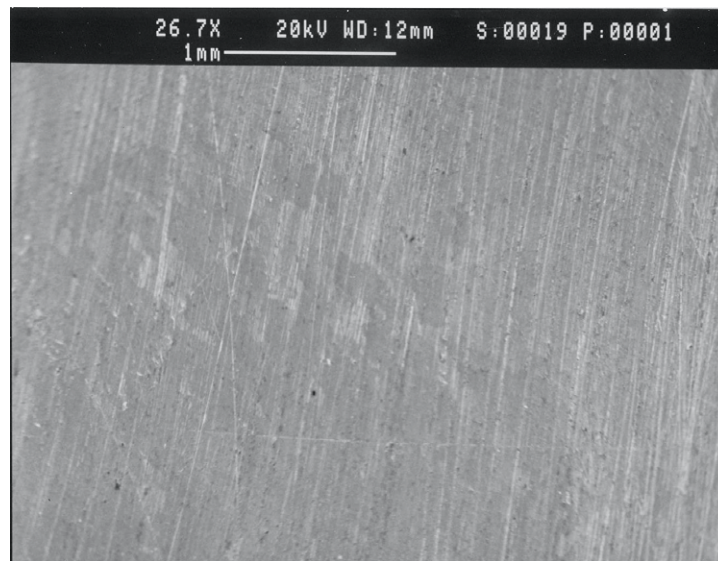
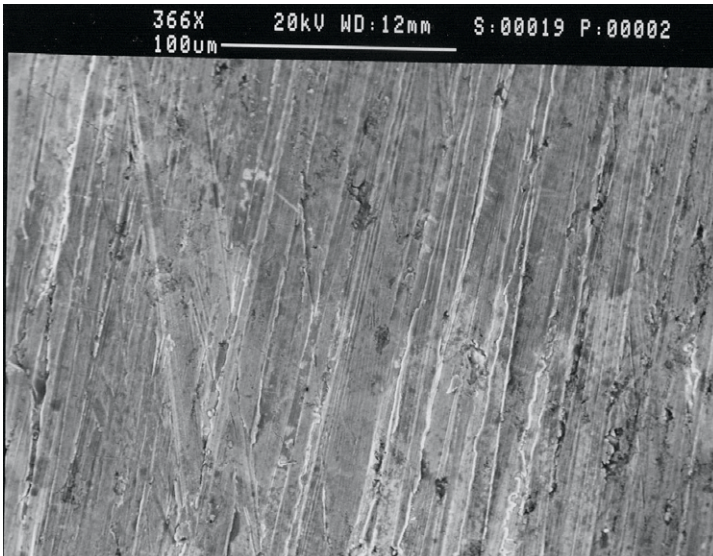
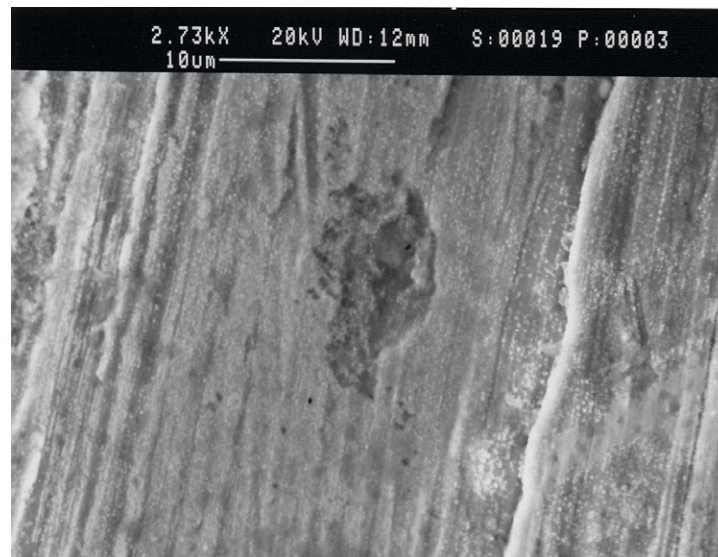
Above the grease line the surface displayed a slightly mottled dark / light pattern (figure 4 top) in the SEM with a few small pits visible at medium magnification (figure 4 middle). The pits were generally less than about 20 micrometers¹ (μm) in their largest dimension and had an estimated depth of only a few micrometers (figure 4 bottom). The surface also displayed a thin surface film that corresponded to the previously noted dark areas and shown in the bottom view of figure 4.

Figure 4--Three SEM views above the grease line on coupon 19. Top view at lower magnification showed mottle pattern on surface. Middle and bottom views show shallow pits and surface film.

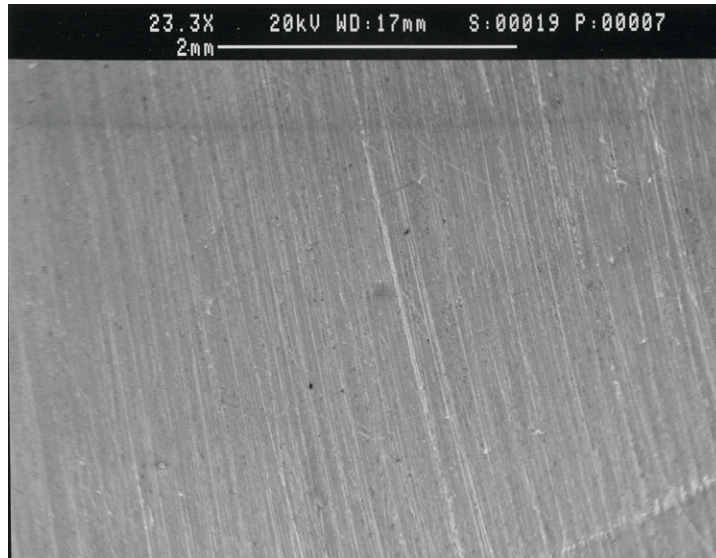
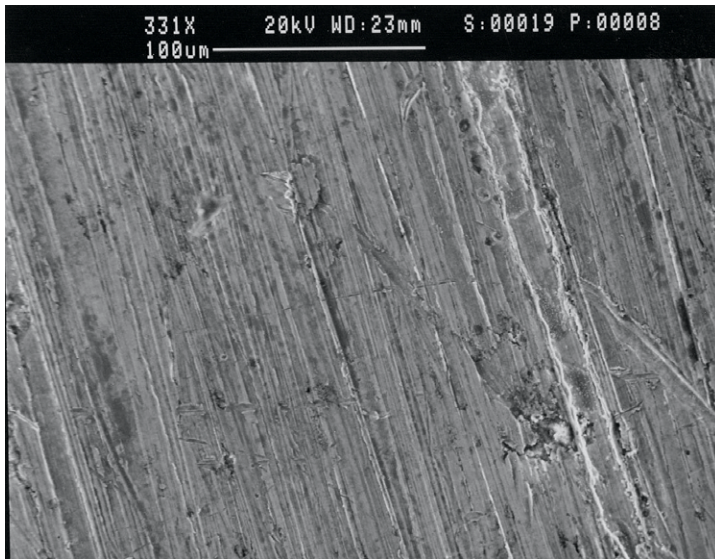
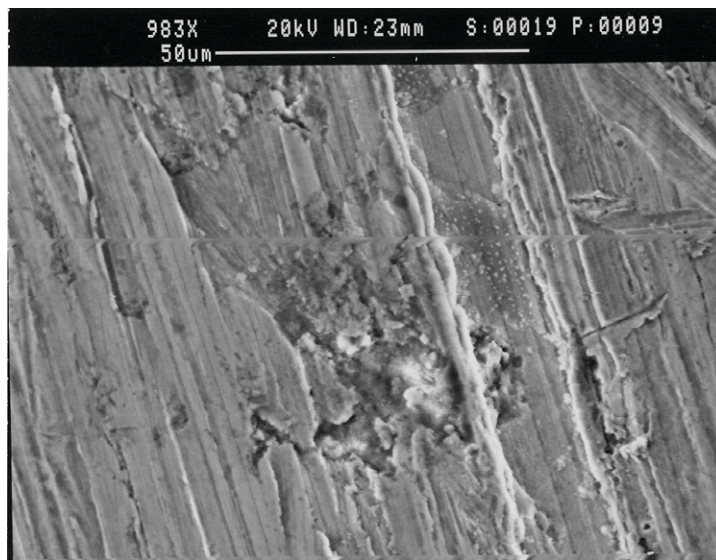
Pitting was also found below the grease line to about the same extent as above. These pits were generally larger than those above the grease line but the largest was still less than 40 μm and most were less than about 20 μm . No film or surface deposit was visible below the grease line at low and medium magnifications but at high magnifications

small areas of surface film were present. These small areas were similar to those previously noted above the grease line (compare bottom views in figure 4 and 5).

Figure 5--Below the grease line on coupon 19. Middle and lower view show pitting.

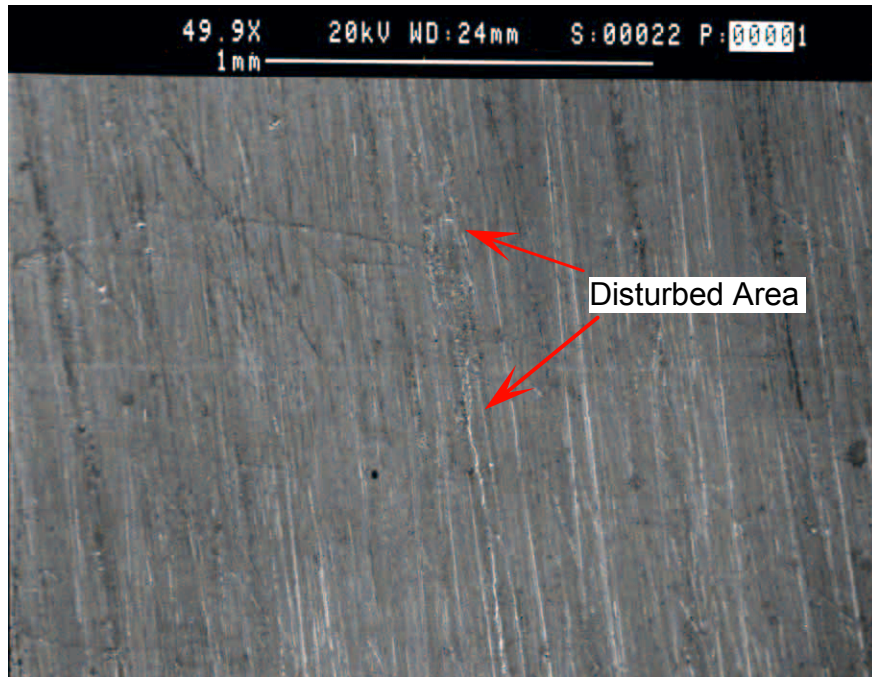
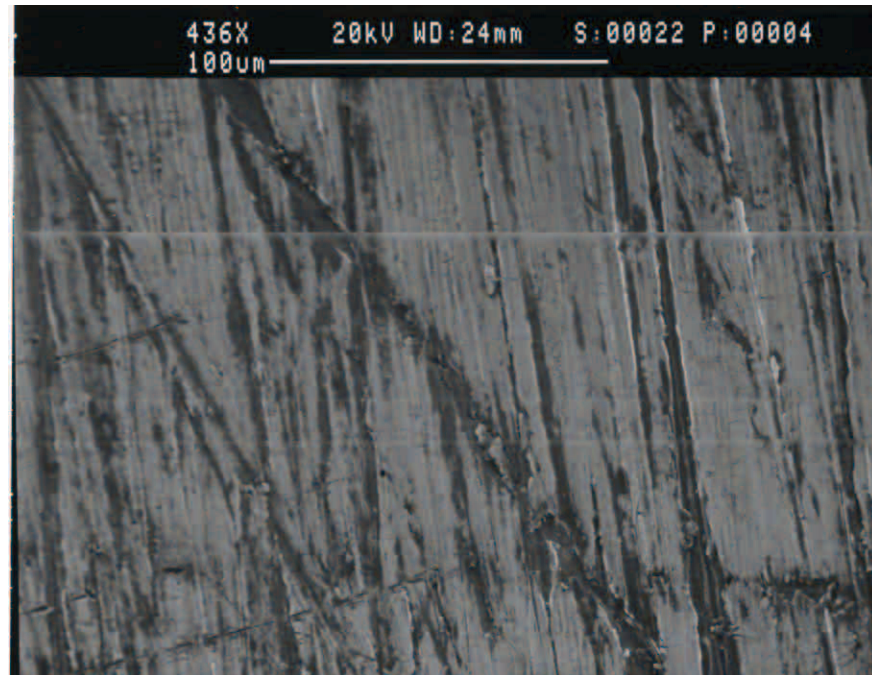
At low SEM magnifications the typical surface above the grease line individual scratches showing dark as in figure 6. A few small, localized bands of disturbed material were also found in this area. A disturbed area is highlighted in the top view of figure 6 and shown at higher magnification in figure 7. The disturbed areas were aligned with the overall direction of the scratch pattern and the one shown measured about 350 μm long (vertical in view) by about 100 μm wide. At higher magnifications these bands of disturbed material appeared as collections of smaller pits as shown in figure 7.

Figure 6--A few disturbed areas were visible above the grease line on coupon 22 as in the top view. Typical features on the majority of the surface appeared as in the lower view.

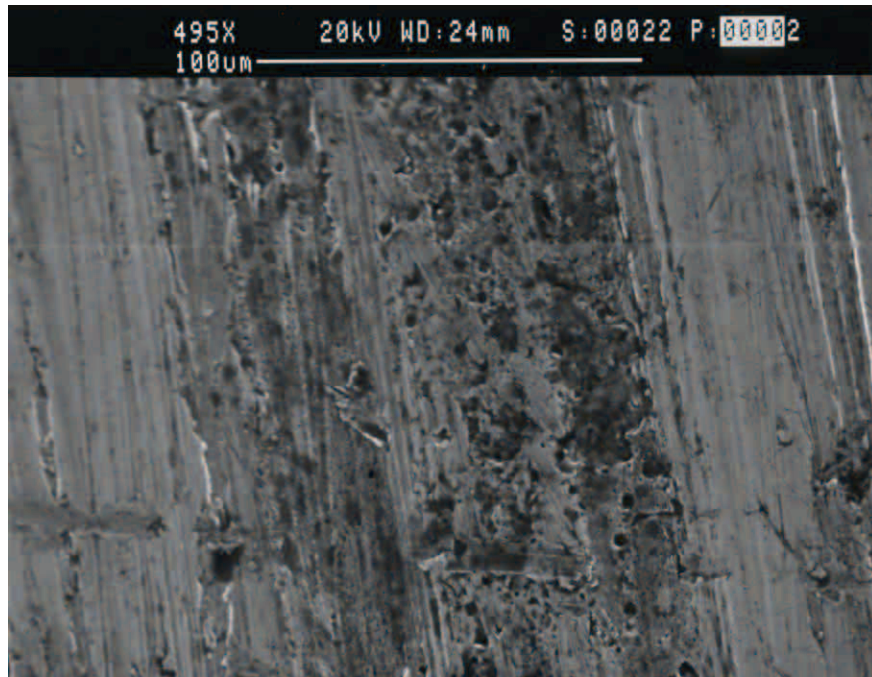
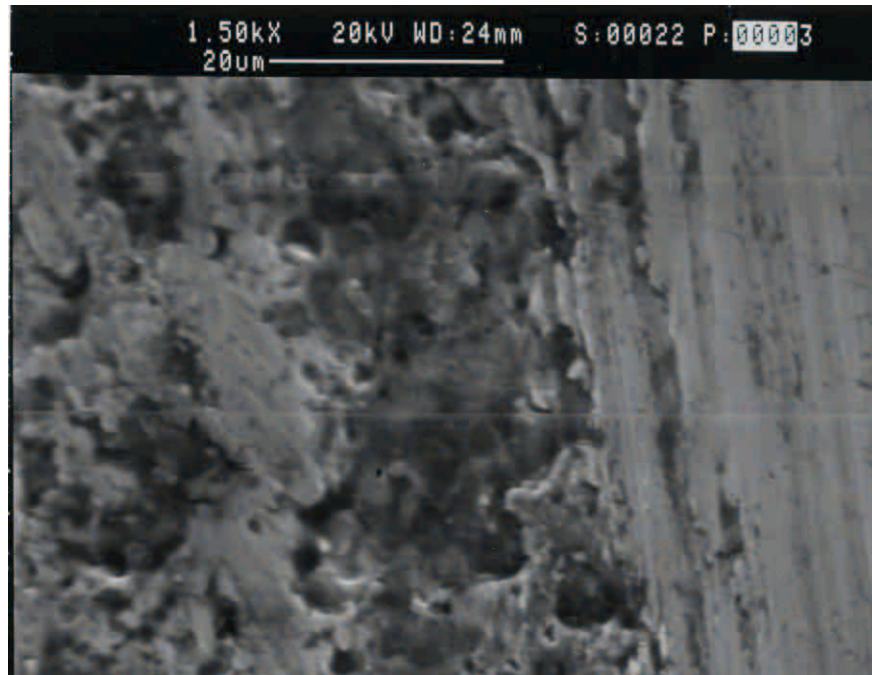
Figure 7--Two SEM views of the disturbed area noted in figure 6 on coupon 22 consisting of collections of pits.

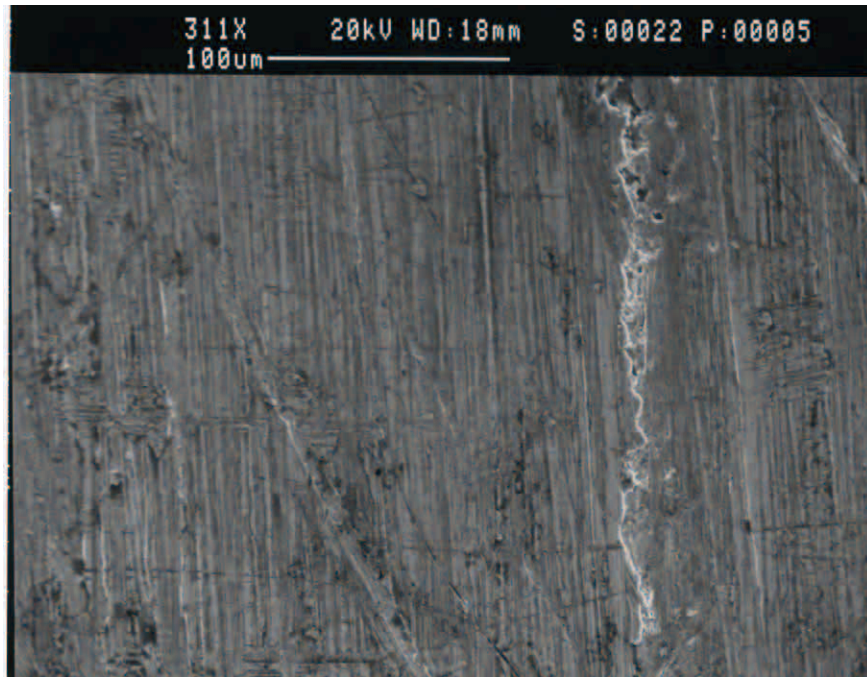
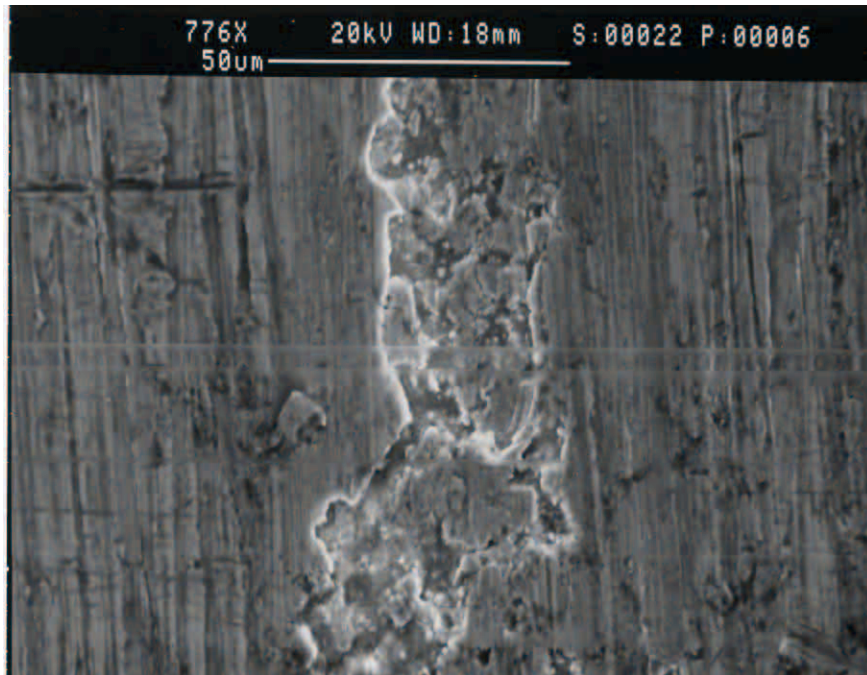
In the two areas examined below the grease line no individual pits were found. However, a single linear area of damage was found in one area examined. The damage line is shown in figure 8.

Figure 8--Two views below the grease line on coupon 22, showing the linear area of damage.

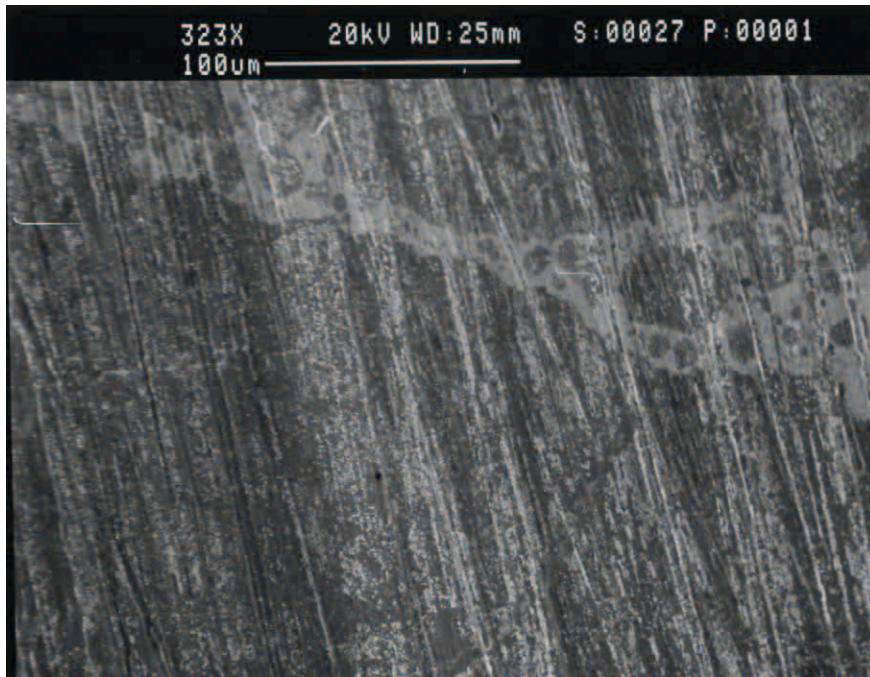
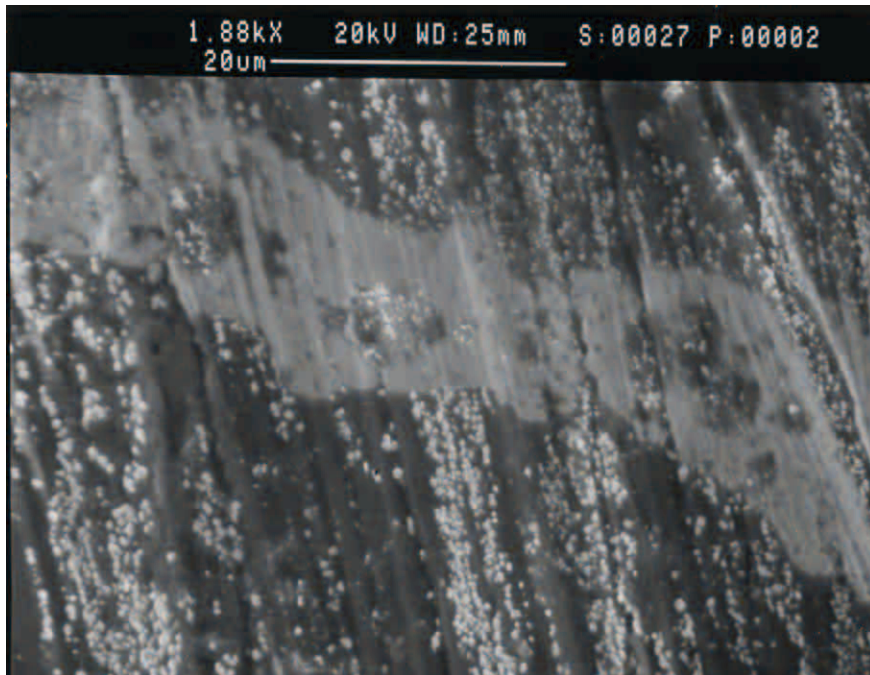
Medium and high magnification SEM views found an almost continuous film on the surface above the grease line as displayed in figure 9. However, no pitting was observed. Slight dark / light mottling was visible below the grease line but no pitting was detected, see figure 10.

Figure 9--Two views of the surface film above the grease line on coupon 27.

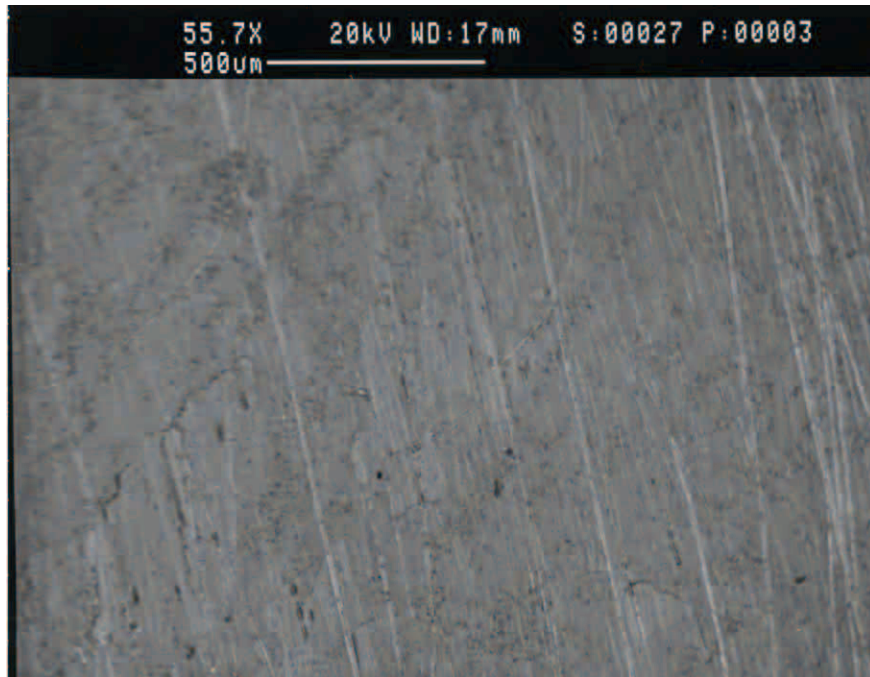
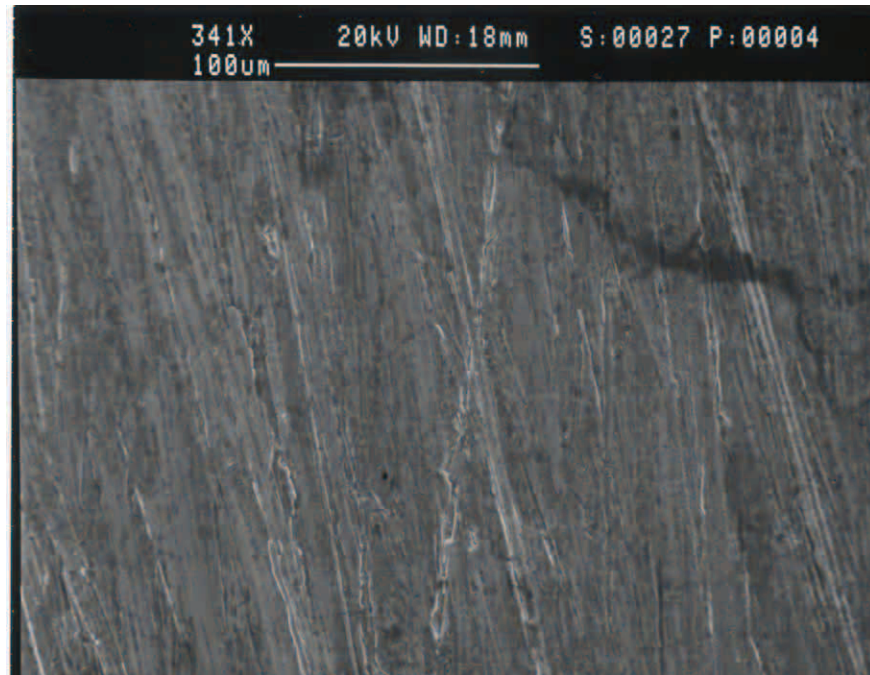
Figure 10--Typical surface features below the grease line on coupon 27. No pitting was evident.

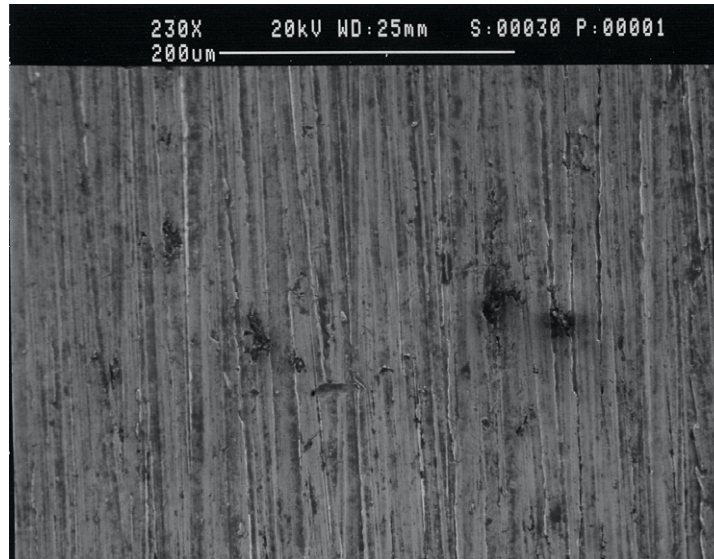
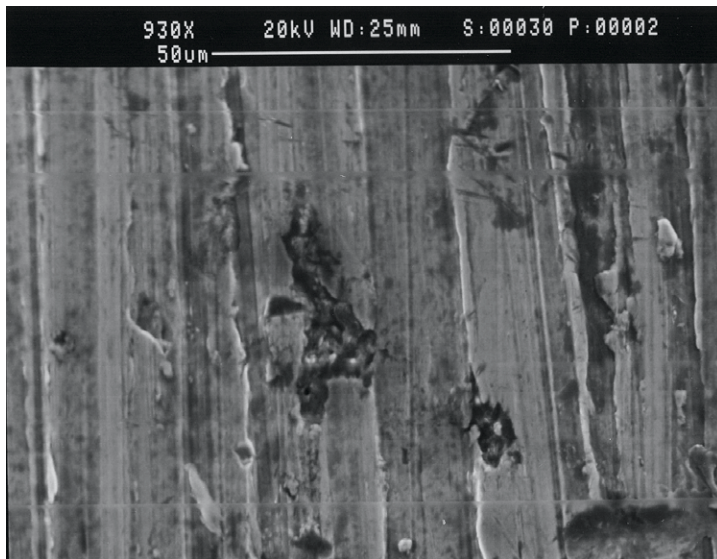
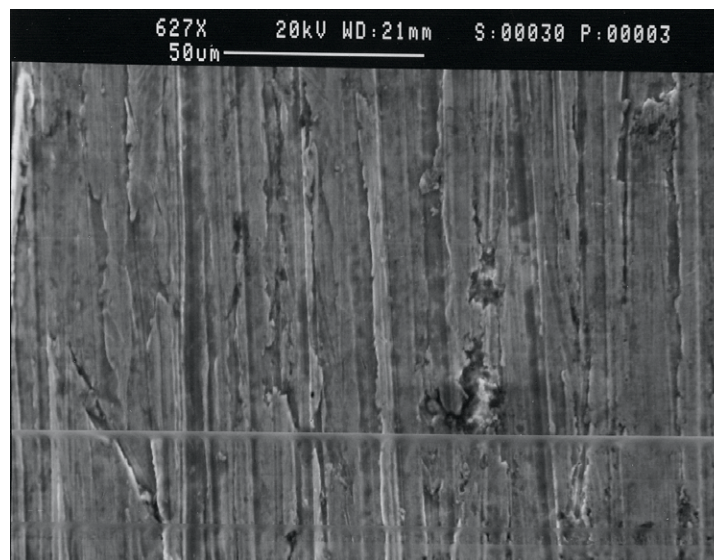
A few randomly located pits were visible above the grease line when viewed at medium and high SEM magnifications, as shown in figure 11. The pits were shallow and generally 20 μm or less in size.

Figure 11--Views of randomly located pits above the grease line on coupon 30.

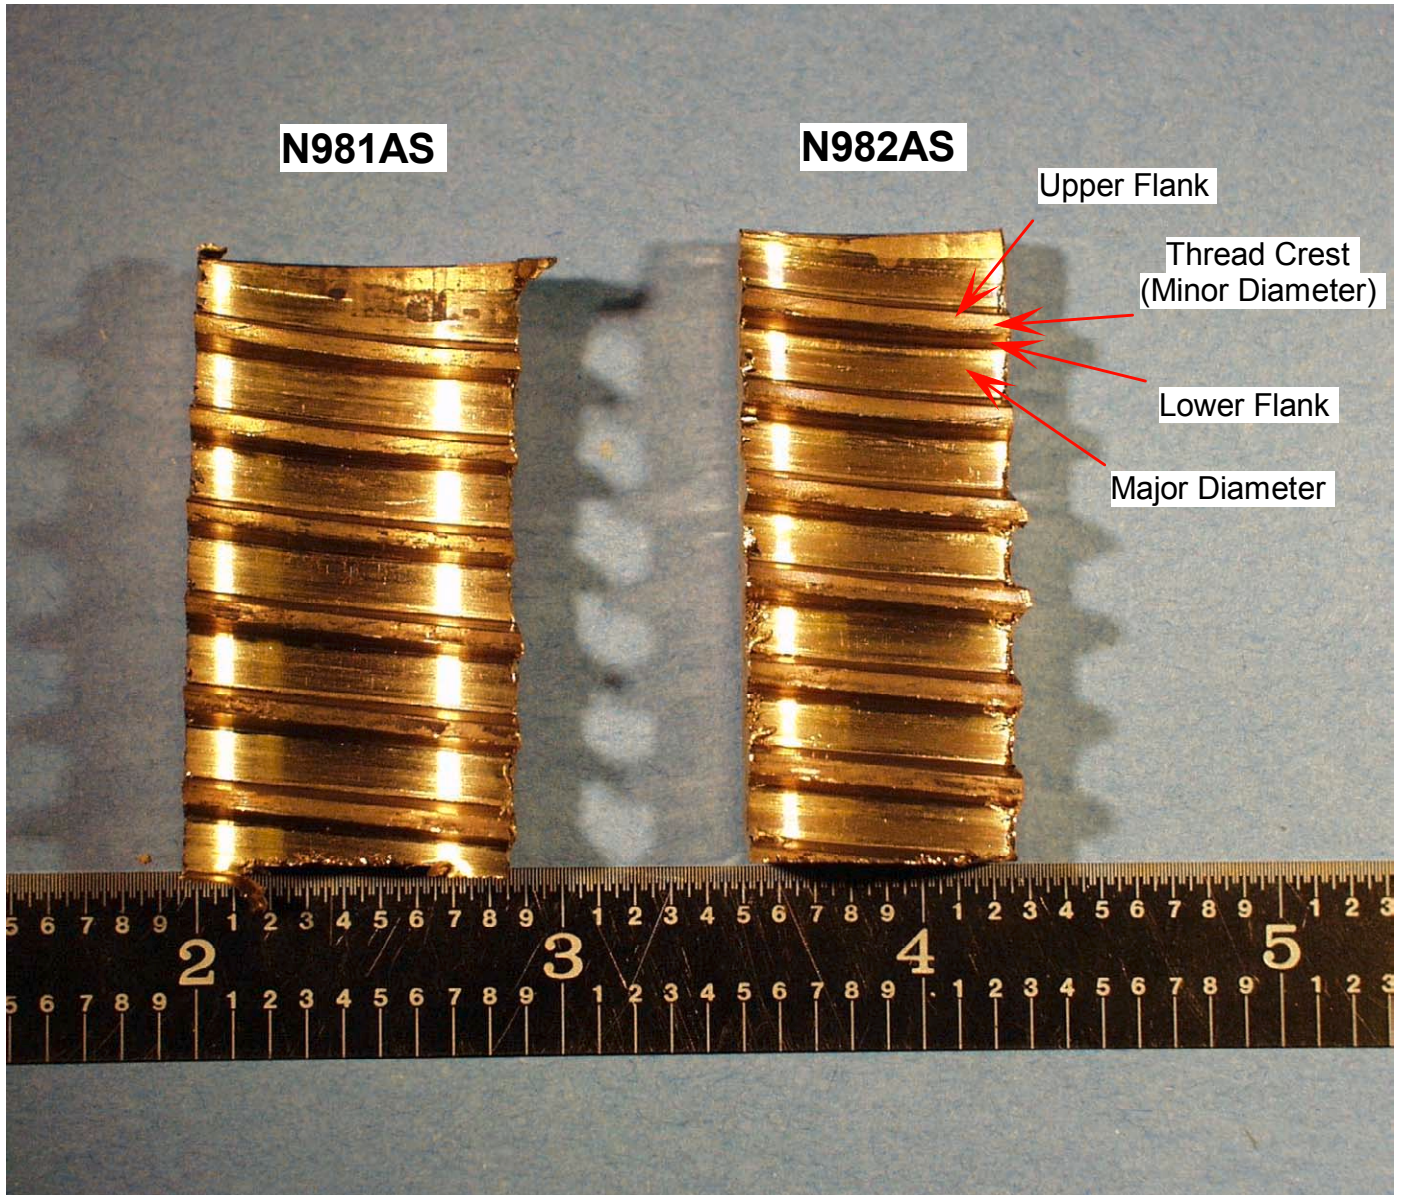
Portions of two used Acme nuts s/n D-3141 and D-3145 were examined optically and with an SEM. The examined sections were milled from Acme nuts removed from jackscrew assemblies s/n DCA-3008 and DCA-3000 previously installed on aircraft N981AS and N982AS and are displayed in figure 12. Each section was less than 1 inch wide and contained about 6 thread forms and had been ultrasonically cleaned in both acetone and toluene prior to examinations.

Figure 12--The examined sections of Acme nuts from N981AS (left) and N982AS (right) with the top of the nut at the top of the view.

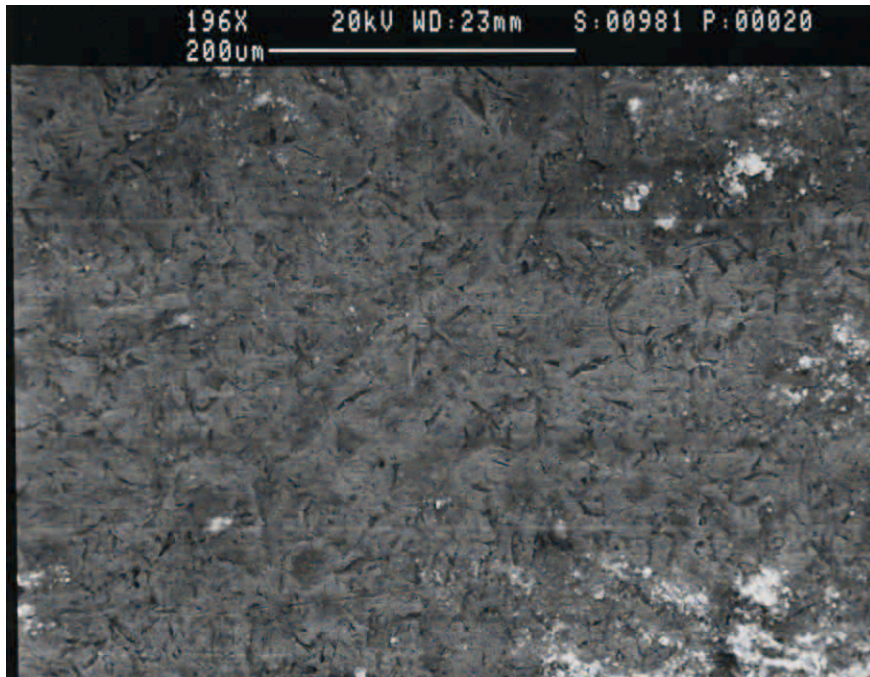
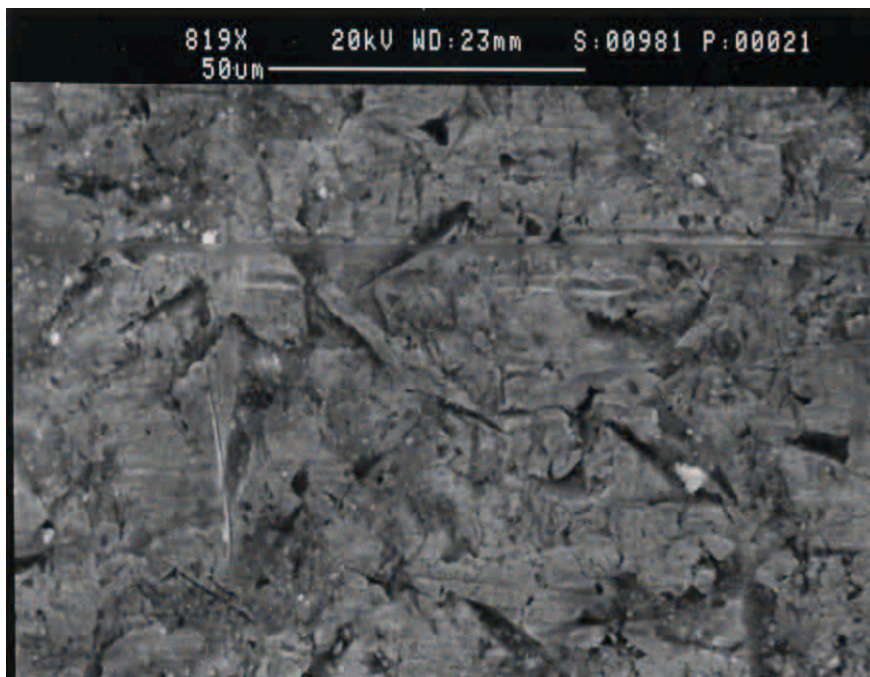
SEM examinations of the thread crest surfaces found deposits overlaying a surface texture composed of randomly oriented generally angular indentations as shown in figure 13. The deposits covered much of the surface and filled most of the indentations.

Figure 13--Typical surface features on the thread crests (minor diameter) of N981AS.

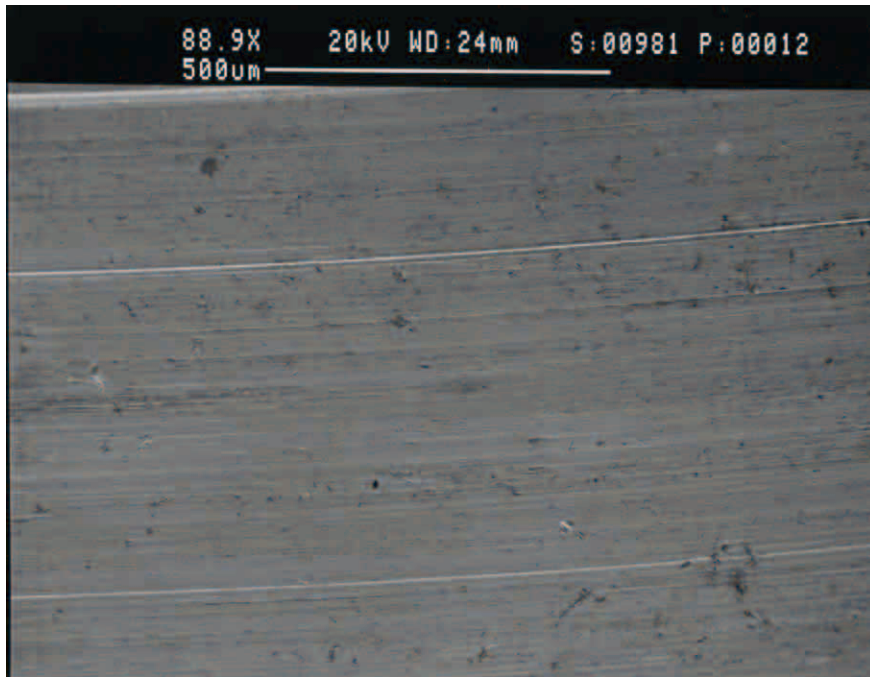
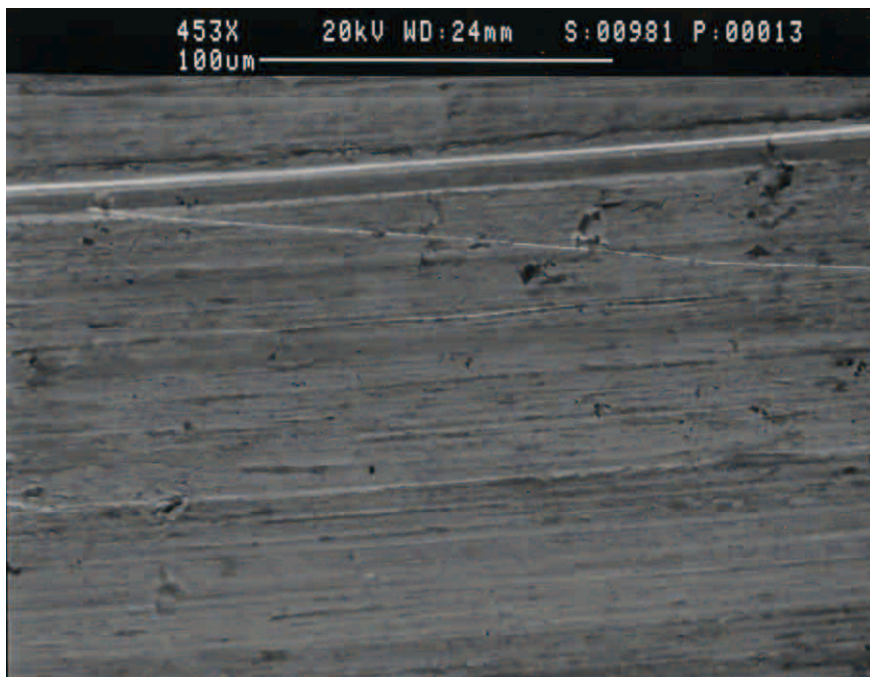
Low and medium magnification examinations of the upper flanks of the thread profiles found the surface mostly composed of fine parallel scratches running circumferentially with a occasional larger scratch as shown in figure 14. Further inspections found some surface disruptions as displayed in the two views of figure 15. The upper view shows a mechanically induced dent about 50 μm wide while the lower view shows small (<5 μm) shallow globular pit-like features only visible at high magnifications, 1,780X for this view. It was also noted that the pebble grain features seen on the thread crest was present on the upper thread flanks adjacent to major and minor diameters.

Figure 14--Typical surface features on the upper thread flank from N981AS.

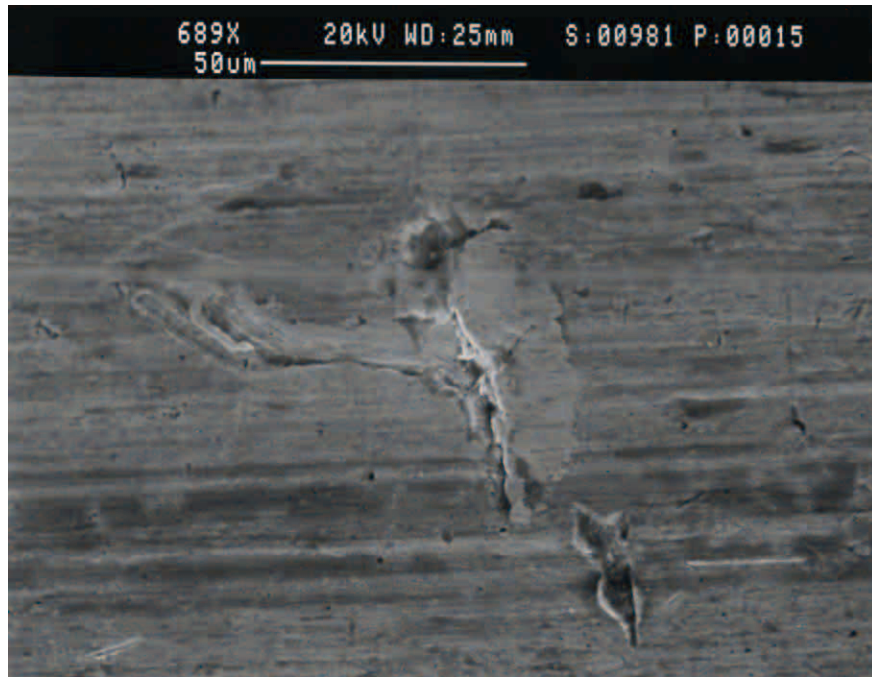
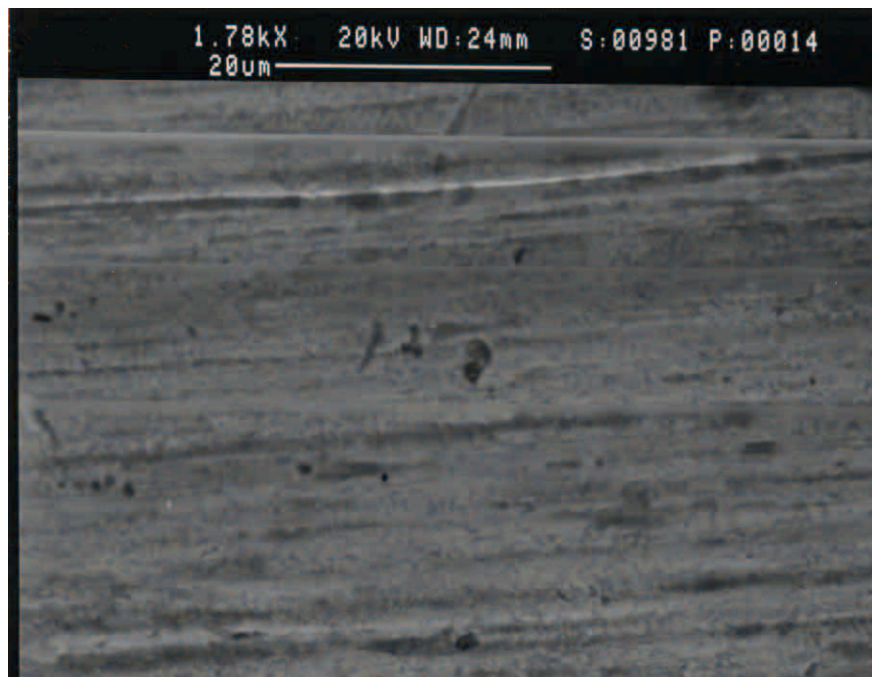
Figure 15--Surface disruptions on the upper thread flank of N981AS. Upper view of mechanically induced damage; lower view of pit-like features at high magnification.

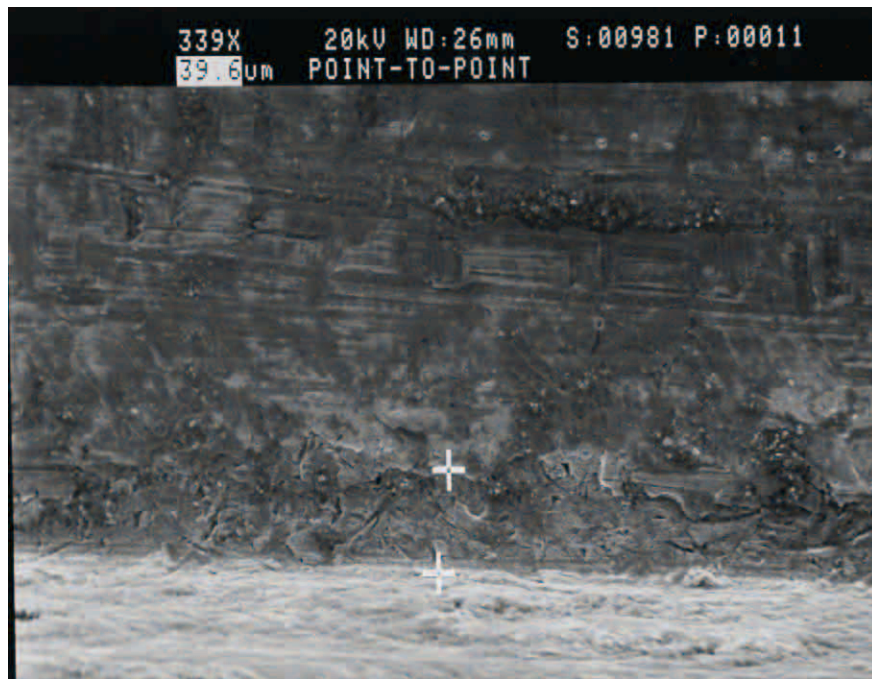
The major diameter surfaces also exhibited a small band of pebble grain finish adjacent to the upper flank as shown in figure 16. The remainder of the major diameter surface displayed mostly parallel scratches running circumferentially. However the relative sizes of the scratches varied considerably with position. An area of typical scratches on the

Figure 16--Thin band of pebble grain finish on the major diameter of N981AS adjacent to the upper flank.

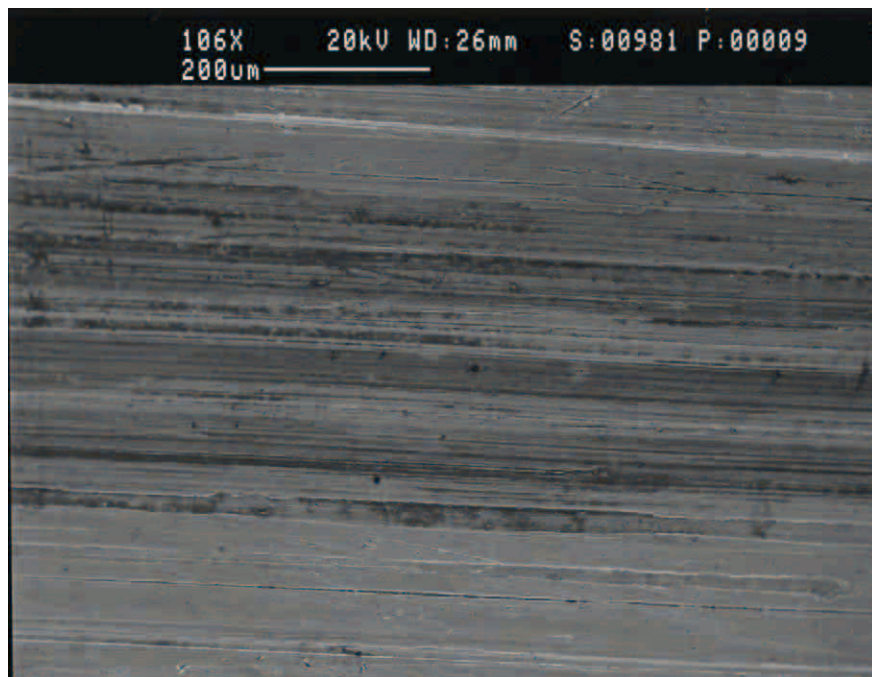
major diameter is shown in figure 17. No demarcations were visible on the major diameters to indicate the original (pre wear) positions of the lower thread flank. At medium magnifications some areas of the major diameter surface displayed small-scale (<50 μm) mechanical indentations into the surface as shown in figure 18. These areas were typically in the lower portions of the major diameter near the upper thread flanks. At high magnifications, an occasional pit structure was found like that shown in figure 19. These were generally less than 20 μm in diameter. The central portions of the pit structure in figure 19 measured approximately 18 μm in diameter.

Figure 17--Typical scratches on the major diameter of N981AS.

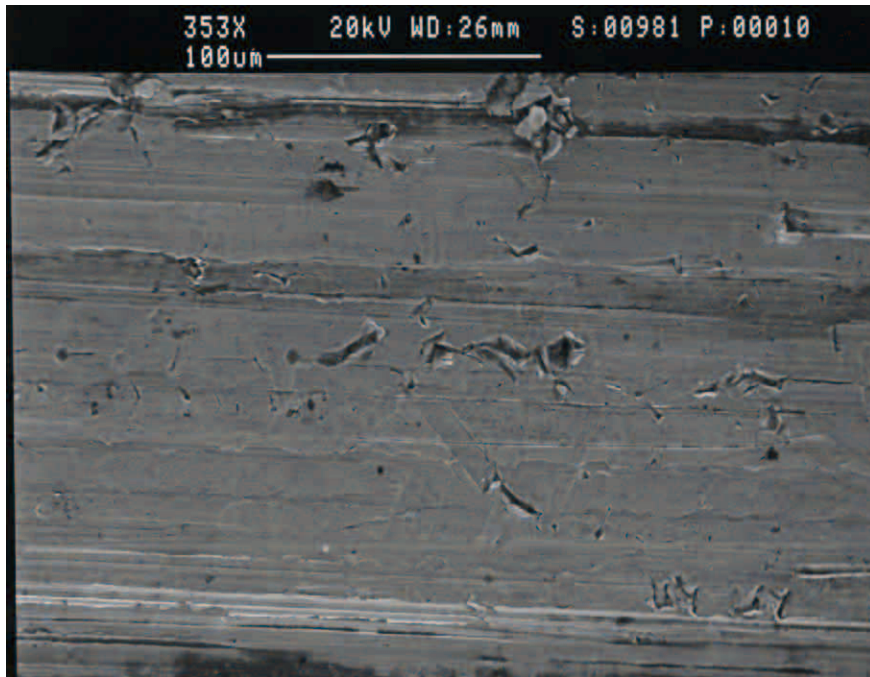
Figure 18--Mechanical indentations into the major diameter of N981AS.

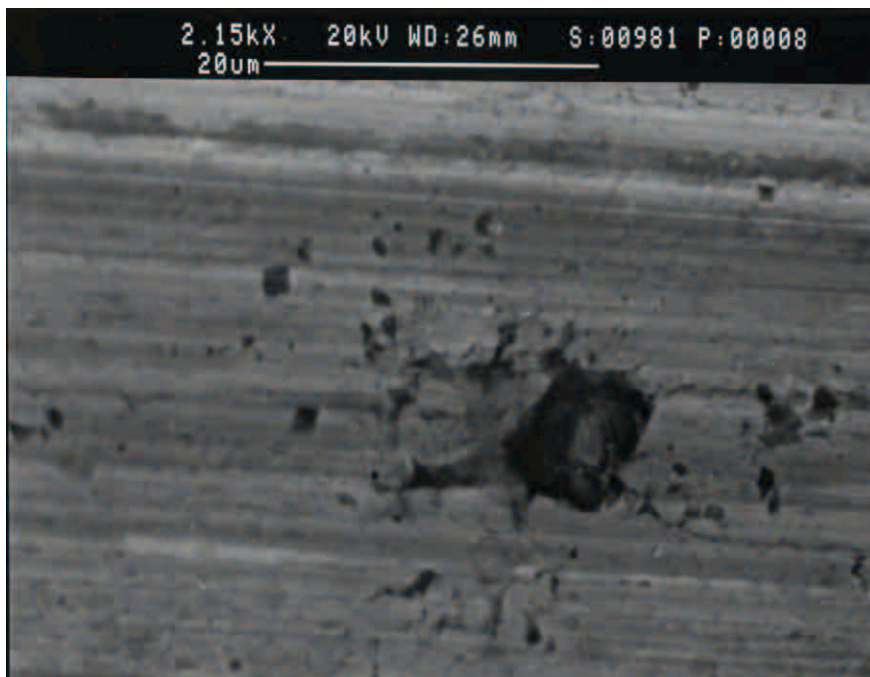
Figure 19--Pit structure in the major diameter of N981AS.
