NATIONAL TRANSPORTATION SAFETY BOARD

MATERIALS LABORATORY FACTUAL REPORT

Report No. 01-150

Place : Near Port Hueneme, California
Date : January 31, 2000
Vehicle : MD-83, N963AS
Operator : Alaska Airlines, Flight 261
NTSB No. : DCA00-M-A023

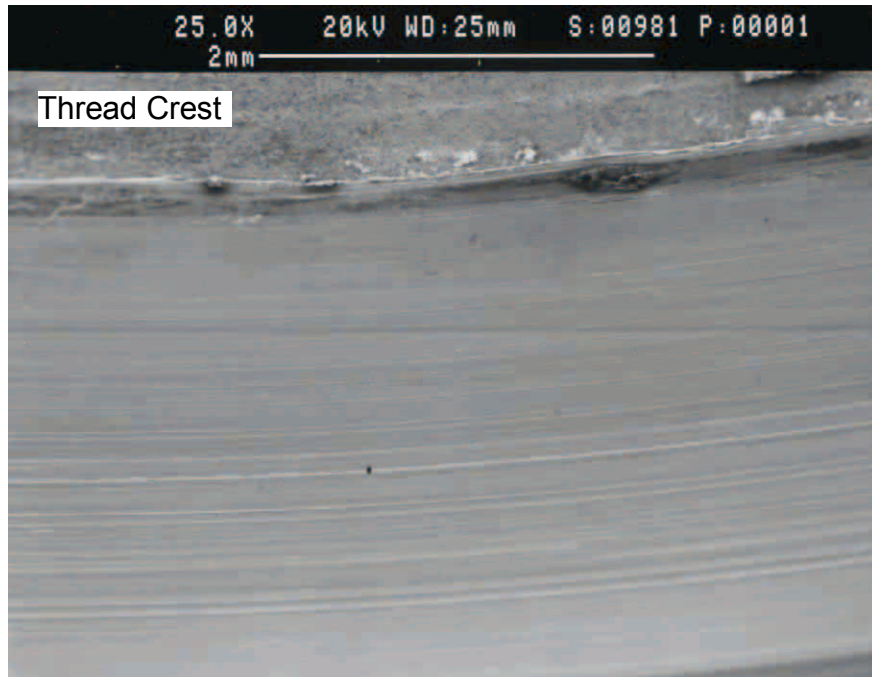
The scratch pattern on the lower flank surfaces was similar to the major diameter with generally smaller scratches intermixed with larger scratches as shown in figure 20. Many of the scratches also contained circumferential surface cracks some of which were closed and some were gapped slightly open and the mating faces displaced as shown in figure 21. Many of these were more than a millimeter in length. Several other short gapping cracks were also noted at medium and high magnifications. A typical one is displayed in figure 22. Further areas of cracking and deformation were found associated with the burrs of the threads at the minor diameters as shown in figure 23.

Figure 20--Typical scratch pattern on the lower flank of N981AS.

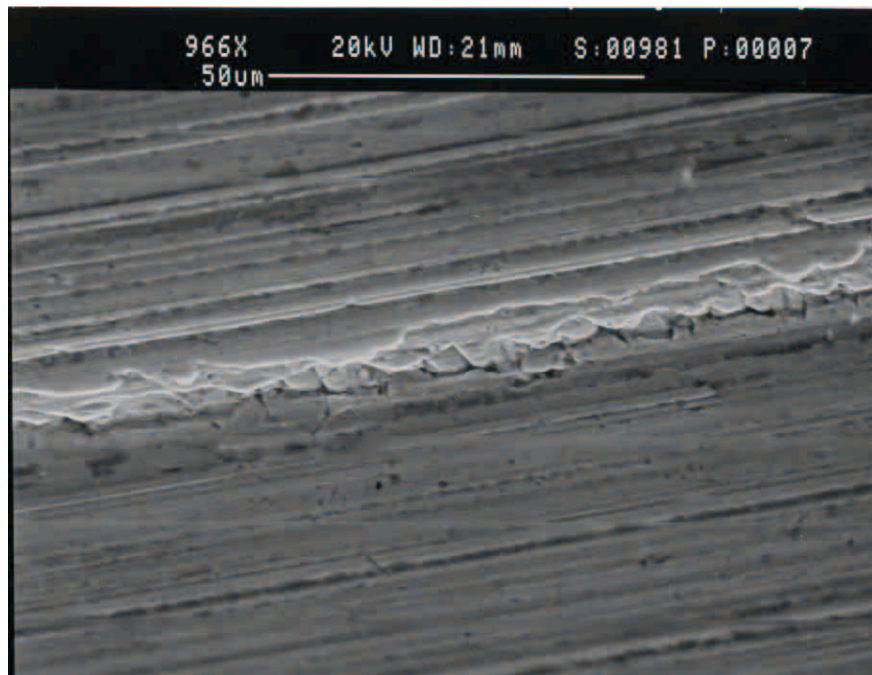
Figure 21--A long gapping crack in the lower flank of N981AS.

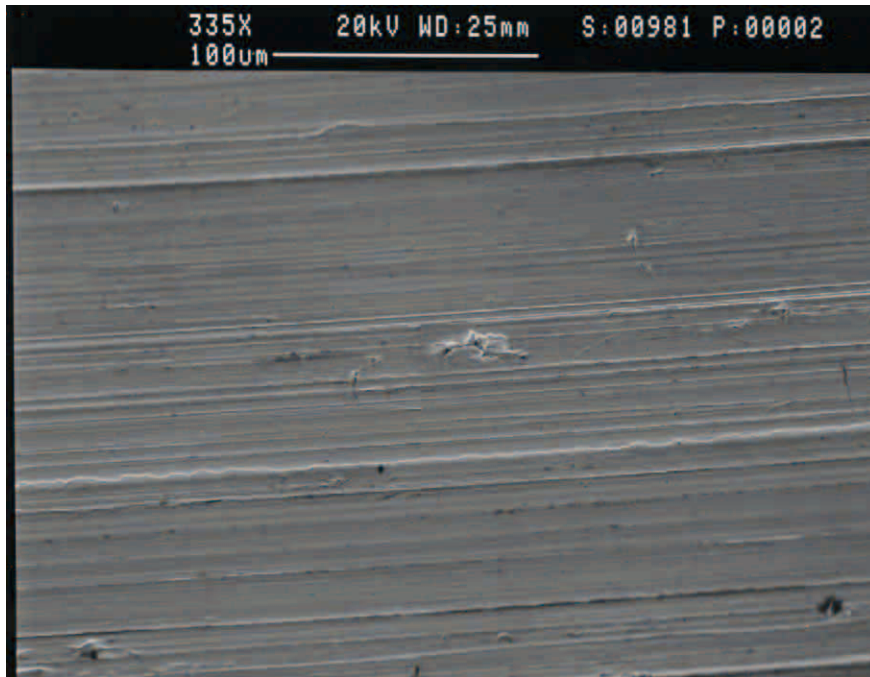
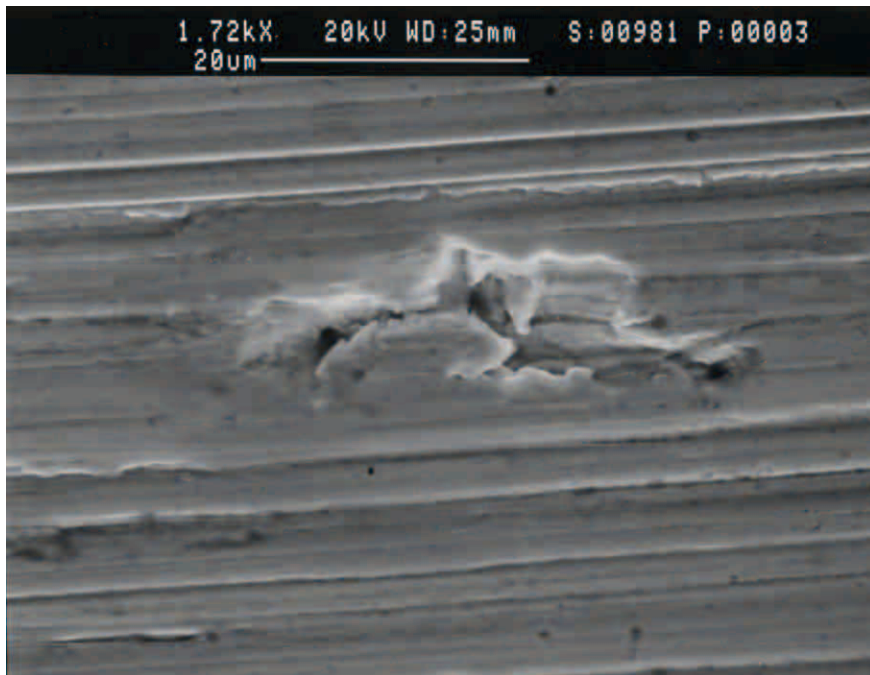
Figure 22--Two views of a typical short crack in the lower flank of N981AS.

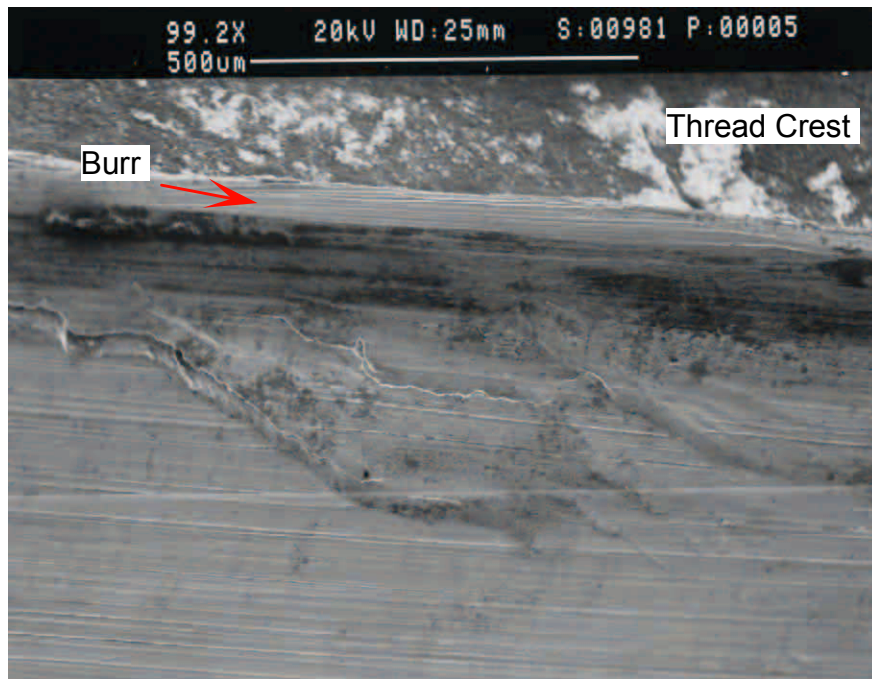
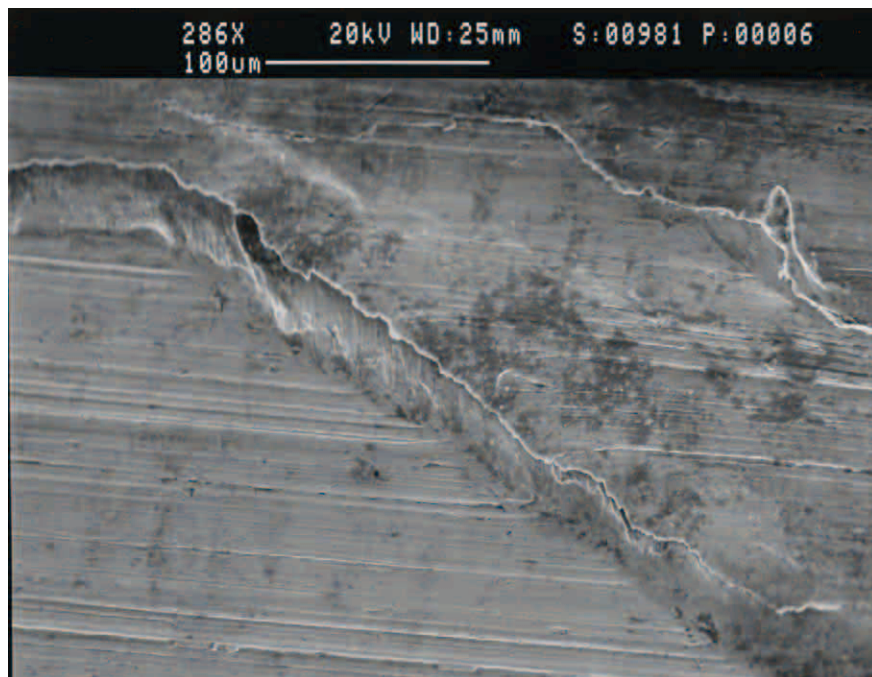
Figure 23--Typical cracking and deformation associated with the burrs protruding from the lower flank of N981AS.

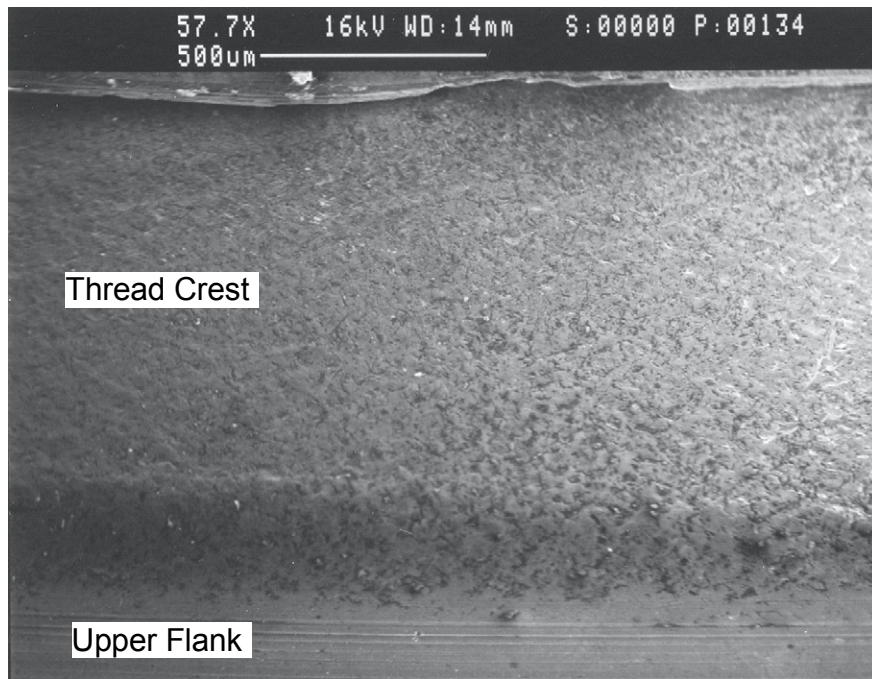
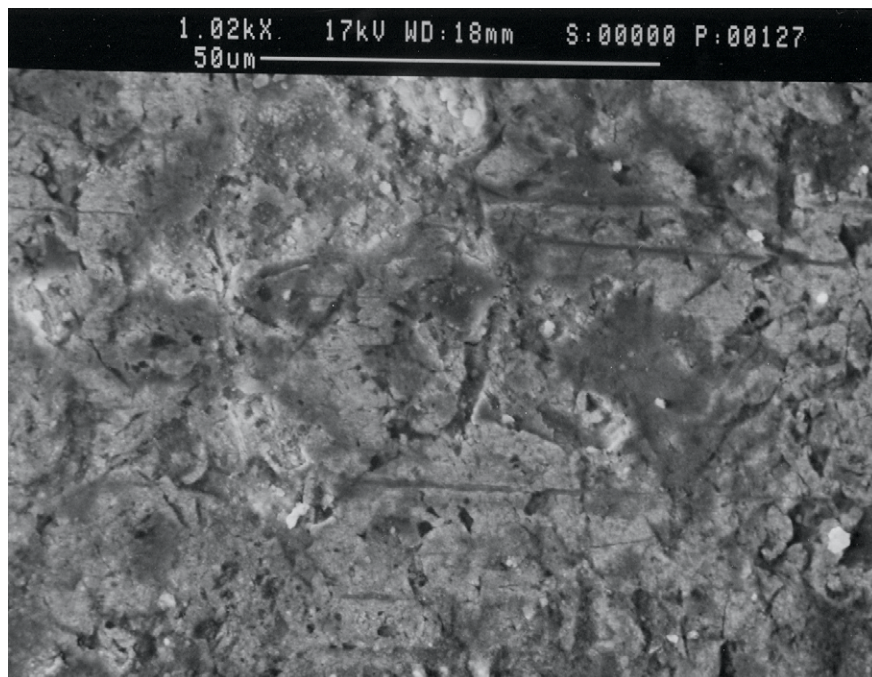
SEM examinations of the thread crests (minor diameter surfaces) revealed a surface composed of randomly oriented angular indentations as shown in figure 24. The surfaces were very similar to those on N981AS but had fewer deposits.

Figure 24--Typical pebble grain surface finish of the thread crests of N982AS.

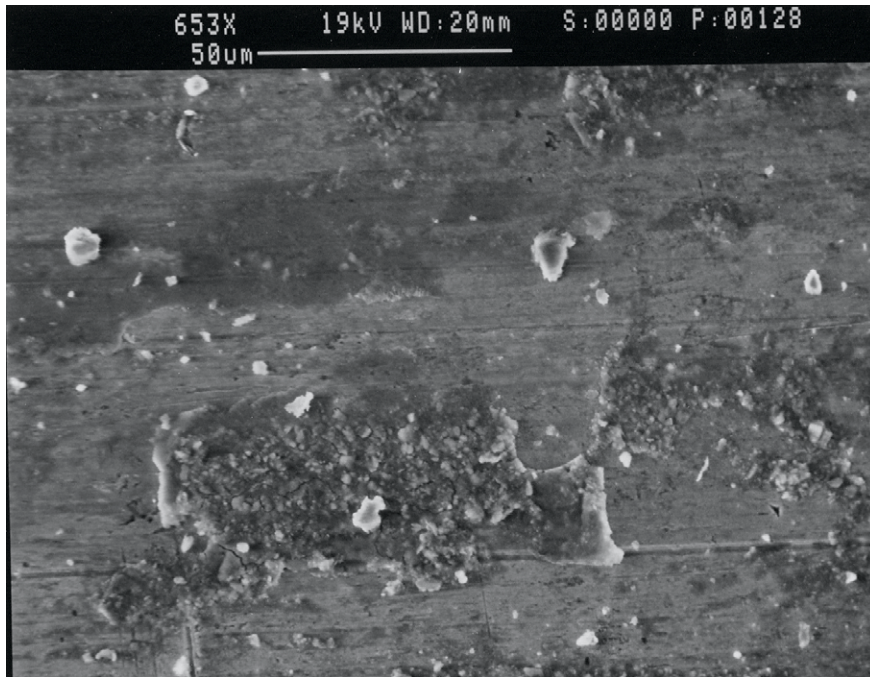
The major diameter surfaces had fine circumferential scratches and areas of surface deposits as shown in figure 25. The deposits were mostly in the area near the upper flank. High magnification examinations found areas of small shallow surface pitting adjacent to the upper flank as shown in figure 26. Many of these pits appeared to be remnants of the pebble grain finish previously noted at the junction of the upper flank and major diameter. Measurements determined that most of these pits were less than 3 μm in width. A few similar pits were found in the central area of the major diameter surface.

Figure 25--Typical scratch pattern and deposits on the major diameter surface of N982AS. White particles are dust on the surface.

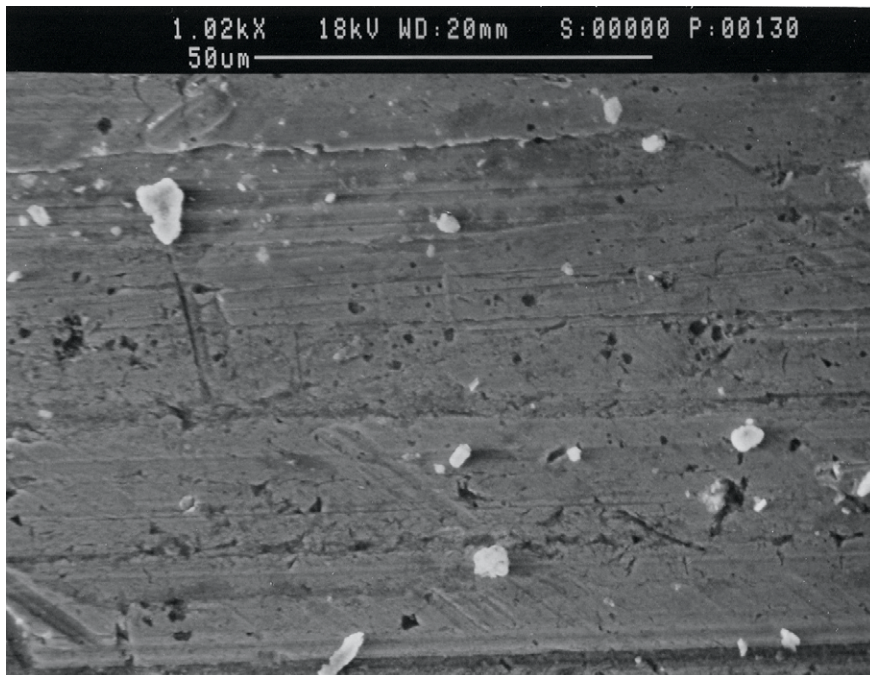
Figure 26--Shallow pits and other features found on the major diameter near the upper thread flank of N982AS. White particles are dust on the surface.

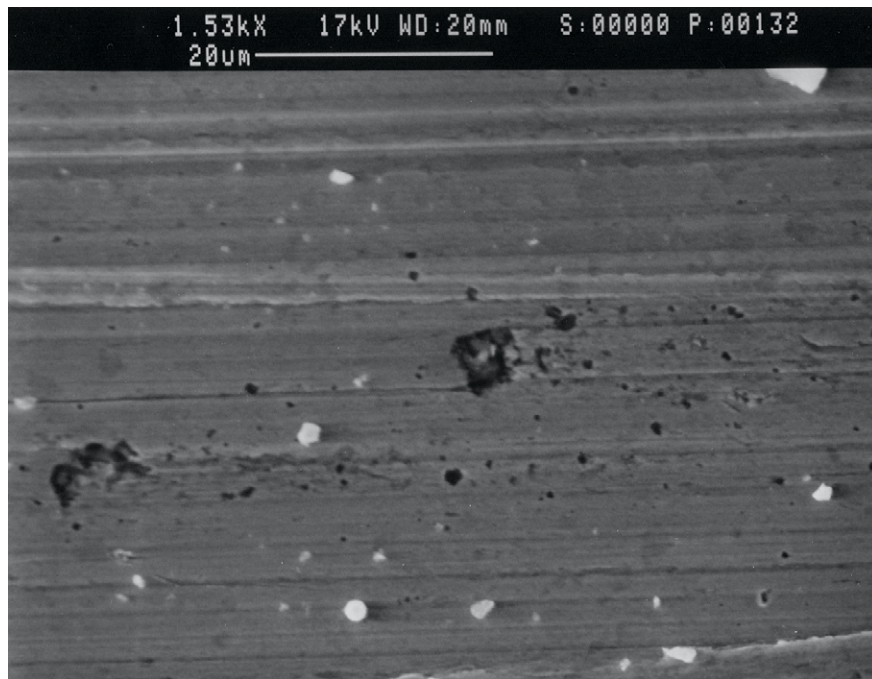
These pits, shown in figure 27, were generally less than 2 μm but a larger one measured up to about 6 μm in diameter.

Figure 27--Pits found in the central area of the major diameter of N982AS. White particles are dust on the surface.

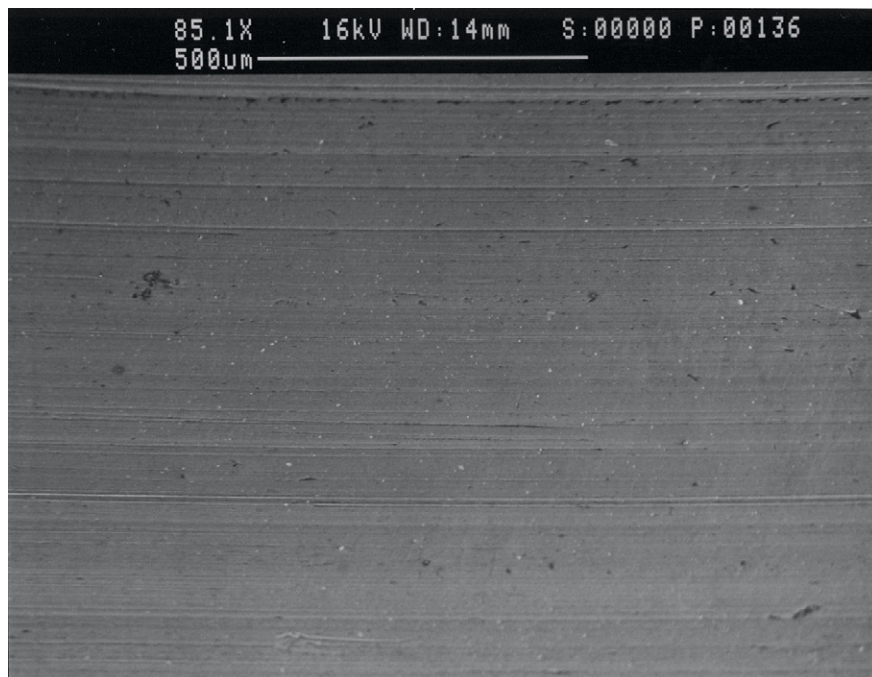
The upper flank surfaces were composed of larger circumferential scratches in a field of finer scratches along with some apparently random surface deposits as shown in figure 28. At high magnifications, some small shallow pits were visible but most were on the upper flank of the top thread as shown in figure 29. These pits were similar in appearance to those noted on the major diameter surfaces. They were generally less than 2 μm in width.

Figure 28--Typical surface of the upper thread flank on N982AS.

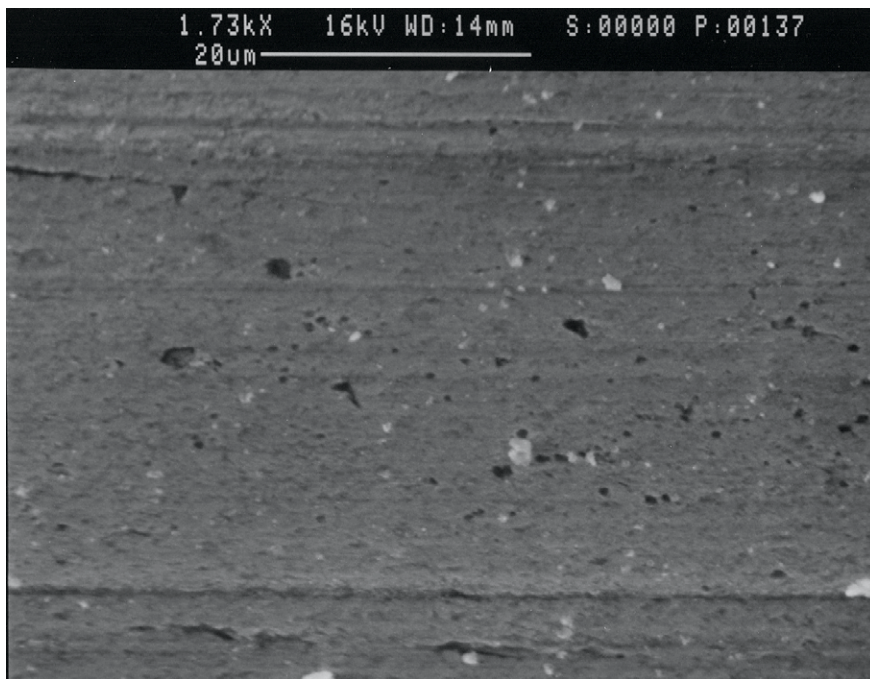
Figure 29--Small shallow pits found on the upper flank of the top thread at high magnification (N982AS).

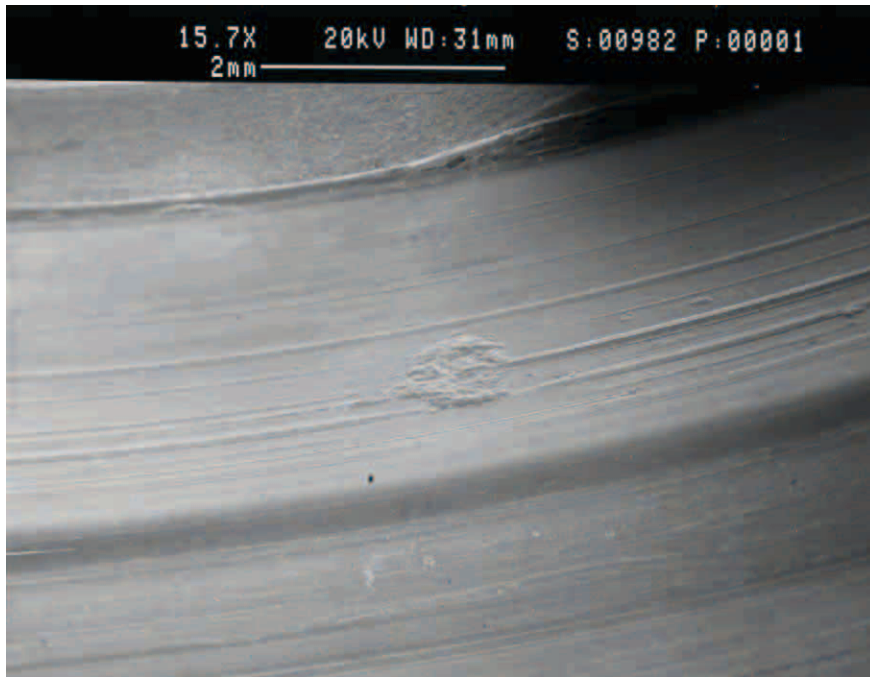
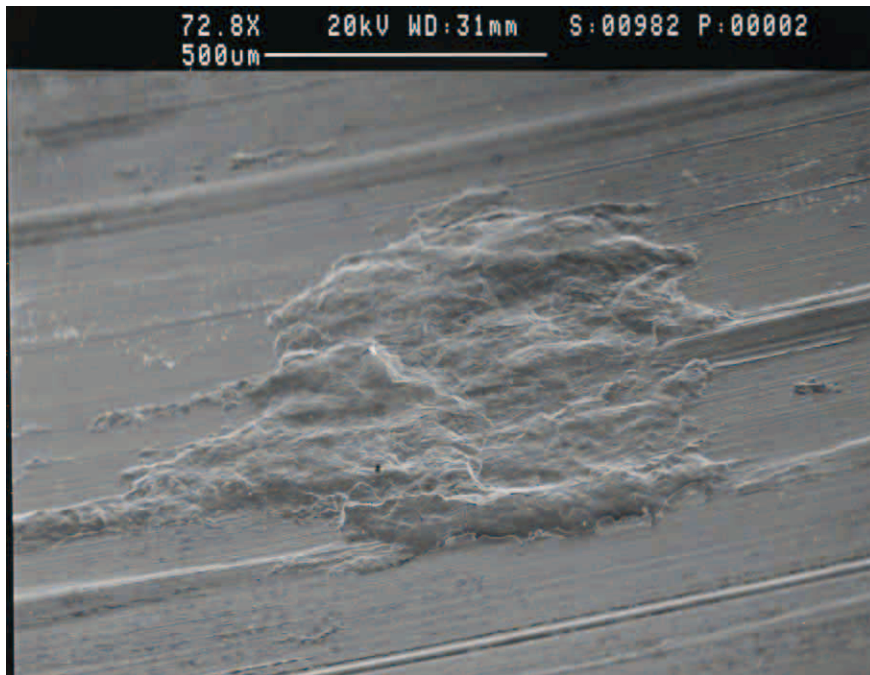
The lower thread flank surfaces were, in general, much rougher appearing than upper surfaces and contained fine scratches with interspersed larger gouges and several previously noted spall-like surface depressions, as shown in figure 30. As can be seen in figure 30 some of the large gouges emanated from the spall areas. Close examinations of the surface depressions found fracture features and cracking within the spalls consistent with mechanical formation, as shown in figure 31. Spalling was generally found between the minor diameter and mid flank on most of the threads, see figure 32. In size they ranged from over 1 mm in length to 20 μm long. The larger optically apparent spalls were on two threads while other smaller spalls were found on several threads.

Figure 30--Lower flank of N982AS showing gouges and spalls.

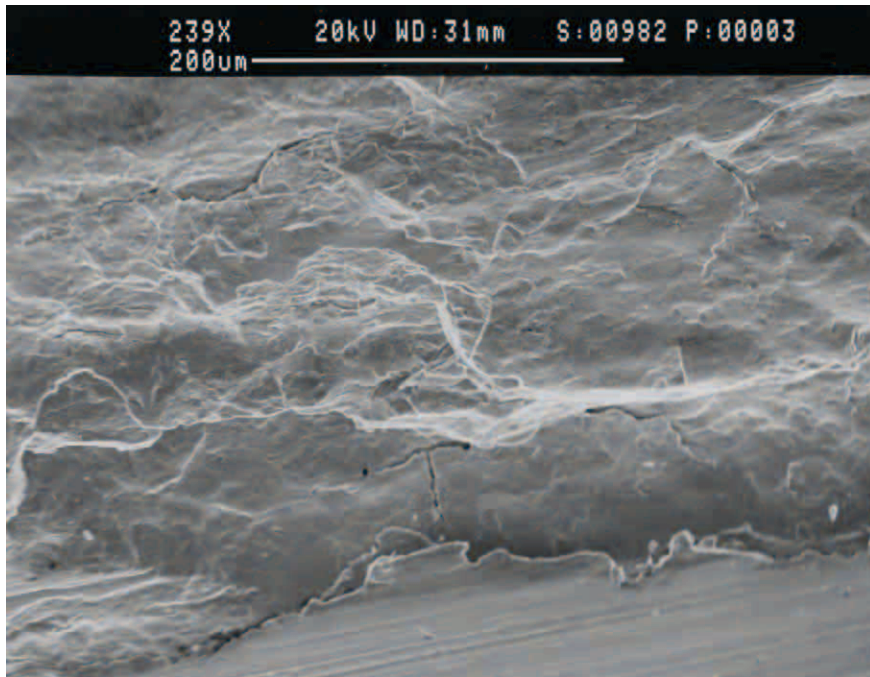
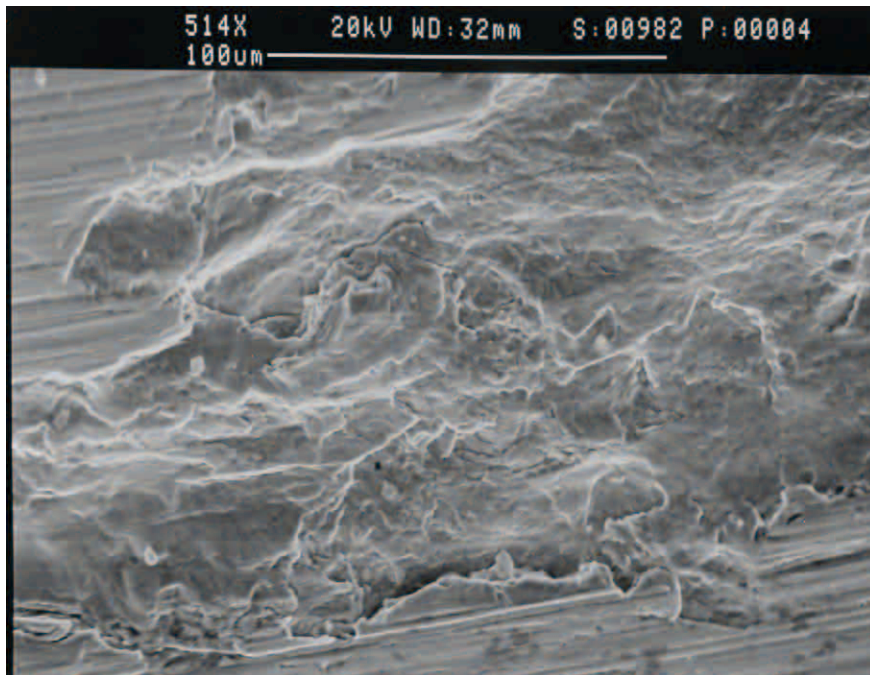
Figure 31--Two medium magnification views of the spall from figure 30 (N982AS) showing surface cracking and fracturing features.

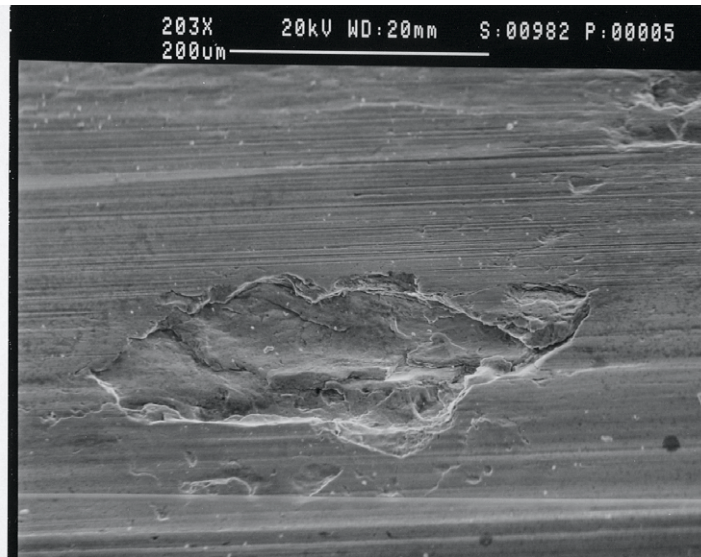
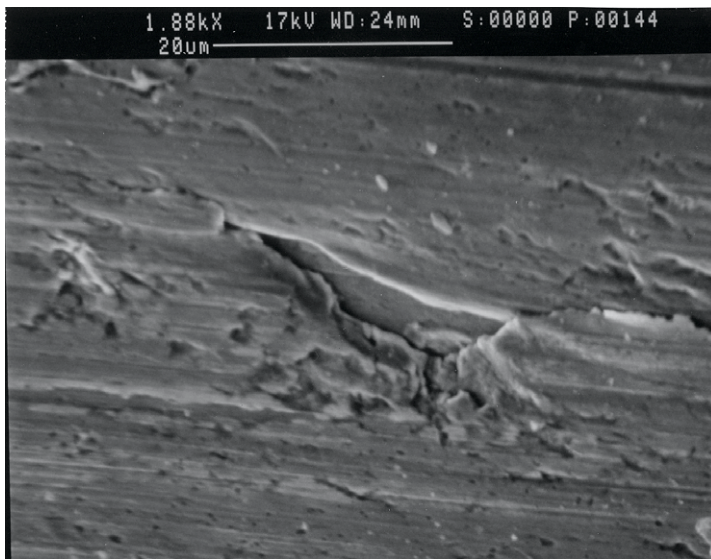
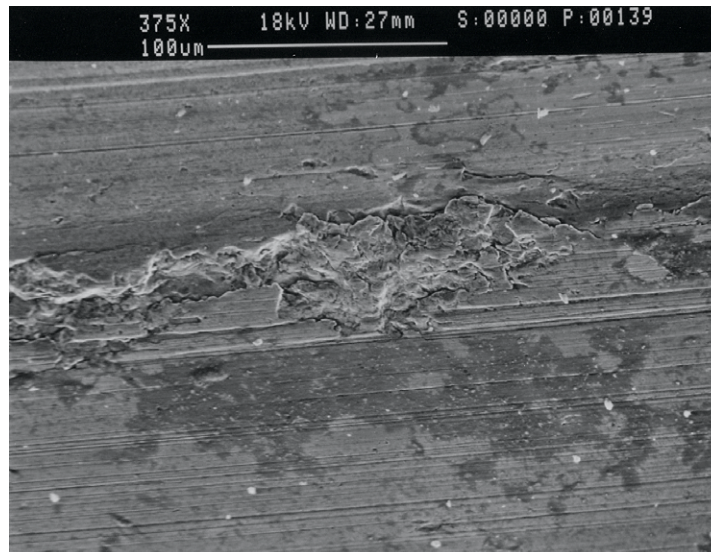
Figure 32--Other spalls on the lower flank of N982AS.

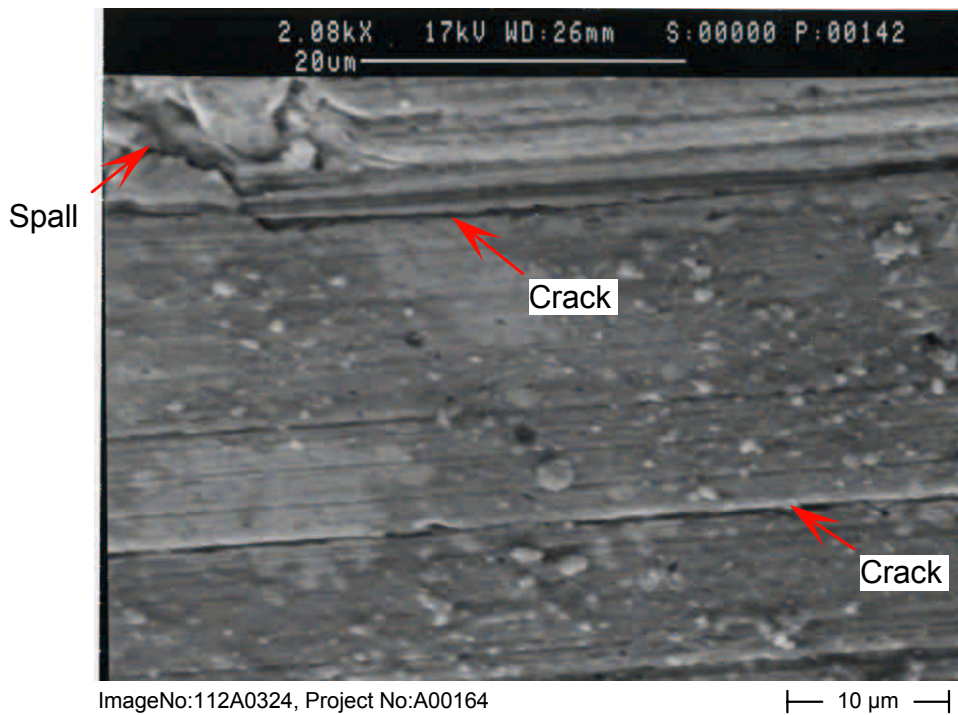
High magnification viewing of the lower flank surfaces also uncovered many circumferential cracks running in some of the scratches. Some of the cracks intersected spalled areas while others did not. Figure 33 shows two typical surface cracks, the upper one intersecting a spall in the upper left of the view. Many of these cracks were more than 1 mm in length.

Figure 33--Long circumferential cracks in the lower flank surface of N982AS. The upper crack intersects a spalled area while the lower crack did not.
