NATIONAL TRANSPORTATION SAFETY BOARD

MATERIALS LABORATORY FACTUAL REPORT

Report No. 02-077

Place : Belle Harbor, New York
Date : November 12, 2001
Vehicle : Airbus A300-600, N14053
NTSB No. : DCA02MA001
Investigator : Brian Murphy, AS-40

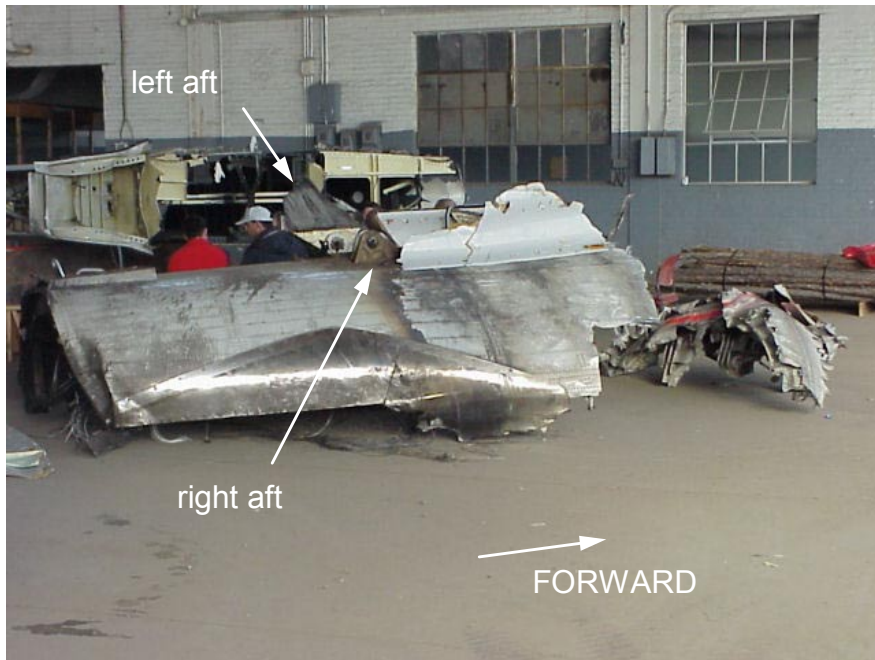
Figure 1. Overall view of the fuselage pieces as examined at Floyd Bennett Field. The vertical stabilizer is shown in the background.

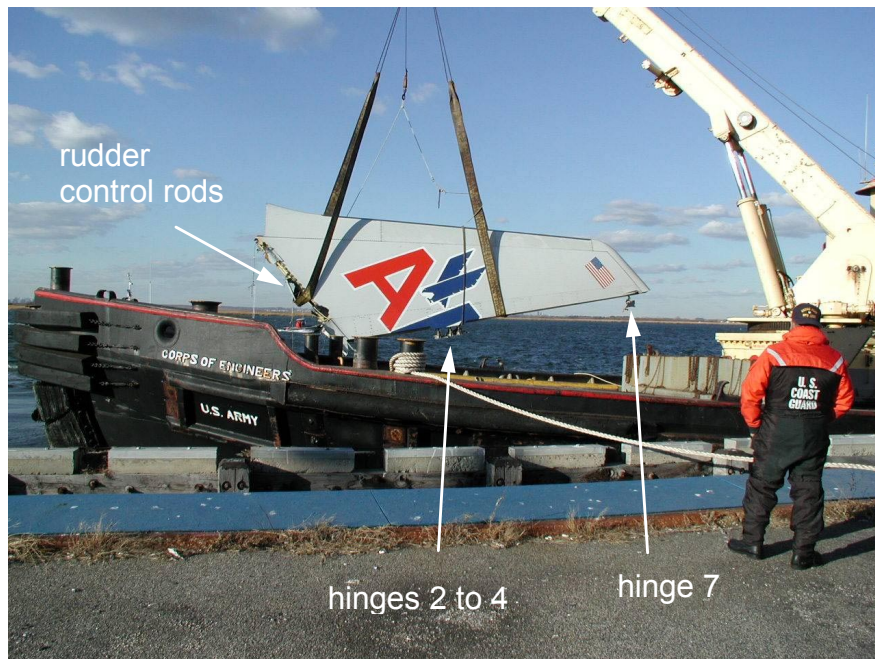
Figure 3. Recovery photo showing the vertical stabilizer being hoisted from the water. Note hinge 5 is not visible and the control rods are swept aft under the strap at the lower end.

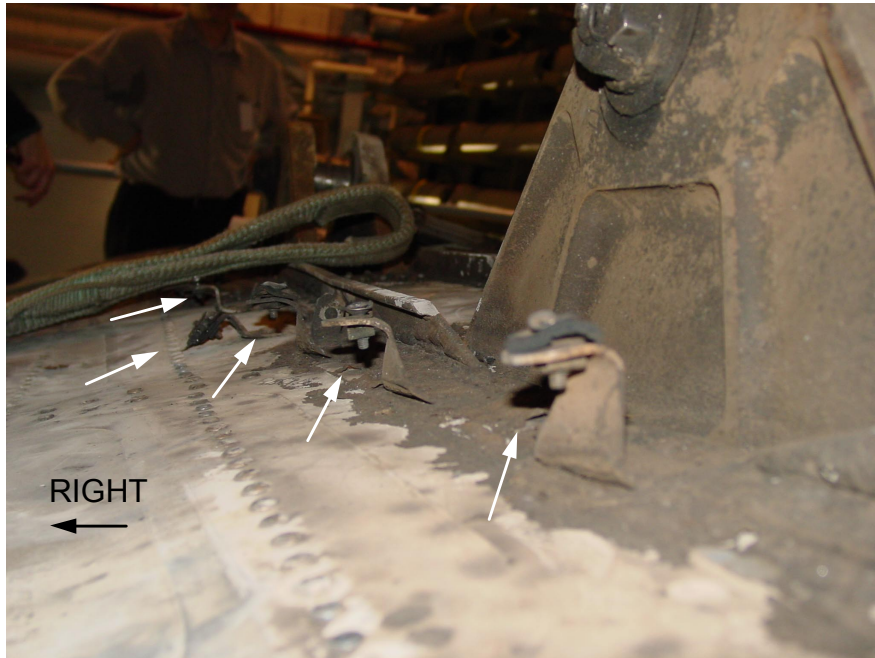
in figure 7. The tenth clip from the rear was broken. On the left side, the nine aft-most clips from the rear were approximately in their normal position. The tenth clip from the aft was bent upward and aft. Figure 8 shows the first through seventh clips as viewed looking aft.

Figure 7. Closer view of the right side fairing clips, indicated by unlabeled arrows, on the aft fuselage piece viewed looking aft.

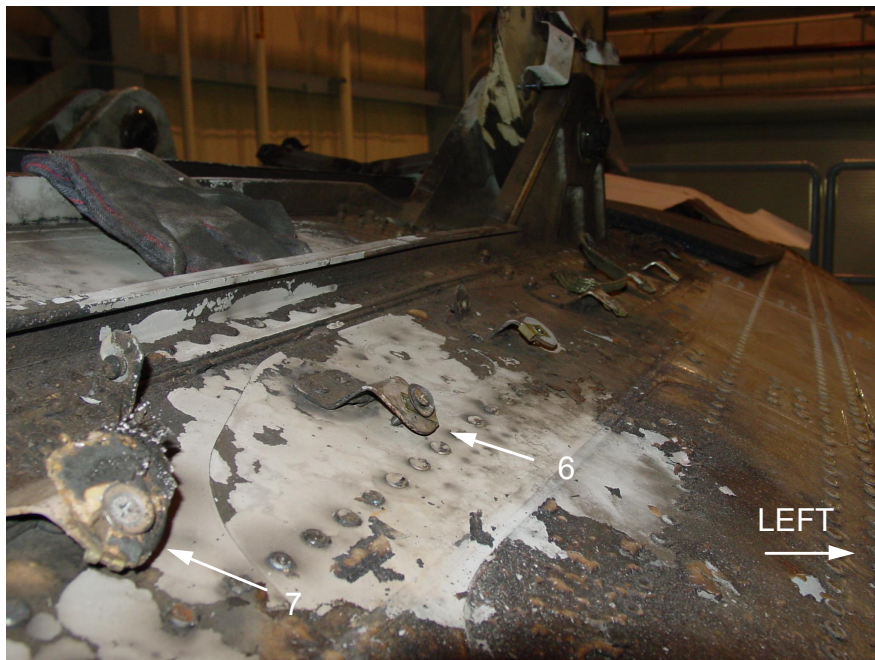
Figure 8. Closer view of the left side fairing clips on the aft fuselage piece viewed looking aft. Arrows indicate the sixth and seventh fairing clips from the aft.

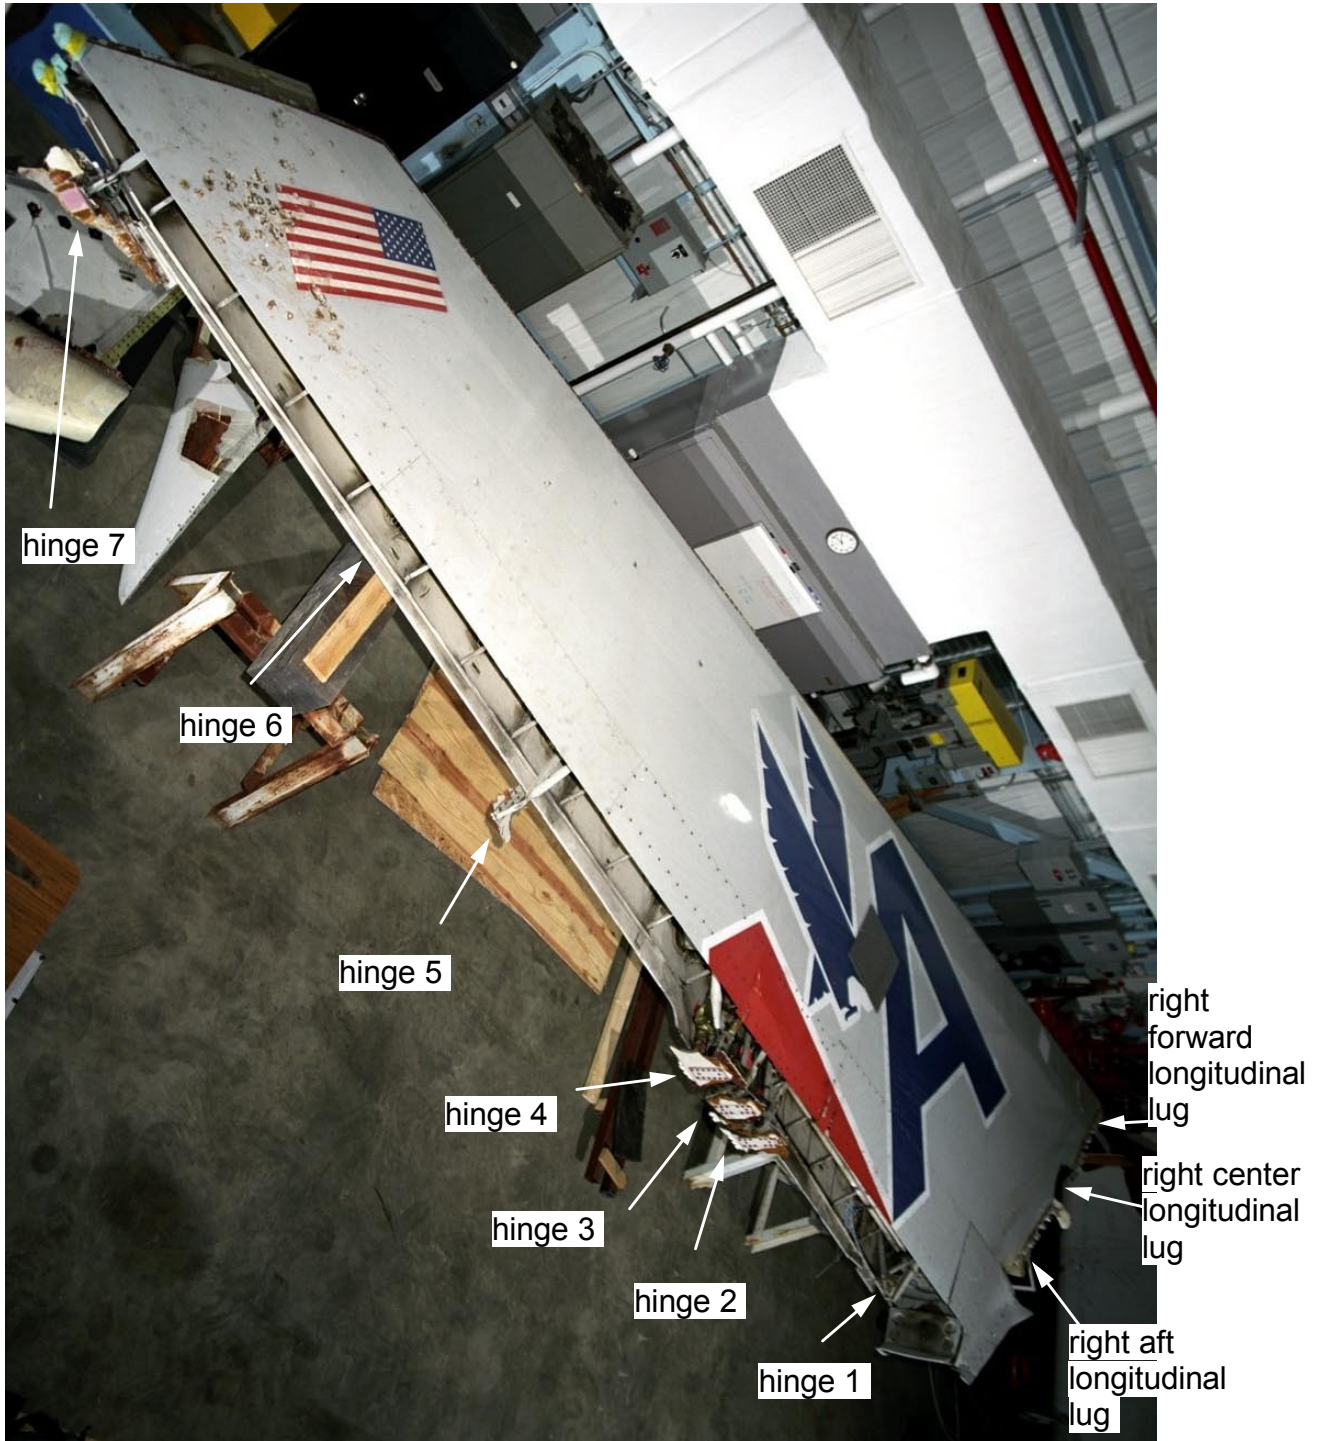
The vertical stabilizer was largely intact with no significant areas of skin buckling. An overall view of the right side of the vertical stabilizer is shown in figure 9 as it was examined at NASA Langley Research Center. The LE fairings were removed for shipping from Floyd Bennett Field. There were some localized areas of damage on the vertical stabilizer, which will be described below. At the lower end, shown in figures 10 and 11, each of the six attachment locations were separated either by fractures that intersected the lug attach hole or by fractures through the structure above the hole. Portions of rib 1, the rib 1 rib-to-skin attach angle, and the lower end of the forward spar also were fractured. Along the trailing edge, the TE panels were damaged in several locations.

Figure 9. Overall view of the vertical stabilizer as it was examined at NASA Langley.

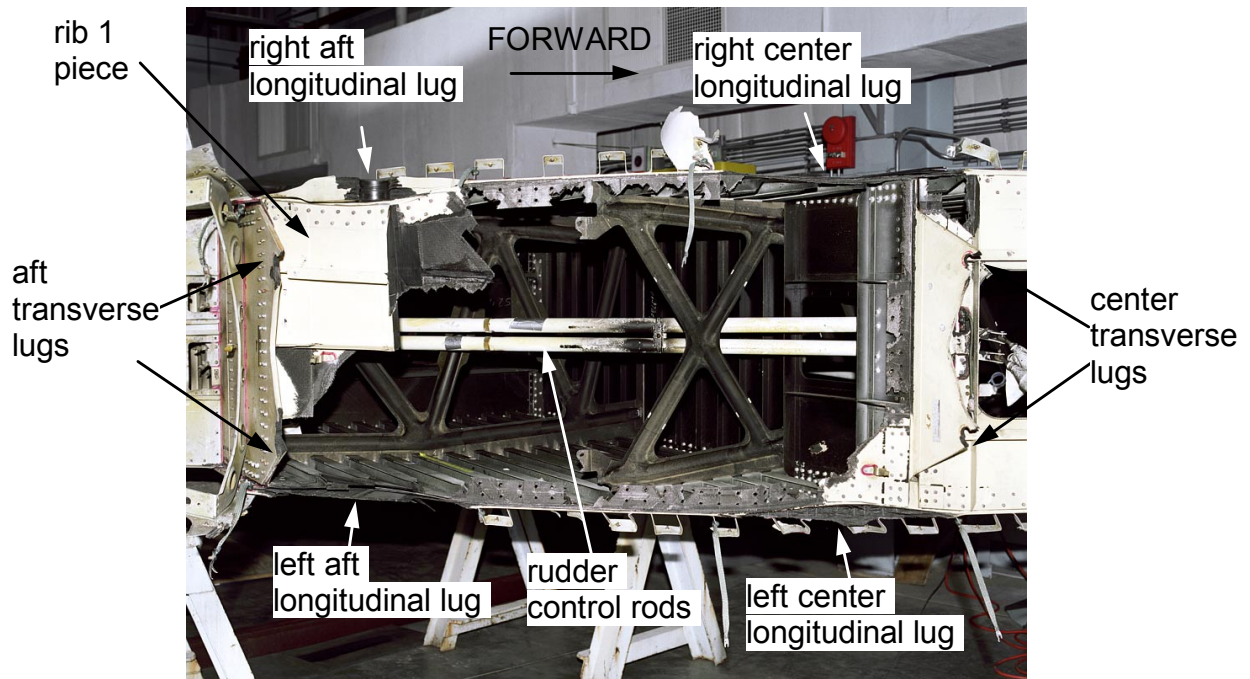
Overall views of the lower end as shown in figures 10 and 11 show the rib 1 damage. The portion of rib 1 between the aft spar and center spar was missing except for two areas: (1) An area adjacent to the right side of the aft spar (about 21 inches by 14 inches). The forward end of this area was deflected downward and was held in position by the fracture surface on the right aft lug. (2) A triangular area at the left center fitting (about 9 inches by 8 inches). Portions of the lower leg of the rib 1-to-skin attach angle remained, and fasteners were pulled downward through those remaining areas. At the forward end, the center portion of rib 1 was missing from the front spar back to the forward end of an access hole, and the left side of rib 1 was missing from the front spar back to the aft end of that access hole.

Figure 10. View of the aft portion of the lower end of the vertical stabilizer.

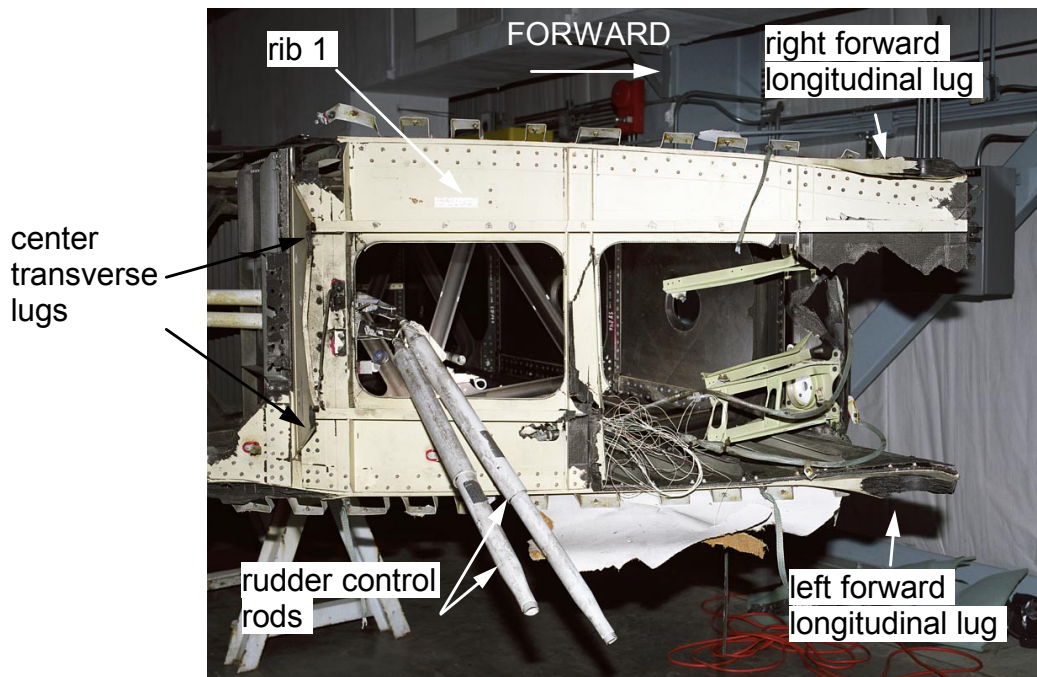
As shown in figure 11, the forward spar was fractured above the forward transverse lug attachment area at a position approximately 14 inches above rib 1, just below two racks for electronic equipment. A piece of the spar remained attached to the fuselage left transverse yoke, as shown in figure 27. This remnant piece had an edge of an access hole at the upper end. The lower piece of the right attach lug also remained in the right transverse yoke. The pieces that remained with the attach yokes had heavy fire damage.

Figure 11. View of the forward portion of the lower end of the vertical stabilizer.

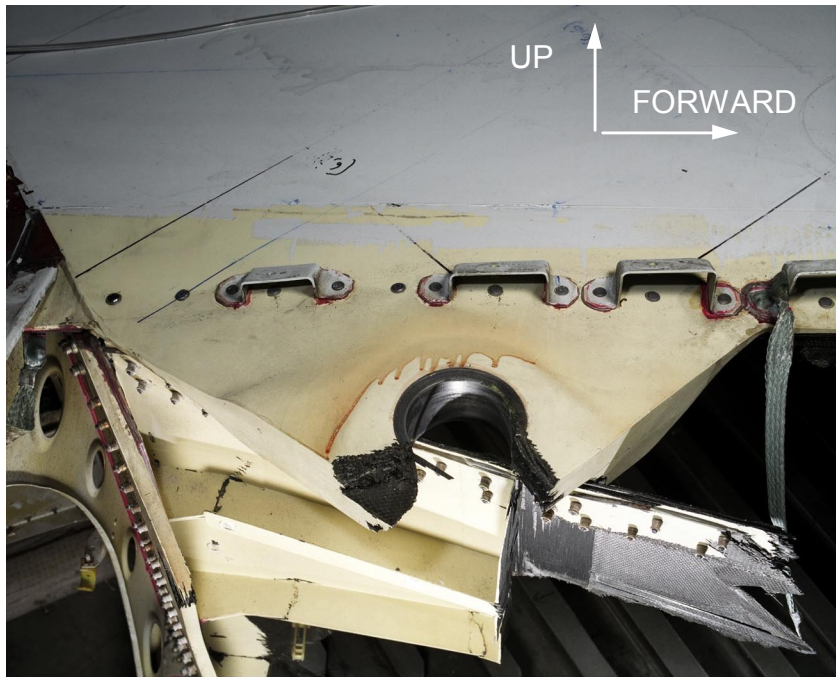
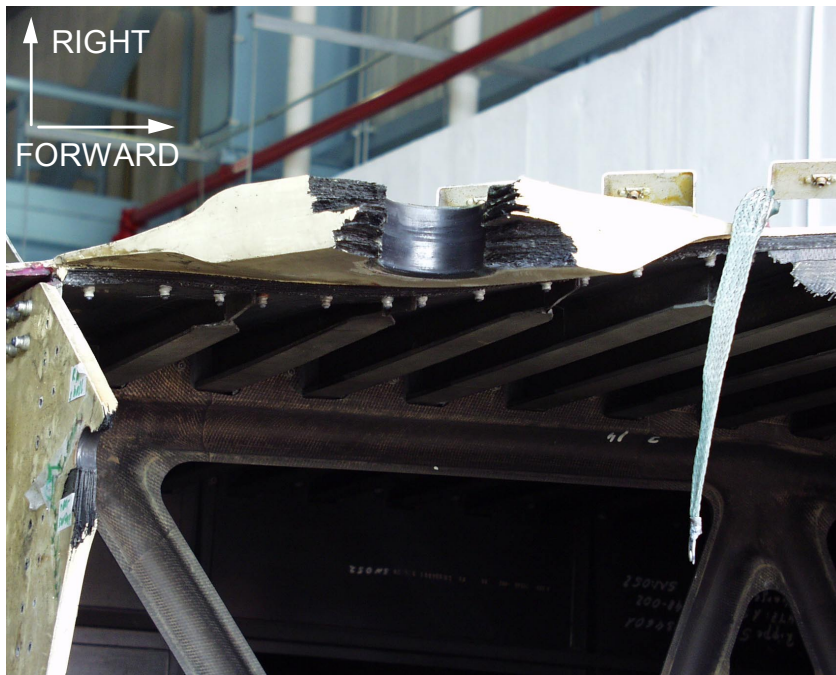
Two views of the right aft longitudinal lug are shown in figures 12 and 13. Figure 13 shows the lug fracture after a piece of rib 1 was removed. As shown in figure 10, the piece of rib 1 covered the inboard side of the translaminar fracture in the forward leg of the lug. The fracture surfaces intersected the lug attach hole. The lower portion of the lug was missing and was not recovered. The translaminar fracture surfaces appeared to have a rough appearance consistent with fracture under primarily tensile loads. Fractures on each leg of the lug were on different translaminar planes, and the change in planes occurred near the center of the lug thickness. On the aft leg, the outboard side of the fracture was in a plane nearly perpendicular to the zero-degree fiber direction, and the inboard side of the fracture was in a plane approximately 45 degrees from the zero-degree fiber direction. On the forward leg, the outboard side of the fracture was in a plane approximately parallel to the zero-degree fiber direction, and the inboard side of the fracture was in a nearly horizontal plane. Some ply separation was observed above the fracture, with the largest separations intersecting the translaminar fracture where the fracture plane changed. The ply separations visible as cracks on the surface were limited to the lug region below rib 1.

The bore of the right rear lug was in good condition, showing bearing contact over a large portion of the bore surface. A few lines of partially circumferential white powdery deposits were noted on the bore surface.

Figure 12. View of the right aft longitudinal lug on the vertical stabilizer.

Figure 13. Another view of the right aft longitudinal lug on the vertical stabilizer shown after the piece of rib 1 that covered part of the fracture was removed.

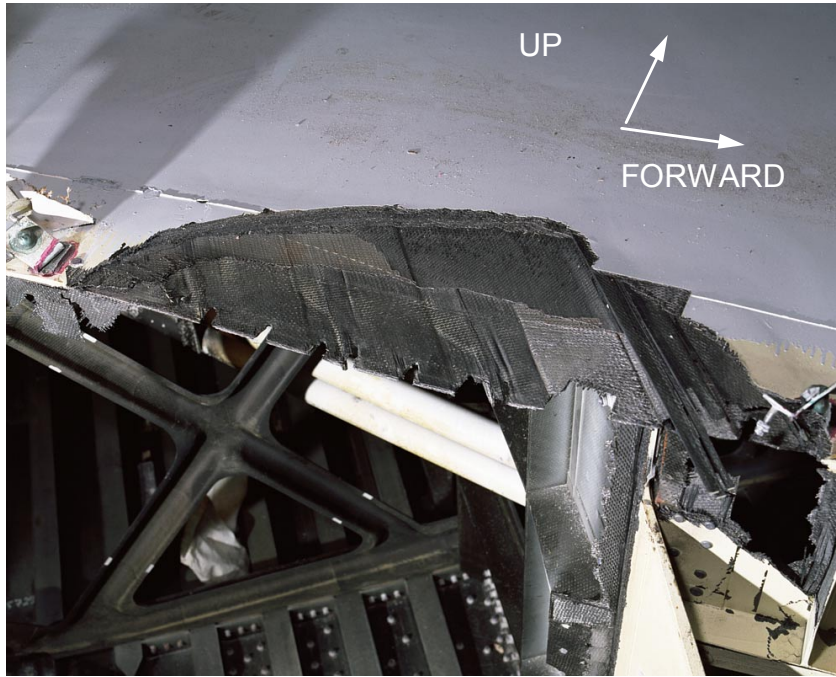
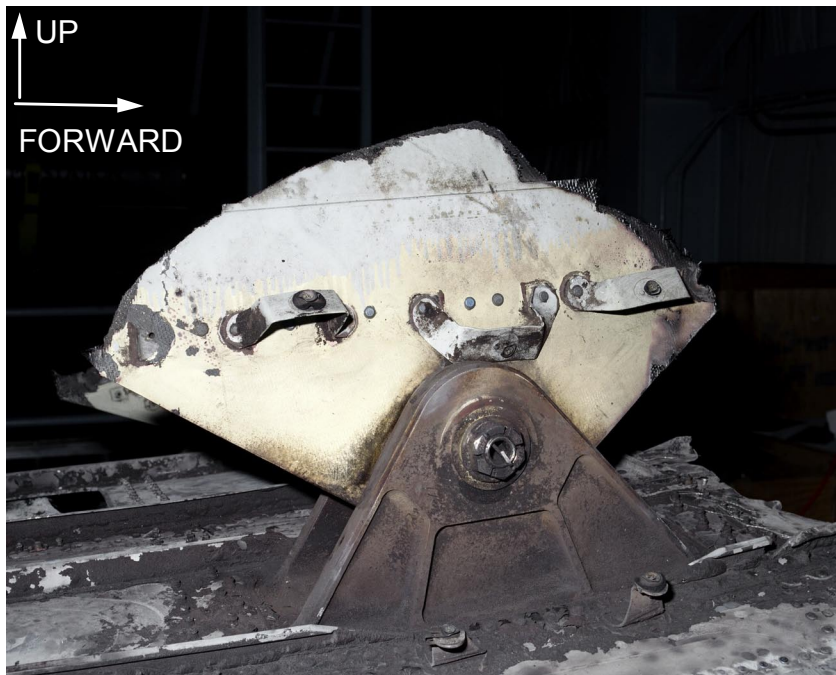
Views of the right center lug area fracture are shown in figures 14 and 15. The fracture occurred in the vertical stabilizer structure above the lug bore, and the lower piece remained attached to the fuselage as shown in figure 15. Translaminar fractures occurred in the skin and the lug build-up layers (pre-cured halves) primarily in a slightly curved plane perpendicular to the zero-degree fiber direction at a location up to approximately 12 inches above the lug attach bolt centerline. The translaminar fracture appeared rough, consistent with fracture from tensile loading. The stringer module layers³, as can be seen in figure 14, remained with the main portion of the vertical stabilizer, and tape layers (stringer outer flange layers) between the stringer module layers and the lug build-up layers (pre-cured halves) also remained with the vertical stabilizer. Rib 1 fastener holes near the lower end of the stringer module layers were torn out in a downward direction for the fasteners that remained with the lower piece. A piece of the upper leg of the rib 1 attach angle also remained with the lower piece. Some layers of tape pulled out from the lower piece near the forward side and remained with the upper piece. There was a ply separation on the forward edge of the lower piece in a fire-damaged area.

Figure 14. View of the right center longitudinal lug area on the vertical stabilizer.

Figure 15. View of the mating piece of the right center longitudinal lug that remained attached to the fuselage.

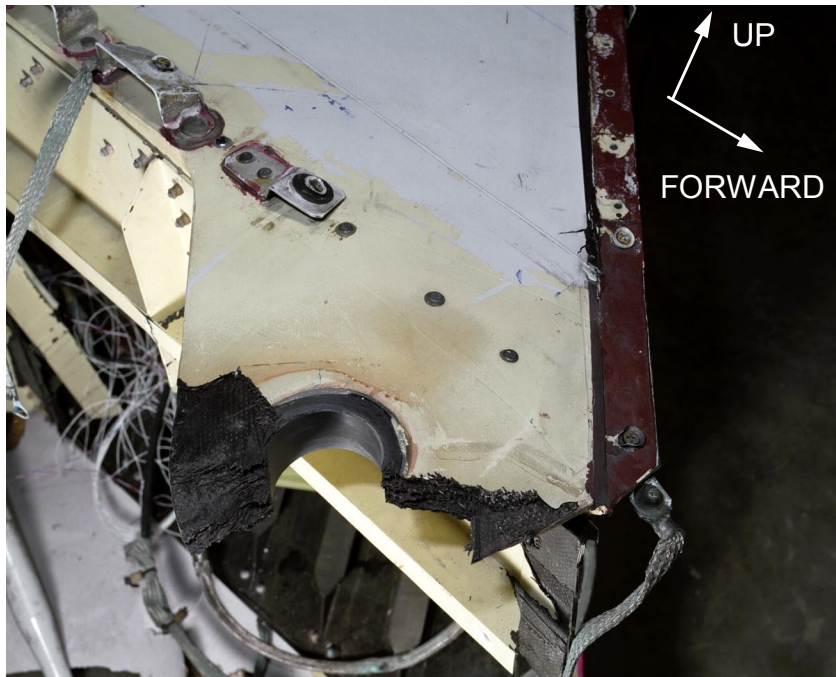
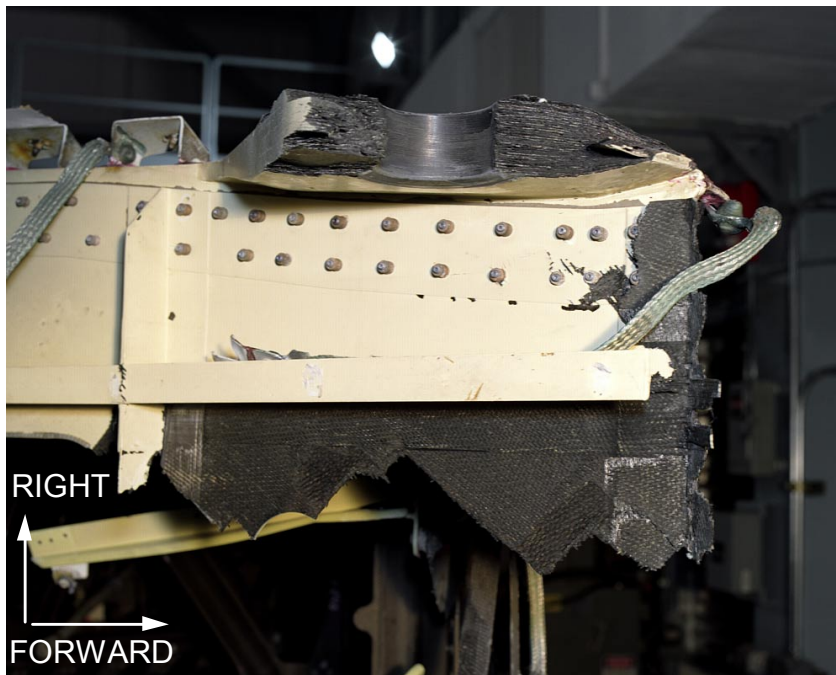
Views of the right forward lug are shown in figures 16 and 17. The fracture surfaces intersected the lug attach hole. Most of the lower portion of the lug was missing and was not recovered, but a small amount of composite material was left in the circumferential groove between the two hat bushings that remained attached to the fuselage. The translaminar fracture surfaces appeared to have a rough appearance consistent with fracture primarily under tensile loading. On the aft leg of the lug, fracture occurred on different planes. On the inboard and outboard sides of the aft leg, the fracture was on planes perpendicular to the length of the front spar, and near the center of the aft leg (with a width of approximately 50 percent of the thickness), the fracture was on a plane at a 45-degree angle to the zero-degree fiber direction. On the forward leg of the lug, the fracture surface was almost entirely on a plane that was perpendicular to the length direction of the front spar.

The bore of the right forward lug was in good condition, showing bearing contact over a large portion of the bore surface. A few lines of partially circumferential white powdery deposits were noted on the bore surface.

Figure 16. View of the right forward longitudinal lug on the vertical stabilizer.

Figure 17. Another view of the right forward longitudinal lug on the vertical stabilizer.

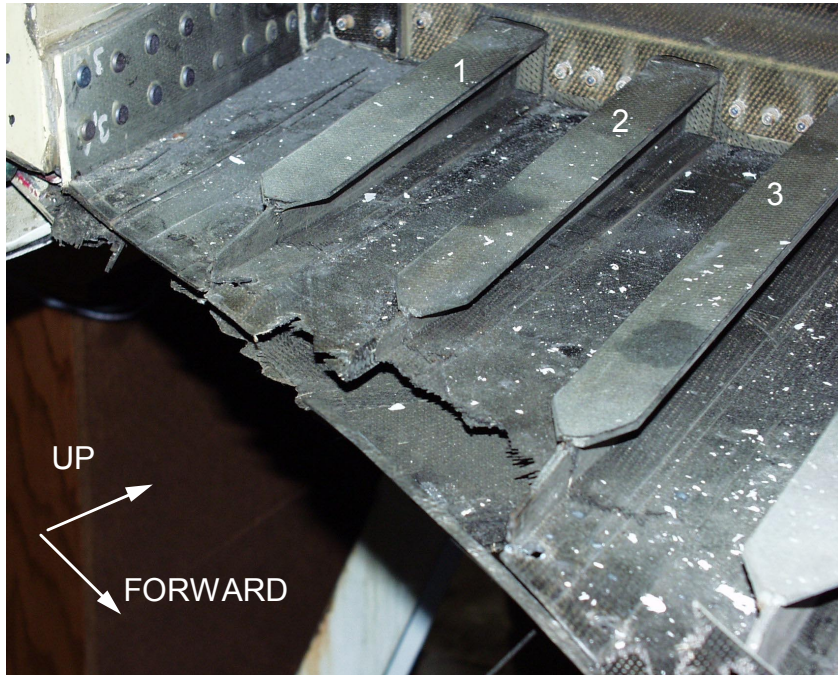
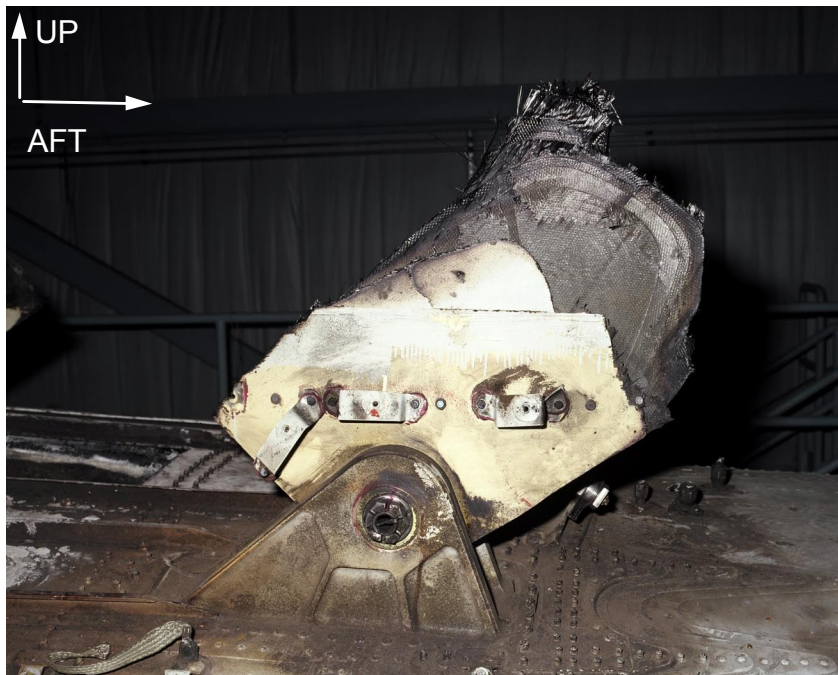
Views of the left aft lug area fracture are shown in figures 18 and 19. The fracture occurred in the vertical stabilizer structure above the lug bore, and the lower piece

remained attached to the fuselage as shown in figure 19. A translaminar fracture occurred near the center of the lug (about four inches above the lug bore), fracturing primarily at the rib 1 fastener row as shown in figure 18. The fracture intersected most of the fastener holes except for an area near the forward end, where the fracture was above the holes. The fracture surfaces were generally rough on the inboard side of the fracture, but appeared smoother on the outboard side of the fracture, consistent with either a bending fracture or a tensile fracture with post-fracture damage. Interlaminar fractures occurred at either side of the middle piece that fractured from the middle of the lug and between the stringer module layers and the lug build-up layers. Some of the tape layers between the stringer module layers and the lug build-up layers also remained with the upper piece and some remained with the lower piece. Fractures at the upper end of the lower piece generally appeared to correspond with the upper ends of the lug build-up layers.

The left stringers 1, 2, and 3 were cracked or fractured at the stringer runout area near the bottom end of the stringers. A small part at the runout of stringers 1, 2, and 3 had web and flange damage consistent with outboard bending. Rib 1 fasteners were pulled out of the stringer module layers and the fasteners remained attached to the lower piece of the lug.

Figure 18. View of the left aft longitudinal lug area on the vertical stabilizer. Stringers 1, 2, and 3 are labeled.

Figure 19. View of the mating left aft longitudinal lug piece that remained attached to the fuselage.

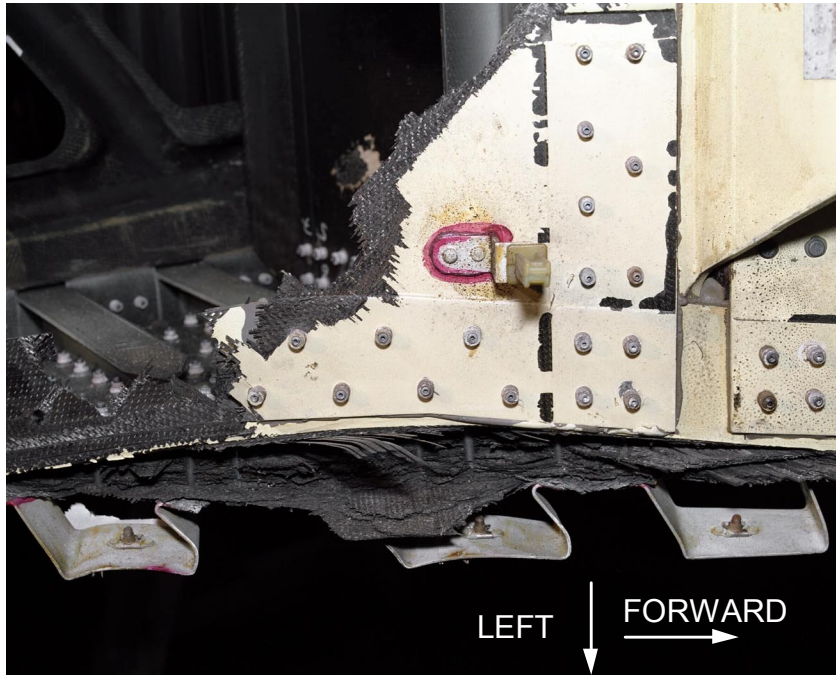
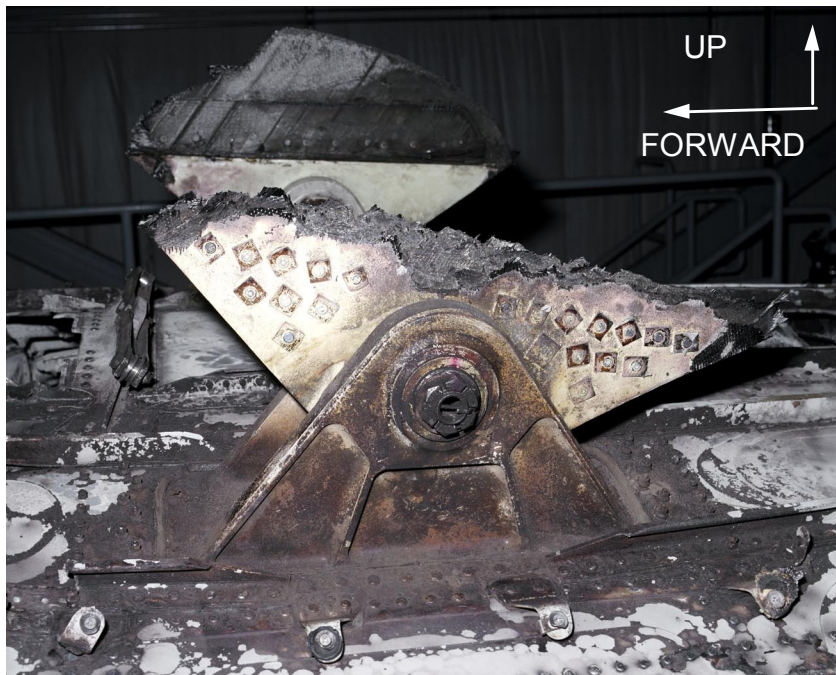
Views of the left center lug area fracture are shown in figures 20 and 21. The translaminar fracture occurred in the vertical stabilizer structure above the lug bore, and the lower piece remained attached to the fuselage as shown in figure 21. There were multiple fasteners through the lug and adjacent structure both above and below the fracture associated with a factory repair (concession number TH-9802). There was no visible sign of distress or fracture associated with the repair fasteners. None of the other fittings had similar fasteners. The translaminar fracture occurred primarily at the rib 1 fastener row as shown in figure 20, intersecting most of the rib 1 fastener holes. The fracture was horizontal and perpendicular to the skin surface. The fracture surfaces were generally rough, consistent with fracture under primarily tensile loading.

Figure 20. View of the translaminar fracture for the left center longitudinal lug.

Figure 21. View of the left center longitudinal lug that remained attached to the fuselage. Repair rivets with square angle shims are visible on the surface.

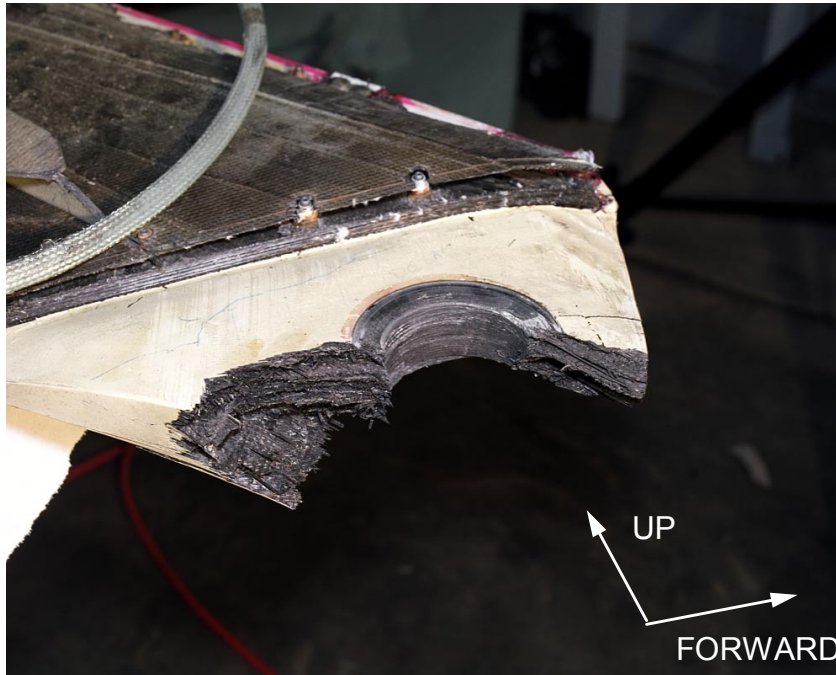
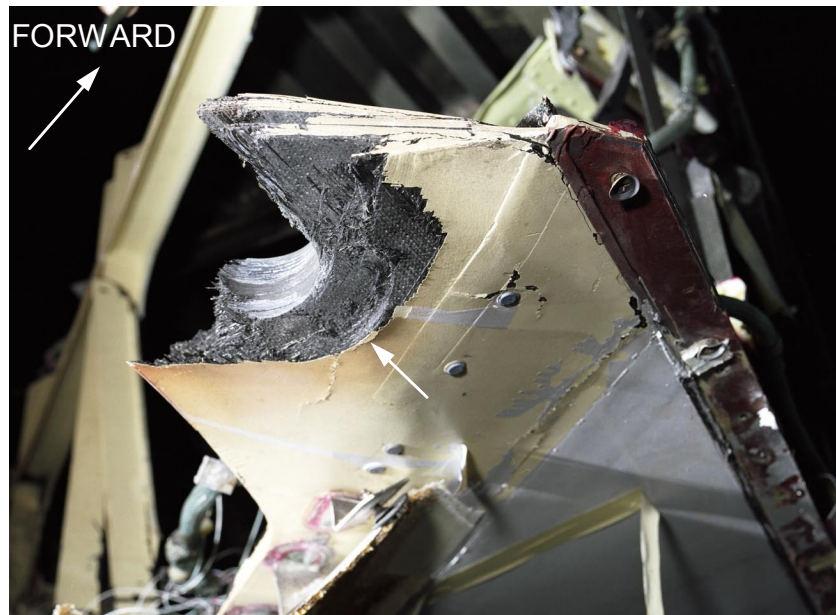
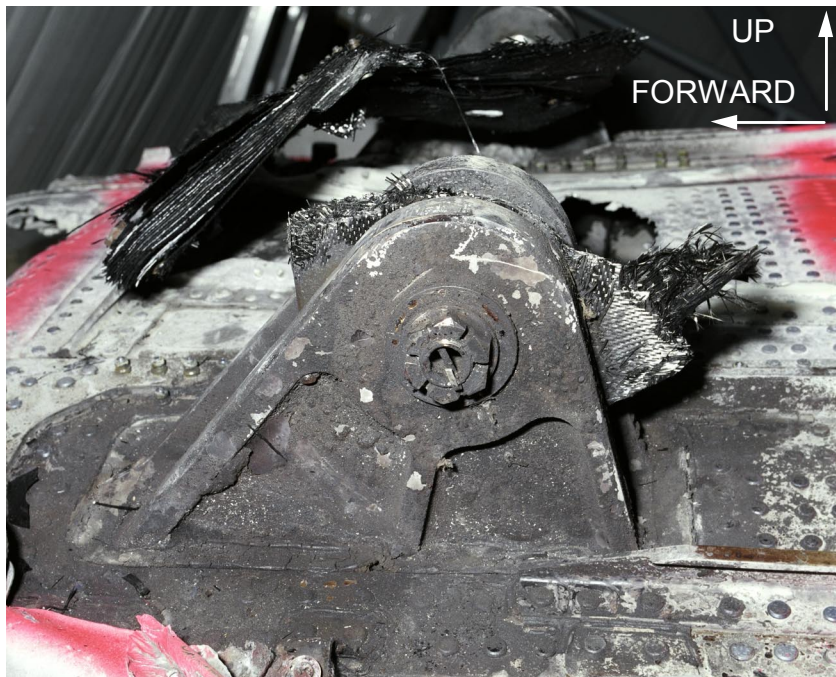
Views of the left forward lug are shown in figures 22 to 24. The fracture surfaces intersected the lug attach hole. The lower portion of the lug remained with the fuselage and had a darkened appearance consistent with severe exposure to heat and fire as shown in figure 24. The upper side of the fracture is shown in figures 22 and 23. On the aft leg of the lug, the translaminar fracture was primarily on a horizontal plane and appeared rough, consistent with fracture under tensile loading. On the forward leg of the lug, the translaminar fracture intersected the bore nearly tangentially and was primarily on a plane parallel to the zero-degree fiber direction. The fracture surfaces on the forward leg of the lug were rough with multiple ply separations in the leg above the fracture surface, consistent with tensile fracture with transverse shear. On the outboard side of the hole above the bore, a bearing indentation was observed as shown in figure 23. The indentation was approximately 1/8 inch deep and the shape corresponded to the profile of the upper

end of the outboard lug on the fuselage clevis attach fitting. Ply separation also was observed in the fire damaged lower portion of the lug that remained with the fuselage.

Above the lug fracture, an interlaminar fracture was observed where the stringer module layers were separated from the lug build-up layers. Rib 1 fasteners at the lower end of the stringer module layers were pulled through the layers. The interlaminar fracture intersected the lower surface of the vertical stabilizer from the front spar aft to approximately 1.5 inches aft of stringer 21. The interlaminar fracture intersected the forward surface of the vertical stabilizer from rib 1 to above rib 2. Between ribs 2 and 3, the interlaminar fracture was observed intersecting the interior surface of the left skin panel at the stringer 24 flanges and at the front spar flange.

Figure 22. View of the left forward longitudinal lug on the vertical stabilizer.

Figure 23. Another view of the left forward longitudinal lug on the vertical stabilizer showing the left side. An unlabeled arrow indicates an area of crushing damage corresponding contact with the upper end of the metal fuselage attach fitting lug.

Figure 24. View of the lower piece of the left forward longitudinal lug that remained attached to the fuselage.

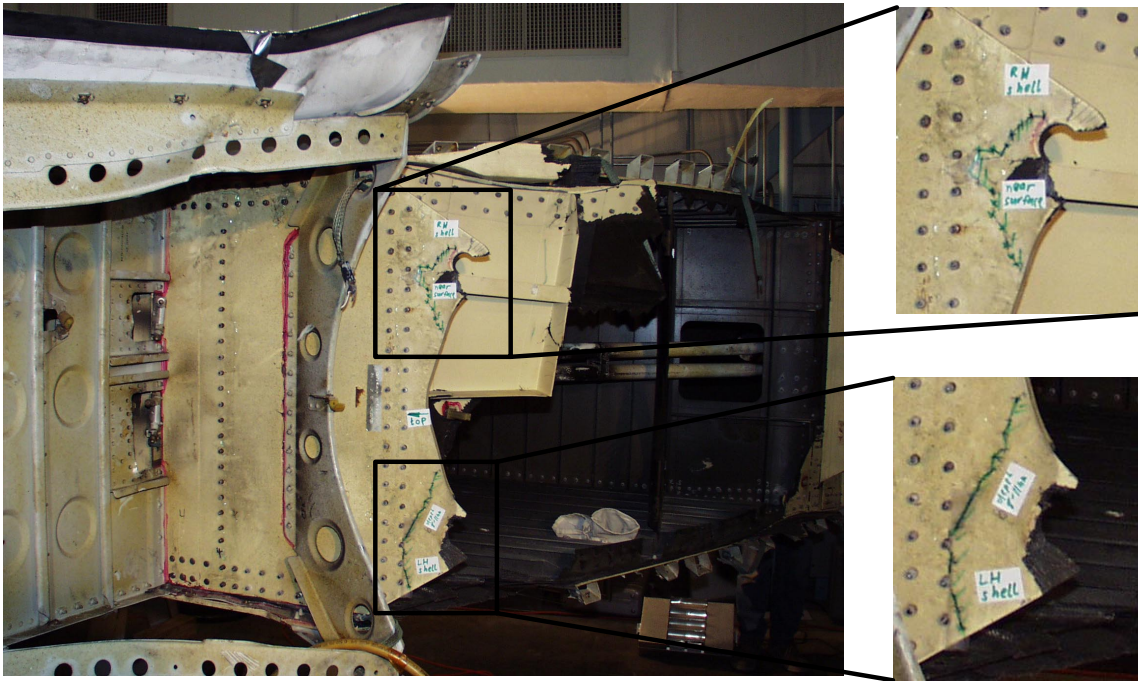
A view of the upper portion of the aft transverse lugs is shown in figure 25. The translaminar fractures of the lugs intersected the yoke attach holes. On the right lug, the outboard leg was fractured in a vertical plane and intersected the yoke attach hole approximately at a 90 degree angle. The inboard leg was fractured at an approximately 45-degree angle to the vertical direction and intersected the yoke attach hole tangentially. On the left lug, the inboard leg was fractured in a near vertical plane, and the outboard leg was fractured at an approximately 45-degree angle to the vertical direction. All fracture surfaces except for the left outboard leg appeared rough, consistent with a tensile fracture. The left outboard leg had a smoother appearance consistent with compression fracture. A bearing failure was observed on the forward face of the left lug with characteristic bearing cracks. The most prominent bearing crack extended approximately one inch upward and outboard from the lug attach hole. The lower pieces of the lugs remained with the fuselage transverse yokes. The lower pieces were darkened and had ply separations, consistent with exposure to heat and fire.

Figure 25. The aft transverse lugs on the vertical stabilizer as viewed looking upward and forward.

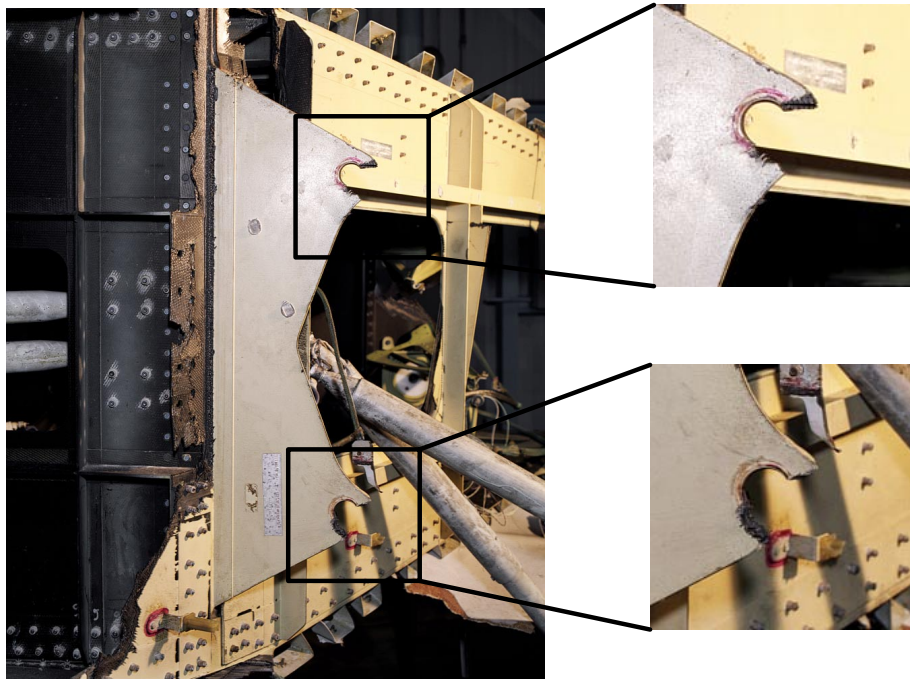
A view of the upper portion of the center transverse lugs is shown in figure 26. The translaminar fractures of the lugs intersected the lug attach holes. On the right lug, the outboard leg was fractured in a vertical plane, intersecting the bore approximately at a 90-degree angle. The inboard leg was fractured at an approximately 45-degree angle to the vertical direction, intersecting the bore approximately tangentially. On the left lug, the inboard leg was fractured in a near vertical plane, intersecting the bore approximately at a 90-degree angle. The outboard leg was fractured at an approximately 45-degree angle to the vertical direction, intersecting the bore approximately tangentially. All fracture surfaces were rough, consistent with fracture under tensile loading. The lower pieces of the lugs were not recovered.

Figure 26. The center transverse lugs on the vertical stabilizer as viewed looking upward and forward.

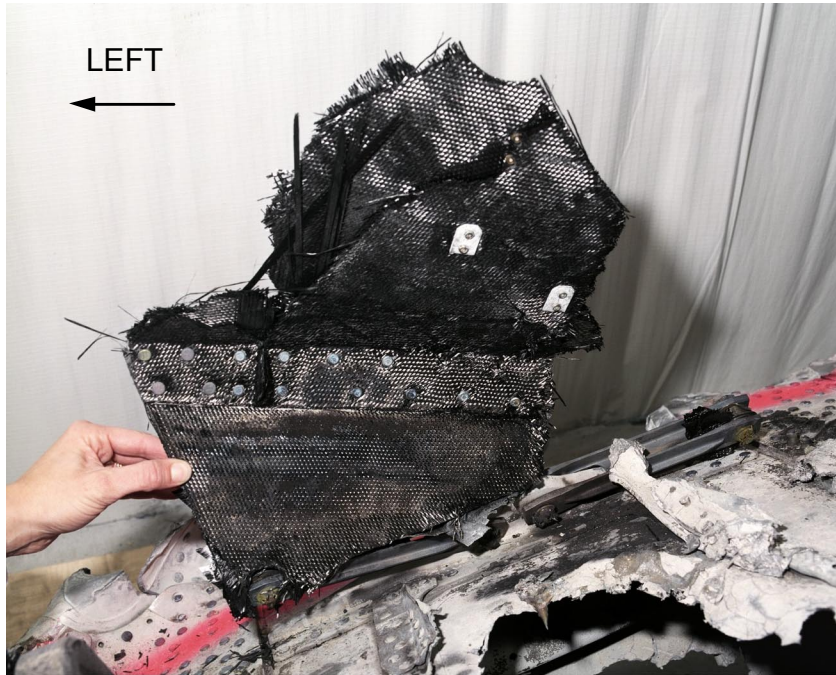
Figure 27. A piece of the forward spar that remained attached to the fuselage as viewed looking forward. The piece is heavily damaged by heat and fire.

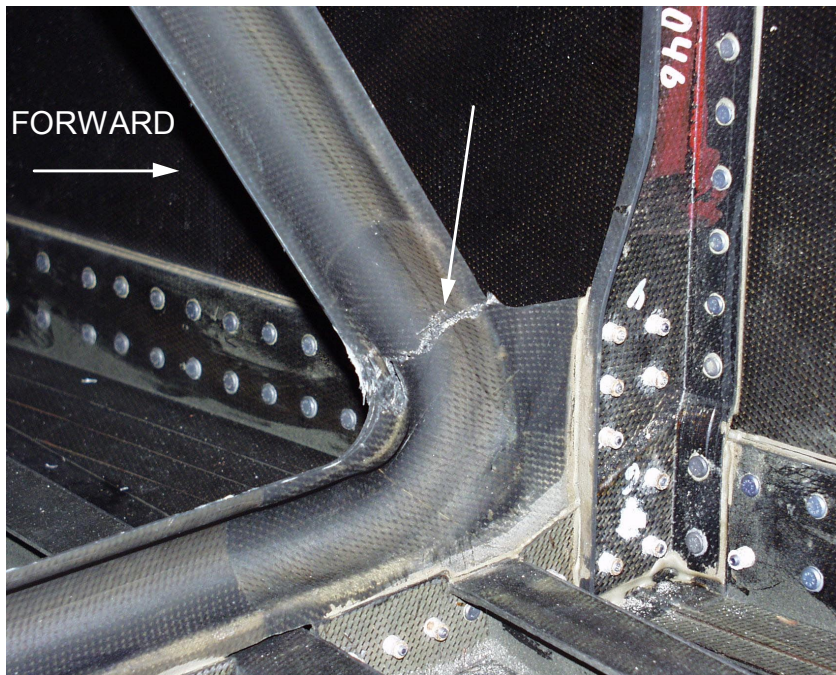
The rib 3 forward section left hand diagonal channel was fractured at the front spar/skin panel junction as shown in figure 28.

Figure 28. An unlabeled arrow indicates the fracture in the rib 3 diagonal channel as viewed from below.

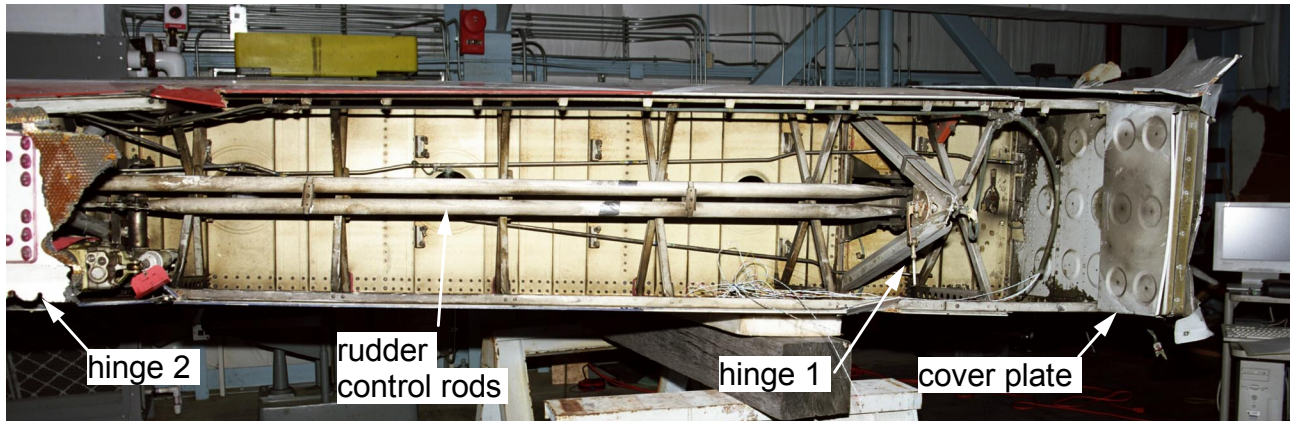
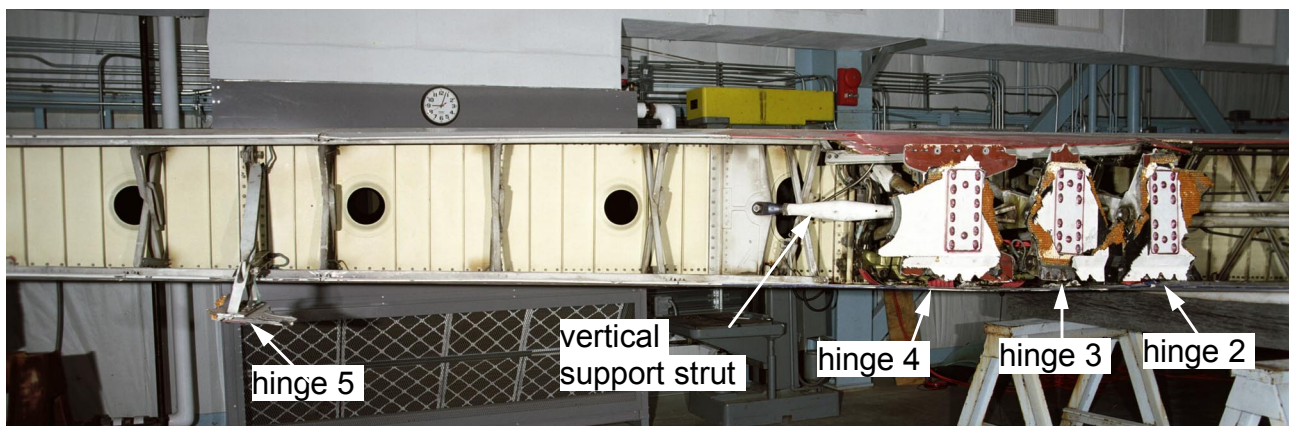
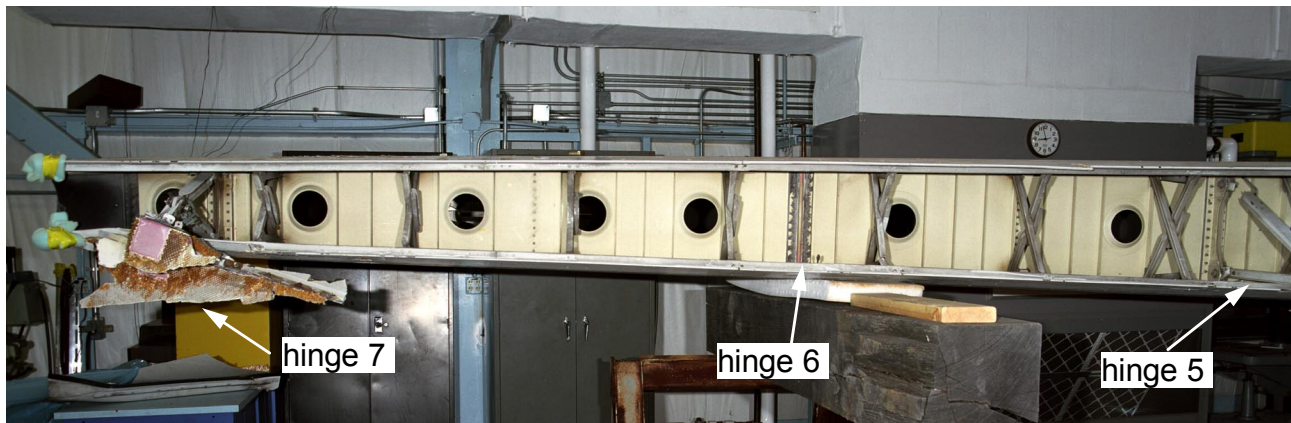
Figure 29. Overall views of the vertical stabilizer trailing edge.
