NATIONAL TRANSPORTATION SAFETY BOARD

MATERIALS LABORATORY FACTUAL REPORT

Report No. 02-077

Place : Belle Harbor, New York
Date : November 12, 2001
Vehicle : Airbus A300-600, N14053
NTSB No. : DCA02MA001
Investigator : Brian Murphy, AS-40

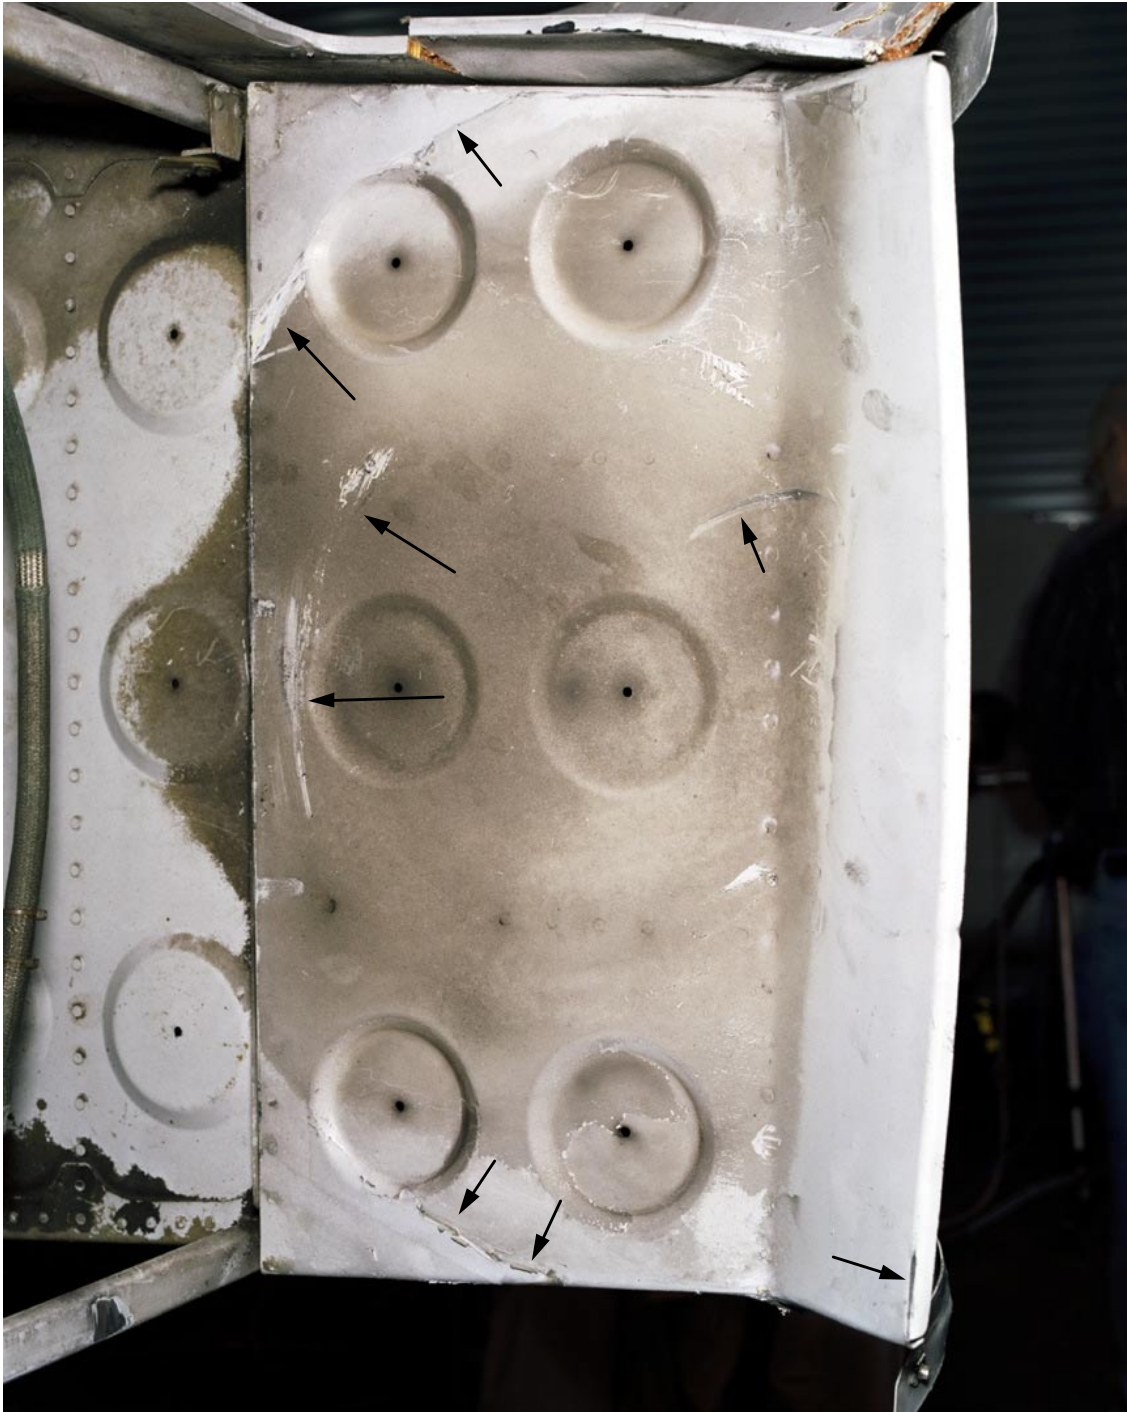
Figure 30. View of the damaged metal cover plate at the lower end of the hingeline on the vertical stabilizer. Unlabeled arrows indicate witness marks that correspond to contact with the lower end of the LE fairing and the fairing lower metal closure.

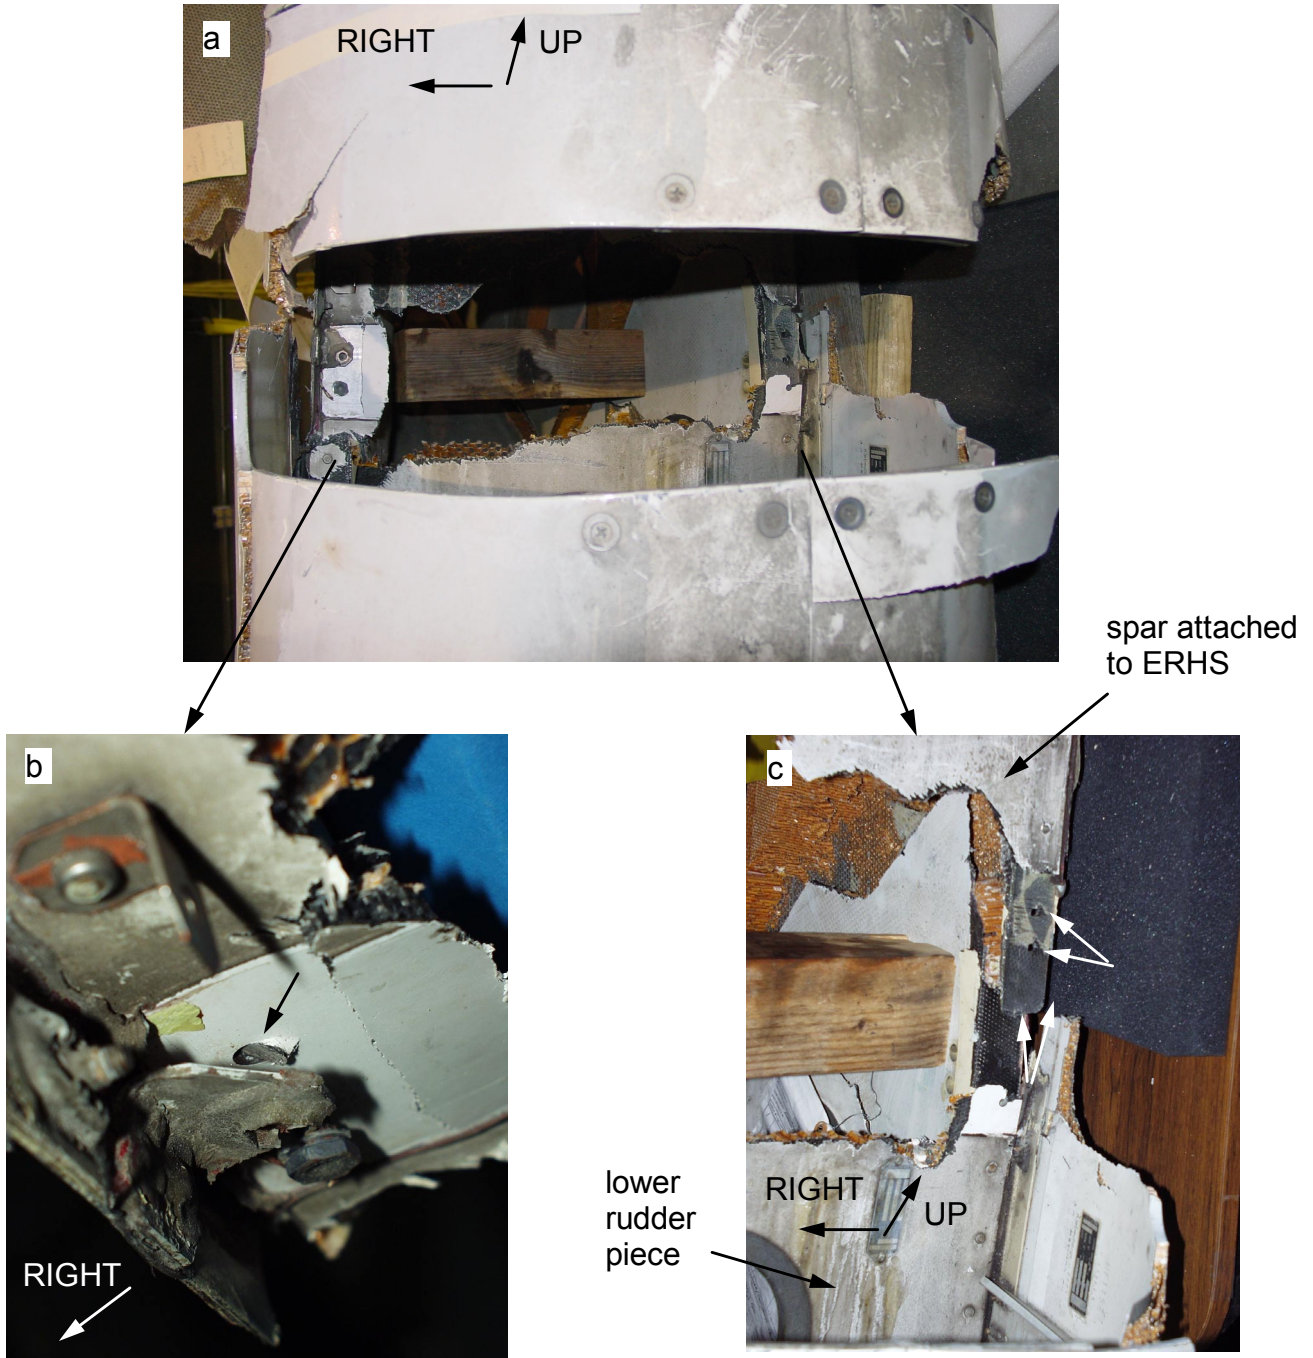
Figure 31. (a) View of hinge 1 aft fitting attach area at the rudder leading edge. (b) Right and (c) left attach bolt areas are shown in detail. The unlabeled arrow in (b) indicates the sheared aft fitting attach bolt. The unlabeled arrows in (c) indicate portions of the left attachment bolt holes in the spar that remained attached to panel ERHS and to the lower piece of the rudder.

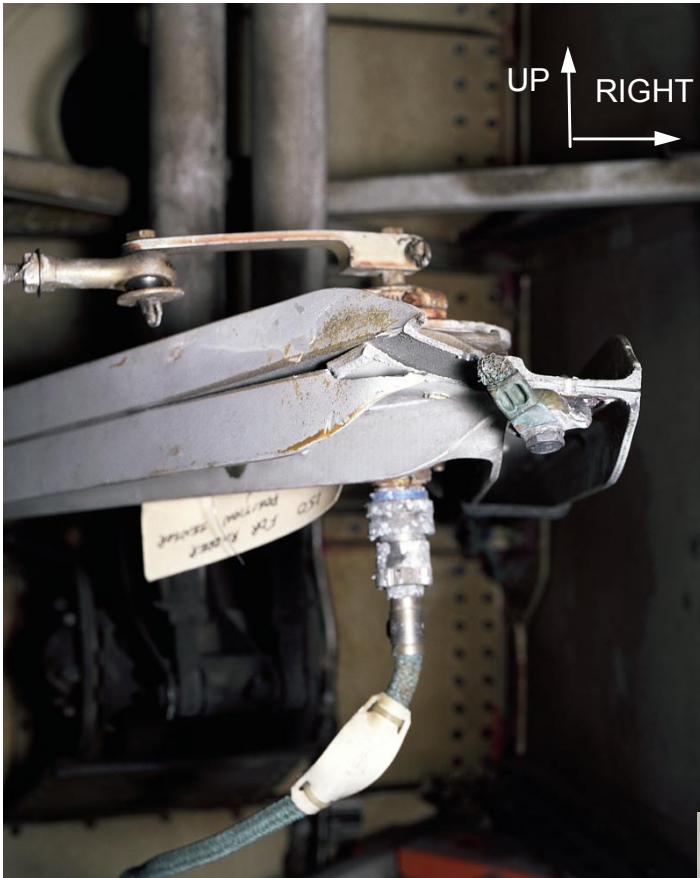
Figure 32. Closer view of the hinge 1 forward fitting fracture.

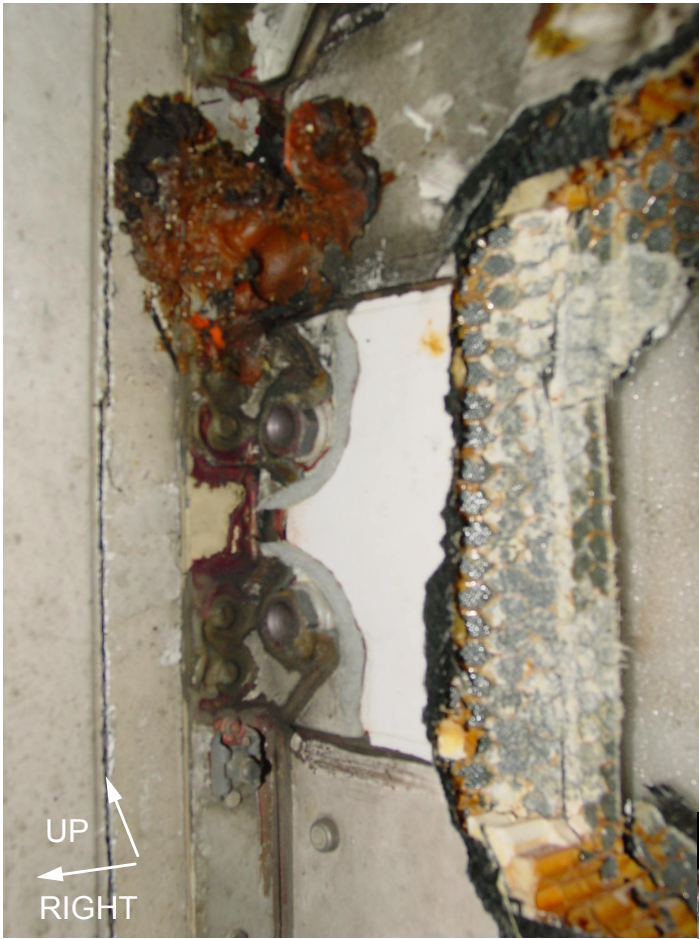
Figure 34. View of the right hinge 3 aft fitting pieces that remained attached to the rudder.

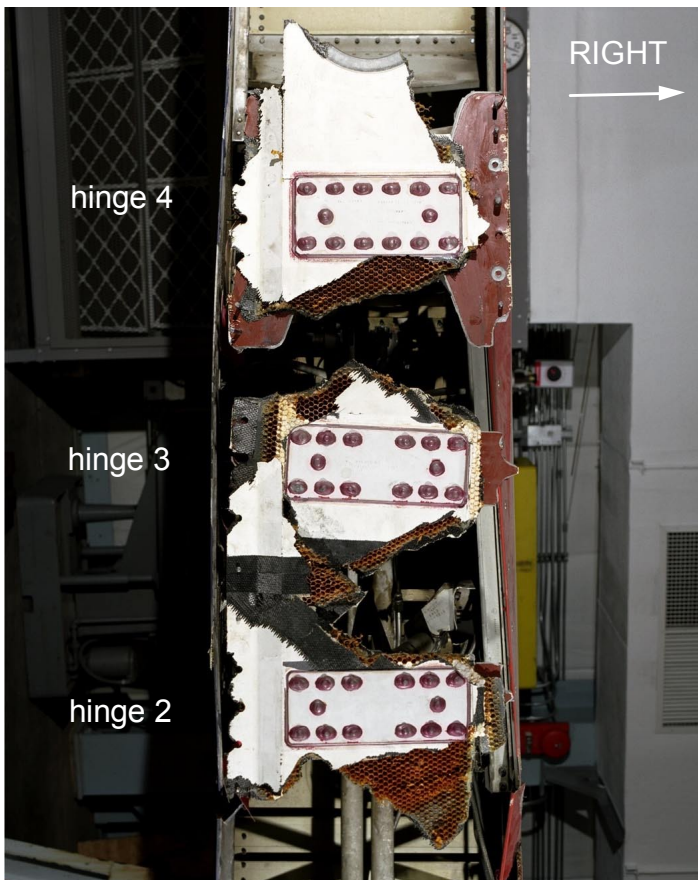
Figure 37. The hinge 2 to 4 fittings and attached rudder spar pieces that remained attached to the vertical stabilizer as viewed looking forward.

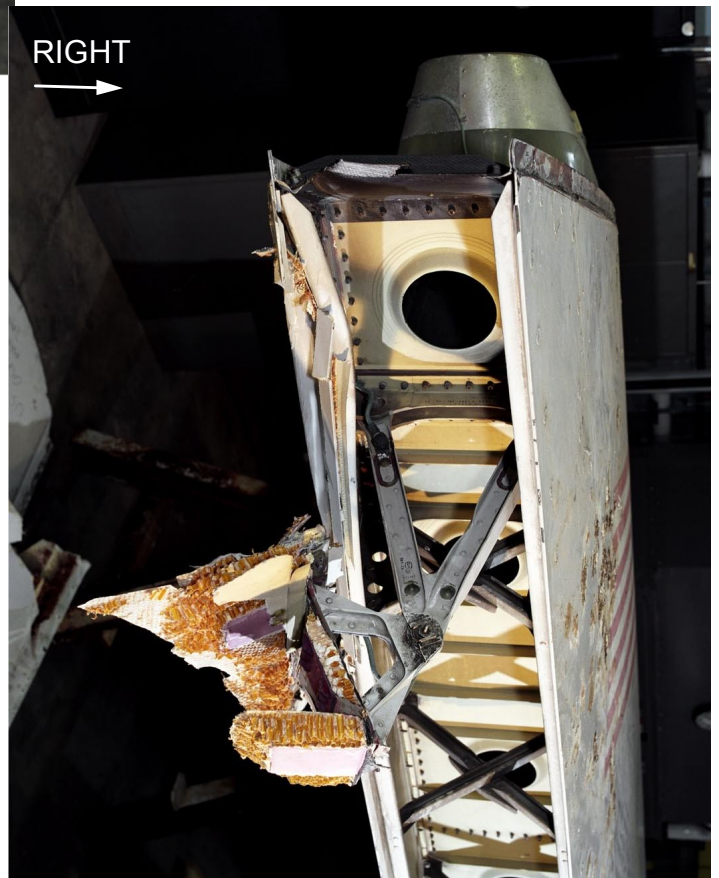
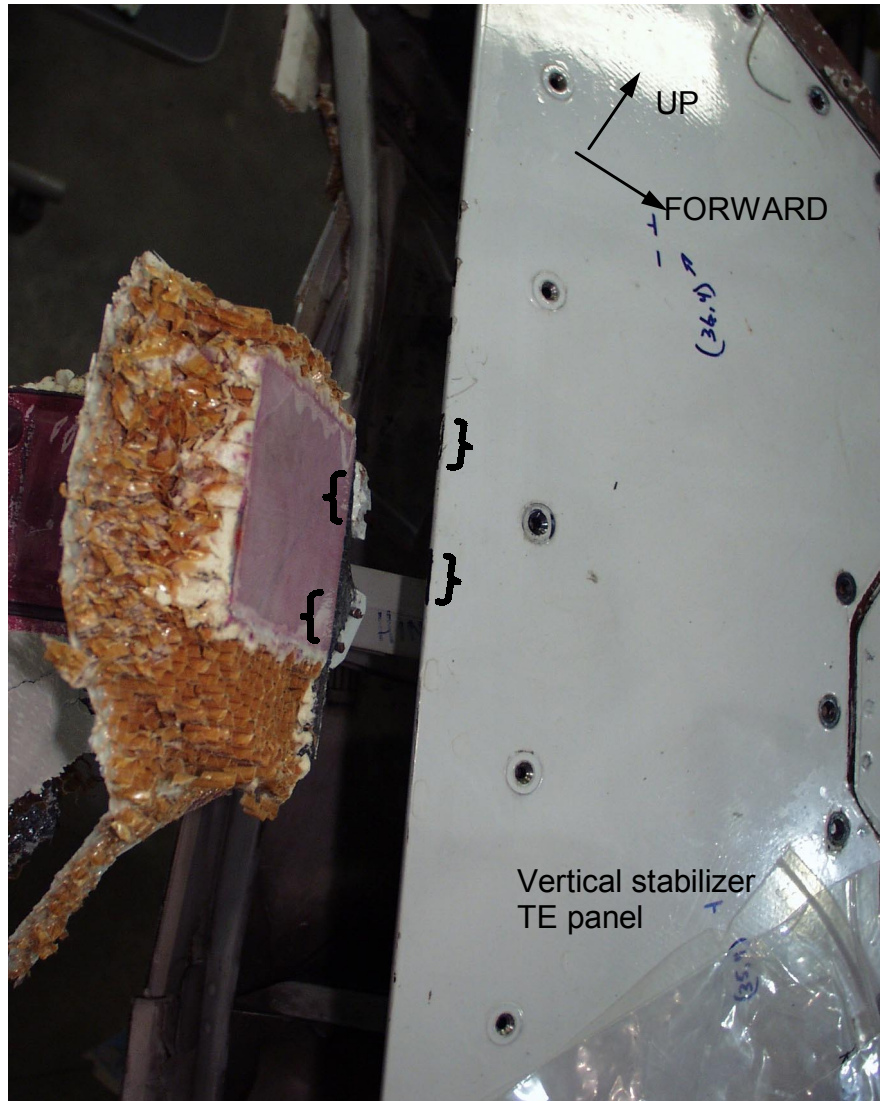
Figure 44. The hinge 7 fittings and attached rudder pieces that remained attached to the vertical stabilizer as viewed looking forward.

Figure 45. Another view of the hinge 7 fitting from the right side. Brackets indicate fractured and deformed angle brackets on the aft fitting and corresponding marks on the vertical stabilizer TE panel. Note that fasteners for the TE panel were removed.

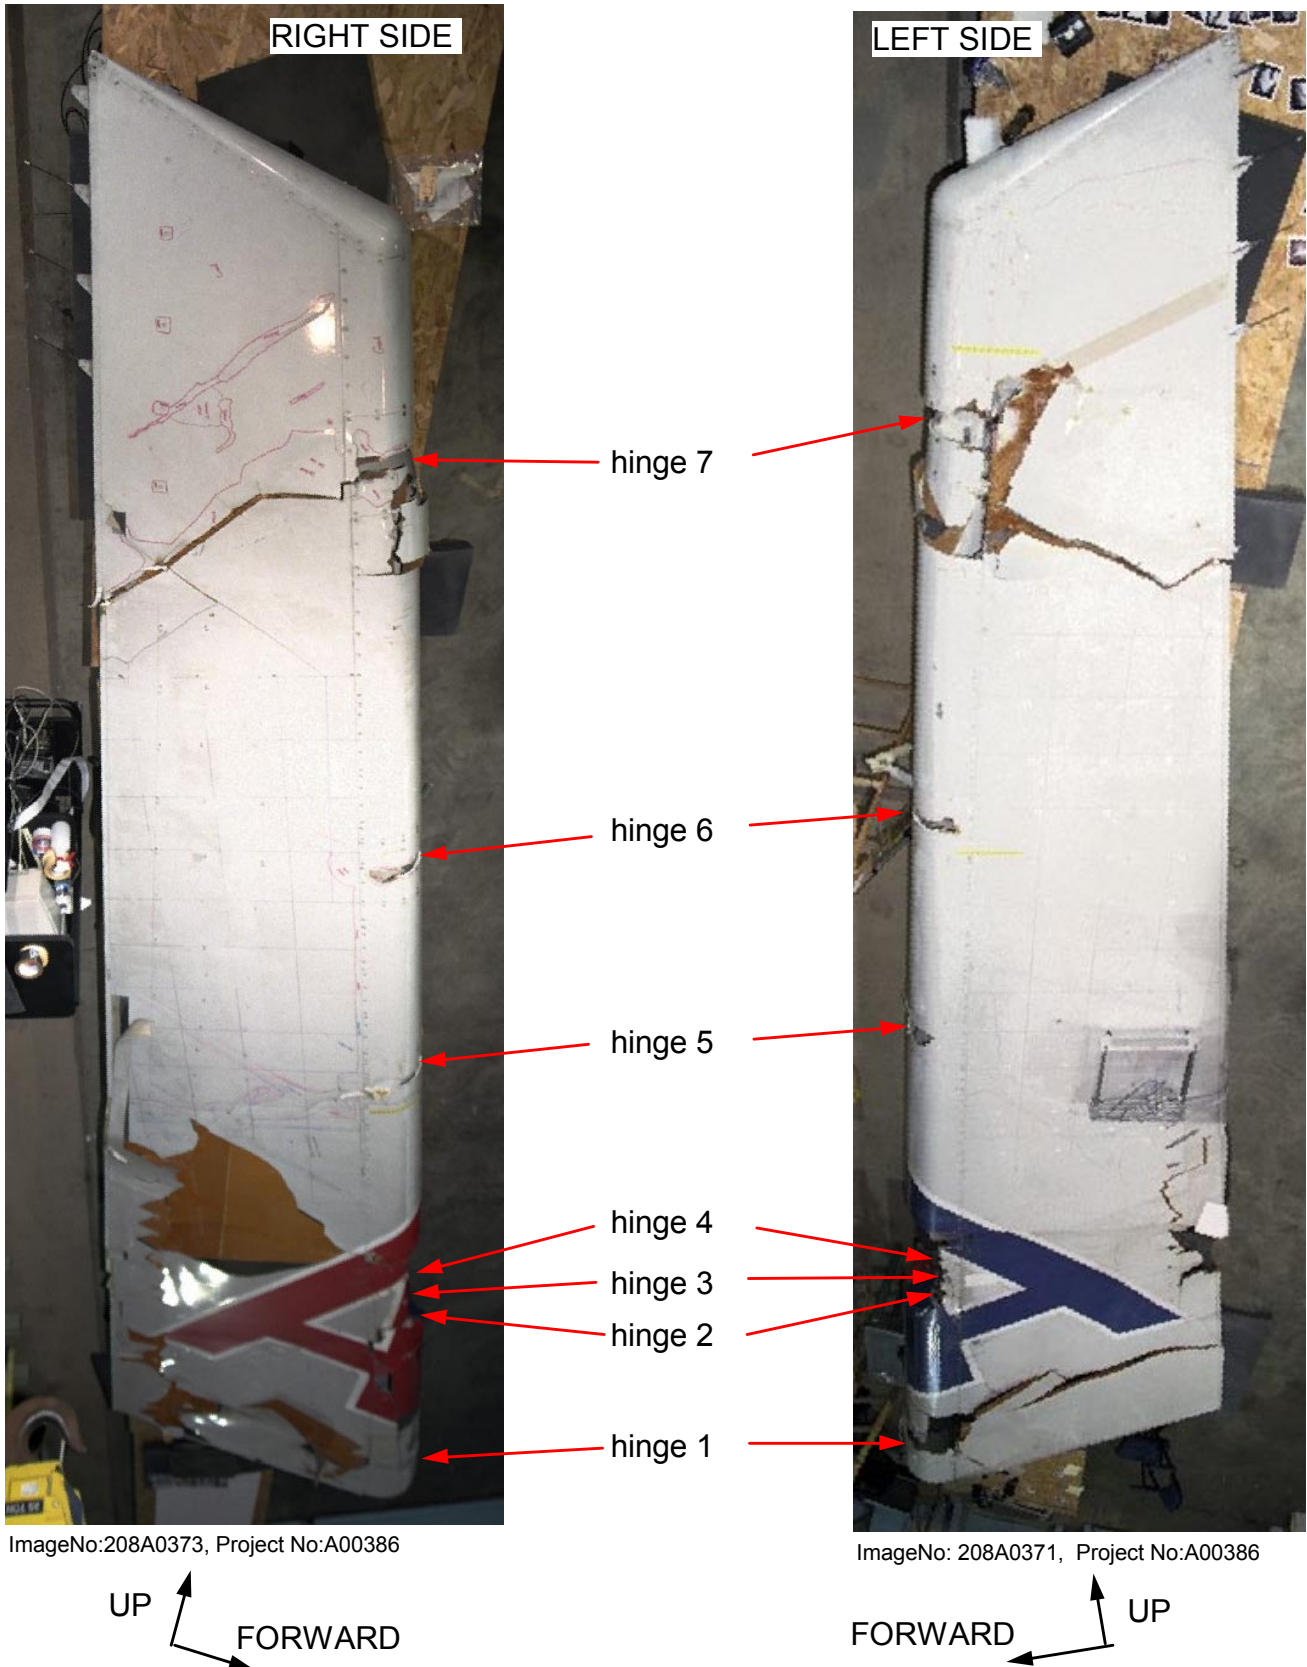
Figure 46. Overall view of the right and left sides of the rudder as viewed from above. With this perspective, the upper and lower ends appear larger and smaller, respectively. Lamb wave equipment used for nondestructive examination is shown on the left skin panel.

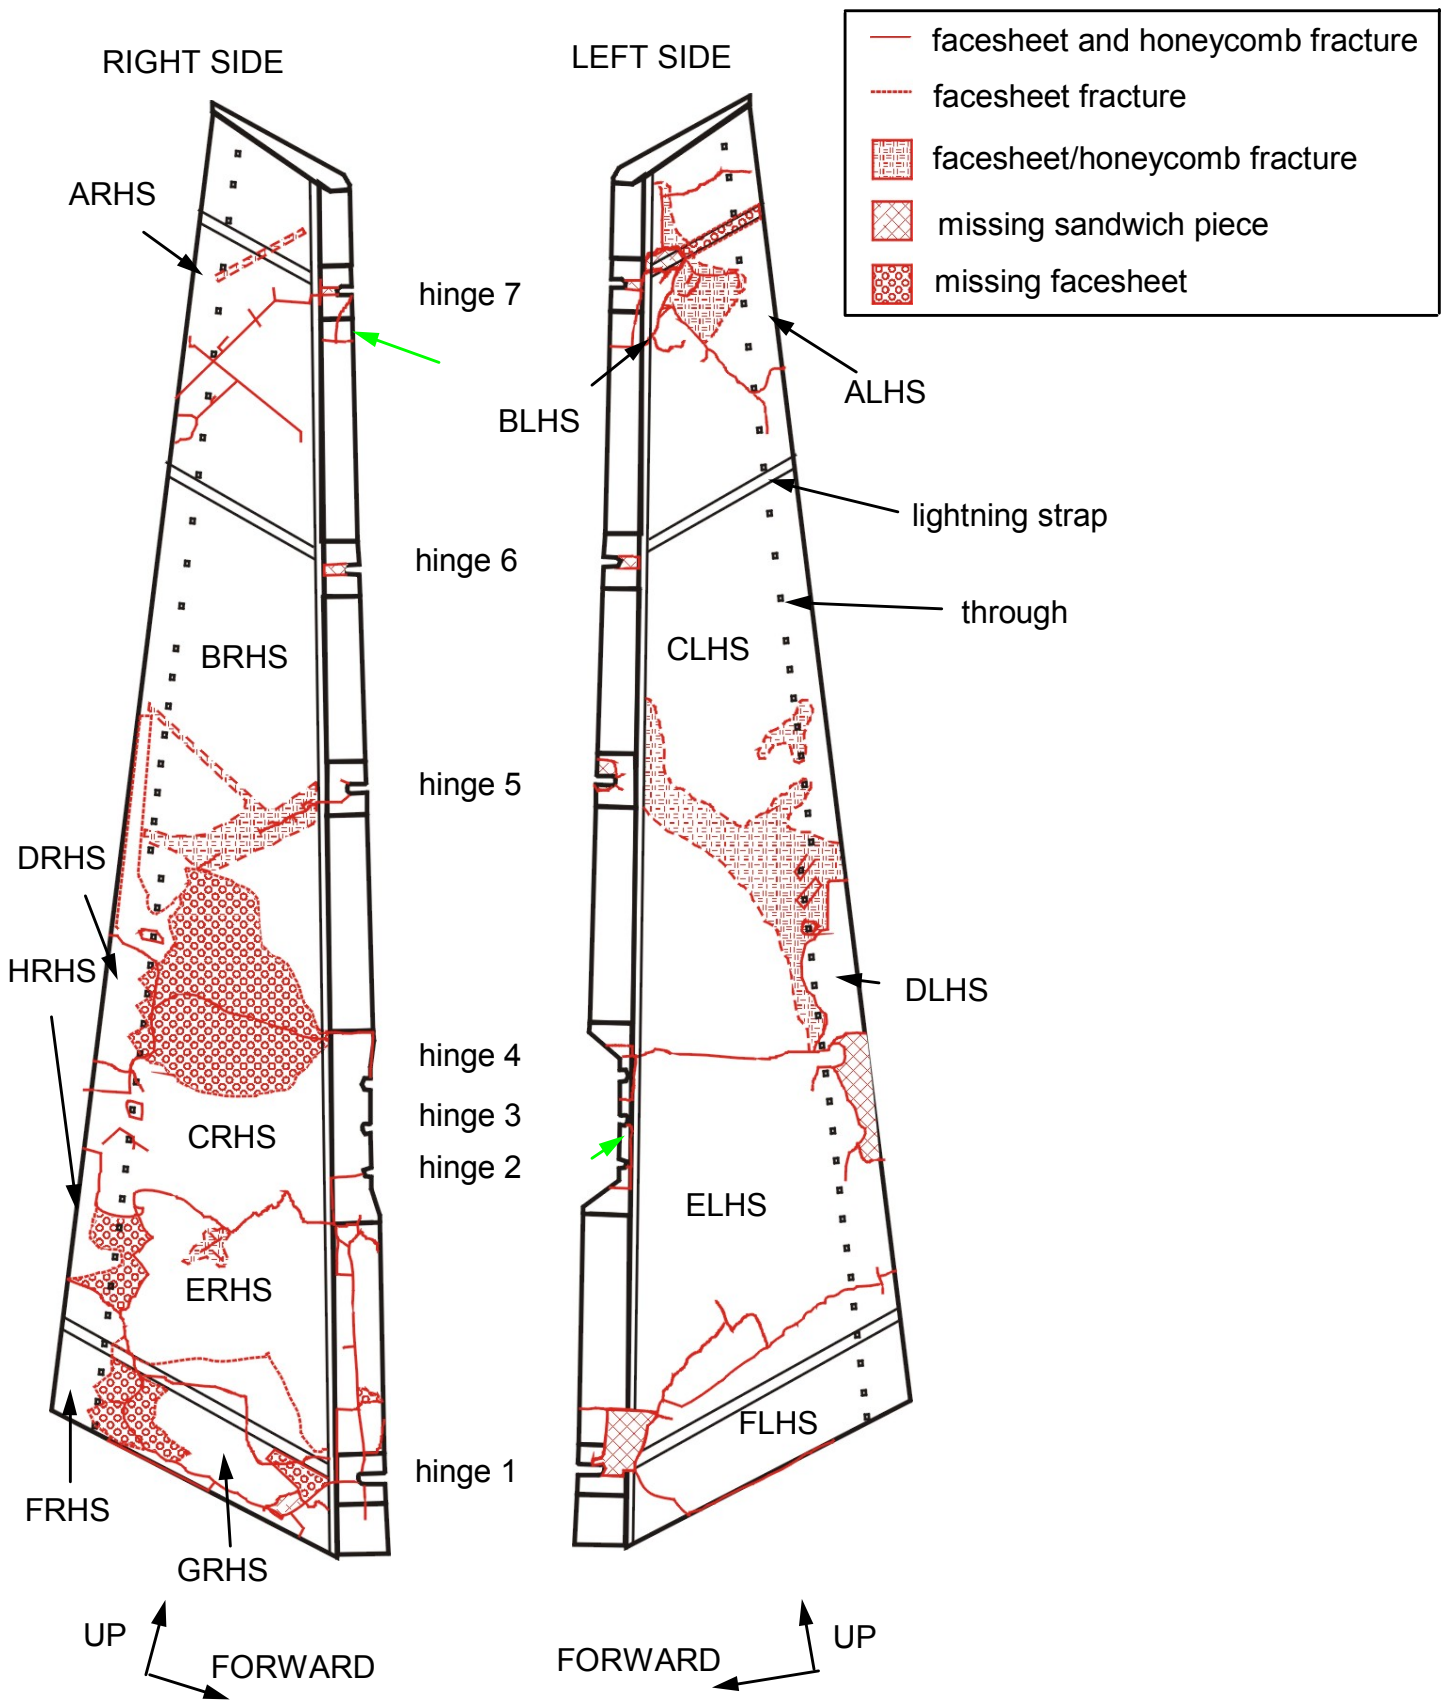
Figure 47. Drawings of the right and left sides of the rudder showing the approximate locations of fractures and missing pieces. Unlabeled green arrows indicate fairing pieces that were found on land. Piece GRHS was also found on land.

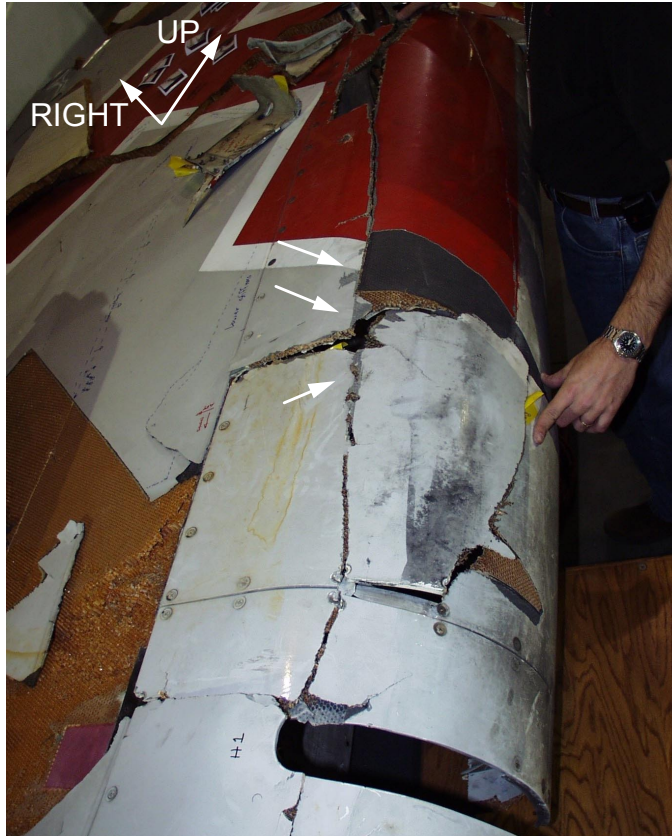
Figure 49. View of the right side of the LE fairing at hinge 1 and up to just below hinge 2. Unlabeled arrows indicate where scuffing damage adjacent to the nearly spanwise fracture was greatest.

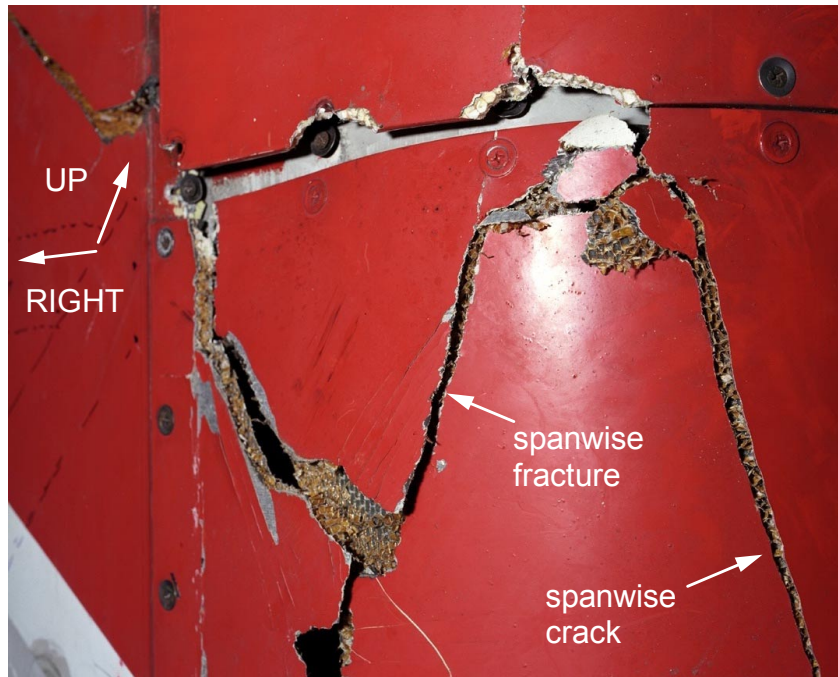
Figure 50. View of the upper ends of the nearly spanwise fracture and crack on the rudder LE fairing right side just below hinge 2.

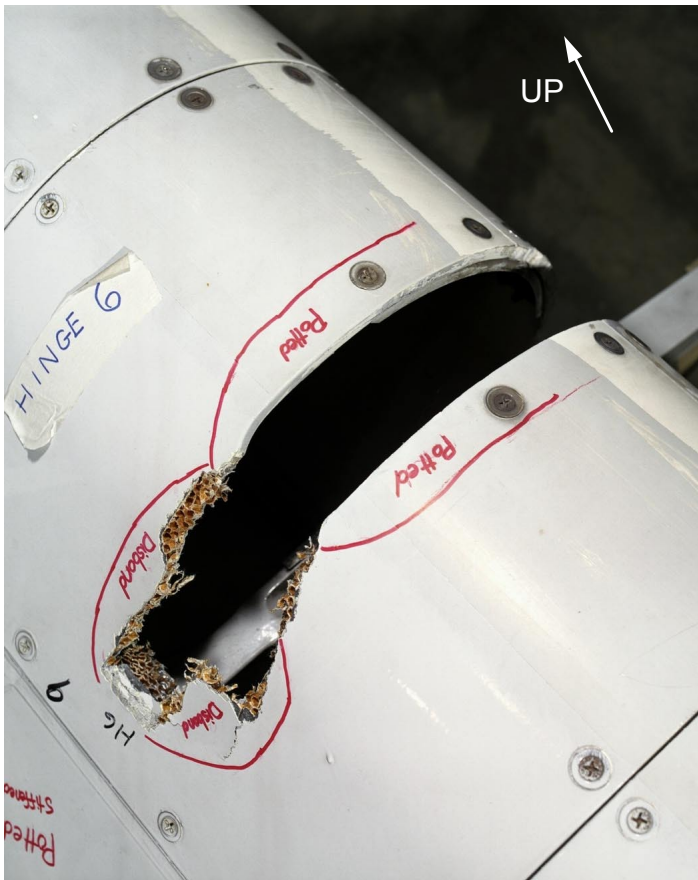
Figure 54. View of the right side of the LE fairing at hinge 6 showing damage to the right cutout end.

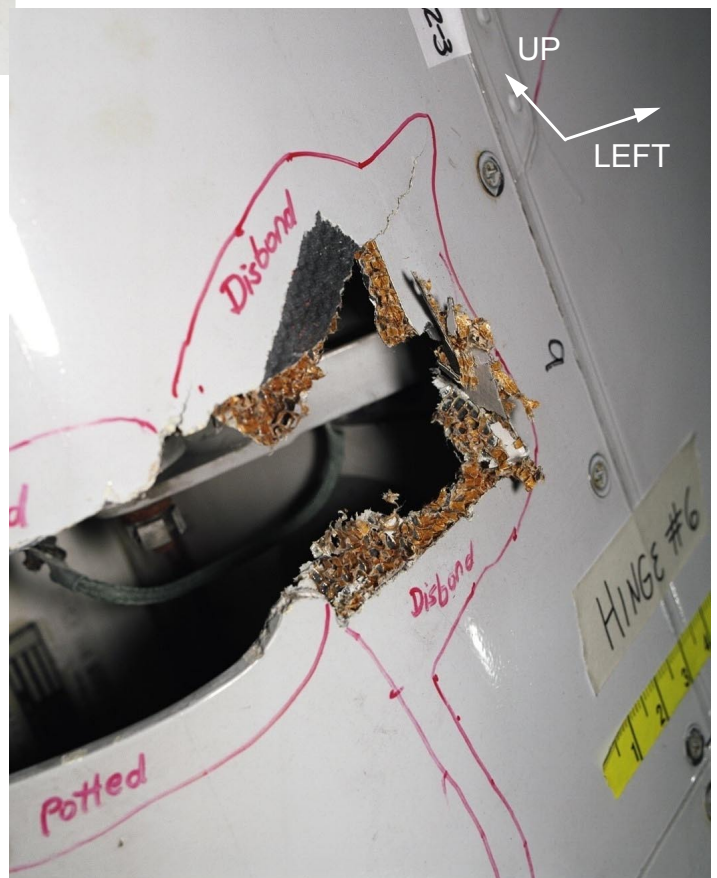
Figure 55. View of the left side of the LE fairing at hinge 6 showing damage to the left cutout end.

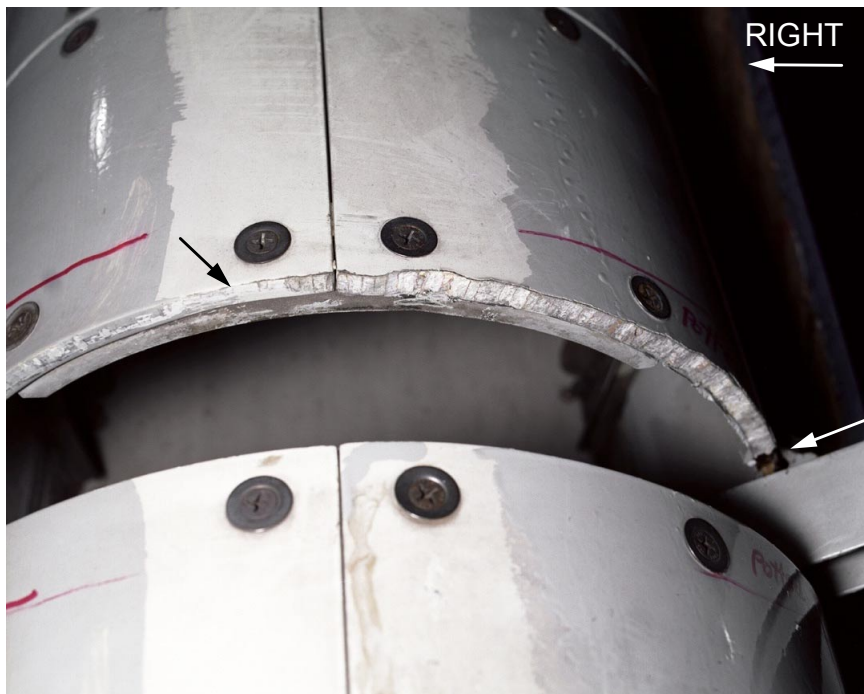
Figure 56. View of the upper side of the hinge 6 rudder LE cutout. Continuous heavy damage was observed between the unlabeled arrows.

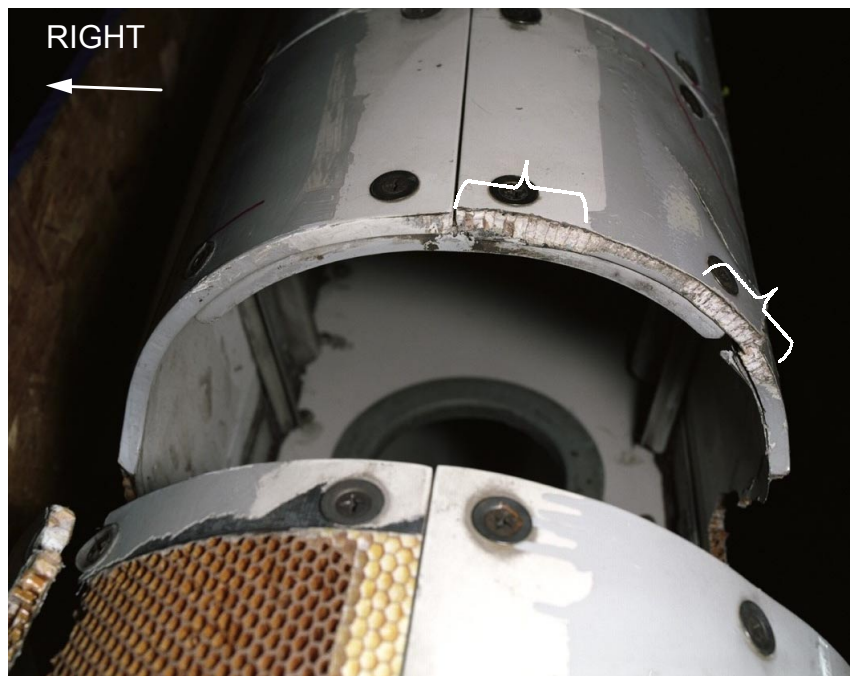
Figure 58. View of the upper side of the hinge 7 LE fairing cutout. Brackets indicate areas of damage on the left side.

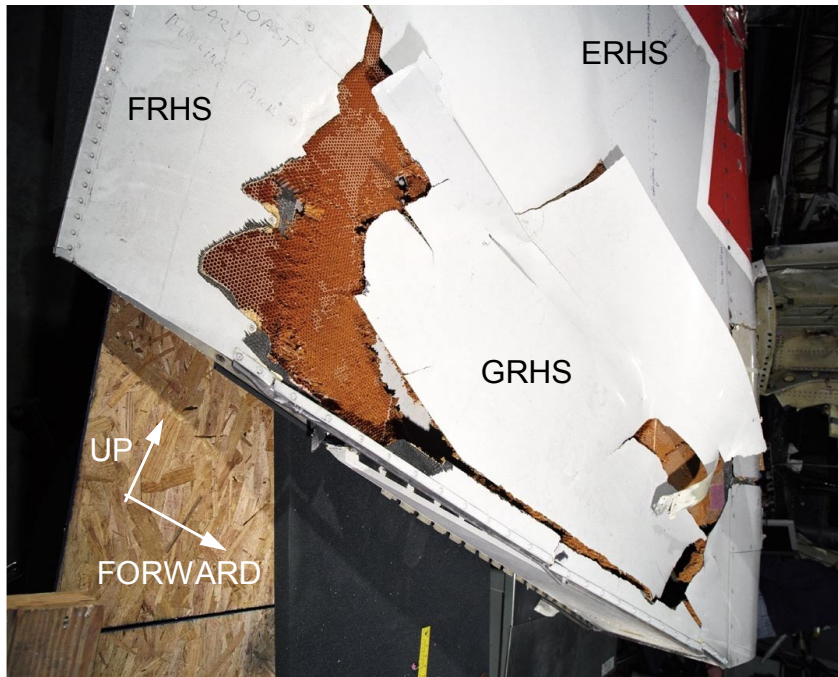
Figure 59. Closer view of the fractures at the right side lower end of the rudder.

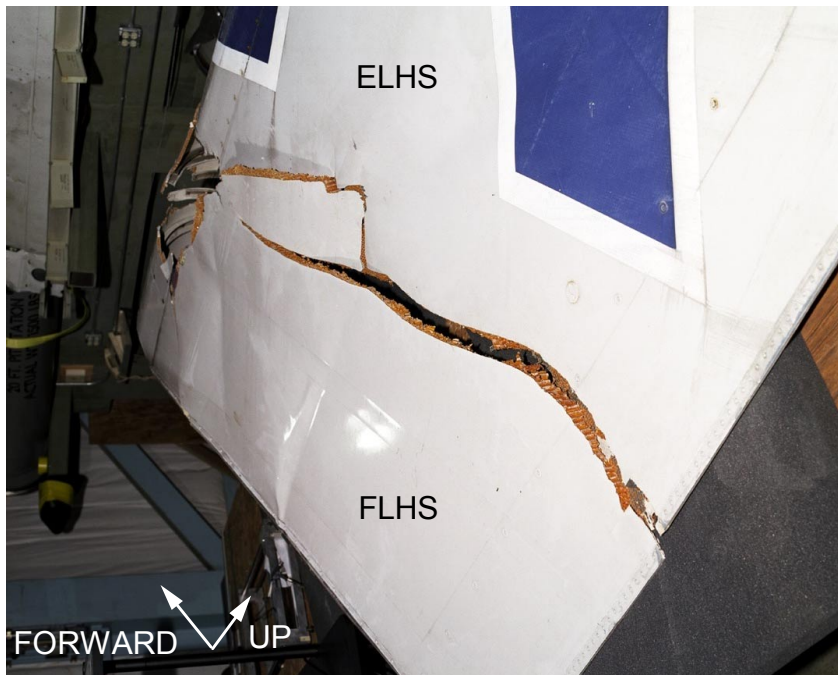
Figure 60. Closer view of the fractures on the left side lower end of the rudder.

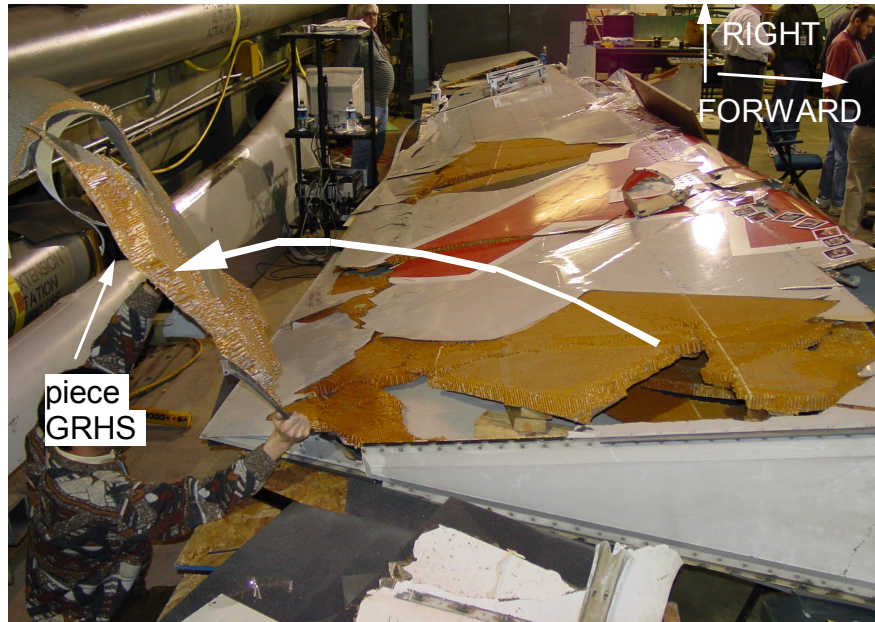
Figure 61. View of the right side of the lower end of the rudder showing fracture matching of the lower metal retaining strip. The curved arrow indicates the motion of piece GRHS relative to the aft piece of the retaining strip.

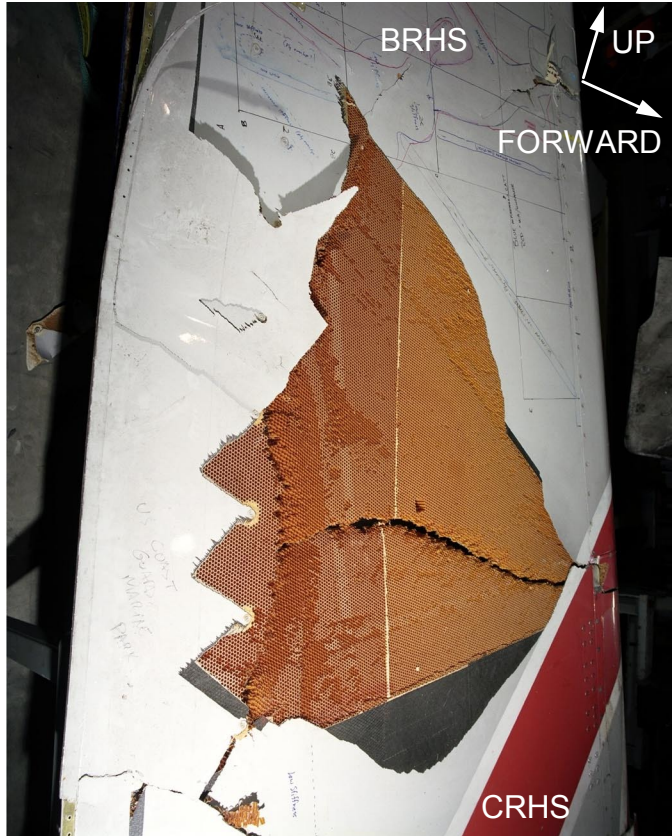
Figure 62. View of the fracture where the external facesheet was missing from the right side at the lower end of piece BRHS and the upper end of piece CRHS.

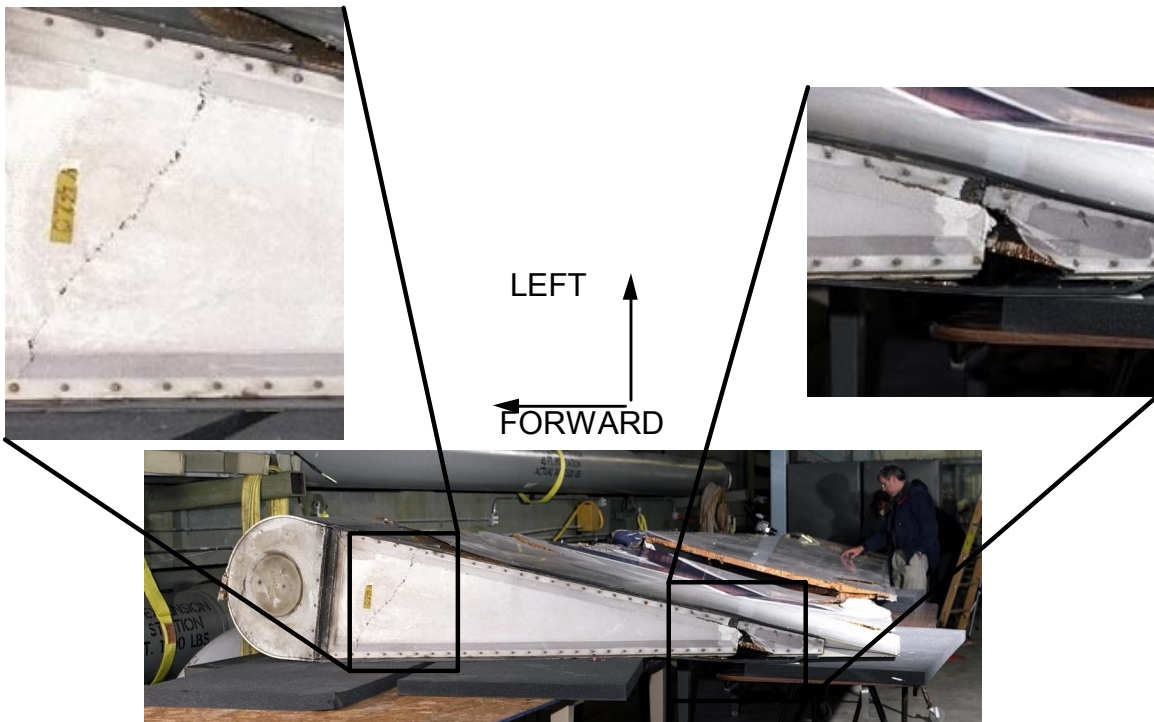
Figure 69. Overall view of the lower rib of the rudder with details showing the compression fracture near the forward spar and the fracture near the trailing edge.
