INSPECTION PROTOCOL

Subject: Fin box and rudder inspection on aircraft A300-600, MSN 420 at NASA Langley Research Center in Hampton, Virginia / USA.

Title: Ultrasonic PHASED ARRAY inspection of vertical stabilizer A300-600 MSN 420, concerning delamination in the area of CFRP-stringers and CFRP-ribs.

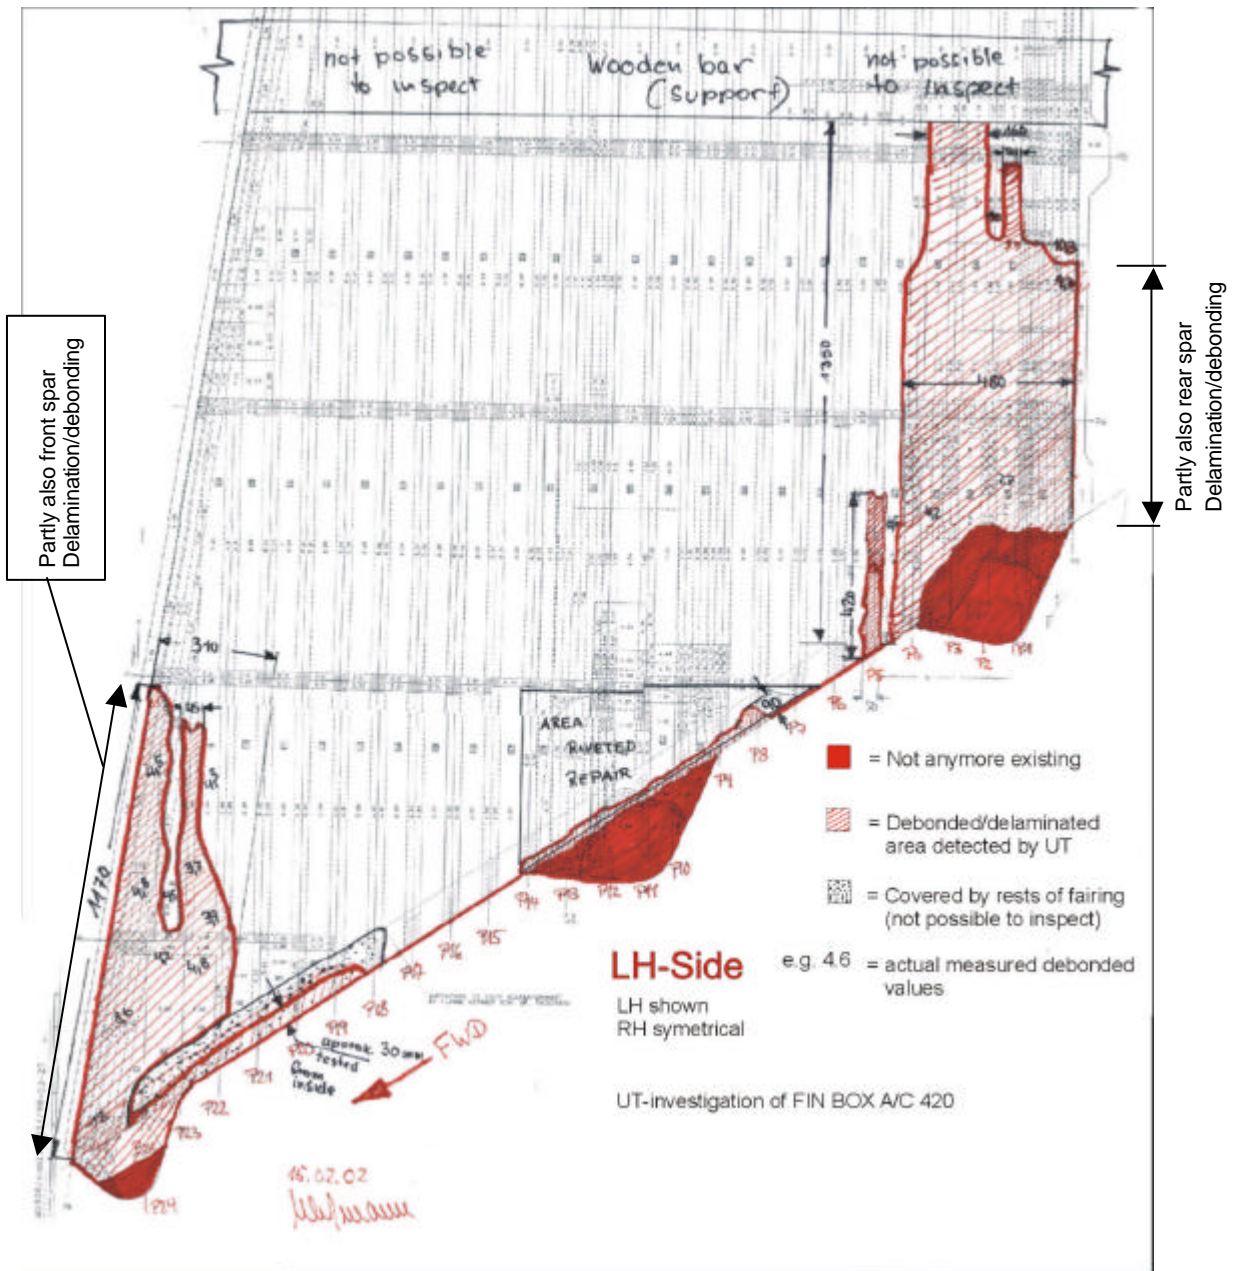
Fig.02: Test Results of Lug region from LH-side and shell above the lugs

NDI-results: Fin box
(ESWNG) - Debondings, Delaminations and Damages were found in the lower part of fin box in the structure of lugs region, in the rib no. 1 area and in spar areas (front/center/rear).
 - No findings in the hinge connection areas

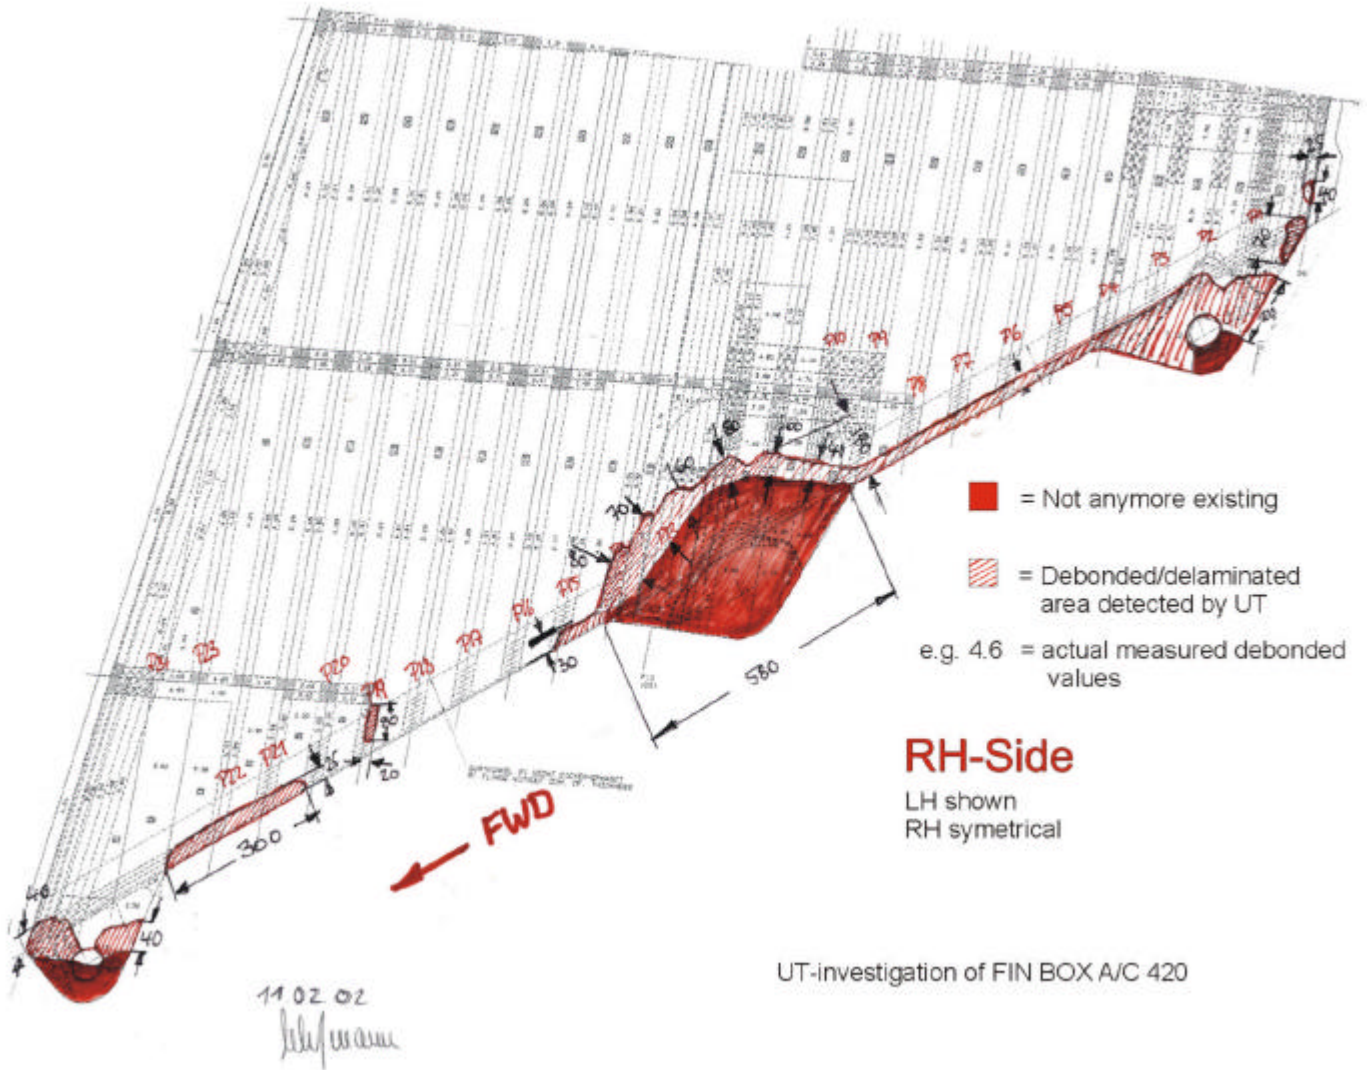
FIG. 03: Test Results of Lug region from RH-side and shell above the lugs

- (b1) Front Spar /Stiffener No. 1 (see also photo no. 1)
 ! Length Dimension of debondings between Skin and Front Spar angle are illustrated in Fig. 02/03

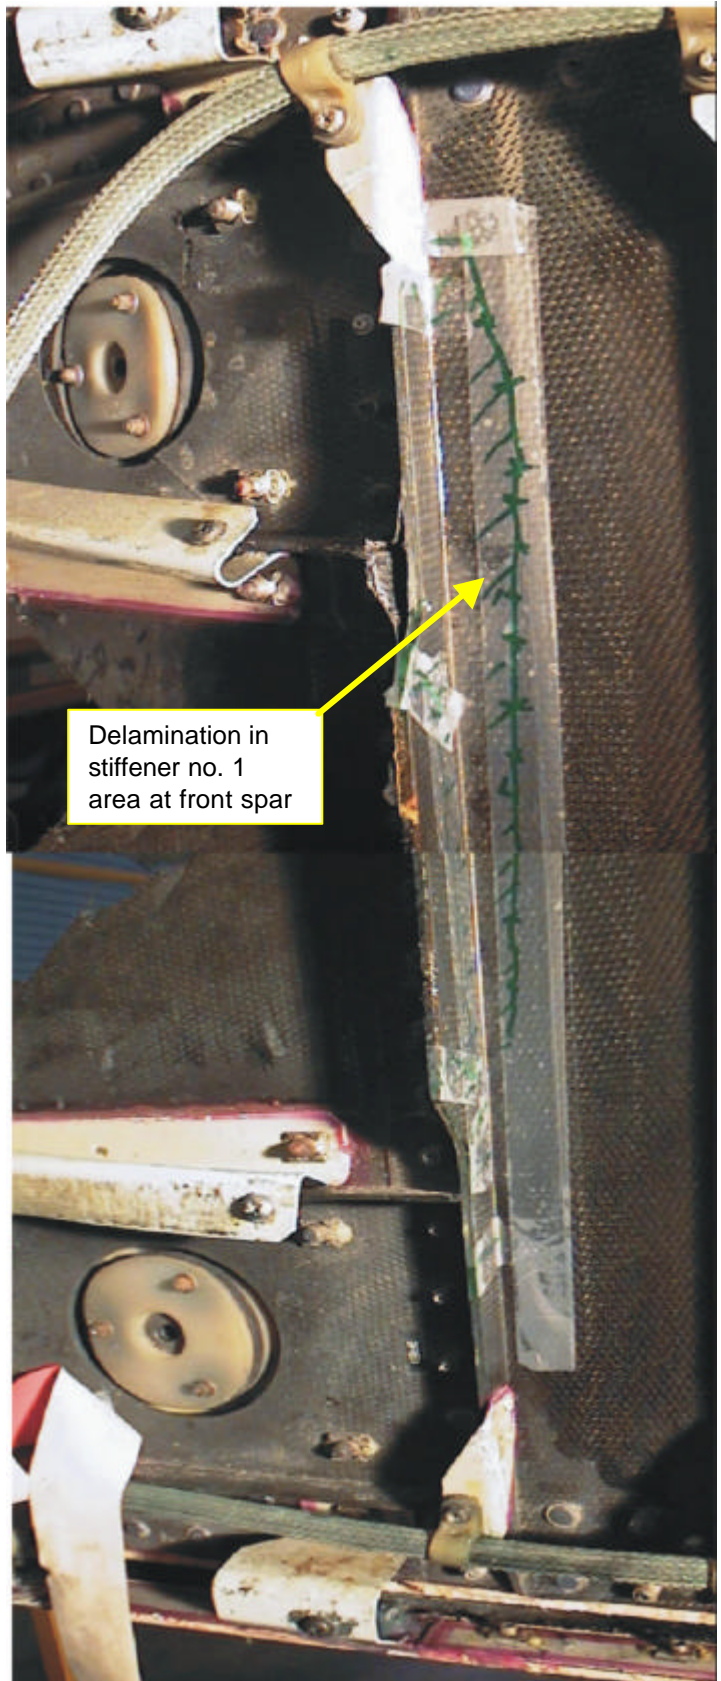
Photo no. 01: Delamination at front spar; stiffener no. 1

Delamination in stiffener no. 1 area at front spar

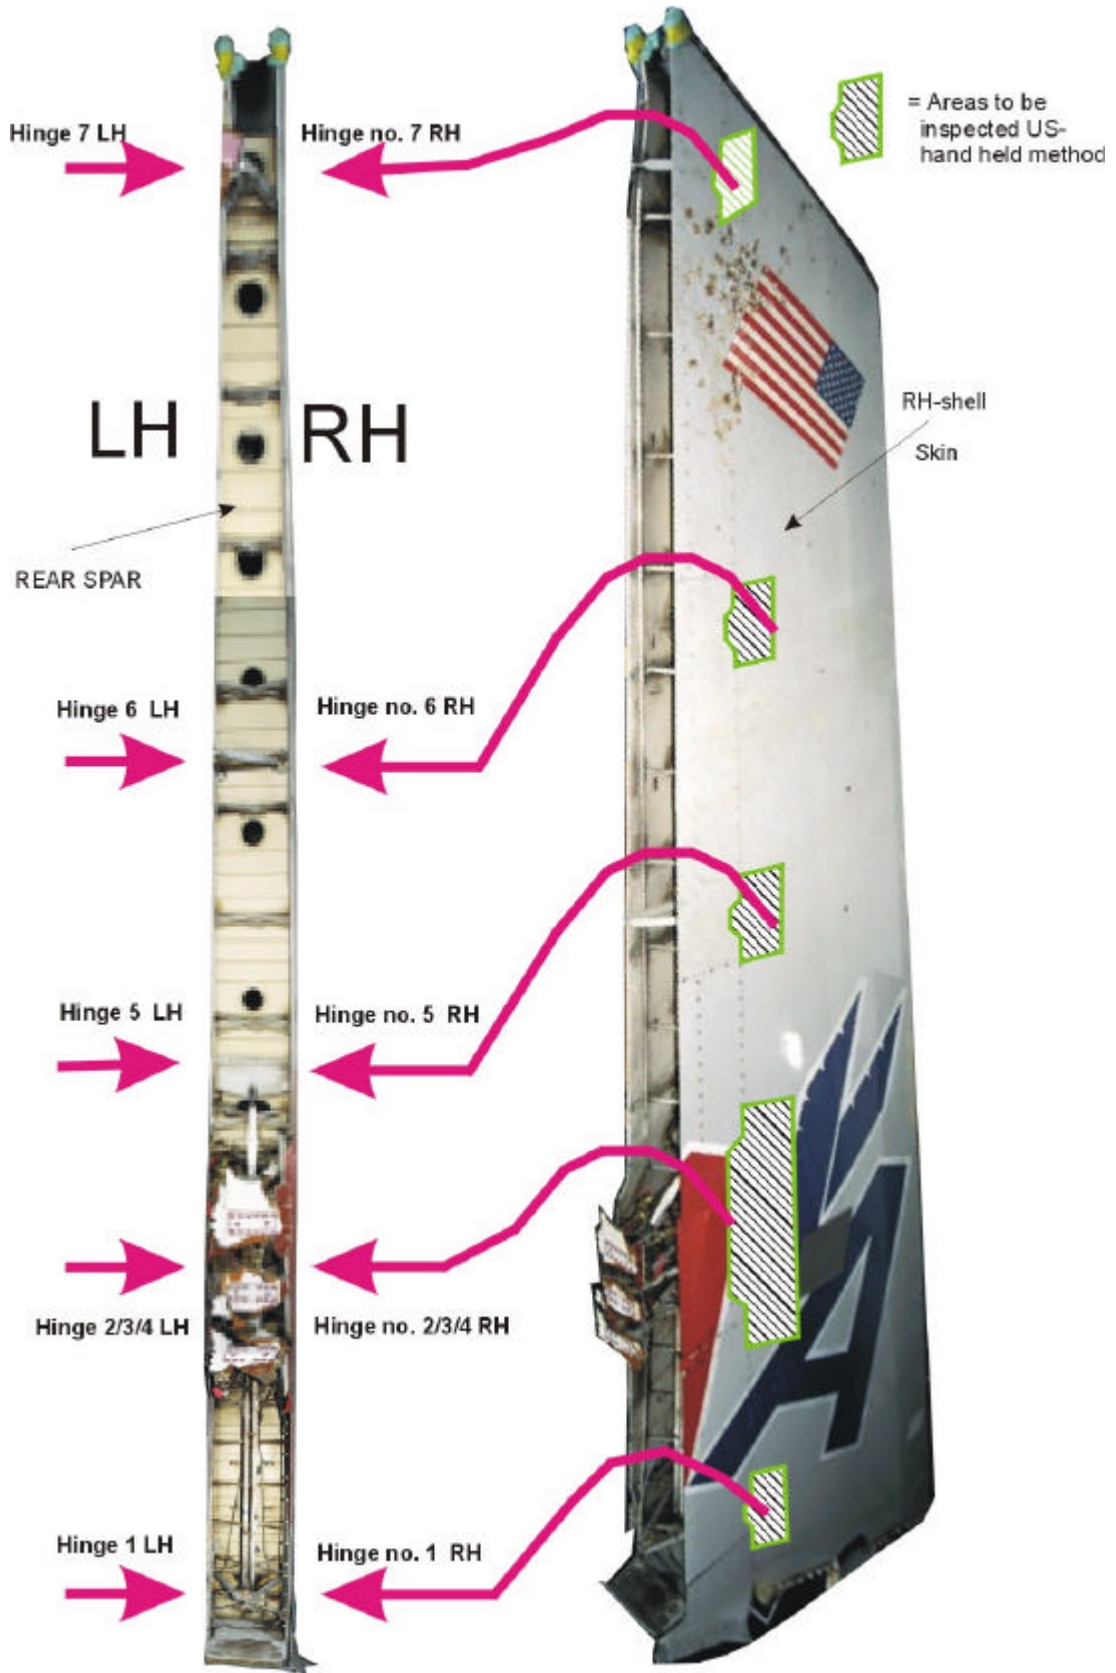
Fig no. 07 : Hinge connection areas to be inspected

On RH-side and LH-side within the hinge connection the areas in shell have been inspected completely in a distance of $\pm 200\text{mm}$ from hinge center line.

Based on still partly attached rear fairing on left hand side the inspection of these covered areas could not be performed. All other rear fairing attachment areas were inspected .

Test result: **NO DELAMINATIONS** in the inspected areas.

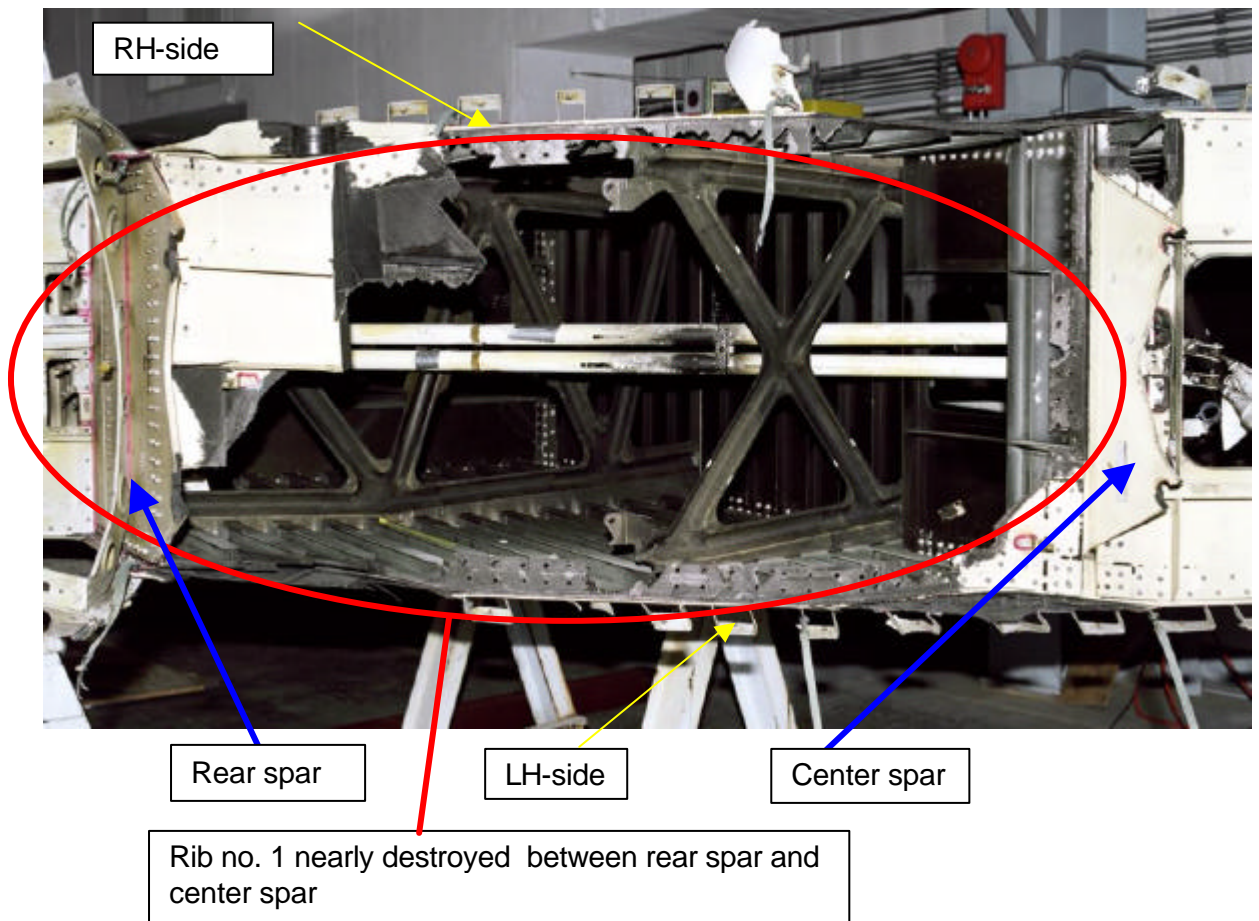
Photo no. 03: View of destroyed rib no.1 between rear spar position and center spar position

(d1) The rib no. 1 was nearly complete destroyed in area between Rear Spar position and Center Spar position therefor a UT-inspection made no sense in the still present parts.
(Refer to Photo no. 3)

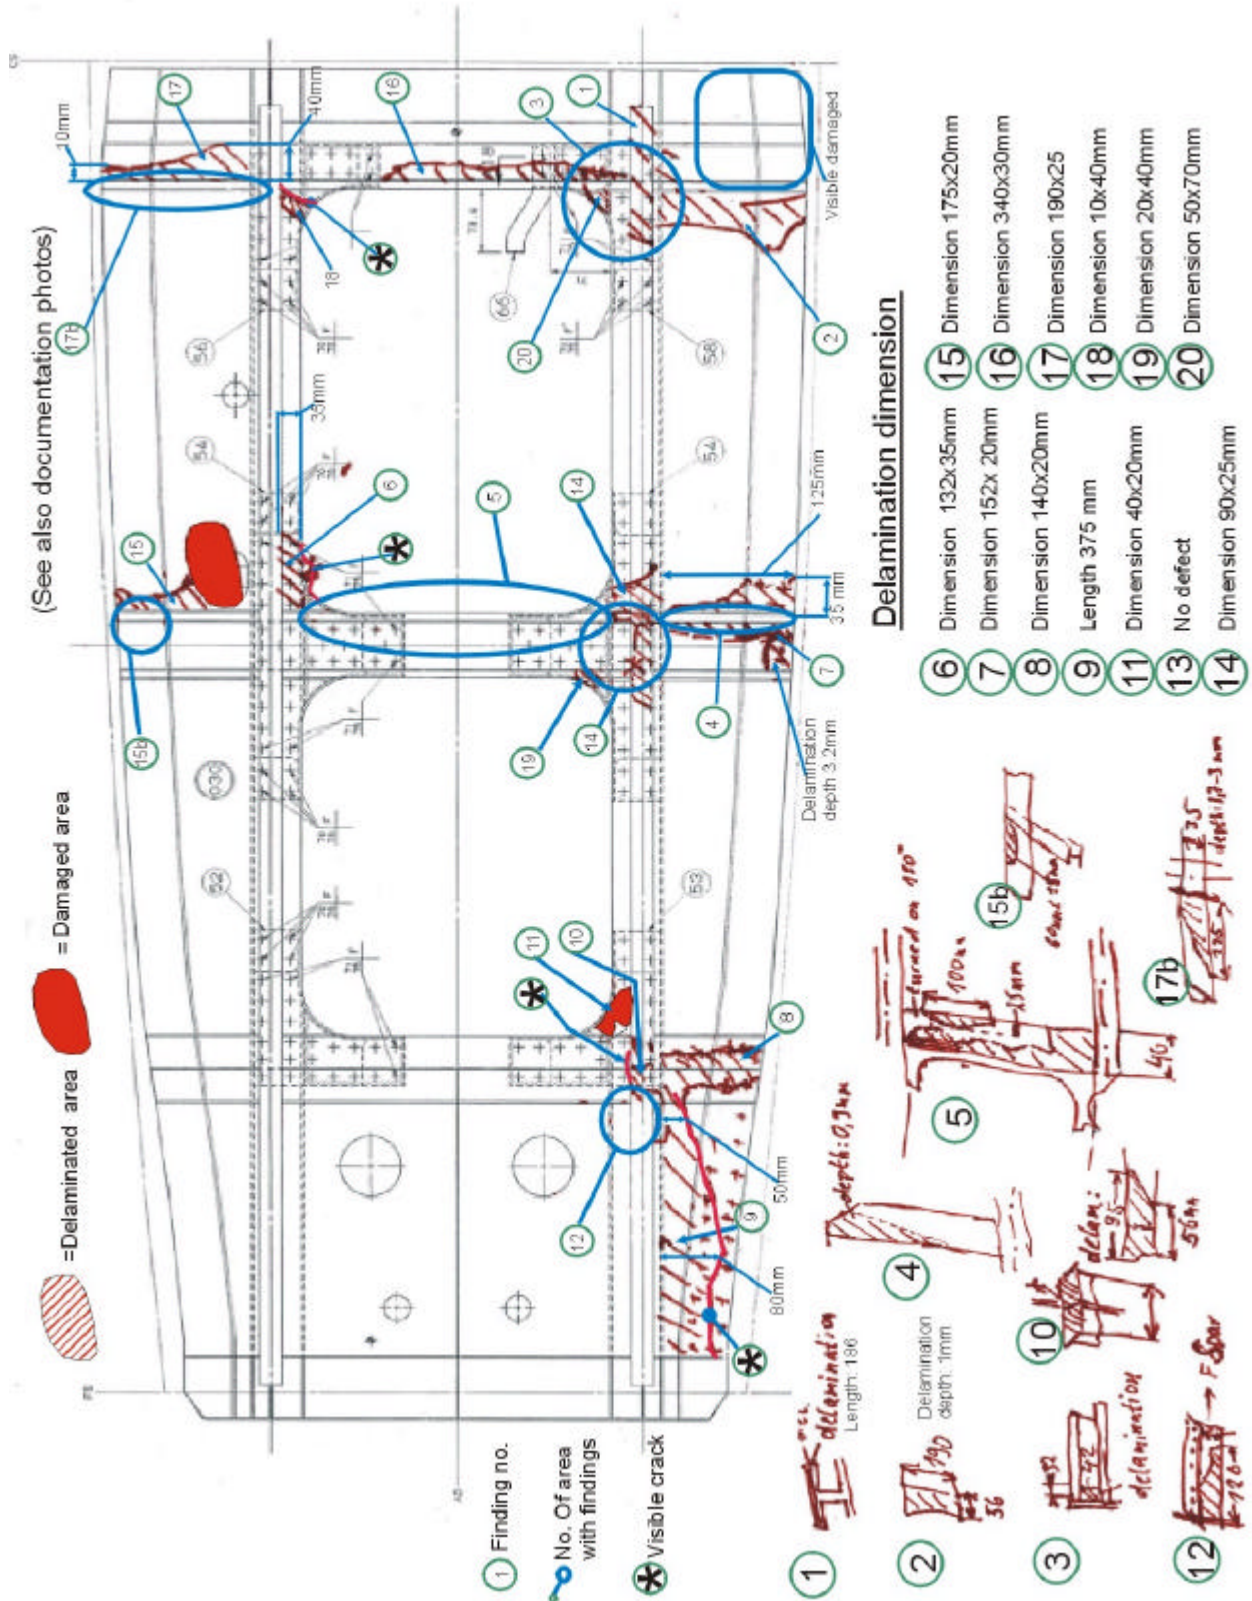
FIG.08: Delamination areas; damages in the area of rib no. 1 between center spar and front spar

(d2) UT-results from rest of rib no. 1 between center spar and front spar (refer to Fig.08 and documentation photos).

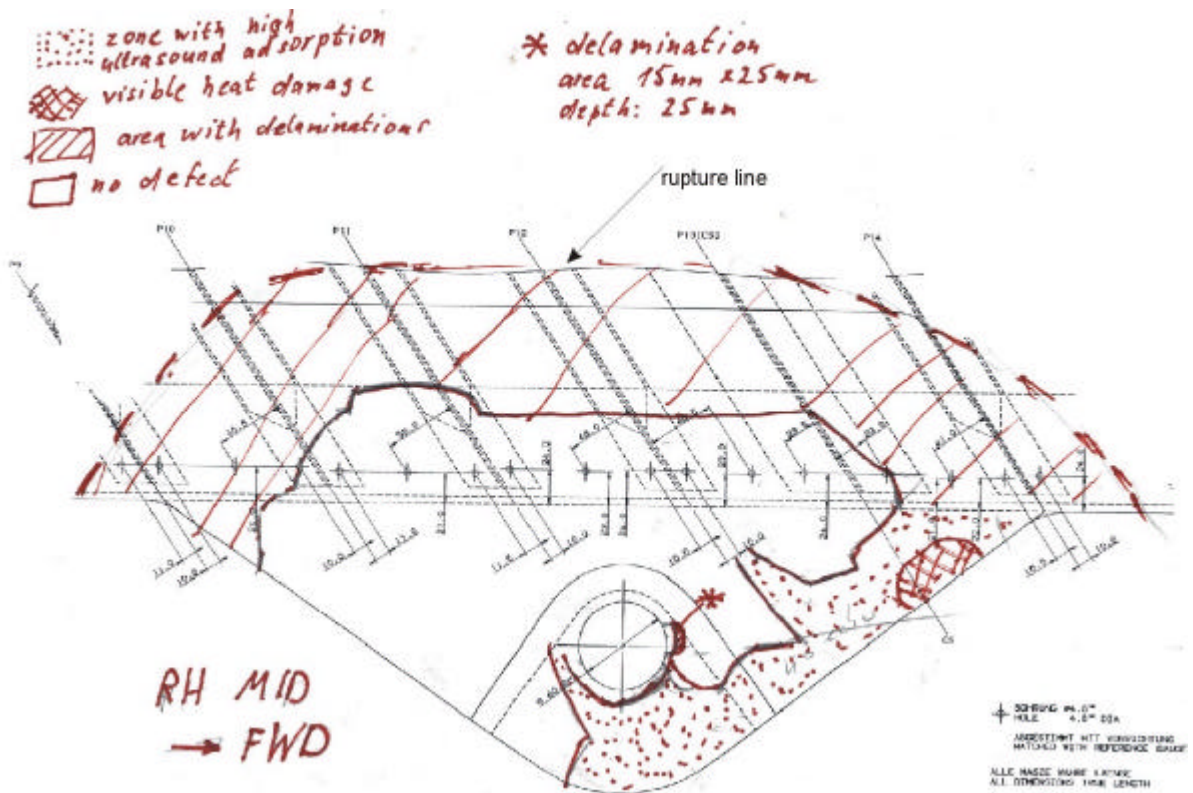
Fig. 13: Test results of UT-inspection at separated center lug / RH

(d3) Special investigation and test results on separated Center Lug /RH

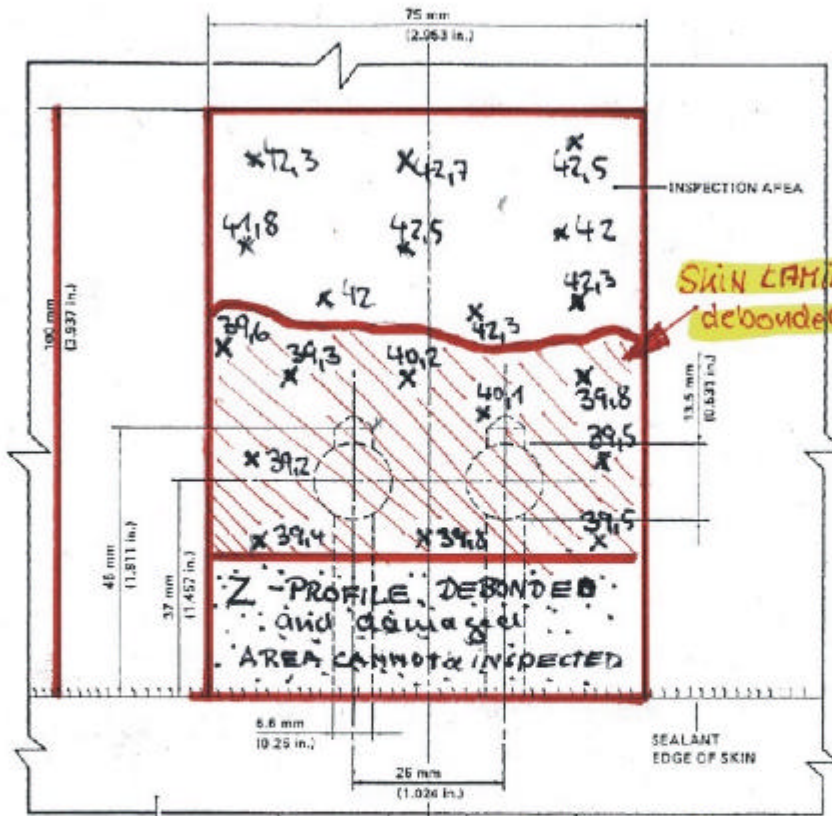
PART 4
Record Sheet - Hinge Attachment Area BR1 LH **55-40-04**
Figure 408

Z-PROFILE DEBONDED

DEBONDING/DELAMINATION

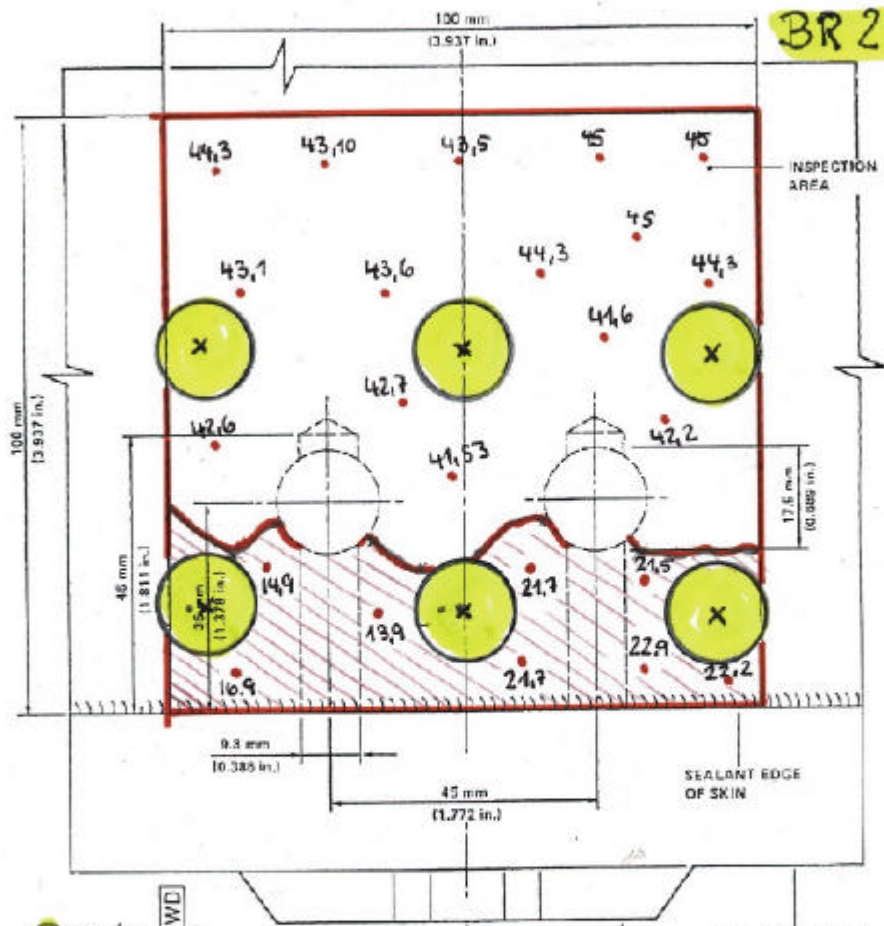
PART 4
 Record Sheet - Hinge Attachment Area BR2-RH 55-40-04
 Figure 410
 Page 416

already repaired
 DEPENDING/DELAMINATION
 X x X mm (in.) - DEPTH OF INDICATION

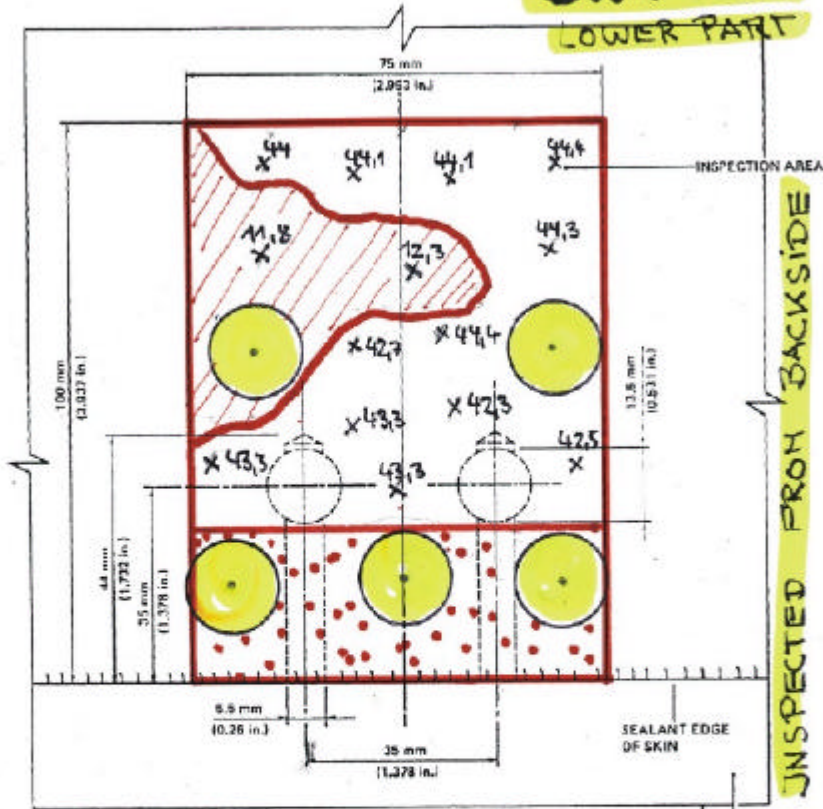
Record Sheet - Hinge Attachment Area BR4 (Upper/Lower) **55-40-04**
Figure 411

Not inspectable (space between bolts)

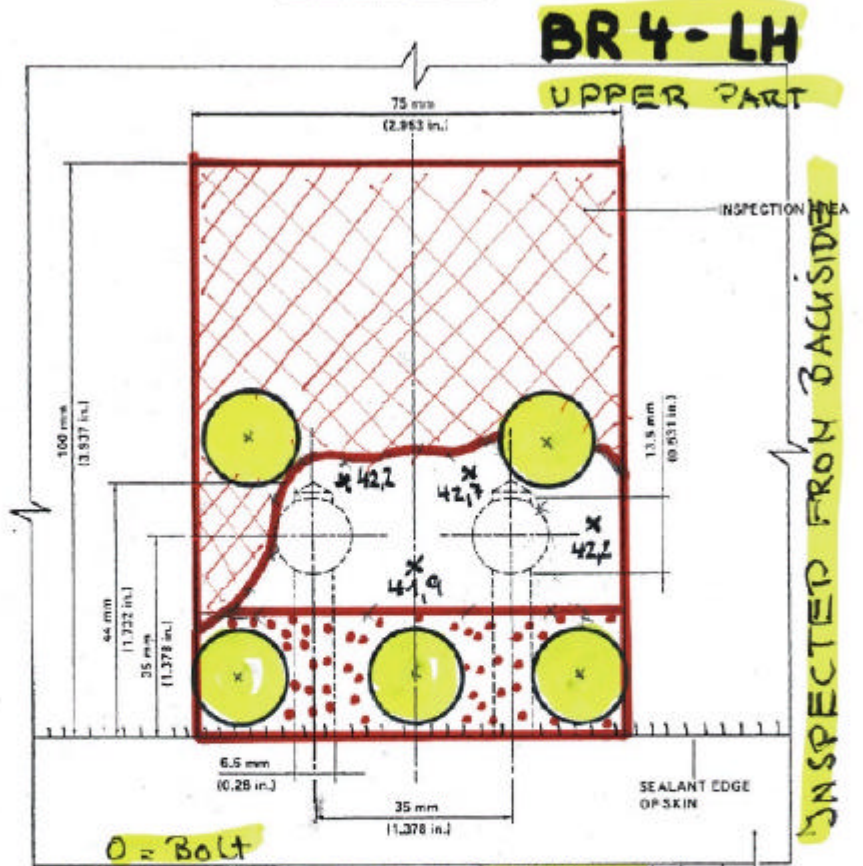
Record Sheet - Hinge Attachment Area BR4 (upper part) **55-40-04**
Figure 411

= DAMAGED AREA (NO BACKWALL ECHO)
 = Not inspectable (space between bolts)

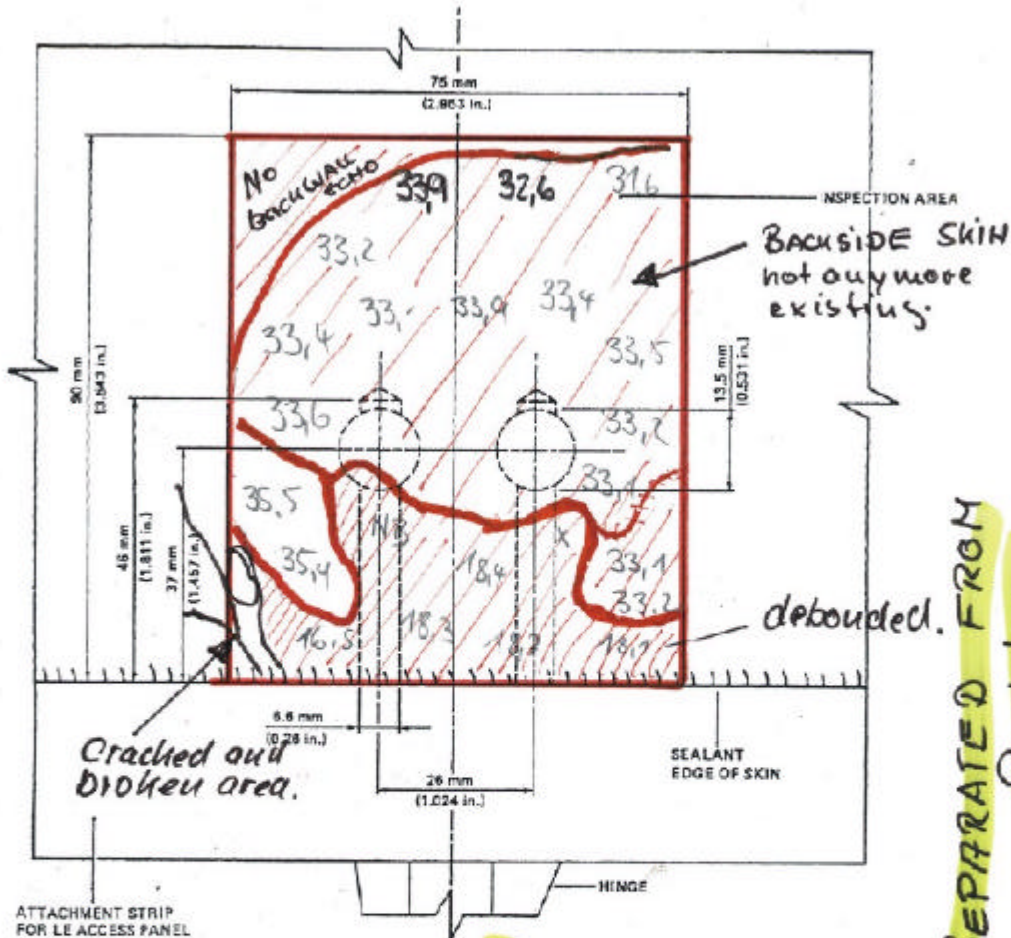
Record Sheet - Hinge Attachment Area BR7/1/7 55-40-04
Figure 414

SEPARATED FROM Rudder

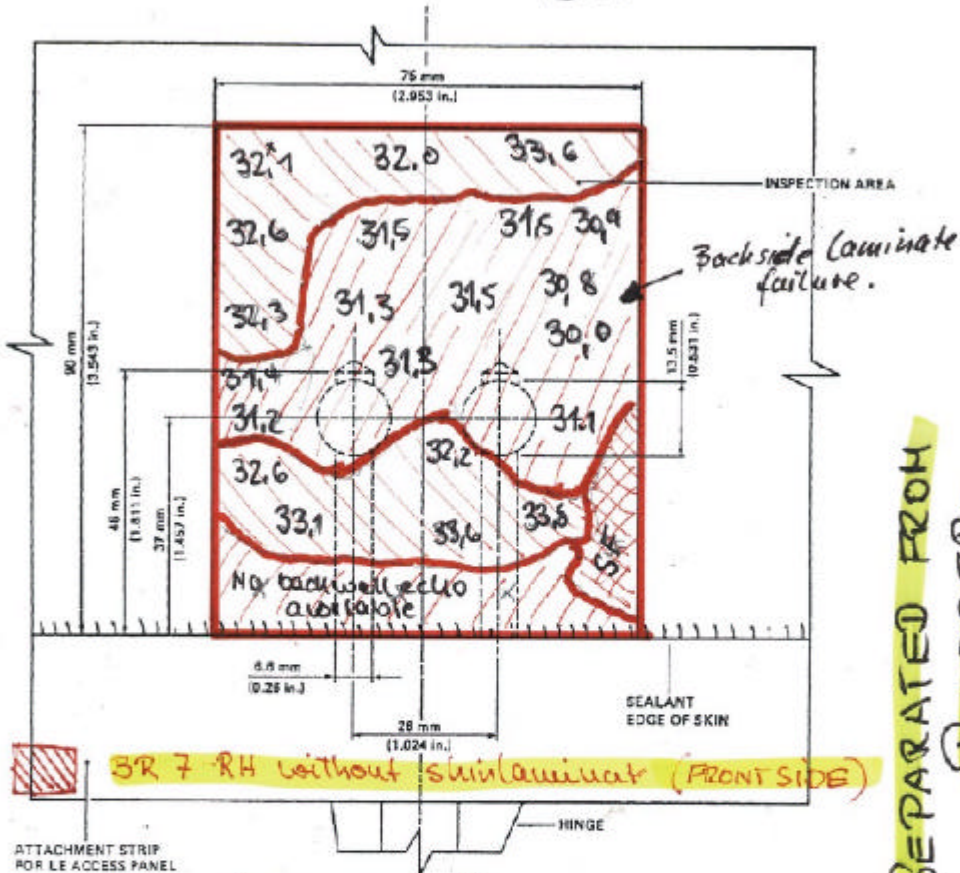
PART 4
 Record Sheet - Hinge Attachment Area BR 7 / 7 55-40-04
 Figure 414

SEPARATED FROM
RUDDER.

SF = SURFACE FAILURE
 DENONING/DELAMINATION
 X X X mm () -2 - DEPTH OF INDICATION

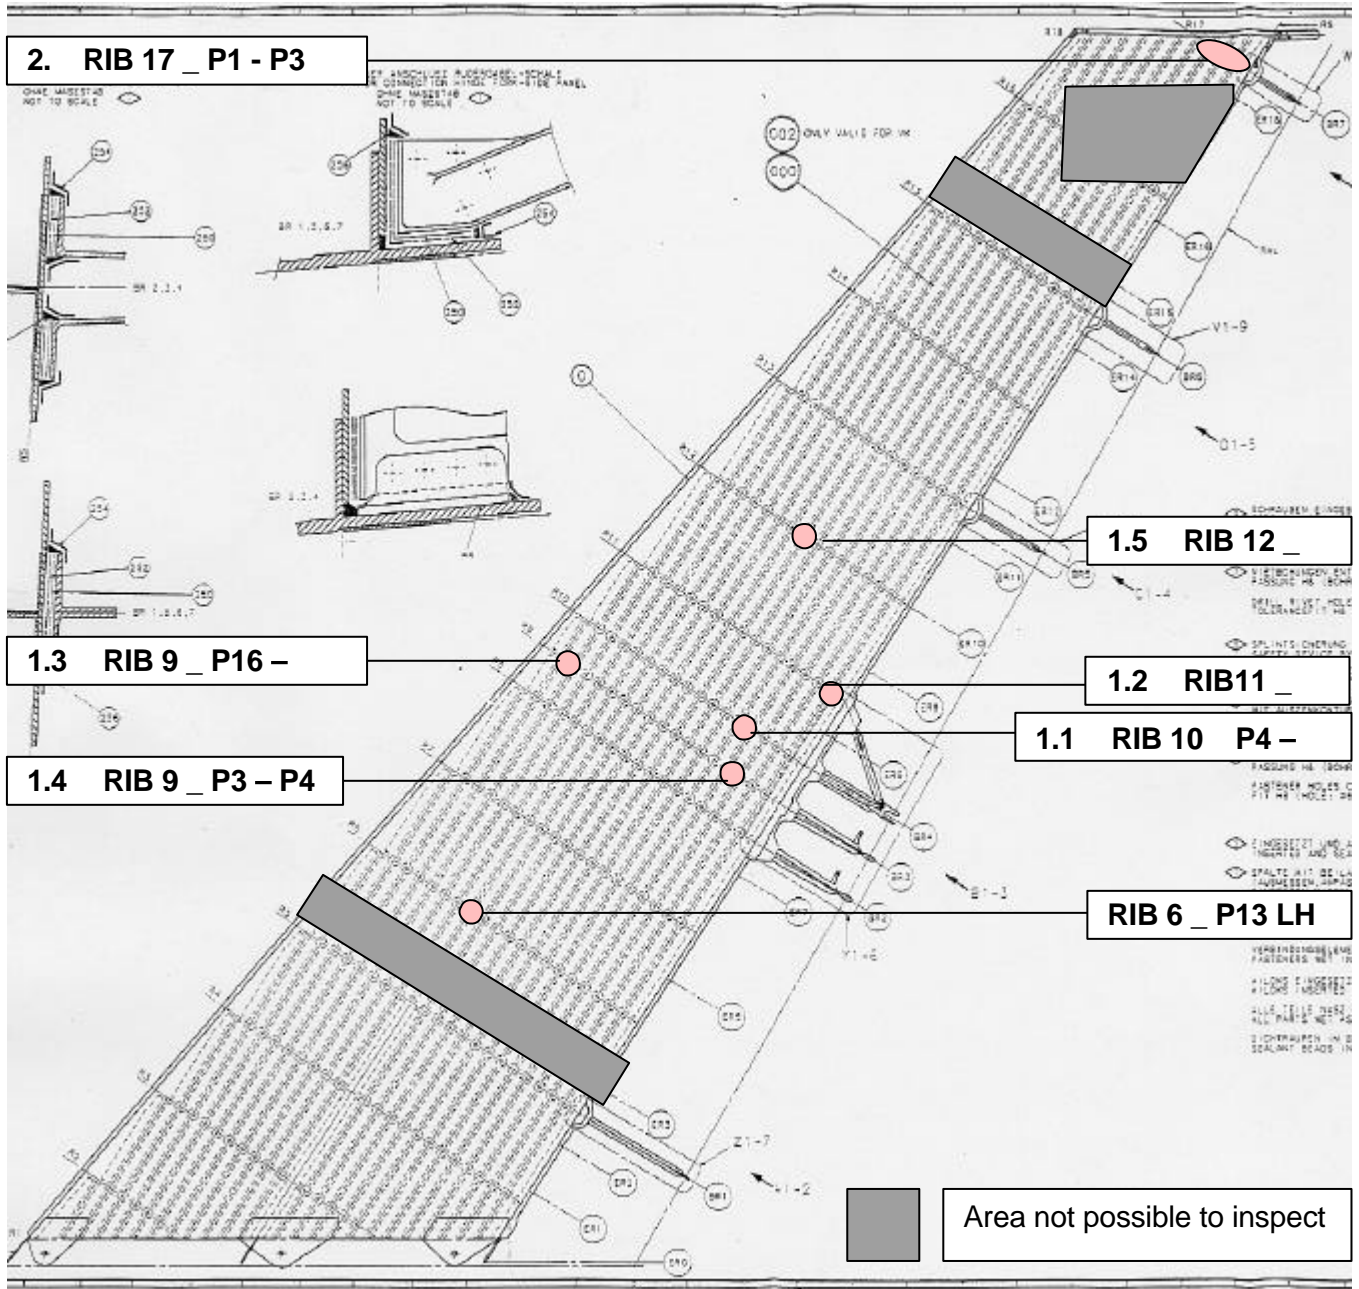
Indication vertical stabilizer A300-600 MSN420 LH

NOTE: All above documented indications are below the size to be registered in accordance with the quality requirements (see also the following detail sketches).

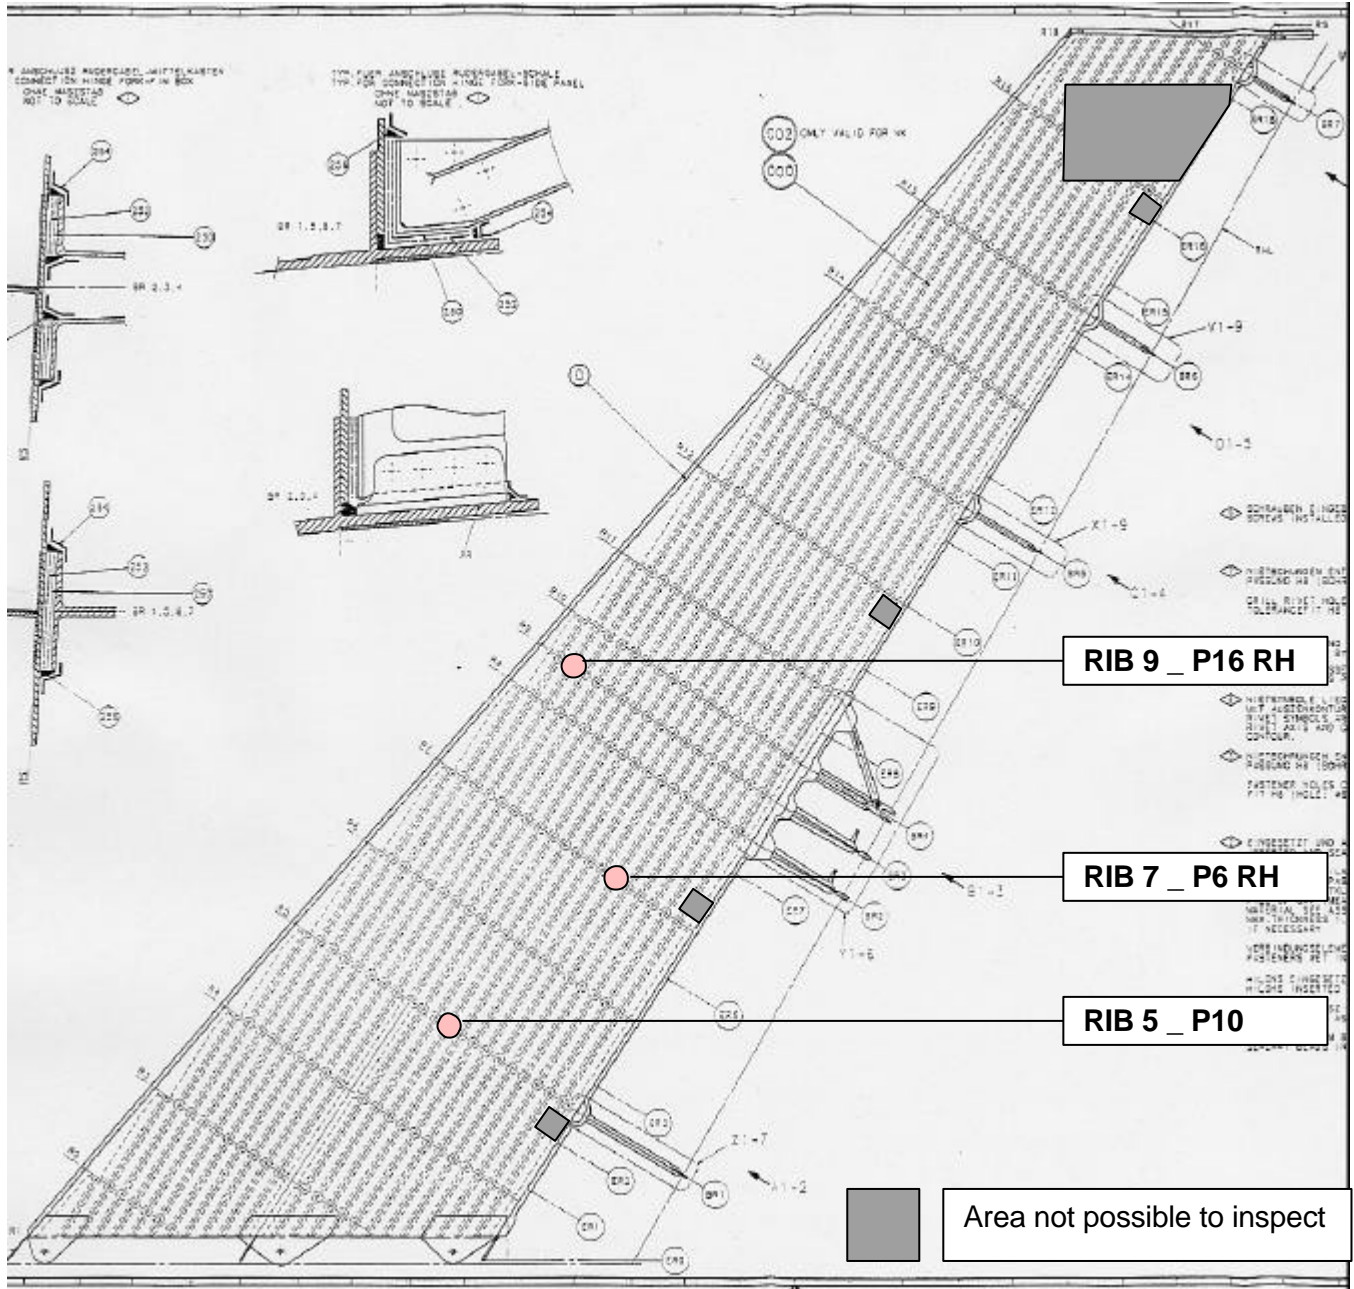
Indication vertical stabilizer A300-600 MSN420 RH

NOTE: All above documented indications are below the size to be registered in accordance with the quality requirements (see also the following detail sketches).

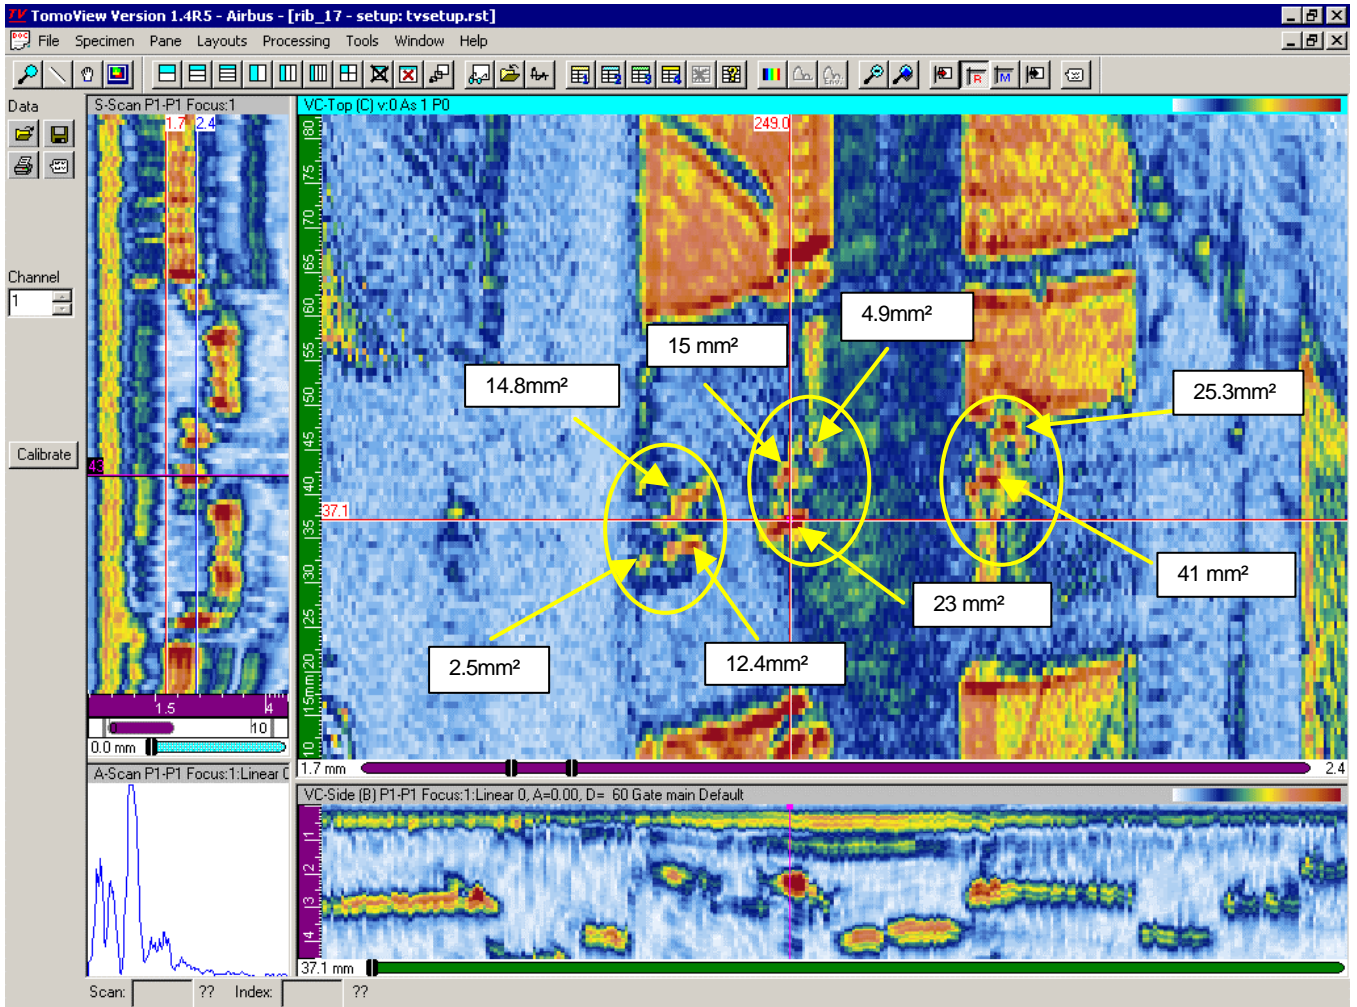
RIB 17 _ P1 - P3 LH

NOTE: The above illustrated area belongs to the quality requirement zone D, which means that a max. extension of de-lamination of 250mm² is permissible.

NOTE: All above documented indications are below the size to be registered in accordance with the quality requirements.

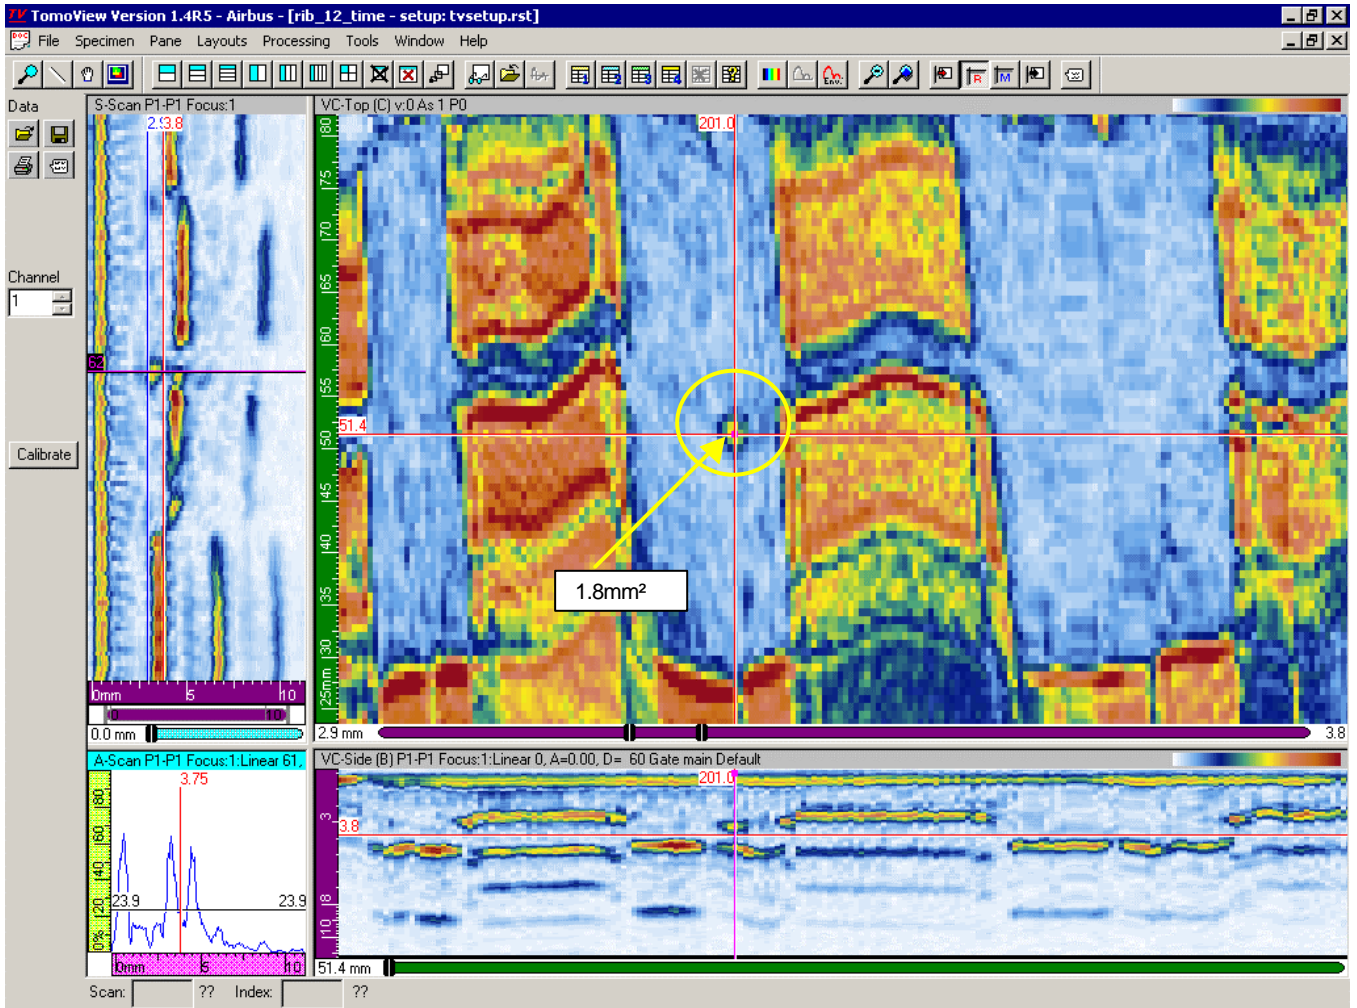
RIB 12 _ P8 LH

NOTE: The above illustrated area belongs to the quality requirement zone D, which means that a max. extension of de-lamination of 250mm² is permissible.

NOTE: Above documented indication is below the size to be registered in accordance with the quality requirements.
