INSPECTION PROTOCOL

Subject: Fin box and rudder inspection on aircraft A300-600, MSN 420 at NASA Langley Research Center in Hampton, Virginia / USA.

Title: Ultrasonic PHASED ARRAY inspection of vertical stabilizer A300-600 MSN 420, concerning delamination in the area of CFRP-stringers and CFRP-ribs.

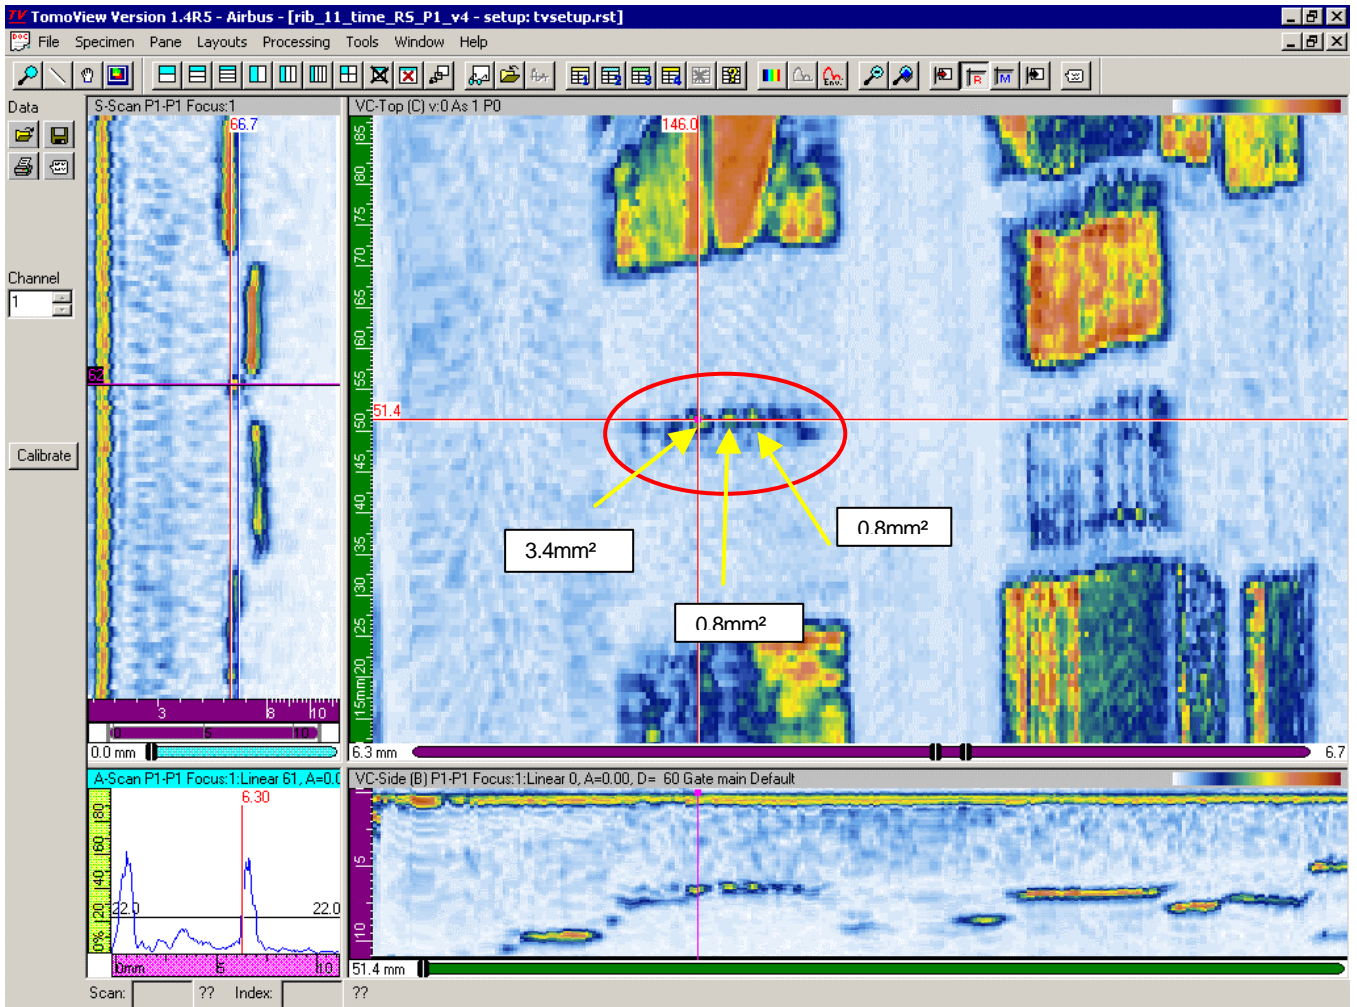
RIB11 _ P1 LH

NOTE: The above illustrated area belongs to the quality requirement zone B, which means that a max. extension of de-lamination of 150mm² is permissible.

NOTE: All above documented indications are below the size to be registered in accordance with the quality requirements.

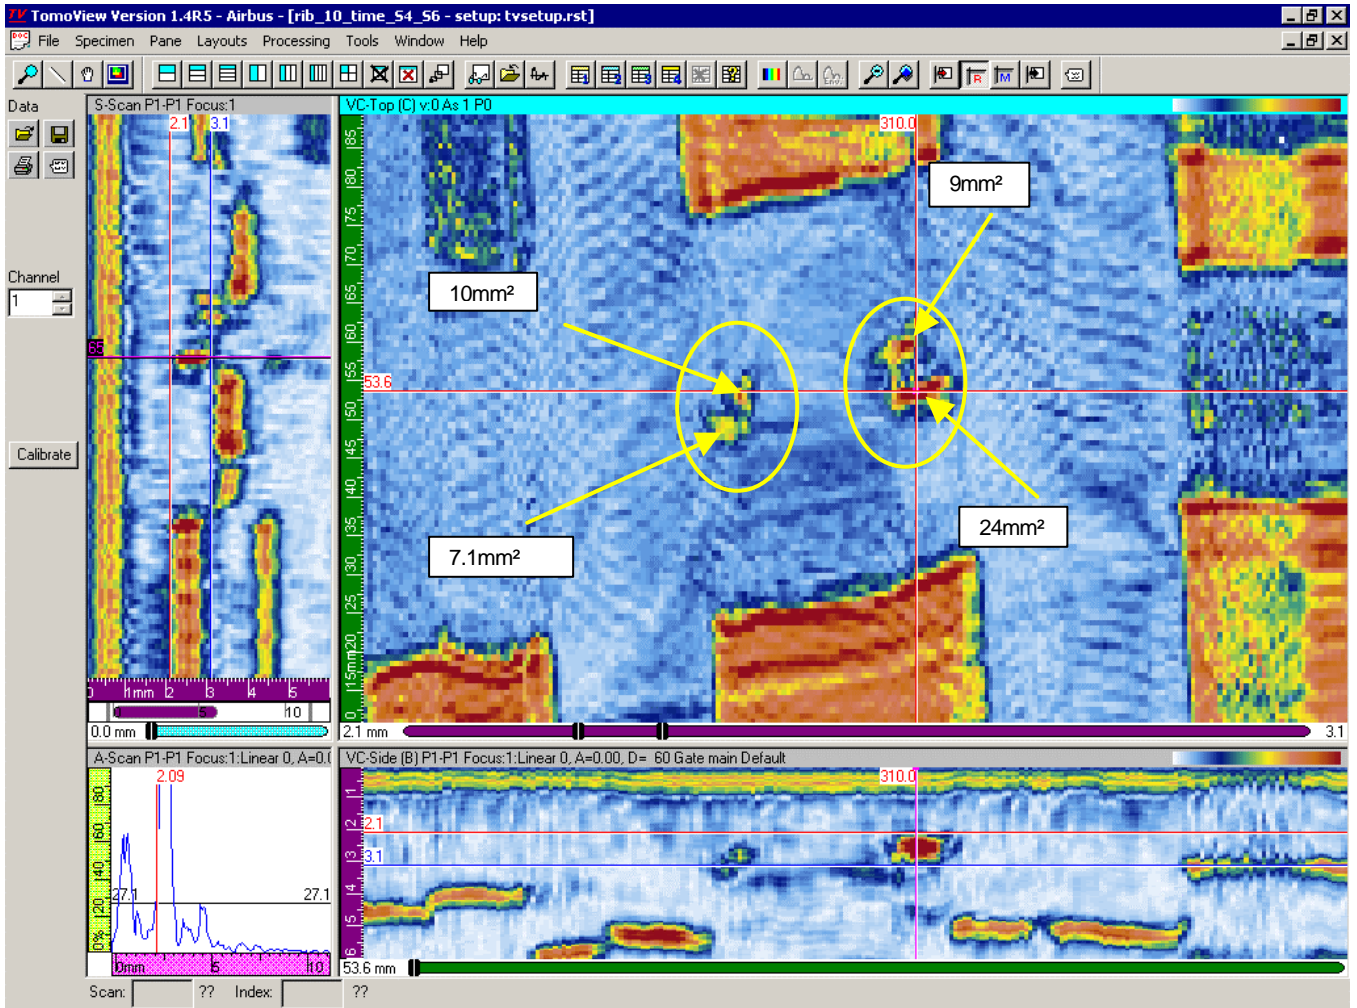
RIB 10 _ P4 – P5 LH

NOTE: The above illustrated area belongs to the quality requirement zone D, which means that a max. extension of de-lamination of 250mm² is permissible.

NOTE: All above documented indications are below the size to be registered in accordance with the quality requirements.

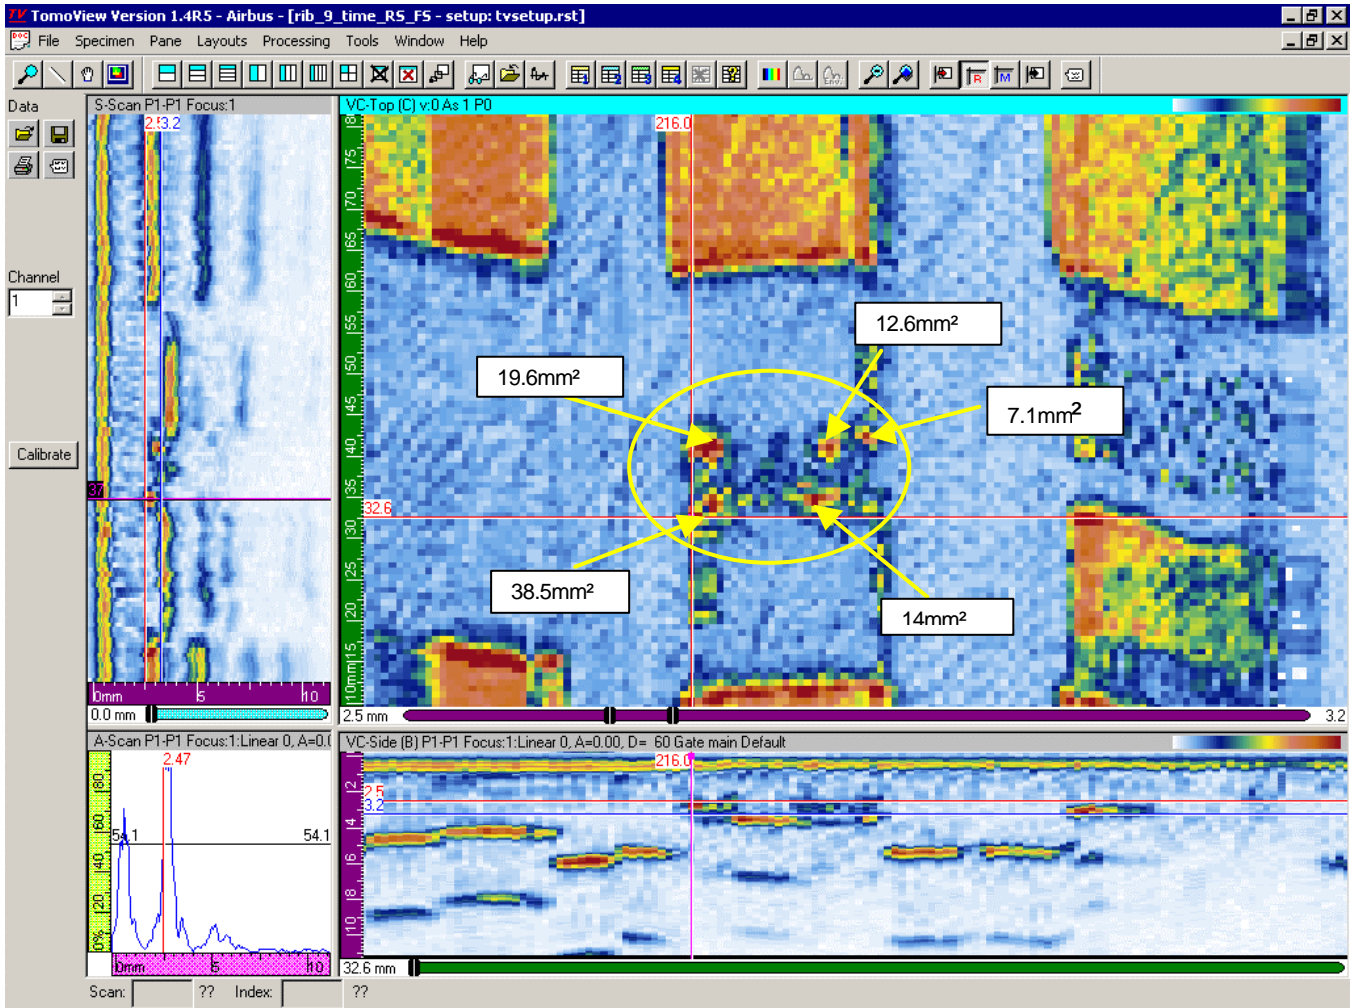
RIB 9 _ P3 – P4 LH

NOTE: The above illustrated area belongs to the quality requirement zone B, which means that a max. extension of de-lamination of 150mm² is permissible.

NOTE: All above documented indications are below the size to be registered in accordance with the quality requirements.

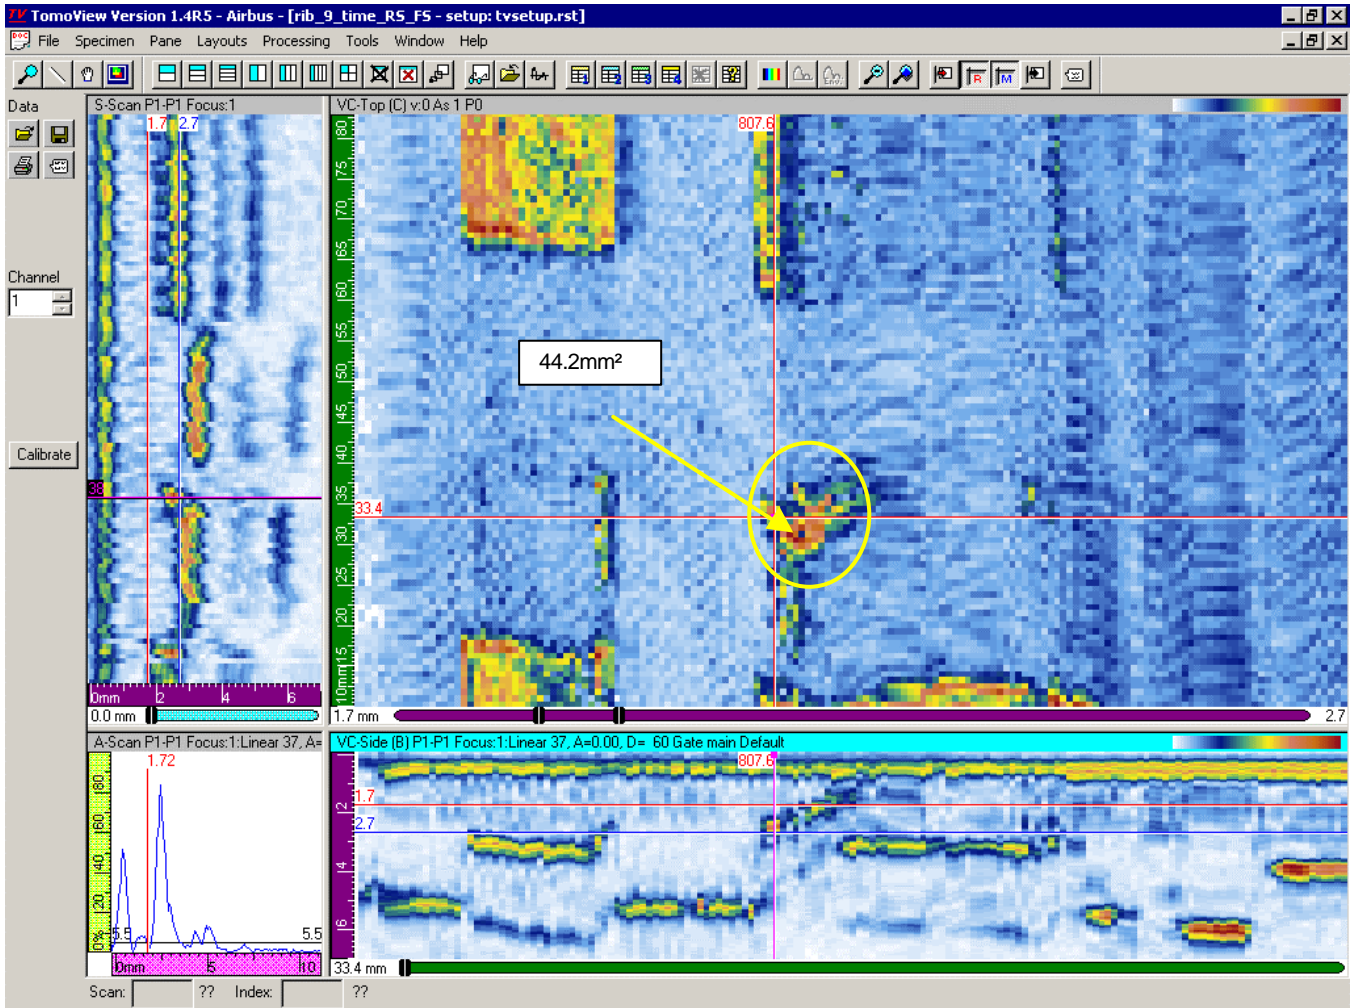
RIB 9 _ P16 – P17 LH

NOTE: The above illustrated area belongs to the quality requirement zone B, which means that a max. extension of de-lamination of 150mm² is permissible.

NOTE: Above documented indication is below the size to be registered in accordance with the quality requirements.

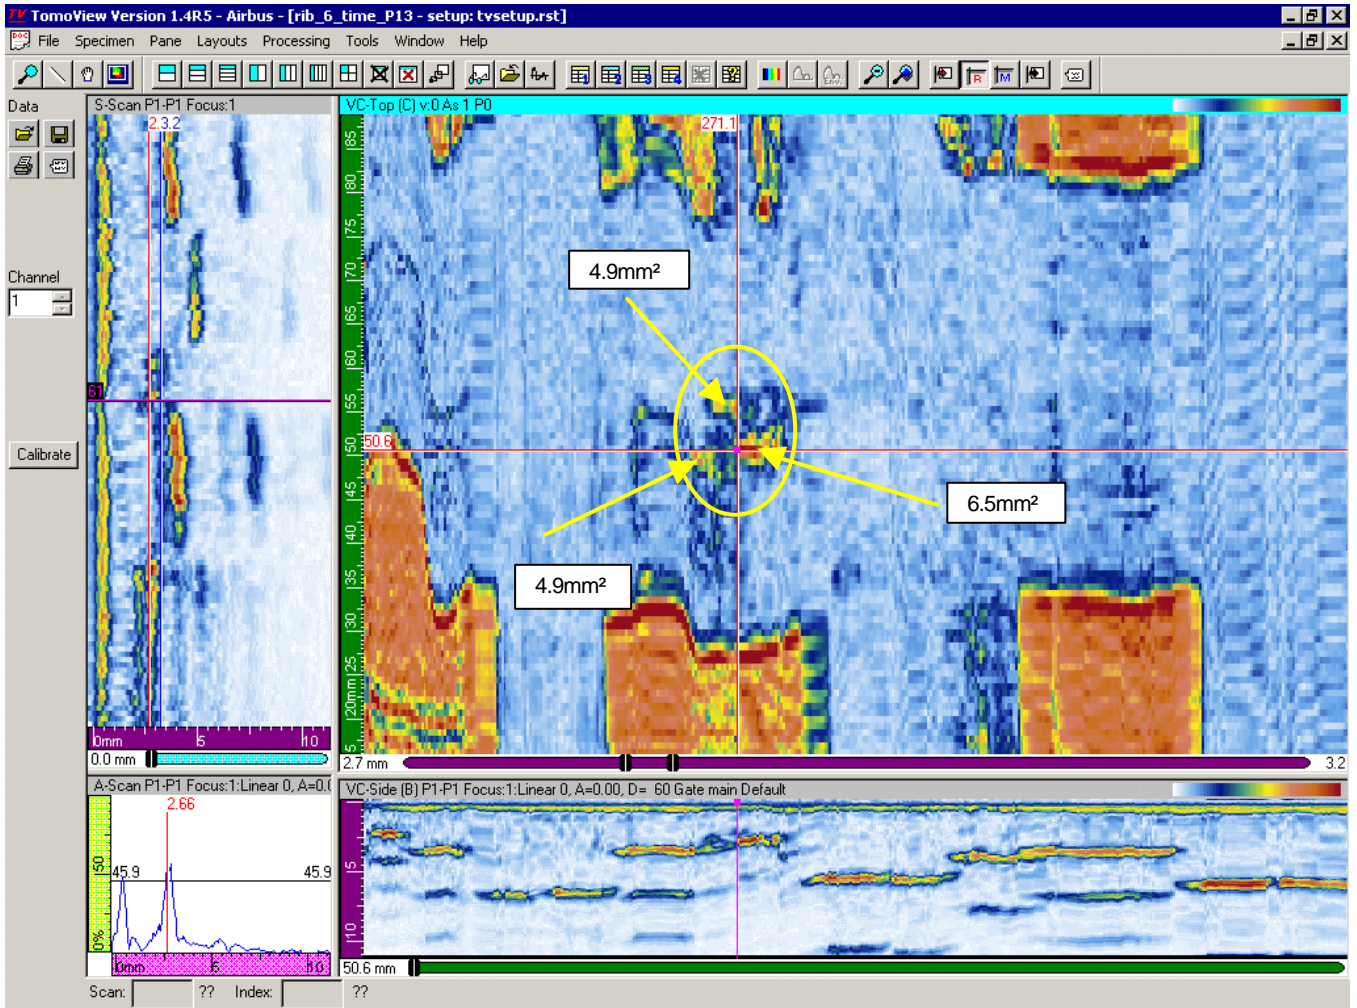
RIB 6 _ P13 LH

NOTE: The above illustrated area belongs to the quality requirement zone B, which means that a max. extension of de-lamination of 150mm² is permissible.

NOTE: All above documented indications are below the size to be registered in accordance with the quality requirements.

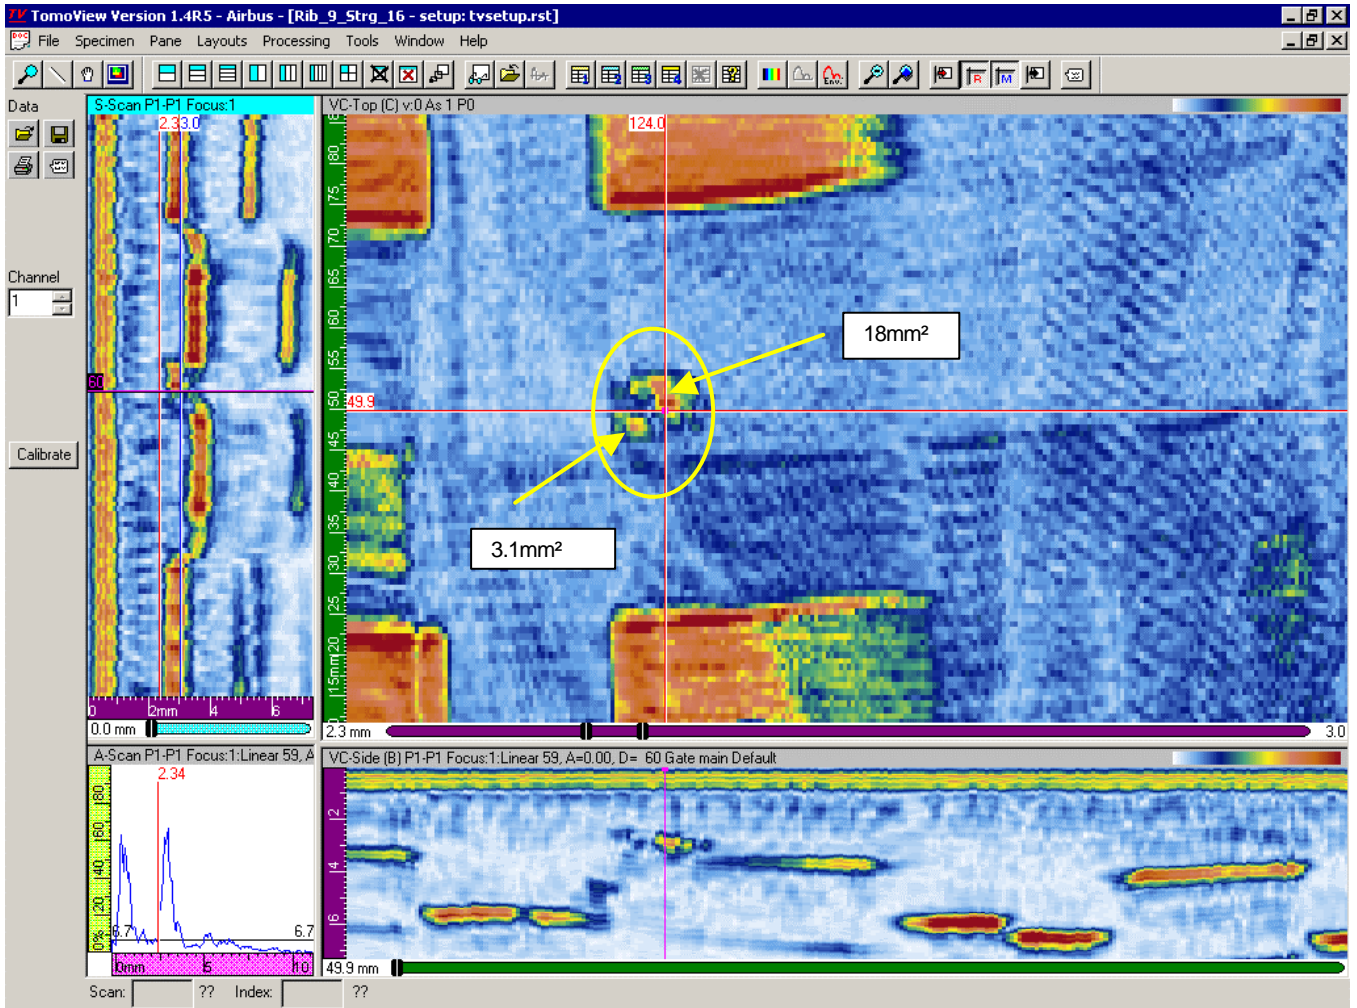
RIB 9 _ P16 RH

NOTE: The above illustrated area belongs to the quality requirement zone B, which means that a max. extension of de-lamination of 150mm² is permissible.

NOTE: All above documented indications are below the size to be registered in accordance with the quality requirements.

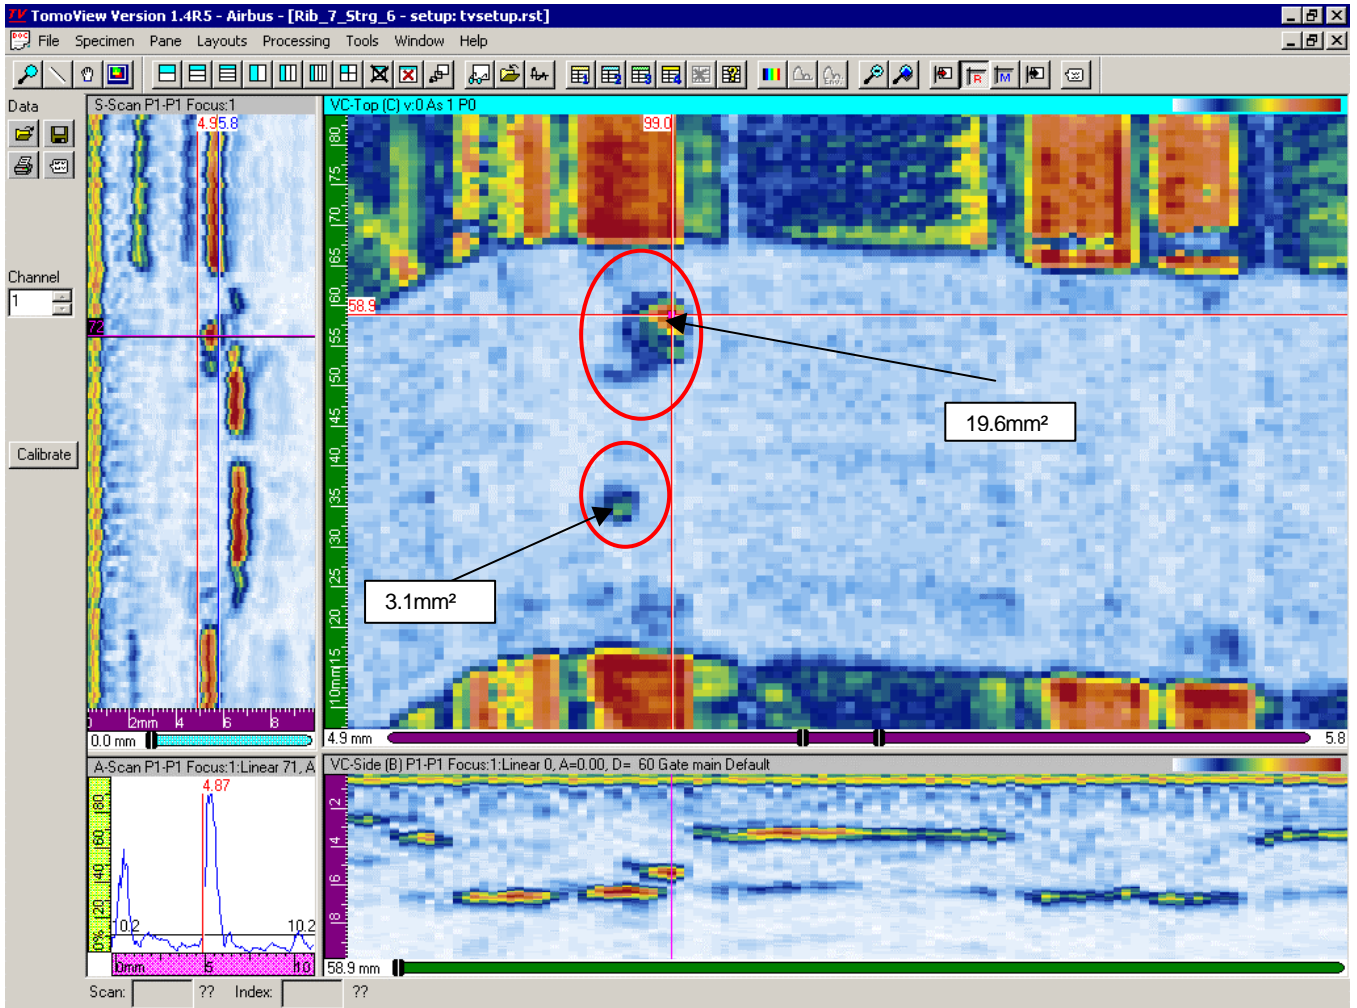
RIB 7 _ P6 RH

NOTE: The above illustrated area belongs to the quality requirement zone D, which means that a max. extension of de-lamination of 250mm² is permissible.

NOTE: All above documented indications are below the size to be registered in accordance with the quality requirements.

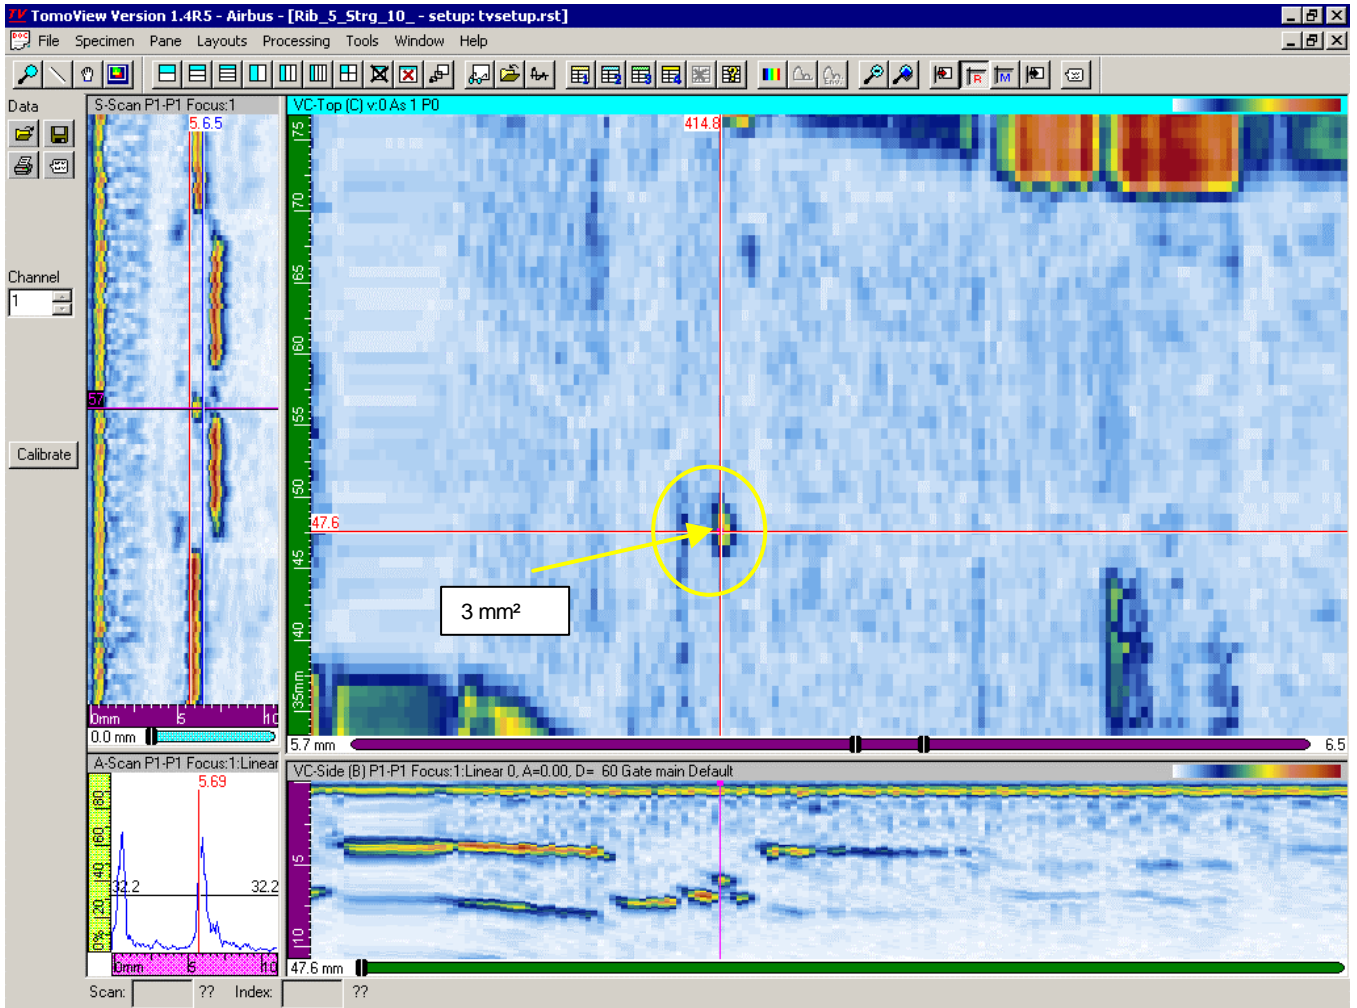
RIB 5 _ P10

NOTE: The above illustrated area belongs to the quality requirement zone B, which means that a max. extension of de-lamination of 150mm² is permissible.

NOTE: Above documented indication is below the size to be registered in accordance with the quality requirements.
