Tap Test Imaging of the AA587 A300-600 Rudder
Second Examination, NASA-LaRC, Langley, VA

A Report Submitted to Matt Fox (NTSB)

Daniel J. Barnard and David K. Hsu
Center for Aviation Systems Reliability
Iowa State University
Ames, IA 50014

May 2001

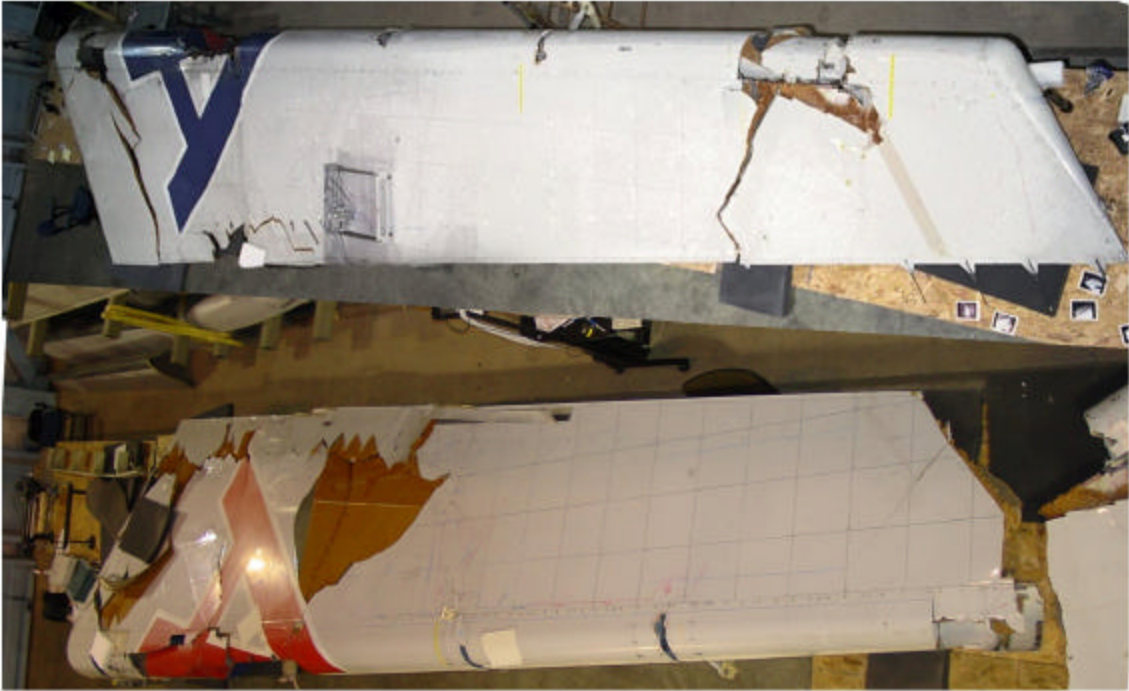
Figure 1 shows a pair of photos of the assembled parts of the rudder, left and right sides. (photos by M. Fox)

1. The photo in Fig. 1 shows the left-hand rudder skin and the right-hand rudder skin after the broken pieces from the lower one third of the rudder were reassembled. Note that the photo was taken at an angle, which distorted the aspect ratio of the rudder. The width of the rudder at the bottom is actually more than twice of that at the top.

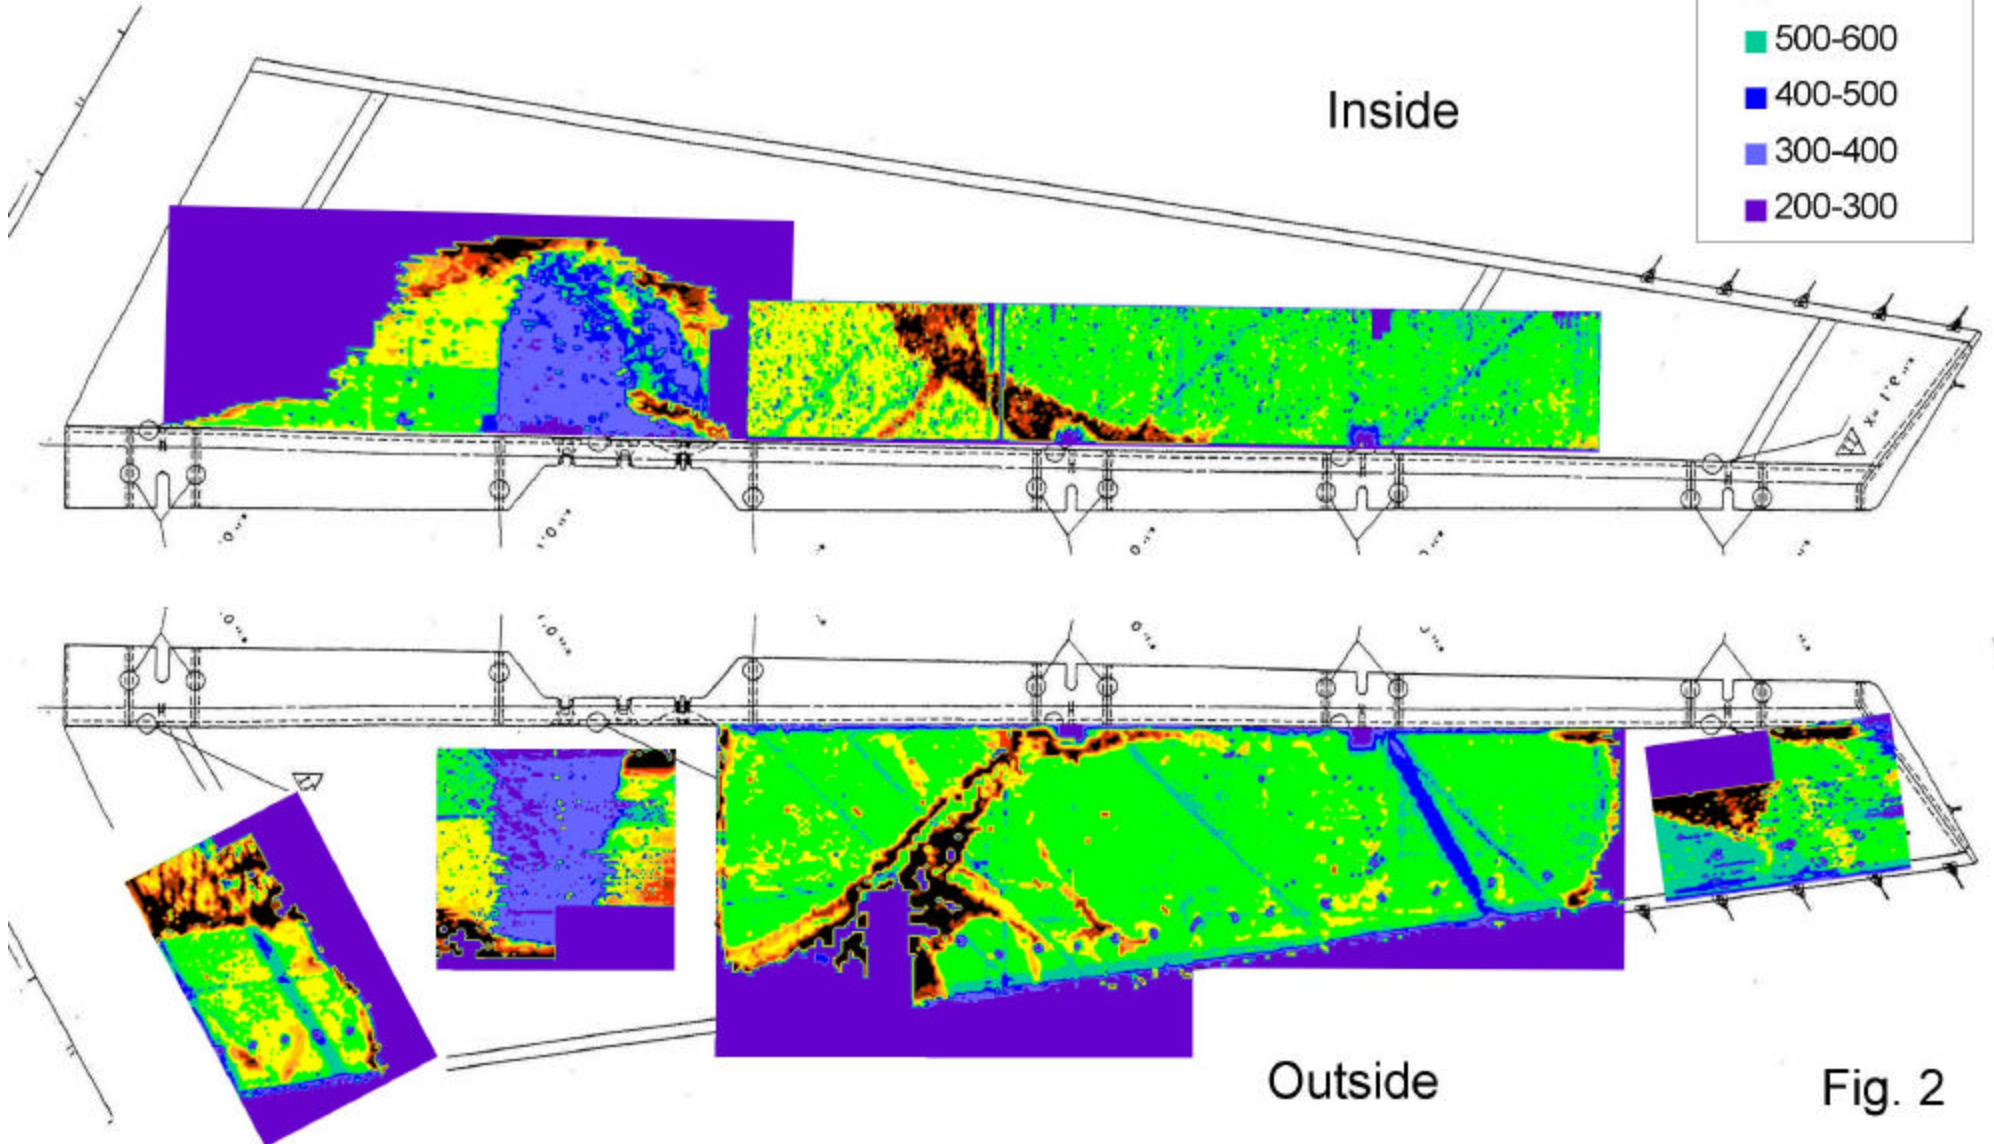
Fig. 2

Figure 2 shows a collage of the rudder left side tap test images, with the inside surface scans on the top and the outside images on the bottom. A legend in the upper right corner of the figure shows the color scale and the corresponding tap duration values. This color scale is common to scan images. Note that the images are superimposed on top of a scale drawing of the rudder.

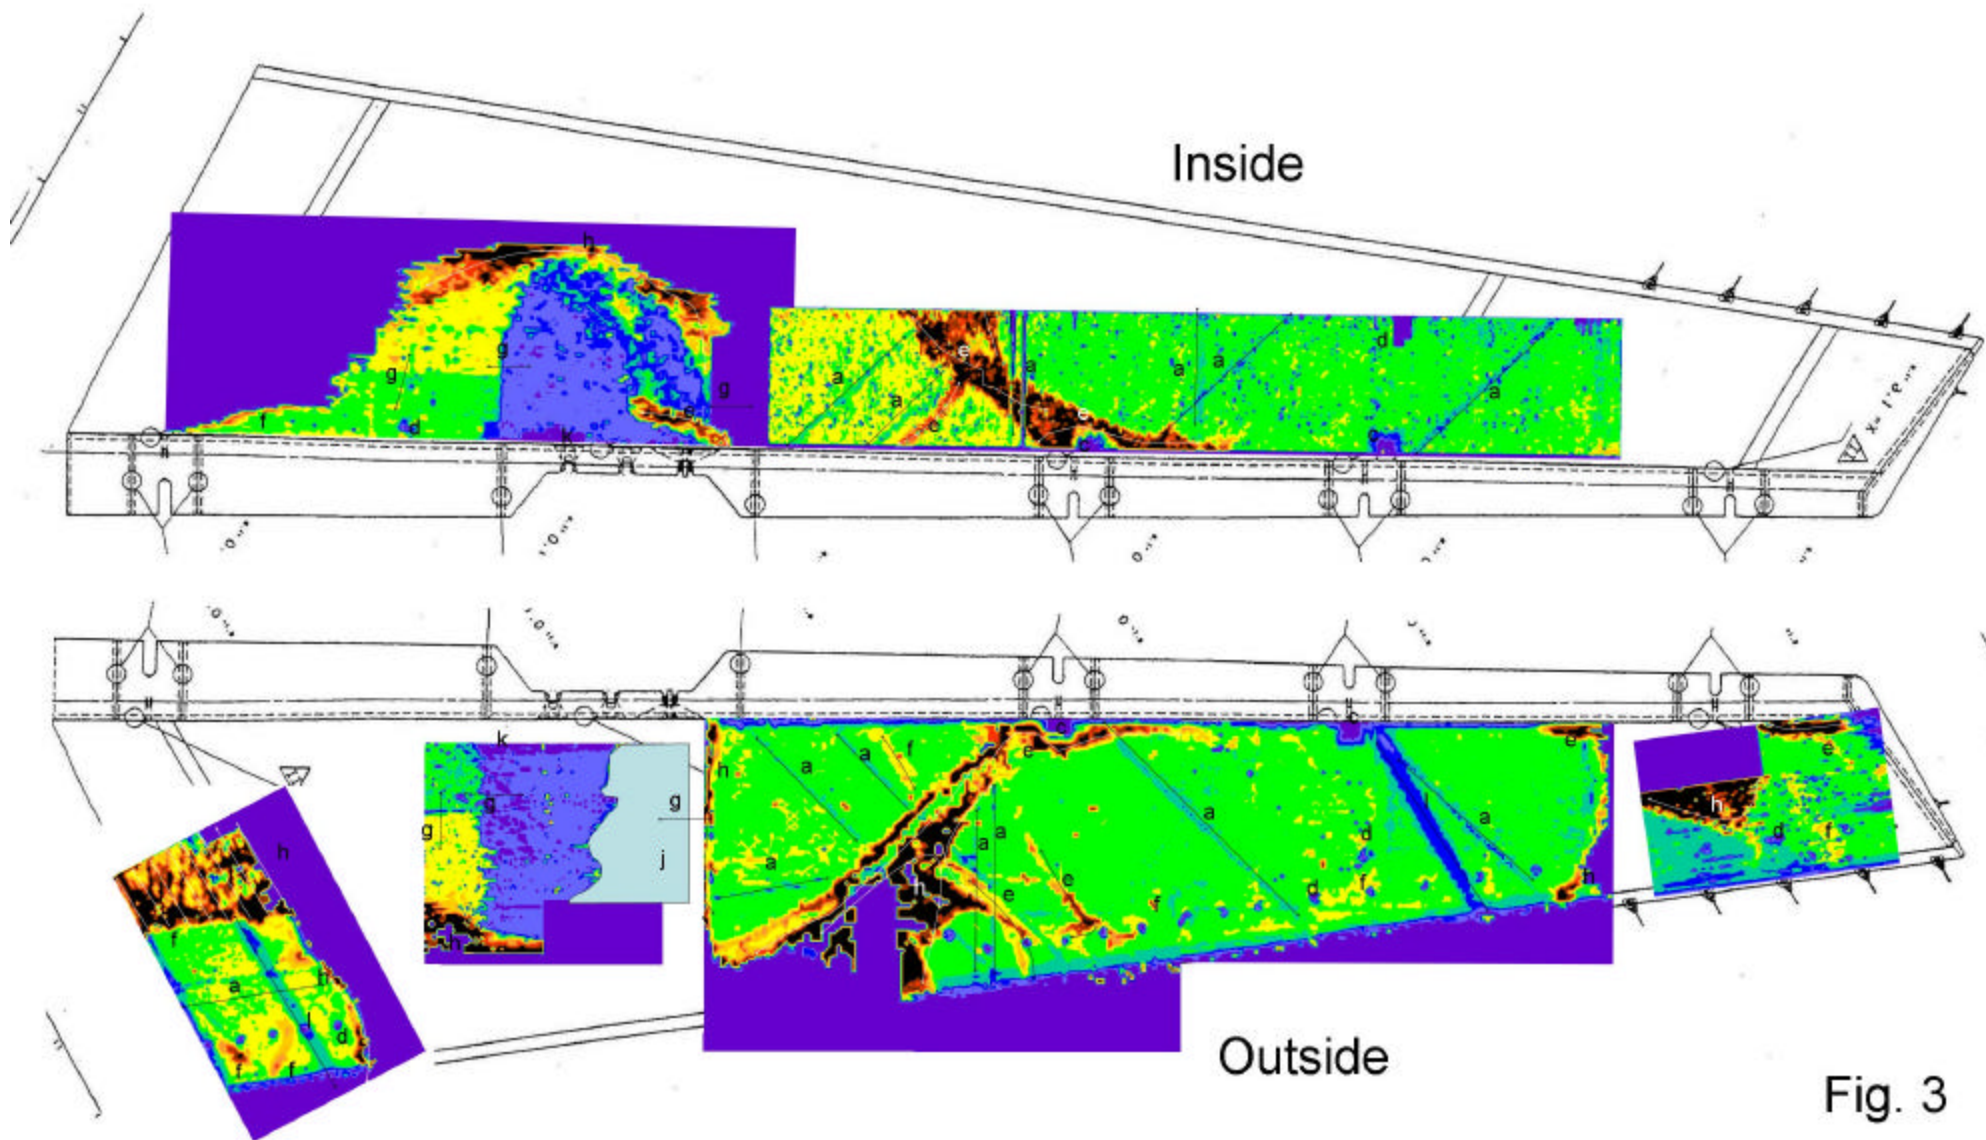
Fig. 3

Figure 3 shows the collage from Figure 2 with markings indicating structural features and damage.

buckle failure on the left-hand skin propagated mostly in a downward 45 degree direction, although a branch also propagated upward along the leading edge spar.

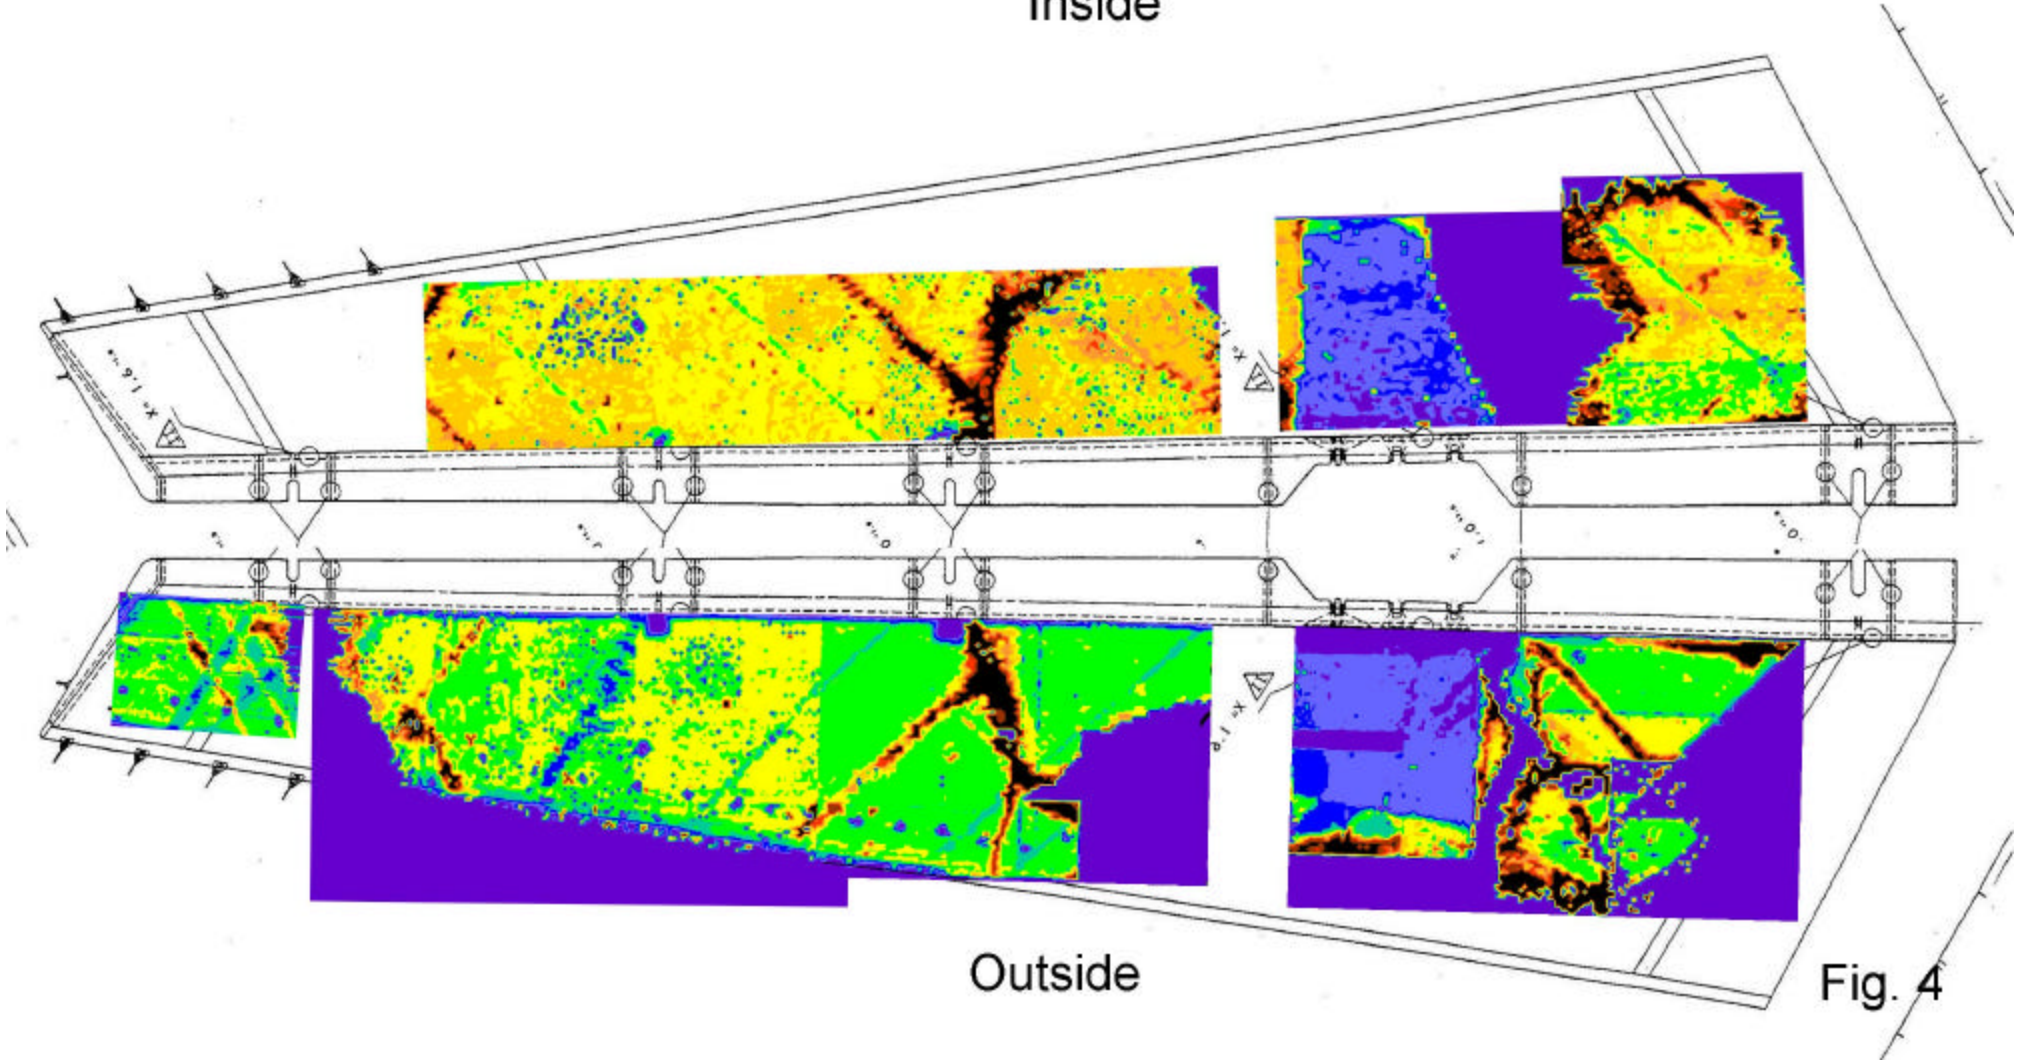
Figure 4 shows a collage of the rudder right side tap test images, with the inside surface scans on the top and the outside images on the bottom. Again, the images are superimposed on top of a scale drawing of the rudder.

2. The images of the inside surface and the outside surface of the rudder skin showed a high degree of consistency. For example, in Fig. 4 of the right-hand skin of the rudder, the same buckle failures (dark brown lines) appeared symmetrically in the CATT scans of both the inside surface and the outside surface throughout the length of the rudder. Thin green/blue lines indicating a higher stiffness (believed to be core splices and/or ply overlaps) also appeared symmetrically on both the inside and outside images. This consistency is particularly noticeable for the upper two thirds of the rudder that remained intact. For the badly broken pieces from the lower one third, the damages detected by CATT scans on the outside surface of the skin were often different from those on the inside surface due to the presence of often different damages on both surfaces.

3. The most severe damages to the rudder occurred near hinges #2, #3 and #4, where the rudder actuator was attached. Unfortunately, the left and right skin panels near these three hinges were badly broken and rather difficult to scan. For the upper two thirds of the rudder, the most prominent damage by far was the large buckle failures near hinge #5. It is interesting to note that the propagation patterns of the facesheet failure were different for the left-hand skin and the right-hand skin. On the right-hand skin of the rudder, the buckle failure seemed to have propagated from hinge #5 at almost 90 degrees outward (toward the trailing edge), quickly forming an upward 45 degree branch and then a downward 45 degree branch after propagating one half of the width. In contrast, the

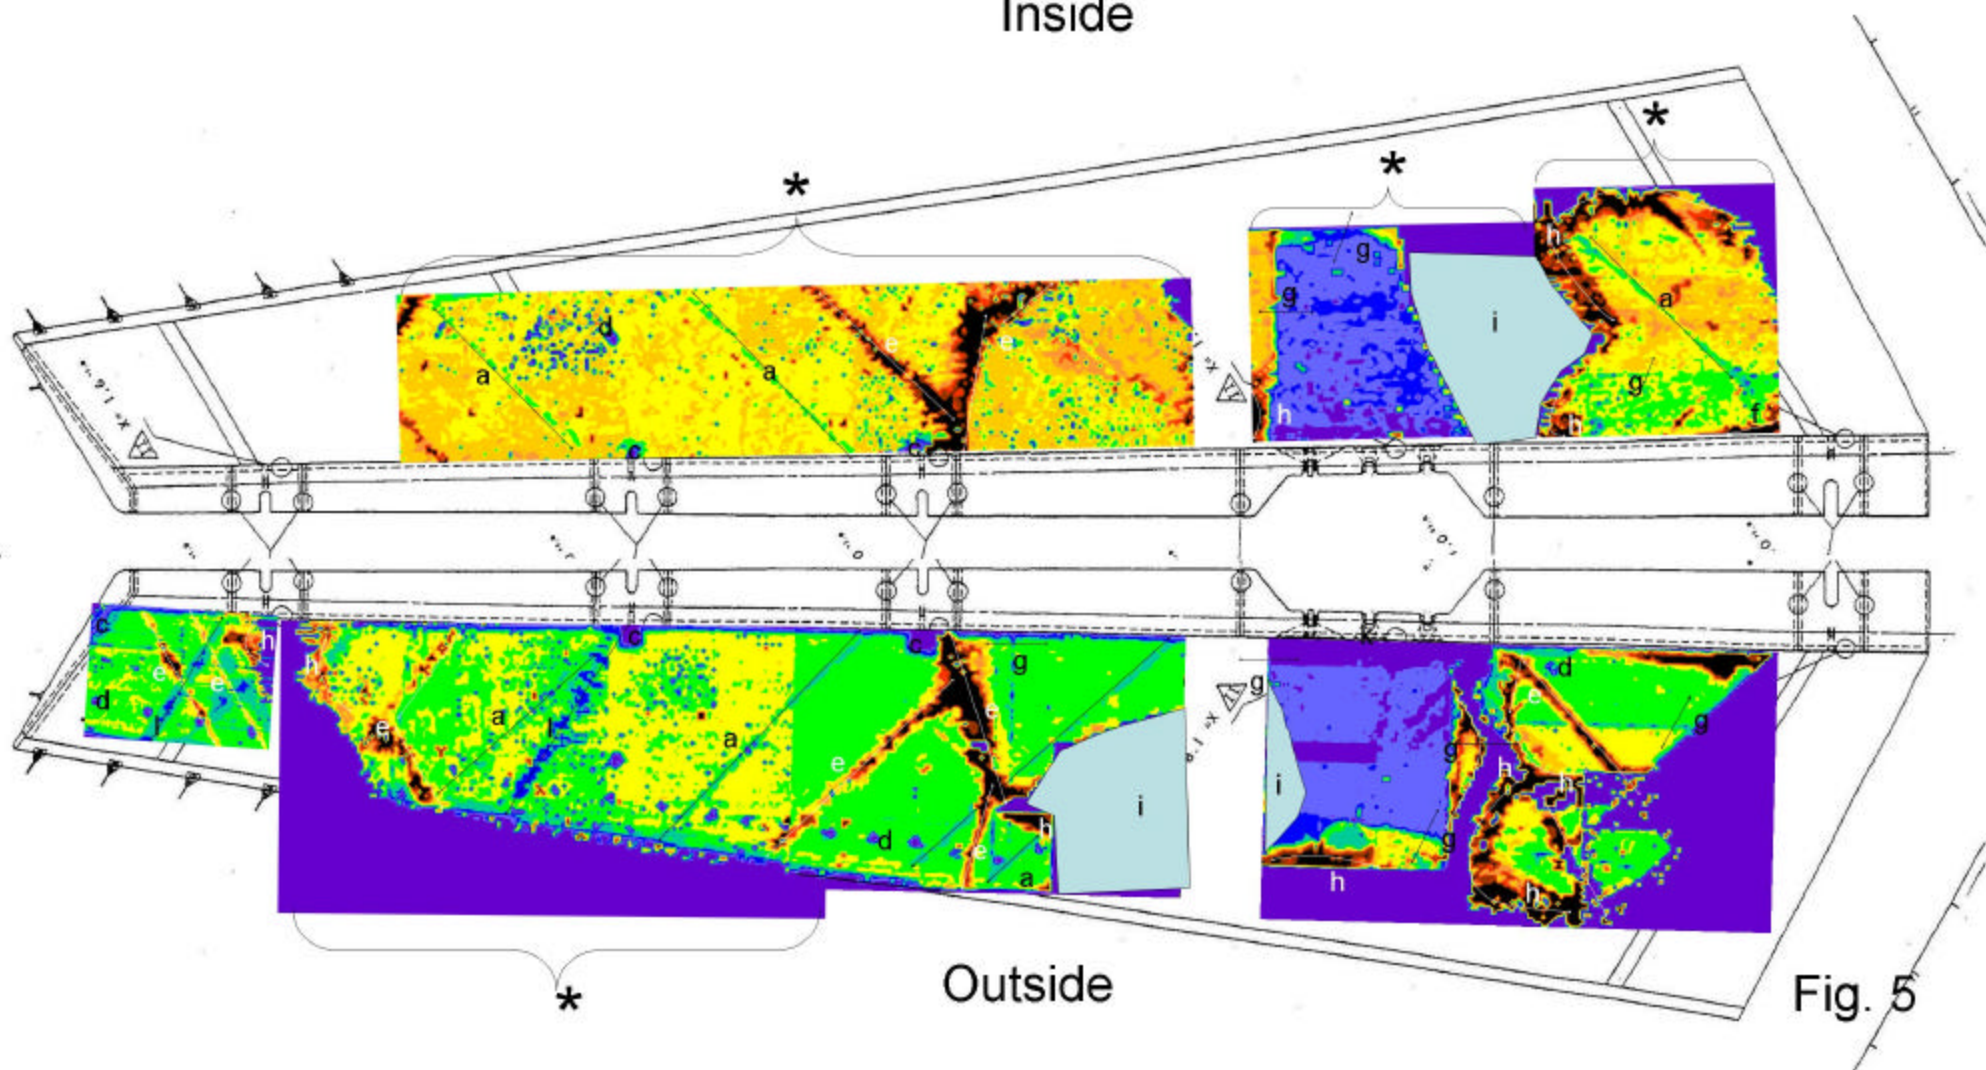
Fig. 5

Figure 5 shows the collage from Figure 4 with markings indicating structural features and damage. The asterisked regions have anomalous colors due to an out-of-spec accelerometer as explained in the text.

5. As stated above, there were some differences in the shade of the images, especially for the right-hand skin, between the scan data acquired in New York and those obtained in NASA Langley. The difference was believed to be due to a failing accelerometer, which was found to be out of spec after the round of scans in Langley. However, the change seemed to be a constant scaling factor which did not affect the ability to image the damages and internal structures of the rudder skins.

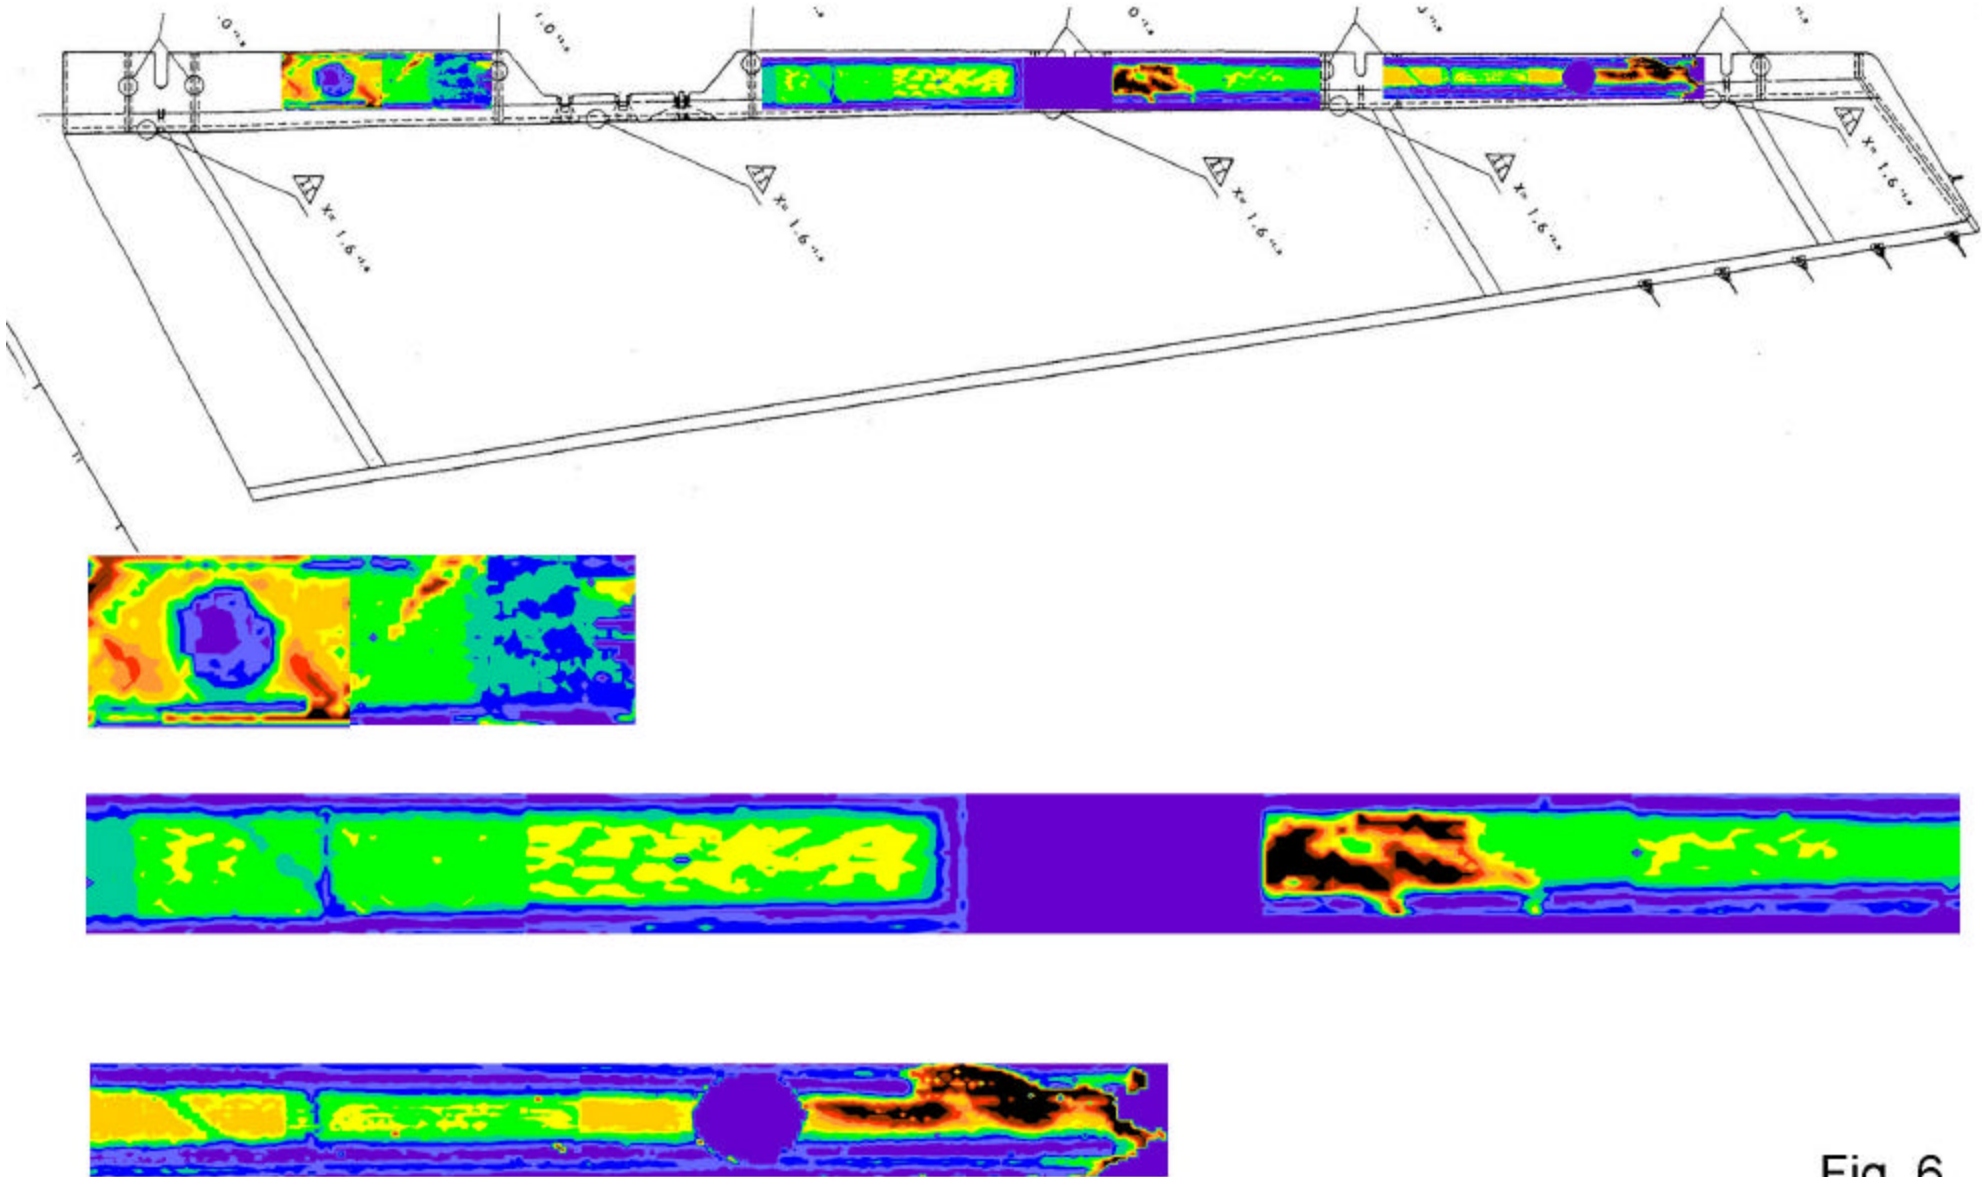
Fig. 6

Figure 6 shows a collage of the rudder front spar tap test images. Only the outer surface of the spar regions was scanned and imaged.

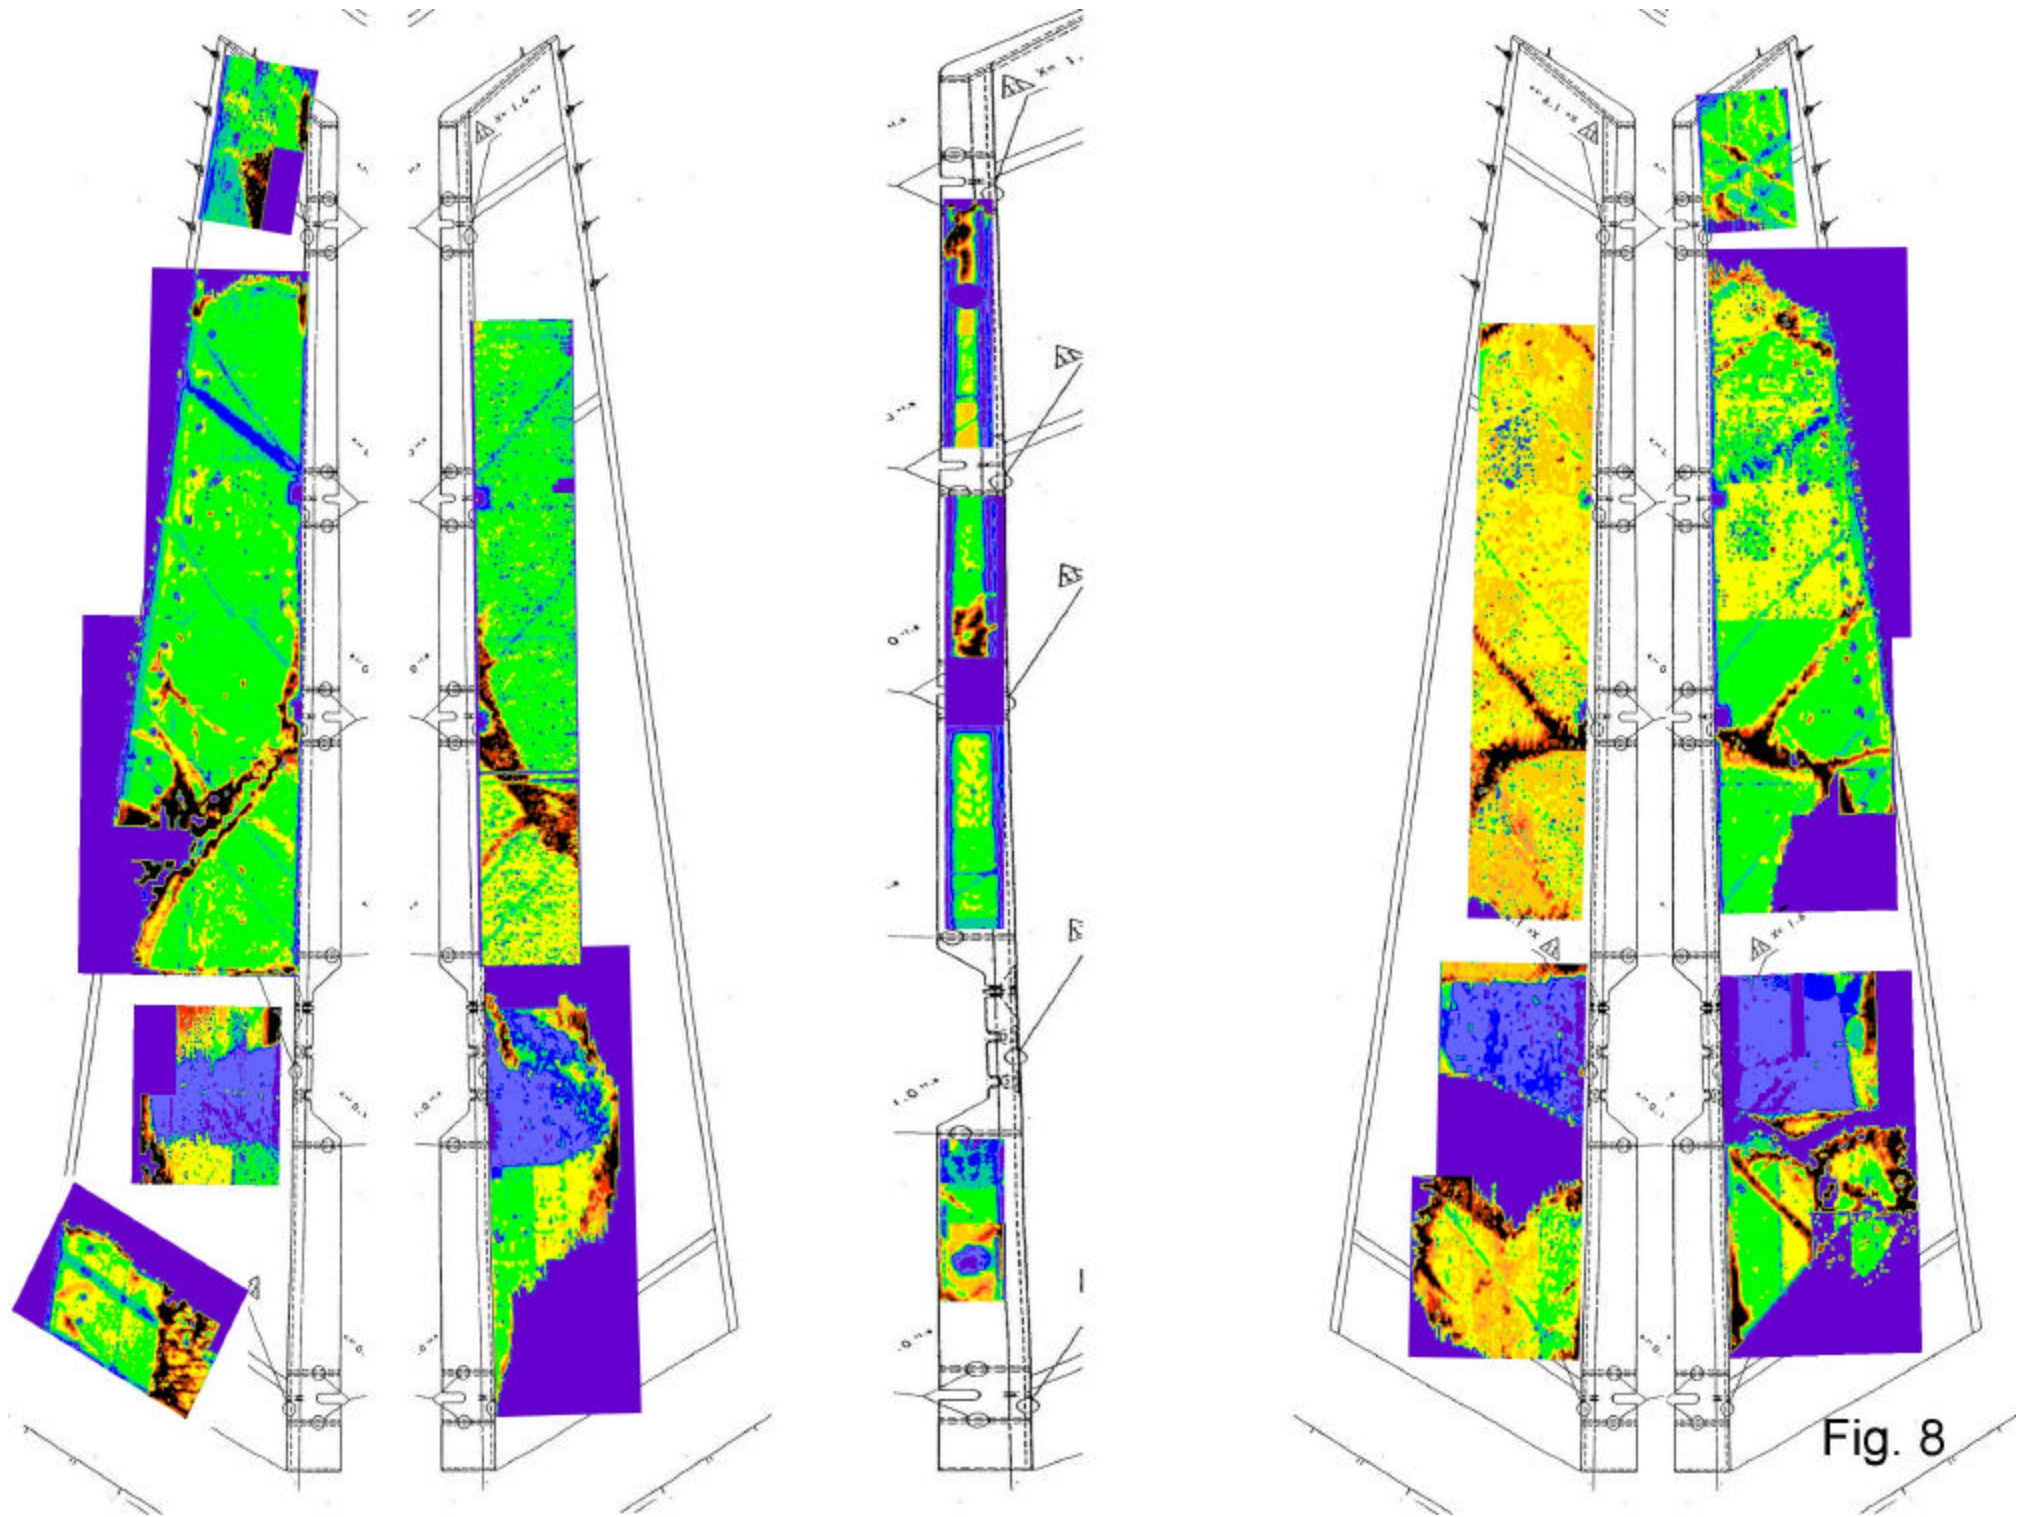
Fig. 8

Figure 8 shows an assembled view of all tap test images, spread symmetrically about the front spar.
