# NATIONAL TRANSPORTATION SAFETY BOARD

MATERIALS LABORATORY FACTUAL REPORT

Report No. 02-078

Place : Belle Harbor, New York  
Date : November 12, 2001  
Vehicle : Airbus A300-600, N14053  
NTSB No. : DCA02MA001  
Investigator : Brian Murphy, AS-40

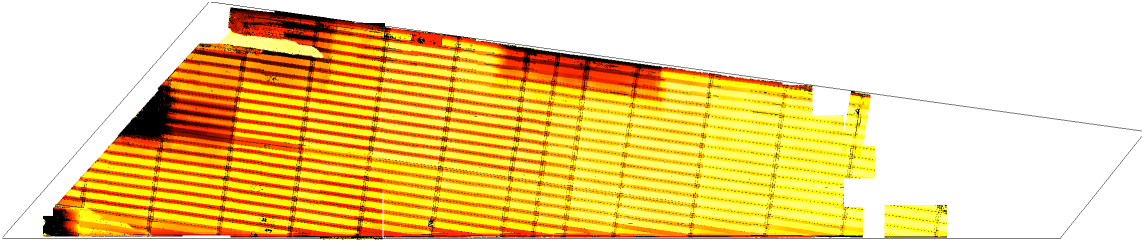
Figures 1.03-1.23 are the results obtained from measurements on the left side of the tail. Figure 1.03 is the compilation of all the time of flight measurements performed on the left side. Two notable delaminations were detected at the lower end near the forward and aft spars. Enlarged images of the data with a designation of the extents of these two delaminations are shown in figure 1.04. Figure 1.05 designates the regions shown in figures 1.06 to 1.23. These are the images of regions with anomalies in the relative attenuation, with responses typical of those found in figure 1.02.

Figure 1.03 Ultrasonic time of flight measurements performed on the left side of the composite tail.

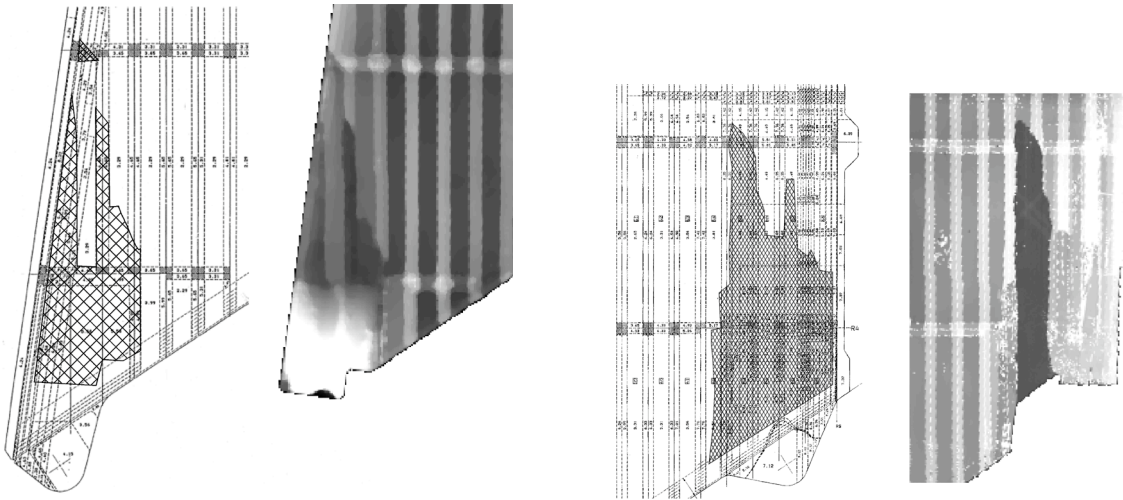
Figure 1.04 Expanded view showing delaminations at the lower end near the forward and aft spars.

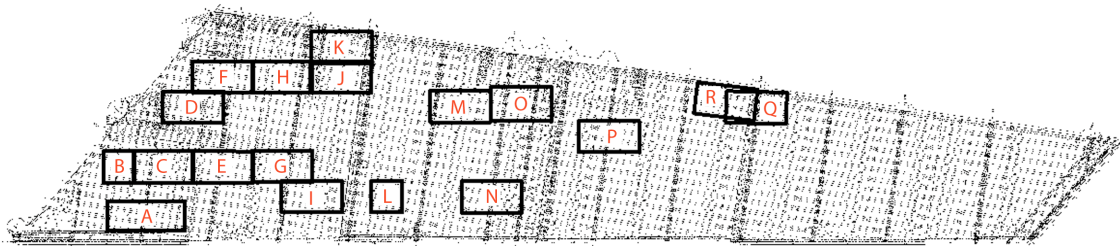
Figure 1.05 Region definitions used in subsequent images for the left side of tail. These are the regions with significant anomalies in ultrasonic attenuation responses.

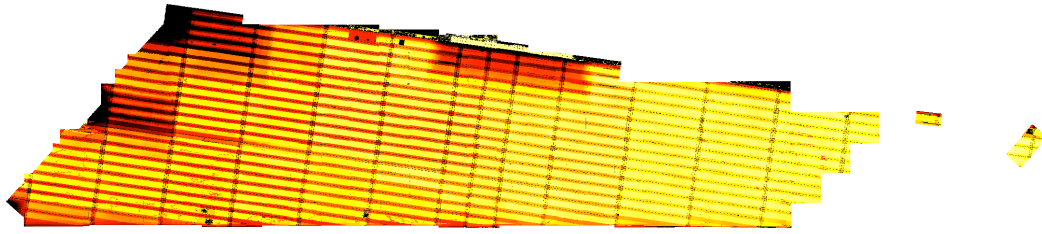
Figures 1.24-1.38 are the results obtain from measurements on the right side of the tail. Figure 1.24 is the compilation of all the time of flight measurements performed on the left side. No notable delaminations were detected on the right side of the tail. Figure 1.25 designates the regions shown in figures 1.26 to 1.38. These are the images of regions with anomalies in the relative attenuation, with responses typical of those found in figure 1.02.

Figure 1.24 Ultrasonic time of flight measurements performed on the right side of the composite tail.

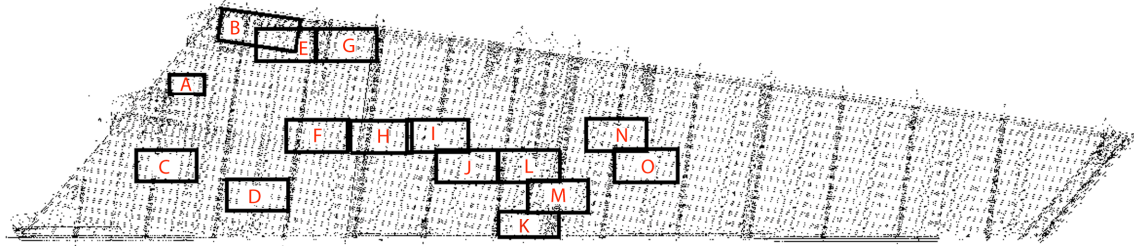
Figure 1.25 Region definitions used in subsequent images for the right side of tail. These are the regions with significant anomalies in ultrasonic attenuation responses.

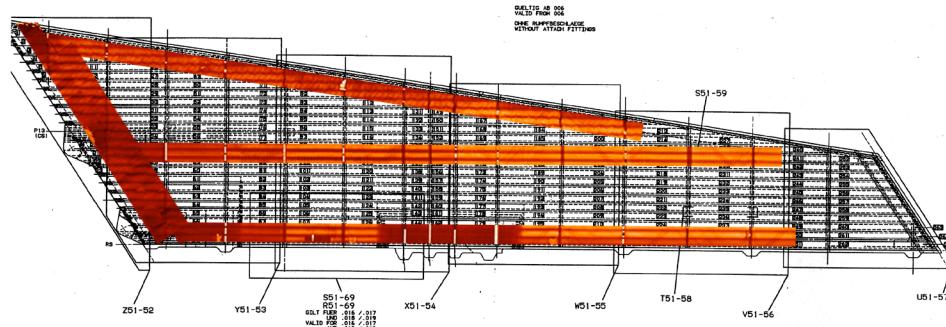
A compilation of all the data from the right side superimposed on a schematic of the tail is shown in figure 2.01. The data from the left side is shown in figure 2.02. Regions of higher stiffness appear red, and lower stiffness regions appear orange in the figures. The most significant characteristics in the images are the variations in thickness of the composites tail. Aside from stiffness changes associated with thickness variations, there is no apparent evidence of any change in stiffness in the data.

Figure 2.01 Lamb wave results for the right side of the composite tail.

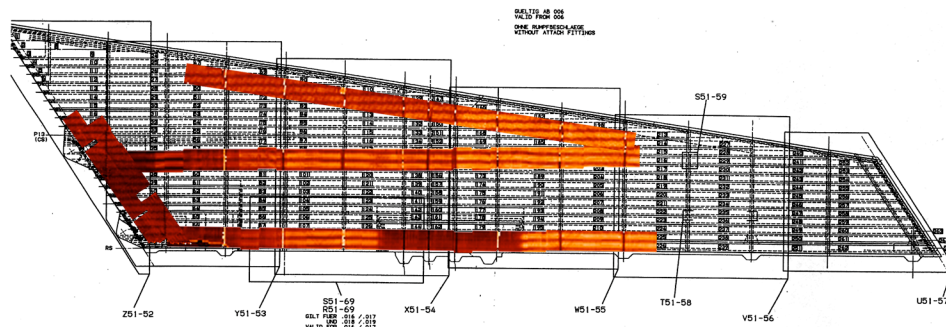
Figure 2.02 Lamb wave results for the left side of the composite tail.

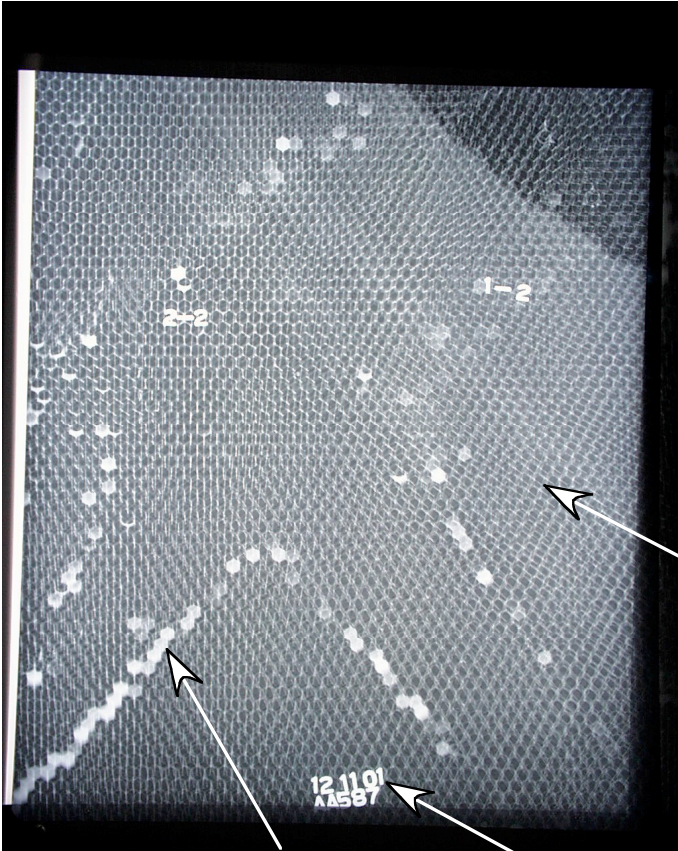
A typical image is shown in figure 3.01. In the image, the entrapped water is clearly visible. Also visible in the image are the lead markers and the walls of the honeycomb. A compilation of all the photos is shown in figure 3.02. In the figure it is clear that the entrapped water is at the lower half of the rudder section.

Figure 3.01 Radiographic image of water in honeycomb of rudder.

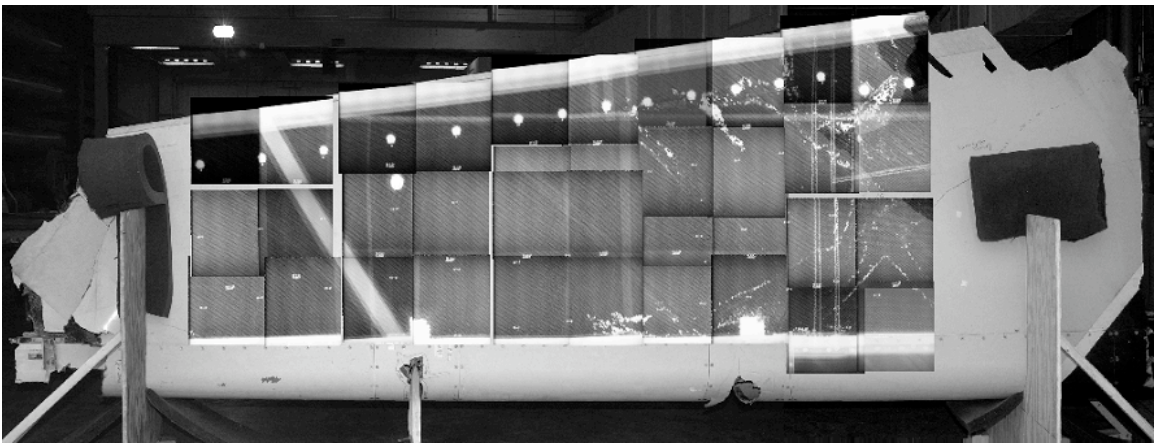
Figure 3.02 Compilation of radiography results superimposed on picture of the section of rudder examined.

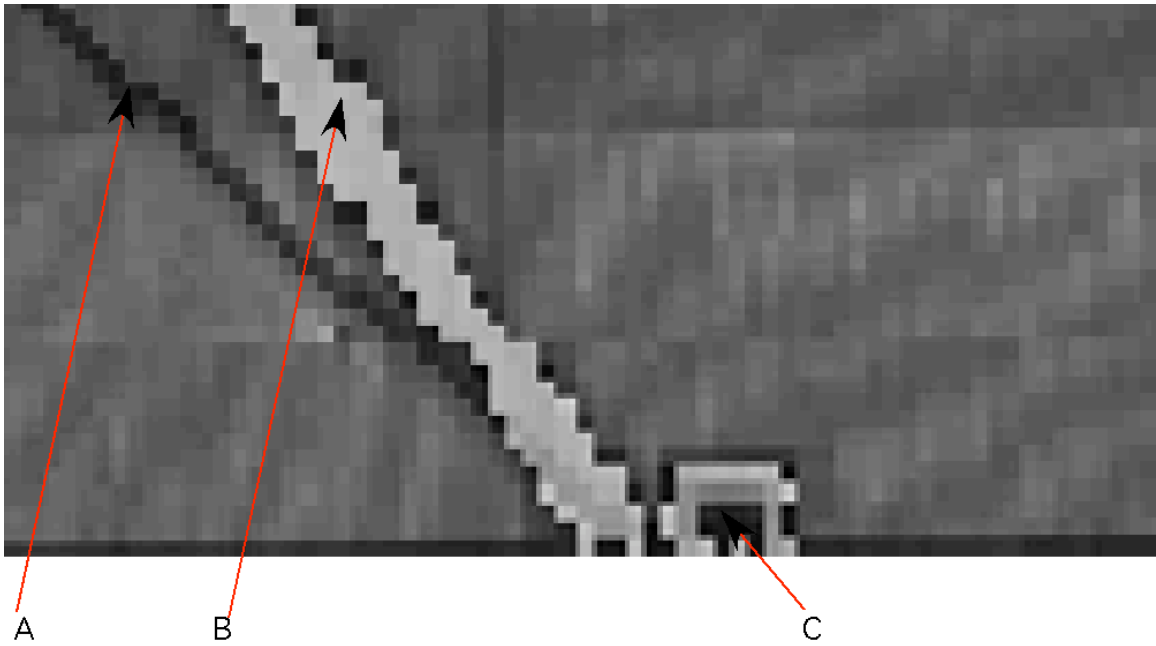
Figure 4.03 Identification of typical structural features in the Lamb wave image. A) Ply overlap, B) lightning strip and C) rudder hinge attach block.

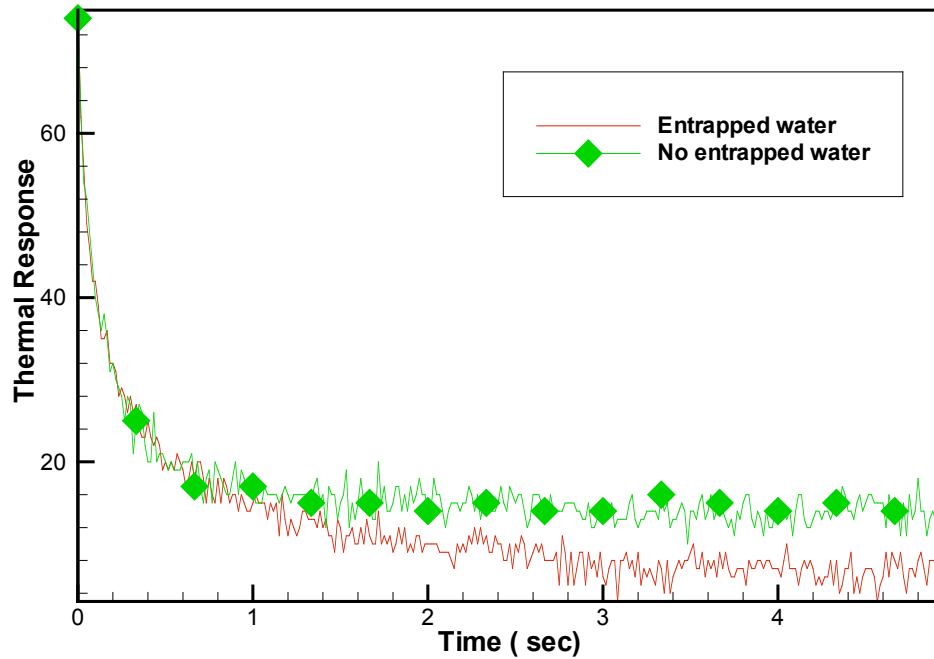
The thermal time response for a region of the rudder with and without entrapped water in the honeycomb is shown in figure 5.01. It is clear from the figure that there is significantly more cooling occurring in the region with entrapped water. The regions that appear darker in the data are indications of water. Other substructures, such as potting in the honeycomb also caused significant additional cooling relative to the unbacked face sheet. A compilation of all the data from the right side of the rudder superimposed on a picture of the right side of the rudder is shown in figure 5.02. The data from the left side superimposed on the same picture is shown in figure 5.03. Figures 5.04 and 5.05 show the same data with the locations of water highlighted in red.

Figure 5.01 The thermal time response for a region of the rudder with and without entrapped water in the honeycomb

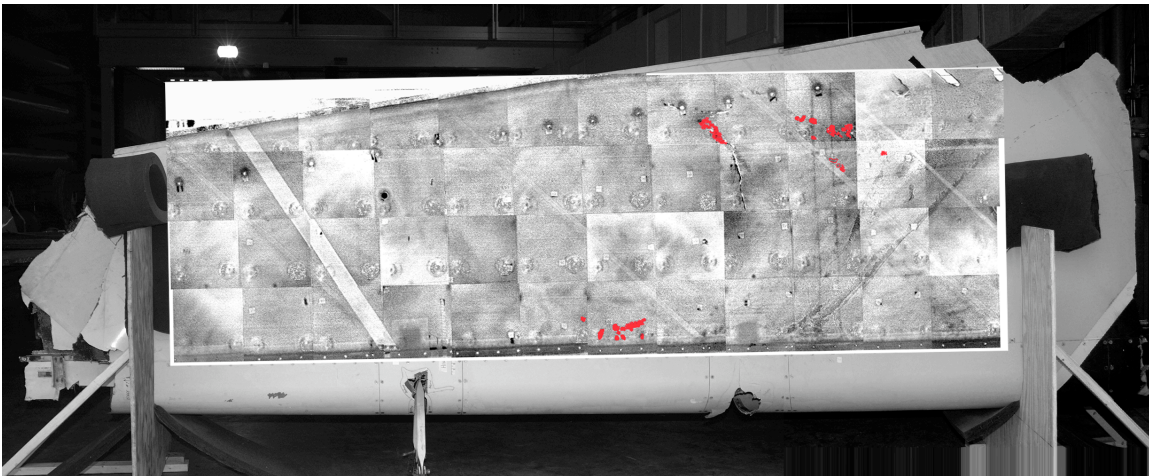
Figure 5.04 A compilation of all the data from the right side of the rudder superimposed on a picture of the right side of the rudder with water highlighted in red

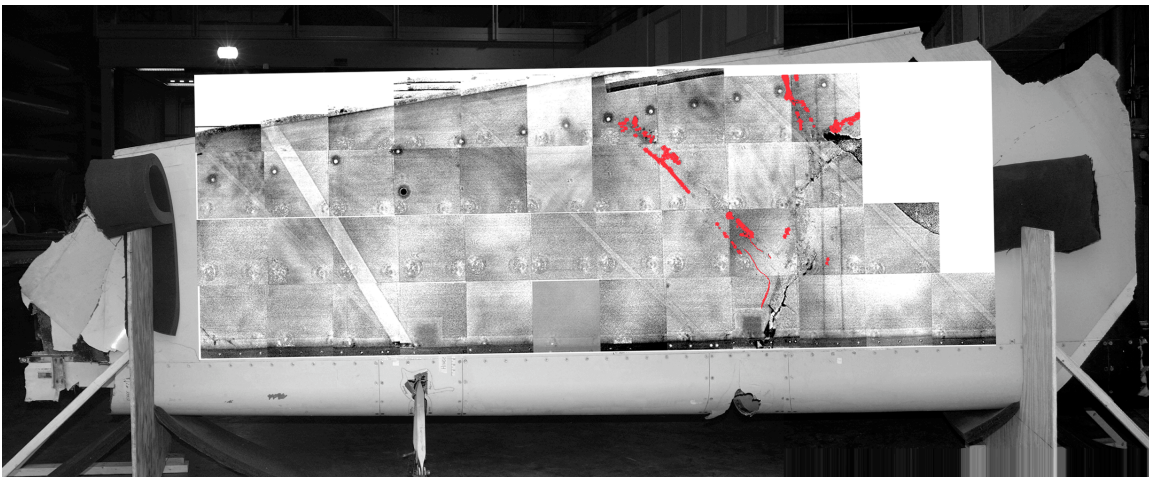
Figure 5.05 a compilation of all the data from the left side of the rudder superimposed on a picture of the right side of the rudder with water highlighted in red
