# NATIONAL TRANSPORTATION SAFETY BOARD

MATERIALS LABORATORY FACTUAL REPORT

Report No. 02-083

Place : Belle Harbor, New York  
Date : November 12, 2001  
Vehicle : Airbus A300-600, N14053  
NTSB No. : DCA02MA001  
Investigator : Brian Murphy, AS-40

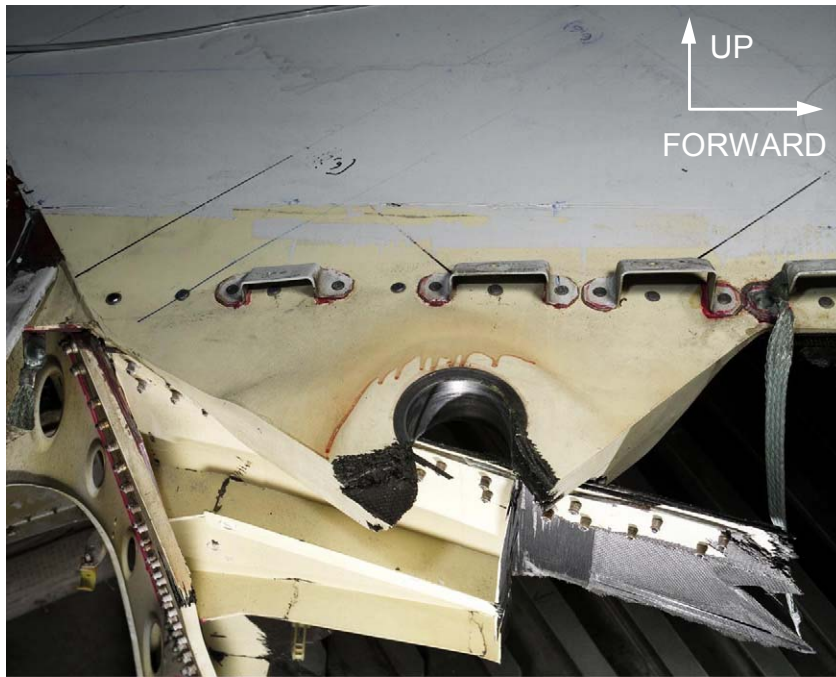
An overall view of the right aft lug upper fracture area on the vertical stabilizer is shown in figure 2. A piece of rib 1 was displaced downward and was covering the inboard side of the fracture surface on the forward leg of the lug. Another view of the right forward lug is shown in figure 3 as viewed from the left after sectioning from the vertical stabilizer. The fracture surfaces intersected the lug attach hole. The lower piece of the lug was not recovered and was missing.

Figure 2. Overall view of the right aft lug viewed from the right showing the upper fracture surfaces. As recovered, a piece of rib 1 was displaced over a portion of the fracture surface.

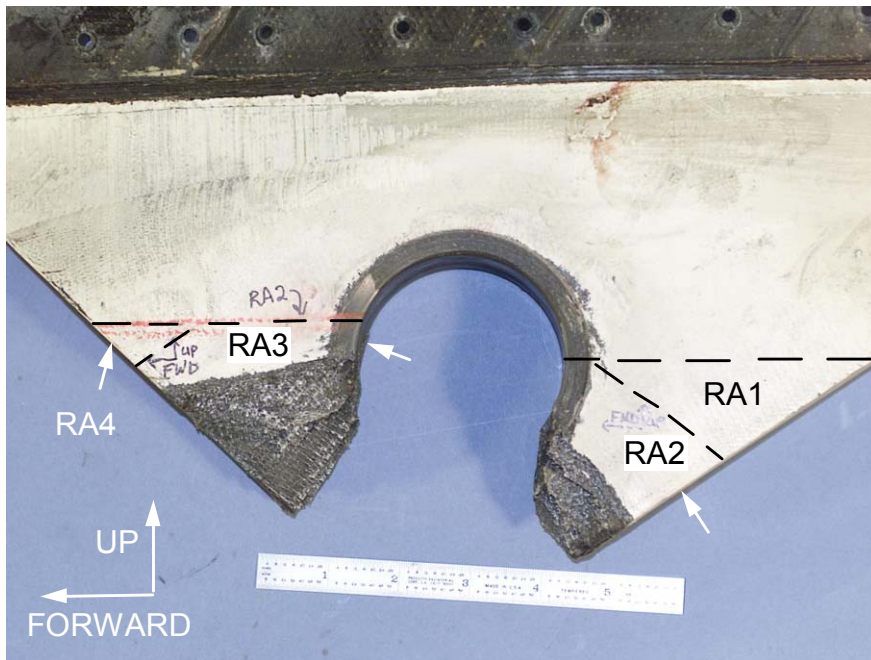
The fracture surfaces were sectioned from the remainder of the lug by cutting at the locations indicated in figure 3. To further facilitate the examination using SEM, specimens RA2 and RA3 were separated along the interlaminar plane that corresponded to the change of plane in the translaminar fracture. This was accomplished by using a screwdriver to pry open the interlaminar cracks indicated in figures 4 and 5. A "-1" and "-2" were added to the specimen labels to indicate the outboard and inboard specimens, respectively. (For example, the inboard portion of specimen RA2 was labeled RA2-2).

Figure 3. View of the right aft lug looking from the left. Dashed lines indicate where cuts were made.

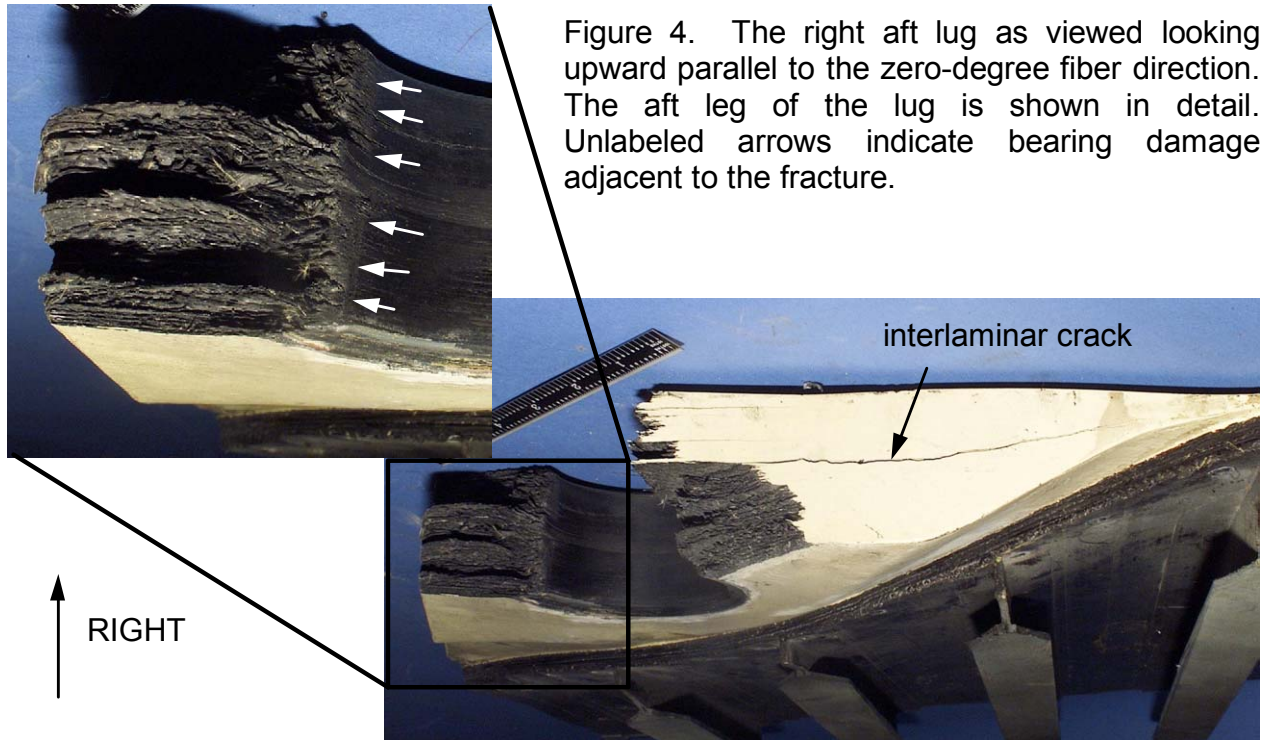
Views of the translaminar fracture surfaces on the aft and forward legs of the right aft lug are shown in figures 4 and 5. The translaminar fracture surfaces had a rough

appearance consistent with fracture primarily under tensile loading. Fractures on each leg of the lug were on different translaminar planes, and the change in planes occurred near the center of the lug thickness. On the aft leg, the outboard side of the fracture was in a plane nearly perpendicular to the zero-degree fiber direction, and the inboard side of the fracture was in a plane approximately parallel to the 45-degree fiber direction. On the forward leg, the outboard side of the fracture was in a plane approximately parallel to the zero-degree fiber direction, and the inboard side of the fracture was in a nearly horizontal plane. Bearing damage was observed at the bore surface near both fracture surfaces, as indicated in figures 4 and 5.

Some interlaminar cracks were observed above the fracture. Black arrows in figures 4 and 5 indicate the largest cracks visible at the outer surface. These cracks intersected the translaminar fracture where the fracture plane changed. The interlaminar cracks visible at the surface were limited to the lug region below rib 1.

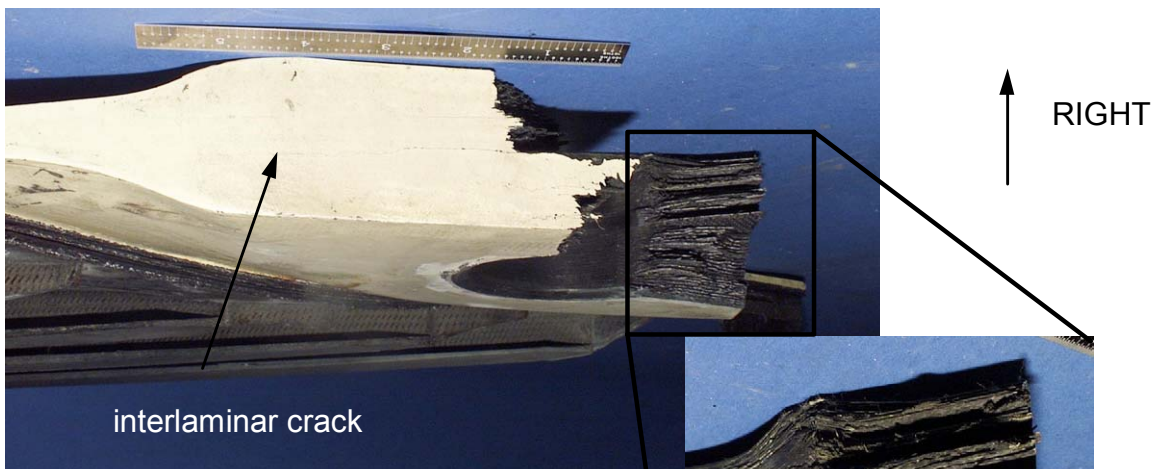
Figure 5. The right aft lug as viewed looking upward and forward. The fracture surface on the forward leg of the lug is shown in detail. Unlabeled arrows indicate bearing damage adjacent to the fracture.

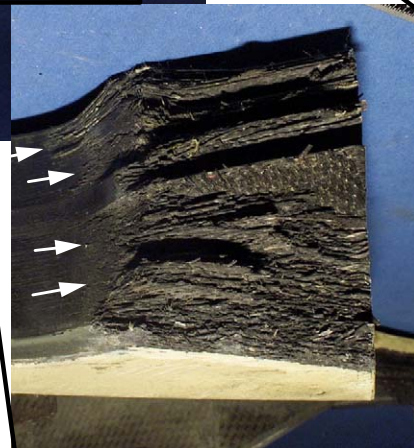
The translaminar fracture surface on the aft leg of the lug, specimens RA2-1 and RA2-2, were examined using SEM. For fibers oriented in the zero-degree direction, the fibers typically showed radial fracture patterns over their fracture surfaces, consistent with overstress fracture under tensile loads. Similar fracture features were observed throughout the fracture surface. Typical fracture surface features for fibers oriented in the zero-degree orientation are shown in figure 6. Unlabeled arrows in figure 6 indicate the direction of crack propagation within individual fibers. The direction of fracture was sampled from fibers in many locations, and the general direction of fracture was to the left of aft.

Figure 6. Typical appearance of the fractured zero-degree fibers on specimen RA2-1 near the outboard surface. Arrows on fractured fibers indicate direction of fracture propagation through the fiber.

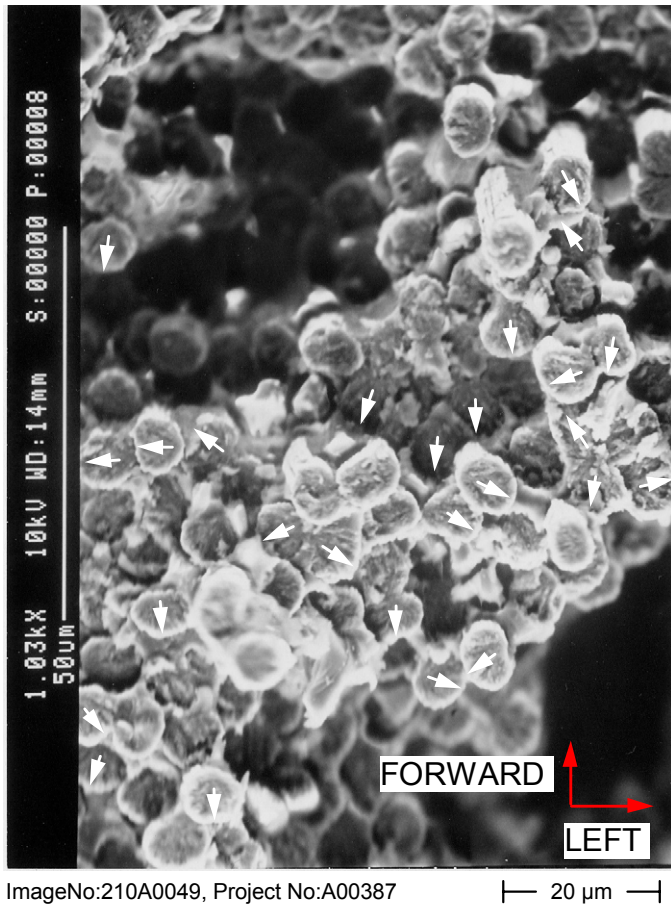
Near the inboard side of specimen RA2-1 (near the center of the lug thickness), the -45-degree fibers were oriented nearly perpendicular to the fracture surface. In this area, these fibers typically showed radial fracture patterns over their fracture surfaces, consistent with overstress fracture under tensile loads. Typical fracture surface features for fibers oriented in the -45-degree orientation in this area are shown in figure 7. Unlabeled arrows in figure 7 indicate the direction of crack propagation within individual fibers. The direction of fracture was sampled from fibers in several locations, and the general direction of fracture was slightly to the right of aft.

Figure 7. Typical appearance of the fractured -45-degree fibers on specimen RA2-1 near the center of the total lug thickness. Arrows on fractured fibers indicate direction of fracture propagation through the fiber.

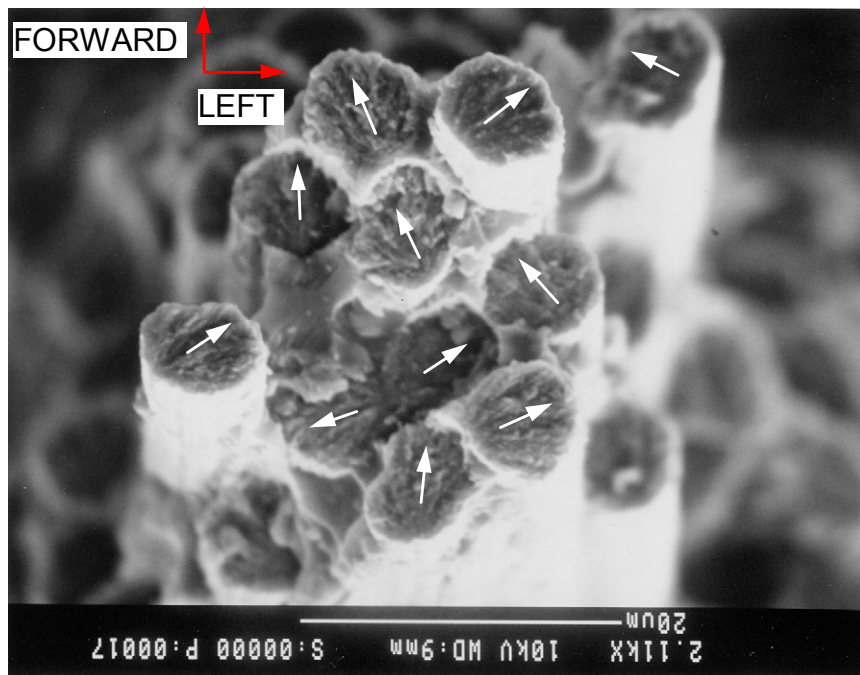
fracture under tensile loads. Similar fracture features were observed throughout the fracture surface. Typical fracture surface features for fibers oriented in the zero-degree orientation are shown in figure 8. Unlabeled arrows in figure 8 indicate the direction of crack propagation within individual fibers. The direction of fracture was sampled from fibers in many locations, and the general direction of fracture was nearly directly forward.

Figure 8. Typical appearance of the fractured zero-degree fibers on specimen RA3-2 near the center of the total lug thickness. Arrows on fractured fibers indicate direction of fracture propagation through the fiber.

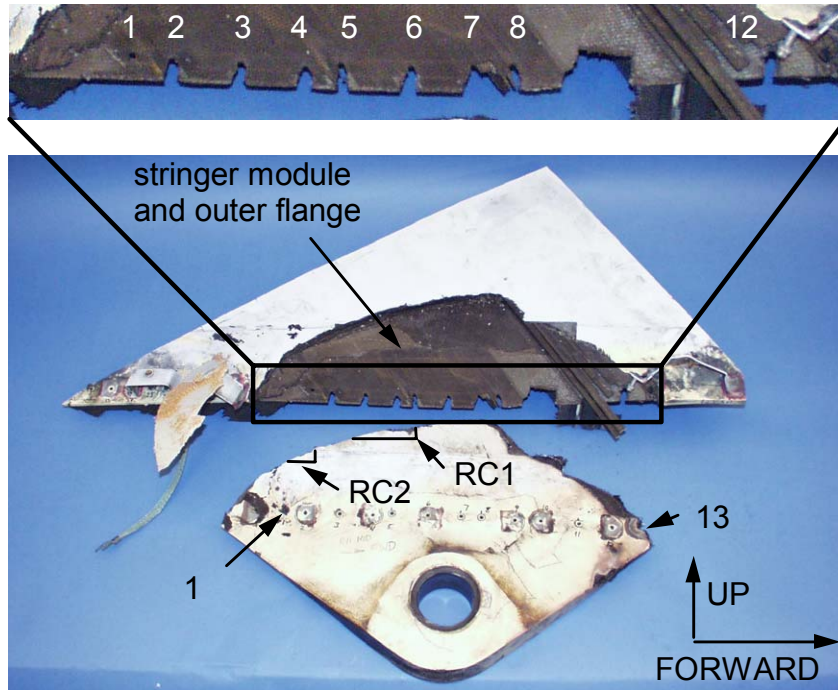
Overall views of the fracture at the right center lug area are shown in figures 9 and 10. The fracture occurred in the vertical stabilizer structure above the lug bore. Translaminar fractures occurred in the skin and the lug build-up layers primarily in a slightly curved plane perpendicular to the zero-degree fiber direction at a location up to approximately 12 inches above the lug attach bolt centerline. As shown in figure 11, the translaminar fracture appeared rough, consistent with fracture from tensile loading. The stringer module structure and stringer outer flange layers, as indicated in figure 9, remained with the upper piece. Rib 1 fastener holes near the lower end of the stringer module and outer flange layers were torn out as shown in the detail in figure 9. The holes are shown numbered aft to forward for reference. The holes for the fasteners that remained with the lower piece were torn out primarily in a downward direction. For holes 2 to 8, the hole was torn out at the lower forward side in a direction parallel to the zero-degree fiber direction, followed by a downward tearout. The material between holes 8 and 9 was torn out and remained attached to the lower piece. A piece of the upper leg of the rib 1 attach angle also remained with the lower piece, as shown in figure 10. Some layers of tape pulled out from the lower piece near the forward side and remained with the upper piece.

The translaminar fracture surface on the lower piece was examined using SEM on two specimens, labeled specimens RC1 and RC2 in figure 9. For fibers oriented in the zero degree direction, the fiber ends generally showed radial fracture patterns over their fracture surfaces, consistent with overstress fracture under tensile loads. Similar fracture features were observed throughout the fracture in areas RC1 and RC2. Typical fracture

Figure 9. Overall view of the right center lug pieces viewed from the right with the upper photograph showing details of the rib 1 fastener hole tearouts in the stringer module and outer flange layers.

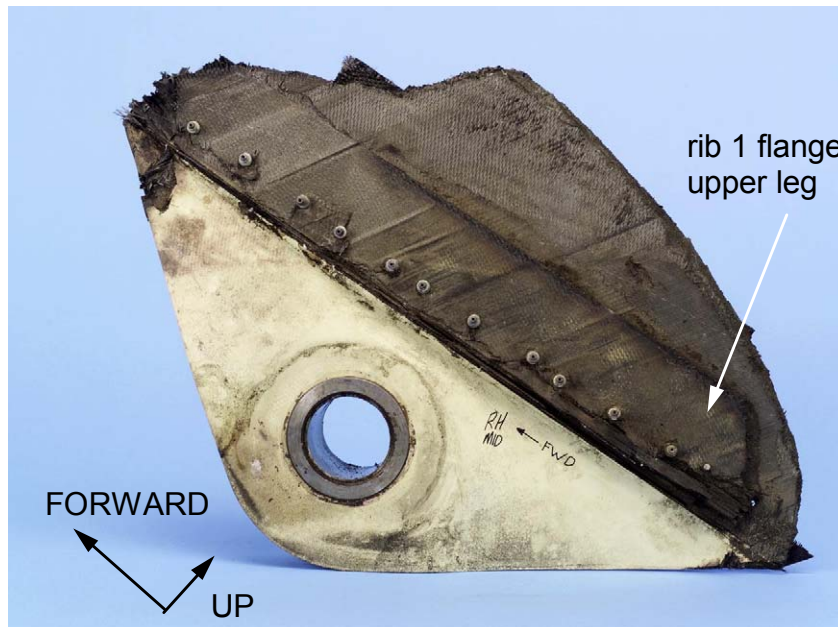
Figure 10. Overall view of the right center lug, lower piece, looking from the left.

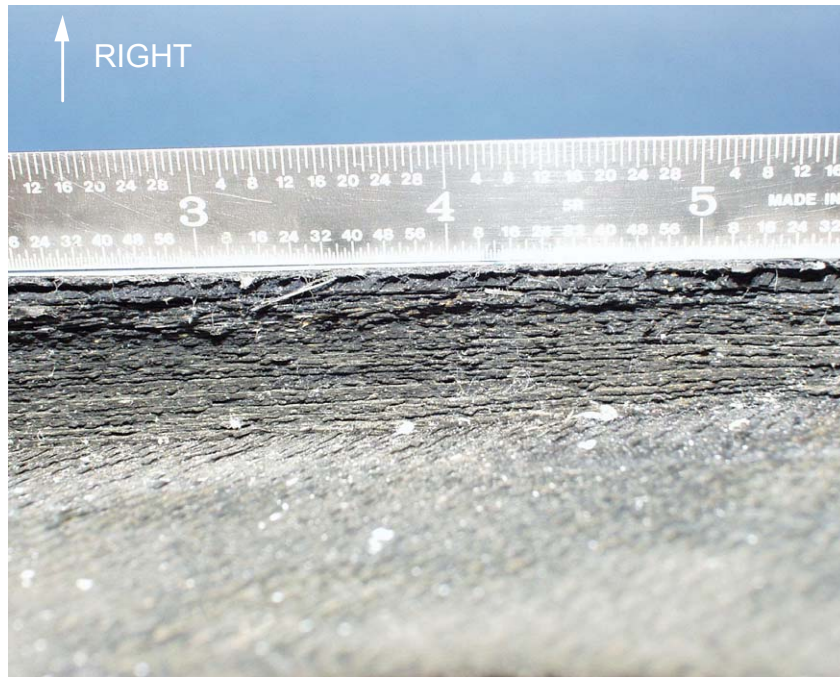
Figure 11. Right center lug upper fracture surface viewed looking upward parallel to the zero-degree fiber direction.

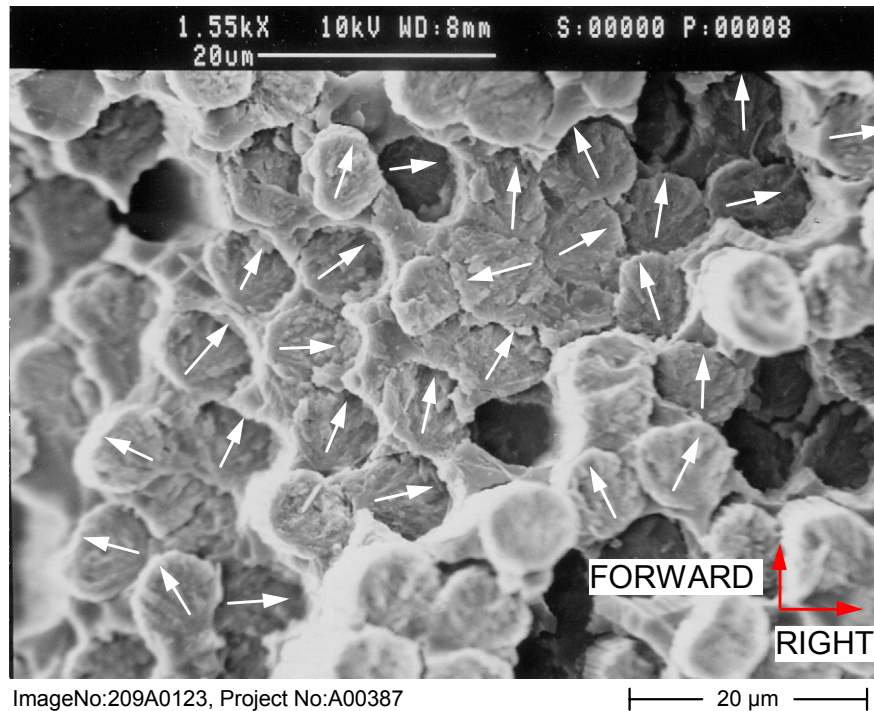
surface features for fibers oriented in the zero-degree orientation are shown in figures 12 and 13 for each area. The area shown in figure 13 was relatively rich in resin compared to other areas on the fracture surface, and the larger areas of resin fracture are indicated in the figure. Unlabeled arrows in figures 12 and 13 indicate the direction of fracture for individual fibers. The direction of fracture was sampled from many locations in the two areas. In specimen RC2, the general direction of fracture was to the right of forward, and in specimen RC1, the direction of fracture was nearly directly forward.

Figure 12. Typical appearance of the fractured zero-degree fibers on specimen RC2 near the exterior surface. Arrows on fractured fibers indicate direction of fracture propagation through the fiber.

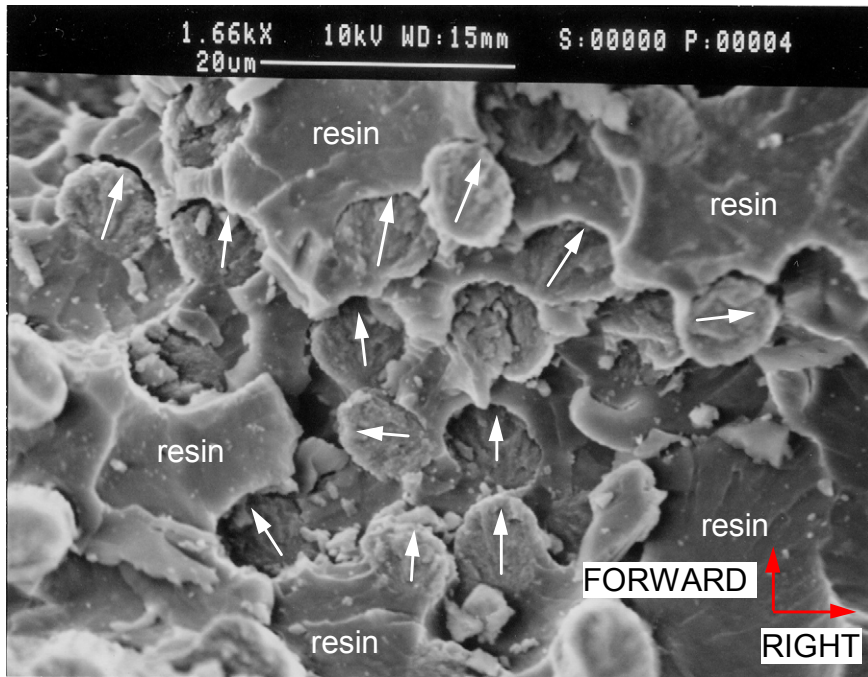
Figure 13. Typical appearance of the fractured zero-degree fibers on sample RC1 near the exterior surface. Arrows on fractured fibers indicate direction of fracture propagation through the fiber.

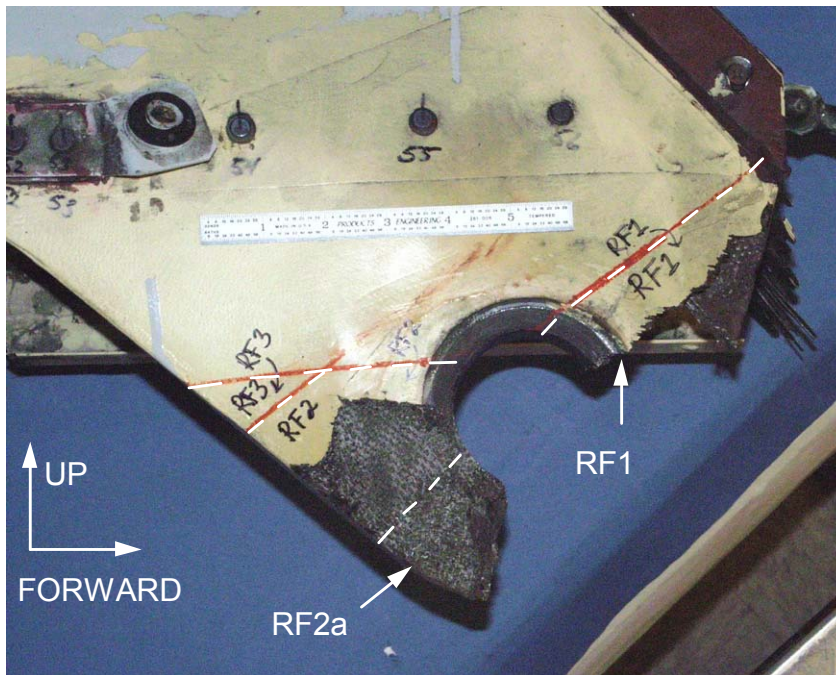
An overall view of the right forward lug upper fracture area is shown in figure 14. Additional views of the right forward lug are shown in figures 15 to 24. The fracture surfaces intersected the lug attach hole. Most of the lower portion of the lug was missing and was not recovered, but a small amount of composite material was left in the circumferential groove between the two hat bushings that remained attached to the fuselage. The translaminar fracture surfaces had a rough appearance consistent with fracture primarily under tensile loading. A few layers near the inboard and outboard surface had translaminar fractures approximately three inches above the remaining translaminar fractures with interlaminar fractures between the translaminar fracture locations.

Figure 14. Overall view of the right forward lug upper fracture area. Dashed lines indicate locations where cuts were made.

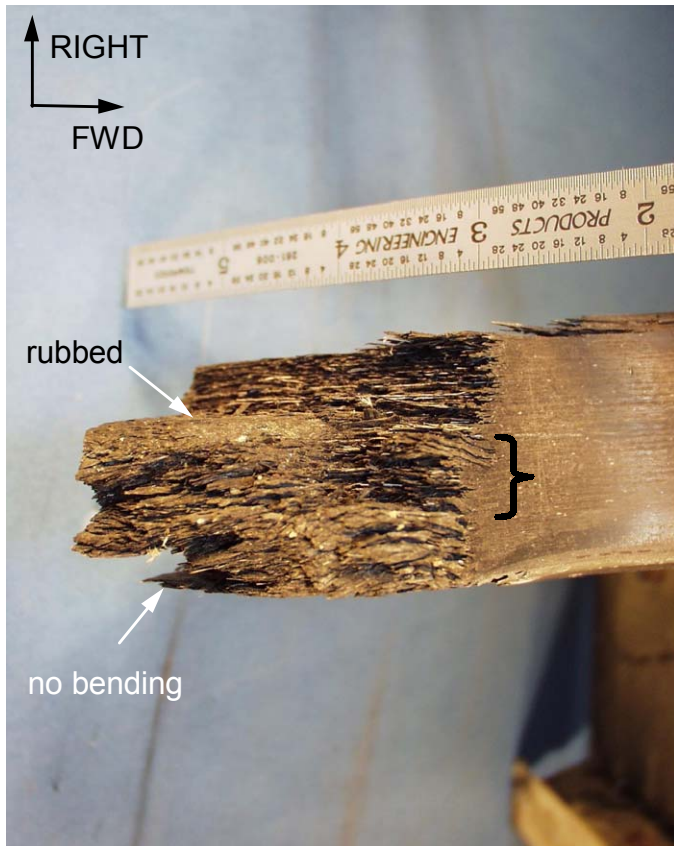
The aft leg of the lug is shown in figures 15 to 20. Fracture on the aft leg of the lug occurred on different planes. On the inboard and outboard sides of the aft leg, the fracture was on planes perpendicular to the zero-degree fibers along the length of the spar, and near the center of the aft leg, the fracture was on a plane approximately parallel to the 45-degree fiber direction. Near the bore surface, some fractured ends of the layers were bent to the right as shown by the black bracket in figure 15. At the aft end, some fractured ends of the layers near the center of the lug thickness were bent to the left, as shown by the white bracket in figure 16. On the right of these center layers, the fracture surface had a smooth appearance consistent with post-fracture contact damage (see arrow labeled "rubbed" in figure 15). A few layers near the inboard interlaminar fracture were not bent, as indicated in figure 15, although many adjacent layers to the right were fractured above the translaminar fracture for the indicated layer. At the aft end as indicated in figure 16, some of the fractured ends of the layers near the outboard surface were bent to the right, and some of the fractured ends of the layers near the inboard surface were bent to the left consistent with a local compressive loading.

Figure 15. Direct view of the right forward lug, aft leg looking upward and aft. The bracket indicates fiber ends bent to the right.

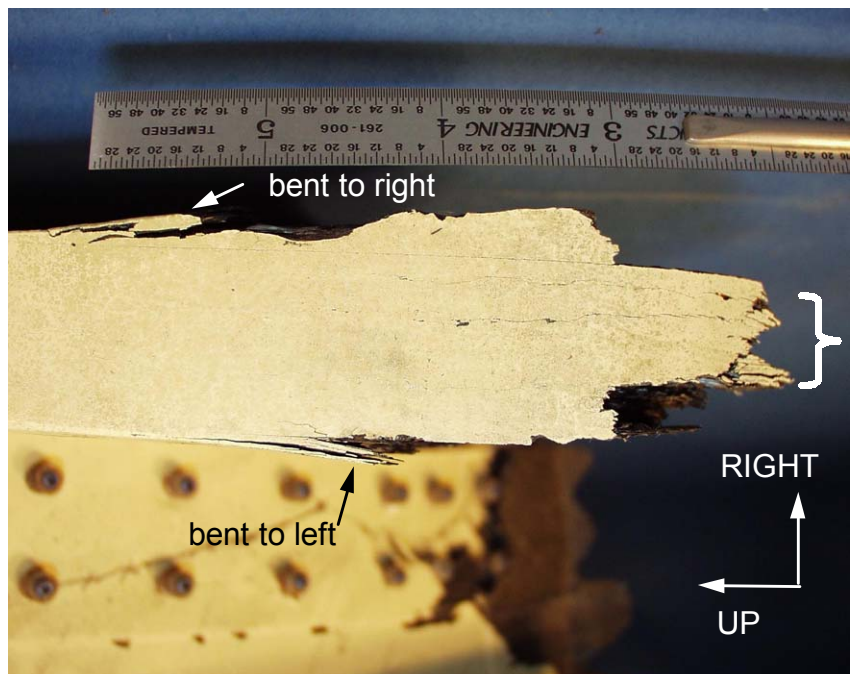
Figure 16. The aft surface of the right forward lug above the fracture through the aft leg, showing delaminations. View is looking upward and forward. The bracket indicates fiber ends bent to the left.

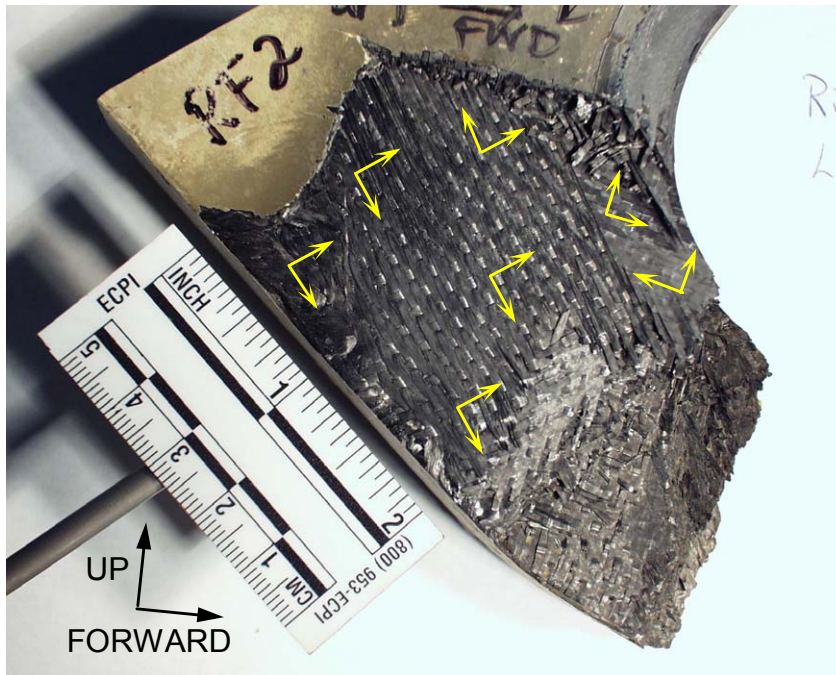
The interlaminar fractures near the inboard and outboard sides of the aft leg were examined using SEM. Relative motions of the mating fractures were determined from the hackle directions in the epoxy matrix, and the general crack propagation direction was determined from river markings<sup>4</sup>, also in the epoxy matrix. The results are shown in figures 17 to 20. Relative to the center layers at the time of fracture, the outer and inner layers

Figure 17. Aft leg of the right forward lug showing the outer delamination surface. Arrows indicate directions of hackles observed. Shear tractions on the surface acted opposite to the direction of the hackles.

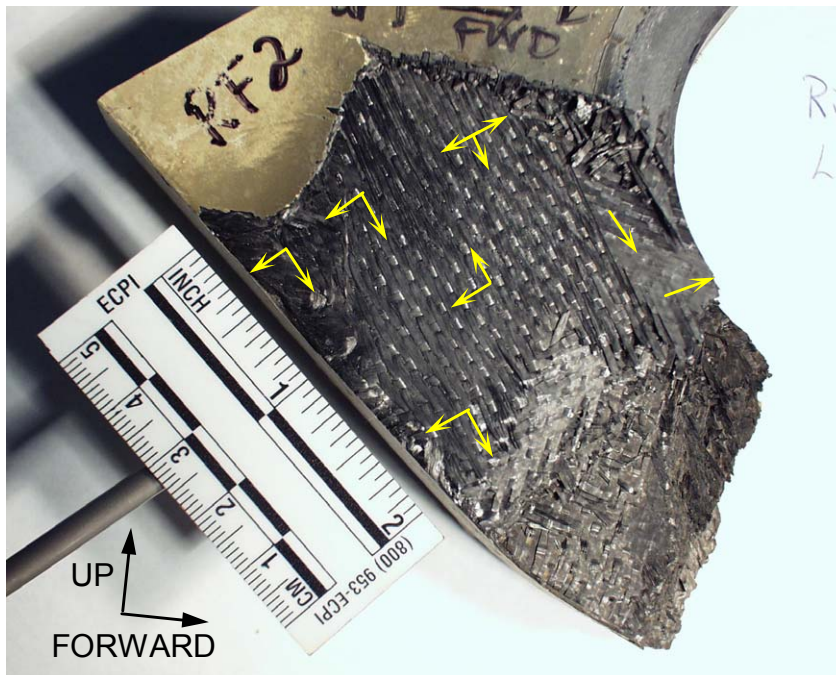
Figure 18. Aft leg of the right forward lug showing the outer delamination surface. Arrows indicate the direction of the river markings at the bases of the hackles.

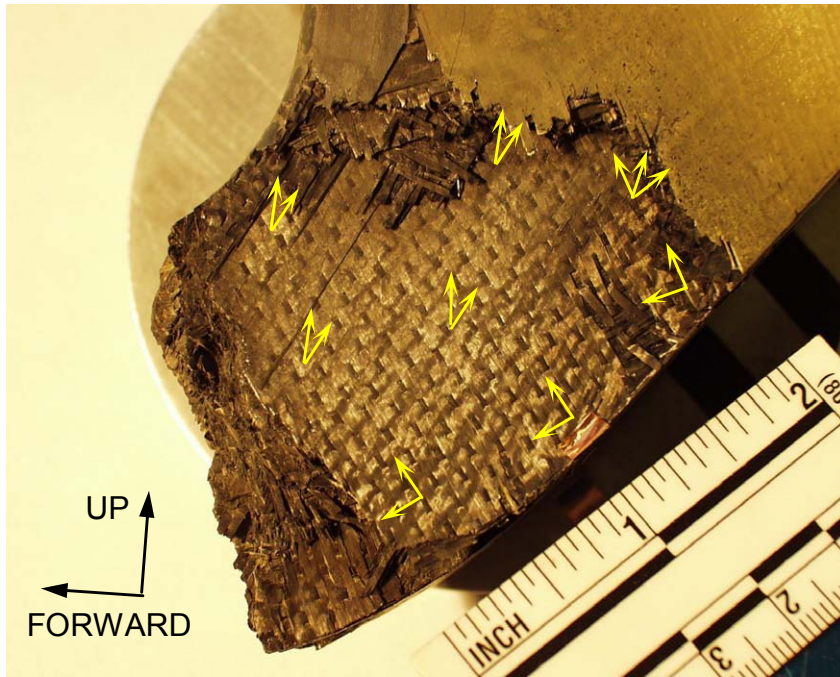
Figure 19. Aft leg of the right forward lug showing the inner delamination surface. Arrows indicate directions of hackles observed. Shear tractions on the surface acted opposite to the direction of the hackles.

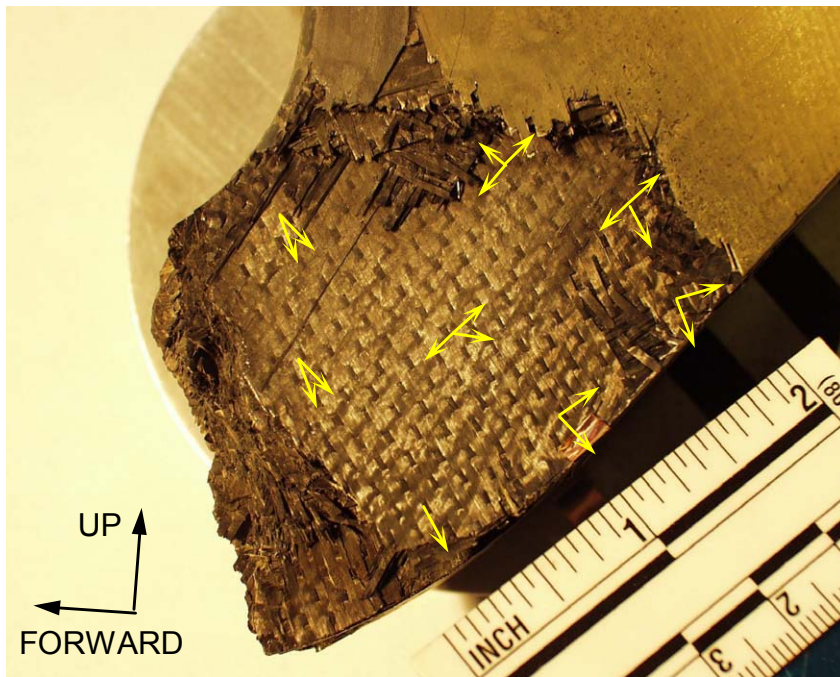
Figure 20. Aft leg of the right forward lug showing the inner delamination surface. Arrows indicate the direction of the river markings at the bases of the hackles.

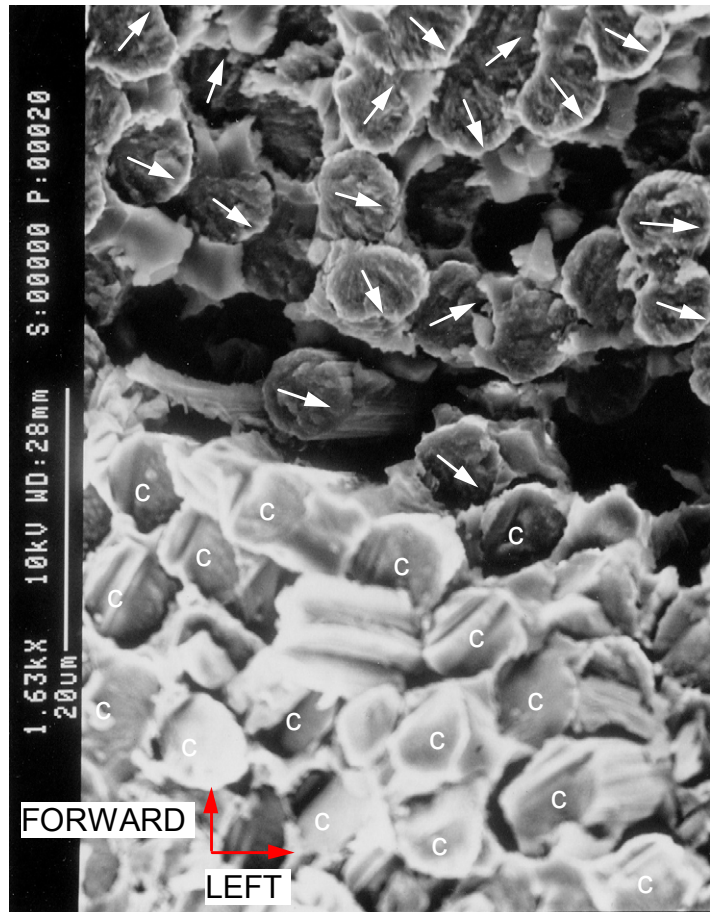
The translamina fracture surface on the aft leg of the lug, specimen RF2a in figure 14, was examined using SEM. For fibers oriented in the zero degree direction, the fiber fractures typically showed radial fracture patterns over their fracture surfaces as shown in figure 21 and the upper portion of figure 22, features consistent with overstress fracture under tensile loads. In some areas near the center of the lug thickness, some of the zero-degree fibers had relatively smooth fracture features with changes in the fracture plane within the fibers (called chop marks), features consistent with local fiber bending under compressive load. These areas were relatively isolated and appeared to coincide with areas where the fractured ends of layers appeared bent or damaged from the optical examination. Other zero-degree fibers in the same areas had radial fracture patterns, consistent with overstress fracture under tensile load. Figure 22 shows a view from the center of the thickness showing fibers with the different fracture features in the same view. Unlabeled arrows in figures 21 and 22 indicate the direction of fracture for individual fibers. The direction of fracture was sampled from many locations throughout specimen RF2a. For most of the fracture area, the general direction of fracture was slightly to the right of downward and aft. In the center of the thickness near the lug bore, the direction of fracture was approximately midway between the left and the downward and aft directions.

Figure 22. Typical appearance of the fractured zero-degree fibers on sample RF2a near the forward and center portions of the fracture. Arrows on fractured fibers indicate direction of fracture propagation through the fiber. Arrows "c" indicate fiber ends having chop marks.

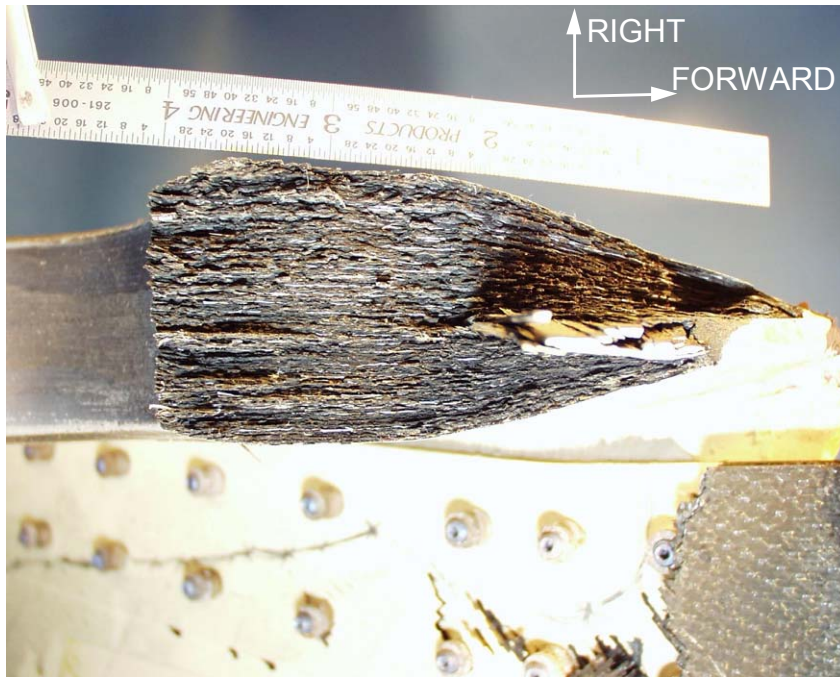
On the forward leg of the lug, the fracture surface was almost entirely on a plane that was perpendicular to the length direction of the front spar as shown in figure 23. Near the forward end, some center layers did not have transverse fractures and extended below the fracture surface to the original lug forward lower surface. The lower ends of these center layers were bent to the left and had a rubbed appearance on the right side. Red-colored deposits were observed on the fracture surface in the adjacent area.

Figure 23. Fracture surface on the forward leg of the right forward lug, View is looking upward parallel to the zero-degree fiber direction.

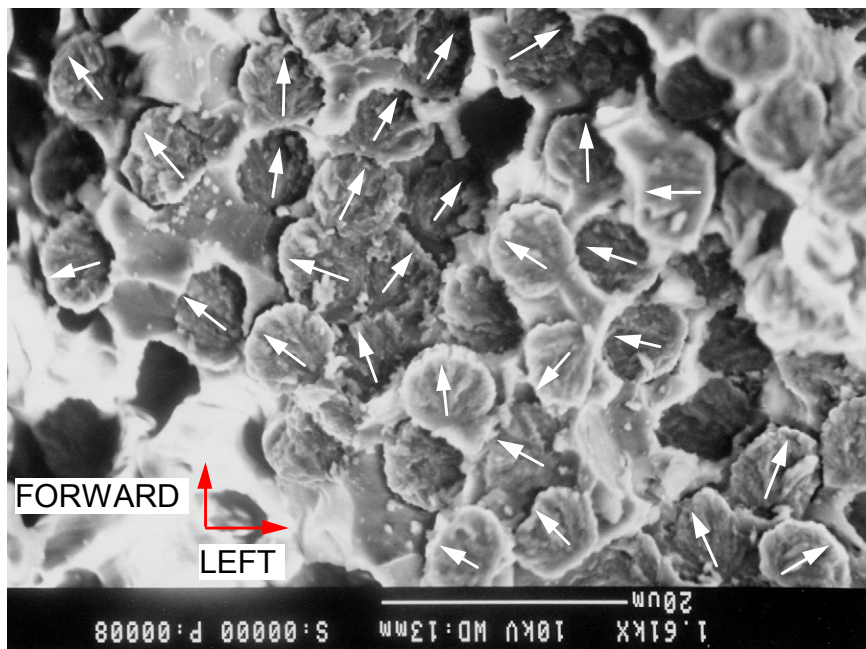
The translamina fracture surface on the forward leg of the lug, specimen RF1 in figure 14, was examined using SEM. For fibers oriented in the zero degree direction, the fibers typically showed radial fracture patterns over their fracture surfaces, consistent with overstress fracture under tensile loads. Similar fracture features were observed throughout the fracture surface. Typical fracture surface features for fibers oriented in the zero-degree orientation are shown in figure 24. Unlabeled arrows in figure 24 indicate the direction of fracture for individual fibers. The direction of fracture was sampled from many locations, and the general direction of fracture was slightly to the left of forward.

Figure 24. Typical appearance of the fractured zero-degree fibers on sample RF1 near the outer and aft portions of the fracture. Arrows on fractured fibers indicate direction of fracture propagation through the fiber.

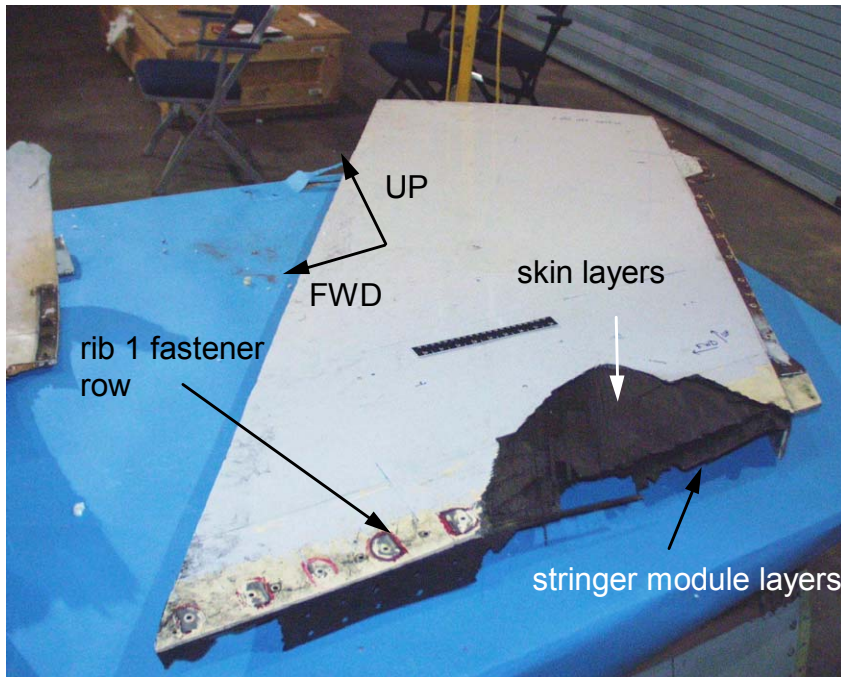
Overall views of the left aft lug area are shown in figures 25 and 26. A combination of fractures listed below allowed the lug structure to separate from the vertical stabilizer and remain attached to the fuselage after the accident, leaving a gap between the skin layers and the stringer module structures at the aft lower end of the vertical stabilizer. Ultrasonic C scans performed by NASA and by Airbus indicated that this gap was part of a continuous interlaminar fracture extending at least 2 inches forward of stringer 4 and 8 inches above rib 4. For more details of the nondestructive examination, see Materials Laboratory Factual

Figure 25. Overall view of the upper piece containing the upper portion of the fracture at the left aft lug, viewed looking up and to the right.

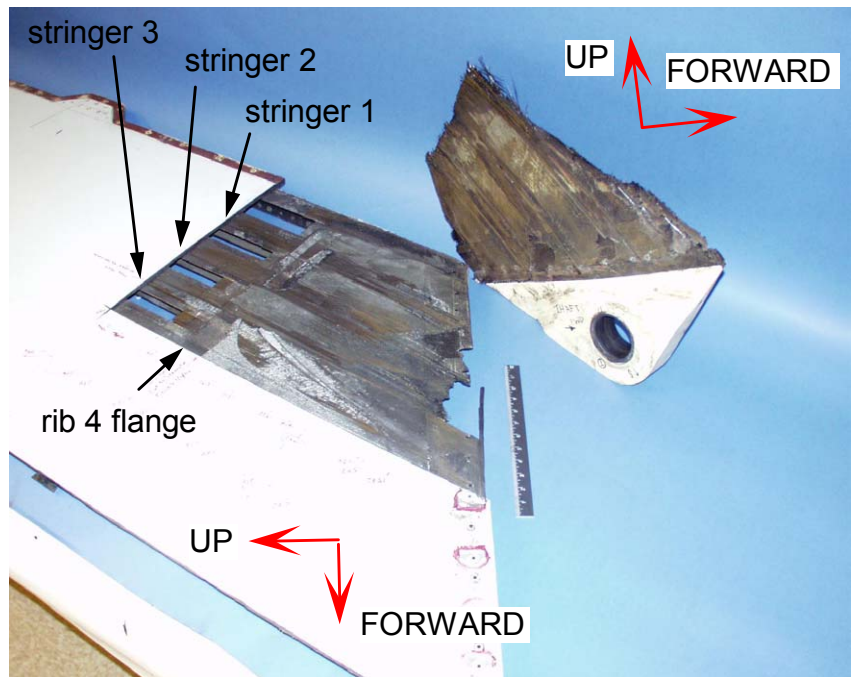
Figure 27. Mating fracture surfaces at the left aft lug area between the lower piece and the stringer module structure of the upper piece after cutting through the skin.

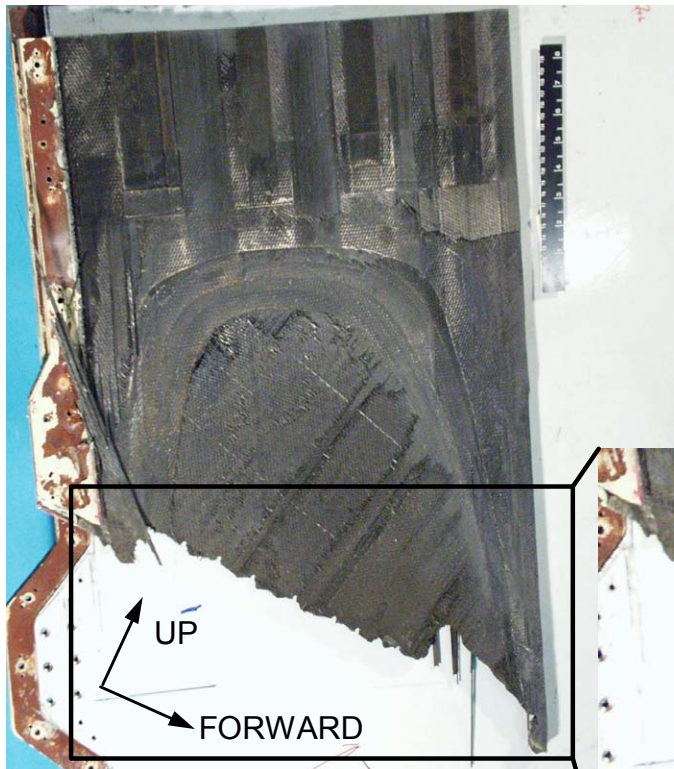
Figure 31 shows the interior surface of the skin section after cutting from the upper piece. The row of rib 1 fastener holes in the skin section is indicated in the inset photograph in this figure. The translaminar fracture in the skin intersected most of these fastener holes except for an area near the forward end, where the fracture was above holes 9 to 11.

Figure 31. The interior surface of the skin section at the left aft lug fracture area after cutting from the upper piece. Inset photograph shows the numbered rib 1 fastener holes.

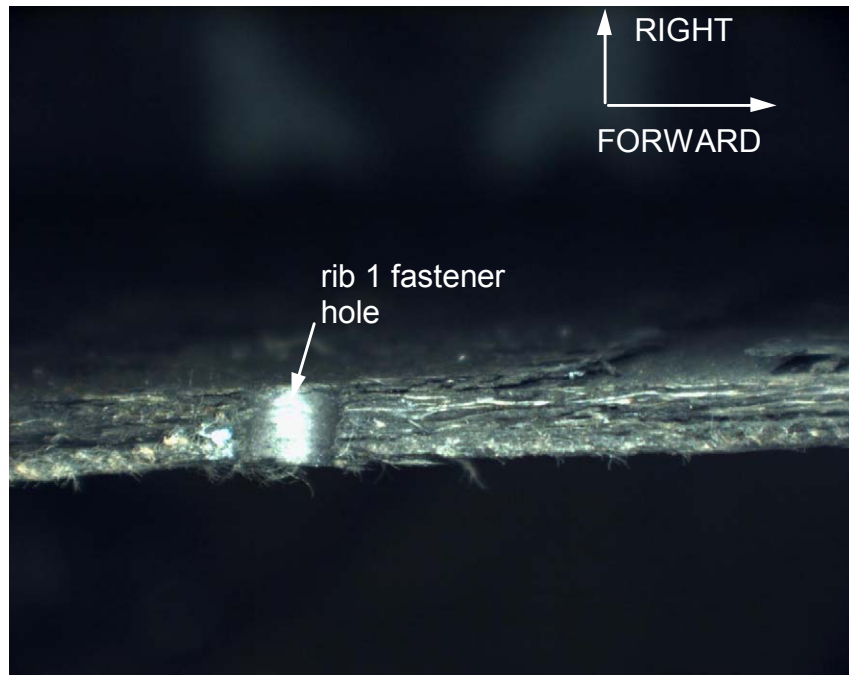
Figure 32. Vertical stabilizer skin fracture at a rib 1 fastener hole in the vicinity of the left aft lug, viewed looking upward.

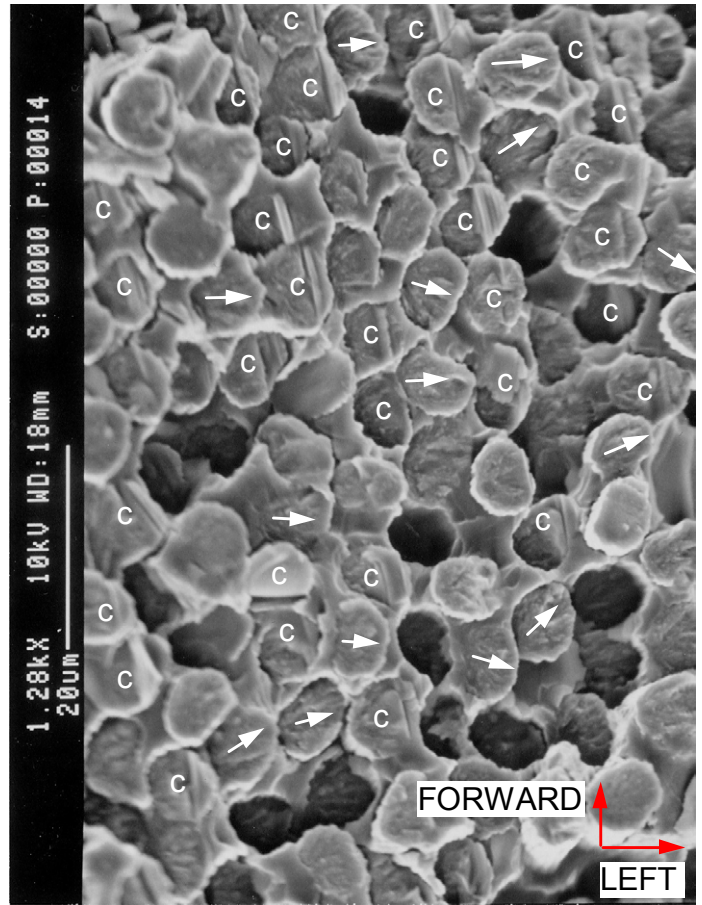
Figure 34. SEM photograph from the center of specimen LA5a. Arrows indicate the direction of tensile crack propagation and labels "c" indicate compressive failure on the ends of zero-degree fibers.

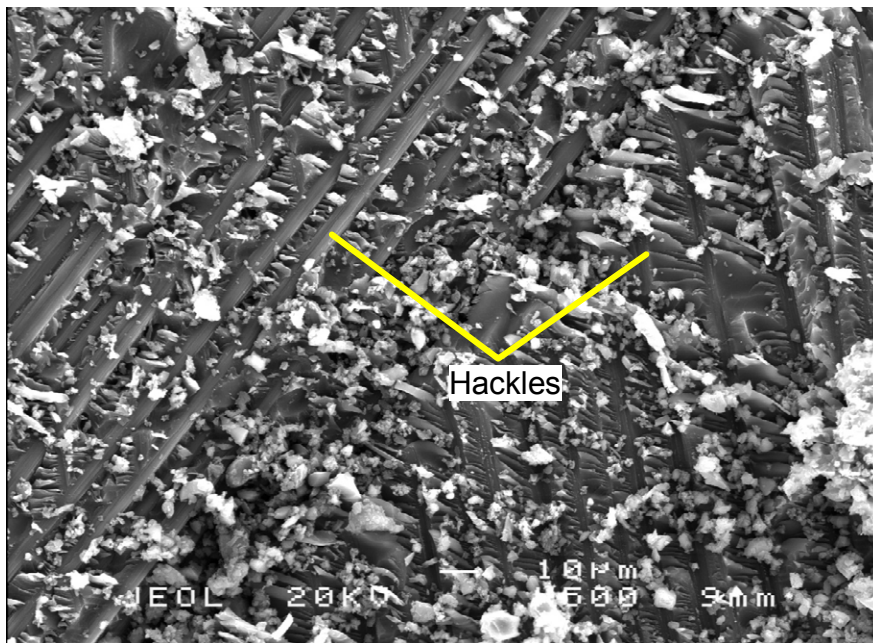
Figure 36. Example SEM photograph from the top forward area of specimen LA1a. Hackles are indicated between +45-degree fibers (left) and zero-degree imprints (right), pointing up and forward. Orientation as in figure 35.

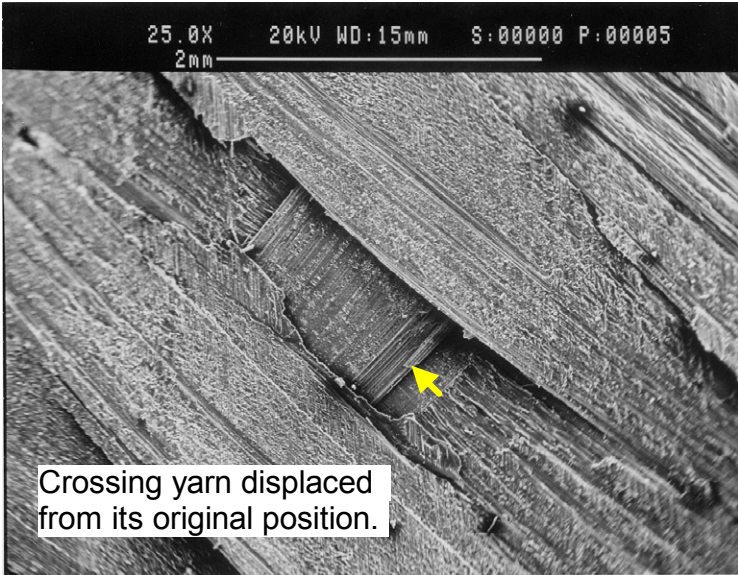
Figure 37. Specimen LA5 inner surface. An unlabeled arrow indicates a crossing bundle that was displaced from its original position. Orientation as in figure 35.

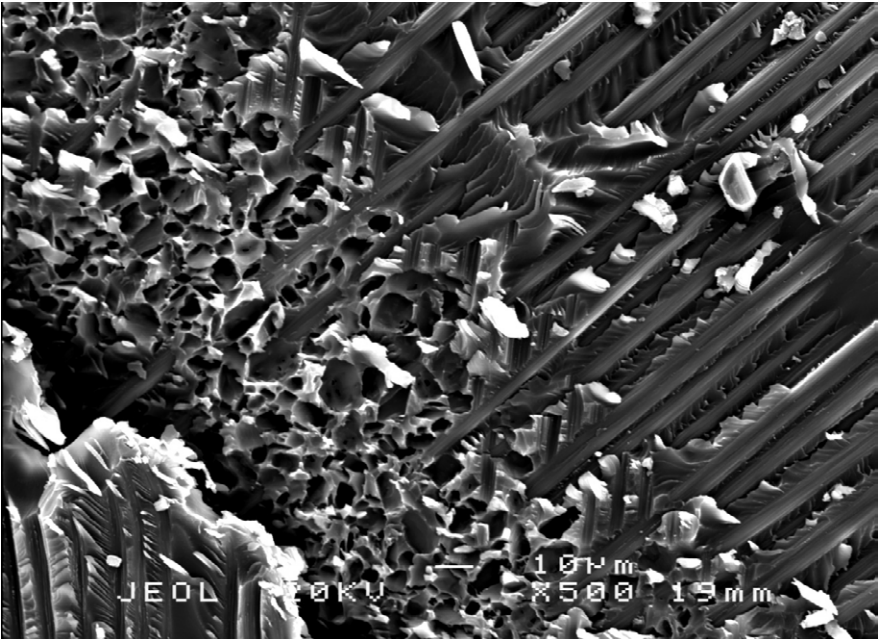
Figure 38. Microscopic matrix porosity in a region where bundles cross on specimen LA1b. The main bundle is at the upper right, and vertical imprints are at the lower left. Orientation as in figure 35.

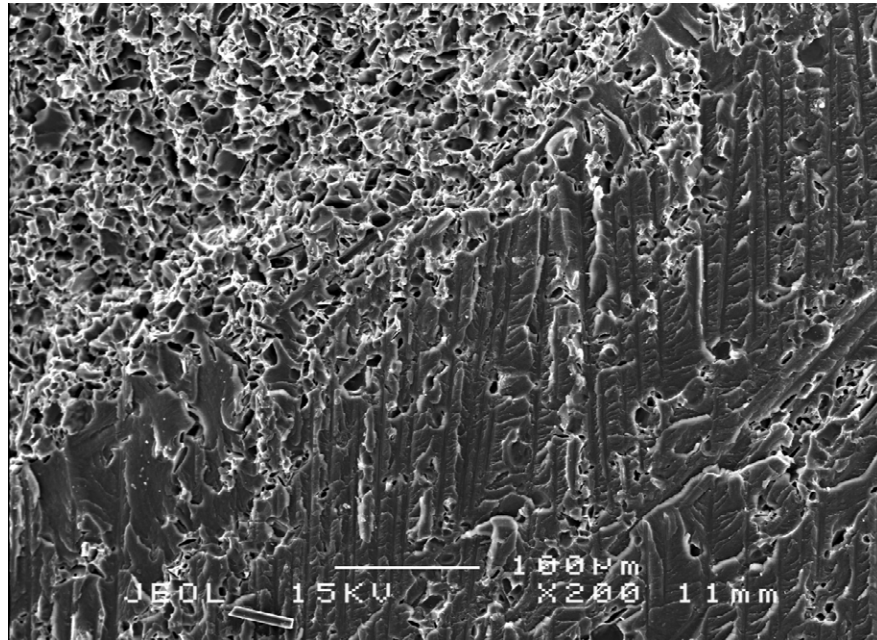
Figure 39. Microscopic matrix porosity on the outboard piece of LA1c. This porosity is shown at the upper left, with ill-defined hackles shown at the lower right. Orientation as in figure 35.
