# NATIONAL TRANSPORTATION SAFETY BOARD

MATERIALS LABORATORY FACTUAL REPORT

Report No. 02-083

Place : Belle Harbor, New York  
Date : November 12, 2001  
Vehicle : Airbus A300-600, N14053  
NTSB No. : DCA02MA001  
Investigator : Brian Murphy, AS-40

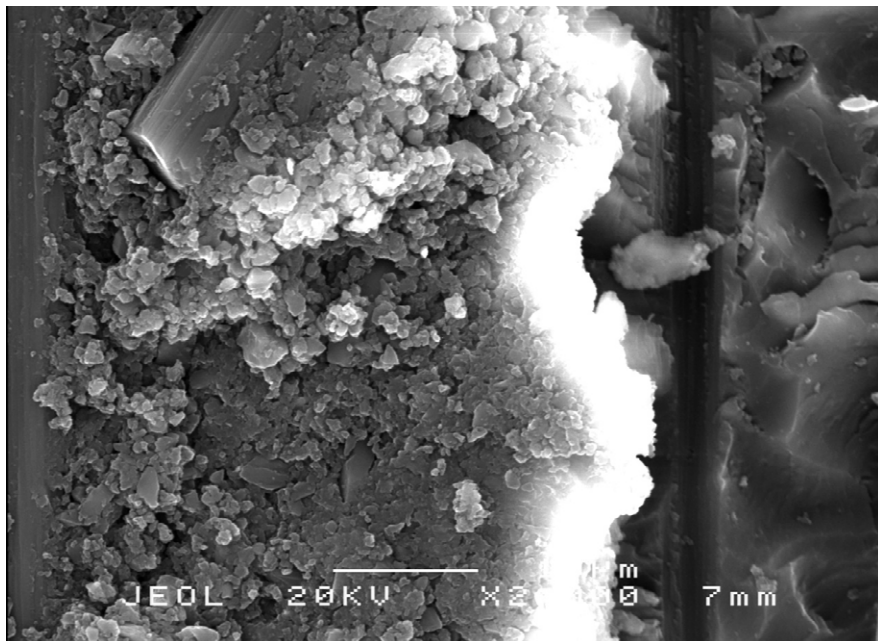
Figure 40. Microscopic matrix granularity on the outboard piece of LA1c. A fiber fragment is shown at the upper left. Orientation as in figure 35.

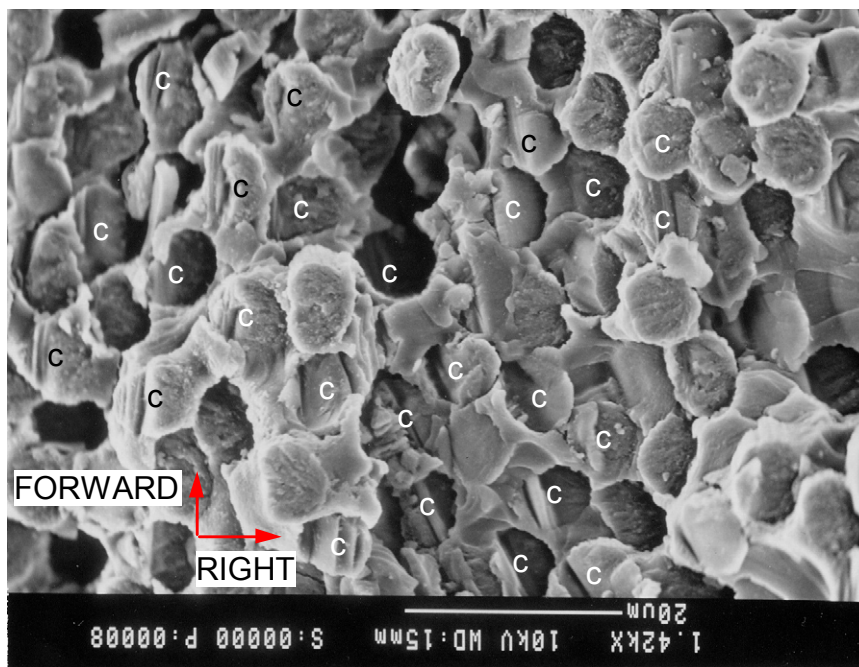
Figure 44. Translaminal fracture surface on the outboard piece from specimen LC2, with the fibers indicated by "c" containing chop marks typical of compressive failure.

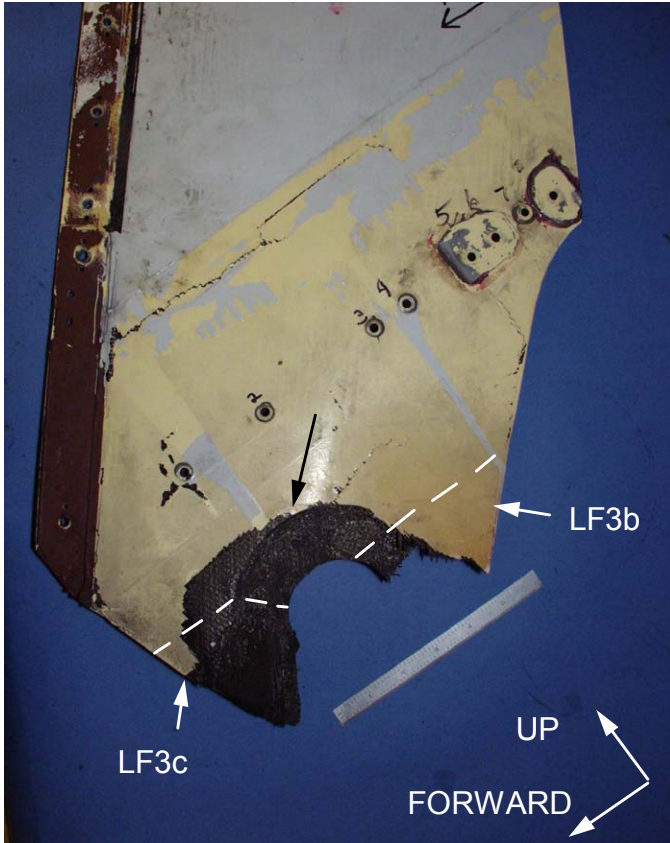
Figure 45. Overall view of the left forward lug translaminar fracture. An unlabeled arrow indicates the upper end of the bearing indentation.

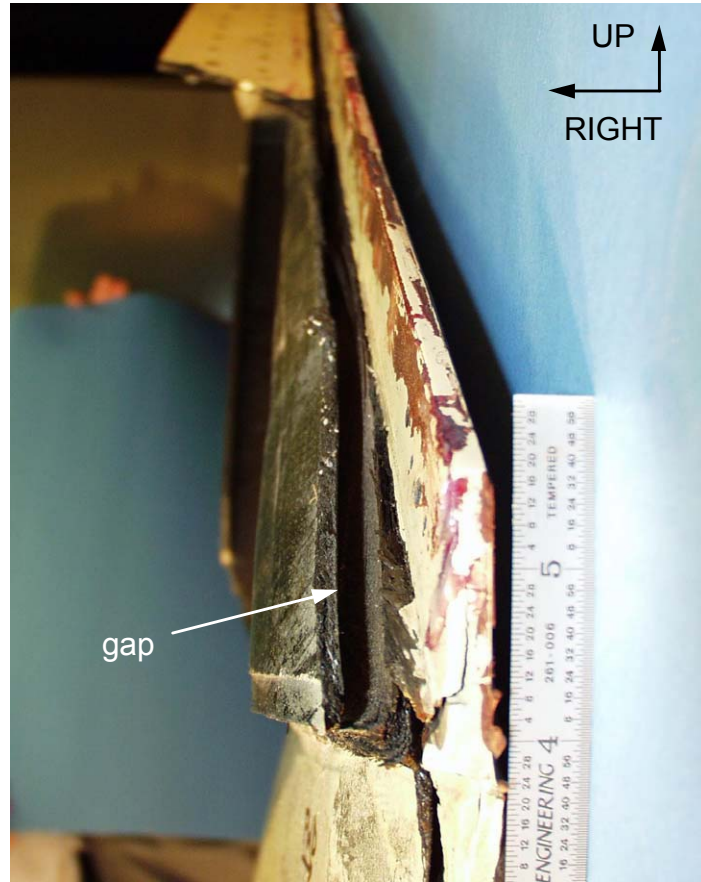
Figure 51. The visible gap at the forward lower end between the inner precured lug structure and the stringer outer flange structure as viewed looking aft.

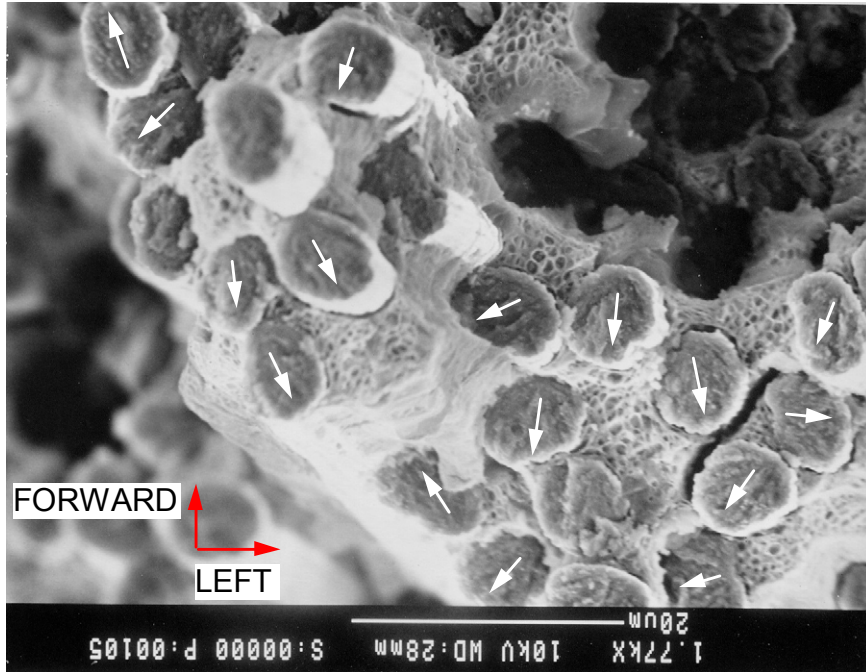
Figure 52. SEM photograph of the ends of zero-degree fibers from specimen LF3b. Arrows indicate fracture propagation direction in fibers with radial marks.

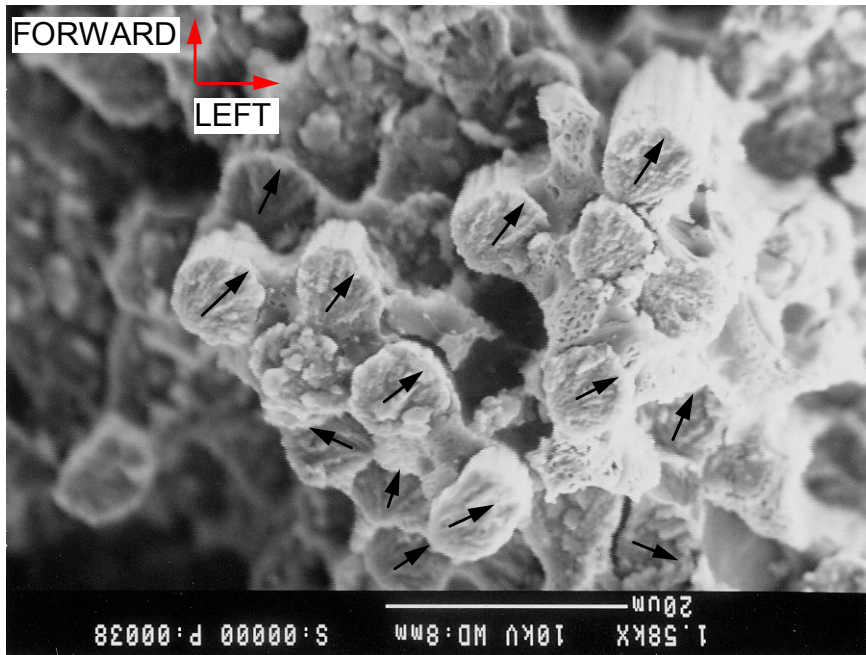
Figure 53. SEM photograph with arrows indicating the direction of tensile crack propagation on the ends of zero-degree fibers from the inboard center piece of specimen LF3c.

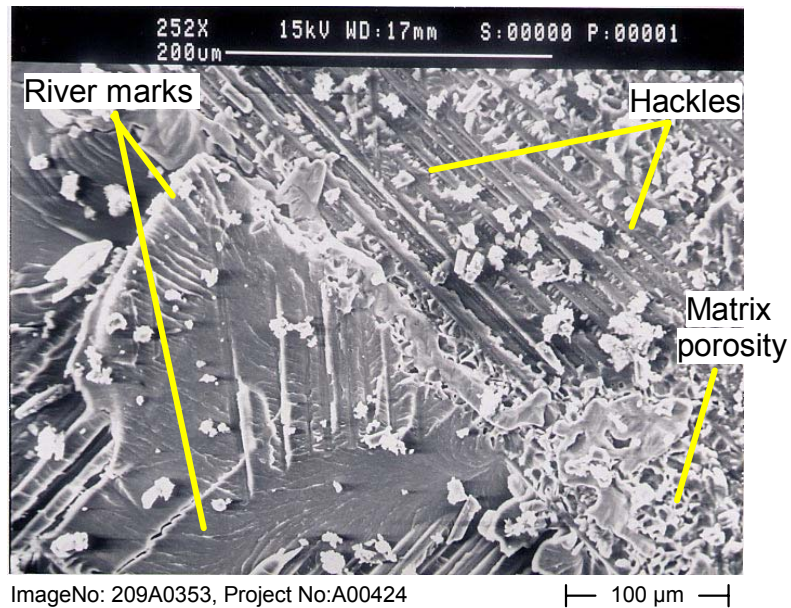
Figure 57. Example SEM photograph from the top forward corner of specimen LF3a-5b. Hackles indicated point up and forward, and river marks also point generally up and forward. Orientation as in figure 56.

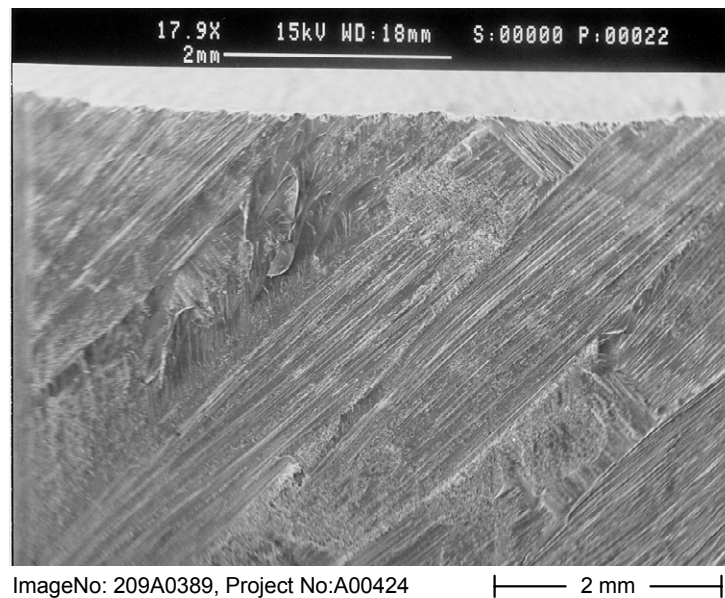
Figure 61. Faint bands at the top forward edge of section LF2b-1 indicate the direction of crack propagation upward and aft. Orientation as in figure 56.
