NATIONAL TRANSPORTATION SAFETY BOARD

MATERIALS LABORATORY FACTUAL REPORT

Report No. 03-018

Place : Belle Harbor, New York
Date : November 12, 2001
Vehicle : Airbus A300-600, N14053
NTSB No. : DCA02MA001
Investigator : Brian Murphy, AS-40

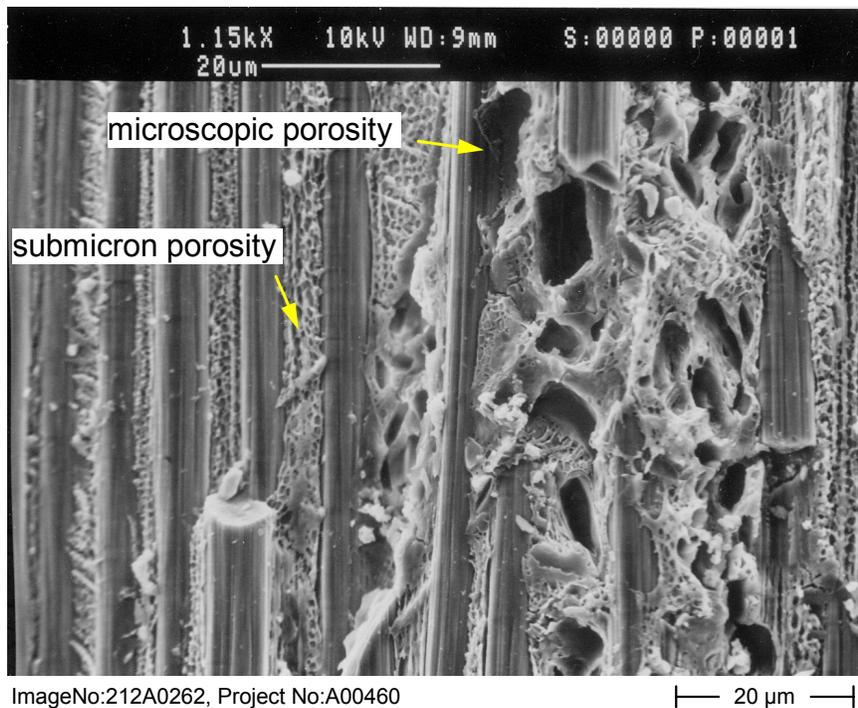
Porosity on both size scales was observed on the left forward lug, as shown in figure 1. Often, submicron porosity was observed associated with a granular appearance in the matrix, as shown in figure 2. This report provides a more detailed description of this submicron porosity.

Figure 1. View of an interlaminar fracture surface on the left forward lug. Two different pore sizes were observed at the fracture surfaces as indicated in the figure.

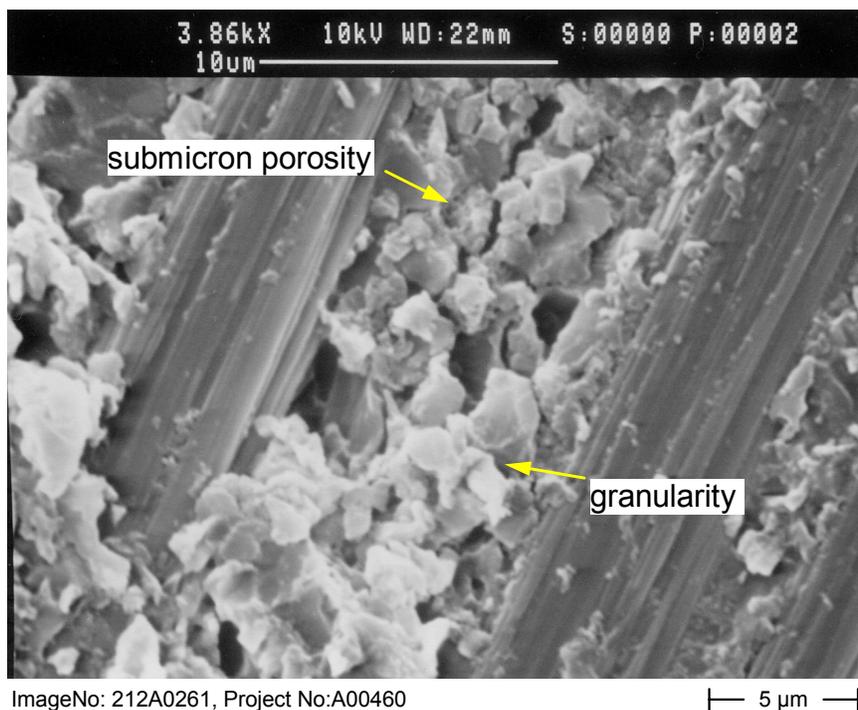
Figure 2. Submicron porosity was often observed with a granular appearance as shown in the figure.

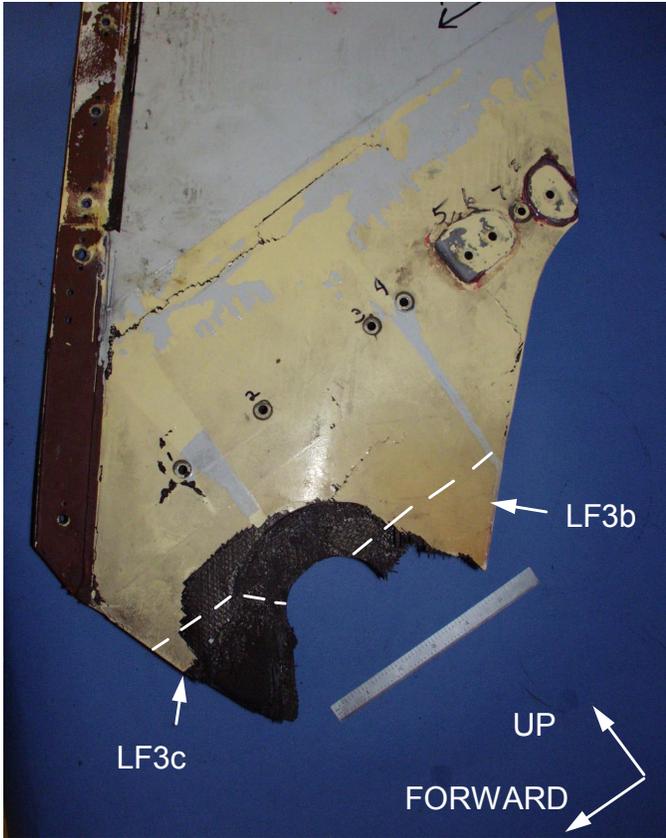
During the fractographic examination, the left forward lug was cut at the locations shown in figure 3. After cutting, specimen LF3b (from the aft leg of the lug) fell into three pieces, and specimen LF3c (from the forward leg of the lug) split into four pieces. The thickness of each piece was measured adjacent to the cut near the bore (outside of the tapered region and where the hat bushing was located). The inboard, center, and outboard pieces of specimen LF3b measured 1.37 inches, 0.16 inch, and 0.13 inch, respectively. The inboard, inboard center, outboard center, and outboard pieces of specimen LF3c measured 0.75 inch, 0.16 inch, 0.44 inch, and 0.24 inch, respectively.

Figure 3. Overall view of the fractured left forward lug. Dashed lines indicate where samples were cut from the remainder of the lug.

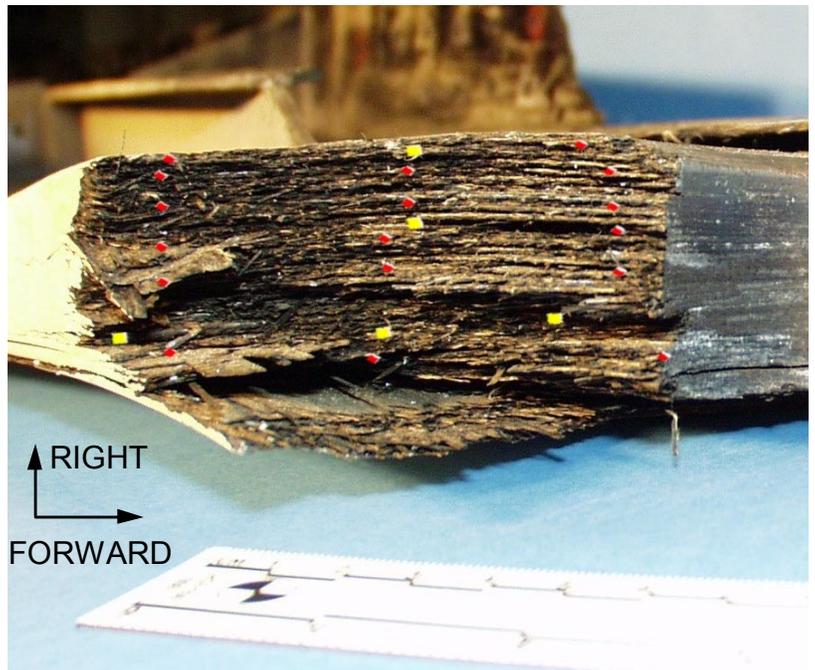
An overall view of the translaminar fracture surface of the aft leg of the lug is shown in figure 4 before cutting specimen LF3b and LF3c. Fractographic features were evaluated at the approximate locations denoted by the yellow boxes and red diamonds on the fracture in this figure, with the red diamonds indicating locations where submicron porosity was observed at the translaminar fracture surface, and the yellow boxes indicating locations where submicron porosity was not observed. Three of the five areas where porosity was not observed corresponded to the skin layers between the precured halves.

Figure 4. View of the translamellar fracture on the aft leg of the left forward lug. Locations where submicron porosity was and was not observed are indicated in red and yellow, respectively.

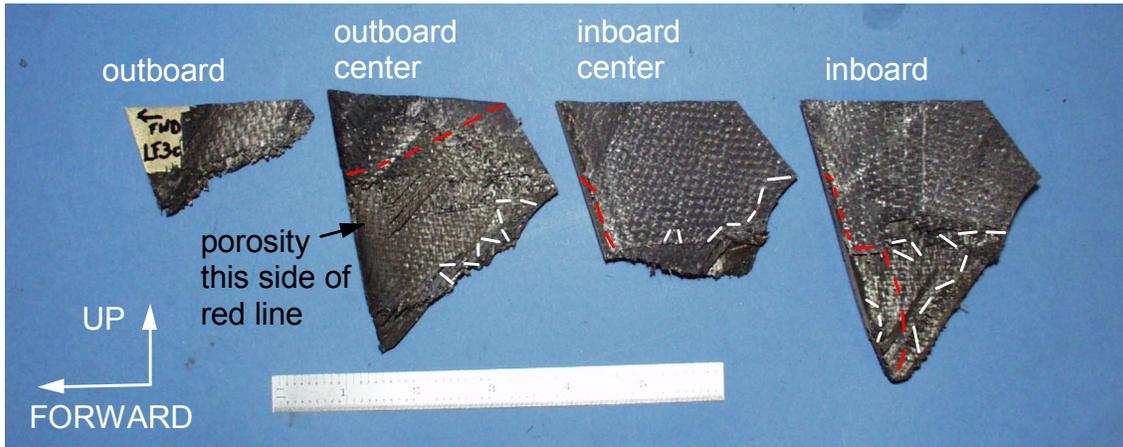
Submicron porosity was also observed at the interlaminar fracture surfaces for the forward leg of the lug. The interlaminar fracture surfaces were examined using SEM in a grid pattern at four-millimeter intervals. Areas where porosity and granularity were observed are shown in figures 5 and 6.

At the outboard interlaminar fracture surface of the outboard center piece, submicron porosity was generally observed within approximately 0.5 inch above the translaminar fracture surface near the hole to two inches above the fracture surface near the forward end. Submicron porosity was also observed within one inch aft of the forward edge.

At the outboard interlaminar fracture surface of the inboard center piece, submicron porosity was observed near the translaminar fracture surface near the forward and aft sides of the interlaminar fracture surface. Matrix granularity was observed near the center, between the areas of submicron porosity.

At the outboard interlaminar fracture surface of the inboard piece of LF3b, submicron porosity was observed within approximately 0.1 inch above the translaminar fracture surface near the hole to one inch above the fracture surface near the forward end. Also, porosity was observed on the fracture surface within approximately 0.5 inch aft of the forward edge.

Figure 5. Outboard surfaces of pieces of LF3c. Approximate areas of porosity and granularity are outlined in red and white, respectively.

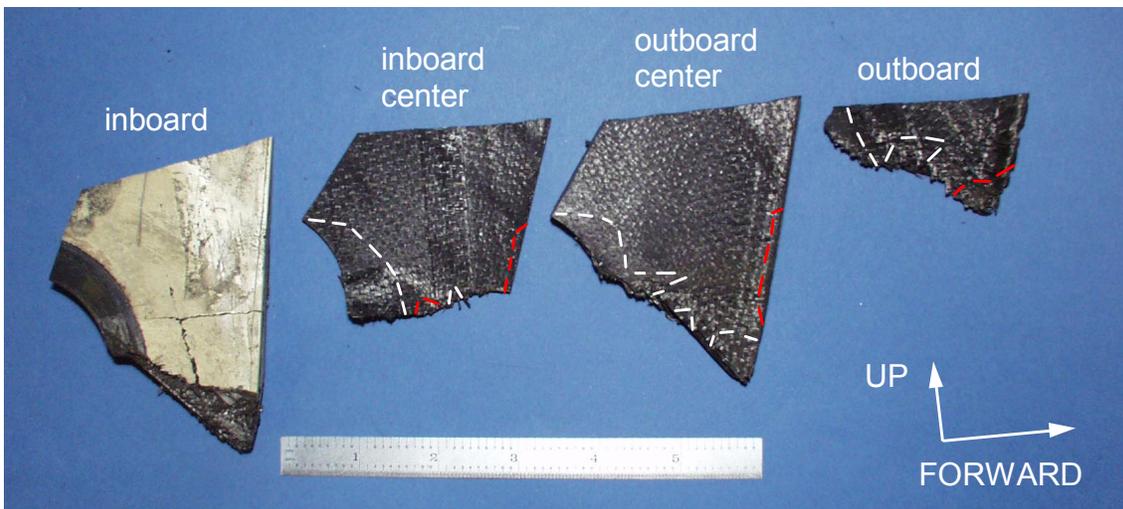
At the inboard interlaminar fracture surface of the outboard center piece, an area of porosity was observed near the fracture surface approximately midway between the forward edge and the attach hole bore. Other areas of the fracture surface near the translaminar fracture surface had a granular appearance with some submicron porosity.

At the inboard interlaminar fracture surface of the inboard center piece, submicron porosity was observed near the translaminar fracture at the forward side. Toward the center and aft, the interlaminar fracture surface had a granular appearance adjacent to the translaminar fracture surface.

Figure 6. Inboard surfaces of pieces of LF3c. Approximate areas of porosity and granularity are outlined in red and white, respectively.
