NATIONAL TRANSPORTATION SAFETY BOARD

MATERIALS LABORATORY FACTUAL REPORT

Report No. 03-033

Place : Belle Harbor, New York
Date : November 12, 2001
Vehicle : Airbus A300-600, N14053
NTSB No. : DCA02MA001
Investigator : Brian Murphy, AS-40

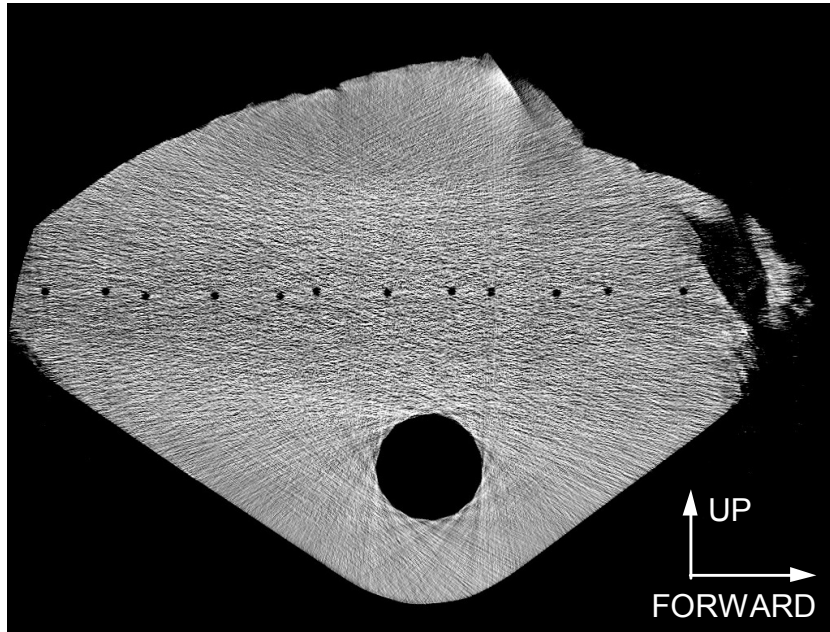
Images may contain artifacts, including streaks and discontinuities, resulting from the scanning and visualization process. A slice image is shown in figure 1 where streaks were present in the reconstructed image. These streaks were artifacts that appeared due to the high aspect ratio of the part and due to photon starvation resulting from the long travel distance through the part. In the visualized images, these streaks have a speckled appearance on the exposed surfaces. Discontinuities in the visualized images may appear

Figure 1. One slice image from the CT scan of the inner portion of the right center lug piece. The image shows the speckled or streaked appearance, which was an artifact of the scanning and reconstruction process.

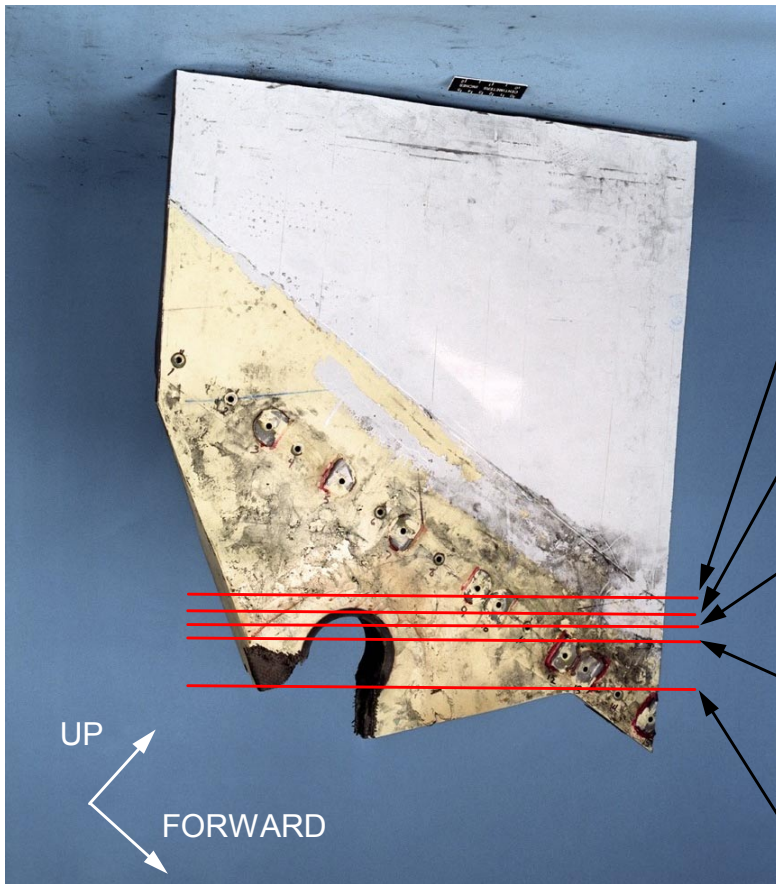
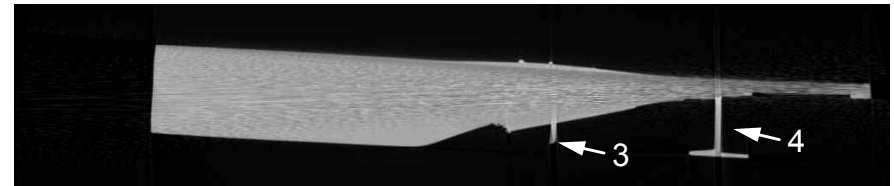
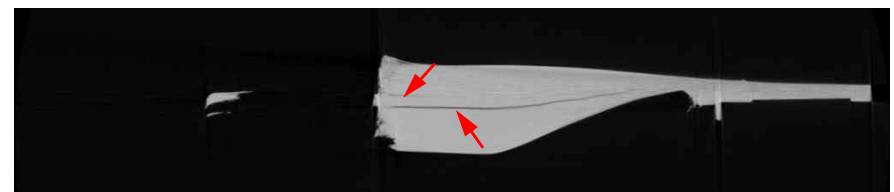
An overall view of the scanned right aft lug section is shown in figure 2 at the left. A total of 29 slices were scanned at the lower end. Characteristic slices from the scanning are shown at the right in figure 2. Unlabeled arrows in figure 2 indicate ply separations. Multiple ply separations through the thickness were observed in slice images at and below the lug attachment hole center. At approximately 0.5 inch above the upper surface of the lug attachment hole, no ply separations were observed. However, the speckled appearance of the cross-section may have obscured the presence of a ply separation with a small opening displacement.

Figure 2. Overall view of the right aft lug fracture area section after removal of the clips and fasteners for CT scanning is shown at the left. Red lines on the photo shown at the left indicate the approximate location of each representative CT slice image shown at the right. The CT slice images are shown as viewed looking upward parallel to the zero-degree fiber direction. Unlabeled arrows on the images indicate ply separations. Stringer numbers are indicated in the uppermost slice image.

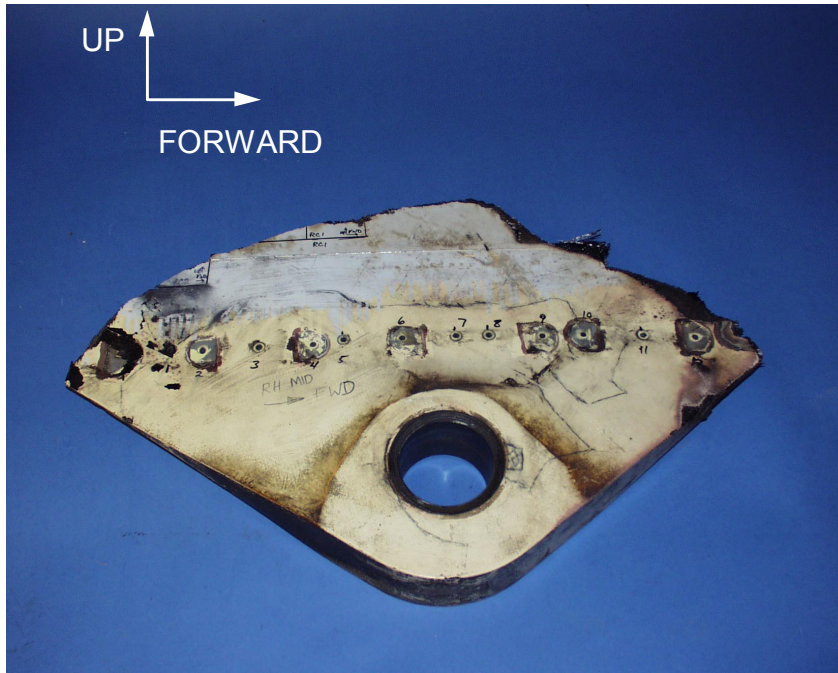
An overall view of the lower piece from the right center lug fracture area is shown in figure 3. The piece is shown with all metal fasteners, clips, and bushings removed.

Figure 3. Overall view of the right center lug piece after metal bushings, clips, and fasteners were removed prior to CT scanning.

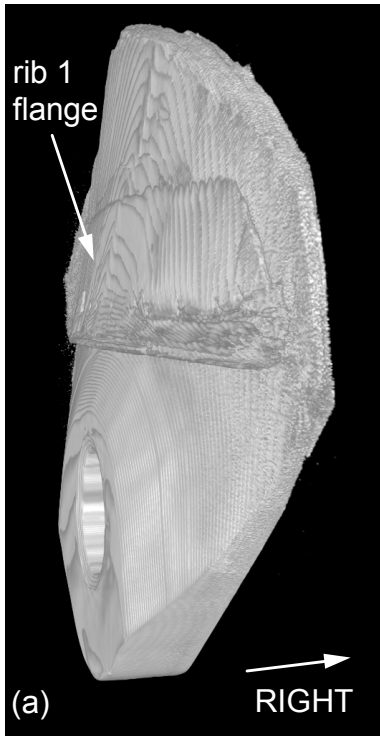
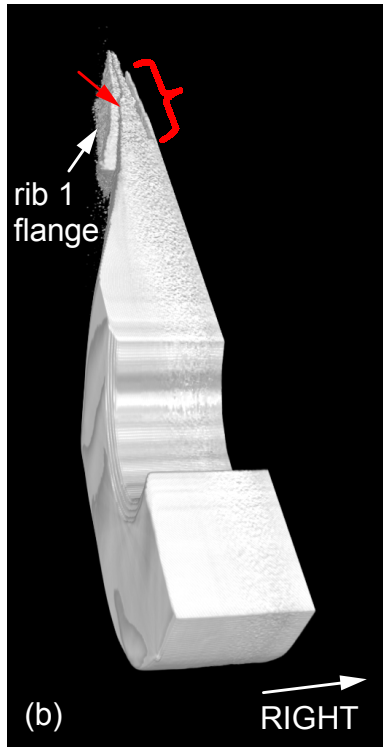
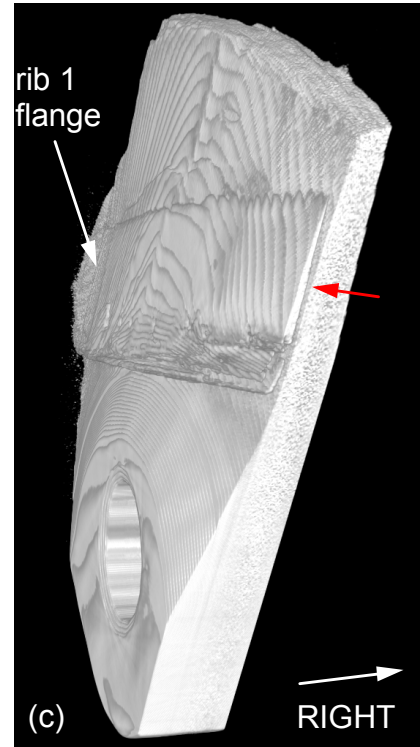
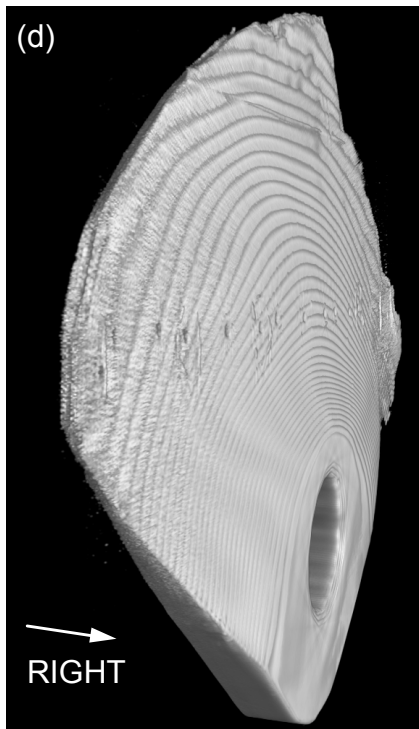
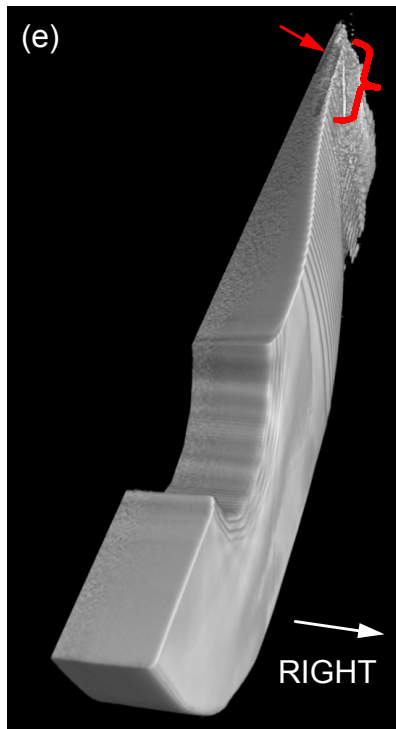
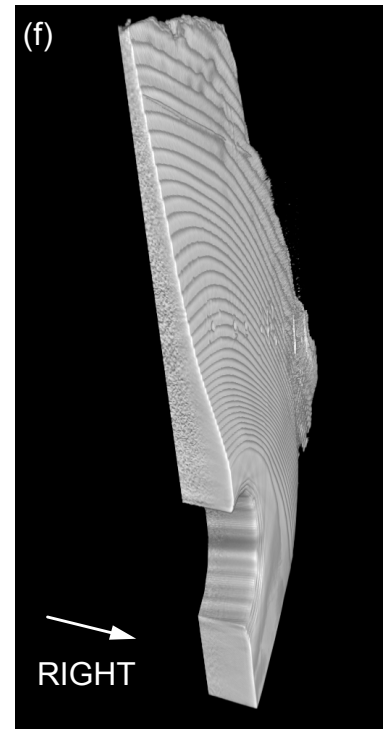
Layers from the upper leg of the rib 1 flange were visible on the inboard portion of the right center lug piece, as shown in figure 4, images (a) to (c). Layers of the upper leg of the rib 1 flange appeared mostly separated from the remainder of the piece, as shown in figure 4, images (b) and (c).

A ply separation with a relatively large opening displacement was observed near the forward edge of the piece near the outboard surface, as indicated by arrows in figure 4, images (b) and (e). The aspect ratio of this ply separation was large with the longer dimension parallel to the zero-degree fiber direction. Also, the through-thickness edges were relatively squared off, features consistent with pull-out of zero-degree tape layers.

Figure 4. Three-dimensional visualization images of the CT scans from the right center lug piece. The upper and lower rows show scans from the inner and outer overlapping portions of the piece, respectively. The center and right images show virtual cut planes perpendicular and parallel to the zero-degree fiber direction, respectively. Unlabeled arrows indicate ply separations, and unlabeled brackets indicate where layers fractured from the piece. (In images (b) and (c), the delaminations are the same, indicating the extent of overlap.)

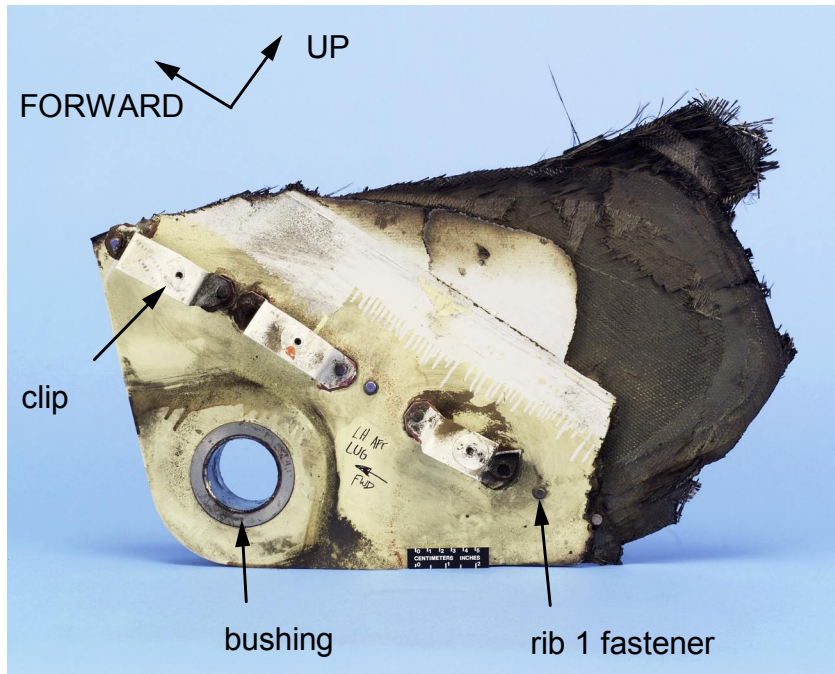
An overall view of the lower piece from the left aft lug fracture area is shown in figure 5 before metal fasteners, clips, and bushings were removed.

Figure 5. Overall view of the lower piece from the left aft lug fracture area. Metal bushings, clips, and fasteners were removed before CT scanning.

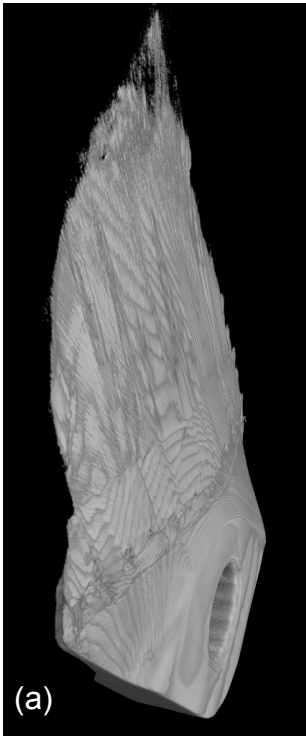
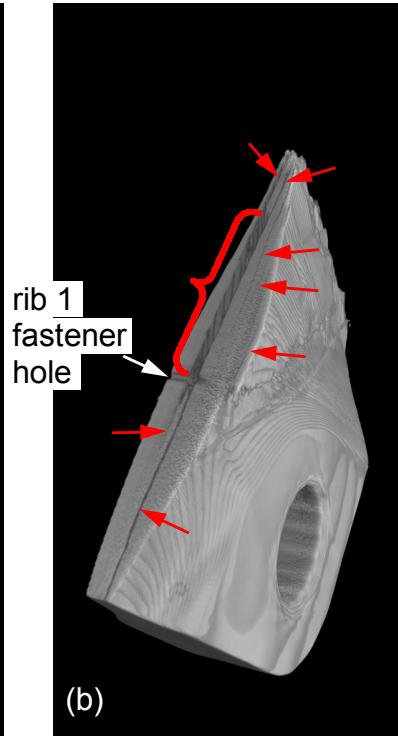
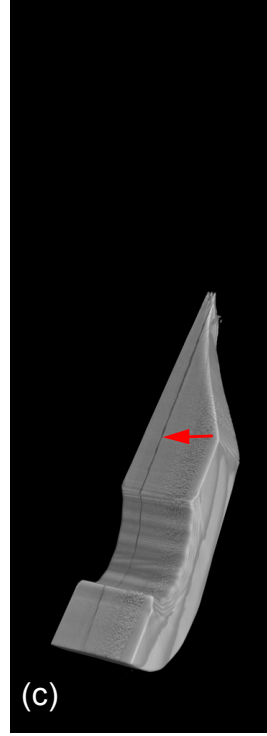
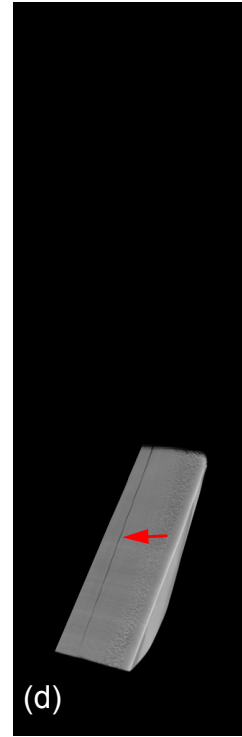
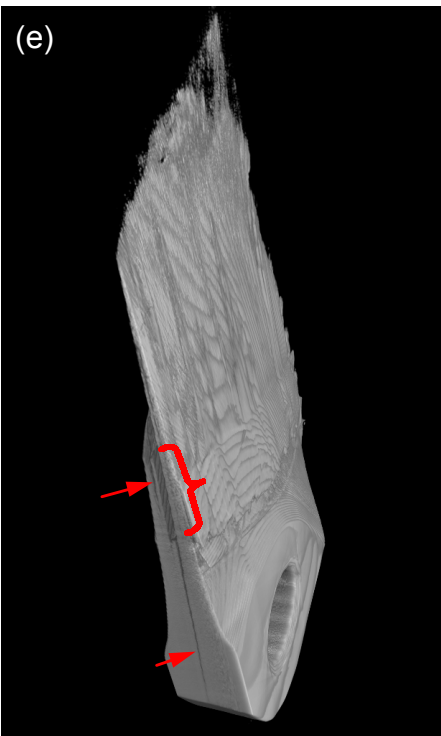
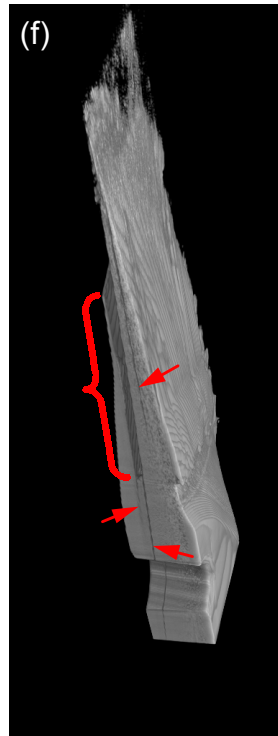
Unlabeled arrows in figure 6 indicate where ply separations were observed. Multiple through-thickness ply separations were observed in areas above the lug attachment hole, as indicated in images (b), (e), and (f). At and below the lug attachment hole, a single ply separation was observed that extended nearly throughout the part.

Above the rib 1 fasteners, a group of layers were fractured and separated from the piece in areas indicated by unlabeled brackets in figure 6, images (b), (e), and (f). The location of these layers was consistent with skin layers that remained attached to the upper section from the left aft lug fracture area. The ply separation that extended nearly throughout the part intersected the innermost surface of these fractured layers.

Figure 6. Three-dimensional visualization images of the CT scans from the lower piece of the left aft lug fracture area as viewed looking forward and to the left. An overall view is shown at the upper left image. The remainder of the upper row shows virtual cut planes perpendicular to the zero-degree fiber direction, and the lower row shows virtual cut planes parallel to the zero-degree fiber direction. Unlabeled arrows indicate ply separations, and unlabeled brackets indicate where layers fractured from the lower piece, remaining attached to the upper piece.

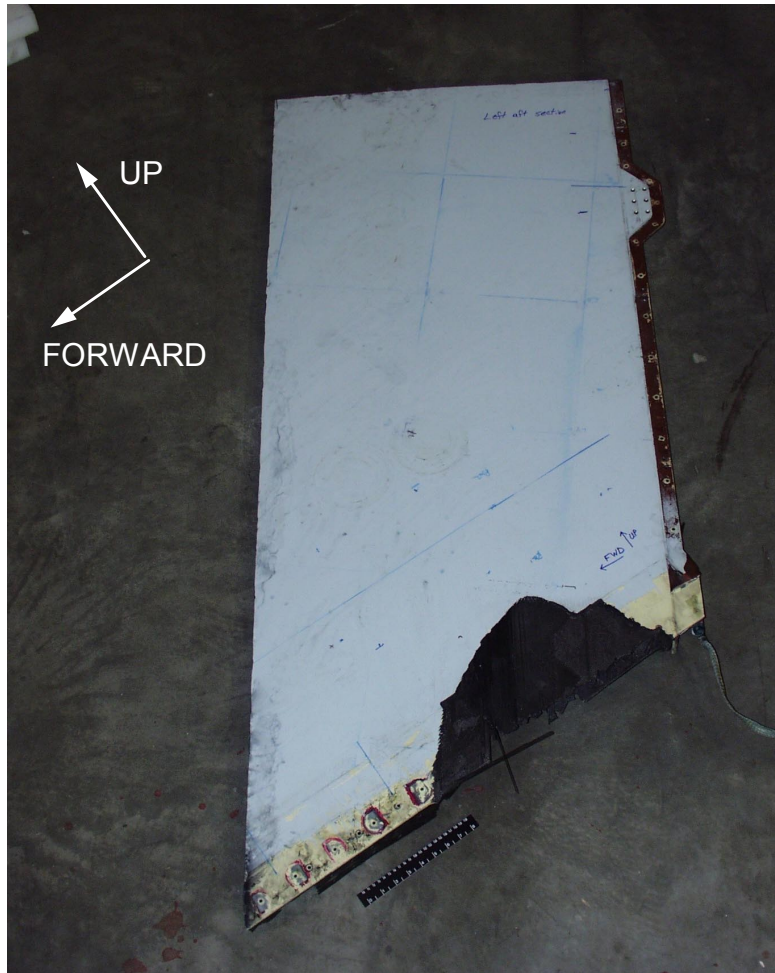
An overall view of the upper section from the left aft lug fracture area is shown in figure 7. The section is shown after metal fasteners and clips were removed.

Figure 7. Overall view of the upper section from the left aft lug fracture area after metal fasteners and clips were removed for CT scanning.

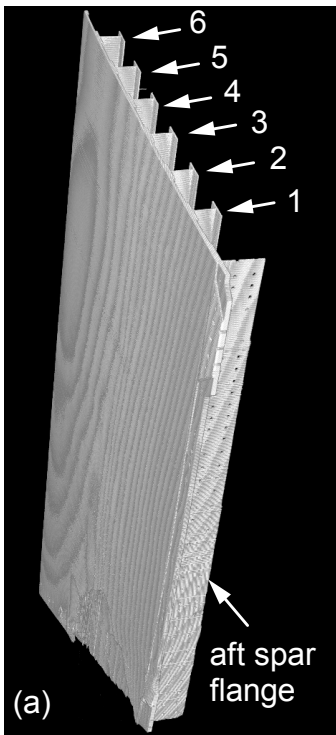
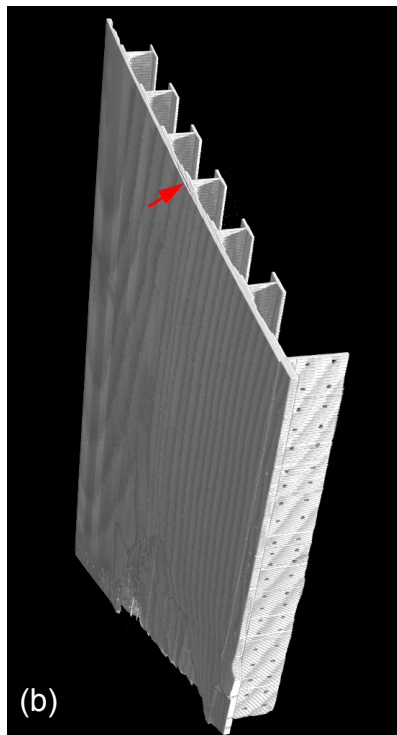
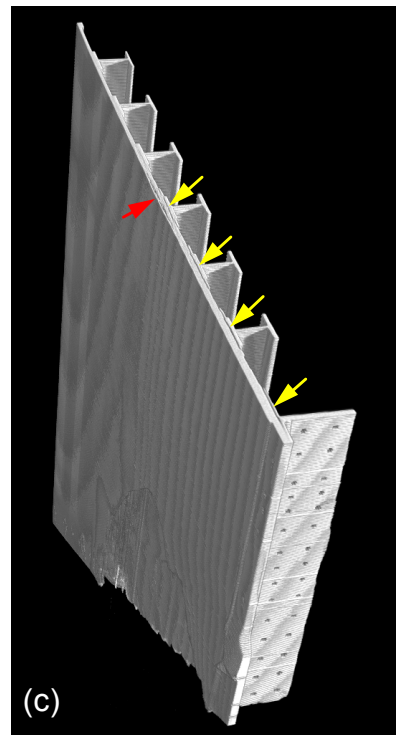
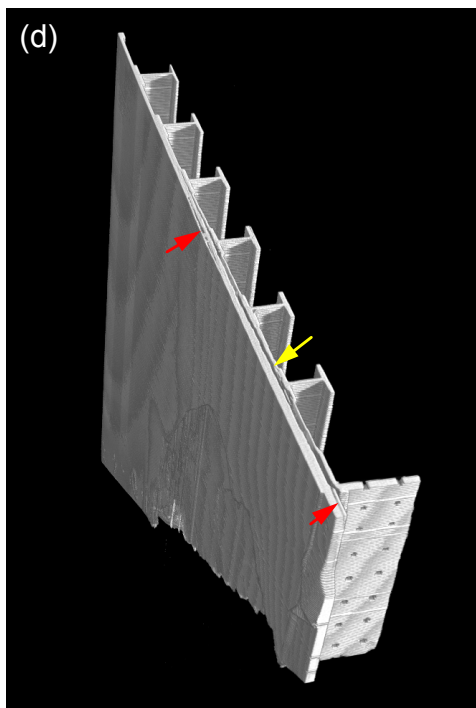
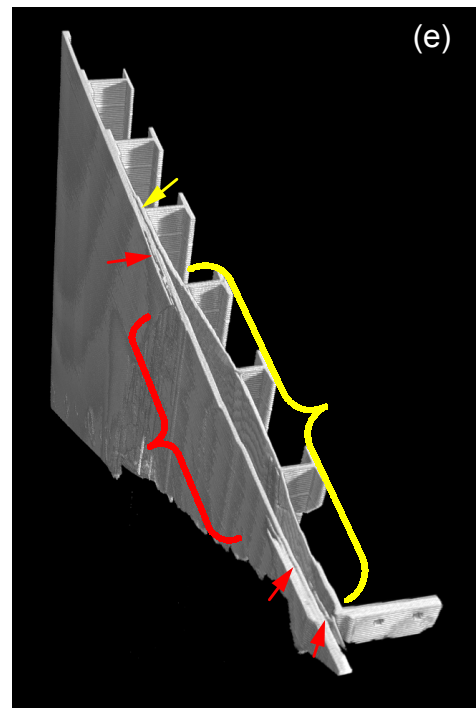
Two areas of ply separation and layer fracture were observed in the upper section of the left aft lug fracture area. One area, indicated with red arrows in figures 8 to 10, was located near the outboard surface. The other area, indicated with yellow arrows and brackets in figures 8 to 10, was located near the inboard surface.

In the ply separation near the outboard surface (indicated in red), some areas had a relatively large opening displacement where material appeared to be missing. The aspect ratios of these areas were large, with the longer sides oriented parallel to the zero-degree fiber direction. Also, the through-thickness edges were relatively squared off, features consistent with pull-out of zero-degree tape layers. At the lower end of the ply separation, layers were missing from the ply separation outboard to the surface as indicated by red brackets in figures 8 to 10. These missing layers corresponded to the layers that remained attached to the lower piece.

Near the inboard surface (indicated in yellow), ply separations above rib 4 were located just outboard of the stringer outer flanges for stringers 1, 2, and 3 and outboard of the rear spar flange. Below rib 4, layers were missing in areas indicated by yellow brackets in figures 8 to 10. These missing layers also corresponded to the layers that remained attached to the lower piece.

Figure 8. Three-dimensional visualization images of the CT scans from the upper section of the left aft lug fracture area as viewed looking forward and to the right. An overall view (not including the uppermost six inches) is shown at the upper left. The remainder of the upper row and the lower row show virtual cut planes perpendicular to the zero-degree fiber direction. Unlabeled arrows indicate ply separations, and unlabeled brackets indicate where skin layers fractured from the upper piece, remaining attached to the lower piece. The six stringers in the panel are numbered as indicated in image (a).

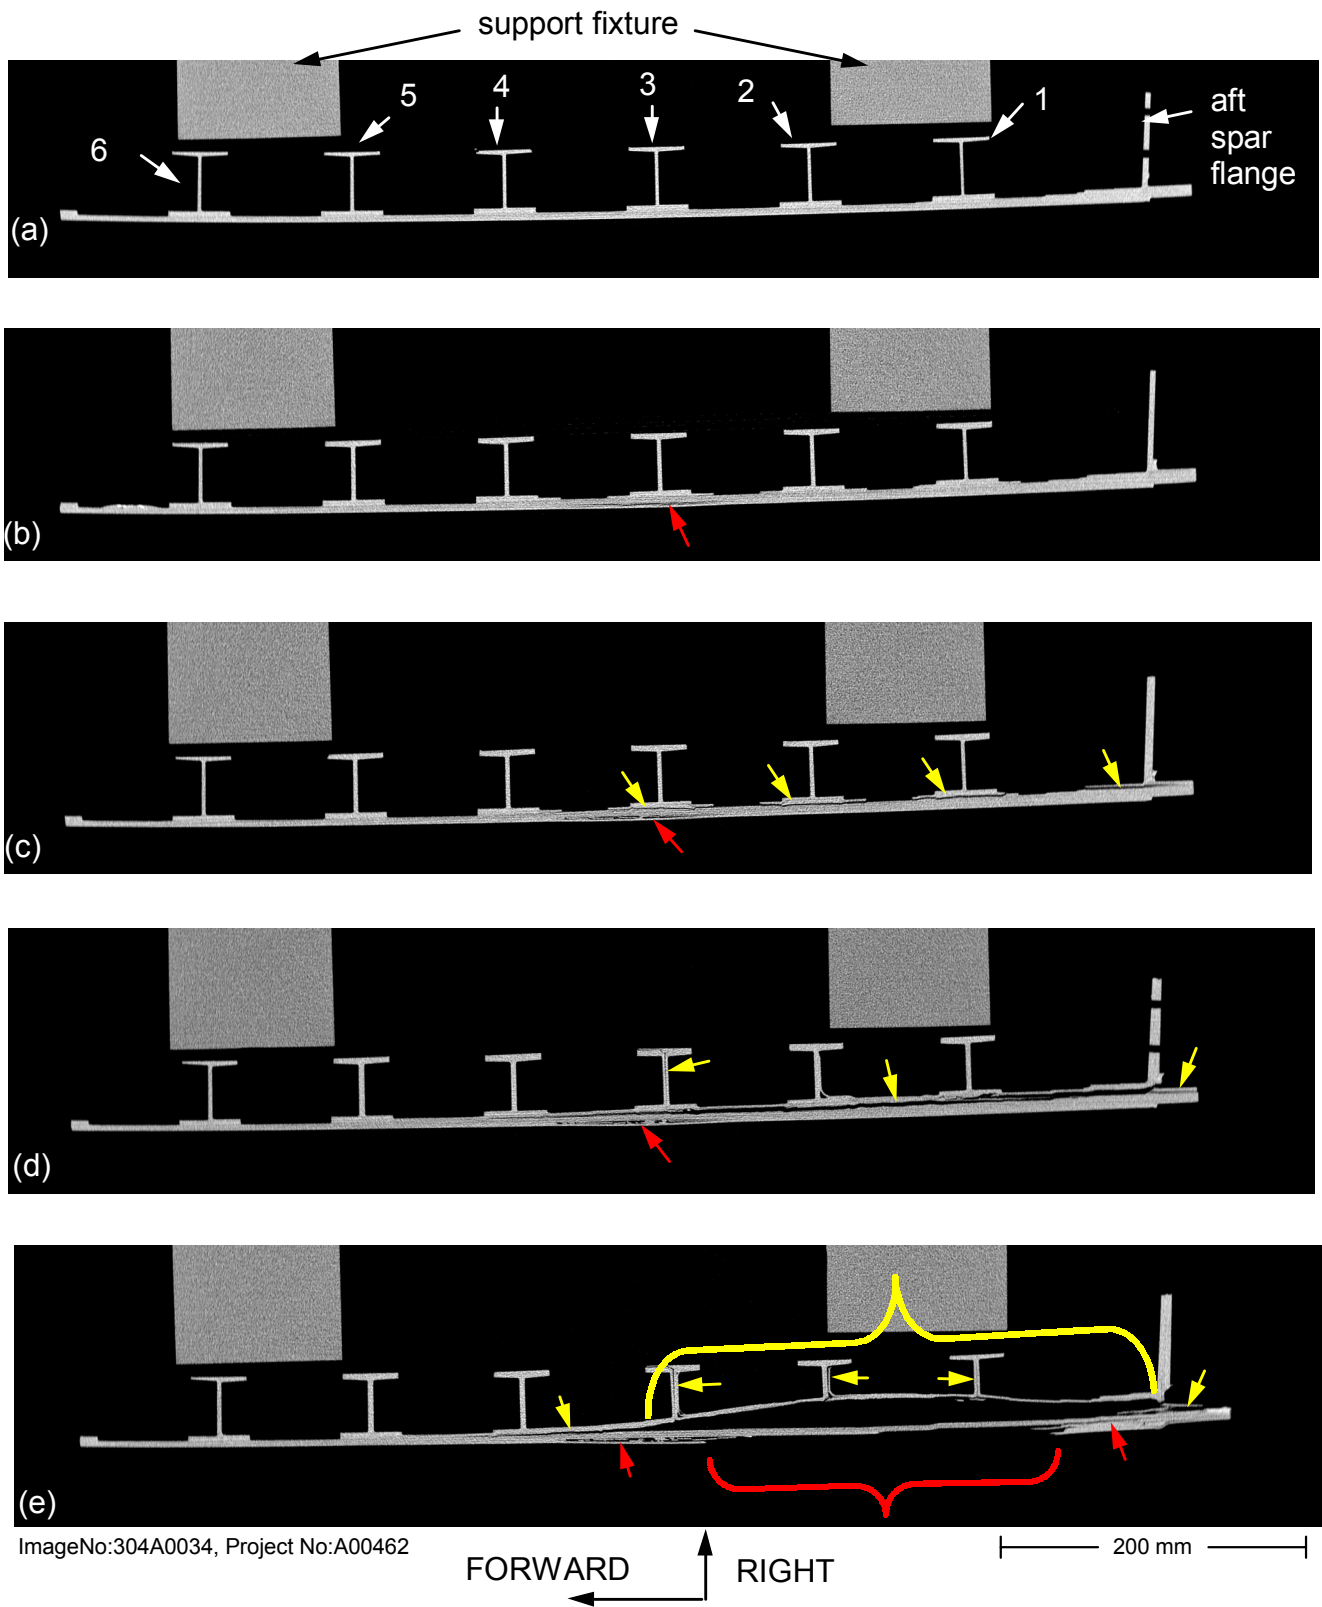
Figure 9. Higher-resolution CT slice images for the upper section of the left aft lug fracture area. Images are for the cut planes shown in figure 8, images (a) to (f), as viewed looking downward parallel to the zero-degree fiber direction. Unlabeled arrows indicate delaminations, and unlabeled brackets indicate the locations where layers fractured from the upper section and remained attached to the lower piece.

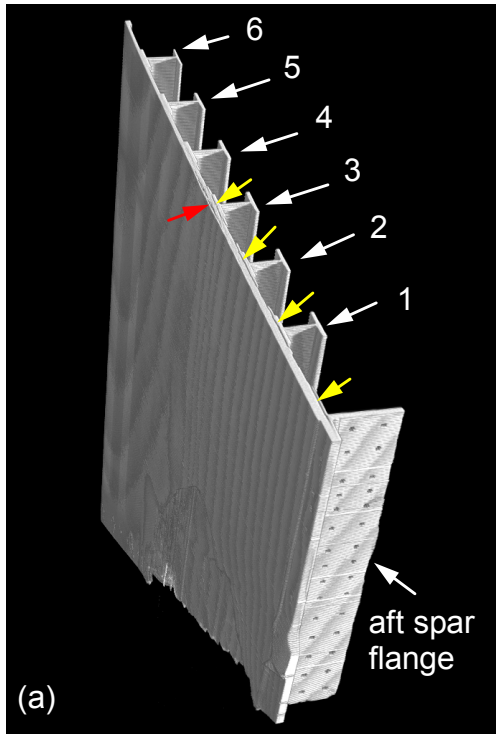
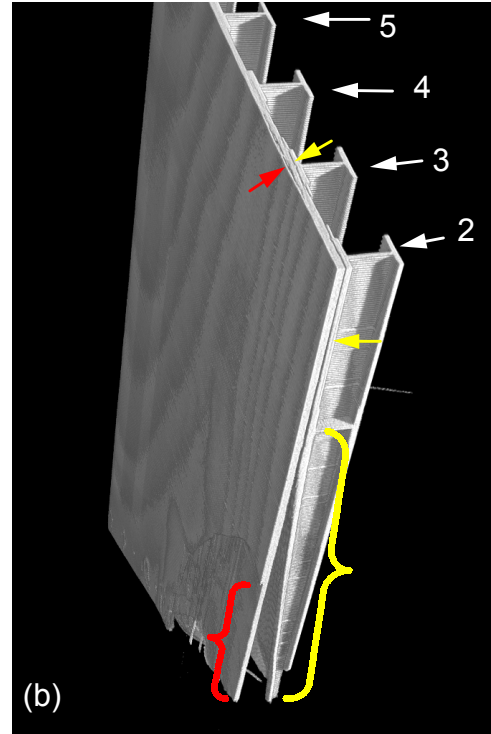
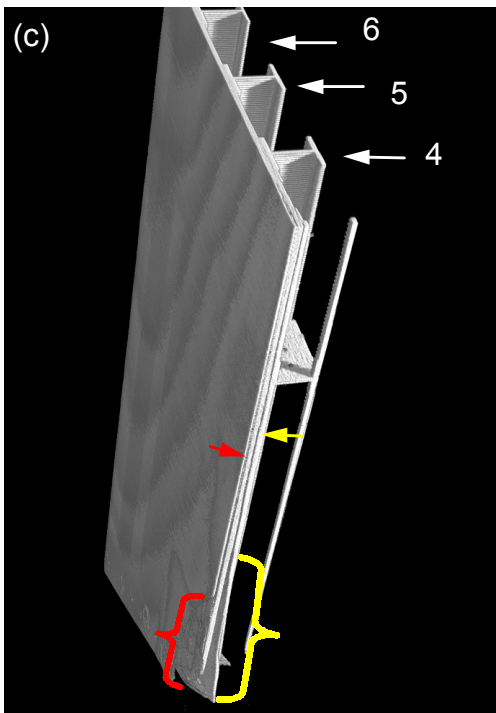
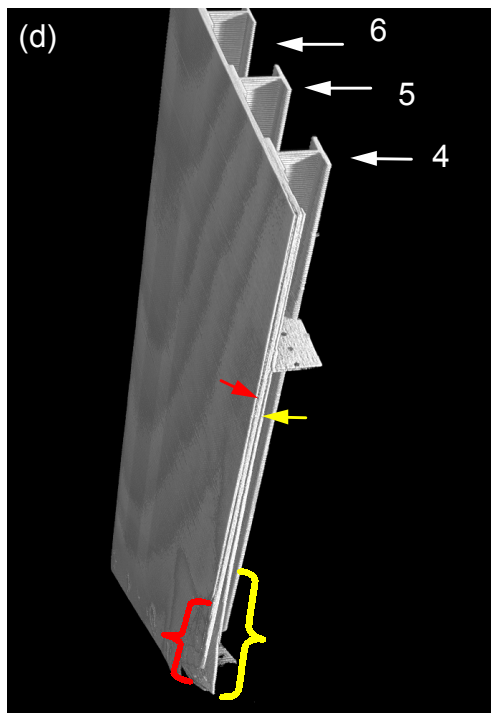
Figure 10. Three-dimensional visualization images of the CT scans from the upper section of the left aft lug fracture area as viewed looking forward and to the right. Image (a) is identical to figure 8, image (c). Images (b) to (d) show additional virtual cut planes parallel to the zero-degree fiber direction. Unlabeled arrows indicate ply separations, and unlabeled brackets indicate where layers fractured from the section and remained attached to the lower piece. The six stringers in the panel are numbered as indicated.

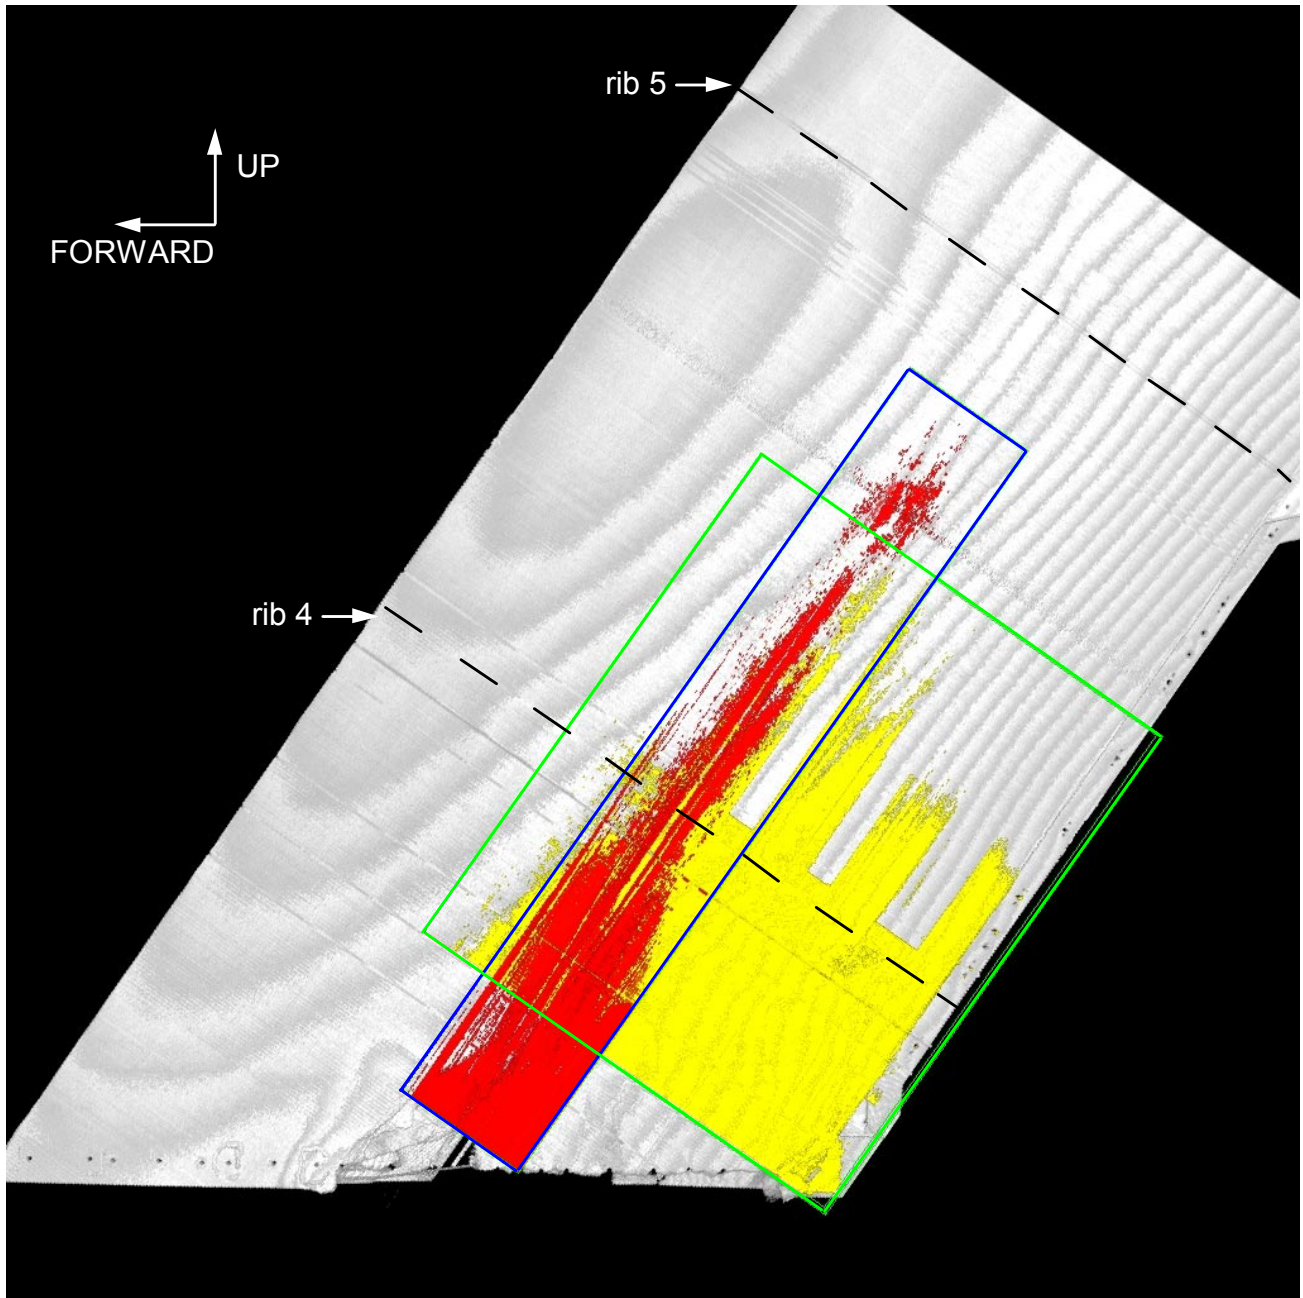
A visualized image indicating where each area of ply separation was located within portions of the structure is shown in figure 11. The ply separation and layer fracture near the outboard surface is indicated in red within the area outlined in blue. The ply separation and layer fracture near the inboard surface is indicated in yellow within the area outlined in green.

Figure 11. Three-dimensional visualization image of the CT scans from the upper section of the left aft lug fracture area as viewed looking to the right. Within the area outlined in blue, ply separation and layer fracture near the outboard surface is shown in red. Within the area outlined in green, ply separation and layer fracture near the inboard surface is shown in yellow.

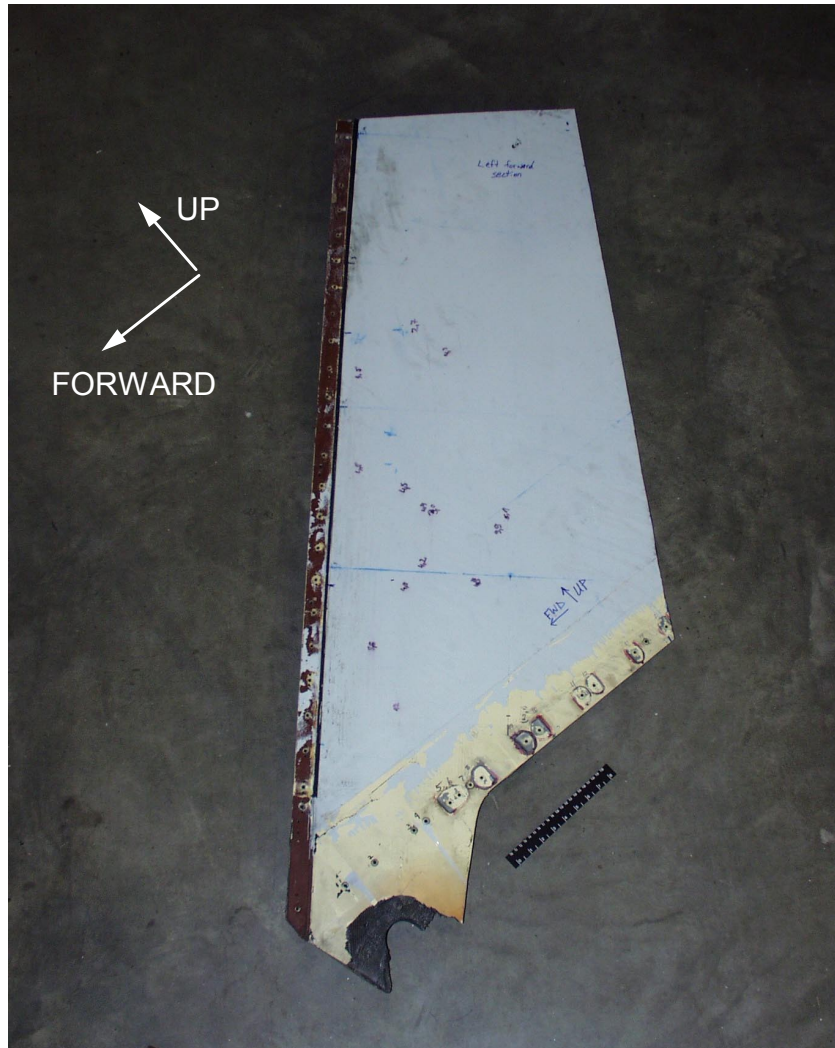
An overall view of the upper section from the left forward lug fracture area is shown in figure 12. The section is shown after metal fasteners and clips were removed.

Figure 12. Overall view of the left forward lug fracture area section after metal fasteners and clips were removed for CT scanning.

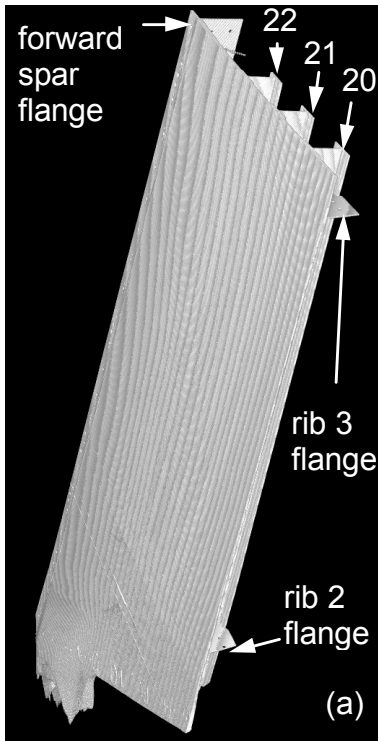
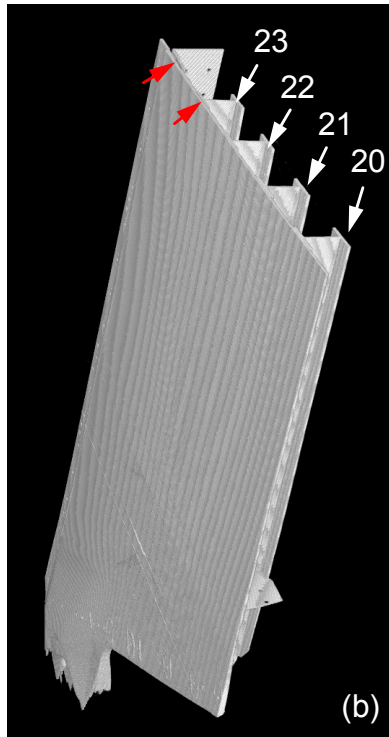
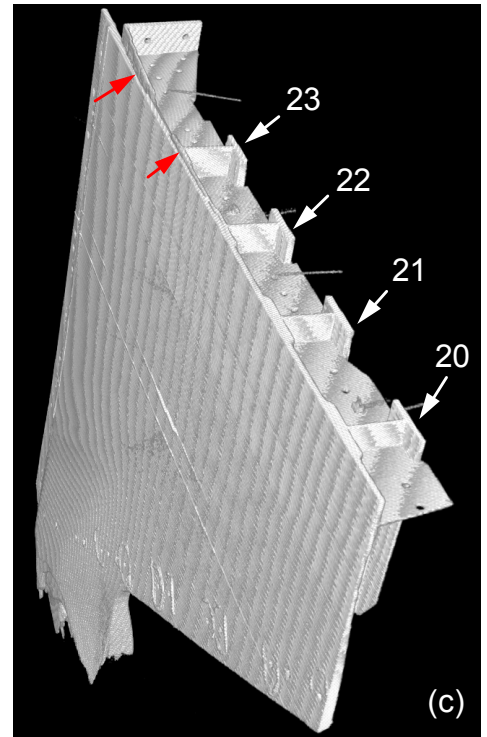
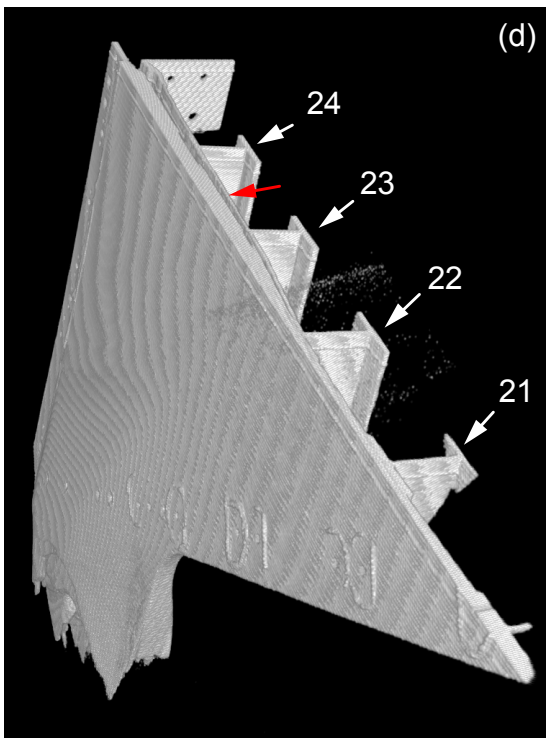
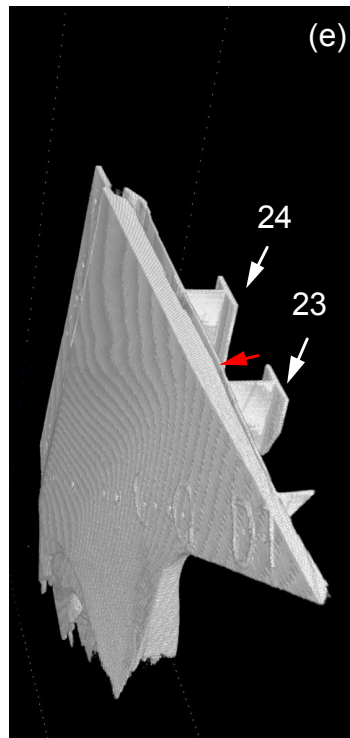
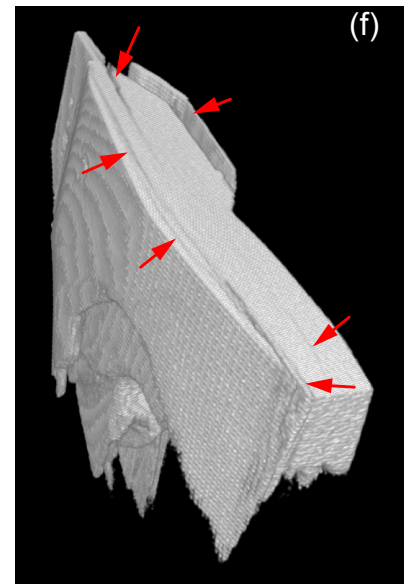
Multiple ply separations through the thickness were observed in the lug area below rib 1 and in locations within approximately four inches above rib 1. These ply separations are indicated by arrows in figure 13, image (b); figure 14, image (e); and figure 15, images (c) to (e). Above rib 1, a ply separation with a relatively large opening displacement was observed just outboard of the stringer outer flanges and the forward spar flange. The edges of this ply separation tapered smoothly to a small opening displacement such that despite the relatively large opening displacement, no material appeared to be missing from between the separated surfaces.

Figure 13. Three-dimensional visualization images of the CT scans of the left forward lug fracture section as viewed looking forward and to the right. An overall view is shown in (a). The remainder of the upper row and the lower row show virtual cut planes perpendicular to the zero-degree fiber direction. Unlabeled arrows indicate ply separations. The stringers in the section are numbered as indicated in the images.

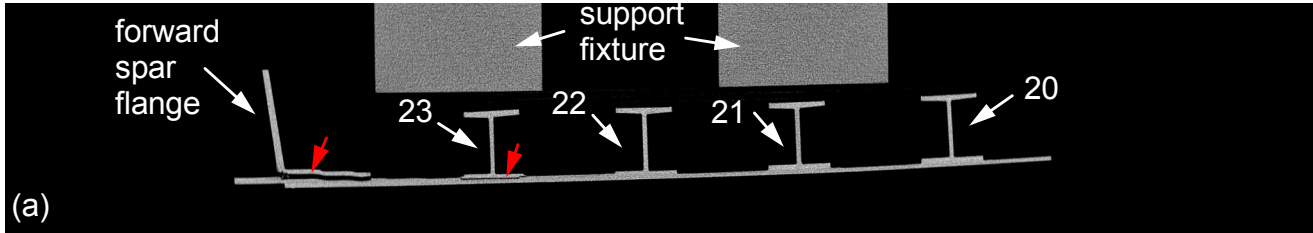
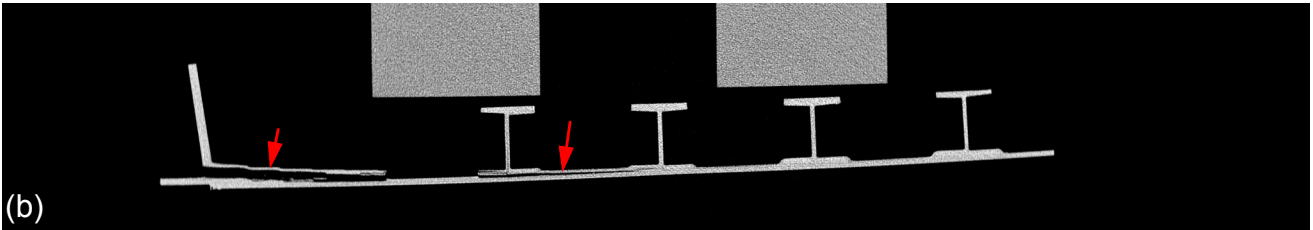
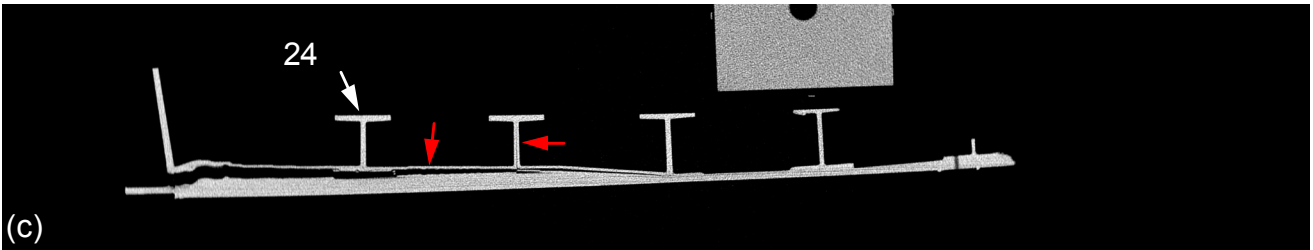
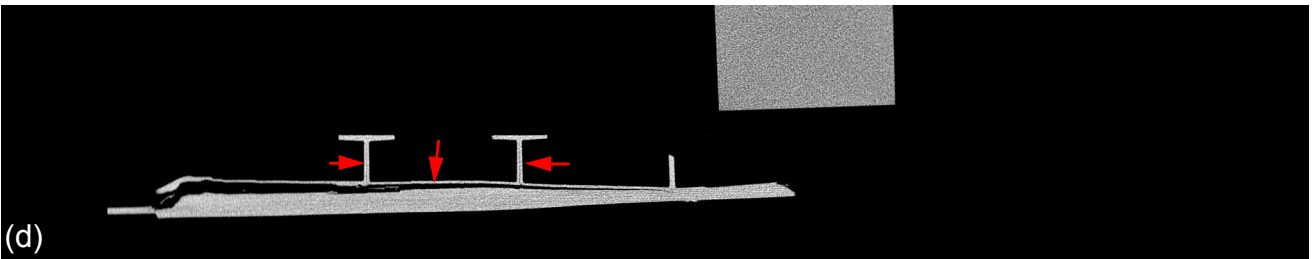
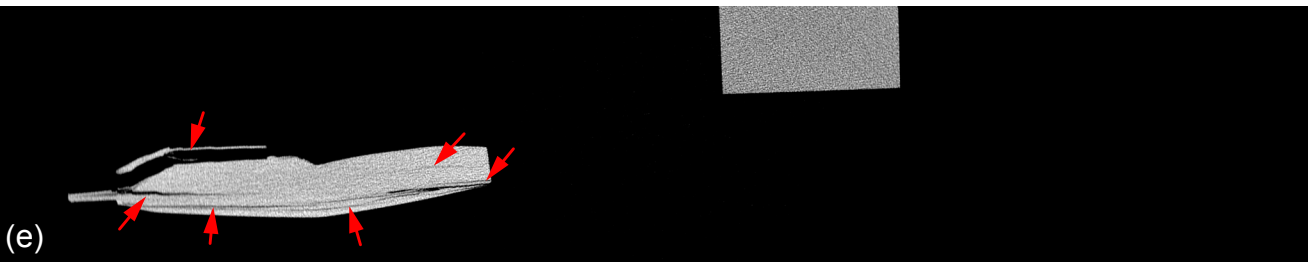
Figure 14. Higher-resolution CT slice images for the left forward lug fracture area section. Images are for the virtual cut planes shown in figure 13, images (b) to (f) as viewed looking downward parallel to the zero-degree fiber direction. Unlabeled arrows indicate delaminations.

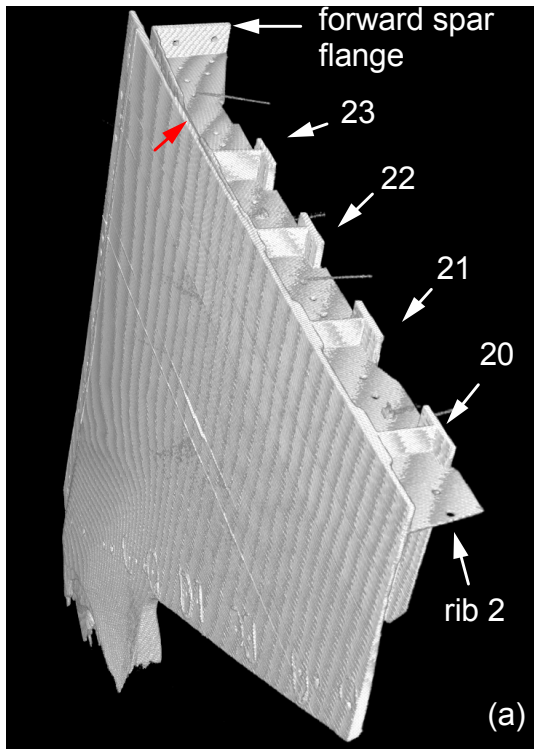
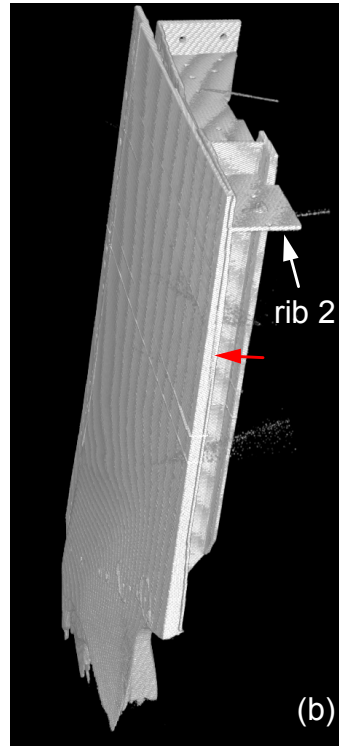
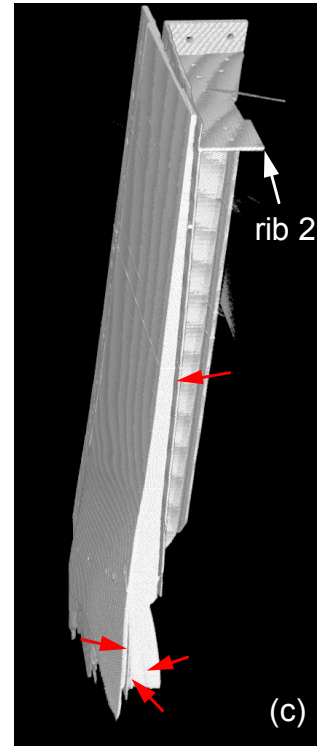
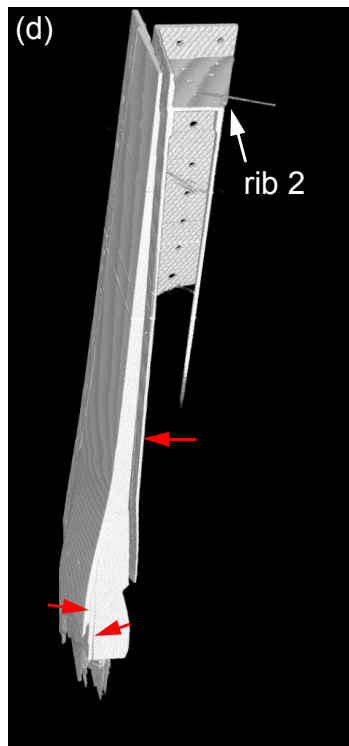
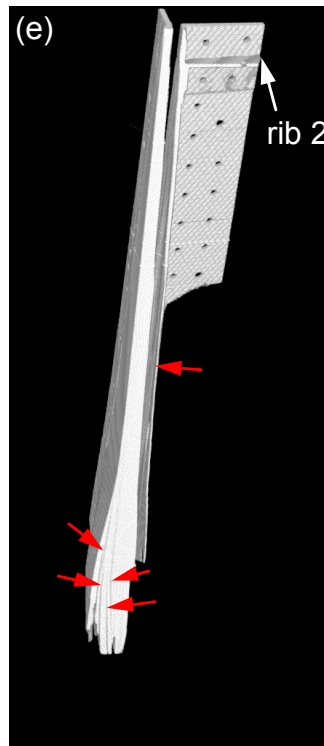
Figure 15. Three-dimensional visualization images of the CT scans from the left forward lug fracture area section as viewed looking forward and to the right. Image (a) is identical to figure 13, image (c). Images (b) to (e) show additional virtual cut planes parallel to the zero-degree fiber direction. Unlabeled arrows indicate ply separations. The stringers in the panel are numbered as indicated.
