Report Nr.: TN – MVQ3 – 001/04

Incoming Inspection (NDI) of the LHS Lug Test#1 specimen

Date: 05.08.2004

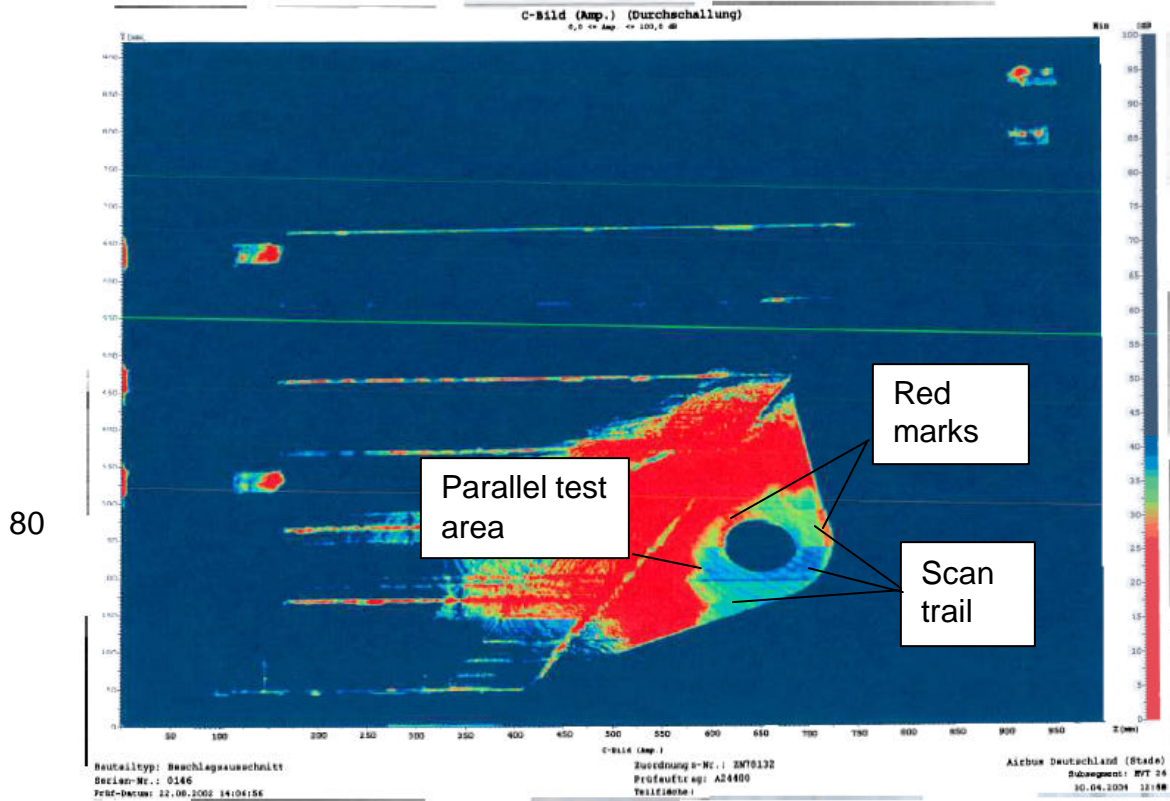
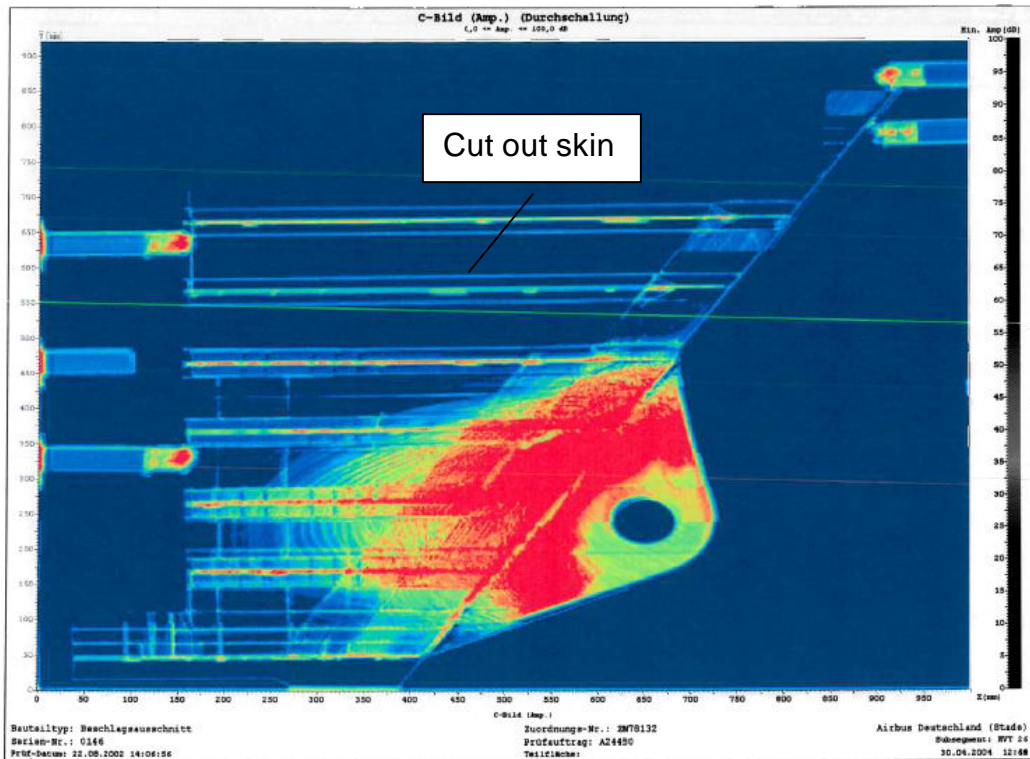
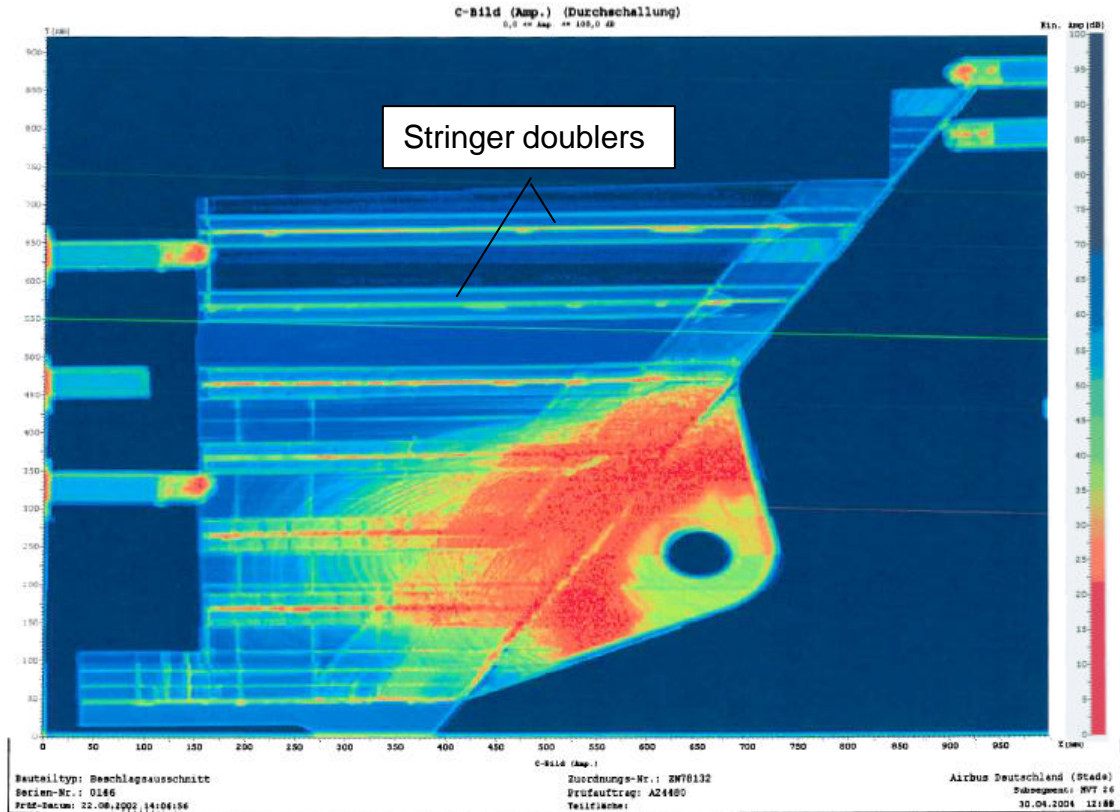
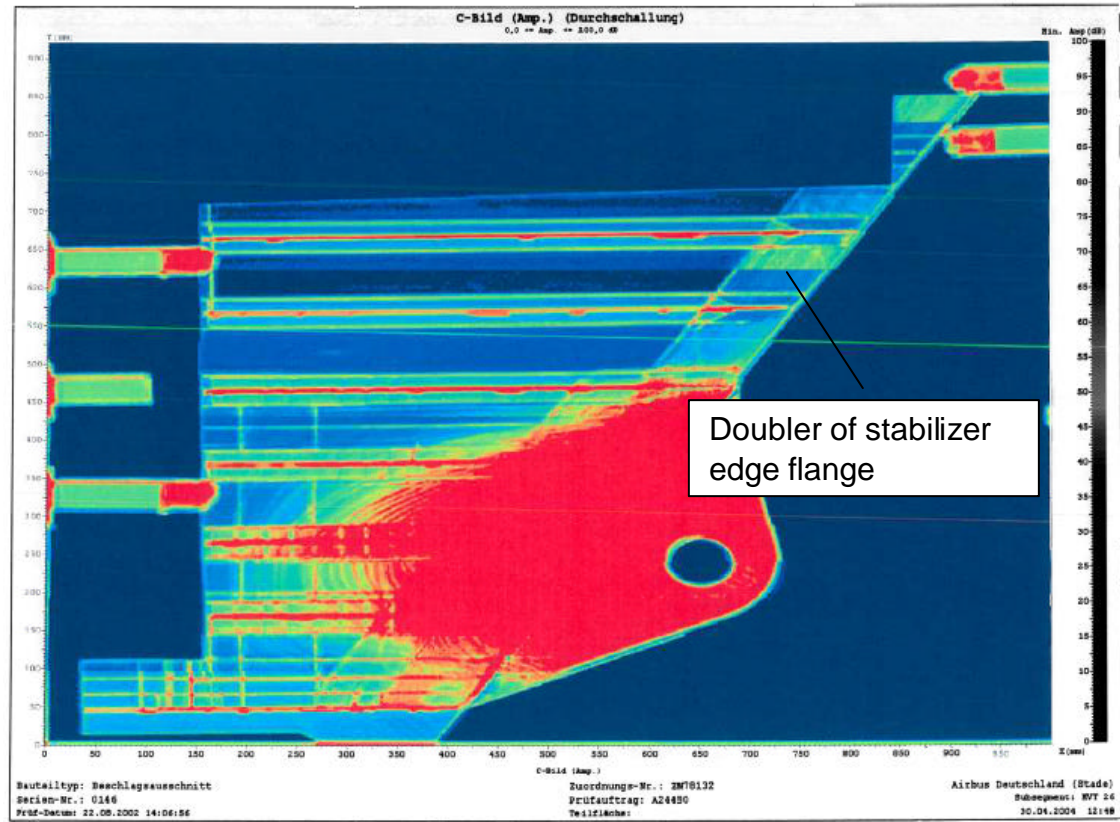
All areas were found to be within tolerance.

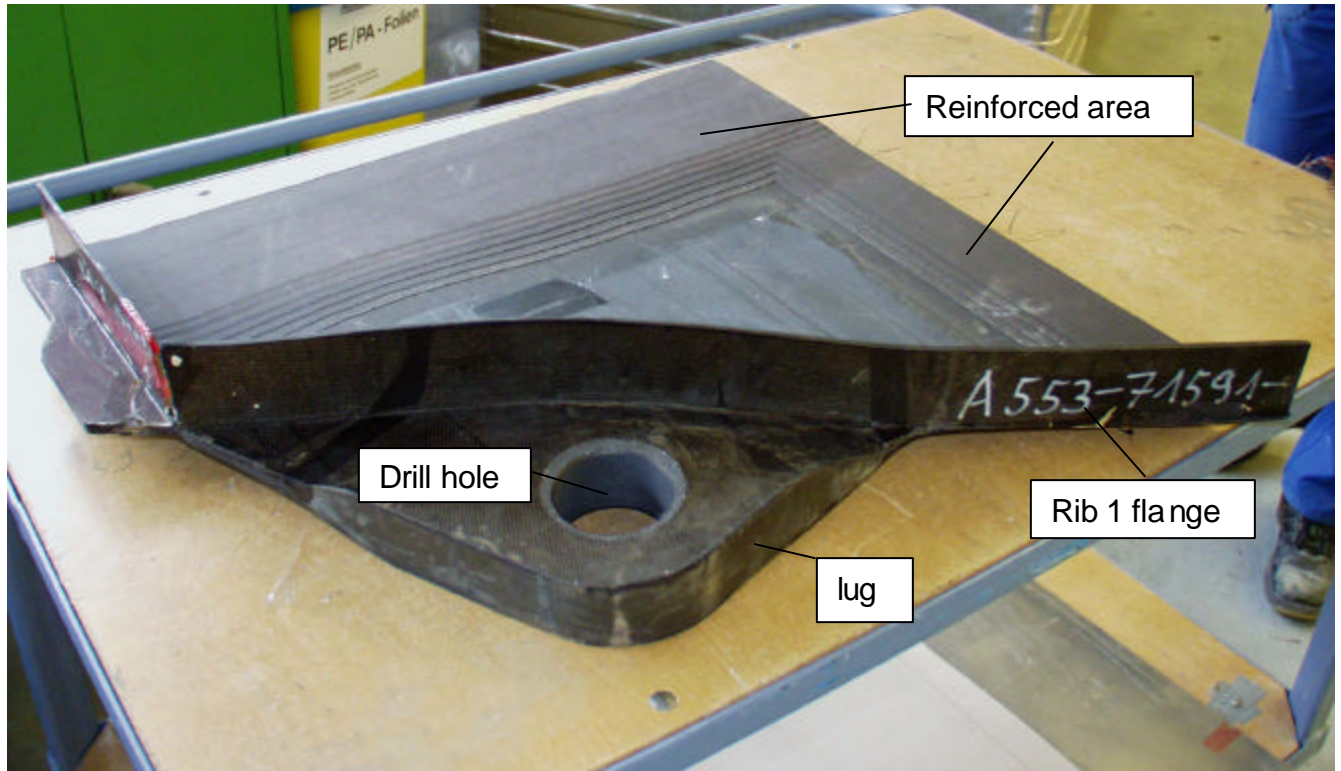
Figure 3.1

Cut out after reinforcement with additional carbon fiber layers.

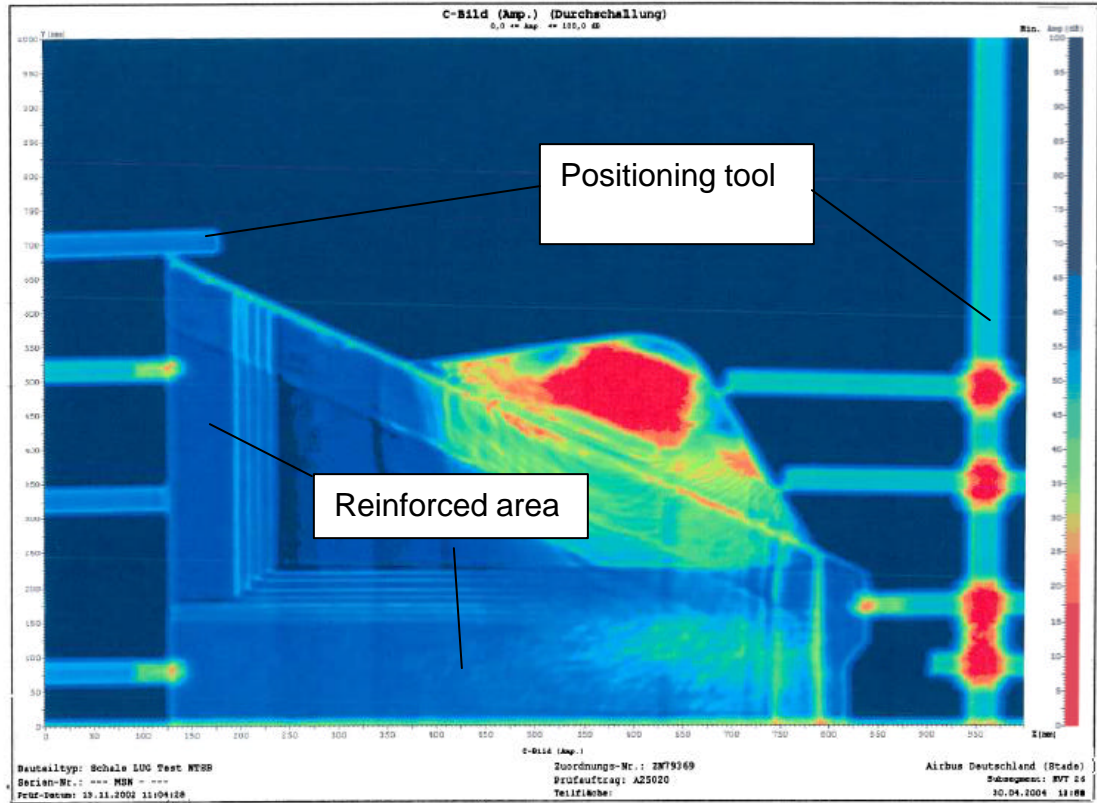
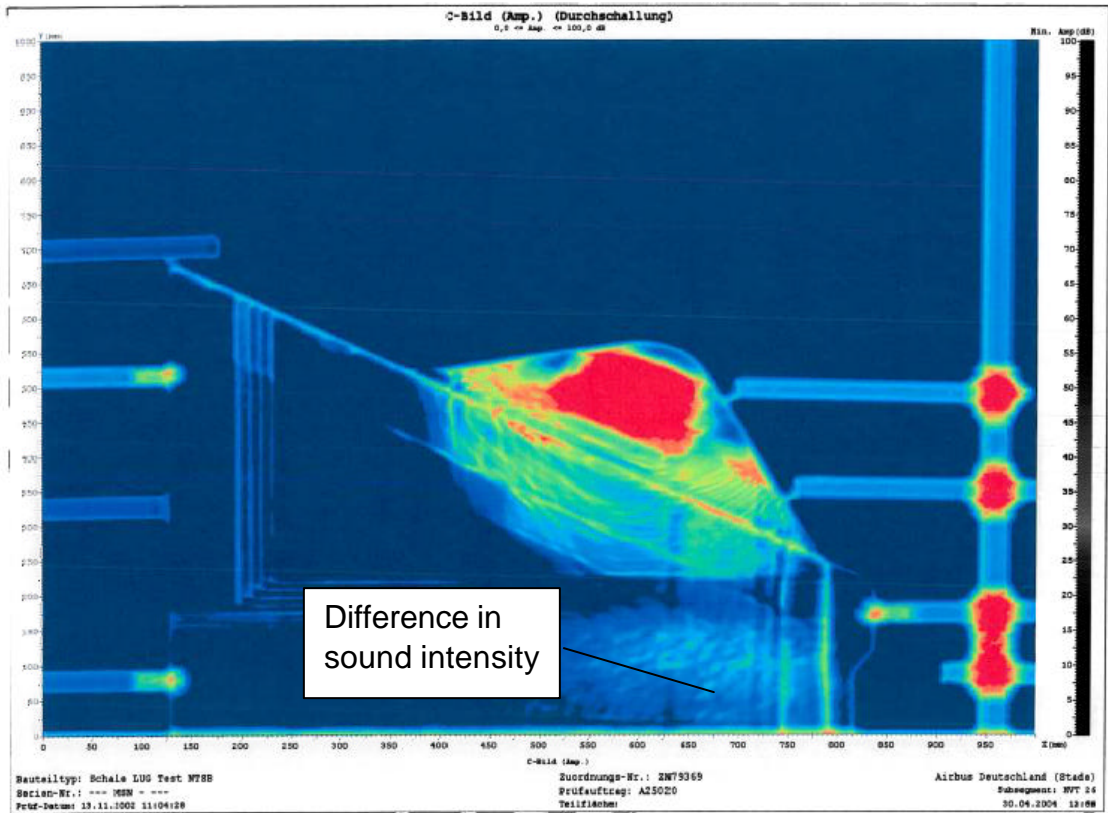
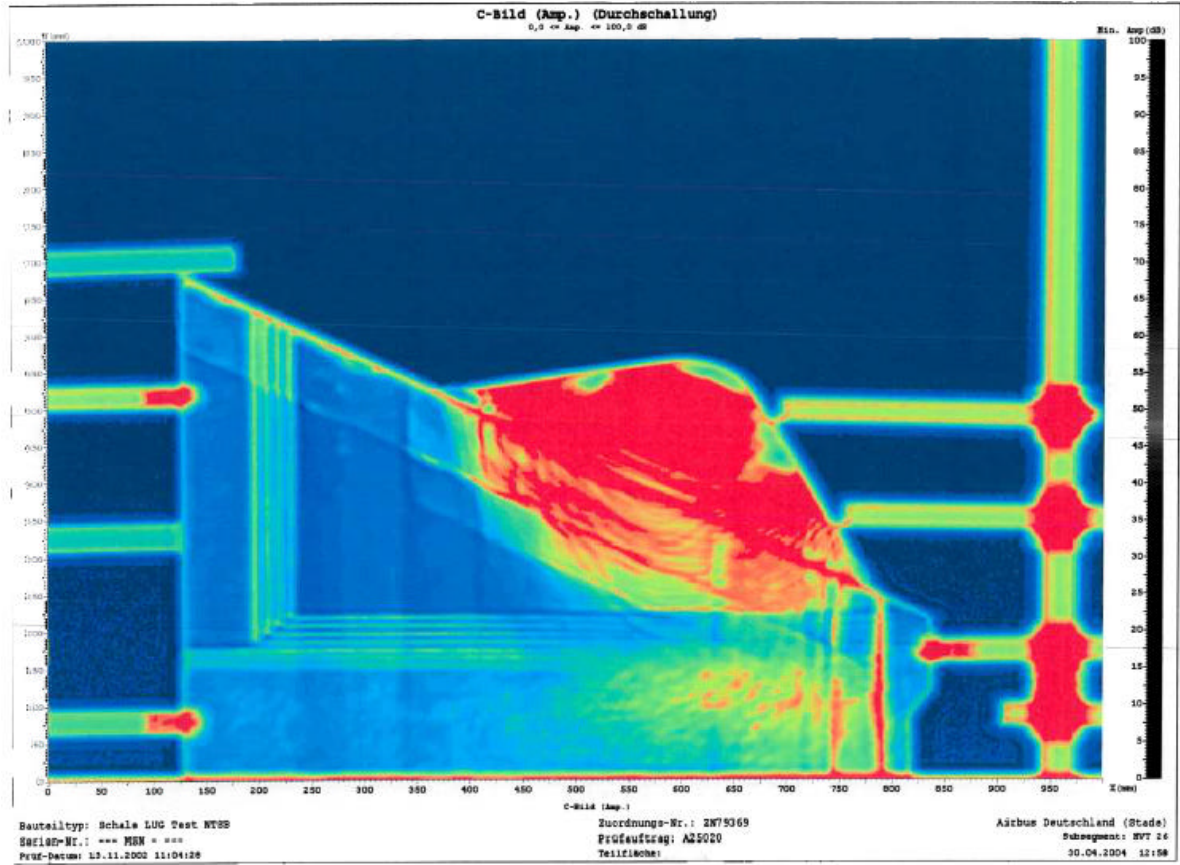
There is no indication for hidden inner defects.
