Report Nr.: TN – ESWNG – 1238/03

Incoming inspection of the rear lug cut outs **LH** side shell of the fin box from the aircraft MSN 513 of the American airlines

Date: 19.12.2003

Rear lug cut outs from MSN 513, operated by American Airlines, were taken from the left hand (LH) shell of the fin box for test purpose.

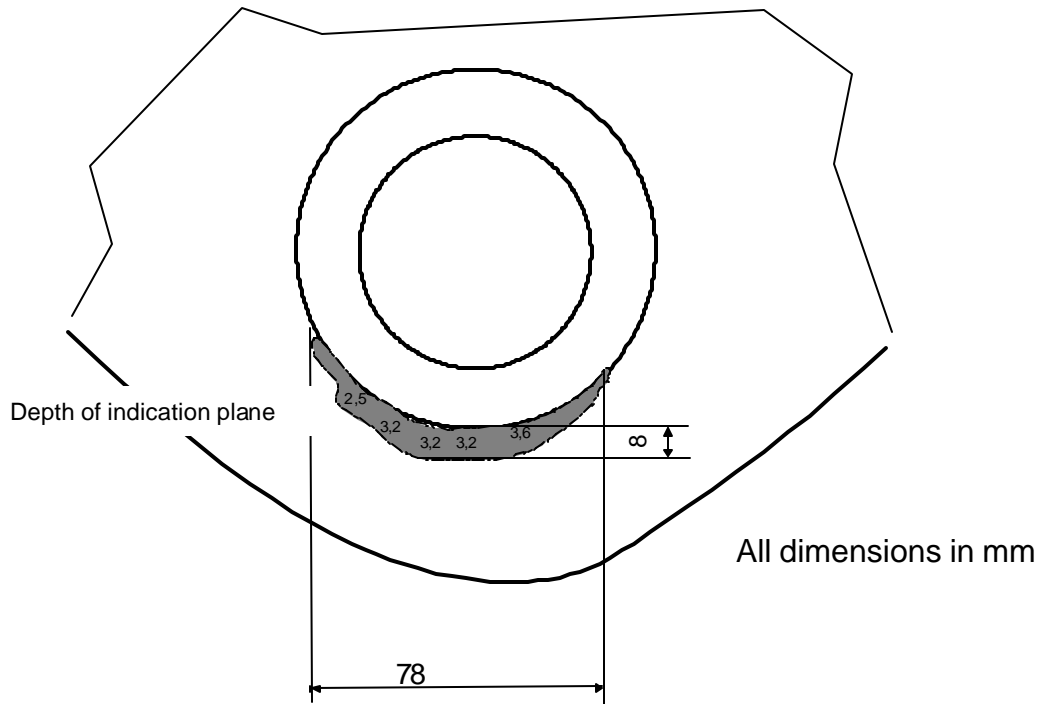
Delamination and cracks around the bushing were found.

Referred to the outboard side of the structure the indication area is in a depth of round about 3 mm (see figure 3 and 4).

At the inspection in Hamburg on the lug a gap between bushing and CFRP structure of 0,3 mm to 0,5 mm is visible.

Figure 4: Delamination and cracks in the rear lug LH side (Inspected from the outboard side of the lug)

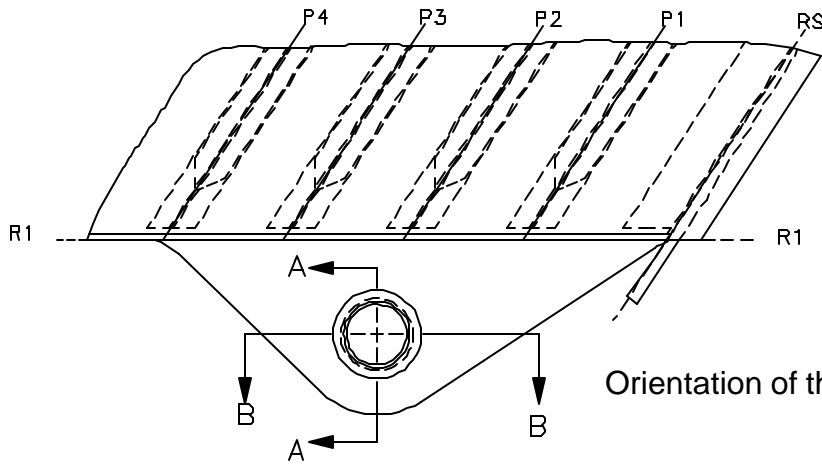
Cut : B – B

The result of a coordinate measuring device about the orientation of the bushing to the CFRP structure is described in the figures 5 and 6.

Figure5: Orientation of the bushing to the attached fitting in the direction of cut B15-B15 at the first incoming inspection (results of a coordinate measuring device)

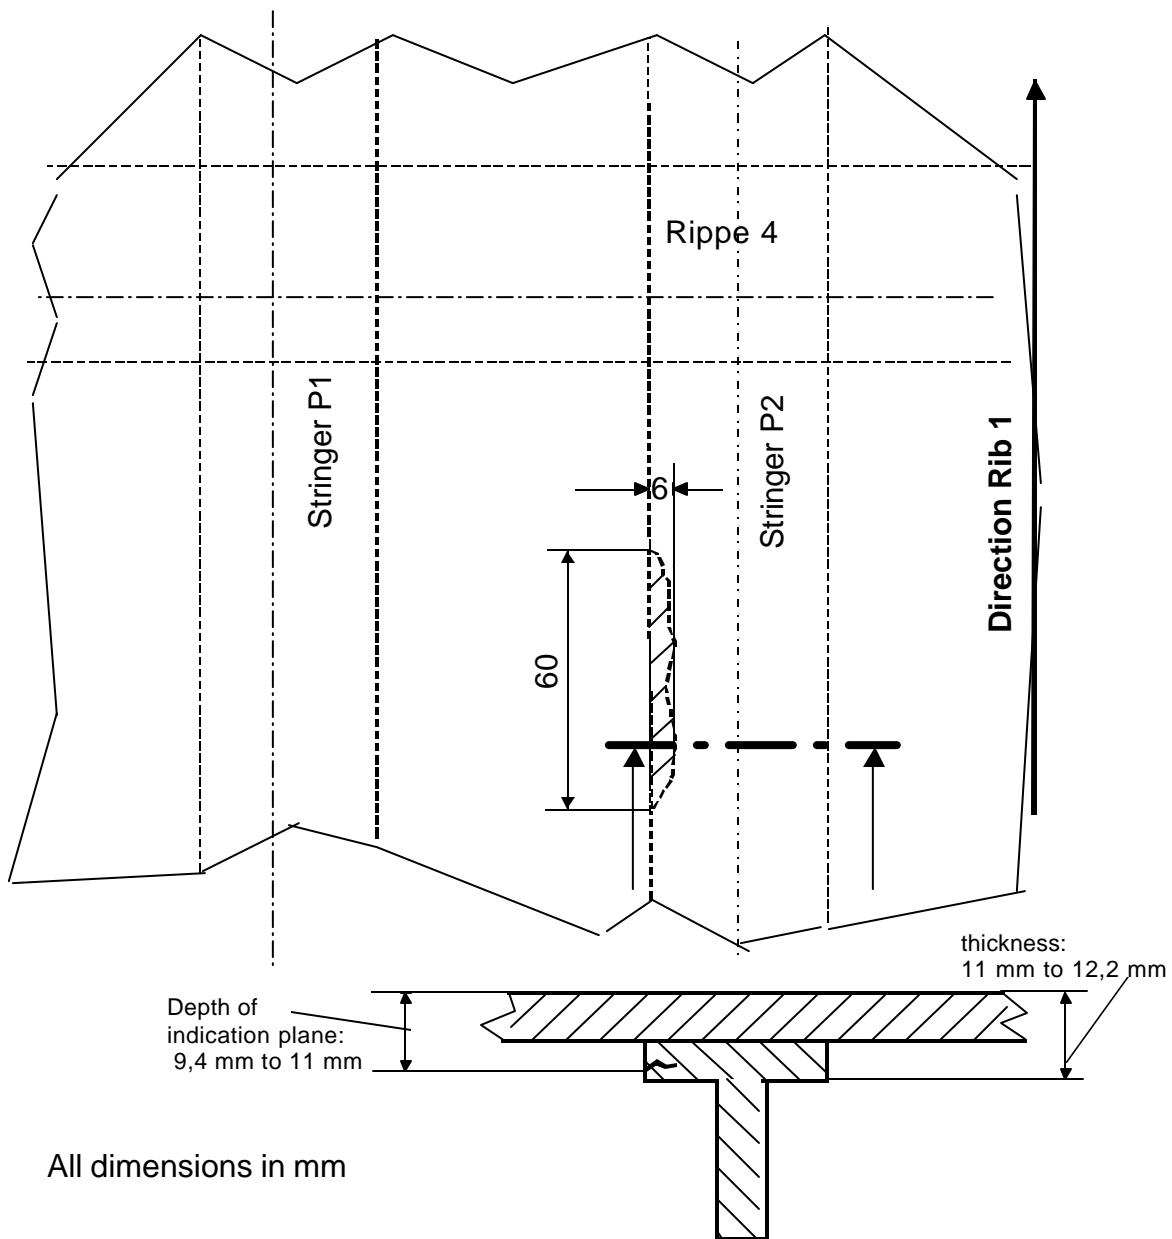
- Delamination in the foot of stringer P2 near rib 4 (figure 11)
- Delamination in the foot of stringer P7 near rib 4 (figure 12)

Figure 11: Delamination in the foot of stringer P2
