Report Nr.: TN – ESWNG – 1239/03

Incoming inspection of the rear lug cut out **RH** side shell of the fin box from the aircraft MSN 513 of the American airlines

Date: 19.12.2003

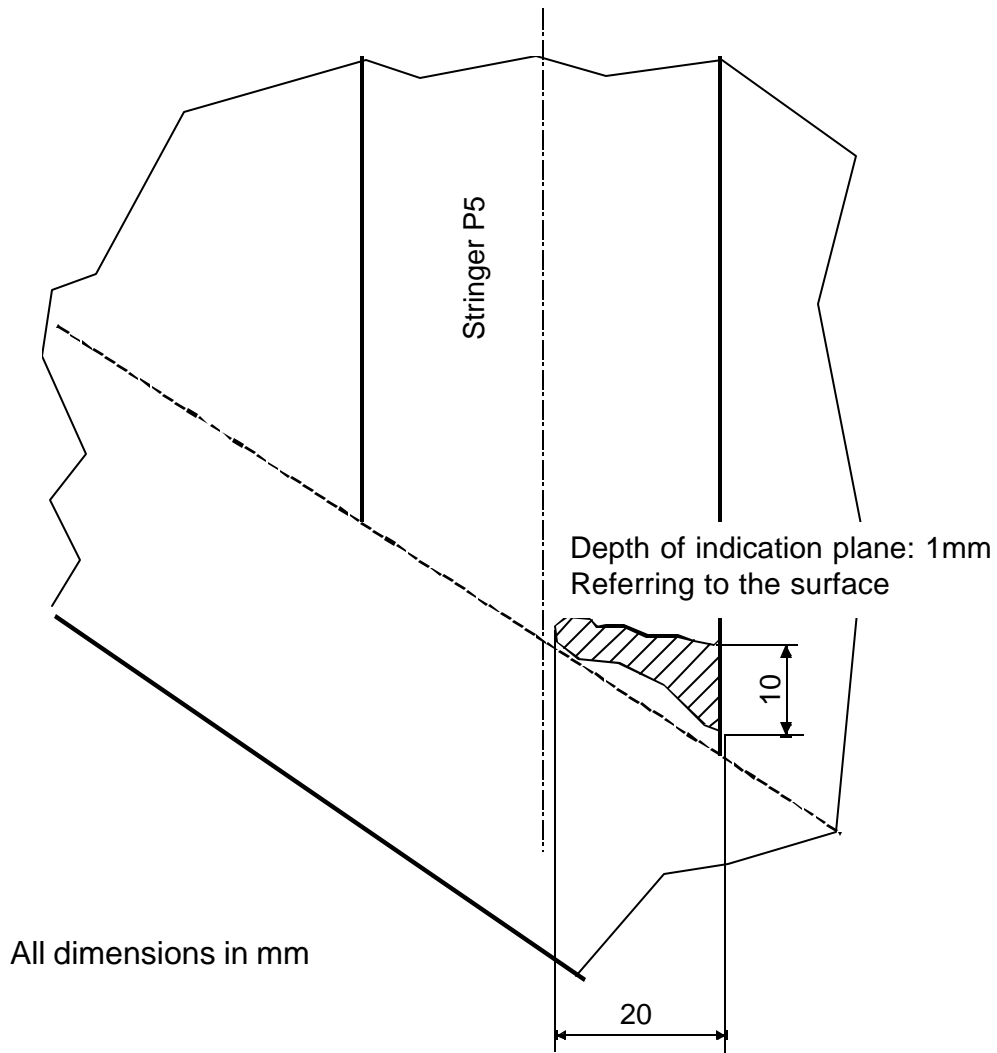
An area with single-depth pores or concentration of small cracks in a certain depth was found on stringer P5 at the connecting area of the rib 1 attachment angle and the skin panel. The indication plane is in a depth of 1 mm measured from the surface (See Figure 9 and 10).

Figure10: Indications on stringer P1 / rib 1 attachment angle; dimensions
(Location of single depth porosity or concentration of small cracks)
