Report Nr.: TN – ESWOG – 1264/04

**AAL587 Investigation**  
**LH side Lug sub-component test #1, Lab investigation**

Date: 29.06.2004

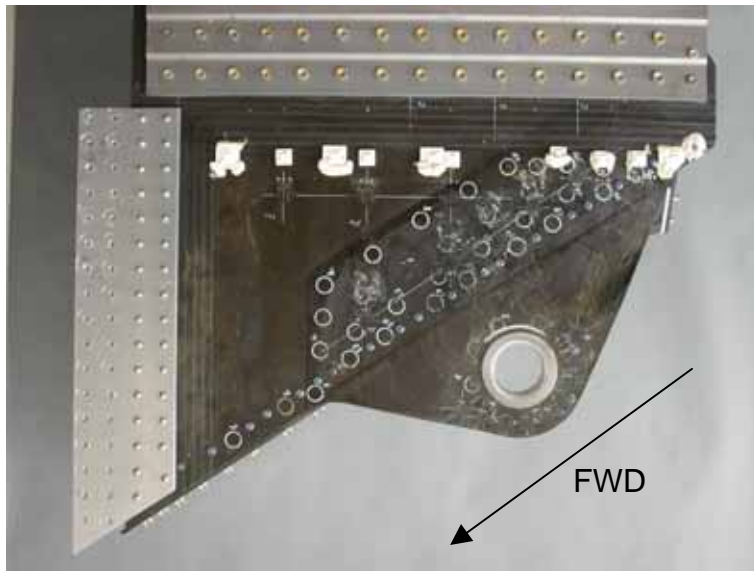
After the static test, the main attachment lug shows a translaminar fracture and multiple delaminations in the area of the precured/cured transition between outer part of lug and skin (s. fig. 1-5)

09358/03 State as delivered  
 Fig. 1: Lug test #1, condition: after static test, view from outboard side

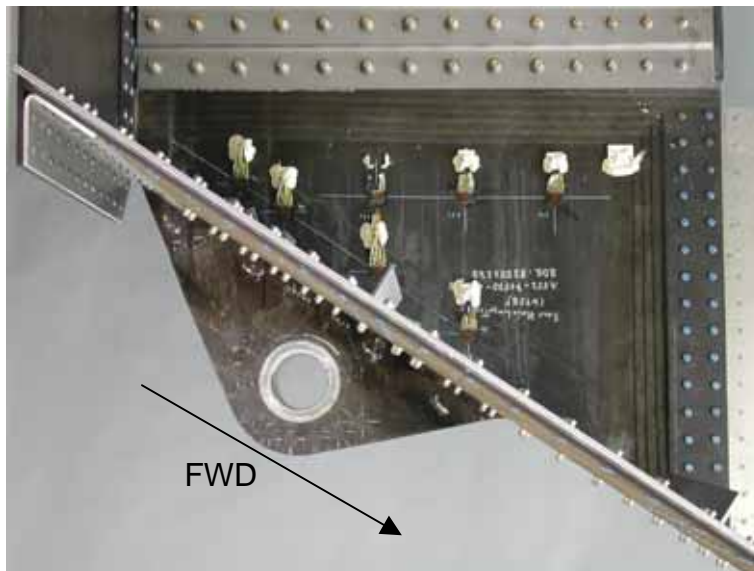
09363/03  
 Fig. 2: Lug test #1, condition: after static test, view from inboard side

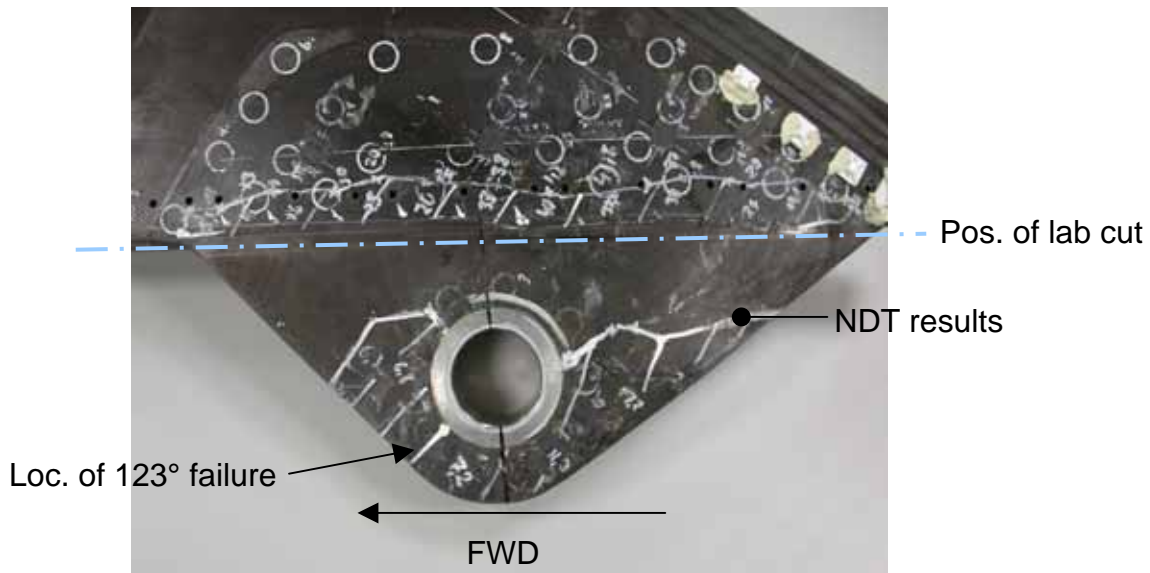
The delamination size, found by NDT, is visible on figures 3 and 4.

Fig. 3: NDT results after static test and separation of load introduction fitting, view from outboard side

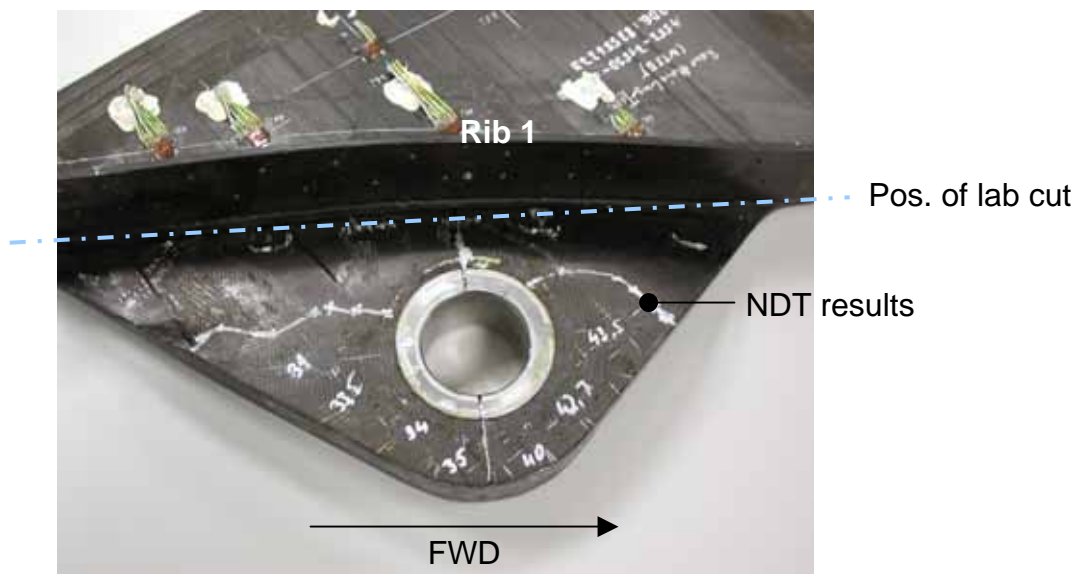
Fig. 4: NDT results after static test and separation of load introduction fitting, view from inboard side

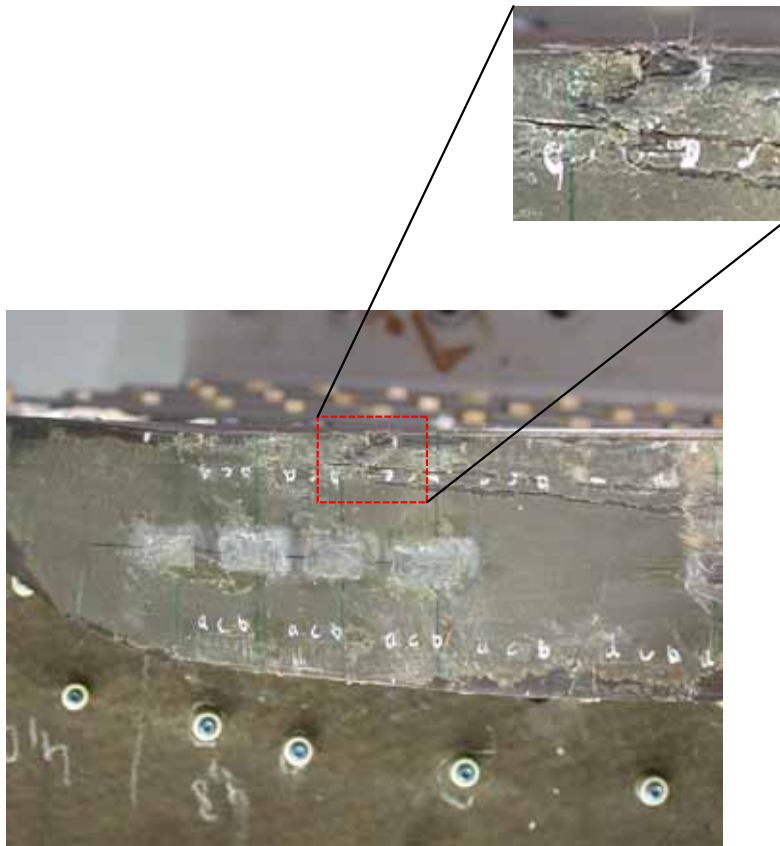
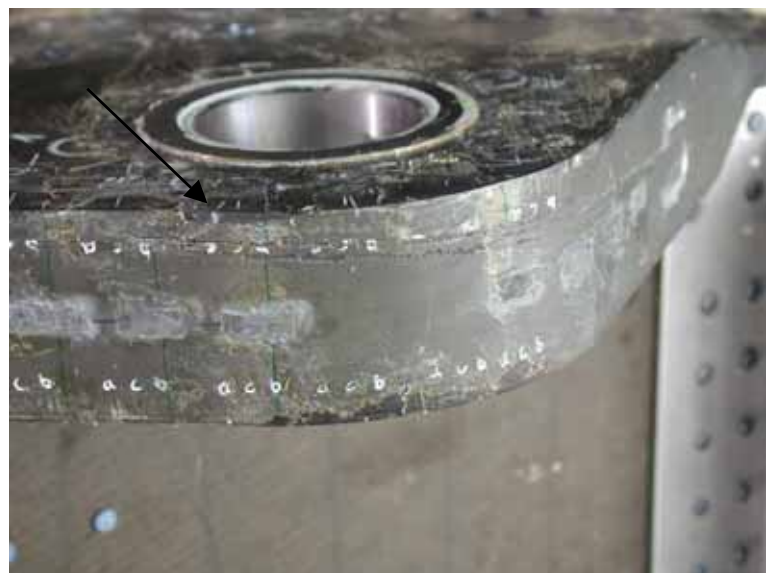
09368/03 09369/03  
 Fig. 5: Delamination path, trans laminar fracture path (arrow), view from lower side, condition: after static test

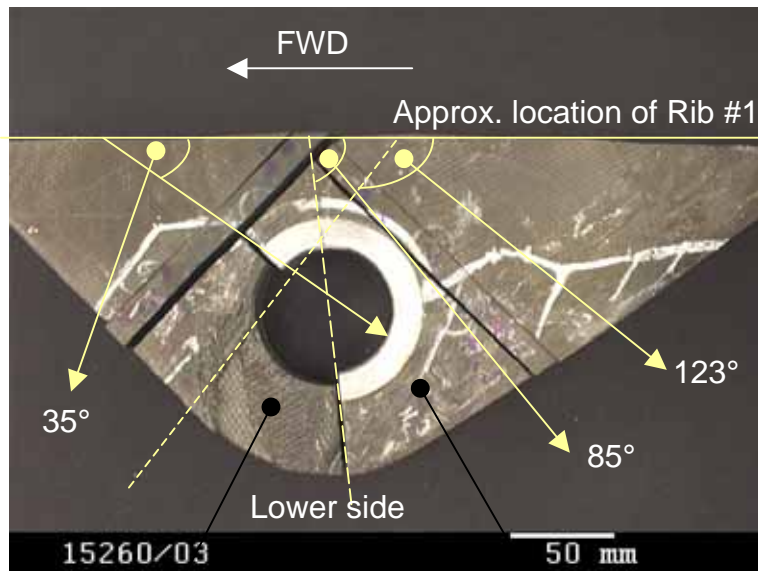
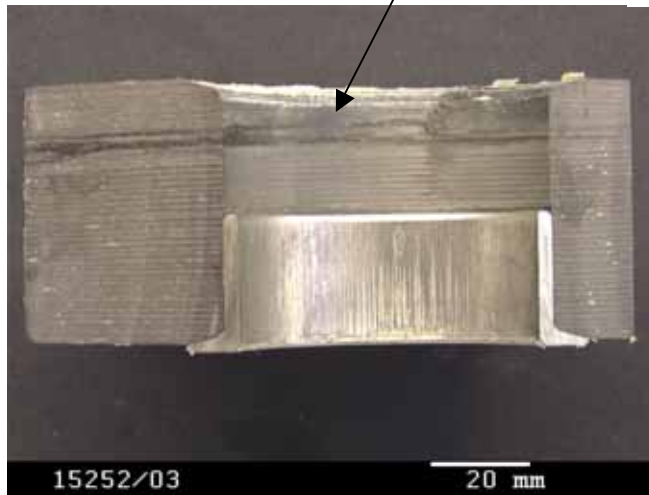
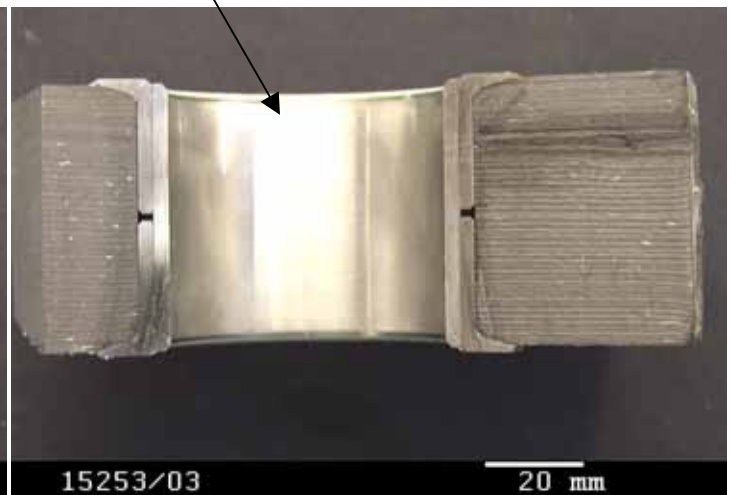
- Translaminar fracture was found, between the main ply separation and the outboard surface, labeled as 123° failure, because the fracture path is orientated approx. 123° to rib #1 (s. fig. 6). Further translaminar cracking was found below the main ply separation (s. fig. 7-10). The maximum failure depth (with fiber fracture) of the bush-hole side is 25.2 mm (s. fig. 7-8). Generally, the bush-hole side is more damaged than the lower side (s. fig. 7-10).

Fig. 6: Schedule of cut out #1 and #2, approx. angle between Rib #1 and:

- Translaminar fracture (labeled as 123° failure)
- Sec. cracked area (labeled as 35° failure)
- Section S3 – S3

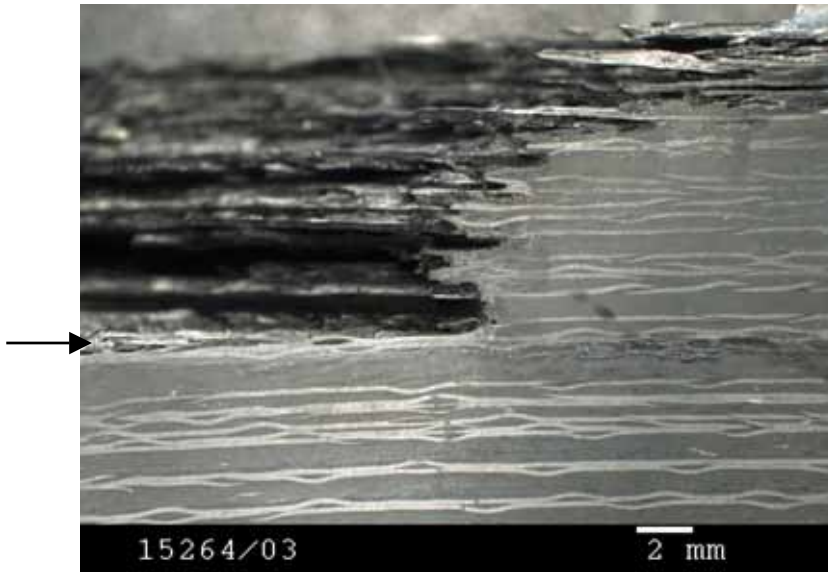
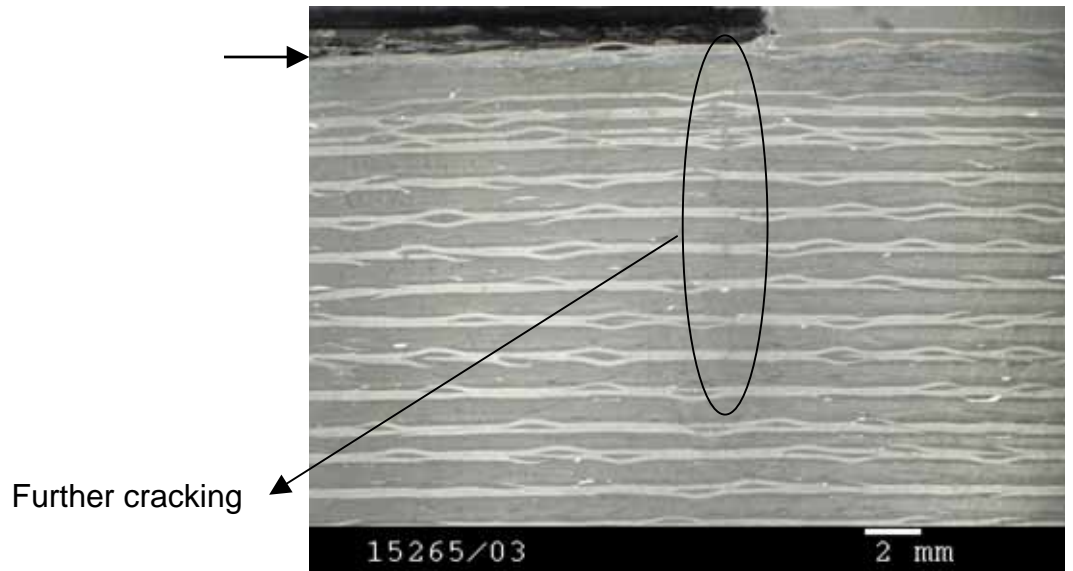
15264/03 15265/03 Grinded  
 Fig. 7: Translaminar fracture path above and further cracking below main ply separation (arrow), detail of fig. 6 /view from bush-hole side/123° failure

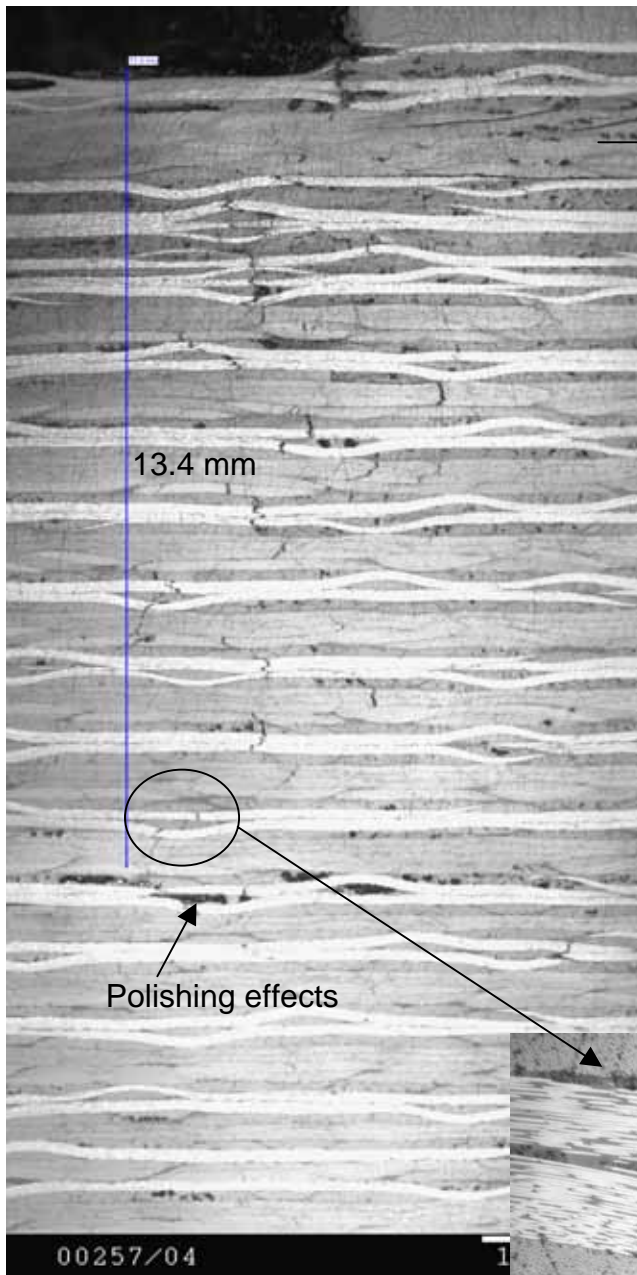
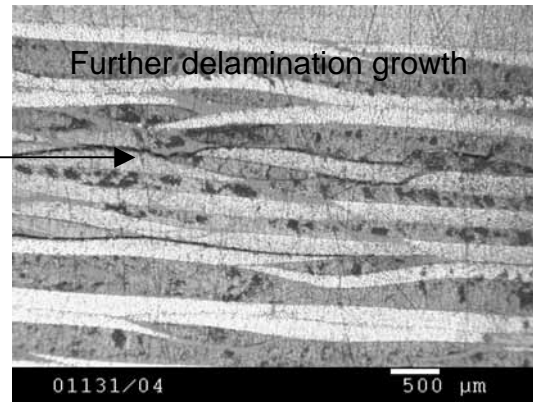
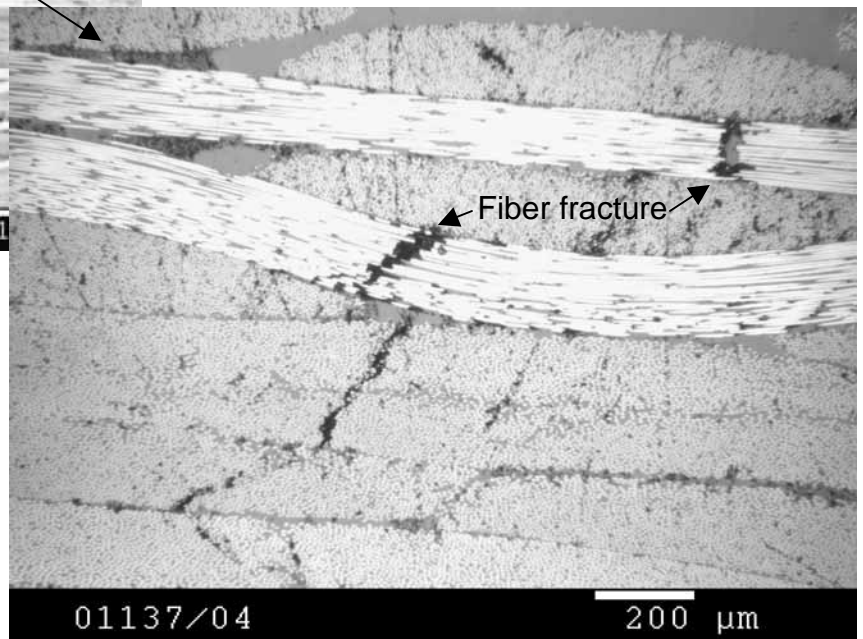
00257/04 Slightly polished  
 Fig. 8: Crack path with fiber fracture below main ply separation, detail of fig. 7, view from bush-hole side

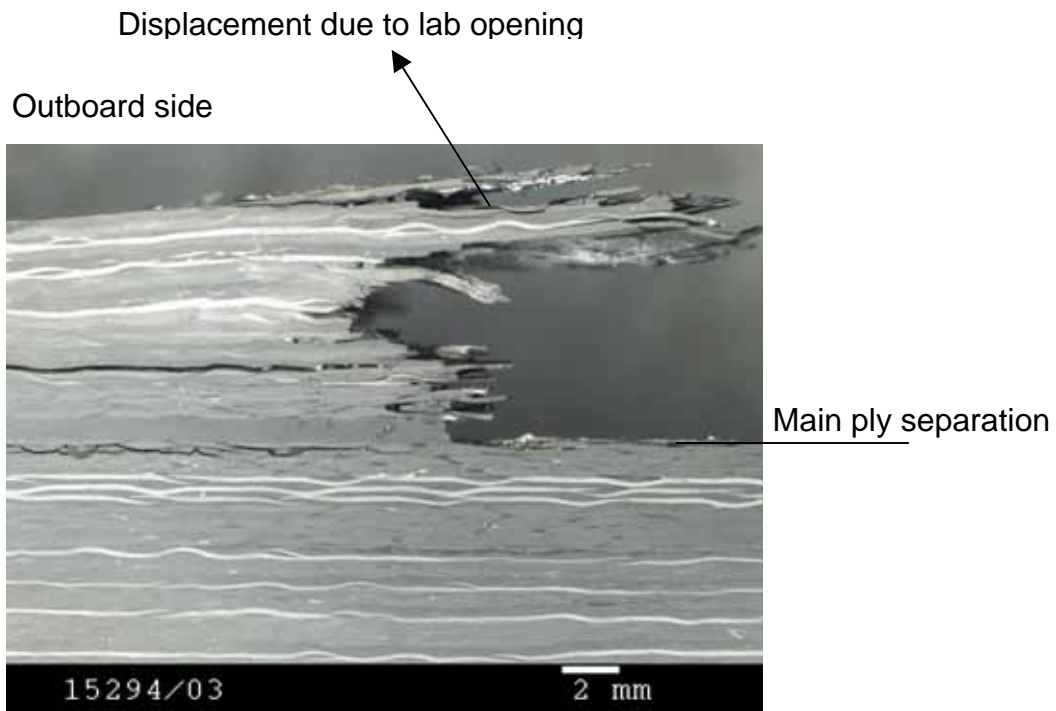
15294/03 Grinded  
 Fig. 9: Translamina fracture path, view from lower side, 123° failure / cf. fig. 6

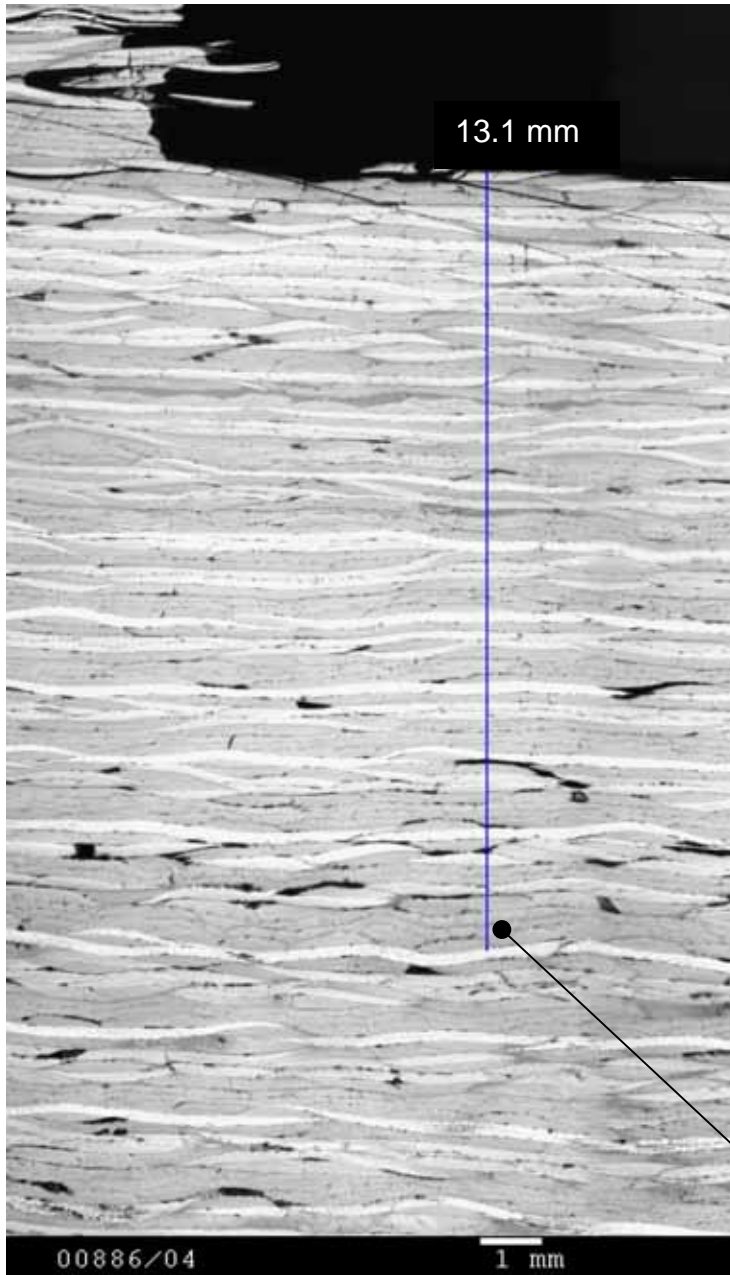
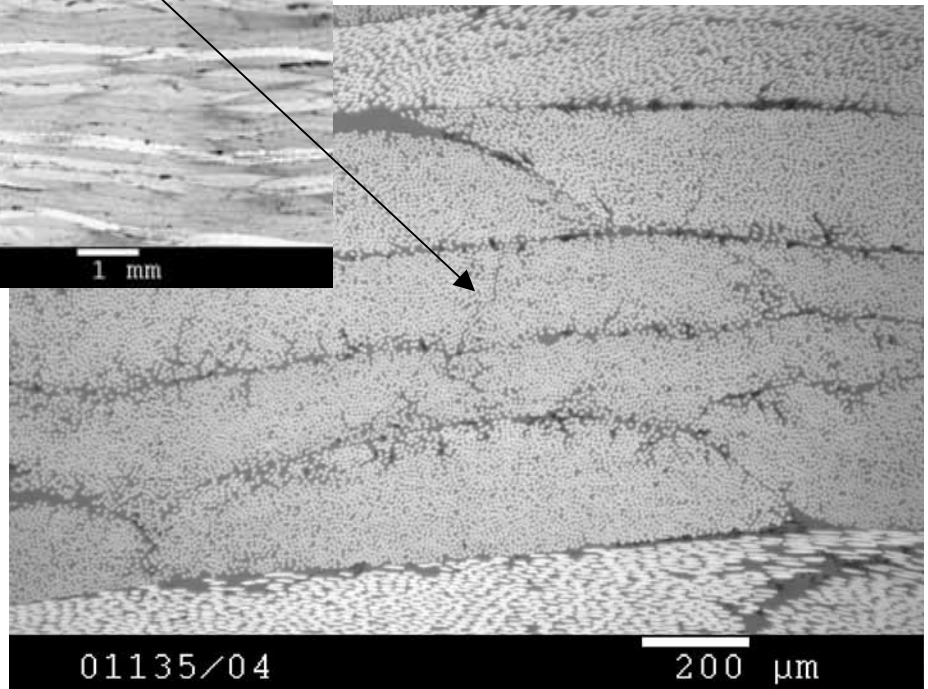
- The main ply separation (delamination/cracking) was found in the area of the precured/cured transition, i.e. the outer part, the precured/cured transition themselves as well as within the skin layers (s. fig. 6-10).

Fig. 10: Further matrix cracking below main ply separation, cf. fig. 9, view from lower side

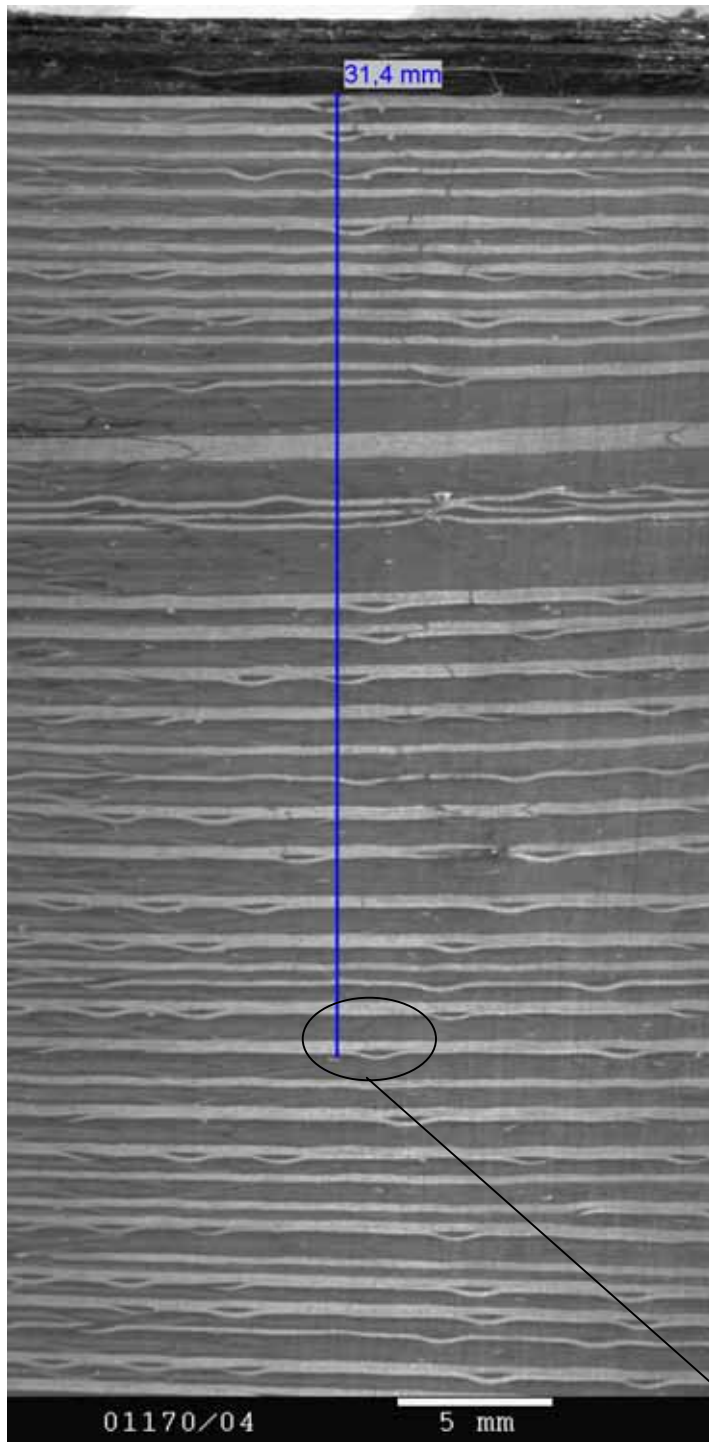
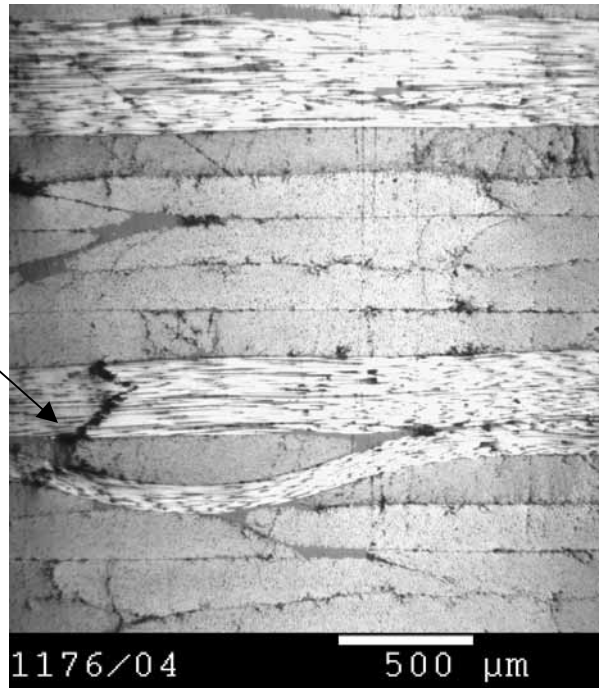
01170/04  
grinded  
Fig. 11:

- Secondary translaminar cracking, labeled as 35° failure because of the estimated crack path in approx. 35° to rib #1, was found only on the bush-hole side (s. fig. 11). The maximum failure depth, including fiber fracture, is 31.4 mm.

01176/04  
slightly polished  
Further cracking, maximum failure depth is 31.4 mm, cf. fig. 7, view from lower edge, 35° failure

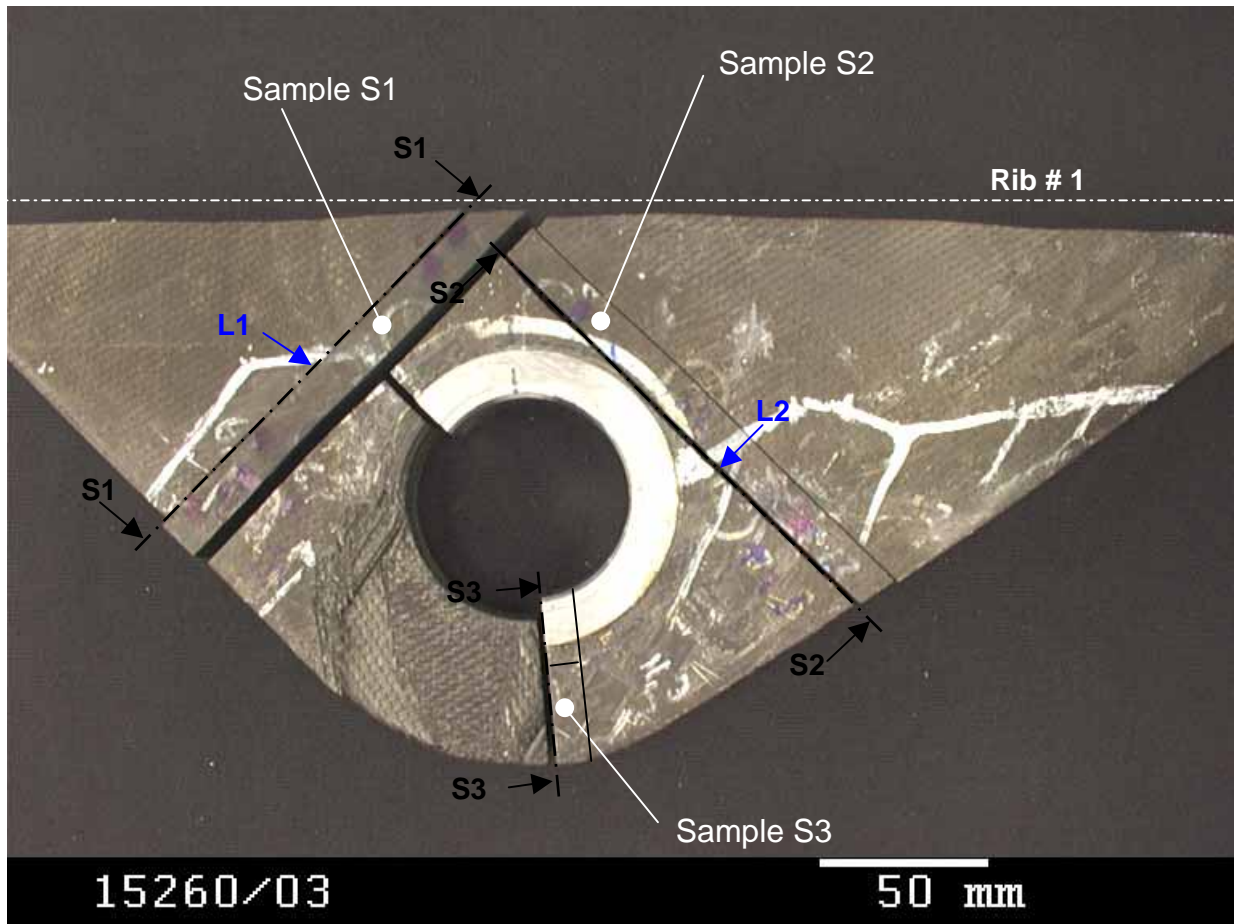
The main ply separation length, measured from the lower edge in upper direction of the lug, is 65.4 mm on section S1-S1 and 58.1 mm on section S2-S2 (s. fig. 13,14). Both values are in good correlation to the NDT results (s. fig. 12).

Fig. 12: Location of sections S1-S1, S2-S2 and S3 – S3, microsection S3 (sample S3), maximum delamination length L1 (65.4 mm) and L2 (58.1 mm) found on section S1 and S2, the 0° orientation acc. to the drawings is approx. 45° to rib #1

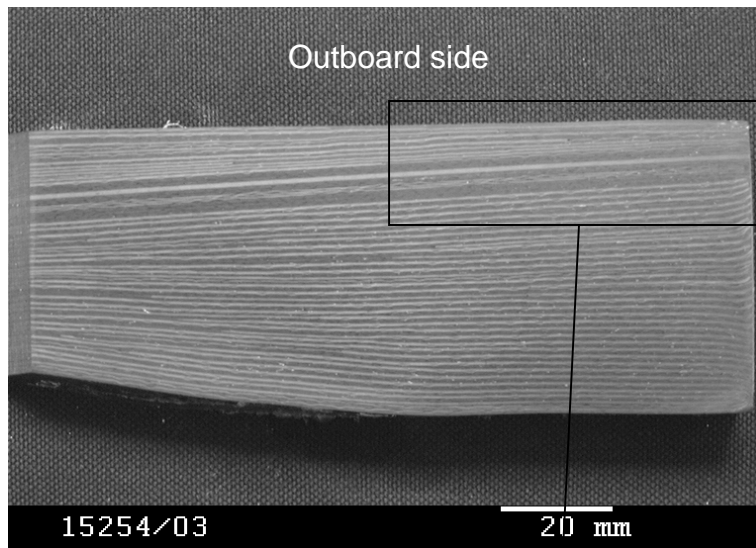
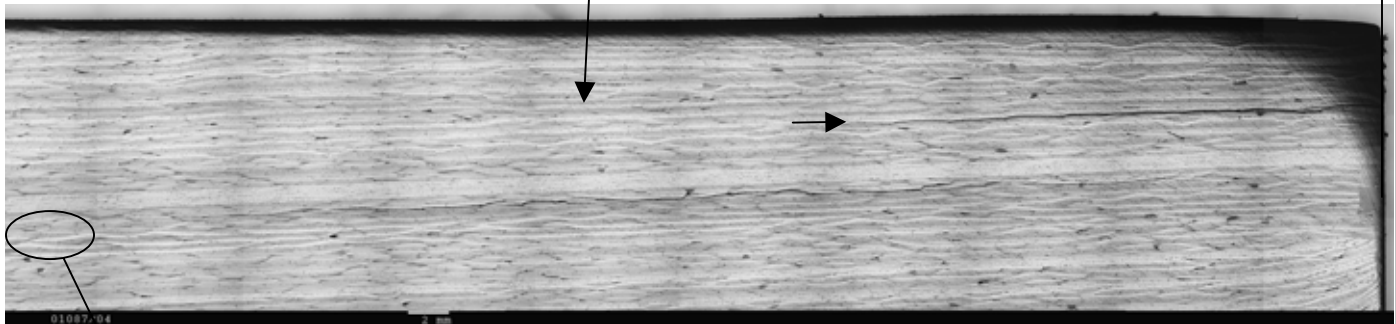
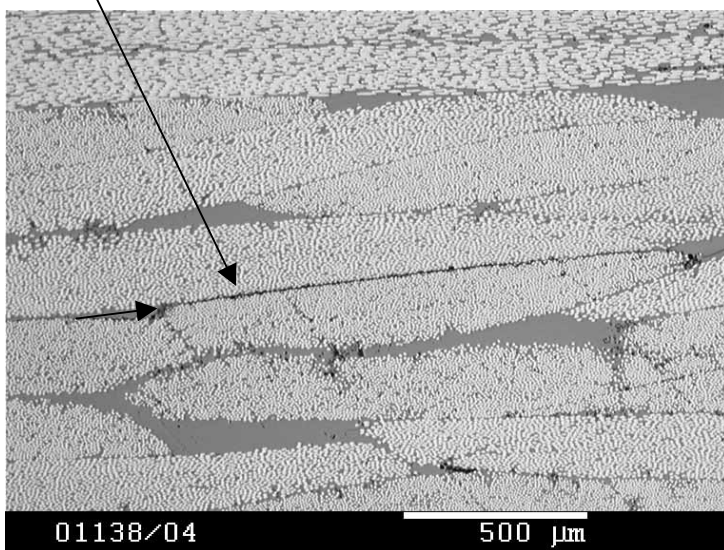
The depth, measured from the outboard side is not constant (s. fig. 13,14). Generally, the main ply separation is located within the skin layers, just below the 4 tape layers (s. fig. 13, 14 and 15 of S3). Furthermore, section S1-S1 contains a delamination within the outer precured part of the lug (s. fig. 13).

Fig. 13: Main ply separation path and further delamination path (arrow) within pre-cured outer part of lug, section S1-S1

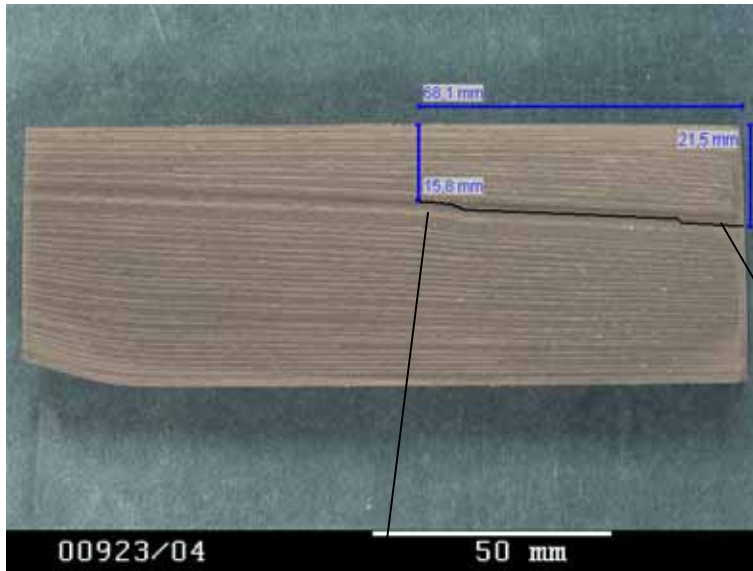
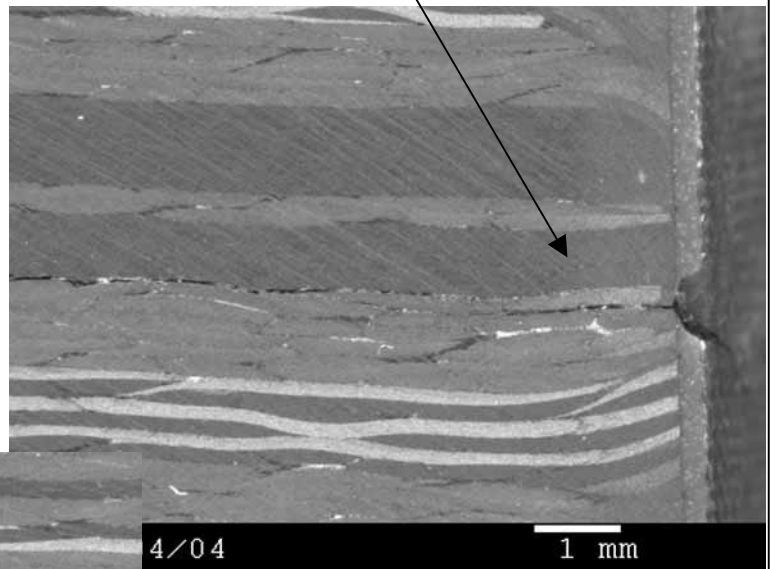
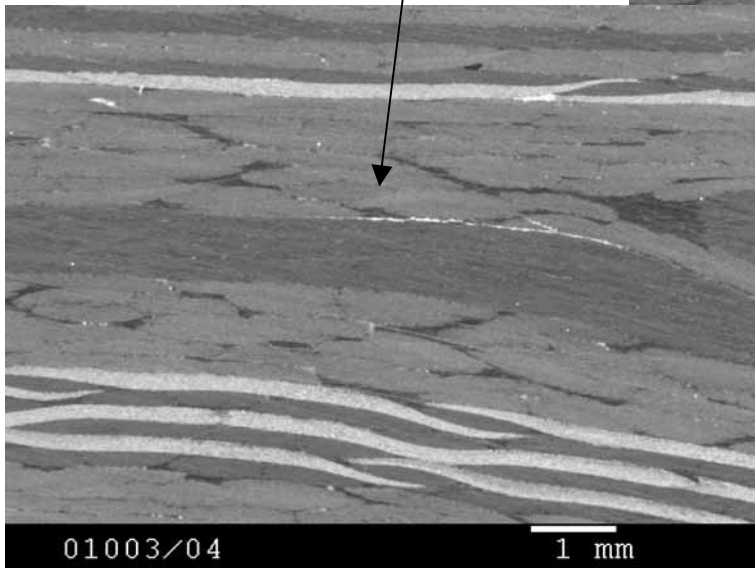
00923/04 1003/04 / 1004/04 Grinded  
Fig. 14: Main ply separation path (de-  
lamination path), section S2-  
S2

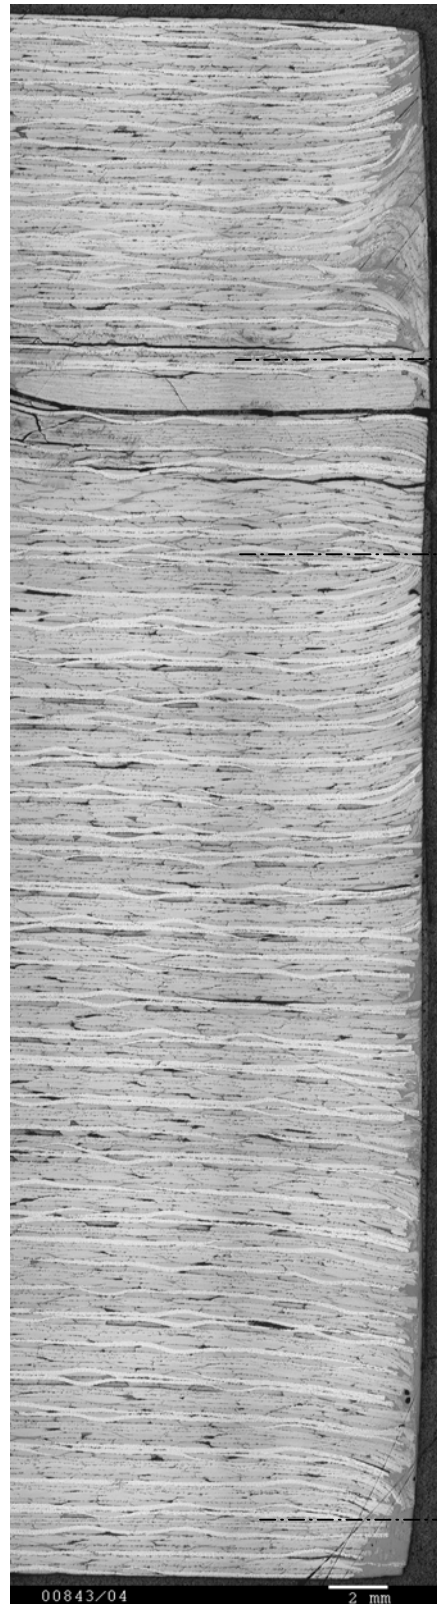
All layers as well as the location of the precured/cured transitions (s. fig. 15) are in accordance with the drawings.

Fig. 15: Microsection S3, lay up sequence, precured/cured transition (interrupted lines)

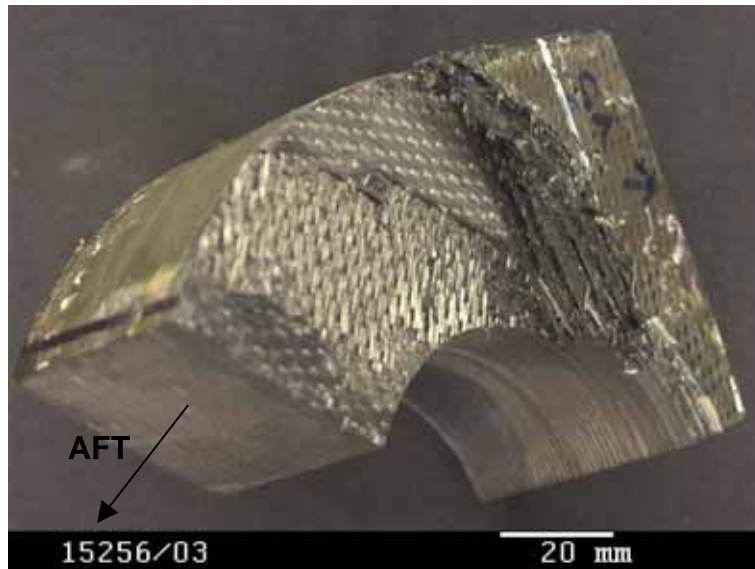
15256/03  
 Fig. 16: General view of cut out #1 after lab separation of main ply separation

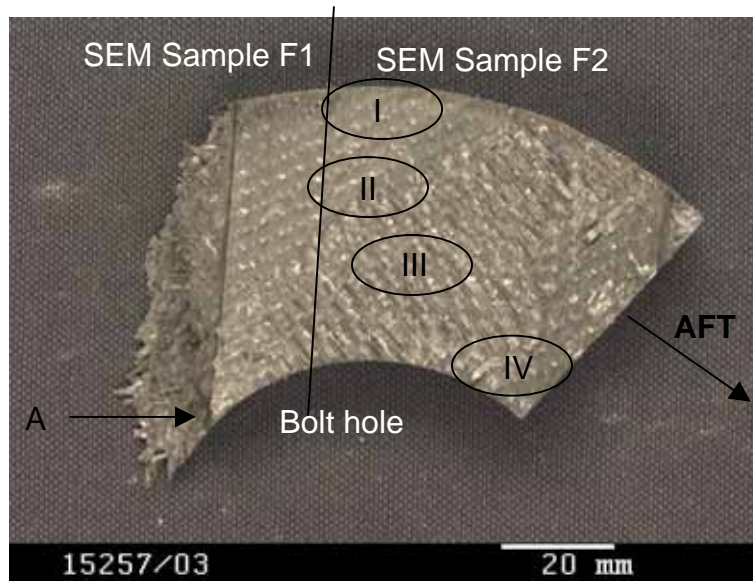
15257/03  
 Fig. 17: General view of main ply separation and fracture after lab separation, location of SEM details

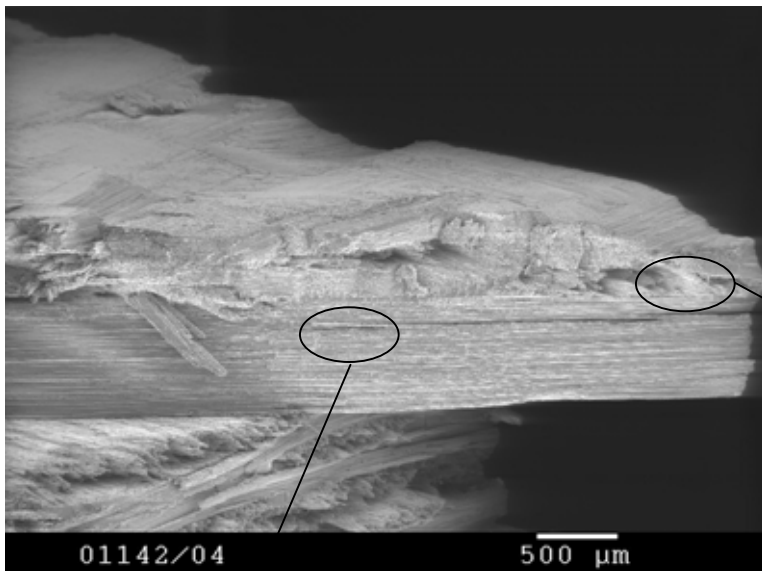
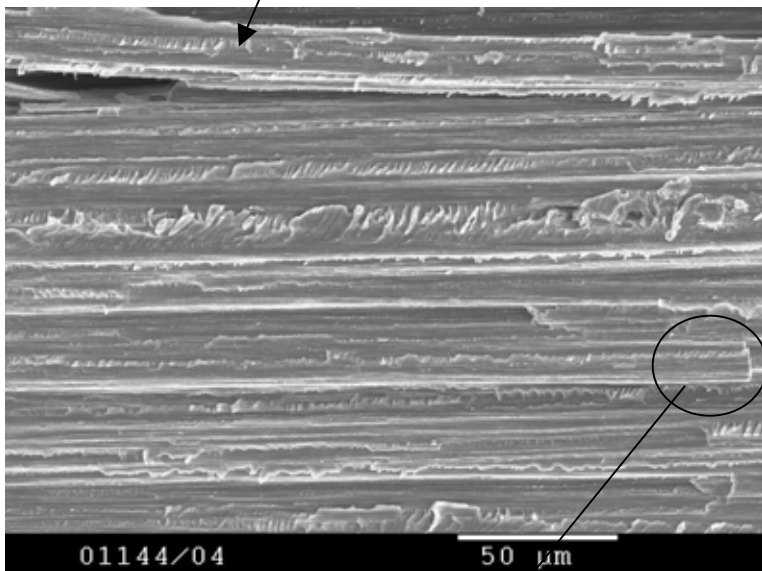
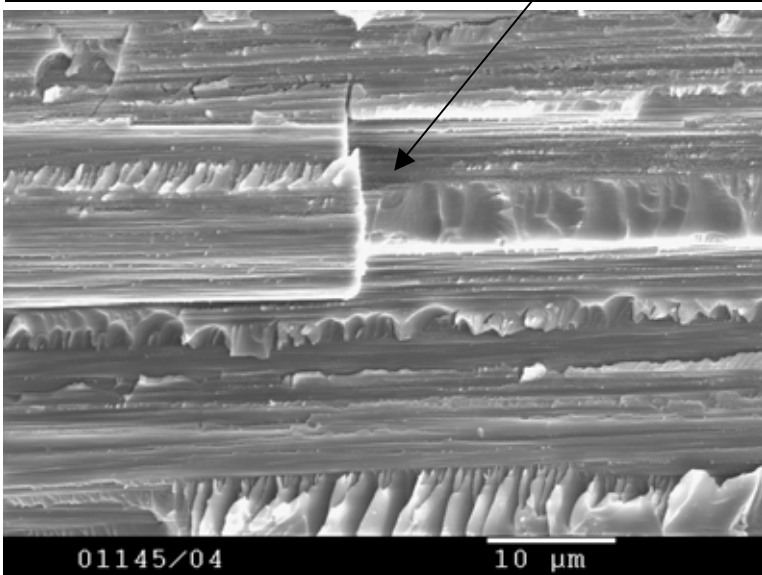
The translaminar fracture (**F1**) shows indications of Mode I (tension) and Mode II (shear) loadings in the area of matrix cracking (s. fig. 18). The fractured fibers obtained radial fracture patterns, locally indications to bending or compression (kinking) were found (s. fig. 19, 20). I.e. the direction of the local fiber fracture is visible.

01142/04 01144/04 01145/04  
 Fig. 18: Translamellar fracture,  
 Mode I and II features,  
 SEM sample F1, pos. A/cf.  
 fig. 18

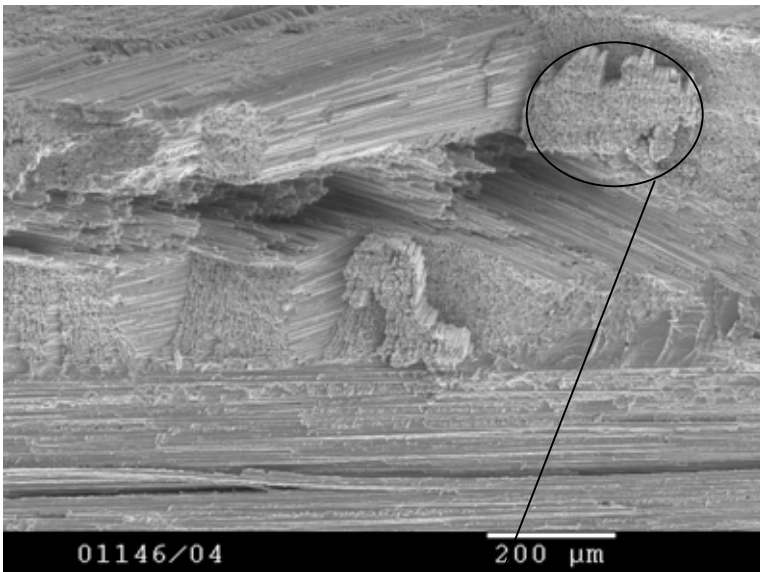
01142/04 01150/04  
 Fig. 19: Fiber fracture of 1<sup>st</sup> layer, indications to bending, det. of fig. 19, sample F1

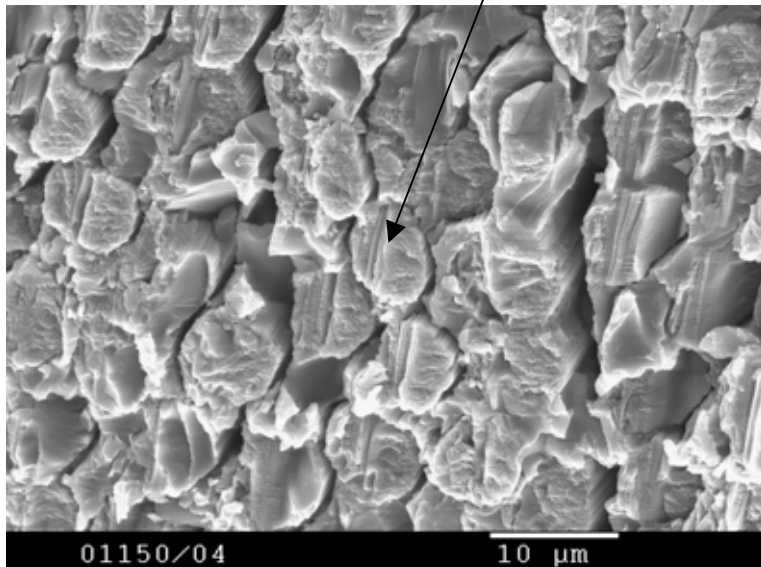
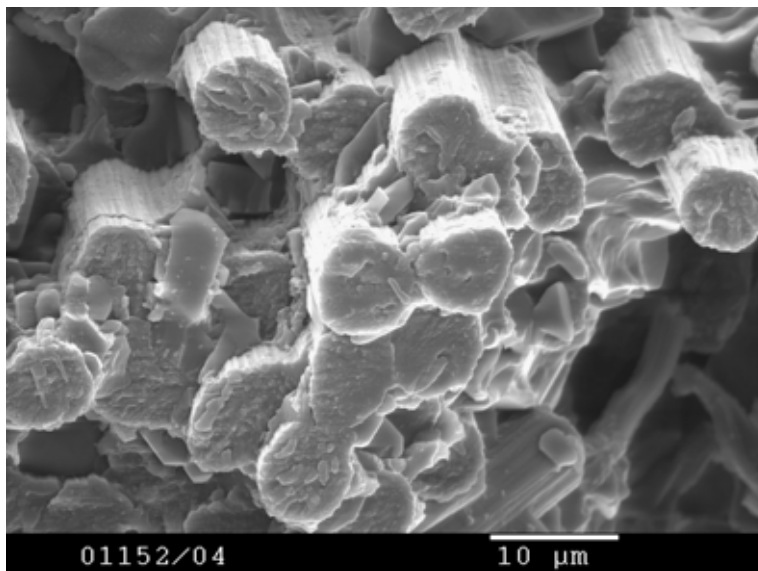
01142/04  
 Fig. 20: Fiber fracture due to tensile load, located just beside the bush-hole, det. of fig. 19, sample F1

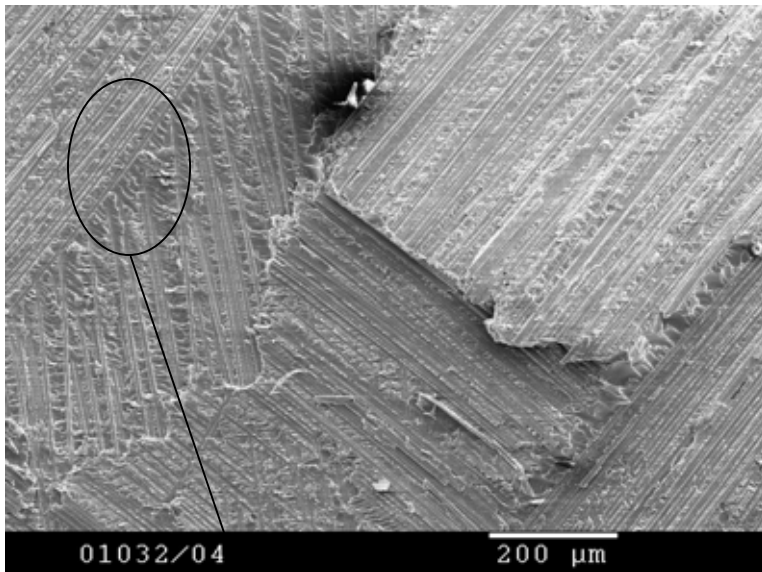
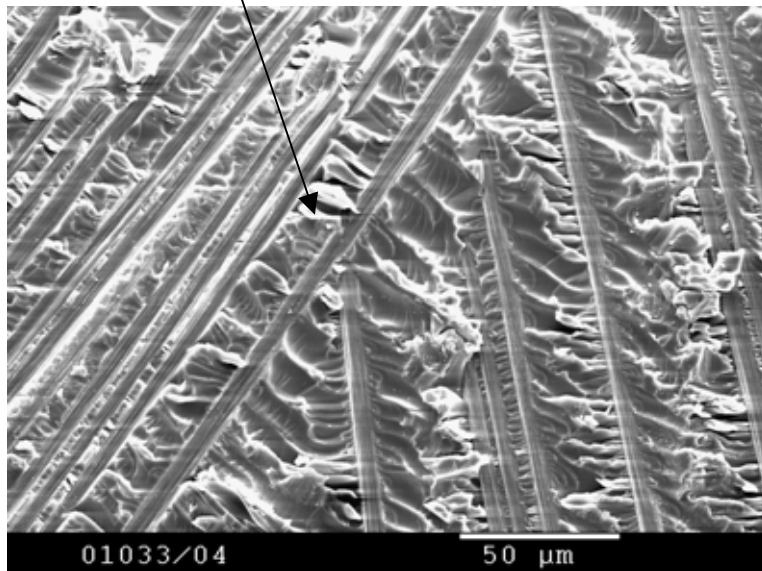
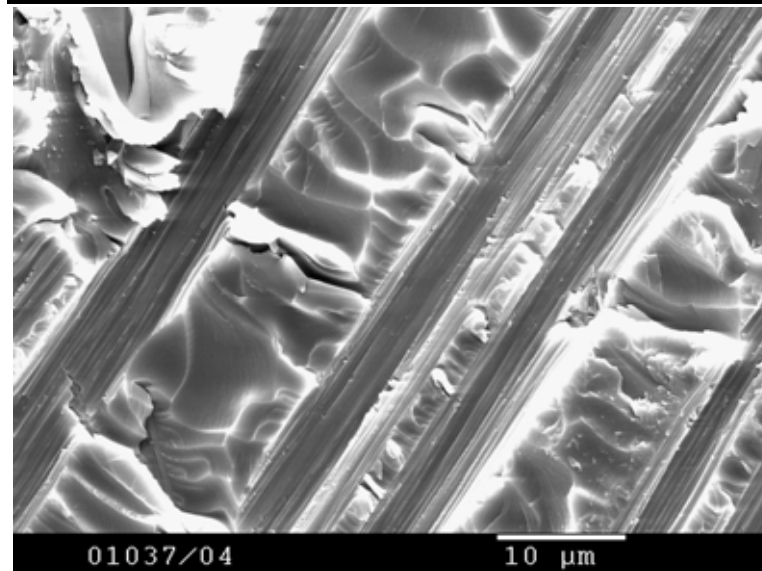
The delamination surface (sample **F2**) contains indications of Mode I (tension) and Mode II (shear), too (s. fig. 21-25). Furthermore, broken fiber bundles caused by delamination bridging or by local cracking thru the layer as well as indications of the resin hardener were found (s. fig. 22, 24).

01037/04 01033/04 01037/04  
 Fig. 21: Indications of Mode I loadings, SEM sample F2/pos. l/s. fig. 18

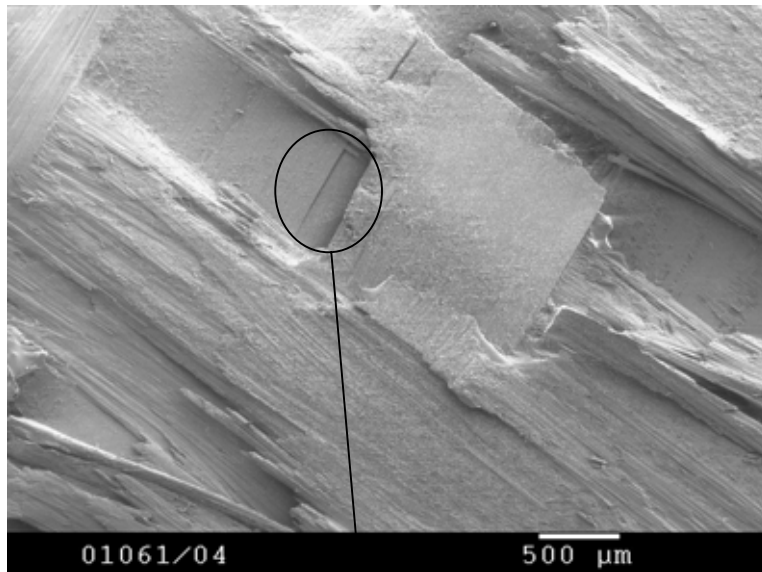
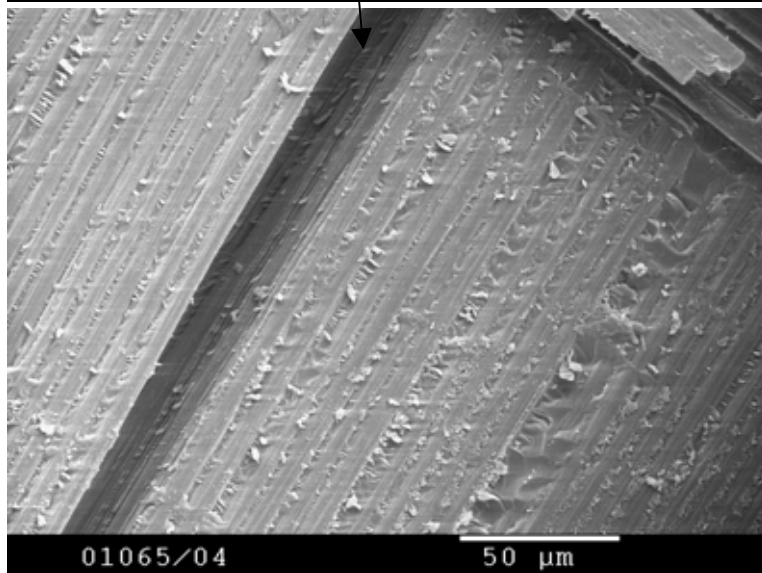
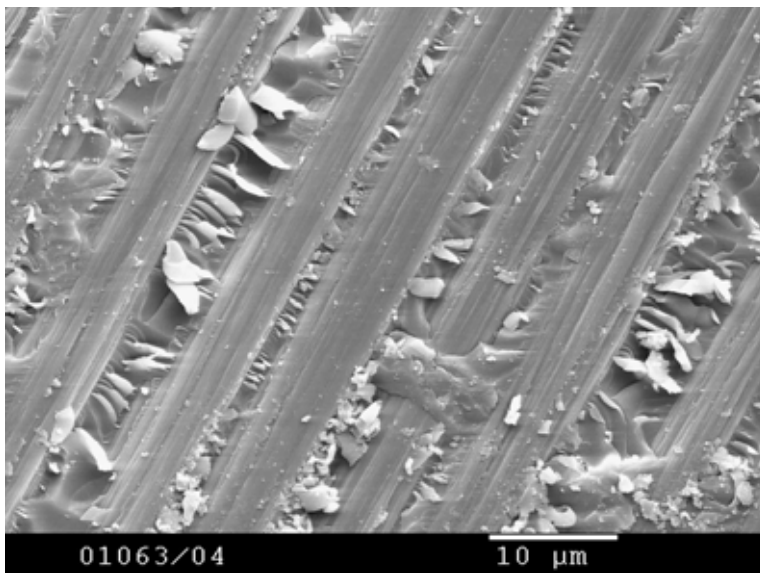
01061/04 01065/04 01063/04  
 Fig. 22: Indications of Mode II loadings, fiber fracture due to delamination bridging or cracking thru the layer, SEM sample F2/pos. II/s. fig. 18
