Report Nr.: TN – ESWOG – 1264/04

**AAL587 Investigation**  
**LH side Lug sub-component test #1, Lab investigation**

Date: 29.06.2004

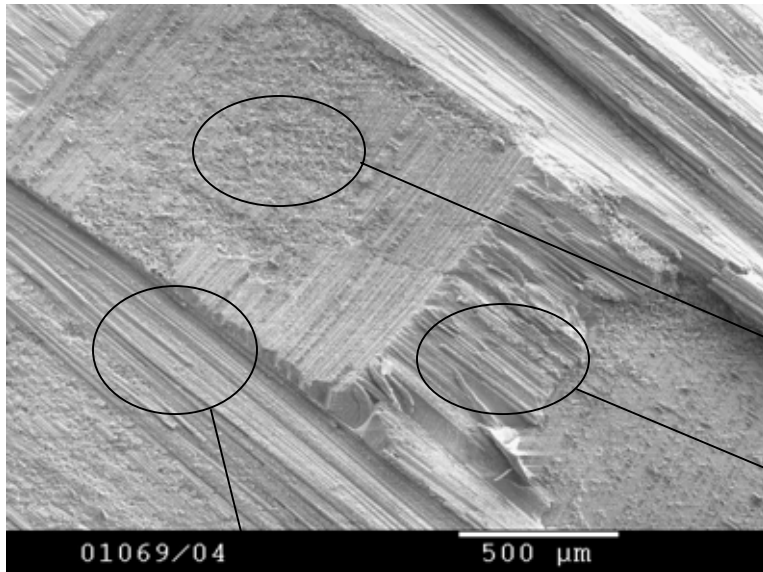
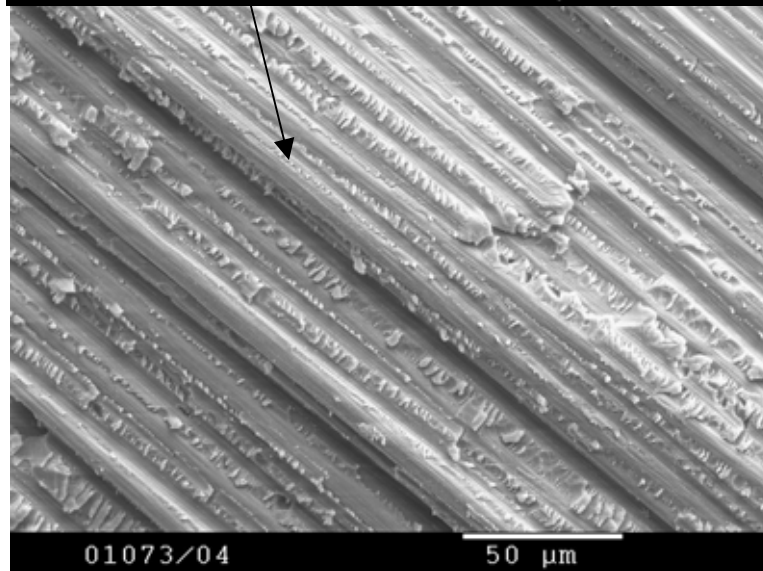
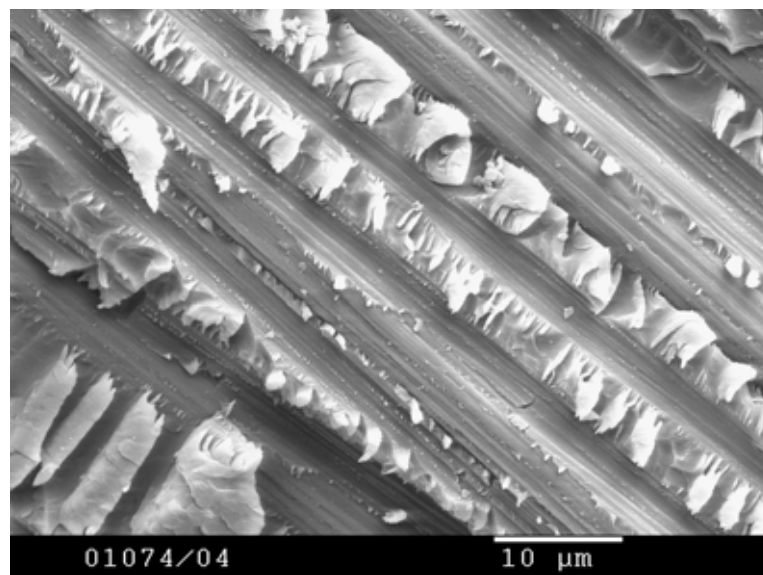
01069/04  
Fig. 23:

01073/04 01074/04  
Indications of Mode II loadings, loc. fiber fracture due to delamination bridging or cracking thru the layer, SEM sample F2/pos. III/s. fig. 18

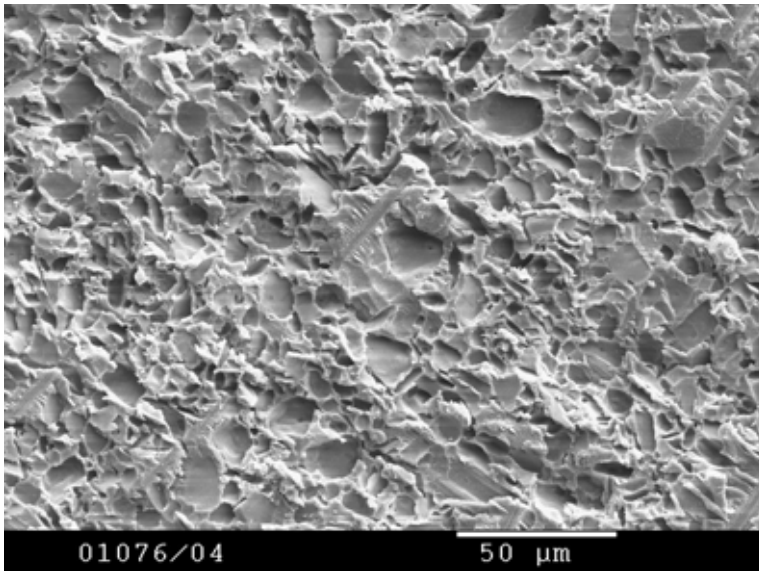
01076/04  
 Fig. 24: Indications of resin hardener, detail of fig. 24, sample F2

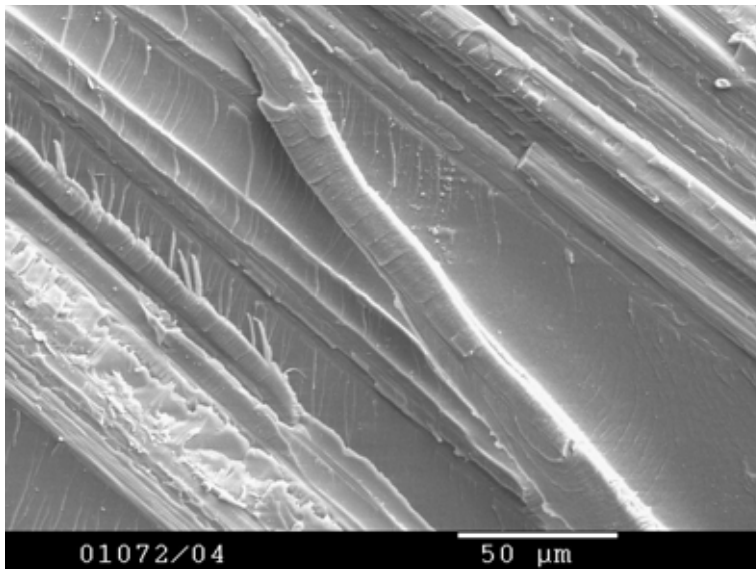
01072/04  
 Fig. 25: River marks, resin enriched area, detail of fig. 24, sample F2

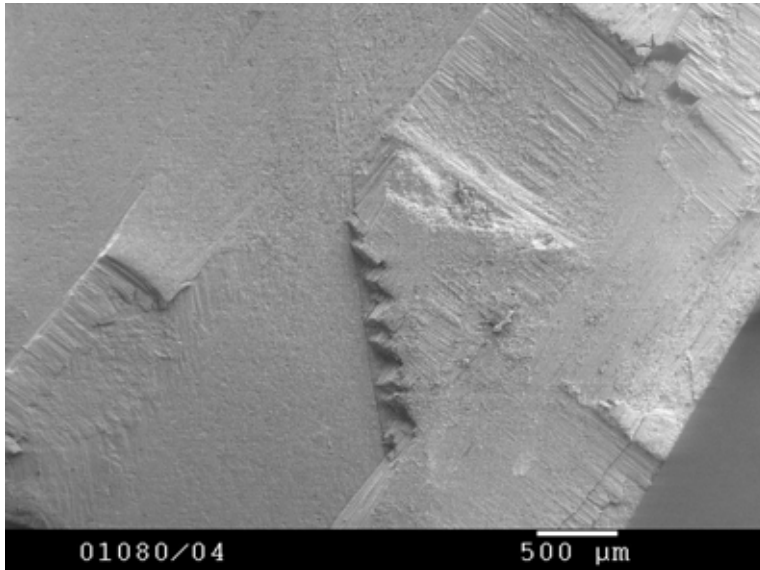
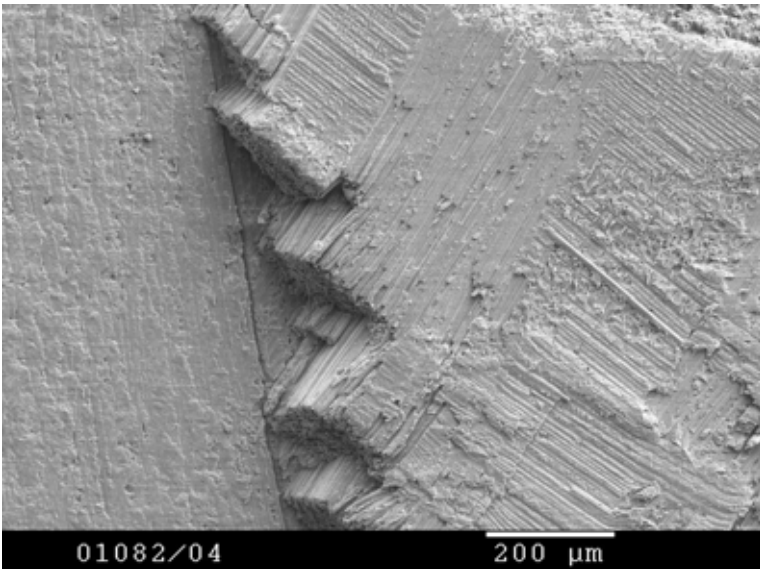
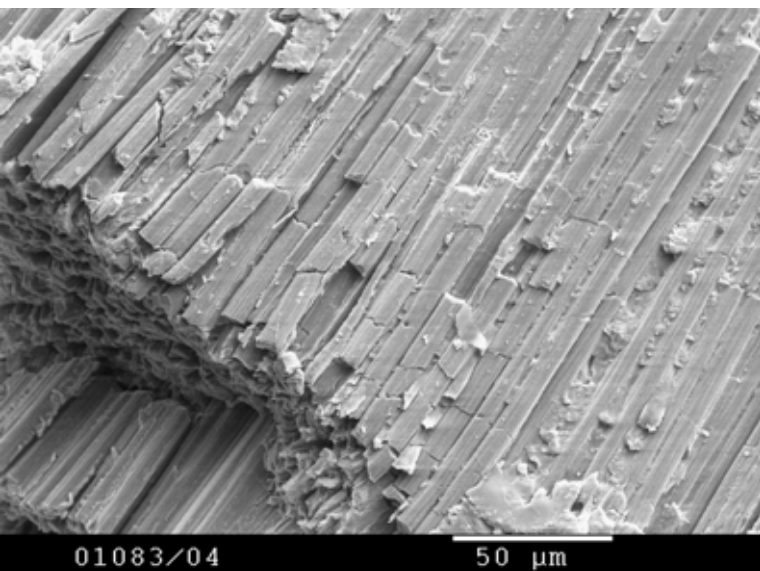
Locally, multiple fractured fibers were found, most probably due to release of elastic energy after fracture (s. fig. 26).

01080/04  
 Fig. 26: Fiber fracture due to de-  
 lamination bridging or  
 cracking thru the layer, loc.  
 multiple fiber fracture, SEM  
 sample F2/pos. IV/s. fig. 18
