Report Nr.: TN – ESWOG – 1265/04

AAL587 Investigation

LH side Lug sub-component test #2, Lab investigation

Date: 30.06.2004

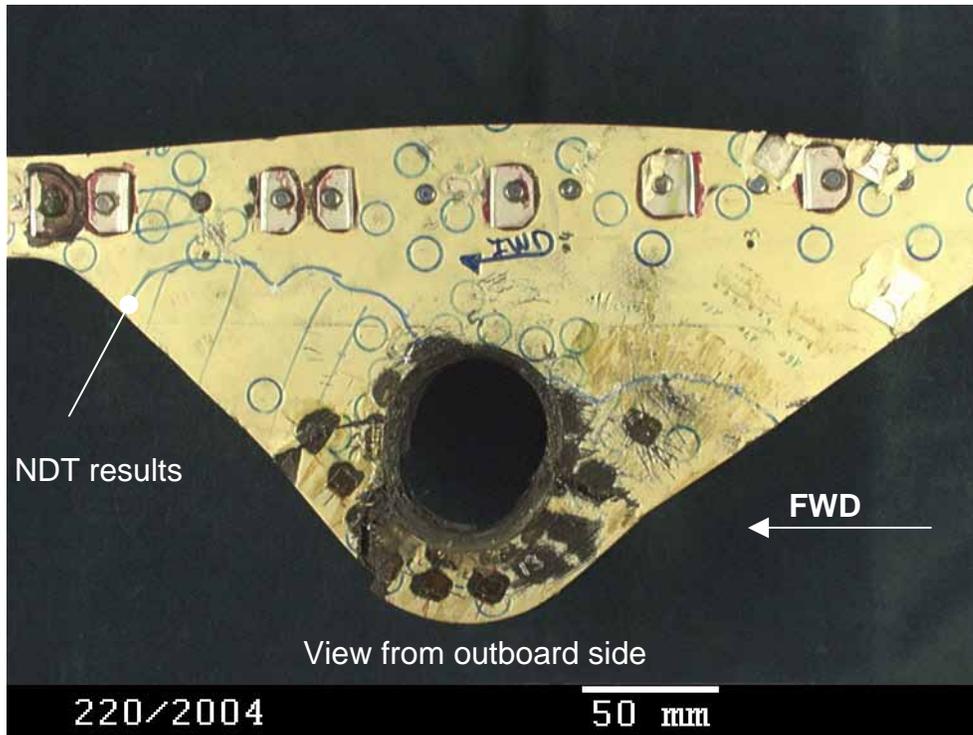
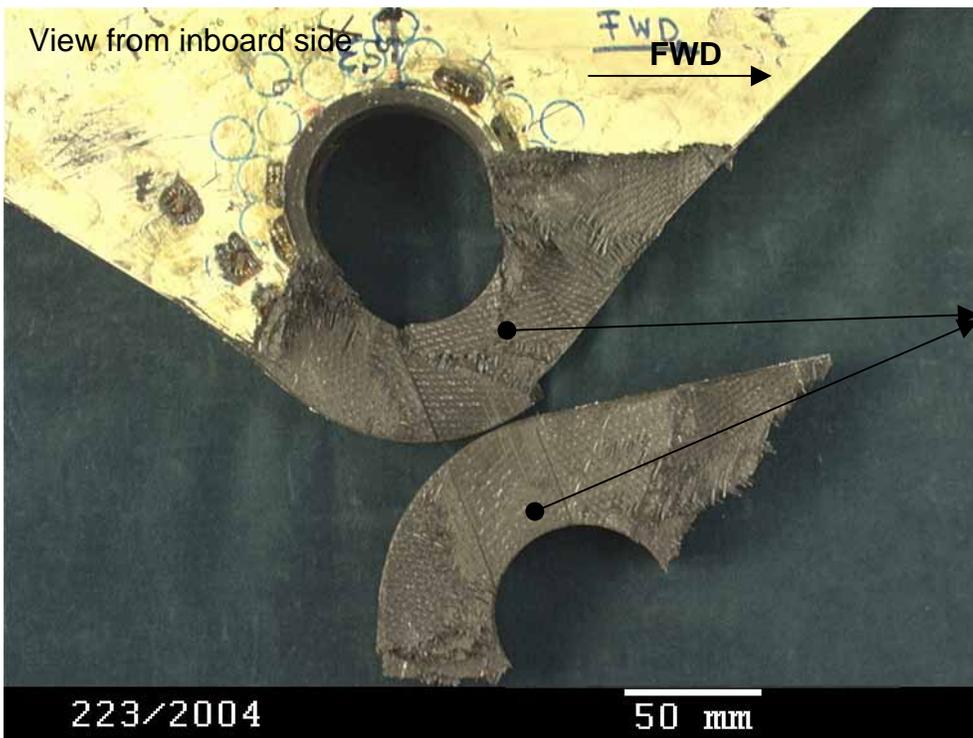
After the static test, the main attachment lug shows two translaminal fractures through the lug (by mostly tension loading) and a translaminal fractured area caused by buckling/compression as well as multiple delaminations (s. fig. 1-3,5). The delamination size, after test, found by NDT, is visible in figure 1.

Fig. 1: Lug Test #2, oval elongation of bore-hole, main ply separation, condition: after test and separation of Lug area above rib #1

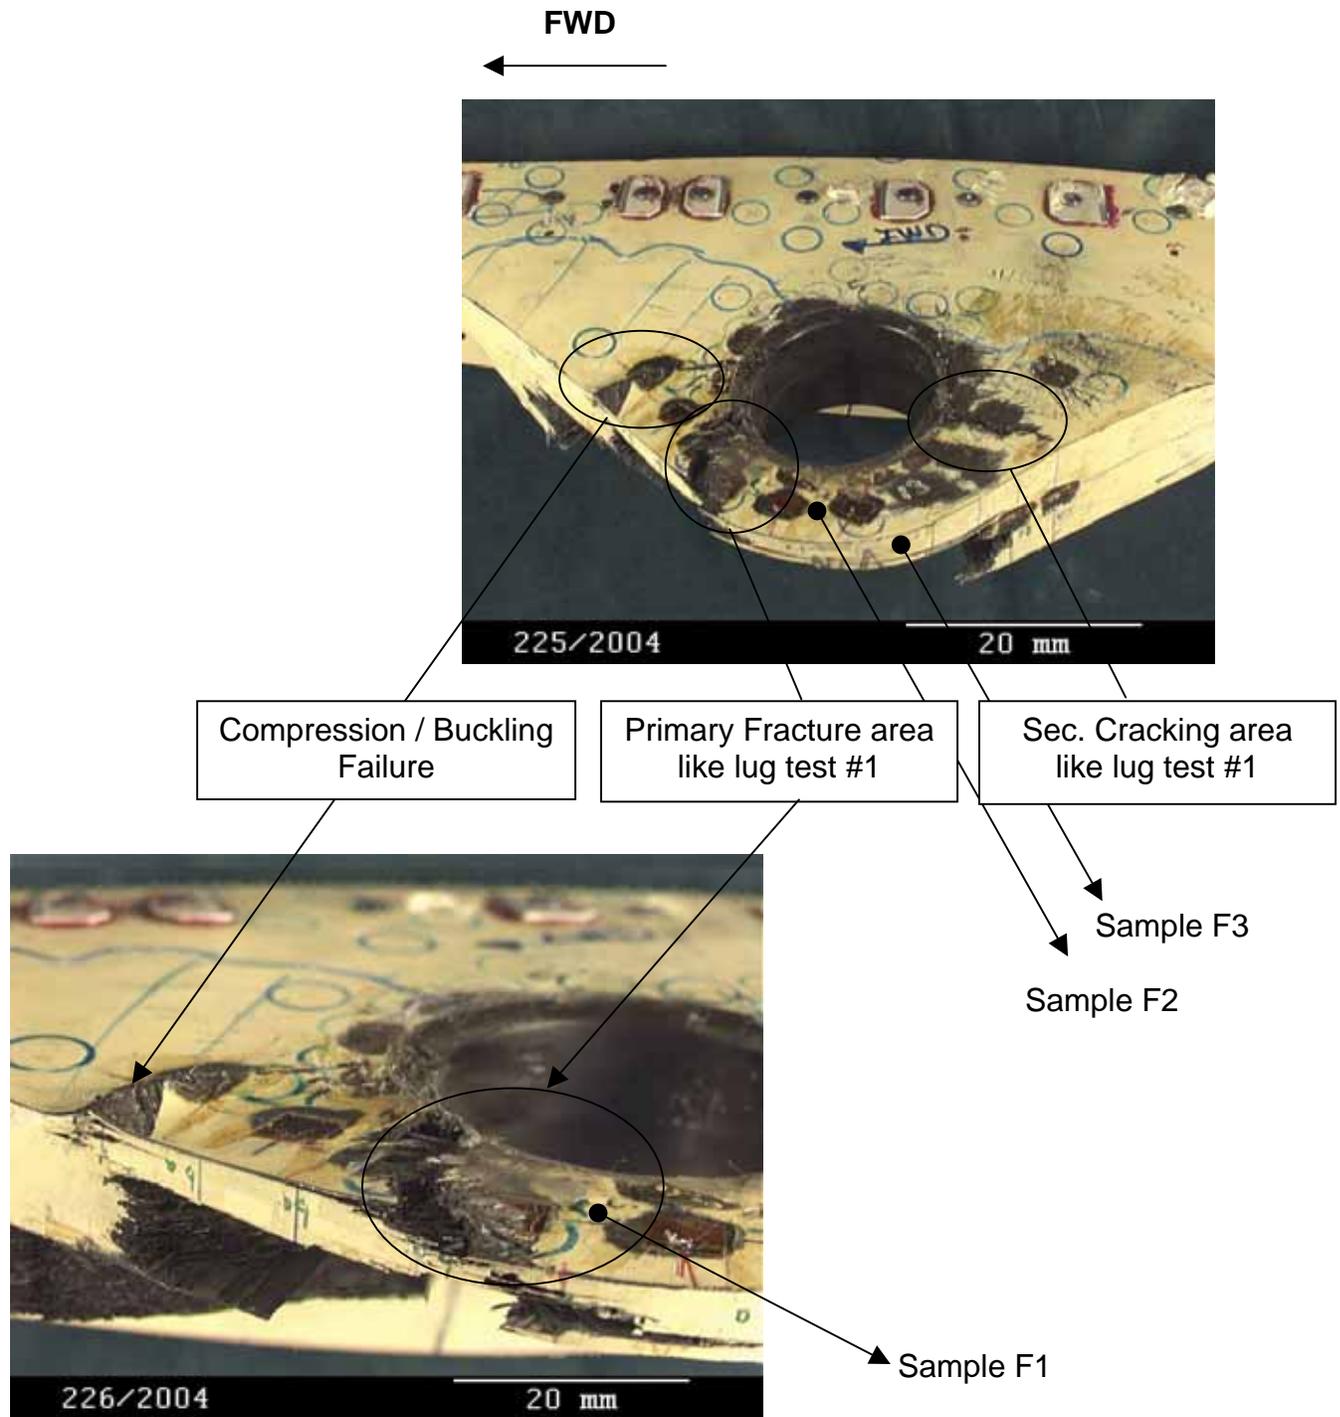
- A translaminal fracture thru the entire wall thickness of the lug was found. The location/orientation on outboard side is comparable to the primary translaminal fracture of lug test #1 (cf. TN-ESWOG-1264/04). This fracture is labeled as 134° failure, because the fracture path on the outboard side is orientated approx. 134° to rib #1 (s. fig. 1-3,5).

- A further translaminal fracture (labeled as 39° failure) thru the entire wall thickness was found (s. fig. 1-3,5). The location/orientation on outer side is comparable to the secondary translaminal cracking of lug test #1 (cf. TN-ESWOG-1264/04).

The fractographic sample **F1** was taken from the translaminar fracture of the 134° failure (s. fig. 2, 8), comparable to sample F1 of lug test #1. I.e., sample F1 obtained mainly the precured outer part of the lug.

225/2004 226/2004
 Fig. 2: Location of translamellar fractures, approx. location of sample F1, F2 and F3, view from outboard side

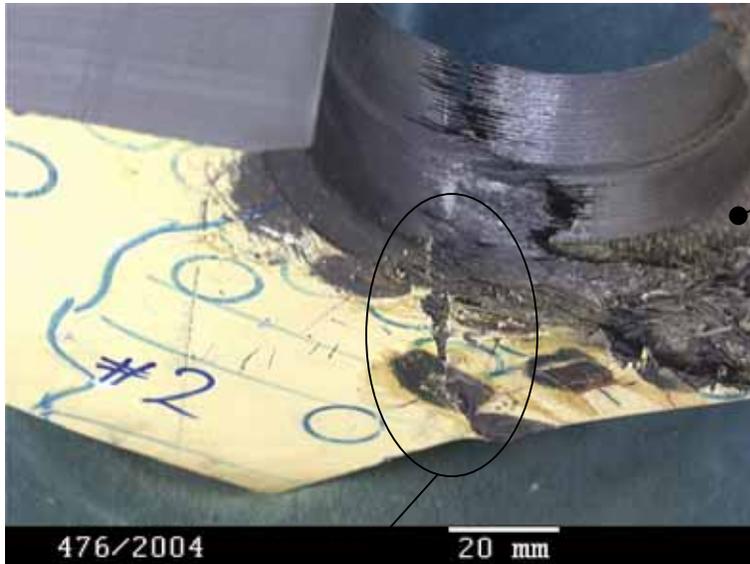
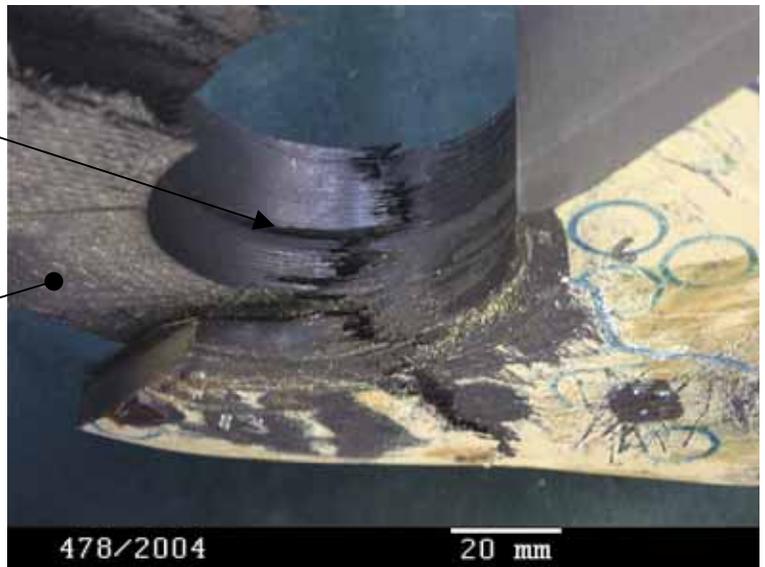
Fig 3: FWD and AFT translaminal fracture path

- The main ply separation area is located in the area of the precured/cured transition, i.e. the outer part, the precured/cured transition themselves as well as within the skin layers (cf. fig. 1-3,5). Furthermore, a delamination located within the gap between outer and inner bush was found (s. fig. 3), besides several other smaller delaminations.

FWD-sided translaminal fracture path (134° failure)

Main ply separation

Compression / Buckling failure

AFT-sided translaminal fracture path (39° failure)

Delamination located in the gap btw. outer and inner bush

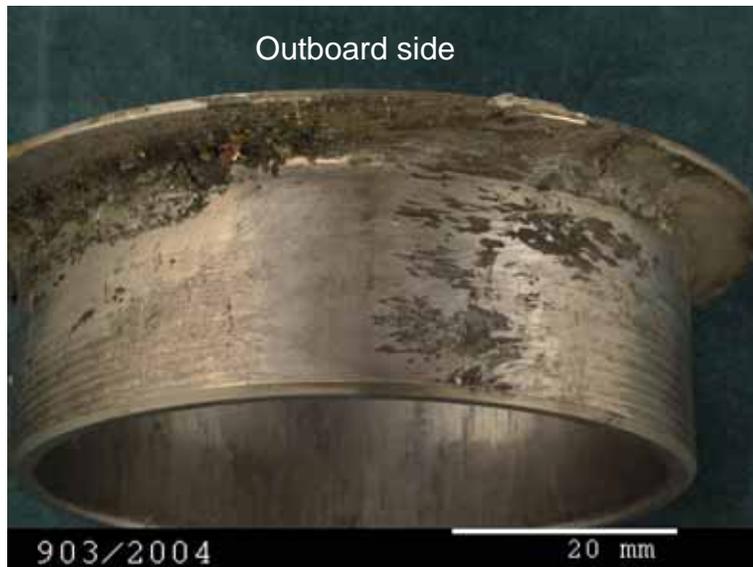
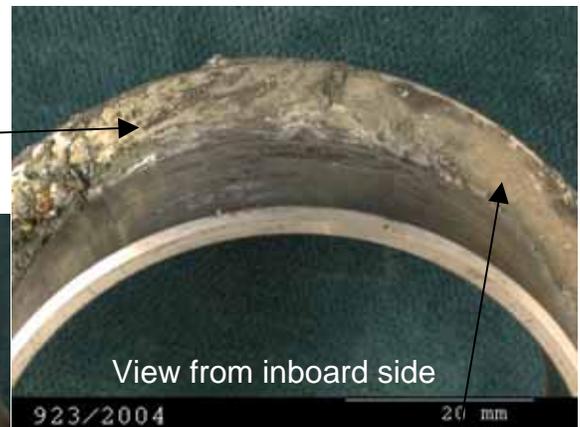
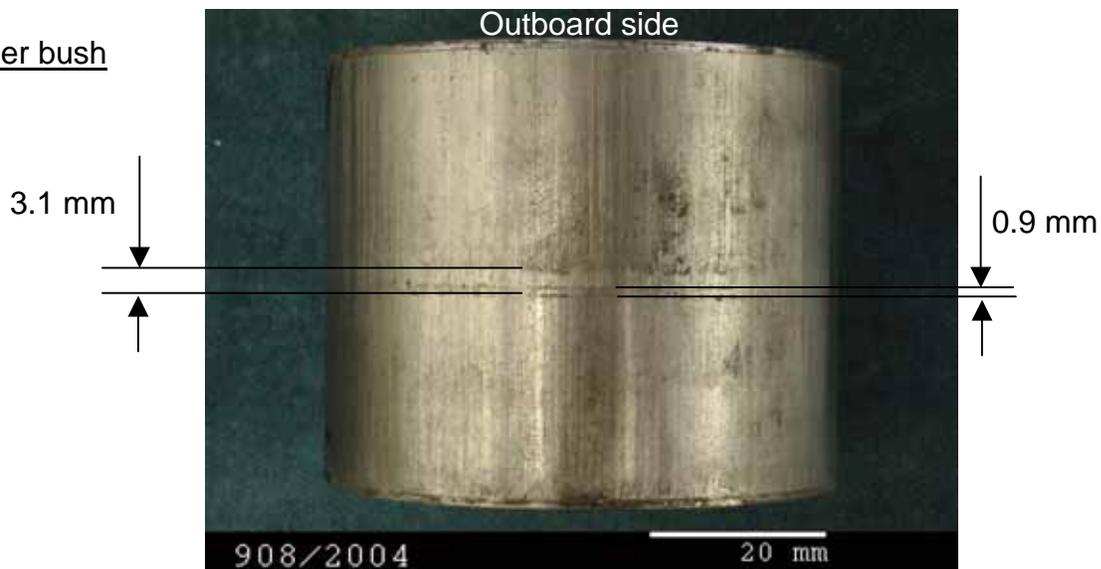
Fig 4:

The outboard-sided outer bush shows a lot of debris besides a green colored coating on the lug sided chamfer surface (s. fig. 4). The inner bush shows circumferential traces indicating a possible movement of outer bush of approx. 2.2mm (s. fig. 4).

- The green layer is detected as an epoxy, most probably used for bonding of the bush.
- Silicone-rubber particles, probably caused by protection of strain gages with Silicone during the static test, were detected.
- The isolated residues, after extraction with Dichloromethane, show minor traces / indications to grease.

Inner and outer bush after disassembling, residues as well as a green colored layer on the chamfer of the outer bush, circumferential markings on the inner bush indicating a possible movement of approx. 2.2mm

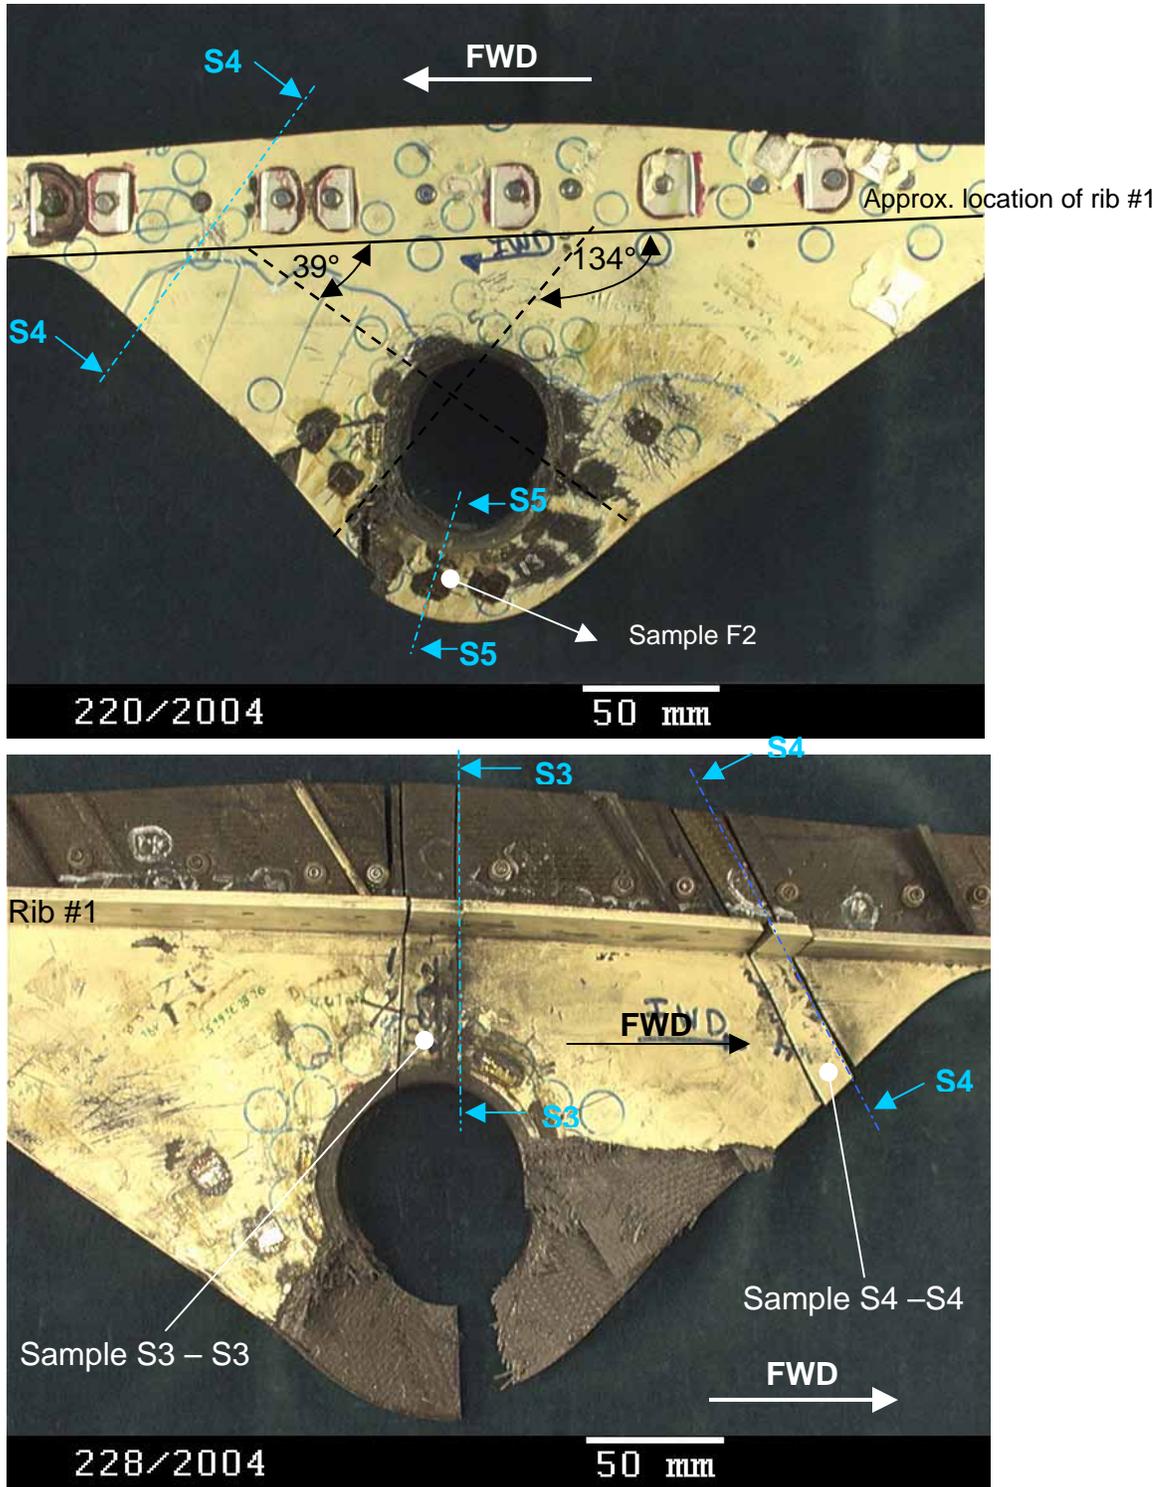
Three macro sections (S3-S3, S4-S4 and S5-S5) and one microsection (sample S3/ part of macro section S3-S3) were used for the metallographic investigation (s. fig. 4 and 5). It was decided between NTSB, BEA and Airbus, that the sections S1 and S2, to obtain the detailed location of the main ply separation (comparable to lug test #1), were not investigated.

Fig. 5: Location of sections, determination of angle between rib #1 and visible fracture path on outer side

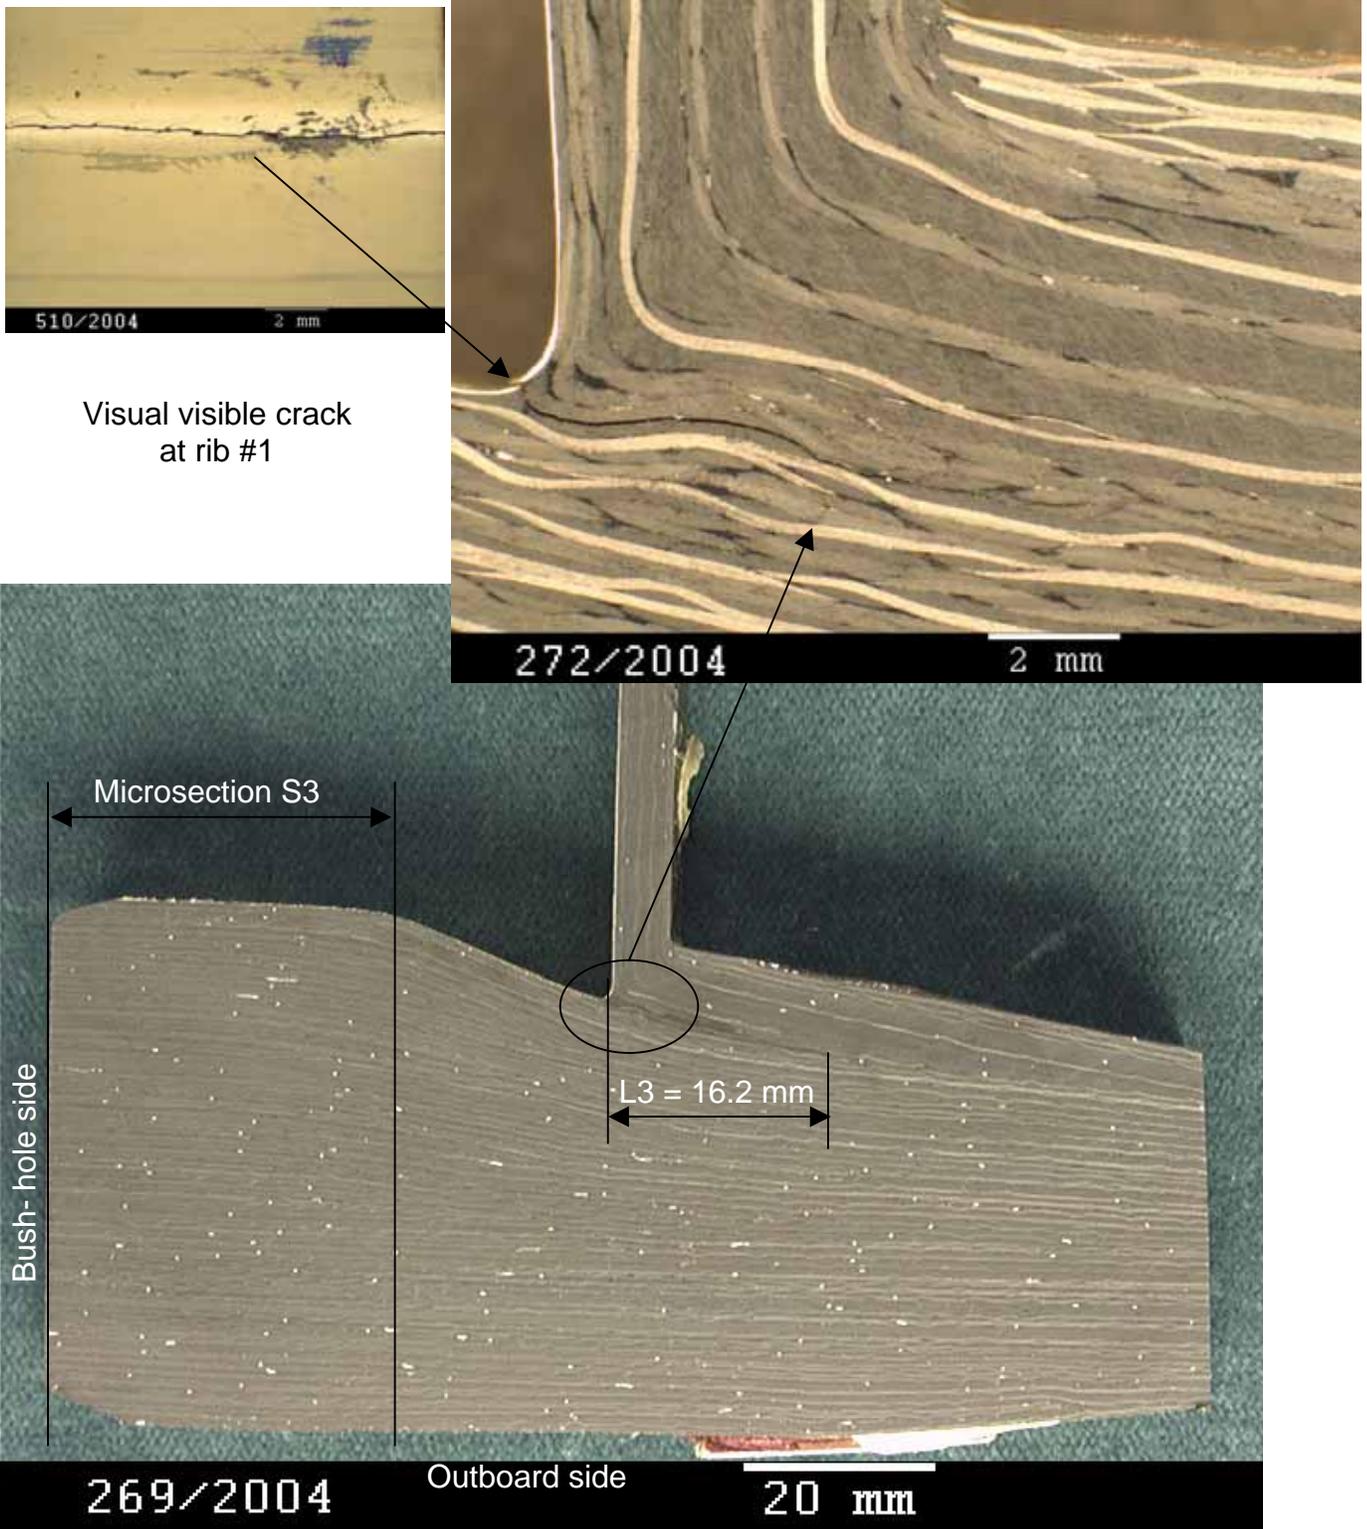
- A crack in the radius area of rib #1 was found (s. fig. 6).

- A crack, located in the radius, followed by a delamination was found on section S3-S3 and S4-S4. The detailed delamination length is given in fig. 6.
- A further delamination from the lower edge, growing up in direction of rib #1, was found on section S4-S4.
- Concession layers, according to the concession were found on inboard side of section S4-S4.
- The pre test delamination, detected on section S5-S5, was 14.3 mm long before the test and 33.5 mm after the test. This delamination is located within the precured outboard part of the lug.

269/2004 272/04 (510/2004) Grinded
 Fig. 6: Delamination starting from crack at rib #1, location of microsection S3, Section S3-S3

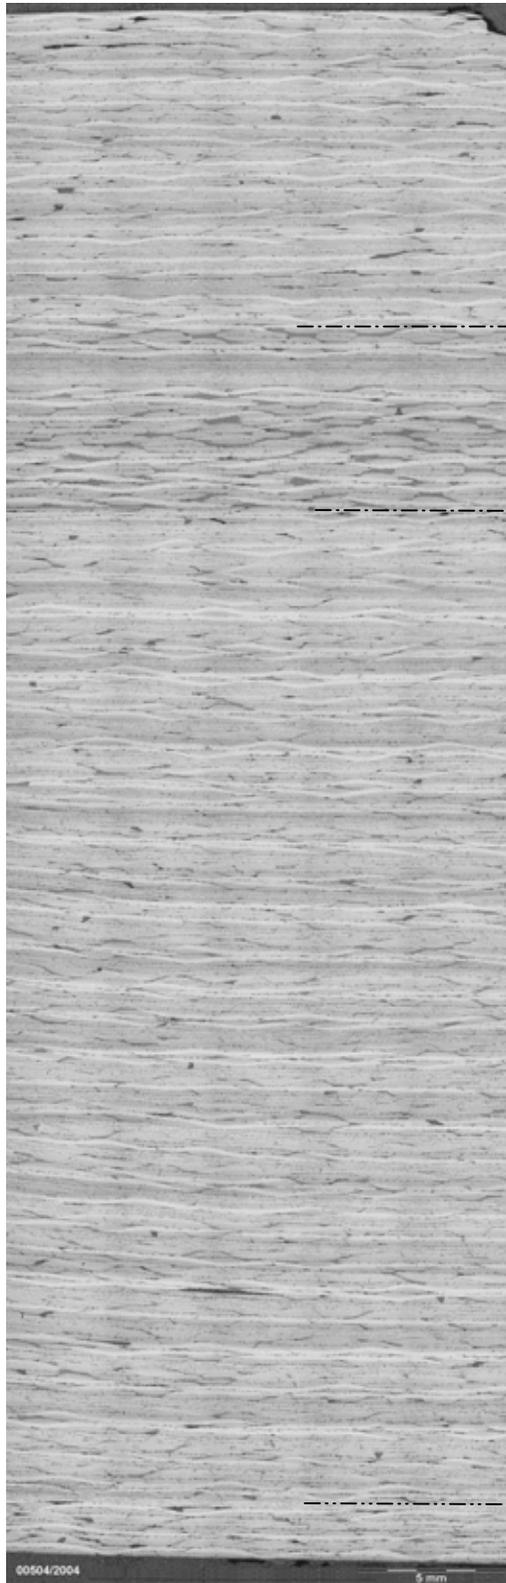
All layers as well as the location of the precured/cured transitions are in accordance with the drawings and concession of the inner part.

Fig. 7: Loc. of precured/cured transitions, loc. of determination of lay up, microsection S3

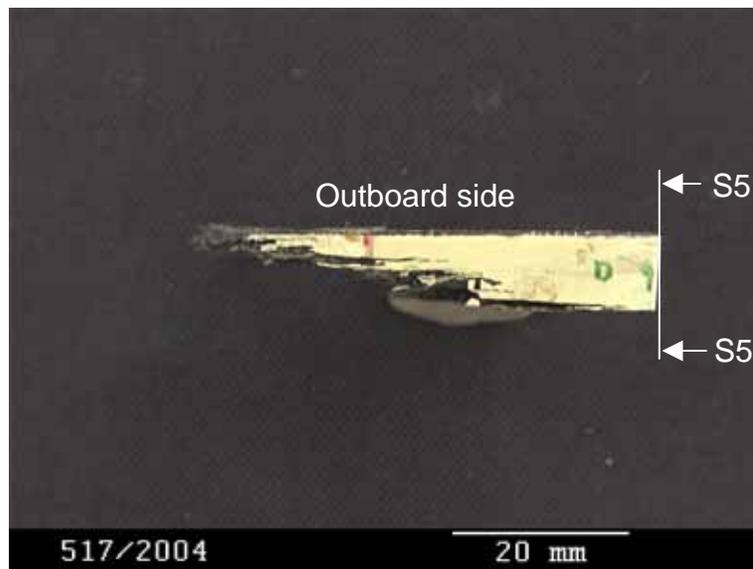
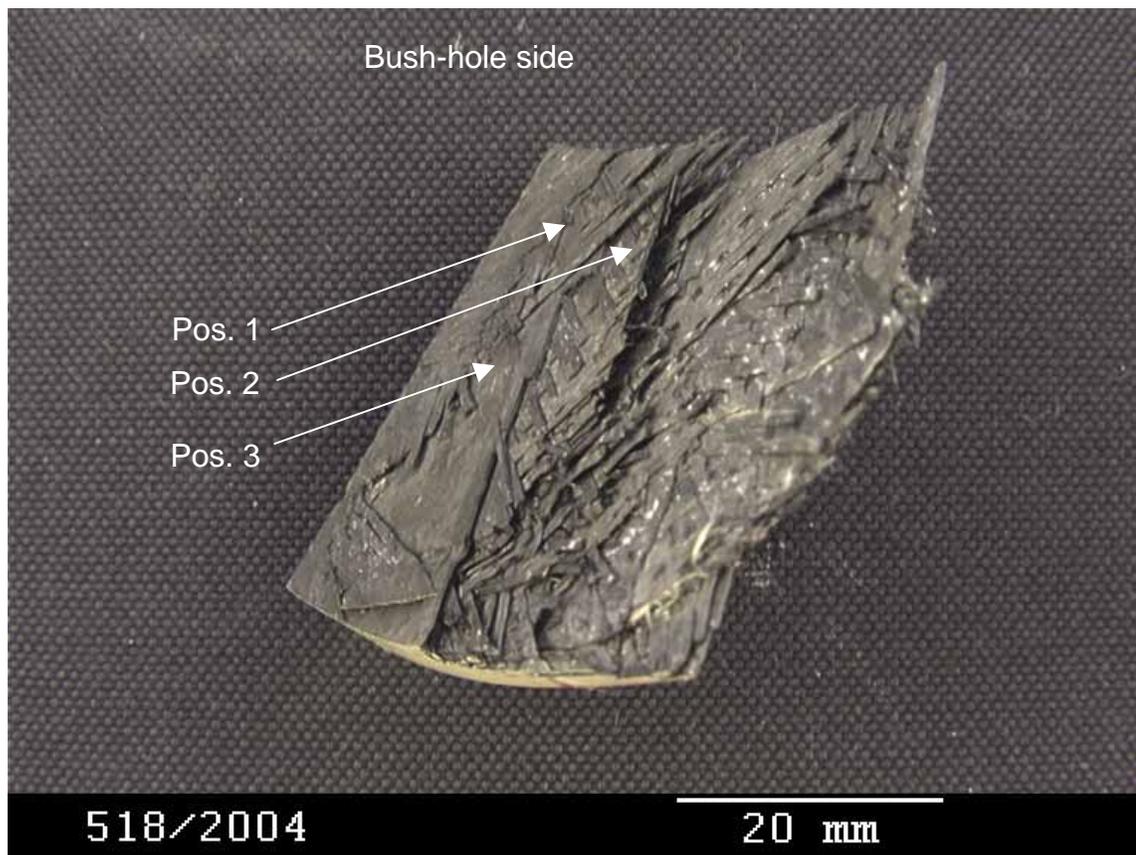
517/2004
Fig. 8:

518/2004 After lab separation
Fractographic **sample F1**, loc. is comparable to sample F1 of
Lug Test #1, location of sample F1 s. fig. 2

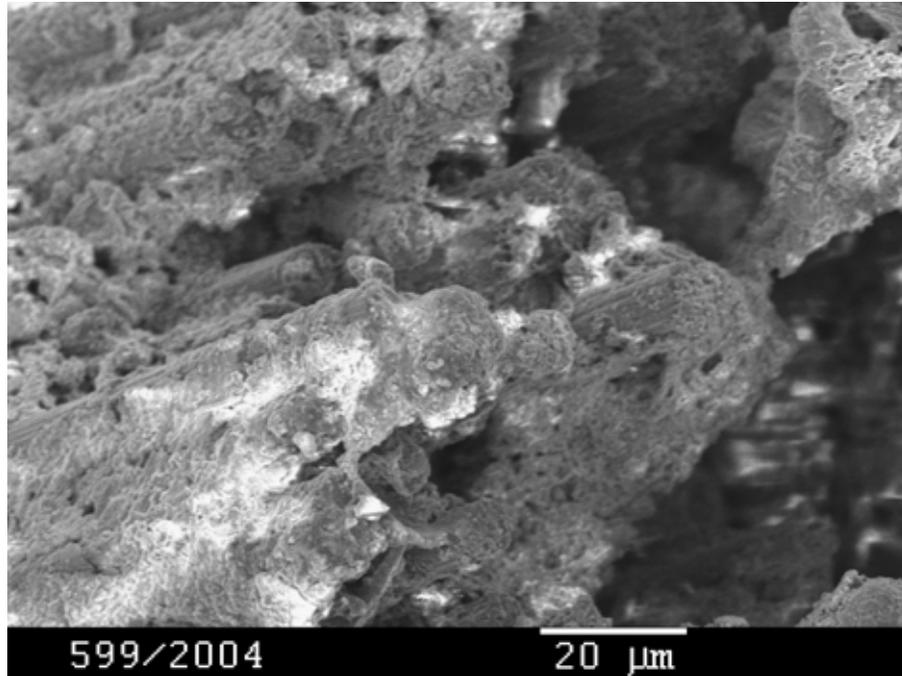
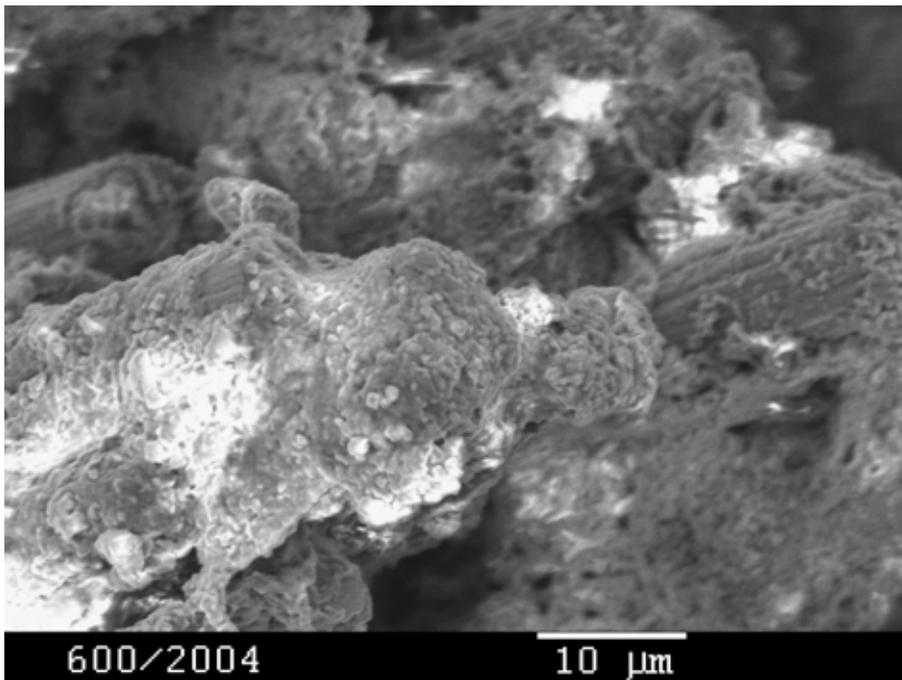
Radial patterns on fractured fibers were only locally visible on the translaminar fracture of sample F1; most of the fibers were covered with debris (s. fig. 9,10) The main ply separation surface of sample F1 shows locally indications to Mode I and II loadings (s. fig. 11).

599/2004 600/2004
 Fig. 9: Fiber fracture mostly covered with debris, detail of fig. 8

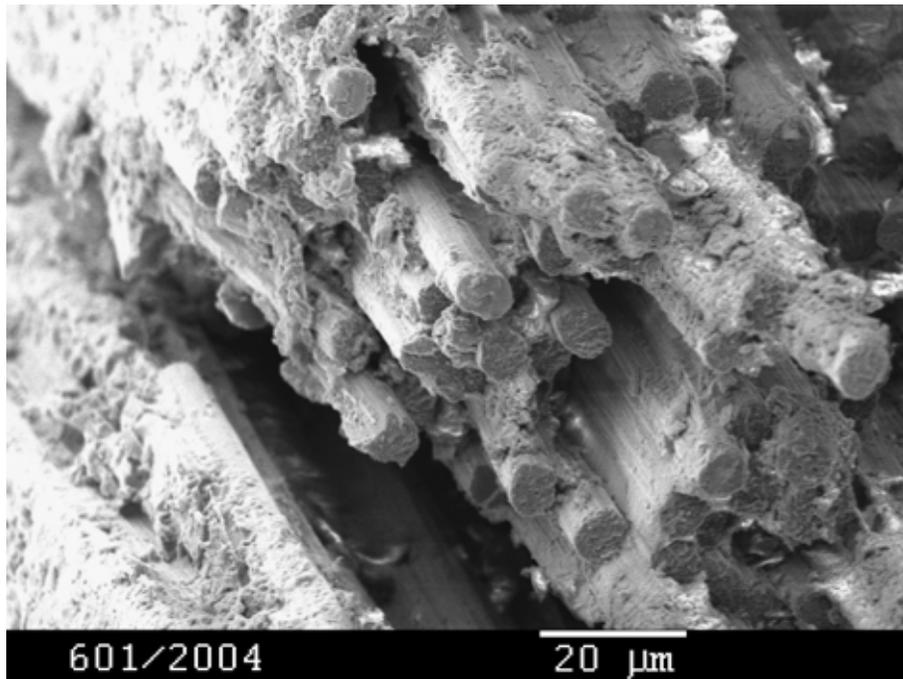
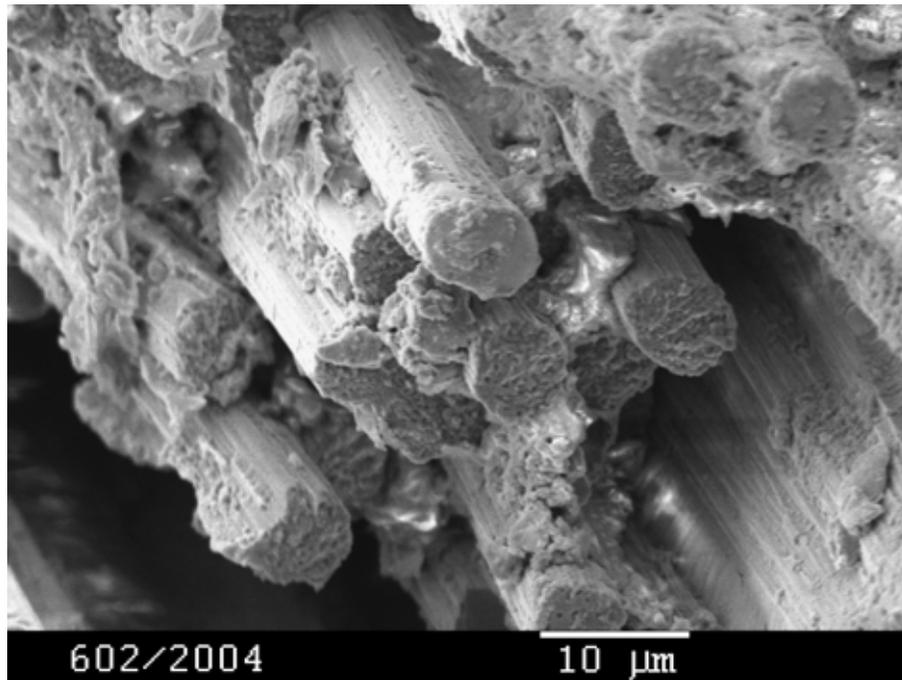
601/2004 602/2004
 Fig. 10: Locally radial pattern, due to tensile fracture, detail of fig. 8

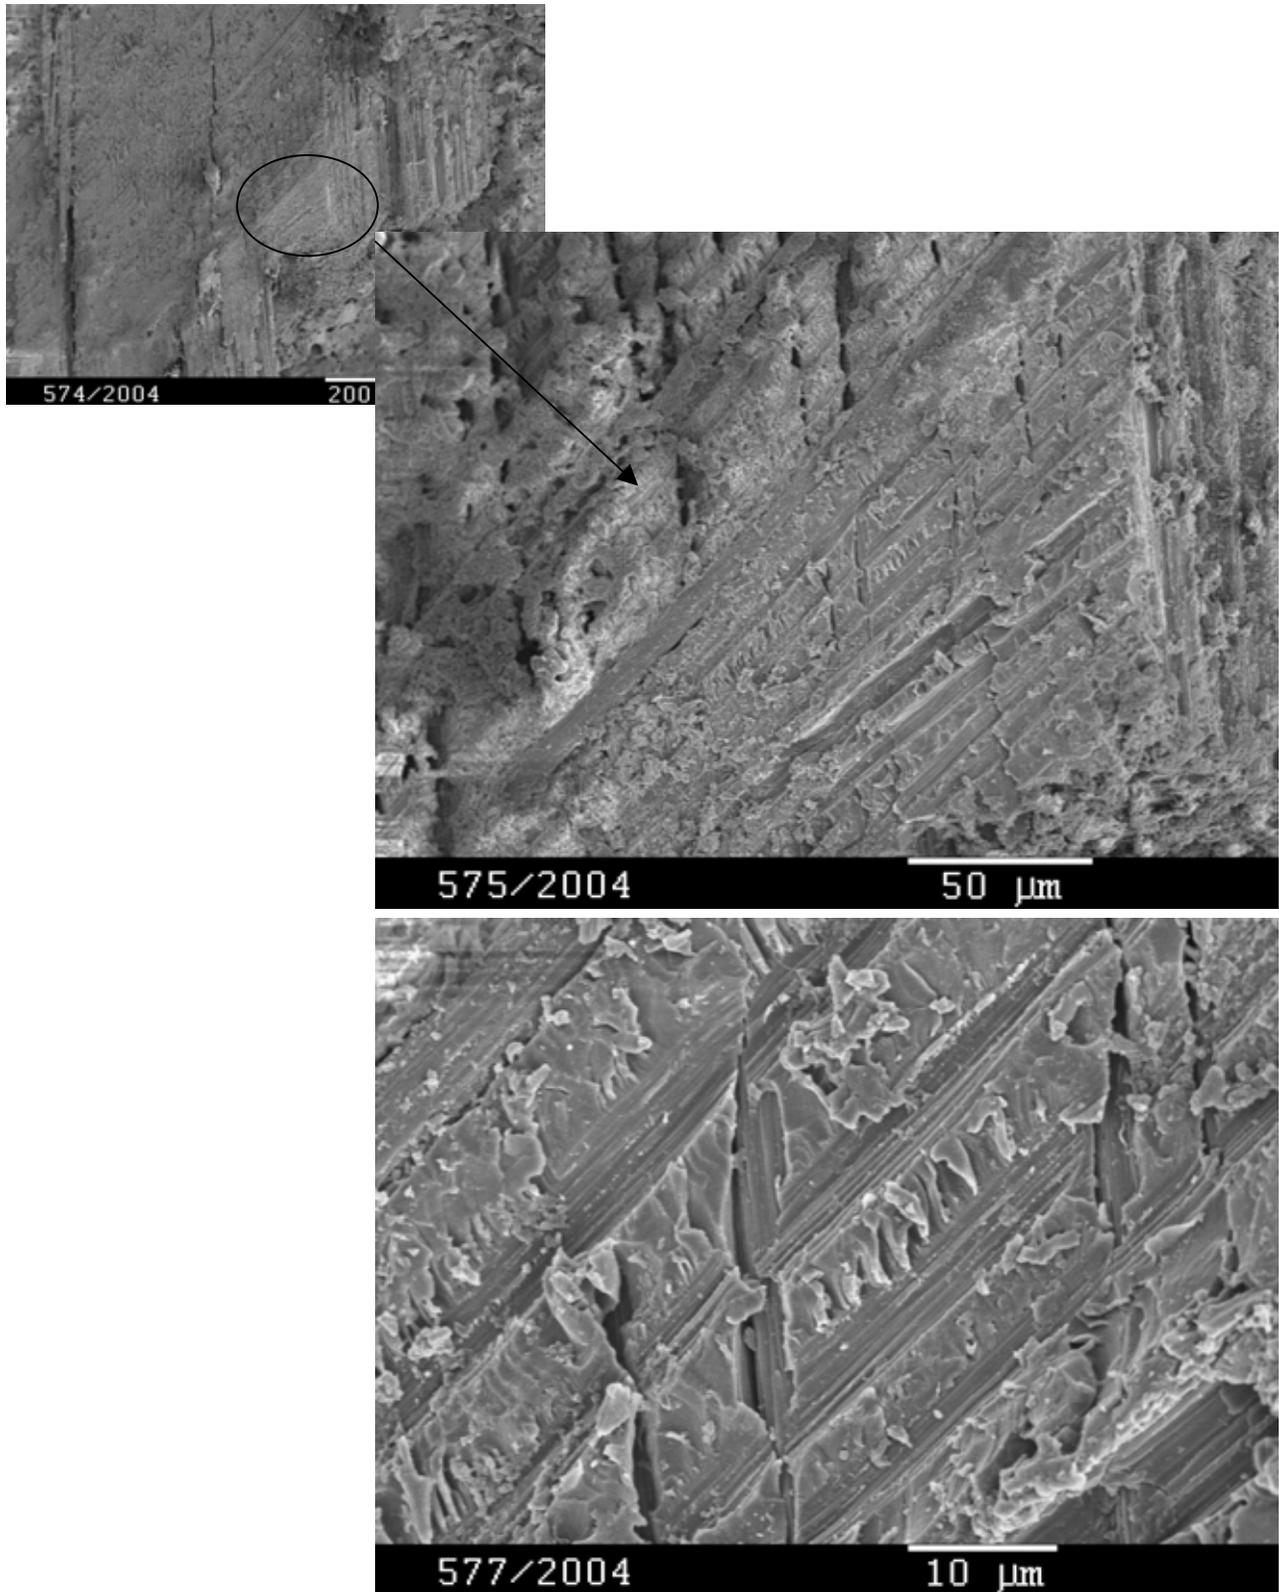
Fig. 11: Main ply separation mostly covered with debris, locally hackles and river pattern, detail of fig. 8

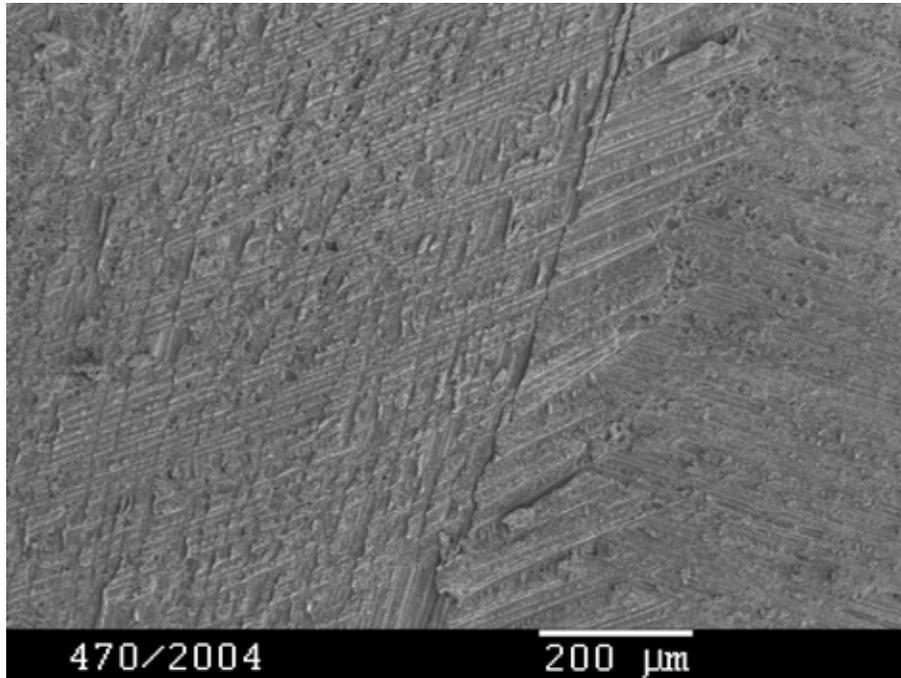
The pre test delamination surface (sample **F2**) and the larger post ruptured delamination area contain indications of Mode I (tension) and Mode II (shear), too (s. fig. 12 -15), whereby the pre test delamination area shows a lot of debris (s. fig. 13). The lab fracture shows mostly indications of Mode I (s. fig. 16-17).

Fig. 12: General view, Pos. 1, sample F2/cf. fig. 2

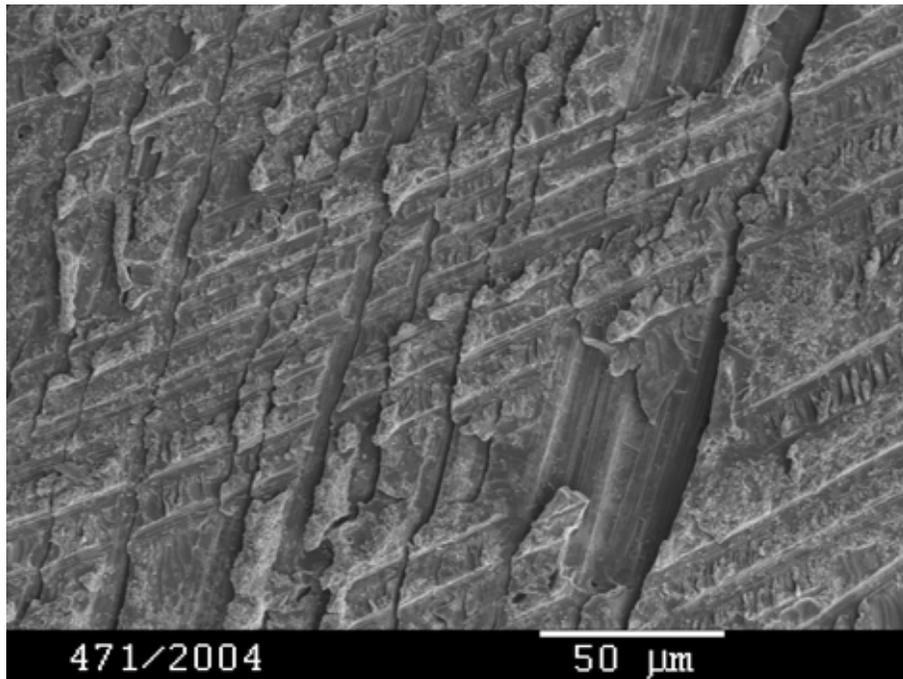
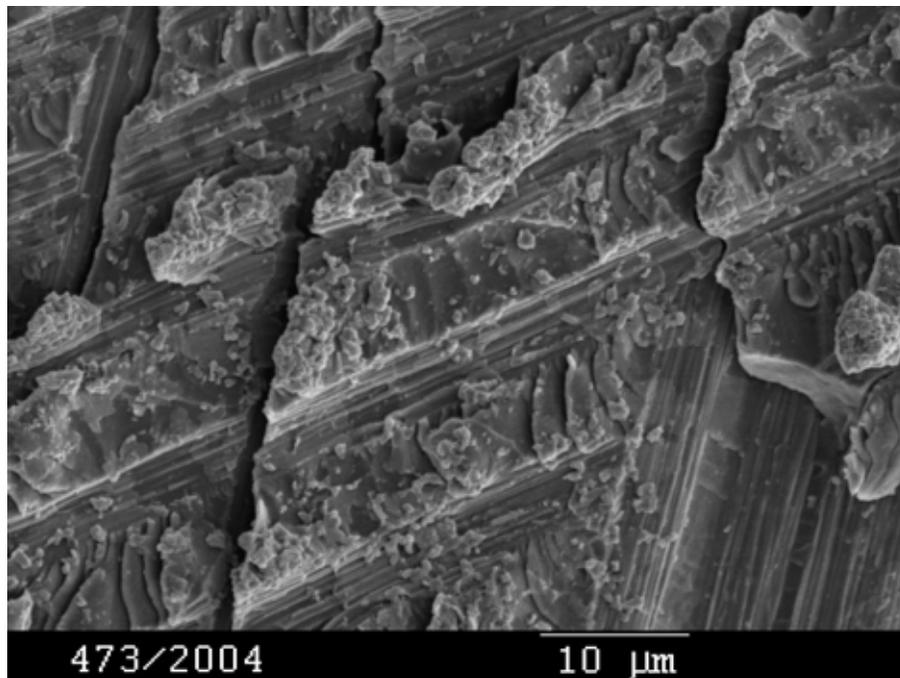
471/2004 473/2004
 Fig. 13: Debris, features of Mode I and II loading, det. of fig. 12

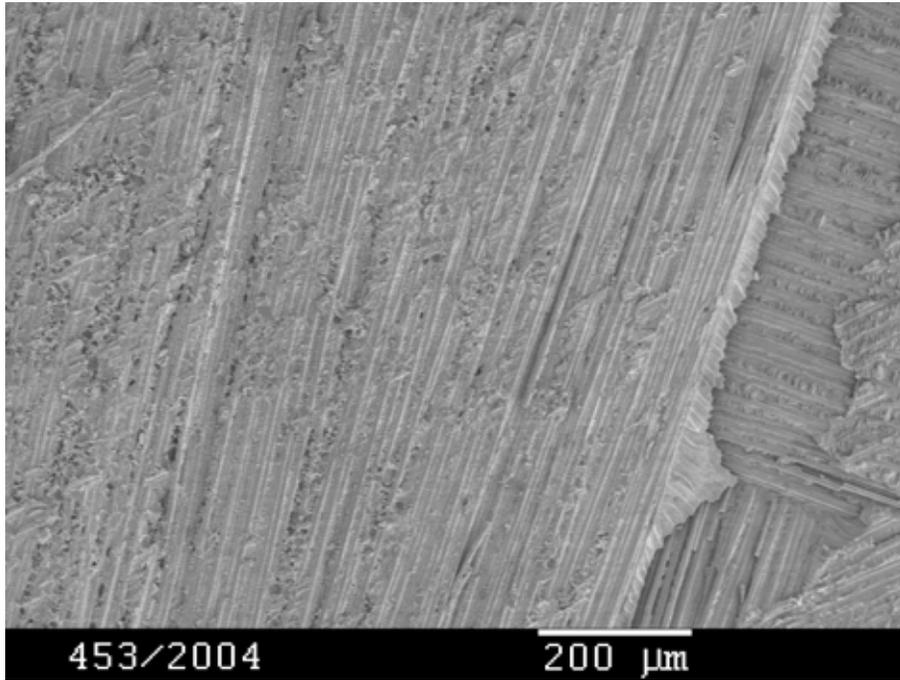
Fig. 14: General view, Pos. 2, sample F2/cf. fig. 2

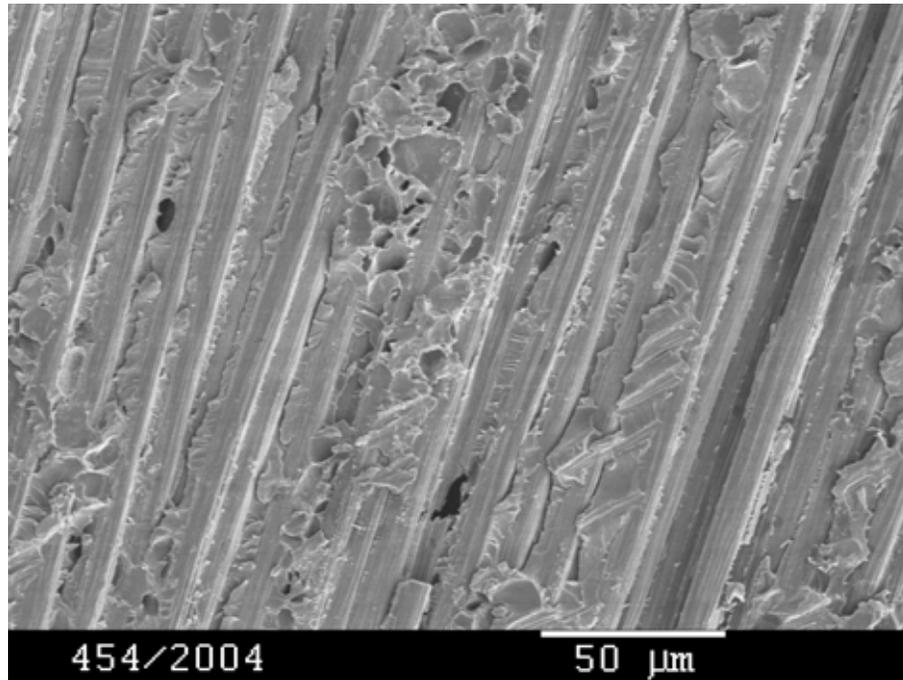
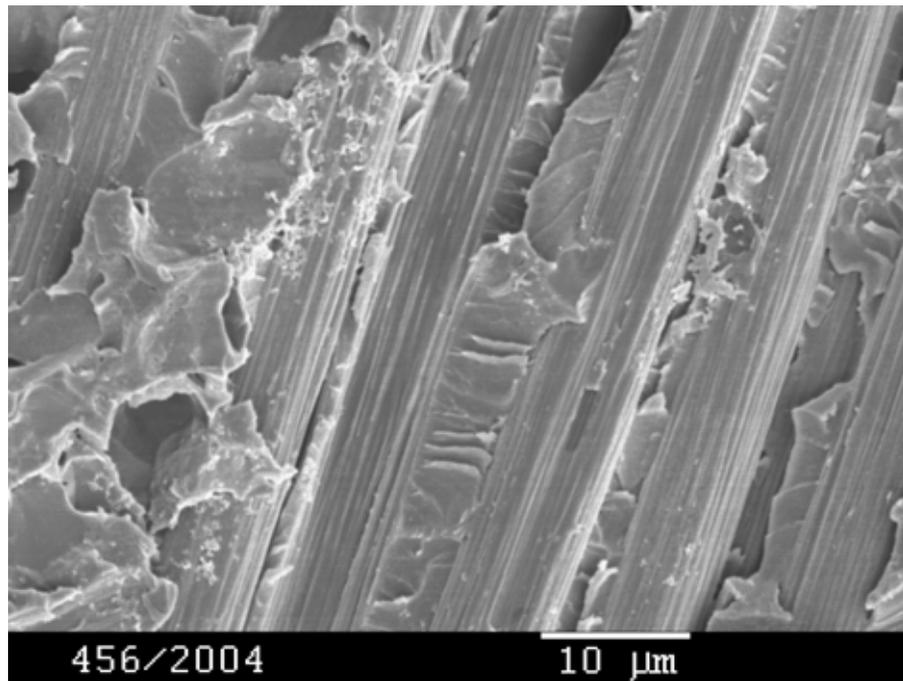
Fig. 15: Features of Mode I and II loading, det. of fig. 14

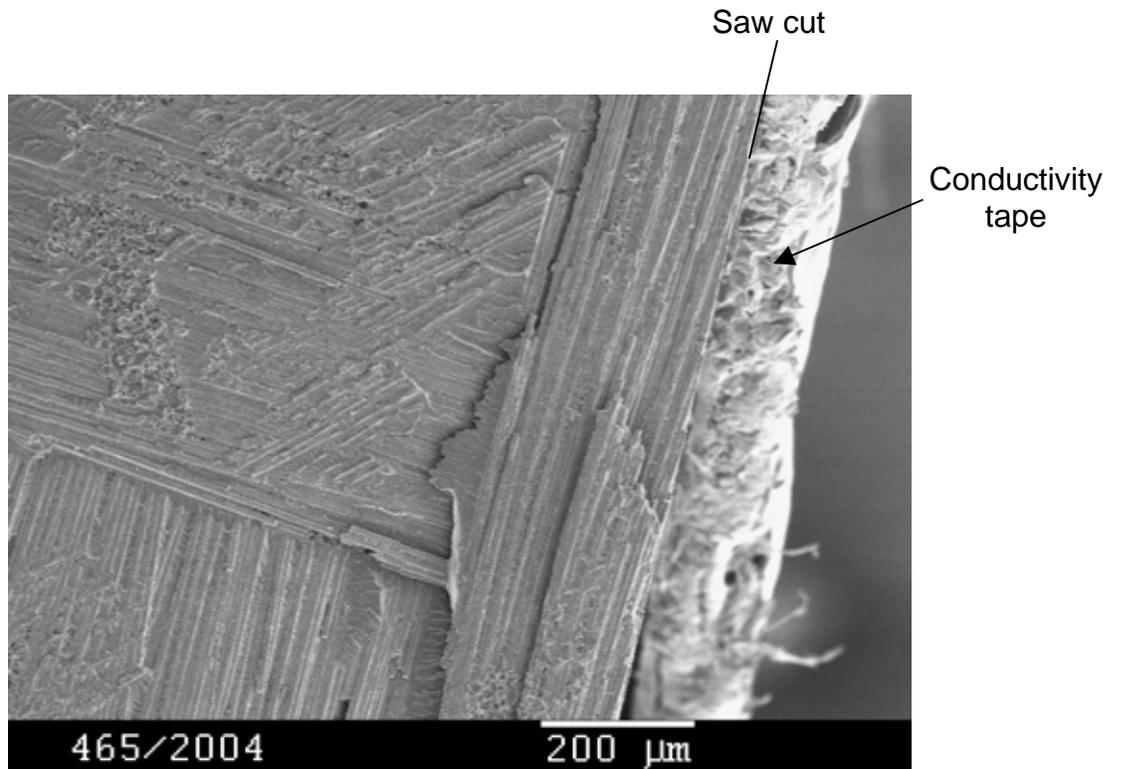
Fig. 16: Lab forced fracture due to lab. separation, Pos. 3, sample F2/cf. fig. 2
