Report Nr.: TN – ESWOG – 1265/04

AAL587 Investigation

LH side Lug sub-component test #2, Lab investigation

Date: 30.06.2004

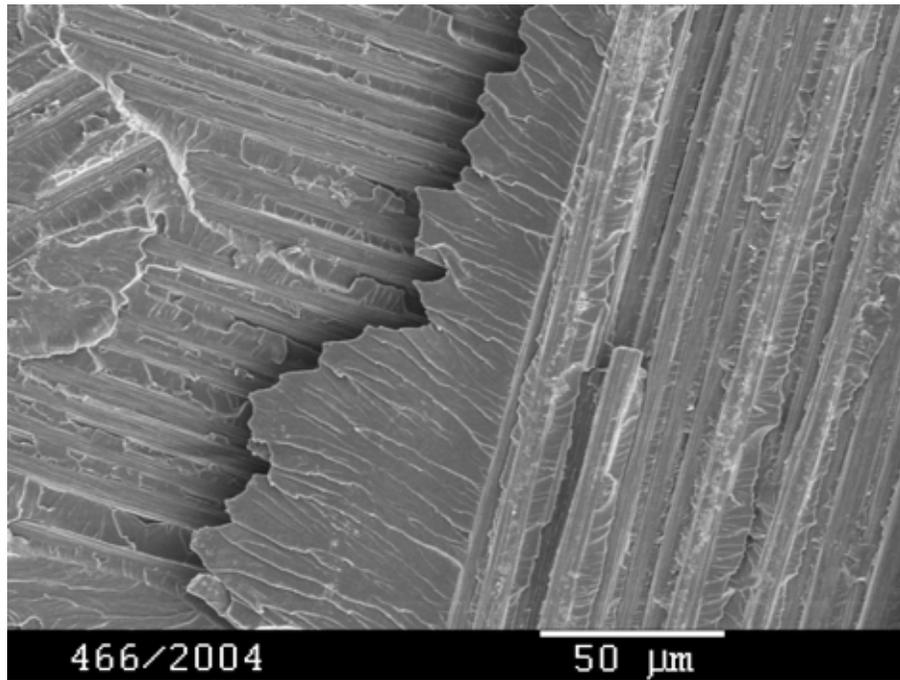
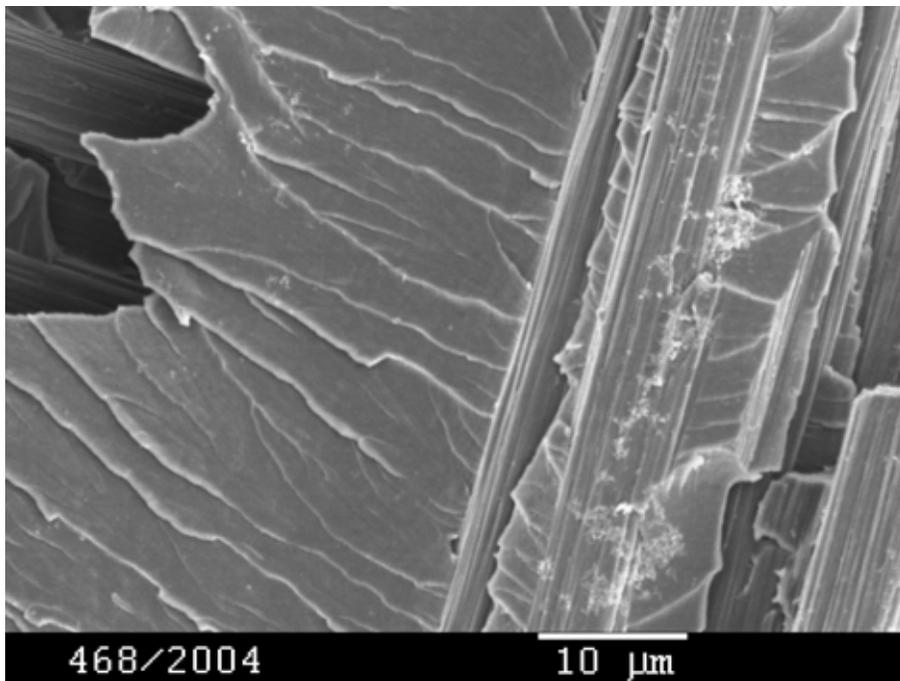
Fig. 17: Mainly features of Mode I loading, det. of fig. 16
