Technical Note

Report Nr.: TN – ESWOG – 1266/04

AAL587 Investigation

RH side Lug sub-component test #3, Lab investigation

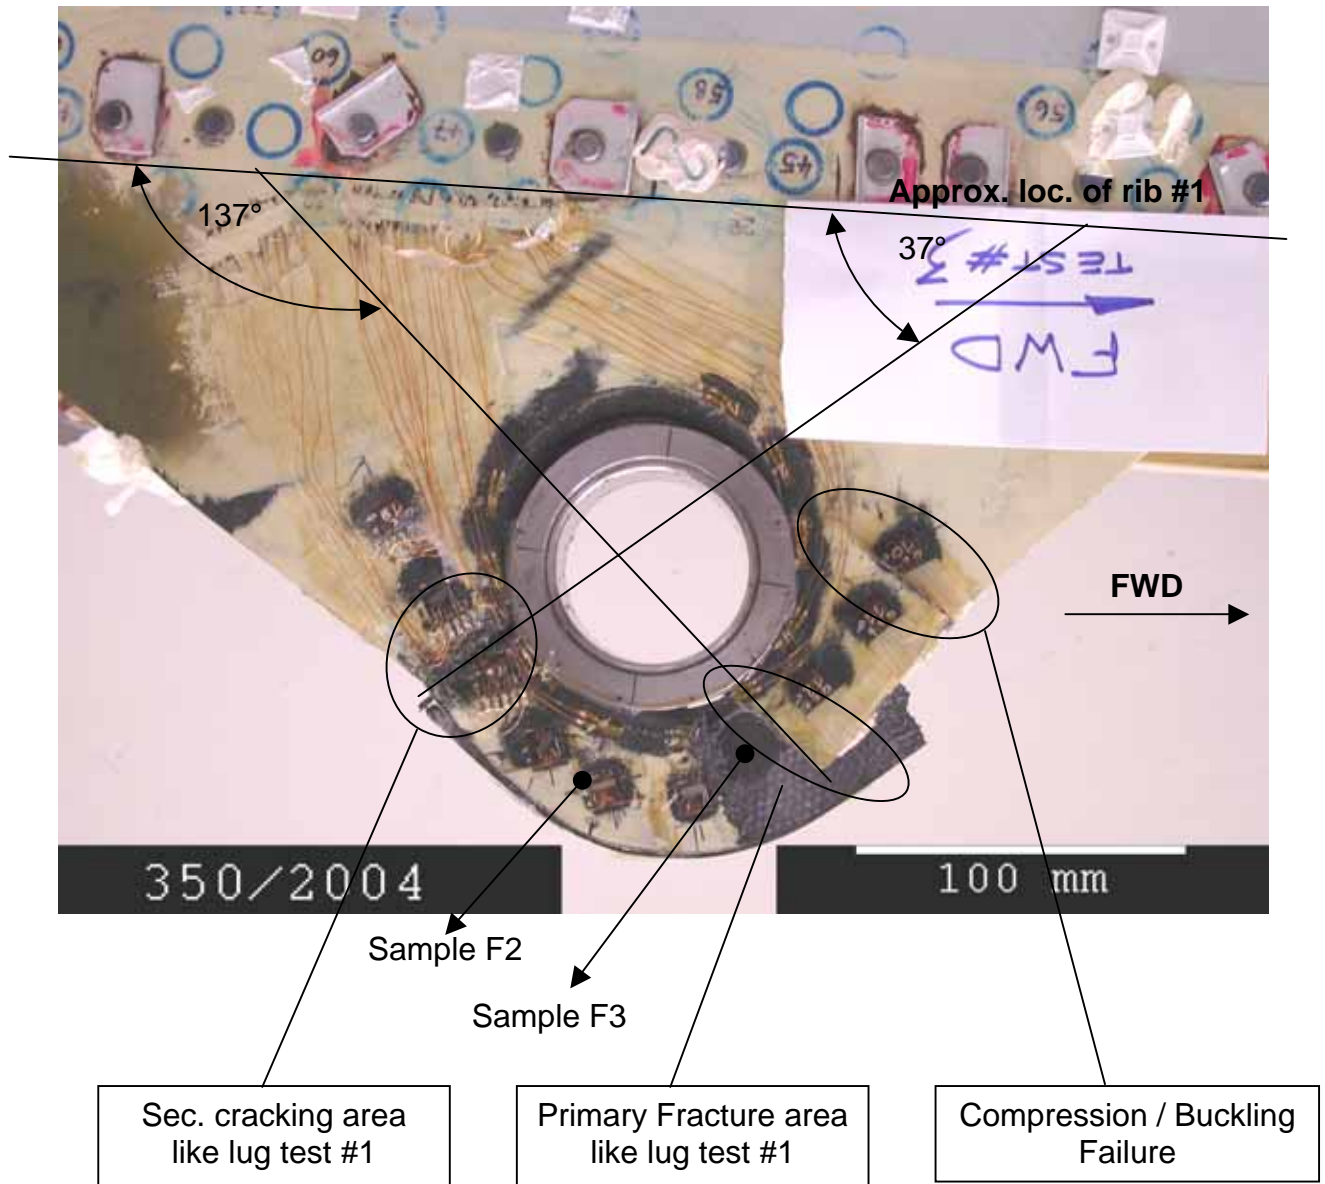
- A translaminar fracture thru the entire wall thickness of the lug was found. The location/orientation on outboard side is comparable to the primary translaminar fracture of lug test #1 (cf. TN-ESWOG-1264/04). This fracture is labeled as 137° failure, because the fracture path on the outboard side is orientated approx. 137° to rib #1 (s. fig. 1-4).

- A further translaminar fracture (labeled as 37° failure) thru the entire wall thickness was found (s. fig. 1-4). The location/orientation on outer side is comparable to the secondary translaminar cracking of lug test #1 (cf. TN-ESWOG-1264/04).

Fig. 1: Lug Test #3, determination of approx. angle between rib #1 and visible fracture path on outer side, view from outboard side, condition: after test

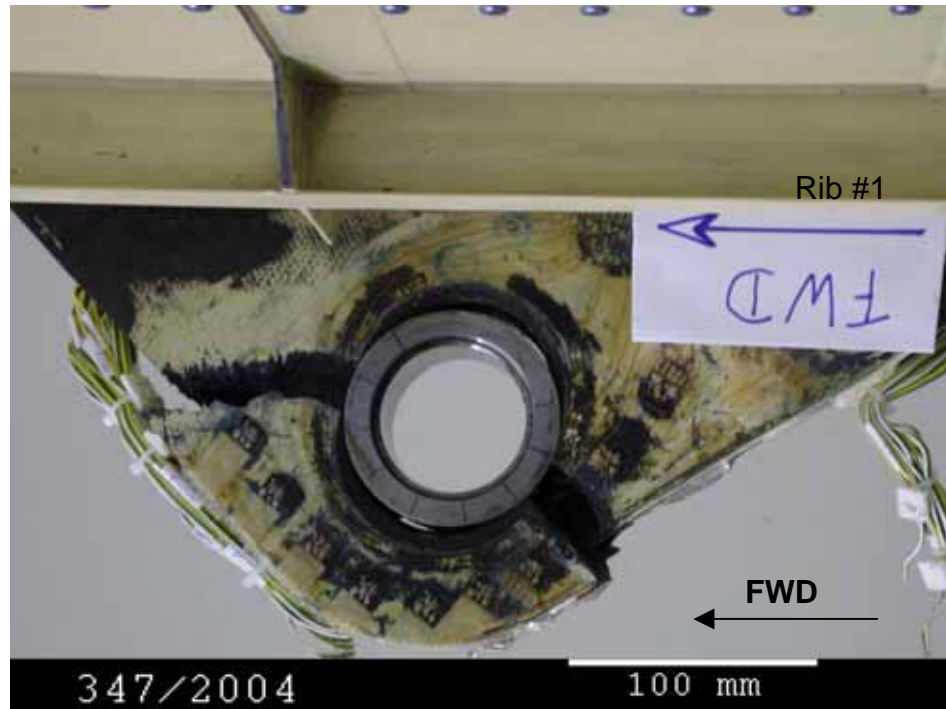
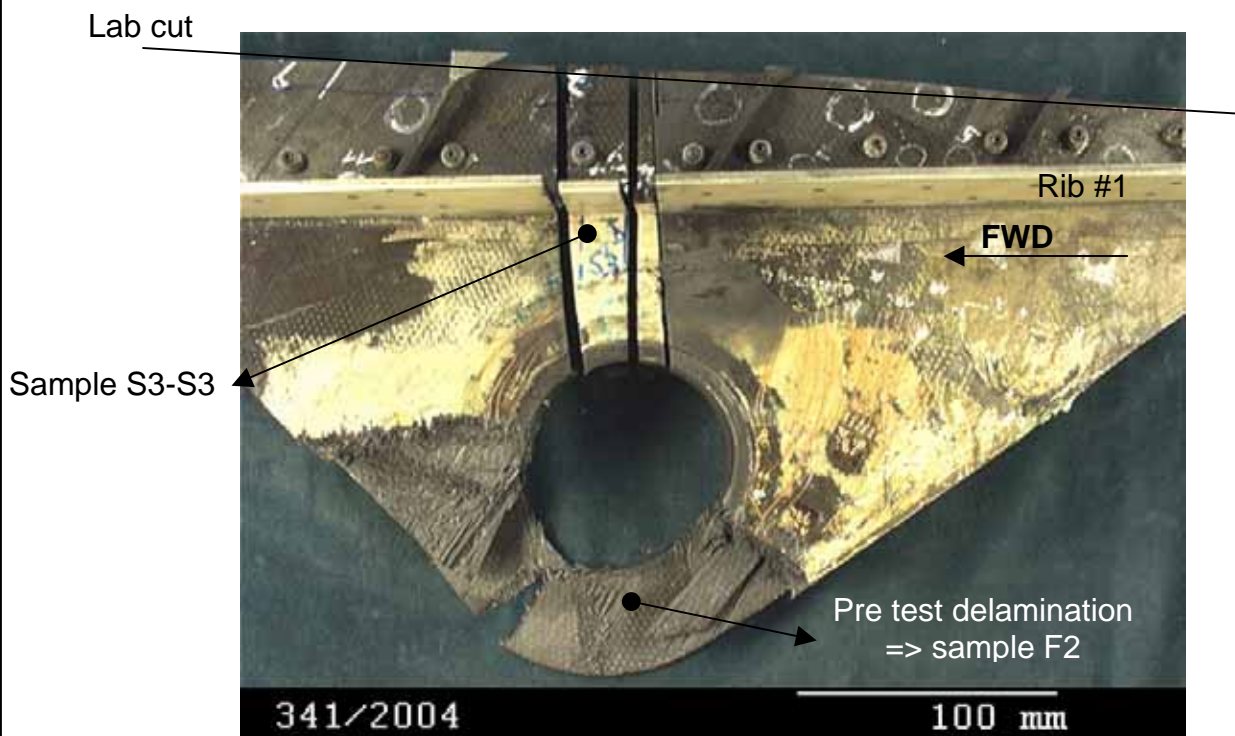
Sample **F2** obtained the pre test delamination after lab separation (cf. fig. 2, 5), found during the incoming NDT inspection (TN-ESWNG-1239/03). This sample obtained dark coatings in the area of the pre test delamination and was investigated in uncleaned and cleaned condition. But a useful documentation is not possible in the uncleaned condition; thus all figures were made in a cleaned condition.

Fig 2: Lug Test # 3, fracture path, view from inboard side, condition: after test (upper fig.) and after lab separation of fractured parts (lower fig.)

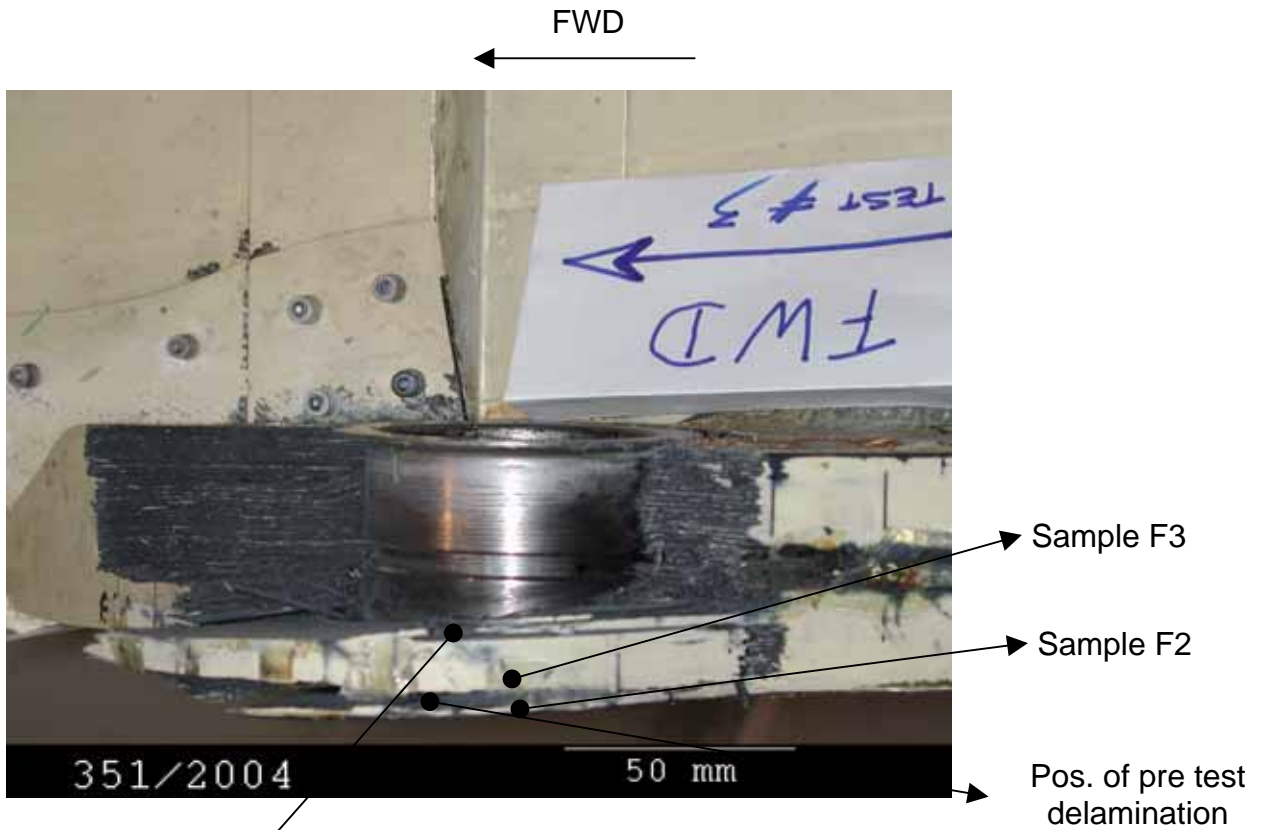
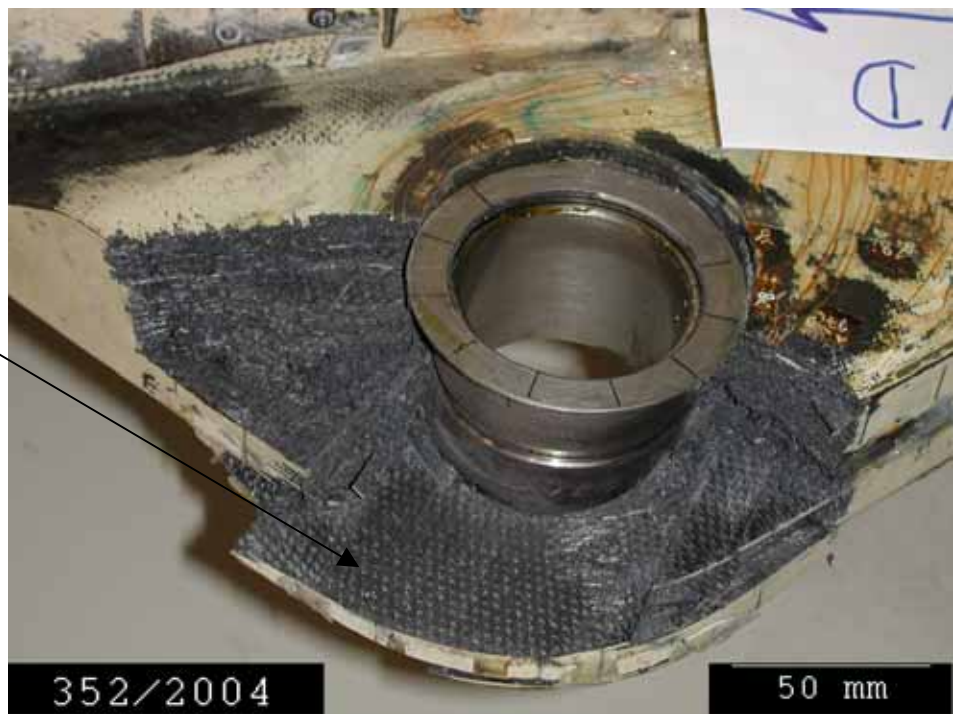
- The main ply separation area is located in the area of the precured/cured transition, i.e. the outer part, the precured/cured transition themselves as well as within the skin layers (cf. fig. 1-4,6), besides several other smaller delaminations.

Main ply separation

Fig 3: Lug Test # 3, fracture path, view from inboard side, condition: after test and partly separation of fractured parts

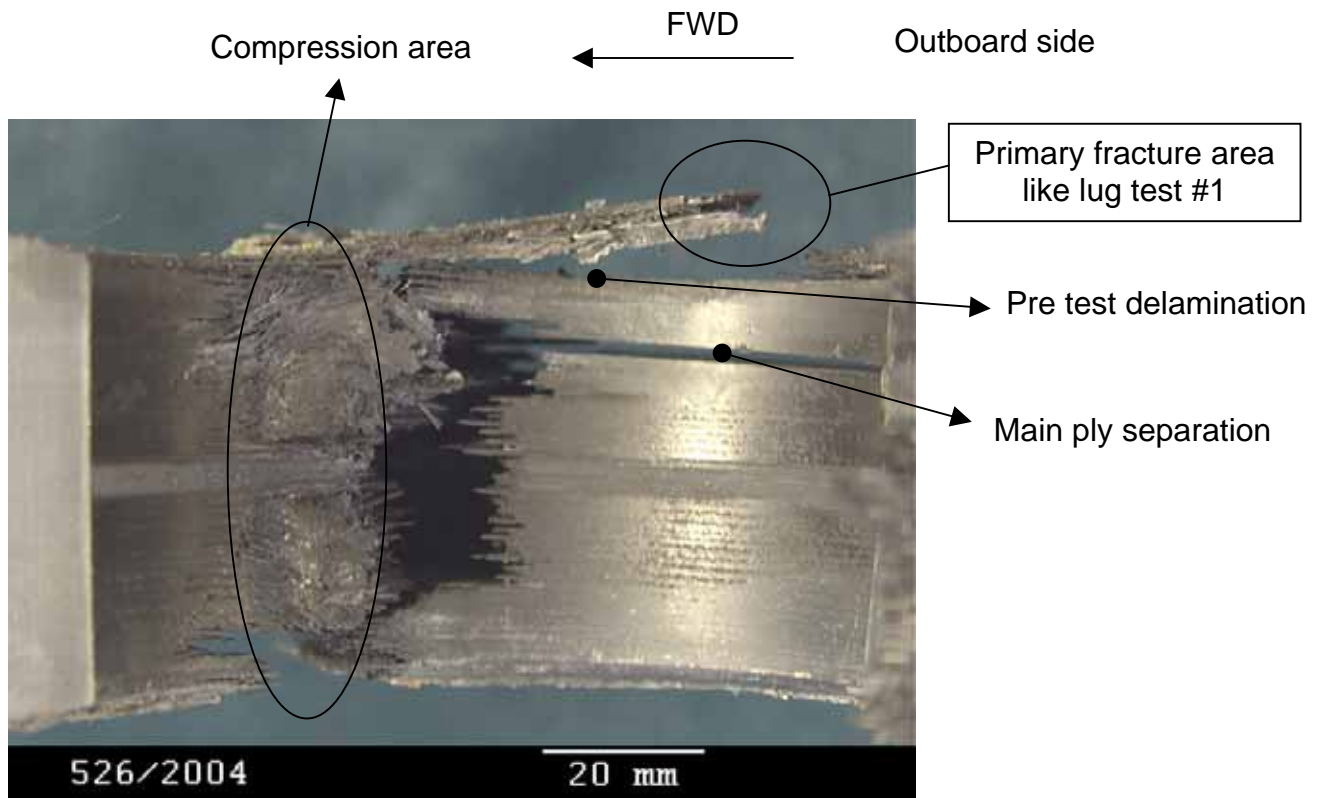
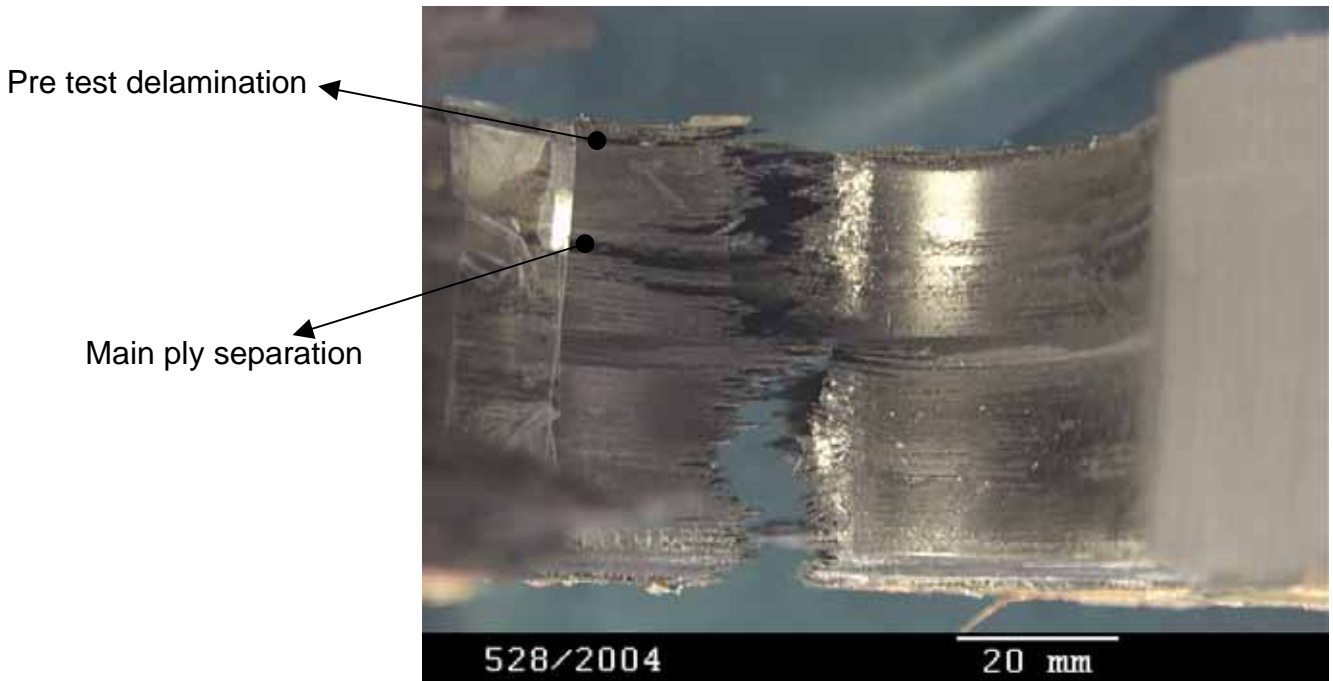
Fig 4: FWD and AFT translamellar fracture path

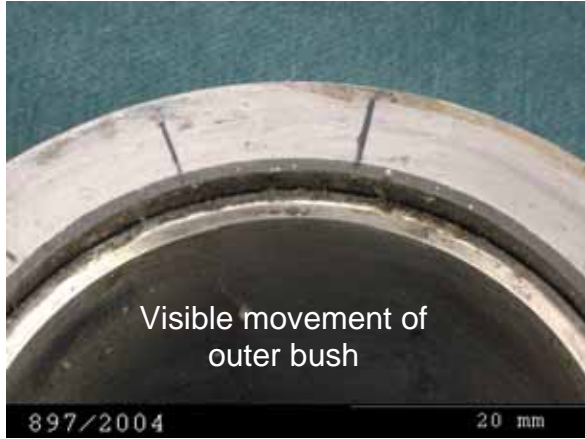
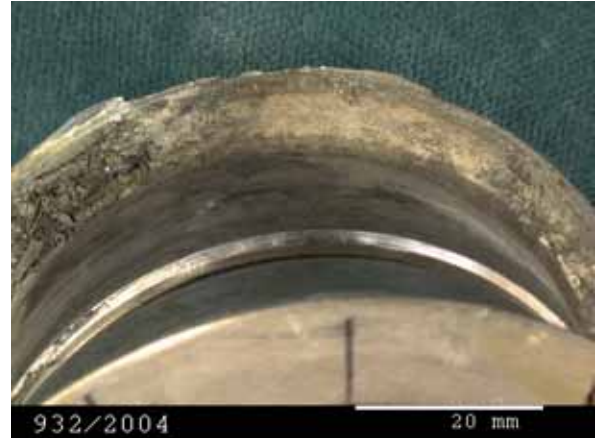
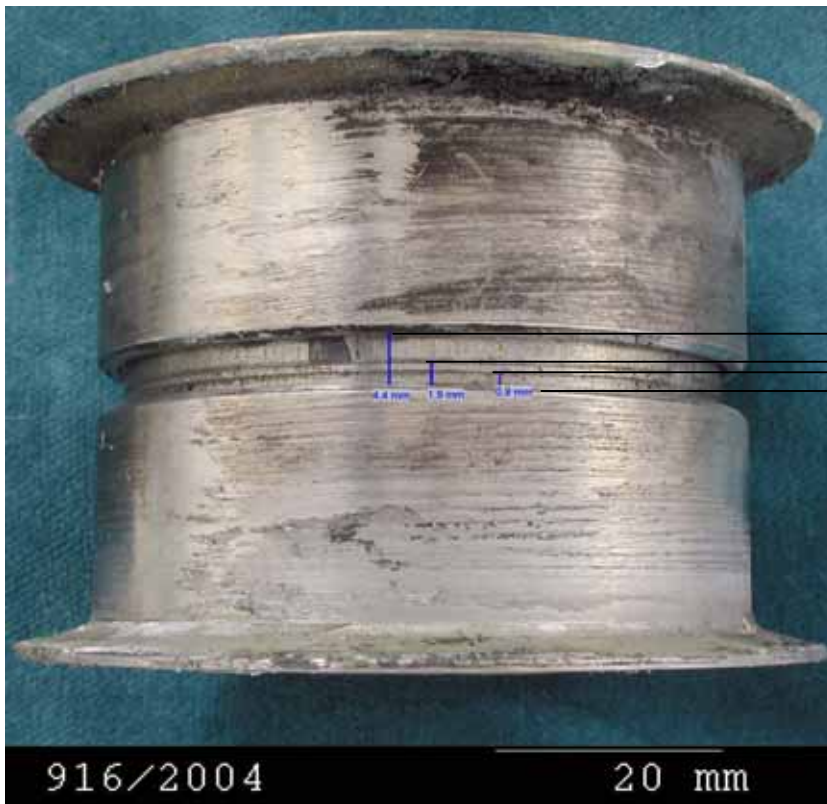
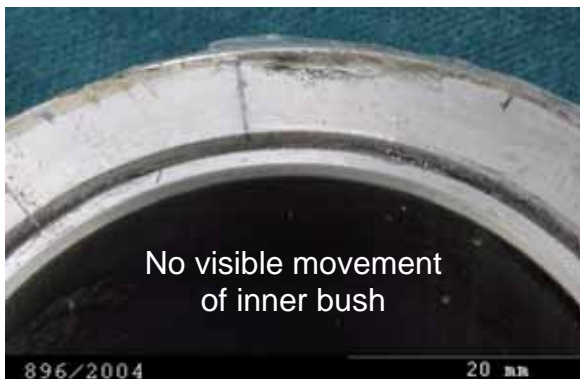
After the static test, the main attachment lug shows two translaminar fractures through the lug and a translaminar fractured area caused by buckling/compression as well as multiple delaminations (s. fig. 1-4,6). The delamination size, found by NDT, is visible in figure 6. The outboard-sided outer bush shows a lot of debris besides a green colored coating on the lug sided chamfer surface (s. fig. 5). The inner bush shows circumferential traces indicating a possible movement of outer bush of approx. 1mm and further 2.5 mm (s. fig. 5). After the first visual inspection, several cut outs were taken to obtain a closer view of the damaged areas.

Fig 5: Inner and outer bush, residues as well as a yellow/brownish colored layer on the chamfer of the bushes, circumferential markings on the inner bush indicating a possible movement of outboard sided outer bush of approx. 1 mm (step 1) and further 2.5 mm (step 2)

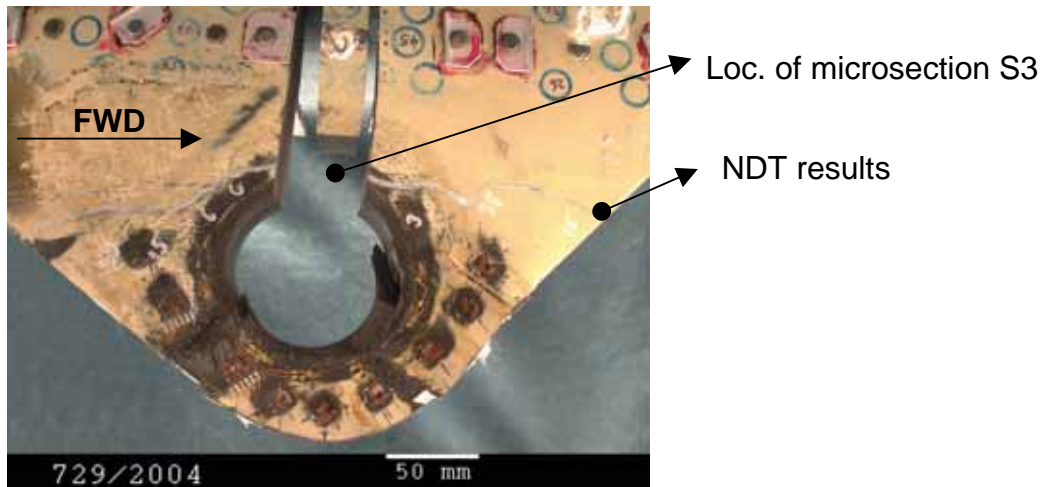
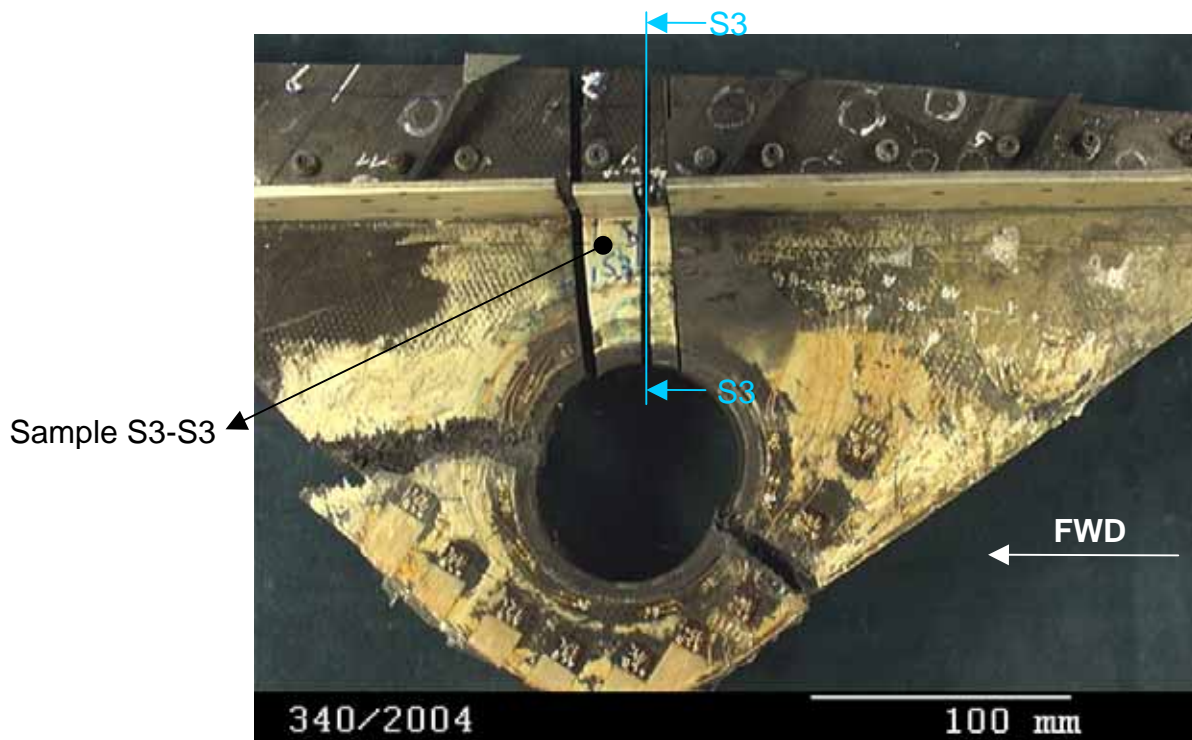
Microsection S3 was used for the validation of the lay up. This microsection is located above the bush-hole and is orientated approx. 90° to rib #1 (s. fig. 6).

Fig. 6: Location of section S3-S3 and microsection S3

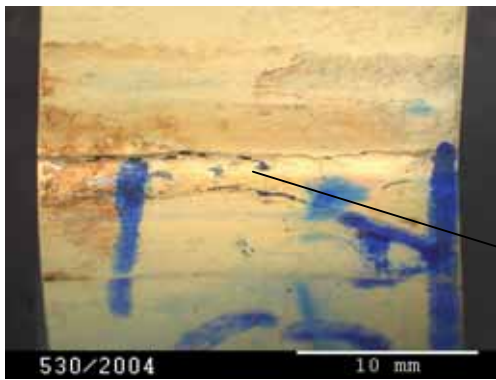
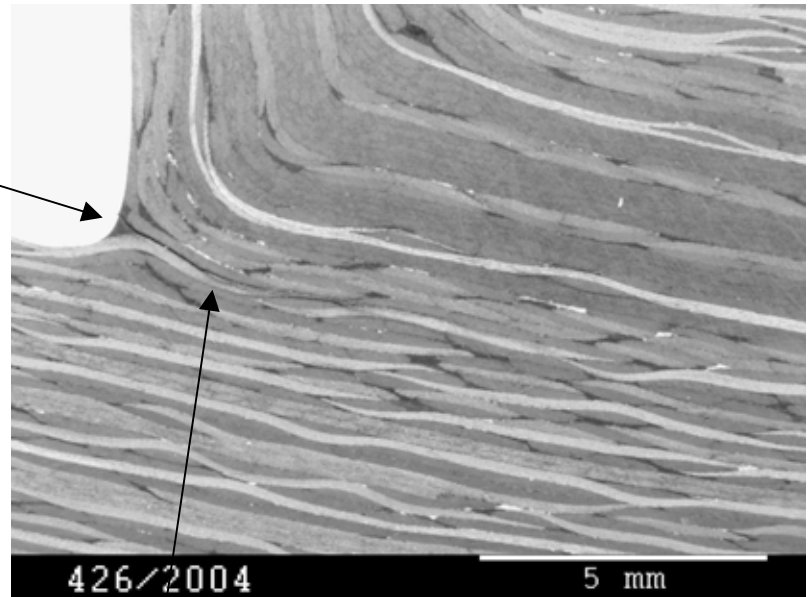
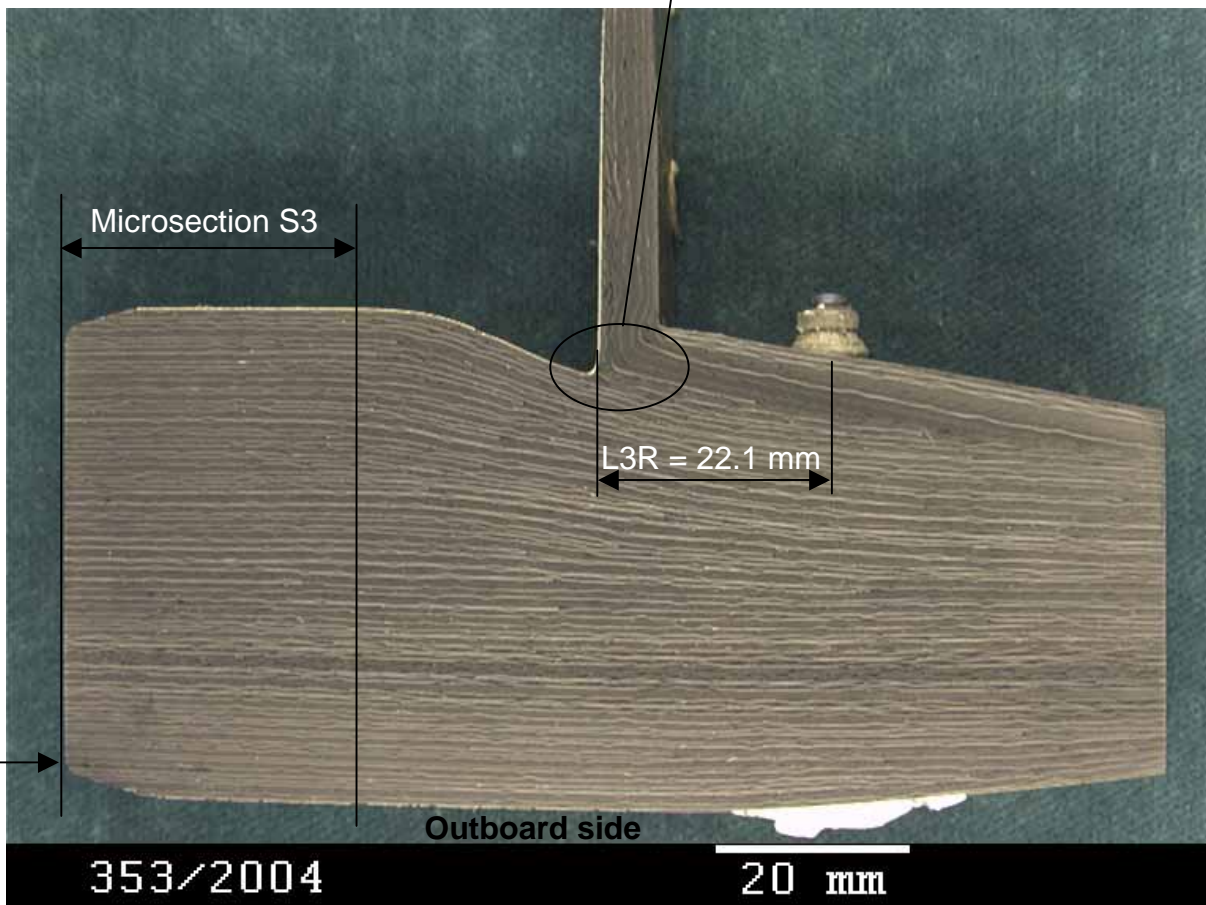
- A crack in the radius area of rib #1 was found (s. fig. 7).

- A crack, located in the radius, followed by a delamination was found on section S3-S3. The detailed delamination length is given in fig. 7.
- The pre test delamination length detected on microsection S3 (also visible on macro section S3-S3) is comparable with the result of the incoming NDT inspection. This delamination is located within the precured outboard part of the lug.

Visual visible crack at rib #1

Fig. 7: Delamination starting from crack at rib #1, further delamination starting at bush-hole (arrow), loc. of microsection S3, delamination length L3R, section S3-S3

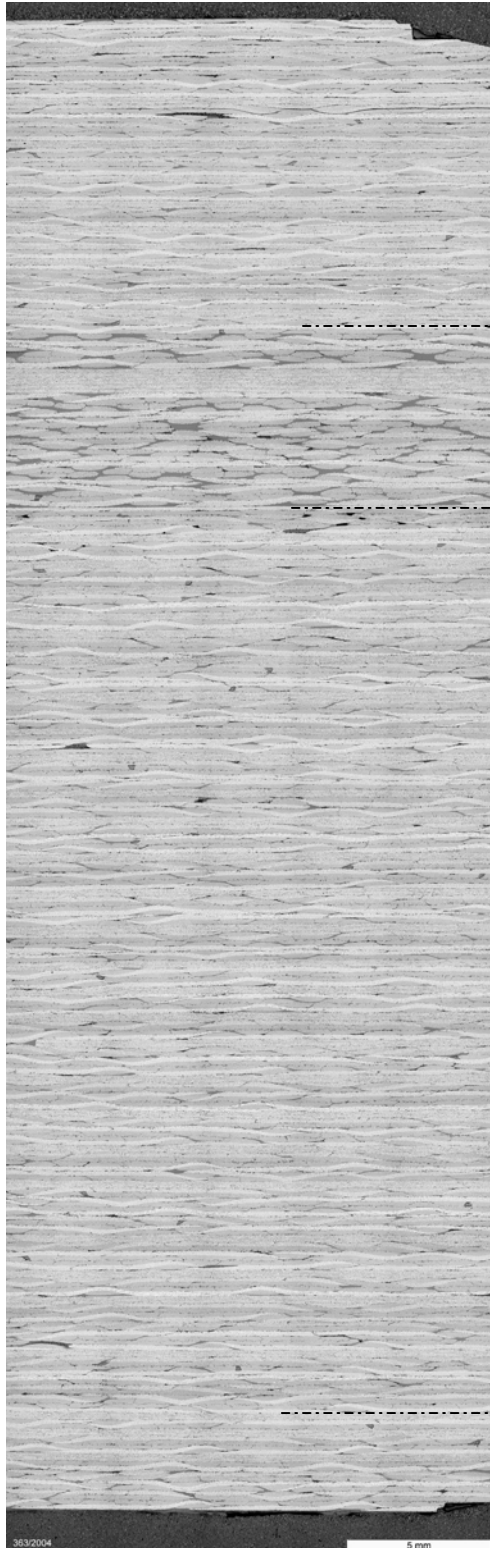
The result is, all detected layers as well as the location of the precured/cured transitions (s. fig. 8) are in accordance with the drawings.

363/2004 391/2004 393/2004 395/2004 Polished
 Fig. 8: Loc. of precured/cured transitions, loc. of determination of lay up, microsection S3

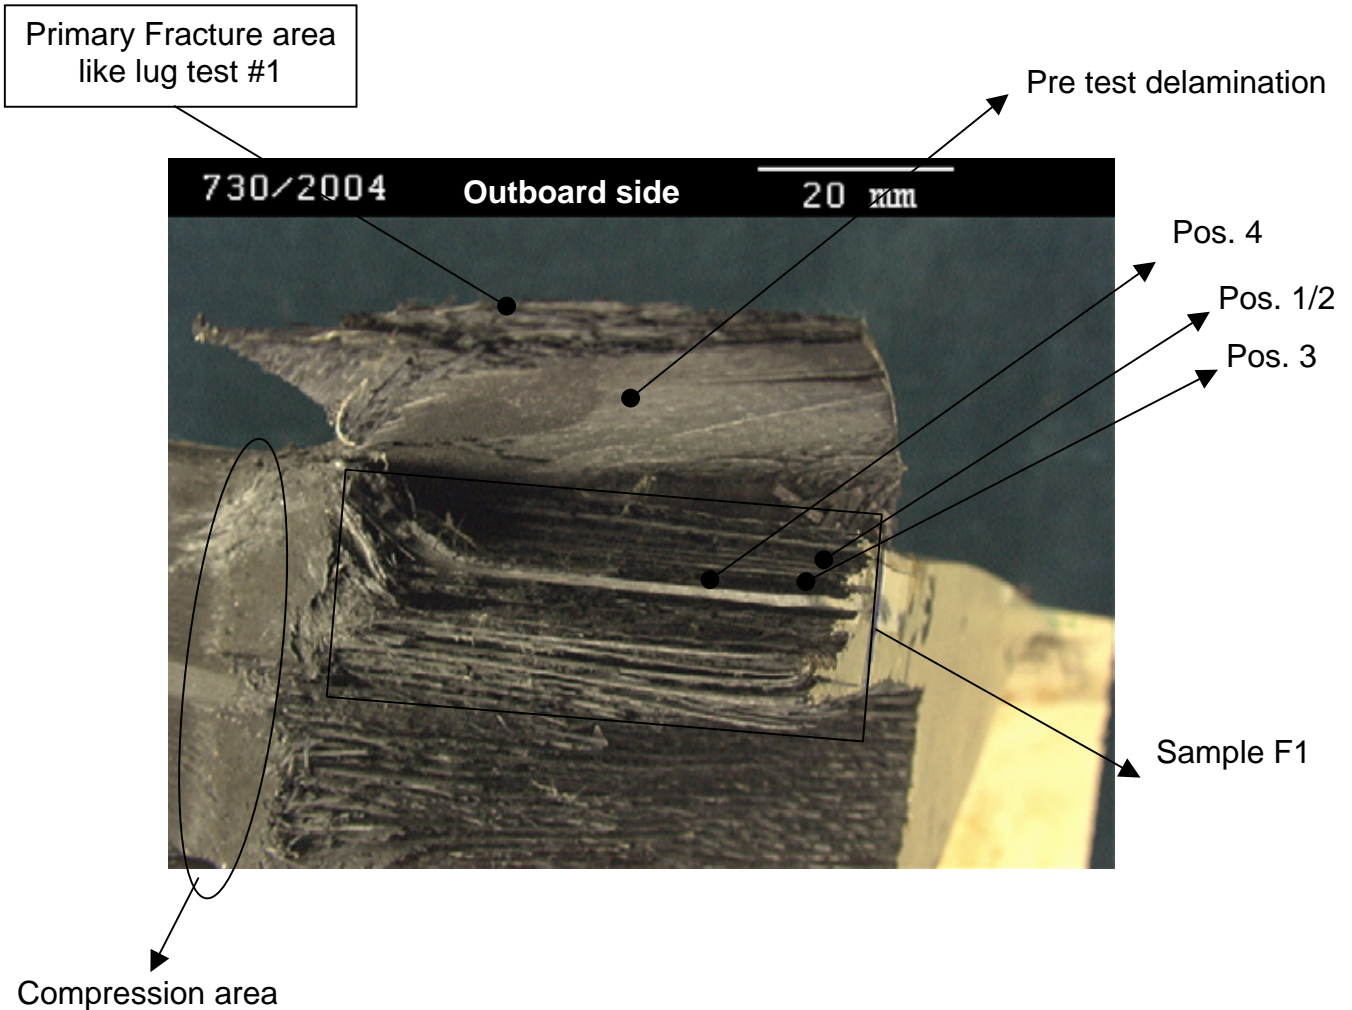
The fractographic sample **F1** was taken from the translaminar fracture of the 137° failure (s. fig. 1, 10), comparable to sample F1 of lug test #1. I.e., sample F1 obtained mainly the precured outer part of the lug.

Fig 9: Lug Test # 3, F1, translamellar fracture path

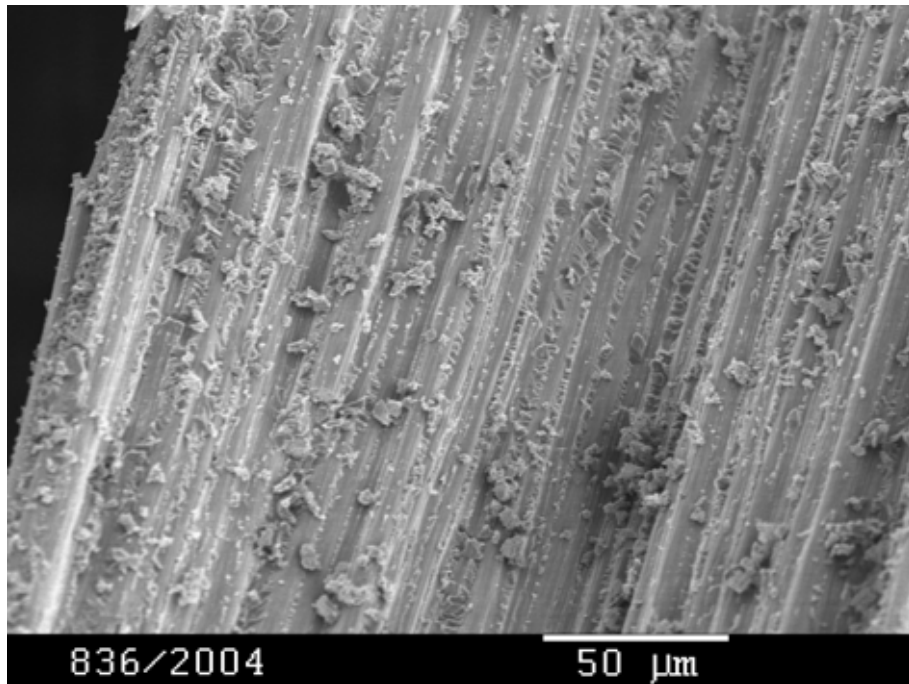
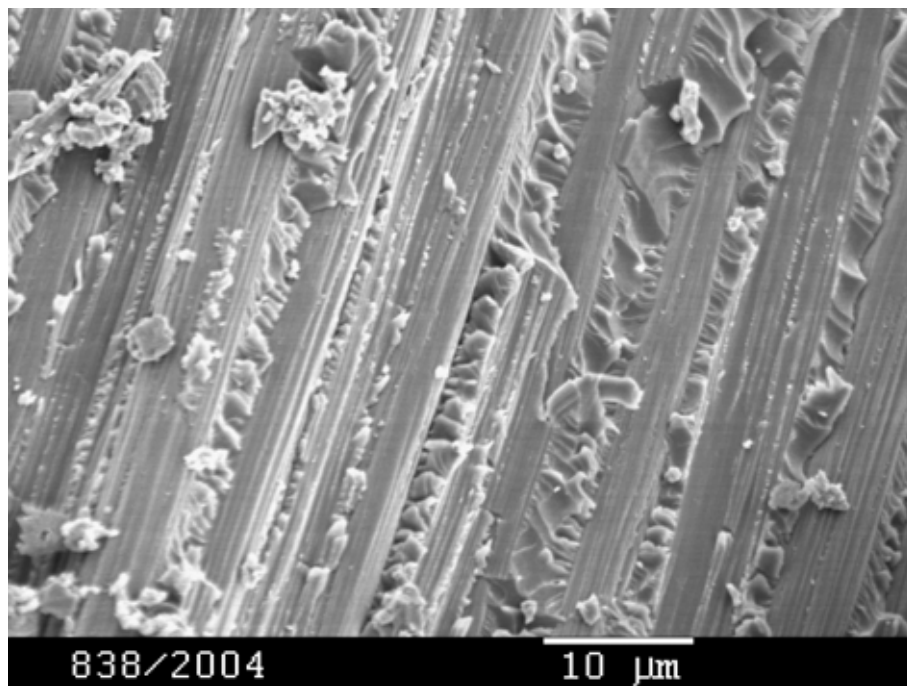
Radial patterns on fractured fibers were only locally visible on the translaminar fracture of sample F1; most of the fibers were covered with debris (s. fig. 11,13). The areas where the fracture path is perpendicular to the fiber direction shows features of mode I and II loadings (s. fig. 10,12).

836/2004 838/2004
 Fig. 10: Features of mode I and II loadings, fracture path approx. parallel to the fibers, det. of fig. 9 / pos. 1

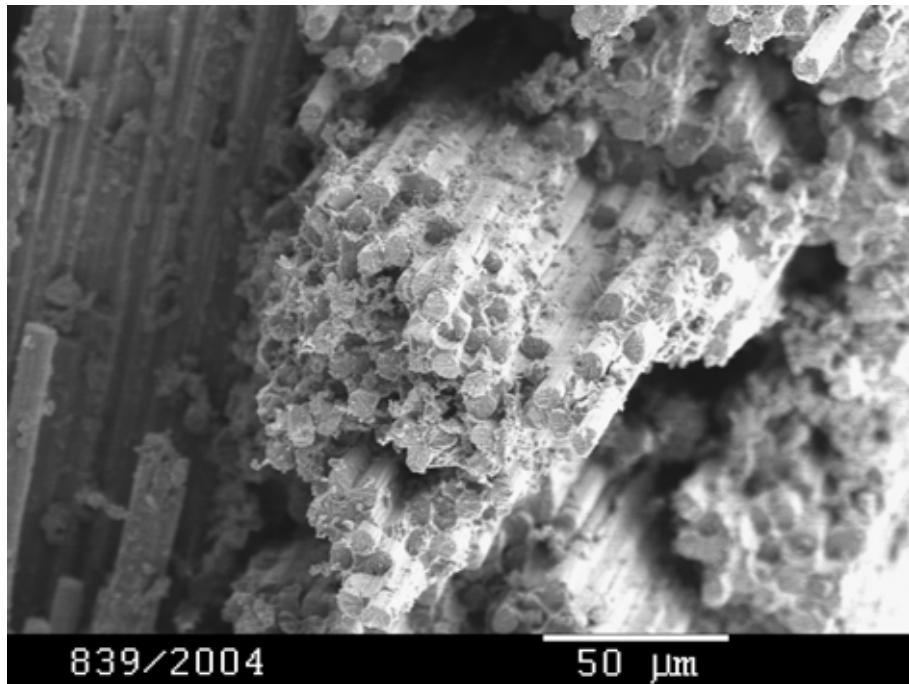
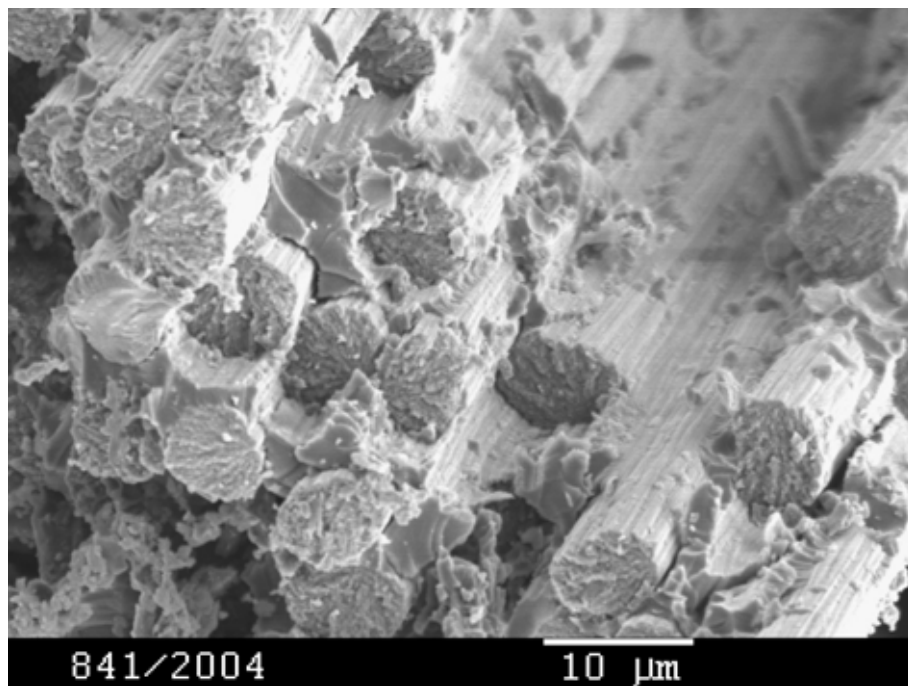
839/2004 841/2004
 Fig. 11: Locally radial pattern, det. of fig. 9, pos. 2

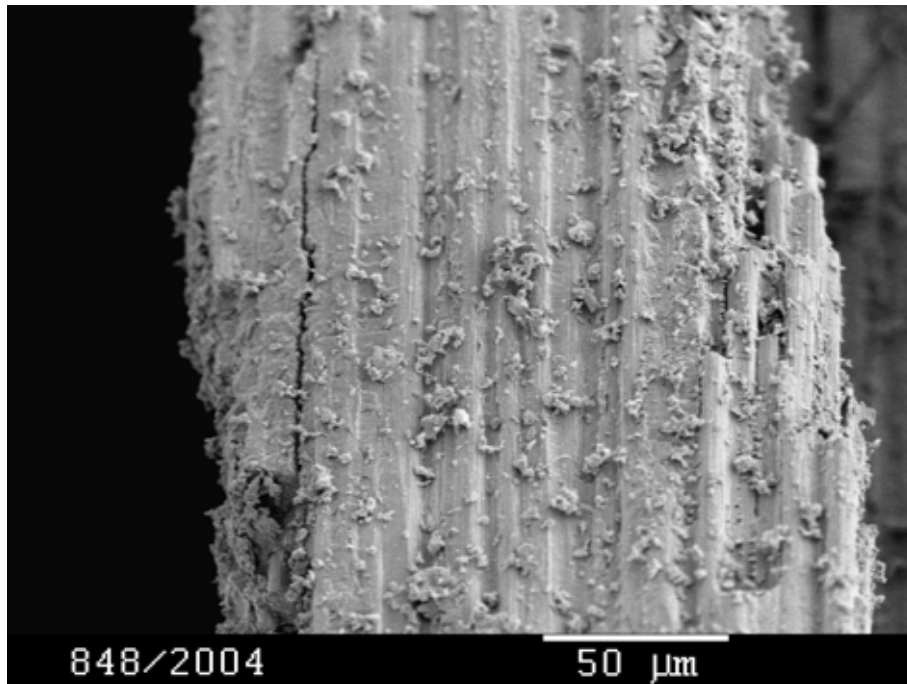
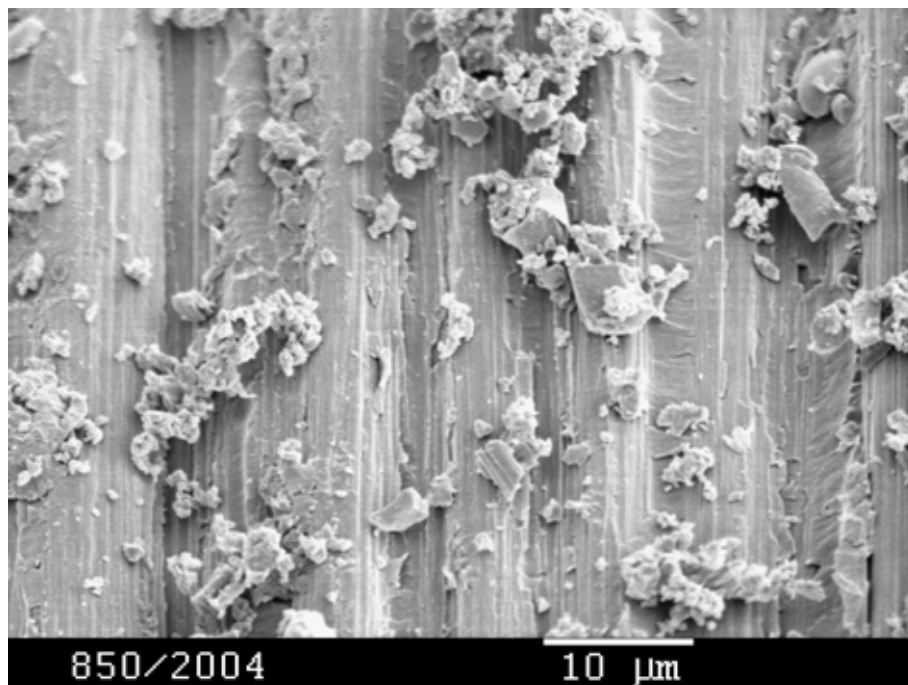
848/2004 850/2004
 Fig. 12: Features of mode I loadings, fracture path approx. parallel to the fibers, det. of fig. 9 / pos. 3

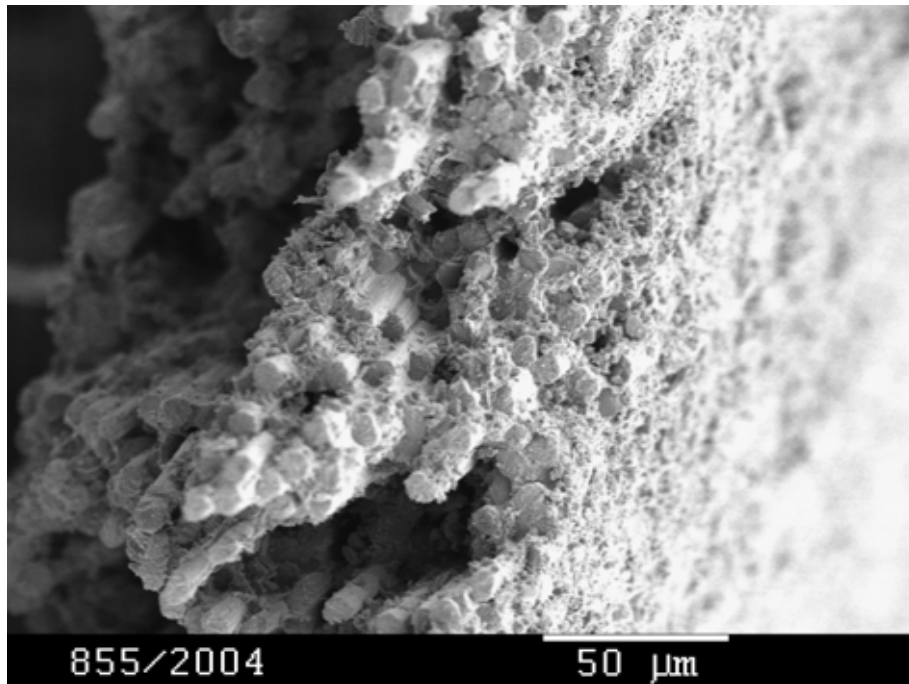
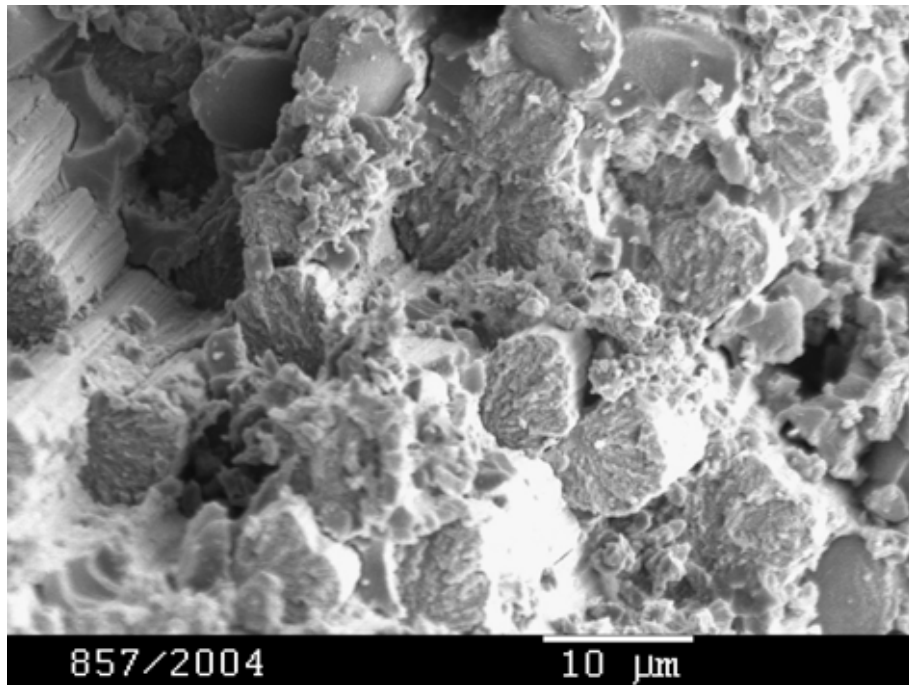
855/2004 857/2004
 Fig. 13: Locally radial pattern, det. of fig. 9, pos. 4
