NATIONAL TRANSPORTATION SAFETY BOARD

MATERIALS LABORATORY FACTUAL REPORT

Report No. 04-065

Place : Belle Harbor, New York
Date : November 12, 2001
Vehicle : Airbus A300-600, N14053
NTSB No. : DCA02MA001
Investigator : Brian Murphy, AS-40

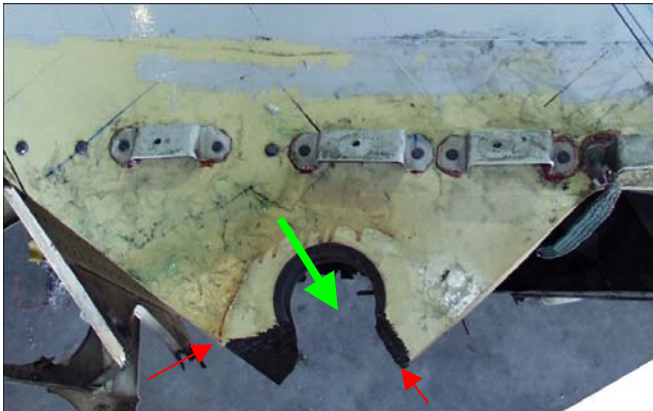
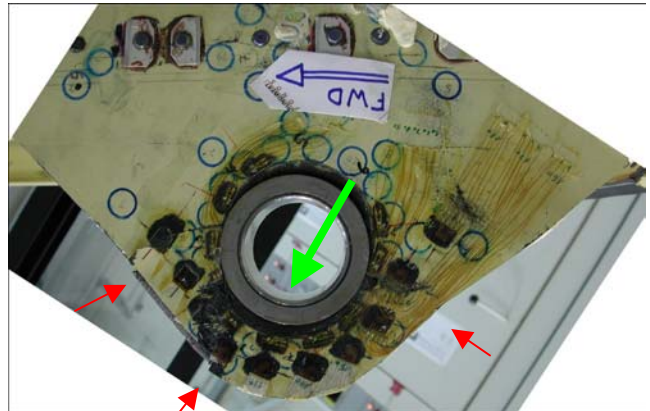
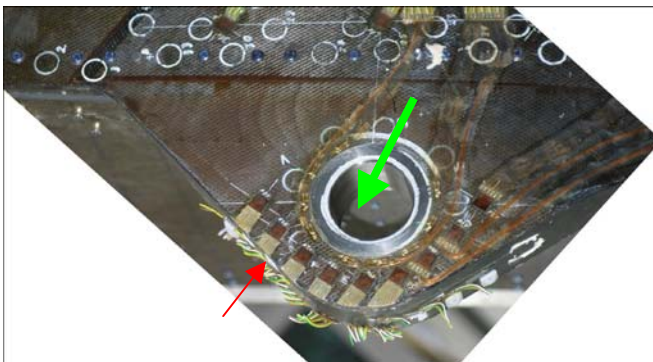
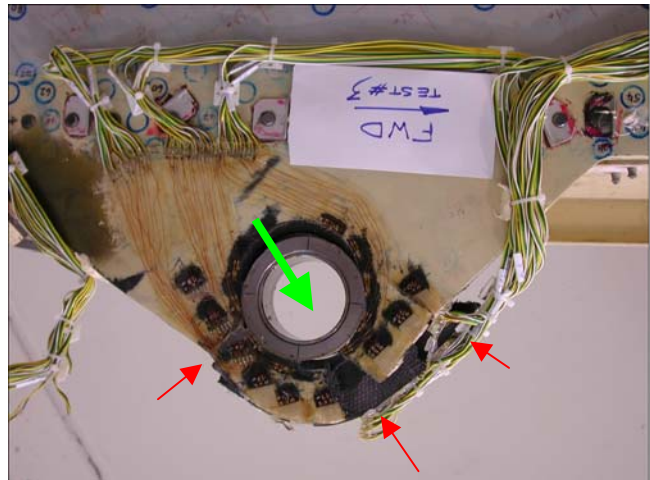
Results from the fractographic examination showed that fractures in the test lugs occurred at locations similar to those on the accident right rear lug. In the first test, loading was interrupted after fracture occurred as shown in figures 1, 3, and 4. The translaminal fracture was located at a position on the forward part of the lug in a plane nearly parallel to the loading direction, similar to one of the translaminal fractures in the accident right rear lug. Also, a delamination was present within the lug having an extent similar to that of the accident right rear lug and in a location through the thickness slightly outboard of that of the accident right rear lug.

Fracture features for lug tests 2 and 3 were similar. The outboard side of each of these lugs had a translaminal fracture on the forward sides of the holes in a plane nearly parallel to the loading direction and another translaminal fracture at the aft side of the hole in a plane approximately perpendicular to the loading direction, fractures similar to that of the accident lug. In addition on the outboard sides, a compression buckling fracture was observed on the forward sides of each lug above the fracture parallel to the loading direction, which is different from features on the accident lug but was attributed to constraints of the loading fixture.

Figure 1. Overall view of the outboard sides of the accident right rear lug and the rear lugs from the three detail tests. Unlabeled red arrows indicate where translaminar fractures intersected the outboard lug surfaces, and unlabeled large green arrows indicate the approximate resultant force vector for the vertical and horizontal force components for each lug.

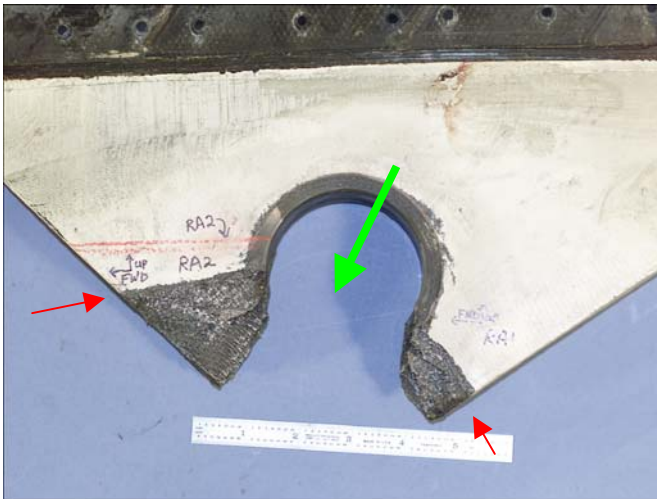
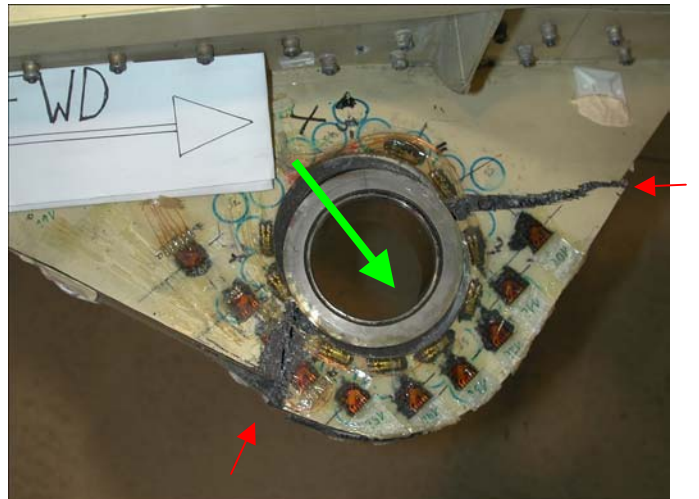
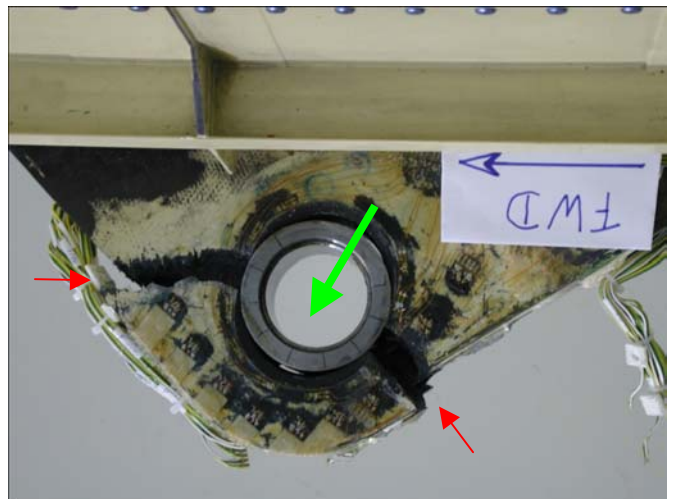
On the inboard sides of lugs 2 and 3, fracture locations were as shown in figure 2, planes different from that of the outboard side of the lug. This change in fracture planes was similar to that of the accident right rear lug.

Figure 2. Overall views of the inboard sides of the accident right rear lug and the rear lugs from the second and third detail tests. Unlabeled red arrows indicate locations where translaminar fractures intersected the inboard surfaces, and unlabeled large green arrows indicate the approximate resultant force vector for the vertical and horizontal force components for each lug. No translaminar fractures intersected the inboard surface of the lug for the first detail test, not shown in this figure.

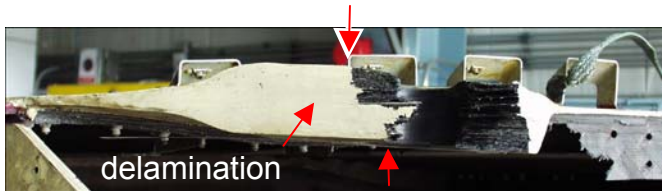
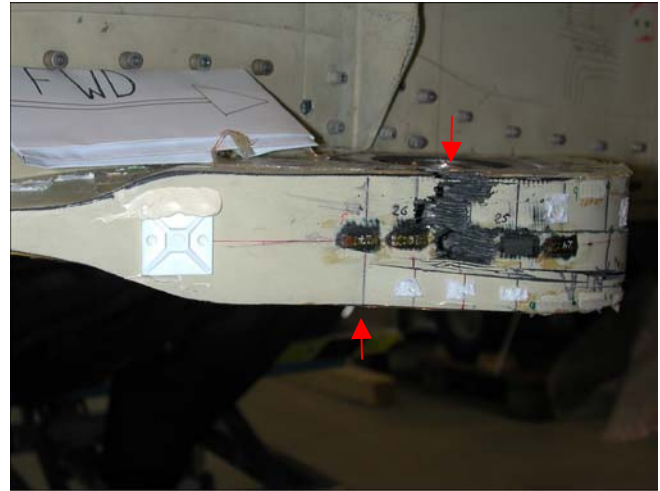
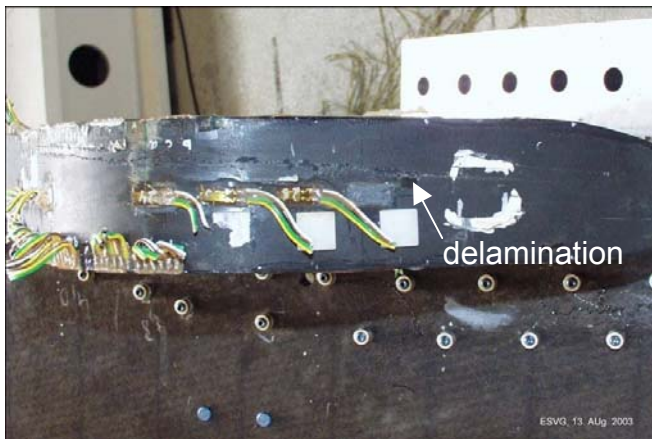
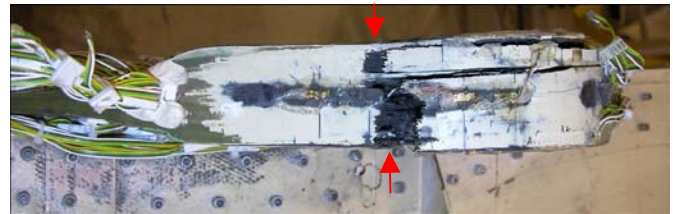
Figure 3. Views looking upward and forward of the accident right rear lug and the rear lugs from the three detail tests. Unlabeled arrows indicate locations where translaminar fractures intersected the inboard and outboard surfaces at the aft side of the lugs. For the first test rear lug, no translaminar fractures intersected the aft side of the lug. Also, delaminations above the translaminar fractures are indicated.

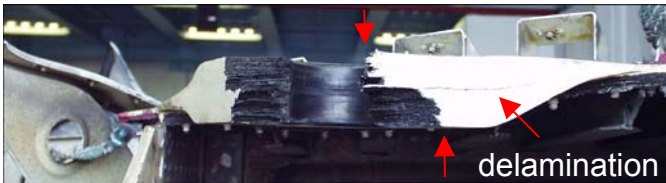
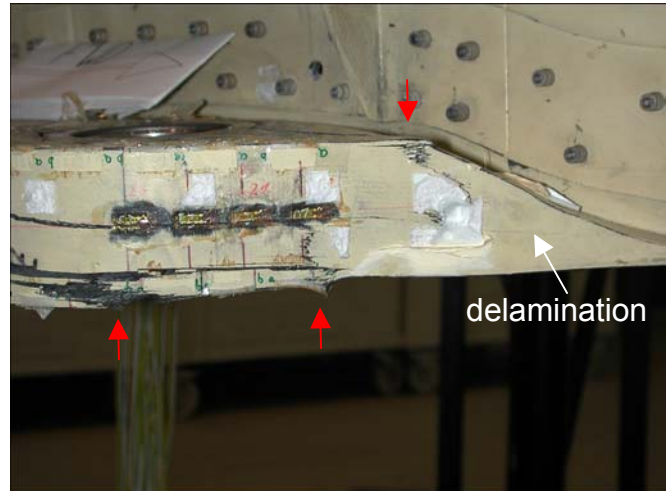
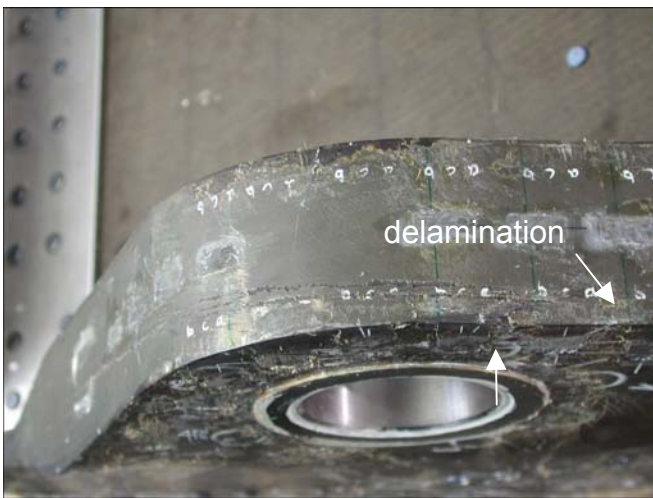
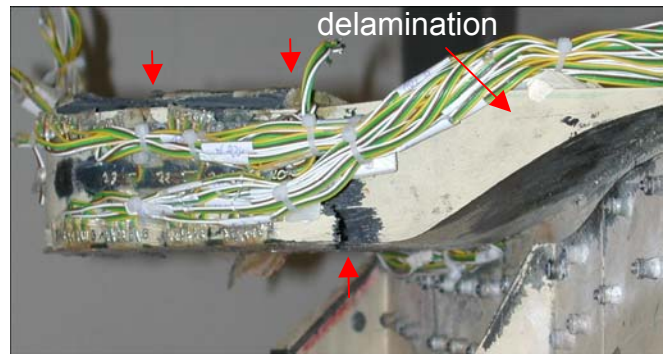
Delaminations were detected by ultrasonic inspection above the translaminal fractures in lugs 2 and 3, as are visible at the forward surfaces in figure 4. The locations of the delaminations through the thickness were similar to that of the accident right rear lug, but the extents of the delaminations in the test lugs were slightly less.

Figure 4. Views looking upward and aft of the accident right rear lug and the rear lugs from the three detail tests. Unlabeled arrows indicate locations where translaminar fractures intersected the inboard and outboard surfaces of the lugs. Also, delaminations above the translaminar fractures are indicated.
