NATIONAL TRANSPORTATION SAFETY BOARD

MATERIALS LABORATORY FACTUAL REPORT

Report No. 06-010

Place : Miami, Florida
Date : December 19, 2005
Vehicle : Grumman G-73T Mallard, N2969
NTSB No. : DCA06MA010
Investigator : Brian Murphy, AS-40

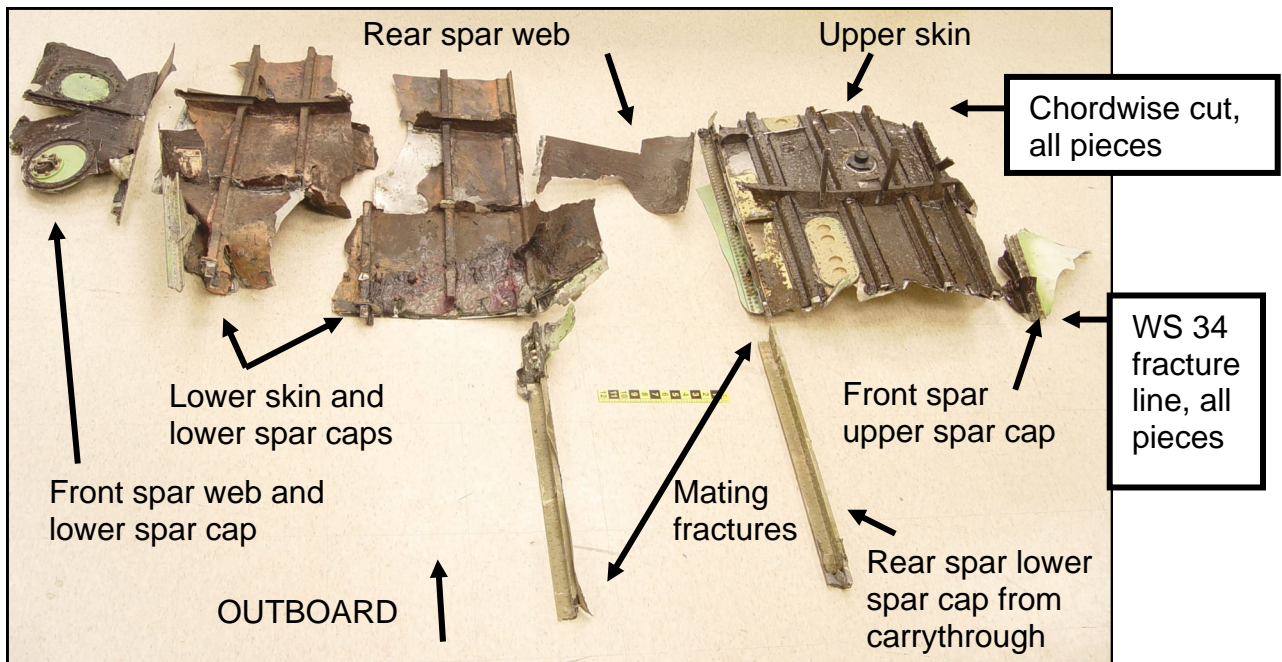
The pieces from the wing box beam that were first to arrive in the Safety Board's Materials Laboratory are shown in the overall view in figure 2. The pieces shown in figure 2 are primarily from the inboard end of the portion of the wing box beam that remained with the right wing. Two pieces of the rear spar lower spar cap from the main portion of the airplane were also in the first group of pieces to arrive. The fracture occurred mostly within the fuel tank just outboard of right WS 34, and the interior of the submitted pieces outboard of the fracture were coated with sealant. The pieces of the wing box beam had been cut approximately 2 to 3.5 feet from the fracture location to facilitate shipping to the Safety Board's Materials Laboratory.

Figure 2. View of wing box beam pieces from the fractured inboard end of the right wing portion of the wing box beam as received. View is of the internal surfaces opened and laid flat. Pieces of the rear lower spar cap from the carrythrough are also shown.

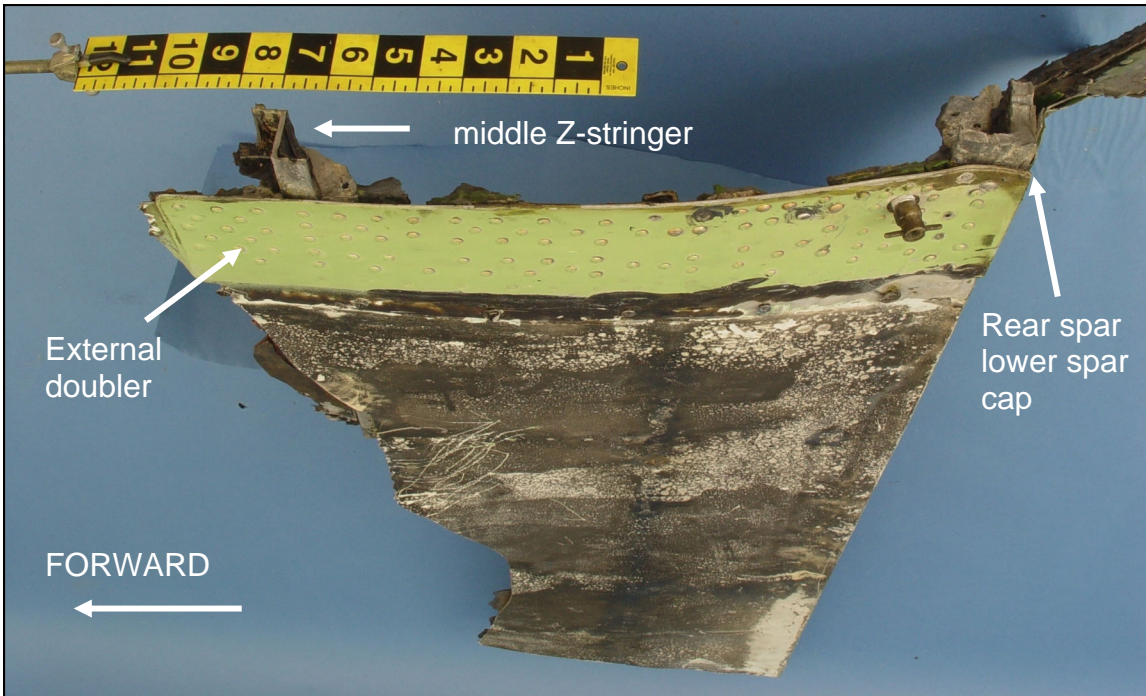
Figure 3. Aft piece of the lower skin panel and rear spar lower spar cap piece from the right wing pieces shown in the previous figure. View is looking outboard and slightly upward at the lower surface and at fractures at the inboard end near right WS 34.

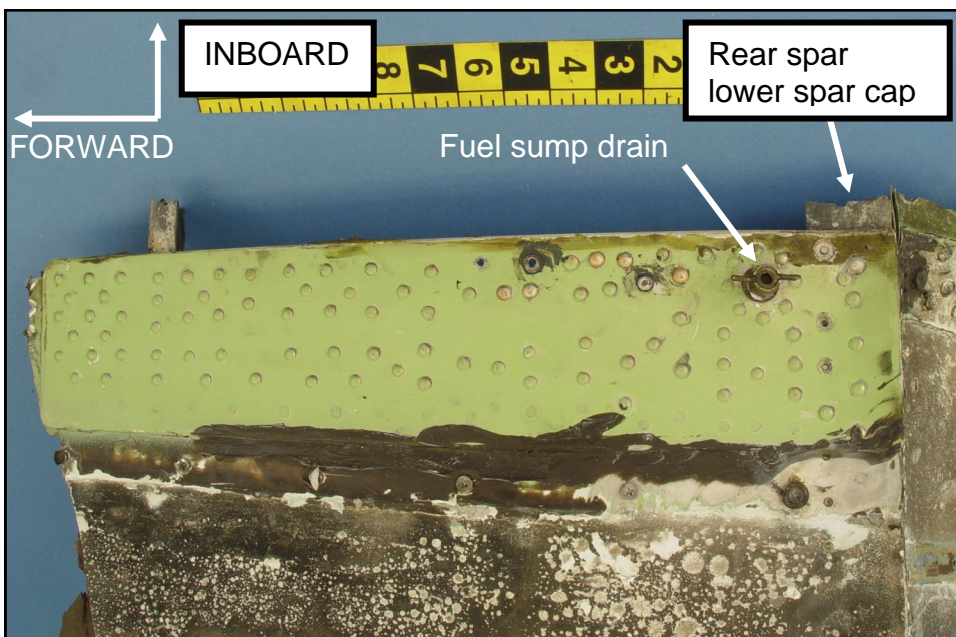
The lower skin panel of the wing box beam contained an external repair doubler and a series of internal repair doublers adjacent to the right WS 34 fracture. The lower skin fracture was mostly recessed between these doublers. Views of the external doubler on the lower surface of the wing box beam adjacent to right WS 34 are shown in figures 3 and 4. Some sooting was present on the lower surface of the lower skin panel piece. The area with the repair doubler was not sooted. On the Grumman model G-73 (and G-73T) airplane, the area with the repair doubler is not visible on the exterior of the airplane since it is covered by a fairing between the wing and the fuselage. A fuel sump drain is also located in the area covered by a fairing as indicated in figure 4.

Figure 4. View of the repair at the inboard end of the wing box beam piece shown in the previous figure. The area with green paint is an external doubler on the lower surface of the skin panel adjacent to right WS 34.

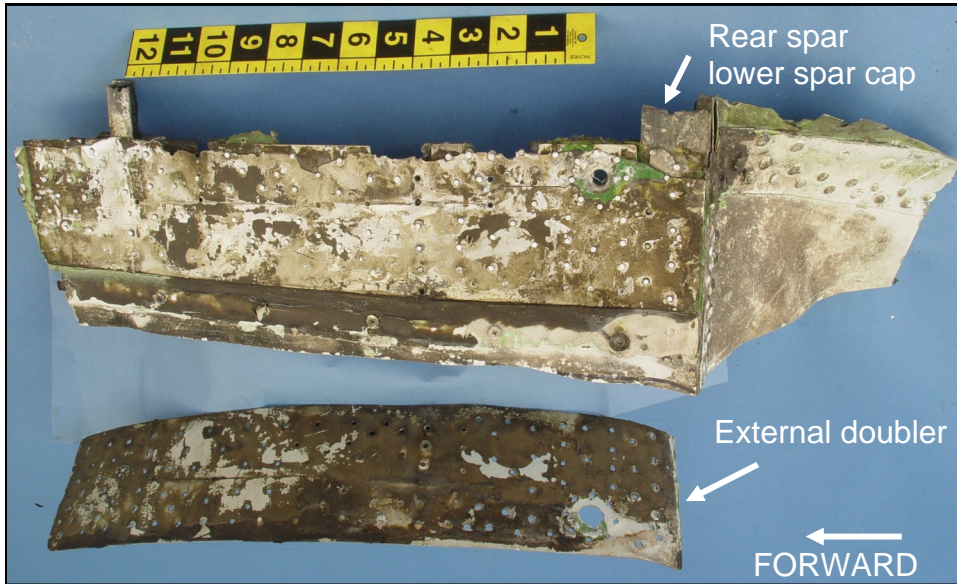
doubler was then pried from the skin using wooden tongue depressors. The faying surfaces between the skin and external doubler after separation are shown in figure 5. The skin fracture is at the top edge of the piece as it is oriented in this figure.

Figure 5. View of faying surfaces of the lower skin and external doubler shown in the previous figure after removing the external doubler.

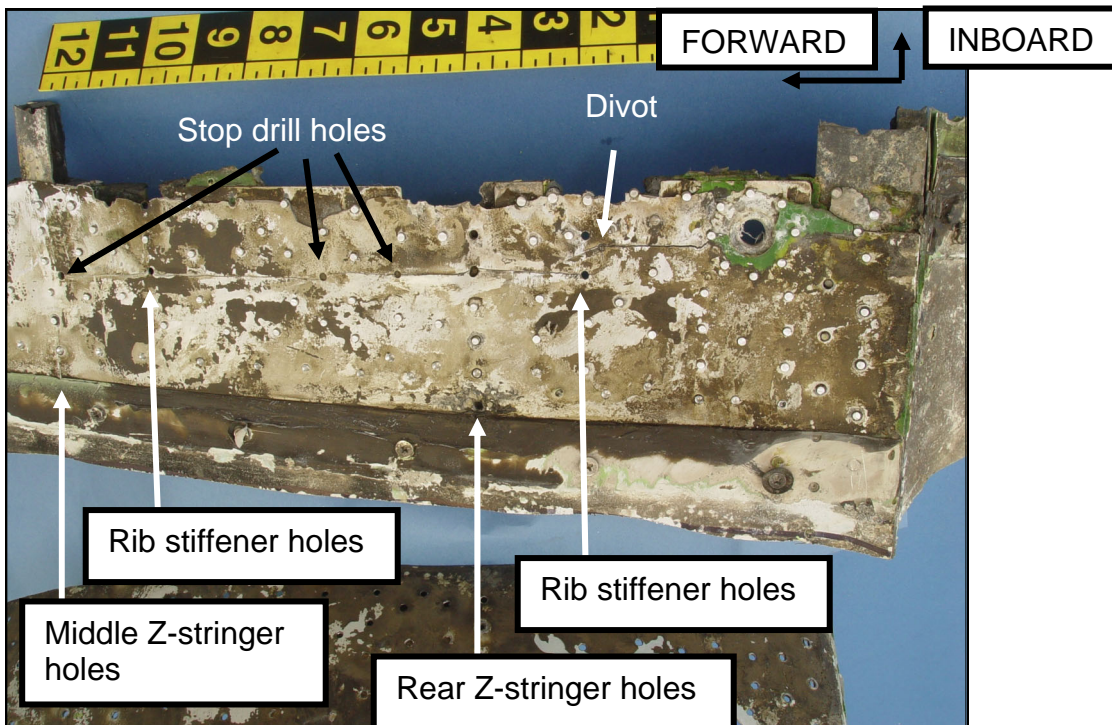
A crack was observed in the skin in the area that had been covered by the external doubler. A closer view of the crack in the lower skin is shown in figure 6. The crack was oriented chordwise, approximately parallel to the skin fracture, and was 15.9 inches long. The aft end of the crack intersected the skin trailing edge, and the skin fracture intersected portions of the crack near the rear spar. The forward end of the crack was located at the aft side of the middle Z-stringer lower flange. The crack also intersected an area of hard green sealant around the sump drain and fastener holes for two rib stiffeners and for the rear Z-stiffener. The crack intersected three unfilled machined holes in the skin that were not in line with fasteners for internal stiffeners and did not have corresponding holes in the doublers, features consistent with stop drill holes. The locations of the stop drill holes were 8.8 inches, 6.9 inches, 15.9 inches forward of the skin trailing edge. The hole at 15.9 inches forward of the skin trailing edge corresponded to the forward end of the crack, and the hole also extended through the edge of the Z-stringer lower flange.

The crack could be considered as two segments consisting of an aft segment that intersected the green sealant around the fuel sump drain and a forward segment that intersected fasteners for the rib stiffeners and the rear Z-stringer. The forward segment of the crack was located slightly outboard of the aft segment of the crack, and the crack segments intersected each other at two locations near the rearmost rib stiffener. The aft end of the forward crack segment intersected the aft crack segment just aft of the rearmost rib stiffener at a feature labeled as a divot in figure 6. The divot was a machined, spherical section of missing material consistent with a partially-drilled hole. The forward end of the aft segment of the crack intersected the forward segment of the crack just forward of the rearmost rib stiffener.

Figure 6. Closer view of the crack in the lower skin on the piece shown in the previous figure. Holes that the crack intersected forward of the fuel sump drain plate are labeled. The divot was a machined spherical segment of missing material that did not penetrate through the skin thickness.

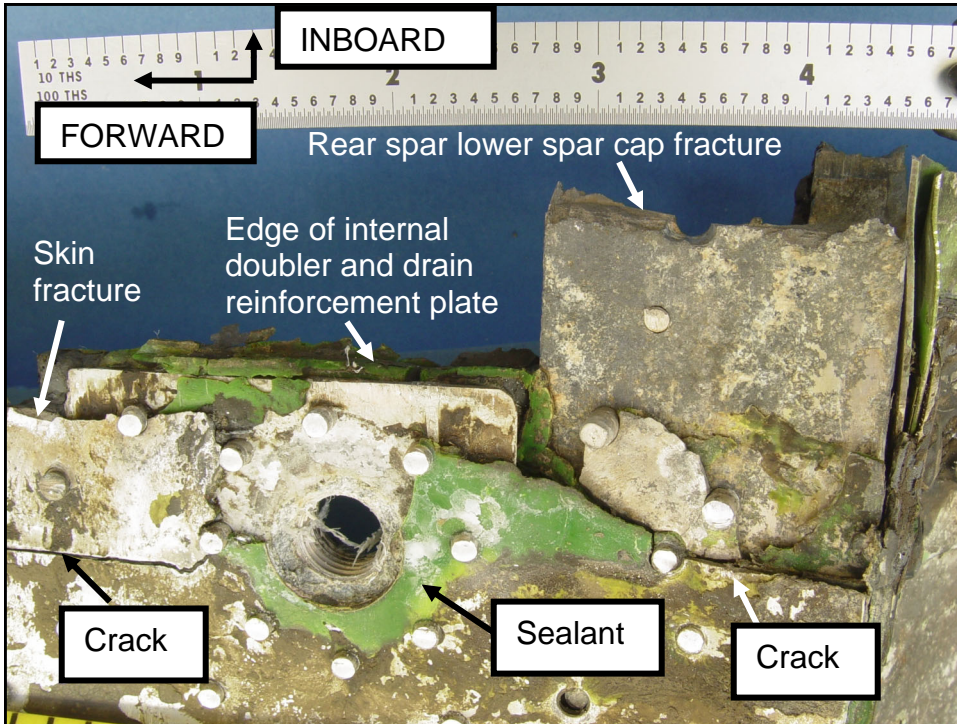
A closer view of the crack in the vicinity of the fuel sump drain hole is shown in figure 7. Skin was mostly missing from the area between the fuel sump drain hole and the ring of fasteners around the hole, and the hard green sealant was observed in its place. Also visible in figure 7, the lower surface of the rear spar was roughened and darkened consistent with corrosion.

Figure 7. Closer view of the lower surfaces of the skin and rear spar lower spar cap shown in the previous figure.

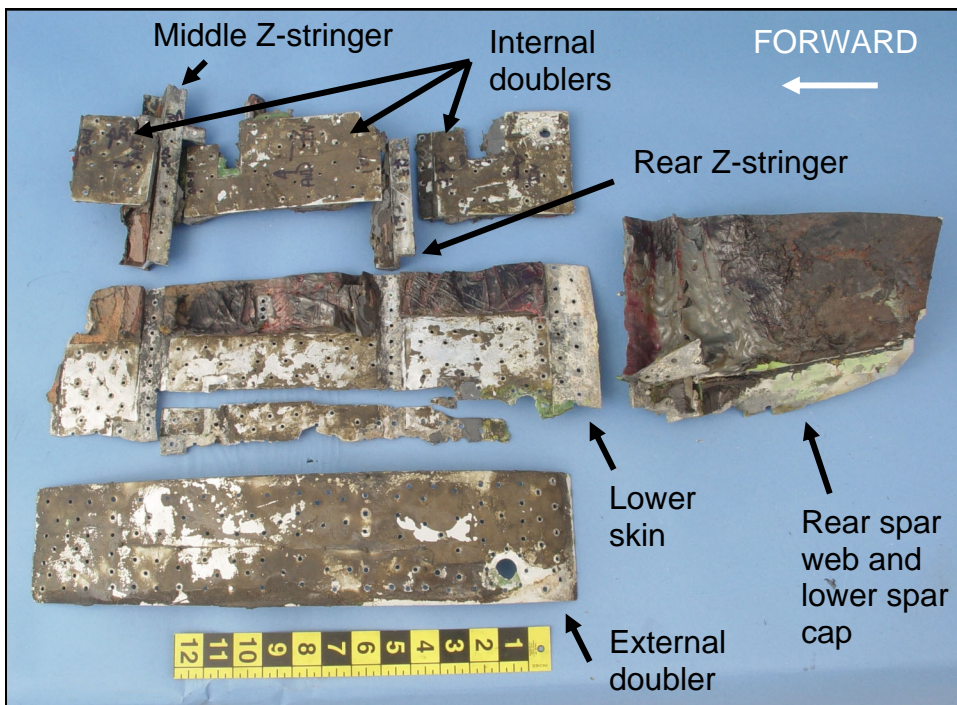
An overall view of the pieces after removing the doublers and stiffeners from the skin is shown in figure 8. Faying surfaces of the doublers and Z-stringers and the upper skin surface are shown. To facilitate examination of the skin crack, the skin was cut from the fracture surface outboard to the forwardmost stop drill hole, and the skin is shown in figure 8 with that cut made.

Figure 8. View of faying surfaces between the right wing lower skin, doublers, and stiffeners in the area of the repair adjacent to right WS 34. For the lower skin, the upper surface is shown.

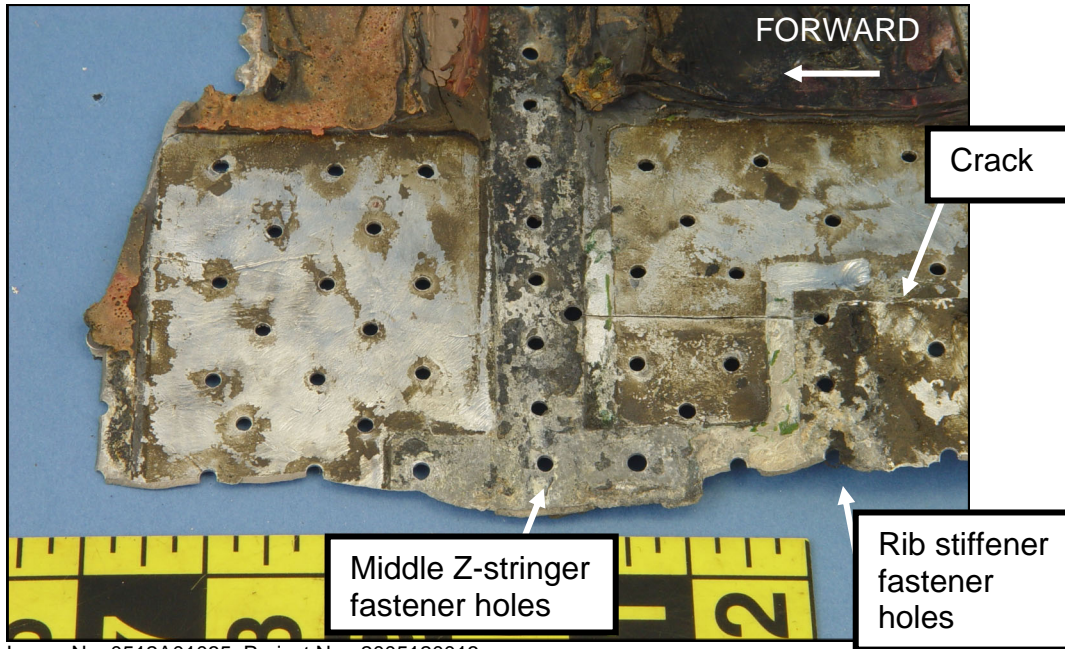
A closer view of the faying surface on the upper side of the skin near the middle Z-stringer is shown in figure 9. The photo shows the area before the cut was made to separate the crack surfaces. The skin faying surfaces for the internal doublers appeared relatively shiny and had a somewhat random scrape pattern. In one area adjacent to the faying surface of the rib stiffener shown in figure 10, material had been removed in a circular area that contained a curved pattern of scratches, identified as a whirl in figure 10. Sealant from this whirl area remained attached to one of the internal doublers, and this sealant retained the shape and scratch pattern from the whirl cavity.

Figure 9. Close view of the upper surface of the lower skin at the middle Z-stringer after removing internal doublers and stiffeners adjacent to right WS 34

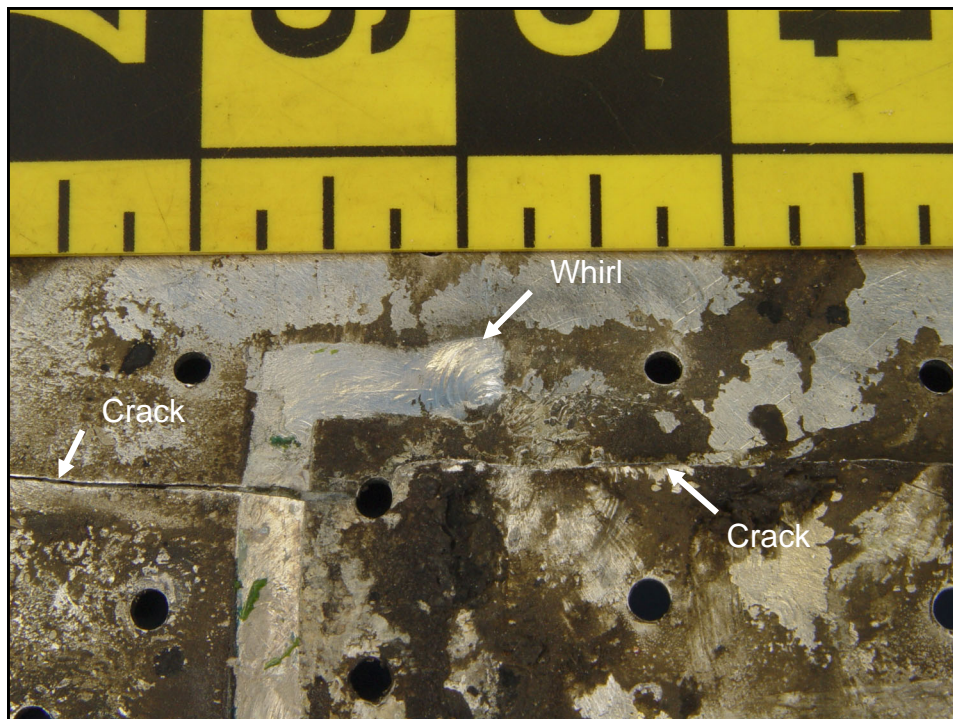
Figure 10. Closer view of the area with a whirl pattern and thinning through the thickness at the edge of the rib stiffener shown in figure 10.

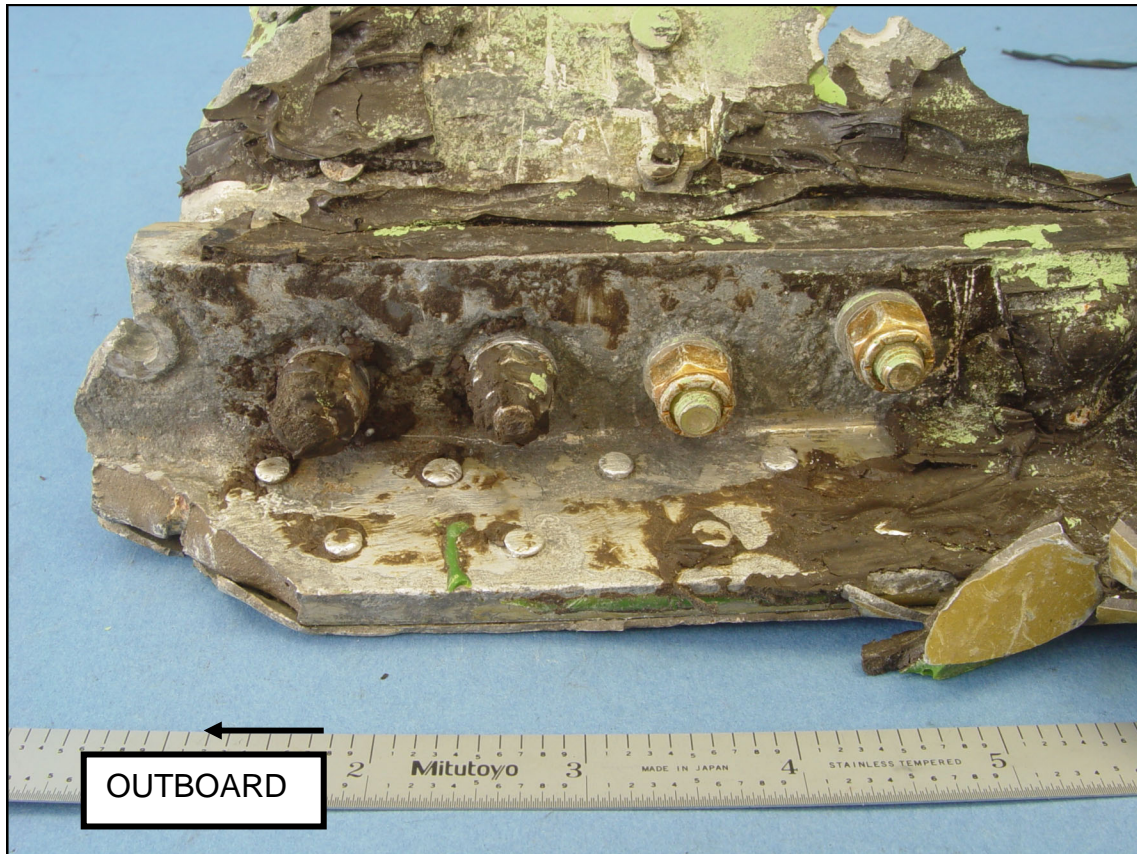
The rear spar lower spar cap adjacent to the fracture just inboard of right WS 34 is shown in figure 11. Sealant was removed from the area by cutting with a razor, soaking with toluene, and scraping with wood or plastic instruments. Grinding or sanding marks were observed on the upper surface of the horizontal flange. Corrosion pits were also observed, particularly around the washers for the threaded fasteners.

Figure 11. View of the rear spar lower spar cap adjacent to the fracture location just inboard of right WS 34 after removal of sealant in the area.

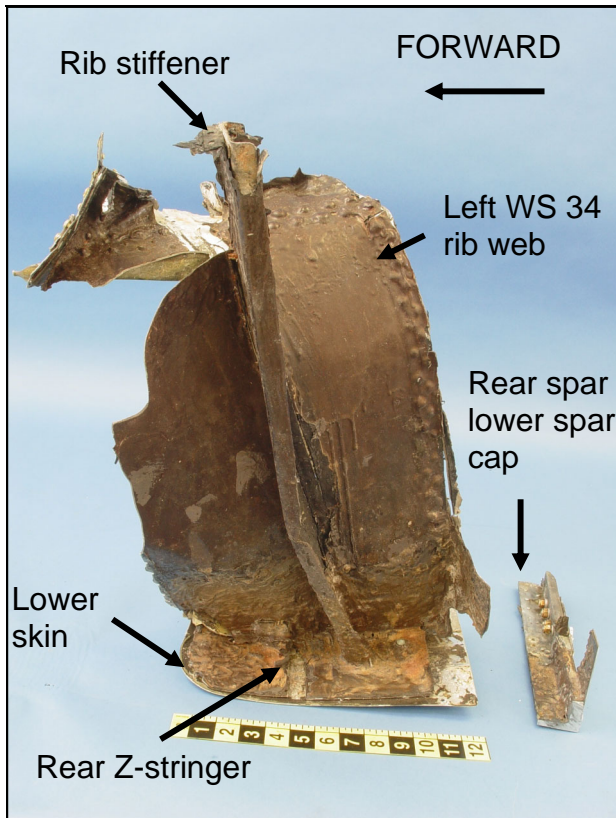
An overall view of the first pieces received in the Safety Board's Materials Laboratory from the left wing side of the wing box beam is shown in figure 12. The pieces included portions of the lower skin panel, the left WS 34 rib, and the rear spar lower spar cap, all from an area near the lower aft side of the wing box beam spanning across left WS 34. Internal and external repair doublers were attached to the skin panel.

The pieces comprised part of the inboard end of the left wing fuel tank, and the internal surfaces outboard of left WS 34 were covered with sealant as shown in figure 12. On the larger piece shown in figure 12, the lower skin panel was fractured at the inboard, outboard, and forward sides of the piece. (The aft edge of the skin panel is a manufactured edge.) The rear spar lower spar cap piece (smaller piece in figure 12) had a fracture surface at its inboard end and a cut surface at its outboard end.

Figure 12. View of the outboard side of wing box beam pieces from the repair area at left WS 34.

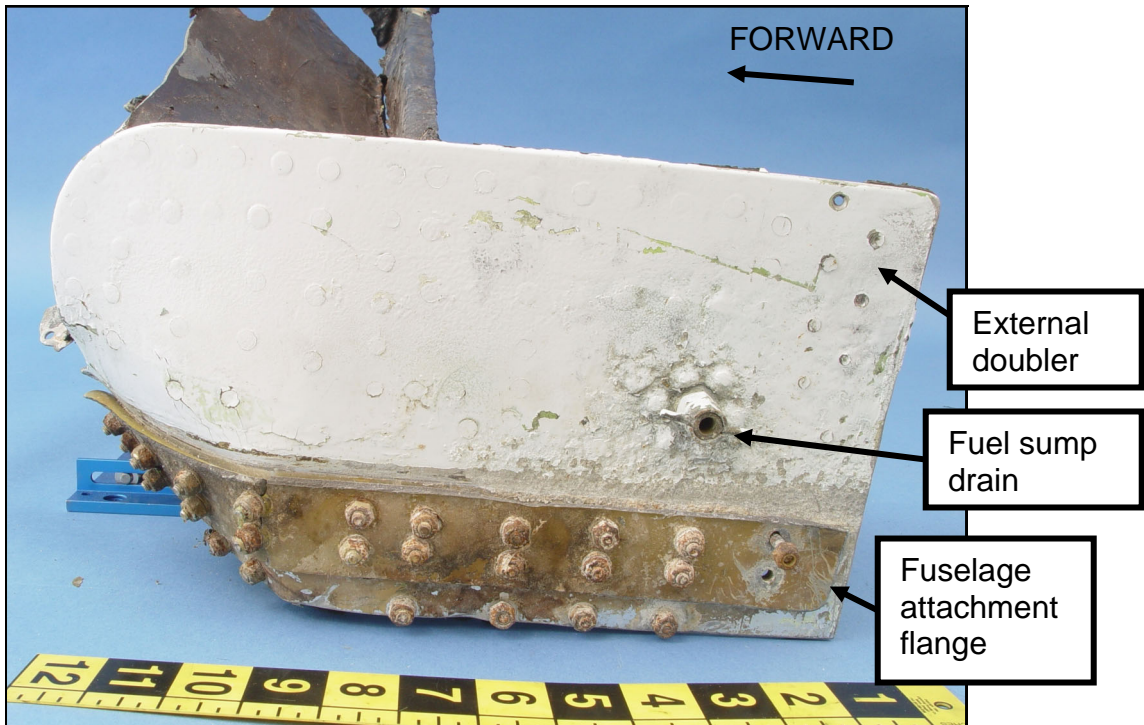
The external doubler on the lower surface of the larger piece from figure 12 is shown in figure 13. The skin fracture occurred mostly within the boundary defined by the edge of the external doubler, and no skin is visible in figure 13. The horizontal flange of a portion of the fuselage attachment angle was attached to the piece as shown in figure 13. The fuselage attachment angle was fractured in the transition radius between the horizontal and vertical flanges of the angle. The lower surface of the external doubler was rough and pitted around the fuel sump drain consistent with corrosion in that area.

Figure 13. View of the external doubler and fuselage attachment angle on the lower surface of the left wing piece shown in the previous figure.

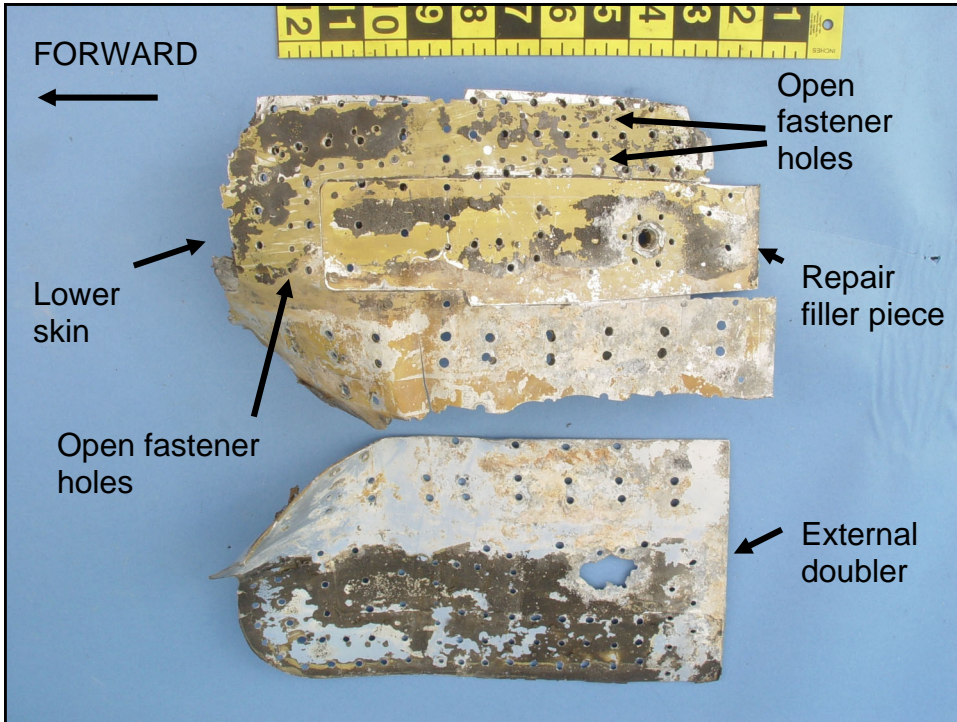
The faying surfaces between the skin and the external doubler are shown in figure 14 after the external doubler was removed. A repair filler piece in the skin as indicated in figure 14 was observed within the area of skin covered by the external doubler. Some corrosion was observed on the faying surface of the lower skin in the area of the fuselage attachment angle holes. Also visible in figure 14 is the irregularly-shaped hole in the doubler material around the sump drain where material substantially thinned by corrosion had broken away during rivet removal.

Figure 14. View of faying surfaces of the lower skin and external doubler after removing the doubler in the repair area at left WS 34.

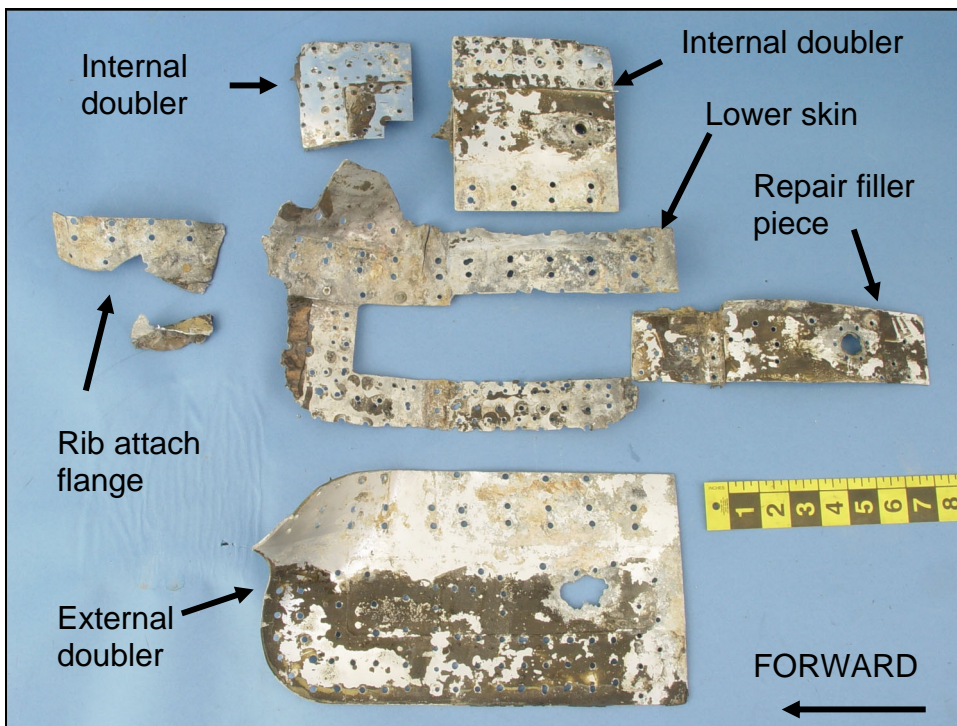
Some flush head fasteners were present fastening the skin and the internal doublers. These fasteners were removed by drilling through the fasteners with a countersink drill bit. Then, the internal doublers and rib attach angle pieces were pried from the skin and repair filler pieces using wooden tongue depressors. An overall view of the skin and the faying surfaces of the pieces that were attached to it is shown in figure 15.

Figure 15. View of faying surfaces of the left wing lower skin and internal and external doublers at left WS 34. For the lower skin, the upper surface is shown.

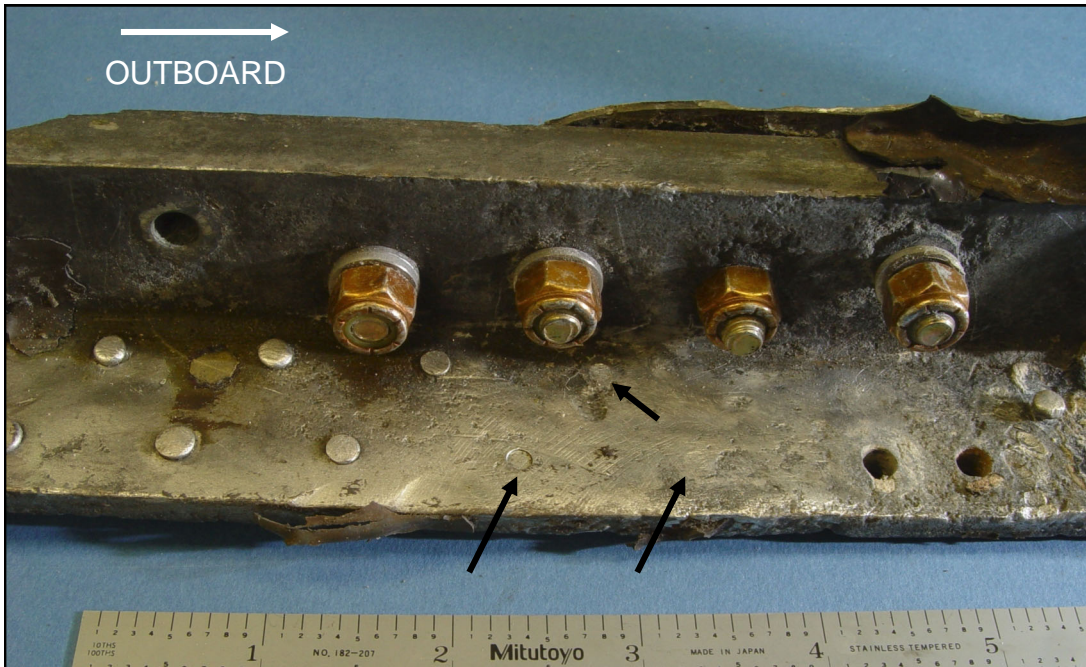
As shown in figure 16, the rear spar lower spar cap was thinned in an area just inboard of left WS 34. Grinding or sanding marks were observed on the upper surface of the horizontal flange, and several rivet tails were missing. Corrosion pits were also observed, particularly around holes for bolted fasteners.

Figure 16. View of the lower spar cap just inboard of left WS 34 showing grinding or sanding marks and corrosion. Unlabeled arrows indicate rivets with missing tails on the horizontal flange.

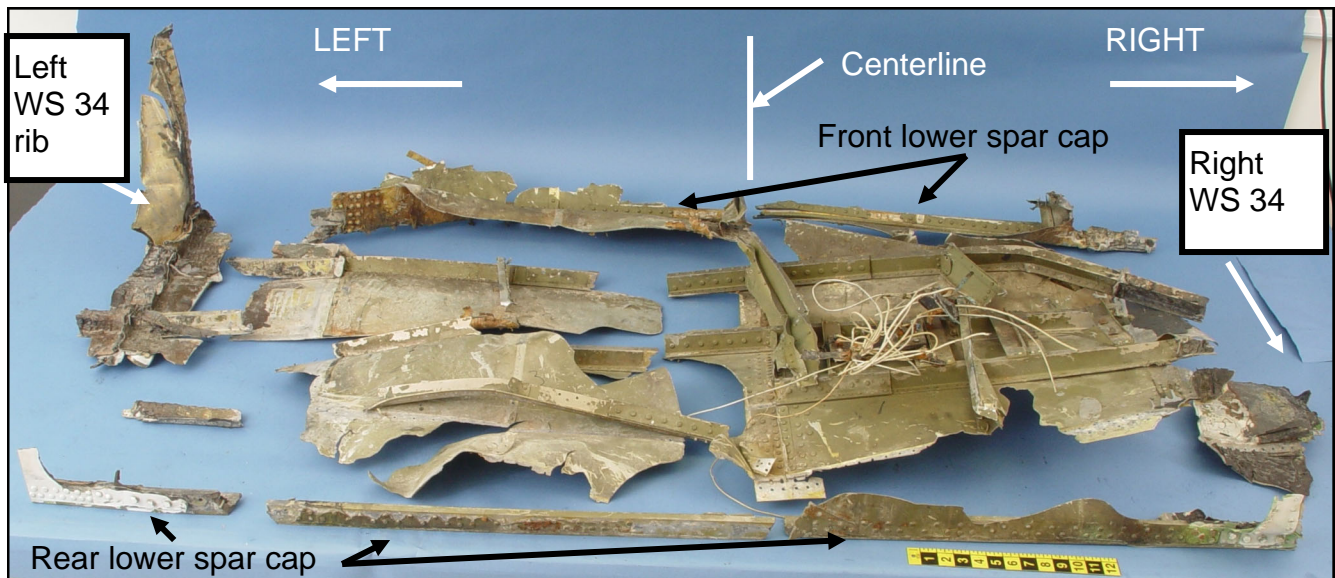
An overall view of the recovered pieces from the lower side of the wing box beam in the carrythrough portion between left and right WS 34 is shown in figure 17. These pieces mostly remained with the main portion of the airplane after separation of the right wing. The lower spar caps for the front and rear spars and the skin panel were fractured chordwise near the centerline. The skin panels also were fractured spanwise in several locations. The chordwise fractures near the centerline and the spanwise fractures in the skin panels showed deformation, rough fracture surfaces, and slant fracture planes consistent with overstress fracture. Other fractures on these pieces near right and left WS 34 will be discussed subsequent sections of this report.

Figure 17. View of recovered pieces of the lower skin panel and lower spar caps for the carrythrough portion of the wing box beam. View is of the internal surface of the wing box beam pieces viewed looking forward.

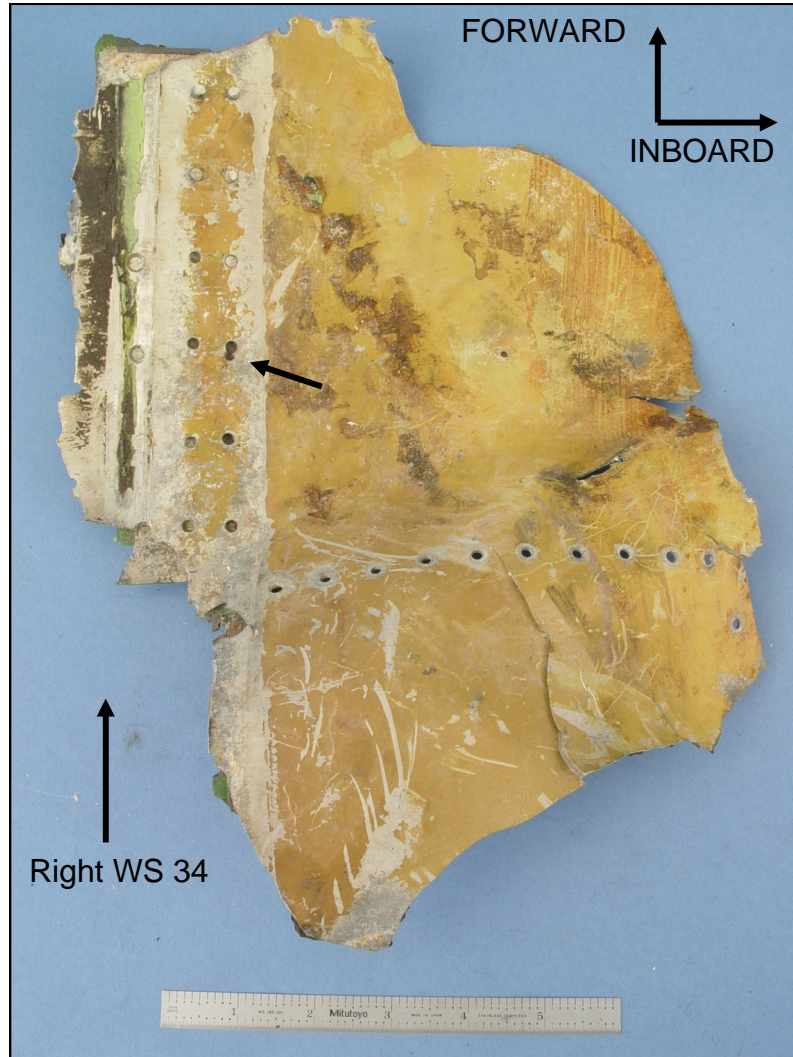
Figure 18. View of the lower surface of the lower skin at the carrythrough portion of the wing box beam near right WS 34. The unlabeled arrow indicates a double-drilled hole in the inboard fastener hole row for the fuselage attachment angle.

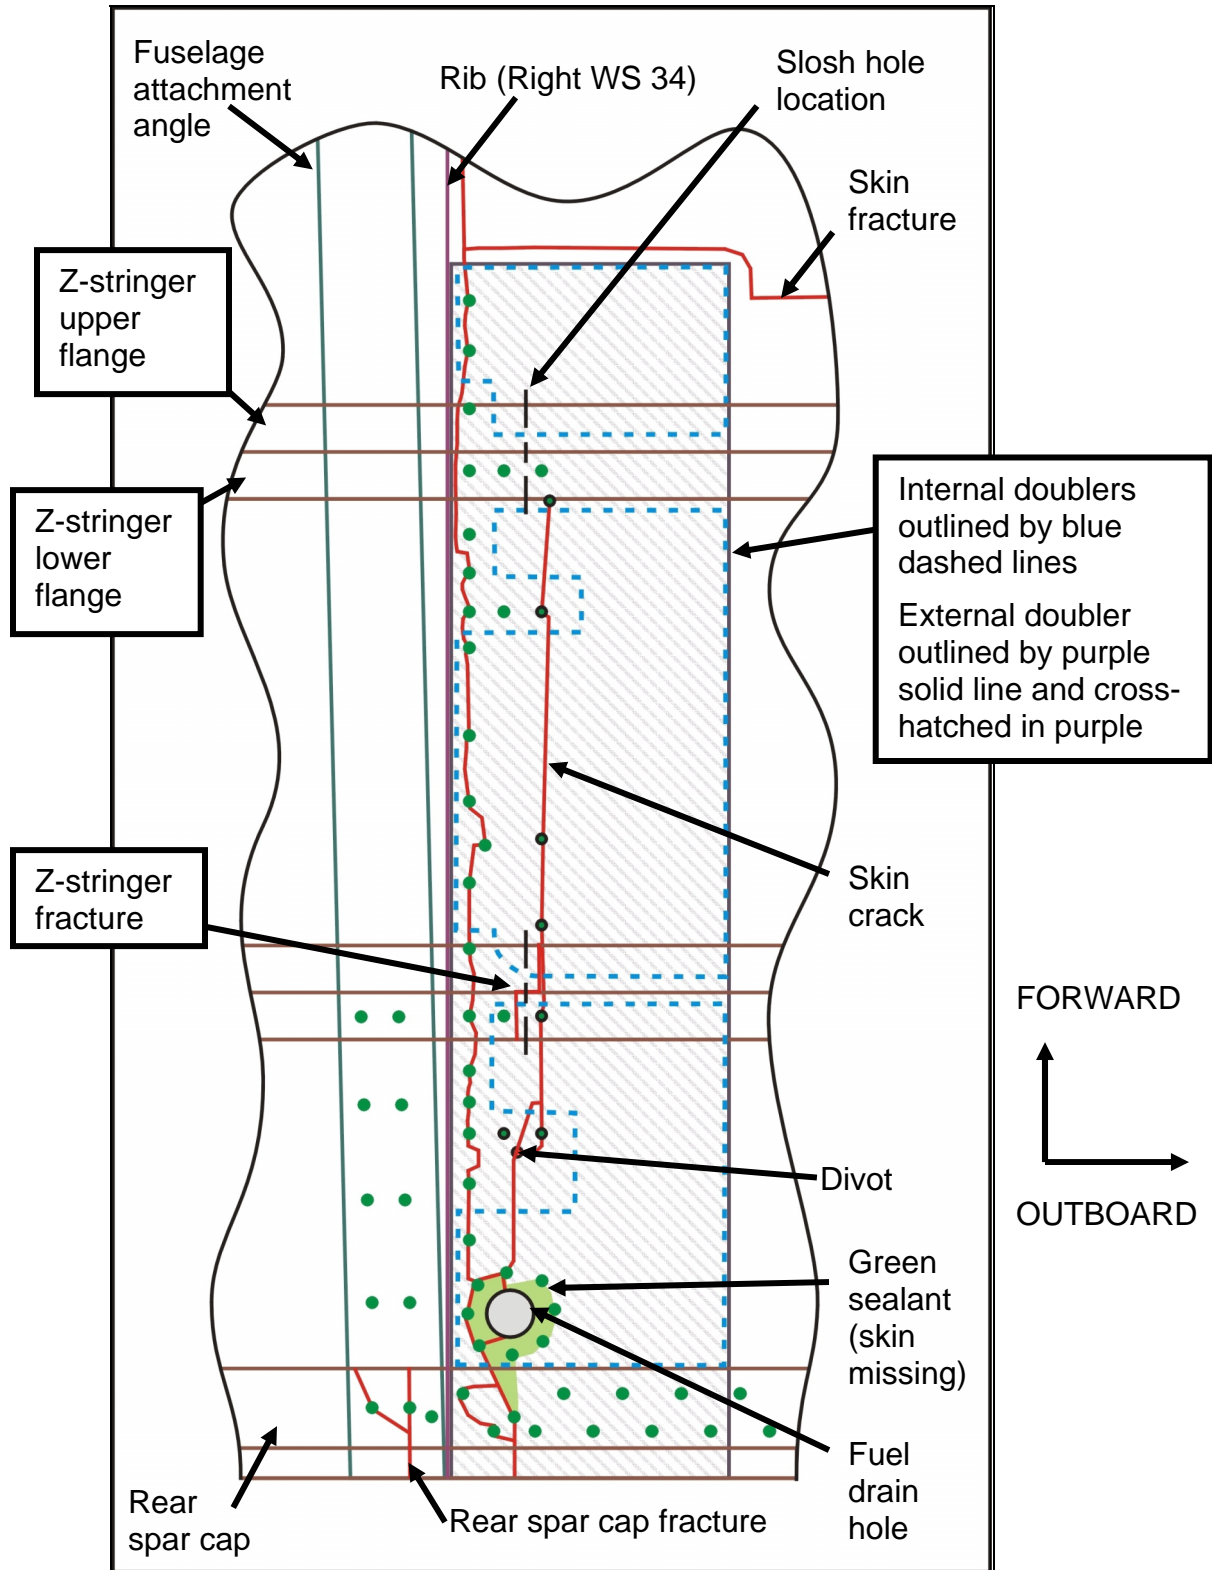
A diagram showing the approximate locations of fractures and the skin crack in the area of the repair near right WS 34 is shown in figure 19. Some of the structural features in the area are also shown, including the repair doublers, Z-stringers, rear spar lower spar cap, rib, and fuselage attachment angle.

The rear spar lower spar cap had a transverse fracture approximately one inch inboard of right WS 34 that intersected the outboard bolt hole for the horizontal flange of the fuselage attachment angle as shown in the drawing in figure 19. A secondary fracture intersected the transverse fracture and the inboard bolt hole for the horizontal flange of the fuselage attachment angle, and the piece of spar cap between the two fractures was missing.

Figure 19. Schematic view of the wing box beam structure including repair doublers at right WS 34. Selected fastener locations are indicated with solid green circles. Circles with black outlines and green centers indicate holes in the skin and/or stringers that did not have fasteners.

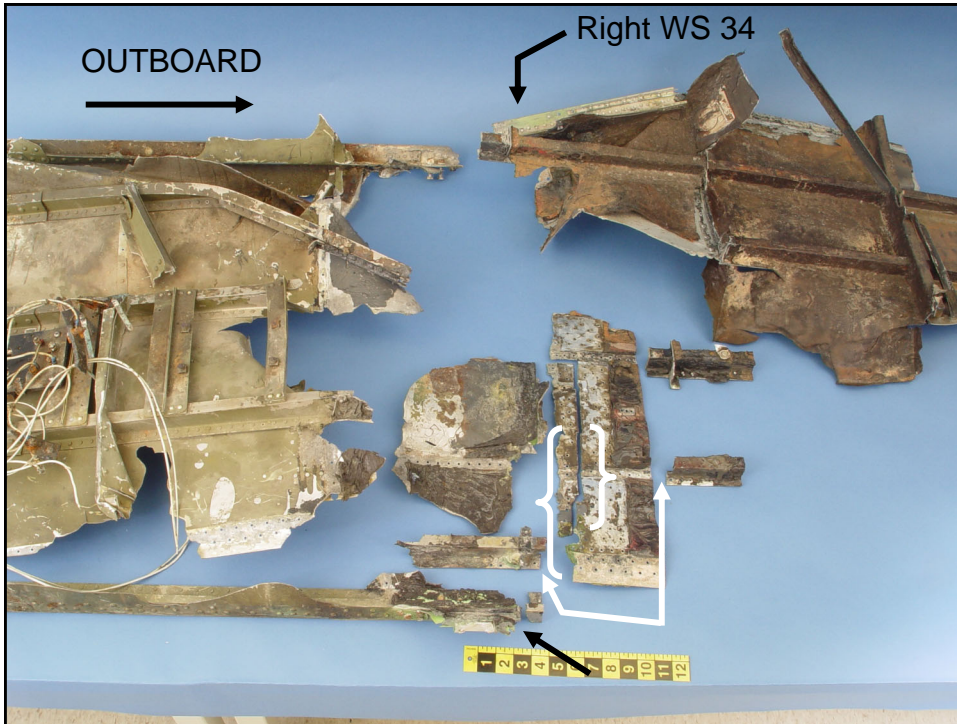
An overall view of the lower skin panel and lower spar cap pieces from the wing box beam at right WS 34 are shown in figure 20. The pieces in this figure are arranged approximately in the same orientation as the diagram in figure 19. Unlabeled arrows and brackets in figure 20 indicate locations in the rear spar lower spar cap, rear Z-stringer, and lower skin where features typical of fatigue were observed on the fracture surfaces. These areas will be individually discussed in the following sections.

Figure 20. View of the lower skin and lower spar cap pieces of the wing box beam at right WS 34. Unlabeled arrows and brackets indicate fatigue locations in the skin, rear Z-stringer, and rear spar lower spar cap.

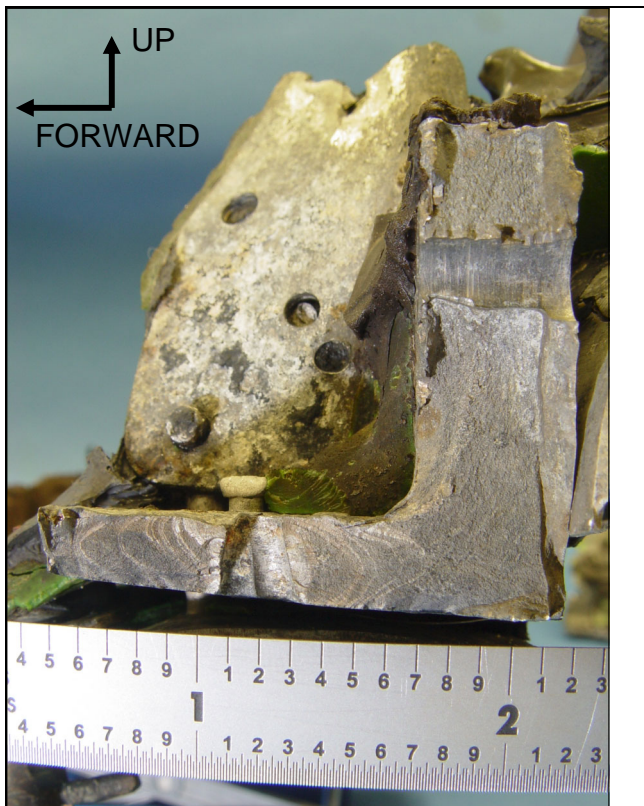
Views of the outboard surface of the transverse fracture in the rear spar lower spar cap are shown in figures 21 and 22. Portions of the fracture surface appeared relatively flat with smoothly curving arrest lines, features consistent with fatigue. A closer view of the

Figure 21. Close view of the outboard side of the rear spar lower spar cap transverse fracture just inboard of right WS 34. Fatigue features emanated from a double-drilled fastener hole.

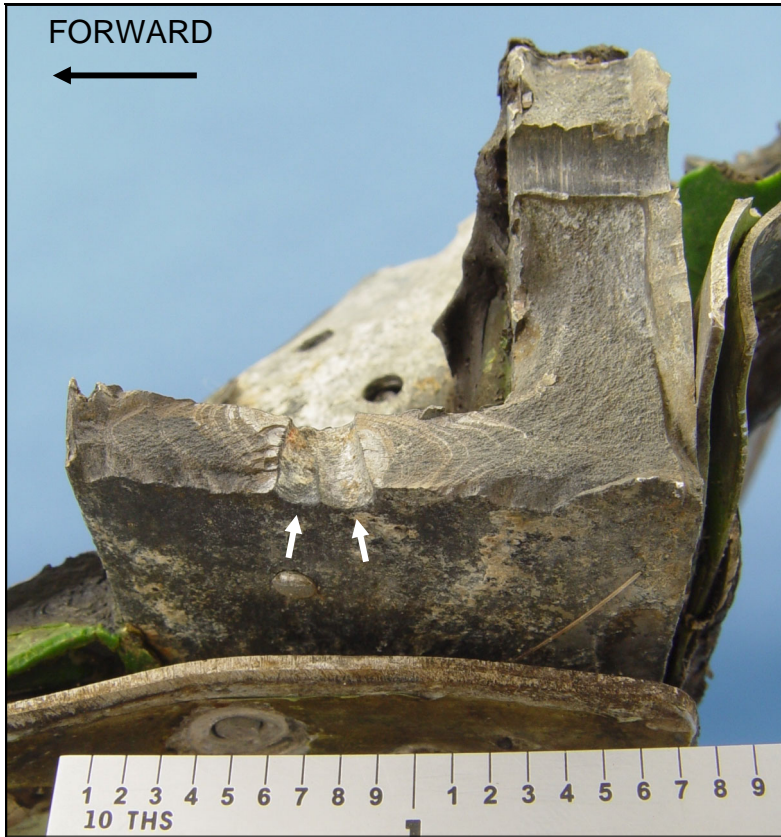
As indicated by the two white arrows in figure 22, the bolt hole consisted of two separately drilled channels. One of these channels had an axis perpendicular to the flange surface, and the other channel had an axis at an angle of approximately 17 degrees from perpendicular, with the lower end of the hole being further aft than the upper end of the hole. Corrosion and deposits were greater in the portion of the hole corresponding only to the perpendicular channel, suggesting that the fuselage attachment angle bolt had last been installed through the angled channel.

Figure 22. Another view of the rear spar lower spar cap fracture shown in the previous figure. Unlabeled arrows indicate a double-drilled hole.

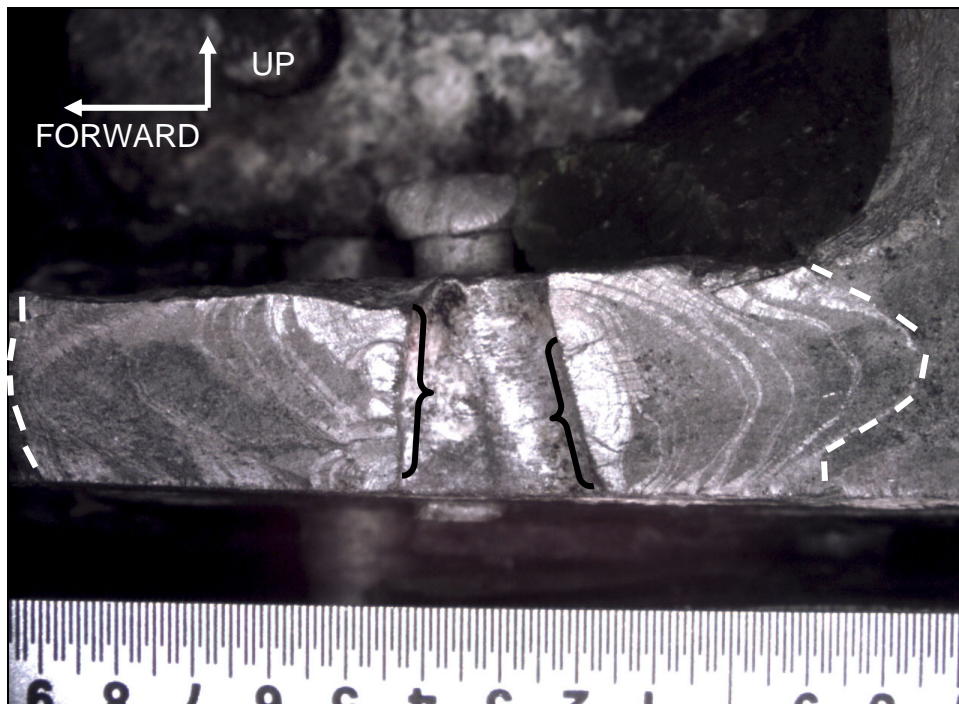
fatigue region in the horizontal flange of the spar cap is shown in figure 23, where dashed lines indicate the fatigue boundaries. Fatigue features emanated from the bolt hole for the outboard fastener for the fuselage attachment angle. Multiple fatigue origins were observed along the hole bore through the thickness within the regions defined by the unlabeled brackets in figure 23. A closer view of the bolt hole and fatigue origin area is shown in figure 24.

Figure 23. Closer view of the fatigue region on horizontal flange of rear spar lower spar cap. Dashed lines indicate the fatigue boundaries, and brackets indicate the fatigue origin areas.

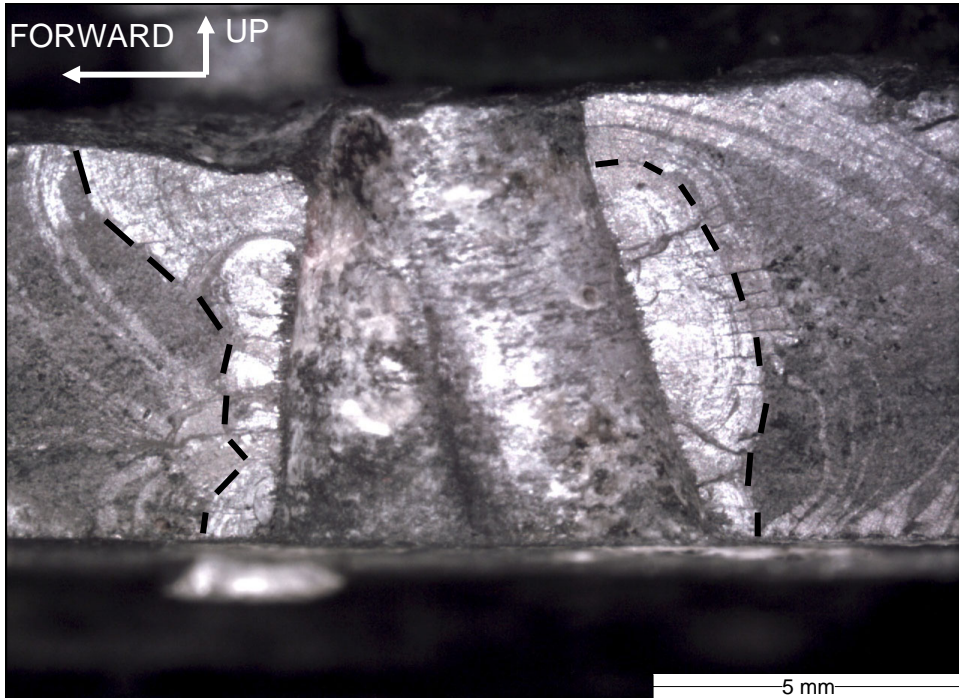
Relatively flat regions with large numbers of crack arrest positions, indicative of slower growth fatigue cracking, emanated from the origin areas both forward and aft of the bolt holes. These slower growth regions extended a maximum of 0.15 inch forward of the bolt hole and 0.07 inch aft of the bolt hole, up to the positions indicated by the dashed lines in figure 24. The remainder of the fatigue region beyond the dashed line positions in figure 24 had a mixture of curving flat regions with crack arrest positions (appearing light gray in figures 23 and 24) separated by rougher regions without crack arrest positions (appearing darker gray in figures 23 and 24). The flat light gray regions indicate areas of relatively slow crack growth and crack arrest, and the rougher, darker gray regions indicate areas of relatively fast crack growth or overstress regions. Upon inspection under magnification, approximately 11 areas of relatively slow growth between areas of fast growth were observed in the fatigue region aft of the bolt hole.

Figure 24. Closer view of the fatigue origin areas. Dashed lines indicate the extent of flat regions near the origin areas.
