NATIONAL TRANSPORTATION SAFETY BOARD

MATERIALS LABORATORY FACTUAL REPORT

Report No. 06-010

Place : Miami, Florida
Date : December 19, 2005
Vehicle : Grumman G-73T Mallard, N2969
NTSB No. : DCA06MA010
Investigator : Brian Murphy, AS-40

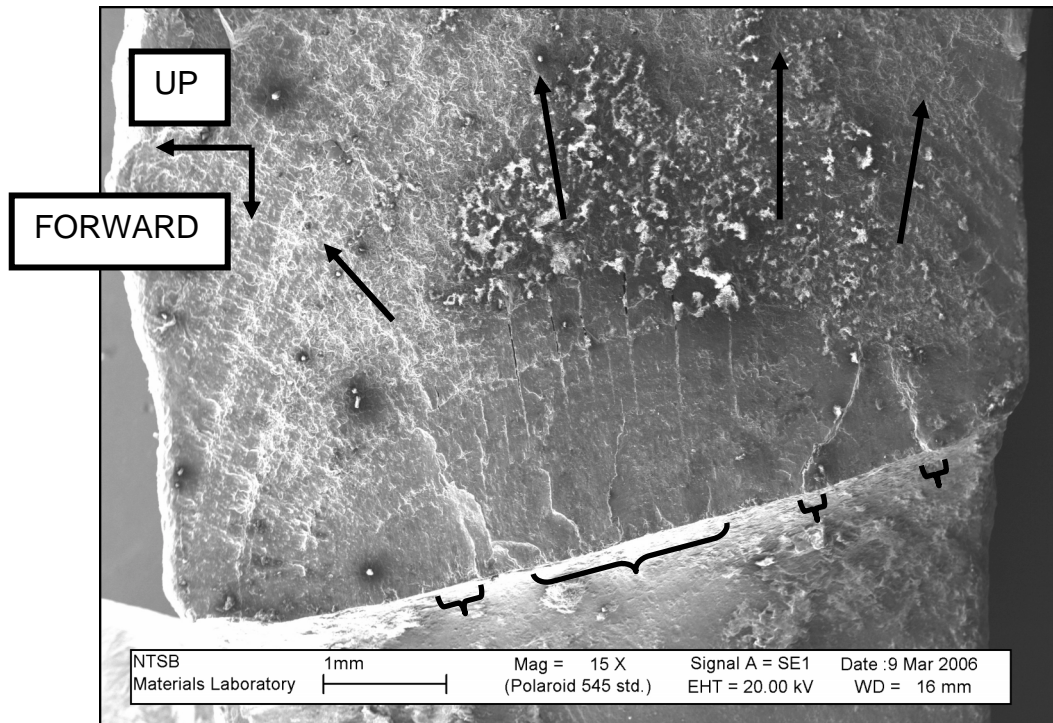
Figure 25. SEM view of the origin areas at the aft side of the hole. Unlabeled brackets indicate origin areas and unlabeled arrows indicate fatigue propagation directions.

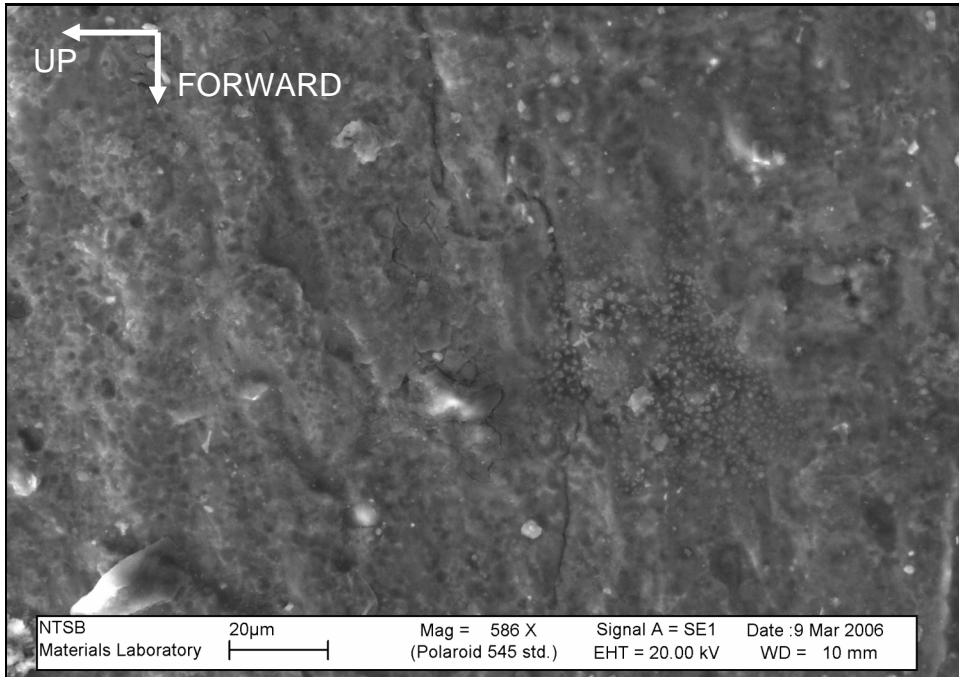
Figure 26. Closer SEM view of the fracture surface near an origin area at the aft side of the hole showing corrosion and rub damage. Orientation of the spar cap is the same as in the previous figure.

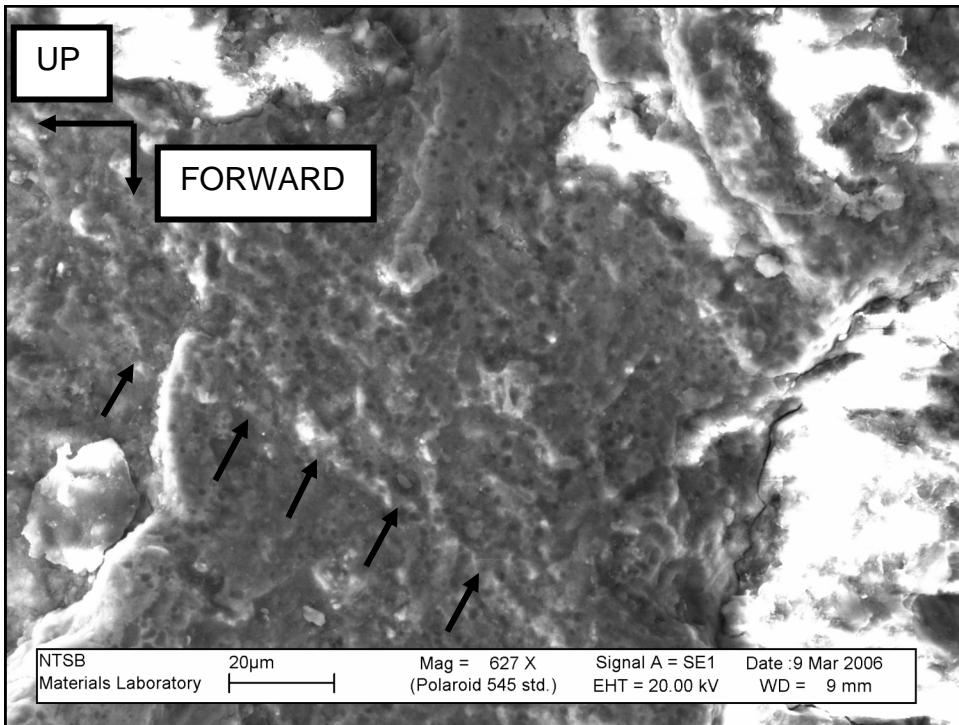
Figure 27. Close view of fracture features near the fatigue boundary showing corrosion damage. Unlabeled arrows indicate a possible striation.

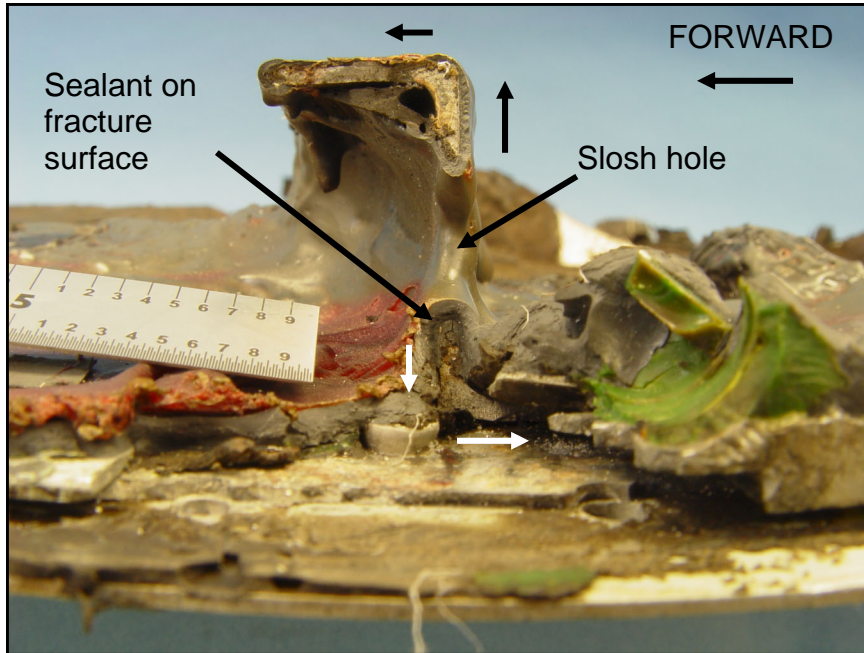
Figure 28. Close view of the rear Z-stringer fracture near right WS 34. Fatigue features emanated from a slosh hole in the stringer web as indicated with unlabeled arrows.

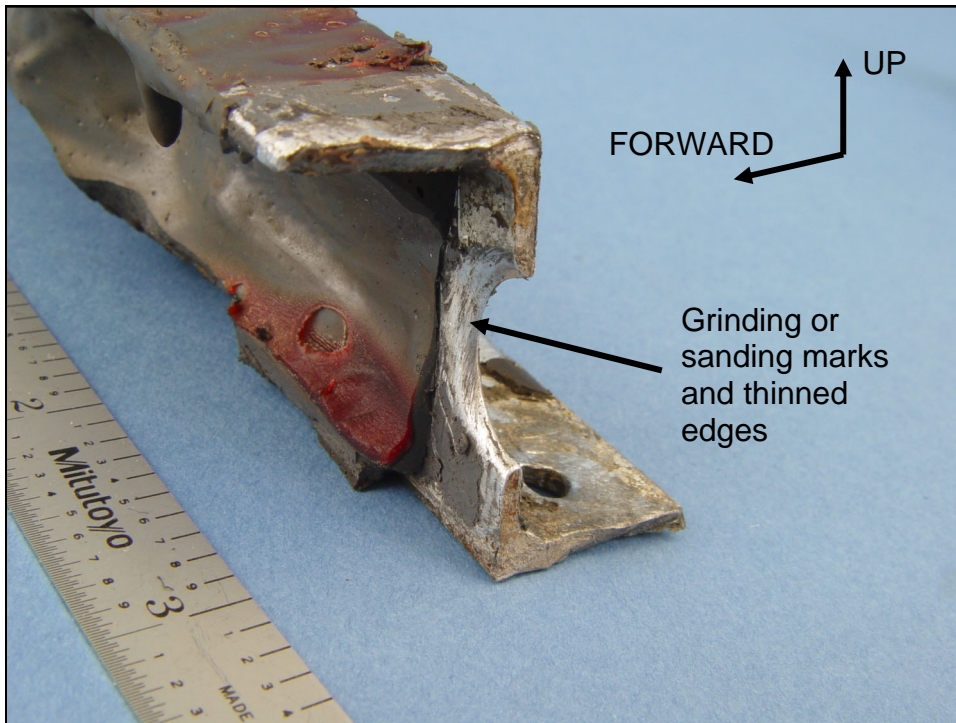
Figure 29. View of rear Z-stringer fracture near right WS 34 after sealant removal.

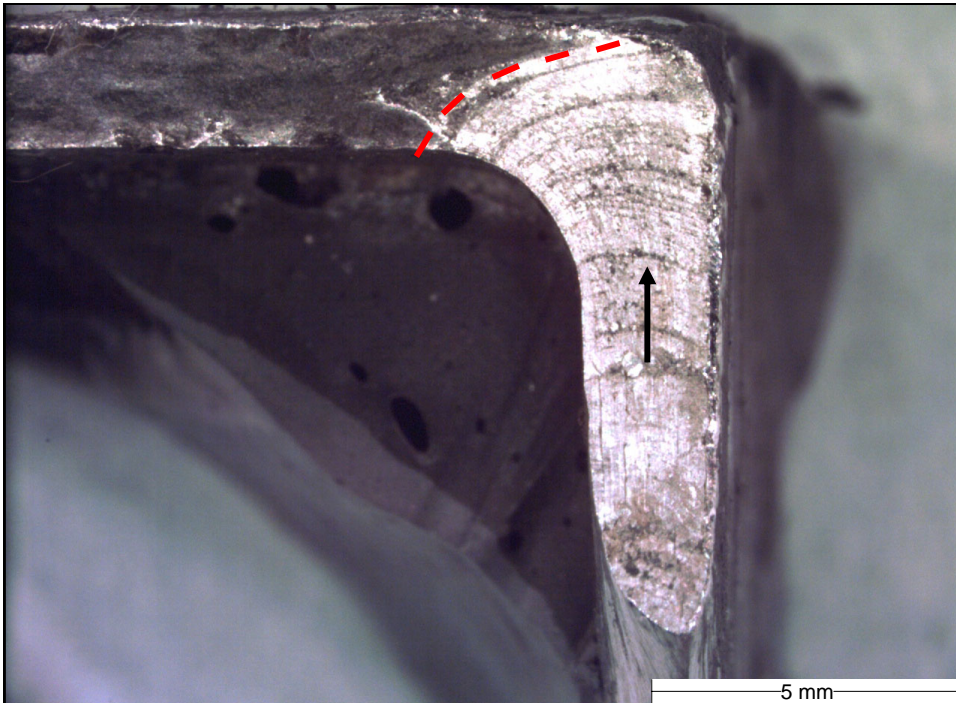
Figure 30. Close view of fatigue at upper side of hole in rear Z-stringer fracture near right WS 34. A dashed line indicates the fatigue boundary, and an unlabeled arrow indicates the local fatigue propagation direction.

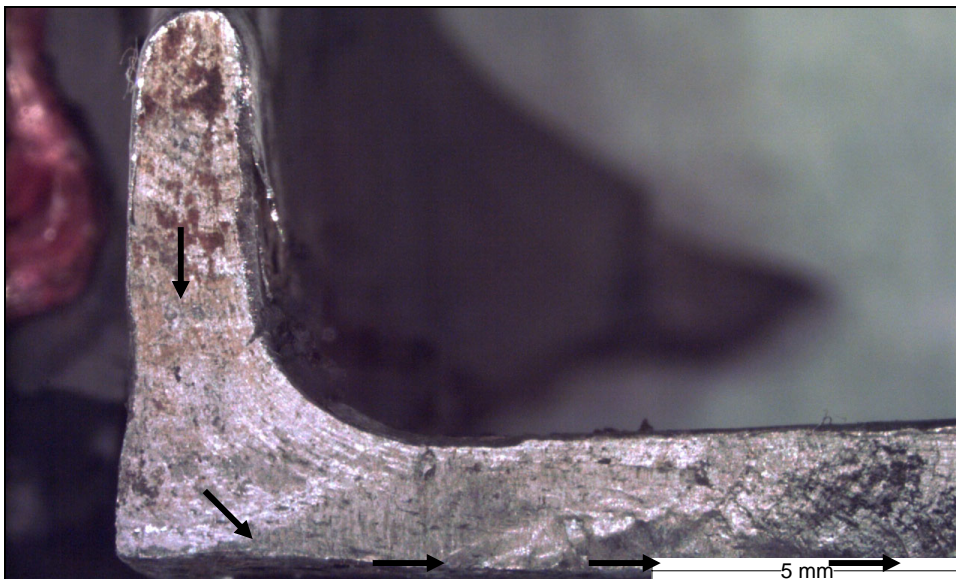
Figure 31. Close view of fatigue at the lower side of the slosh hole in the rear Z-stringer fracture near right WS 34. Unlabeled arrows indicate the local fatigue propagation directions.

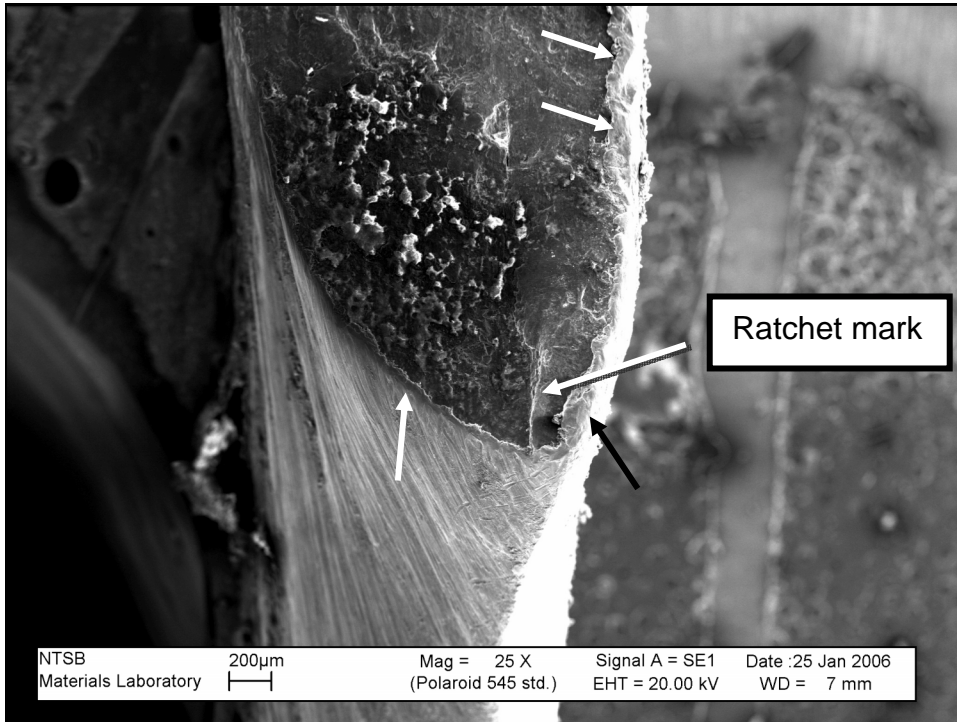
Figure 32. SEM view of the fatigue origin area at the upper side of the sash hole in the rear Z-string near right WS 34. Unlabeled arrows indicate deformation lips at the edge of the fracture surface.

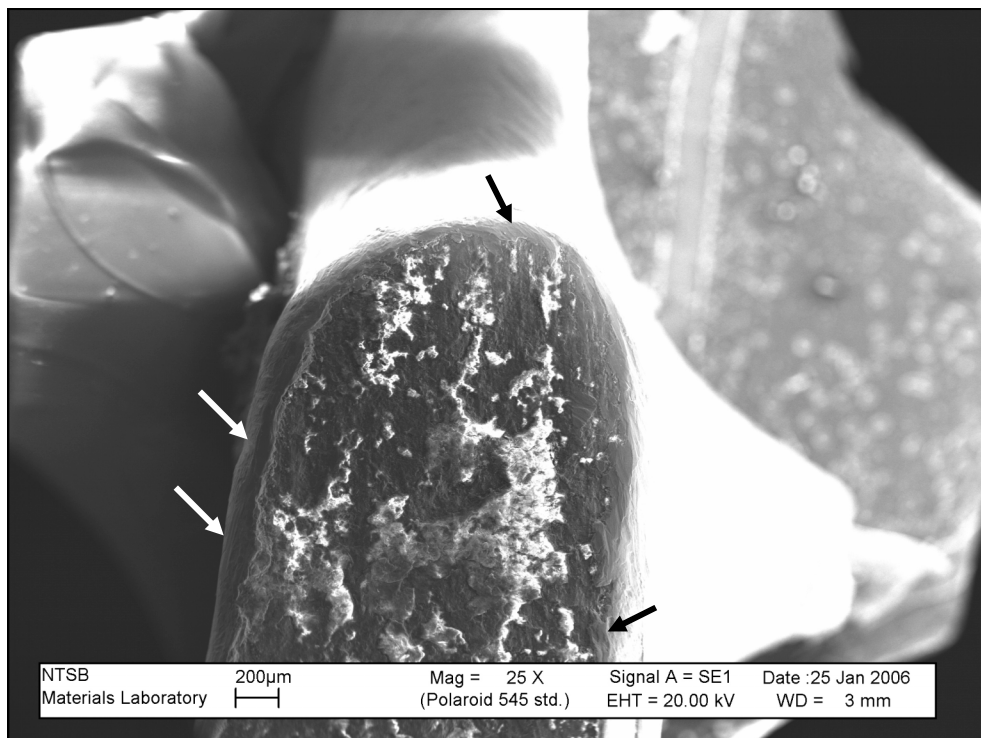
Figure 33. View of the fatigue origin area at the lower side of the sash hole for the rear Z-stringer fracture near right WS 34. Arrows indicate deformation lips at the edge of the fracture surface.

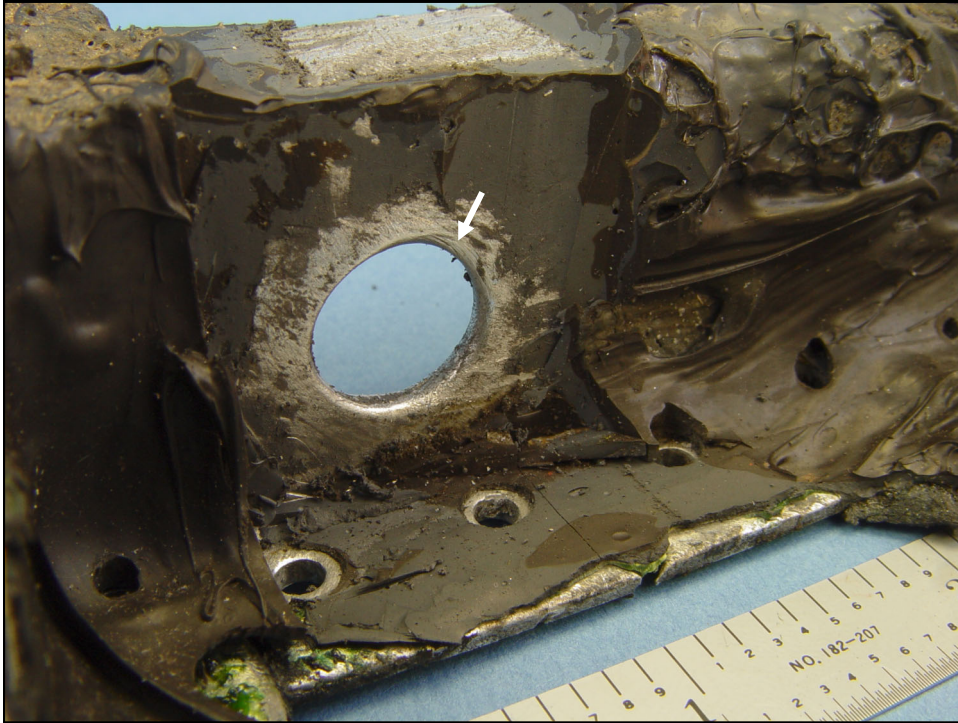
Figure 34. View of the slosh hole for middle Z-stringer just outboard of right WS 34. An arrow indicates a small area of grinding or sanding marks and thinning at the edge of the hole.

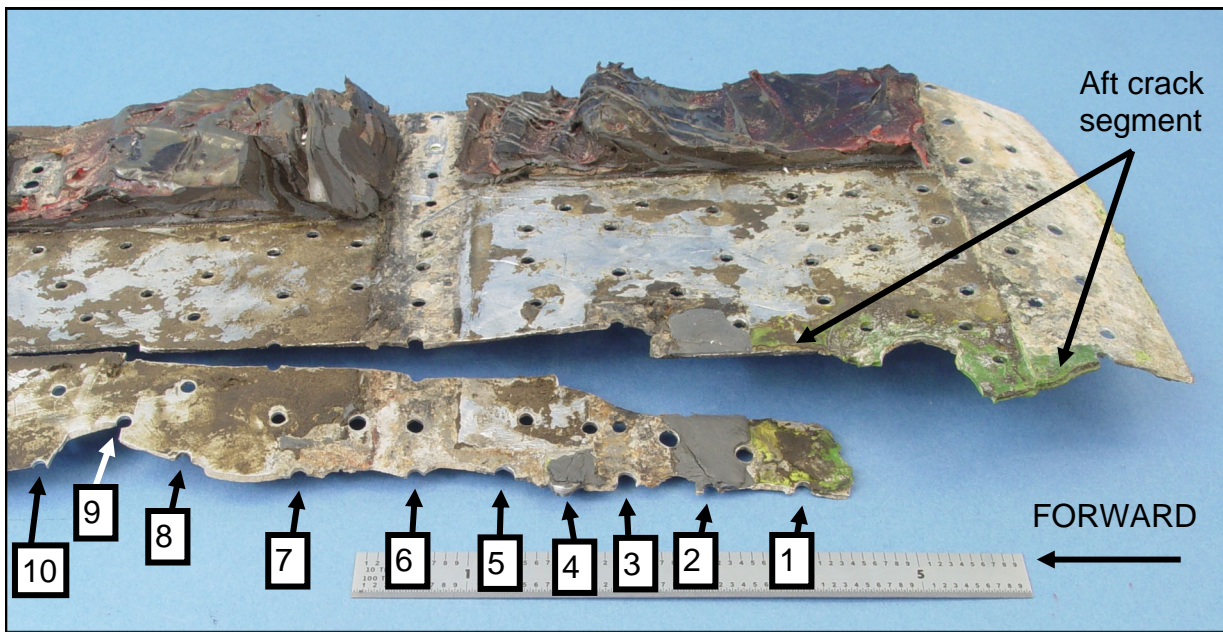
Figure 35. View of right wing lower skin fracture at inboard fastener holes for doublers. Fastener holes intersected by the skin fracture forward of the green sealant are numbered for reference. Fatigue features were observed emanating from holes 1, 2, 5, 6, 7, and 9.

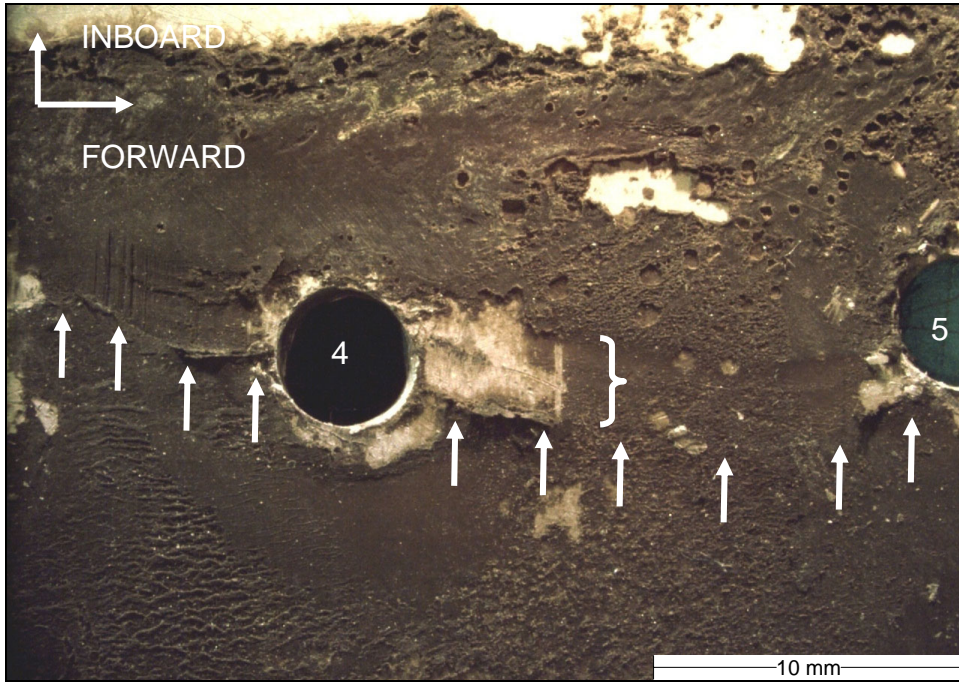
Figure 36. View of the faying surface of the external doubler near fastener holes 4 and 5. Arrows indicate locations of sealant pushed up at the skin fracture, and a bracket indicates a region of spanwise sliding contact.

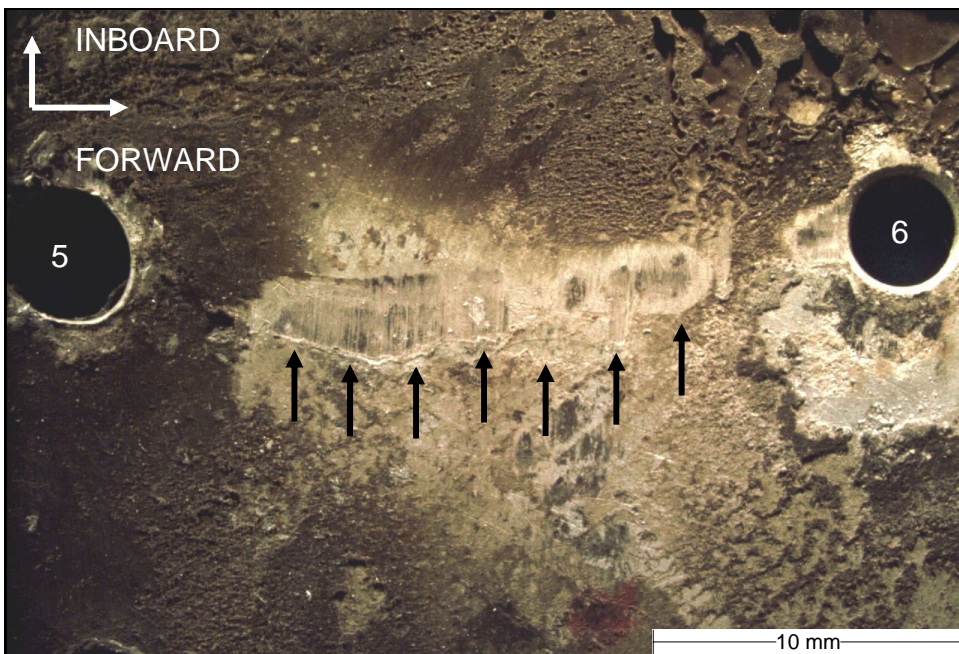
Figure 37. View of the faying surface of the external doubler between fastener holes 5 and 6. Unlabeled arrows indicate a step in the doubler surface at the skin fracture and spanwise sliding contact marks just inboard of the step.

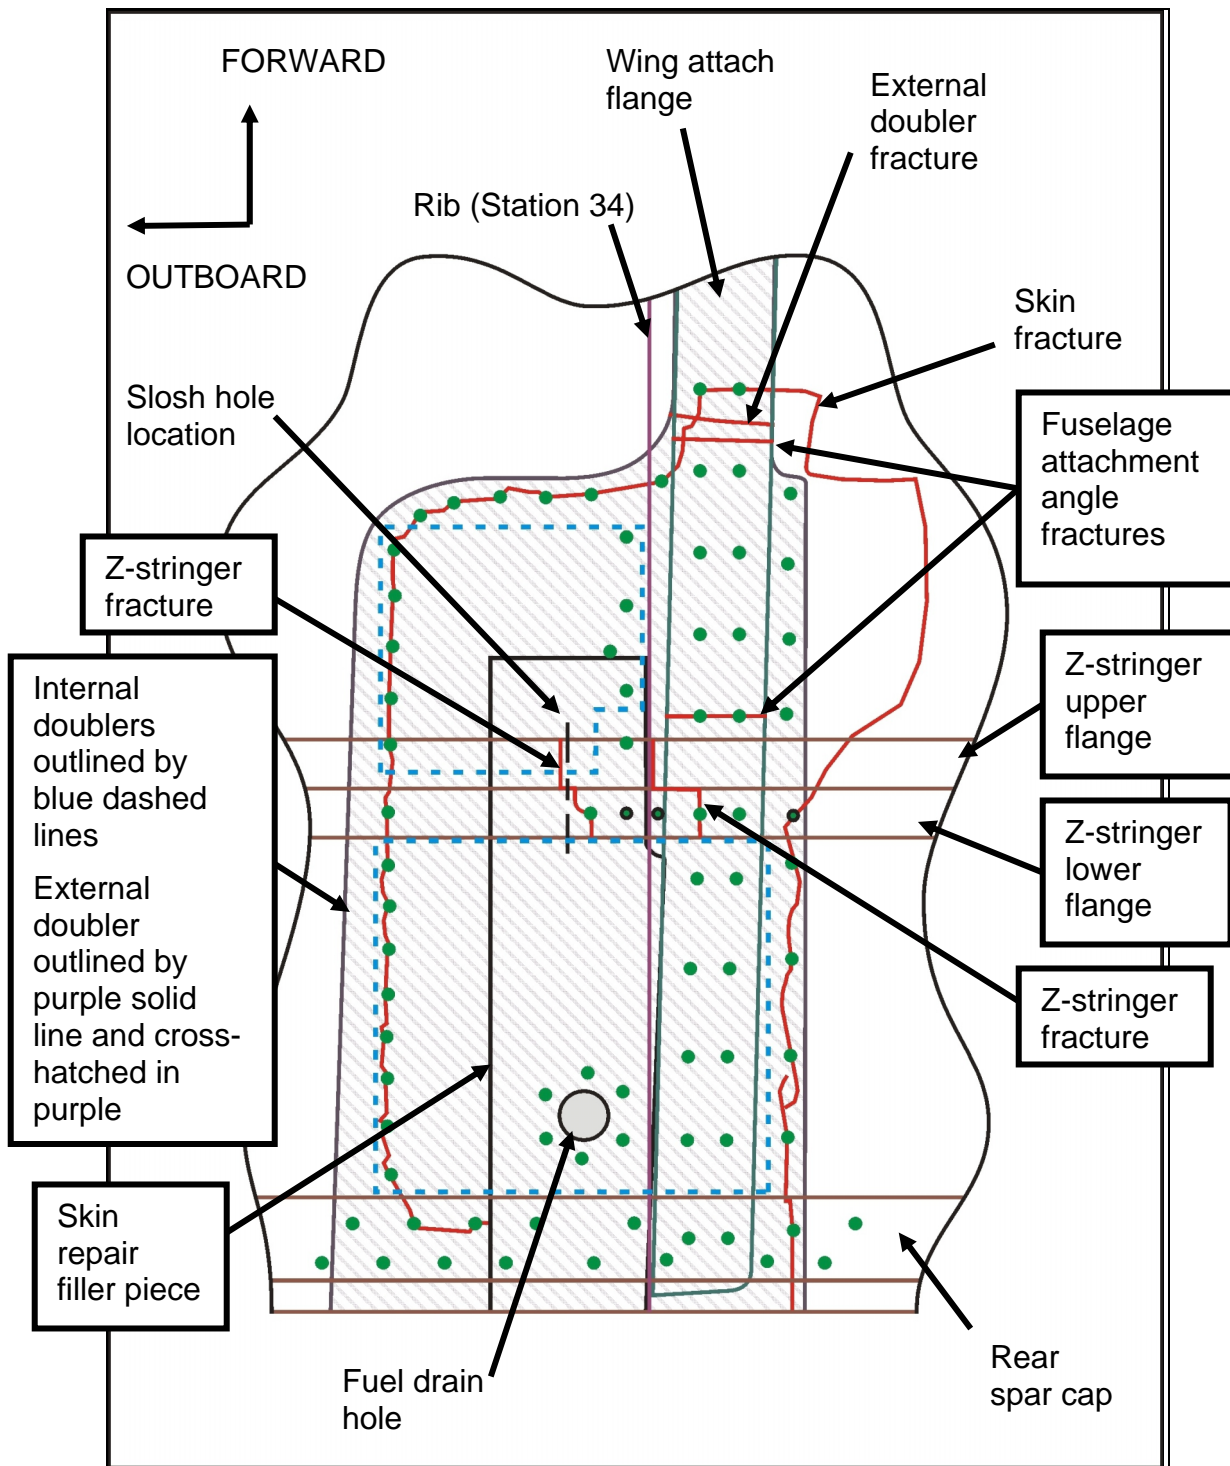
Figure 38. Schematic view of the wing box beam structure at left WS 34. Selected fastener locations are indicated with solid green circles. Circles with black outlines and green centers indicate holes in the skin and/or stringers that did not have fasteners.

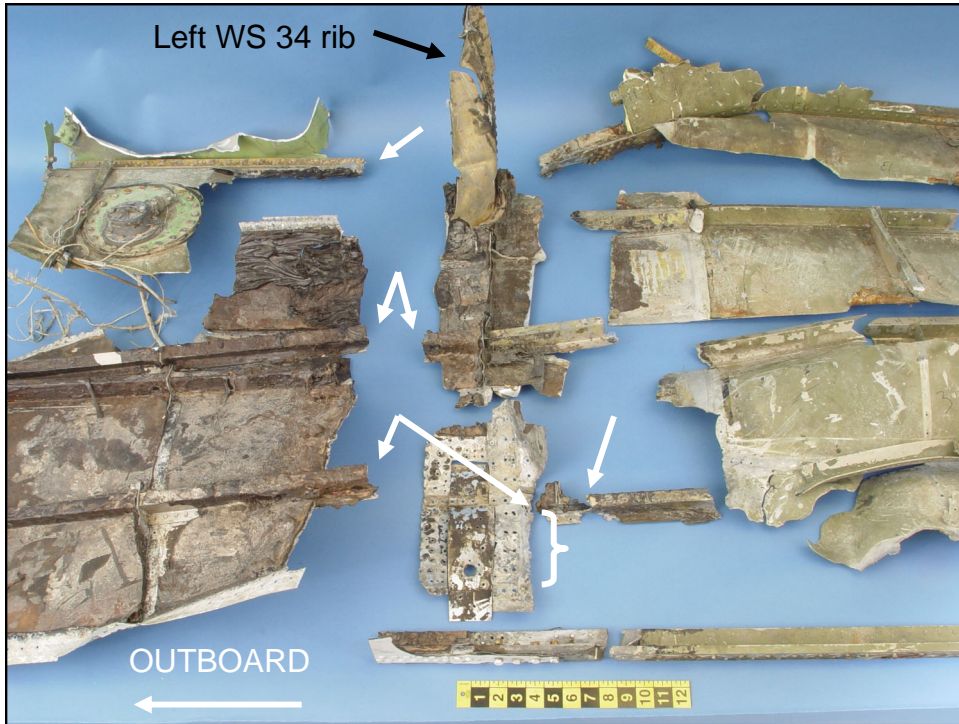
Figure 39. View of pieces of the wing box beam at left WS 34. The lower skin piece is shown with internal and external doublers removed. The unlabeled arrows and bracket indicate fatigue locations in the skin, Z-stringers, and front spar lower spar cap.

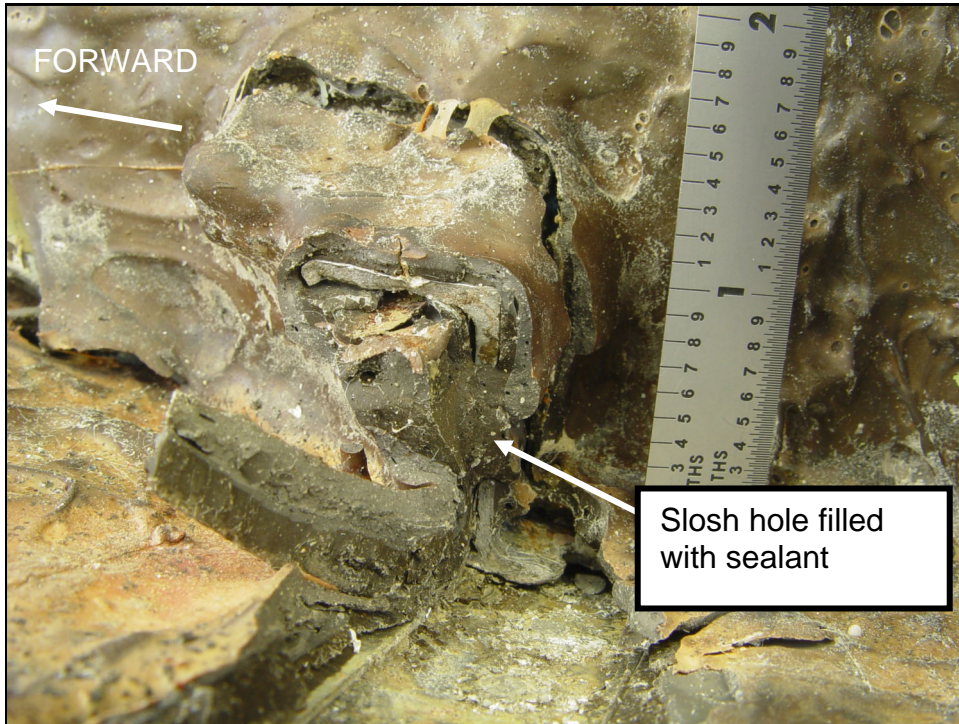
Figure 40. Close view of the rear Z-stringer fracture just outboard of left WS 34 as received.

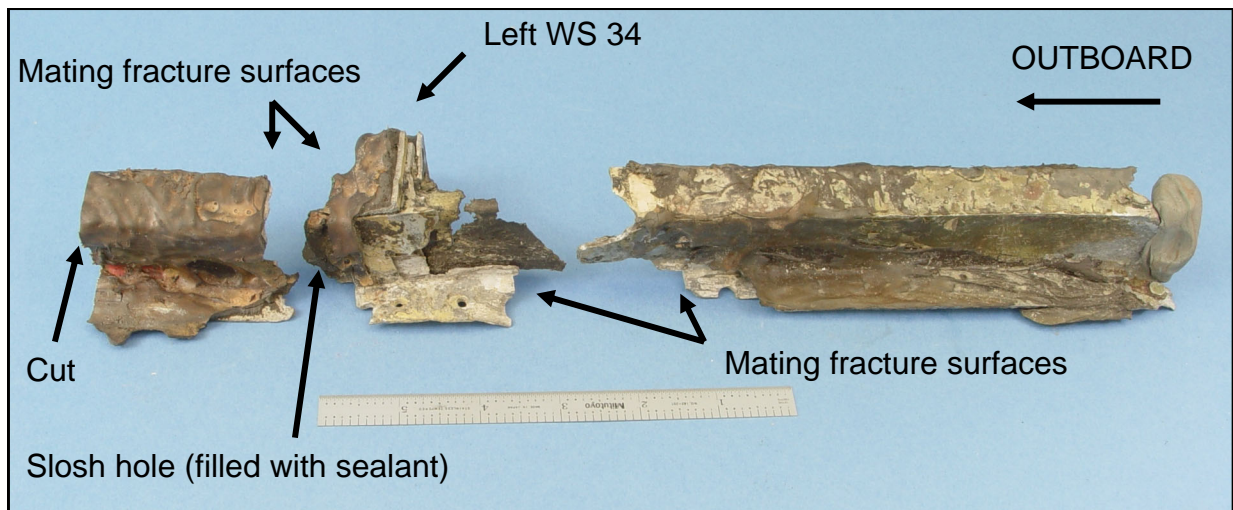
Figure 41. View of rear Z-stringer pieces from left wing side of the wing box beam lower skin panel shown after separating the piece at left WS 34 from the lower skin and cutting the outboard piece from the rest of a skin panel piece.

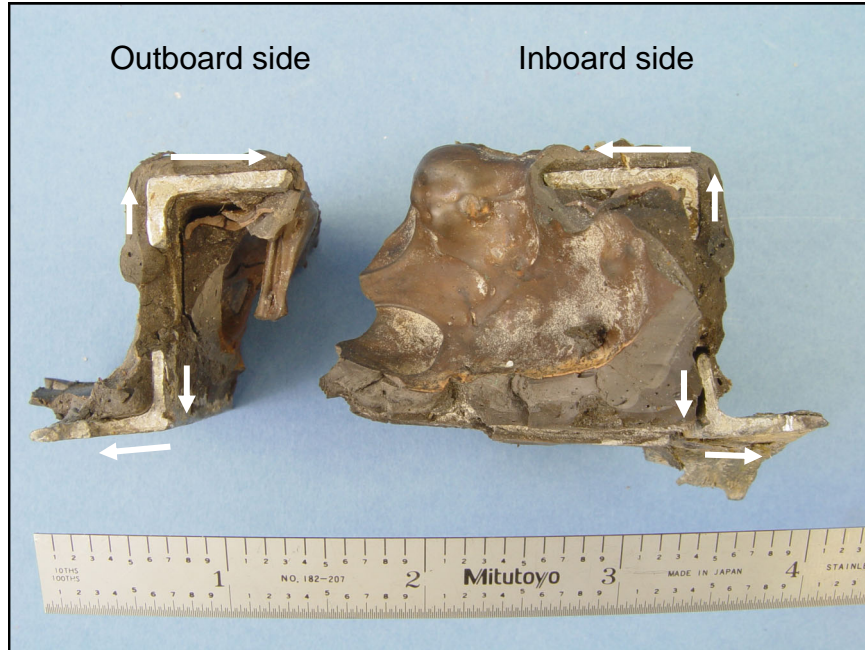
Figure 42. View of the mating fracture surfaces just outboard of left WS 34 for the rear Z-stringer shown in the previous figure.

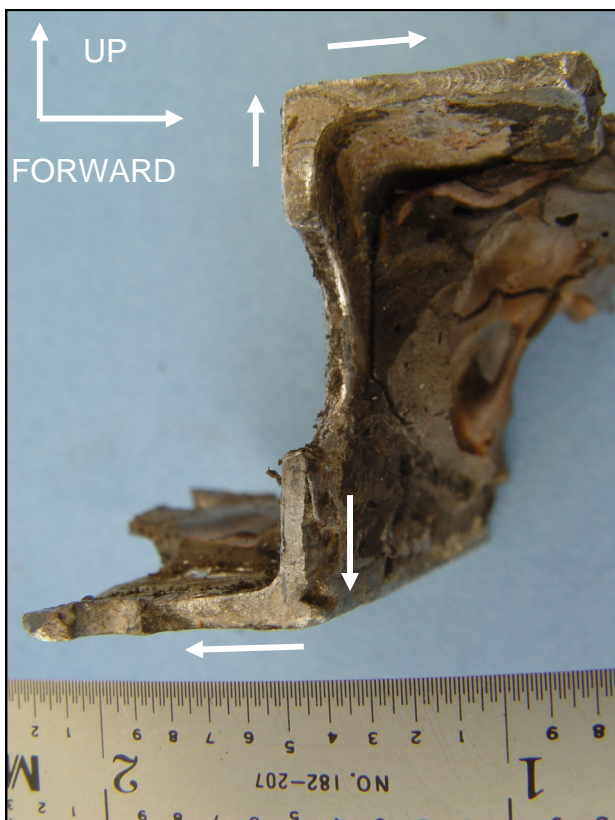
Figure 43. Closer view of the outboard fracture surface shown at the left in the previous figure. Unlabeled arrows indicate the directions of fatigue propagation emanating from the slosh hole in the web.

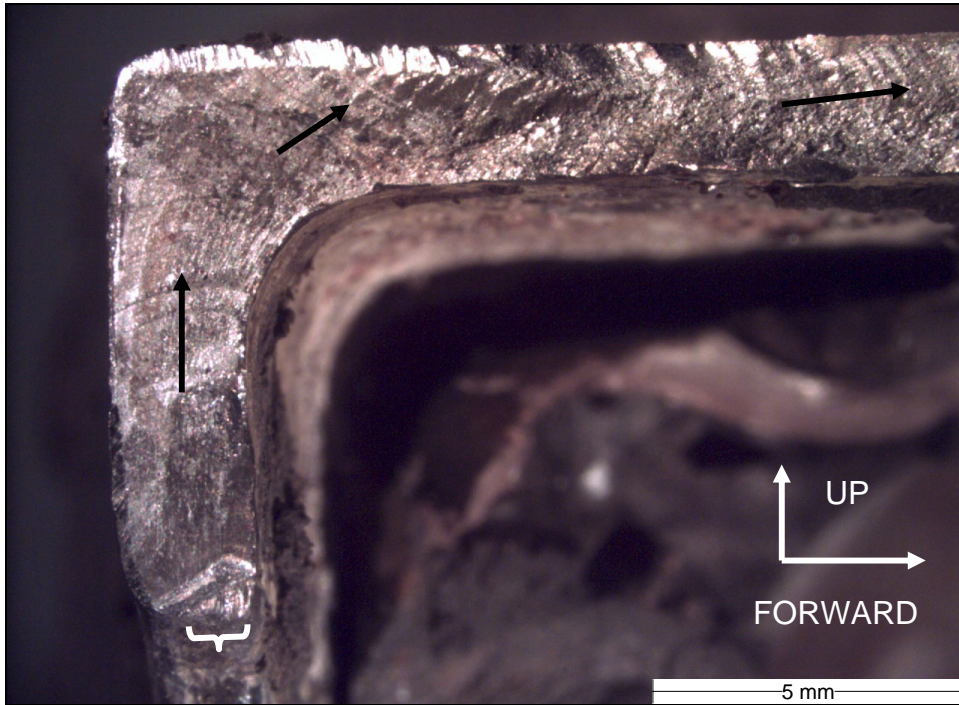
Figure 44. Close view of fatigue features of the Z-stringer fracture shown in the previous figure at the upper side of the slush hole. Unlabeled arrows indicate general fracture propagation directions and an unlabeled bracket indicates the origin area at the slush hole.

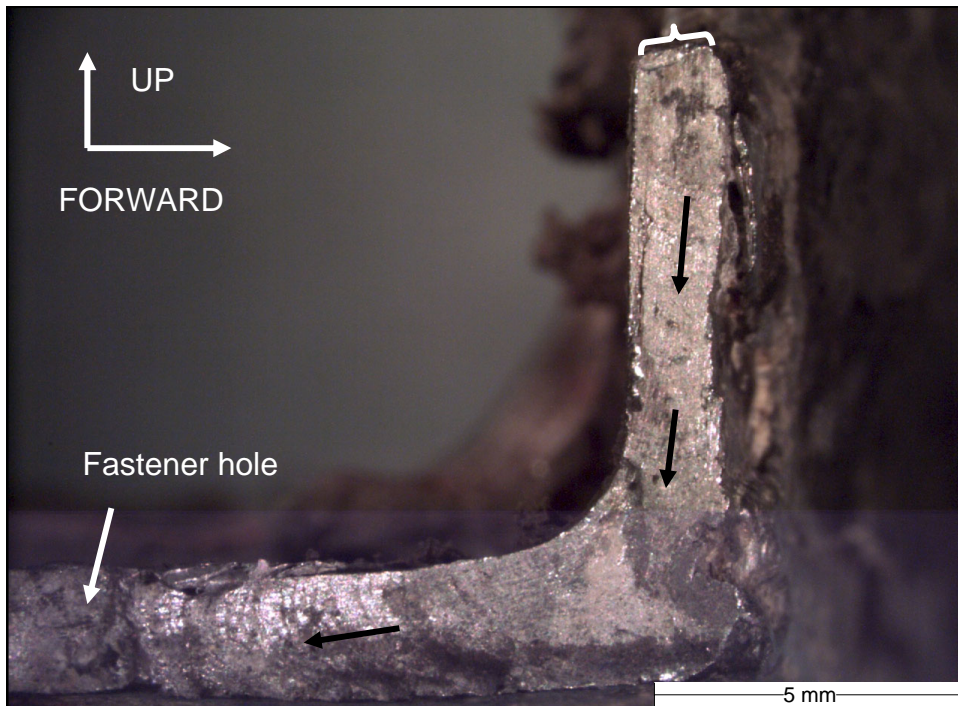
Figure 45. Close view of fatigue features of the Z-stringer fracture shown in the previous figure at the lower side of the slush hole. Unlabeled arrows indicate general fracture propagation directions and an unlabeled bracket indicates the origin area at the slush hole.

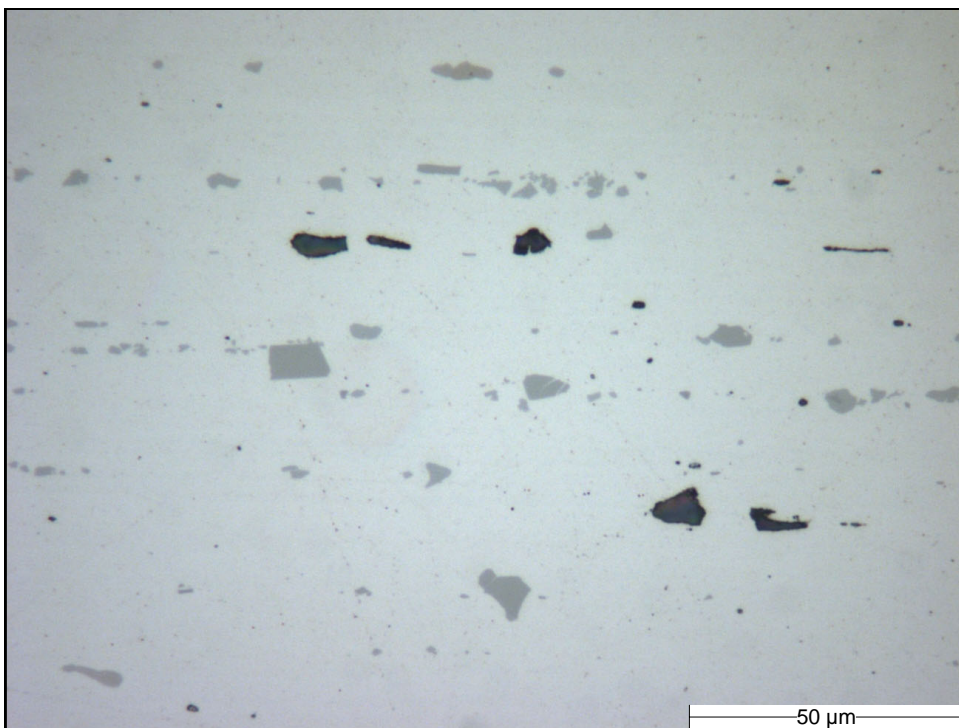
Figure 55. Rear Z-stringer microstructure as polished.
