# NATIONAL TRANSPORTATION SAFETY BOARD

MATERIALS LABORATORY FACTUAL REPORT

Report No. 06-042

Place : Miami, Florida  
Date : December 19, 2005  
Vehicle : Grumman G-73T Mallard, N2969  
NTSB No. : DCA06MA010  
Investigator : Brian Murphy, AS-40

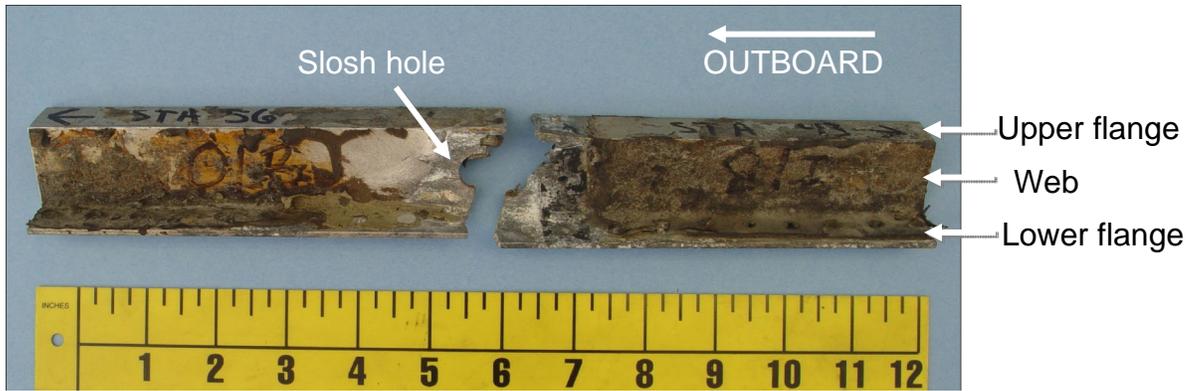
Overall views of the submitted foot-long section of rear Z-stringer are shown in figures 1 and 2. The submitted rear Z-stringer was cut from a Grumman G-73T Mallard, N632SS, which was manufactured in the same year as the accident airplane. The pieces were sectioned from the rearmost of three Z-stringers in the lower skin panel of the wing box beam for the left wing. The Z-stringer had a fracture located approximately 1.5 inches outboard of the rib at left wing station (WS) 48<sup>1</sup>. The fracture intersected the slosh hole in the web of the Z-stringer.

Figure 1. View of the rear Z-stringer section looking forward and slightly downward.

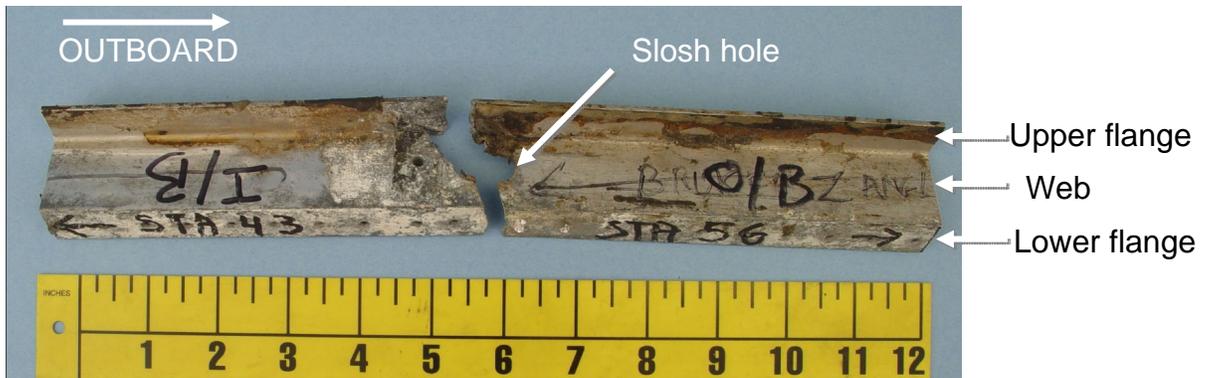
Figure 2. View of the rear Z-stringer section looking aft and slightly upward.

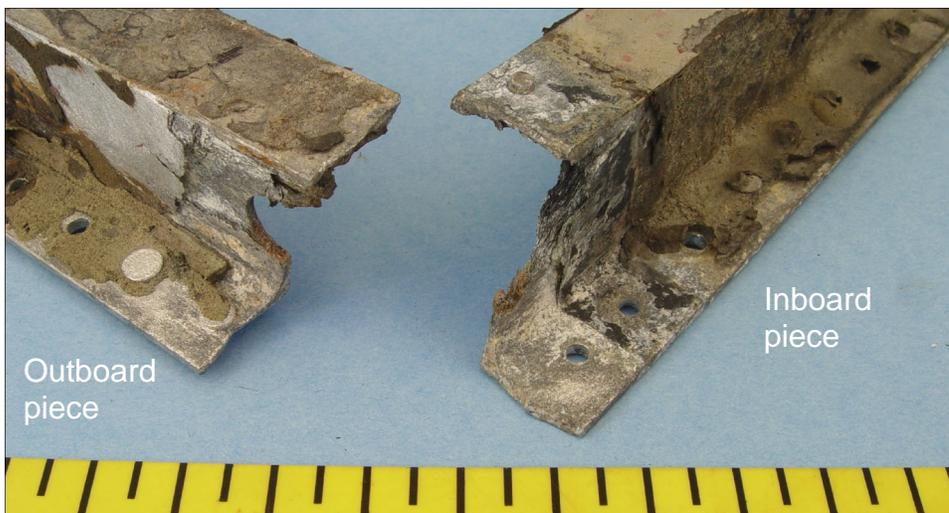
A closer view of the fracture area of the rear Z-stringer is shown in figure 3. Corrosion was observed in the area and was particularly severe in the web and flange areas above the slosh hole. In the upper portion of the web and the upper flange, exfoliation<sup>2</sup> was present both forward and aft of the fracture location, and layers of material were missing.

Figure 3. Close view of the fractured ends of the rear Z-stringer.

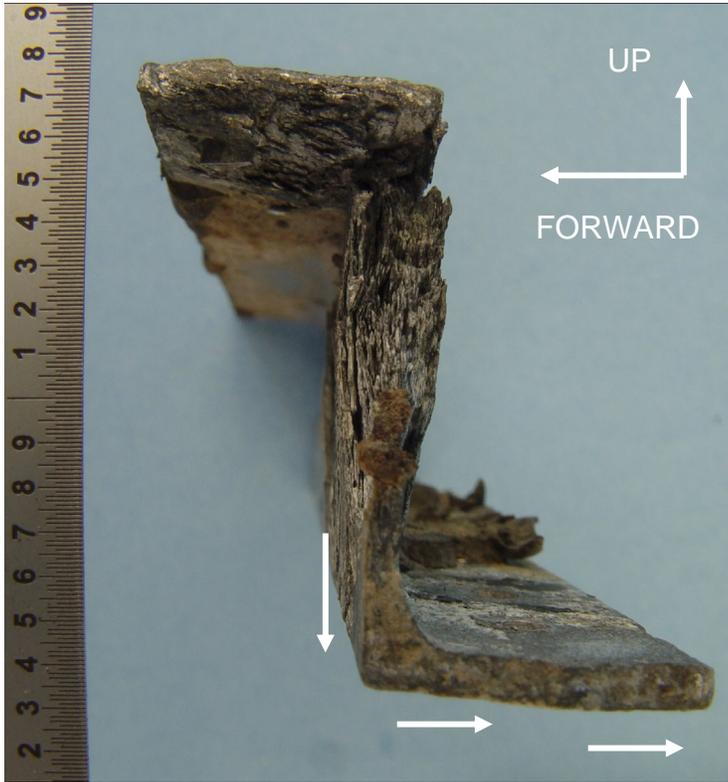
Views of the fracture surfaces are shown in figures 4 and 5. No clear fracture features were observed above the slosh hole. Fracture features in this area were

obliterated by exfoliation, surface corrosion, and post-fracture contact damage. Fracture features were present in the web and lower flange below the slosh hole. The fracture was relatively flat and perpendicular to the Z-stringer surface, and faint crack arrest marks were observed, features consistent with fatigue. A closer view of the fracture surface below the slosh hole after cleaning with soap water and a brush is shown in figure 6. Crack arrest marks were observed across most of the fracture surface shown in figure 6, and unlabeled arrows indicate examples of arrest marks at 2 locations. No specific origin could be identified, but fatigue features generally emanated downward in the web portion of the fracture and aft in the lower flange portion as indicated with unlabeled arrows in figures 4 and 5.

Figure 4. View of the inboard side of the rear Z-stringer fracture. Unlabeled arrows indicate the general direction of fatigue propagation in areas where fracture features were observed.

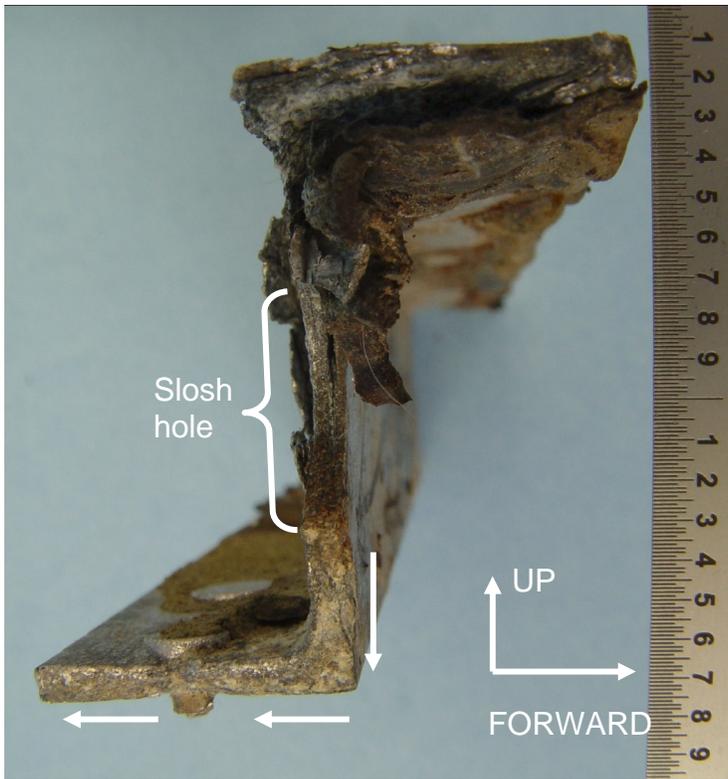
Figure 5. View of the outboard side of the rear Z-stringer fracture. Unlabeled arrows indicate the general directions of fatigue propagation in areas where fracture features were observed.

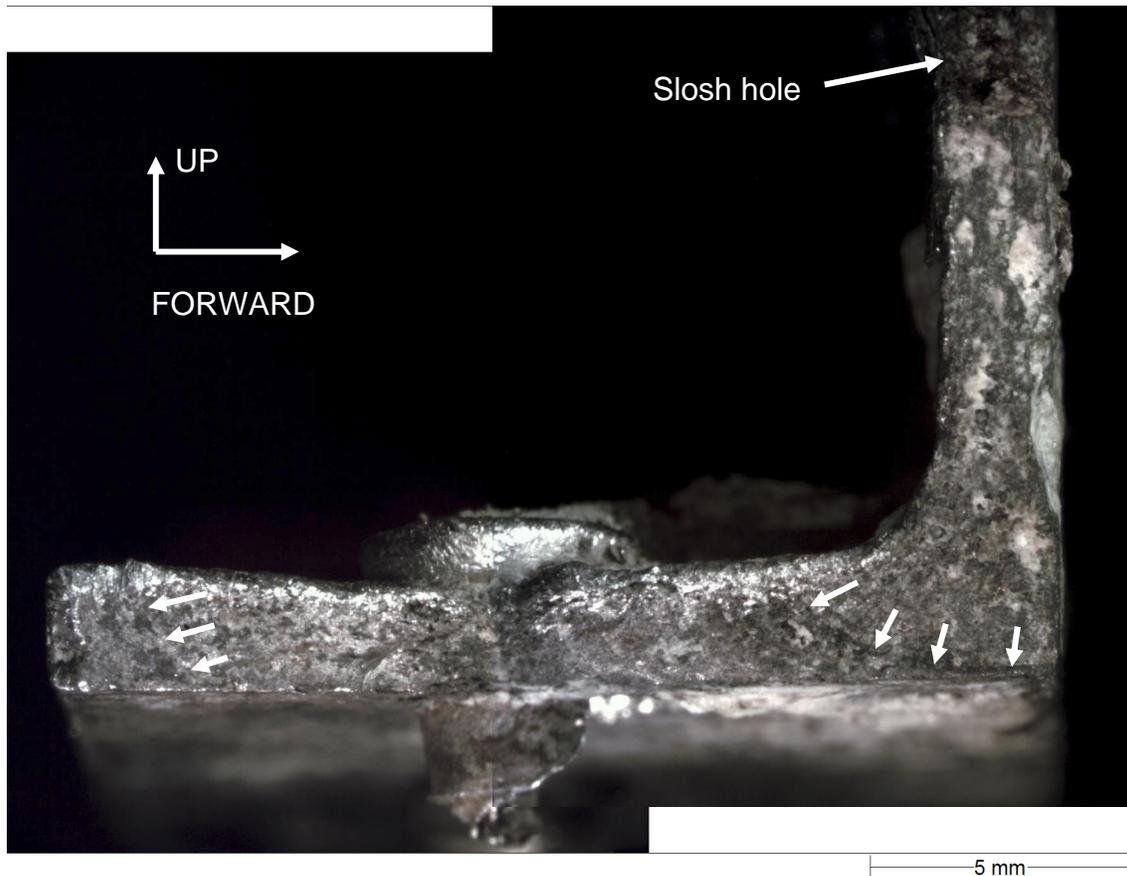
Figure 6. Closer view of the outboard side of the rear Z-stringer fracture surface below the slosh hole after cleaning. Unlabeled arrows indicate examples of crack arrest lines observed across the fracture surface.
