# NATIONAL TRANSPORTATION SAFETY BOARD

MATERIALS LABORATORY FACTUAL REPORT

Report No. 06-076

Place : Memphis, Tennessee  
Date : July 28, 2006  
Vehicle : McDonnell Douglas MD-10-10F, N391FE  
Operator : FedEx Corporation  
NTSB No. : DCA06MA058  
Investigator : Bill English IIC,  
Clint Crookshanks, Structures

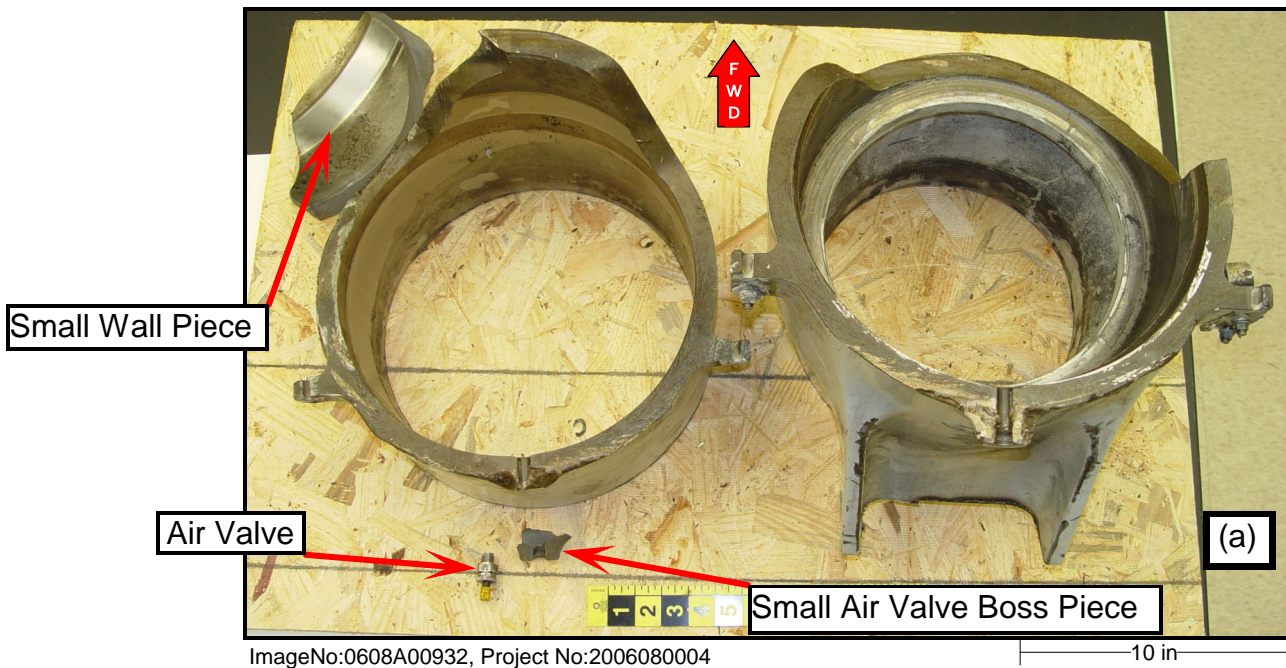
The received pieces of the landing gear outer cylinder are displayed in figure 1. The outer cylinder was circumferentially fractured at the air valve boss just below the intersection of the aft drag brace arm as indicated by red lines in figures 1(b) and (c). The landing gear had reportedly accumulated 33,148 landing cycles since new with 27,042 cycles since its last overhaul.

The outer cylinder was fractured into two large pieces comprising the upper and lower portions of the cylinder and two smaller pieces. The majority of the cylinder had been cut away prior to shipment and one to two foot long sections above and below the fracture were received. The yellow boxes in figures 1(b) and (c) denote the approximate received portions of the outer cylinder. One of the small pieces was from the lower half of the air valve boss; the other was a portion of the cylinder wall from the forward side of the cylinder. The separated air valve was also received.

Figure 1--The received fractured pieces with the lower fracture on left and the upper piece on the right. The small pieces and air valve are noted. The received region of the landing gear is denoted on the illustration below (yellow box) along with the approximate fracture location (red line).

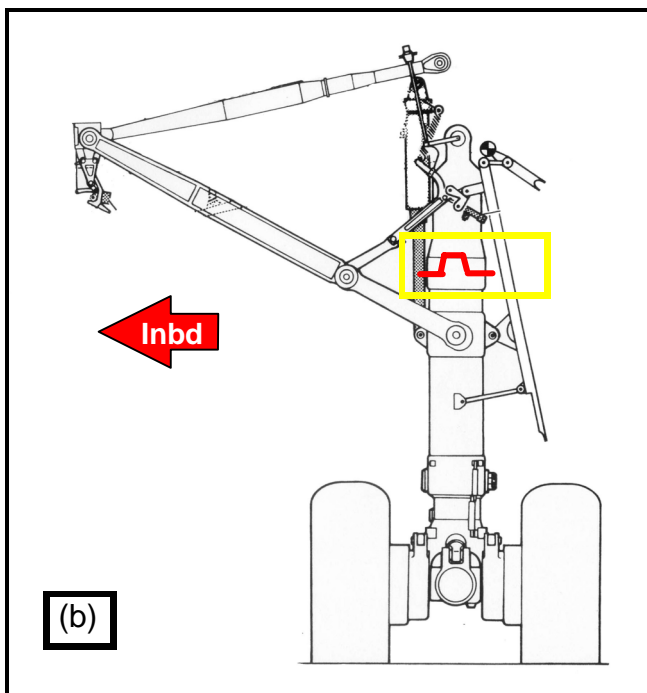
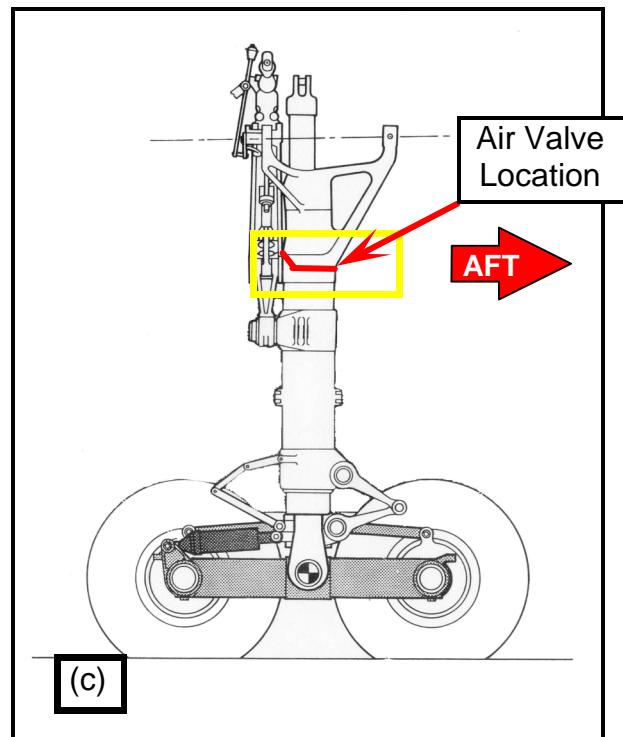
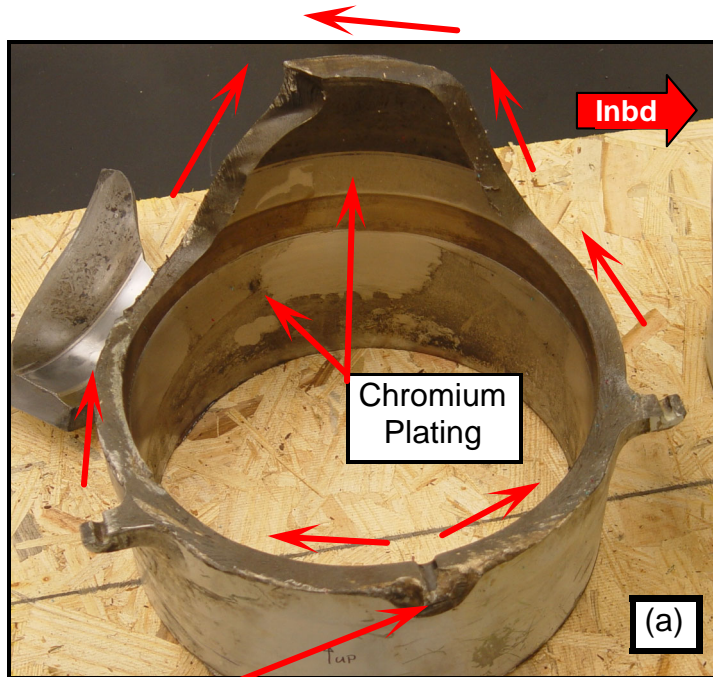
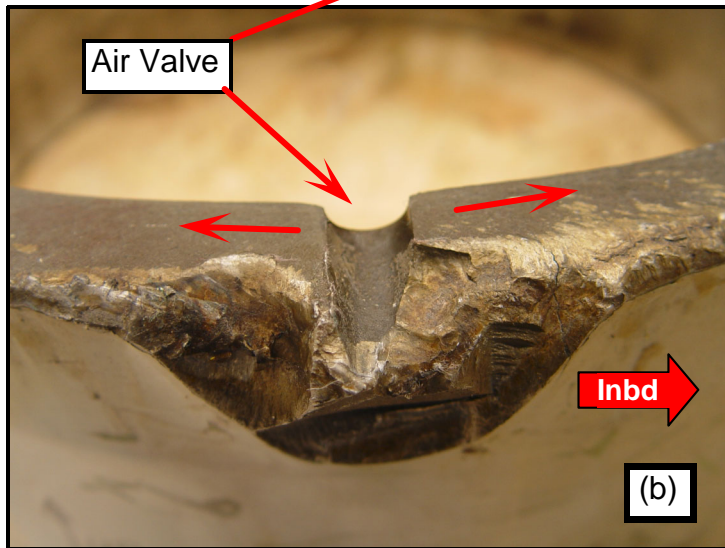
Optical examinations of the fracture faces found chevrons and other markings indicating that the overall separation initiated at individual locations on the inboard and outboard sides of the air valve hole and propagated separately around the cylinder. The two fractures, referred to as the inboard and outboard fractures, joined at the forward side and separated the outer cylinder into two main pieces. Away from the air valve hole, the fracture features were typical of overstress separations in high strength steel. Figure 2(a) displays the entire lower fracture face with arrows denoting the directions of propagation.

Close examinations established that the chevron markings led back to initiation sites on the smooth portion of the air valve hole near the inner diameter as shown in figures 2(b) and (c). The threaded portion of the hole was at the outer diameter of the cylinder and contained in the small portion of the boss fractured from the lower cylinder piece. Silver colored plating, later determined to be nickel, was noted on portions of the air valve hole bore, see figure 2(c). The plating was discontinuous and spotty with a nodular surface appearance. Both chromium and cadmium plating are noted for specific areas of the cylinder, but no nickel plating was specified for any location on the original component. Maintenance<sup>1</sup> and service documents do allow repair nickel and chromium plating in the bore of the outer cylinder but not in the air valve hole.

Figure 2--The lower fracture face (a) with arrows denoting the fracture directions away from the air valve hole. Closer views of the fracture initiation area (b) and (c) and air valve boss and hole. Areas of nickel plating (c) are indicated in the smooth portion of the hole.

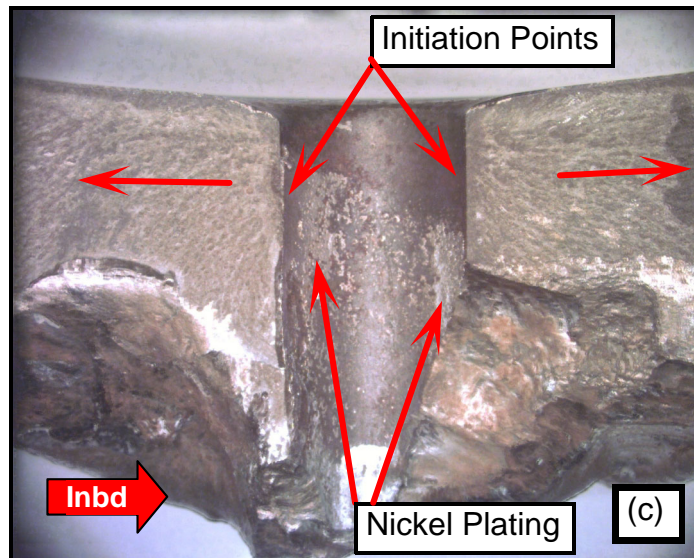
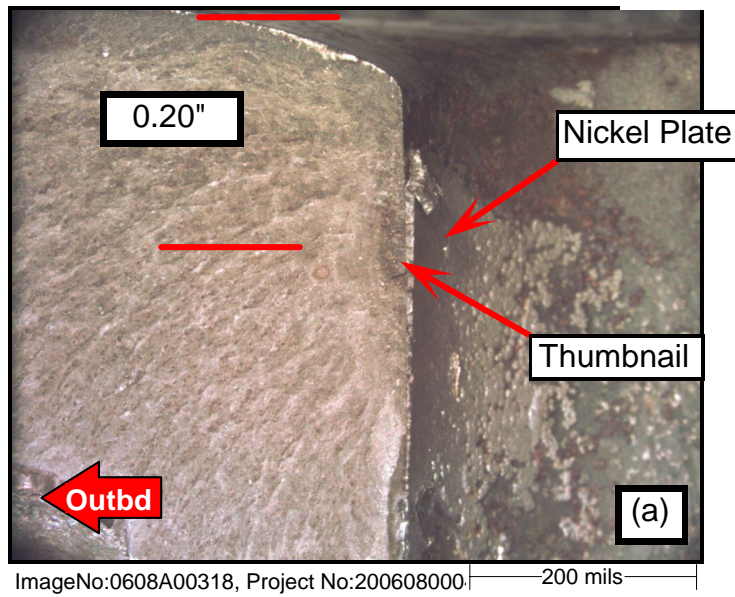
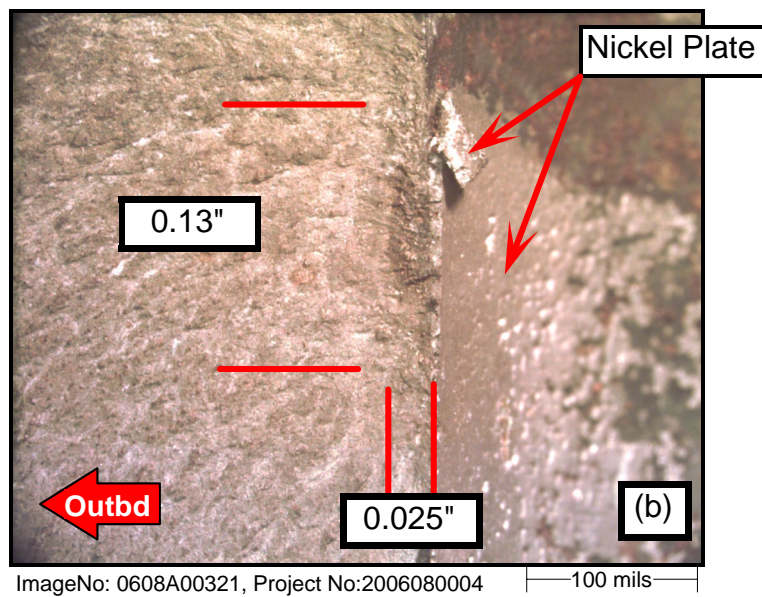
At the initiation site for the outboard fracture, a slightly darkened thumbnail-shaped fracture region was observed at the outboard side of the air valve hole as shown in figure 3. The thumbnail was centered about 0.20 inch from the projected inner diameter of the cylinder. The inner corners of the hole were heavily blended and located a distance from the projected inner diameter of the outer cylinder. The thumbnail region measured about 0.13 inch along the hole bore and about 0.025 inch deep. The bore surface adjacent to the thumbnail was covered with a 0.008 inch thick layer of nickel plating. The plating appeared tightly adherent to the bore and was fractured in-plane with the cylinder separation.

Figure 3--Successively closer views of the outboard side of the hole at initiation area. (a) the darker preexistent thumbnail is centered ~0.2" from projected ID. (b) thumbnail region ~0.13" wide and 0.025" deep with the overlaying nickel plate visible on the bore. (c) 0.008" thick nickel layer on hole surface covering the thumbnail region and adjacent areas.

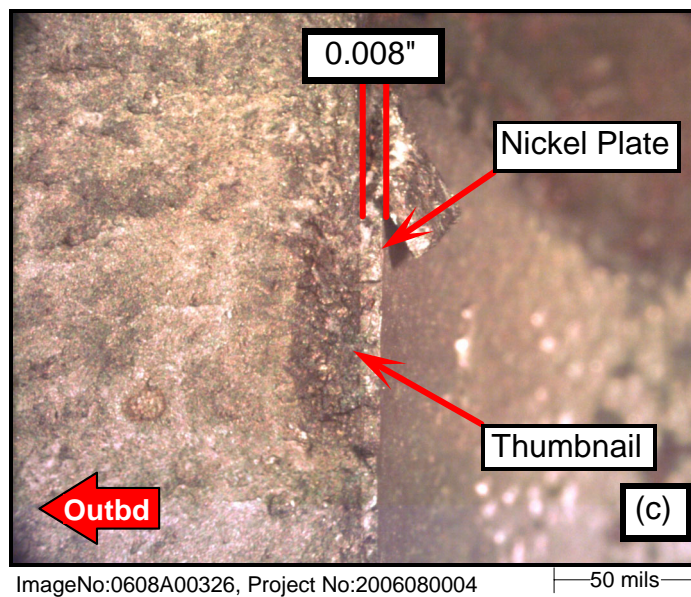
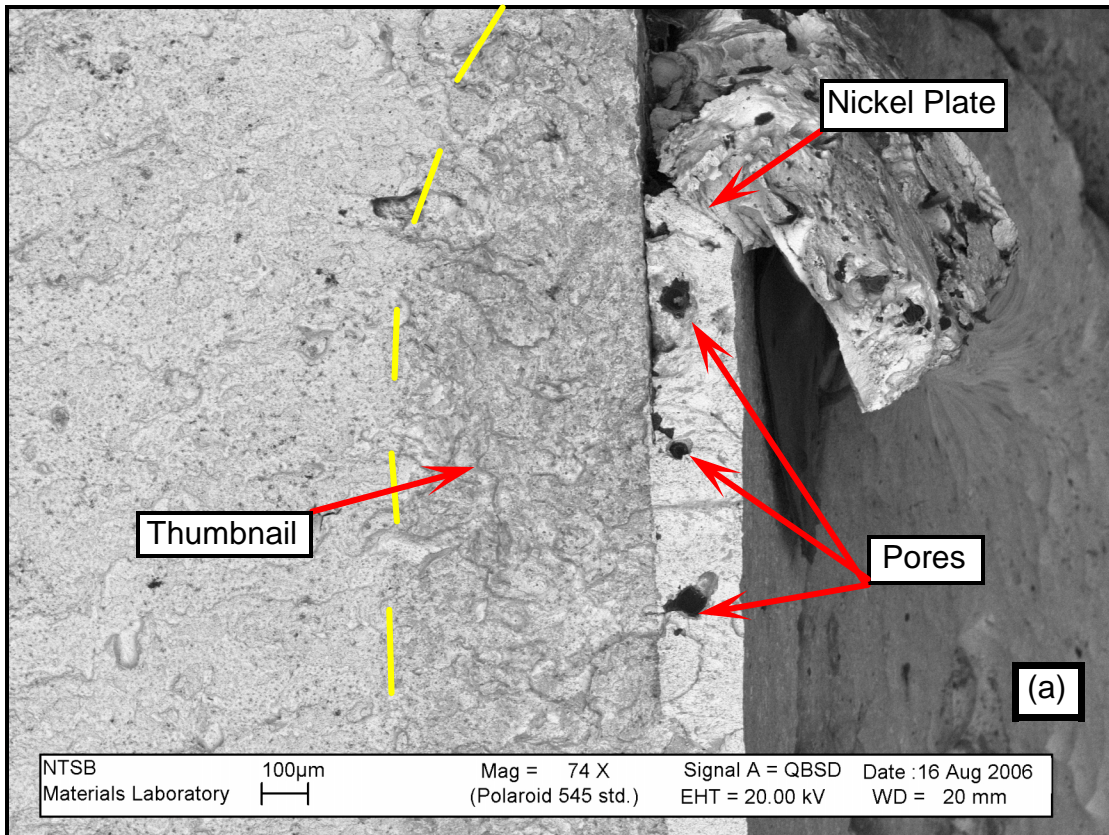
Scanning electron microscope (SEM) examinations in conjunction with energy dispersive x-ray spectrography (EDS) revealed an oxide layer on the thumbnail region at

the outboard side of the hole, as shown in figure 4(a). Multiple pores were also discovered in the nickel plate layer. The fracture features within the thumbnail were a mixture of intergranular and transgranular separations, as shown in figure 4(b). The intergranular features were consistent with stress corrosion cracking and the transgranular features were consistent with fatigue propagation. The fracture immediately outside of the thumbnail region was composed entirely of ductile dimples consistent with overstress separation.

Figure 4--Backscattered electron image (a) of the thumbnail, outlined in yellow, at the outboard initiation and the adjacent porous nickel plate. Secondary electron image (b) shows mixed fatigue and intergranular (SCC) features in thumbnail region at higher magnification.

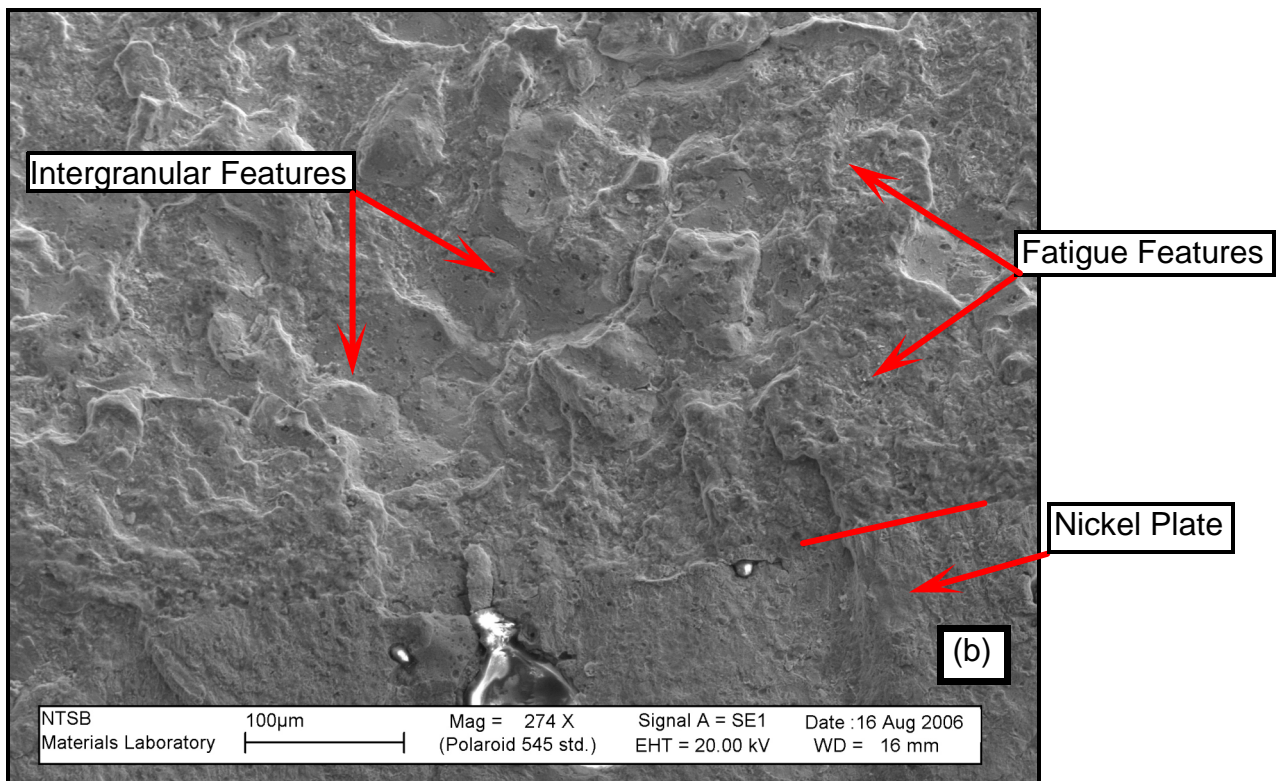
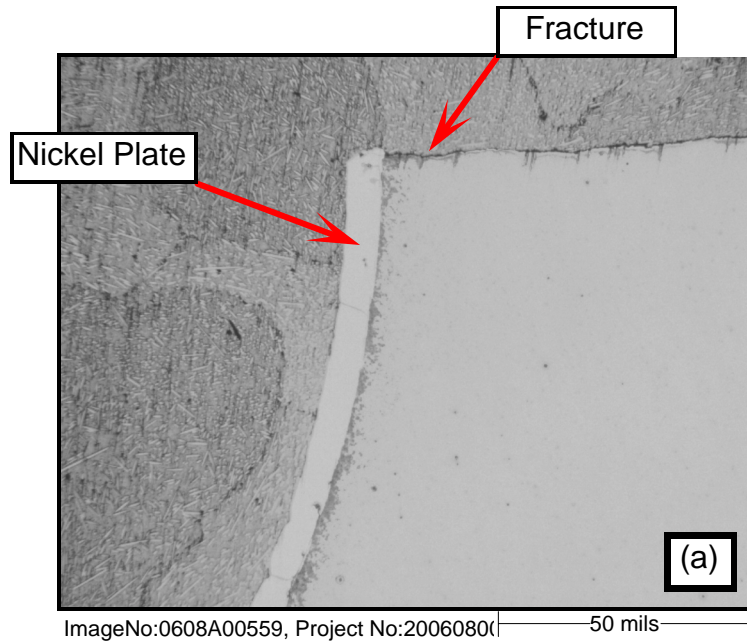
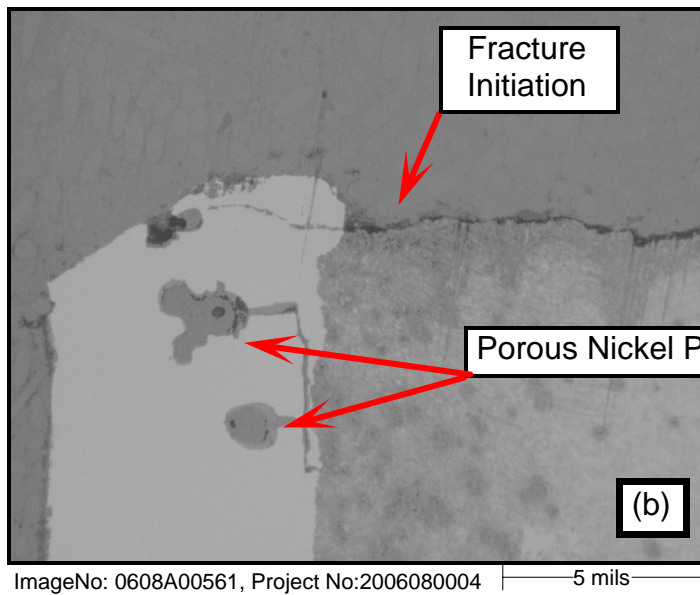
A metallographic section cut through the air valve hole and the thumbnail region perpendicular to the air valve hole axis is displayed in the views of figure 5. When etched with 4% Nital<sup>2</sup>, a fine tempered martensite microstructure was revealed in the cylinder material. The fracture path was generally transgranular with some intergranular areas. No crack branching was noted.

The nickel layer was clearly visible on the section and displayed extensive porosity and through – the - thickness cracking, as shown in figures 5(b) and (c). Corrosion and corrosion products were found where the plating cracks intersected the cylinder surface as illustrated in figure 5(c).

Figure 5--Metallographic images of a cross section of outboard initiation area. (a) Low magnification image of the nickel plating (light gray) on the bore. (b) Closer view of the initiation region with adjacent porous nickel plate. (c) An area away from fracture showing corrosion under the cracked plating.

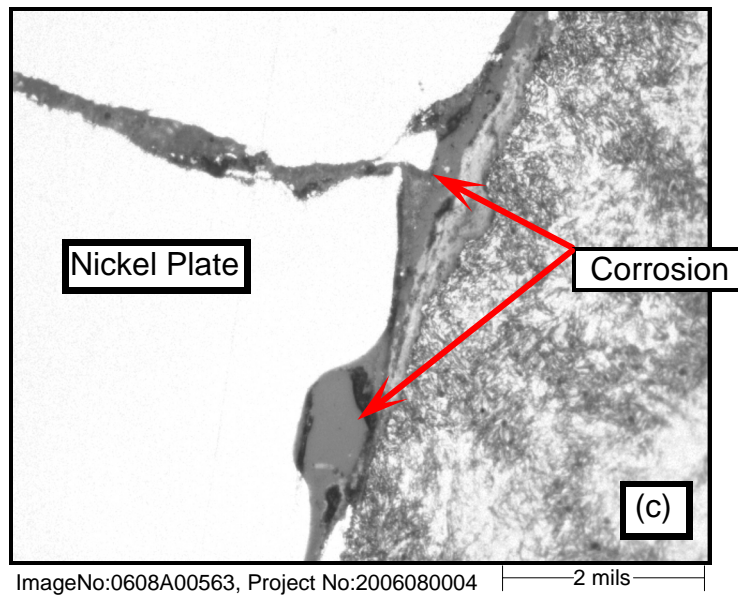
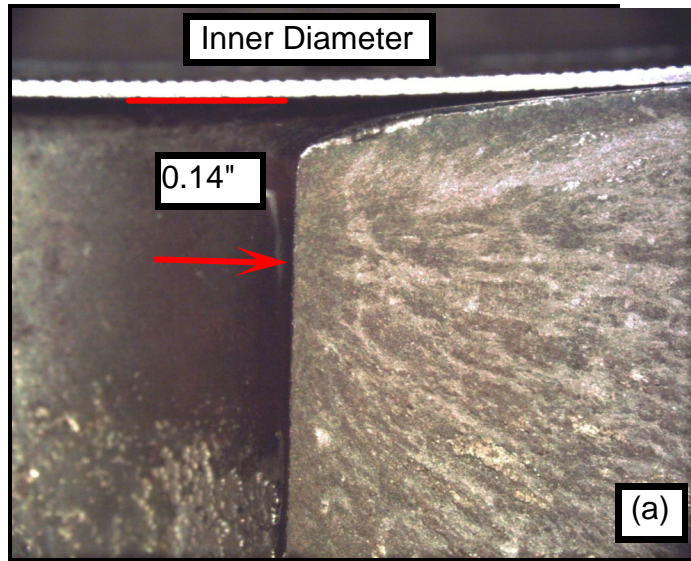
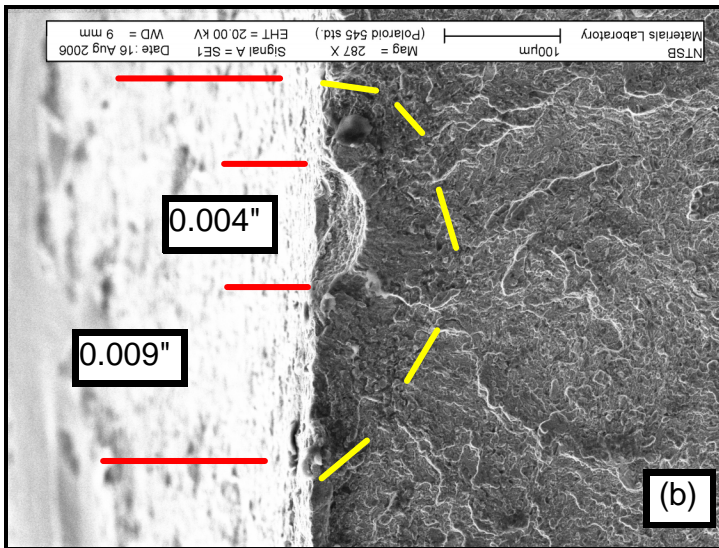
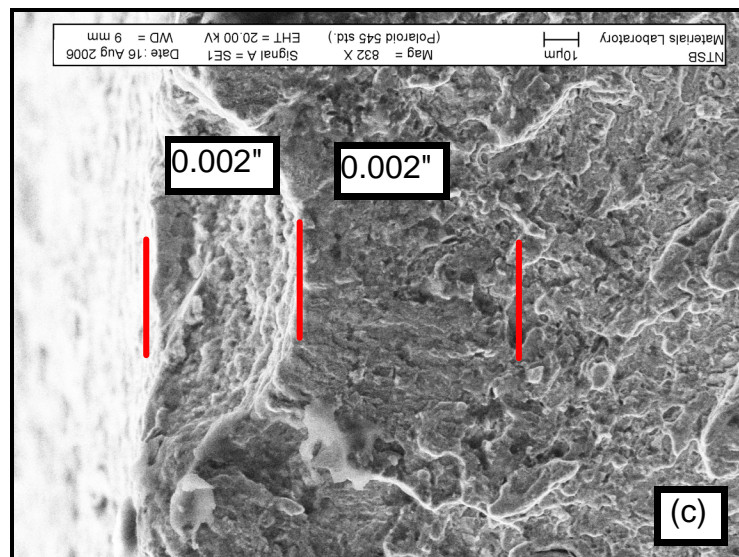
Examinations on the inboard fracture initiation area revealed a single point initiation on the bore surface approximately 0.14 inch from the projected inner diameter of the cylinder as displayed in figure 6(a). SEM viewing uncovered a small spherical corrosion pit at the initiation but no plating. The pit measured 0.004 inch wide and 0.002 inch deep as illustrated in figure 6 (b) and (c). Closer view also revealed a small semicircular region of transgranular fatigue features surrounding the pit, outlined in yellow in figure 6(b). The fatigue region measured about 0.009 inch along the bore and 0.004 inch deep, including the pit. Ductile dimples were evident outside of the fatigue region.

Figure 6--Optical image (a) of the inboard fracture showing fracture initiation at a corrosion pit located ~0.14 inch from projected inner diameter of the cylinder. SEM image (b) shows fatigue region 0.009 wide (yellow dashed lines) surrounding the 0.004" wide pit. Image (c) shows depth of corrosion and fatigue region.

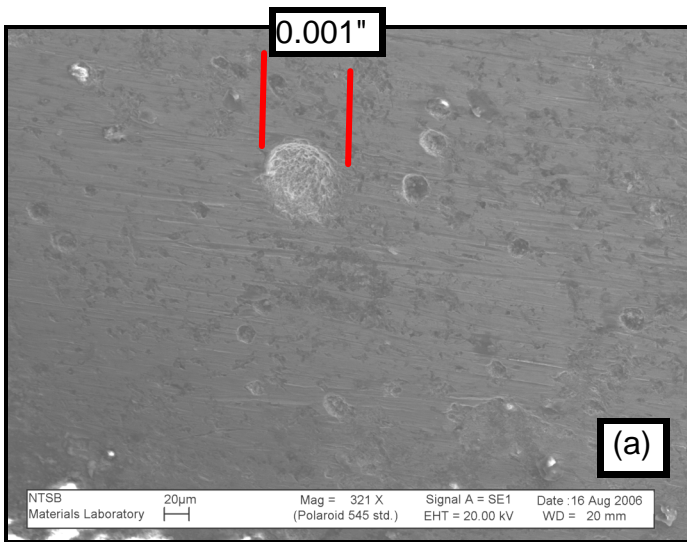
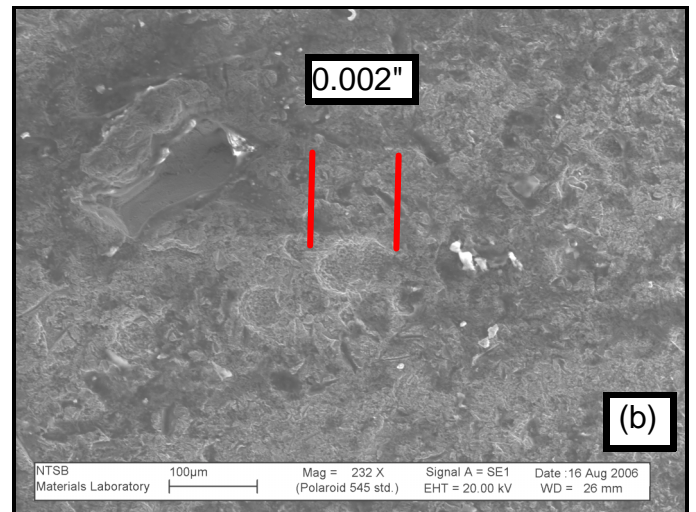
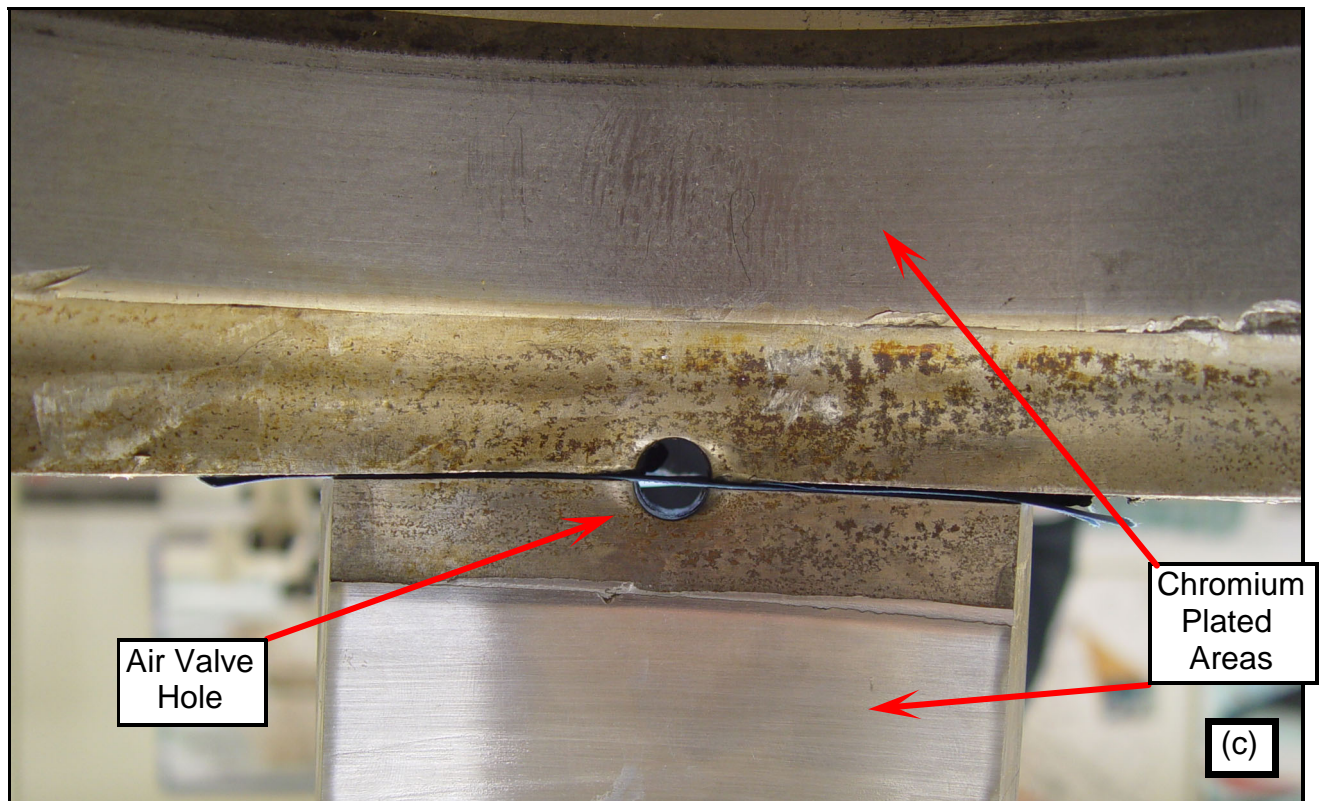
The smooth portion of the air valve hole displayed a fine surface finish with no machining tears or marks. However some corrosion pits up to 0.002 inch in diameter, were noted as shown in figure 7(a) and (b). The inner diameter of the cylinder also displayed corrosion pitting in the unplated band at the location of the hole; see figure 7(c).

Figure 7--SEM views (a) and (b) of corrosion pits in the air valve bore. Optical view (c) showing widespread corrosion (brown spots) of the inside surface of the cylinder in the area of the air valve hole.

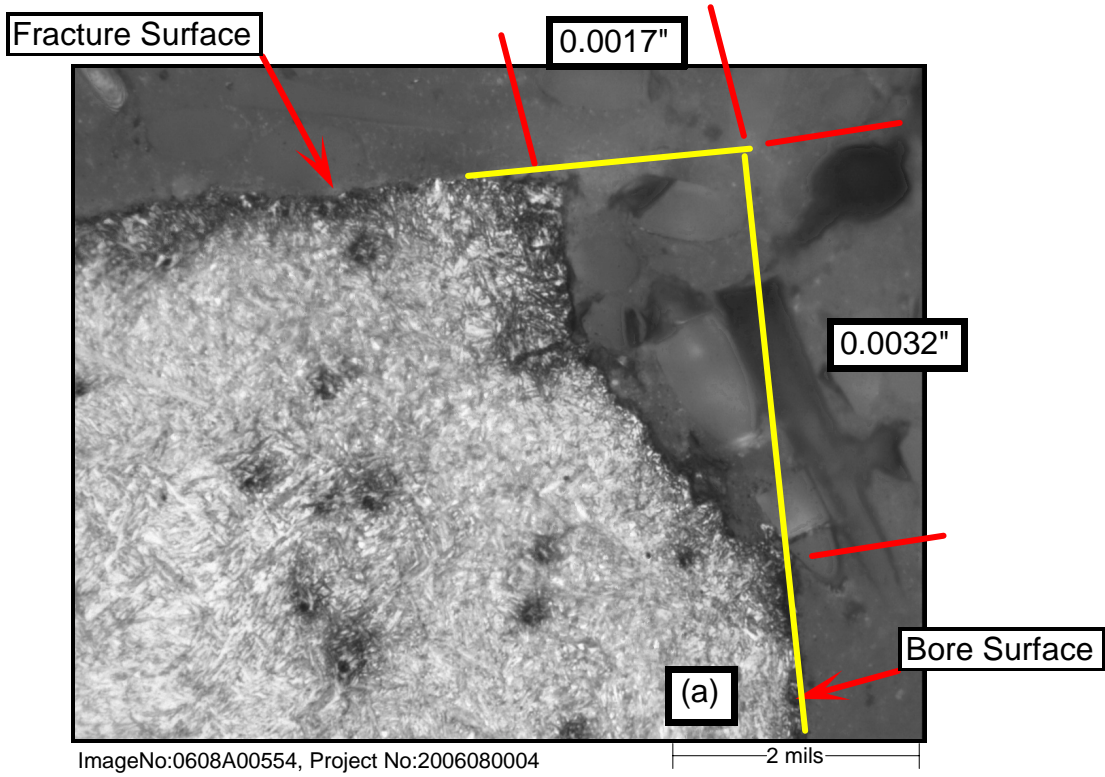
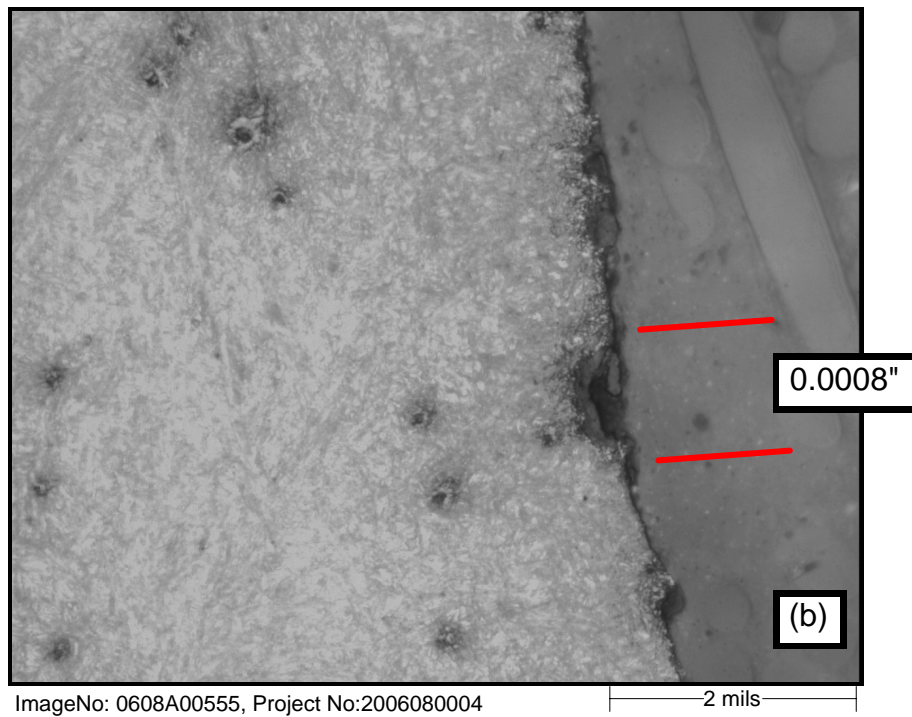
A metallographic section perpendicular to the air valve hole axis was cut through the inboard fracture initiation site, intersecting the initiating corrosion pit as shown in figure 8(a). At this point the pit measured 0.0017 inch deep and 0.0032 inch along the bore. The metallographic section also intersected other pits in the bore as displayed in figure 8(b). The pit shown in figure 8(b) measured less than 0.001 inch wide and deep.

Figure 8--Metallographic sections through the pit at the origin of the inboard crack (a) and an additional pit in the air valve bore (b). Both Nital Etch.

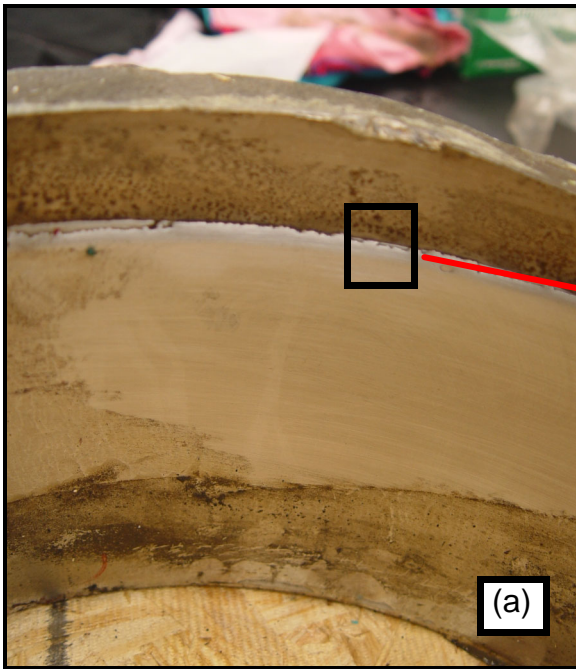
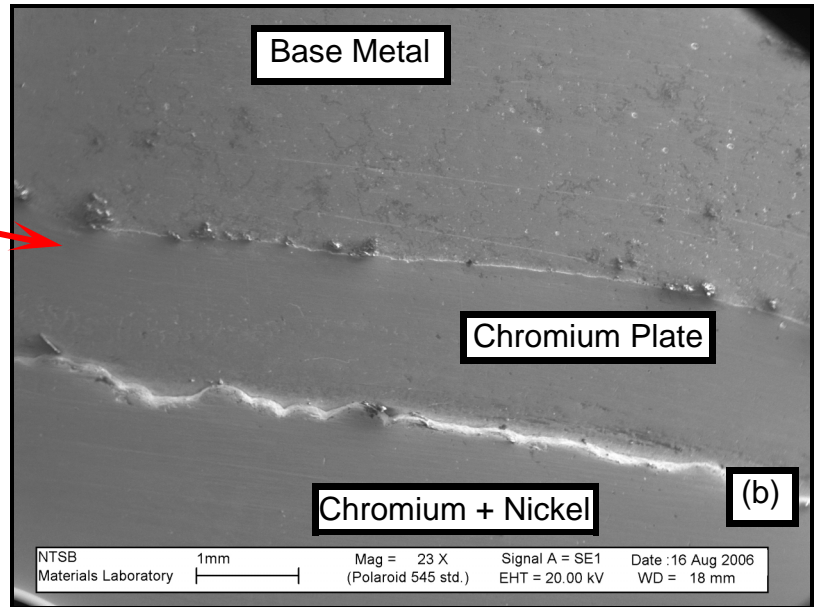
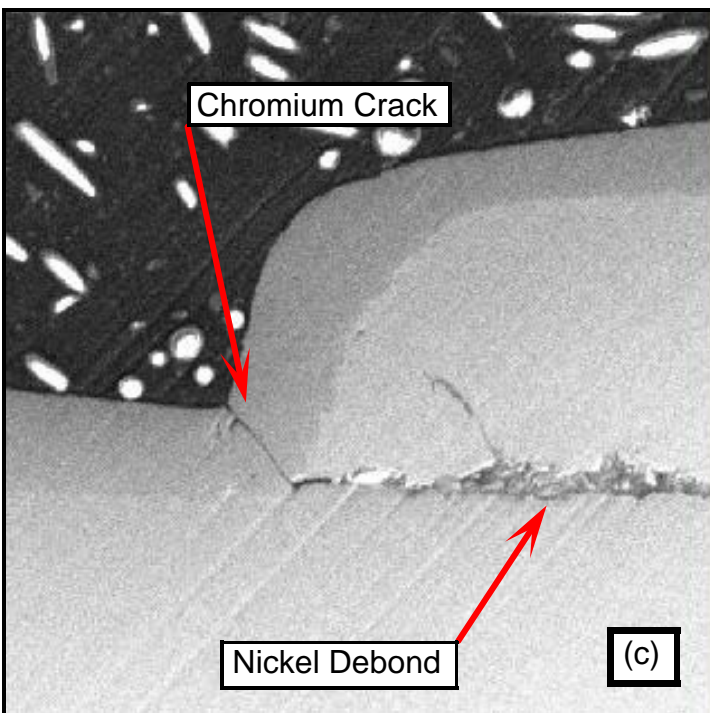
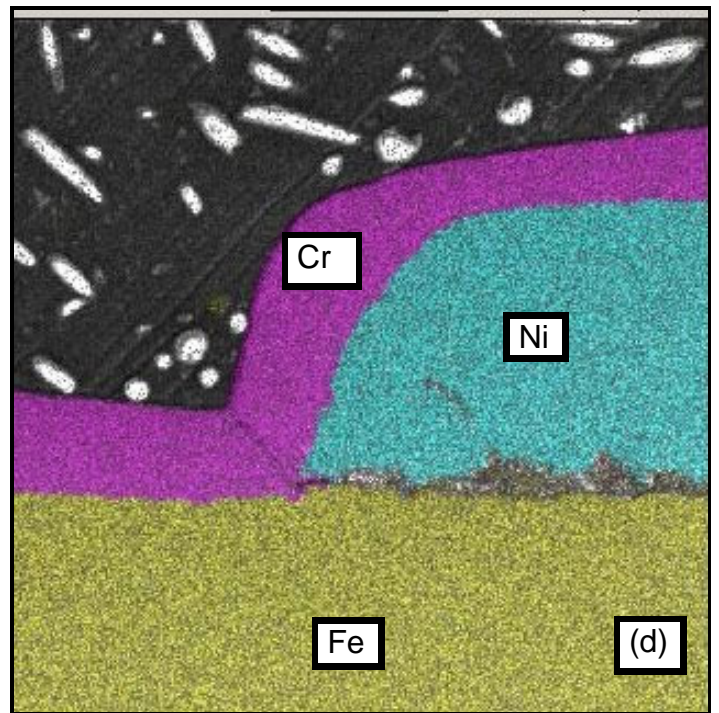
The bore of the outer cylinder was plated over a wide area below the air valve hole and a narrow band above the hole, as noted in figure 2(a). The plating appeared relatively thick with a stepped runout as shown in figure 9(a) and (b). A metallographic cross section through the plating along with EDS mapping revealed a two layer structure, as shown in figure 9(c) and (d). As illustrated with color mapping in figure 9(d), a thick underlying nickel layer (light blue) was overplated with chromium (purple). The nickel layer measured about 0.007 to 0.008 inch thick with a 0.002 to 0.003 inch thick chromium overplate. The chromium plating appear well bonded to the base metal and to the nickel but was cracked at the edge of the nickel as shown in figure 9(c). The adjacent area of the nickel was debonded from the base metal.

Figure 9-- Wide plating region on ID below fracture (a) with an SEM closeup of plating edge (b) showing two plating thicknesses and the runout. SEM image (c) of a cross section through the plating showing the cracked chromium plating and adjacent debonded nickel. EDS maps (d) of the same section identifying thick nickel (blue) underplating and thinner chromium (magenta) overlay on top of iron (yellow) base metal.
