NATIONAL TRANSPORTATION SAFETY BOARD

MATERIALS LABORATORY FACTUAL REPORT

Report No. 08-048

Place : Salt Lake City, Utah
Date : January 23, 2008
Vehicle : Boeing MD-82
Operator : American Airlines, Flight 1400
NTSB No. : ENG08SA009
Investigator : Harald Reichel, AS-40

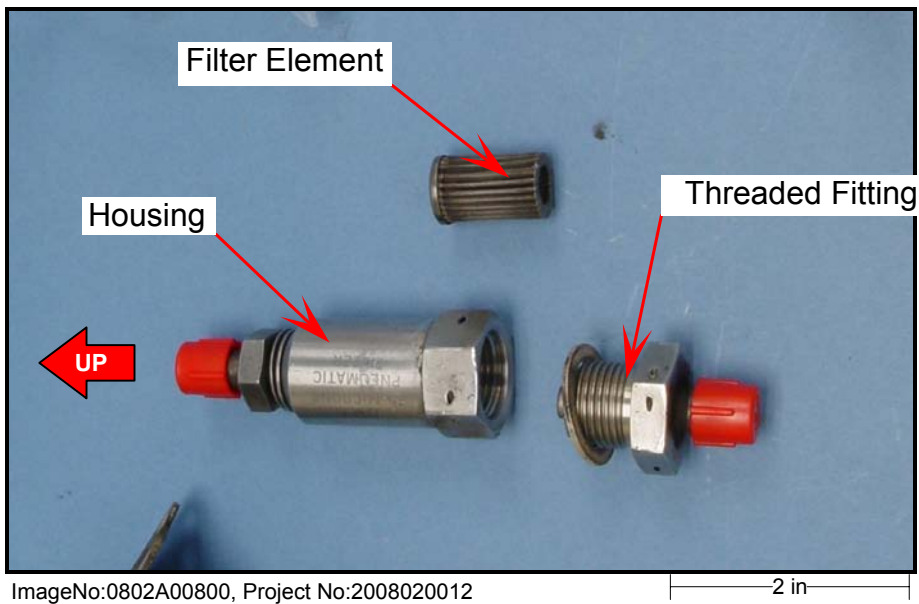
The as-received air filter assembly is displayed in figure 1. The components included the filter housing and separated filter element assembly with metal O-ring. The housing was marked "HRT Part No. 11-10656 S/N 1187". The end cap of the filter element was marked "Lot No. 0067" and part number "21-10930".

Figure 1--The as-received components with separated filter element.

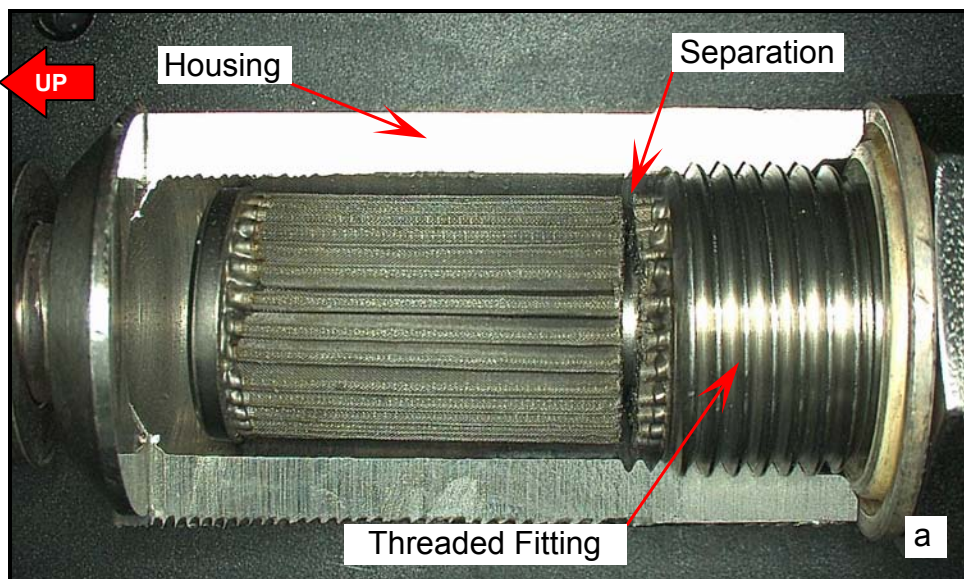
As received, the filter element was transversely separated just above the lower braze line as shown in figure 2 and 3 (a) and (b). Both sides of the separation displayed severe mechanical damage and rubbing that obliterated the majority of the fracture features, see figure 3 (c) and (d) and figure 4. However, one pleat on the fitting side of the fracture was relatively undamaged as indicated in figure 4. In this pleat, the longitudinal wires of both the fine outer screen and coarse inner screen were fractured and relatively undamaged.

Figure 2--The filter element and fitting placed in the sectioned housing (a). An illustration of the filter assembly construction (b).

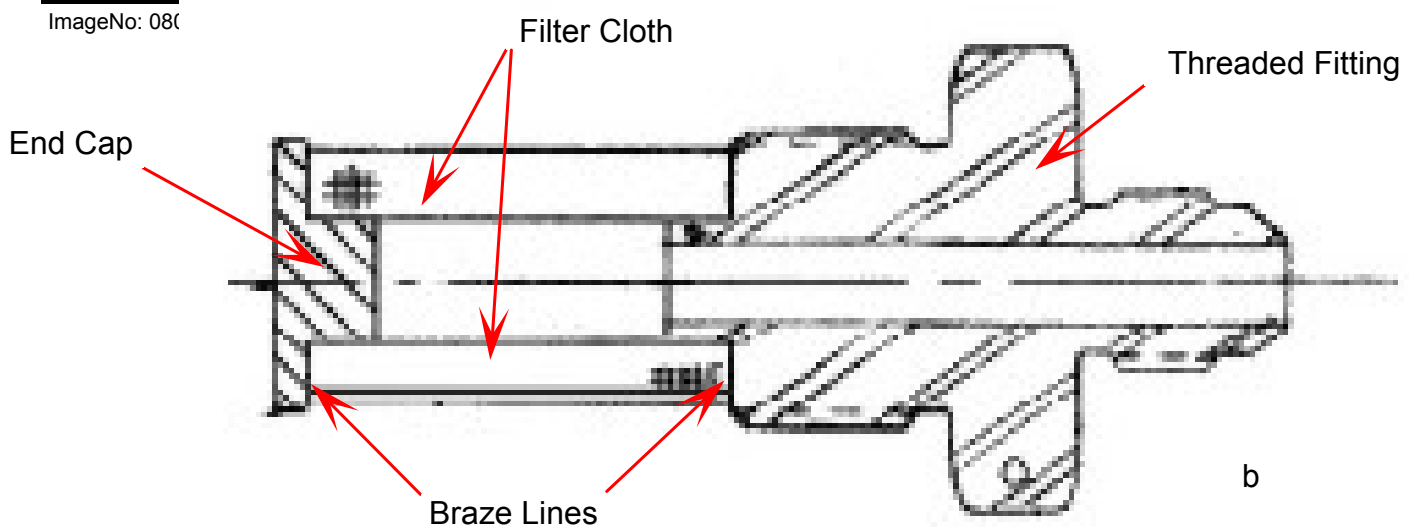
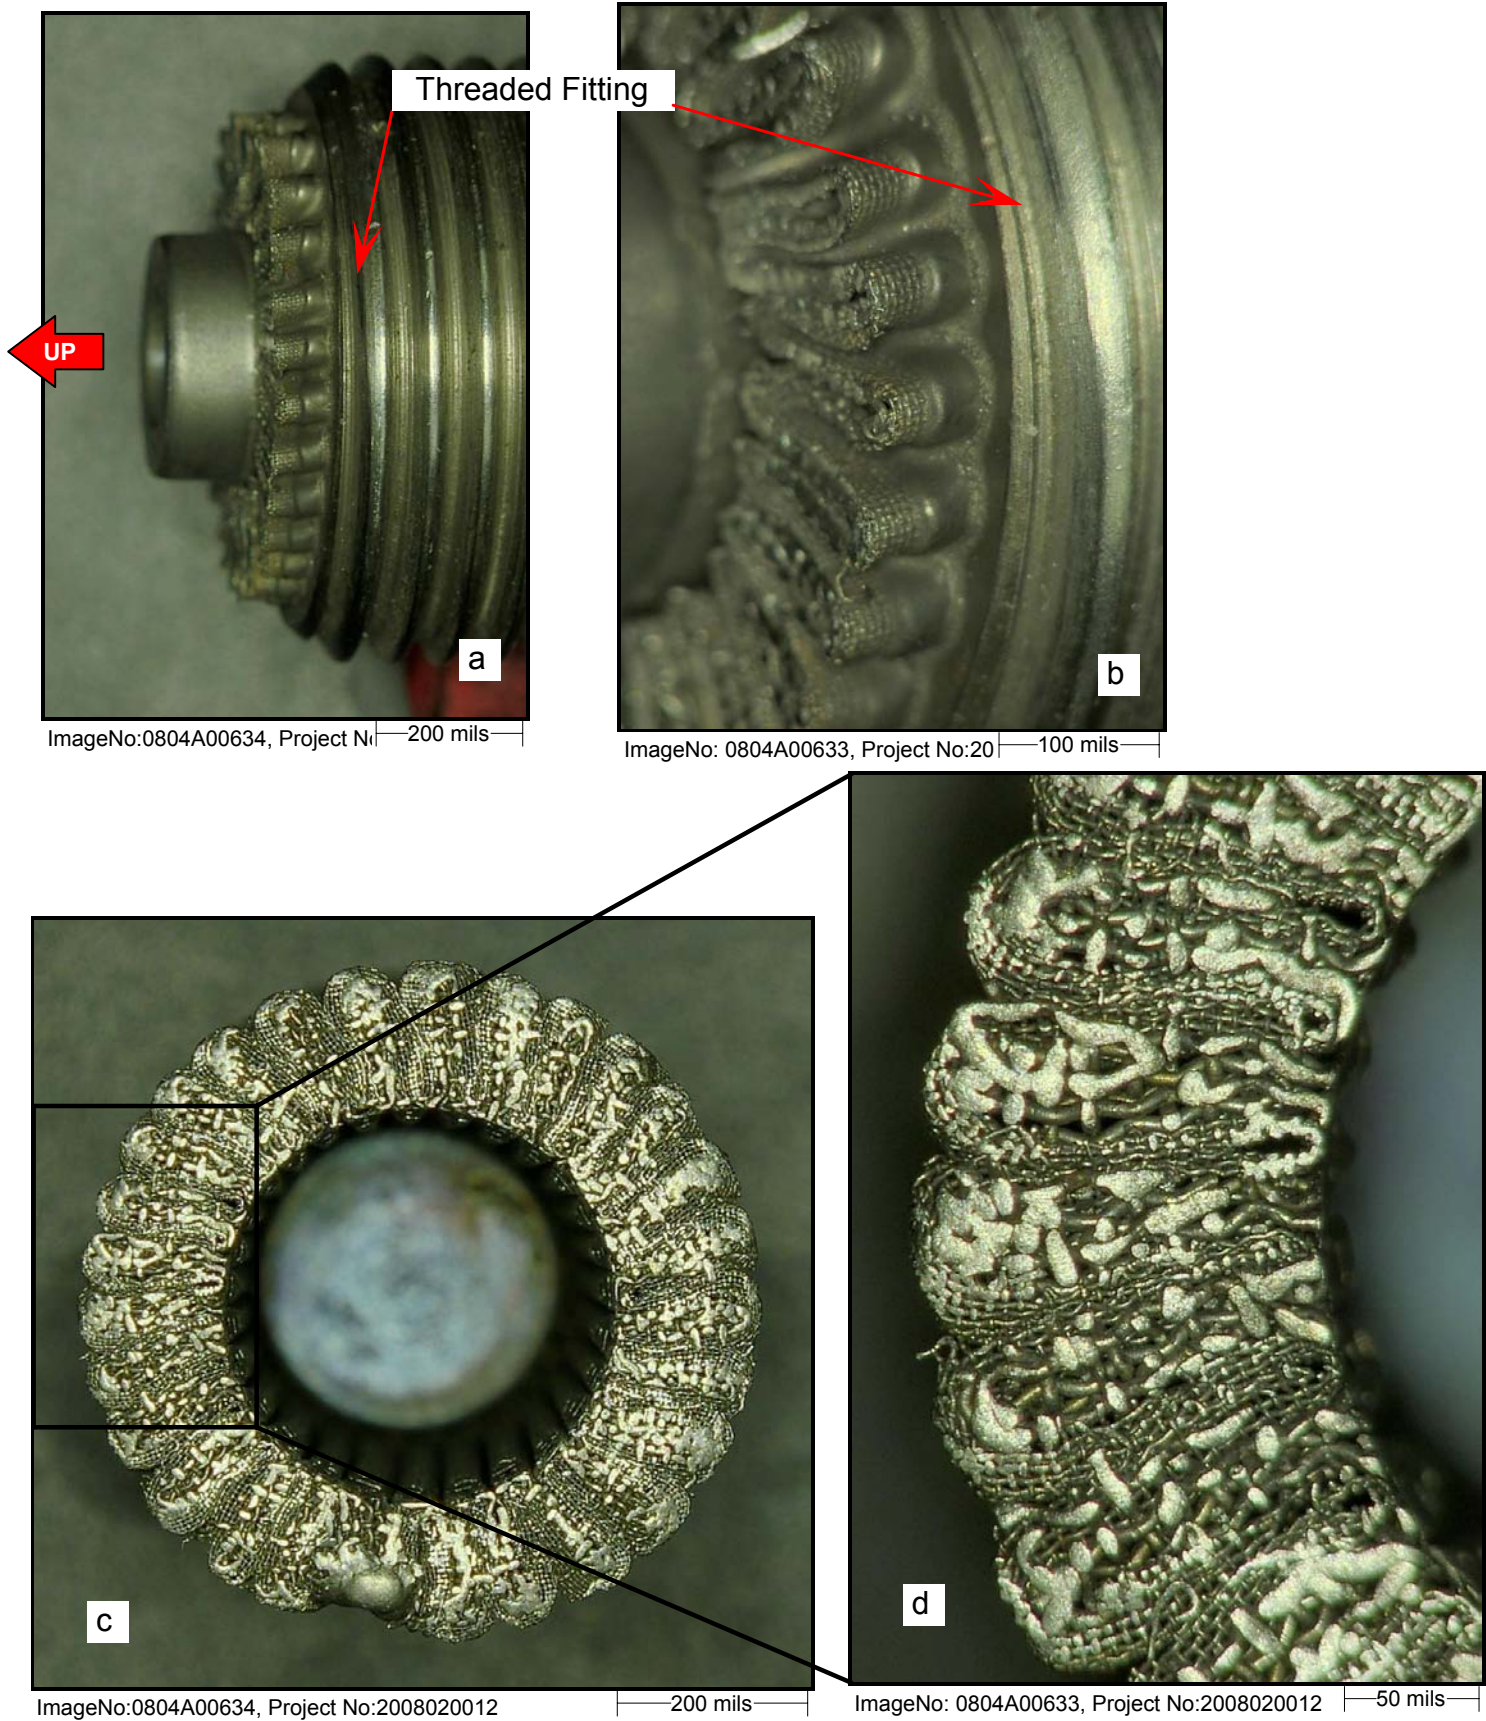
Figure 3--The element separation adjacent to the lower braze line (a) and (b). The damaged element side separation showing extensive damage (c) and (d).

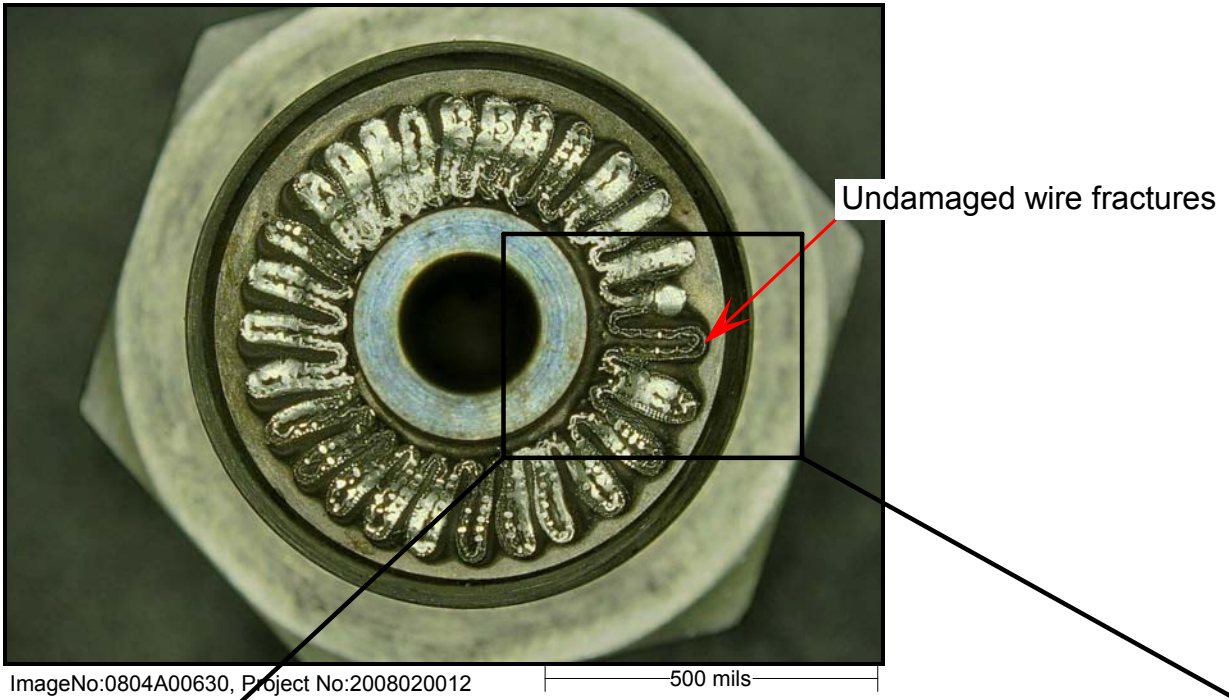
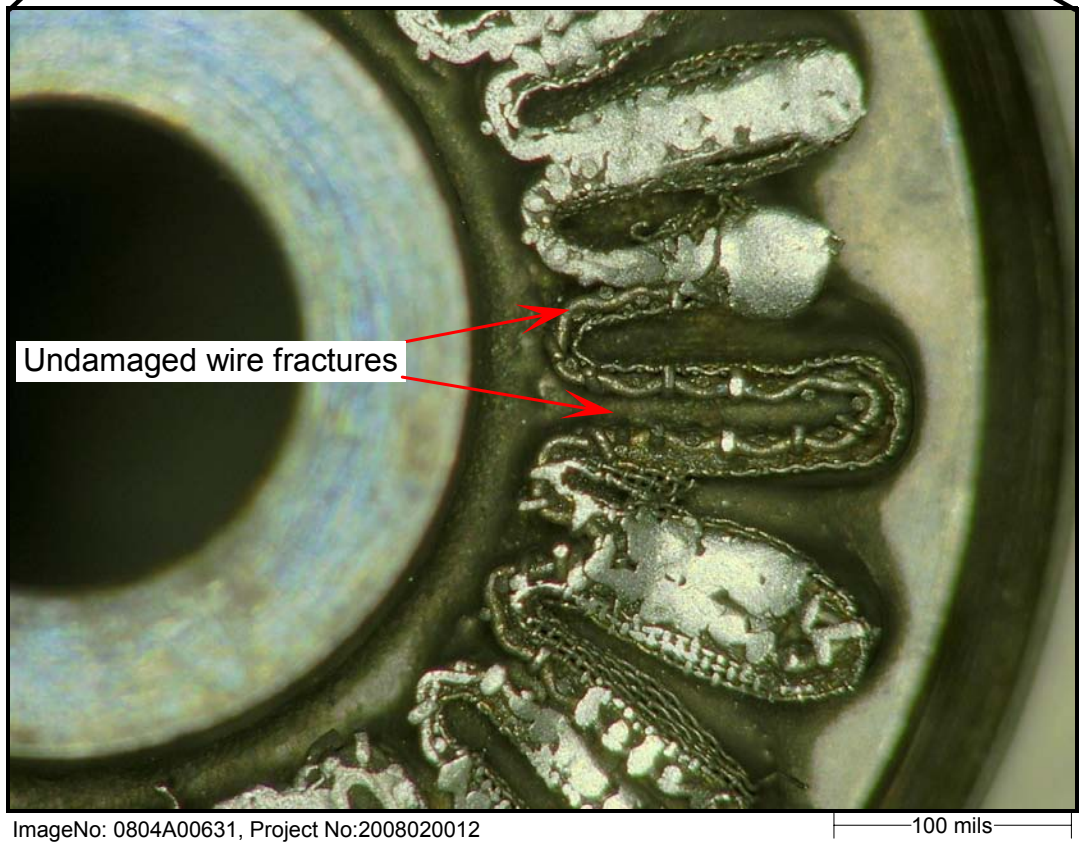
Figure 4--The fitting side separation showing the pleat with undamaged wire fractures.

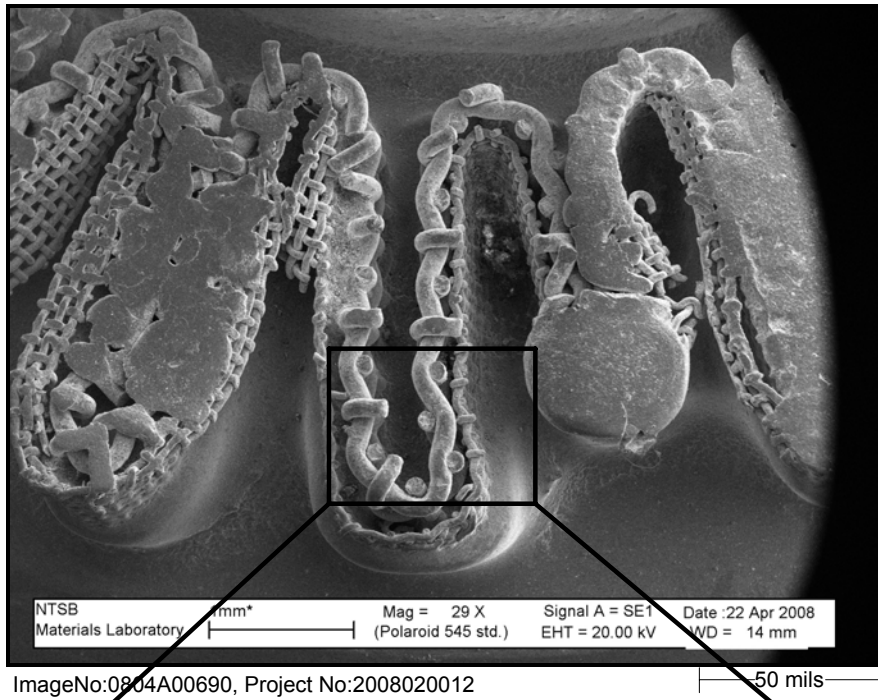
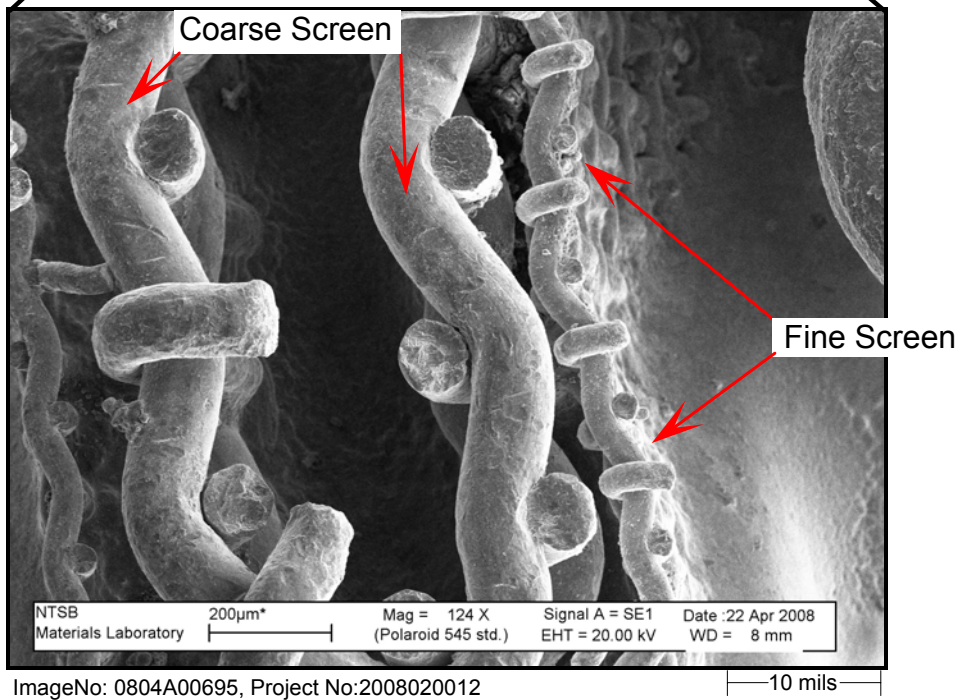
Scanning electron microscope (SEM) viewing found that both the fine and coarse wires were fractured at the intersection with the cross wires as shown in figures 5 and 6. High magnification viewing revealed features consistent with fatigue propagation completely through both the fine and coarse wires. Fracture traces indicated that the fatigue initiated at the contact points with the cross wires and propagated completely through the wire cross sections, as indicated in figure 6.

Figure 5--SEM views of the undamaged wire fractures.

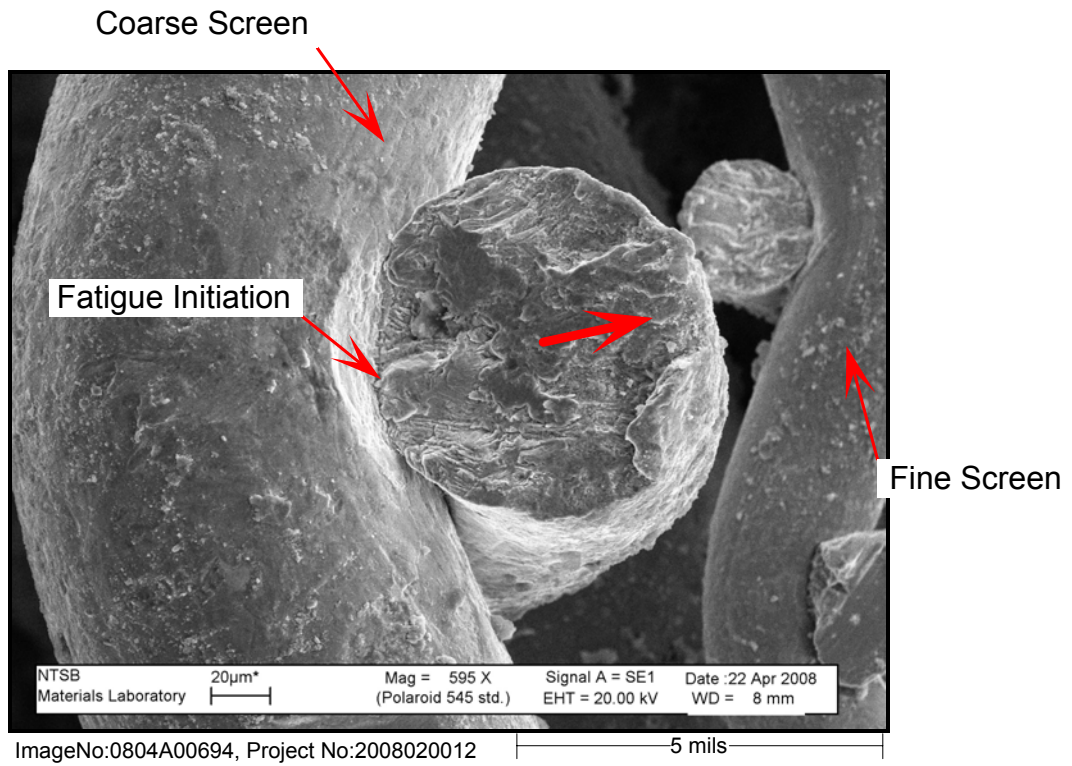
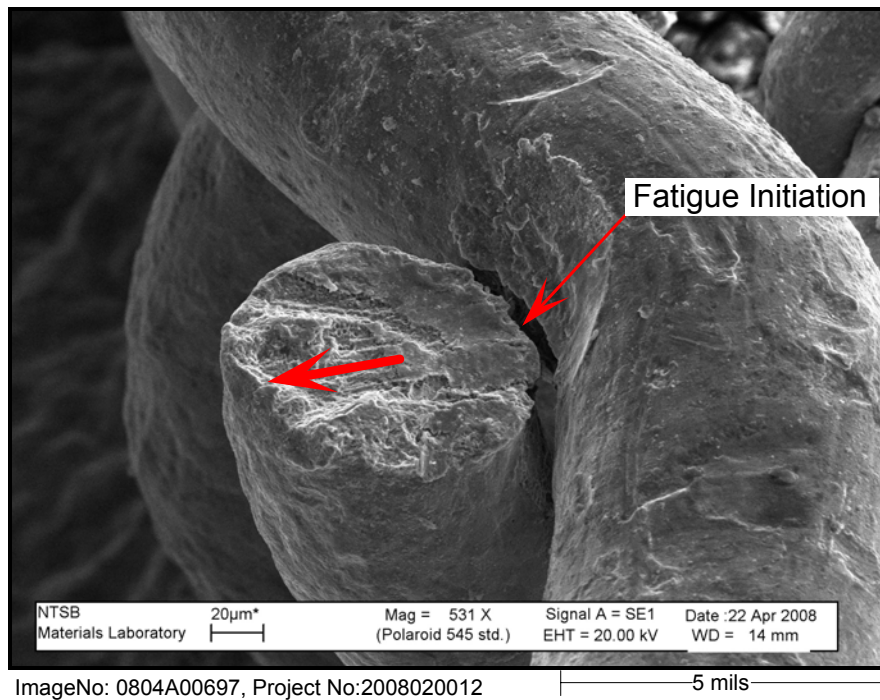
Figure 6--Typical fractures on coarse wires. Initiation at intersections with cross wires. Propagation indicated by bold arrows.

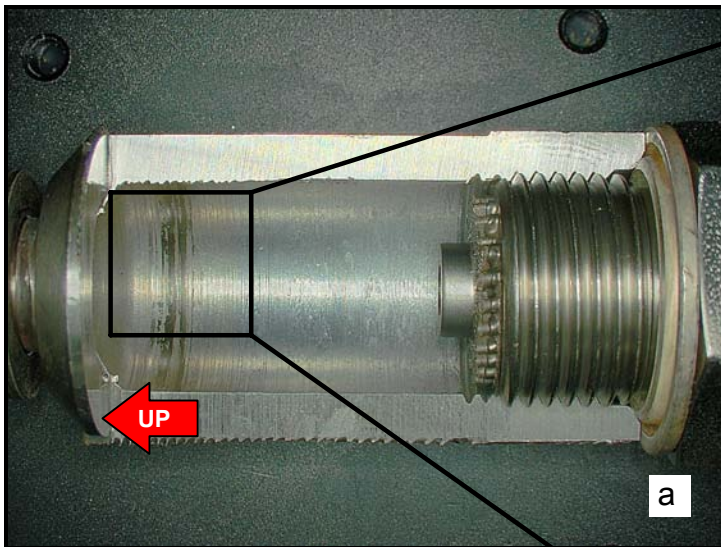
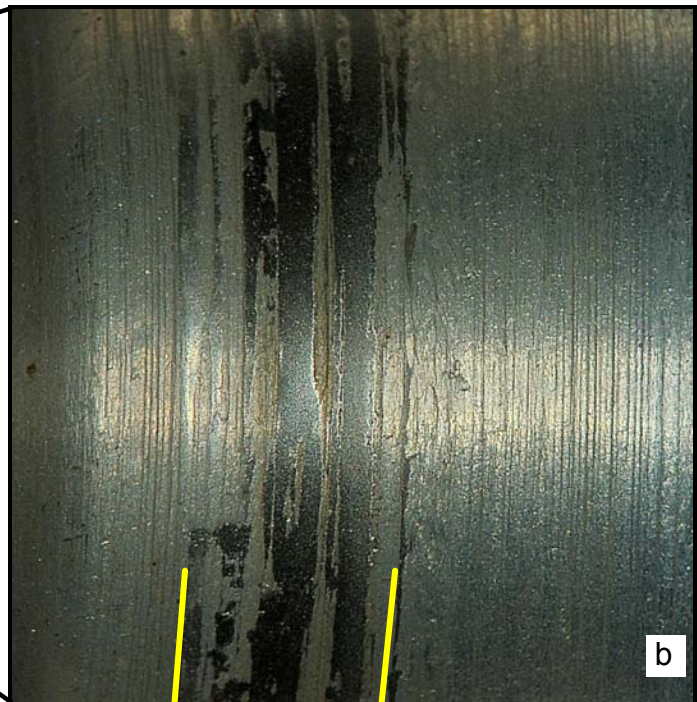
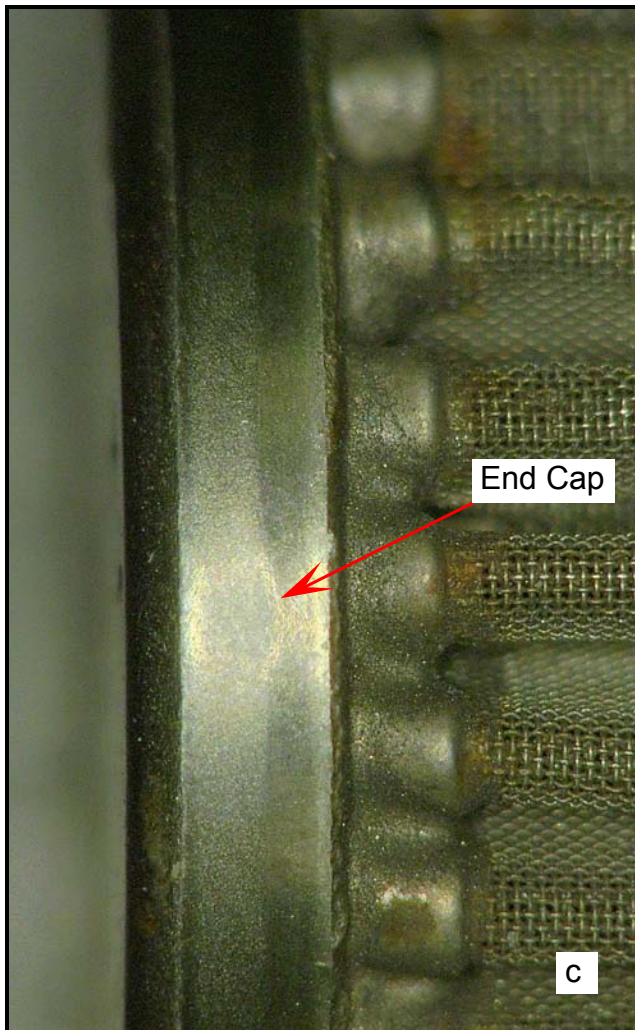
The housing was longitudinally sectioned (see figure 7 (a)). Examination of the interior surface after sectioning showed a circular burnished band where the original machined finish had been polished smooth as shown in figure 7 (b). The band was located at the approximate installed location of the filter element end cap. The outer diameter of the end cap displayed matching burnishing as shown in figure 7 (c).

Figure 7--The interior of the housing (a) showing a burnished band between the yellow lines in (b). The burnished and polished outerr diameter of the filter in cap in (c).
