# NATIONAL TRANSPORTATION SAFETY BOARD

MATERIALS LABORATORY FACTUAL REPORT

Report No. 08-049

Place : St. Louis, Missouri  
Date : September 28, 2007  
Vehicle : Boeing MD-82, N454AA  
Operator : American Airlines, Flight 1400  
NTSB No. : DCA07MA310  
Investigator : Harald Reichel, AS-40

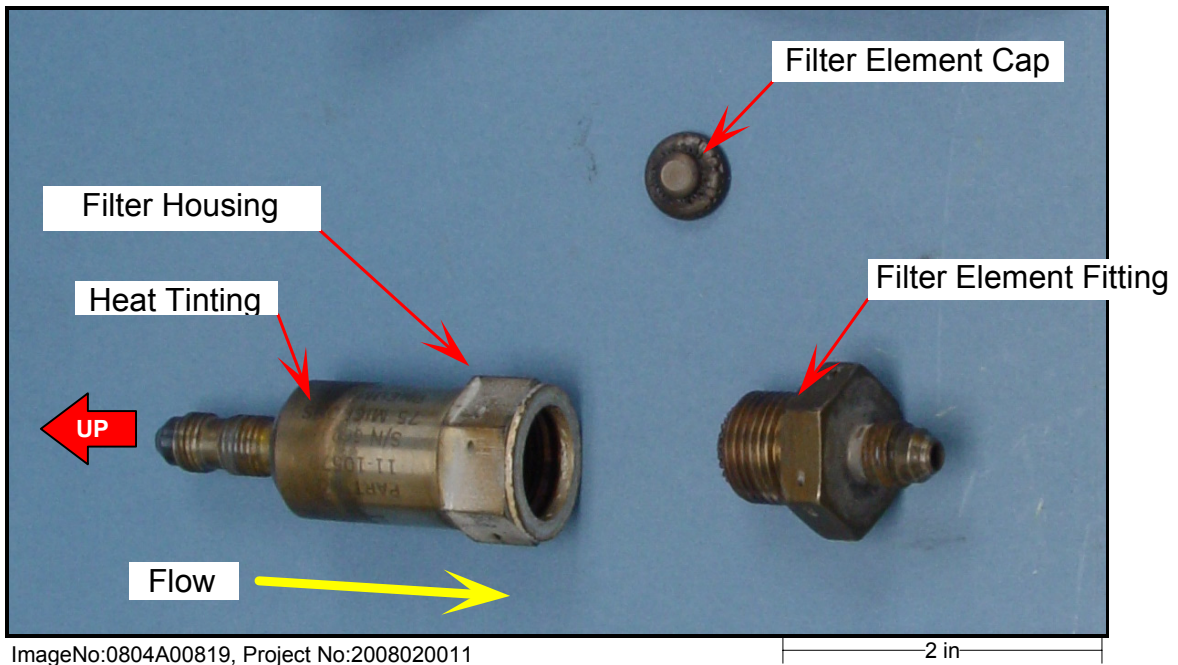
The received pieces of the accident air filter assembly are displayed in figure 1. These consisted of the filter housing, the threaded fitting with metal O-ring for the filter element assembly, and the filter element end cap. As shown in figure 2, a portion of the filter cloth was found lodged inside the bore of the housing. The outer surface of the housing was marked with "PTI, Part No. 11-10579, S/N 6628, 75, PN Filter, DAC, 7958540-1, DC-A". The upper end of the filter element end cap was marked "PTI, Lot No. 00??<sup>1</sup> 21-10930".

The exterior of the filter assembly showed darkening of the surface consistent with heat tinting from high temperature exposure. The cadmium plating on the washer between the fitting and the body was bubbled indicating temperatures near the melting point of cadmium, 610 °F.

Figure 1--The as recieved air filter components. Heat tinting is noticable on the upper end of the filter housing.

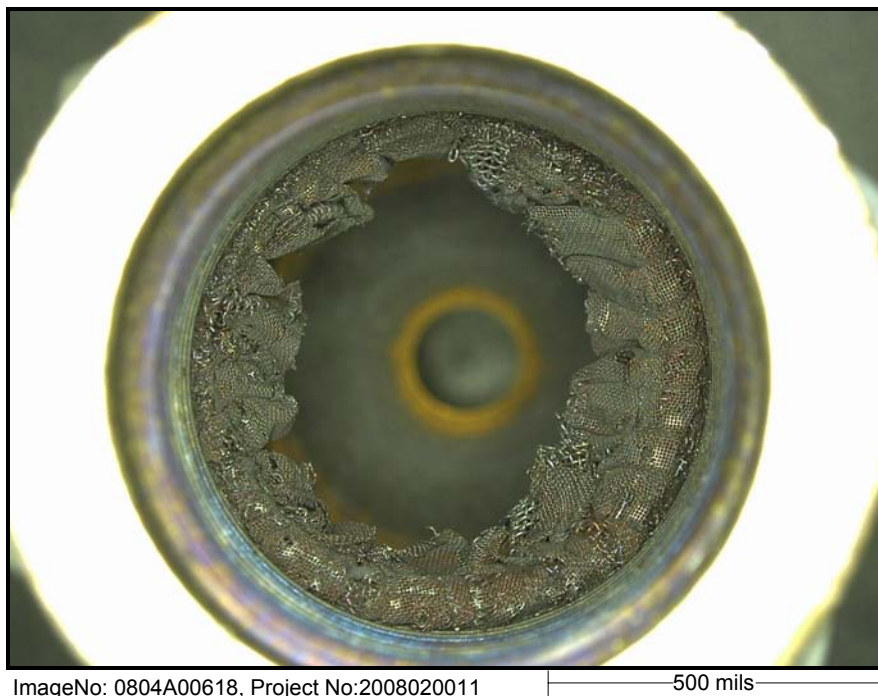
Figure 2--A view inside the filter housing at the remaining filter cloth material.

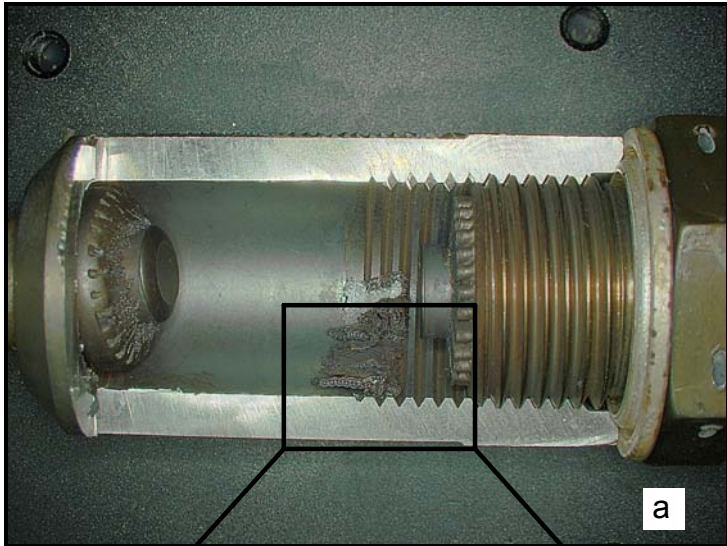
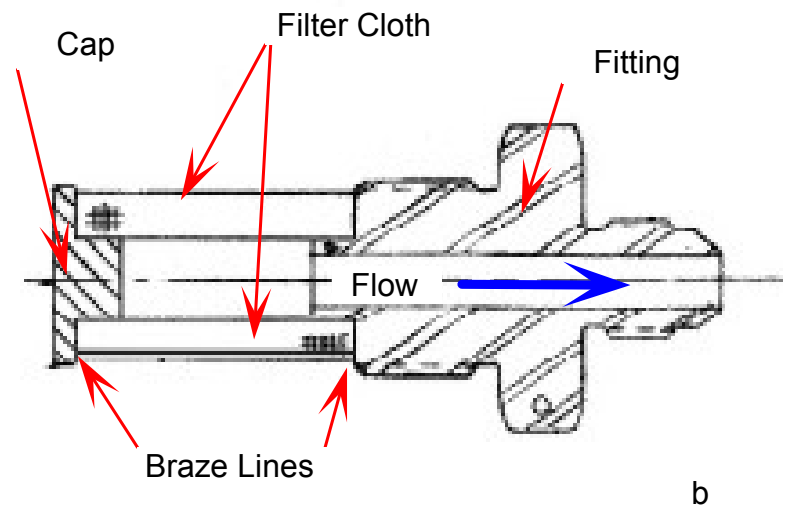
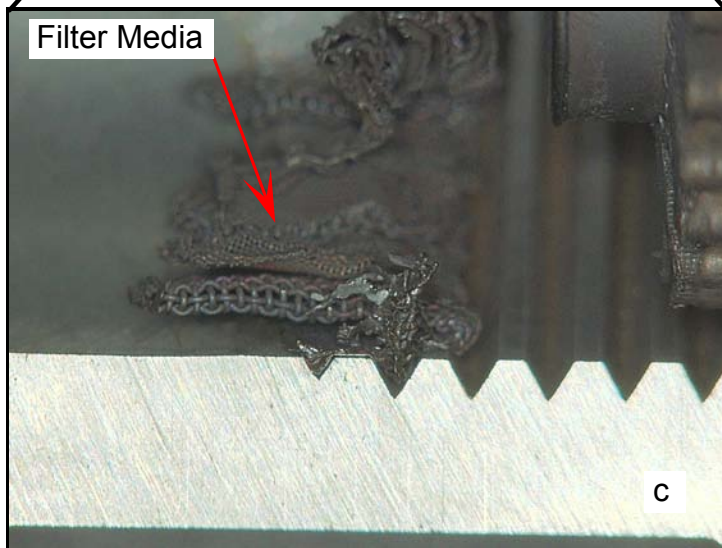
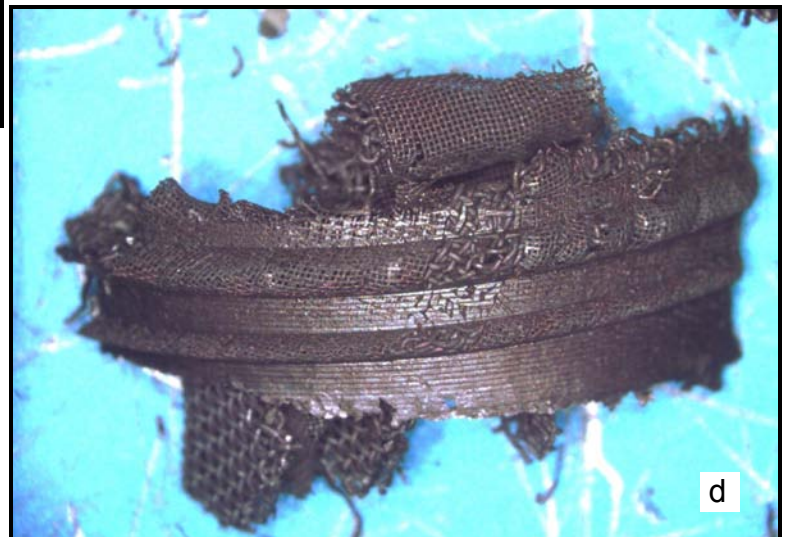
The portion of the filter cloth found inside the housing was folded and tightly compressed and partially imbedded into the internal threads of the housing. Figure 3 (a) and (c) depict the approximate location and condition of the cloth (shown after sectioning of the housing). Figure 3 (d) shows a piece of the removed cloth. The received portion of the filter cloth represented about ¼ to ½ inch of the filter element length. The filter cloth is

part of the brazed (inseparable) filter element assembly p/n 21-10930, along with the threaded fitting and filter end cap as illustrated in figure 3 (b).

Figure 3--View of the components installed in the sectioned housing (a) with a closer view of some of the filter material positioned as found in the threads (c). Illustration of the fitting assembly components (b). A closer view of the filter material showing the outline of the housing threads (d).

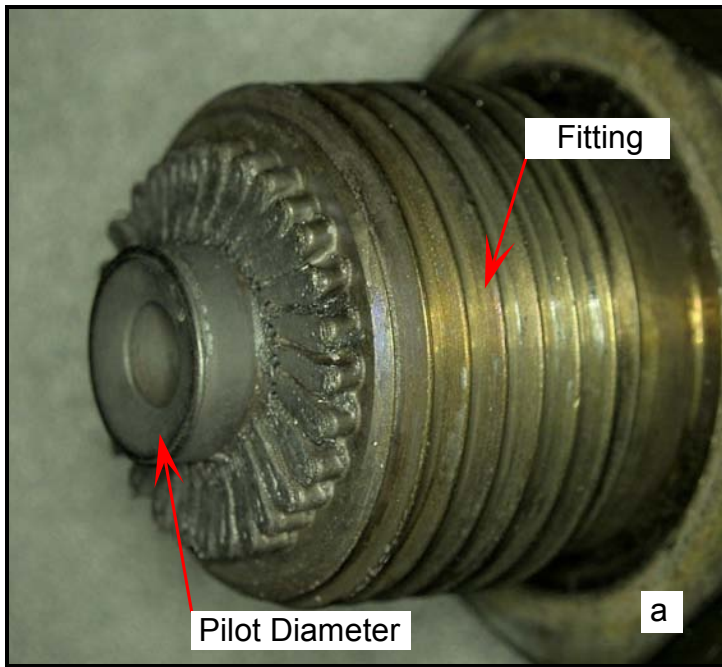
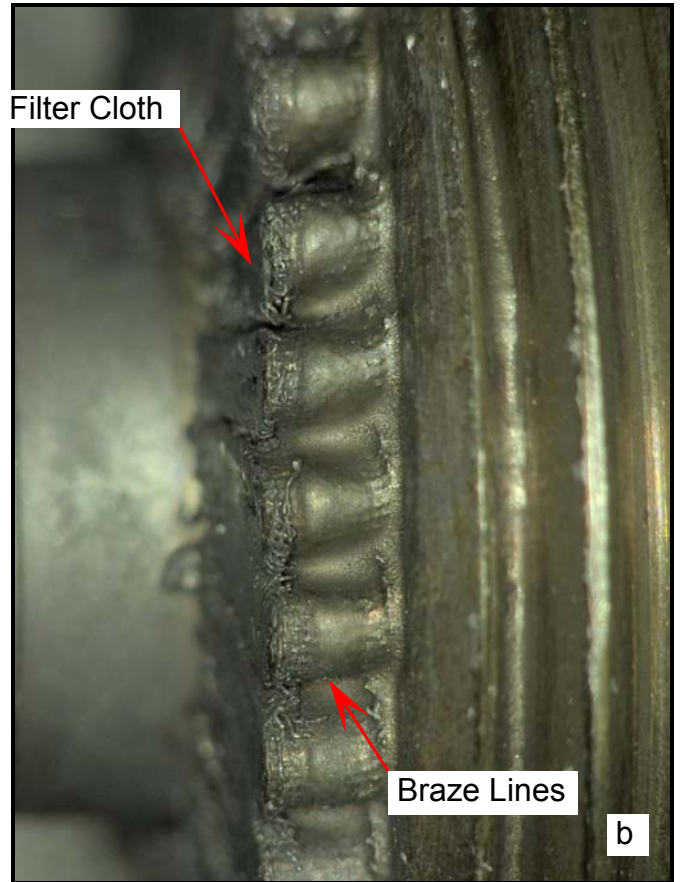
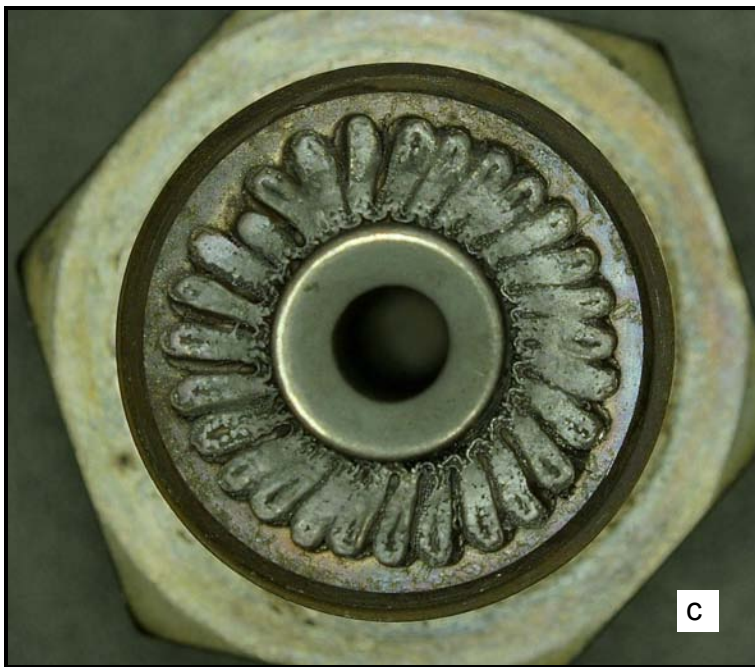
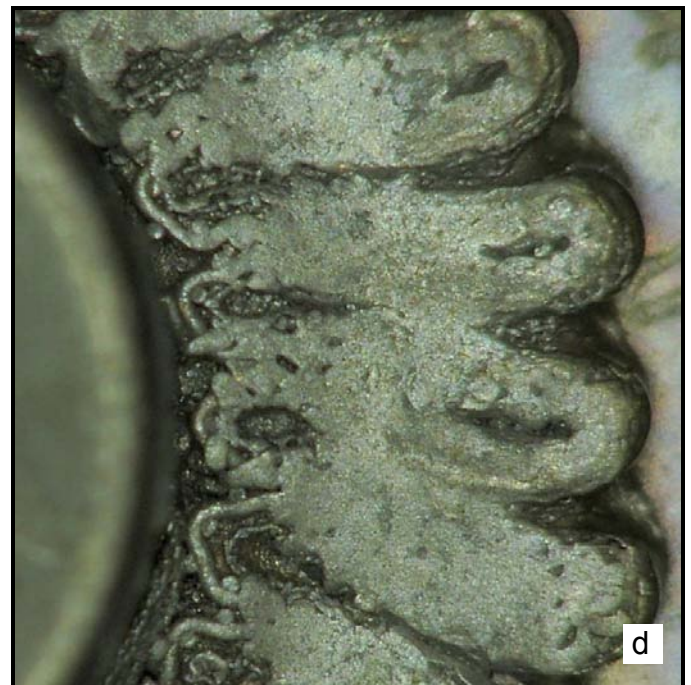
The filter element assembly had major separations through the cloth adjacent to the braze joints at the fitting and the end cap. The braze metal and small portions of the cloth remained attached to the fitting (figure 4) and cap (figure 5). Magnified examinations found severe rubbing damage at the separations, as shown in figure 4 (c) and (d) and figure 5. The damage completely obliterated any fracture features at the separations. Similarly, mechanical damage obliterated separation features on the portion of cloth removed from the housing. The damage was consistent with small amplitude rubbing between opposed side of the separations and not from foreign objects.

Figure 4--The as-received fitting end at the separation of the filter adjacent to the braze joint (a) and (b). Closer views of the face separation showing extensive mechanical damage that obliterated fracture features.

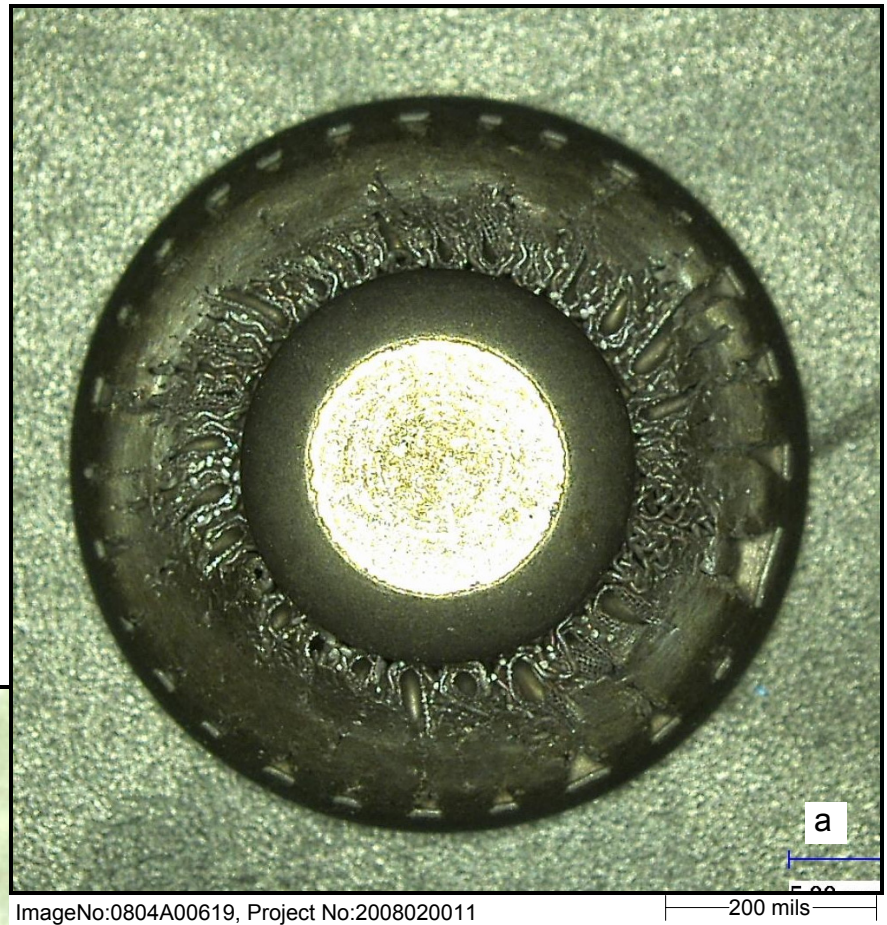
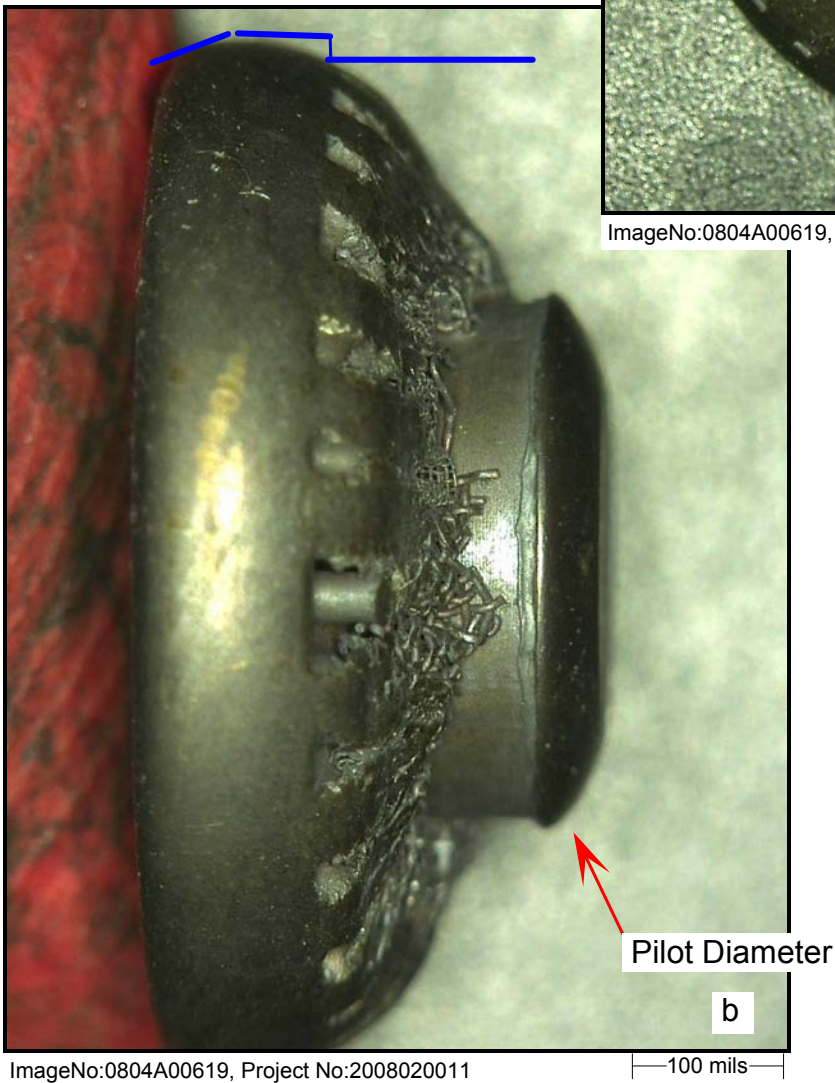
The filter end cap was also mechanically damaged as shown in figure 5. The outer diameter edge of the cap was rubbed and rounded as indicated by blue lines in figure 5 (b). Comparisons to exemplar end caps found the accident cap was reduced in diameter by as much as 0.020 inch. The cap's pilot diameter, see figure 5 (b), was also rubbed and rounded with a similar mating pattern found on the pilot diameter of the fitting, normally at the opposite end of the filter.

The damage to the interior of the housing, the end cap and the filter cloth was consistent with vibratory motion of the filter cloth and end cap within the housing. Contact between the end cap and housing mutually burnished the surfaces. The extent of polishing of the housing indicated that the end cap progressed downward in the housing, eventually contacting the fitting end.

Figure 5--The filter element end cap showing the deformation and burnishing damage to the outer diameter and pilot diameter. The approximate original cap profile is indicated by blue lines in (b)

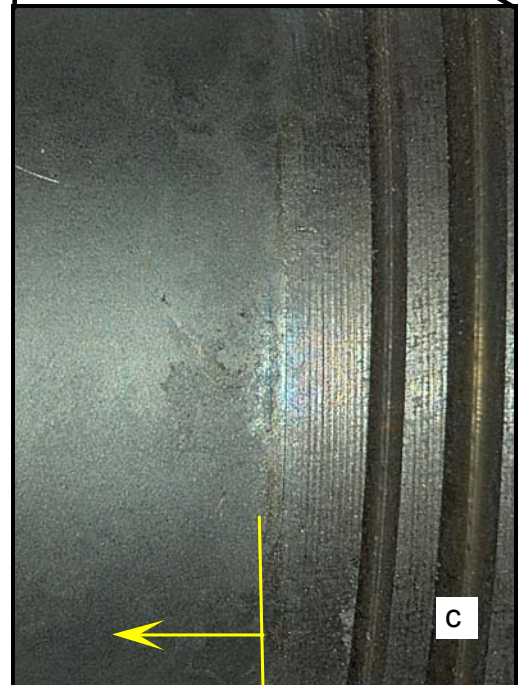
The filter housing was longitudinally sectioned to display the interior surface as shown in figure 6. The central region of the cylindrical interior surface (between yellow lines in (a)) was burnished and polished smooth, obliterating the original turned surface finish. The original machined finish only remained in small bands at the upper (b) and lower (c) end of the section. The interior of an exemplar housing is shown in figure 6 (d) with an enlargement of the surface for comparison.

Figure 6--The sectioned housing showing burnishing features between yellow lines on the interior (a). The upper and lower extents are shown in (b) and (c). The interior of an exemplar is shown in (d) for comparison.

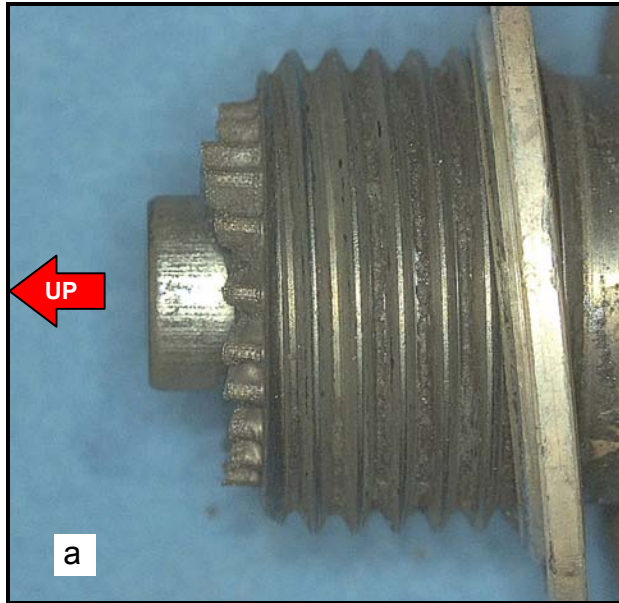
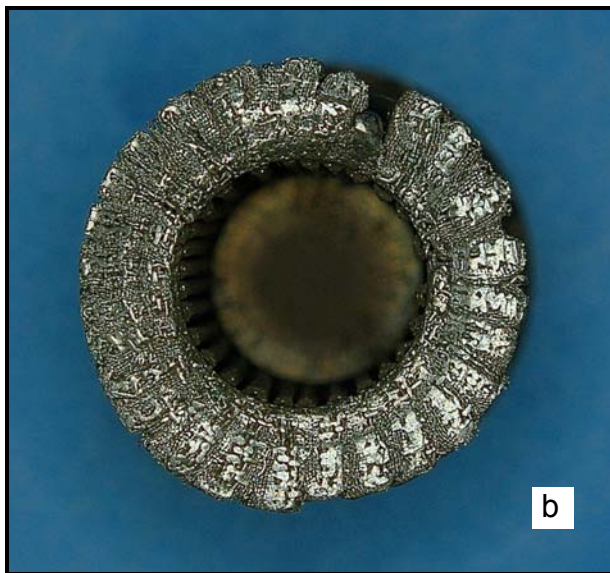
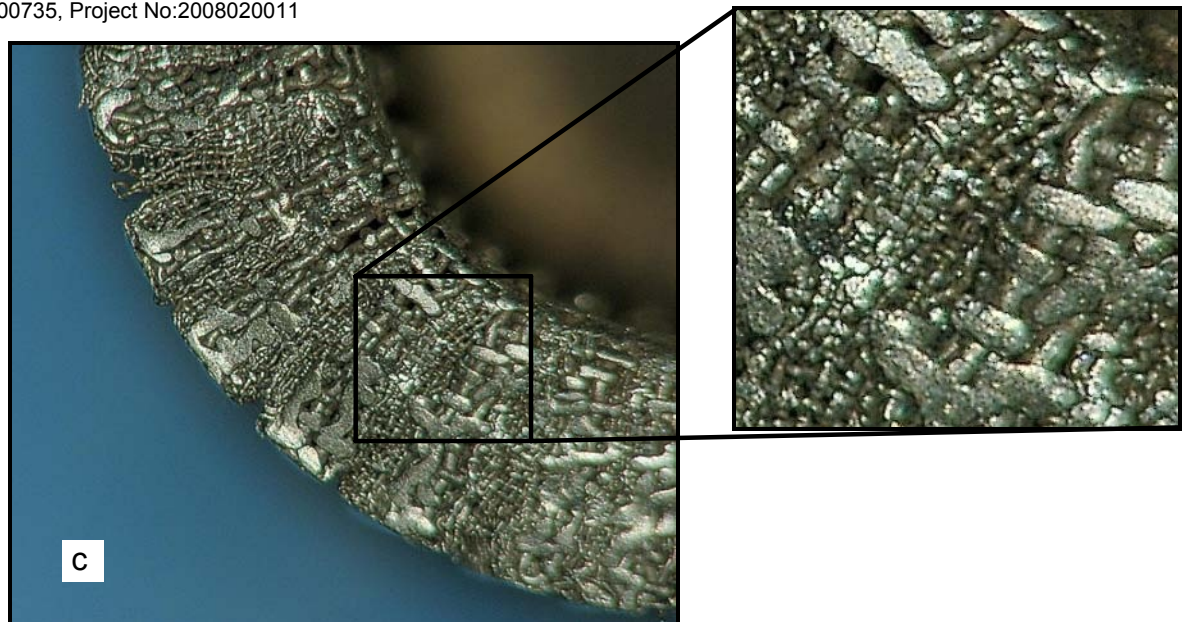
The separated filter was transversely fractured through the filter cloth just above the lower braze joint to the threaded fitting, as shown in figures 7 and 8 (a). With the housing longitudinally sectioned, a burnished ring was apparent on the interior surface corresponding to the approximate installed location of the filter end cap. The polished ring is shown in figure 7 (c) between the yellow lines. The outer diameter of the end cap was also burnished as shown in figure 7 (b), removing the original machined finish.

Optical examinations of the separated filter revealed that the longitudinal wires of the cloth screens were fractured near the edge of the braze joint. Close examinations found that the wire fracture surfaces and surrounding areas were rubbed and mechanically damaged to the point that no original fractures remained, see figures 8 (b) and (c).

Figure 8--The separated filter element (a) with extensive mechanical damage of the faces (b) and (c).

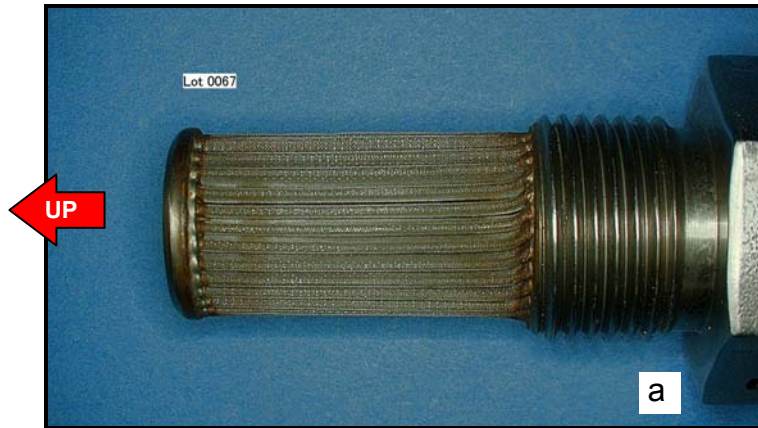
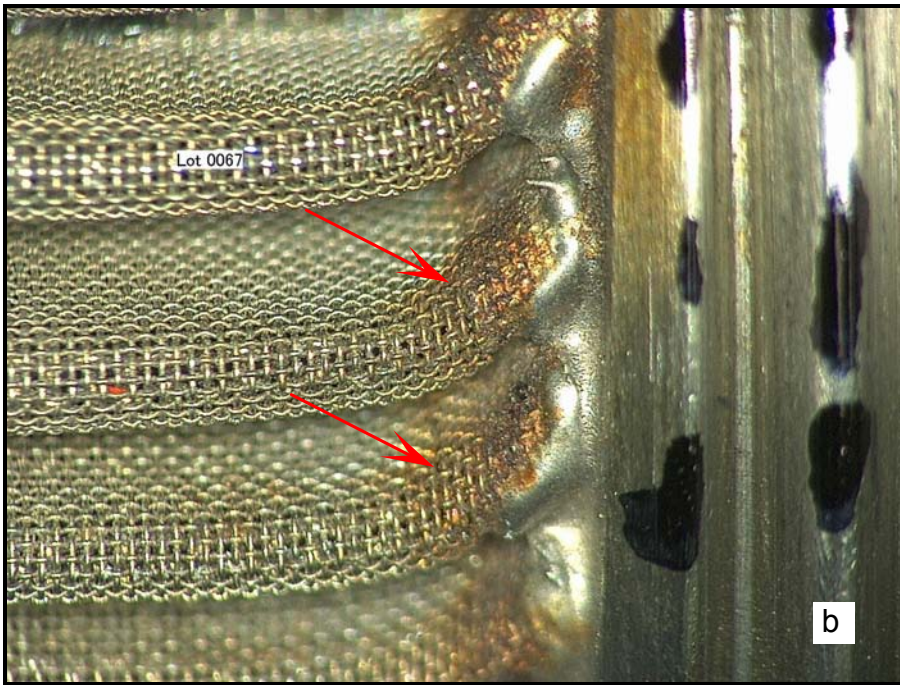
wires were in general only visible at magnifications of 30X and above. Typical areas of the cracked filters are displayed in figures 9, 10 and 11. Filters from lots 0067 and 125 had transverse cracks near the lower braze, as shown in figures 9 and 10. While the filter from lot 012 showed transverse cracks near the upper and lower braze lines and longitudinal cracks along the pleats at the upper braze, as shown in figure 11.

The end cap of the filter from lot 0067 had polishing of the outer diameter. The end caps of the other two filters displayed typical machining marks with no polishing. No housings were received to inspect for comparable burnishing rings.

Figure 9--Exemplar from lot 0067 (a) with arrows denoting locations of cracked fine screen (b). Burnishing of the cap diameter shown in (c) and enlargement.

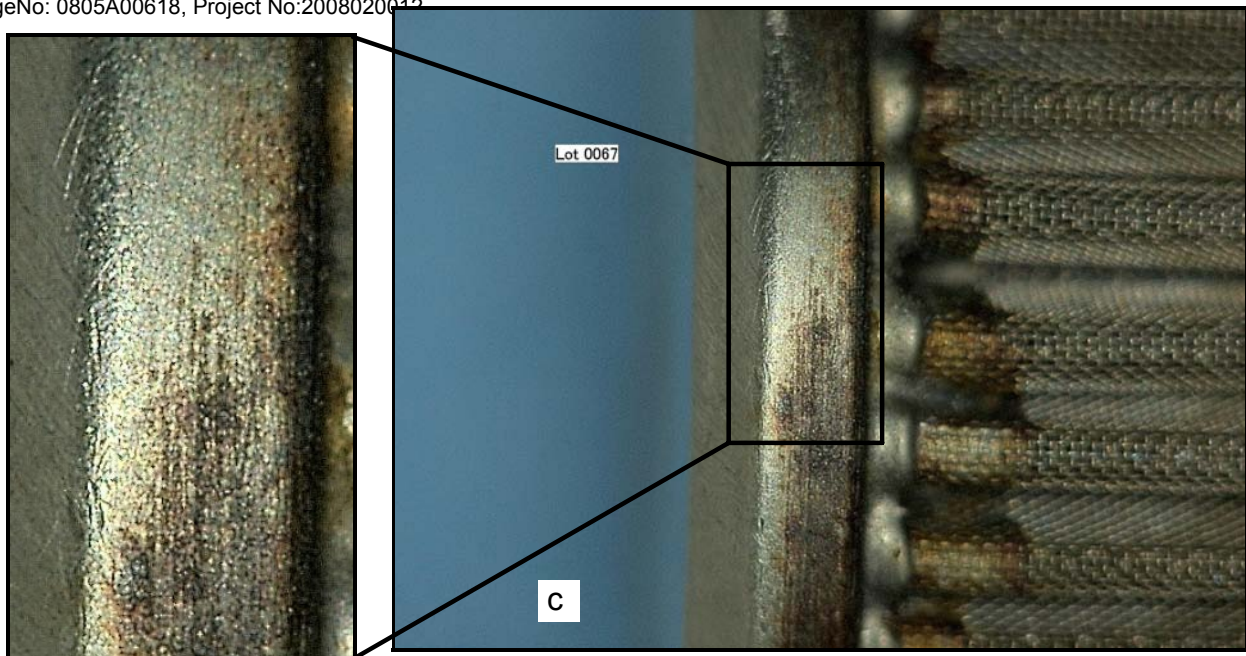
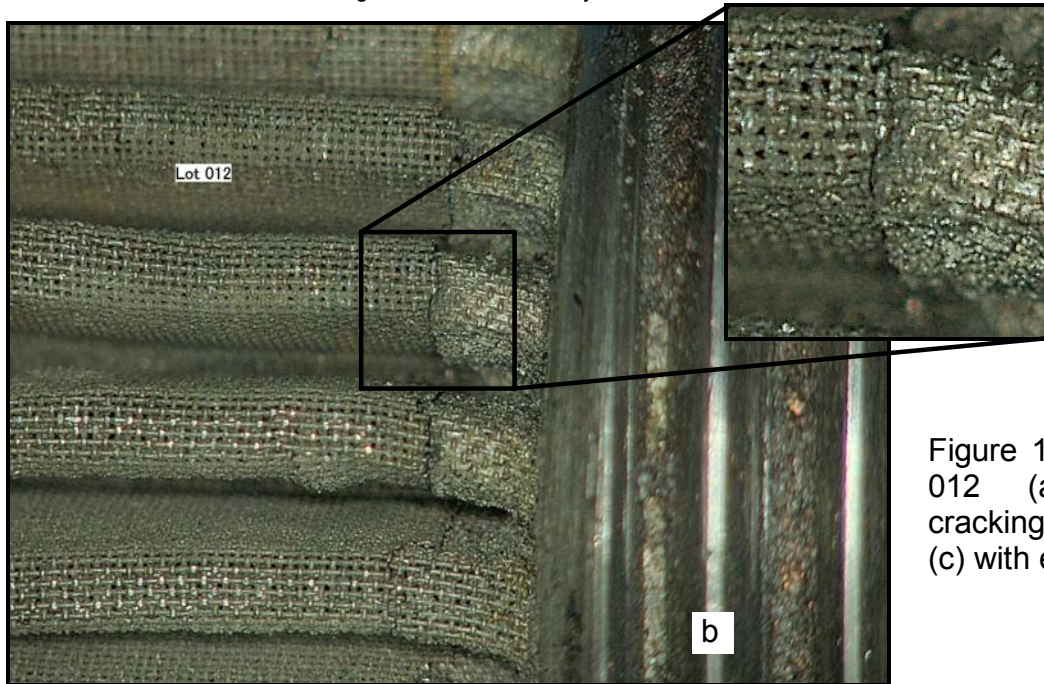
Figure 10--Filter element from lot 012 (a) showing extensive cracking of the fine screen (b) and (c) with enlarged areas.

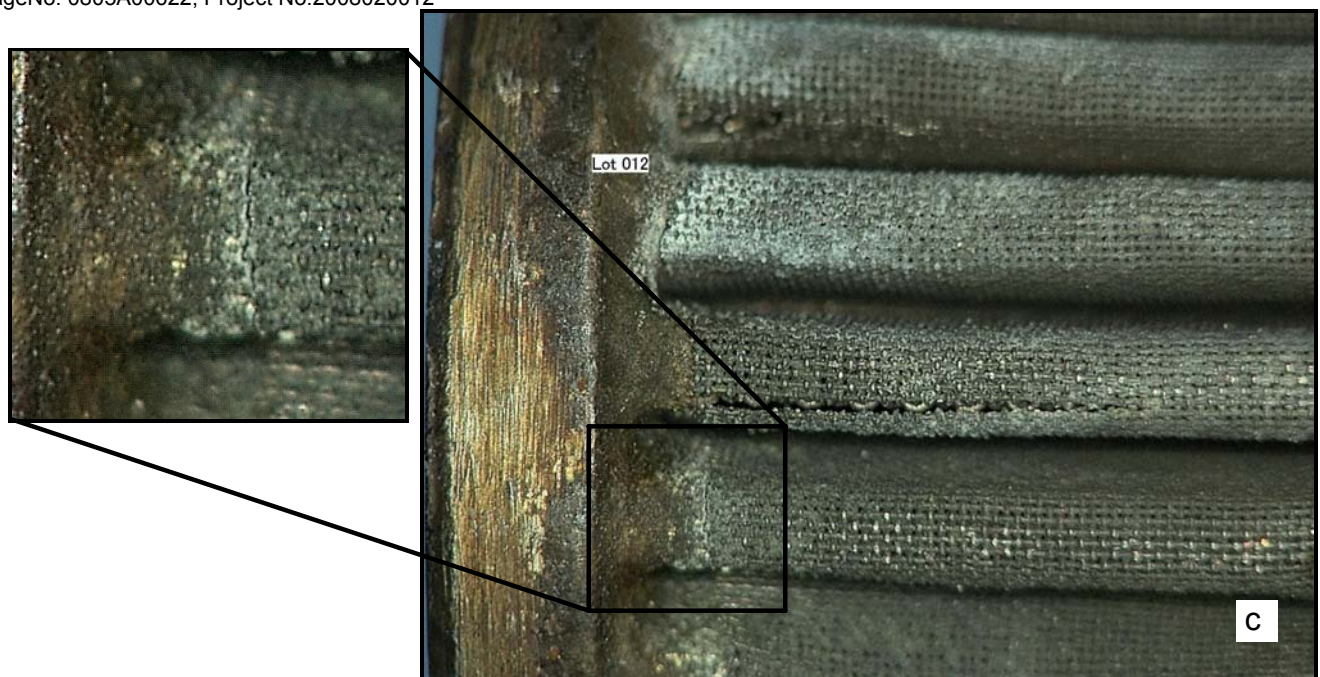
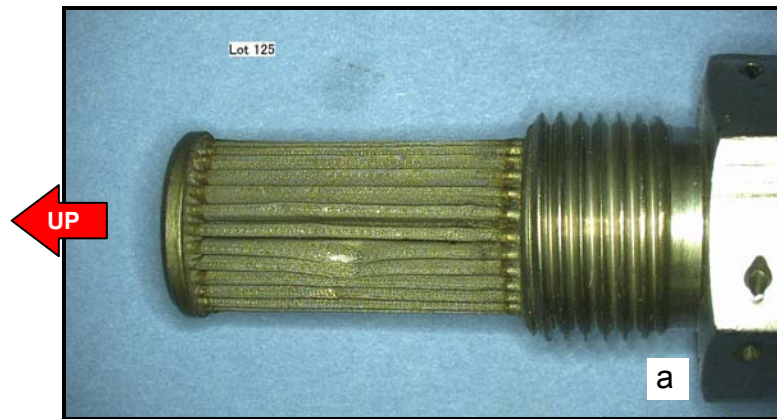
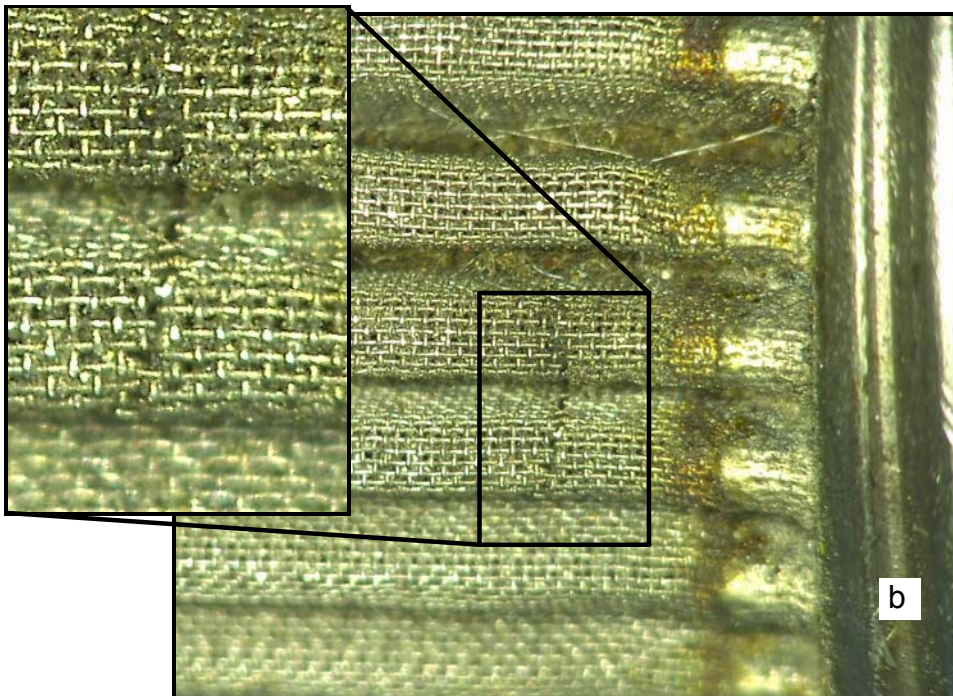
Figure 11--Filter element from lot 125 (a) with cracks in the fine screen (b). Original machined finish on the end cap.

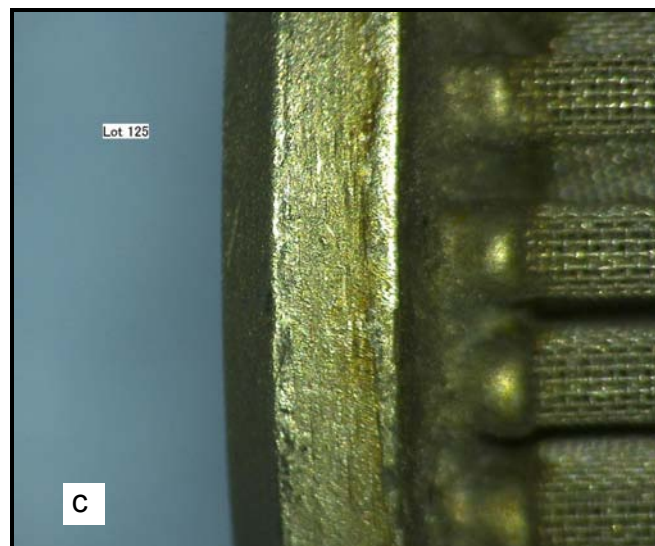
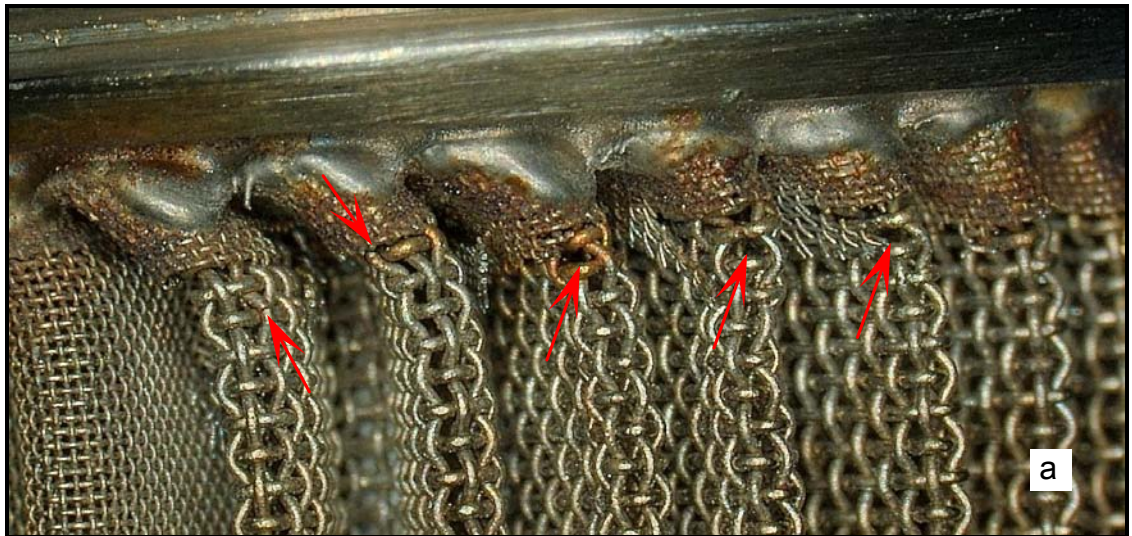
The fine outer screen was partially removed from the filters from lot 012 and 0067 in the area of the cracks. No cracks were found in the underlying coarse screen wires of the lot 012 filter but multiple cracked were visible in the longitudinal wires of the coarse screen of 0067, as shown in figure 12.

Figure 12--Views of typical fractured coarse screen wires (arrows) in the filter from lot 0067.

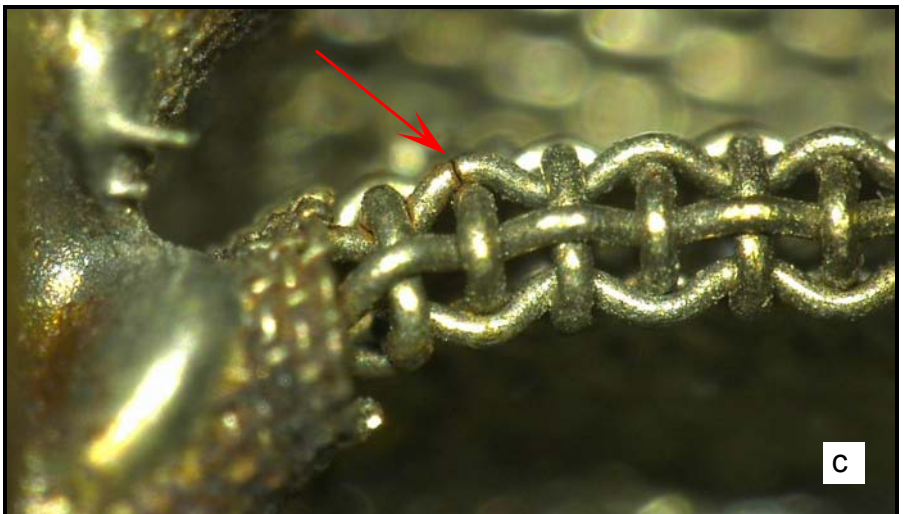
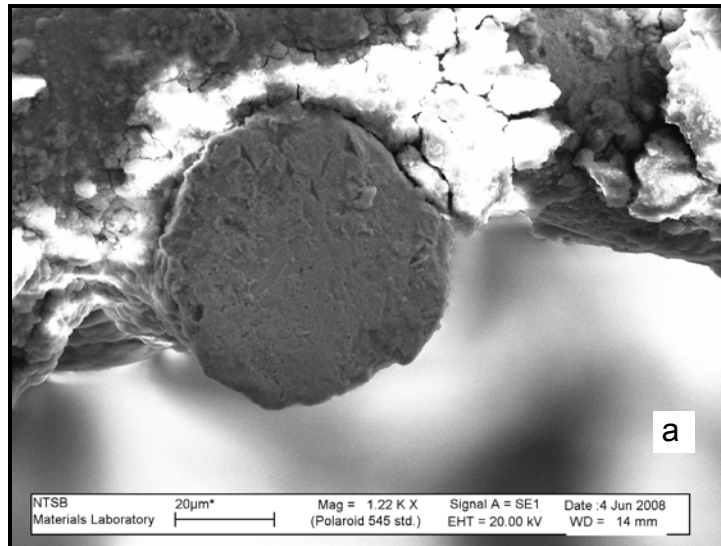
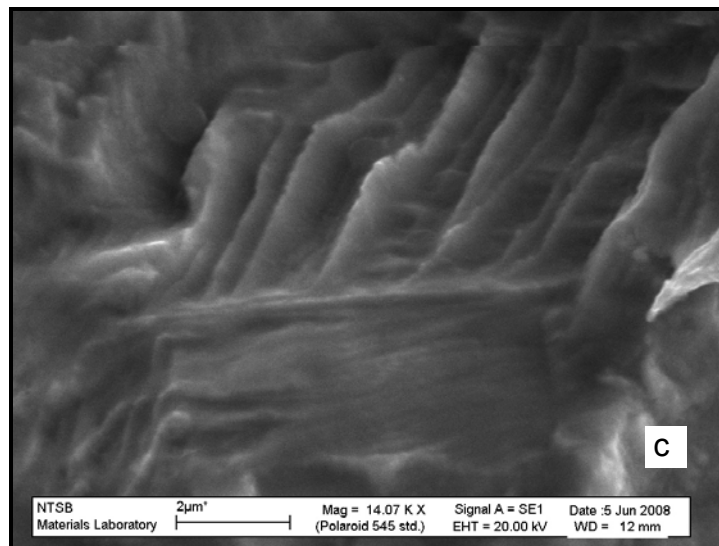
SEM examinations of the fractured fine wires revealed oxidation and mechanical damage to the majority of the wire fracture faces that obliterated most of the separation features. The wire fractures appeared brittle in nature in that there was no apparent yielding or necking adjacent to the breaks. A typical damaged fracture is displayed in figure 13 (a). A few wire fractures were undamaged. These fracture contained micro features indicative of fatigue propagation with initiation at the contact point of the crossing wires. A typical undamaged fracture is displayed in figure 13 (b) with the initiation area and direction of propagation denoted. Intact wires that were fractured during removal of the fine screen displayed significant necking and a dimpled fractured face.

Figure 13-- SEM views of fractured wires from the fine screen of lot 012. Damage wire in (a). Fatigue fractured wire in (b) with a high magnification view of fatigue features in (c).
