NATIONAL TRANSPORTATION SAFETY BOARD

MATERIALS LABORATORY FACTUAL REPORT

Report No. 08-116

Place : San Francisco, California
Date : June 28, 2008
Vehicle : Boeing 767-200 Freighter
NTSB No. : DCA08MA076
Investigator : Lorenda Ward

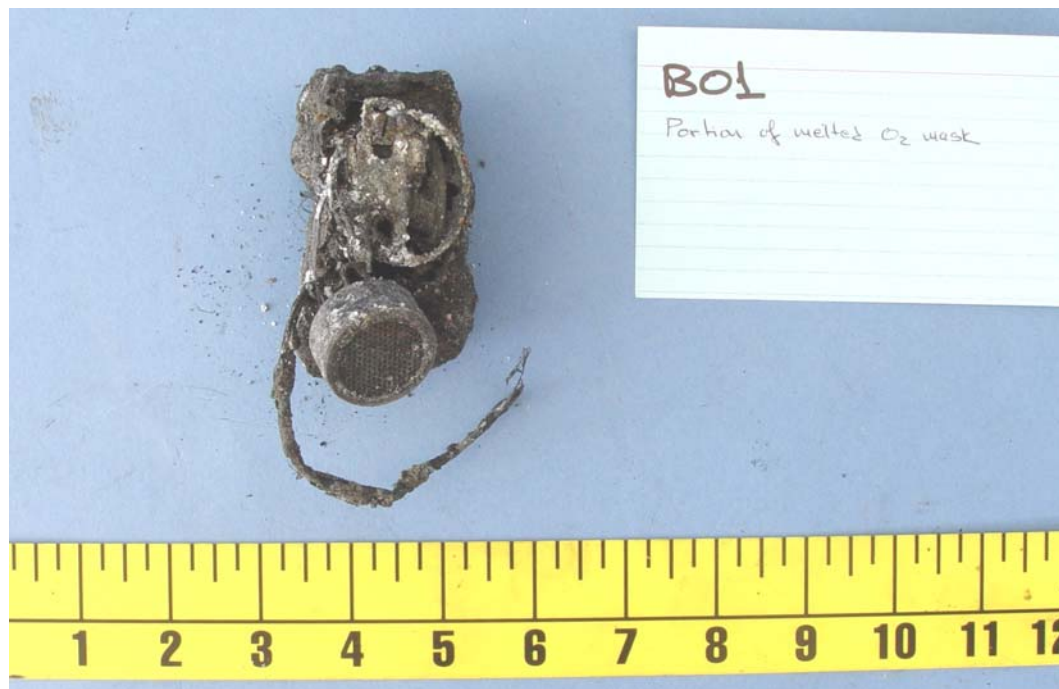
The portion of the oxygen mask (figure 1) that was examined had been severely fire damaged, having melted and deformed, and did not resemble its original shape. It was identified as being a portion of the oxygen mask by the microphone assembly, which was metallic and had not been deformed. Overall this item had a black, charred appearance, and was friable when handled. The main body of the oxygen mask was comprised of a plastic material, which had melted, and resolidified into an amorphous mass with the

microphone stuck to it by means of wires, which would have carried the signal from the microphone.

Figure 1: Portion of oxygen mask

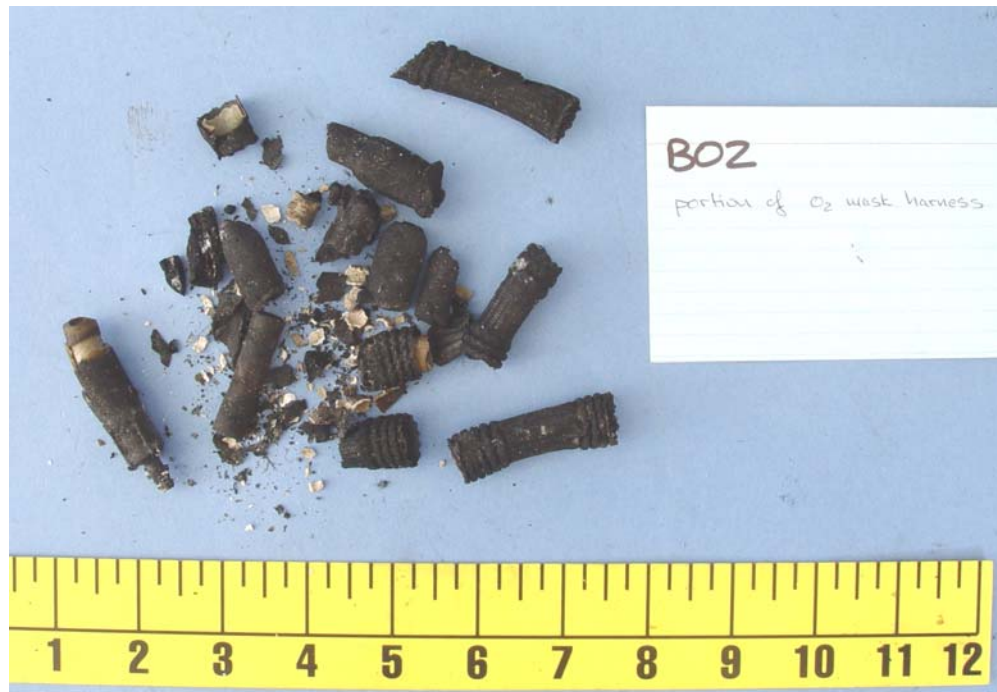
Small portions of the oxygen mask harness (figure 2) that were recovered exhibited severe thermal damage and had become charred and friable. The aluminum fittings (figure 3) that were used to secure the harness to the oxygen mask had reached their incipient melting temperature and had become deformed. These fittings had a heavy oxide formation on their outer surface. Portions of charred harness material were still present inside these fittings.

Figure 2: Portions of oxygen mask harness

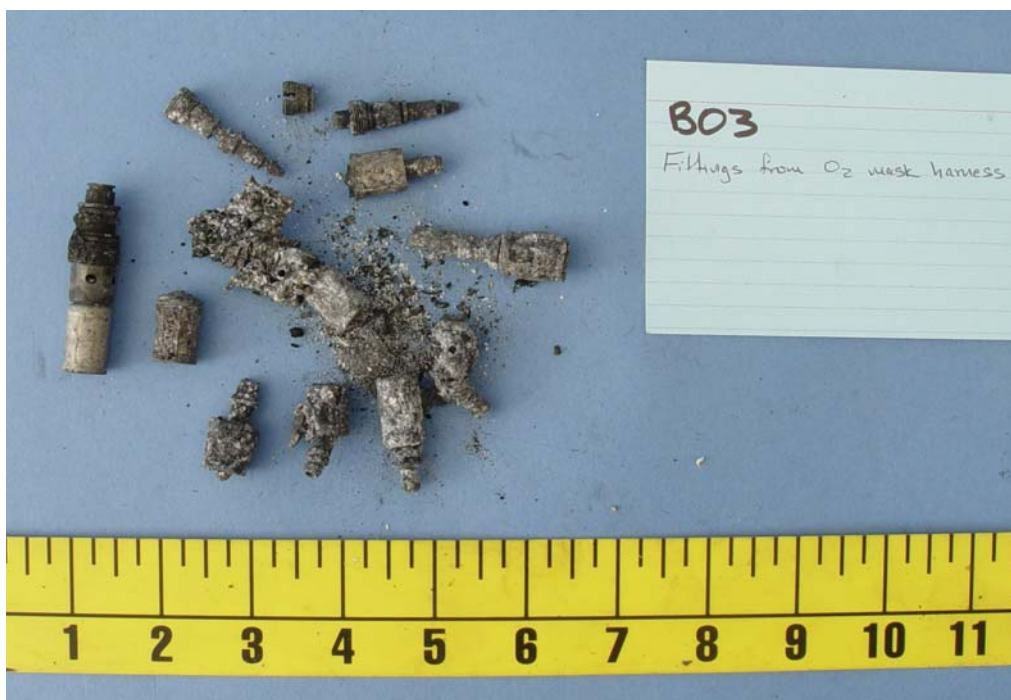
Figure 3: Oxygen mask harness fittings

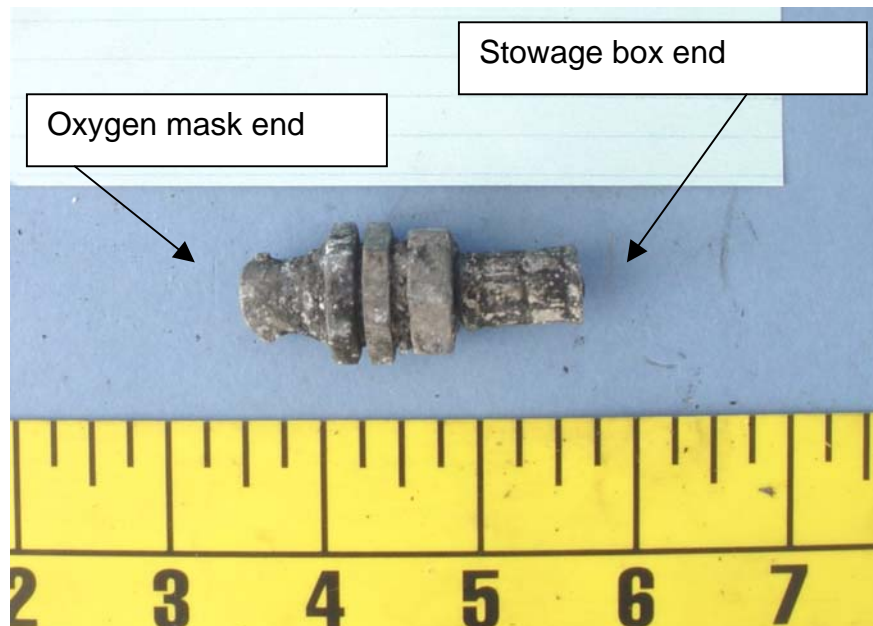
An aluminum fitting (figure 4) which would connect the oxygen mask to the oxygen mask stowage box had sustained severe thermal damage. The fitting was deformed indicating that it had reached its incipient melting temperature. The end of the fitting that would have been contained within the stowage box had remnants of the flexible line that would have been supplying it with oxygen. This remnant of the flexible oxygen line was friable and white in appearance.

Figure 4: Fitting connecting an oxygen mask to an oxygen mask stowage box

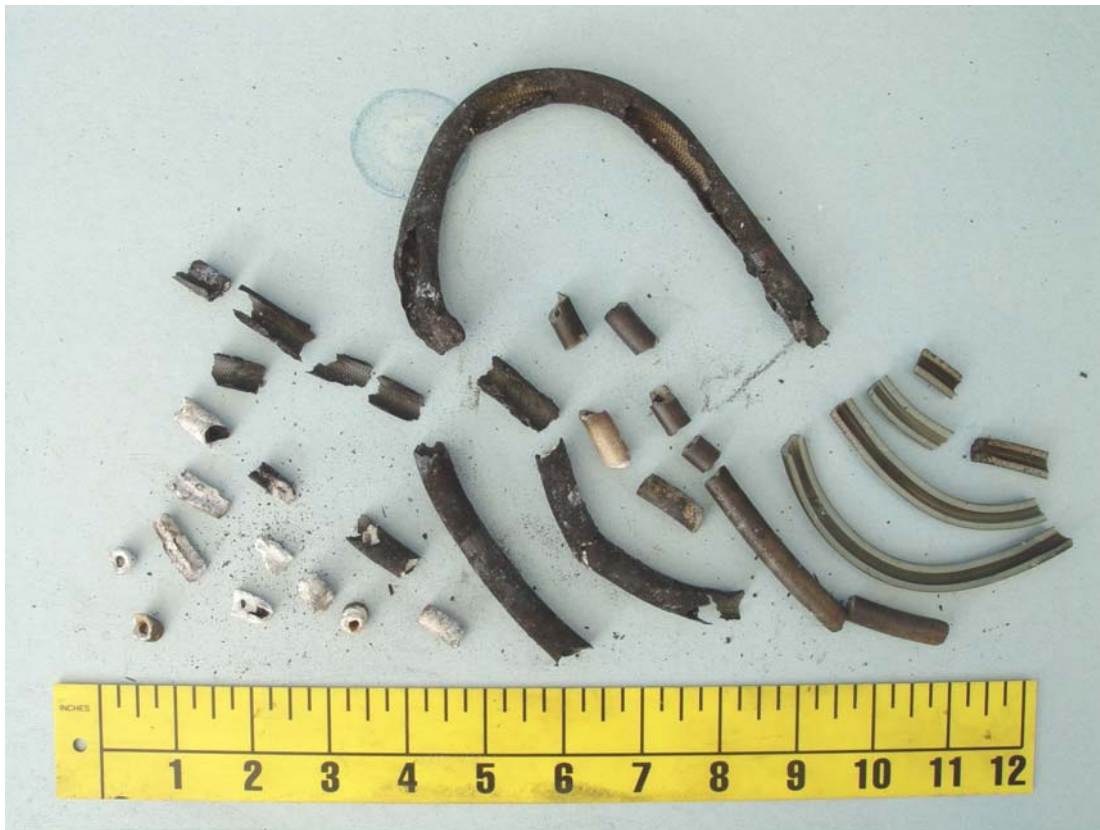
The portions of the flexible oxygen lines (figure 5) that were recovered appear to be of the type connecting oxygen masks to the oxygen mask stowage boxes. The over braid which would cover the inner flexible PVC tubing was heavily charred and brittle. The inner portions of the tubing were white in appearance and friable when handled. Some of the small portions of the white colored tubing were blackened on the inner surface. One portion of tubing that was approximately 8 inches in length had a heavily charred over braid and the flexible tube inside was olive green in color. This tube was sectioned to observe the inner surface, which was found to have sustained lesser thermal damage than the exterior surface. The photograph in figure 5 shows a portion of the tube that was sectioned. This tubing was still pliable although it would fracture when bent a sufficient amount. Examination of the corresponding flexible oxygen lines from exemplar components found that the tubing they were constructed with was white in color. The olive green flexible tubing

appears to have been olive green from manufacture and not caused by exposure to high temperature.

Figure 5: Portions of flexible oxygen lines consistent with those used to connect oxygen masks to oxygen mask boxes

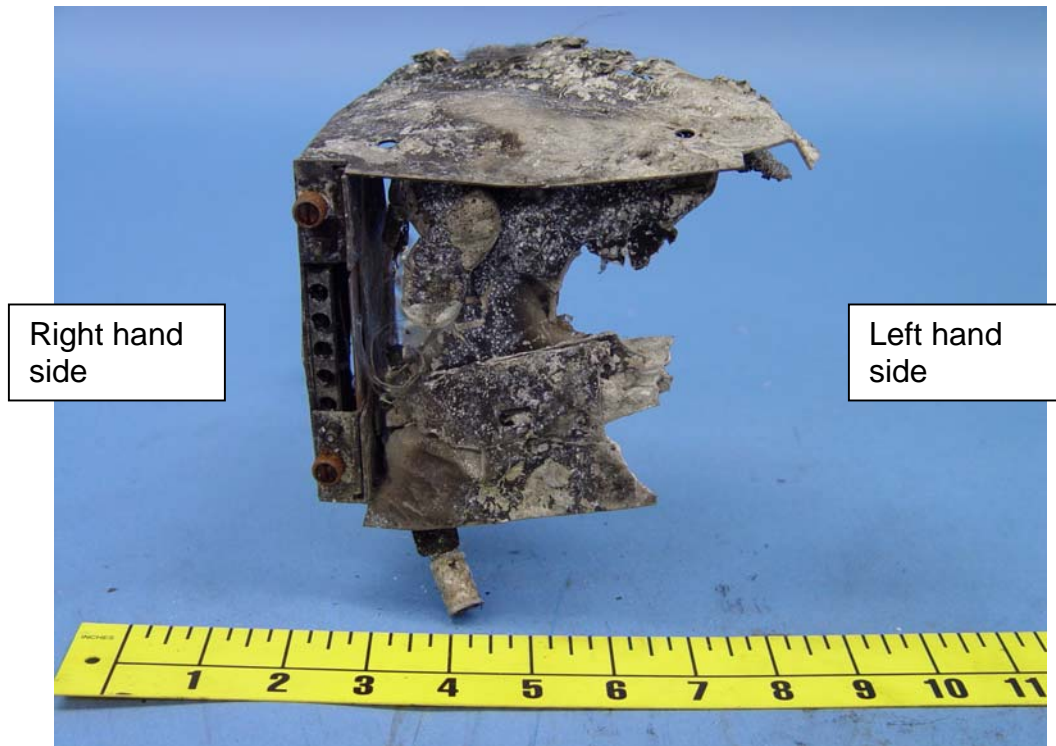
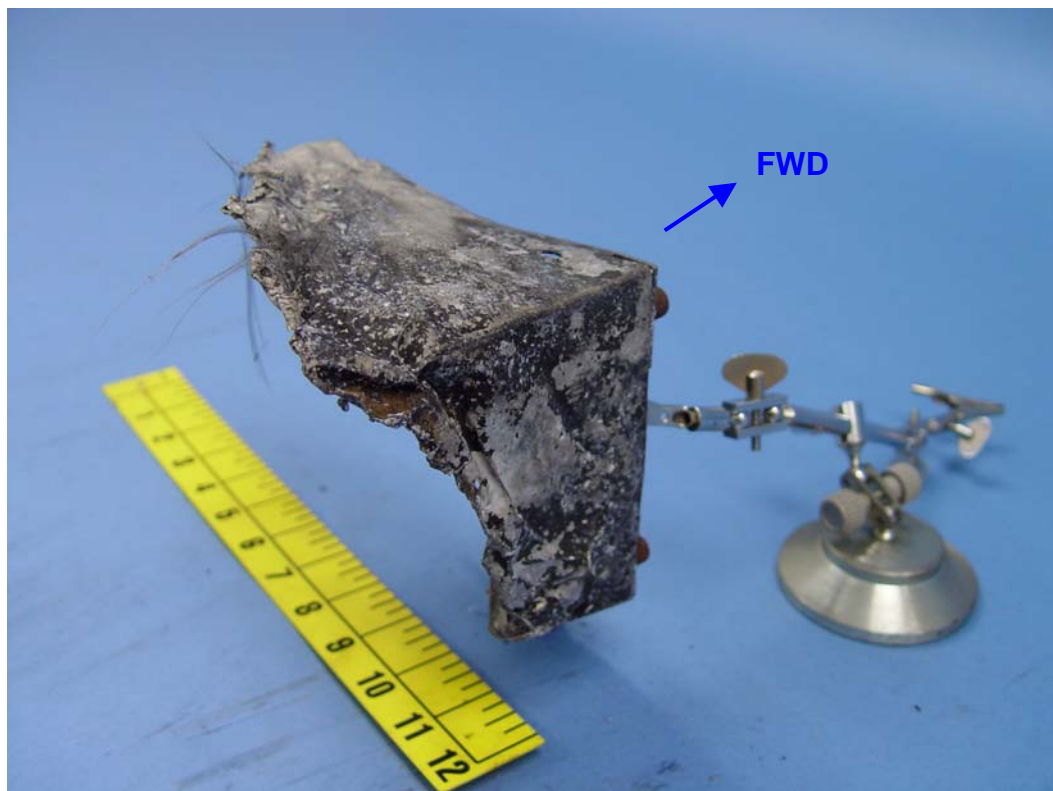
The portion of the oxygen mask box (figures 6 & 7) was found on the floor deck between the location of the weight and balance computer and the right seat frame of the supernumerary seating. The portion of the mask box was severely fire damaged and only approximately half of the box remained. The fitting that would connect the stowage box to the oxygen mask was still attached. The left hand side of the box as well as the rear panel was missing. The rear most section of the right hand side of the box was also missing. The bottom of the box was also missing as well as the left rear portion of the top.

Figure 6: Oxygen mask stowage box as viewed from the front.

Figure 7: Oxygen mask stowage box as viewed from right hand rear corner

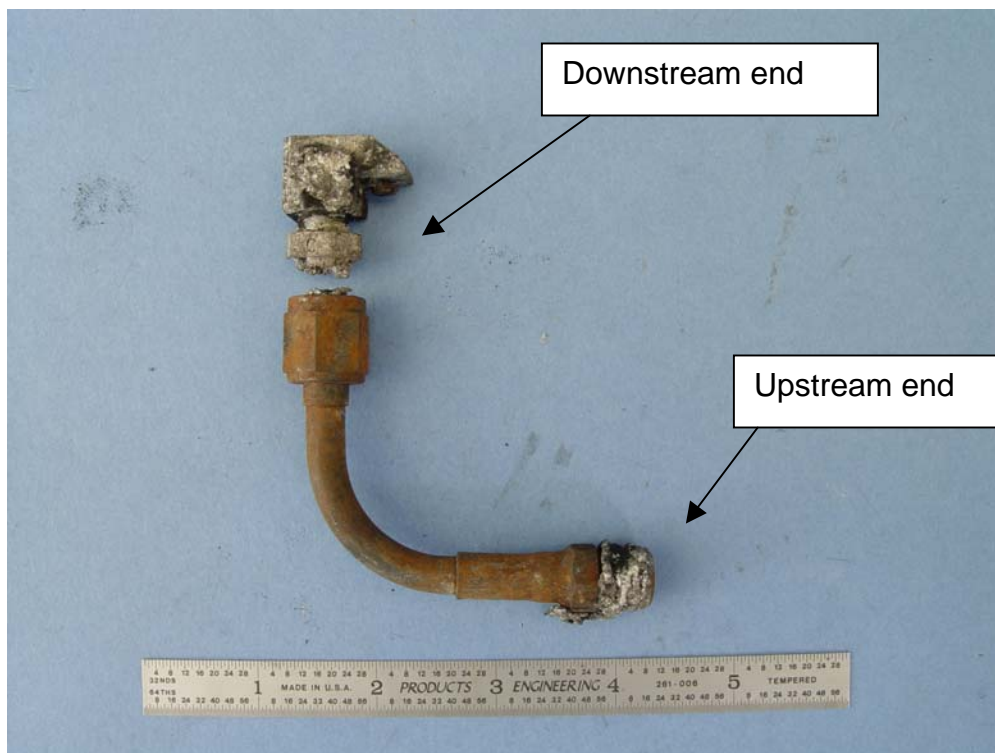
A stainless steel tube forming a 90-degree elbow (figure 8) was found in the fire damaged supernumerary compartment. This tube was found on the floor deck near the centerline of the compartment at the base of the bulkhead separating the supernumerary compartment and the main cargo deck. This tube was intact but heavily oxidized, consistent with being exposed to a high temperature fire environment. A large portion of the aluminum AN type fitting that would connect this tube to one of the oxygen mask stowage boxes was still attached to the down stream end of the elbow. This fitting broke off during examination. The fitting had evidence of having reached its incipient melting temperature and was slightly deformed. The upstream end of the elbow had remnants of an aluminum fitting adhering to the threads of the stainless steel threaded nipple at the end of the tube.

Figure 8: Stainless steel elbow with large portion of an aluminum fitting

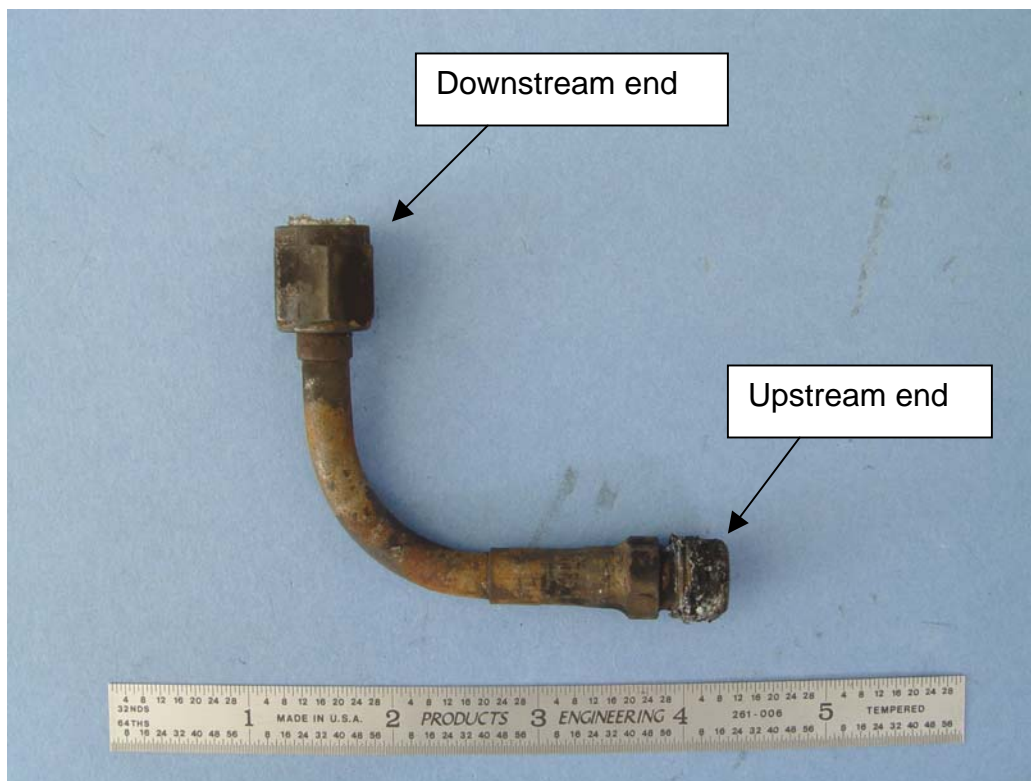
A second stainless steel 90-degree elbow (figure 9) was also recovered near the centerline of the supernumerary compartment at the base of the bulkhead separating the supernumerary from the main cargo deck. This 90-degree elbow was also intact and exhibited heavy oxidation consistent with exposure to a high temperature fire environment. This elbow had remnants of an aluminum fitting adhering to the threaded nipple on the up stream portion

of the elbow. The down stream portion of the elbow had a portion of the AN type aluminum fitting still contained within the stainless steel nut.

Figure 9: Stainless steel elbow with remnants of aluminum fittings

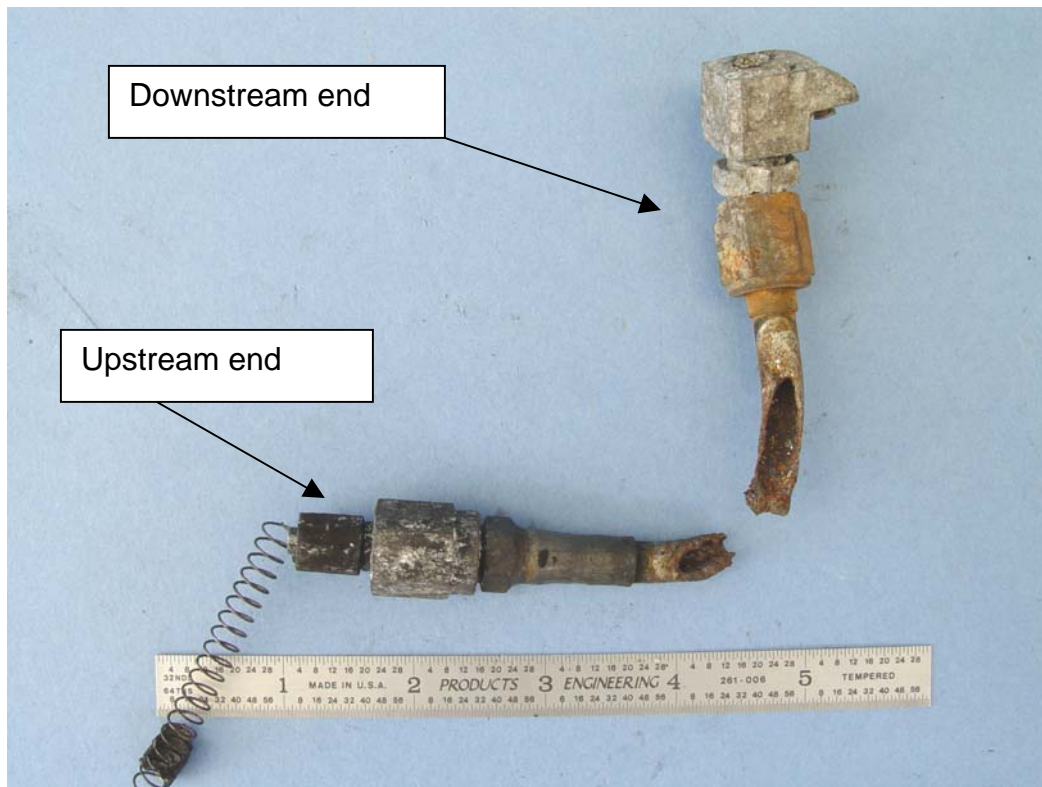
Two portions of a third 90-degree stainless steel elbow (figure 10) were recovered from the floor deck of the supernumerary compartment at the base of the bulkhead between the location of the right hand seat frame and where the weight and balance computer would have been. The two portions of the elbow were heavily oxidized and melted at the location of the radius of the 90-degree bend. The location of the melting was concentrated along the inner radius of the bend and on the portion of the tube that would have been facing toward the aft of the aircraft when attached to the oxygen mask stowage box. The upstream portion of the elbow had the aluminum fitting still attached and in intact condition although exhibiting surface oxidation. At the location where this upstream portion of the elbow had melted, the resolidified metal appeared to have slumped inward into the tube (figure 11). An approximately 2.5 inch portion of the wire spiral that would have been contained within the flexible oxygen line and connected to the elbow through the aluminum fitting was still present. This wire spiral was hooked into a small hole in the end of the aluminum fitting on the upstream portion of the elbow, but not rigidly connected (figure 10). The upstream end of the wire spiral had evidence of melting and re-solidification (figure 12). The down stream portion of the elbow had the aluminum AN type fitting still attached. The fitting had reached its incipient melting temperature

and had deformed. Close examination revealed that it had softened and bent out of plane with the elbow but had not rotated out of position.

Figure 10: Two portions of 90-degree stainless steel elbow with aluminum fittings

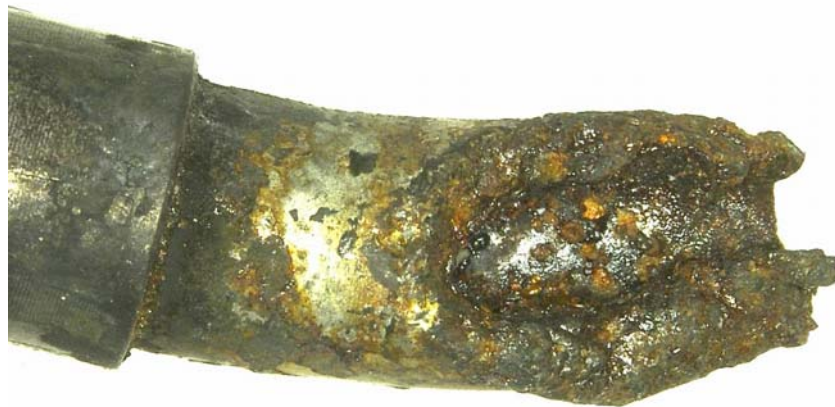
Figure 11: Melted area of up stream portion of 90-degree elbow

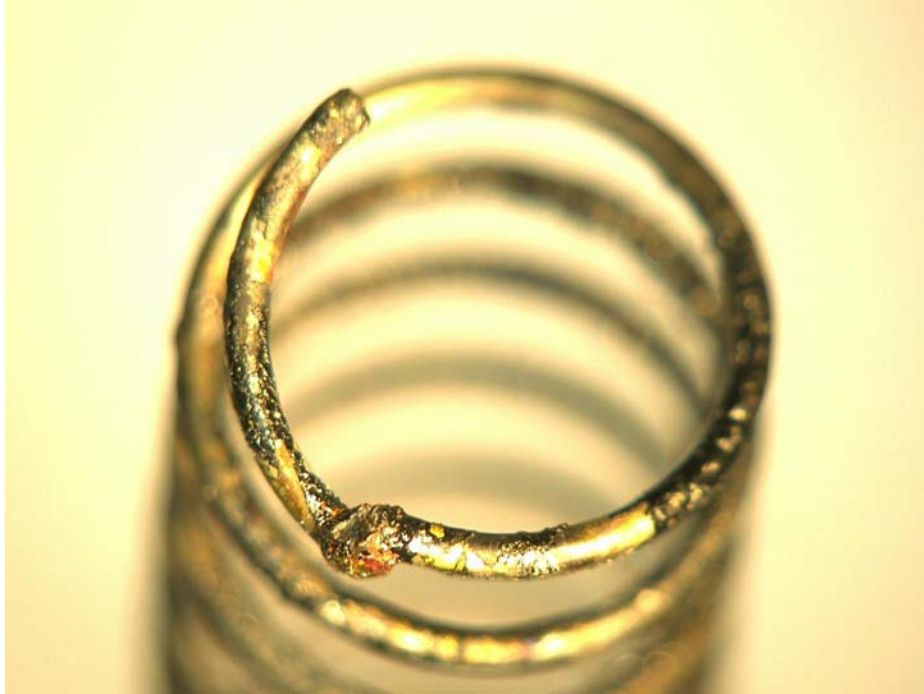
Figure 12: Up stream end of wire spiral exhibiting evidence of melting and re-solidification

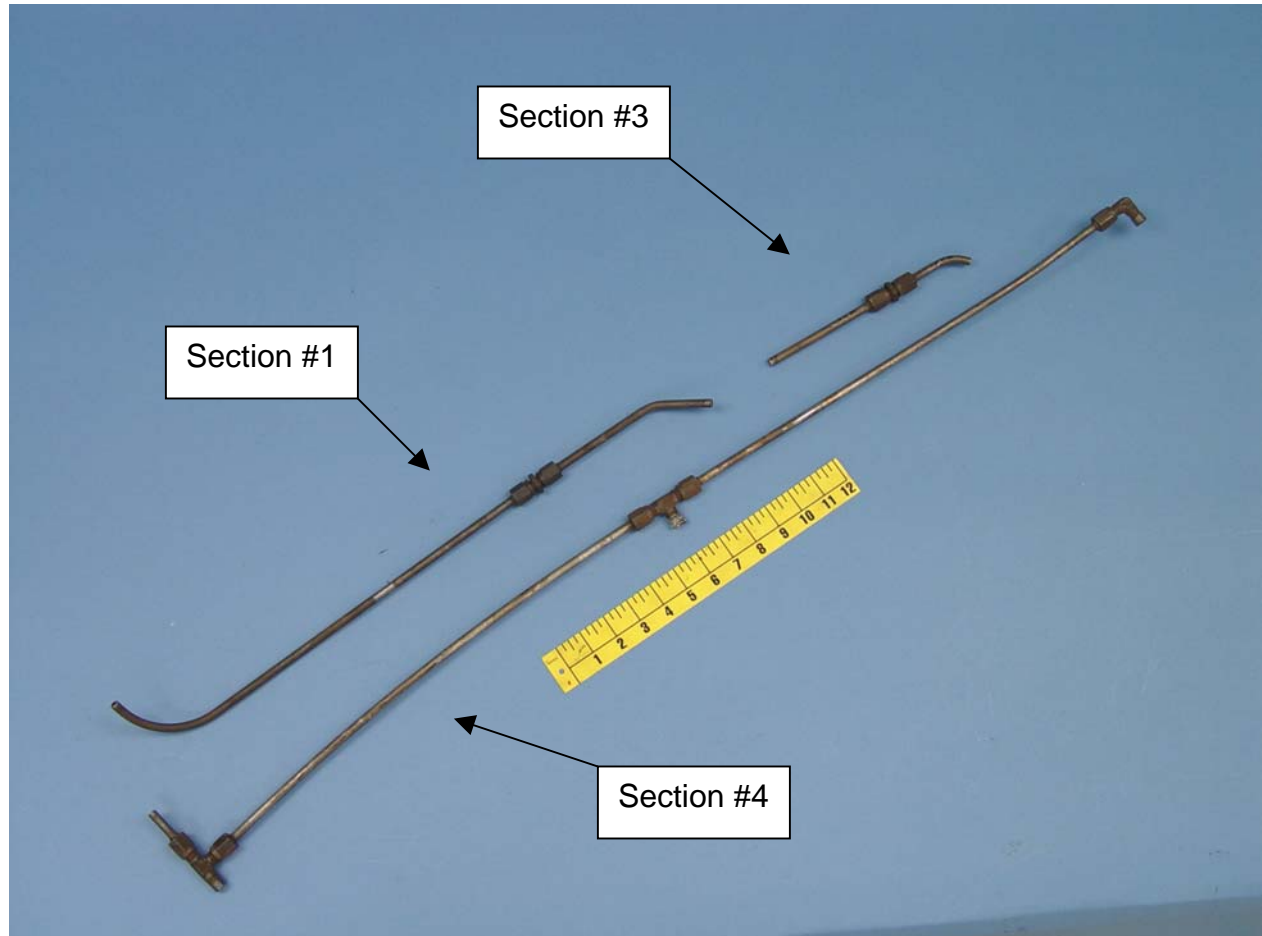
Section #1 of the stainless steel tubing (Figure 13) was cut from just behind the galley bulkhead and extended just past the first union fitting within the supernumerary compartment. The tubing generally had a dark grey color with some brown colored areas consistent with oxidation from exposure to a high temperature fire environment. In particular an orange brown stain was found on both ends of the union fitting included within this section of tubing. This stain was observed where the tube entered the nut. No mechanical damage was observed on this section and no evidence of electrical arcing was found. This section was pressure tested at 120 psi and no leaks were observed.

Section #3 of the stainless steel tubing (figure 13) contained the second union fitting within the supernumerary compartment. This section would have been oriented vertically leading from the overhead area down into the bulkhead above the oxygen mask stowage boxes. The tubing and fitting were dark grey in appearance consistent with exposure to a high temperature fire environment. A small fleck of re-solidified aluminum was found adhering to the exterior surface of the tubing. No mechanical damage was observed on this section and no evidence of electrical arcing was found. Pressure testing at 120 psi revealed that there was a small leak at the union fitting at the location where a ferrule of the union fitting was attached to the tubing. This leak was very small, producing only a few tiny bubbles when a soap water solution was applied.

Section #4 of the stainless steel tubing (figure 13) was located within the bulkhead above the oxygen mask stowage boxes. It would have been oriented horizontally a few inches above the height of the oxygen mask stowage boxes. This section of the tubing contained three fittings. Connected to these fittings would have been flexible PVC oxygen lines to supply the oxygen mask stowage boxes. The upstream most fitting was a T fitting, the middle fitting was also a T fitting and the fitting at the end of the line was a 90-degree elbow. The tubing contained within this section had a light grey appearance consistent with minor oxidation. This oxidation appears to be less than that observed on sections #1, #2 and #3. No evidence of mechanical damage or electrical arcing was observed on the tubing contained within this section. The most upstream T fitting had light blue/green discoloration on the threads (figure 15) and darker blue discoloration inside the body of the fitting. This threaded connection is where the flexible oxygen line would have attached. This light blue discoloration is consistent with the area having reached a high temperature. No remnants of the aluminum nut, which would have been attached at this location, were observed. The middle T fitting (figure 16) did not appear to have any discoloration on the visible portion of the threads or inside the fitting body. Remnants of the aluminum fitting attaching the flexible PVC oxygen line to this T fitting were found adhering to the threads. This fitting did not have any evidence of physical damage. The last fitting on the stainless steel oxygen line, the 90-degree elbow (figure 17), did not have any discoloration. The threads of this fitting did not have any remnants of the aluminum fitting

which would have attached the flexible PVC oxygen line at this location. Re-solidified aluminum was observed on the inside of the fitting while looking in from the open end.

Figure 13: Stainless steel oxygen lines from supernumerary

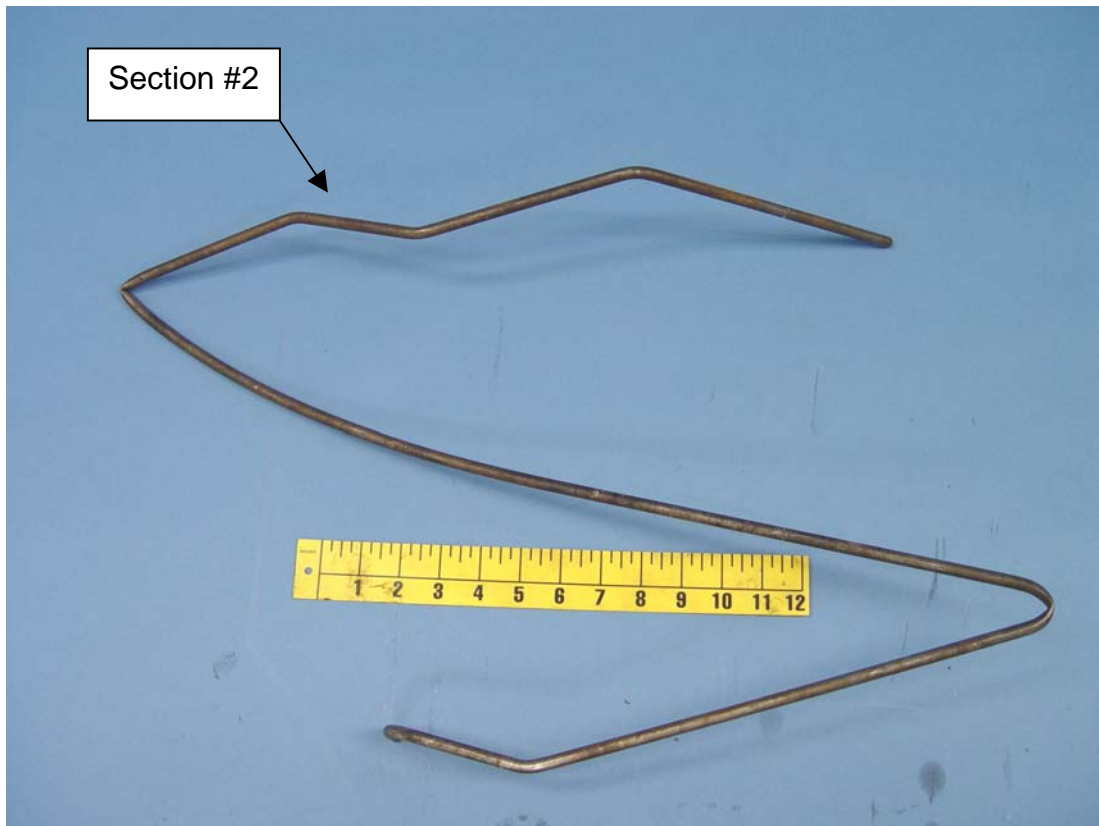
Section #2 of the stainless steel tubing (figure 14) was cut from between the first and second union fittings within the supernumerary compartment. This section would have been located in the overhead area above the ceiling panels extending from the area of the galley to just before the bulkhead above the oxygen mask stowage boxes. The tubing was bent from its original shape to accommodate shipping. This section had a dark grey appearance consistent with oxidation from exposure to a high temperature fire environment. Small flecks of re-solidified aluminum were found adhering to the surface of the tubing. No mechanical damage was observed on this section and no evidence of electrical arcing was found. This section of tubing was pressure tested to 120 psi and no leaks were observed.

Figure 14: Stainless steel oxygen line from supernumerary

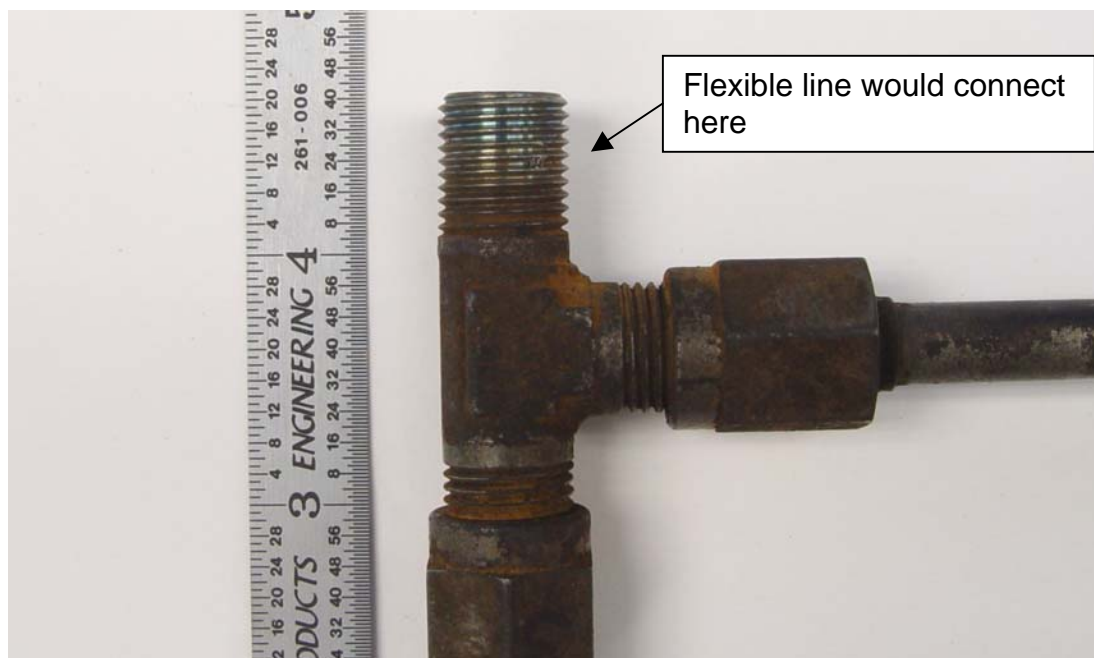
Figure 15: Upstream T fitting from section #4

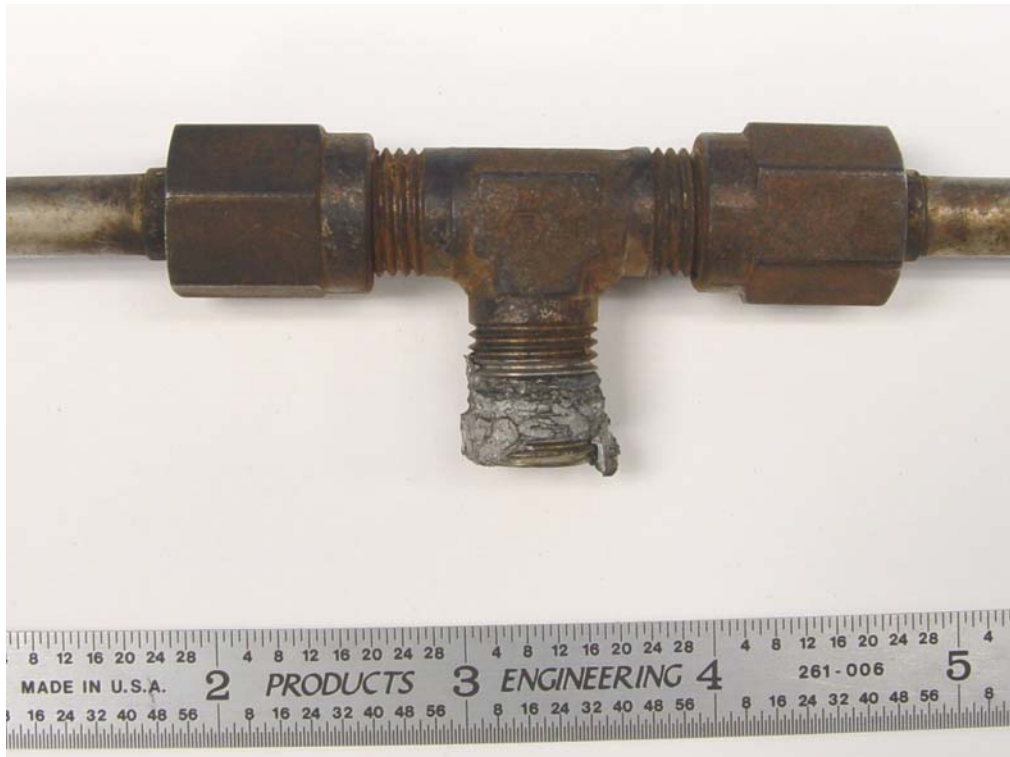
Figure 16: Middle T fitting from section #4

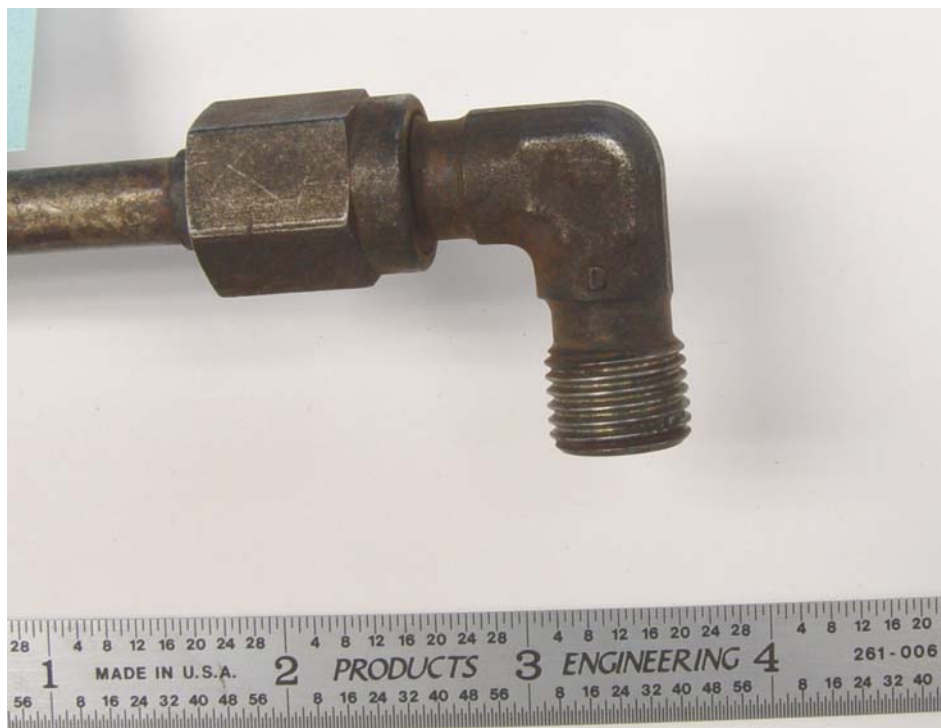
Figure 17: 90- degree elbow from section #4

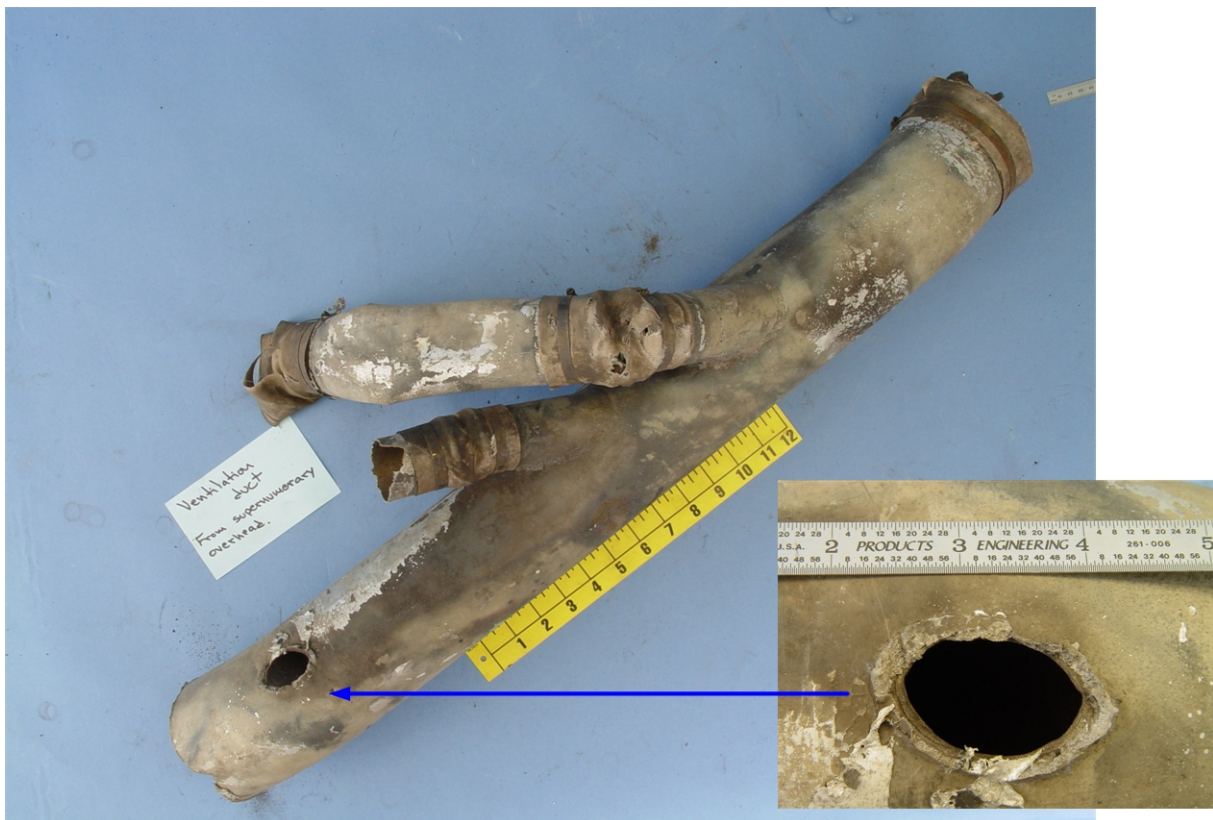
A portion of an aluminum ventilation duct (figure 18) that would have been located in the overhead of the supernumerary compartment was examined. This portion of the ventilation duct had sustained thermal damage and had areas with a light amount of soot adhering to its surface. Additionally, there were some areas exhibiting clean burn that indicates that the surface had reached a temperature sufficient to burn off the soot at those locations. A hole was observed in this portion of the duct. The hole is where a smaller branch line would have been attached. The area around the hole has evidence that the aluminum duct reached its incipient melting temperature.

Figure 18: Portion of aluminum ventilation duct
